**CONSERVATION AND RESTORATION PROBLEMS OF  
KAYA KÖYÜ (LEVISSİ) HOUSES**

**A THESIS SUBMITTED TO  
THE GRADUATE SCHOOL OF NATURAL AND APPLIED SCIENCES  
OF  
THE MIDDLE EAST TECHNICAL UNIVERSITY**

**MAY 2001**

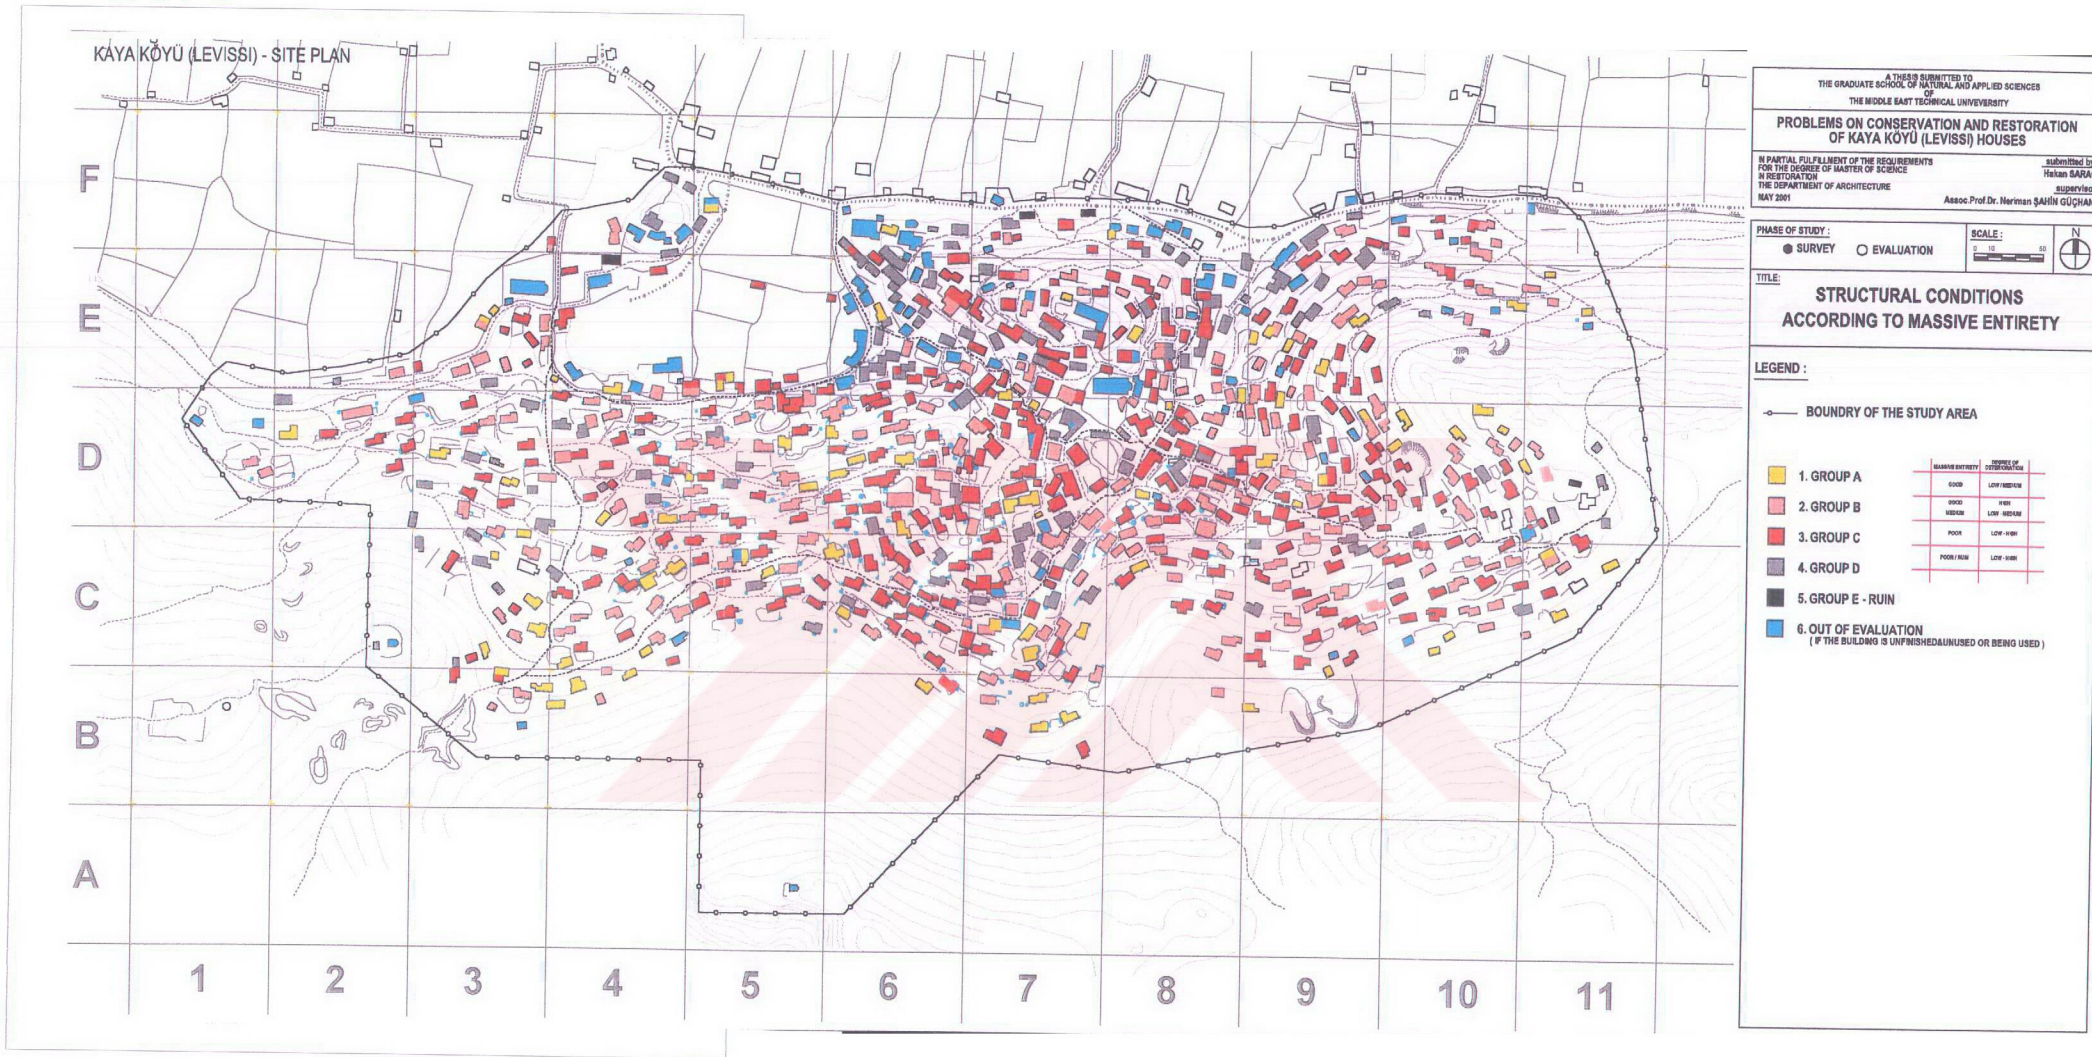
Figure 3.20 : Structural Conditions

**Structural Condition of the Buildings:** As the structural condition of the buildings varies extensively, different evaluation criteria have been applied during the survey. First of all the monumental buildings and the buildings which are in use, have been regarded as out of survey because they should have different evaluation criteria. The rest have similar physical characteristics. As the wooden elements of the buildings had been destroyed, it is not possible to talk about the architectural elements such as floors, upper structures and doors or windows. For this reason, the evaluation has been limited to the criteria such as the massive entirety and decay in stone walls. The buildings have been classified in 5 groups, starting from the ones in good condition, which have structural entirety and less-damaged elements, and ending with the ones in ruins (table 3.6). According to this classification, 93 (12.79%) of the buildings within the study area are in good condition, 209 (28,75%) in medium condition, 284 (39,06%) in poor condition, 137 (18,84%) are in bad condition, whereas 4 buildings are completely in ruin condition. In general, there is homogeneity in the distribution of the buildings within the study area with respect to their structural conditions. These data have been presented in details in figure 3.20 named Structural Conditions.

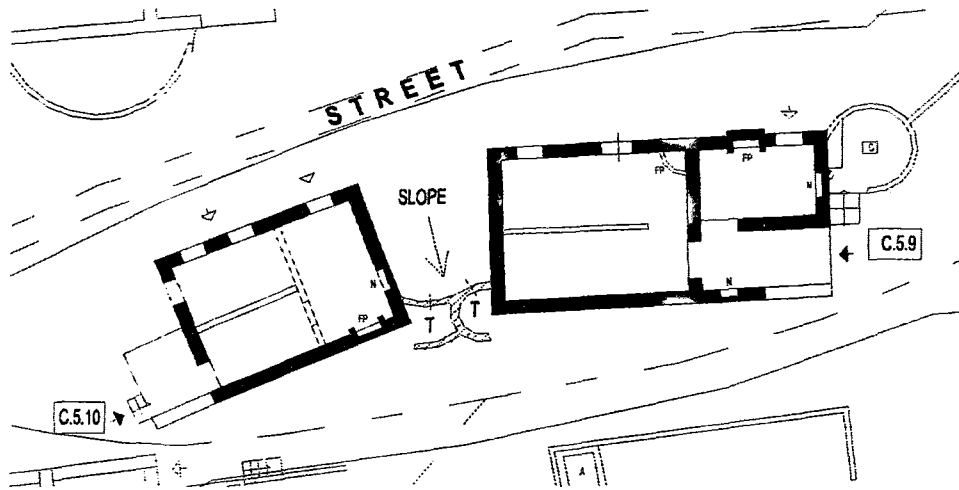
**Figure 3.28 : Sharing the Toilet Walls**

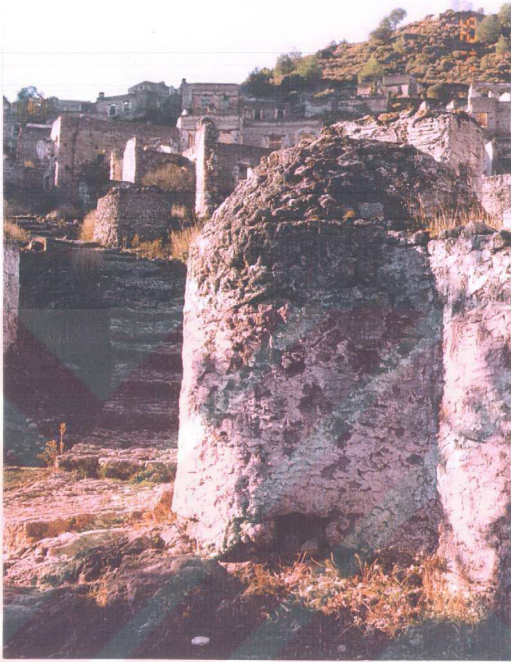
Kaya Köyü settlement does not have a sewage system. Toilets have small septic tanks. It has been observed that these tanks have an open drainage hole in the back of toilets. It has been regarded that these drainage holes had been opened to clean the septic tanks occasionally. The entrances of the toilets are at the higher side of the slope, and the holes slope down. Thus, it can be considered that wastewater had been carried away from these holes at least with intervals. Probably because of

Figure 3.29 : Toilet Drainage Hole Running Down to the Street

been constructed back to back and they share toilet walls (Figure 3.28). The positions of the toilets had always been considered even in the sections where the building density is high. However, it has been observed that the drainage holes of some of the buildings run down to the streets (Figure 3.29).

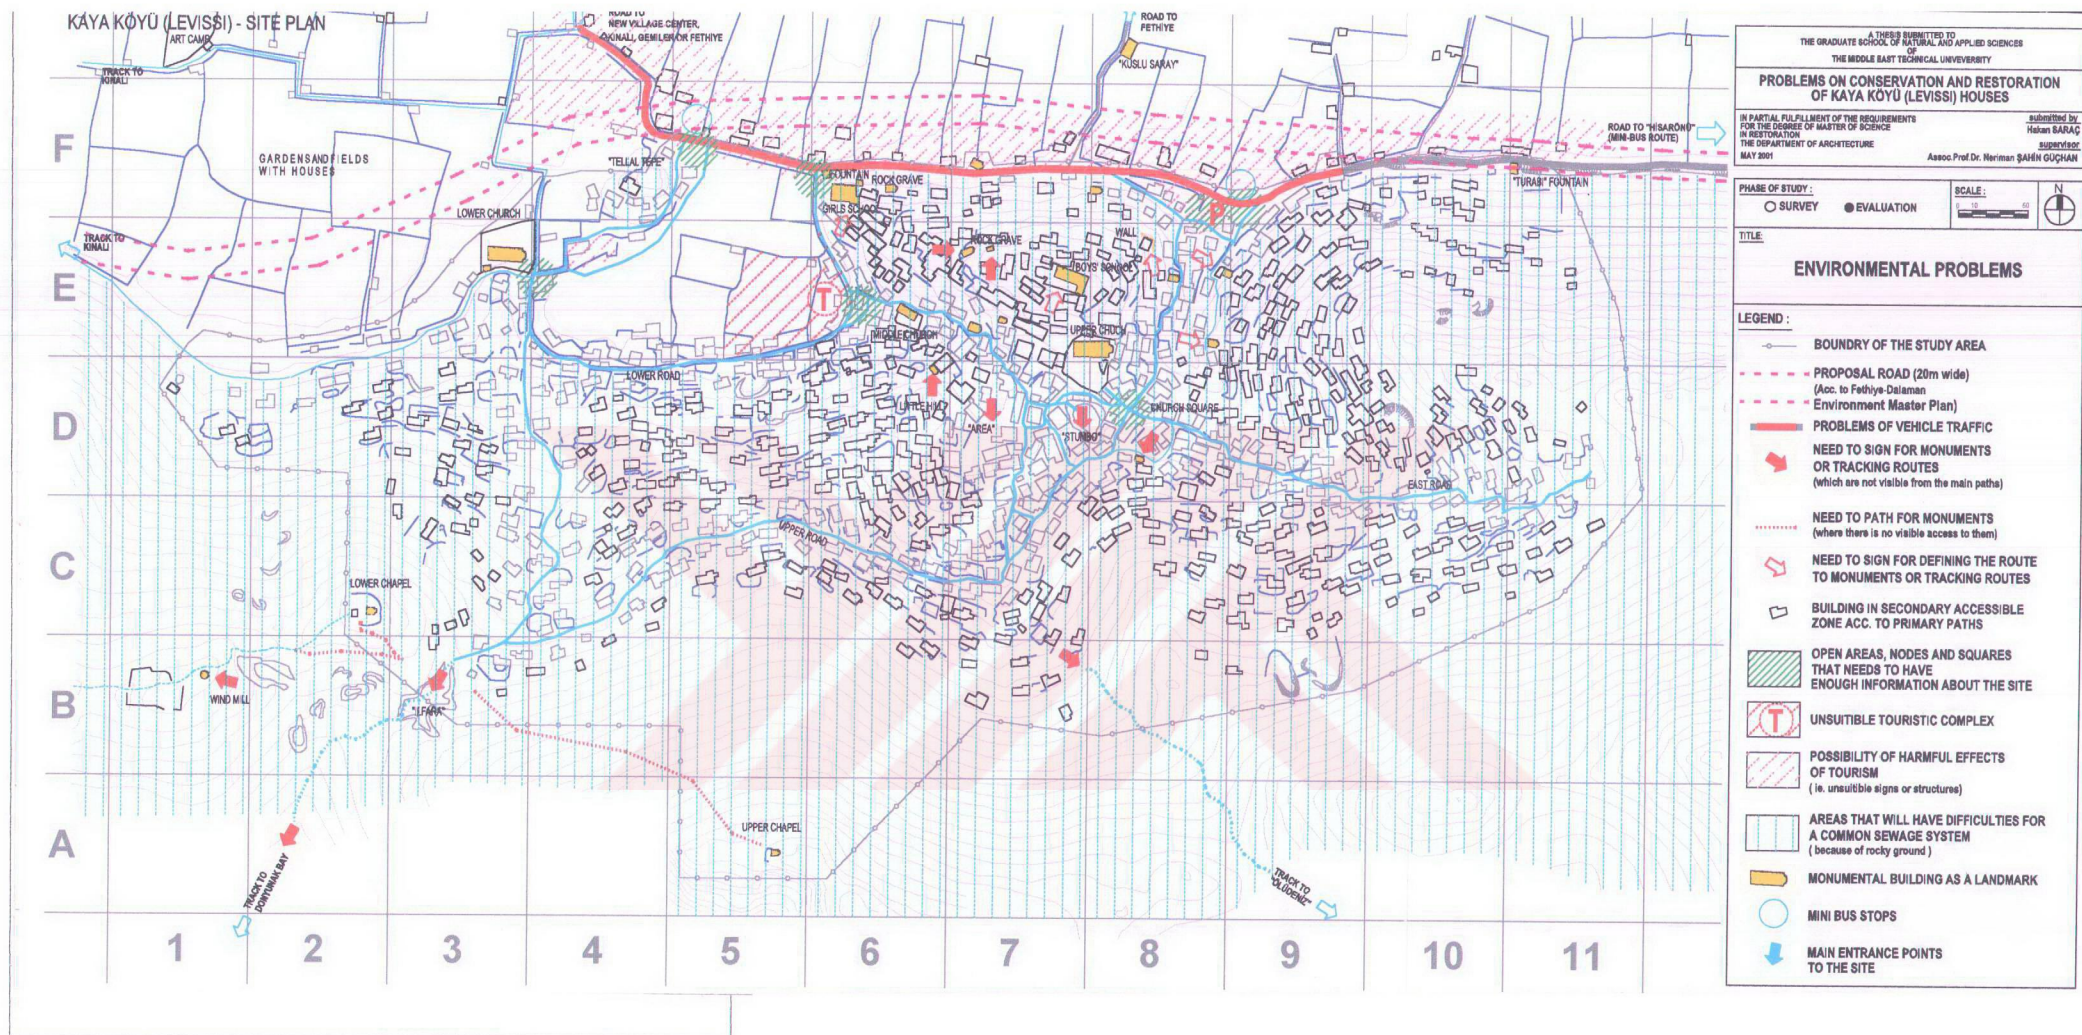
Figure 4.37: Problems of Kaya Köyü

4. Villagers of *Kayaçukuru* leave the traditional production activities because of economical problems and involve in tourism activity. The traditional construction techniques are also left aside for the same reason. Demands for seasonal houses, pensions and restaurants and the pressure of implementations lead to a transition that has started to deform the quality of the physical structure the area, which has been regarded as a value. Such a transformation is regarded as a problem.

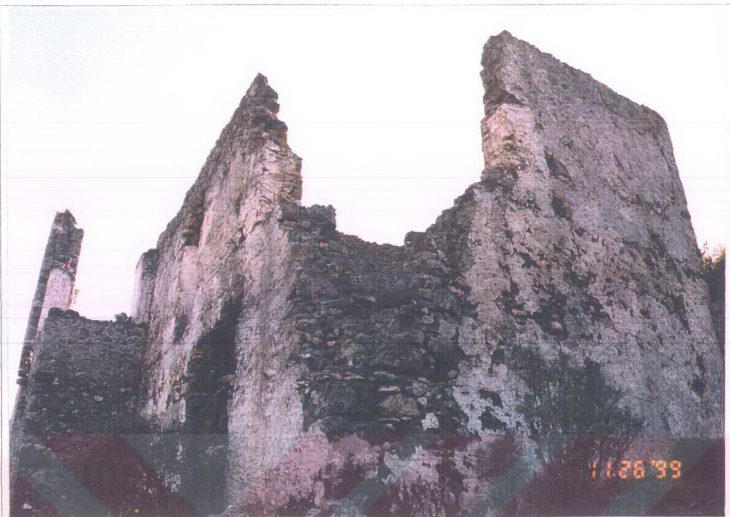
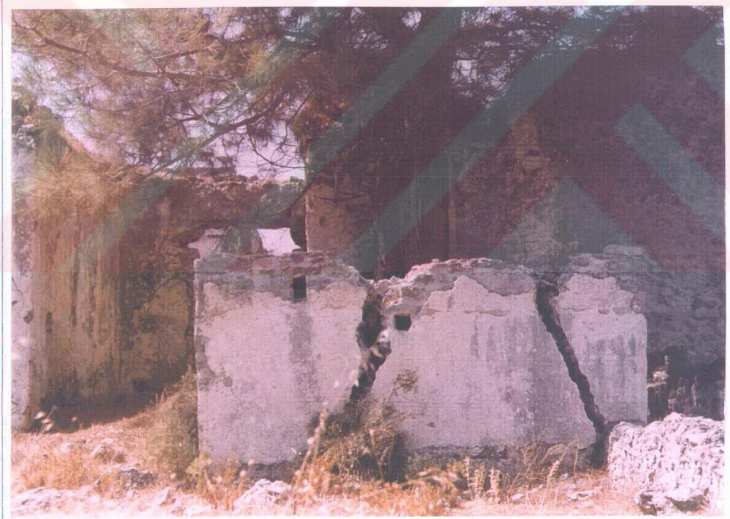
Figure 4.38: Partial Demolitions

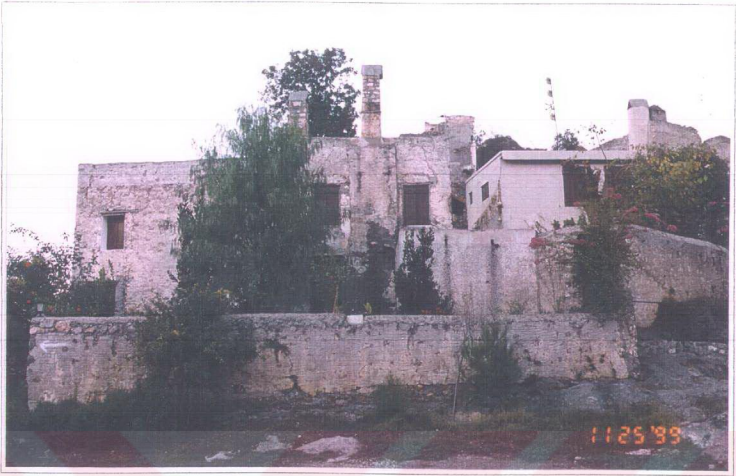
**Inappropriate interventions:** Inappropriate interventions, which are not convenient with the original spaces and materials, have been observed in all of the buildings that have been subjected to restoration in order to be used as summer houses and/or touristic complexes. Some of these interventions are the alteration of architectural elements, addition of spaces and/or buildings and the use of improper materials (Figure 4.41).

Figure 4.41 : Elongation of Chimney (F.4.3.) and  
Additional Building (F.4.4)

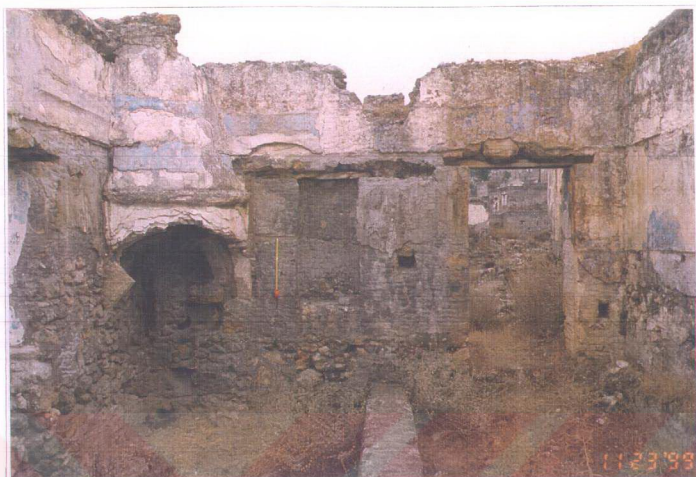
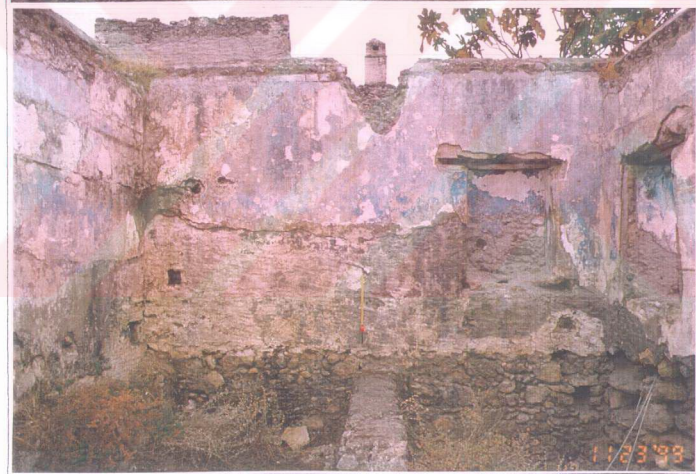
The floor beams support wall is 40cm wide. It is a rubble stone masonry wall, which had been given the shape of the floor levels. A wide and flat stone has been found on this wall between the second and the third floor levels. It has been considered that this is the place where *stylos*, which had supported the roof beams, had been set on.

Figure 5.6: Eastern Wall of Space MR1
