**GEO TECHNICAL EVALUATIONS AND DETERMINISTIC DESIGN
CONSIDERATIONS FOR PITWALL SLOPES AT ESKİHİSAR
(YATAĞAN-MUĞLA) STRIP COAL MINE**

**A DOCTOR OF PHILOSOPHY THESIS
in
Geological Engineering
Middle East Technical University**

**By
ULUSAY, Reşat
September - 1991**

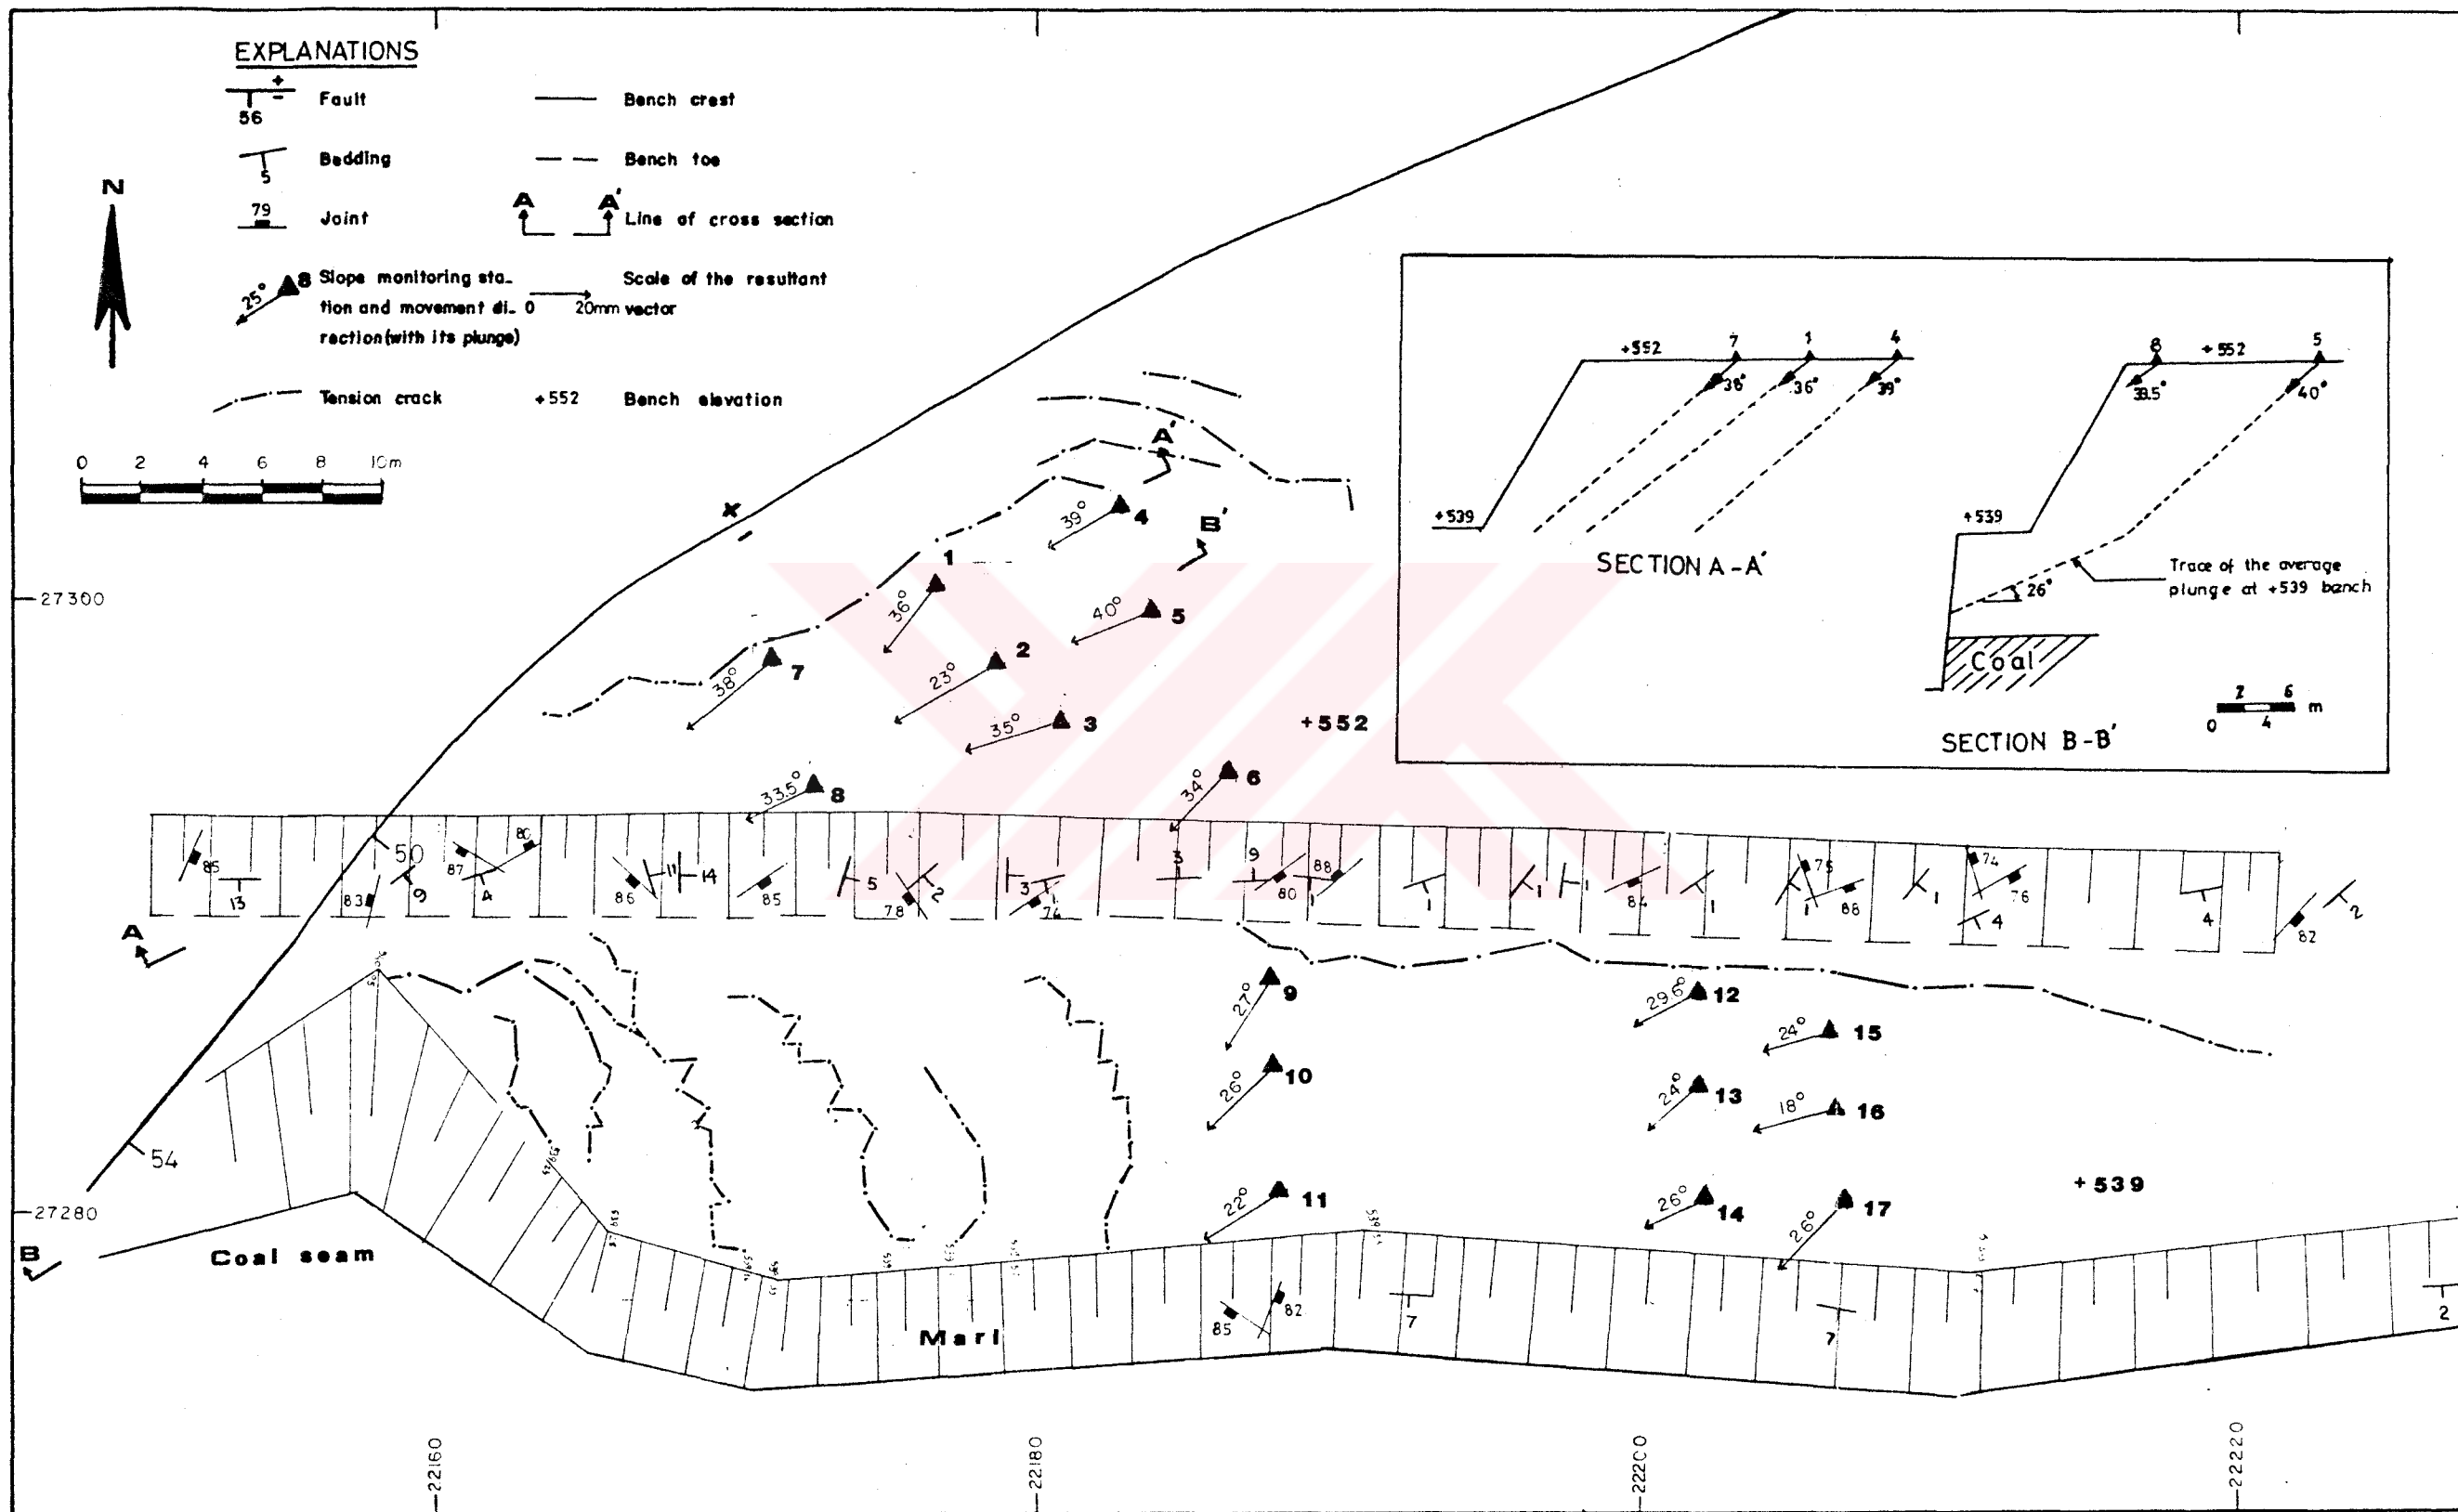
Figure 36: Slope instability map of the slide 6 and monitoring information.

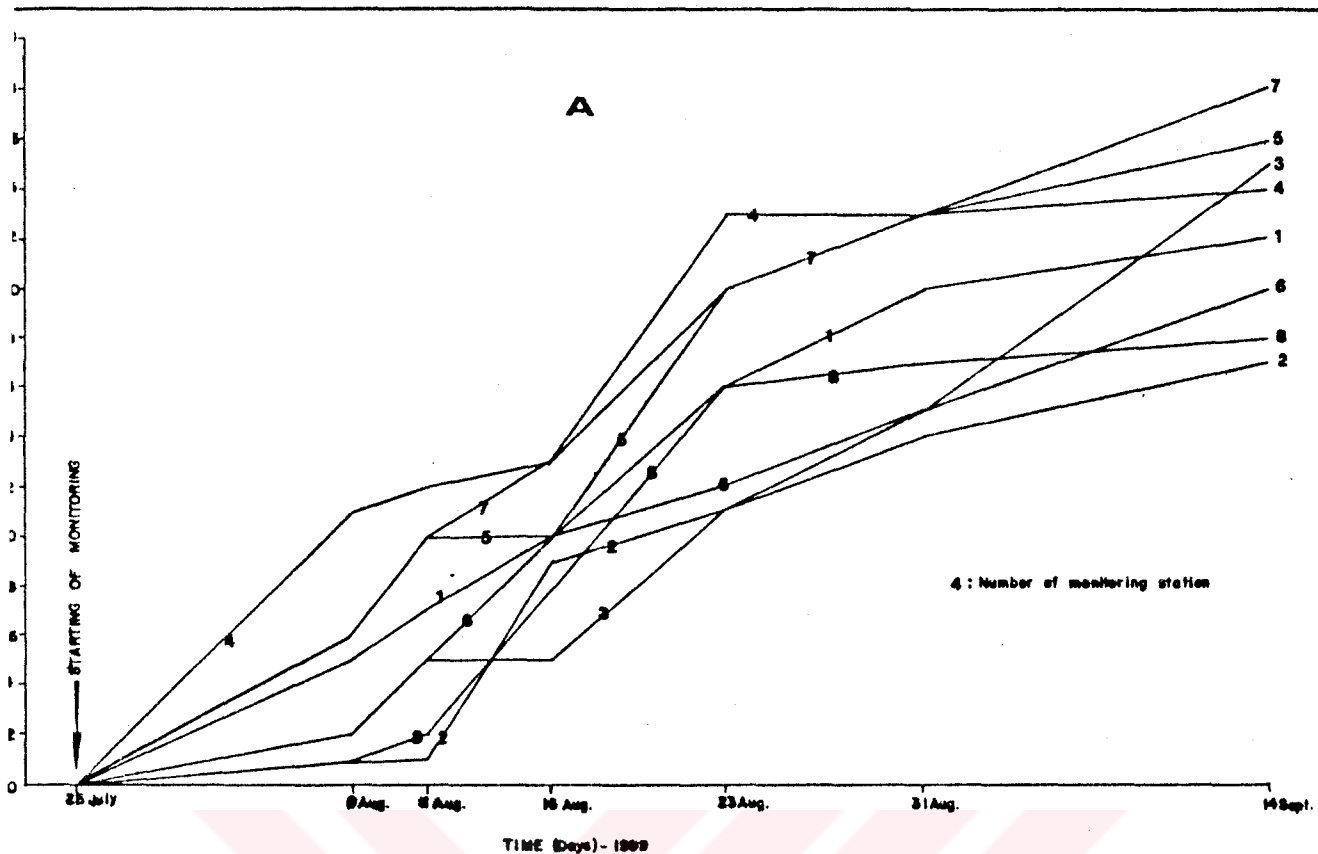
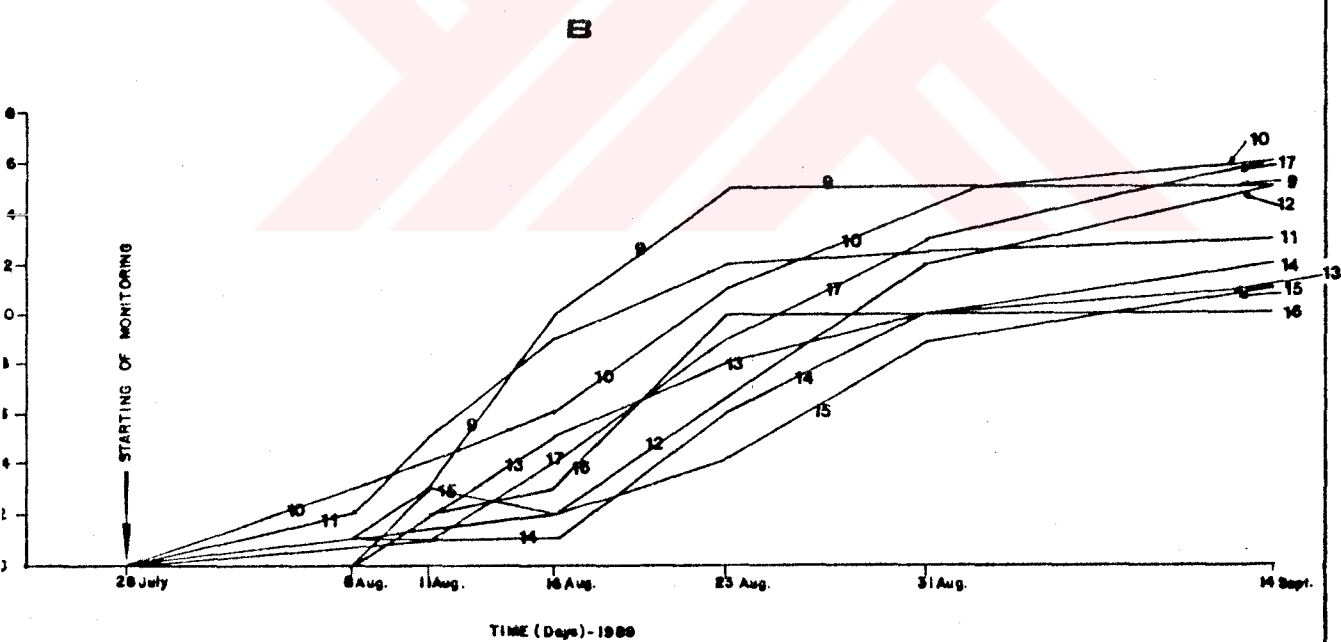
Figure 37: Cumulative vertical displacement versus time plots for stations at +552 bench(A) and +539 bench(B).

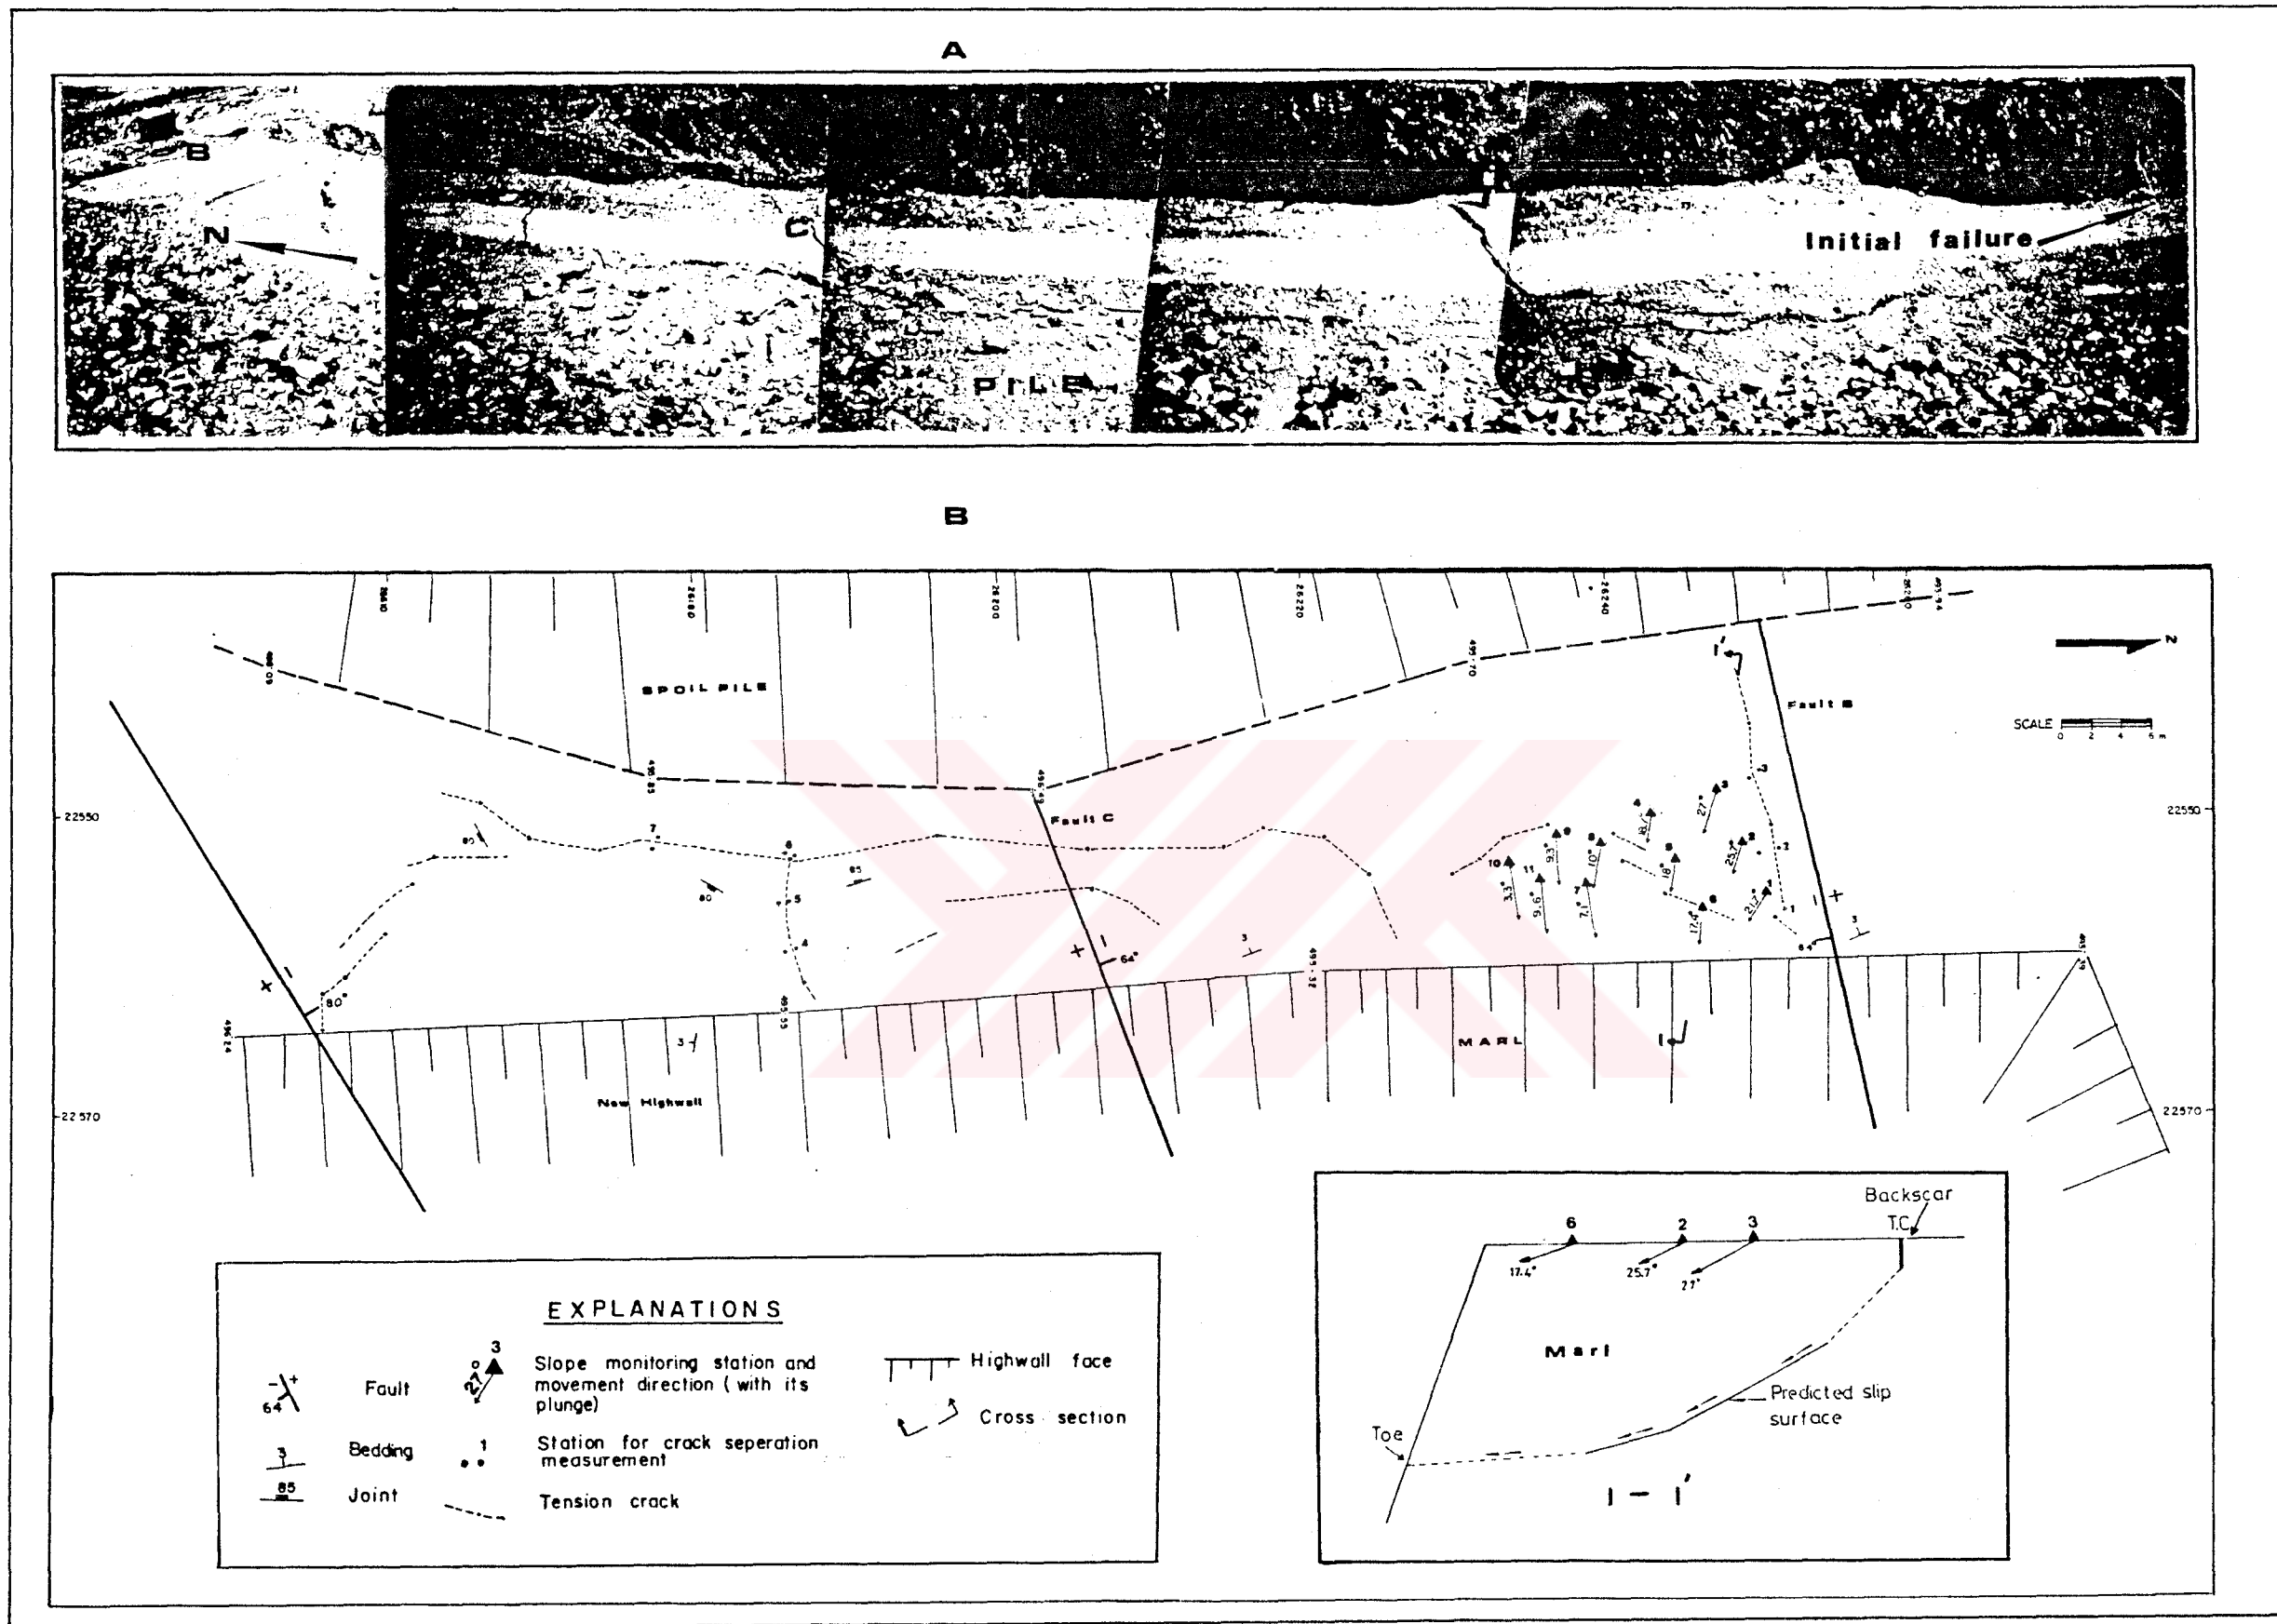
Unstable area II : Development of tension cracks parallel to fault-B and sub-parallel cracks were observed on the new highwall at the south part of the ninth slice in August 28, 1989 (Figure 38a). This situation was taken as a sign of instability. The following day preparation of an

Figure 38: (a) General view of monitored area II and tension cracks (Plate 3-Photo. No.20);
 (b) slope instability map and monitoring information.

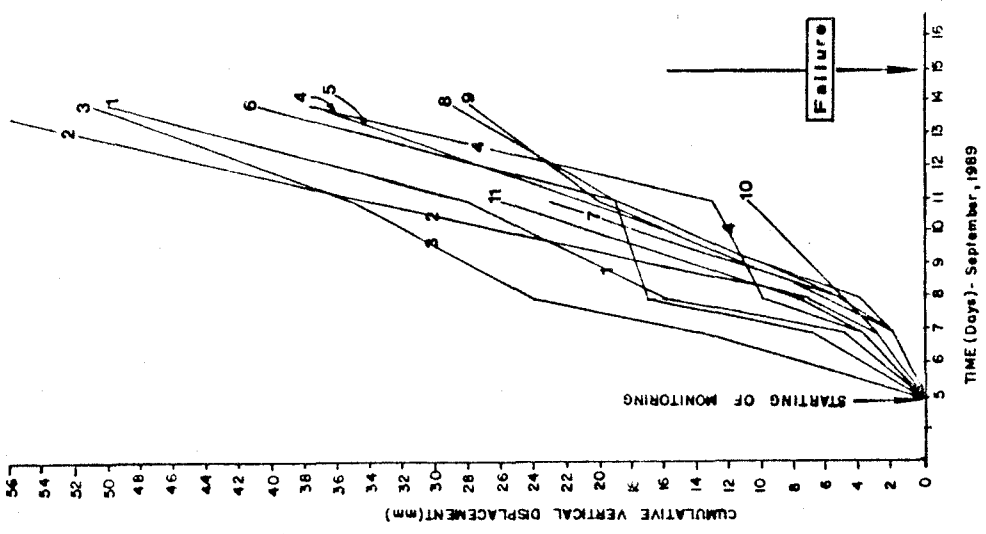
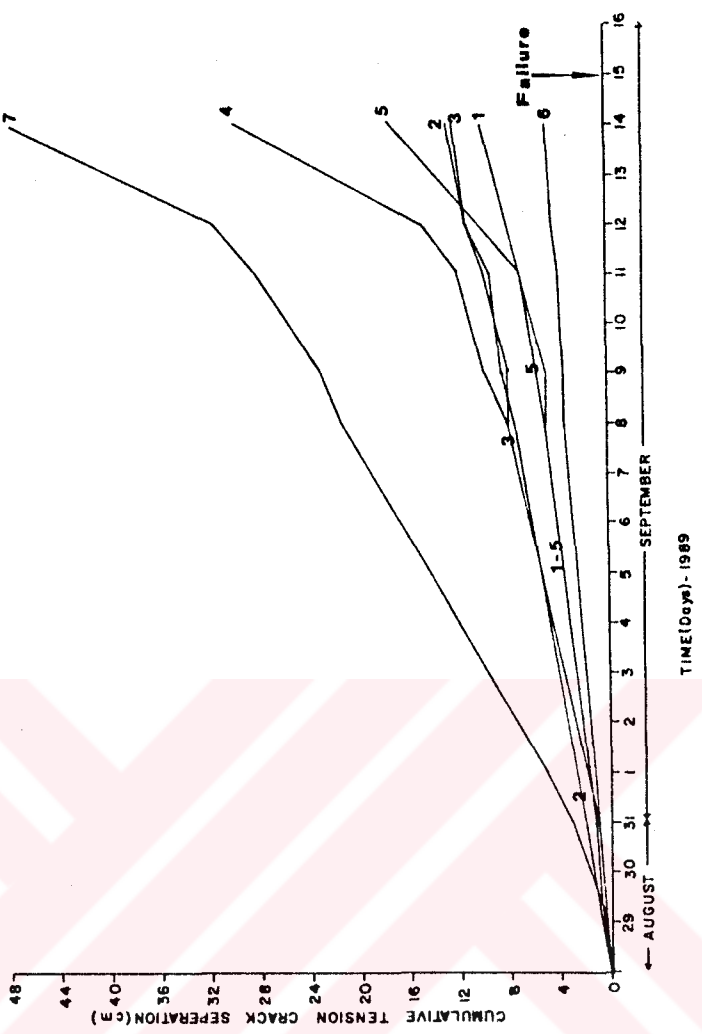
Figure 39: Plots of movements measured during September 1969 proceeding failure at the end of ninth slice: (A) vertical displacement versus time plot; (B) tension crack separation versus time graph.

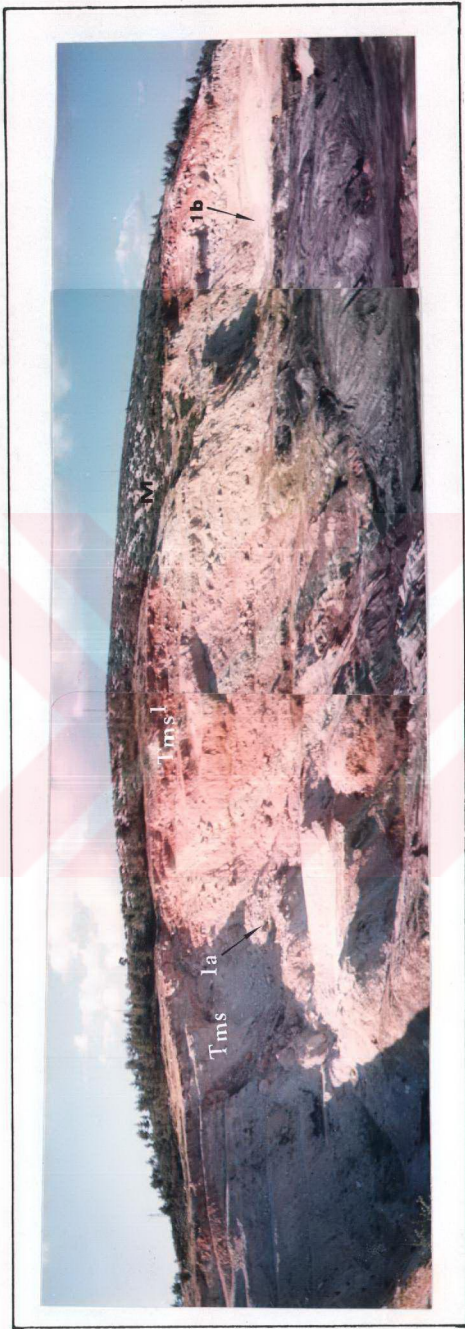
In 1988, tension cracks were recognized by TKİ staff between the southern edge of the eighth slice and the highway. The displacements were immediately deflected by filling the excavated material into the void to make a toe

Figure 61: General view of slide 1 occurred in Ertrans section (Tms: main Sekkőy formation, Tms1: Detrital facies of Sekkőy formation, M: Marble, 1a, b: Slide 1; Plate 3-Photo. No. 23)

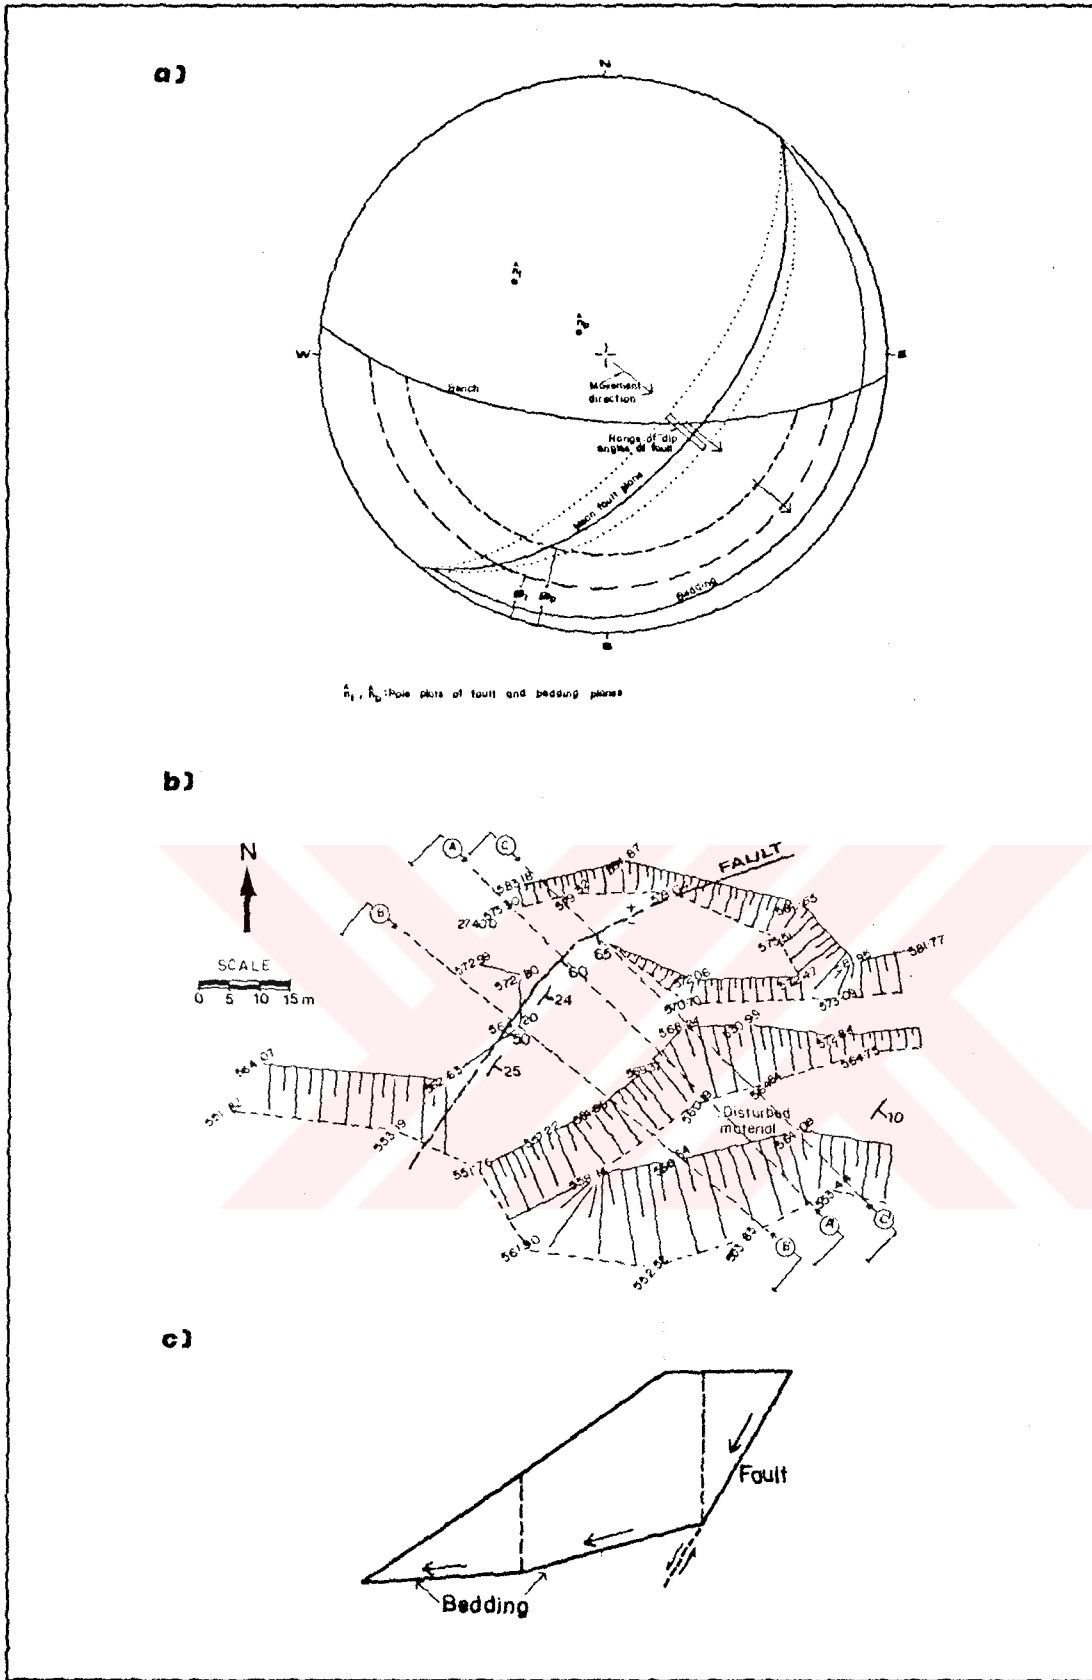
The slide 2 in Özdemirler Section (Plate 3) had occurred in thinly bedded and alternated upper sequence of main Sekköy formation through two benches. The sliding mass is bounded from the west by a normal fault dipping SE with an inclination of 50° to 60° (Figure 64b). With the

Figure 64: Kinematic check (a), instability plan (b), and mode of failure (c) for slide 2.

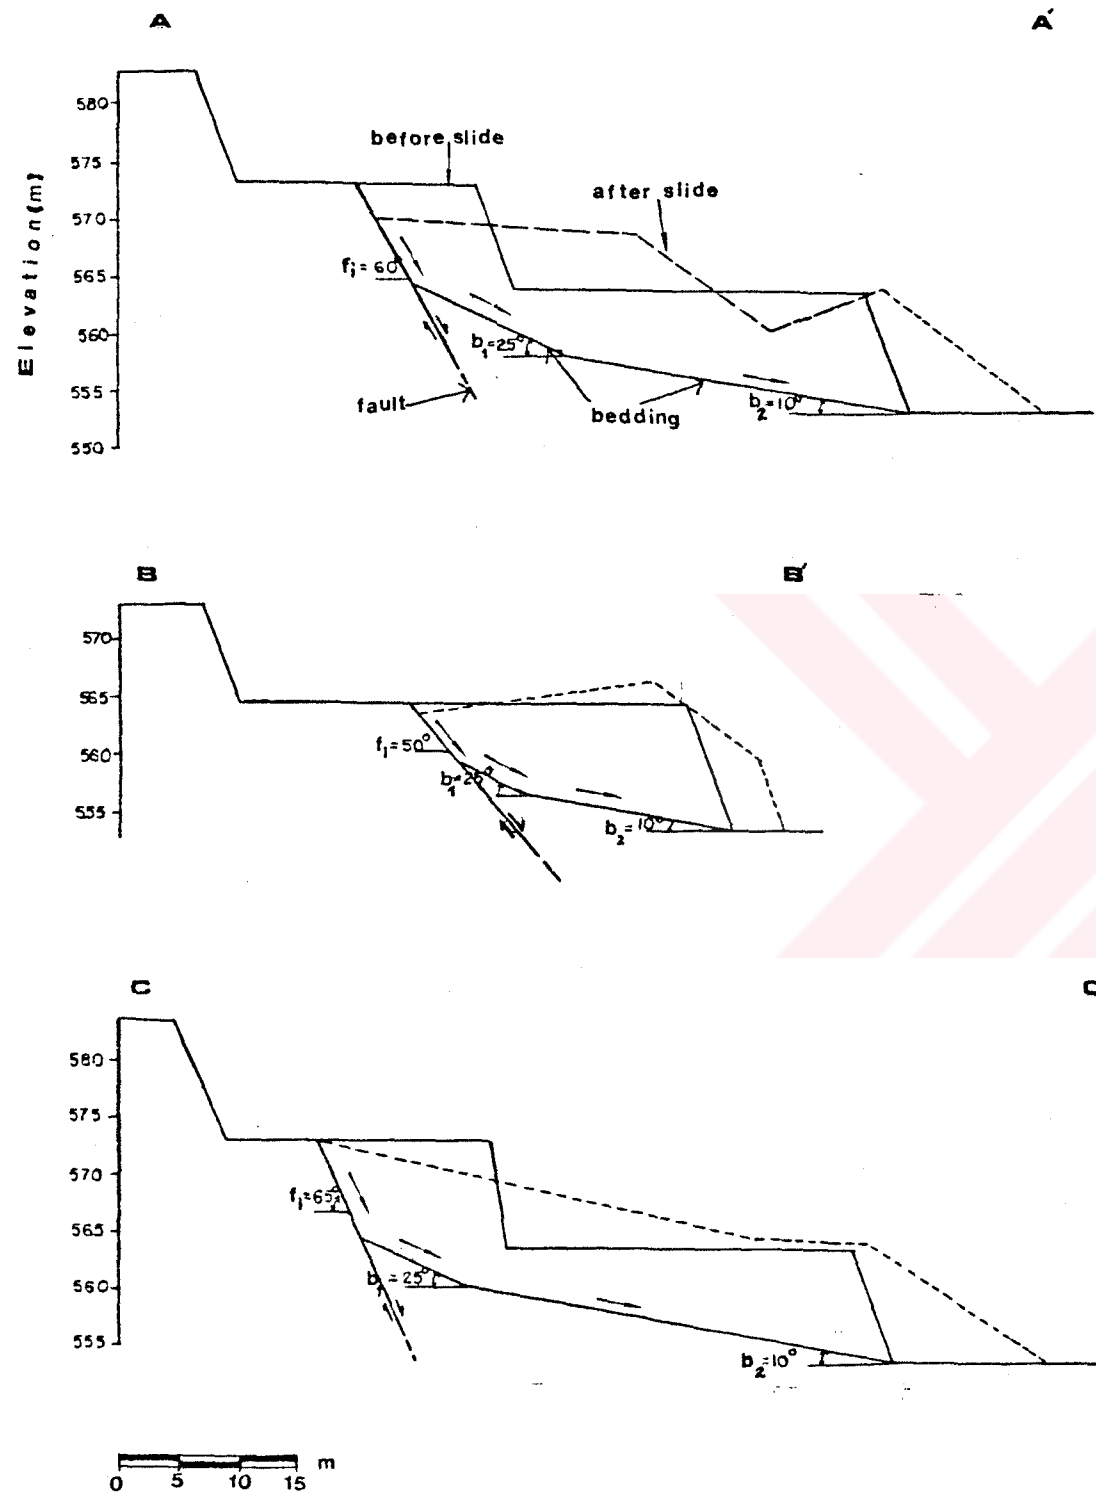
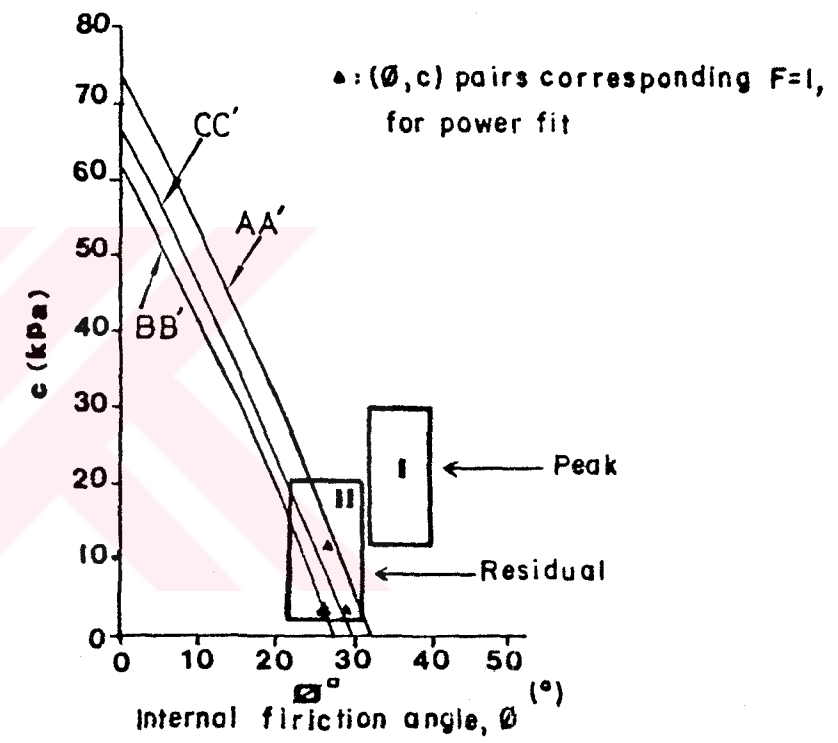
Figure 65: Back analysis of slide 2 developed along multiplanar failure surface.

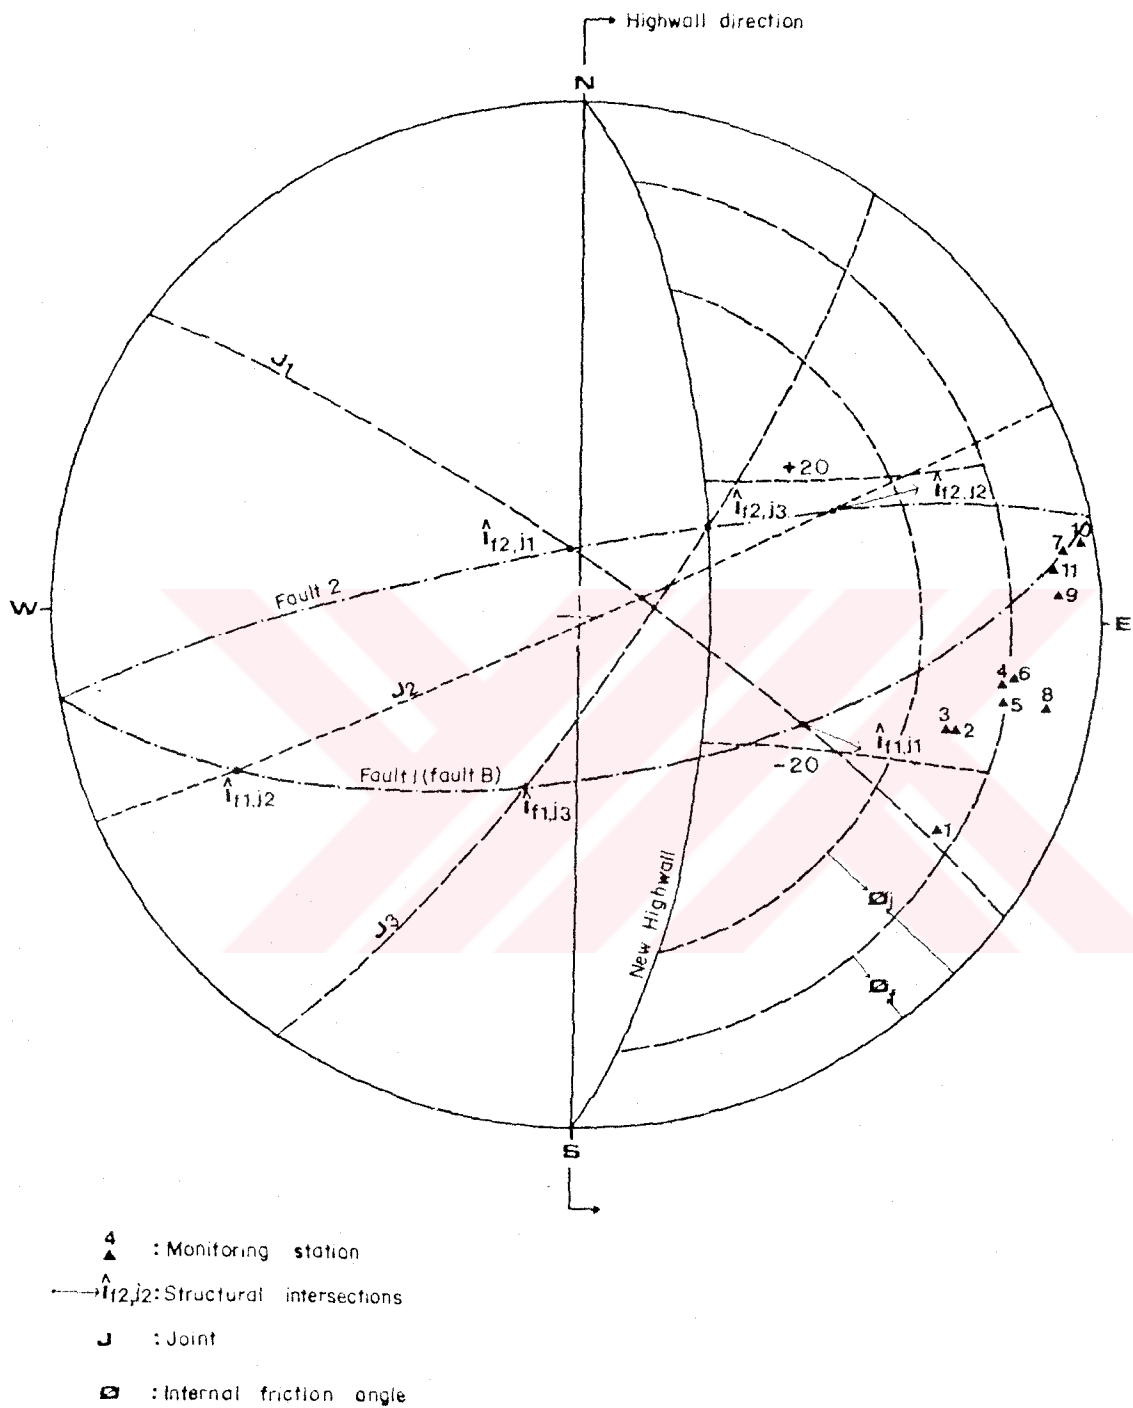
The movement vector analysis carried out for the failure monitored on highwall of ninth slice has indicated that the failure was more likely to occur along a shallow seated surface rather than fully structurally controlled mode of failure. In order to determine the mechanism of this failure and to compare the monitoring data with those of kinematic analysis, the data obtained from the site was plotted on the equal area projection (Figure 68).

Figure 68: Kinematic analysis of possible lines of intersection and monitoring station movements for the highwall instability at the end of ninth slice.

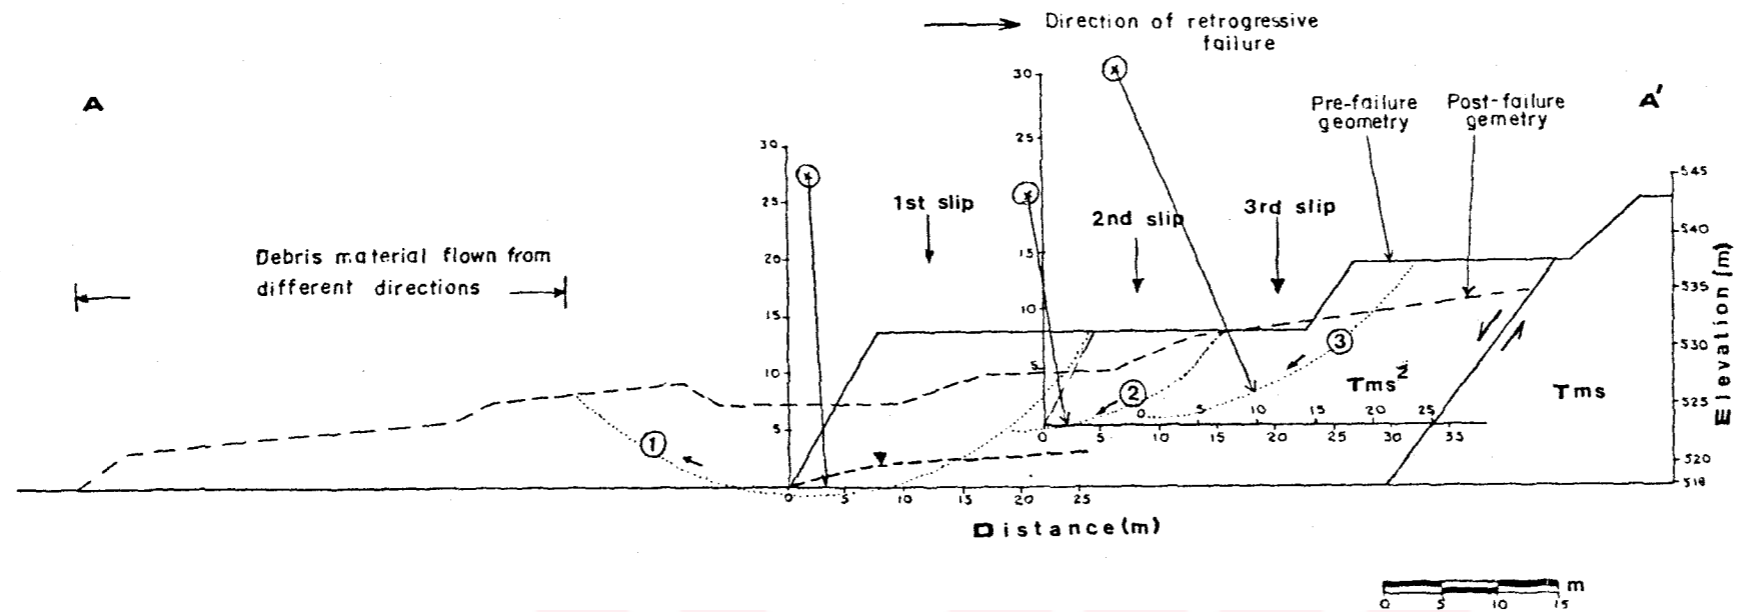
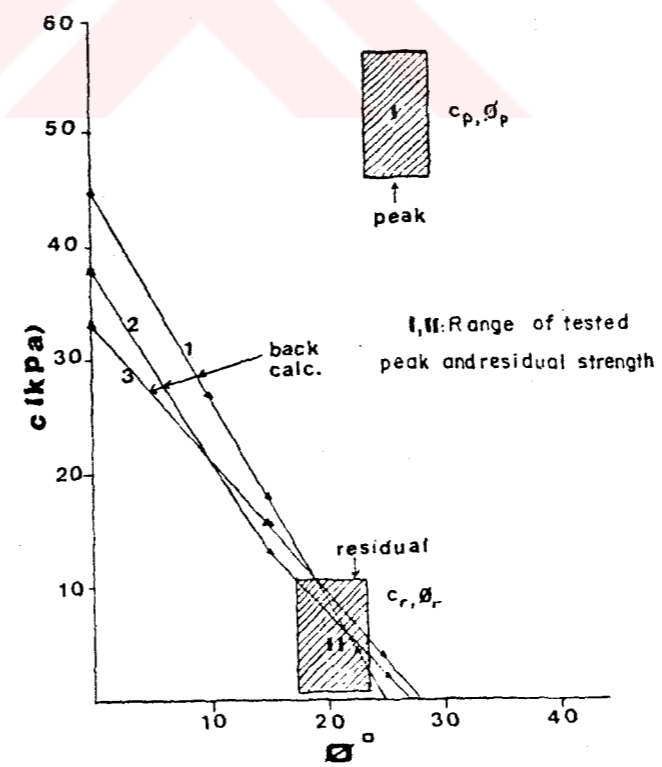
Figure 69: Back analysis of slide 7 located within the transition zone soils.

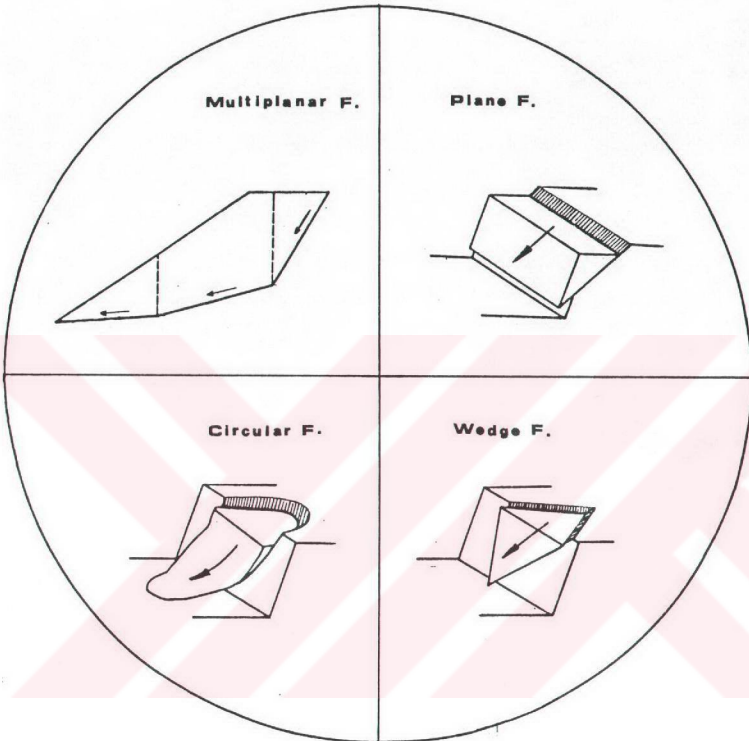
Figure 72: Typical modes of failure experienced at the Eskihisar open pit.
