**THE RESTORATION PROJECT OF
ZAIMOĞLU KONAĞI IN SİVRİHİSAR**

**A THESIS SUBMITTED TO
THE GRADUATE SCHOOL OF NATURAL AND APPLIED SCIENCES
OF
THE MIDDLE EAST TECHNICAL UNIVERSITY**

**IN PARTIAL FULFILLMENT OF THE REQUIREMENTS FOR THE DEGREE OF
MASTER OF SCIENCE
IN
RESTORATION
THE DEPARTMENT OF ARCHITECTURE**

APRIL 2003

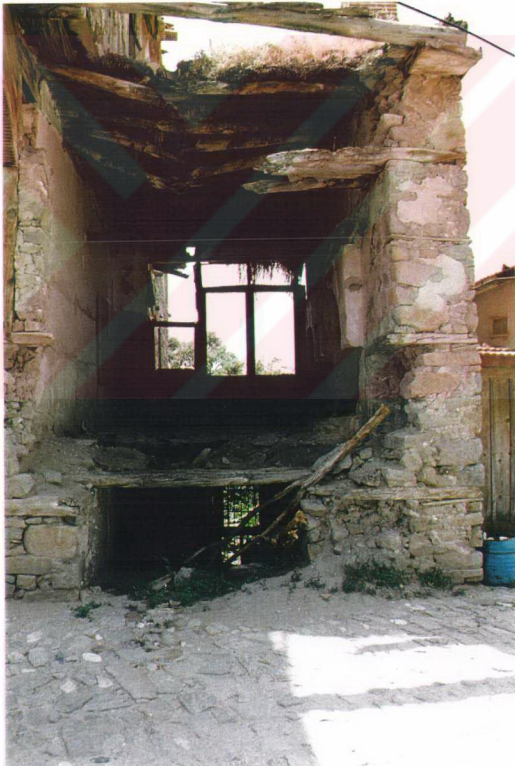
Figure 3.10 View through space SG-01

There are detachments of plaster from the wall and surface cracks on the plaster. There are partial losses of the mud plaster. Here the stone masonry wall is exposed. There is the empty joint problem on these stone surfaces. The stones are in good condition although the joint mortar is washed away on the upper north part.

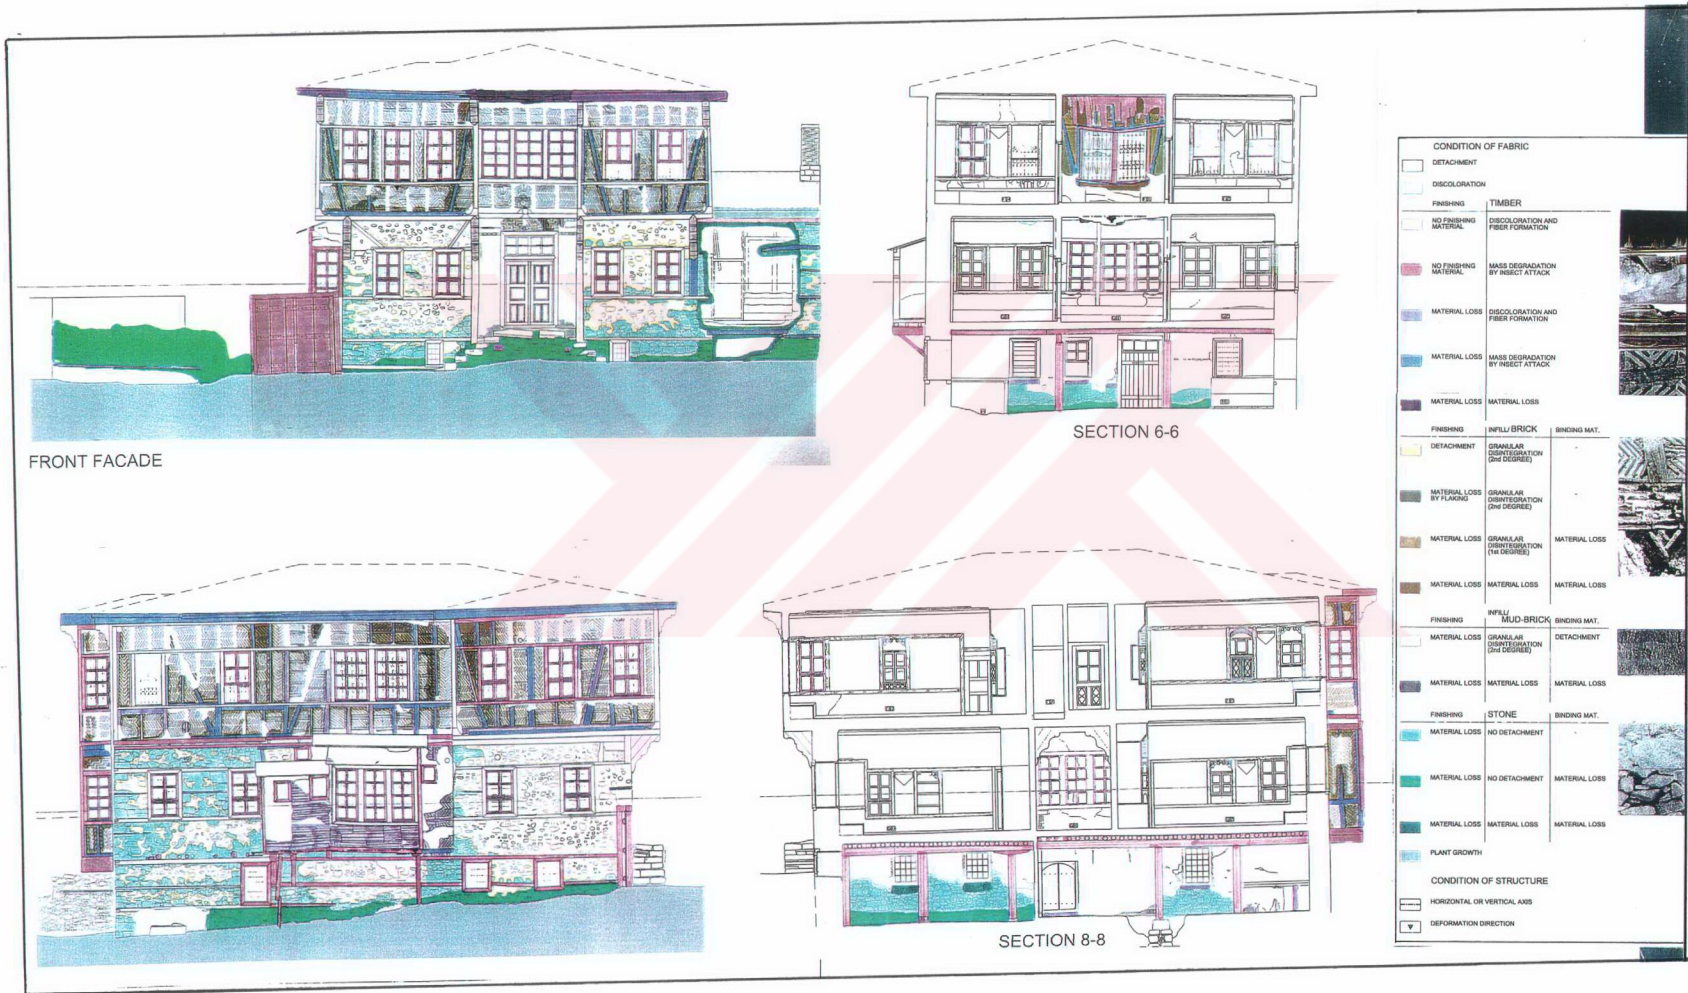
Drawing 3.45 Condition of fabric

Only the rough-cut stone masonry wall constituting the northwest façade of the space C-02, the service courtyard has the buckling problem.

The horizontal deformations are observed on the floor and ceilings of the spaces on the ground floor and first floor and on the horizontal timber frame structural elements. The ceiling of space MG-01 has a 24cm horizontal

deformation between the SW-NE ends at the middle. The floor of the space MG-03 has a 6,5cm horizontal deformation between the NW-SE ends. The floor of the space MG-05 has a 14cm horizontal deformation between the NW-SE ends.

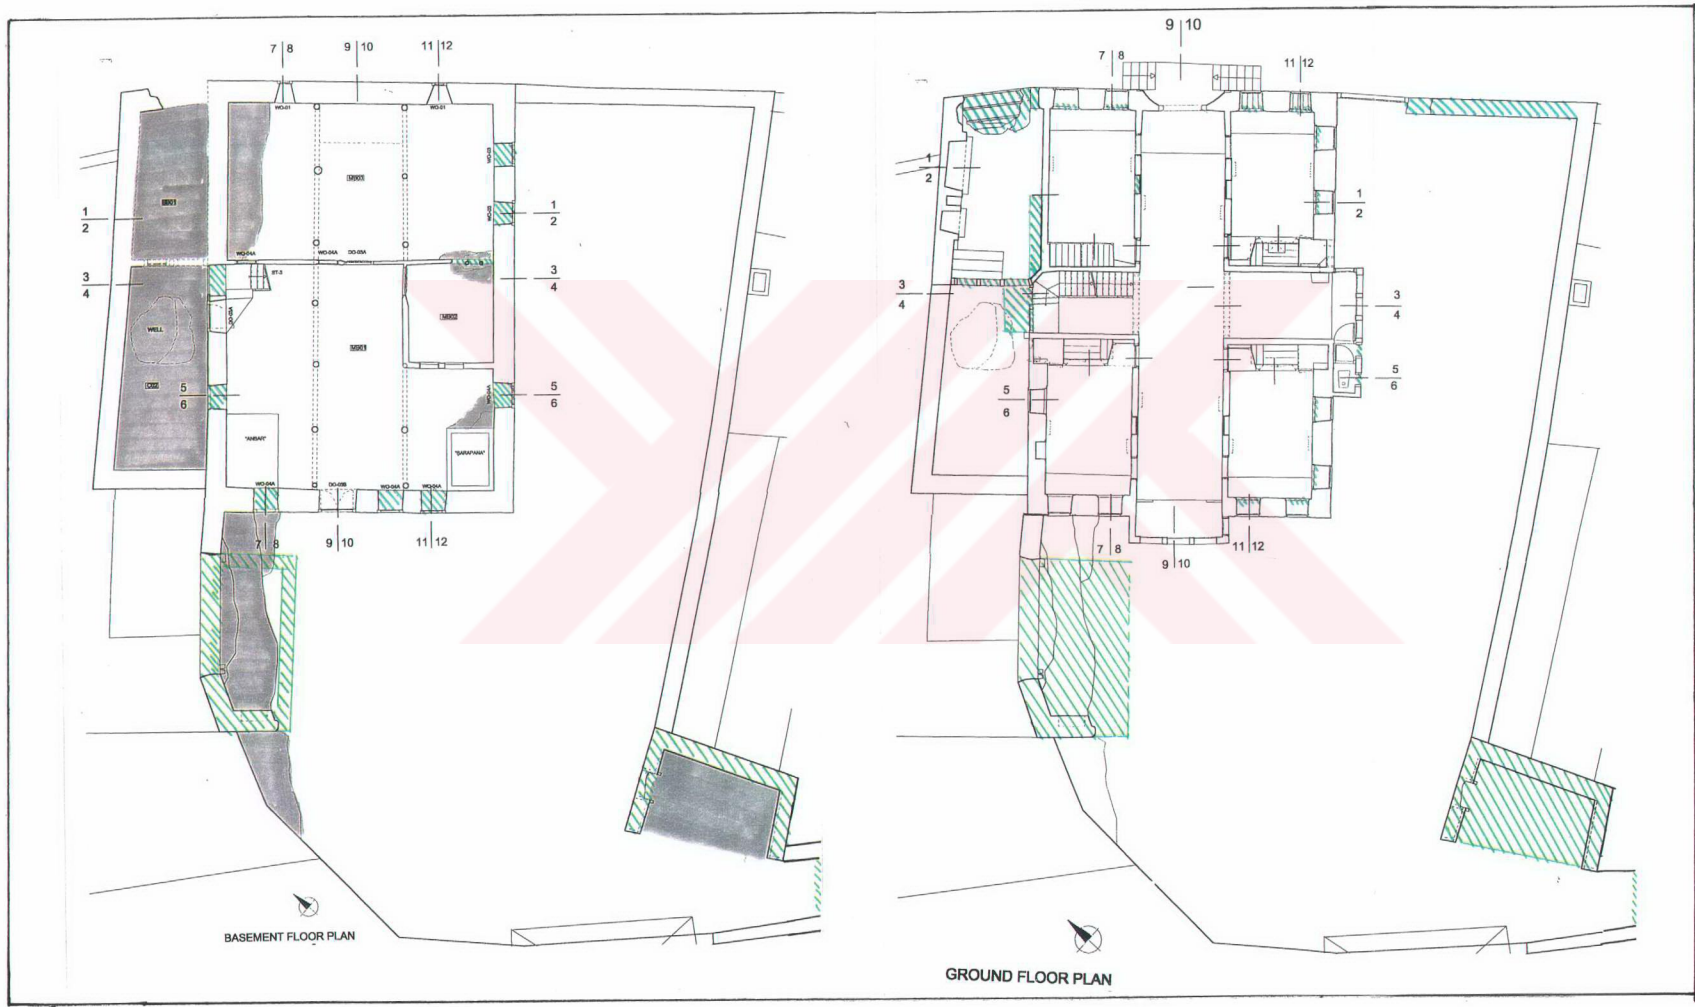
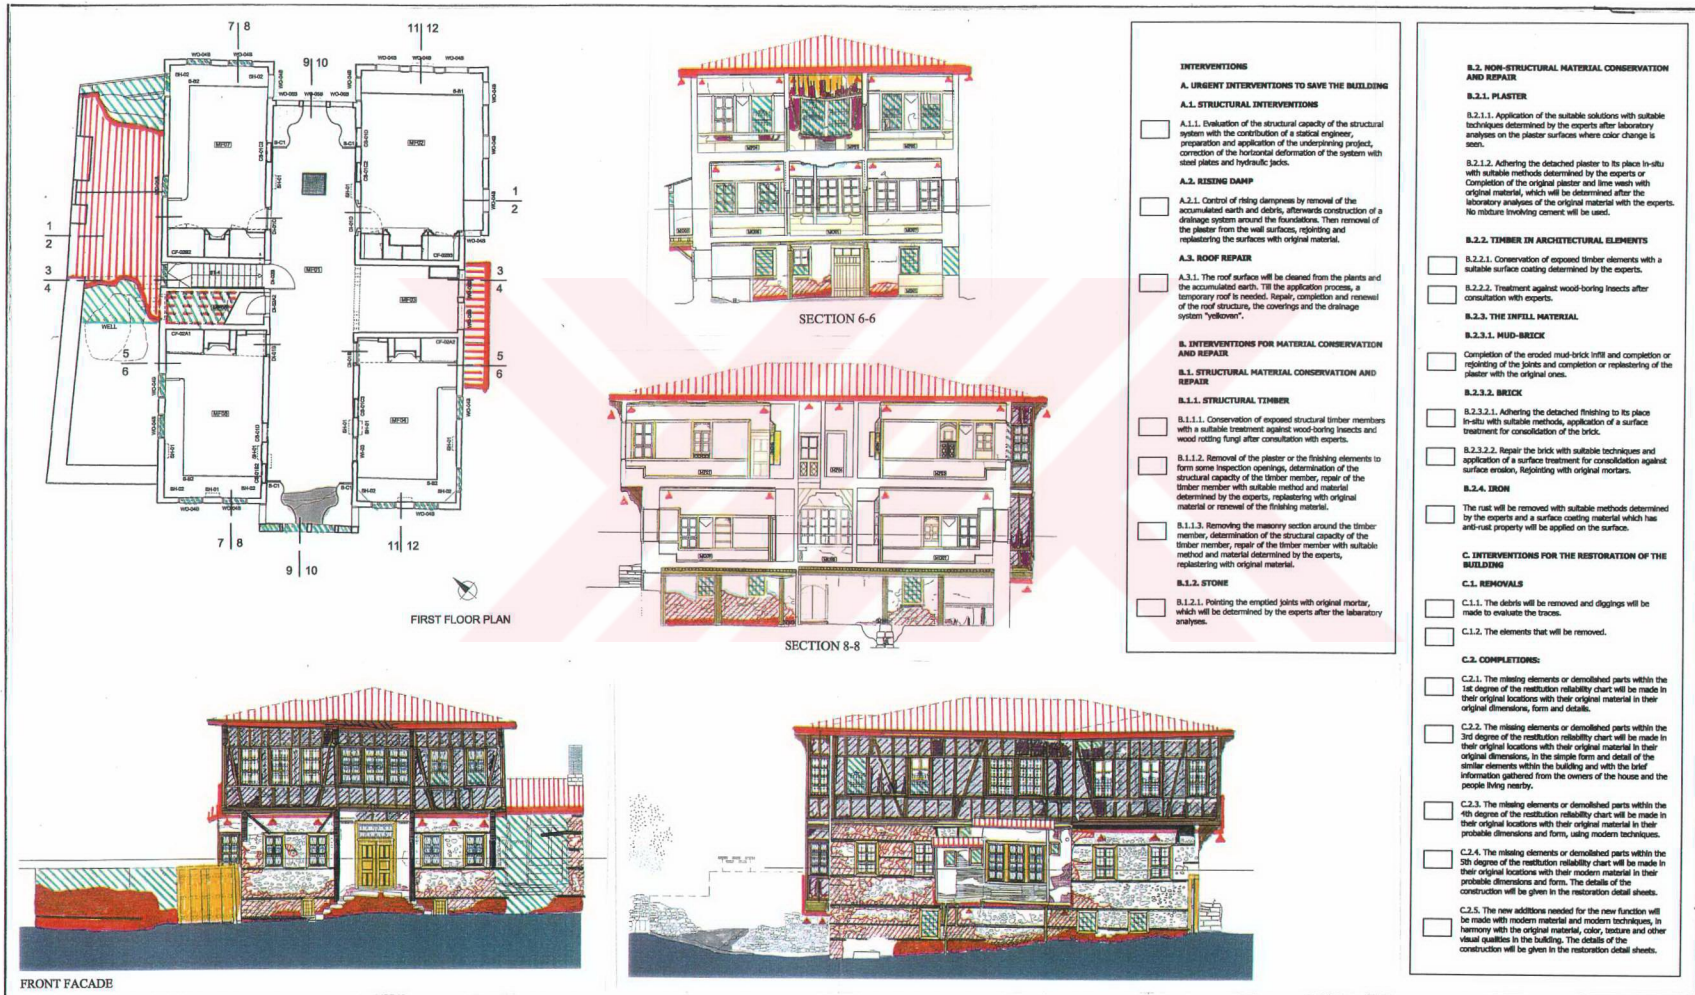
Drawing 7.2 Interventions

The insect attack seen on the timber members cause major structural problems on the timber framed section. Besides these there are major structural deformations on the horizontal structural members like sagging and settlement.

The structural timber elements and the system need underpinning and jacking up. To evaluate the structural capacity of the elements, to make diagnosis of the problems and to choose the proper methods for solutions, the contribution

of a statical engineer is necessary. The statical project of underpinning should be prepared and it will be applied on the building with careful workmen and expert aid.
