RESTORATION PROJECT OF ABACIOĞLU HANI
IN KEMERALTI, İZMİR

A THESIS SUBMITTED TO
THE GRADUATE SCHOOL OF NATURAL AND APPLIED SCIENCES
OF
THE MIDDLE EAST TECHNICAL UNIVERSITY

HÜLYA YÜCEER

SEPTEMBER 1997

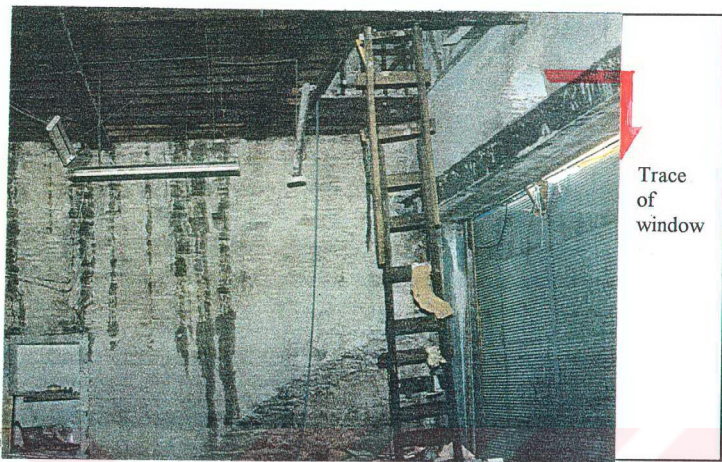
Figure 2- North East wall of Space 1 in 1997 (Interior)

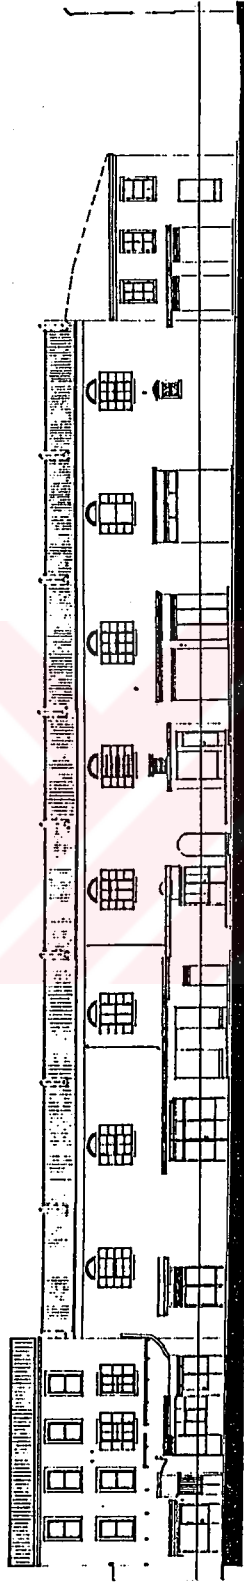
Figure 7- North East Elevation

STRUCTURAL ELEMENT	DIRECTION	PLACE	OPENING AND ARCHITECTURAL ELEMENT	FORM	MATERIALS		CONDITION OF MATERIALS	NOTES	PHOTO	
					STRUCTURAL	SURFACE				
WALL	NE	GROUND FLOOR	OPENING 15	RECTANGULAR	A.S.B.?	PLASTER + OIL PAINT	DETACHMENT OF PLASTER UP TO 0.91M HEIGHT		18,15	
			OPENING 16	RECTANGULAR	A.S.B.?	PLASTER+WASH			10	
			ROLL SHUTTER	CORRUGATED	METAL					
			OPENING 17	RECTANGULAR	A.S.B.?	PLASTER+WASH				
			ROLL SHUTTER	CORRUGATED	METAL					
			AWNING	CORRUGATED	METAL					
			WINDOW 29	RECTANGULAR	CUT STONE FRAME			DISCOLORATION HAS DUE TO CORROSION		11,10
			RAILING		IRON		OIL PAINT	CORROSION		
			OPENING 18	RECTANGULAR						9
			ROLL SHUTTER	CORRUGATED	METAL			CORROSION		
			AWNING	CORRUGATED	METAL			CORROSION		
			OPENING 19	RECTANGULAR	A.S.B.?	PLASTER+WASH		DETACHMENT OF PLASTER UP TO 1.2M		7,9
			ROLL SHUTTER	CORRUGATED	METAL			CORROSION		
			OPENING 20	RECTANGULAR	A.S.B.?	PLASTER+WASH				
			ROLL SHUTTER	CORRUGATED	METAL	OIL PAINT		LOSS OF PAINT CORROSION		7,9

AWNING	CORRUGATED	METAL					
			OPENING 21	RECTANGULAR	A.S.B.?					9
			ROLL SHUTTER	CORRUGATED	METAL					
			WINDOW 29	RECTANGULAR	A.S.B.?	CEMENT PLASTER				7,9
			RAILING		IRON		OIL PAINT	CORROSION		
			AWNING	CORRUGATED	METAL					
			OPENING 22	ARCHED	A.S.B.?	CEMENT PLASTER + WASH				7,8
			ROLL SHUTTER	CORRUGATED	METAL			CORROSION		
			OPENING 23	RECTANGULAR	A.S.B.?	CEMENT PLASTER		DETACHMENT OF PLASTER UP TO 1.1M		7,8
			ROLL SHUTTER	PERFORATED	IRON		OIL PAINT	CORROSION		
			WINDOW 29	ARCHED	A.S.B.?	CEMENT PLASTER				7,9
			AWNING	FLAT	METAL+GLASS		OIL PAINT	CORROSION		
			OPENING 24	RECTANGULAR	A.S.B.?	CEMENT PLASTER + WASH				4
			ROLL SHUTTER	CORRUGATED	METAL			CORROSION		
			OPENING 25	RECTANGULAR	A.S.B.?	CEMENT PLASTER + WASH		DETACHMENT OF PLASTER UP TO 0.95M		4
			ROLL SHUTTER	CORRUGATED	METAL			CORROSION		
			AWNING	CORRUGATED	METAL			CORROSION		
			OPENING 26	RECTANGULAR	A.S.B.?	PARTIALLY CEMENT PLASTER		DISCOLORATION UP TO 1.2M HEIGHT

ROLL SHUTTER	CORRUGATED	METAL					
			OPENING 27	RECTANGULAR	A.S.B.?	WASH				
			ROLL SHUTTER	CORRUGATED	METAL			CORROSION		
			OPENING 28	RECTANGULAR	A.S.B.?	CEMENT PLASTER + WASH		DETACHMENT OF PLASTER UP TO 1.3M		
			ROLL SHUTTER	CORRUGATED	METAL		OIL PAINT	CORROSION		
			AWNING	CORRUGATED	METAL					
			OPENING 29	RECTANGULAR	A.S.B.?	CEMENT PLASTER +

STRUCTURAL ELEMENT	DIRECTION	PLACE	OPENING AND ARCHITECTURAL ELEMENT	FORM	MATERIALS		CONDITION OF MATERIALS	NOTES	PHOTO
					STRUCTURAL	SURFACE			
WALL	NE	FIRST FLOOR					BLACKENING		
			WINDOW OPENING 74	RECTANGULAR	CUT STONE FRAME	WASH			10,18
			SHUTTER	RECTANGULAR	METAL	OIL PAINT		TWO LEAVES	
			WINDOW OPENING 75	RECTANGULAR	CUT STONE FRAME				10,18
			SHUTTER	RECTANGULAR	METAL	OIL PAINT		TWO LEAVES	
			WINDOW OPENING 76	RECTANGULAR	CUT STONE FRAME				10,18
			SHUTTER	RECTANGULAR	METAL	OIL PAINT		TWO LEAVES	
			WINDOW OPENING 77	RECTANGULAR	CUT STONE FRAME			DISCOLORATION	10,11
			SHUTTER	RECTANGULAR	METAL			CORROSION	TWO LEAVES
			WINDOW OPENING 78	RECTANGULAR	CUT STONE FRAME			DISCOLORATION	9
			SHUTTER	RECTANGULAR	METAL			CORROSION	TWO LEAVES
			WINDOW OPENING 79	RECTANGULAR	CUT STONE FRAME			DISCOLORATION	7
			SHUTTER	RECTANGULAR	METAL			CORROSION	TWO LEAVES
			WINDOW OPENING 80	RECTANGULAR	CUT STONE FRAME			DISCOLORATION	7

SHUTTER	RECTANGULAR	METAL	OIL PAINT		TWO LEAVES	
			WINDOW OPENING 81	RECTANGULAR	CUT STONE FRAME			DISCOLORATION	7,8
			SHUTTER	RECTANGULAR	METAL			CORROSION	TWO LEAVES
			WINDOW OPENING 82	RECTANGULAR	CUT STONE FRAME			DISCOLORATION	4
			SHUTTER	RECTANGULAR	METAL			CORROSION	TWO LEAVES
			WINDOW OPENING 83	RECTANGULAR	CUT STONE FRAME			DISCOLORATION	4
			SHUTTER	RECTANGULAR	METAL			CORROSION	TWO LEAVES
			WINDOW OPENING 84	RECTANGULAR	CUT STONE FRAME			DISCOLORATION	4
			SHUTTER	RECTANGULAR	CUT STONE FRAME			CORROSION	TWO LEAVES
			WINDOW OPENING 85	RECTANGULAR	CUT STONE FRAME			DISCOLORATION	3,4,5,6
			SHUTTER	RECTANGULAR	CUT STONE FRAME	OIL PAINT		CORROSION	TWO LEAVES
			WINDOW OPENING 86	RECTANGULAR	CUT STONE FRAME			DISCOLORATION	3
			SHUTTER	RECTANGULAR	CUT STONE FRAME	OIL PAINT		CORROSION	ONE LEAF
			WINDOW OPENING 87	RECTANGULAR	CUT STONE FRAME	WASH			3
			WINDOW OPENING 88	RECTANGULAR	CUT STONE FRAME	WASH			3

WINDOW OPENING 89	RECTANGULAR	CUT STONE FRAME	WASH			3,5
			WINDOW OPENING 90	RECTANGULAR	CUT STONE FRAME	WASH			3
			WINDOW OPENING 91	RECTANGULAR	CUT STONE FRAME	WASH			3
WINDOW OPENING 92	RECTANGULAR	CUT STONE FRAME	WASH			3			
WINDOW OPENING 93	RECTANGULAR	CUT STONE FRAME	WASH			3			
WINDOW OPENING 94	RECTANGULAR	CUT STONE FRAME	WASH			3			
WINDOW OPENING 95	RECTANGULAR	CUT STONE FRAME	WASH			3			
WINDOW OPENING 96	RECTANGULAR	CUT STONE FRAME	WASH			3			
WINDOW OPENING 97	RECTANGULAR	CUT STONE FRAME	WASH			3			
WINDOW OPENING 98	RECTANGULAR	CUT STONE FRAME	WASH			3			
WINDOW OPENING 99	RECTANGULAR	CUT STONE FRAME	WASH			3			
WINDOW OPENING 100	RECTANGULAR	CUT STONE FRAME	WASH			3			
WINDOW OPENING 101	RECTANGULAR	CUT STONE FRAME	WASH			3			
		EAVE

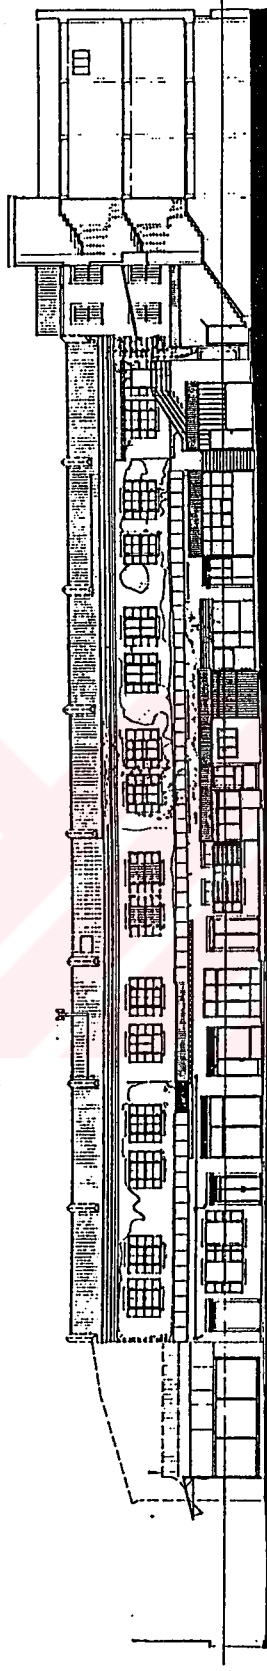
Figure 8- South West Elevation

STRUCTURAL ELEMENT	DIRECTION	PLACE	OPENING AND ARCHITECTURAL ELEMENT	FORM	MATERIALS		CONDITION OF MATERIALS	NOTES	PHOTO
					STRUCTURAL	SURFACE			
WALL	SW	GROUND STOREY			A.S.B.?	PLASTER+WASH			34
			VITRINE		METAL + GLASS	OIL PAINT			30
			AWNING		METAL	PATENT TILE	CORROSION	ALONG SPACE a	29,33
			DOOR OPENING 1	RECTANGULAR	CUT STONE FRAME	OIL PAINT			33
			WINDOW OPENING 1	RECTANGULAR	CUT STONE FRAME	OIL PAINT			35,45
			SHUTTER	RECTANGULAR	METAL	OIL PAINT		TWO LEAVES	
			WINDOW OPENING 2	RECTANGULAR	CUT STONE FRAME	OIL PAINT			45
			SHUTTER	RECTANGULAR	METAL	OIL PAINT		TWO LEAVES	
			DOOR OPENING 2	RECTANGULAR	CUT STONE FRAME	OIL PAINT			45,46
			ROLL SHUTTER	CORRUGATED	METAL				
			OPENING 1	RECTANGULAR		PLASTER+WASH			51
			ROLL SHUTTER	CORRUGATED	METAL				
			OPENING 2	RECTANGULAR		PLASTER+WASH			51,53
			ROLL SHUTTER	CORRUGATED	METAL				
			OPENING 3	RECTANGULAR		PLASTER+WASH			51,55,58
			DOOR OPENING 3	RECTANGULAR	CUT STONE FRAME	OIL PAINT			58,59,60

STRUCTURAL ELEMENT	DIRECTION	PLACE	OPENING AND ARCHITECTURAL ELEMENT	FORM	MATERIALS		CONDITION OF MATERIALS	NOTES	PHOTO
					STRUCTURAL	SURFACE			
SPACE c			IT IS AN ADDITIONAL SPACE IN FRONT OF SPACE 6. WHICH IS USED AS ITS OFFICE ENTERED ONLY FROM INTERIOR BY DOOR 5. IT IS CONSTRUCTED OUT OF IRON BARS HAVING EITHER METAL SHEETS OR GLASS IN BETWEEN						28, 75
			DOOR OPENING 5	RECTANGULAR	CUT STONE FRAME	WASH			
			OPENING 4	RECTANGULAR	A.S.B.	WASH			
			WINDOW	RECTANGULAR	ALUMINUM+GLASS				
			DOOR WING	RECTANGULAR	ALUMINUM+GLASS				
			AWNING	RECTANGULAR	METAL	CLOTH			
			DOOR OPENING 6	RECTANGULAR	CUT STONE FRAME	WASH			
SPACE d			IT IS ADDITIONAL SPACE IN FRONT OF SPACE 7 WHICH IS USED AS ITS OFFICE. CONSTRUCTED OUT OF METAL BARS HAVING METAL SHEETS AT BOTTOM PARTS AND GLASS AT UPPER PARTS. IT IS ENTERED BY A DOOR ON NW. CORROSION IS OBSERVED ON METAL SHEETS.						28, 80, 90
			WINDOW OPENING 7	RECTANGULAR	CUT STONE FRAME	WASH	LOSS OF WASH EXFOLIATION	THERE ARE THE ORIGINAL HINGES ON CUT STONE FRAME

WINDOW OPENING 8	RECTANGULAR	CUT STONE FRAME	WASH		THERE ARE THE ORIGINAL HINGES ON CUT STONE FRAME	
			STAIRCASE		REINFORCED CONCRETE			IT CONNECT THE GROUND LEVEL TO FIRST FLOOR OF SPACE 8	
SPACE e			IT IS ADDITIONAL SPACE IN FRONT OF SPACE 8, USED AS ITS STORAGE. IT IS CONSTRUCTED OUT OF METAL BARS HAVING METAL SHEETS AT BOTTOM PARTS AND GLASS AT UPPER PARTS. IT IS ENTERED BY A DOOR ON SW. CORROSION IS OBSERVED ON METAL SHEETS AND BARS WHICH ARE OIL PAINTED.						28, 90
			DOOR OPENING 7	RECTANGULAR	CUT STONE FRAME		EXFOLIATION		
			WINDOW OPENING 9	RECTANGULAR	CUT STONE FRAME	WASH		THE OPENING IS CLOSED BY BRICKS	
			WINDOW OPENING 10	RECTANGULAR	CUT STONE FRAME	WASH		THE OPENING IS CLOSED BY BRICKS	
SPACE f			IT IS AN ADDITIONAL SPACE IN FRONT OF SPACE B, USED AS ITS STORAGE. IT IS CONSTRUCTED OUT OF BRICK, PLASTERED AND WASHED. IT IS ENTERED BY A METAL OIL PAINTED DOOR ON SW.						97
WALL	sw	GROUND FLOOR	DOOR OPENING 8	RECTANGULAR	A.S.B.	WASH+ FAIENCE		TRACES OF CUT FRAME ARE PRESENT

WINDOW OPENING 11	RECTANGULAR	CUT STONE FRAME	WASH+ FAIENCE		THERE ARE THE ORIGINAL HINGES ON CUT STONE FRAME	98, 99, 100, 101
IN BETWEEN TWO STOREYS THERE ARE AWNINGS STARTING FROM SPACE A BY TIMBER CONSTRUCTED AND PATENT TILE COVERED AWNING CONTINUE WITH ORIGINAL METAL SHEET ONES. IN FRONT OF SPACE 3 THERE IS A CORRUGATED METAL SHEET AWNING. THE ORIGINAL AWNING THEN CONTINUES TILL THE STAIRCASE IN FRONT OF SPACE 8.									
		FIRST FLOOR			A.S.B.+TIMBER ?	PLASTER+WASH	PARTIALLY LOSS OF PLASTER LOSS OF WASH		28, 29, 34, 91
			WINDOW OPENING 30	RECTANGULAR	CUT STONE FRAME		CORROSION STAINS ON SILL		34
			SHUTTER	RECTANGULAR	METAL		CORROSION	TWO LEAVES	
			WINDOW OPENING 31	RECTANGULAR	CUT STONE FRAME		CORROSION STAINS ON SILL		34
			SHUTTER	RECTANGULAR	METAL		CORROSION	TWO LEAVES	
			WINDOW OPENING 32	RECTANGULAR	CUT STONE FRAME		CORROSION STAINS ON SILL		34, 51

STRUCTURAL ELEMENT	DIRECTION	PLACE	OPENING AND ARCHITECTURAL ELEMENT	FORM	MATERIALS		CONDITION OF MATERIALS	NOTES	PHOTO
					STRUCTURAL	SURFACE			
WALL	SW	FIRST FLOOR	WINDOW OPENING 34	RECTANGULAR	CUT STONE FRAME	OIL PAINT			51, 58
			SHUTTER	RECTANGULAR	METAL	OIL PAINT			
			WINDOW OPENING 35	RECTANGULAR	CUT STONE FRAME	OIL PAINT			51, 58
			SHUTTER	RECTANGULAR	METAL	OIL PAINT			
			WINDOW OPENING 36	RECTANGULAR	CUT STONE FRAME	OIL PAINT			58, 68
			SHUTTER	RECTANGULAR	METAL	OIL PAINT			
			WINDOW OPENING 37	RECTANGULAR	CUT STONE FRAME	OIL PAINT			58, 68
			SHUTTER	RECTANGULAR	METAL	OIL PAINT			
			WINDOW OPENING 38	RECTANGULAR	CUT STONE FRAME	OIL PAINT			68
			SHUTTER	RECTANGULAR	METAL	OIL PAINT			
			WINDOW OPENING 39	RECTANGULAR	CUT STONE FRAME		CORROSION STAINS ON SILL		68
			SHUTTER	RECTANGULAR	METAL		CORROSION	TWO LEAVES	
			WINDOW OPENING 40	RECTANGULAR	CUT STONE FRAME	OIL PAINT			75
			SHUTTER	RECTANGULAR	METAL	OIL PAINT		TWO LEAVES

WINDOW OPENING 41	RECTANGULAR	CUT STONE FRAME	OIL PAINT			75
			SHUTTER	RECTANGULAR	METAL	OIL PAINT		TWO LEAVES	
			WINDOW OPENING 42	RECTANGULAR	CUT STONE FRAME		CORROSION STAINS ON SILL		75
			SHUTTER	RECTANGULAR	METAL		CORROSION	ONE LEAF	
			WINDOW OPENING 43	RECTANGULAR	CUT STONE FRAME		CORROSION STAINS ON SILL		75
			SHUTTER	RECTANGULAR	METAL		CORROSION	TWO LEAVES	
			WINDOW OPENING 44	RECTANGULAR	CUT STONE FRAME		CORROSION STAINS ON SILL		80
			SHUTTER	RECTANGULAR	METAL		CORROSION	TWO LEAVES	
			WINDOW OPENING 45	RECTANGULAR	CUT STONE FRAME			PRESENTLY USED AS DOOR OPENING	80
			SHUTTER	RECTANGULAR	METAL	OIL PAINT	CORROSION		
			WINDOW OPENING 46	RECTANGULAR	CUT STONE FRAME	CEMENT PLASTER+WASH	DISCOLORATION	ON THE FIRST FLOOR SPACE B	80
			WINDOW OPENING 47	RECTANGULAR	CUT STONE FRAME	CEMENT PLASTER+WASH	DISCOLORATION	ON THE FIRST FLOOR SPACE B	80
			WINDOW OPENING 48	RECTANGULAR	CUT STONE FRAME	CEMENT PLASTER+WASH	DISCOLORATION	ON THE SECOND FLOOR OF SPACE B	80

WINDOW OPENING 49	RECTANGULAR	CUT STONE FRAME	CEMENT PLASTER+WASH	DISCOLORATION	ON THE SECOND FLOOR OF SPACE B	80			
EAVE				PLASTER+WASH	PARTIALLY EXFOLIATION LOSS OF WASH	STARTS FROM SPACE 1 AND SPACE B	79, 80, 95, 96, 97

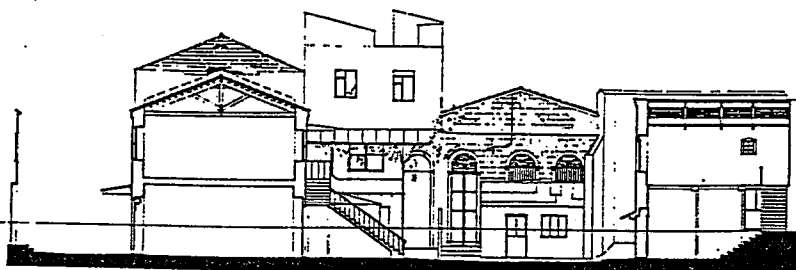
Figure 9- North Elevation

STRUCTURAL ELEMENT	DIRECTION	PLACE	OPENING AND ARCHITECTURAL ELEMENT	FORM	MATERIALS		CONDITION OF MATERIALS	NOTES	PHOTO
					STRUCTURAL	SURFACE			
WALL	N	GROUND FLOOR			A.S.B.	PLASTER + WASH	DETACHMENT OF PLASTER UP TO 0.6 M. HEIGHT	REINFORCED CONCRETE STRUCTRE ADDED TO SPACE G	102, 103
			WINDOW OPENING 12	ARCHED	CUT STONE FRAME	OIL PAINT		PRESENTLY USED AS A DOOR REACED BY 13 STEP	105
SPACE g IT IS AN ADDITIONAL SPACE IN FRONT OF SPACE 9, USED AS ITS OFFICE. IT IS CONSTRUCTED OUT OF BRICK, PLASTERED AND WASHED. IT HAS TWO TIMBER. WINDOWS FACING NW AND AN ENTRANCE DOOR FACING SW.									
			WINDOW OPENING 13	ARCHED	CUT STONE FRAME	WASH	LOSS OF WASH		
			DOOR OPENING 9	ARCHED	CUT STONE FRAME	WASH			
			DOOR OPENING 10	ARCHED	CUT STONE FRAME	OIL PAINT	LOSS OF PAINT		106, 107
SPACE h IT IS AN ADDITIONAL SPACE IN FRONT OF SPACE 10, USED AS A STORAGE. IT IS CONSTRUCTED OUT OF BRICK, PLASTERED AND WASHED. IT HAS A DOOR AND A WINDOW OF TIMBER+ GLASS FACING NW.

WINDOW OPENING 14	ARCHED	CUT STONE FRAME	OIL PAINT	DISCOLORATION		106
			RAILING		IRON	OIL PAINT	CORROSION		
			WINDOW OPENING 15	ARCHED	CUT STONE FRAME	OIL PAINT	DISCOLORATIO		106, 109, 110
			RAILING		IRON	OIL PAINT	CORROSEON		
		FIRST FLOOR			A.S.B.+BRICK	CEMENT PLASTER+WASH	DISCOLARATION		103, 104
			WINDOW OPENING	SQUARE	HALLOW BRICK	CEMENT PLASTER+WASH			
			WINDOW	SQUARE	TIMER+GLASS	OIL PAINT	LOSS OF PAINT		
		SECOND FLOOR			HALLOW BRICK	CEMENT PLASTER+WASH	DISCOLARATION DETACHMENT OF PLASTER		103, 104
			WINDOW OPENING	RECTANGULAR	HALLOW BRICK	CEMENT PLASTER+WASH			
			WINDOW	RECTANGULAR	TIMBER+GLASS	OIL PAINT	CRACKS		
			WINDOW OPENING	RECTANGULAR	BRICK	CEMENT PLASTER+WASH			
			WINDOW	RECTANGULAR	TIMBER+GLASS	OIL PAINT	LOSS OF PAINT

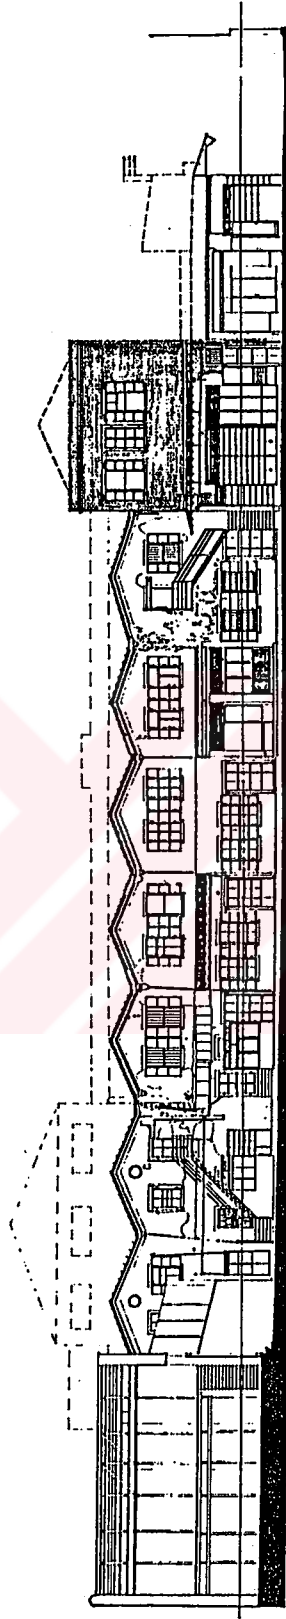
Figure 10- East Elevation

STRUCTURAL ELEMENT	DIRECTION	PLACE	OPENING AND ARCHITECTURAL ELEMENT	FORM	MATERIALS		CONDITION OF MATERIALS	NOTES	PHOTO	
					STRUCTURAL	SURFACE				
<p>TOILETS</p> <p>THERE ARE THREE TOILETS ON THE SW CORNER OF COURTYARD WHICH HAVE DOORS FACING E. THESE ARE CONSTRUCTED OUT OF HALLOW BRICK CEMENT PLASTERED AND WASHED. DOORS ARE OF TIMBER+GLASS AND OIL PAINTED.</p>										125
WALL	E	GROUND FLOOR			A.S.B	PLASTER+WASH			122, 123	
			WINDOW OPENING 16	RECTANGULAR	CUT STONE FRAME	WASH	CORROSION ON SILL		129	
			SHUTTER	RECTANGULAR	METAL	OIL PAINT	LOSS OF PAINT CORROSION	TWO LEAVES		
			RAILING		IRON		CORROSION			
			WINDOW OPENING 17	RECTANGULAR	CUT STONE FRAME	WASH	CORROSION ON SILL	TWO LEAVES	129, 130, 131	
			SHUTTER	RECTANGULAR	METAL	OIL PAINT	LOSS OF PAINT CORROSION			
			RAILING		IRON			TRACES OF CUT STONE FRAME ARE PRESENT		
			DOOR OPENING 11	RECTANGULAR	A.S.B	WASH			129, 130, 131	
ROLL SHUTTER	CORRUGATED	METAL		CORROSION

STAIRCASE		METAL	OIL PAINT	CORROSION	IT IS LYING IN BETWEEN COURTYARD AND WINDOW 52	123, 127, 143, 144, 146, 147	
<p>SPACE I</p> <p>IT IS AN ADDITIONAL SPACE IN FRONT OF SPACE 12, USED AS ITS OFFICE. IT IS CONSTRUCTED OUT OF METAL BARS SPANNED BY METAL SHEETS AND GLASS. IT IS OIL PAINTED BUT STILL CORROSION IS OBSERVED.</p>										
			WINDOW OPENING 18	RECTANGULAR	CUT STONE FRAME	WASH	EXFOLIATION	ORIGINAL HINGES OF SHUTTERS ARE PRESENT	146	
			RAILING		IRON	OIL PAINT	CORROSION			
			WINDOW OPENING 19	RECTANGULAR	CUT STONE FRAME	WASH	EXFOLIATION	ORIGNA HINGES OF SHUTTERS ARE PRESENT		
			RAILING		IRON	OIL PAINT	CORROSION			
			DOOR OPENING 12	RECTANGULAR	A.S.B	CEMENT PLASTER	DETACHMENT OF PLASTER	TRACES OF CUT STONE FRAME ARE PRESENT	147	
			WINDOW OPENING 20	RECTANGULAR	CUT STONE FRAME	OIL PAINT	LOSS OF PAINT	TWO LEAVES	154	
			SHUTTER	RECTANGULAR	METAL	OIL PAINT	CORROSION			
<p>SPACE J</p> <p>IT IS AN ADDITIONAL SPACE IN FRONT OF SPACE 13, USED AS ITS OFFICE. IT IS CONSTRUCTED OUT OF METAL BARS SPANNED BY METAL SHEETS AND GLASS. IT IS OIL PAINTED AND ENTERED BY A DOOR FACING N.</p>

WINDOW OPENING 21	RECTANGULAR	CUT STONE FRAME	WASH		NOT SEAN FROM EXTERIOR		
			DOOR OPENING 13	RECTANGULAR	CUT STONE FRAME	OIL PAINT	EXFOLIATION AT LOVER PARTS		156, 157, 158, 159, 160	
			AWNING	CORRUGATE + FLAT	METAL		CORROSION	BOTH ORIGINAL AND NEW ONE IS PRESENT, LYING A LONG SPACE 13	154	
			WINDOW OPENING 22	RECTANGULAR	CUT STONE FRAME	WASH			173	
			SHUTTER	RECTANGULAR	METAL	OIL PAINT				
			WINDOW OPENING 23	RECTANGULAR	CUT STONE FRAME	WASH			173	
			SHUTTER	RECTANGULAR	CUT STONE FRAME	OIL PAINT				
			DOOR	RECTANGULAR	METAL+GLASS	OIL PAINT		TWO LEAVES OPENING TO EXTERIOR	173, 175	
			DOOR OPENING 14	RECTANGULAR	CUT STONE FRAME	WASH	PARTIALLY LOSS OF MATERIAL AT SILL			
			AWNINGS	CORRUGATED	ASBESTOS SHEET			LYING ALONG SPACE 14

STRUCTURAL ELEMENT	DIRECTION	PLACE	OPENING AND ARCHITECTURAL ELEMENT	FORM	MATERIALS		CONDITION OF MATERIALS	NOTES	PHOTO
					STRUCTURAL	SURFACE			
			WINDOW OPENING 24	RECTANGULAR	TRAVERTINE FRAME				188
			SHUTTER	RECTANGULAR	METAL	OIL PAINT		HINGES ARE NEW	
			RAILING		IRON	OIL PAINT	CORROSION		
			WINDOW OPENING 25	RECTANGULAR	TRAVERTINE FRAME				188
			SHUTTER	RECTANGULAR	METAL	OIL PAINT		HINGES ARE NEW	
			RAILING		IRON	OIL PAINT	CORROSION		
			DOOR OPENING 15	RECTANGULAR	TRAVERTINE FRAME				189, 190
			OPENING 5	RECTANGULAR		CEMENT PLASTER+WASH			196
			ROLL SHUTTER	CORRUGATED	METAL		CORROSION		
			OPENING 6	RECTANGULAR		CEMENT PLASTER+WASH			196
			ROLL SHUTTER	CORRUGATED	METAL		CORROSION		
			AWNING	CORRUGATED	ASBESTOS SHEET			LYING ALONG SPACE 16	196
			WINDOW OPENING 26	RECTANGULAR	CUT STONE FRAME	OIL PAINT	LOSS OF MATERIAL AT SILL		203
			SHUTTER	RECTANGULAR	METAL	OIL PAINT	CORROSION		
			RAILING		IRON	OIL PAINT	CORROSION

WINDOW OPENING 27	RECTANGULAR	CUT STONE FRAME	OIL PAINT	CORROSION		
			SHUTTER	RECTANGULAR	METAL	OIL PAINT	CORROSION		
			RAILING		IRON	OIL PAINT	CORROSION		
			STAIRCASE		METAL	OIL PAINT	CORROSION	LYING IN BETWEEN COURTYARD AND WINDOW 61	
WALL	E	GROUND FLOOR						WALL OF SPACE	
			SHELVES	RECTANGULAR	METAL	OIL PAINT	CORROSION	IN FRONT OF SPACE	223
			ROLL SHUTTER	CORRUGATED	METAL			IN ORDER TO CLOSE THE SHELVES	
			OPENING 7	RECTANGULAR	A.S.B.	CEMENT PLASTER+WASH			224
			ROLL SHUTTER	CORRUGATED	METAL			IN ORDER TO CLOSE OPENING 7.	
			DOOR OPENING 18	RECTANGULAR	CUT STONE FRAME	WASH	EXFOLIATION AT LOWER PARTS		226, 228, 229
			OPENING 8	RECTANGULAR	A.S.B.	CEMENT PLASTER+WASH		ON THE WALL OF SPACE D	229, 231
			ROLL SHUTTER	CORRUGATED	METAL			IN ORDER TO CLOSE OPENING 8	
			OPENING 9	RECTANGULAR	A.S.B.	CEMENT PLASTER+WASH	DETACHMENT OF PLASTER UP TO 0.6 M.		227
			ROLL SHUTTER	CORRUGATED	METAL

OPENING 10	RECTANGULAR	A.S.B.	CEMENT PLASTER+WASH			227, 231
			ROLL SHUTTER	CORRUGATED	METAL				
			AWNING		TIMBER CONST.	OIL PAINT		PATENT TILE AS FINISH ALONG SPACE C	230
			AWNING		METAL			PATENT TILE AS FINISH ALONG SPACE D AND E	
		FIRST FLOOR			A.S.B.	PLASTER+WASH			
			WINDOW OPENING 49	RECTANGULAR	CUT STONE FRAME		CORROSION STAINS ON SILL		129, 130, 143
			SHUTTER	RECTANGULAR	METAL		CORROSION		
			WINDOW OPENING 50	RECTANGULAR	CUT STONE FRAME		CORROSION ON SILL		129, 130, 143
			SHUTTER	RECTANGULAR	METAL		CORROSION

SHUTTER	RECTANGULAR	METAL	OIL PAINT		TWO LEAVES	
			WINDOW OPENING 57	RECTANGULAR	TRAVERTINE				188
			SHUTTER	RECTANGULAR	METAL	OIL PAINT		TWO LEAVES HINGES ARE NEW	
			WINDOW OPENING 58	RECTANGULAR	TRAVERTINE		CORROSION STAINS ON SILL		188
			SHUTTER	RECTANGULAR	METAL	OIL PAINT		TWO LEAVES HINGES ARE NEW	
			WINDOW OPENING 59	RECTANGULAR	CUT STONE FRAME		CORROSION STAINS ON SILL		196

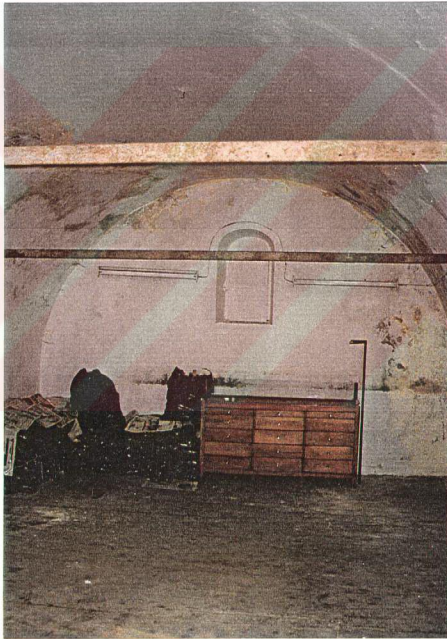
Vaults: Vaults are used as the super structure of space 13, 14, 15, 16 and 17. These are barrel vaults having depressed semicircular profiles and strengthen by two tie bars of iron (Figure 21). The construction technique and material could not be observed since all of them are plastered.

Figure 21- Vault and Tie bar of Space 13 (First Floor)

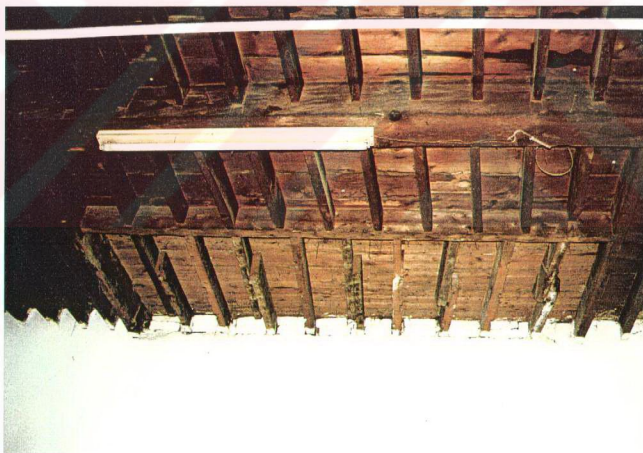
Staircases: There are several different staircases reaching upper floor from interior or exterior that are of reinforce concrete, metal or timber. There are three original staircases in Space 1, Space 11 and Space 15, which are similar to each other. These staircases are placed on the opposite of the door L shaped with landings. The first step is out of stone and there are 20 others of timber. They also have timber balustrades. In the spaces where this type of staircase is not found, the traces of the staircase hole is observed on the timber beams and joists (Figure 27).

Figure 27- Trace of staircase in Space13
