REHABILITATION OF MALATYA-NARLI NO:7  
RAILROAD TUNNEL

A THESIS SUBMITTED TO  
THE GRADUATE SCHOOL OF NATURAL AND APPLIED SCIENCES  
OF  
MIDDLE EAST TECHNICAL UNIVERSITY

BARIŞ DİVLELİ

SEPTEMBER 2004

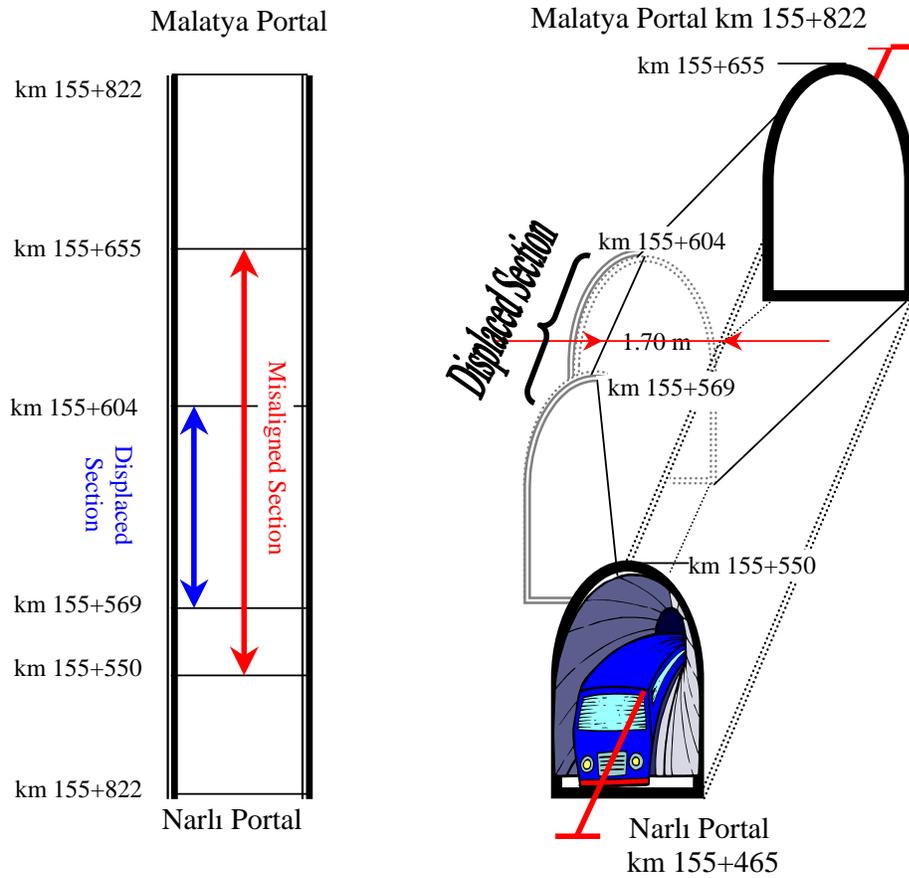
An obvious misalignment was observed within 105 meters of the tunnel between kilometers 155+550 and 155+655 and 35 meter section of it (between kilometers 155+569.15 and 155+604.15) was displaced about 1.70 meters over the years. Figure 4.1 demonstrates excessive displacements occurred in the tunnel.

Figure 4.1 Excessive Displacements Occurred in the Tunnel

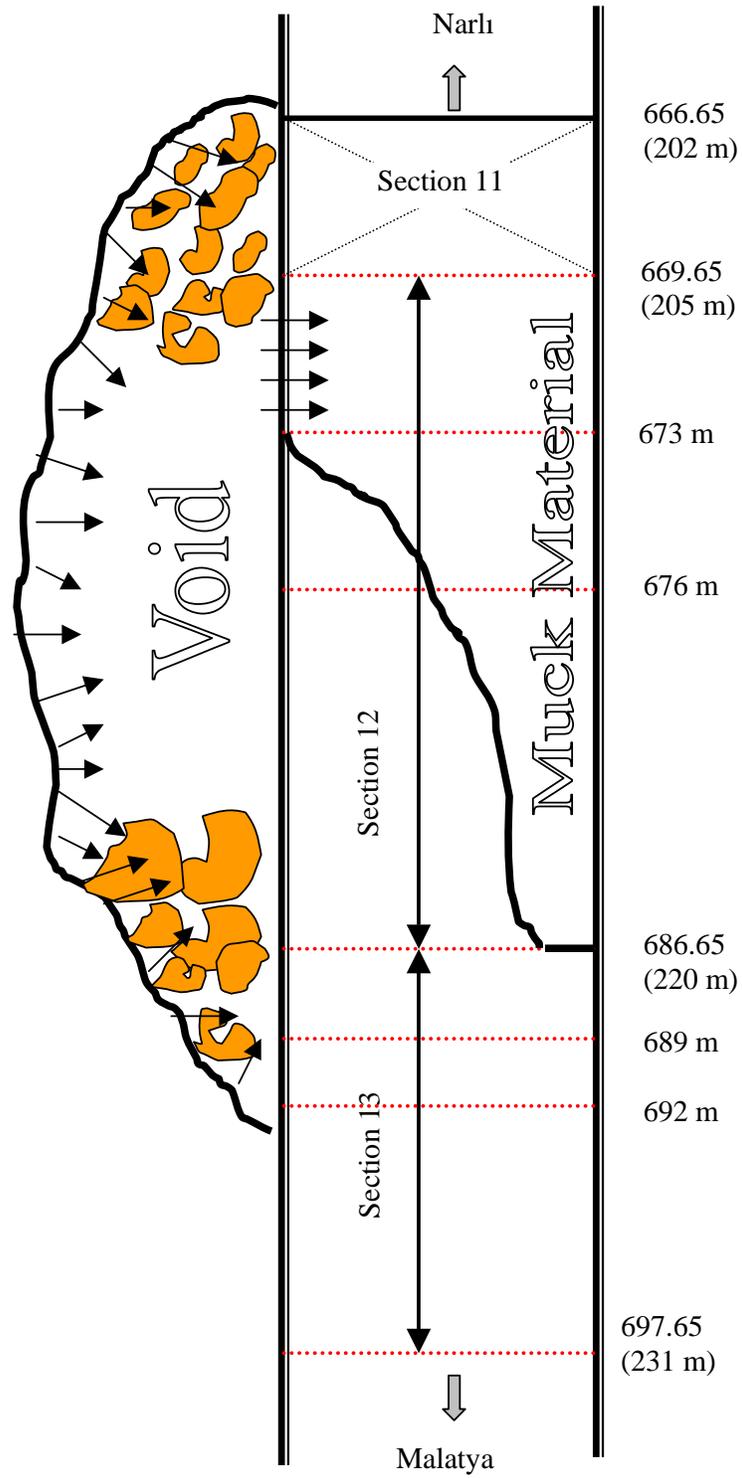
The problems in the past include surface and underground water, deformation, roof rock fall, clay bearing strata and voids existing in the rock mass. The first collapse in the tunnel (roof-fall) occurred on July 30, 2002 due to breakage of the existing concrete-lining during enlargement of No: 7 Railroad Tunnel. This collapsed material flowed from the roof filled a 21-m long section of the tunnel between km 155+666 and 687 as shown in Figure 4.2. The volume of the roof-fall material flowed into the tunnel was estimated to be 500 m<sup>3</sup>. Because of this roof-fall the tunnel stayed close to traffic for about 10 months.

Figure 4.2 Collapse Area and the Void Developed above the Tunnel

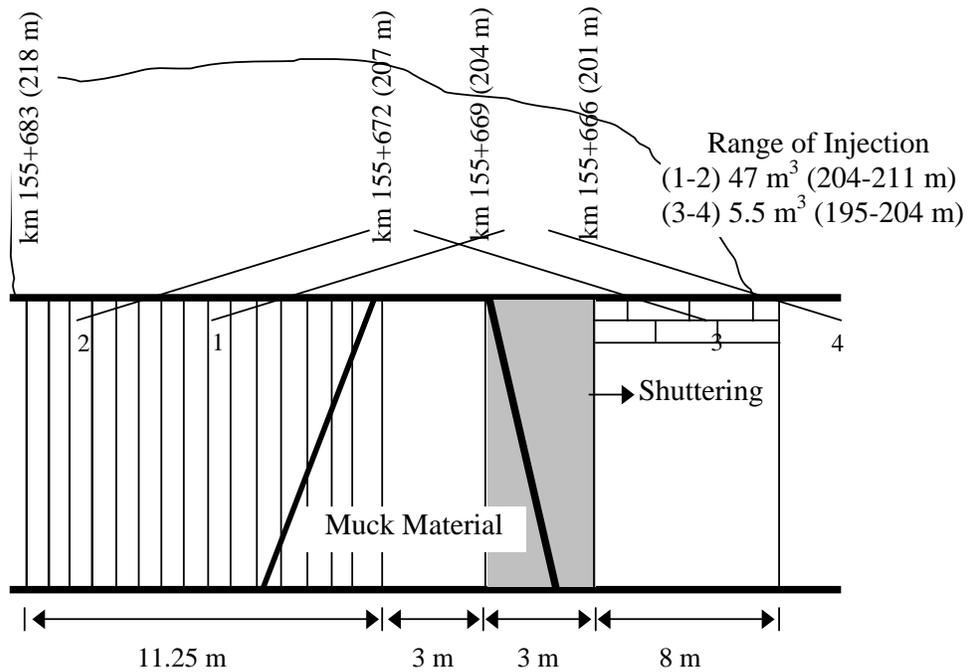
Figure 4.4 Range of Injection Made above the Roof of the Collapsed Area

Before removal of the muck-material a cement injection was made into the loose material existing in the roof. Initially, 5.5 m<sup>3</sup> of cement was grouted between km 155+660 and 669 (195-204 m from the Narlı entrance) and then 47 m<sup>3</sup> of cement between km 155+669 and 676 (204-211 m) as demonstrated in Figure 4.4.

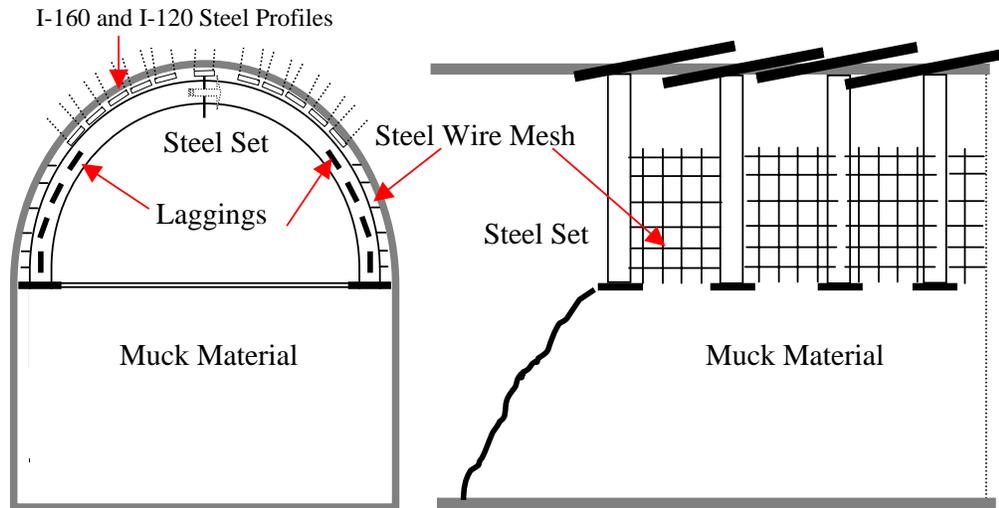
Figure 4.5 Views of the Support System Used During Clearance of the Collapse

The forepoles, made of I-120 and I-160 steel profiles and having a length of 3 meters were hammered into the loose material existing in the tunnel roof. Out of 28 forepoles, 6 were made of I-120, and the remaining be made of I-160. A general view of the support system used during the clearance of the collapse is shown in Figure 4.5.

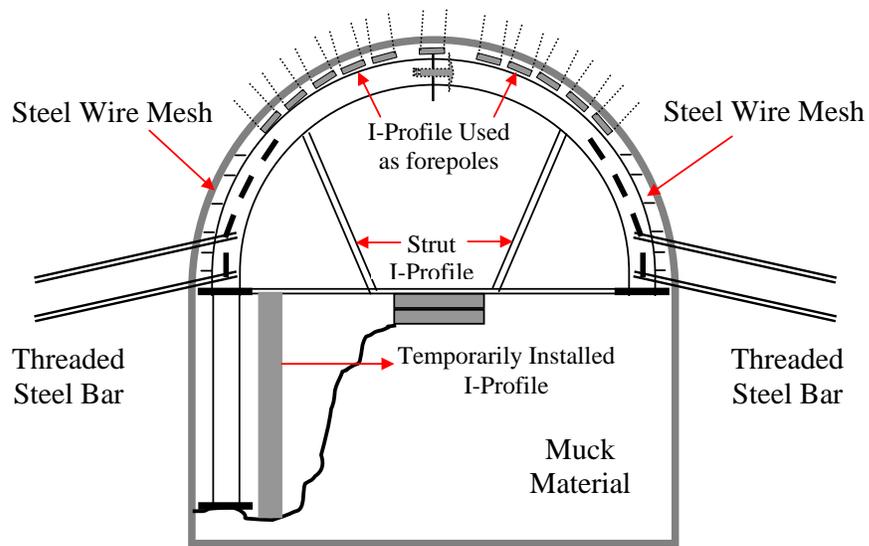
Figure 4.7 Installation of the Limp (Short) Leg of the Steel-Arch and of the Temporary I-Profiles

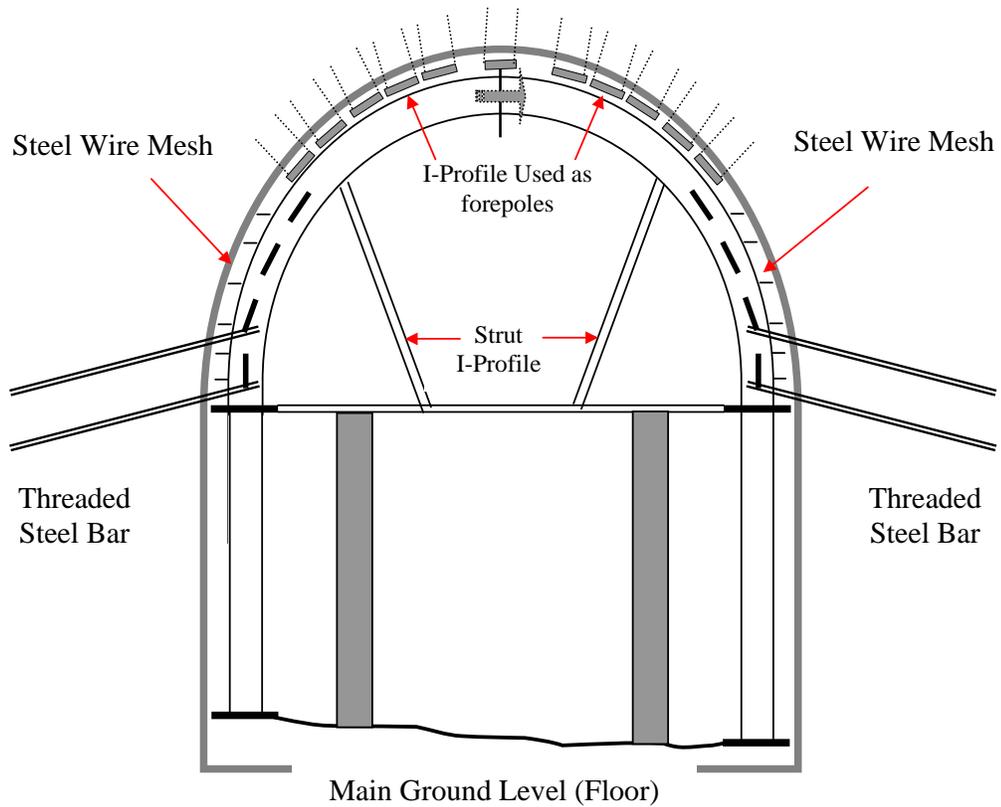
Figure 4.8 Support Used in No: 7 Tunnel During Clearance of the Caved Material

Using this procedure explained above, the installation of 8 steel-sets was completed. Initially, it was not possible to put the legs of the steel-sets on the ground level (floor of the tunnel) as shown in Figure 4.8. In the meantime, two vertical steel I-profiles were welded temporarily to the horizontally welded I-profile at the shoulder level. Starting from one side, the muck material on the bottom of the tunnel was removed.

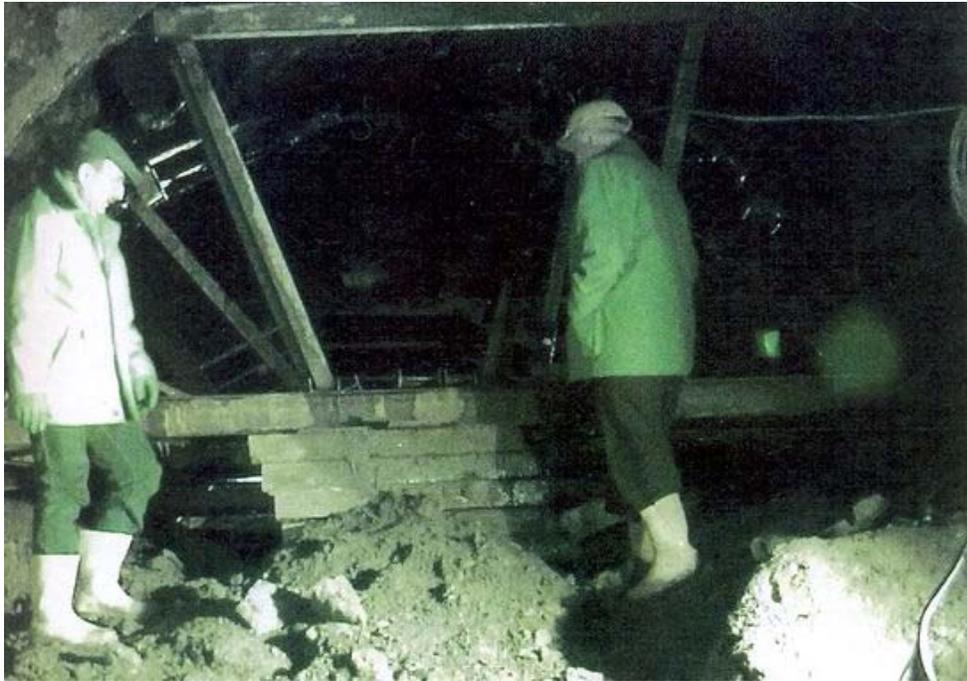
Figure 4.9 Bench Support Used During Clearance of the Collapsed Material

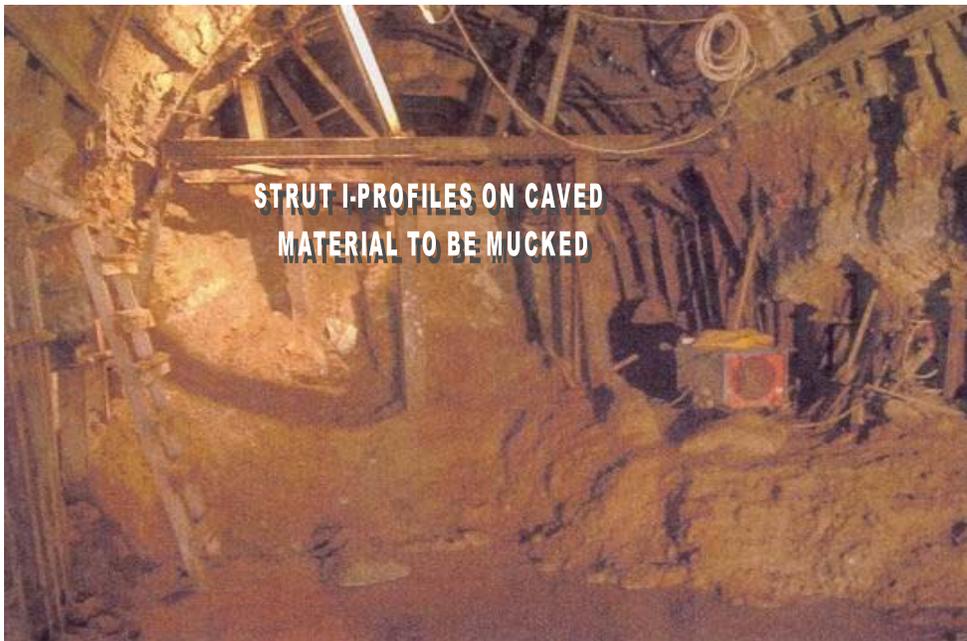
Figure 4.10 Last Stage of the Clearance of the Collapse

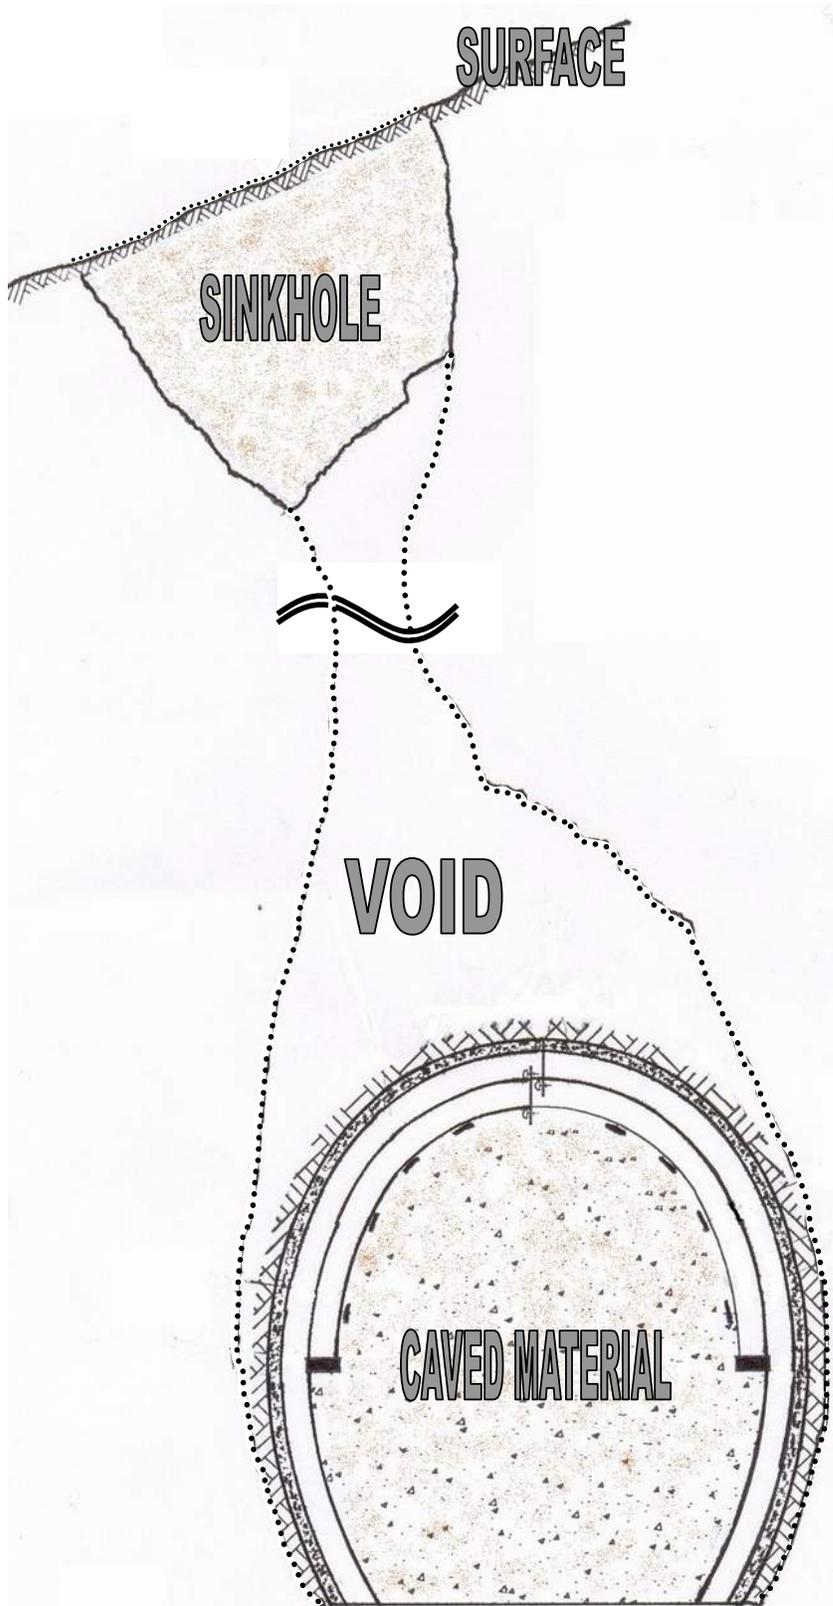
Figure 4.12 Estimated Geometry of the Subsidence above the Collapsed Tunnel

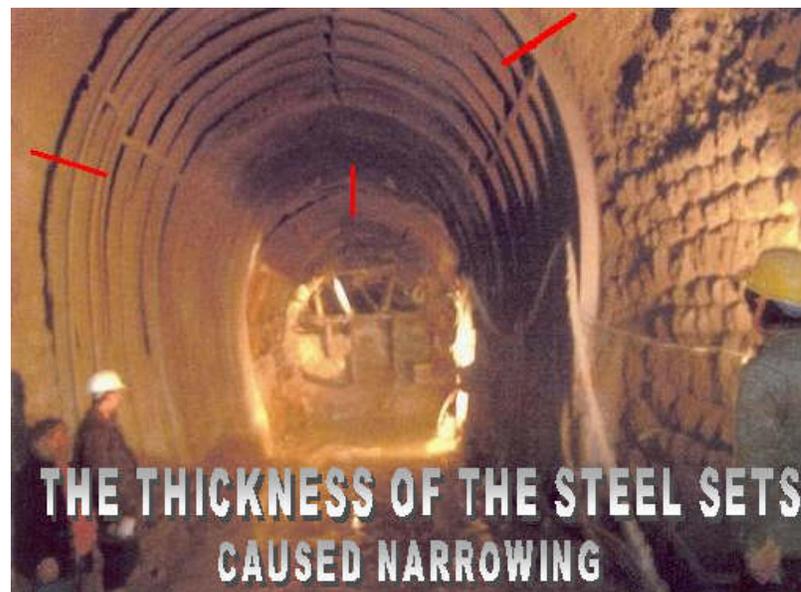
Figure 4.13 Photograph Showing a Reduced Span Close to the Collapsed Area

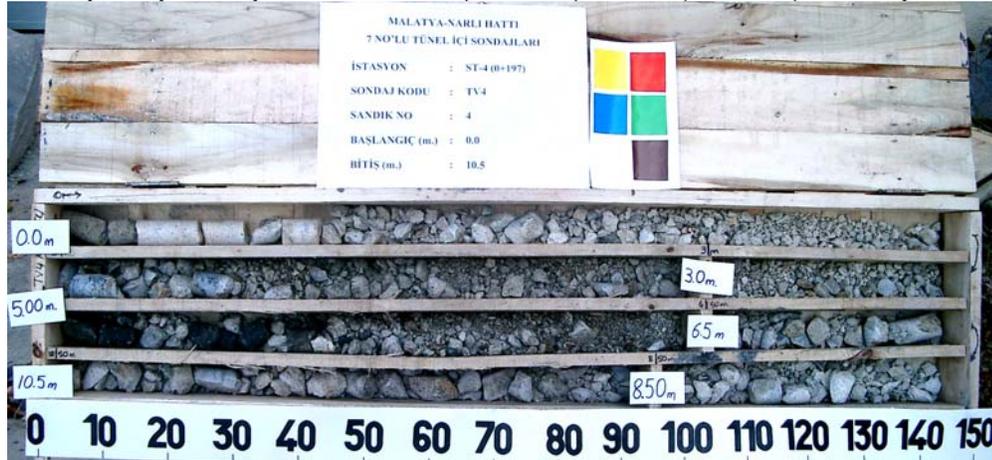
Figure 4.14 Cores Taken from the Roof at Station No: 4

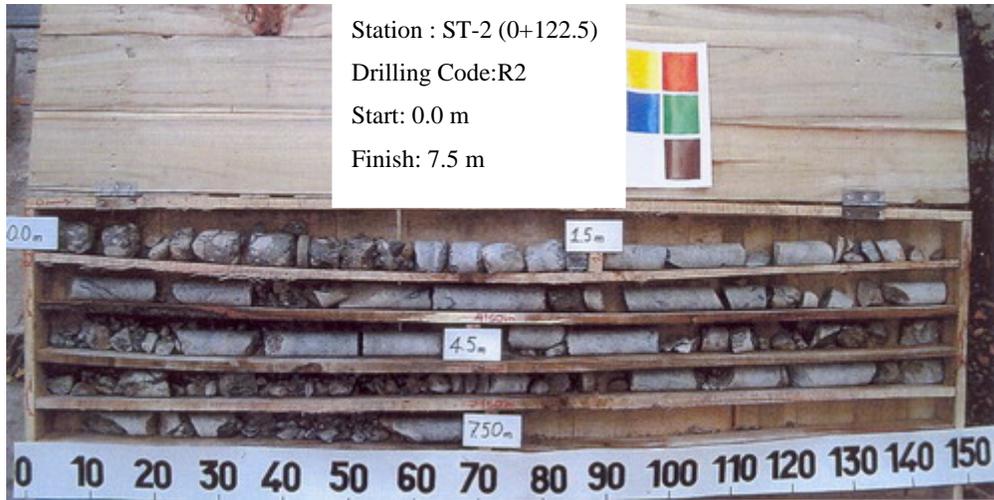
Figure 4.15 Typical Rock Mass at 122.5 m (ST-2) on the Mountain Side of the No: 7 Tunnel

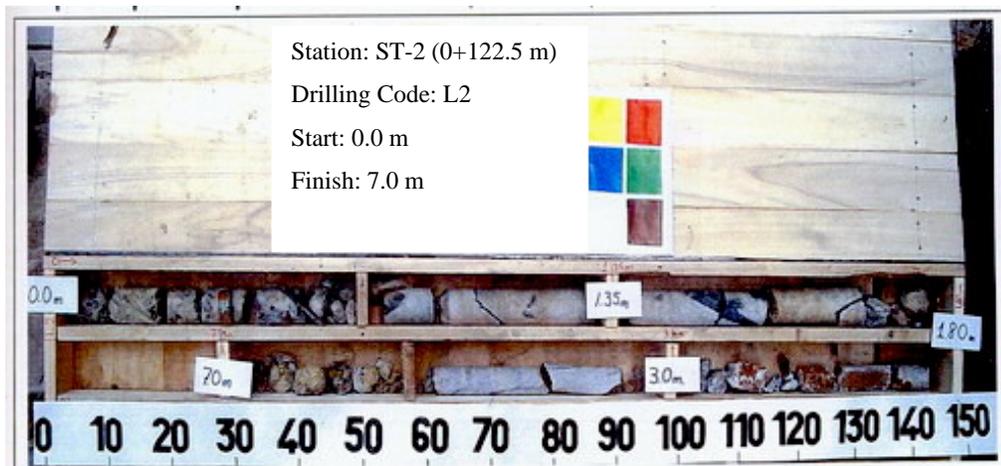
Figure 4.16 Typical Rock Mass at 122.5 m (ST-2) on the Creek Side of the No: 7 Tunnel

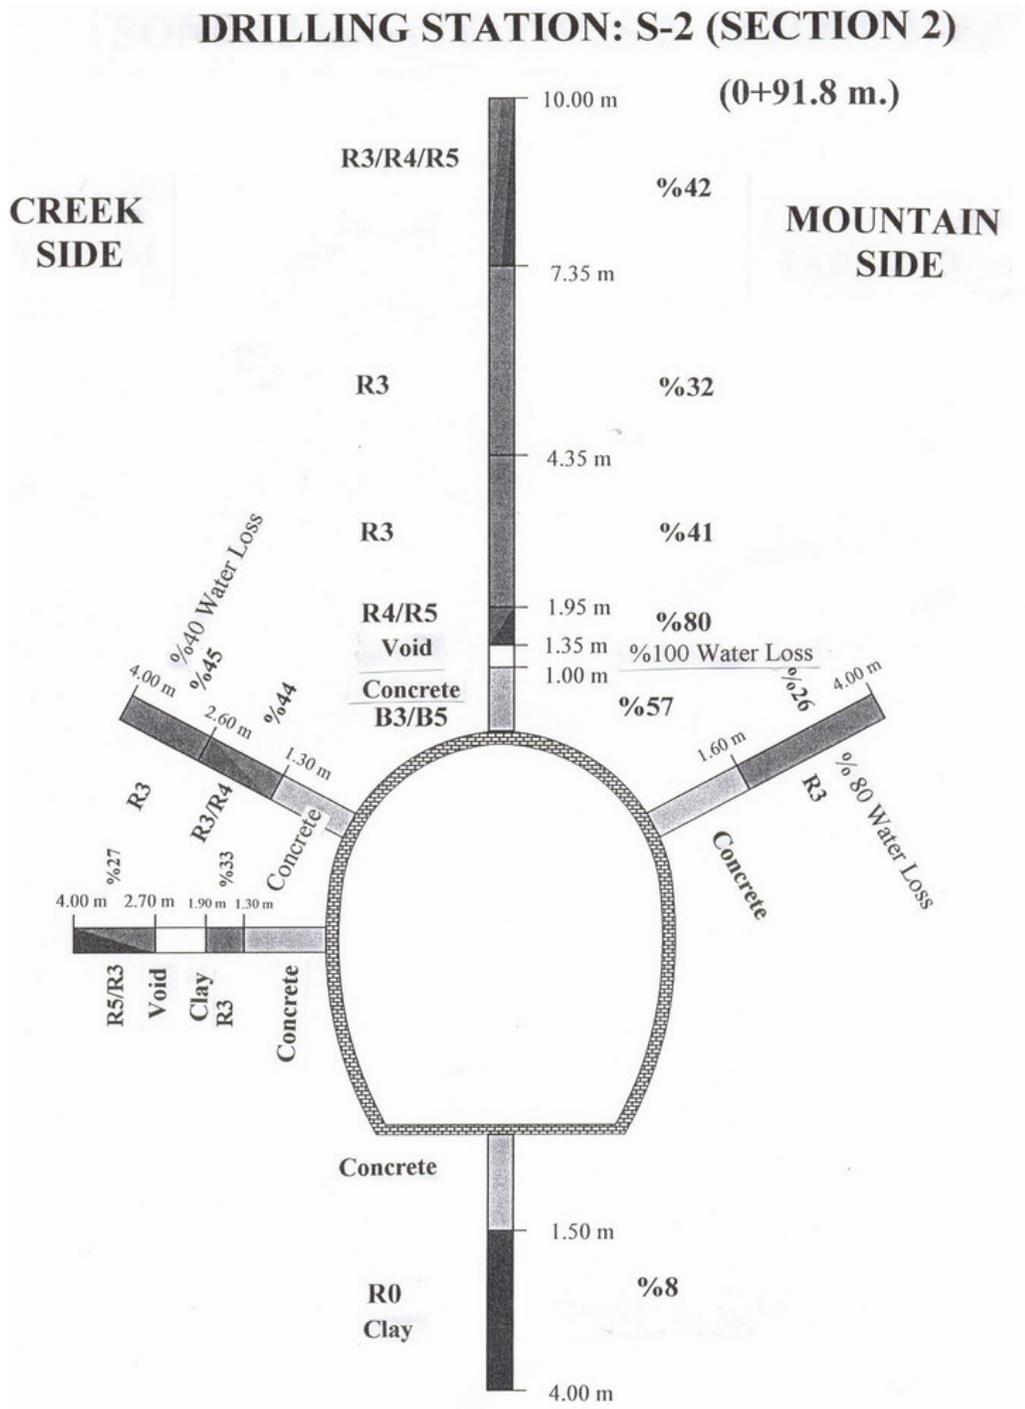
Figure 4.21 Coreholes Showing Rock Mass Conditions Surrounding Station 2

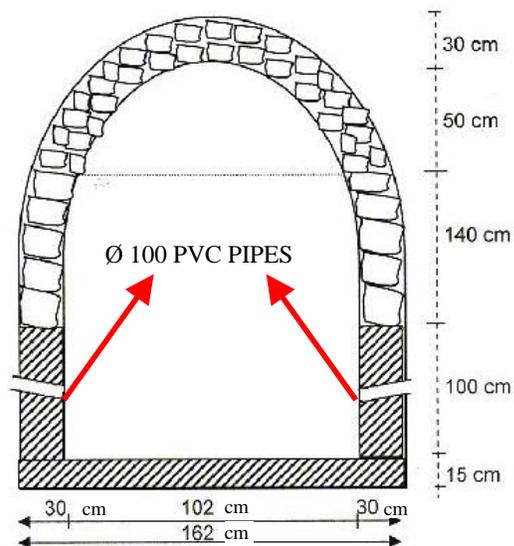
Figure 4.26 The Condition of Drainage Gallery after Rehabilitation

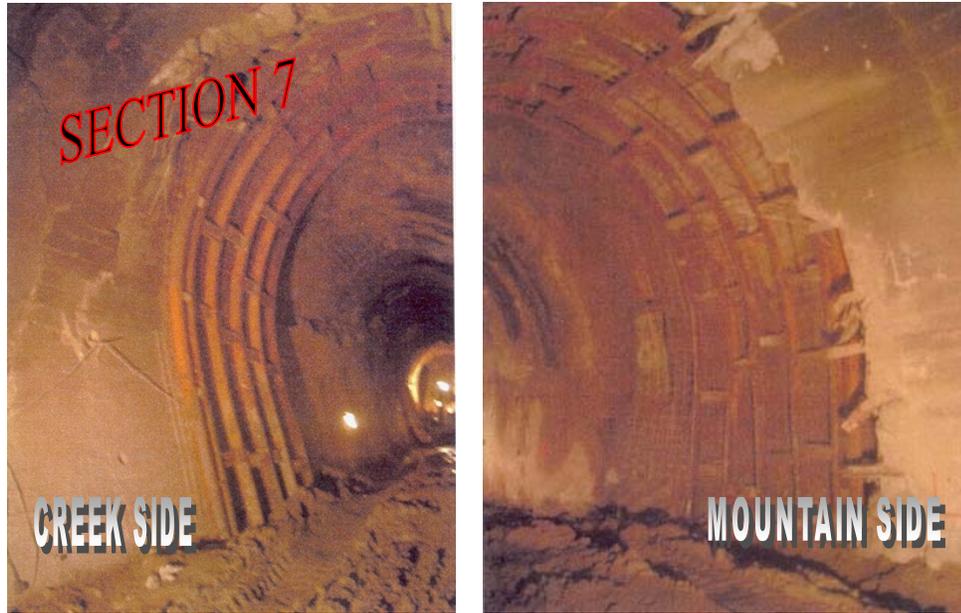
Figure 4.27 The Condition of Section 7 before the Rehabilitation of the Tunnel

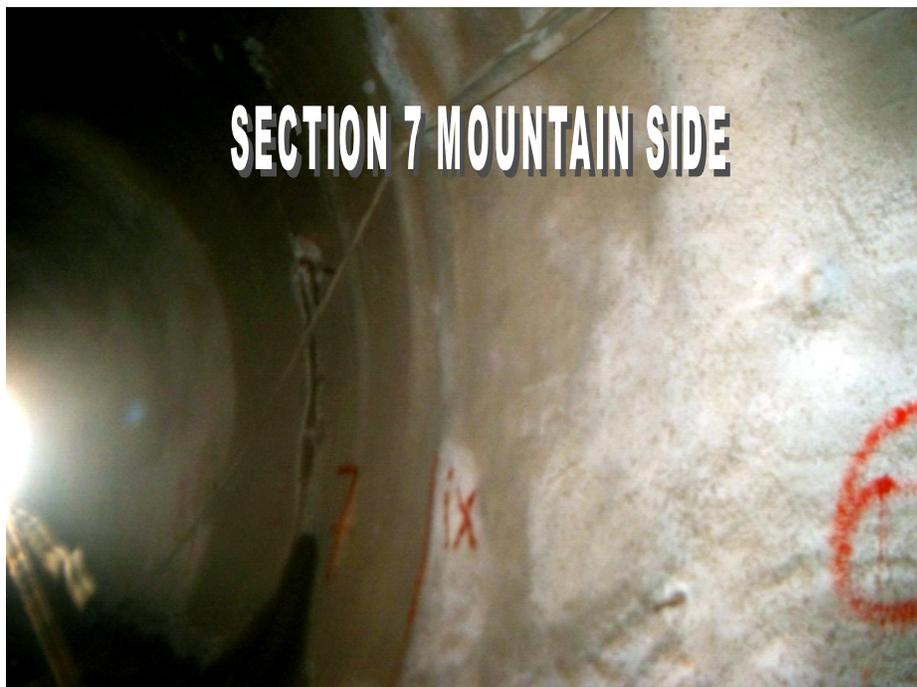
Figure 4.28 The Condition of Section 7 after the Rehabilitation of the Tunnel

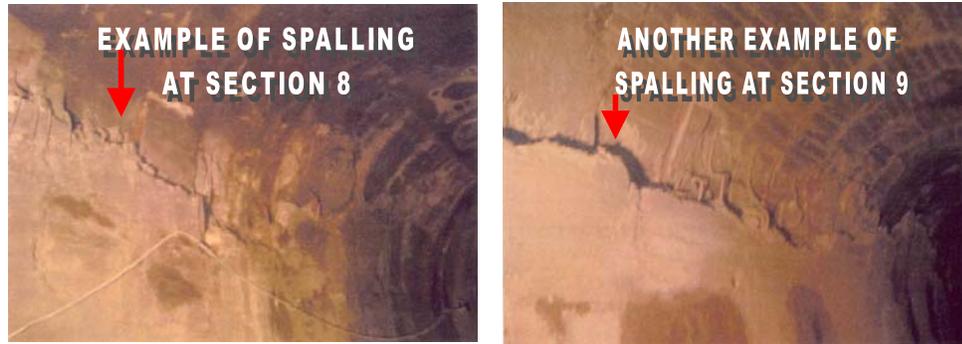
Figure 4.29 Examples of Spalling at the Tunnel before Rehabilitation Work

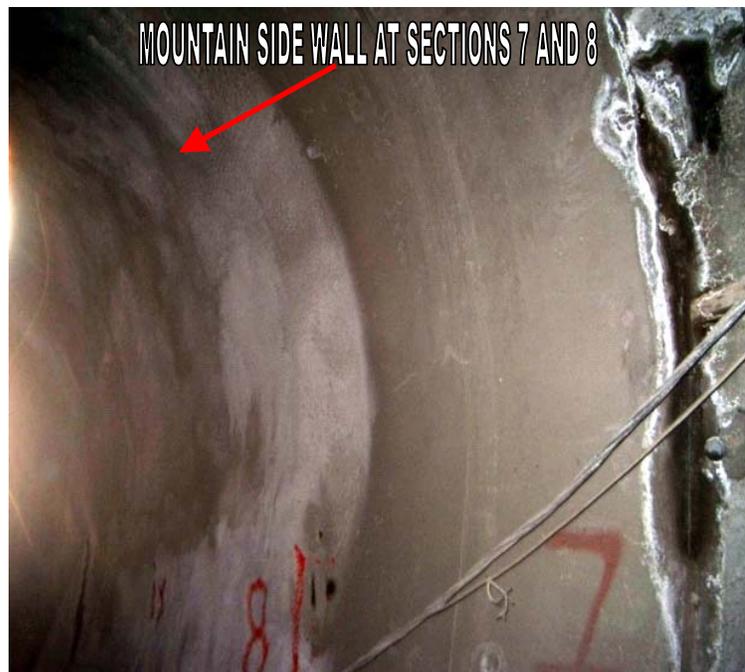
Figure 4.30 The Condition of the Sections 7 and 8 at the Mountain Side after Rehabilitation works

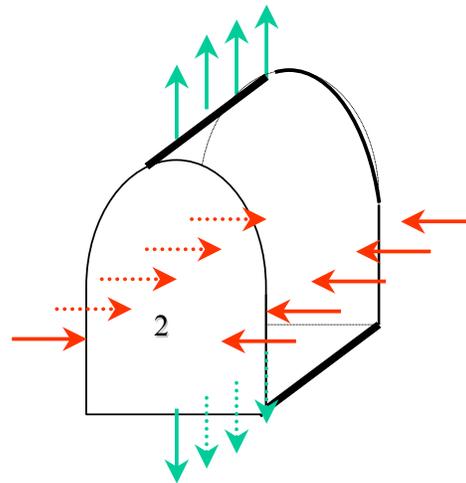
Figure 6.7 Horizontal Closure and Vertical Dilation in Section 2

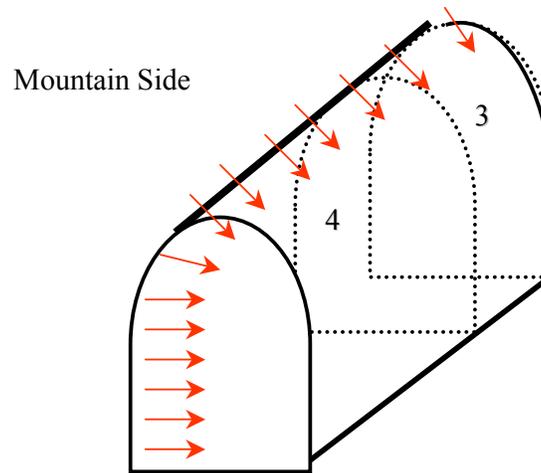
Figure 6.8 The Behaviour of Tunnel Sections 3 and 4
