**RESTORATION PROJECT OF A TRADITIONAL HOUSE
IN CAMİŞERİF DISTRICT 5227 STR. NO: 14 MERSİN**

**A THESIS SUBMITTED TO
THE GRADUATE SCHOOL OF NATURAL AND APPLIED SCIENCES
OF
MIDDLE EAST TECHNICAL UNIVERSITY**

JULY 2005

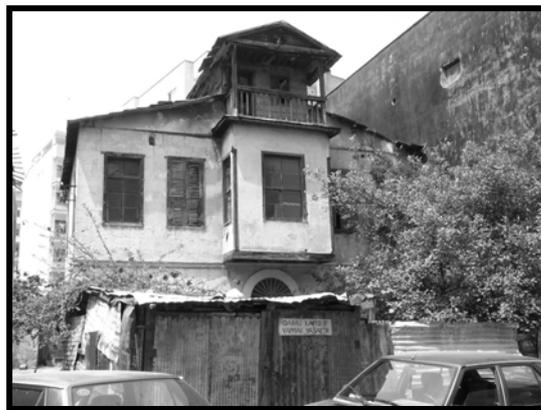
Figure 3-1 South Façade

window (WG1) is located 8,69m from the west end and begins at +1,07m from datum line with 1,77*0,91m dimensions. The ground floor is plastered which is a cement based plaster with a rough surface and a dark grey color, from ground up to 1,14m from datum line with a rough surfaced cement based plastered. After this height, the ground floor is plastered with a cement based, smooth surfaced and light gray of plaster fully up to the cornice. The plaster is detached and fades away in patches and in these places; we can see the cut stone masonry. These plaster

detachments are mostly begins at the +1,14m from datum line to the maximum 2,26m from datum line. There is an almost circular shaped hole with a 0,21m diameter, on the stone masonry wall at 0,34m from datum line and 2,12m from the west end of the façade.

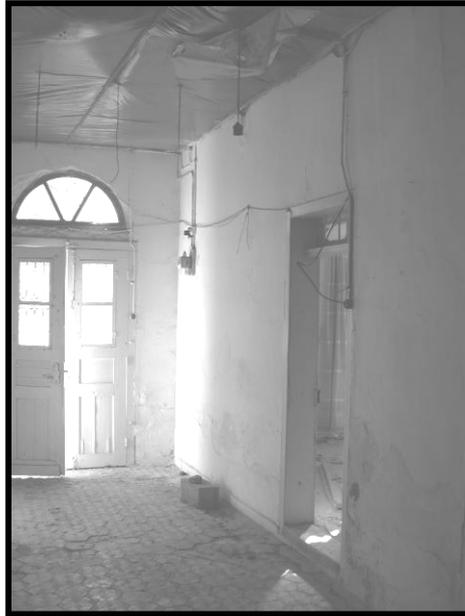
Figure 3-5 Space G01

The space G01 is entered through a double winged with an arched clearstory door (DG1) on the south façade. This door is located in the middle of the southern wall of the space. The door is 0,42m from the east wall of the space G01. From ground up to the 0,57m from datum line, the wall is deteriorated and white deposit on the plaster can be observed.

The west wall of the space G01 is 7,76m in length and 3,44m in height. There are two doors located on this wall. The first door (DG3) is a single wing timber door with 1,01*2,33m dimensions and it is 2,79m from the south wall of the space. This door opens to the space G02. The other door (DG3) on the wall is 4,82m from the south wall with 1,01*2,33m dimensions. The door opens to the space G03. There is a timber baseboard all through the wall from ground with a 0,12m height. The wall is deteriorated because of the dampness problem most probably caused by the rising damp problem from ground up to the 0,94m from the datum line, average level. The wall can only be observed from ground up to +3,39m from datum line, because of the plastic based covering material of the ceiling.

The north wall of the space G01 is 2,41m in length and 3,44m in height. There is a window and a door is located on this wall. The window and the door are constructed together as one (DG2). The window is a timber sash window with 0,99*1,72m dimensions and it begins directly from the east wall of the space. The window is located at +1,10m from datum line. This window opens to the space G06. The door is 1,02m from the east wall with 1,35*2,59m dimensions. The door opens to the space G06. There is a timber baseboard all through the wall from ground with a 0,12m height. The wall is deteriorated because of the dampness problem most probably caused by the rising damp problem from ground up to the 0,94m average from datum line. The wall can only be observed from ground up to +3,32m from datum line, because of the plastic based covering material of the ceiling.

4,03m from the north wall with 1,01*2,33m dimensions. The door opens to the space G05. There is a timber baseboard all through the wall from ground with a 0,12m height. The wall is deteriorated because of the dampness problem most probably caused by the rising damp problem from ground up to the 0,98m average from datum line. The wall can only be observed from ground up to the 3,33m from datum line, because of the plastic based covering material of the ceiling.

The floor is covered by hexagonal mosaic tiles. All the sides of the mosaic tiles are 0,11m long. There are 40 tiles on the long side and 15 tiles on the short side. The ground level is deformed but tiles are in good condition.

The ceiling is covered by a plastic based fabric material. This additional material is nailed by some timber laths irregularly to the ceiling. The ceiling can not be observed from the covering material. From the partially observed parts from the small holes on the covering material, it appears that the ceiling is a lathed timber ceiling type and severely deteriorated.

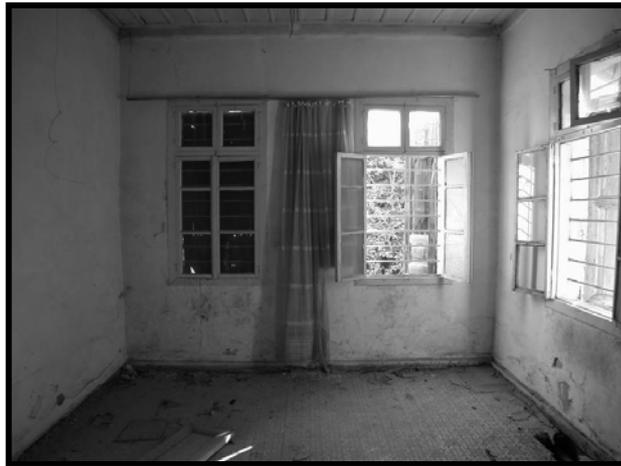
Figure 3-6 Space G02

The space G02 is entered through a single winged door (DG3) on the east wall of the space. This door is located 0,64m from the north wall of the space and the dimensions of the door are 1,01*2,33m. The east wall of the space is 4,42m long and 3,20m in height. There is a timber baseboard all through the wall from ground with a 0,12m height. The wall is deteriorated because of the dampness problem most probably caused by the rising damp problem from ground up to the 0,42m average from datum line.

wall of the space. The other window (WG1) on the wall is 2,23m from the east wall with 0,91*1,77m dimensions, beginning at +0,92m from datum line. There is a timber baseboard all through the wall from ground with a 0,12m height. The wall is deteriorated because of the dampness problem most probably caused by

the rising damp problem from ground up to the 0,94m average from datum line and the penetration of the water from the windows.

The west wall of the space G02 is 4,43m in length and 3,29m in height. There is a window (WG2) located on this wall. The window is a double winged timber window with solid timber shutter and balustrades with 0,91*1,77m dimensions, beginning at +0,93m from datum line and it is 0,86m from the south wall of the space. There is a timber baseboard all through the wall from ground with a 0,12m height. The wall is deteriorated because of the dampness problem most probably caused by the rising damp problem from ground up to the 0,28m average from datum line and the penetration of the water from the window.

The ceiling is a timber lathed ceiling. The laths are in south to north direction. It is in a good condition.

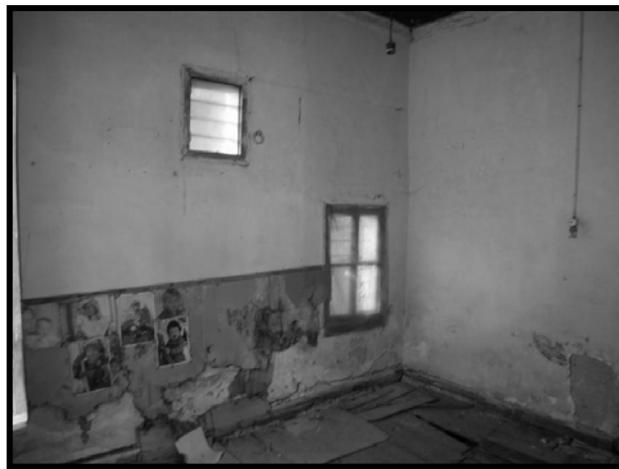
Figure 3-7 Space G03

The space G03 is entered through a single winged door (DG3) on the east wall of the space. This door is located 1,85m from the north wall of the space and the dimensions of the door are 1,01*2,33m. The east wall of the space is 2,99m long and 3,24m in height. There is a timber baseboard all through the wall from ground with a 0,12m height. The wall is deteriorated because of the dampness problem most probably caused by the rising damp problem from ground up to +0,51m average from datum line.

a 0,21m diameter, 0,42m from the south wall. The window (WG2) is a double winged timber window with solid timber shutter and balustrades with 0,91*1,77m dimensions, beginning at the 0,96m from datum line and it is 1,04m from the south wall of the space. There is a timber baseboard all through the wall from ground with a 0,12m height. The wall is deteriorated because of the dampness problem most probably caused by the rising damp problem from ground up to the 0,10m average from datum line and the penetration of the water from the window.

The ceiling is a timber lathed ceiling. The laths are in east to west direction. The ceiling, at the south end, begins from a timber element which projects 0,10m from the wall. It is in a good condition.

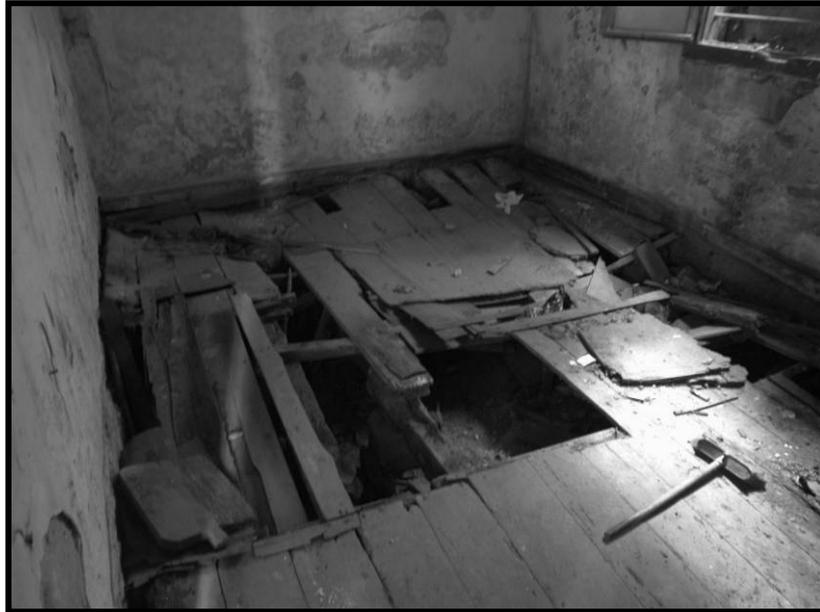
Figure 3-8 Space G04

The space G04 is entered through a single winged door (DG3) on the west wall of the space. This door is located 3,50m from the north wall of the space and the dimensions of the door are 1,01*2,33m. The west wall of the space is 4,59m long and 3,28m in height. There is a door which has been described and a window located on this wall. The window (WG3) is a single winged timber window with balustrades with 0,93*0,97m dimensions, beginning at +1,82m from datum line and it is 0,34m from the north wall of the space. There is a timber baseboard all through the wall from ground with a 0,12m height. The wall is deteriorated because of the dampness problem most probably caused by the rising damp problem from ground up to +0,58m average from datum line.

The north wall of the space G04 is 3,21m in length and 3,28m in height. There is a timber baseboard all through the wall from ground with a 0,12m height. There is a circular shaped hole on this wall with 0,18m diameter at +2,70m from datum line. The wall is deteriorated because of the dampness problem most probably caused by the rising damp problem from ground up to +0,98m average from datum line.

The east wall of the space G04 is 4,01m in length and 3,29m in height. There is a window on this wall. The window (WG6) is a double winged timber window with solid timber shutter and balustrades with 1,15*1,62m dimensions, beginning at +1,08m from datum line and it is 1,89m from the south wall of the space. There is a timber baseboard all through the wall from ground with a 0,12m height. The wall is severely deteriorated because of the dampness problem most probably caused by the rising damp problem from ground up to the 1,50m average from datum line from the datum line and the penetration of the water from the window. The deteriorated portion of the wall rises up to +2,10m from datum line at the south end of the east wall.

The south wall of the space G04 is 3,17m in length and 3,26m in height. There is a timber baseboard all through the wall from ground with a 0,12m height. The wall is severely deteriorated because of the dampness problem most probably caused by the rising damp problem from ground up to +2,10m from datum line at the east end and +0,30m from datum line at the west end.

The floor is timber structure and severely deteriorated. The floor has collapsed and a lot of material loss is observed. The ground is at the -0,44m from datum line. There is a stone vertical element which supports the floor structure can be observed from the collapsed structure.

The ceiling is a timber lathed ceiling. The laths are in north - south direction. The ceiling is in good condition but there are some small regional white deposits can be seen.

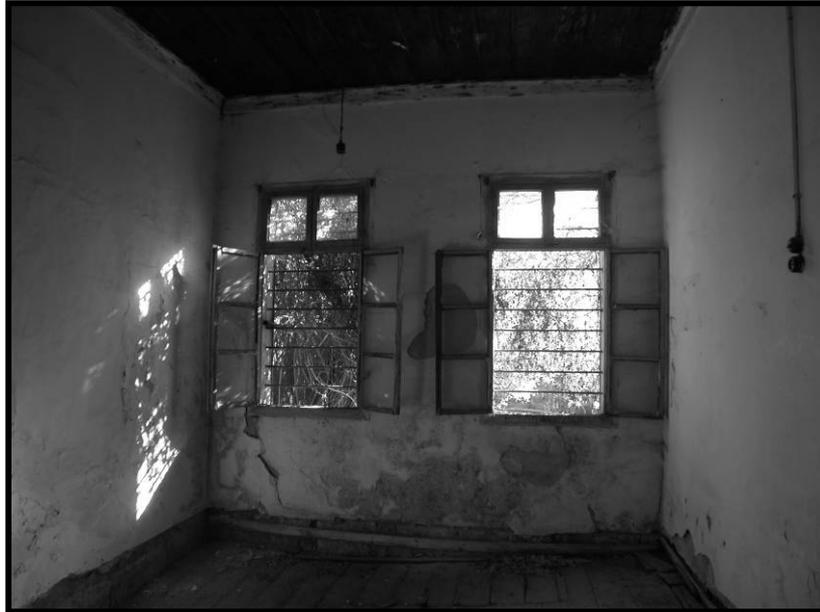
Figure 3-9 Space G05

The space G05 is entered through a single winged door (DG3) on the west wall of the space. This door is located 2,72m from the north wall of the space and the dimensions of the door are 1,01*2,33m. The west wall of the space is 4,44m long and 3,25m in height. There is a timber baseboard all through the wall from the round with a 0,12m height. The wall is deteriorated because of the dampness problem most probably caused by the rising damp problem from ground up to +0,18m average from datum line.

The north wall of the space G05 is 3,20m in length and 3,25m in height. There is a timber horizontal element is projecting 0,02m from the wall with 0,12m thickness located at +1,82m from datum line and continues all through the wall. There is a timber baseboard all through the wall from ground with a 0,12m height. The wall is severely deteriorated because of the dampness problem most probably caused by the rising damp problem from ground up to +1,52m from datum line at the east end and +0,20m from datum line at the west end.

is a rectangular well shaped crack which could be a trace, on the plaster, 2,73m from the north wall at +0,90m from datum line with 0,91*1,77m dimensions. The wall is severely deteriorated because of the dampness problem most probably caused by the rising damp problem from ground up to +1,50m average from datum line and the penetration of the water from the window. The deteriorated portion of the wall rises up to +1,90m from datum line at the north end of the east wall.

The south wall of the space G05 is 3,18m in length and 3,25m in height. There are two windows located on this wall. The first window (WG1) is a double winged timber window with solid timber shutter and balustrades with 0,91*1,77m dimensions, beginning at +0,90m from datum line and it is 0,29m from the east wall of the space. The other window (WG1) on the wall is 1,94m from the east wall with 0,91*1,77m dimensions, beginning at +0,88m from datum line. There is a timber baseboard all through the wall from ground with a 0,12m height. The wall is deteriorated because of the dampness problem most probably caused by the rising damp problem from ground up to the 0,94m average from datum line and the penetration of the water from the windows.

The floor is timber structure and severely deteriorated. The floor has collapsed and the only the western side of the floor is structurally still connected to the main building.

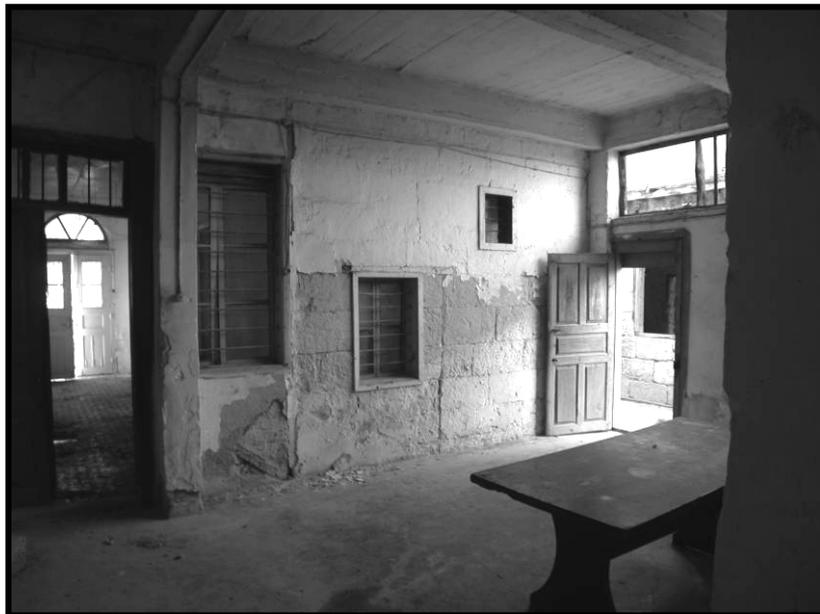
Figure 3-10 Space G06

north wall of the space is 5,86m long and 3,43m in height. There is a reinforced concrete column with 0,24*0,20m dimensions located 0,03m in front of the wall, 1,36m from the east wall of the space. There are two more windows on the wall other than the described one. The first window (WG5) on the wall is 2,90m from the east wall with 0,71*1,02m dimensions, beginning at +0,78m from datum line. The second window (WG4) on the wall is 4,26m from the east wall with 0,48*0,62m dimensions, beginning at +2,05m from datum line. The wall is deteriorated because of the dampness problem most probably caused by the rising damp problem from ground up to +0,26m average from datum line. The plasters up to +1,84m from datum line are lost and the stone masonry can be observed.

The west wall of the space is 4,41m long and 3,43m in height. There is a door located 0,26m from the south wall with 0,99*2,14m dimensions. This door is a jerrybuilt door constructed with reused timber elements and located on the west façade of the dwelling. There is a opening at +2,43m from datum line beginning 0,29m from the south wall with 3,86*0,74m dimensions. The space G07 is a WC space in the space G06. The partition walls of the space G07 begins from the

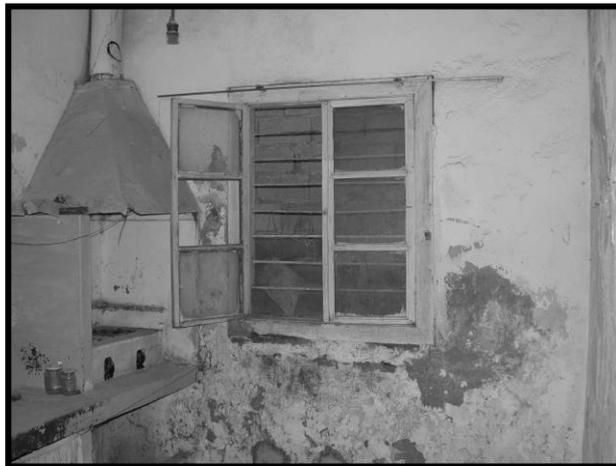
Figure 3-11 Space G09

+0,93m from datum line. There is a partition wall on the bench which is 2,32m from the west wall with 0,08m thickness and 0,80m in height. There is a metal based chimney hood located between the partition wall on the bench and the east wall. The chimney hood begins from +1,23m from datum line with 0,82m wideness and reaches +2,50m from datum line with 0,28m wideness. From the point where the chimney hood finishes, the chimney with 0,15m wideness begins and the chimney goes through the ceiling. There is a kerosene kitchen stove located just under the chimney hood. The wall is deteriorated because of the

dampness problem most probably caused by the rising damp problem from ground up to +1,29m average from datum line.

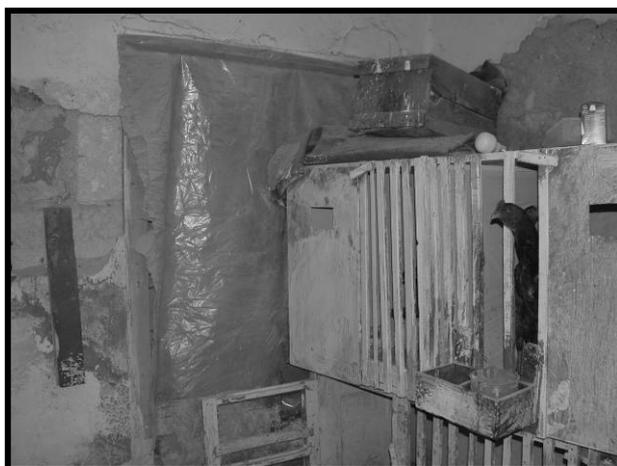
Figure 3-13 Space G15

The space G15 is entered through a door (DG5) on the west wall of the space. The west wall of the space is 3,81m long and 3,32m in height. This door is located attached to the north wall of the space and the dimensions of the door are

1,09*2,33m. The wall is deteriorated because of the dampness problem most probably caused by the rising damp problem from ground up to +1,11m average from datum line.

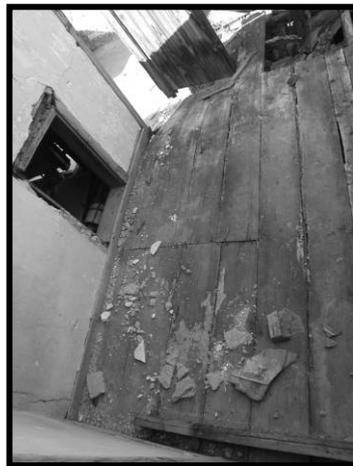
Figure 3-26 Space C03

The north wall of the space is 2,34m long and 2,27m in height. There is a severely deteriorated and deformed window located on this wall. The window is 0,62m from the west wall, at +8,27m from datum line with 0,87*1,23m dimensions. It is constructed with stone masonry. The wall is timber skeleton structure constructed with the walls without infill with *bağdadi* technique. The wall is severely deteriorated and deformed. There is no plaster left on the walls and the deformation of the wall is more severe at the north end. Structurally the wall is not stable.

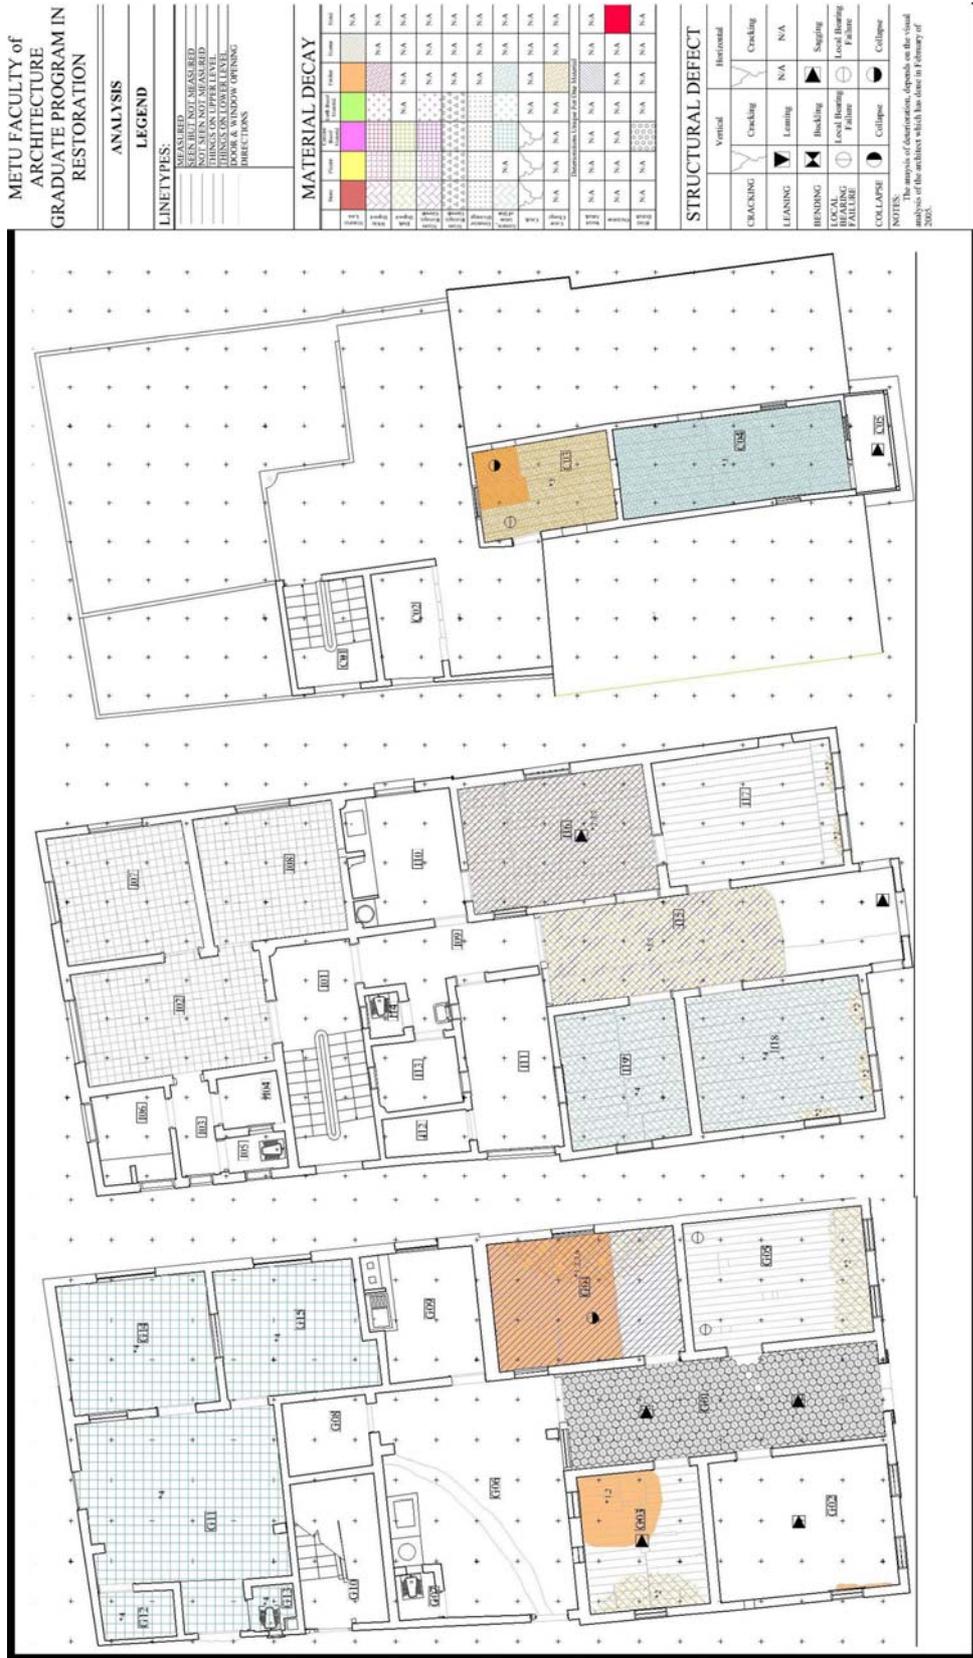
Figure 3-76 Material Decaying Forms and Structural Defects 1

It is obvious that the main reason of the deteriorating problems is the dampness. The damp problem possibly caused by two main factors. These are; rain water penetration and the rising damp problem. Rain water penetration to the materials caused by deteriorated and partially collapsed timber roof structure, wrong or inadequate detailing, deteriorated window and door openings and drainage problems.
