**A STUDY ON DAM INSTRUMENTATION RETROFITTING:
GÖKÇEKAYA DAM**

**IN PARTIAL FULFILLMENT OF THE REQUIREMENTS
FOR
THE DEGREE OF MASTER OF SCIENCE
IN
CIVIL ENGINEERING**

DECEMBER 2008

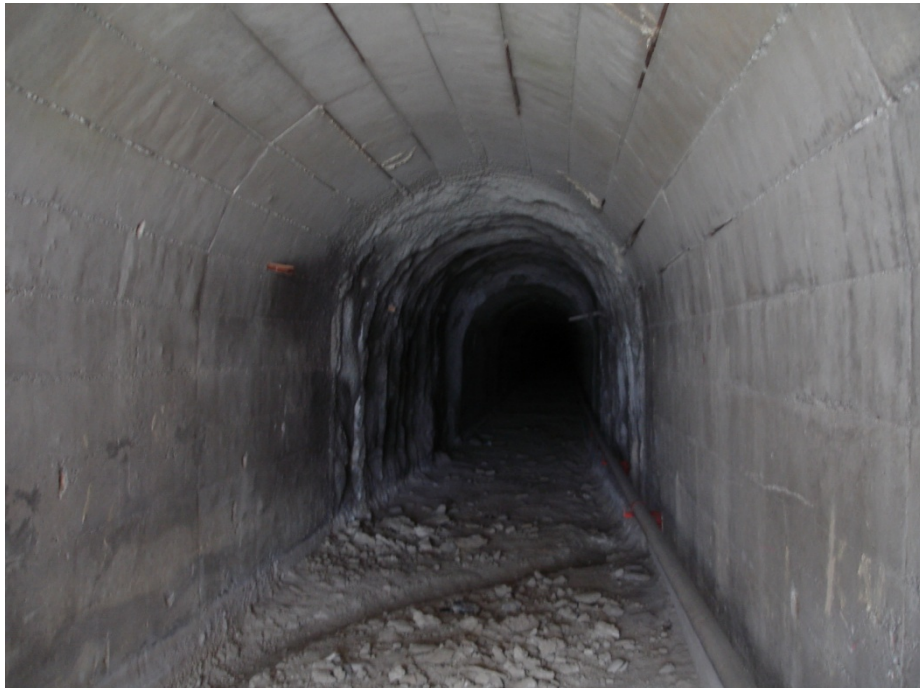
Figure 4.7 Left abutment inspection gallery (LA-1)

The investigation has been started in an inspection gallery (LA-1) on the left abutment at relatively high level (see Figure 4.7). This gallery extends towards the left abutment and the access road to the dam crest passes just above. The inside of the gallery was full of debris and concrete wastes. On the walls and ceiling of the gallery, traces of leaked water could be easily noticed. Water was seeping through the ceiling, starting from the construction joints which were deteriorated as a result of seeped water. Some traces were dry, some others were leaking. Some calcium deposits were noticed, possibly related with the surrounding earth material (see Figure 4.8).

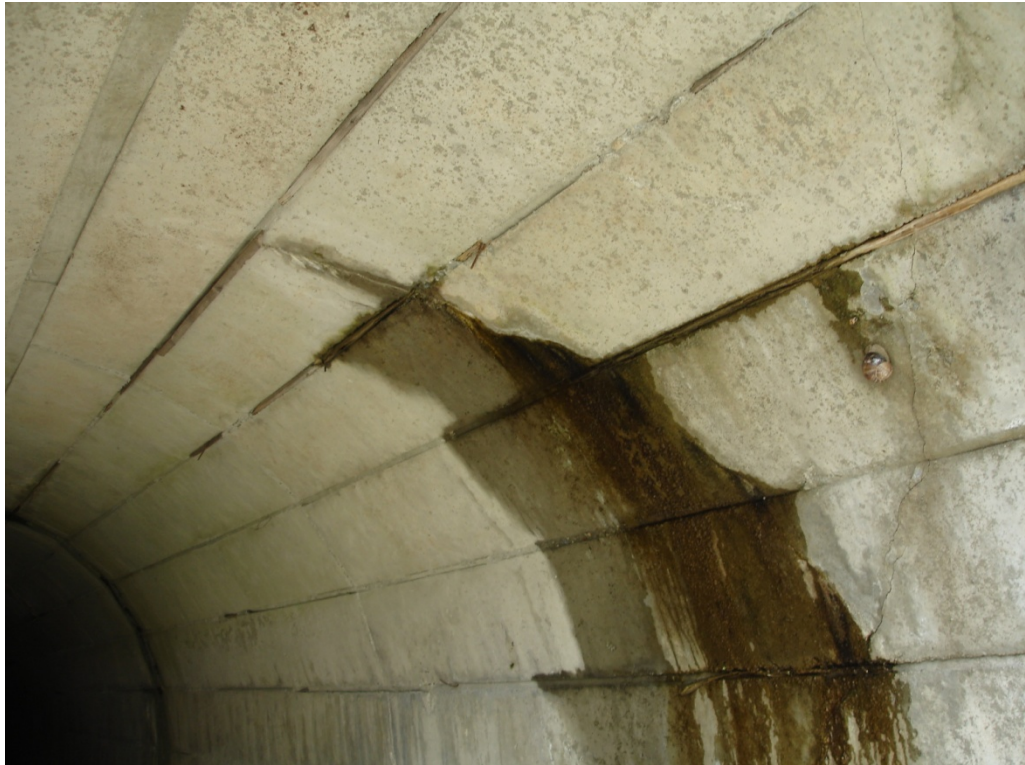
Figure 4.8 Seeping water through the ceiling of gallery

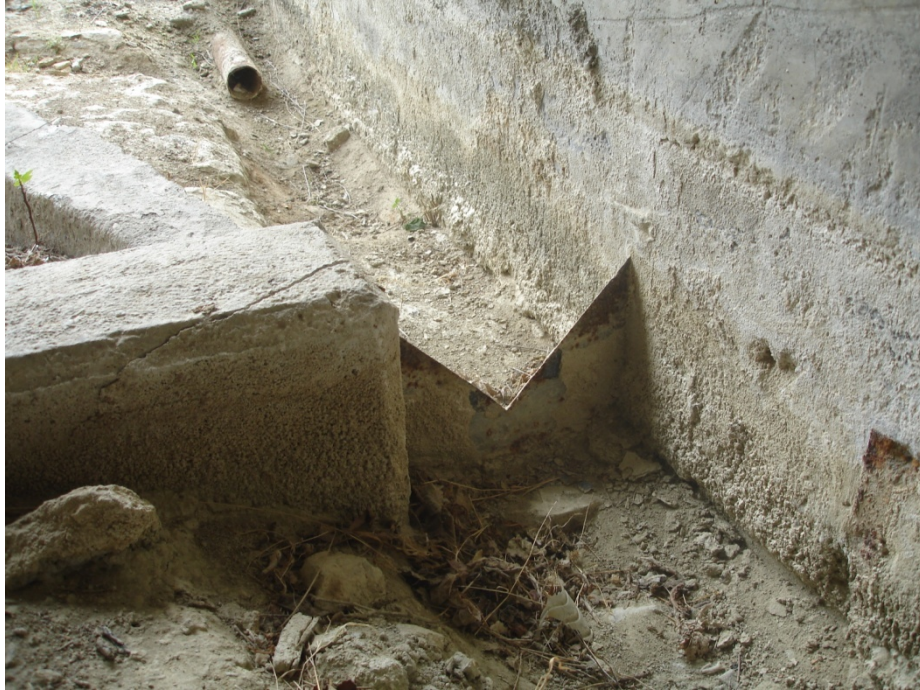
As a result of low seepage flow, collector on the base of the gallery was dry. At the exit of the gallery, a triangular weir exists to measure seepage flow; however it was full of debris and wastes. So the possible future measurements cannot be taken correctly. The condition of the aforementioned weir is shown in Figure 4.9. Some diagonal cracks were also discovered on the walls of the aforementioned inspection gallery as shown in Figure 4.8.

Figure 4.9 Accumulated debris at the weir

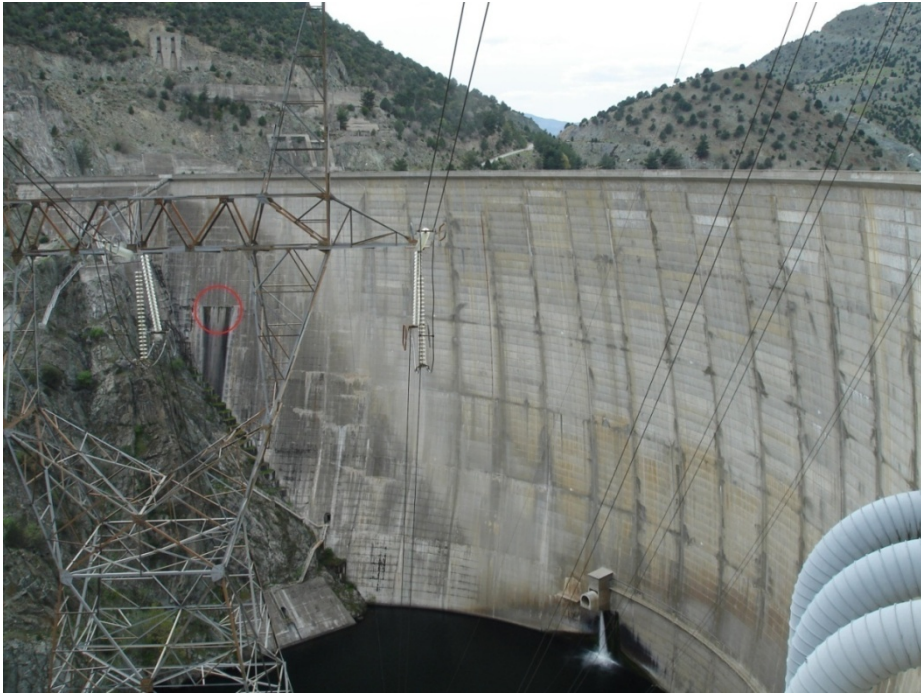
Figure 4.10 Crack on the face of the dam

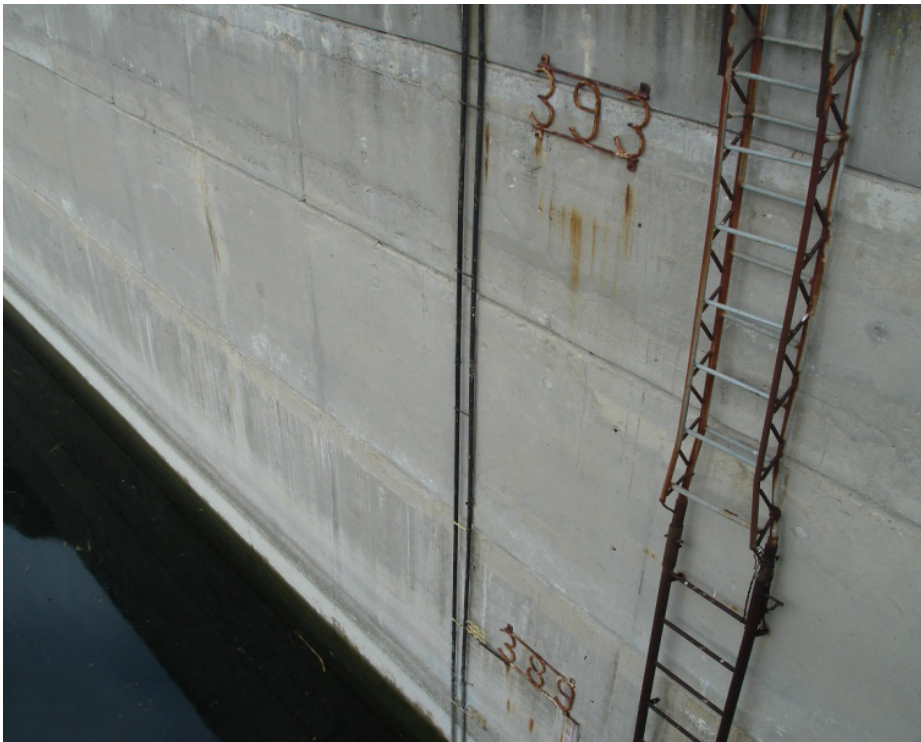
At the dam crest, there was no equipment to measure and log the reservoir level. A graduated stick which was possibly mounted during the construction was observed at the upstream face. A view from the graduated stick of Gökçekaya Dam is given in Figure 4.11.

Figure 4.11 Reservoir level measurement

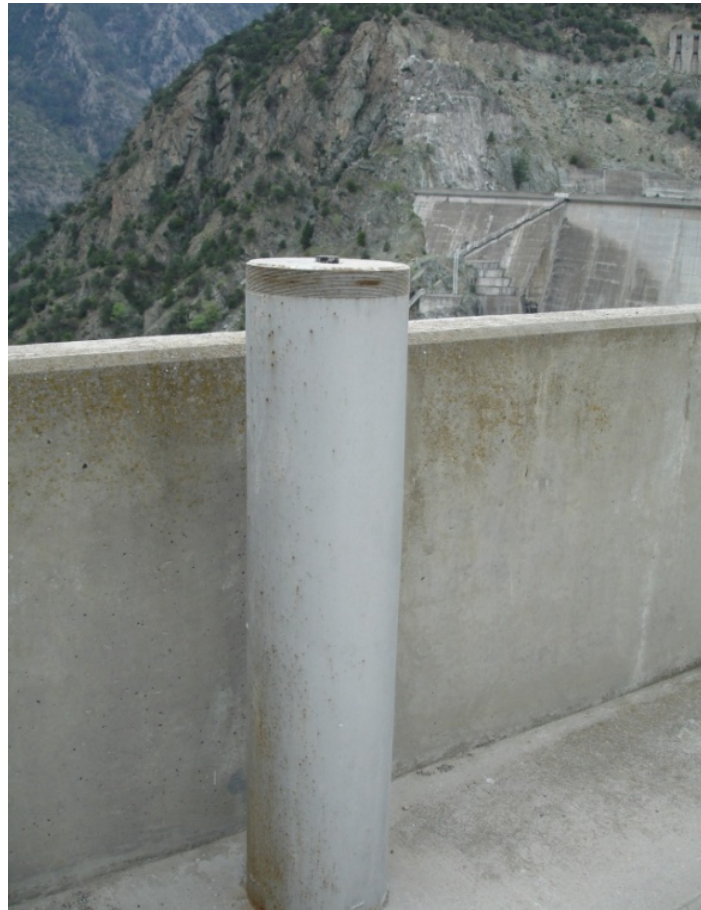
On the dam crest, a number of surface monuments exist which were in good condition. A sample view from one of the surface monuments is presented in Figure 4.12. On downstream face of the dam, a number of surface markers exist at different levels whose surrounding area was painted to white in order to find them easily. However, the white paint seems deteriorated greatly. DSI officials noted that no systematic dam surface monitoring have been taken by conventional surveying techniques on this dam.

Figure 4.12 A surface monument

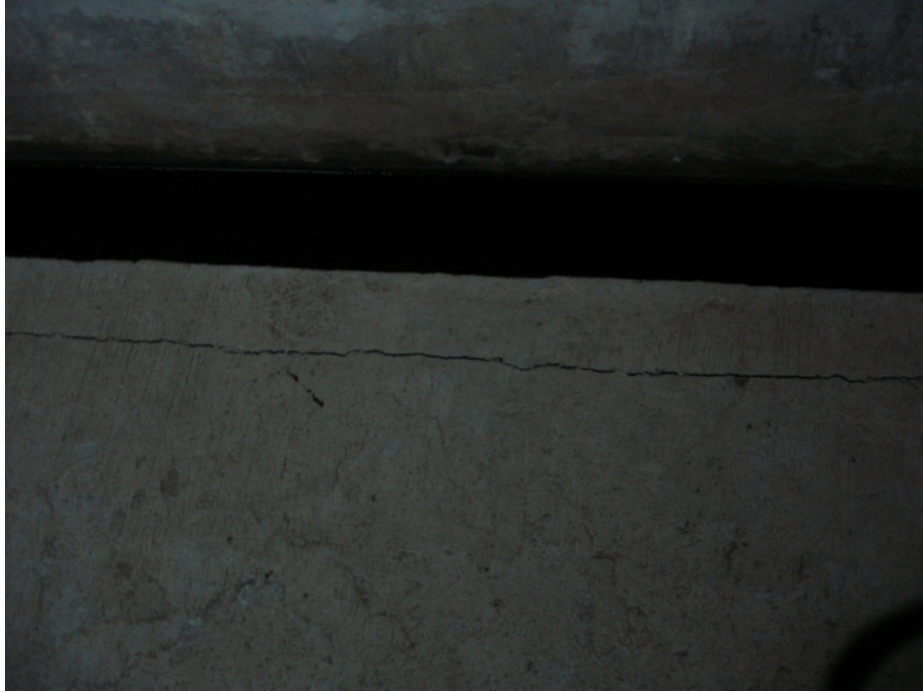
Figure 4.13 Crack on the base of the gallery

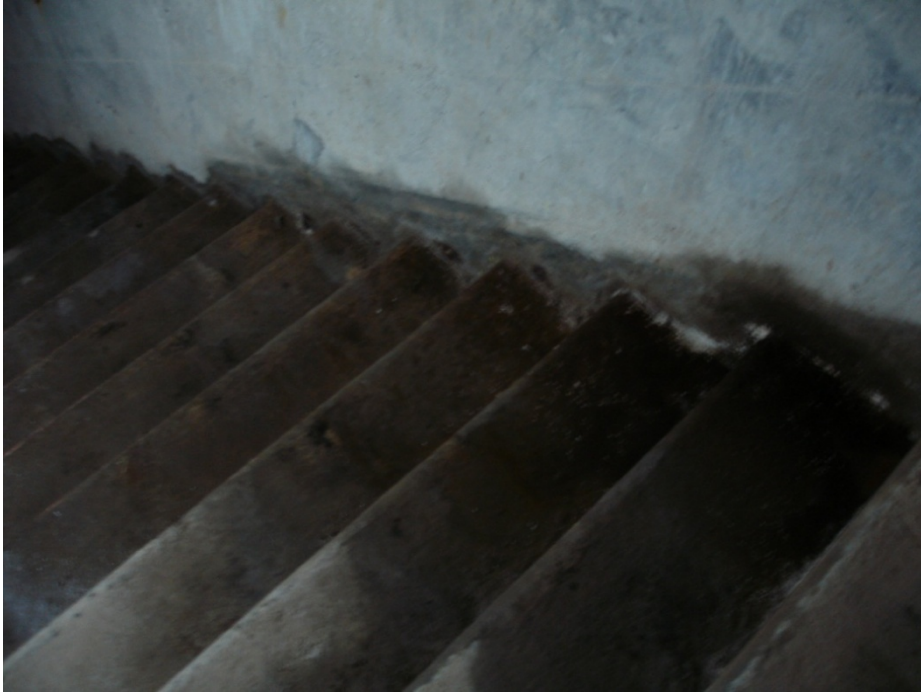
Figure 4.15 Wet stairs

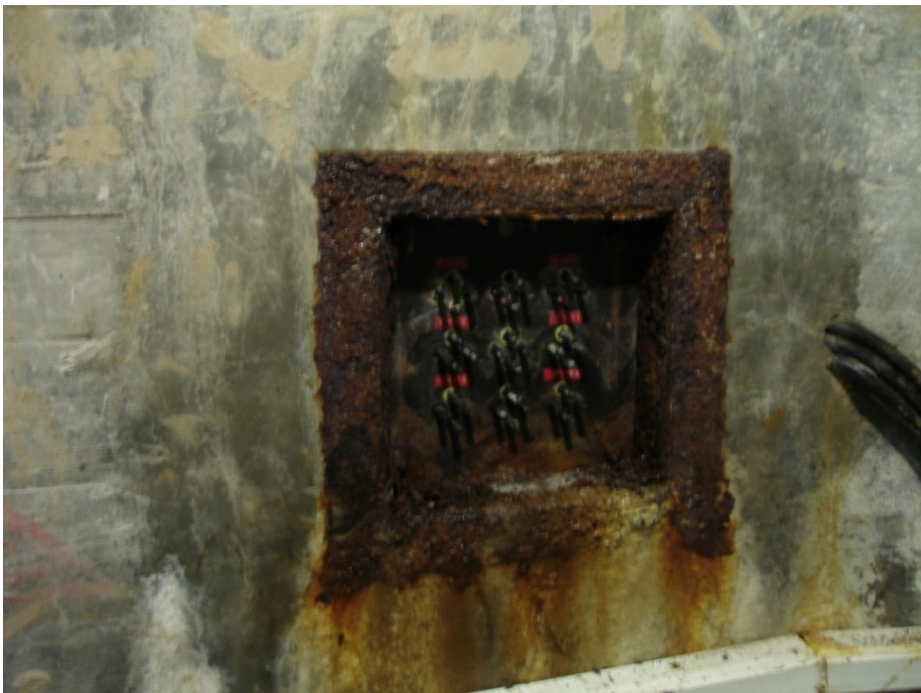
Figure 4.16 Corroded strainmeter ports

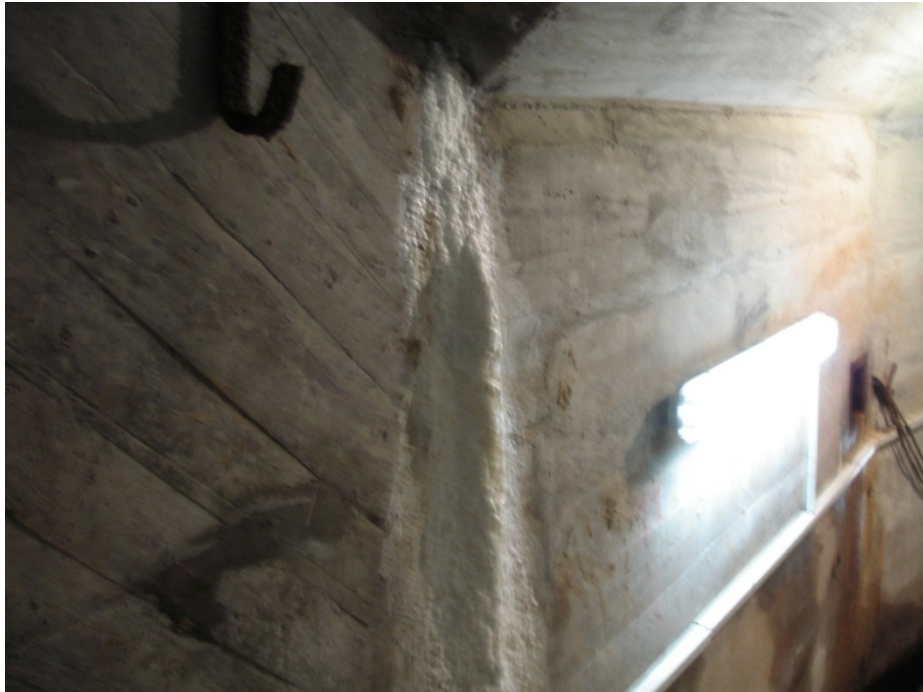
Figure 4.17 Calcium deposits along a construction joint

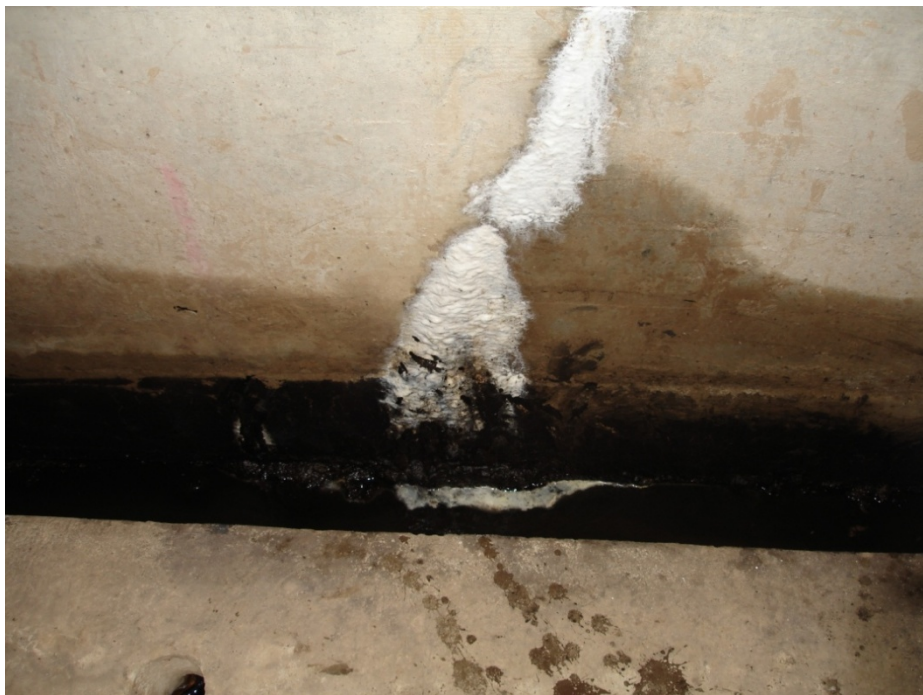
Figure 4.18 Calcium deposits

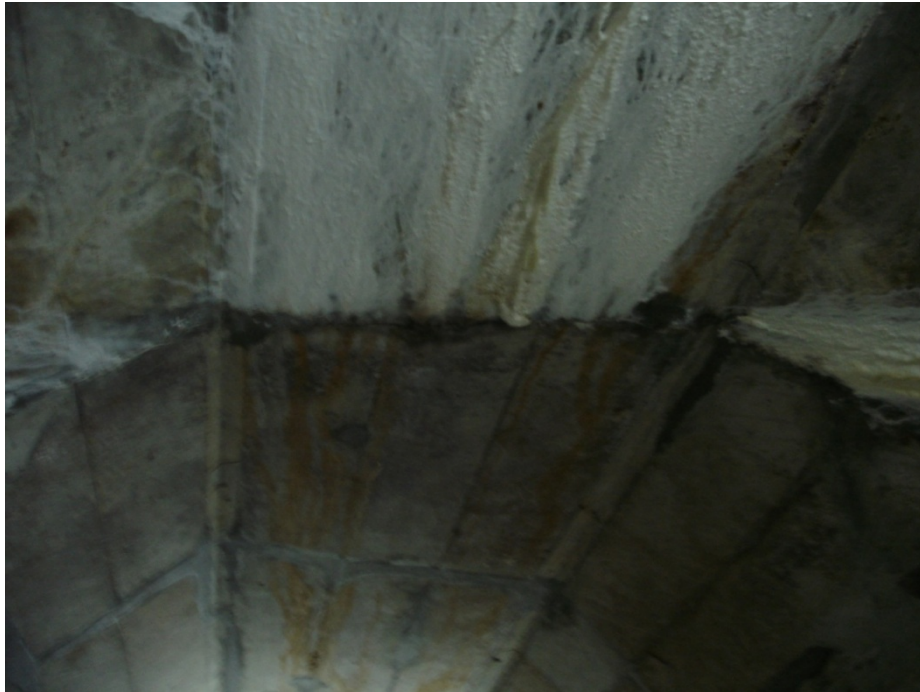
Figure 4.19 Calcium deposits at the ceiling of gallery

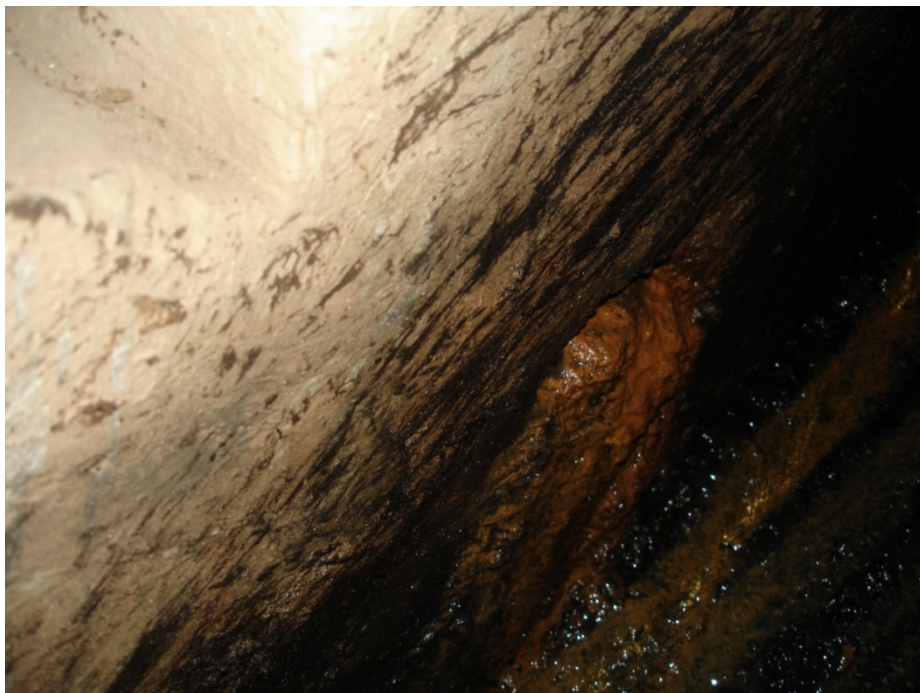
The inspection gallery of Gökçekaya Dam begins from the highest body elevation at side abutments. By following the foundation line, the gallery continuously lowers to the thalweg level of the dam by steep stairs. At the entrance of the gallery from the power plant access (Block 18), a crack on the base of the gallery, perpendicular to the dam axis was observed as shown in Figure 4.13. These types of lateral cracks are generally treated as an indication of differential settlement due to foundation movement. The triangular weir (B-18) had a flow with some debris accumulation (see Figure 4.14). The stairs were wet as shown in Figure 4.15 and the measurement ports of strain-meters were all corroded and were out of order (see Figure 4.16). On both the upstream and downstream walls along the construction joints, water leakage had formed a lime accumulation (see Figures 4.17 and 4.18). The ceiling had these traces of water leakage on several places as shown in Figure 4.19. Leakage from construction joints can be evaluated as a sign of joint movement. A red mud was also noticed on the side canal, which was observed in several drain holes on the stairs of the dam gallery. The traces of the aforementioned mud in two different drain holes and in drain canal are shown in Figures 4.20, 4.21, and 4.22, respectively.

Figure 4.20 Traces of red mud

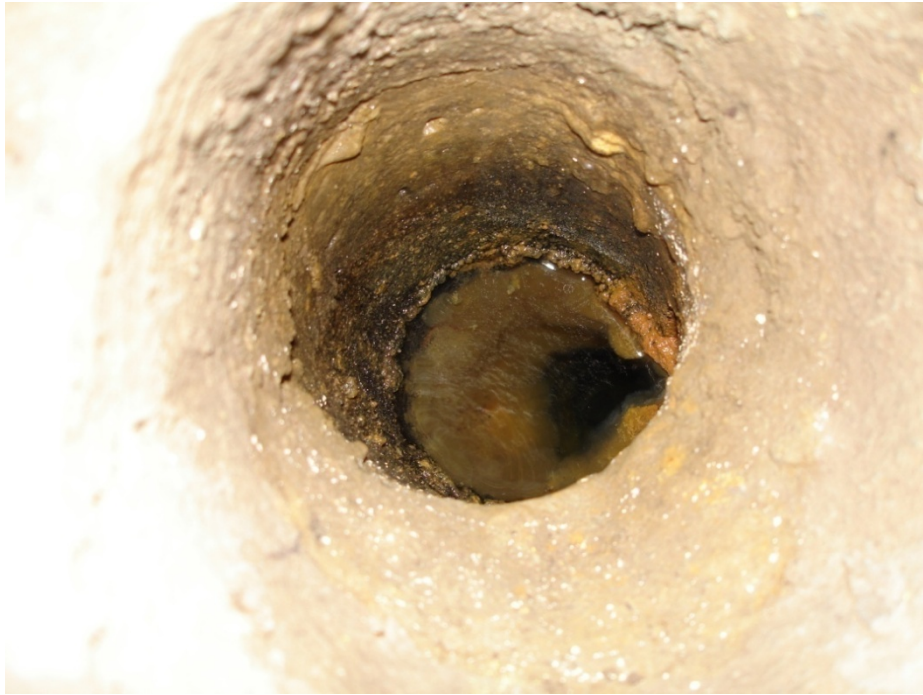
Figure 4.21 Red mud in a drain hole

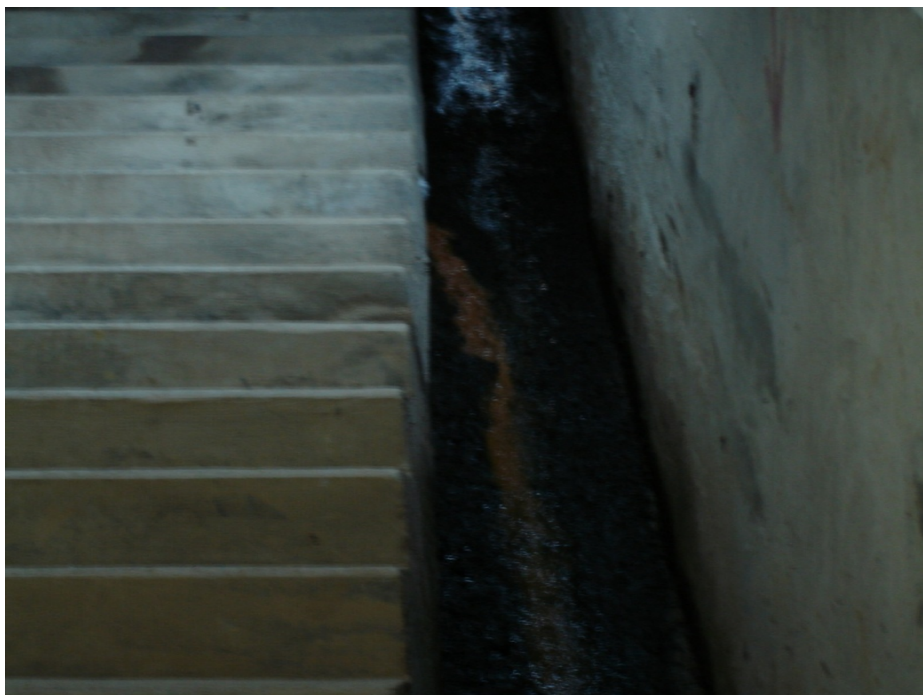
Figure 4.22 Traces of red mud in the drainage channel

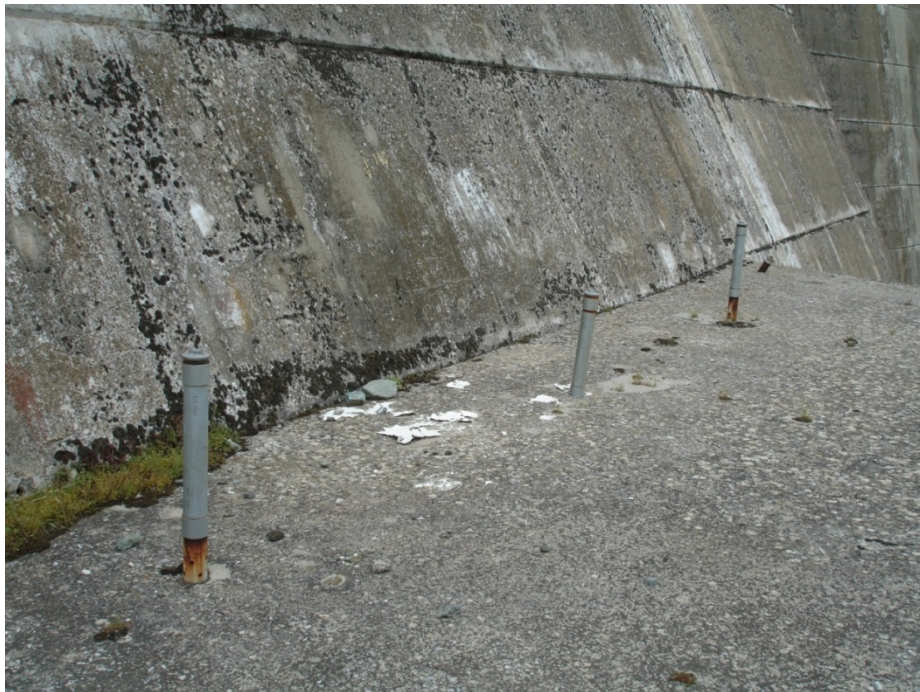
On the right abutment, around the right thrust block, eleven drain wells exist as shown in Figure 4.23. They have been used as a standpipe piezometer. One of them is out of order due to a subsidence. A table of readout of these drain wells recorded on 04.06.2001 by DSI officials implied that three of these wells had no water, possibly due to clogging.

Figure 4.23 Standpipe piezometers on the right thrust block

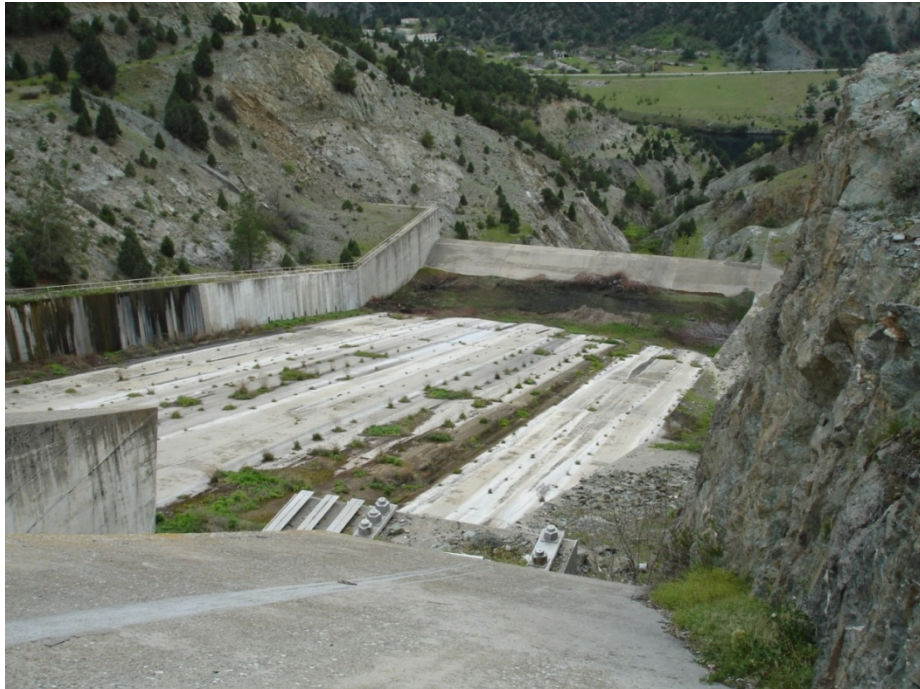
Figure 4.24 Gökçekaya Dam Spillway

The chute and deflector bucket sections of the spillway were heavily covered by plants as seen in Figure 4.24, which would significantly decrease the capacity of the spillway during operation. DSI officials stated that the gates have not been opened since 1982. Therefore, the

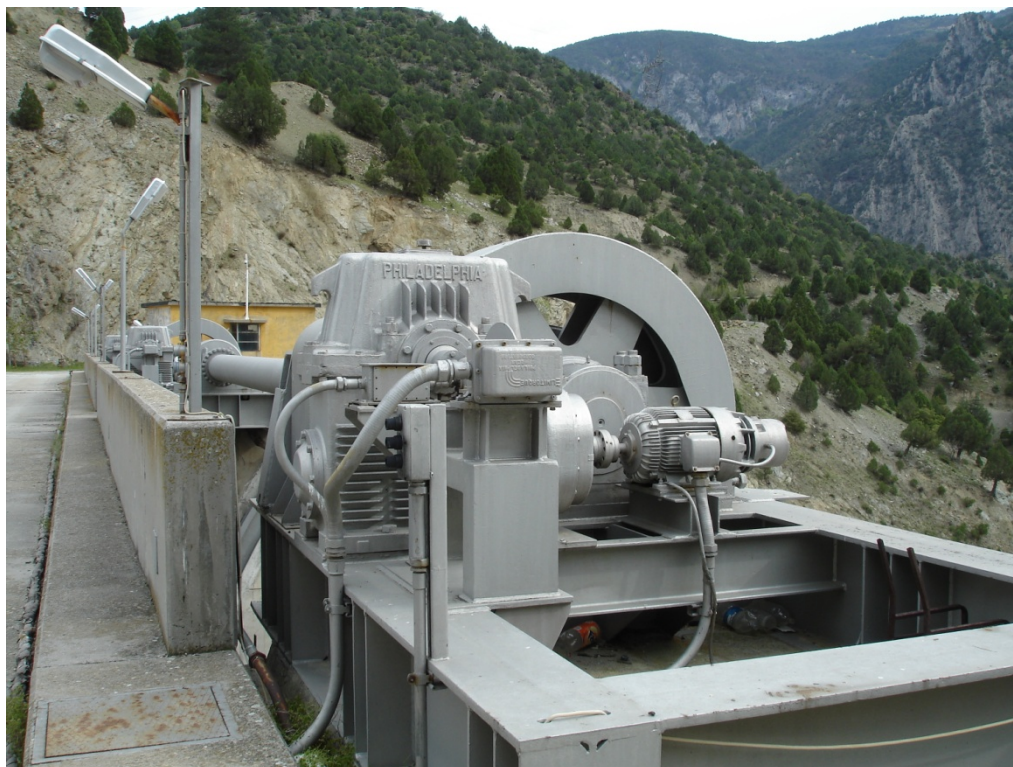
probability of failure of the mechanism during an emergency situation may be high (see Figure 4.25). Such an operational failure would create severe situation which may lead to a catastrophic event. An unexpected overtopping may occur as a result of this operational deficiency. It would, therefore, not only create a flood wave through the downstream, but also greatly erode the concrete body and the foundation of the dam. Moreover, the increased water level also leads to a greater seepage head and thus results in increased foundation seepage rate. Furthermore, appurtenant structures, such as three cranes on the crest of dam and the HEPP would be seriously damaged.

Figure 4.25 Spillway gate mechanism
