BUILDINGS UNDER RECURRING NEAR-FIELD EARTHQUAKES

A THESIS SUBMITTED TO
THE GRADUATE SCHOOL OF NATURAL AND APPLIED SCIENCES
OF
MIDDLE EAST TECHNICAL UNIVERSITY

SEPTEMBER 2010

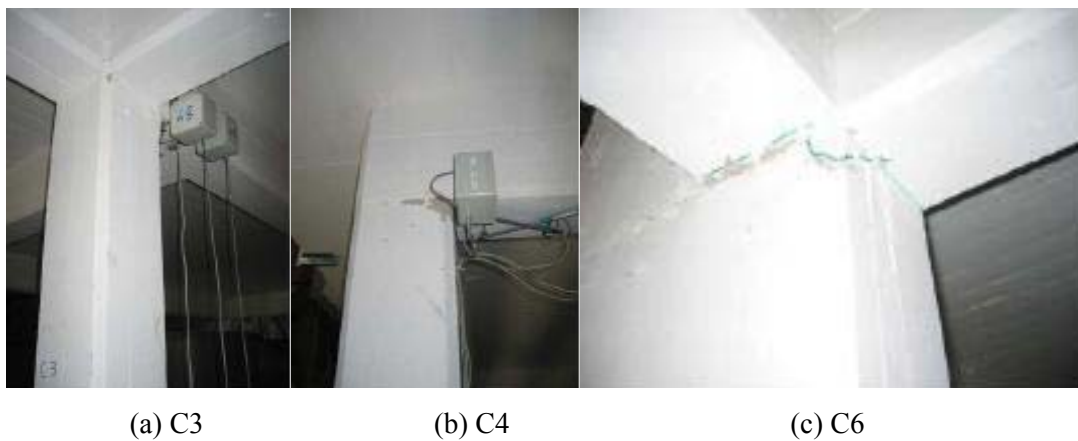
Damage pattern was identified by visual inspection after the 0.15 PGA test (Figs. 3.6 and 3.7). Only minor damage occurred during the test. It was observed at the top of second story columns. No cracks were observed at the bottom of these members. The beams were undamaged (Jeong and Elnashai, 2004).

Figure 3.6 Damage observed at the second story columns after the 0.15 PGA test (Adapted from Jeong and Elnashai, 2004)

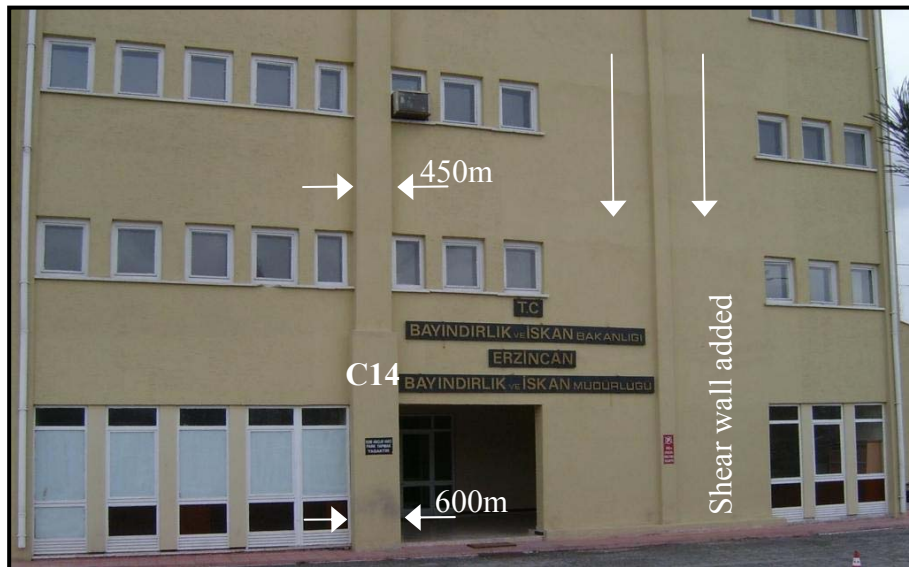
Damage in the Erzincan building consisted of minor hairline cracks in the ground and first story L-shaped corner columns. Hairline cracks in the ground and first story beams were observed. Minor shear cracks were noticed in first story masonry infill walls. In upper stories hairline cracks in the beams and infill walls and L-shaped corner columns at the window level were observed. The most significant damage that occurred in the Erzincan building was the minor shear cracks observed in the first story captive column-C14. Thus, different from the Bingöl building, an additional retrofit was conducted for the column-C14 in the Erzincan building as shown in Figs. 4.17 and 4.18.

Figure 4.17 The front view of the Erzincan building after the retrofit. Shear walls added at the exterior frame. Jacketed column-C14 at the ground and upper floors; the initial width of the column was 300 mm.

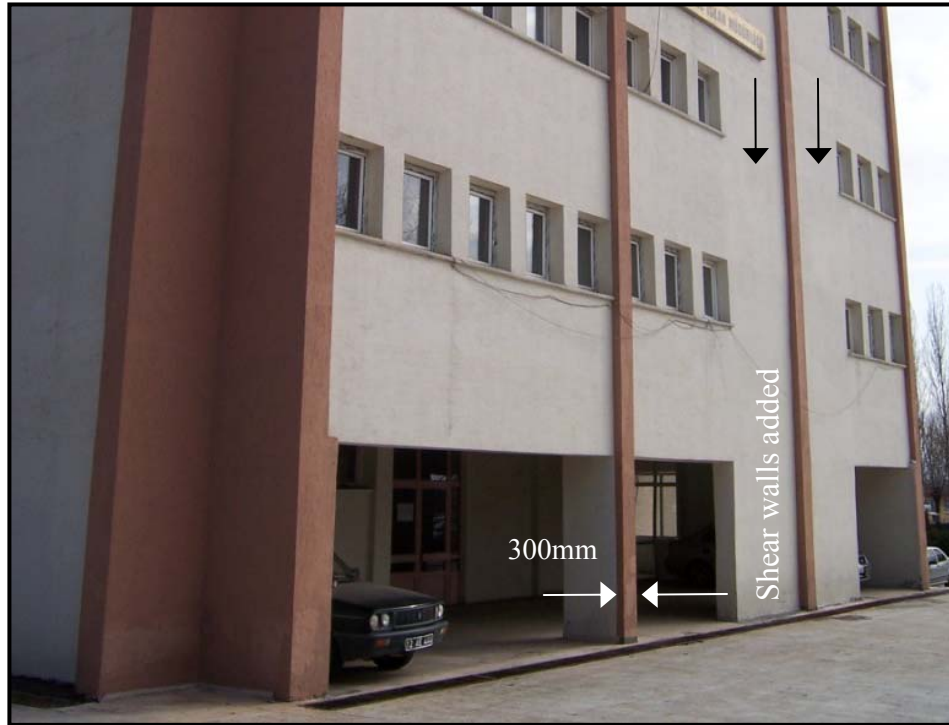
Figure 4.18 The front view of the Bingöl building after the retrofit. Shear walls added in the exterior frame.

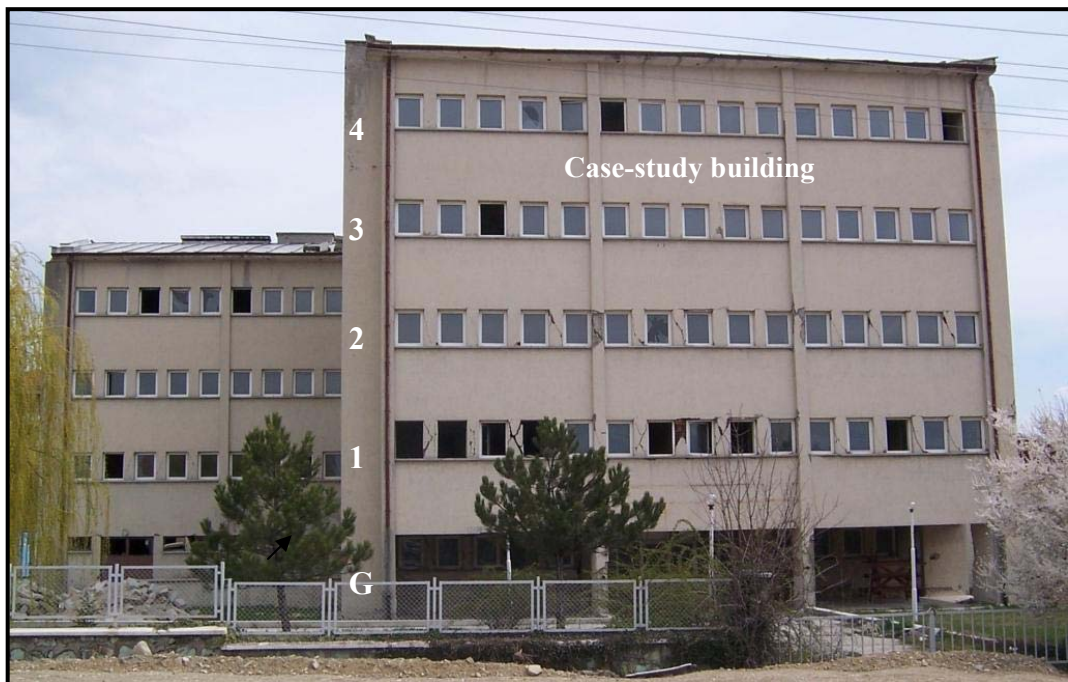
Figure 4.19 (a) Front view of the Bolu building: Shear failures in masonry infills between the narrow windows

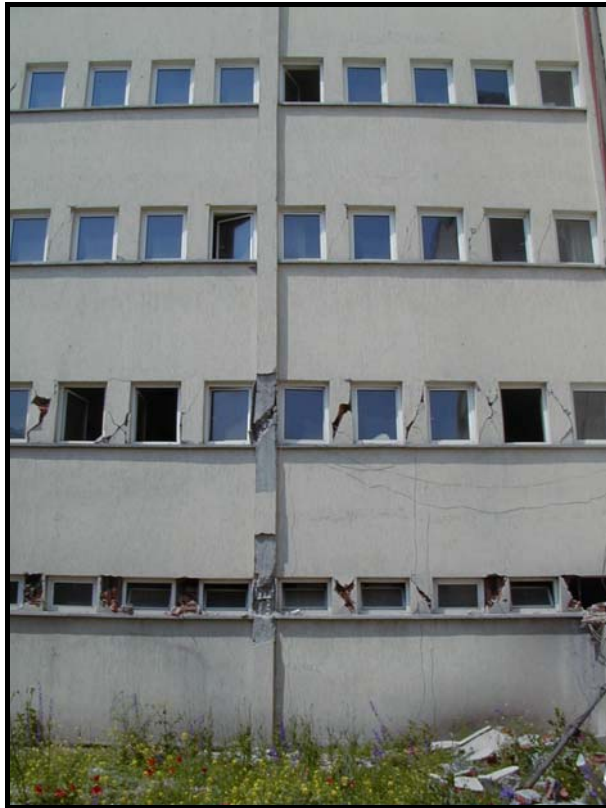
Figure 4.20 Rear view of the Bolu building: Infill failures at the bottom three stories and shear failures of the captive columns at the ground and first story

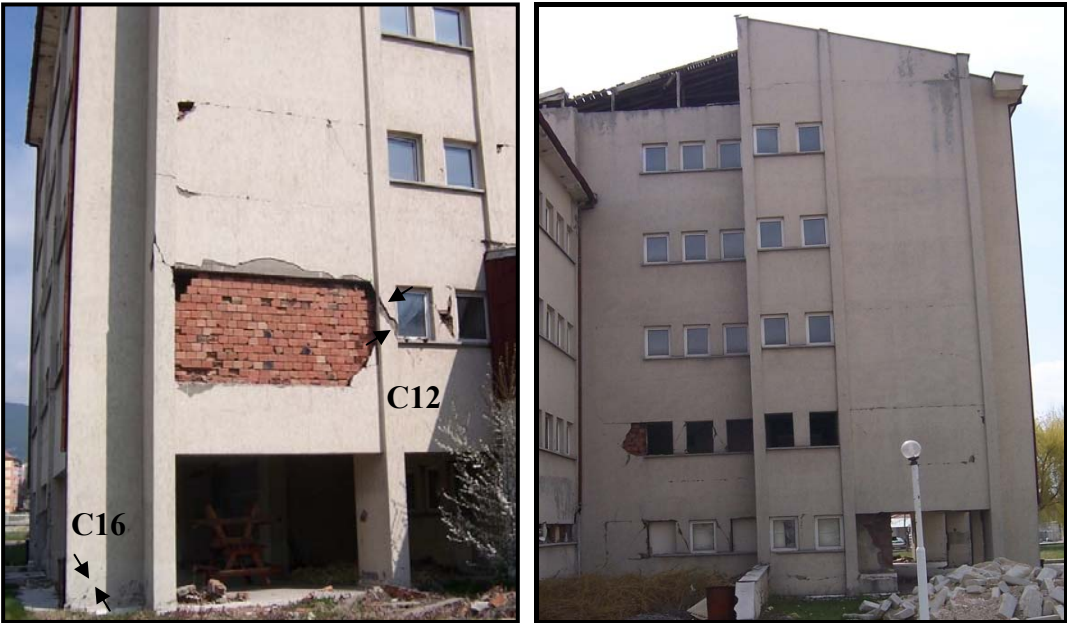
Figure 4.21 Lateral views from the Bolu building: Damage in infill walls, shear cracks in the ground story column-C16 and first story column-C12

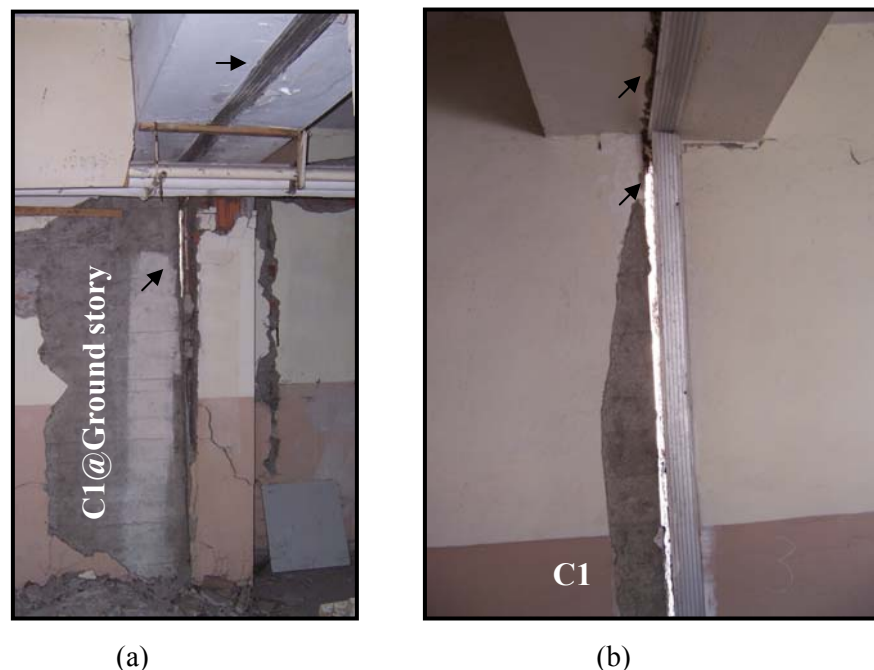
The building had been initially separated with the adjacent structures by a 50 mm seismic joint. However, it was evident that an impact had occurred with the adjacent building during the earthquake due to insufficient separation provided by the seismic joints. After the earthquake, column-C1 at the ground floor was in close contact with the adjacent building and the gap was closed at the bottom (Figure 4.22).

Figure 4.22 Seismic joints between the case-study building and ground-plus-three story building at the (a) ground and (b) third floor levels in Bolu

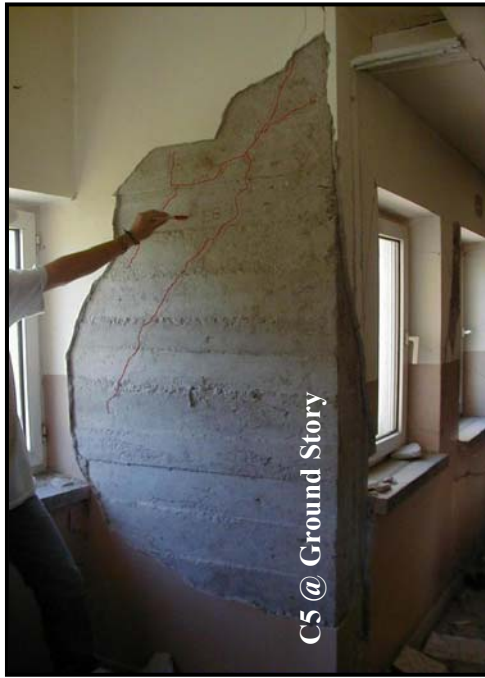
At the ground floor, column damage consisted essentially of shear cracks (Figs.4.23-4.33). Most of the columns sustained shear damage due to insufficient lateral reinforcement.

Figure 4.23 Shear cracks in the ground story column-C5 (Bolu)

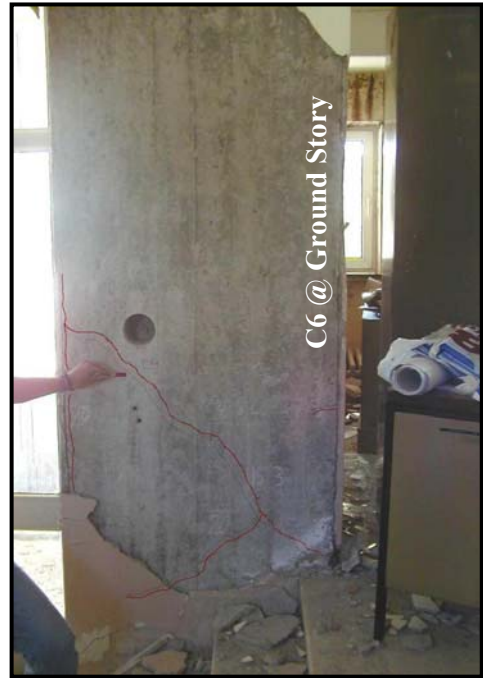
Figure 4.24 Shear cracks in the ground story column-C6 (Bolu)

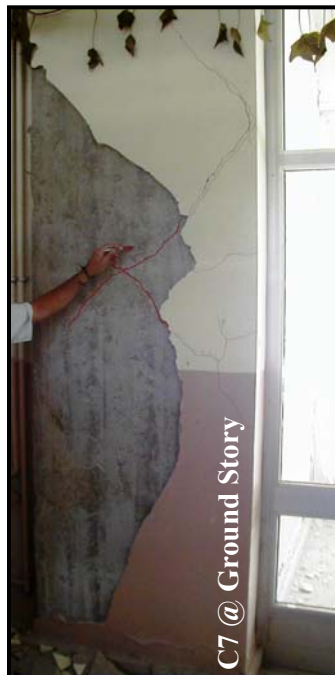
Figure 4.25 Shear cracks in the ground story column-C7 (Bolu)

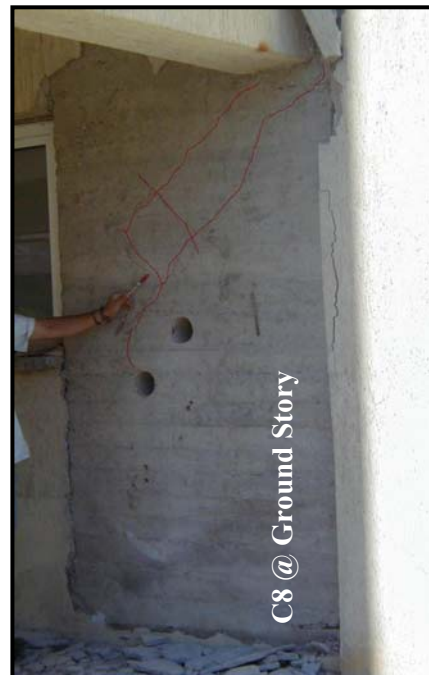
Figure 4.26 Shear cracks in the ground story column-C8 (Bolu)

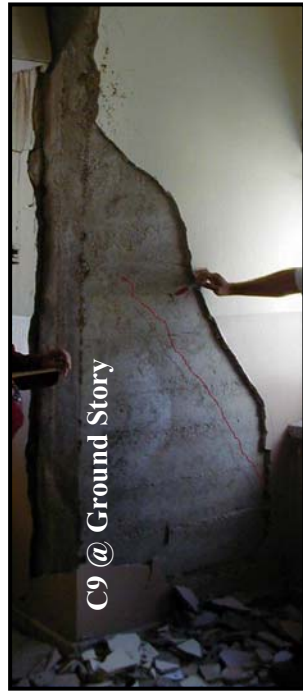
Figure 4.27 Shear cracks in the ground story column-C9 (Bolu)

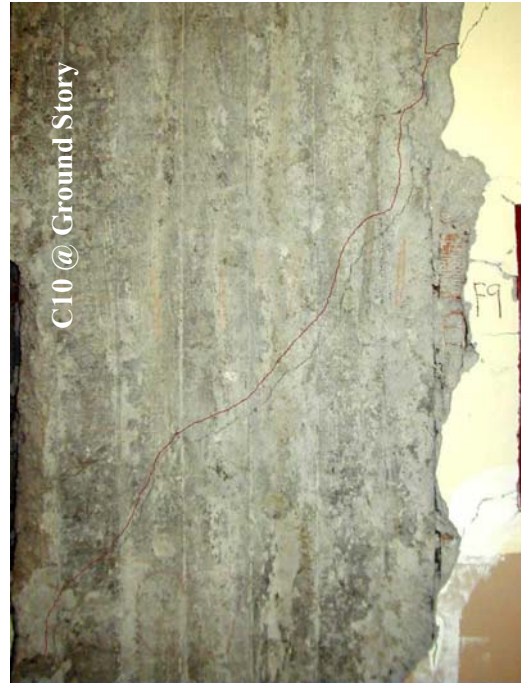
Figure 4.28 Shear cracks in the ground story column-C10 (Bolu)

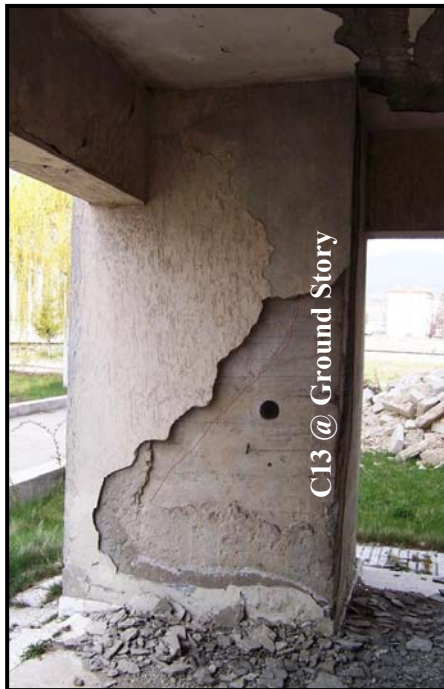
Figure 4.29 Shear cracks in the ground story column-C13 (Bolu)

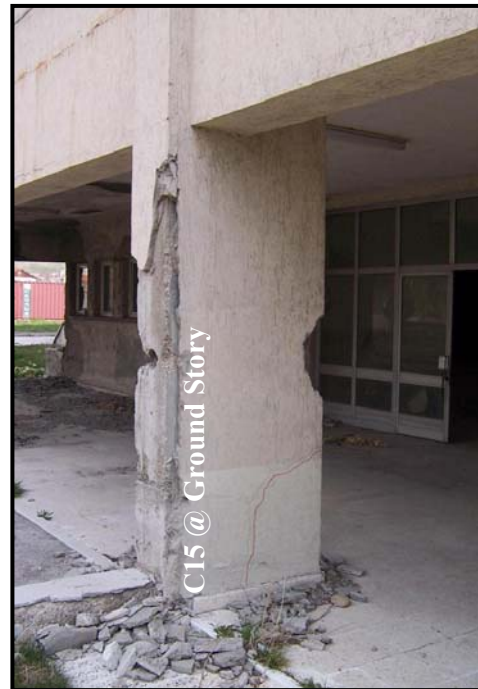
Figure 4.30 Shear cracks in the ground story column-C15 (Bolu)

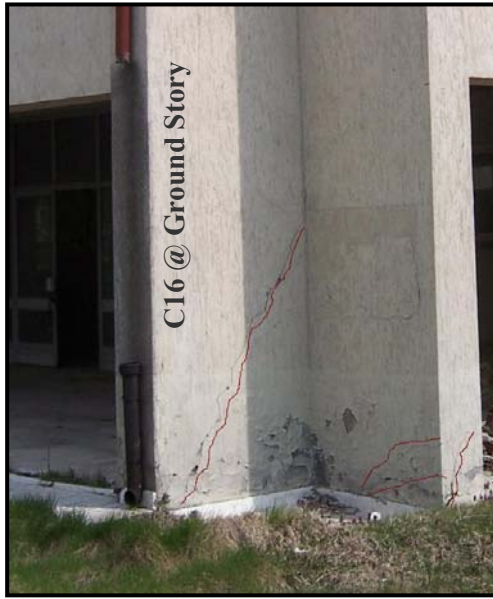
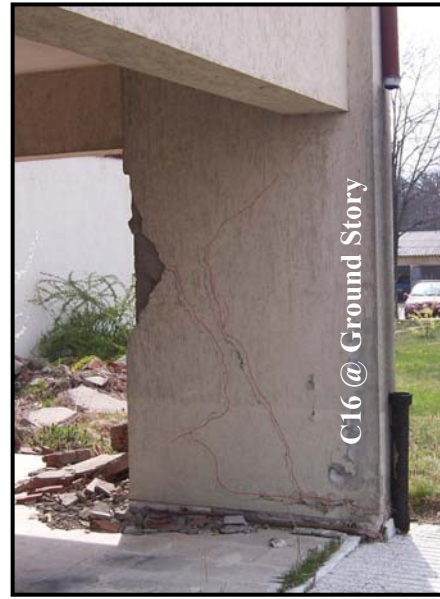
Figure 4.31 Shear cracks in the ground story column-C16 (Bolu)

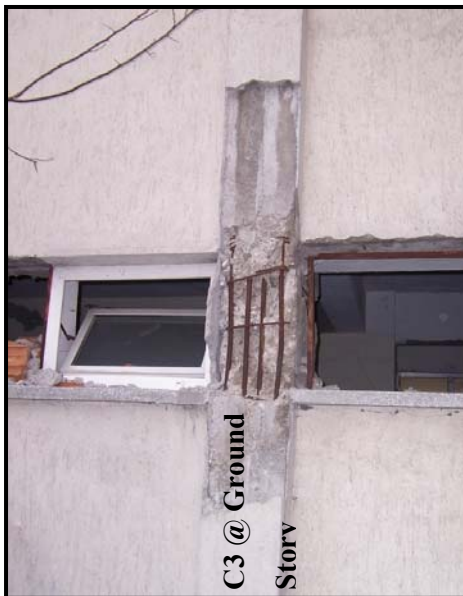
Figs. 4.32 and 4.33 show damaged C3-column due to captive column condition. The clear height of the column is reduced with the narrow windows and this caused an increase in shear demand that the column could not resist.

Figure 4.32 Damage to the ground story captive column-C3 (outside view)

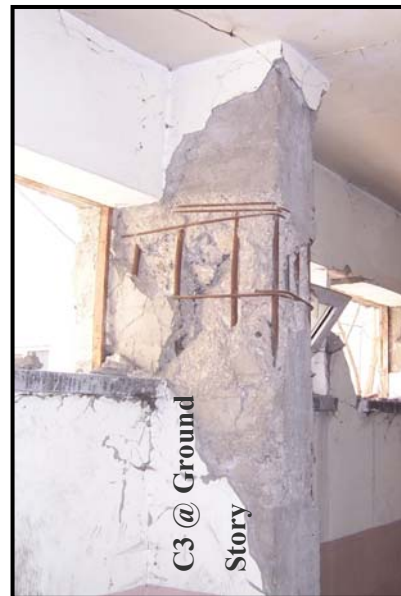
Figure 4.33 Damage to the ground story captive column-C3 (inside view)

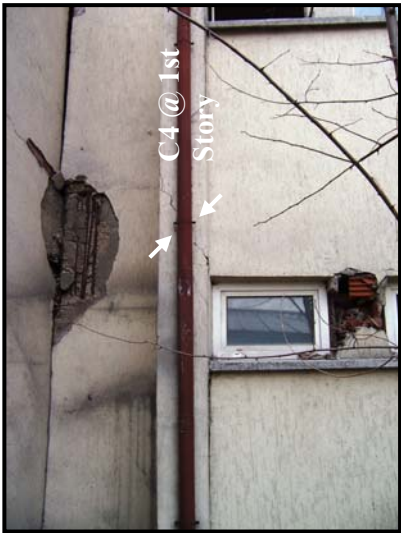
Damage in the first and second story was also extensive but number of damaged elements was less than that of the ground story. Figs. 4.34 and 4.35 indicate shear cracks in the first story L-shaped corner column-C4 and first story column-C6.

Figure 4.34 Shear cracks in the first story L-shaped corner column-C4 (Bolu)

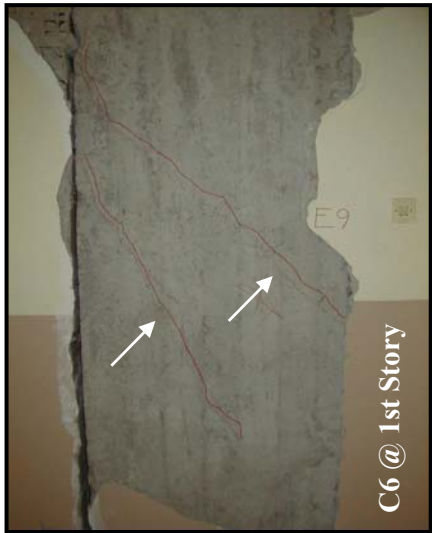
Figure 4.35 Shear cracks in the first floor column-C6 (Bolu)

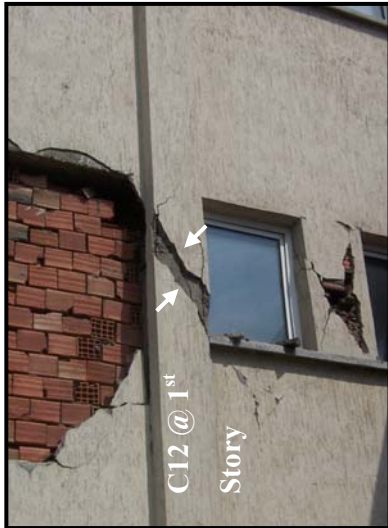
Figs 4.36 and 4.37 indicate extensive shear damage in the first story captive column-C12 and first story captive column-C3.

Figure 4.36 Shear cracks in the first story column-C12 (Bolu)

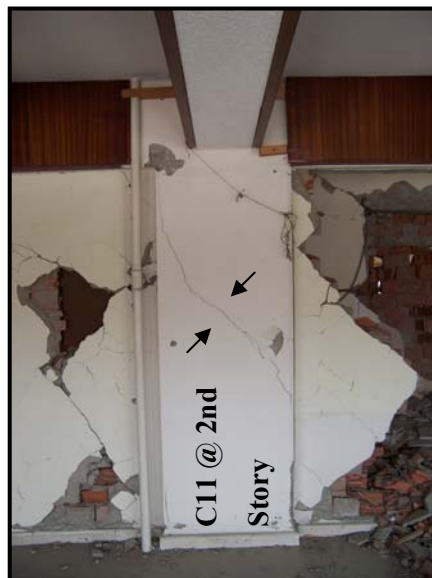
In the second story columns, damage was lighter than that of the first story. It consisted of shear (Figure 4.38) or combined flexural and shear cracks (Figs. 4.39 and 4.40).

Figure 4.38 Shear cracks in the second story column-C11 (Bolu)

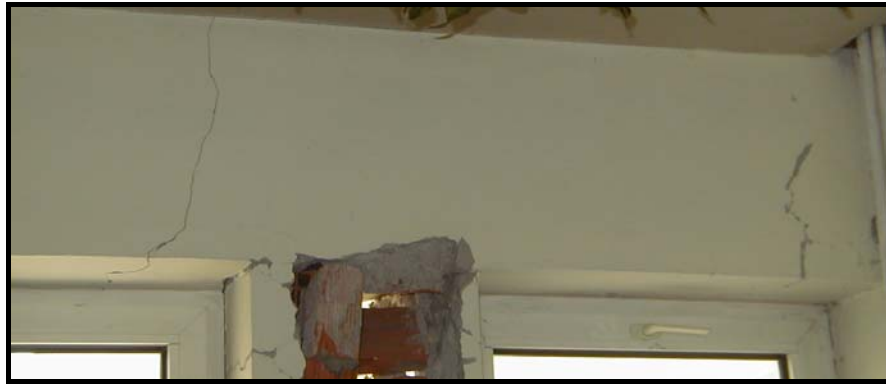
Figure 4.42 Flexural cracks in the ground floor beam-B12 (Bolu)

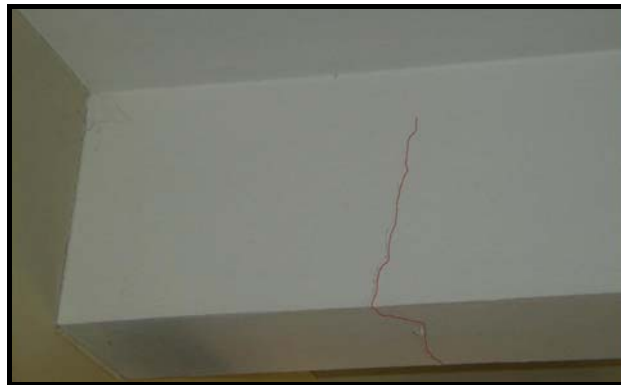
Figure 4.43 Flexural crack in the ground floor beam-B18 (Bolu)

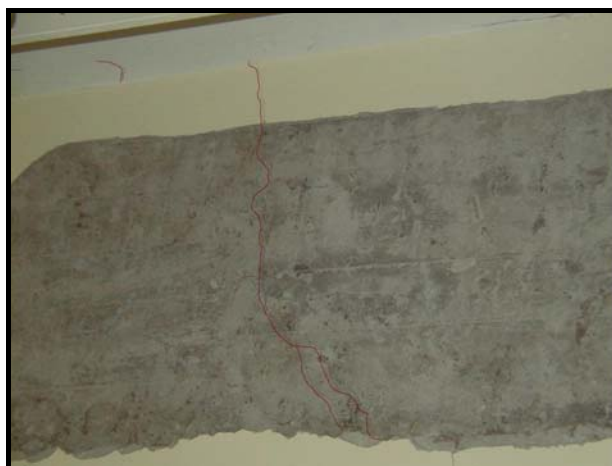
Figure 4.44 Flexural crack in the ground floor beam B24 (Bolu)

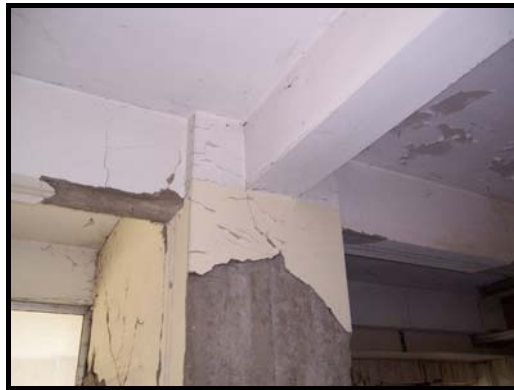
Figure 4.45 Interior joint between the ground story column-C6 and beams B7-B8-B17-B18 (Bolu)

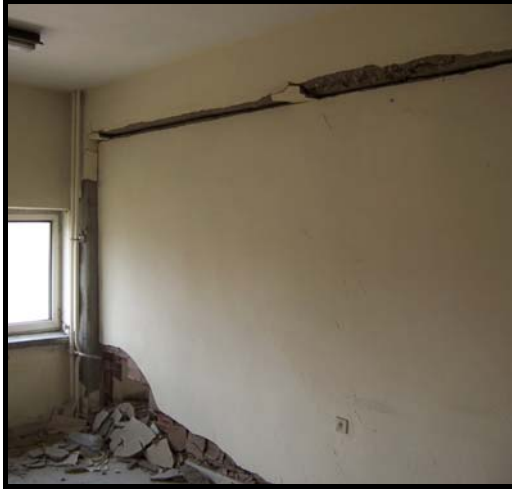
Figure 4.53 Severe damage to the infill wall between the first floor columns-C11 and C15 (Bolu)

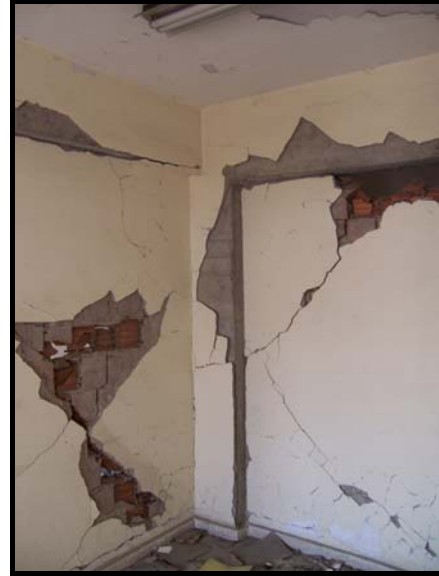
Figure 4.54 Severe damage to the infill wall in the first story (Bolu)

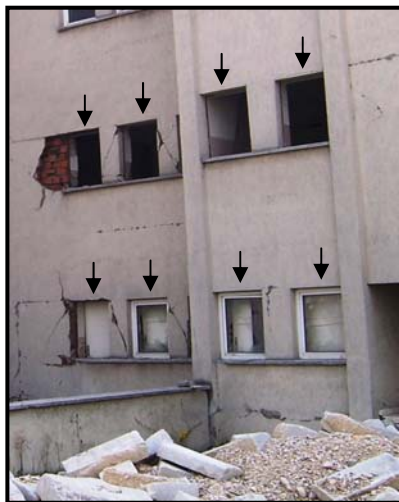
Figure 4.55 Nonstructural damage: The broken windows (Bolu)

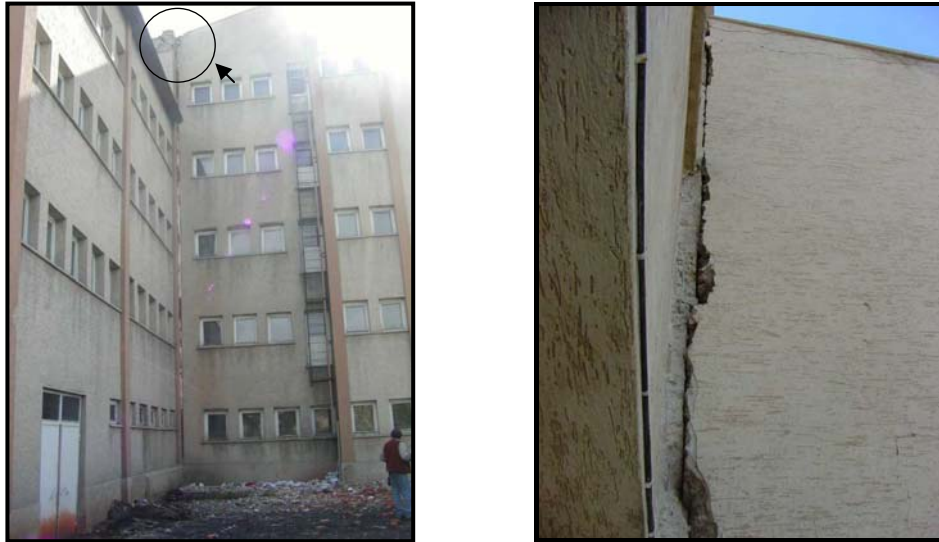
Figure 4.61 Impact was observed at the roof with the adjacent mid-rise building (Bingöl)

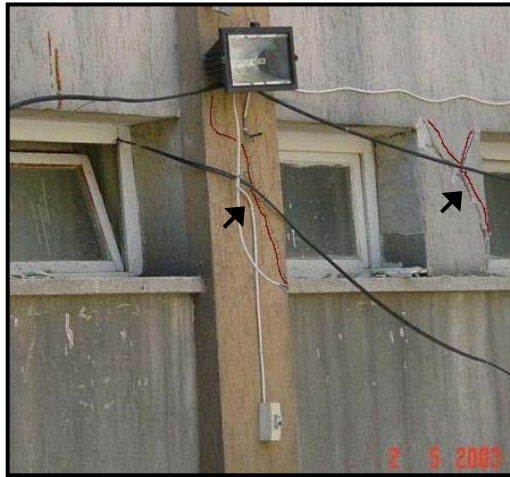
Figure 4.62 Damage to the ground story captive column-C3 and infill wall between the windows (Bingöl)

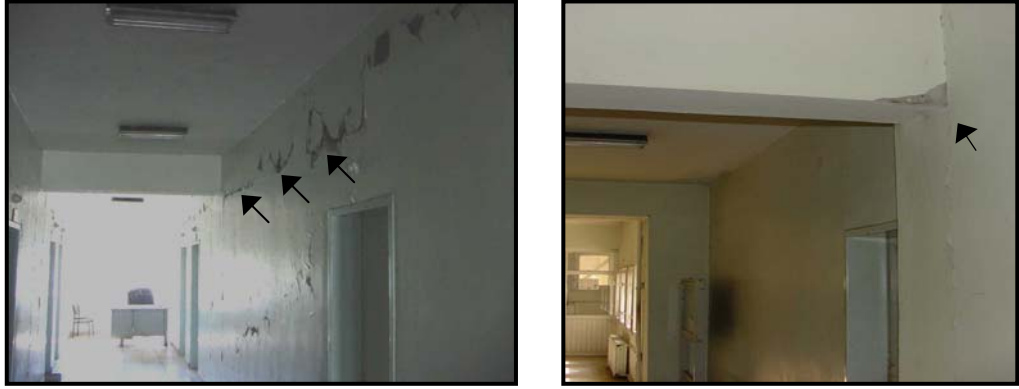
Figure 4.65 Light damage to the beams (Bingöl)

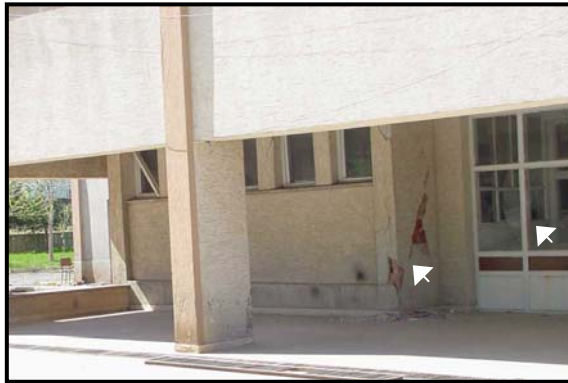
Figure 4.66 Structural damage to the ground story infill wall and broken windows (Bingöl)

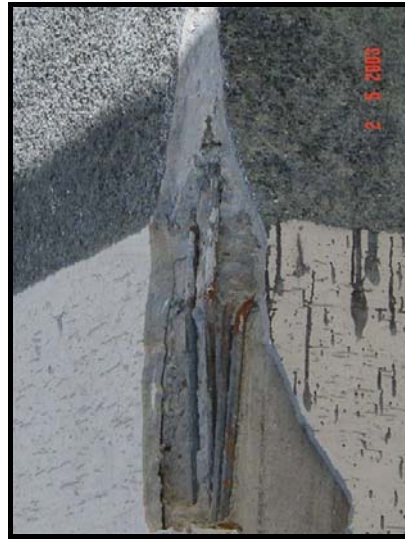
Figure 4.67 Disengagement of reinforcement bars in the columns (Bingöl)
