THE RESTORATION PROJECT OF UKUR HAMAM IN BİRĐİ

A THESIS SUBMITTED TO
THE GRADUATE SCHOOL OF NATURAL AND APPLIED SCIENCES
OF
MIDDLE EAST TECHNICAL UNIVERSITY

SEPTEMBER 2011

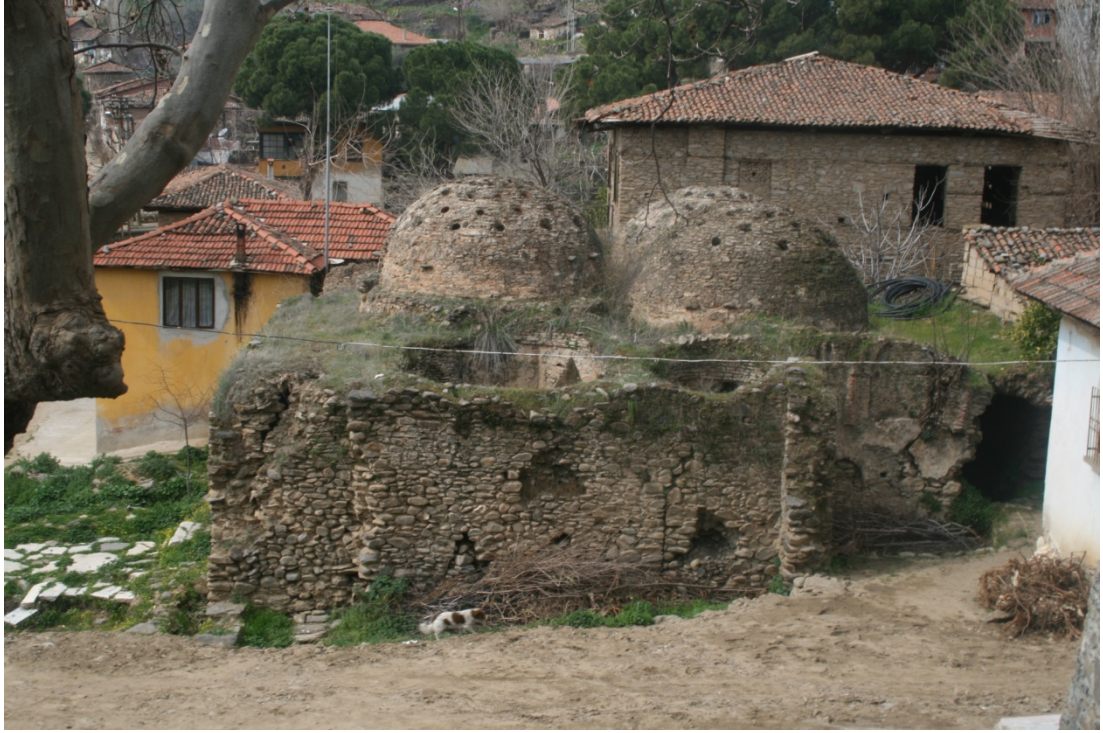
Figure 9, South Facade of Çukur Hamam

The south facade of the hamam is much more damaged than the west facade of the building. The corner of south facade and west facade is highly damaged. Starting 0.26m below the datum line to the top of the facade, the exterior face of it lost with a “v” shape in dimensions 0.17m at bottom and 1.18m at the widest point. Starting from the right corner, while facing, the wall the upper parts of the wall is also damaged. Rain water penetration caused material loss at these areas.

The infill material of the wall is exposed due to the plaster and mortar loss below the datum line 3.85m, 5.71 and 7.63m from the west wall. Moreover, the cause of these detachments and loss of mortar below the datum line can be rising damp.

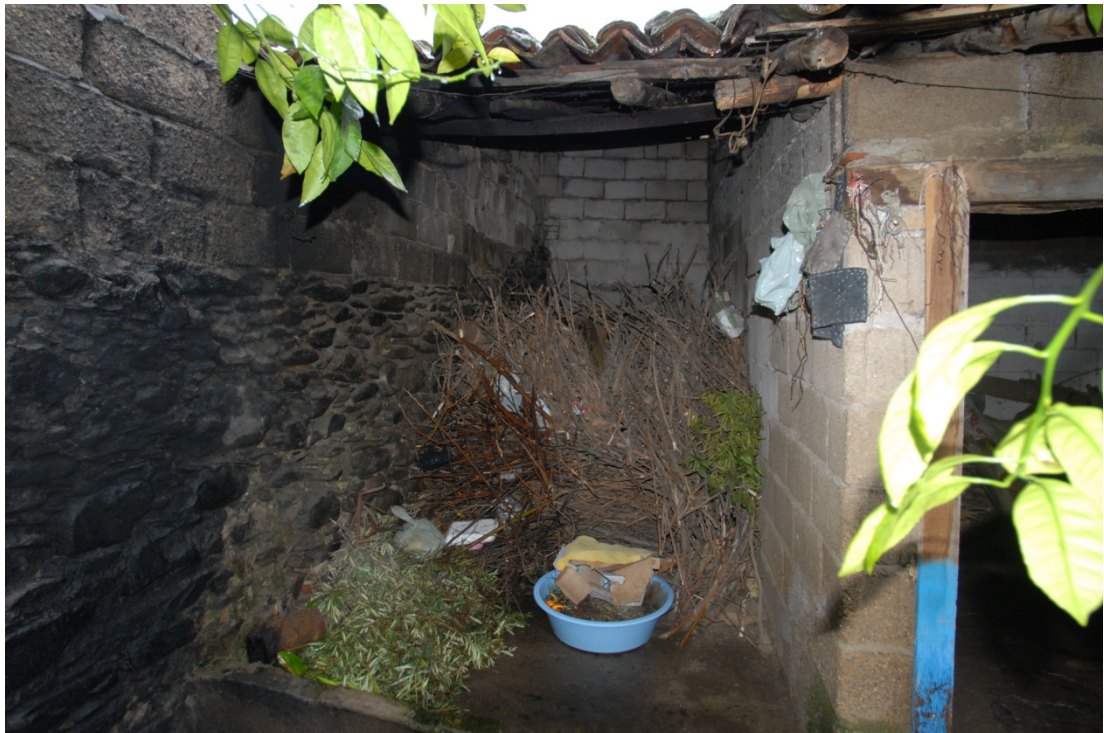
Figure 10, East Facade of Çukur Hamam

The south facade of the hamam measures 9.88m. The east wall and *Külhan* of the hamam is not visible. The courtyard of the adjacent building was constructed on the east facade. So any part of this facade could be documented during the site survey.

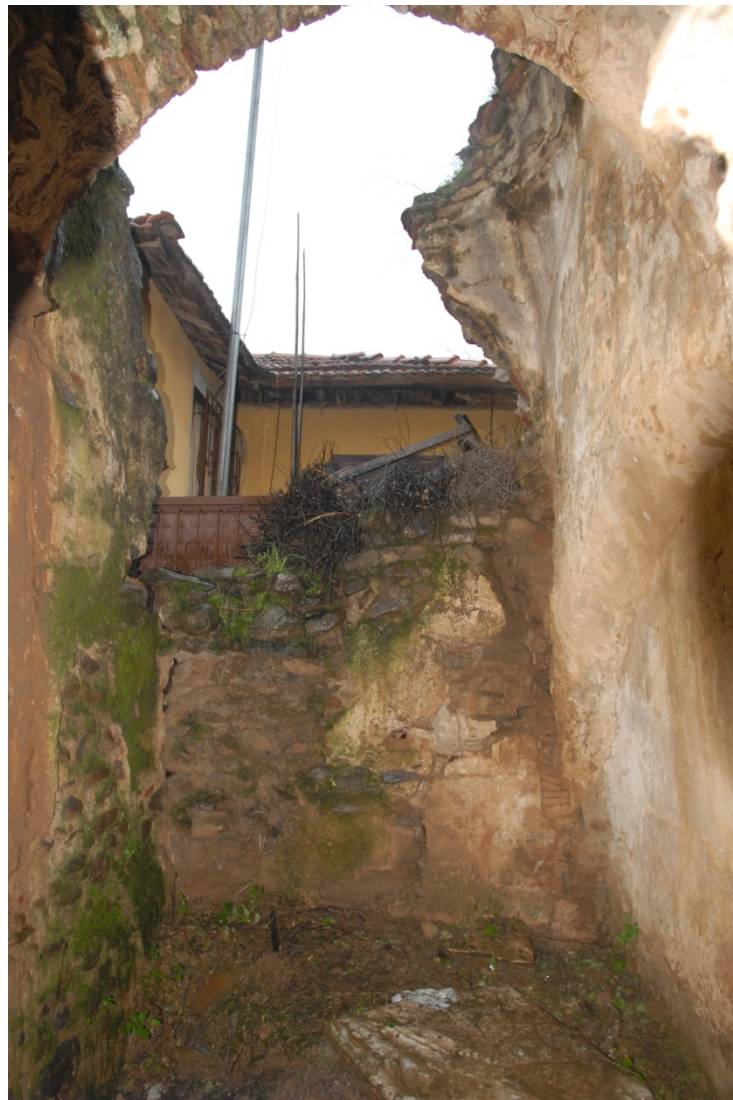
Figure 12, Space Z01

The south wall of the space is 2.94m in height till to the top of the vault and 1.76m in width is the entrance wall where an arched door with 0.59m to 1.64m is located 0.65m from the west wall of the space. The surface of the wall is covered with lime plaster and from the deteriorated parts it is seen that the wall construction is rubble stone masonry with mud mortar as binding material. There are cracks and fissures on the wall. Also the demolition of the superstructure let the rain water penetrate in

and this has caused colour change and micro flora on the surface of the upper parts of the wall. In the mean time rising damp caused the detachment of the plaster at the lower parts of the wall.

The west wall of the space is 2.92 m in height till the top of the vault and 2.98 m in width. The surface is covered with lime plaster. The construction system is seen as rubble stone masonry with mud mortar as binding material. The upper level of the north part of the wall is collapsed and there is a deep crack between the north wall and the west wall at their corresponding point. Colour change and micro flora is seen on the surface of the wall due to the rain water penetration mostly at the areas close to the north wall. In addition to that; rising damp caused the detachment of the plaster at the lower parts of the wall.

The north wall of the space is approximately 2.09 m in height and 1.81 m in width. The upper part of this wall had been collapsed. In some parts of the wall lime plaster is seen. There is a deep crack at the intersection of west and north walls. The crack between east wall and north wall was filled with brick. The wall construction system is rubble stone masonry with brick fragments but there are some supplementary additions on this wall. These additions differ from the other part with the materials used and their workmanship. There are cracks and fissures on the wall. Micro flora is seen on the surface of the wall due to the rain water penetration. In addition to that; rising damp caused the detachment of the plaster at the lower parts of the wall.

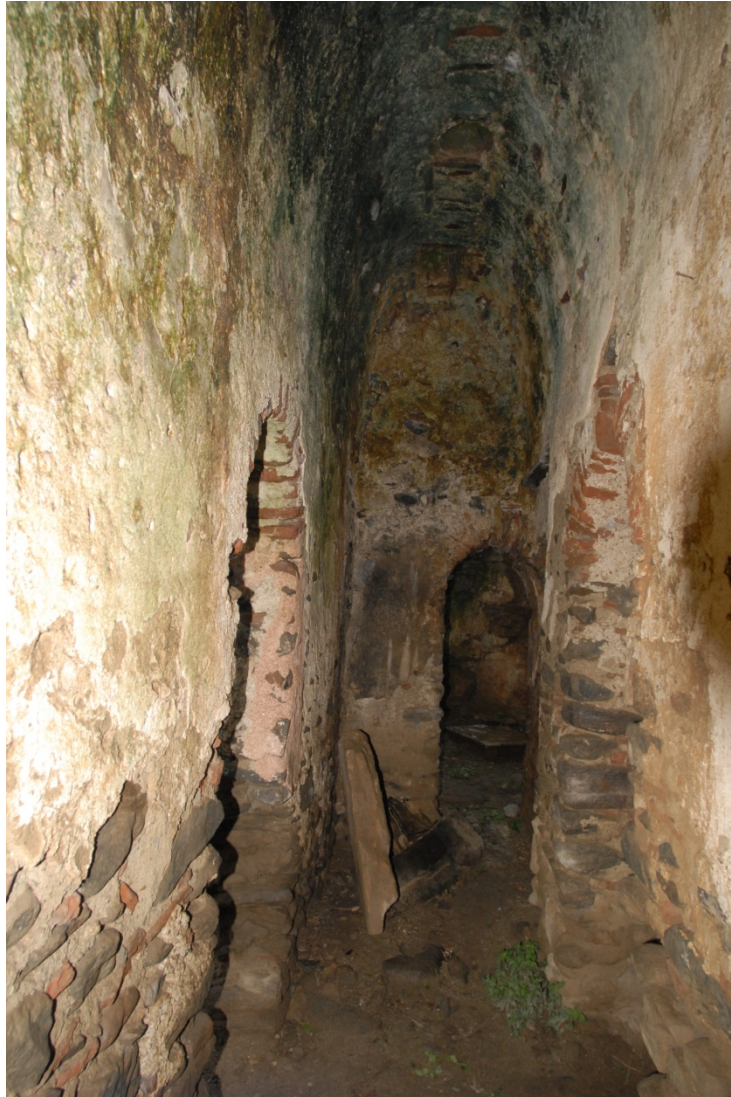
Figure 13, Space Z02

The west wall of the space with 2.84m in height till the springing line of the vault and 4.13m in width has the arched door which is 2m in height and 0.71m in width placed 1.66m from the south wall. The surface of the wall is covered with lime plaster and from the deteriorated parts, it is seen that rubble stone and brick fragments used irregularly with mud mortar as binding material at the construction of this wall. Rising damp caused the detachment of the plaster at the lower parts of the wall. Because of the rain water penetration at the upper parts of the wall approximately 0.96m higher from the datum line change in colour and micro flora are easily seen.

The north wall of the space is 3.61m in height till the top of the vault and 1.04m in width. There is an arched door with dimensions of 0.59m to 1.81m on the wall 0.59m from the west which establishes the connection with Z01. Except the deteriorated parts all the walls of this space is covered with lime plaster. Rubble stone masonry with brick fragments are used for the construction system of this wall. At the upper parts of this wall approximately 0.91m above the datum line change in colour and micro flora is observed. There is also rising damp on the wall. The mortar between stones at the level of 0.23m below the datum line had detached because of the rising damp.

plaster and because of the deteriorations on the surface; some part of them detached irregularly. The construction technique of the wall is rubble stone masonry with brick fragments. The binding material of this wall construction is mud mortar. Rising damp caused detachment of the plaster at the lower parts of the wall. Because of the rain water penetration at the upper parts of the wall approximately 1.17m above the datum line change in color and micro flora are observed.

The south wall of the space with dimensions 3.62m in height till the top of the vault and 0.99m in width has an arched door which is 1.59m in height and 0.62m in width. The door is placed 0.19m from the west wall of the space. This arched door establishes the connection between Z02 and Z03. The surface of the wall is covered with lime plaster. The construction technique of the wall is rubble stone masonry with brick fragments. The binding material of this wall construction is mud mortar. The plaster has detached because of rising damp from the ground to 0.09m above the datum line. Moreover, rain water penetration at the upper parts of the wall, approximately 0.87m above the datum line; changes in colour and micro flora formation are easily seen.

The superstructure of this space is barrel vault and there are 4 circular holes for illumination which are shaped by using terra cotta pipes with approximately 0.21m diameter. Brick and lime mortar are used as main construction materials. From the surface, two dimensions of the brick units can be measured. (3cm*20cm). The surface of the vault is covered with lime plaster, but rain water penetration caused micro flora and change in colour on the surface of the plaster.

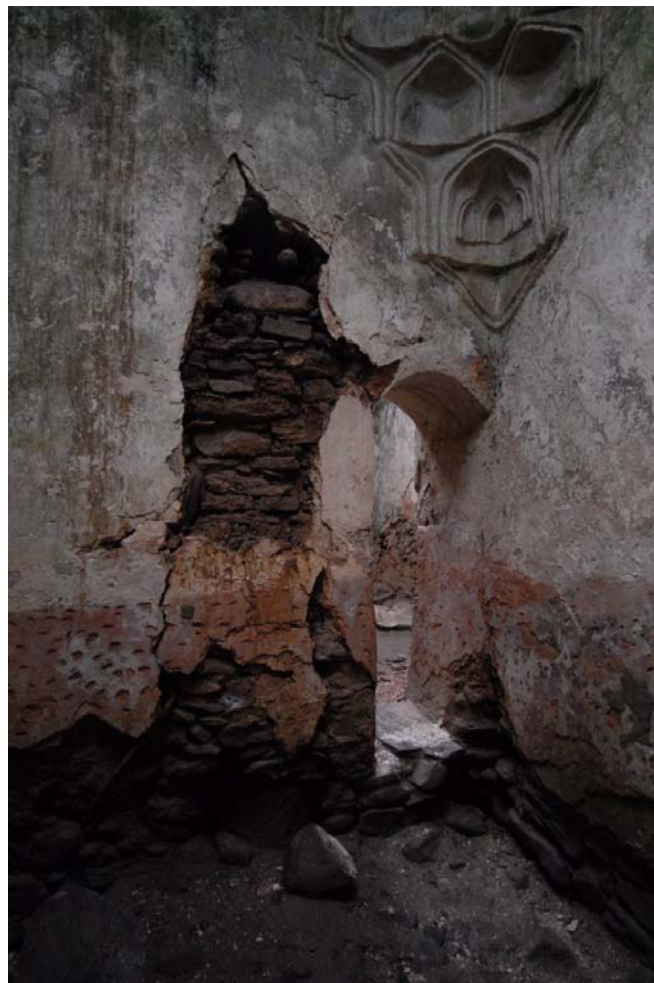
Figure 14, Space Z04

Stalactites were used as transition elements in this space. Unfortunately the rain water penetrated from the lightening holes of the dome caused micro flora. At west wall the traces of the chimney divides the stalactite into two. From the detached parts of the plaster, brick fragments are seen.

The superstructure of this space is dome which is constructed on the stalactites. There are 31 illumination holes on the dome. Except the one at the centre of the dome, the others are all lined up in an order. All these holes are circular in shape and this shape was given to them with terra cotta pipes which have 1cm thicknesses. The construction material of the dome is Brick (4cm thickness on surface x30cm thickness inside the dome) and lime mortar. Loss of plaster is seen at the centre of the dome and at the lower levels of the dome micro flora is visible.

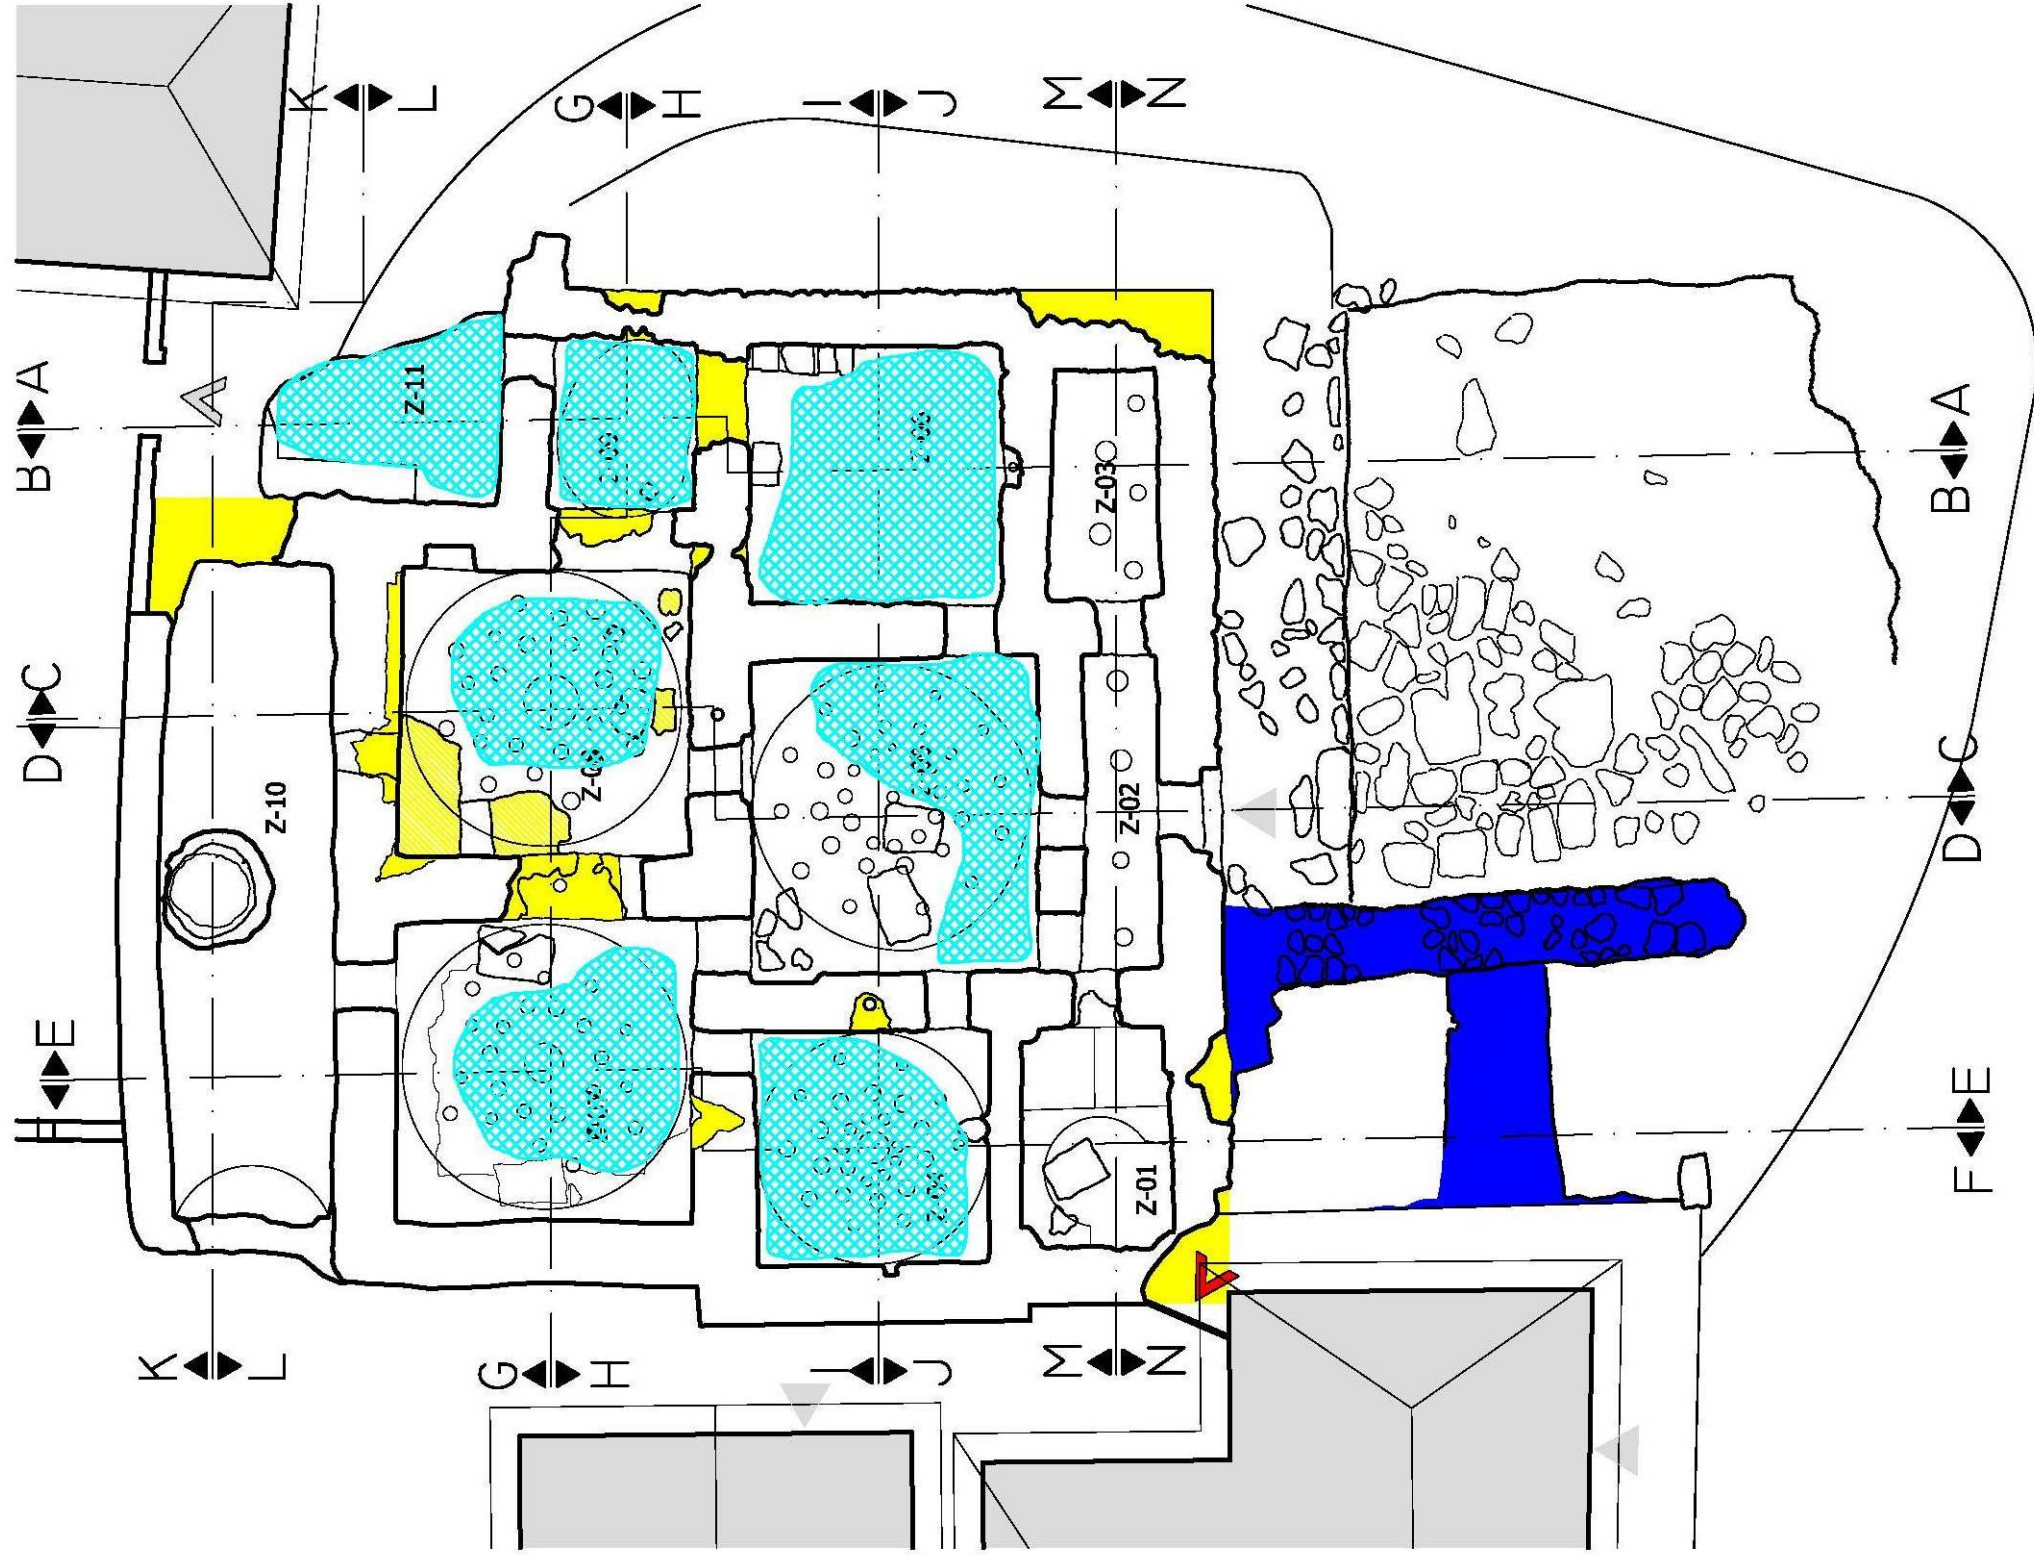
Figure 34, Deterioration Mappings, Plan

Rising damp caused loss of plaster and mortar on the south façade, and the walls of Z01, Z02 and Z03 which decreased the load bearing capacity of these walls.

On behalf of these, the superstructures of spaces Z01, Z06, Z09 are demolished and because of the deep cracks on the vaults of spaces Z03 and Z10 are severely deteriorated.
