THE CONSERVATION PROPOSAL OF
HASANAĞALAR (ALAYDIN) HOUSE IN ALANYA

A THESIS SUBMITTED TO
THE GRADUATE SCHOOL OF NATURAL AND APPLIED SCIENCES
OF
MIDDLE EAST TECHNICAL UNIVERSITY

FEBRUARY 2012

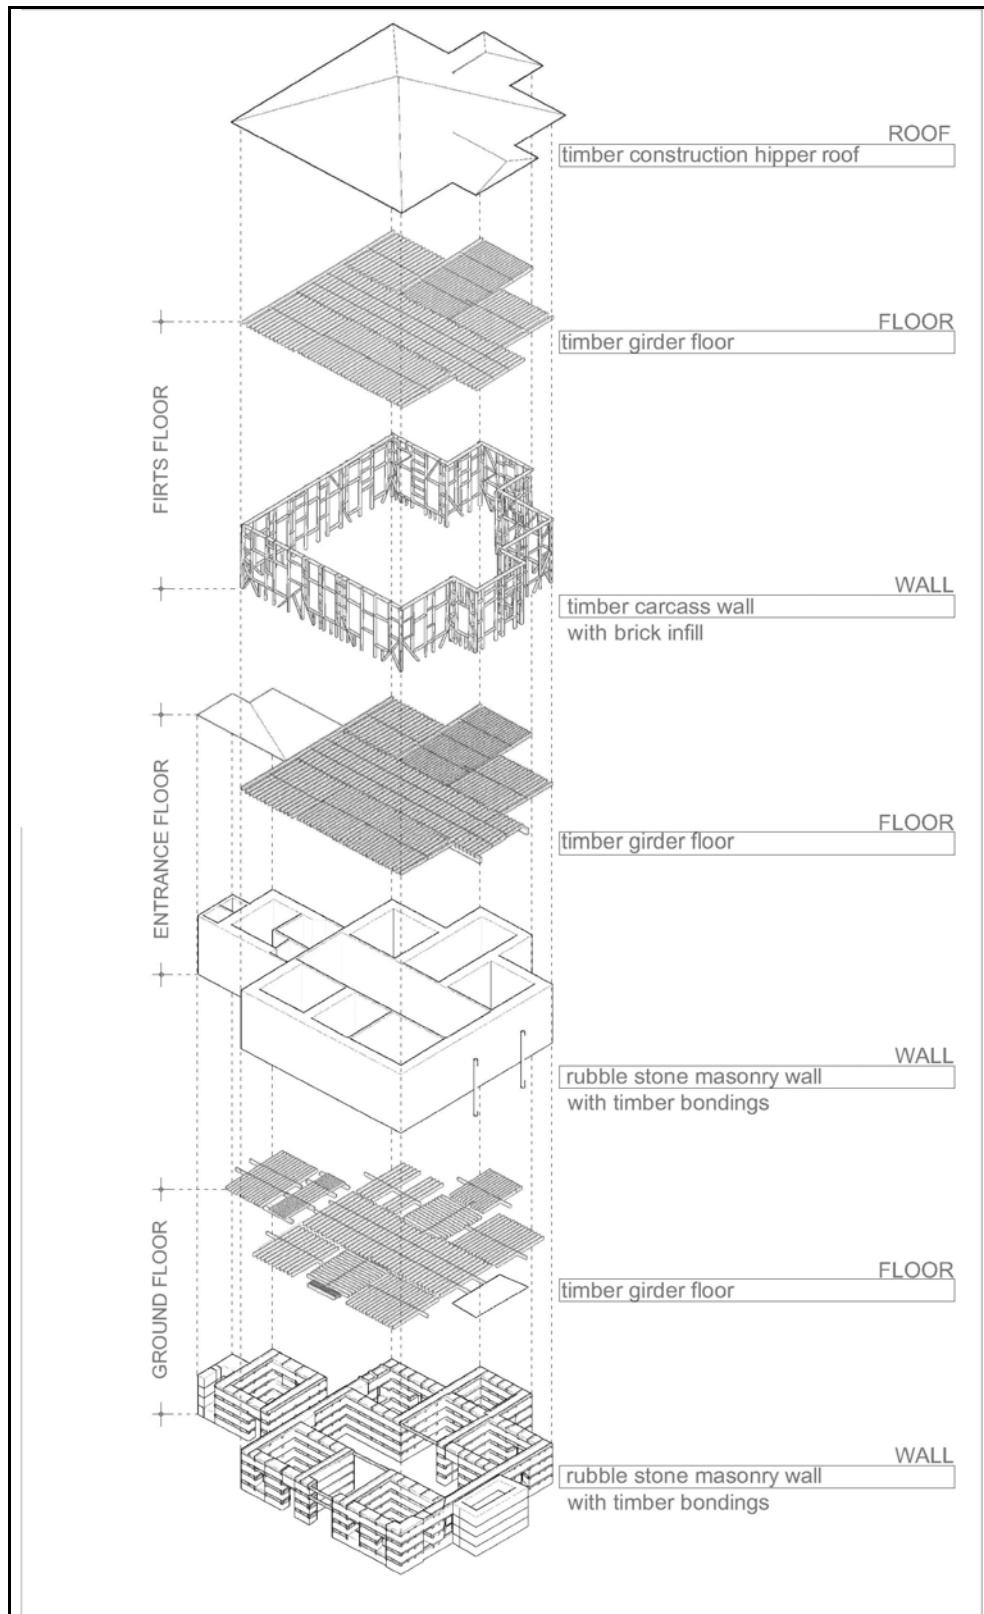
Figure 2.69. Structural system of the building

The results of this analysis show that structural cracks are concentrated in the first floor of the building. On the first floor, the walls of the east and west façade, east part of the south façade and north part of the east façade tend to fall apart. Also there are structural cracks on the east part of the projection. In the middle part of the west façade located in the ground floor and in the north part of the main building that extends toward east, structural cracks were identified.

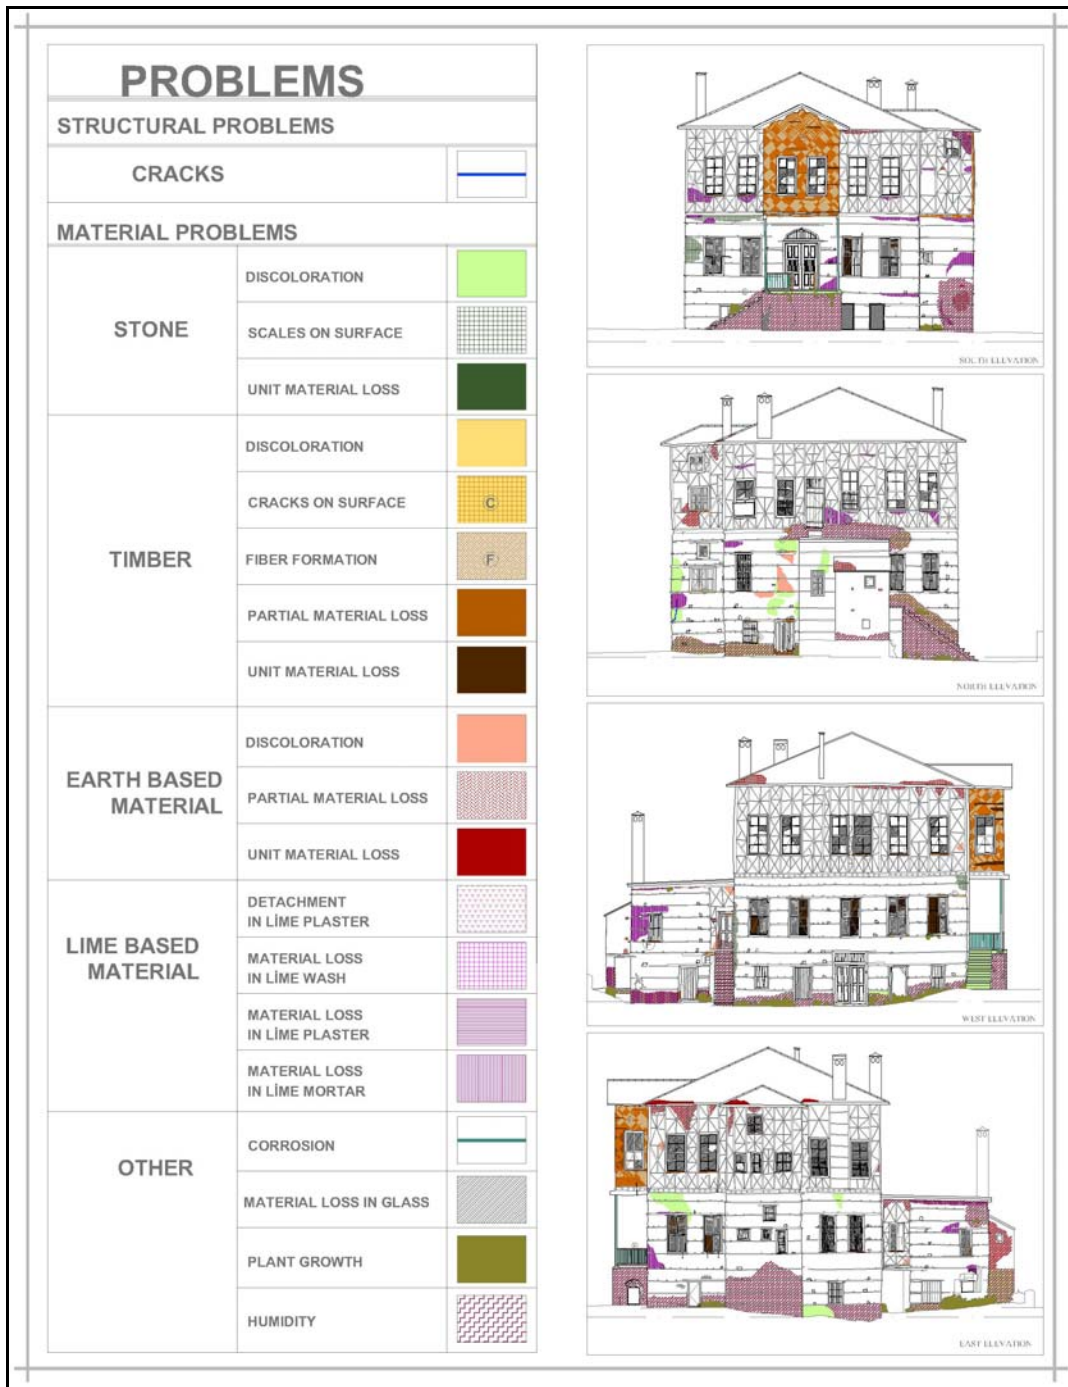
Figure 2.93. Problems of the building – 1

In bottom casings of windows at outside, there are **cracks on surface** and **fiber formation** problems. Also fiber formation is seen in; cement repaired parts of the building, *bagdadi* laths at outside of the projection on a small scale, vertical and horizontal construction elements of south part off the east service mass in entrance floor level, upper parts of the architectural elements W03 and D05 at north façade, stair railing of staircase S01

Discoloration problem is seen at; bricks used as infill material between timber frame in upper parts of entrance floor level, bricks used as infill material in frame wall parts between the main building and north service mass (at east and west facades), brick masonry wall on east façade of the WC mass in north, bricks in closed window and chimney trace at entrance floor level of the north façade, bricks in north façade of the main mass around cement repairs in terrace of north service mass

Partial material loss problem is seen at; repaired part with cement mortar in lower parts of north service mass' east façade, bricks used as infill material in frame wall parts between the main building and north service mass (at east and west facades), east wall of the space G09, roof tiles near eave levels of west façade of the building and roof of WC mass, located at north

Unit material loss problem had determined at; repaired part with cement mortar in lower parts of north service mass' east façade, roof tiles near eave level at east façade of the building.

Material loss in lime mortar problem had determined at; masonry walls around repaired part with cement mortar in lower parts of north service mass' east façade, masonry walls around entrance door D01, masonry walls in ground floor and first floor flooring levels at south façade, masonry walls upper parts of north service mass, masonry walls at entrance floor level in northeast corner of the north service mass, ground level of north service mass, masonry walls in ground levels of spaces G01 and G04, carcass walls, in some parts near eaves level at south façade, especiallt sourtheast corner of east service mass, carcass walls, under some windows a south façade, north façade of the main mass around cement repairs in terrace of north service mass

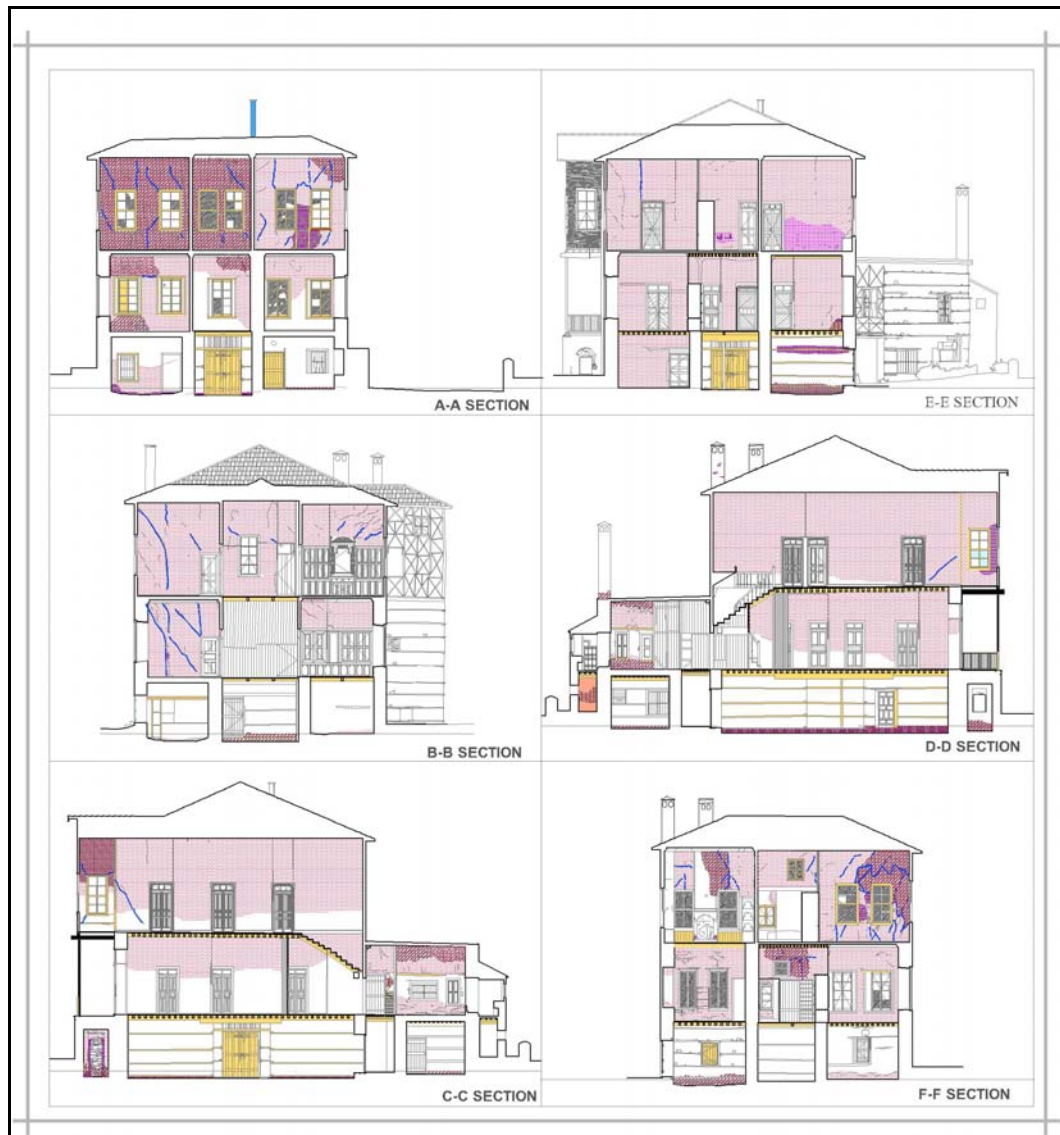
Figure 2.94. Problems of the building – 2

All **metal elements** had been **corroded**.

Humidity is a serious problem for the building. This problem can be cause many other problems too. In ground levels through out the building, around cement based material uses and in some parts of the building near eaves levels, humidity is a visible problem.
