1st International Workshop on Plasticity, Damage and Fracture of Engineering Materials

Investigation of fretting fatigue failure mechanism of lug-bush connection members

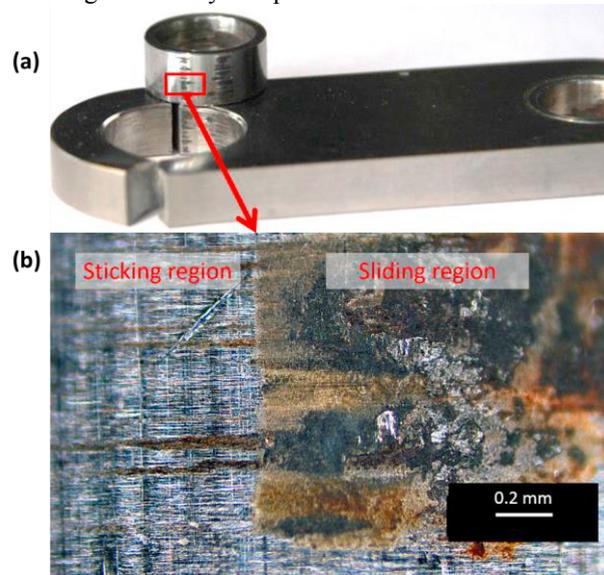
Observations of the lug and bush mating surfaces using both camera and digital microscope revealed that the fracture of the lug of specimen A occurred near the boundary of an intense residue and a clean surface, as shown in Fig. 4-b. The two distinct regions of black residues and clean parts raised the question of whether the residues are product of relative motion and the clean parts are product of sticking of the contacting surfaces.

To answer that question, surface of the steel bush is investigated under digital microscope using extending depth of field (EDF) feature. The EDF analysis of the residues exhibited a rough surface whereas the clean parts were quite smooth. These analyses indicated that the relative motion of the contacting surfaces of the lug and bush created a wear debris which is observed as a rough surface under digital microscope. On the other hand, the clean parts had no evidence of a relative motion. These surfaces stuck together during the cyclic tensile loading, resulting in a clean surface and smooth appearance. As a result, the region with residues and the clean region are called sliding and sticking

regions, respectively. Also note that the sticking and sliding regions in Fig. 4 are not composed of two different photographs, the boundary of these regions is very sharp.

Fig. 4. (a) The photograph of the matching lug-bush surfaces, (b) Boundary of the sticking and the sliding regions on the steel bush surface under digital microscope at 200x magnification.

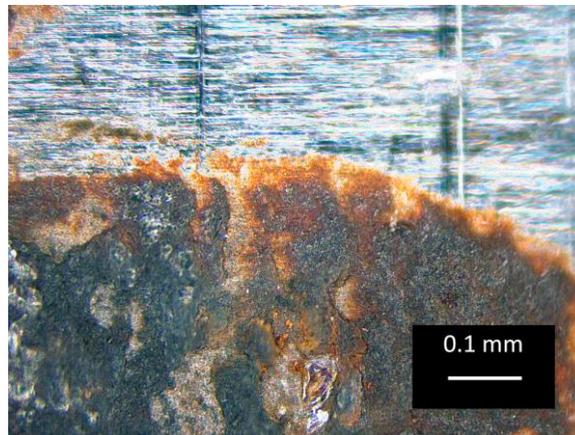
After discussing the reasons for different surface regimes, the color of these two distinct regions were the second question to be answered. Although the color of the residues looked like a corroded surface under the digital microscope at 500x magnification as shown in Fig. 5, scanning electron microscope (SEM) is used to further investigate the differences in sticking and sliding regions on the surface of the bush.

Fig. 5. Sliding region (at the bottom) on the steel bush surface, showing black residues, under digital microscope at 500x magnification.

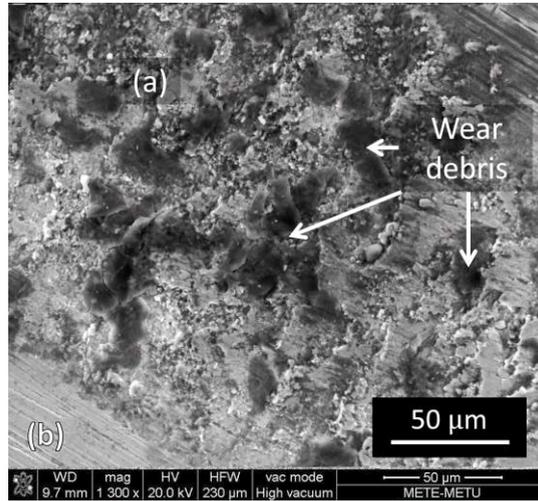
SEM image of the residues on the steel bush surface is shown in Fig. 6. The surface which represents the sliding region is not smooth and the wear can be observed. Furthermore, one can realize that the SEM photograph of the worn surface, in Fig. 6, is very similar to a typical corroded surface appearance. In order to determine the differences between sticking and sliding regions in terms of elemental composition, EDS analysis is conducted. According to the results of the EDS analysis, sliding regions contain high amount of oxygen whereas the sticking regions do not have any oxygen content.

Fig. 6. SEM photograph showing (a) sliding region and (b) sticking region on the steel bush surface at 1300x magnification.

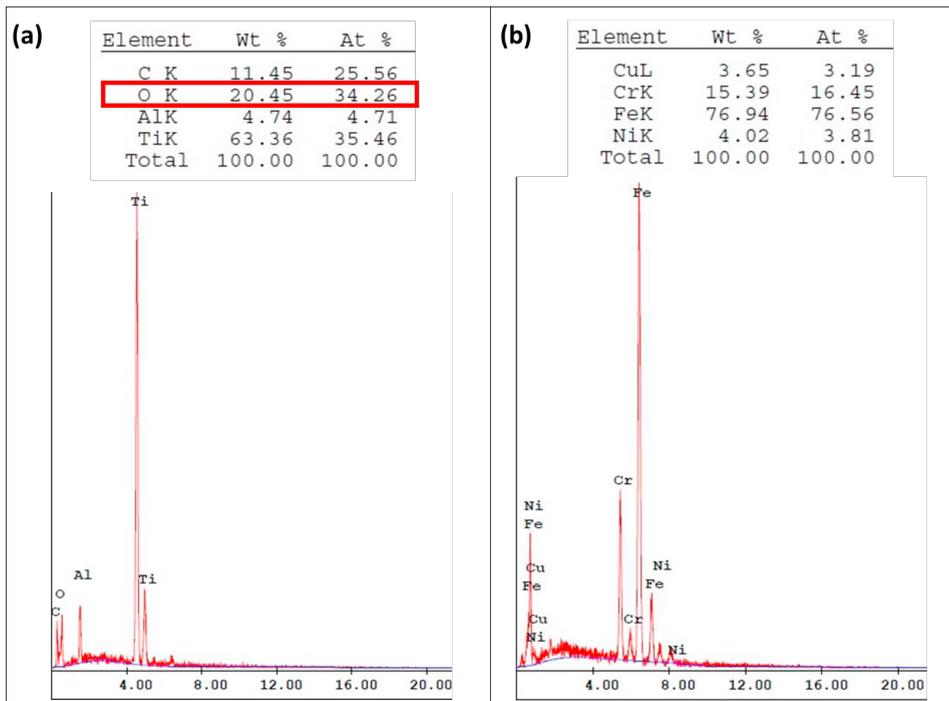
Macro and micro observations are certified with these results concluding that the worn surfaces oxidized and attained a black-brown color, which are referred as black residues in the observations. EDS results show that 20 % (by mass) oxygen exists within the residues as shown in Fig. 7-a. On the other hand, the clean surfaces in other words sticking regions did not experience relative motion of the contacting surfaces. In these regions, the black-brown residues were not observed. EDS results revealed that no oxygen content was detected in the sticking regions as shown in Fig. 7-b.

Fig. 7. EDS analysis results of (a) sliding region and (b) sticking region on the steel bush surface.

These results indicate that the oxidation of wear debris occurred at the sliding region, which is called tribolayer, as stated in Blau (2009). The tribolayer contains fine metallic particles from the two contacting surfaces as well as oxides. The frictional behavior of the two contacting surfaces are determined by the characteristics of the formed tribolayer, as discussed in Iwabuchi (1991).

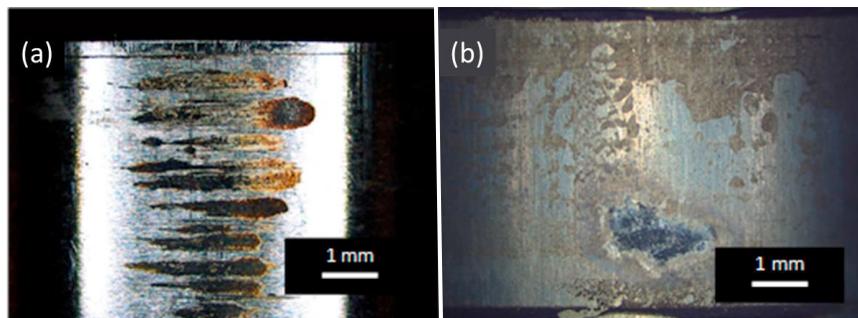
Sticking-sliding regions of the four different lug-bush members are compared. The shape of tribolayer appearances of specimens A, B, and C, which have dissimilar lug and bush materials, are observed to be directional and discontinuous as shown in Fig. 8-a. However, in Al lug – Al bush member (specimen D) the surface features of the bush include rounded residues, as shown in Fig. 8-b.

Fig. 8. The sliding region morphologies on the bush surfaces of (a) Ti lug – steel bush member (specimen A) and (b) Al lug – Al bush member (specimen D), at 50x magnification.

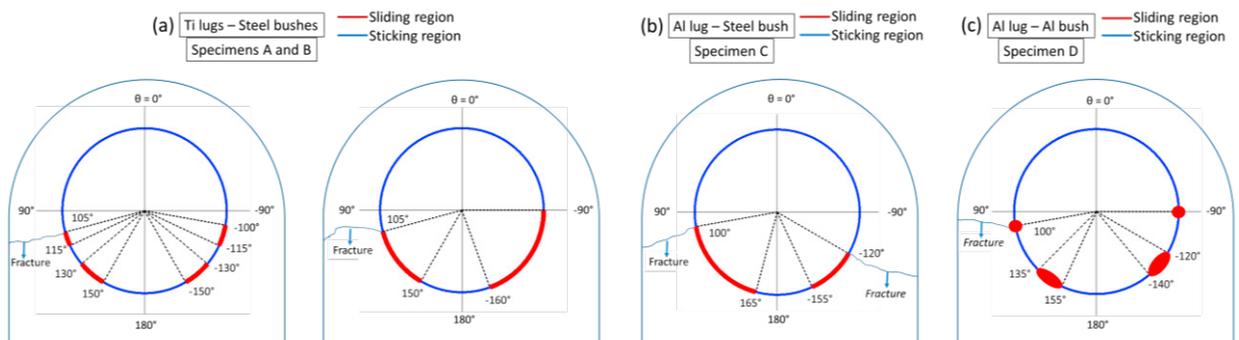
Locations of fracture and sticking-sliding regions of these four members made of Ti and Al lugs with Al and steel bushes are mapped as shown in Fig. 9. The red lines in the maps represent the sliding regions where black residues of the oxidized wear debris is observed on the contacting lug and bush surfaces. Remaining surfaces were free from any residues and are represented with blue, indicating the sticking surfaces.

A crack was found to initiate near the boundary of sticking and sliding regions after which it propagated, breaking one side of the lug. The boundary location of the sticking and sliding regions lies at $100^\circ - 105^\circ$, as shown in Fig. 9. The reason for the difference in sliding region representation in Fig. 9-c is the rounded tribolayer shape.

Fig. 9. Location of fracture and sticking-sliding surfaces of tested (a) Ti lug – steel bush members, (b) Al lug – steel bush member, and (c) Al lug – Al bush member.

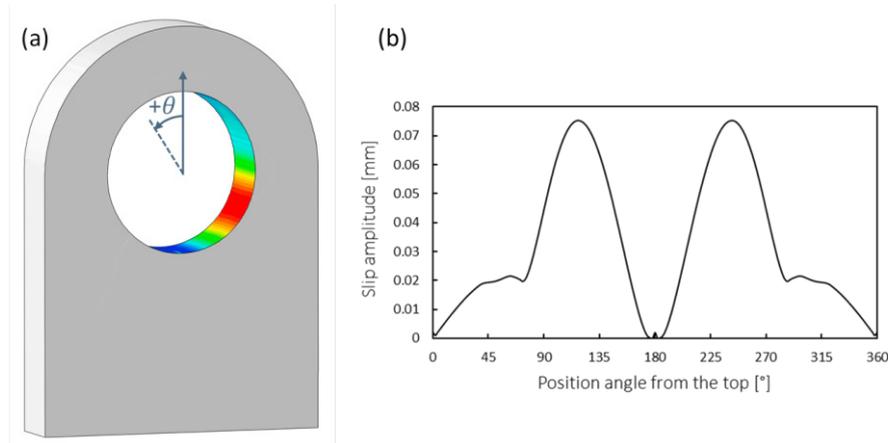
Relative slip amplitude between the contacting surfaces of Ti lug and steel bush at the end of second step is shown in Fig. 12-a. The slip amplitude is provided as an output when contact is defined through master-slave algorithm and it is defined as the relative nodal displacement between the nodes of the mating surfaces (ABAQUS Analysis User's Manual (2011)). The slip amplitude is plotted against the position around the contacting Ti lug – steel bush surface, as shown in Fig. 12-b. Slip amplitude is symmetric with respect to $\theta = 0^\circ$ and it reaches its maximum value around 115° and 245° (or in -115°).

Fig. 12. Slip amplitude around the contacting Ti lug – steel bush surface (a) shown on the lug model and (b) with respect to position angle from the top.

These results agree with the aforementioned observations of the fractured lug – bush members, since the residues are observed around the peak slip amplitude locations.
