# High-Modulus Columns for Liquefaction Mitigation

James R. Martin II, A.M.ASCE<sup>1</sup>; C. Guney Olgun, S.M.ASCE<sup>2</sup>; James K. Mitchell, Hon.M.ASCE<sup>3</sup>; and H. Turan Durgunoglu, M.ASCE<sup>4</sup>

**Abstract:** This paper presents the performance of a shopping complex in Turkey where the soils were improved with jet-grout columns and preload fills and subjected to the 1999 Kocaeli Earthquake ( $M=7.4$ ). Under construction at the time of the earthquake, the Carrefour Shopping Center covers an area of 55,000 m<sup>2</sup> and is founded on shallow footings, mats, and slabs-on-grade that rest on soft, saturated alluvial sediments consisting of clays, silts, and sands. High-modulus columns constructed by jet grouting were installed at close-to-moderate spacings to reduce anticipated static settlements in the clays and mitigate liquefaction in the sands. The site was subjected to a peak acceleration of approximately 0.2g during the earthquake. Grouting had been completed for about two-thirds of the site when the earthquake struck. Following the event, a field reconnaissance found stark contrast between the performance of the improved and unimproved sections. The

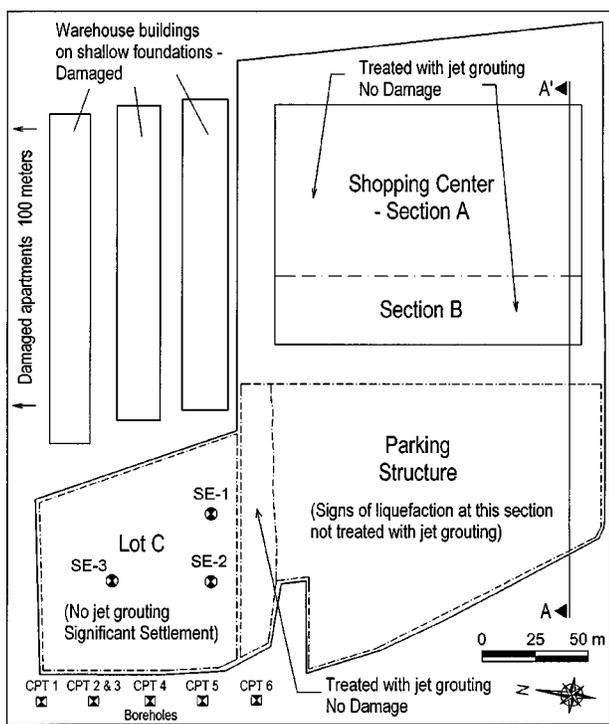
**Fig. 2.** Site plan of Carrefour Shopping Center showing improved area and unimproved areas along with observed earthquake damages. Locations of post-earthquake soil investigations are also indicated.

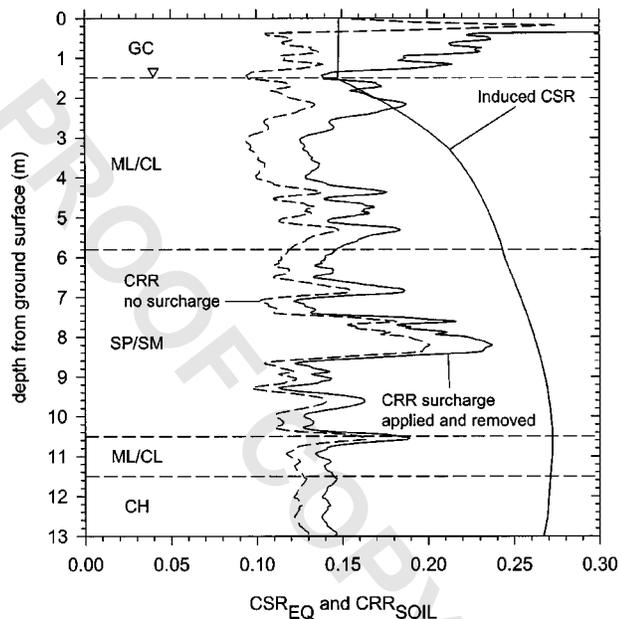
Using CPT data, an average CRR of about 0.14 was estimated for the upper 11.5 m of the profile, as indicated by the dotted curve shown in Fig. 6. The curve accounts for the estimated fines content of each layer and is representative of conditions where no improvement was used. (The solid CRR curve shown in the figure illustrates the effect of improvement due to surcharge fills and will be discussed later.) As shown, the CSR is higher than the CRR throughout most of the profile, with the factor of safety against liquefaction ranging from about 0.5 to 0.7, and averaging about 0.6. This factor of safety typically indicates liquefaction accompanied by flow of water to the surface (sand boils) and significant settlements. Because the soil profile is mixed with pockets of sandy and clayey material and the pertinent strata vary in thickness and fines content across the site, the liquefaction is expected to be erratic. Ishihara's procedure (1985) was used to

**Fig. 6.** Liquefaction analysis results for representative soil conditions at Carrefour site prior to jet grouting. Dotted cyclic resistance ratio curve is for nonsurcharged areas; solid curve indicates increased liquefaction resistance from OCR effects associated with 3.3-m surcharge fill application and removal in the Parking Garage area.

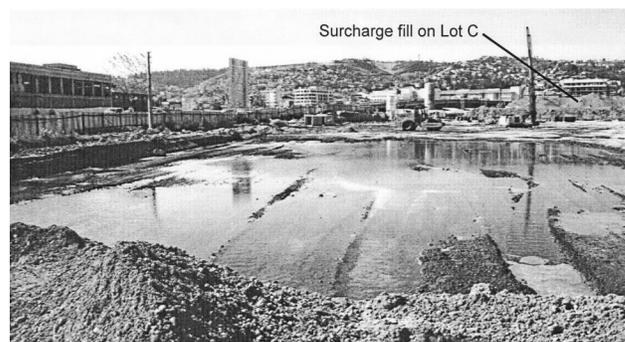
**Fig. 7.** Ponding of water (7–10 cm deep) at untreated portions of parking structure that was expelled through wick drains following M7.4 Kocaeli Earthquake. Lot C, under surcharge fill, is visible at right rear of inundated area. Photograph taken the morning after the event.

The parking structure had not yet been built and jet-grout column installation was just beginning in this section when the earthquake occurred. Wick drains had been installed and the area surcharged with a 3.3-m-high fill that had been removed a few weeks before the earthquake. In contrast to the supermarket area, significant settlements occurred in this section. Site personnel reported that the nongROUTED portion of the parking structure area was inundated with 7–10 cm of water that ponded on the ground surface the morning after the earthquake, as shown in Fig. 7. During field reconnaissance, it became apparent that the water originated from the underlying soil deposit via drainage through the wicks. The magnitude of the settlement should have equaled the depth of water ponding on the surface, as the amount of expelled water is expected to be reflective of the earthquake-induced volumetric change that occurred in the soil profile. The fairly uniform depth of water suggests the settlement was uniform. No sand boils were observed anywhere in the area.

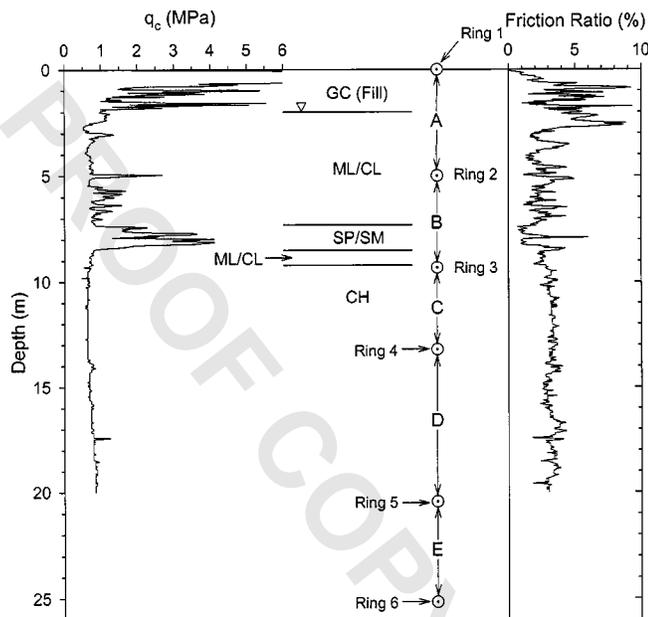
**Fig. 8.** Soil conditions near SE2 in Lot C (unimproved soils) where settlements were measured. Fig. shows positions of settlement rings, soil layers A–E, and CPT results.

Similar to the parking garage area, Lot C was surcharged with 3.3 m of fill and wick drains were installed. The fill was still in place at the time of the earthquake (see fill in background of photograph in Fig. 7). To monitor settlements in the clayey soils due to the fill, settlement extensometers were installed at three locations in Lot C (SE1, SE2, SE3 in Fig. 2). The extensometers consisted of plastic guide pipes 5 cm in diameter with a set of magnetic rings that slid down along the outside of the fixed-in-place pipes as the soil profile settled. The positions of the magnetic rings were measured daily to determine the settlement at specific elevations within the soil profile. It is fortuitous that these devices were in place during the earthquake. Fig. 8 shows the elevations of the six settlement rings installed at SE2, and Fig. 9 shows the measured settlement versus time. The behavior at this location is representative of that observed at the other extensometers.

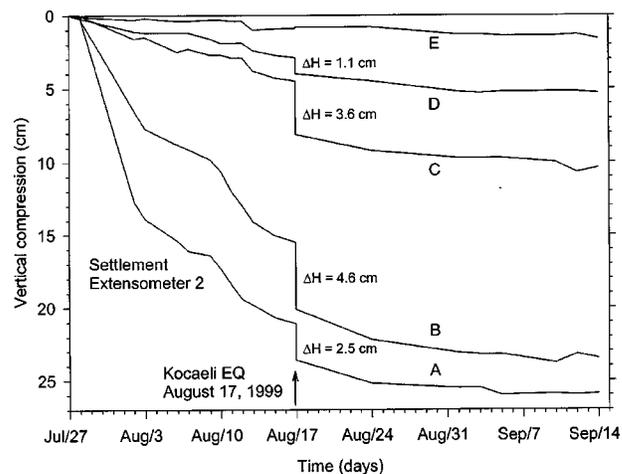
Of particular importance is the sudden offset in the curves following the Kocaeli Earthquake on August 17, 1999. By comparing pre- and post-earthquake readings, the settlements associated with the earthquake could be estimated for each ring location. And by subtracting the settlement of a given ring from that of the ring located immediately above, the settlement attributed to the portion of the soil profile situated between the two rings could be obtained. As such, the profile was divided into five sections (layers A through E) and the earthquake-induced settlement of

**Fig. 9.** Settlement versus time for Layers A–E (shown in Fig. 8) under surcharge fill in Lot C. Note abrupt offset in curve on 17 August 1999 that indicates settlement induced by Kocaeli Earthquake ( $\Delta H$  values).

each layer is noted in Fig. 9. The earthquake-induced settlements indicated in the figure occurred in less than 24 h, the elapsed time between the reading of the instruments the day before and morning after the earthquake. As can be seen, the total earthquake-induced settlement of Lot C was about 12 cm, and it was surprising that a significant percentage of the settlement was attributed to the clayey and silty strata. Layer A, which contains 2 m of medium dense unsaturated fill (GC) and 3 m of soft saturated ML/CL material, experienced a settlement of 2.5 cm. The gravely fill is not believed to have contributed significantly to the measured settlements. Layer B contains 1.5 m of cleaner SM material and 3 m of the ML/CL soil. The measured settlement in this layer was 3.5 cm. The average apparent volumetric strain in these upper layers was about 0.8%. Unexpectedly, the balance of the settlement, nearly 6 cm, was associated with the underlying materials classified as CH (layers C, D, and E) and reaching to a depth of more than 20 m, especially layer C, which underwent 3.6 cm of settlement (apparent volumetric strain of 0.9%). A definitive explanation as to how these fine-grained soils could have experienced such rapid settlements cannot be given at this time. It is suspected that the settlements are due to earthquake-induced strength loss/softening and subsequent constant-volume shearing distortions due to the overlying fill. It is possible, too, that the instruments malfunctioned and some of the settlement readings were in error; however, we have not yet been able to conceive of how any such malfunctions could have occurred.
