29 October 2007, Çameli earthquake and structural damages at unreinforced masonry buildings

Abstract. A recent earthquake of $M=4.9$ occurred on 29 October 2007 in Çameli, Denizli, which is located in a seismically active region at southwest Anatolia, Turkey. It has caused extensive damages at unreinforced masonry buildings like many other cases observed in Turkey during other previous earthquakes. Most of the damaged structures were non-engineered, seismically deficient, unreinforced masonry buildings. This paper presents a site survey of these damaged buildings. In addition to typical masonry damages, some infrequent, event-specific damages were also observed. Reasons for the relatively wide spread damages considering the magnitude of the event are discussed in the paper.

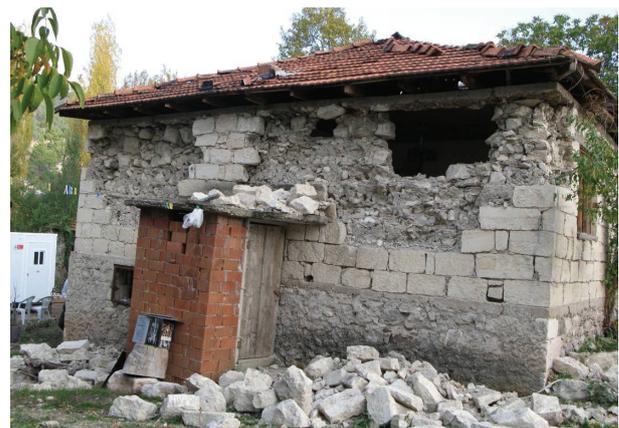
Fig. 7. Typical damage pattern in Çameli earthquake.

Another example of out-of-plane failure due to unsupported wall length is given in Fig. 16. Unsupported length of walls in plan is beyond the code limits, as the building is used as animal shed, which did not have any partitioning wall. Unsupported wall length is not only due to improper partition wall configuration but also unconnected wythes. A typical example of that type is given in Fig. 7. Net length of slender outer wythe was increased significantly and it failed finally.

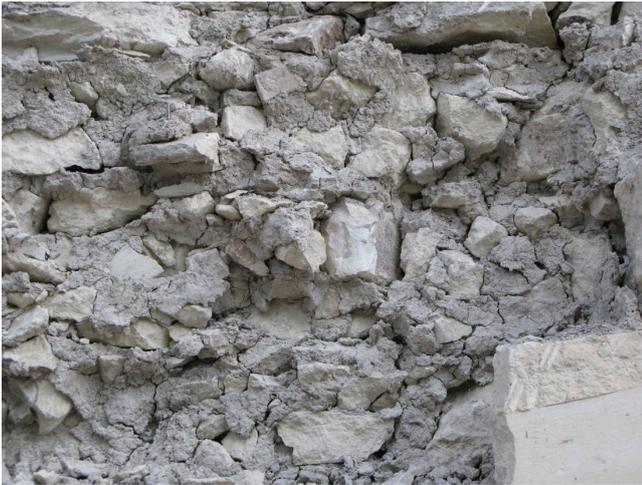
Fig. 8. Bad profile of a damaged wall.

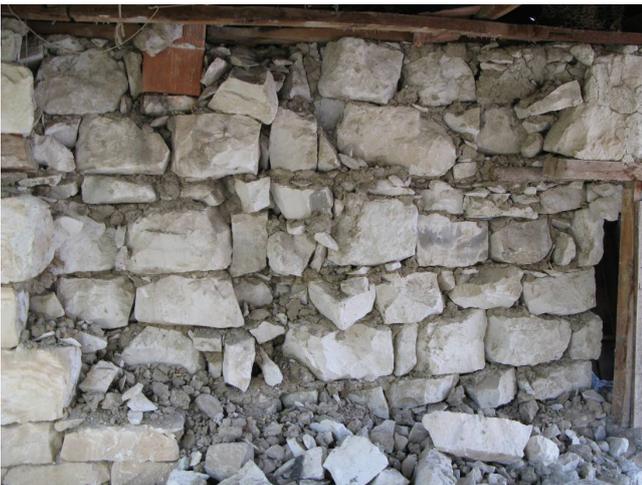
Fig. 9. Unconnected outer and inner wythes.

Marl blocks have low strength and ductility values. When the natural stone blocks are used as a wall material, selected stones usually do not have a proper shape to be used in the masonry walls; instead they have smooth and oval surfaces. Walls were formed by varying sizes of stone blocks, from 4–5 cm to 30 cm. These variations made it impossible to form an overlapping wall section. In addition to non-overlapping wall sections, walls were composed of an inner and an outer wythes, which were not connected to each other by interlocking elements. This bad wall configuration also made the walls more prone to out-of-plane failure, as the net length of the outer wythes of walls increased considerably. Some examples of these types of damages are shown in Figs. 7–9. Typical wall section observed at the site is compared with an earthquake resistant section in Fig. 10, where lack of connection between outer and inner wythes can be seen easily.

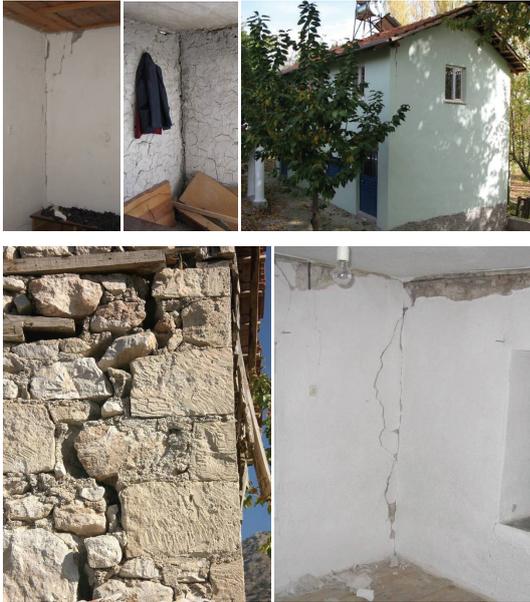
Although, masonry units have to be interlocked to satisfy a proper connection in crossing sections of walls, they were not connected or their connection was very poor in most of the damage cases. Typical cases of such damages are shown in Fig. 11. This is also proven by a building which was damaged during its construction (Fig. 12). External walls were constructed before the partition walls. Due to this bad connection detail of the crossing walls, safety of connections is relied on tensile strength of the mortar used for connection.

These type of deficiencies were not limited to external partition wall connections. At the corners of the buildings, where two external walls meet, masonry units were not overlapped properly to ensure an earthquake-resistant connection (Fig. 11).

Fig. 11. Damages observed at connection of crossing walls.

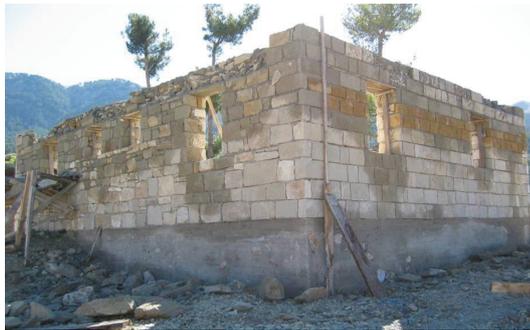
Fig. 12. Damaged building during its construction without partition walls.

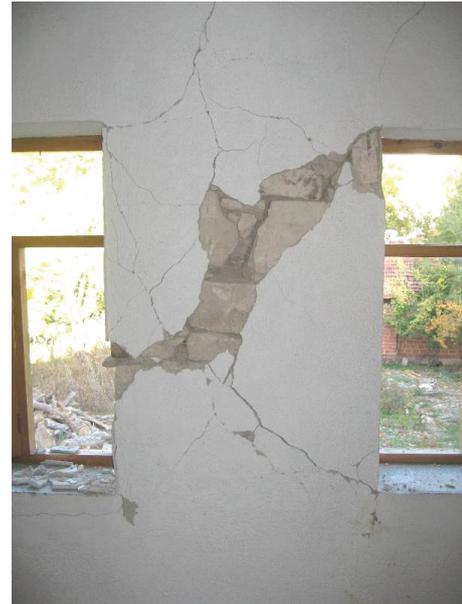
As the masonry walls are the only load resisting mechanisms of the masonry buildings, wall openings should be regular and minimized as much as possible in order to improve earthquake resistance. Seismic design codes give the rules about these openings, restricting distance between the two openings, distance between an opening and a corner, etc. (MPW, 1975; MPW, 1998; MPW, 2007). For example, the new seismic code (MPW, 2007) limits the minimum distance between two openings as 1 m for seismic zone 1 and minimum allowable distance between an opening and a building corner is 1.5 m.

Two examples of damages due to wall openings are given in Figs. 13 and 14. The problem in the former is the short distance between two adjacent windows. In the latter figure

Fig. 13. Damage between two wall openings.

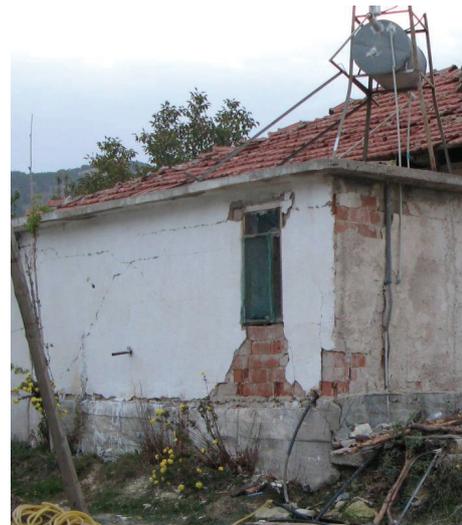
Fig. 14. Damage concentrated around wall opening near the building corner.

the problem is the short distance between the opening and the building corner. Due to this wall formation, damage was concentrated around the opening.

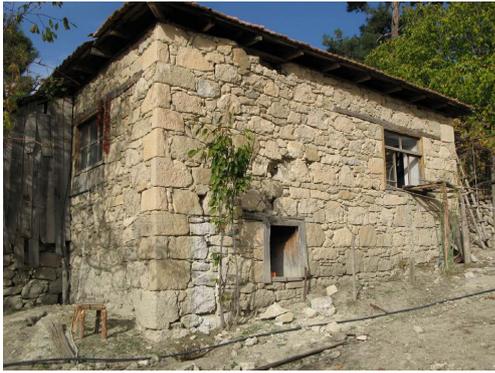
Fig. 15. Out of plane failure due to lack of bond beam.

are some of those deficiencies. The lack of bonding beams at the top of the walls and having a light roof with insufficient in-plane rigidity, which does not provide diaphragm effect, are also important reasons of this type of damage (Fig. 15).

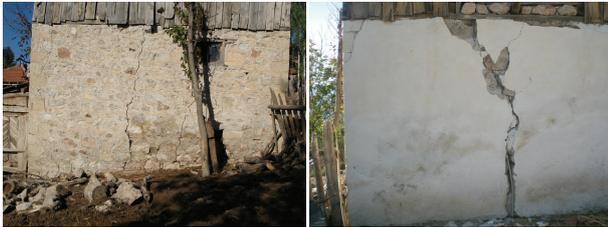
Fig. 16. Out of plane failure due to long unsupported wall length.

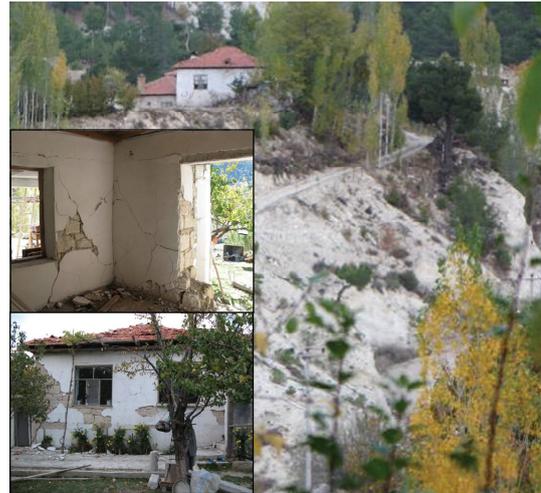
Topographical characteristics of the Çameli Basin played an important role for extensive damages in the region. Many of the damaged buildings were located on a hilly and rugged terrain. According to some corroborative studies, local topographical irregularities on ground surface may affect ground acceleration significantly (Kramer, 1996). Because of amplified ground accelerations, the number of damaged buildings increased significantly. Some damages on a building located on a hill are shown in Fig. 17. Due to the concentration of seismic energy and amplification of the ground acceleration at the top of the hill, damage level of the building is heavier than those located on the foot of the hill. It is also worth noting that cracks on the ground and on the top of the hillside are observed at the same place (Fig. 18).

Fig. 17. Damaged building due to slope/hill affect.

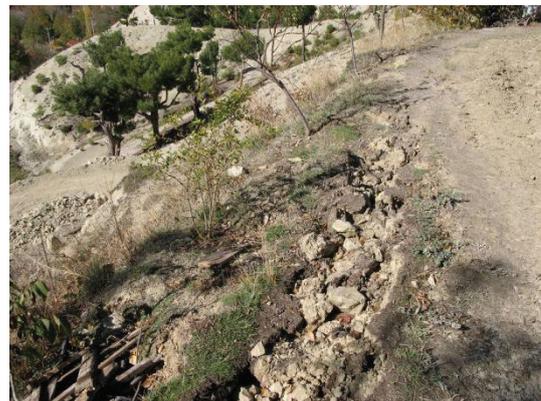
Fig. 18. Cracks on the ground at top of hillside.
