THE RESTORATION PROJECT OF A XIIIth CENTURY ANATOLIAN
SELJUK "MESCİD" IN KONYA WITH THE EMPHASIS ON THE MATERIALS
AND RELATED PROBLEMS

A Master's Thesis

Selim Sarp TUNÇOKU

February, 1993

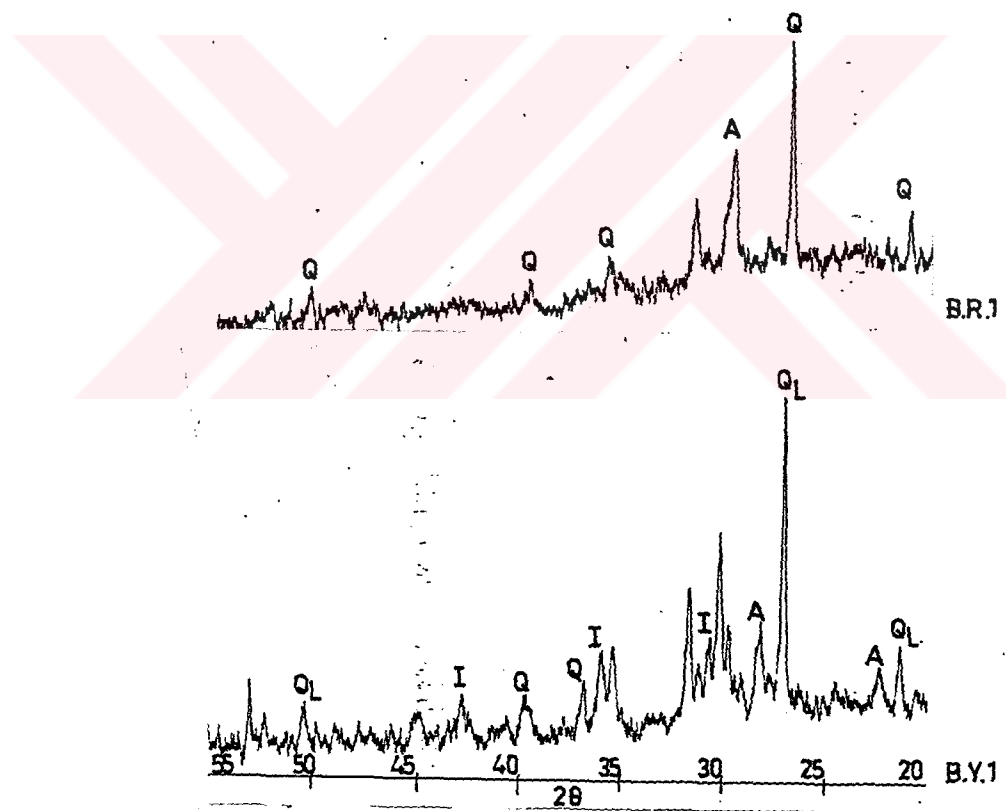
Figure 19. X-ray Diffraction Patterns of Bricks

The mineralogical compositions of the original bricks were determined by using X-ray powder diffraction technique. X-ray diffraction patterns of the original bricks show that they consist of feldspar (albite), iron oxides and quartz (Figure 19).

However, the absence of clay minerals peaks is also noticed. It is assumed that the bricks must have been fired up to

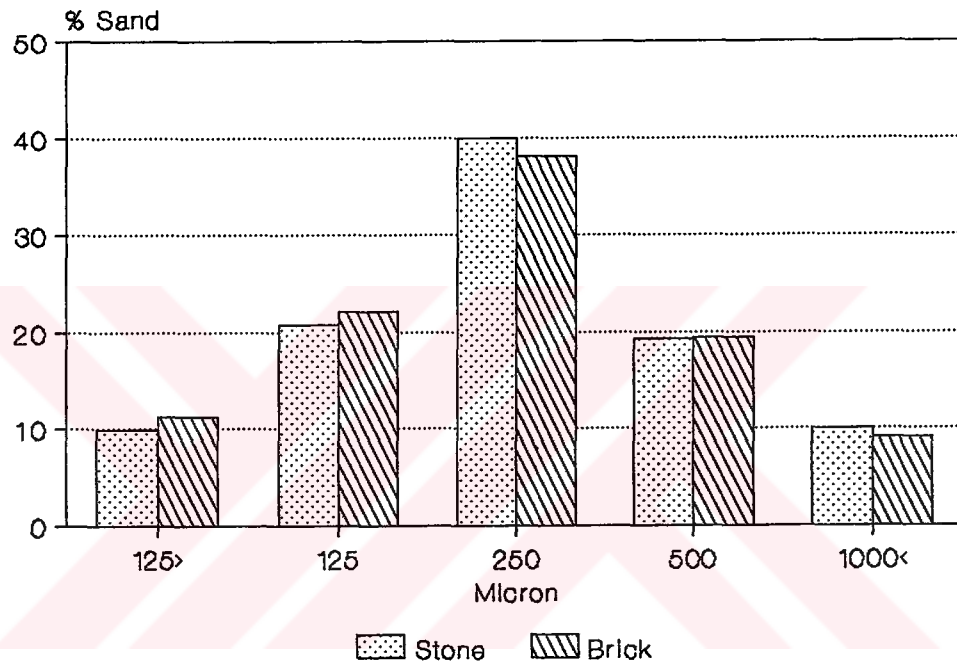
Figure 20. Percent Size Distribution in Original Mortars (Average of 16 samples of stone and 54 samples of brick mortars)

As the Table 2 shows, the percentage of binder is more than the percentage of aggregate in mortars of stone and brick masonries. This difference is higher in the mortars of brick masonry. Aggregate percent of mortars in stone masonry is higher than the ones in brick masonry, average densities of sand particles being equal (2.44gr/cm³). As a result of that stone masonry mortars are denser than the brick masonry mortars. Gypsum renderings however have the least amount of aggregates.

The size distributions of sand in the original mortars of stone and brick masonries are similar and proper (ASTM, 1980). 250 microns size particles are in high amounts, the smallest and largest size particles are in minimum amounts (Figure 20). On the other hand size distributions of sand in the lime mortars of 1958 intervention are variable and out of standards.

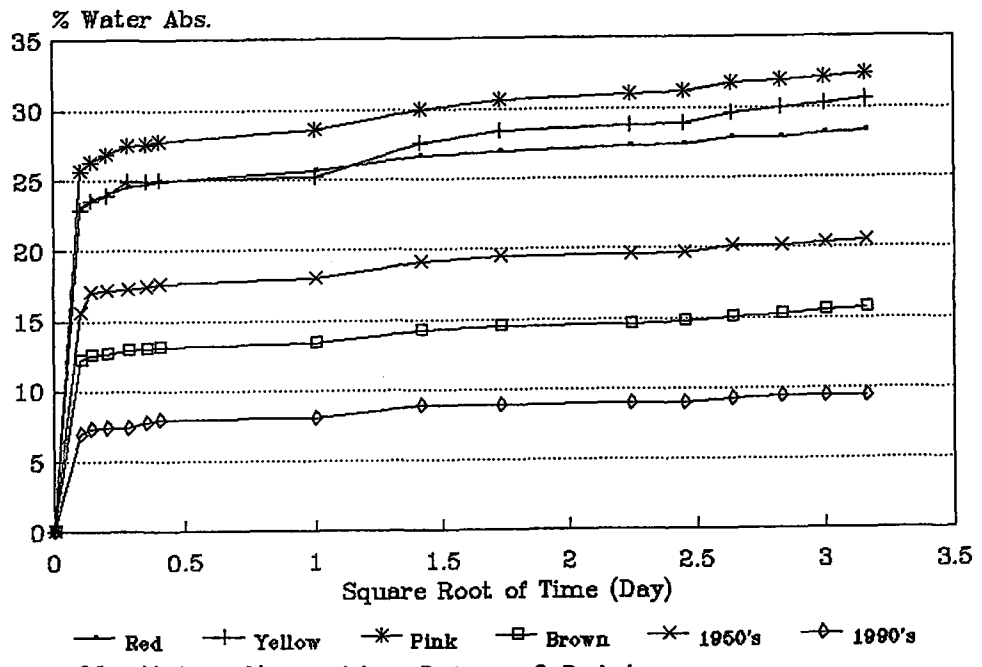
Figure 21. Water Absorption Rates of Bricks

Water absorption rates of bricks were determined by total immersion (Teutonico, 1986). The weight increase of the samples are measured at certain time intervals in ten days. The results are given in the Appendix B. The highest amount of water was absorbed within the first 15 minutes corresponding to more than 70 percent of the total absorption. The original red, yellow and pink bricks showed the same trends except for the brown bricks which have the least absorption rates. The bricks of the 1958 intervention differed from the original bricks with less amount of absorption rates but more than the original brown bricks. The absorption rates of all bricks are graphed (Figure 21).

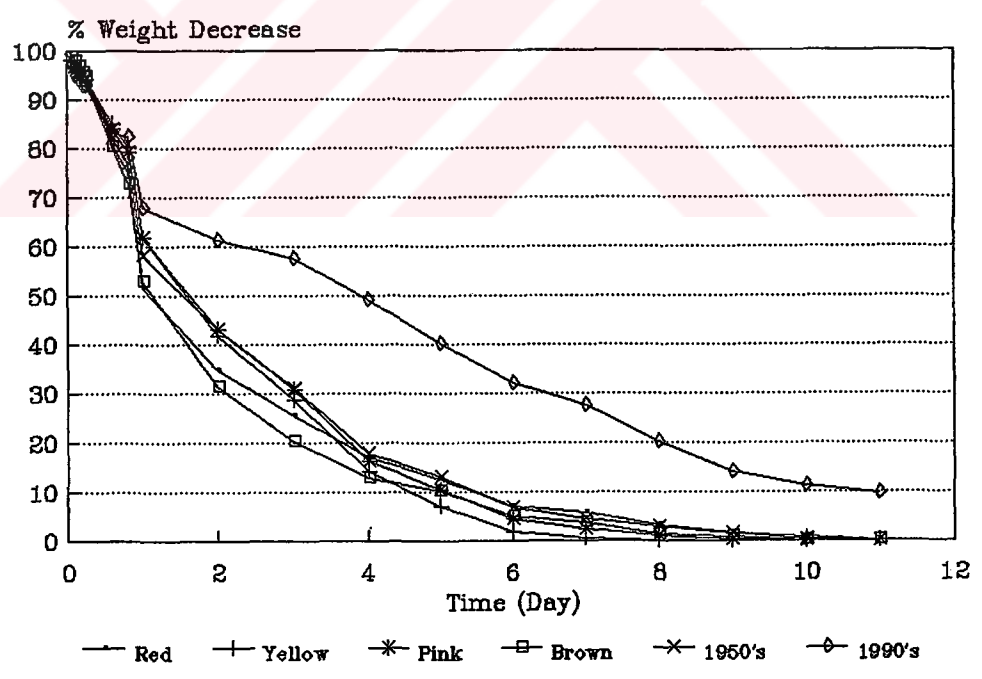
Figure 22. Drying Rates of Bricks

The determination of the drying rates of the bricks were carried out at 20°C and approximately 40% relative humidity (Appendix C). The weight decreases are measured within certain time intervals in ten days. The all bricks dried within ten days. The obtained results are graphed in Figure 22.

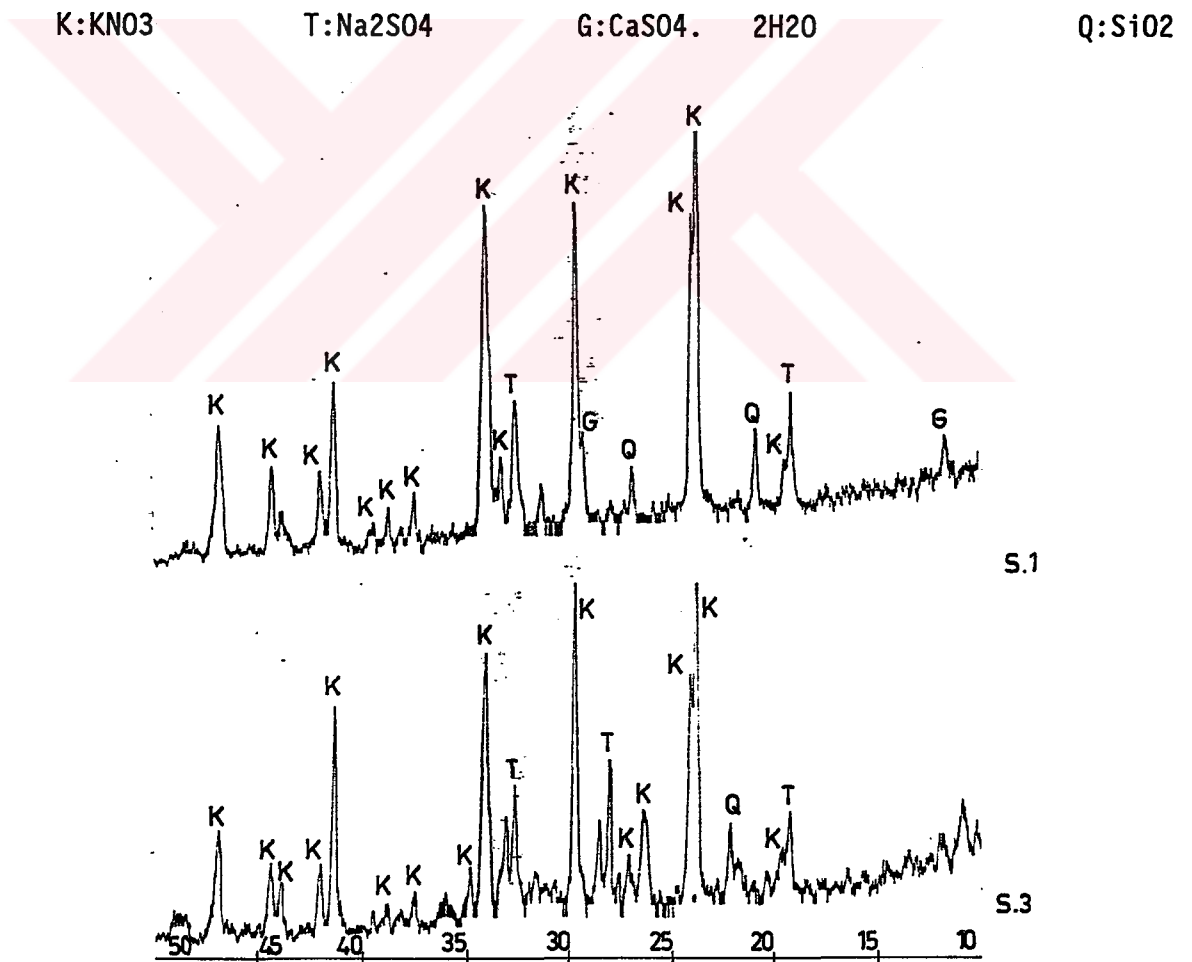
Figure 23. X-ray Diffraction Patterns of Soluble Salts

Soluble salts collected from the efflorescences and from the decayed bricks, stones and mortars have been analyzed qualitatively (Arnold, 1983). Sulphate, nitrate and chloride ions were detected in all samples from the decayed parts.

The mineralogical compositions of the soluble salts were determined by using X-ray powder diffraction technique. Sodium sulfate (Na_2SO_4), potassium nitrate (KNO_3) and gypsum ($\text{CaSO}_4 \cdot 2\text{H}_2\text{O}$) were observed in diffraction patterns (Figure 23).

Alkaline sulphates detected by the analyses originate from portland cement and nitrates are most likely due to the soil.

As a conclusion, salt problem of the monument may be better controlled by closing the monument with doors and windows so that climatic fluctuations are minimized at least at the inside of the monument. Salt cleaning should be done to decrease the salt content as much as possible.

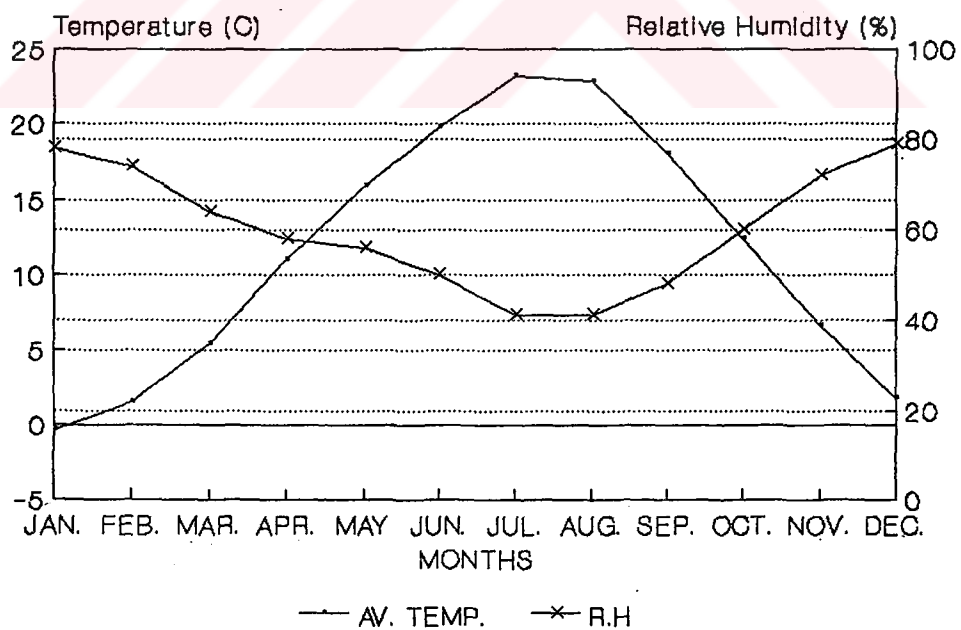
Figure 24. Average Relative Humidity and Temperatures in Konya.

The climatic data of Konya, covering last few decades are shown in Figure 24, 25, 26 and 27. As the figure shows, the maximum risk of condensation is in winter months when the average relative humidity is 80 being at its maximum. By looking at the equilibrium relative humidities at which the salts get wet, one can figure out that the parts of the monument with heavy salt problem (the domes and the vault) will be thoroughly wet in winter (Table 4).
