Assessment of kinematic rock slope failures in Mudurnu Valley, Turkey

A Arslan Kelam¹, H Akgun¹, A Bobet² and MK Kockar³

¹ Geotechnology Unit, Department of Geological Engineering, Middle East Technical University (METU), Ankara, Turkey

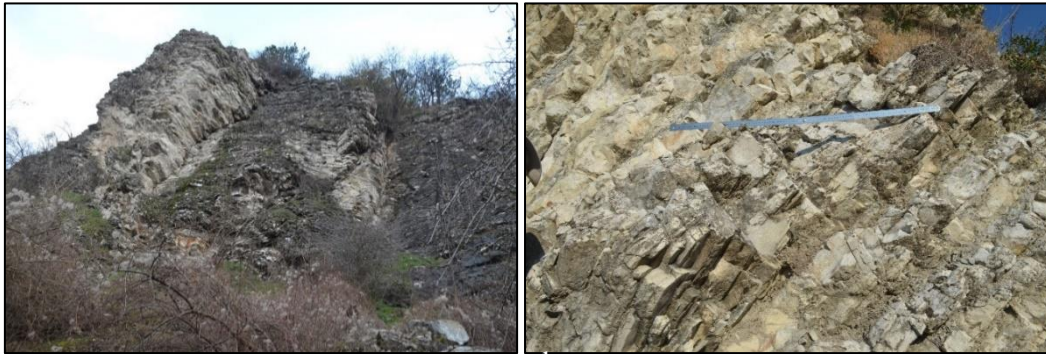
The focus of this study was the valley slopes on the west side of Mudurnu. The methodology that has been followed to evaluate the geological units, structures, discontinuities and their distribution in the area can be briefly described as follows. First, the morphology and geology of the area, which were examined based on an extensive literature review and preliminary field studies were defined. Second, field investigation studies and scan-line survey measurements were completed. Discontinuity properties proposed in [7] were investigated carefully by scan-line surveys in the accessible locations which were performed by fixing a 5 m long measuring tape to the rock face (figure 3). As mentioned earlier, the unit that outcrops in the valley is pelagic limestone. It is pinkish gray to light gray in color (figure 3). In the study area, the scan-line surveys revealed that there were three discontinuity sets: a bedding plane (BP) and two discontinuity sets (J1 and J2). The discontinuity sets had strong to very strong strengths according to field identification [7] and the Schmidt hammer rebound values [8]. In general, the limestone was slightly weathered to moderately weathered in several locations. The discontinuities were described as undulating rough to undulating smooth, and the apertures were classified as open (0.5-2.5 mm) in general, but there were very tight and moderately wide surfaces as well. Clay and silty clay infillings were observed in the apertures. The discontinuities were close to moderately spaced, in

general. Persistence was high. Water leakage was not observed during the field work but color changes were detected in several places. It was expected that surface water would have an effect on the rock masses due to the rate of annual precipitation (mean annual precipitation of 571 mm) in the area [9].

Figure 3. a) A view of discontinuous limestone, b) A photo taken during scan-line survey studies.

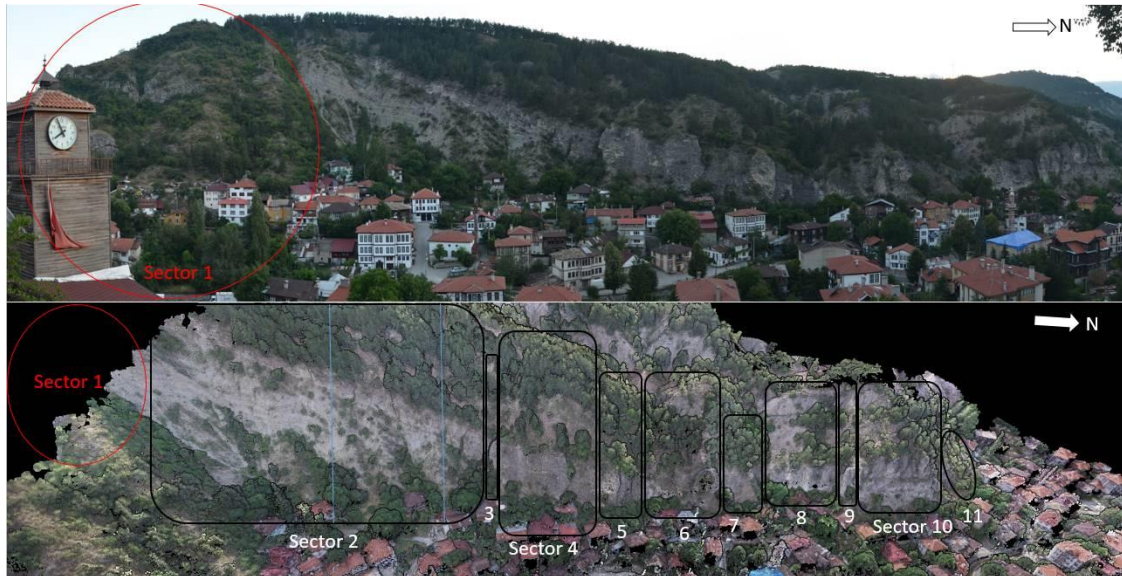
In addition to the scan-line surveys, digital images of the area were collected by an Unmanned Aerial Vehicle (UAV) and then a 3D point cloud of the area was generated. This step was crucial because a significant part of the slopes was inaccessible as a result of the steep topography. However, due to the highly irregular and non-homogenous nature of the rock masses, a detailed investigation was necessary. This need was fulfilled by utilizing high-resolution images followed by generating surface models and a point cloud. The point cloud, together with the field observations, was analyzed through the division of the west side of the Mudurnu valley into 11 different sectors of similar rock mass characteristics and discontinuity orientations (figure 4). However, since the rock mass characteristics included significant uncertainty, the determination of representative mechanical values of the rock mass for stability analysis was challenging. The uncertainty of the rock mass properties was addressed through a probabilistic analysis, where the rock properties were obtained from the statistical evaluation of the available data. For this purpose, a detailed statistical characterization study was conducted by utilizing the point cloud. Statistical distributions were obtained for the orientation, spacing and persistence of all joint sets. The Discontinuity Set Extractor (DSE) method was utilized for the identification of the discontinuity set orientations, where changes in joint orientation were evaluated by obtaining the distribution of orientations for each discontinuity set [10]. The DSE is a semi-automatic identification tool of the planar features of a rock mass from 3D point cloud data. In the method, the discontinuity sets were identified by calculation of the local curvature of normal vectors, statistical analysis of discontinuity poles and cluster analysis. For the determination of spacing and persistence distributions, the DSE method uses the previously analyzed point cloud data used to identify discontinuity sets and clusters. The DSE method calculates the normal spacing between a given plane and a plane closest to it, through 3D relationships [11]. For persistence, a co-planarity test was applied to the clusters. Based on the results from the co-planarity check, the cluster parameters were modified and the clusters were merged. Then, persistence measurements were made by a transformation matrix [12]. Afterwards, the results were compared with the field survey measurements of the physically accessible locations to validate the DSE results. Validation was done in Sectors 2, 6, 8 and 10. The results obtained with the DSE were comparable with those extracted from the field observations, suggesting that the DSE results were reliable and, hence, utilization of DSE to extract discontinuity properties in inaccessible sectors was justified. As a result of the analyses described, several sectors were merged and a total of 7 geomechanically-uniform sectors were identified. Finally, kinematic analyses of the sectors revealed that planar, wedge and toppling failures were possible. In the area, it was previously determined that Joint Set-1 (J1) causes planar failures, intersection of Joint Set-1 (J1) and Joint-Set 2 (J2) creates wedge failures and the Bedding Plane (BP) could produce toppling failures [9]. Toppling failures were

associated with blocks of small size, but planar and wedge failures could produce very large unstable blocks. This is the reason why planar and wedge failures are very critical in the region.

Figure 4. Geomechanical sectors defined as a result of a detailed evaluation of the rock mass characteristics

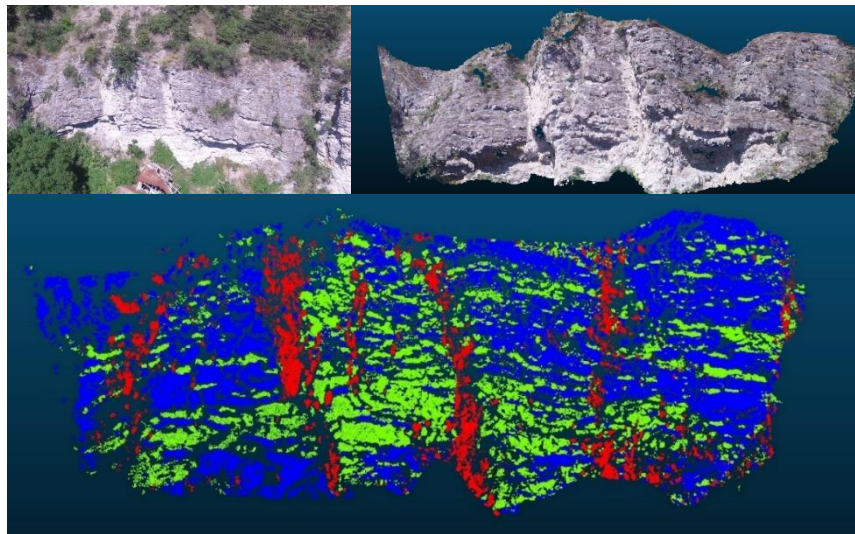
The focus of the paper is on Sector 8 as a representative high risk example, albeit the methodology and work done to the entire valley. Statistical distributions of the discontinuity characteristics were evaluated in addition to the scan-line survey measurements and field observations. As discussed, the point cloud was used with the DSE method. The discontinuity sets identified with the DSE for Sector 8 are given in figure 5, where each set is represented by a different color. The discontinuity set orientations were $255^{\circ}/44^{\circ}$, $083^{\circ}/79^{\circ}$ and $141^{\circ}/80^{\circ}$ for the Bedding Plane, Joint Set-1 and Joint Set-2, respectively. The two pairs of numbers provide, in that order, the dip direction and the dip angle.

Figure 5. Discontinuity sets and orientations of Sector 8 identified by utilizing DSE.

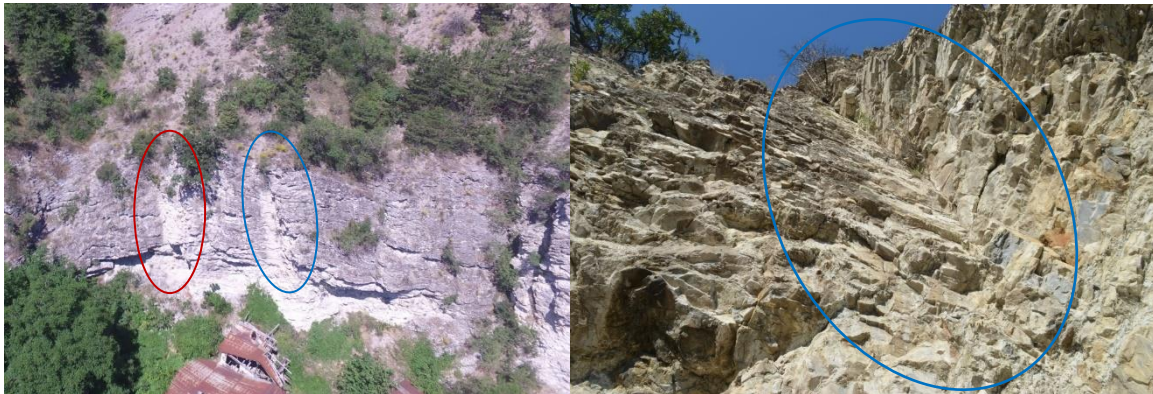
Further estimates of the friction angles of the discontinuities in Sector 8 were done through back analysis of failures observed in the field [15]. The blocks identified for the back analysis are shown in figure 8. Those were wedge failures along the joints J1 and J2. The friction angles estimated from the back analysis were 43° and 45° for J1 and J2, respectively. The friction angles obtained from Eqn. (1) for J1 and J2 were 45° and 49°.

Figure 8. Blocks identified in Sector 8 for back analysis.

The shear strength parameters for the identified blocks given in figure 8 were obtained by using SWedge software [16] for the wedge type of failure where the blocks slide along the line of intersection of J1 and J2. After that, by using the estimated strength parameters, the Factor of Safety for both static and dynamic conditions were calculated. A design Factor of Safety of 1.8 and 1.1 were assumed for static and dynamic conditions, respectively. To evaluate dynamic condition in the stability analysis, the horizontal seismic load coefficient estimated was 0.24g according to Turkish Building Earthquake Code [4, 5]. The support force required to ensure these Factor of Safety values for Sector 8 was determined as 9.85 kPa per unit volume of the wedges.
