# Preliminary Report on Engineering and Geological Effects of the January 24, 2020 Magnitude 6.7 Earthquake in Elaziğ, Turkey

A report of the NSF-Sponsored Geotechnical Extreme Event Reconnaissance Association

Report GEER-065

**January 24, 2020 Elazığ-Sivrice Earthquake ( $M_w=6.8$ )  
Reconnaissance Study Report**

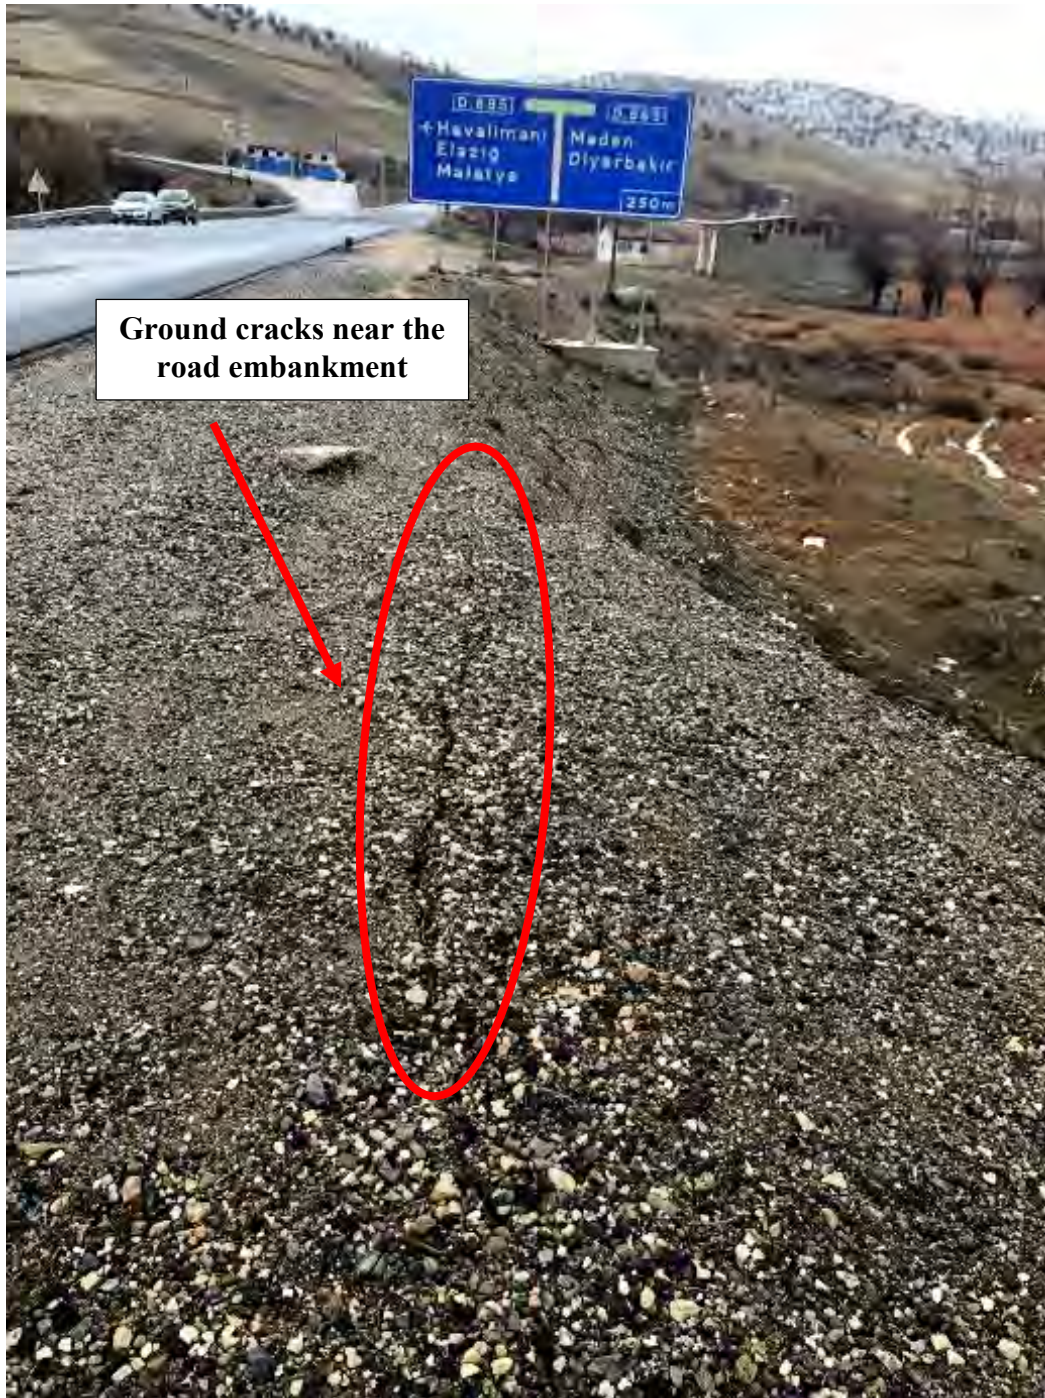
Ground cracks near the  
road embankment

A small crack indicating a local bench failure was observed near the Sivrice road embankment, as shown in Figure 4.9. The crack is examined and presumed as a sign of a local small-scale slope instability problem.

Figure 4.9. A small crack observed near the highway embankment  
( $38^{\circ}28'08.0''N$   $39^{\circ}16'38.7''E$  / 31.01.2020 / 11:50)

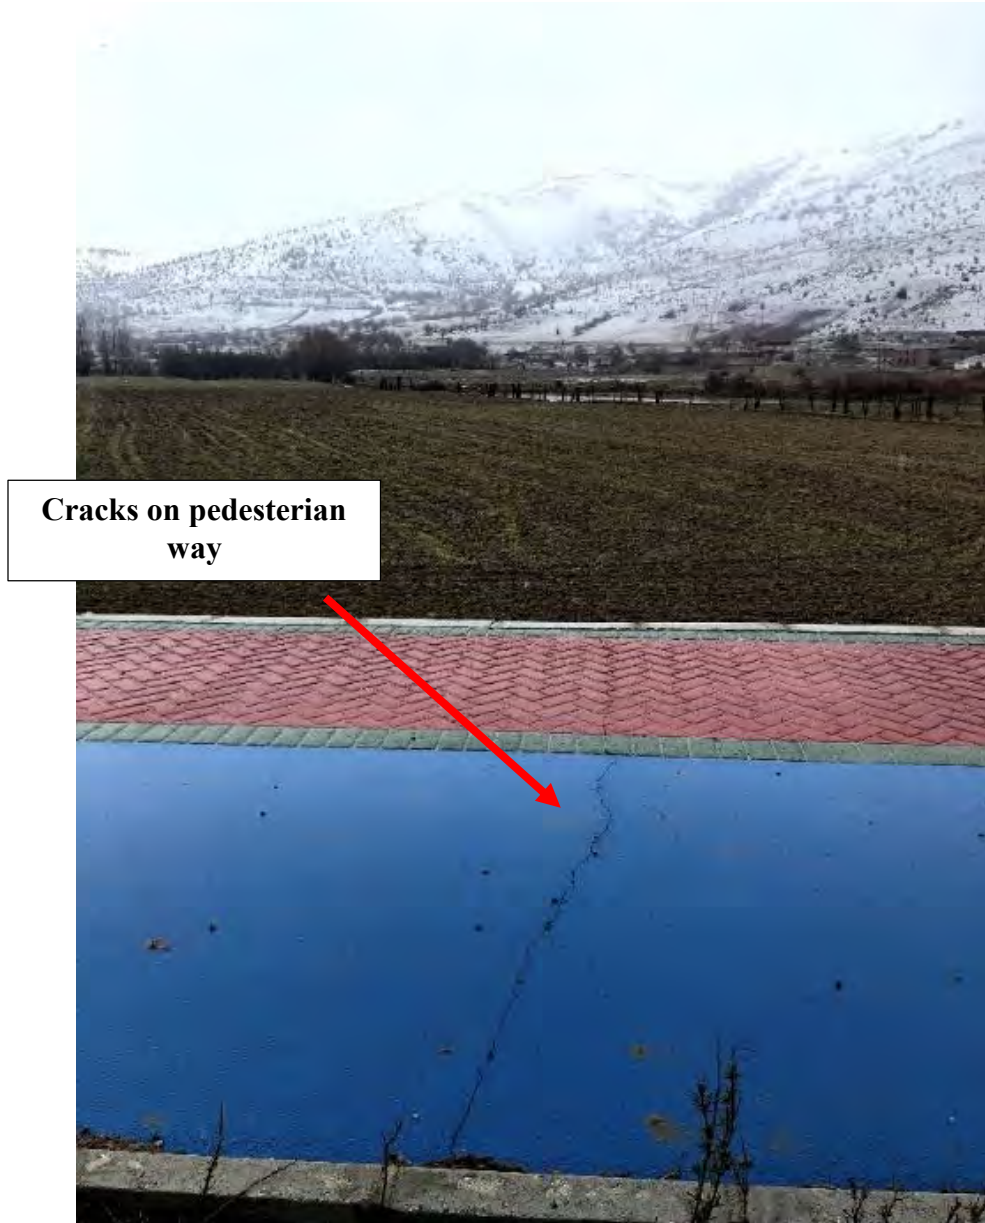
A crack was observed on the sidewalk near to Sivrice road as presented in Figure 4.11. The orientation of the cracking does not support a slope instability problem, which may be interpreted as an old crack existing before the earthquake.

Figure 4.11. Clayey site, no signs of failure  
( $38^{\circ}28'10.0''N$   $39^{\circ}17'03.6''E$  / 31.01.2020 / 11:56)

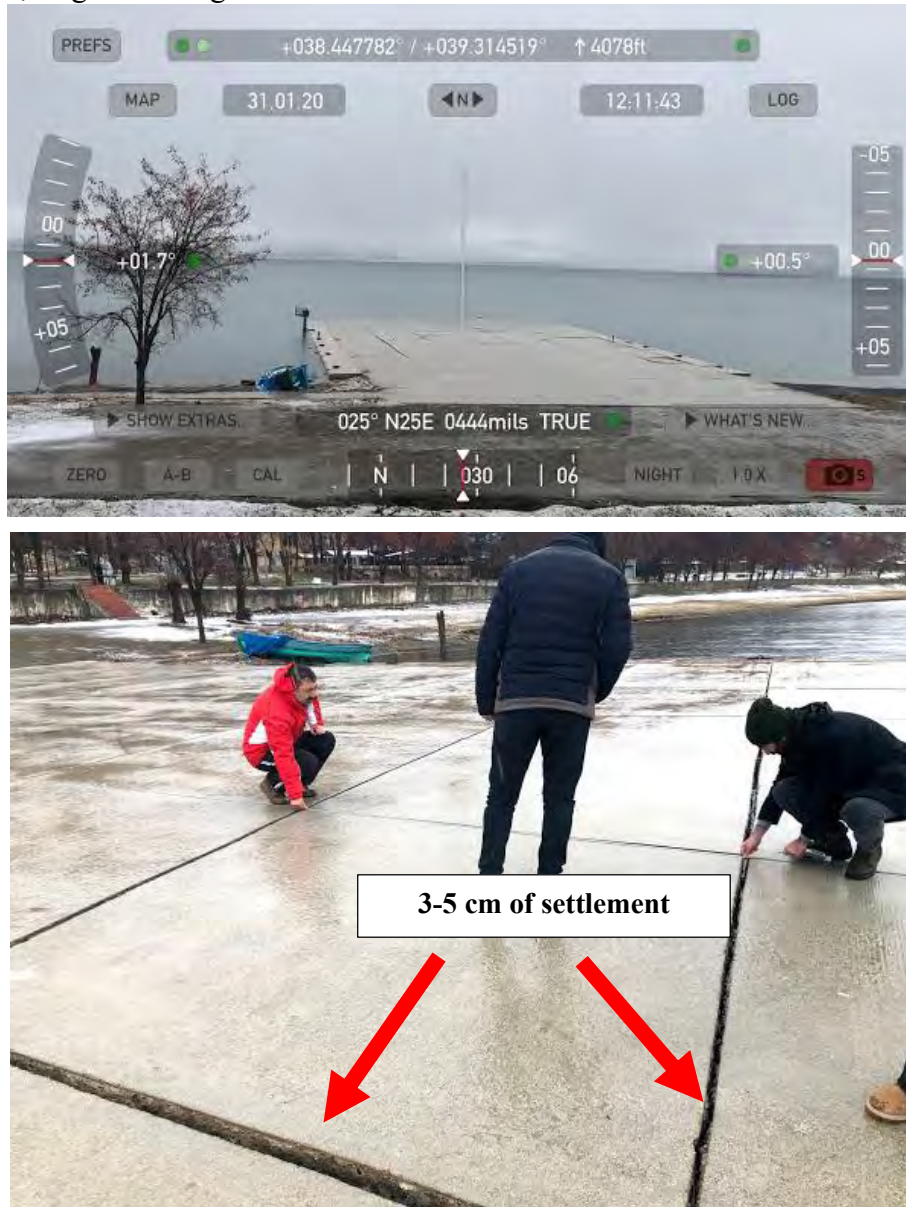
Figure 4.12. Seismically-induced volumetric settlement in the dock of Hazar Lake  
(38°28'10.0"N 39°17'03.6"E / 31.01.2020 / 12:11 & 38°26'53.2"N 39°18'53.4"E / 31.01.2020 / 12:14)

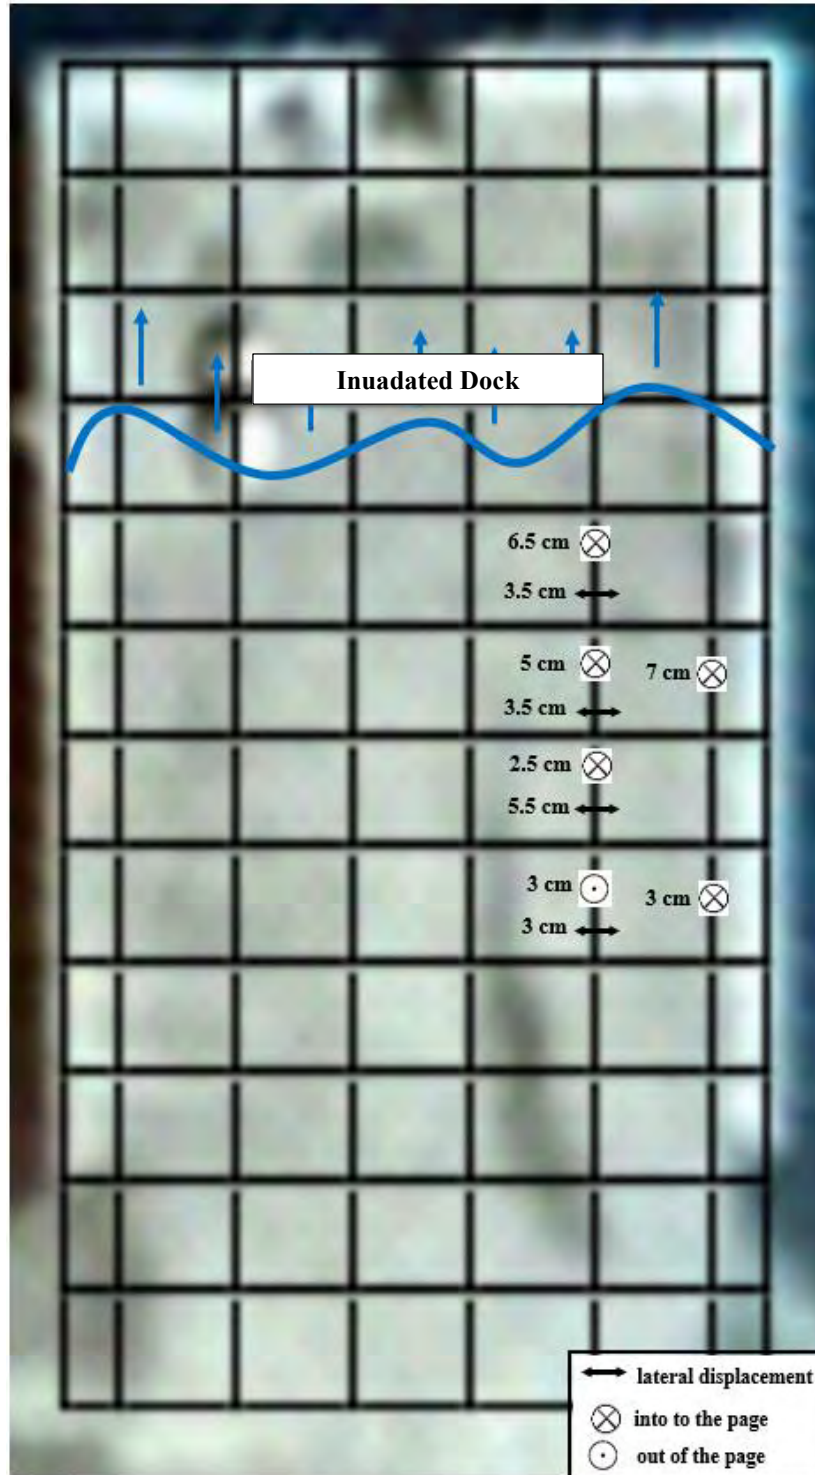
Figure 4.14. Displacements observed on reinforced concrete dock blocks

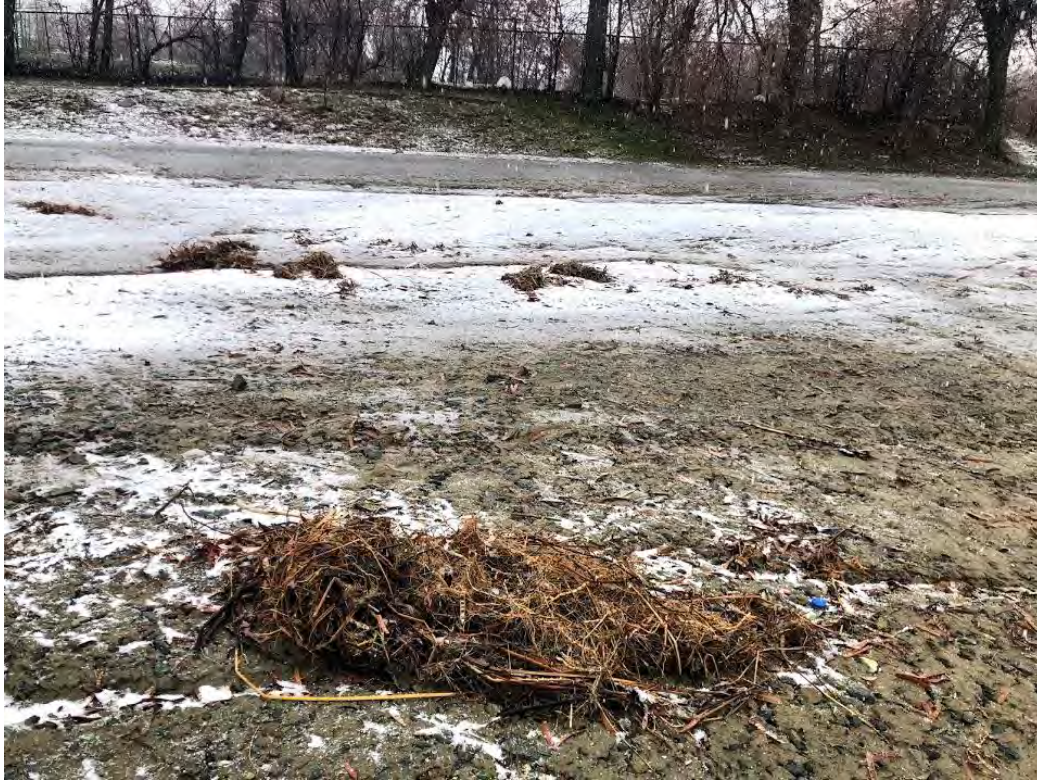
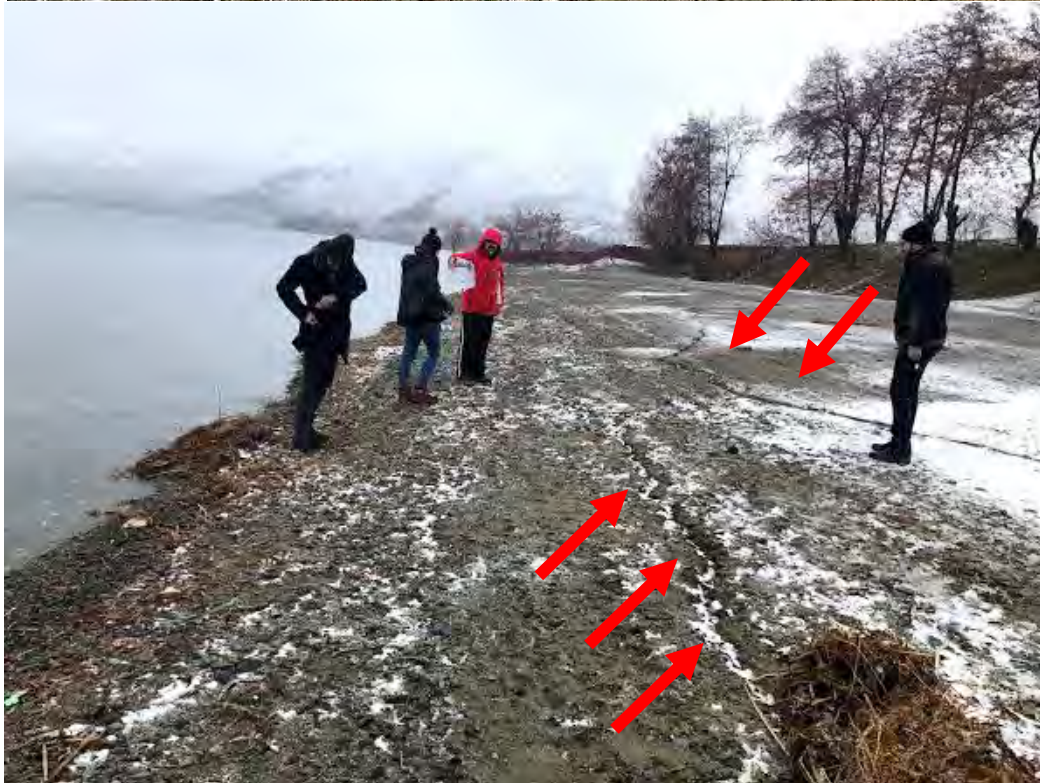
Figure 4.15. Seismically-induced lateral spreading on the beach of Hazar Lake  
( $38^{\circ}26'53.7''N$   $39^{\circ}18'54.2''E$  / 31.01.2020 / 12:21 &  $38^{\circ}26'50.7''N$   $39^{\circ}18'56.9''E$  / 31.01.2020 / 12:21)

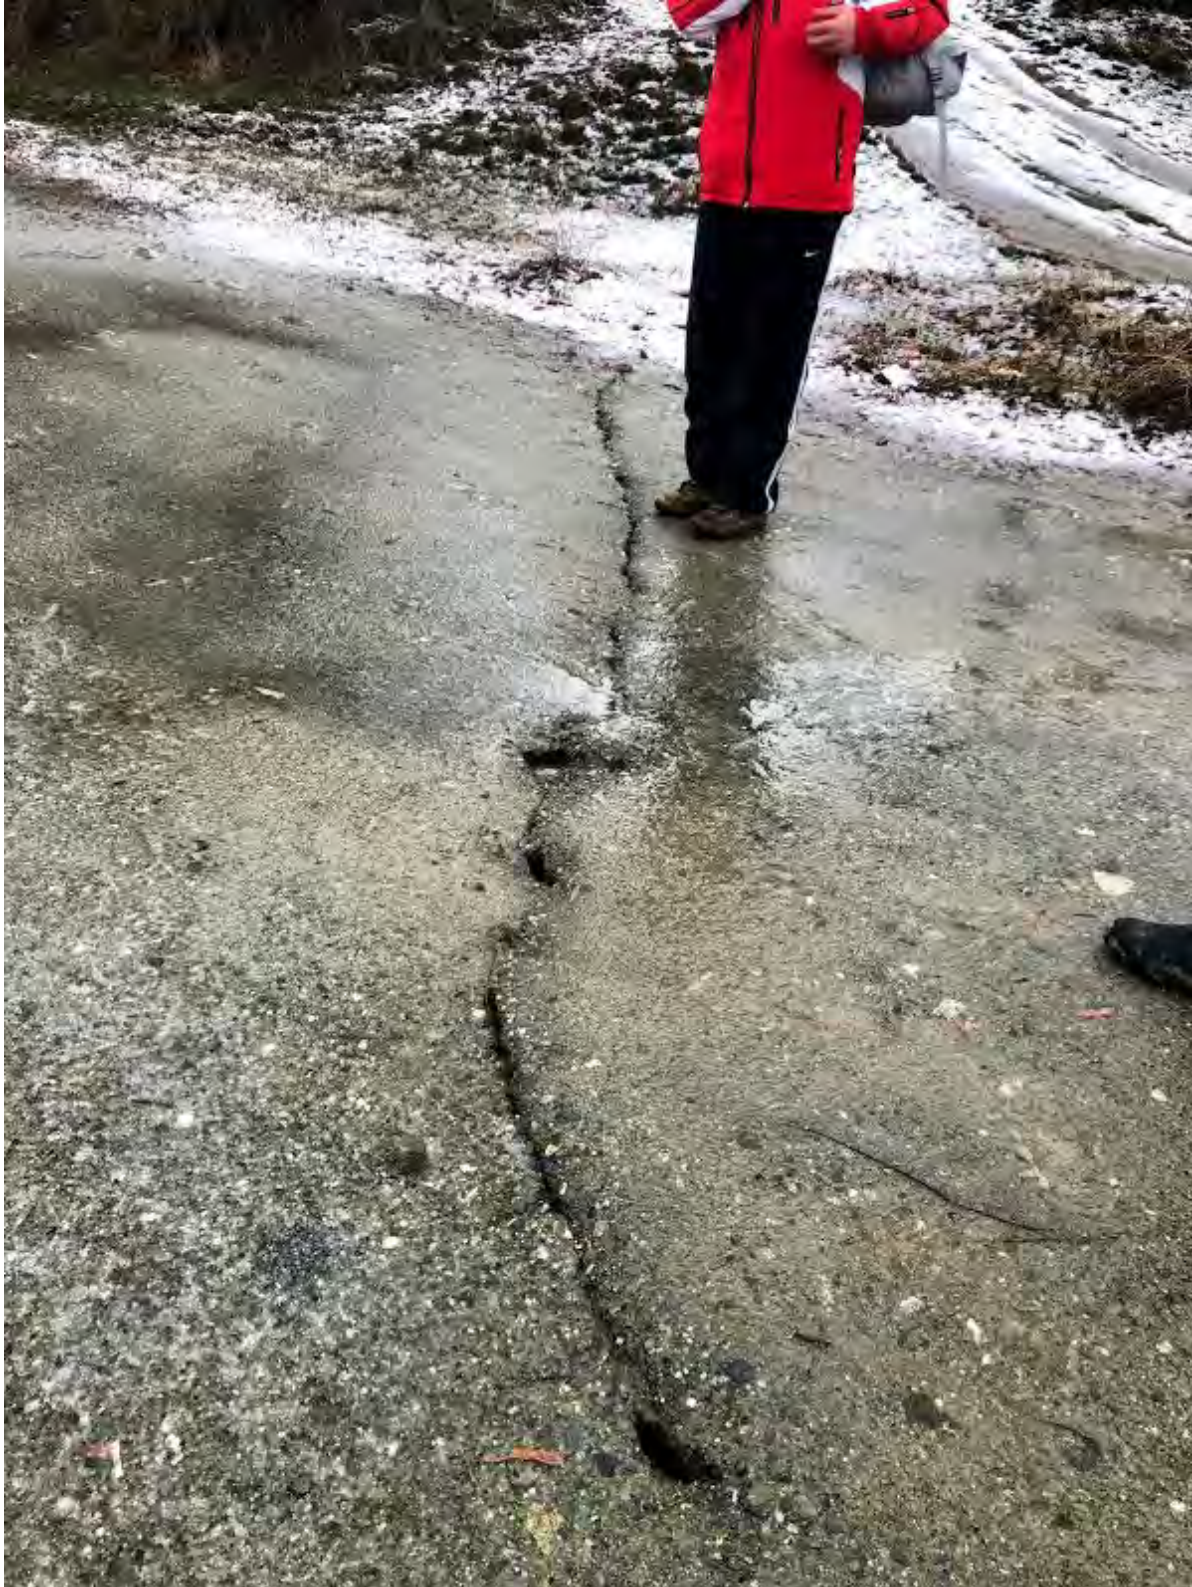
Figure 4.18. Another view of seismically-induced lateral spreading cracks  
( $38^{\circ}26'50.7''N$   $39^{\circ}18'55.4''E$  / 31.01.2020 / 12:36)

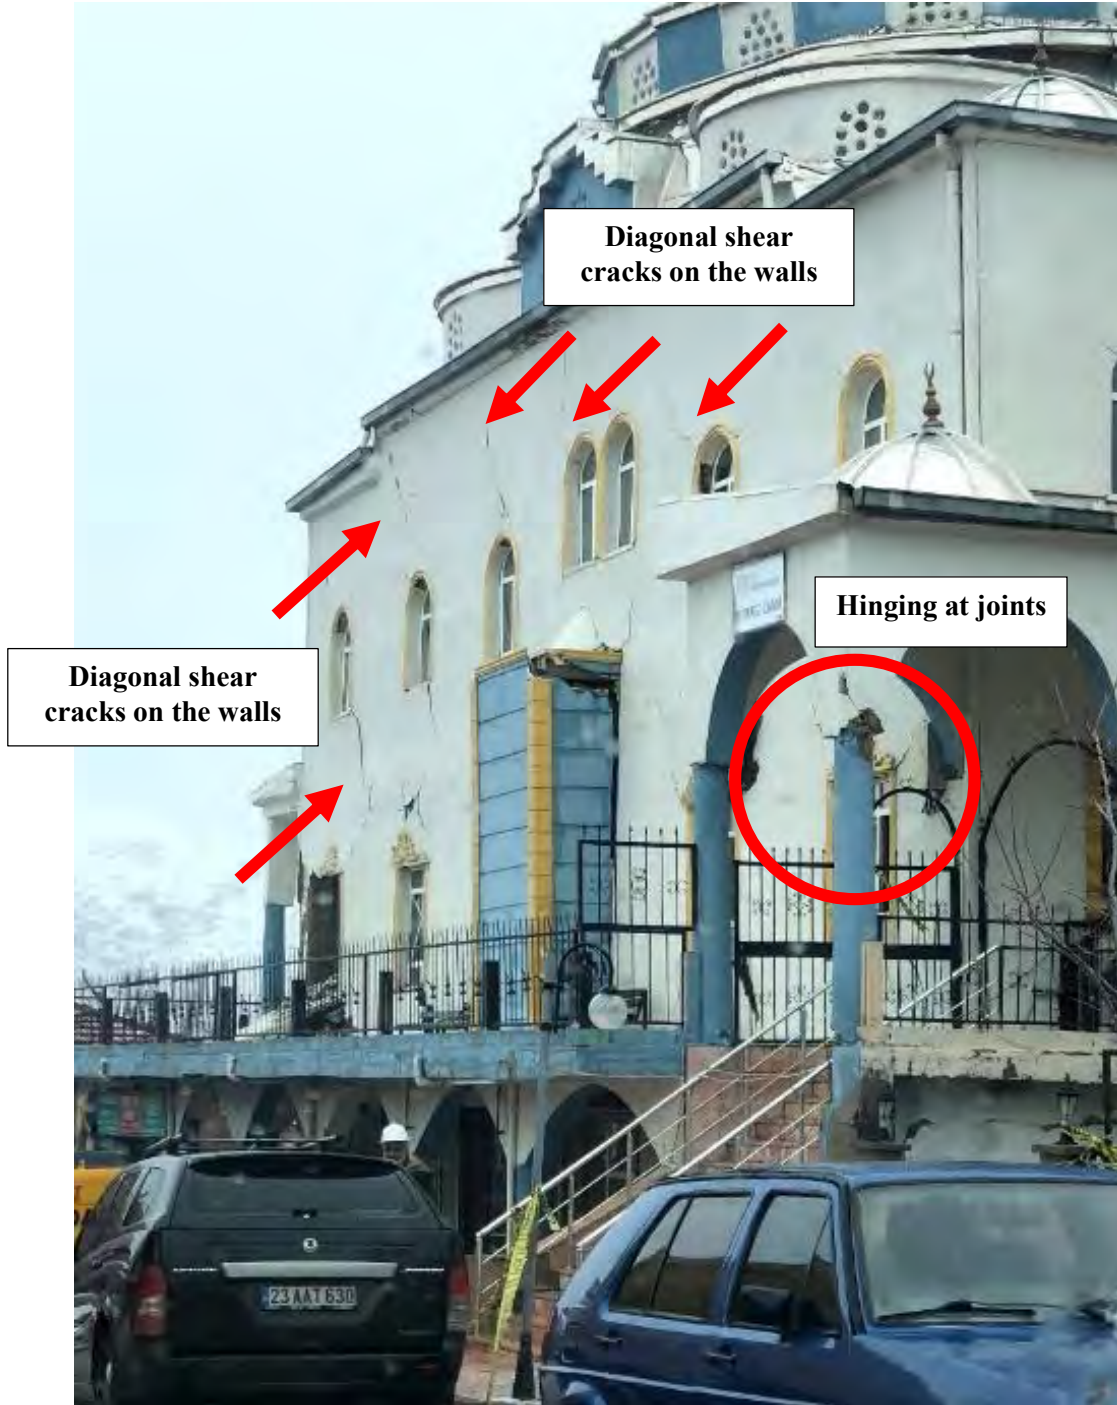
A structurally damaged Mosque located in Sivrice is shown in Figure 4.22.

Figure 4.22. A view of a damaged Mosque at Sivrice (Merkez Camii)  
( $38^{\circ}26'54.2''N$   $39^{\circ}18'34.6''E$  / 31.01.2020 / 13:25)

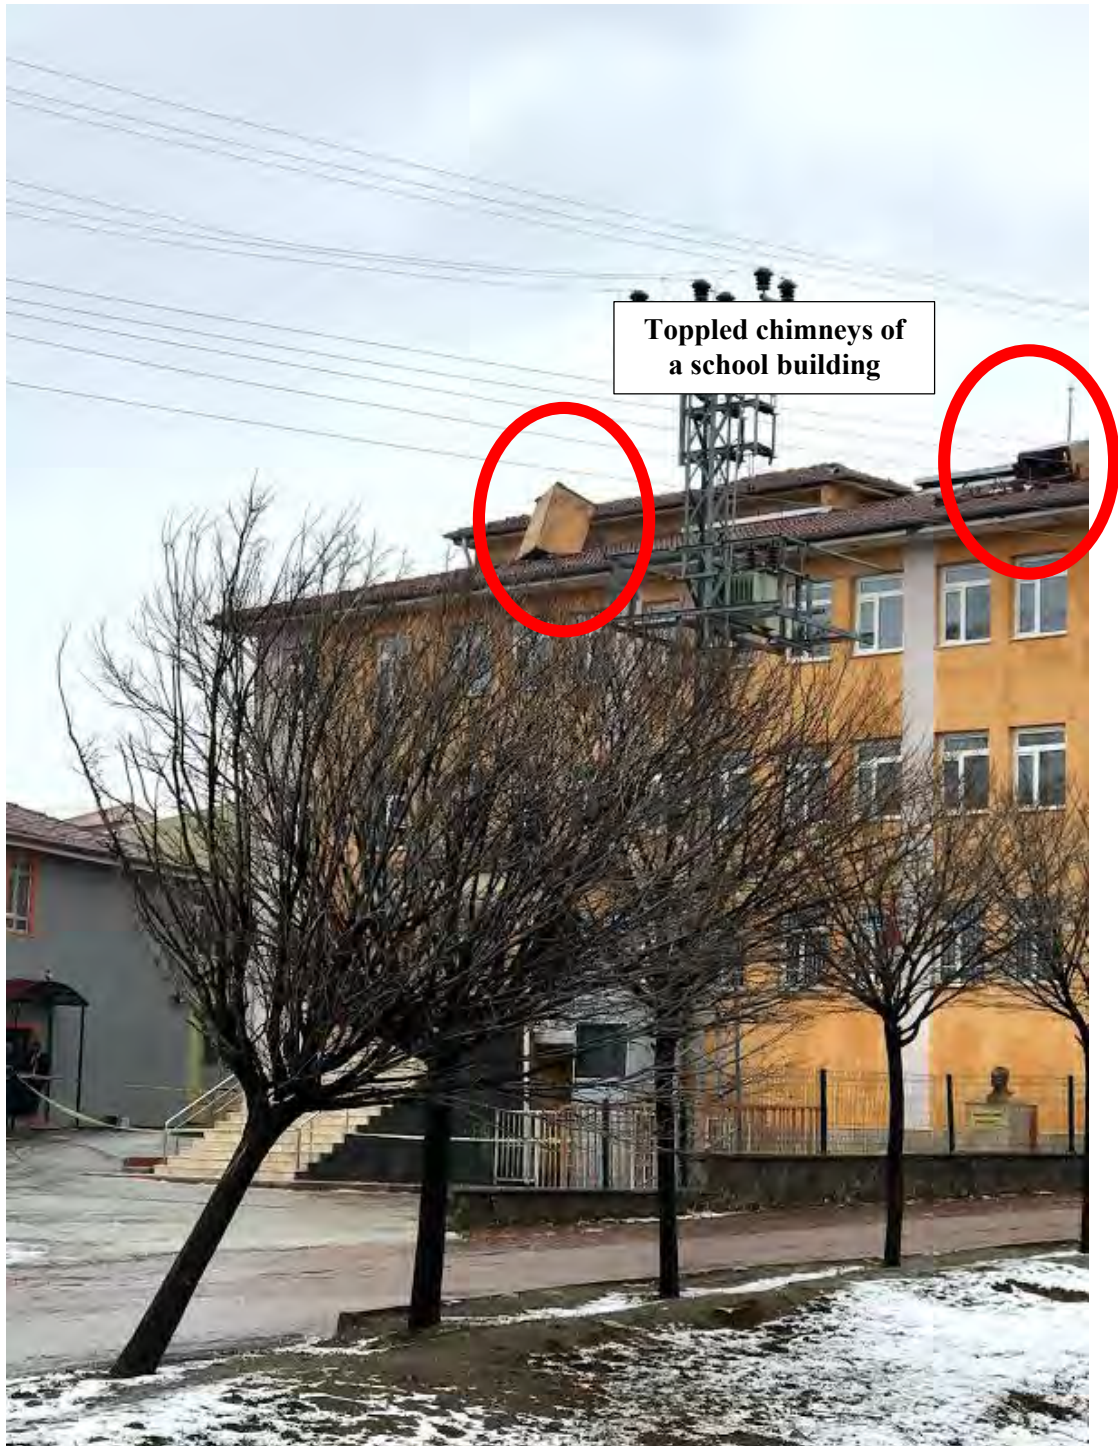
Figure 4.24. Toppled chimneys in Sivrice  
( $38^{\circ}26'49.6''N$   $39^{\circ}18'32.9''E$  / 31.01.2020 / 13:29)

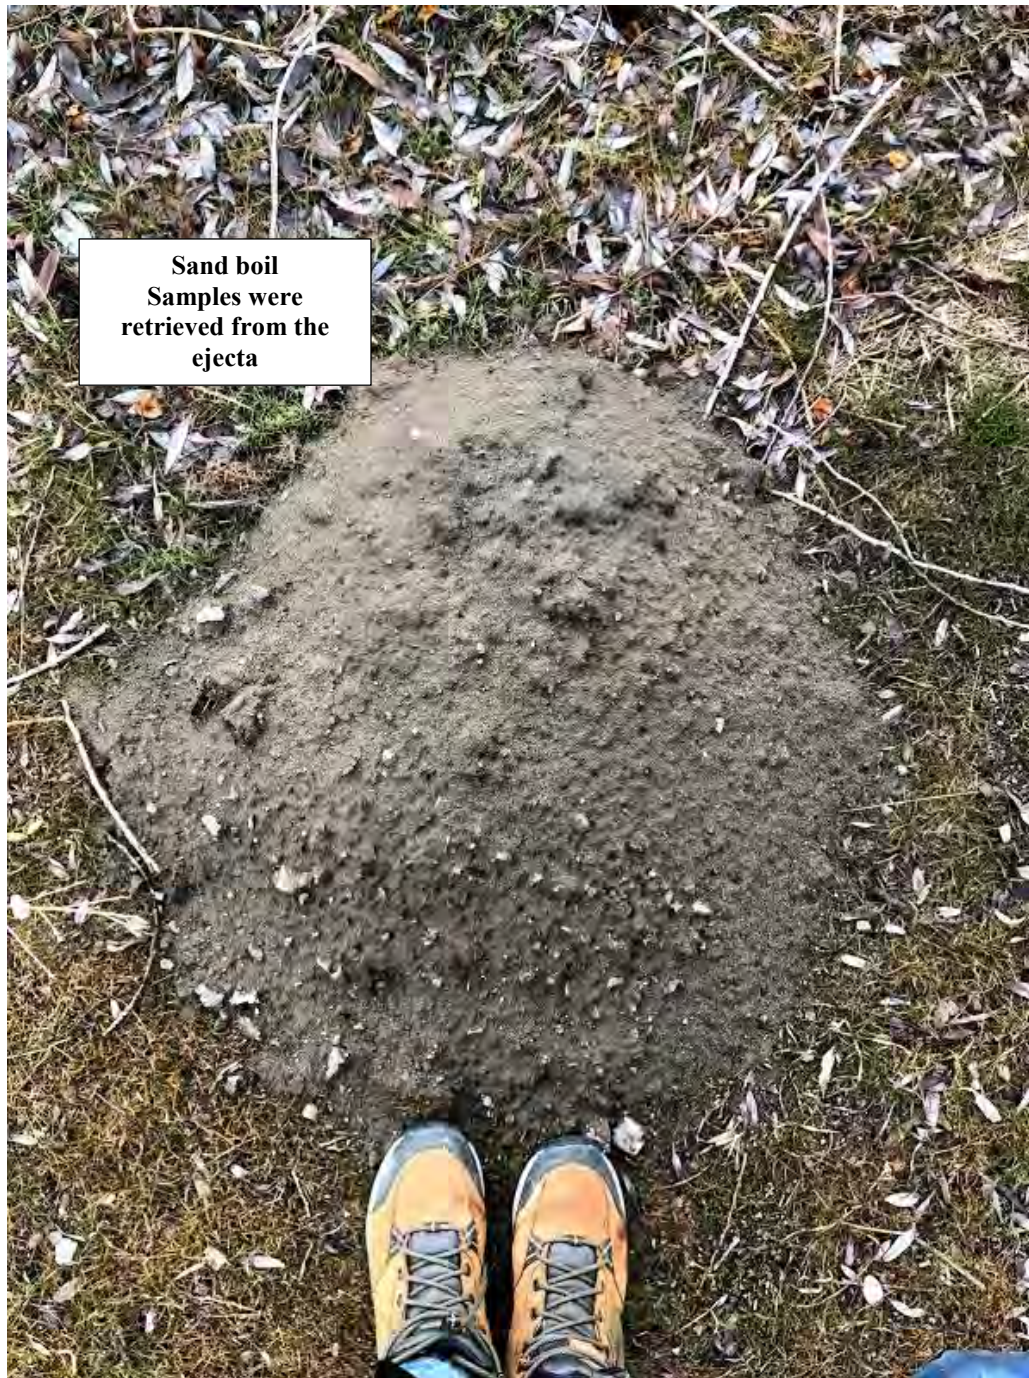
Figure 4.32. Sand boil observed in Stop 8  
(38°27'49.7"N 39°24'01.1"E / 31.01.2020 / 14:38)

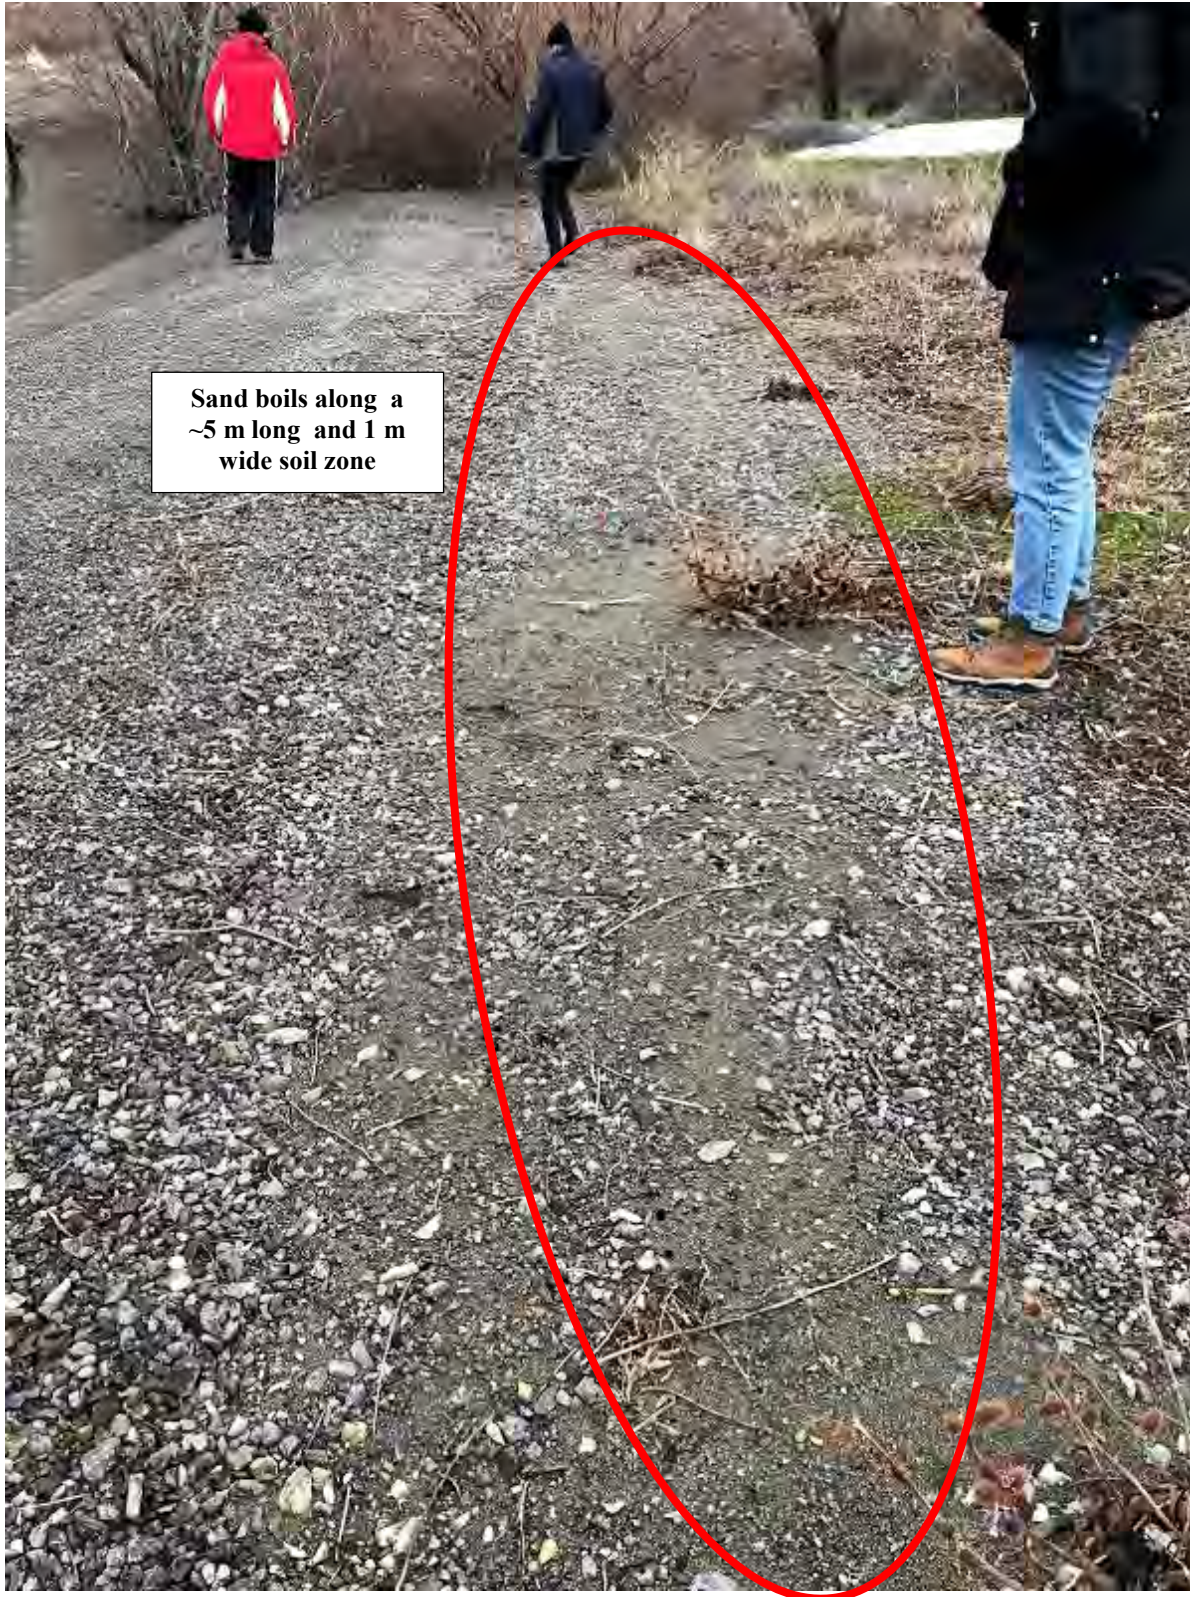
Figure 4.33. Sand boils observed in Stop 8  
( $38^{\circ}27'49.8''N$   $39^{\circ}24'03.0''E$  / 31.01.2020 / 14:14)

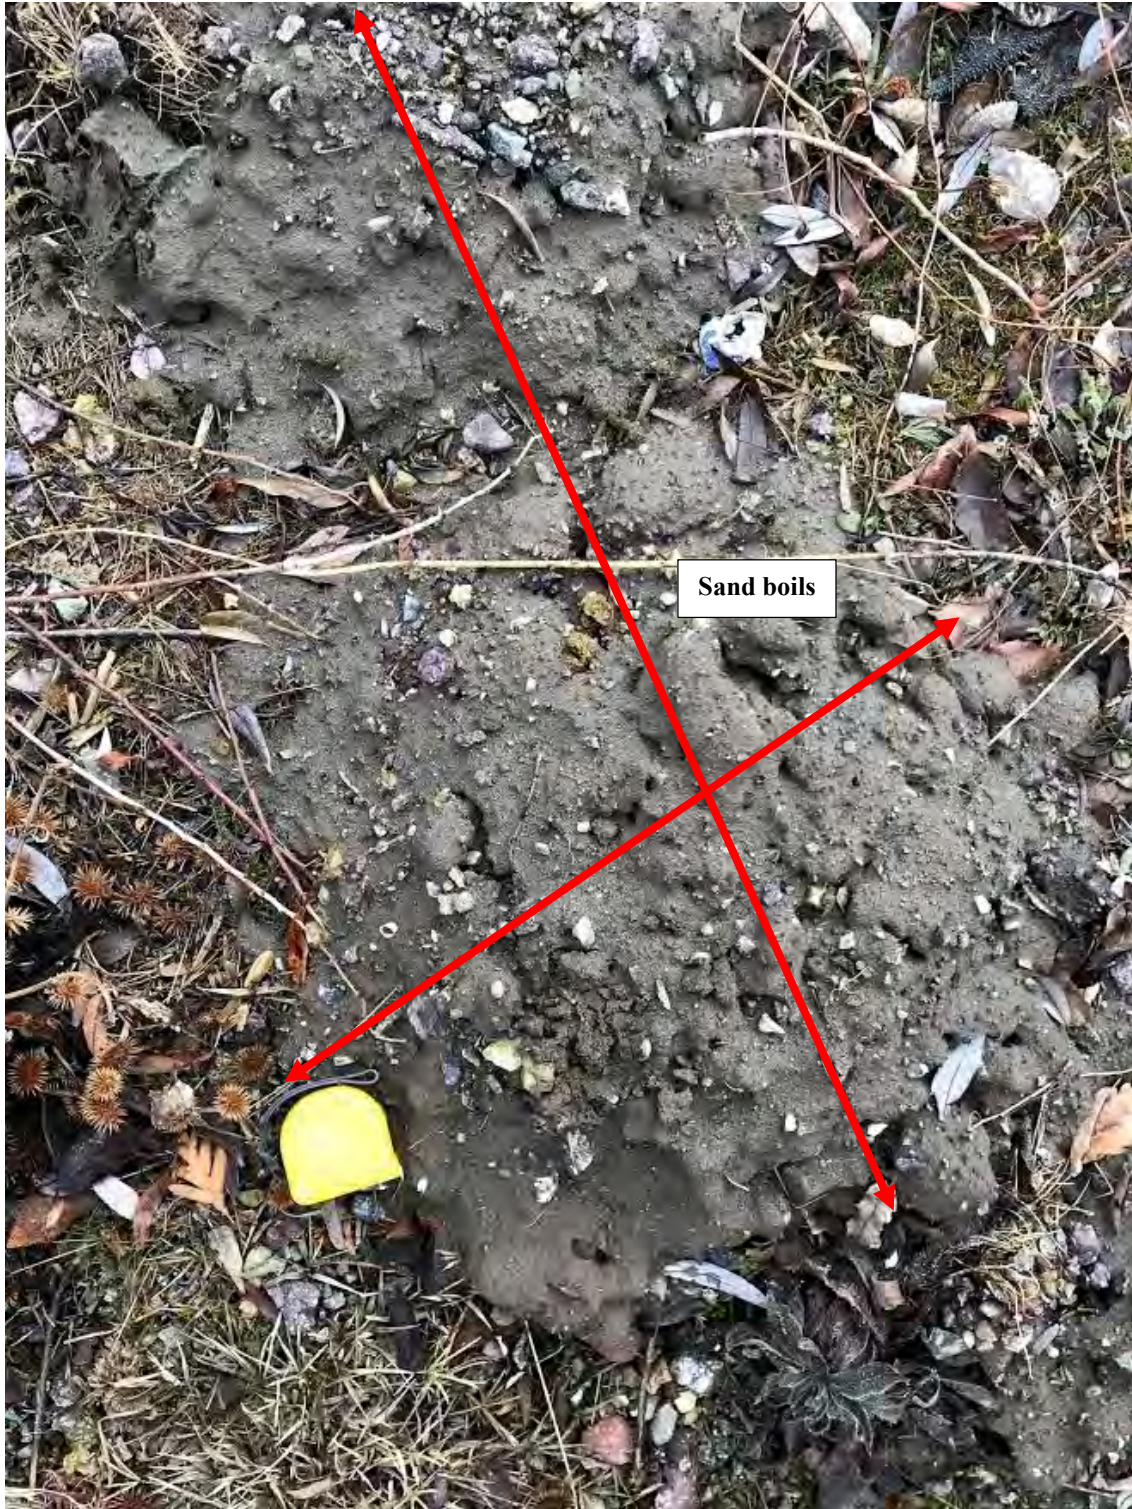
Figure 4.34. Sand boils observed in Stop 8  
( $38^{\circ}27'49.9''N$   $39^{\circ}24'02.8''E$  / 31.01.2020 / 14:17)

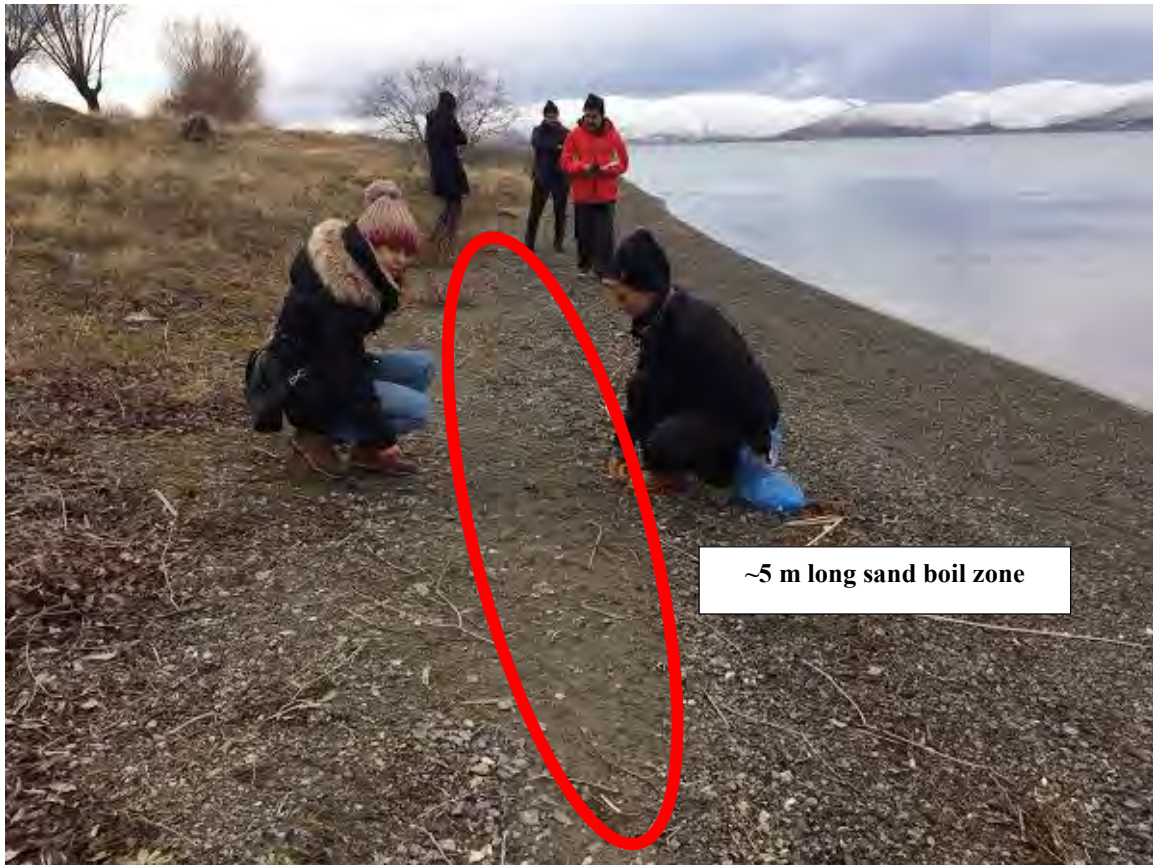
Figure 4.36. A line of sand boils observed in Stop 8  
( $38^{\circ}27'49.7''N$   $39^{\circ}24'03.3''E$  / 31.01.2020 / 14:16)

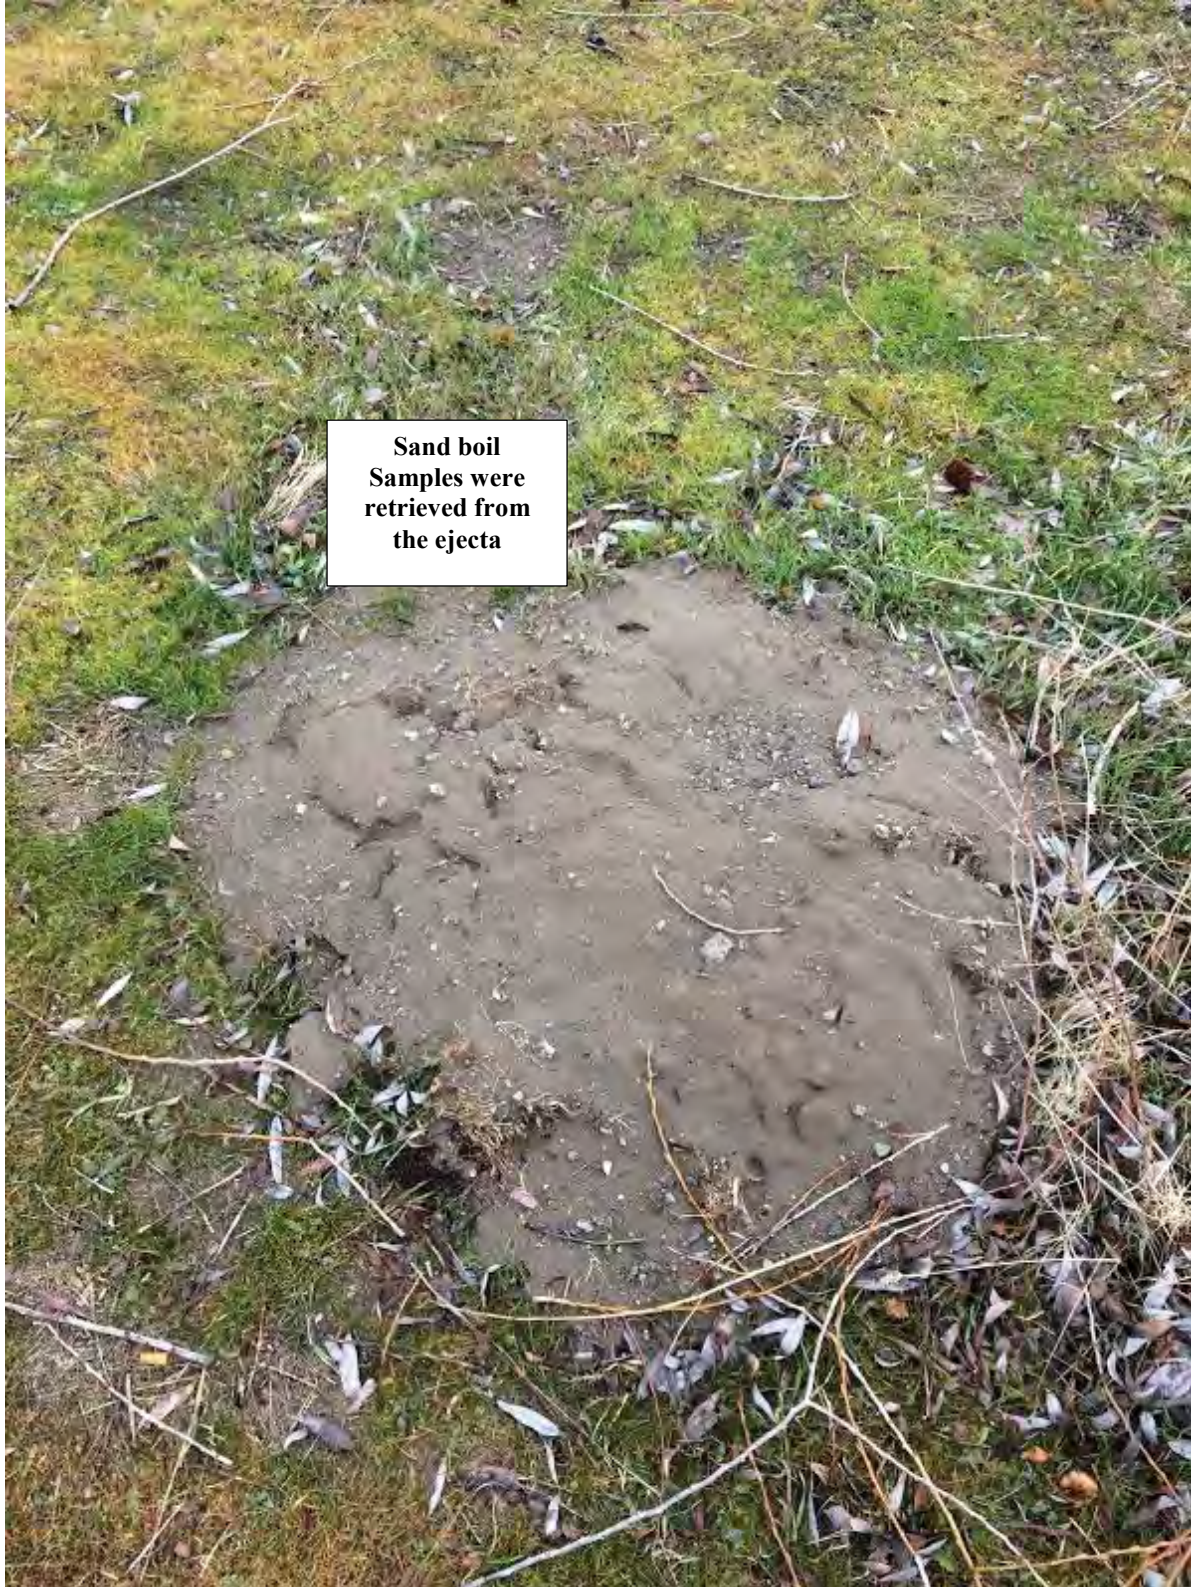
Figure 4.37. Sand boil observed in Stop 8  
(38°27'49.6"N 39°24'01.7"E / 31.01.2020 / 14:38)

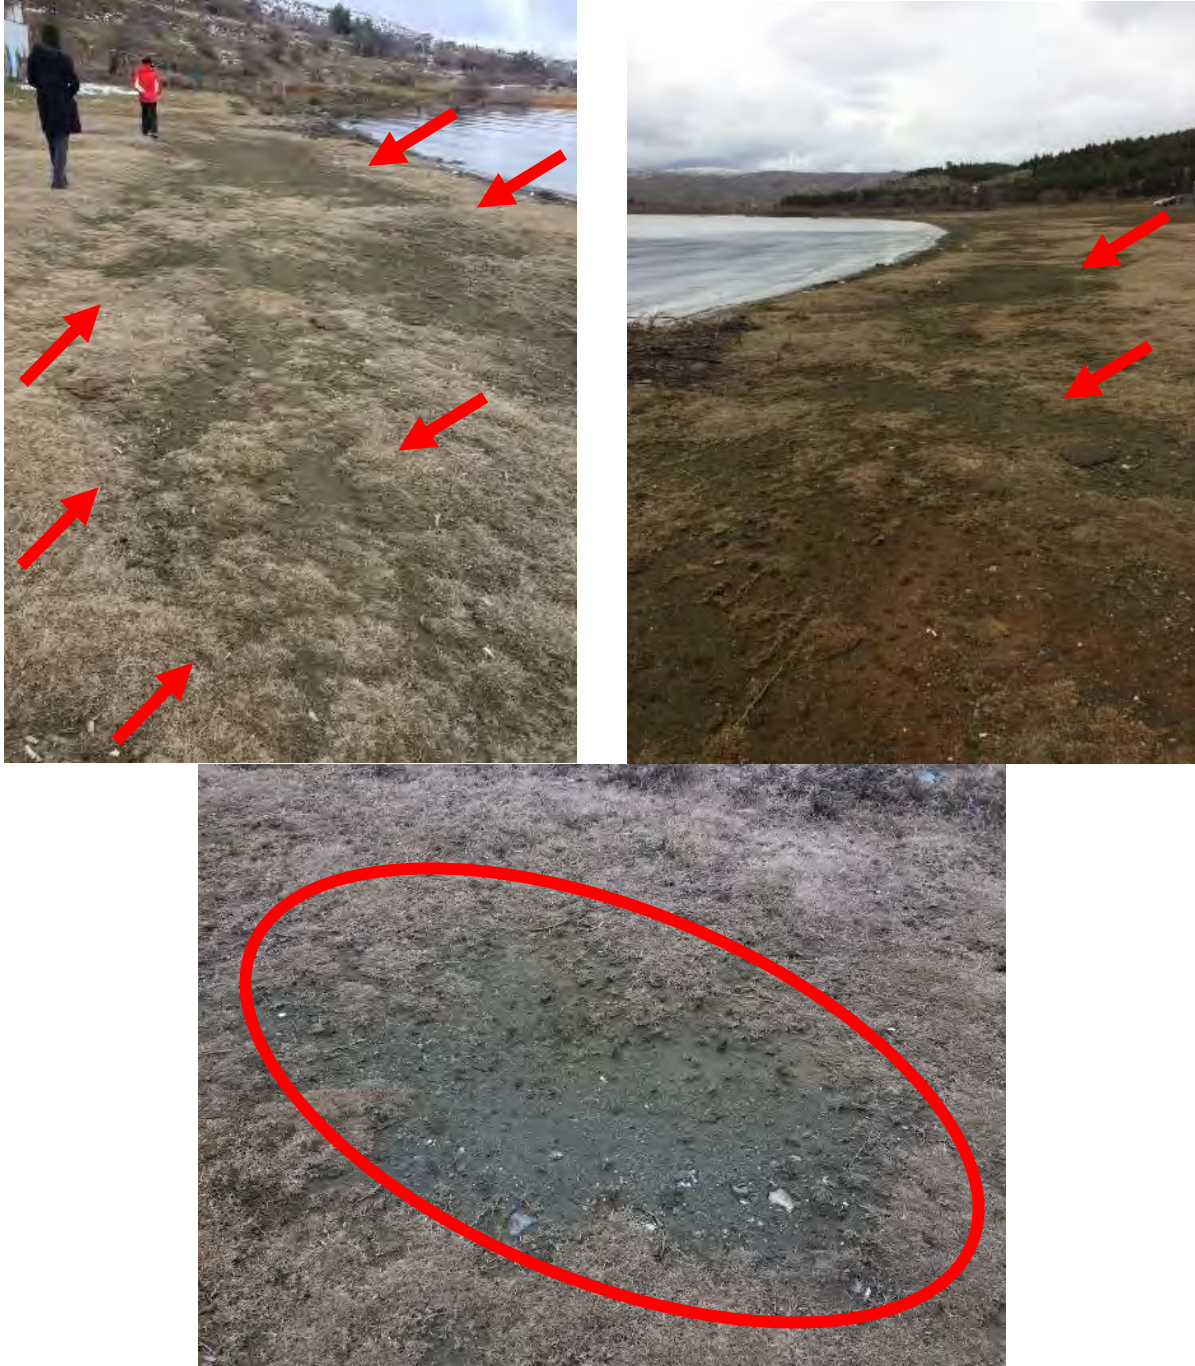
Figure 4.46. Sand boils observed

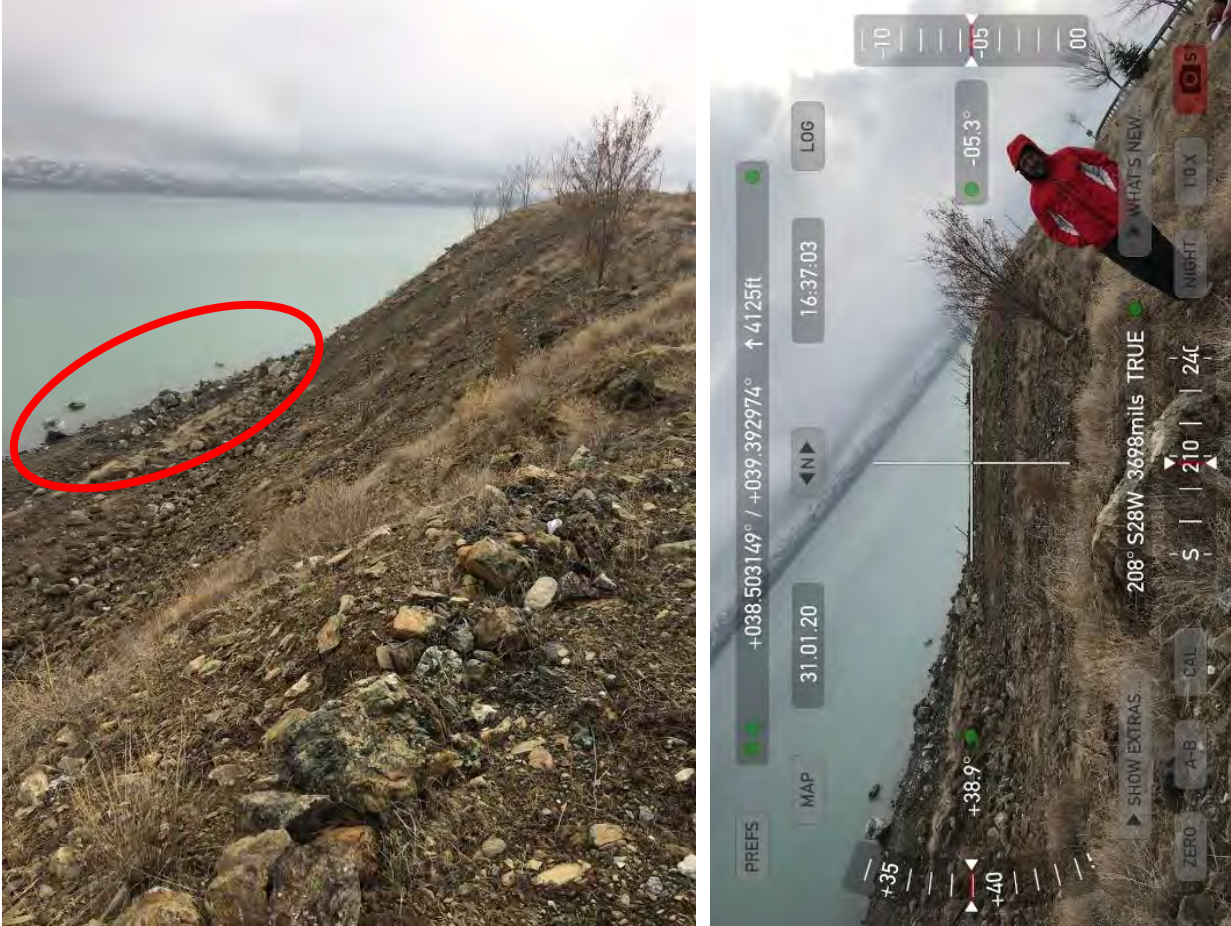
Figure 4.54. Rockfalls at 14<sup>th</sup> stop  
( $38^\circ30'11.4''\text{N}$   $39^\circ23'34.9''\text{E}$  / 31.01.2020 / 16:37 &  $38^\circ30'11.3''\text{N}$   $39^\circ23'34.7''\text{E}$  / 31.01.2020 / 16:37)
