# Preliminary Report on Engineering and Geological Effects of the January 24, 2020 Magnitude 6.7 Earthquake in Elaziğ, Turkey

A report of the NSF-Sponsored Geotechnical Extreme Event Reconnaissance Association

Report GEER-065

**January 24, 2020 Elazığ-Sivrice Earthquake ( $M_w=6.8$ )  
Reconnaissance Study Report**

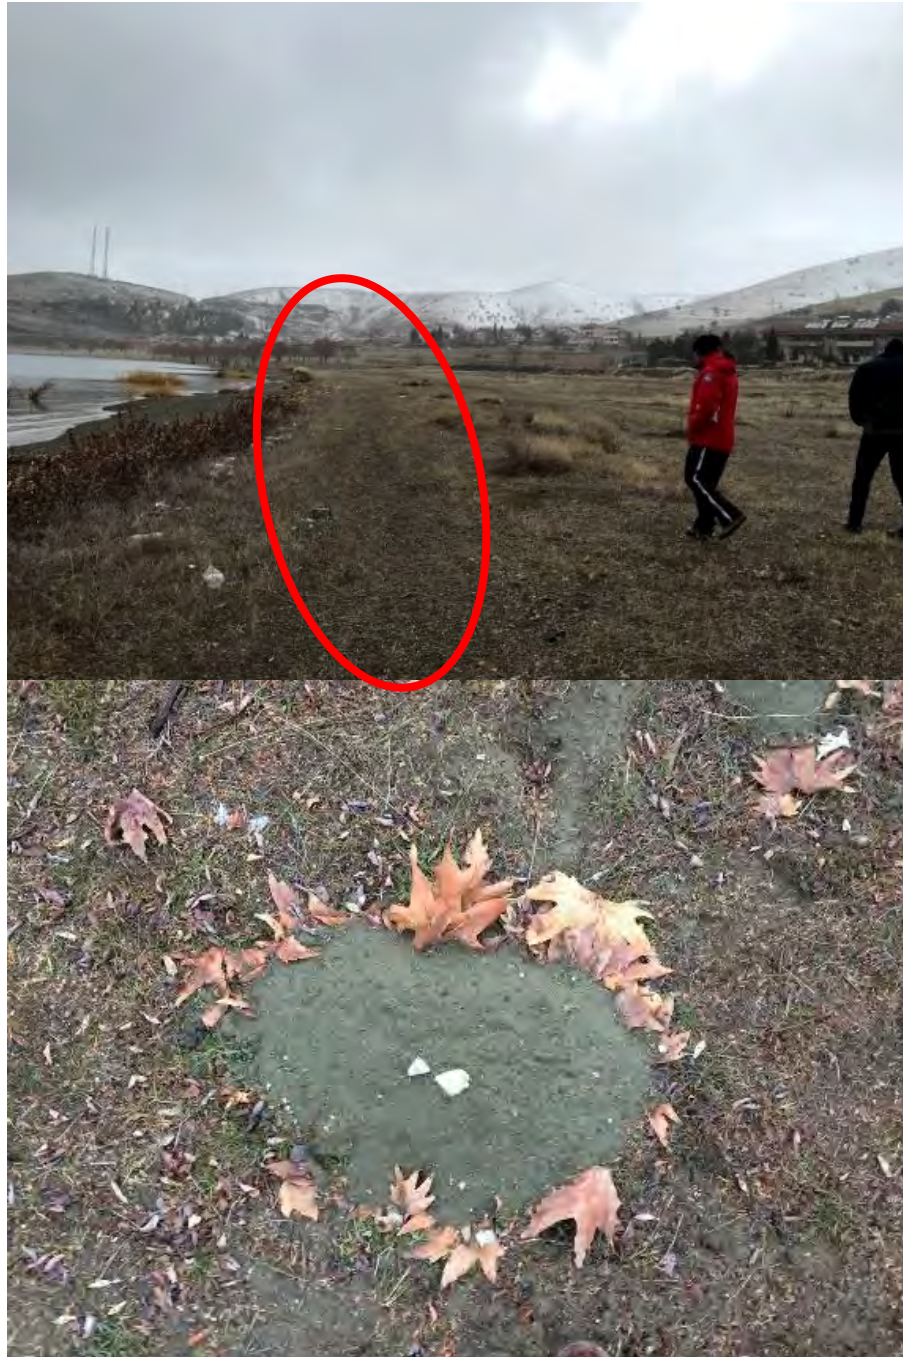
Figure 4.55: Seismic soil liquefaction-induced sand boils at Stop 15  
(38°29'32.3"N 39°21'03.8"E / 31.01.2020 / 16:57 & 38°29'34.5"N 39°21'03.6"E / 31.01.2020 / 17:11)

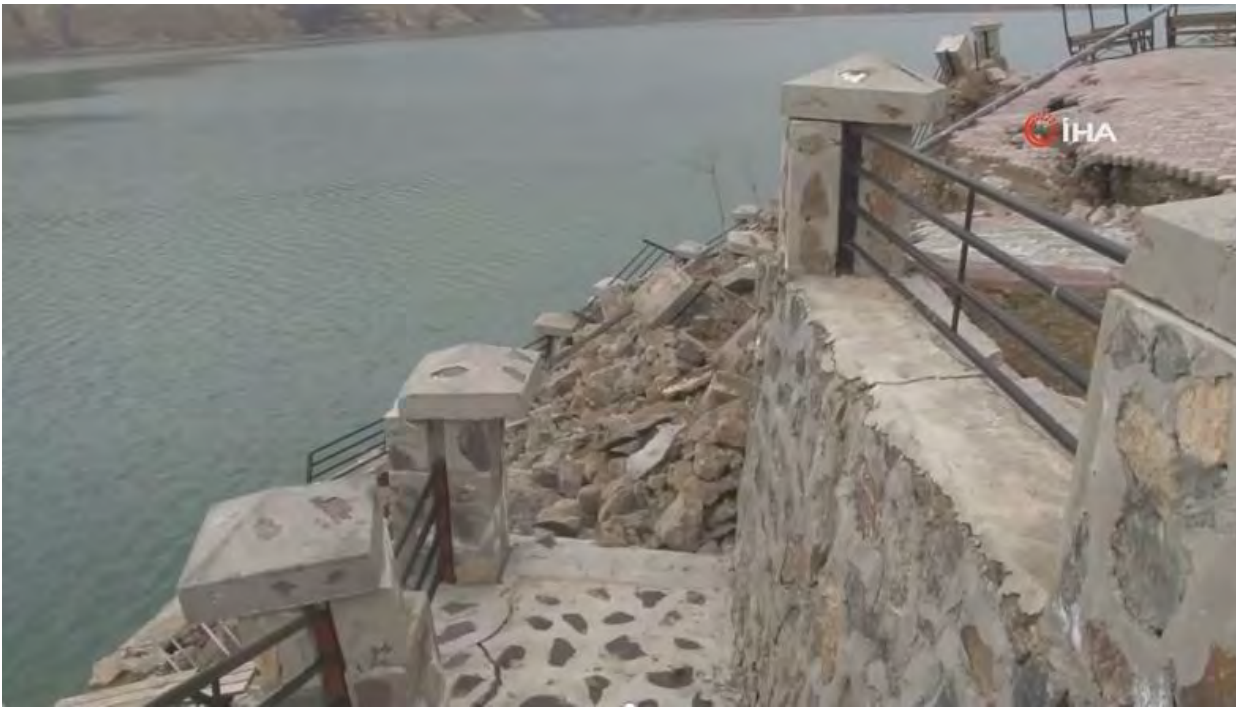
Figure 4.58. Doğanyol Port Failure adapted from IHA report  
(38°33'34.6"N 39°04'10.6"E)

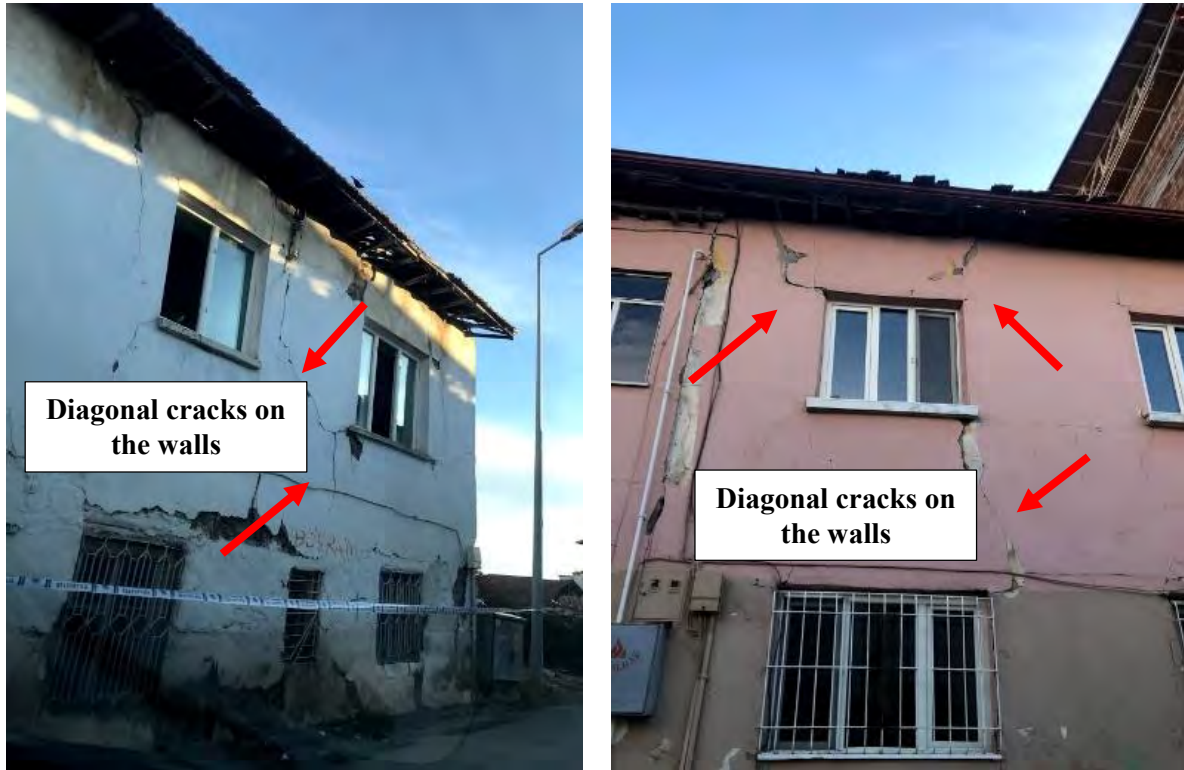
Figure 4.62. Cracks on the wall of a residential building in Battalgazi Village  
(38°25'21.7"N 38°21'56.9"E / 01.02.2020 / 8:30 & 38°25'24.4"N 38°21'53.6"E / 01.02.2020 / 8:28)

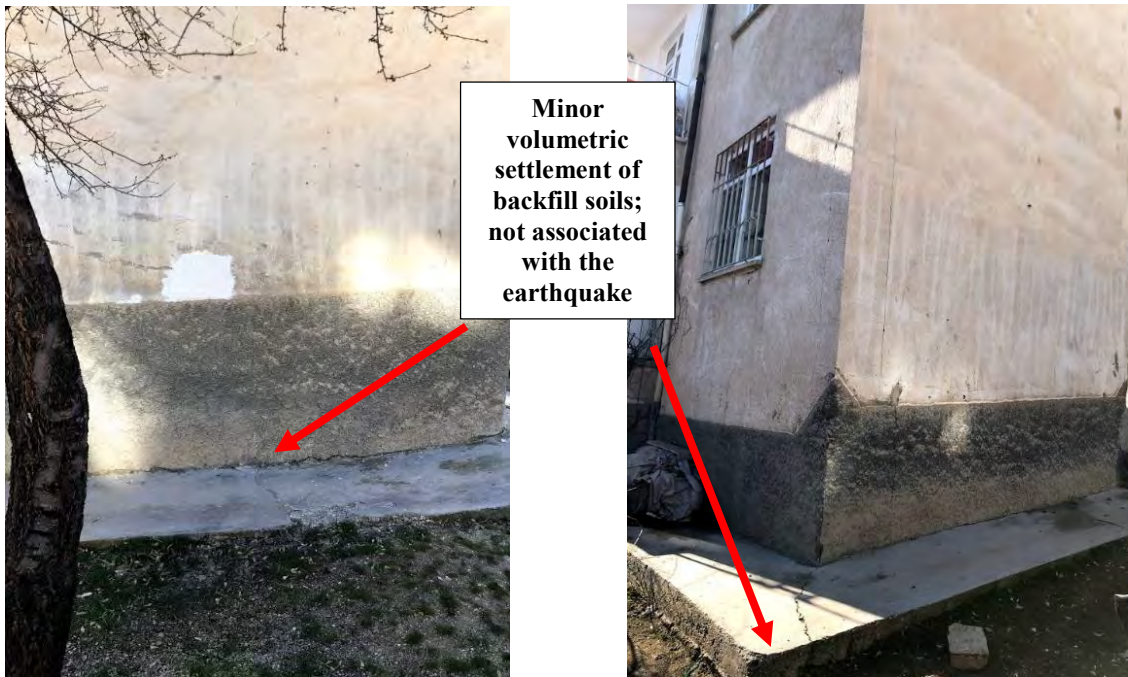
Figure 4.94. Volumetric settlement at the foundation of a residential building  
( $38^{\circ}39'29.8''N$   $39^{\circ}08'58.4''E$  / 01.02.2020 / 14:29 &  $38^{\circ}39'28.9''N$   $39^{\circ}09'01.9''E$  / 01.02.2020 / 14:30)

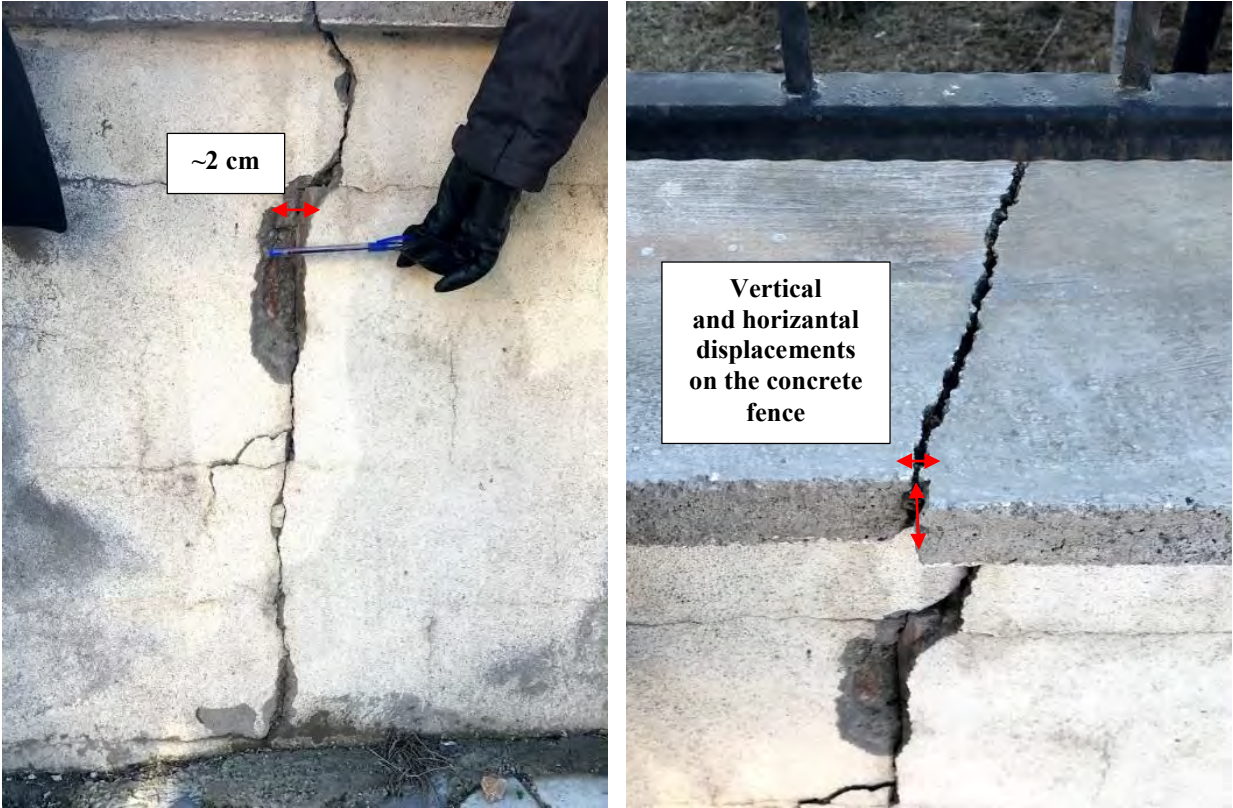
Figure 4.102. A crack on a concrete fence in Sürsürü district of Elazığ city center  
(38°40'05.5"N 39°11'12.4"E / 01.02.2020 / 15:28 & 38°40'05.5"N 39°11'12.4"E / 01.02.2020 / 15:28)

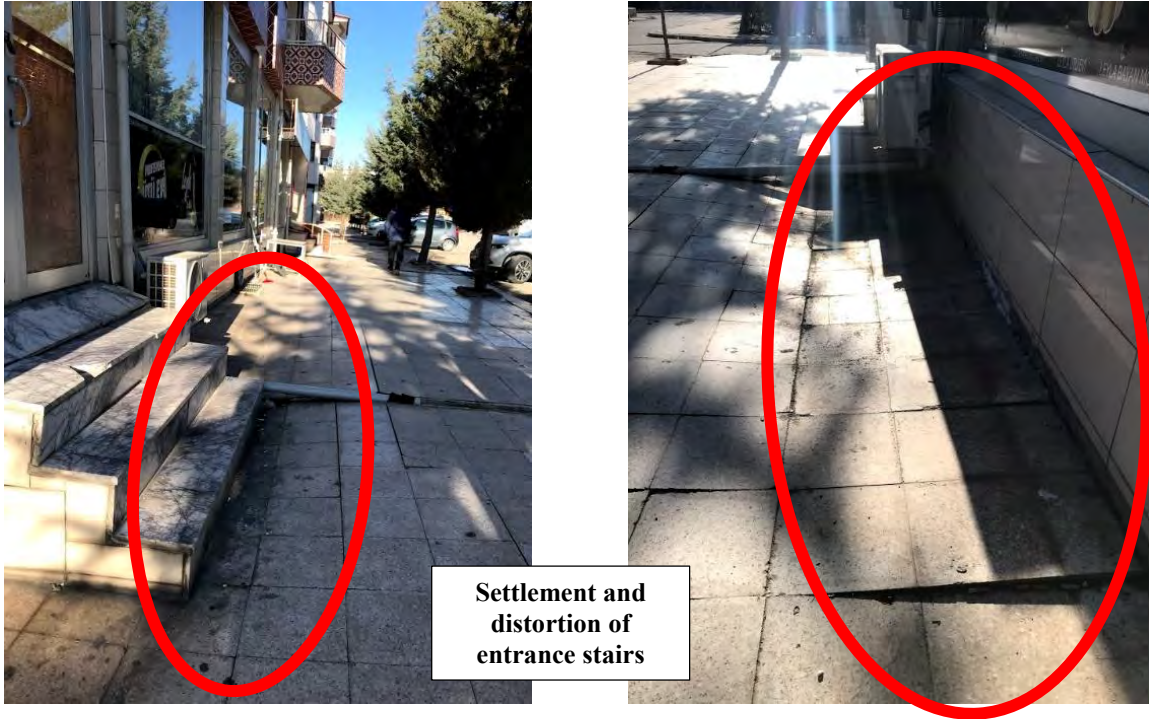
Figure 4.104. Settlements observed  
( $38^{\circ}40'05.7''N$   $39^{\circ}11'09.6''E$  / 01.02.2020 / 15:57 &  $38^{\circ}40'05.1''N$   $39^{\circ}11'10.0''E$  / 01.02.2020 / 15:57)

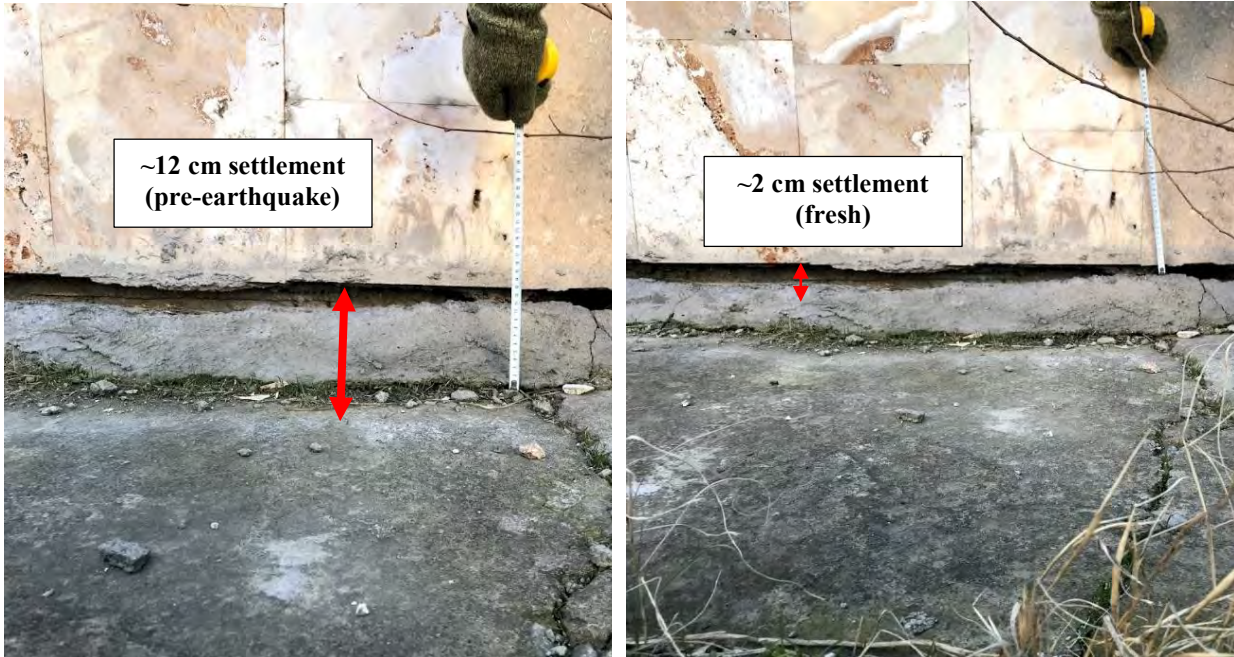
Figure 4.105. Settlement observed.  
( $38^{\circ}40'07.0''N$   $39^{\circ}11'04.8''E$  / 01.02.2020 / 15:47)

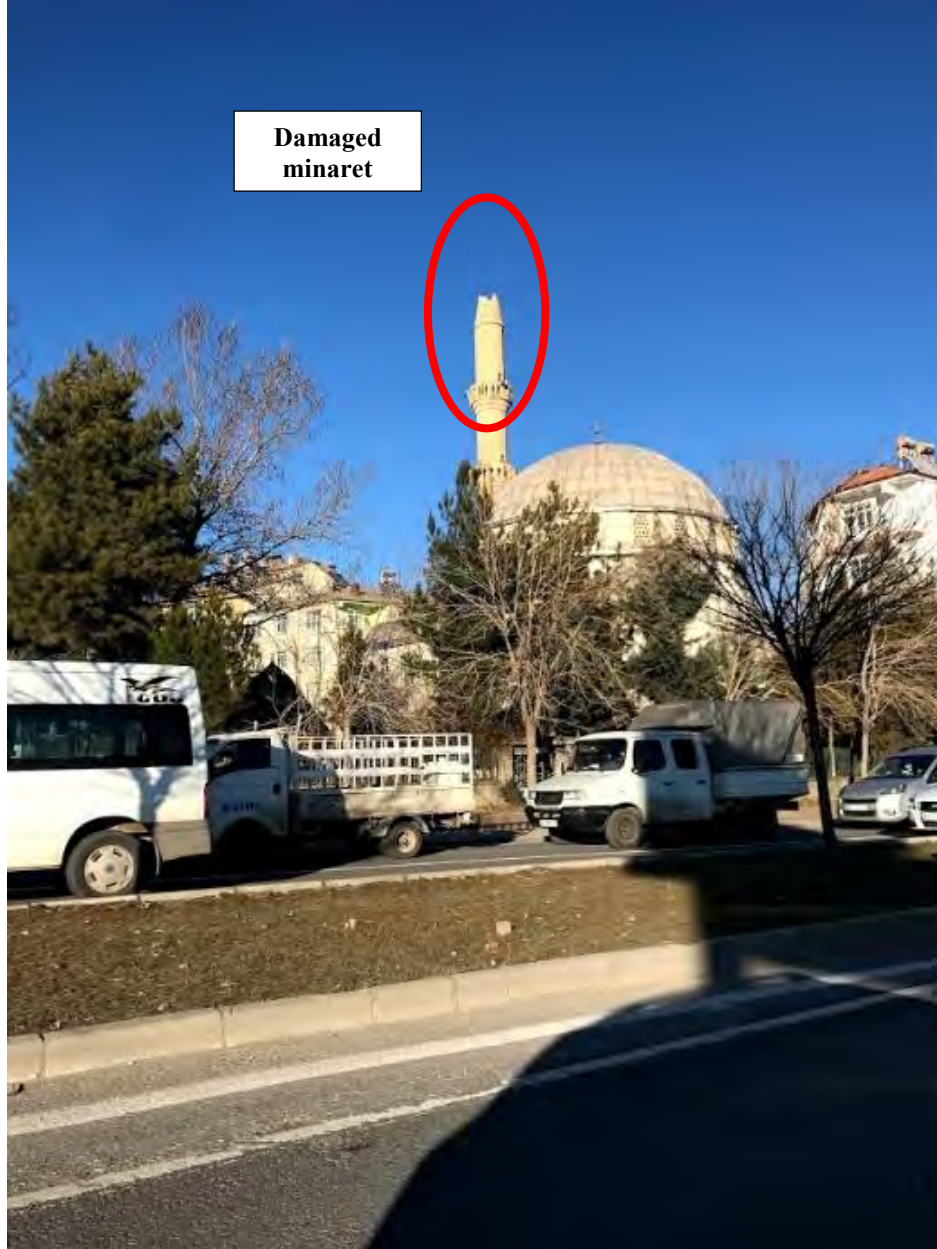
Figure 4.108. Damaged Minaret of Rüstem Paşa Yol Üstü Mosque  
in Rüstem Paşa district of Elazığ city center  
(38°39'58.4"N 39°13'54.7"E / 01.02.2020 / 16:22)

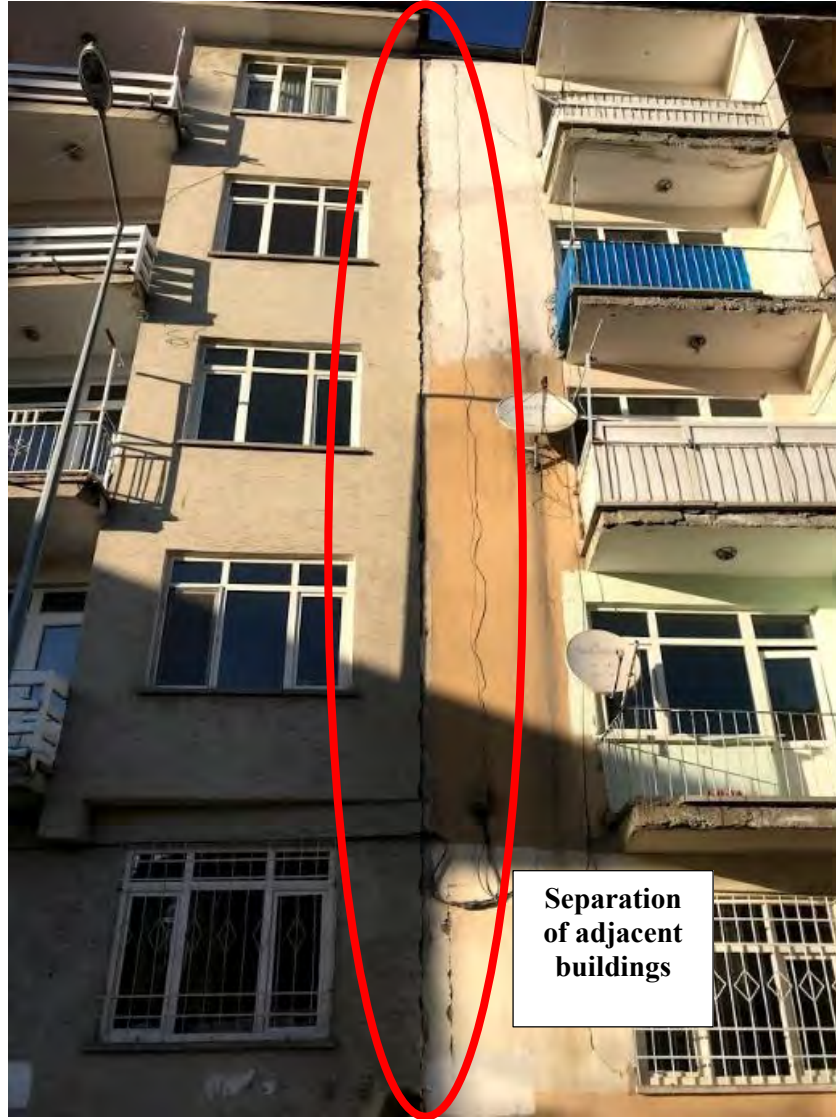
Figure 4.109. Longitudinal cracks observed on a building located in the Mustafa Paşa district  
(38°40'15.9"N 39°13'59.9"E / 01.02.2020 / 16:34)

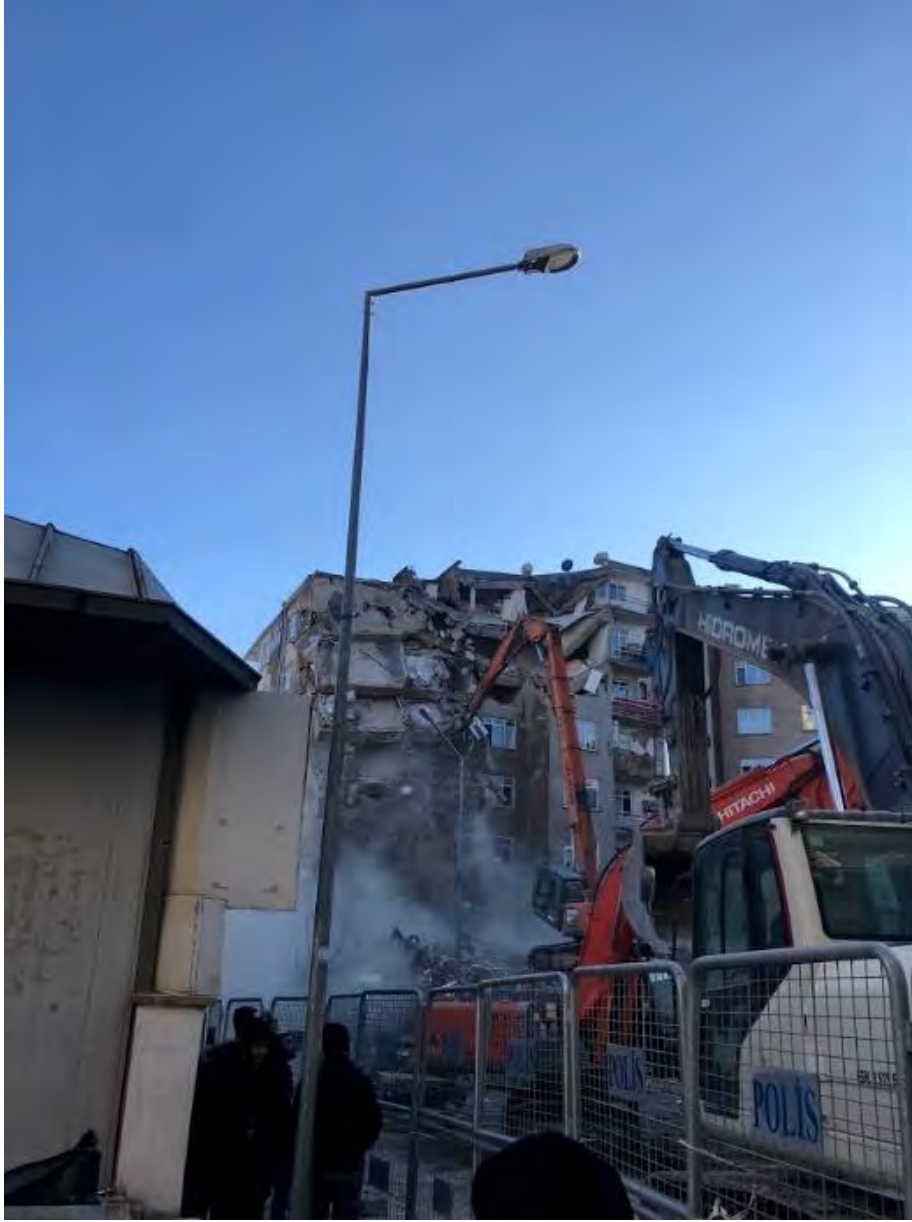
Figure 4.110. Demolishment of a heavily-damaged building in the Mustafa Paşa district of Elazığ city center  
(38°40'15.2"N 39°13'57.5"E / 01.02.2020 / 16:31)

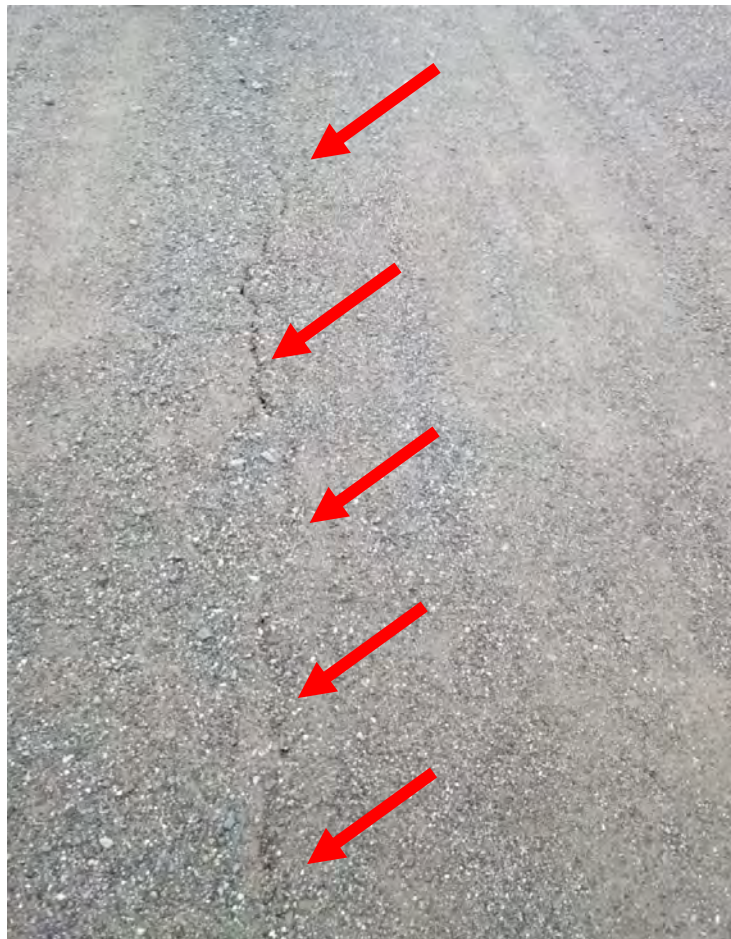
Figure 4.119. Longitudinal cracks on Dedeyolu Dam crest (DSI)

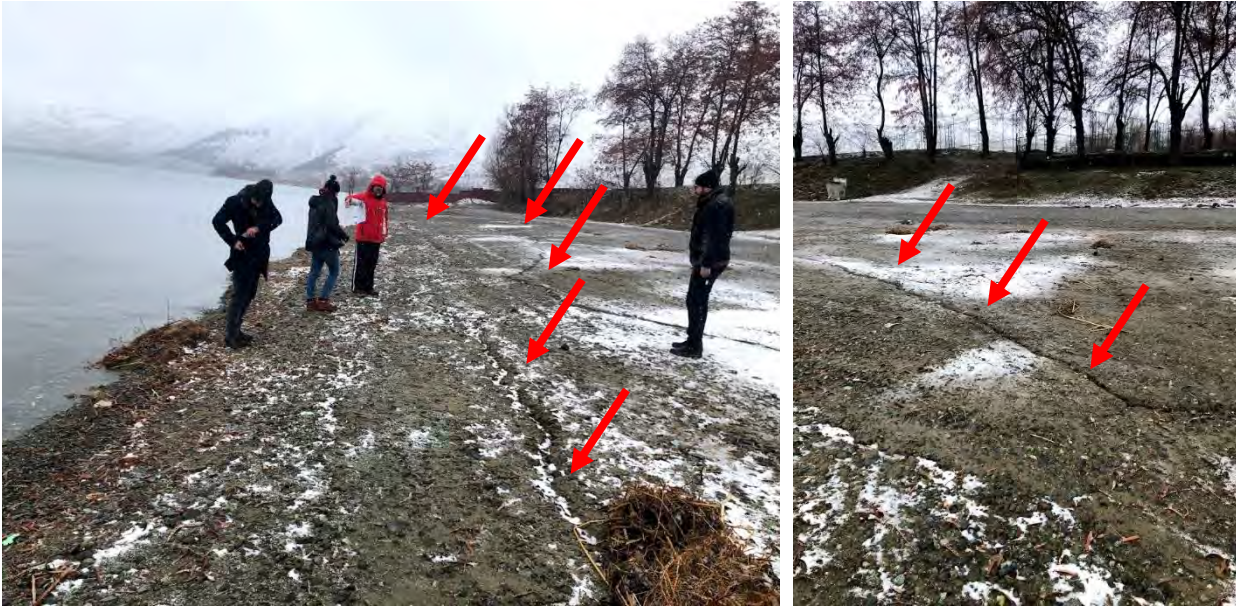
Figure 4.124. Deformations and cracks due to lateral spreading observed along Hazar Lake (2<sup>nd</sup> stop)

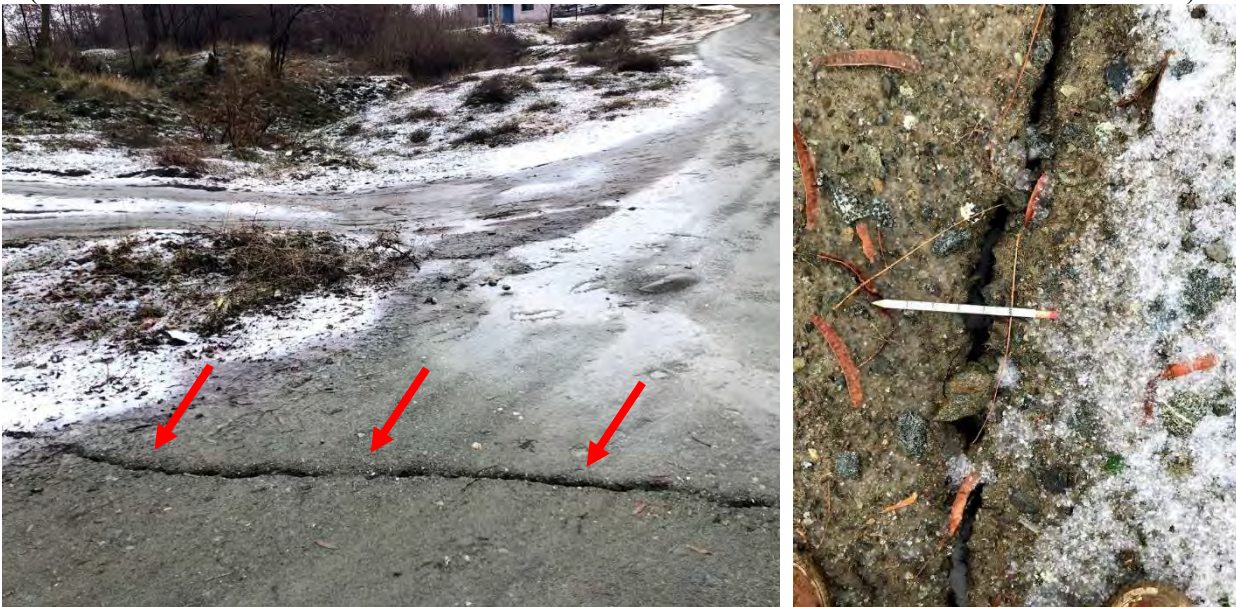
Figure 4.125. Deformations and cracks due to lateral spreading observed along Hazar Lake (2<sup>nd</sup> stop)
