A STUDY ON CONSERVATION AND REHABILITATION PROBLEMS OF  
HISTORIC TIMBER HOUSES IN ANKARA

A THESIS SUBMITTED TO  
THE GRADUATE SCHOOL OF NATURAL AND APPLIED SCIENCES  
OF  
THE MIDDLE EAST TECHNICAL UNIVERSITY

NERİMAN ŞAHİN

JUNE, 1995

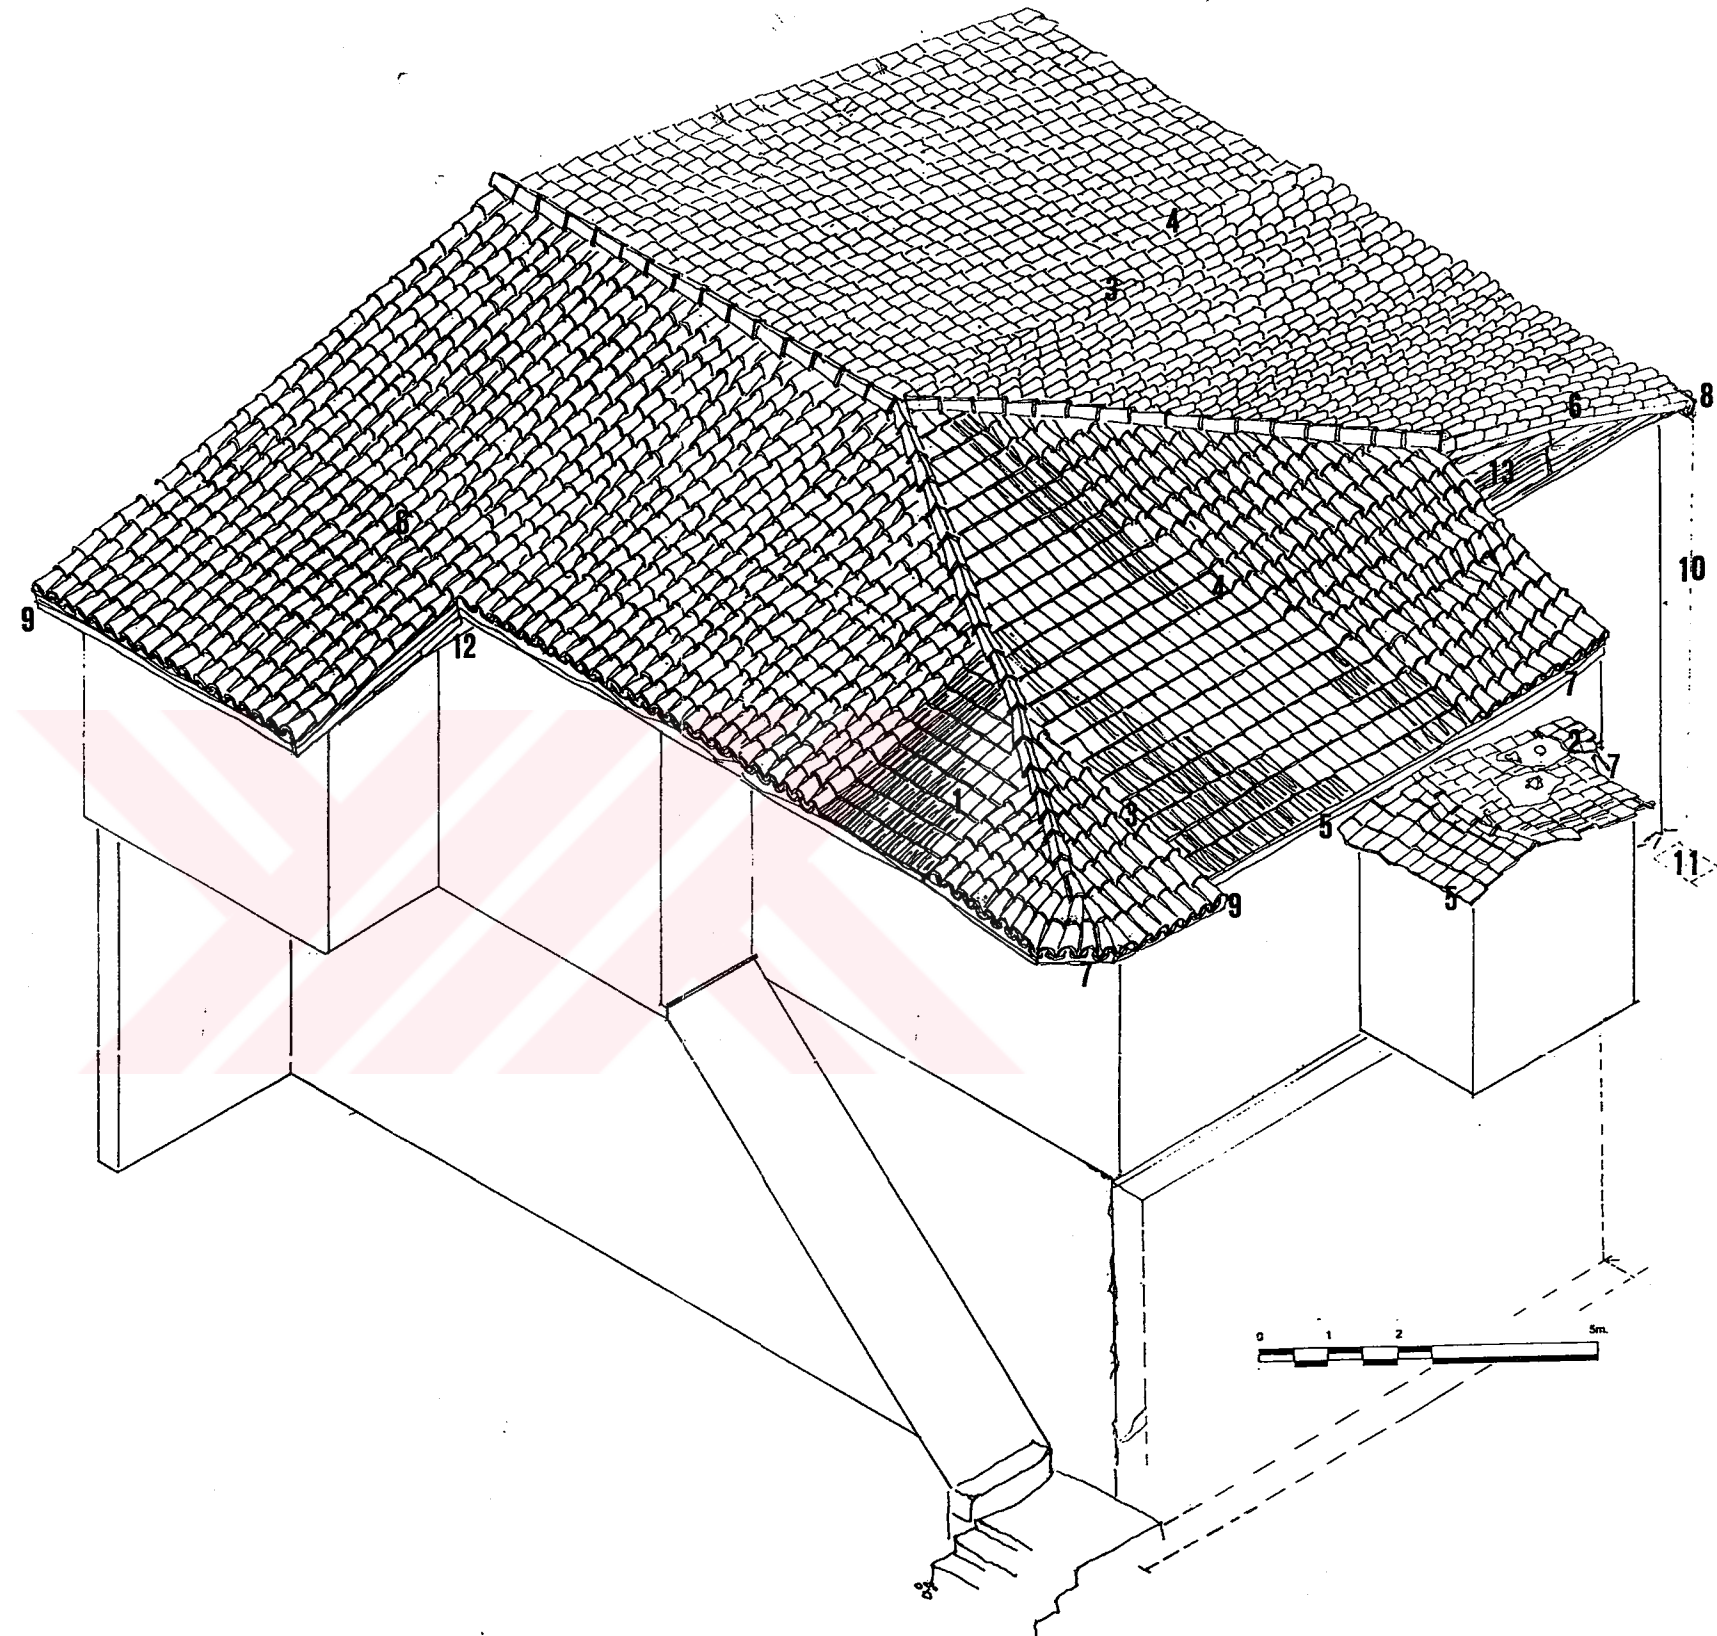
Figure 4.7 Typical Forms of Decay in Ankara Houses; Condition of the Roof of the House at Erzurum St., 48, in 1994

1. Removed original chimney, altered tiling
2. Loose and/or missing tiles
3. Poorly altered original tiling
4. Rain flow through the inadequate connection between the Allaturca and Marsilia type tiles; due to poor workmanship causing wetting of roof boards underneath the tiles
5. Narrow eaves without gutters
6. Sagging purlins of roof causing distortion
7. Open rafter ends decayed due to weathering
8. Inadequate or damaged rain water gutters
9. Lack of gutters
10. Lack of rainwater pipe
11. Lack of rainwater gully, causing build-up of water source and damage to foundations
12. Deteriorated timber eaves due to weathering
13. Unventilated roof space, roof timbers susceptible to insect and fungi attack

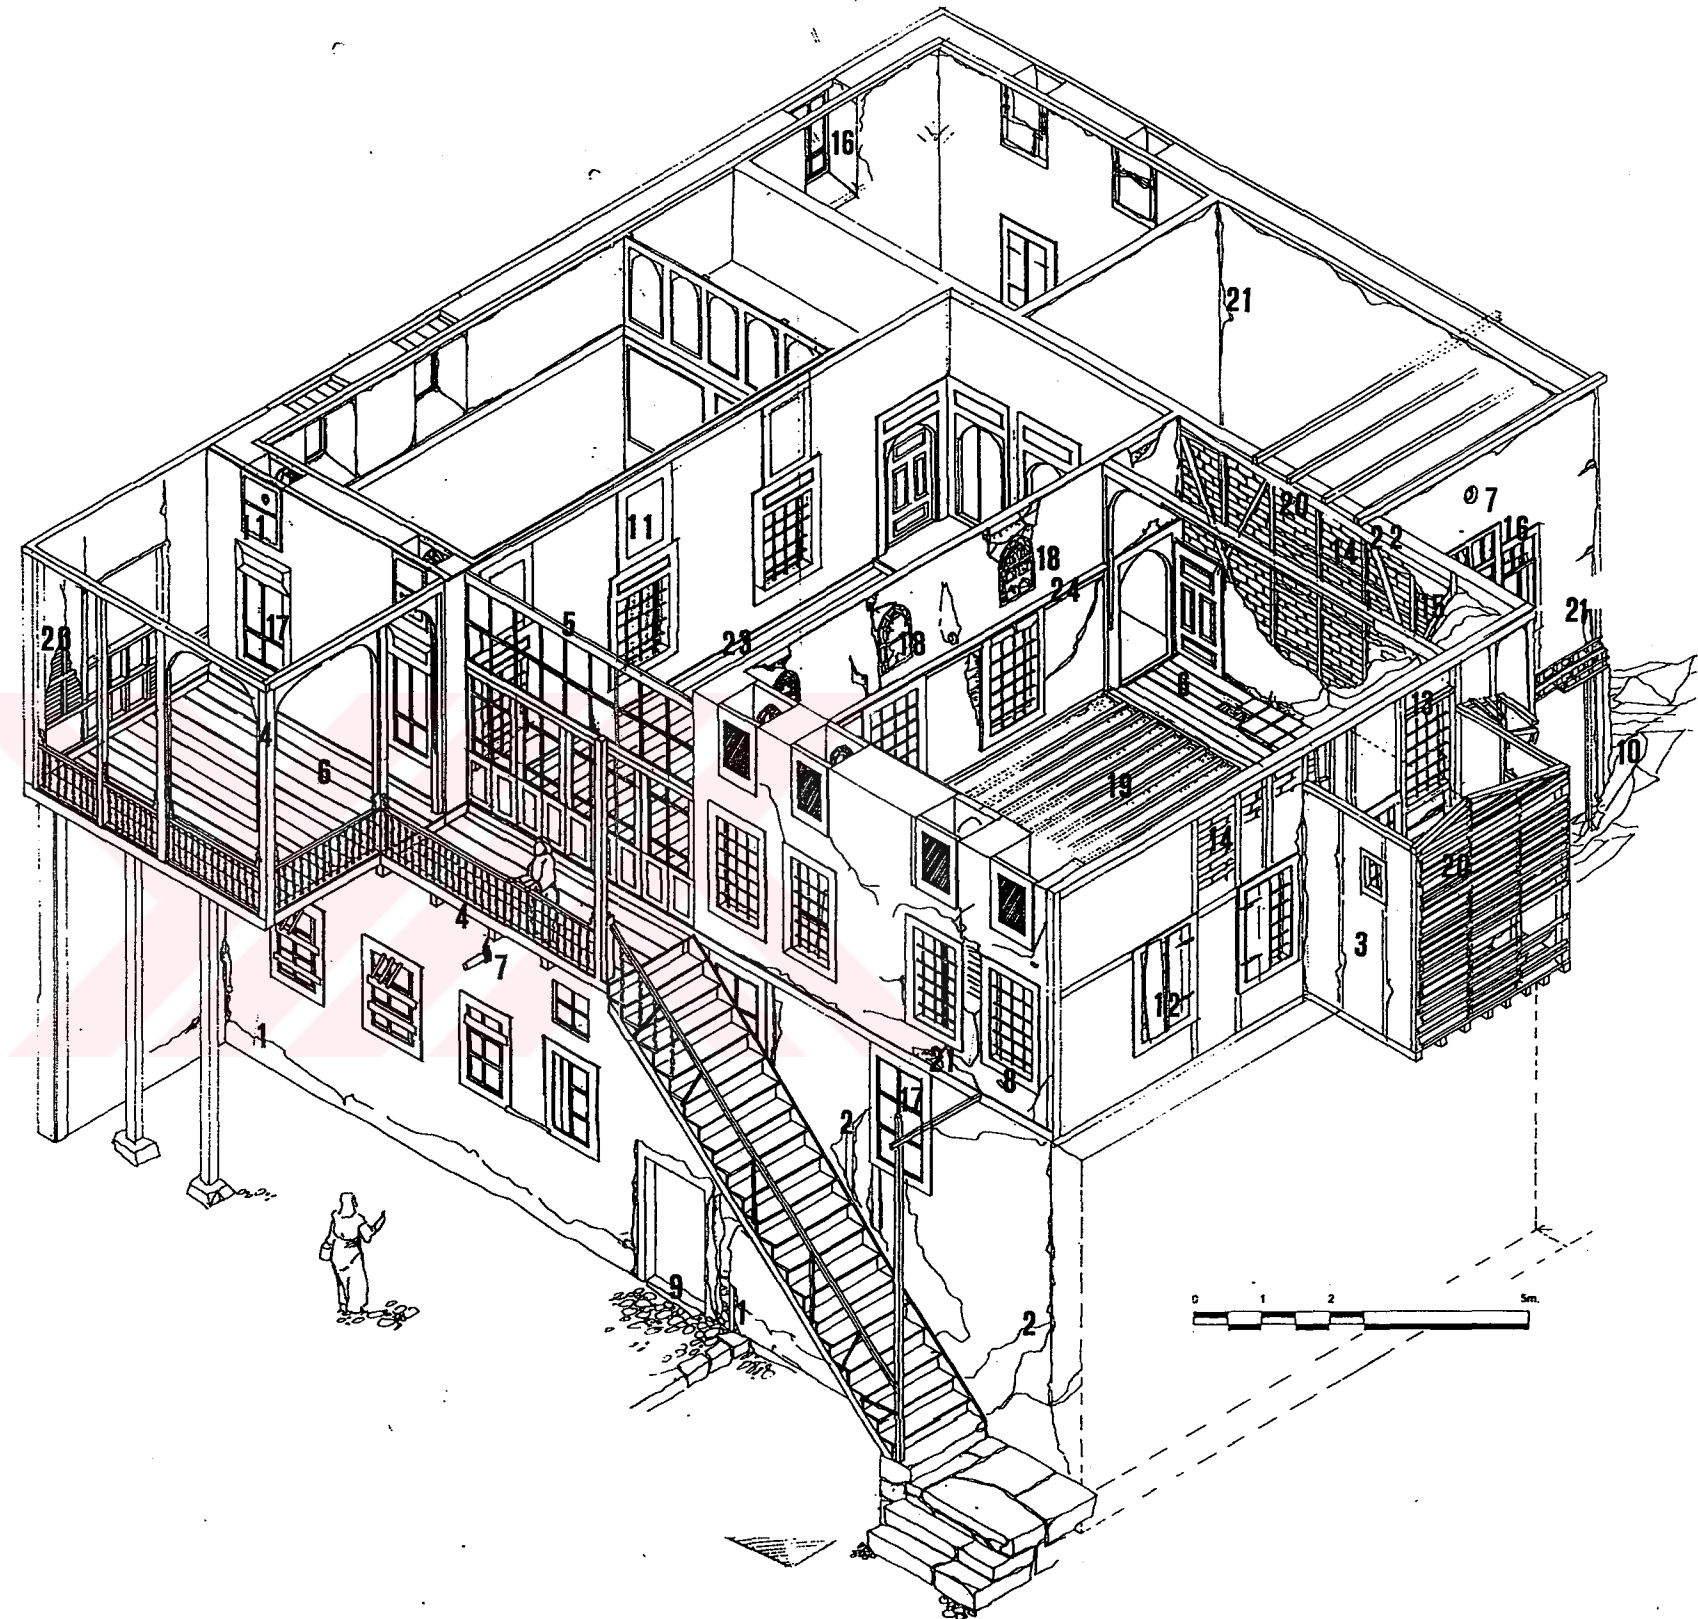
Figure 4.8 Typical Forms of Decay in Ankara Houses; Present Condition of the House at Erzurum St., 48, in 1994; corrected & redrawn after M. Akok

23. Altered floor pavement
24. Stain on decorated timber work

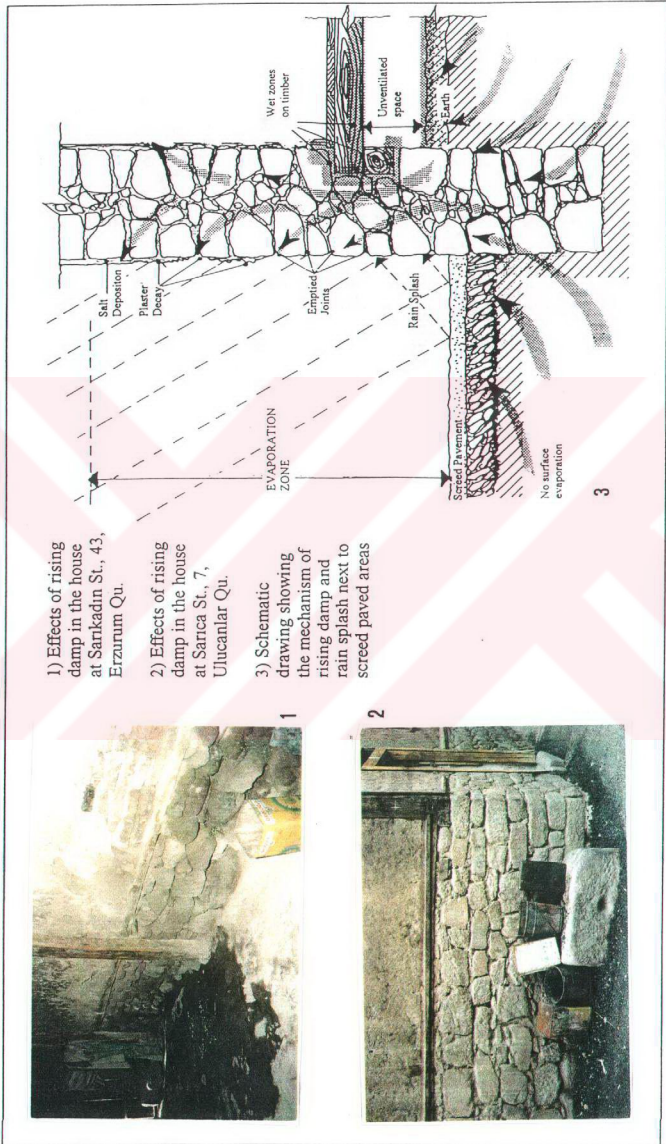
Figure 4.11 Effects of Rising Damp

However, the visible signs of rising damp can easily be noticed in Ankara houses as discoloration, stains, flacking and powdering on the stone and plaster surfaces, sharp changes from wet to dry zones near to ground level and presence of surface salts as white efflorescence. Rising damp greatly effects the walls of timber framed houses in Ankara, which are all made with materials capable to attract water by capillary action and have no damp proof courses. Moreover the detachment and the fall of the plaster skin may be seen. Besides, if a weak mortar is used in the stone masonry, it deteriorates quickly and disintegrates from its place by the effects of rising damp and the masonry wall may loose its stability (Figure 4.11.).

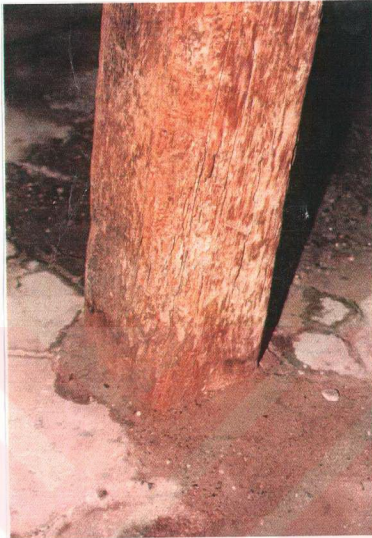
1) Cingöz St., 20, Ulucanlar Qu.

On the contrary we should specifically mention that there is limited research on wood boring insects in building timbers in Anatolia<sup>3</sup>. In the surveys done by O. Özkazanç on houses in the Citadel (Altındağ Municipality, 1987:260) insect problem is commonly detected on building timbers. *Hylotrupes Bajulus* (House longhorn beetle) and *Anobium Punctatum* (Common furniture beetle) were detected in the timber elements used in the buildings.
