physical, functional, and social features. In 2009 after the revision of the conservation development plan, this process accelerated. While some of these changes can be beneficial for the city, they also cause problems like extensive interventions to historic buildings, the loss of the resident's collective memory and spirit of the place, and the displacement of the inhabitants. At present, the Zenginler Quarter, a quarter near the historic urban core, has experienced severe transformation and there are not many studies on the impacts of heritage-led regeneration on Antakya's tissue and residents. This thesis aims to assess the impacts of heritage-led urban regeneration projects on the historic Zenginler Quarter in Antakya. The impacts are evaluated first by defining the parameters related to Antakya's physical, functional, social, and cultural features. Secondly, the changes in relation to these parameters are studied and analyzed. Based on the analysis of these changes, the evaluations are done in terms of physical, functional, and social aspects of the quarter. Accordingly, the impacts of heritage-led regeneration projects are assessed. This assessment enables us to present gene

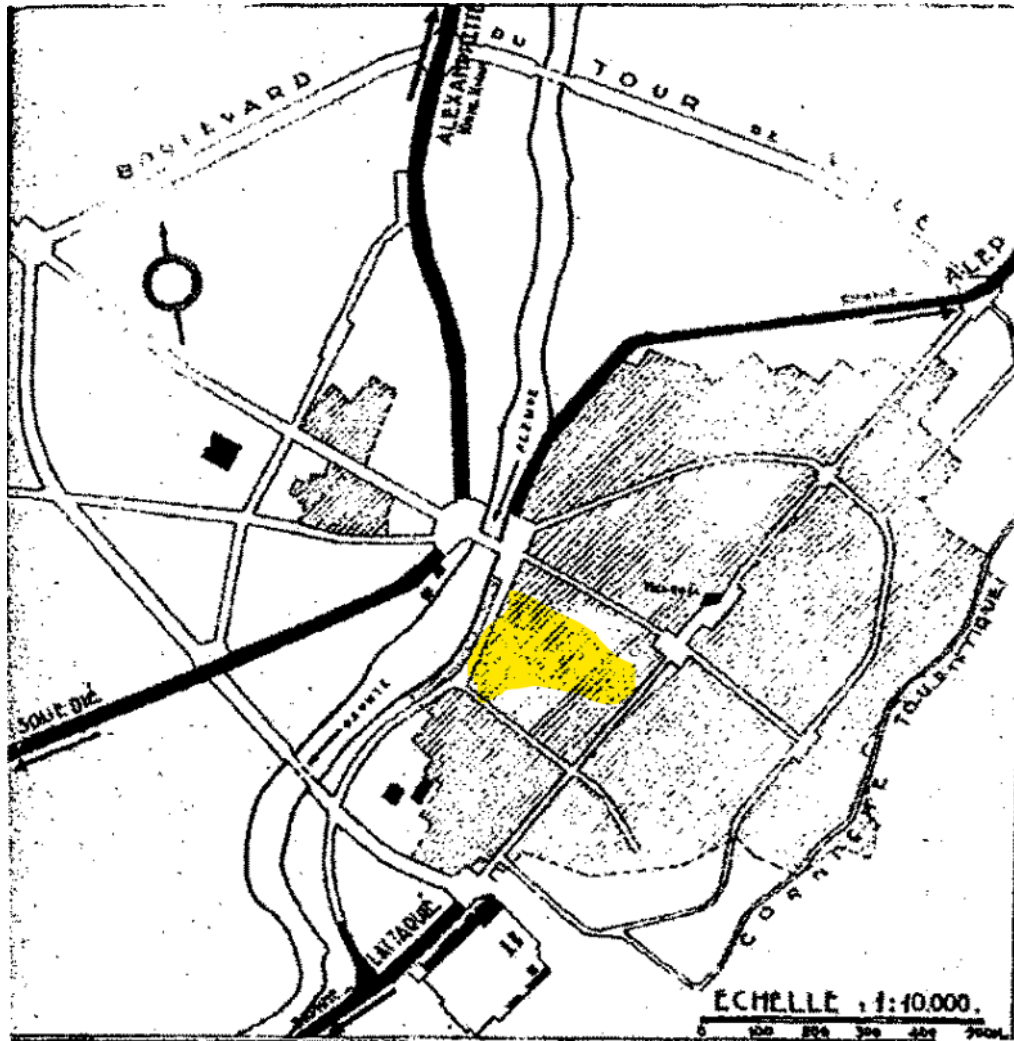
Figure 3.9. The proposed street network of Antakya by Danger (Source: Pinto, V., 1938 revised by the author)

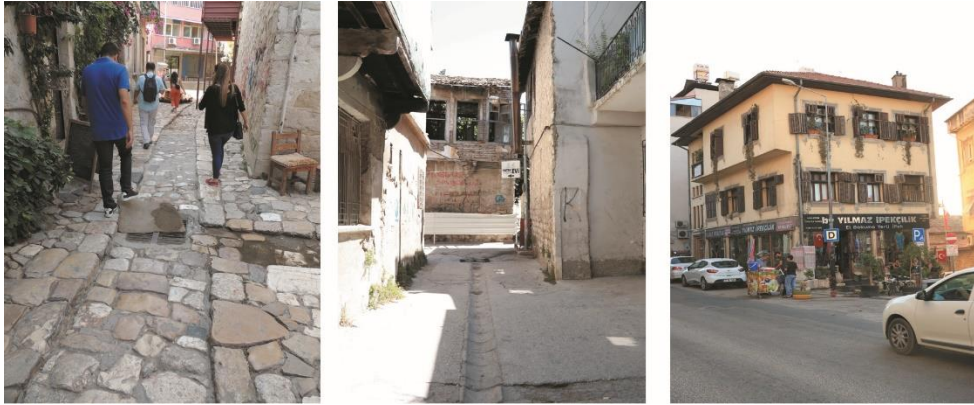
Figure 3.39. Pavement material (source: left: Neriman Şahin Güçhan 2019, middle and right, Author 2021)

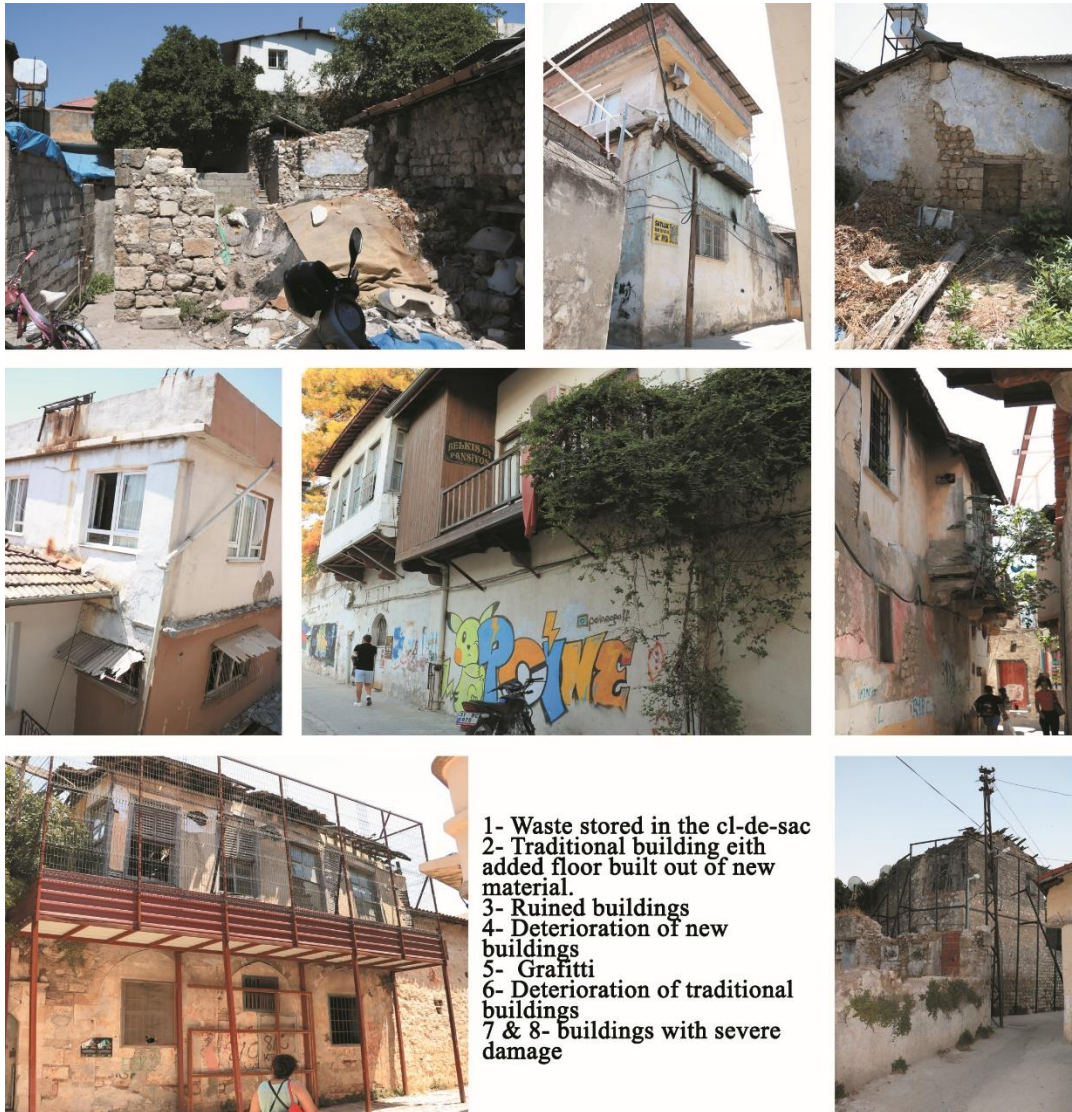
- 1- Waste stored in the cl-de-sac
- 2- Traditional building eith added floor built out of new material.
- 3- Ruined buildings
- 4- Deterioration of new buildings
- 5- Graffiti
- 6- Deterioration of traditional buildings
- 7 & 8- buildings with severe damage

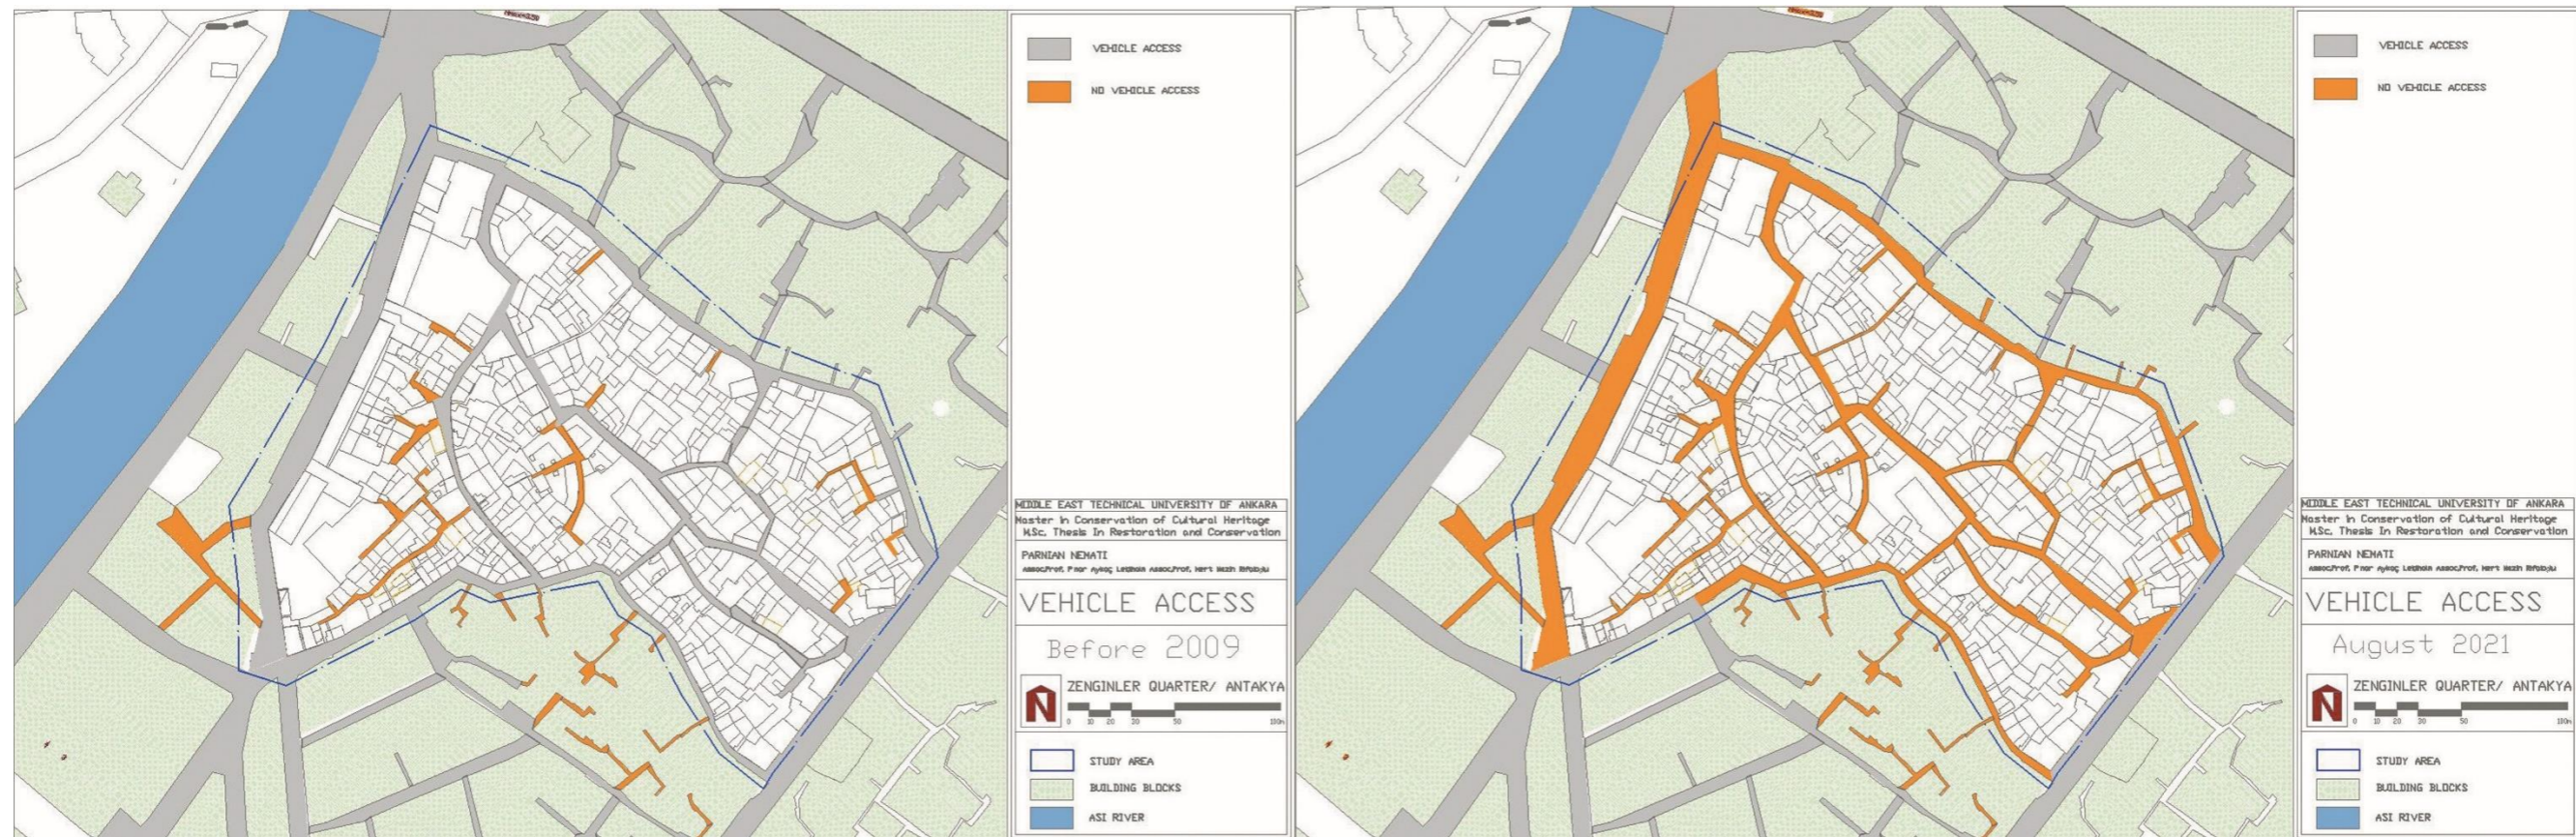
Figure 4.2 Evaluation of Car Access in Zenginler Quarter (prepared by author)
