CONSERVATION OF MODERN HOUSING BUILDINGS: EARLY
REPUBLICAN ROW APARTMENT-BLOCKS IN ULUS, ANKARA

A THESIS SUBMITTED TO
THE GRADUATE SCHOOL OF NATURAL AND APPLIED SCIENCES
OF
MIDDLE EAST TECHNICAL UNIVERSITY

DECEMBER 2022

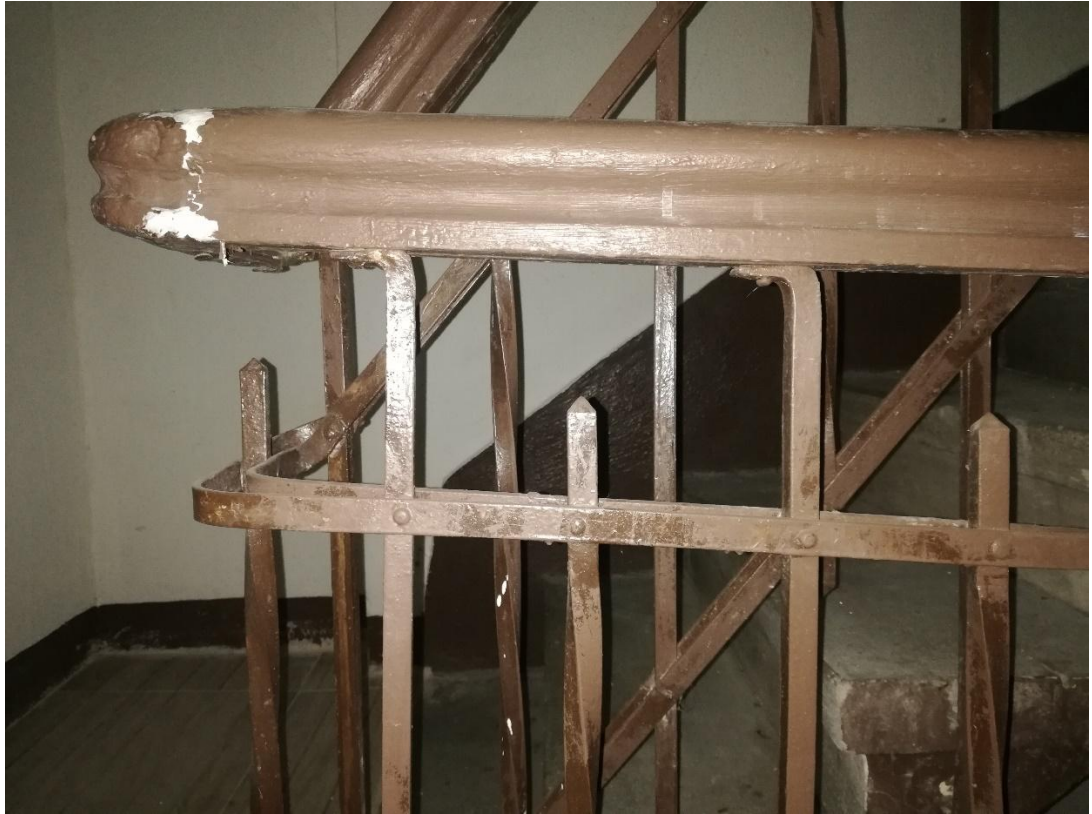
Figure 3.15. Stair railings of Building C. (Author, 2022)

The railings are constructed of timber, while the balustrade is built of iron. The landings of the stairs are likewise cast in mosaic. When it comes to the flooring in the rooms, mosaic tiles are typically employed. Ceramic coating can be found in toilet and kitchens. Cast mosaic can also be found in storage areas as “yüklük”.

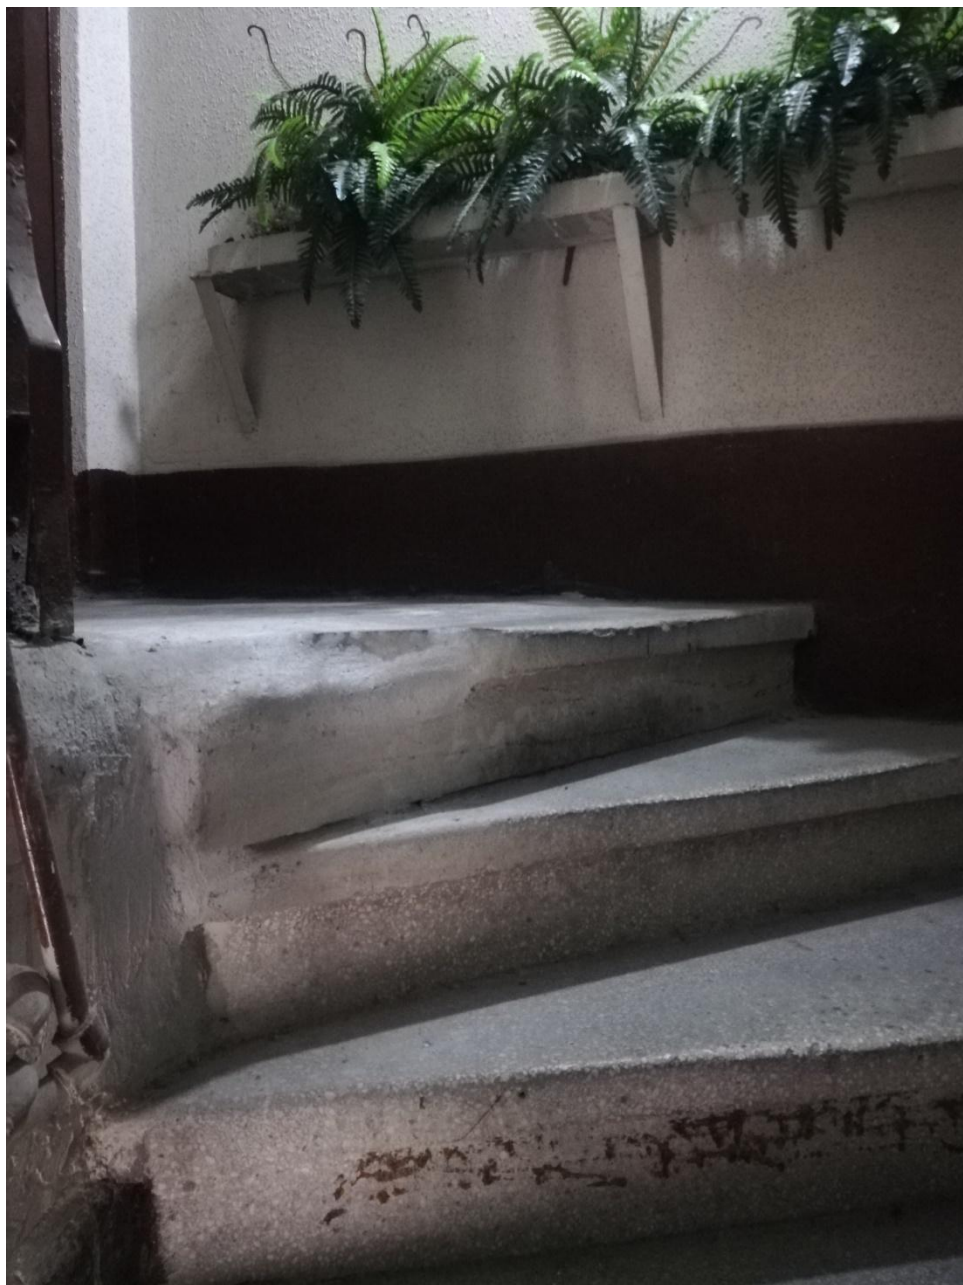
Figure 3.16. Cast mosaic stairs, Building B. (Author, 2022)

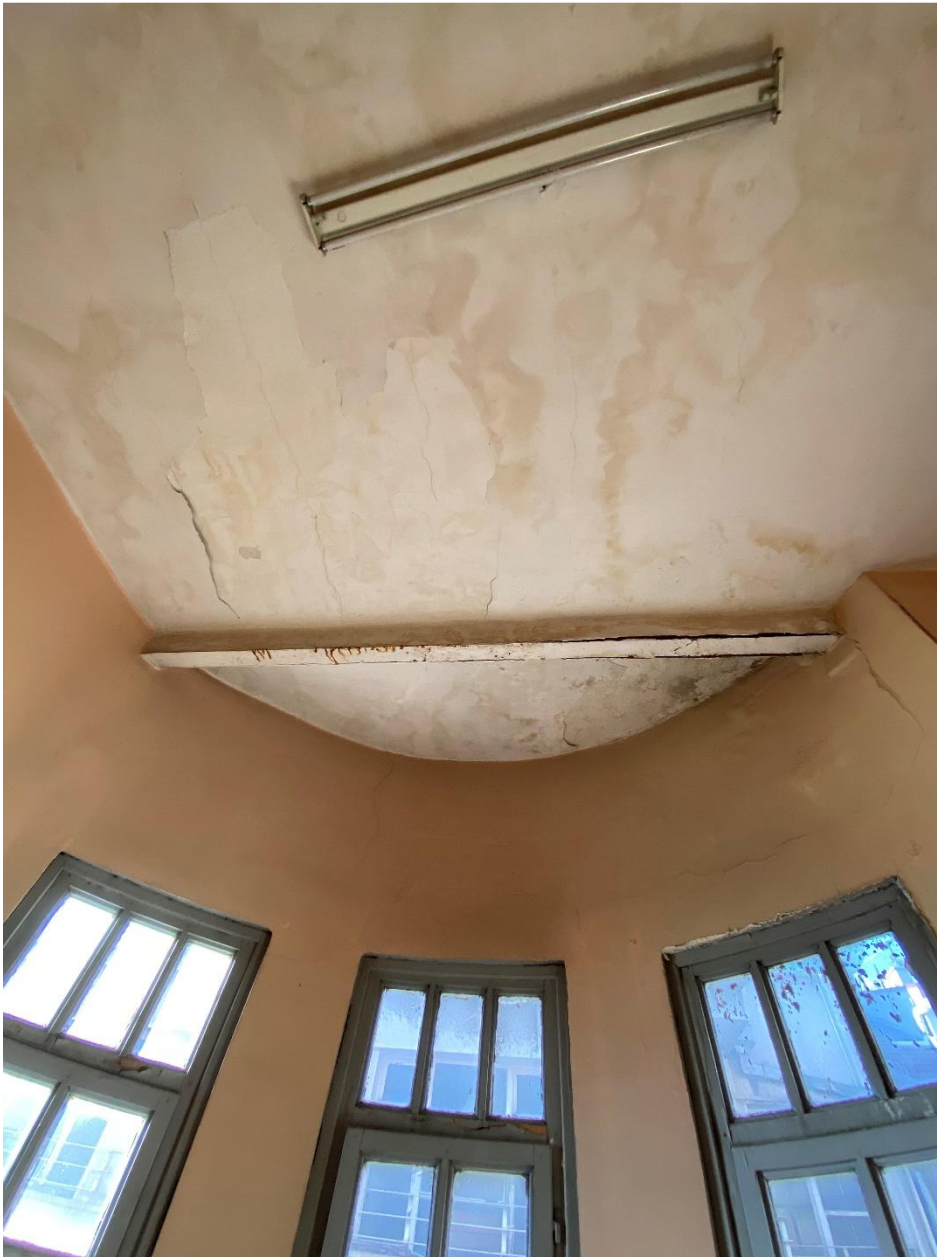
Figure 3.28. Third floor steel beam of Building A (Author, 2021)

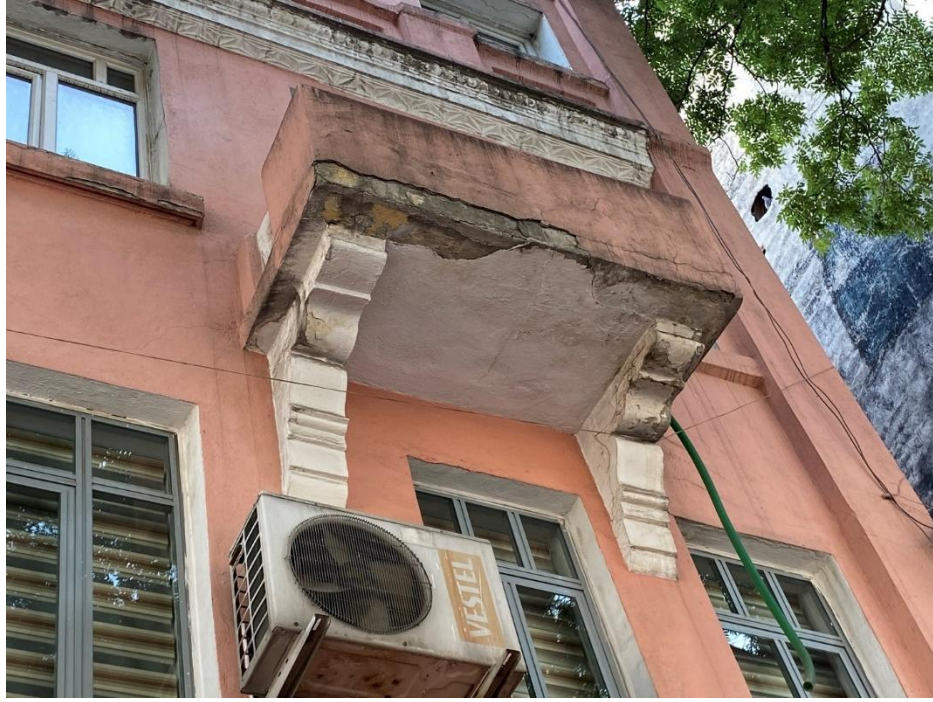
When the problems are analyzed, there are surface cracks and dust and dirt accumulations in the plaster on the facade as material decay. There is material loss (stone) and loss of plaster, especially on the balcony railing and lower parts.

Figure 3.29. Anafartalar Street façade detaching of plaster (Author, 2021)

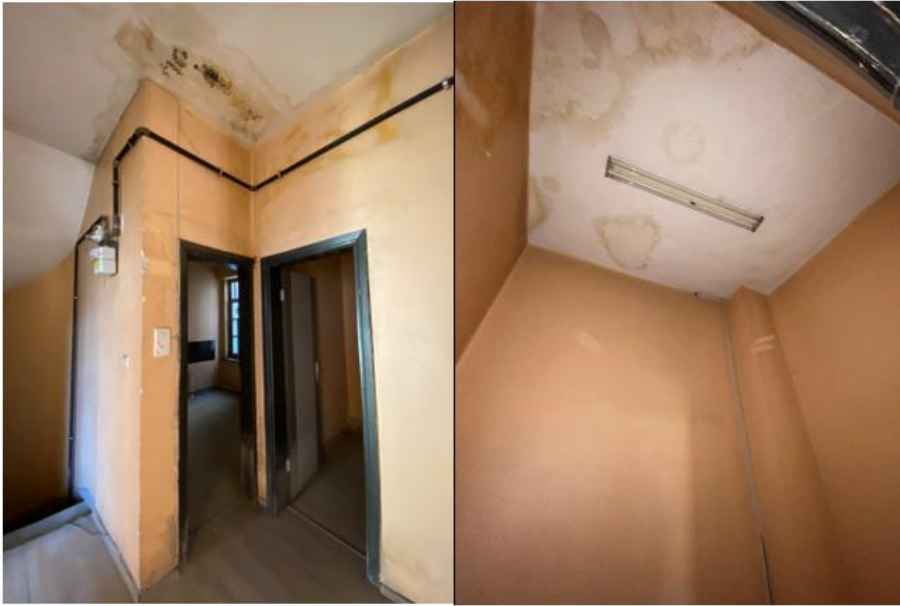
There are loss of paint, abrasions and deformations on the timber joinery on the facade. The most obvious interventions as new intervention problems are on the ground floors. There are signage applications that prevent the character of the façade by changing the showcases on the ground floor. There are staining and blistering due to humidity in the interior spaces. Oxidation was observed on the steel beams.

Figure 3.30. Building A staining due to humidity, Third Floor (Author, 2021)

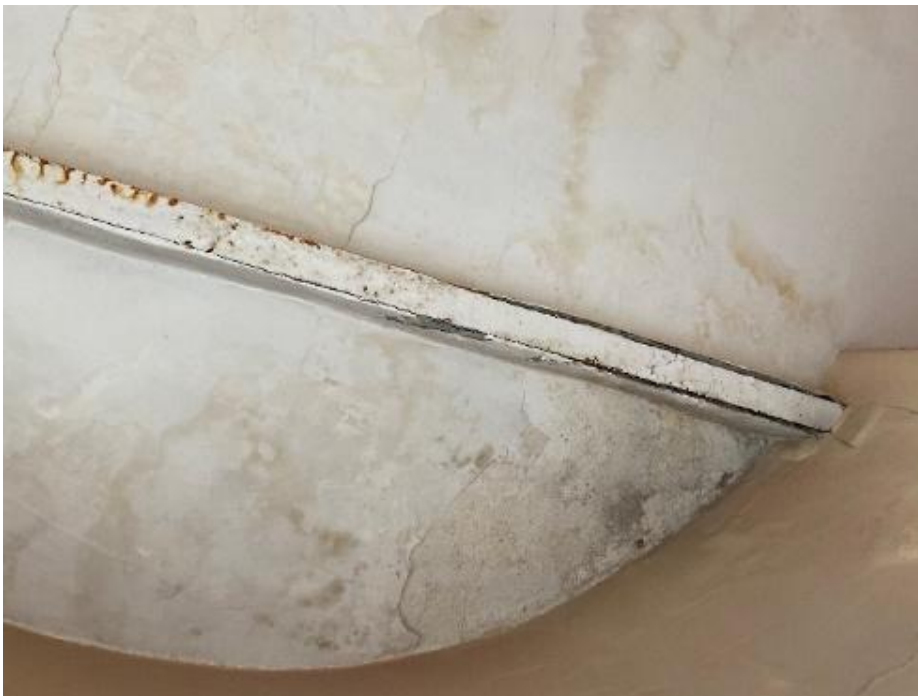
Oxidation was observed in metal beams.

Figure 3.31. Oxidation in steel beam, Third Floor (Author, 2021)

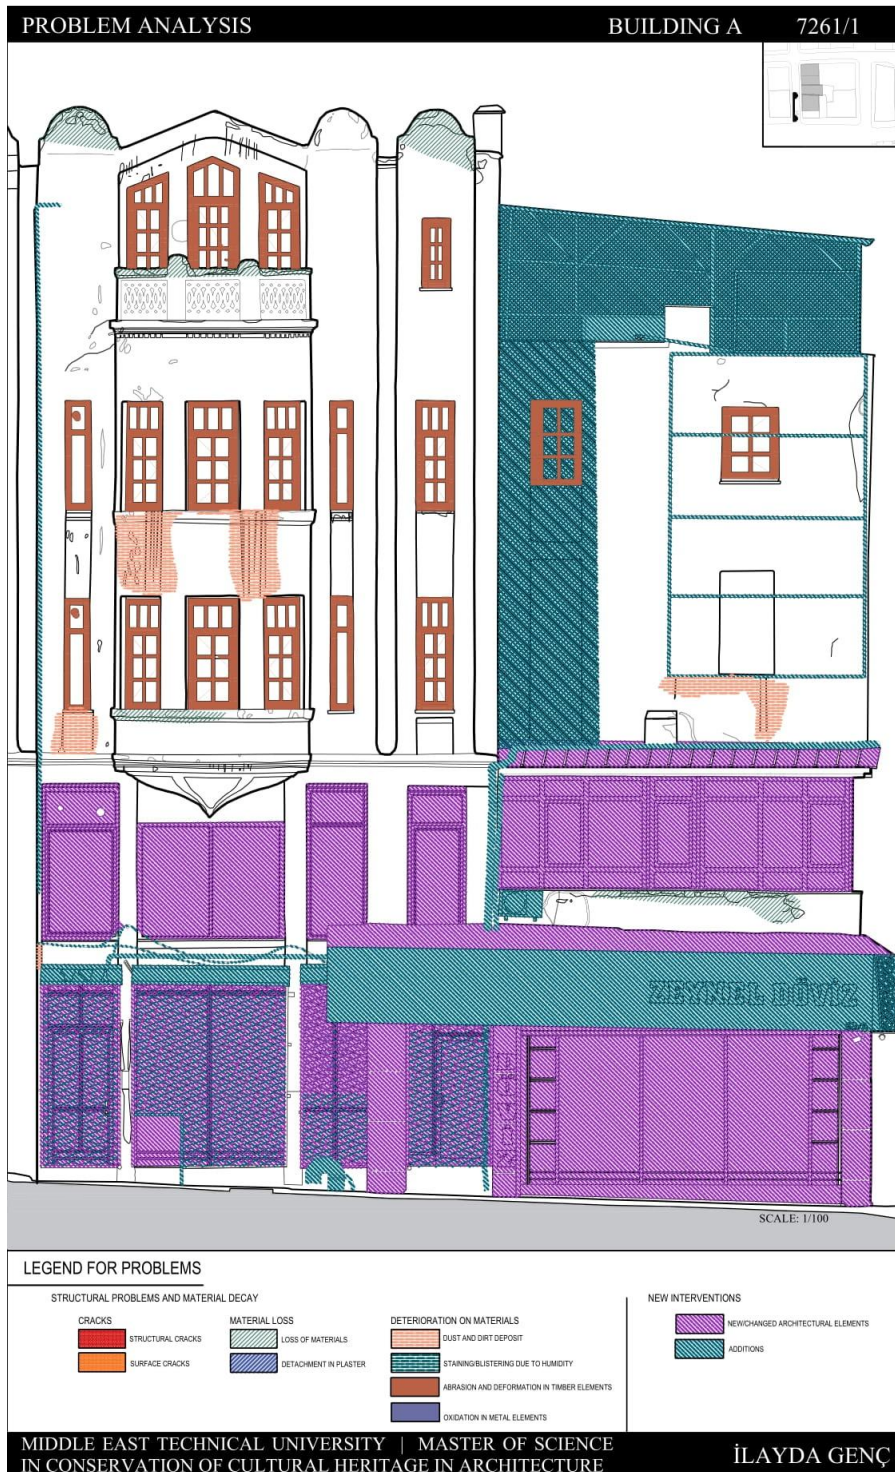
Table 3.24. Material Decay and Structural Problems of Building A – Mevsim Street Facade (Author, 2021)

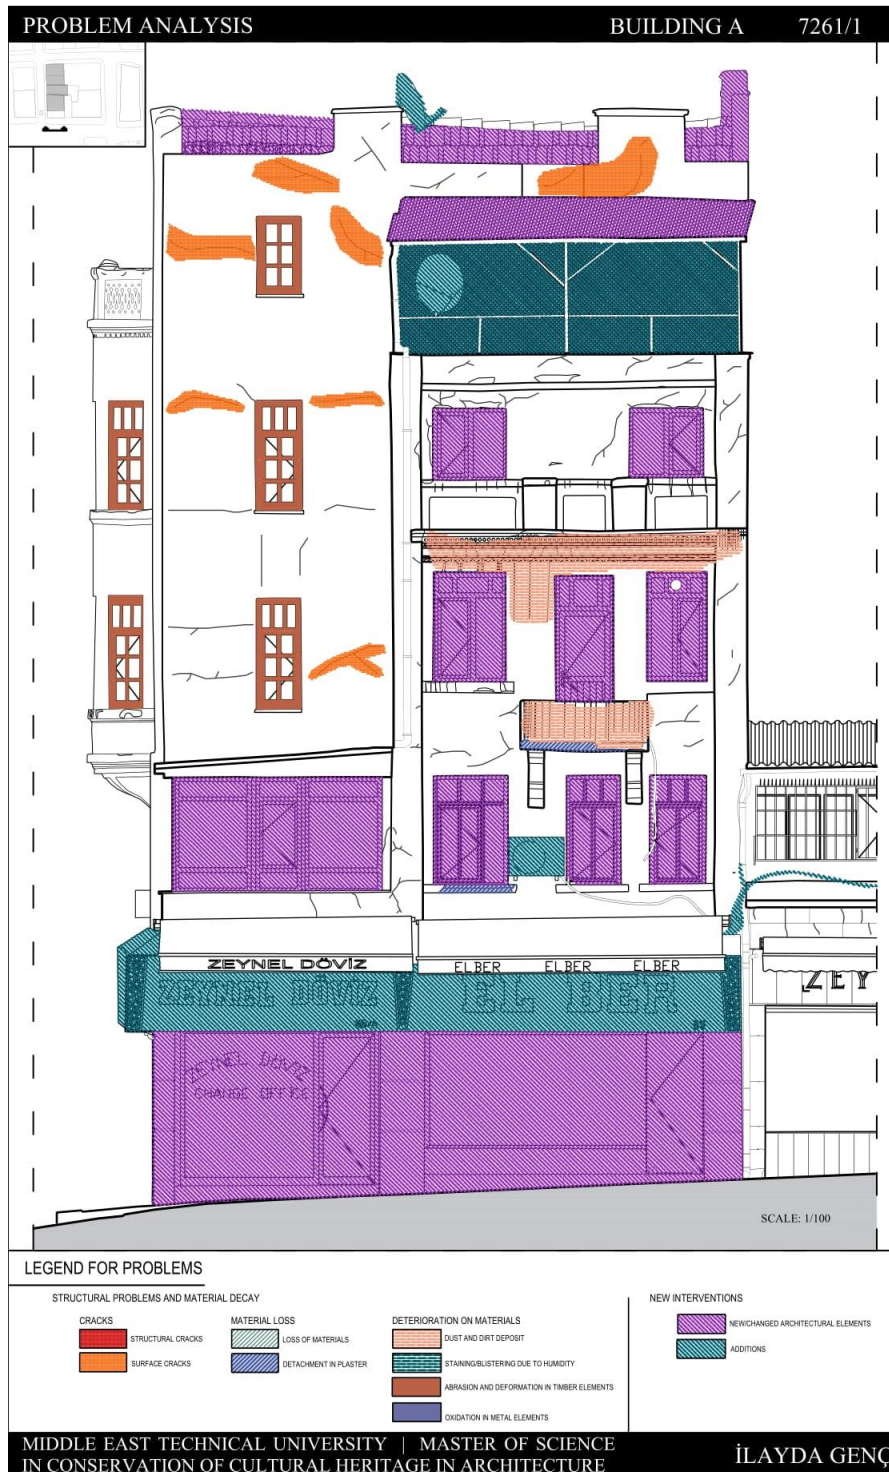
Table 3.25. Material Decay and Structural Problems of Building A Anafartalar Street Facade (Author, 2021)

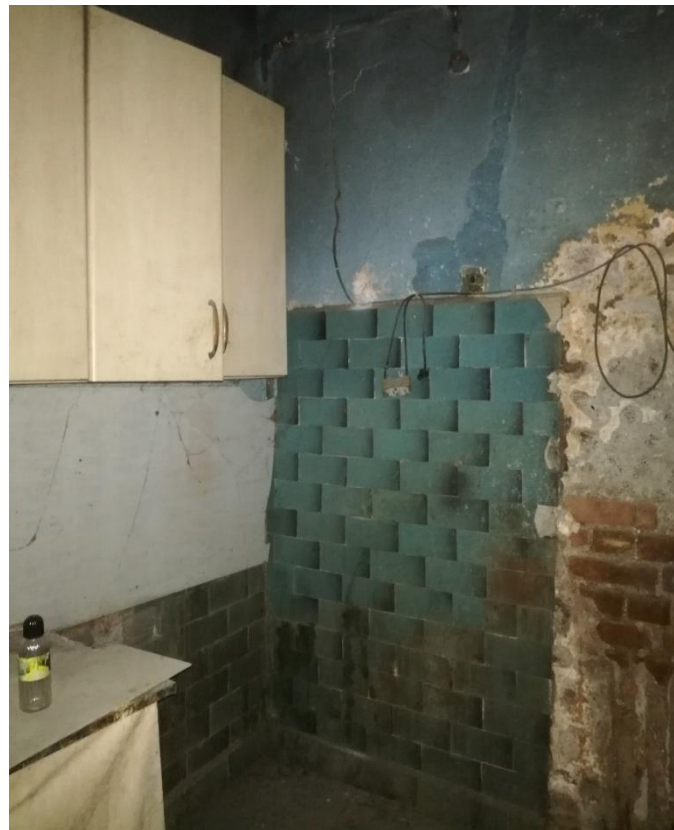
Except for the entrance and the first floor, which are actively used indoors, there is heavy dirt and bird droppings on the unused floors. There are loss of plaster on the wall due to humidity and neglect.

Figure 3.38. Deteriorations due to humidity on wall (Author, 2022)

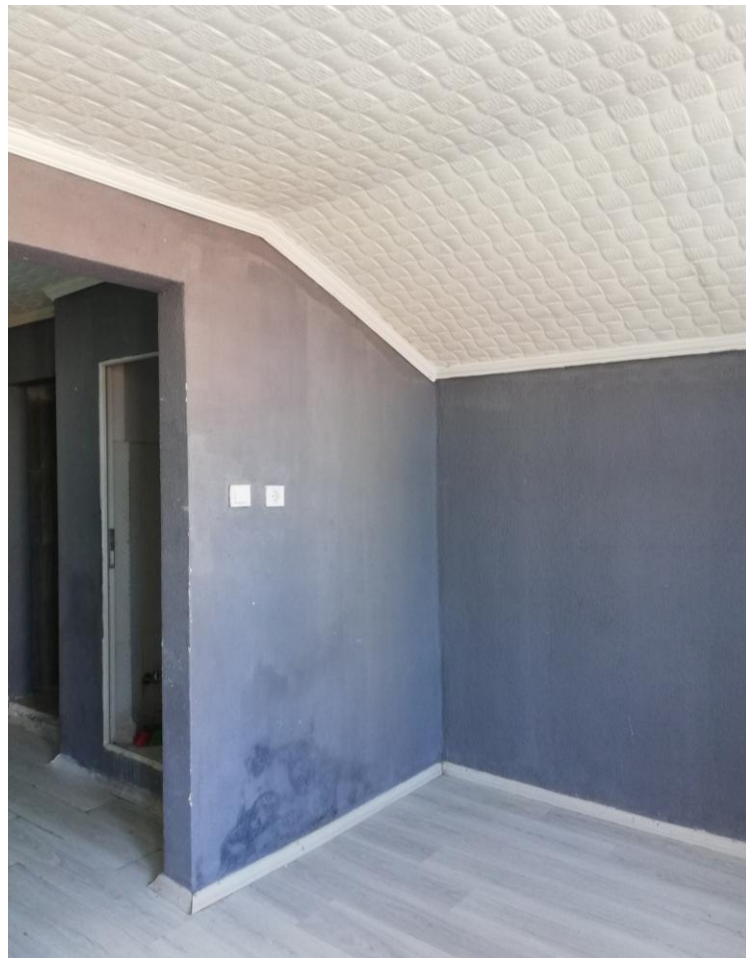
Figure 3.43. Moisture staining on fourth floor of Building C (Author, 2022)

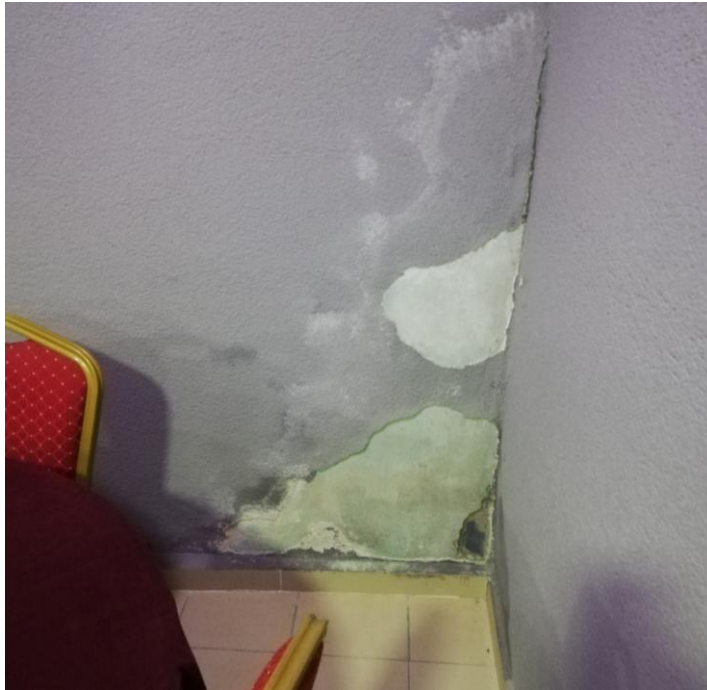
Figure 3.44. Loss of paint due to plumbing leak in basement, Building C (Author, 2022)

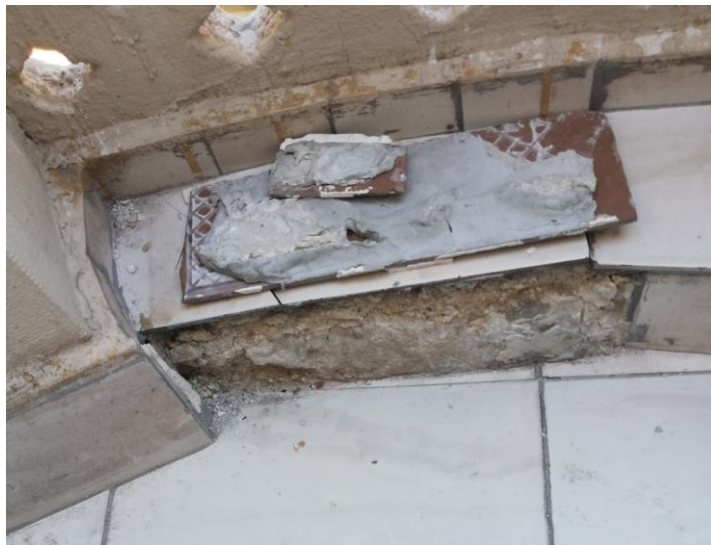
Figure 3.45. Deterioration of ceramics on the balcony, Building C (Author, 2022)

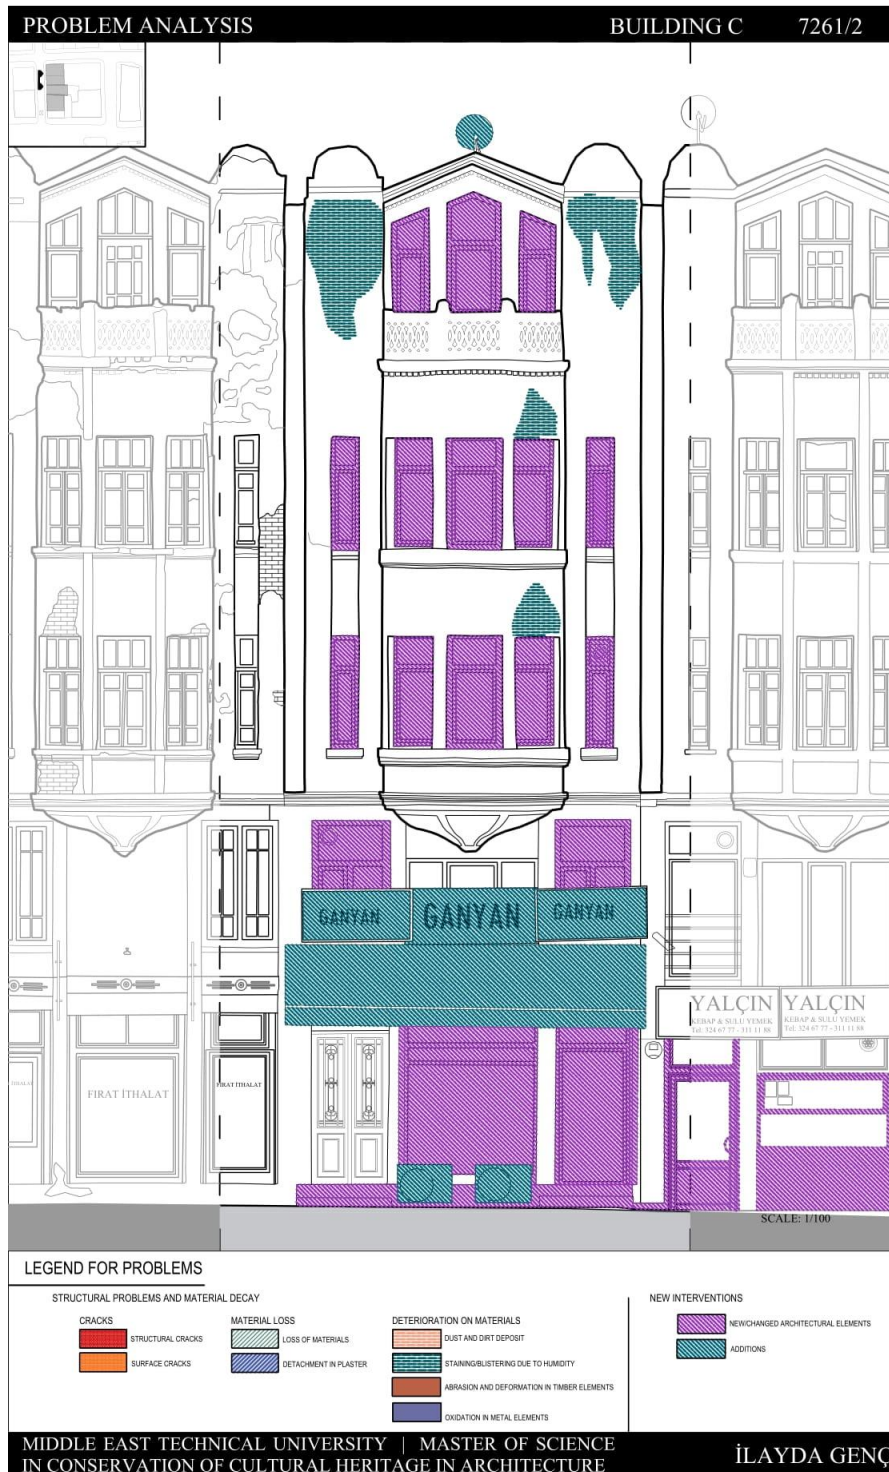
Table 3.29. Material Decay and Structural Problems of Building C Mevsim Street Facade (Author, 2021)

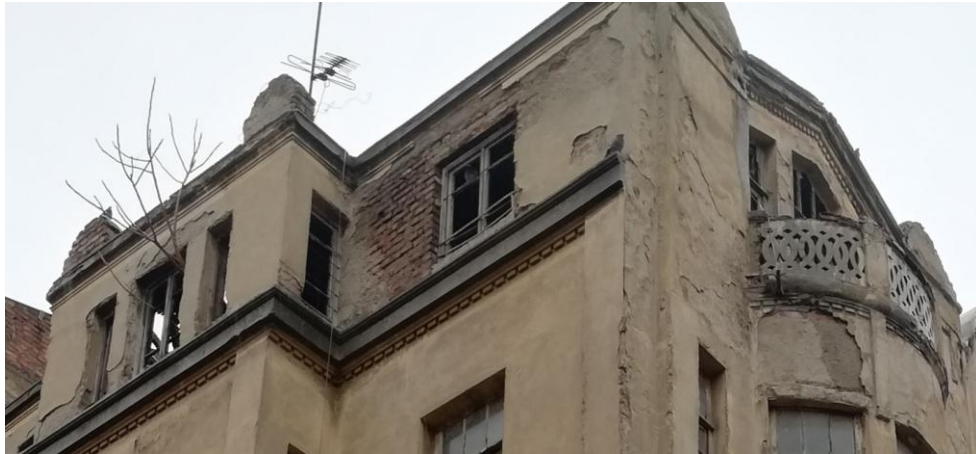
Figure 3.48. Plaster and paint detachment on the façade, Building D (Author, 2021)

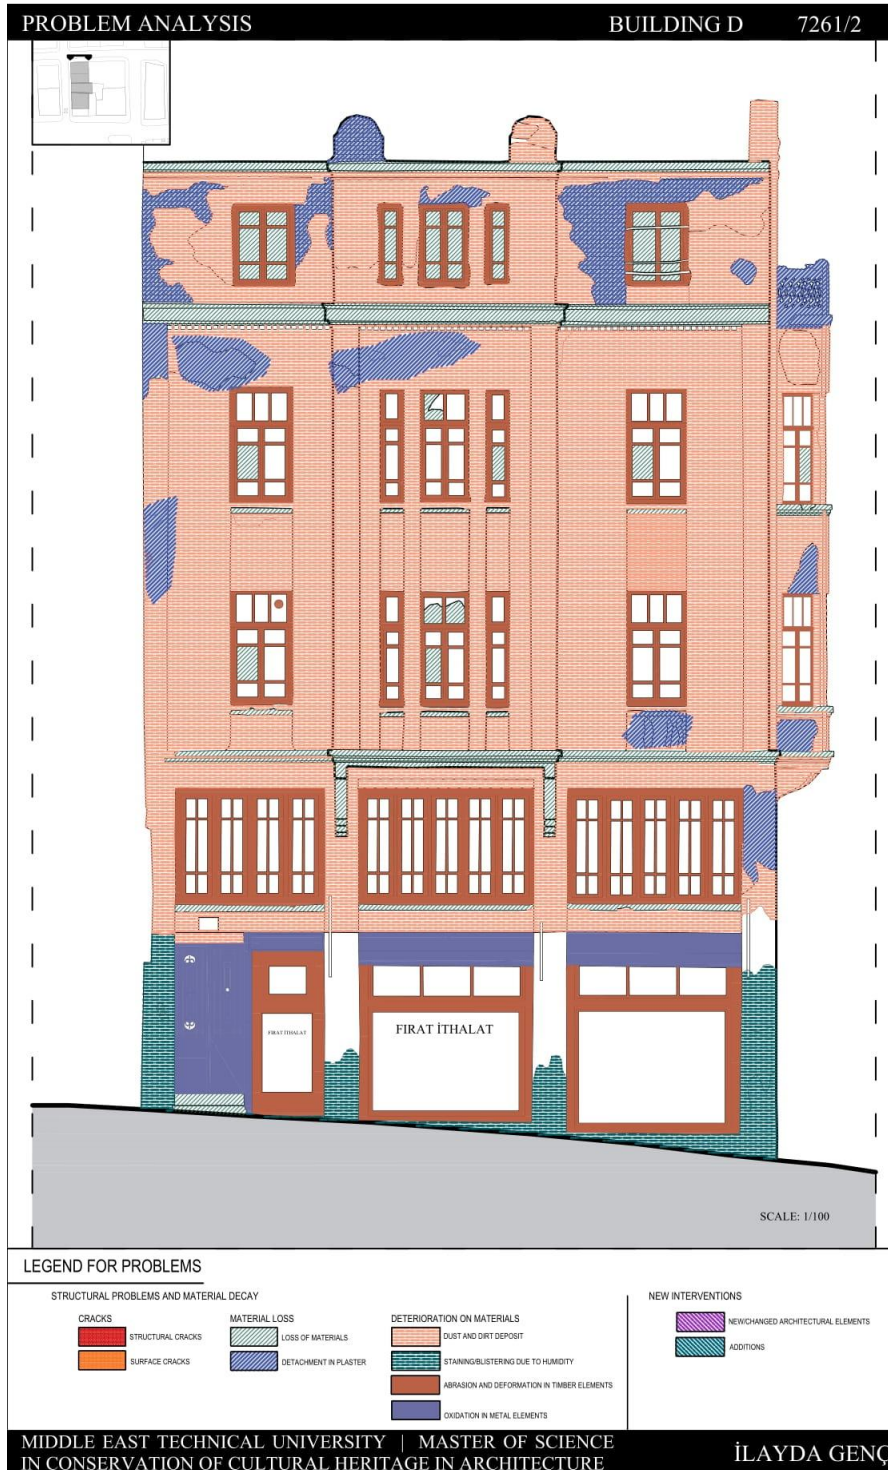
Table 3.33. Material Decay and Structural Problems of Building D Konya Street Facade (Author, 2021)

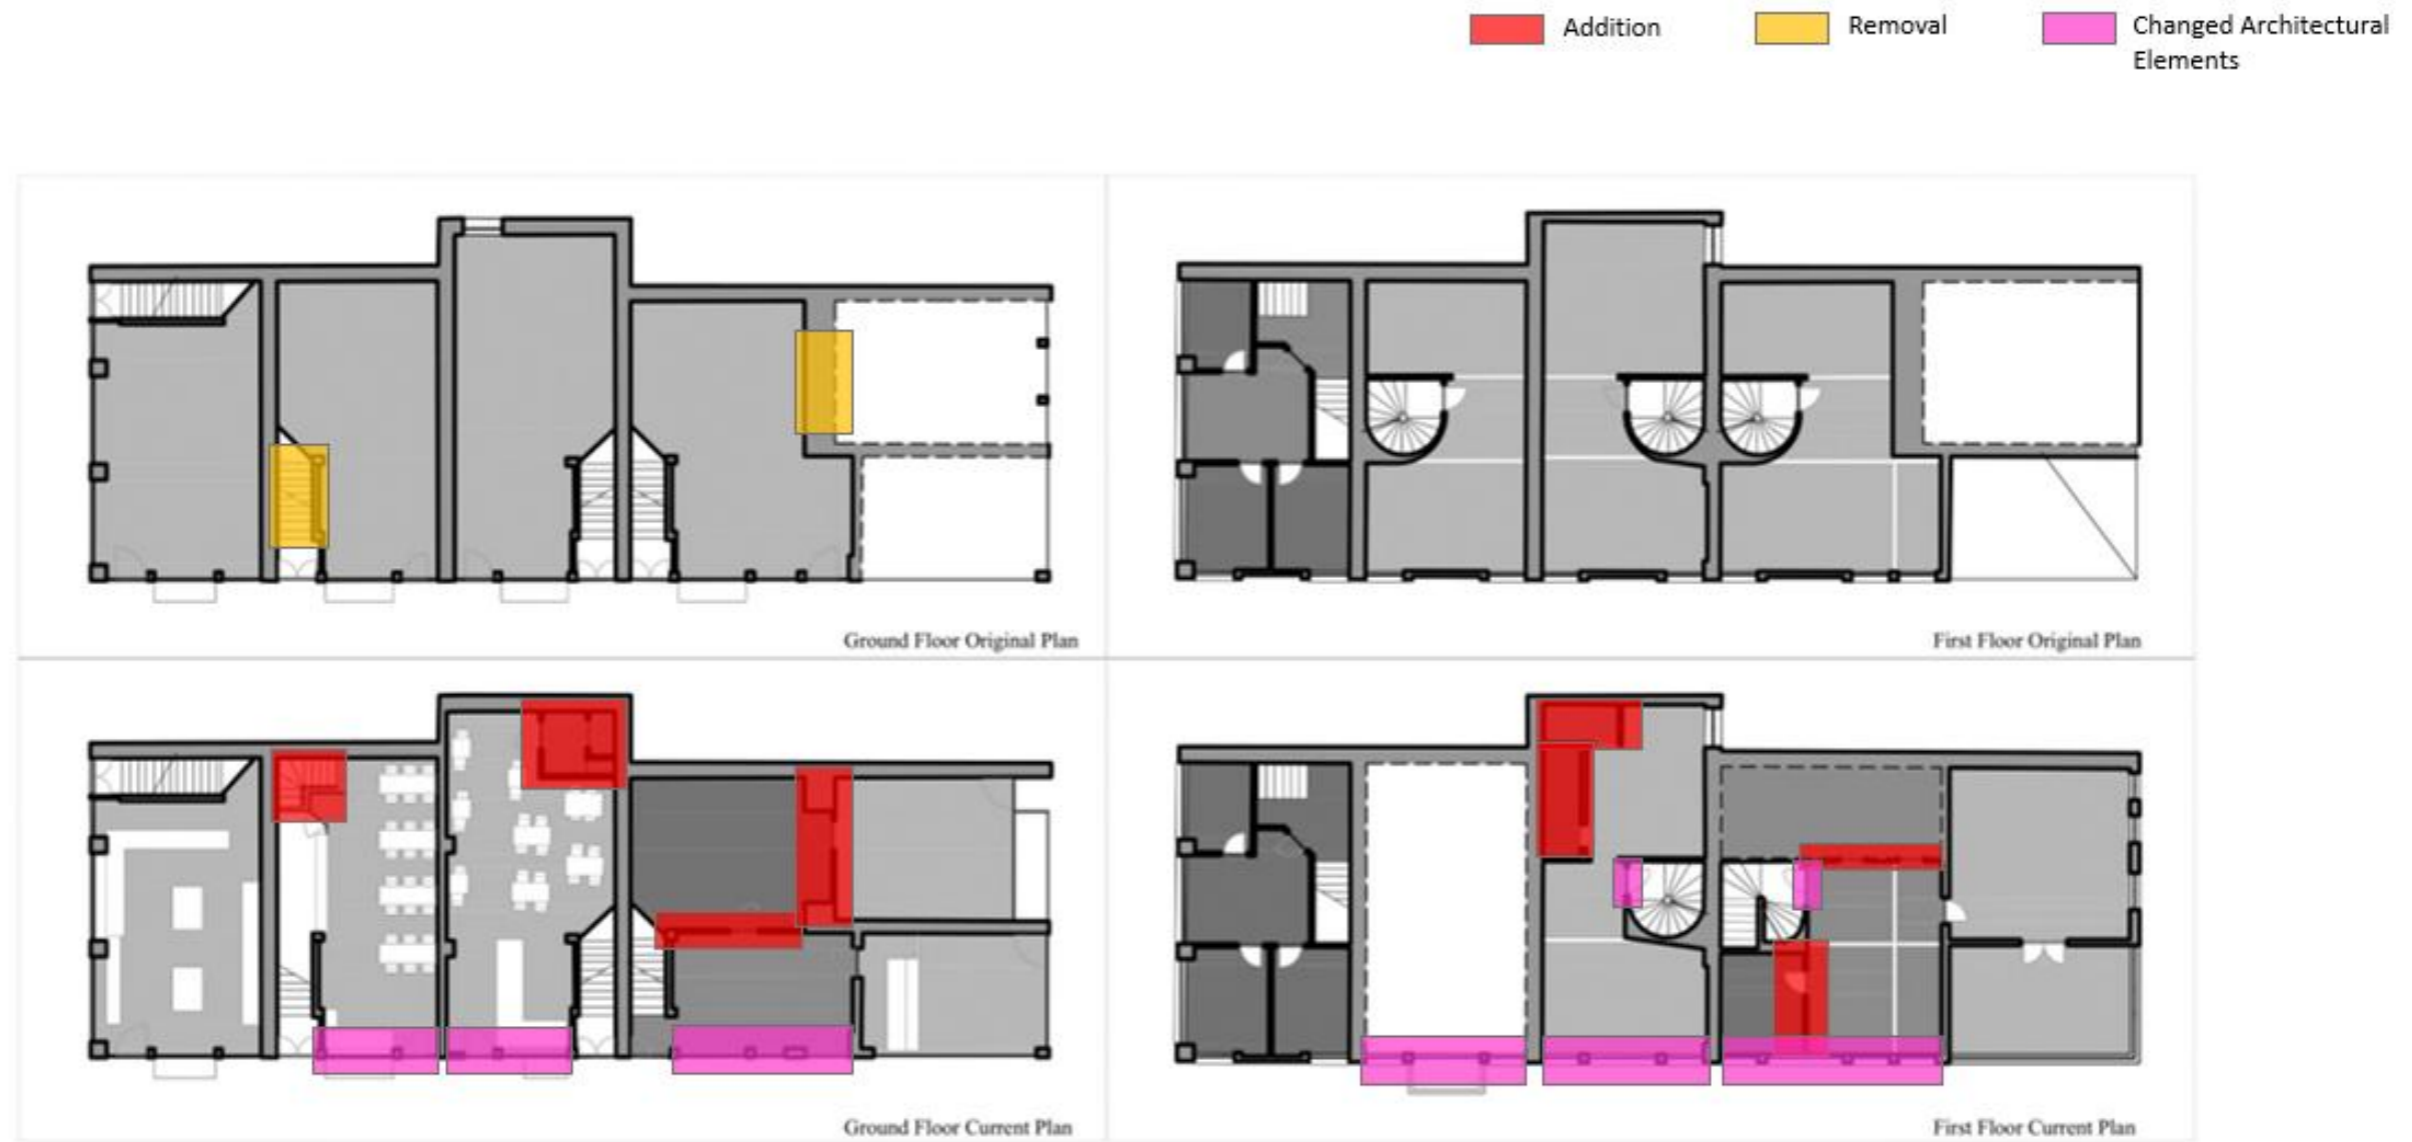
Figure 4.1. Changes in Ground Floor and First Floor

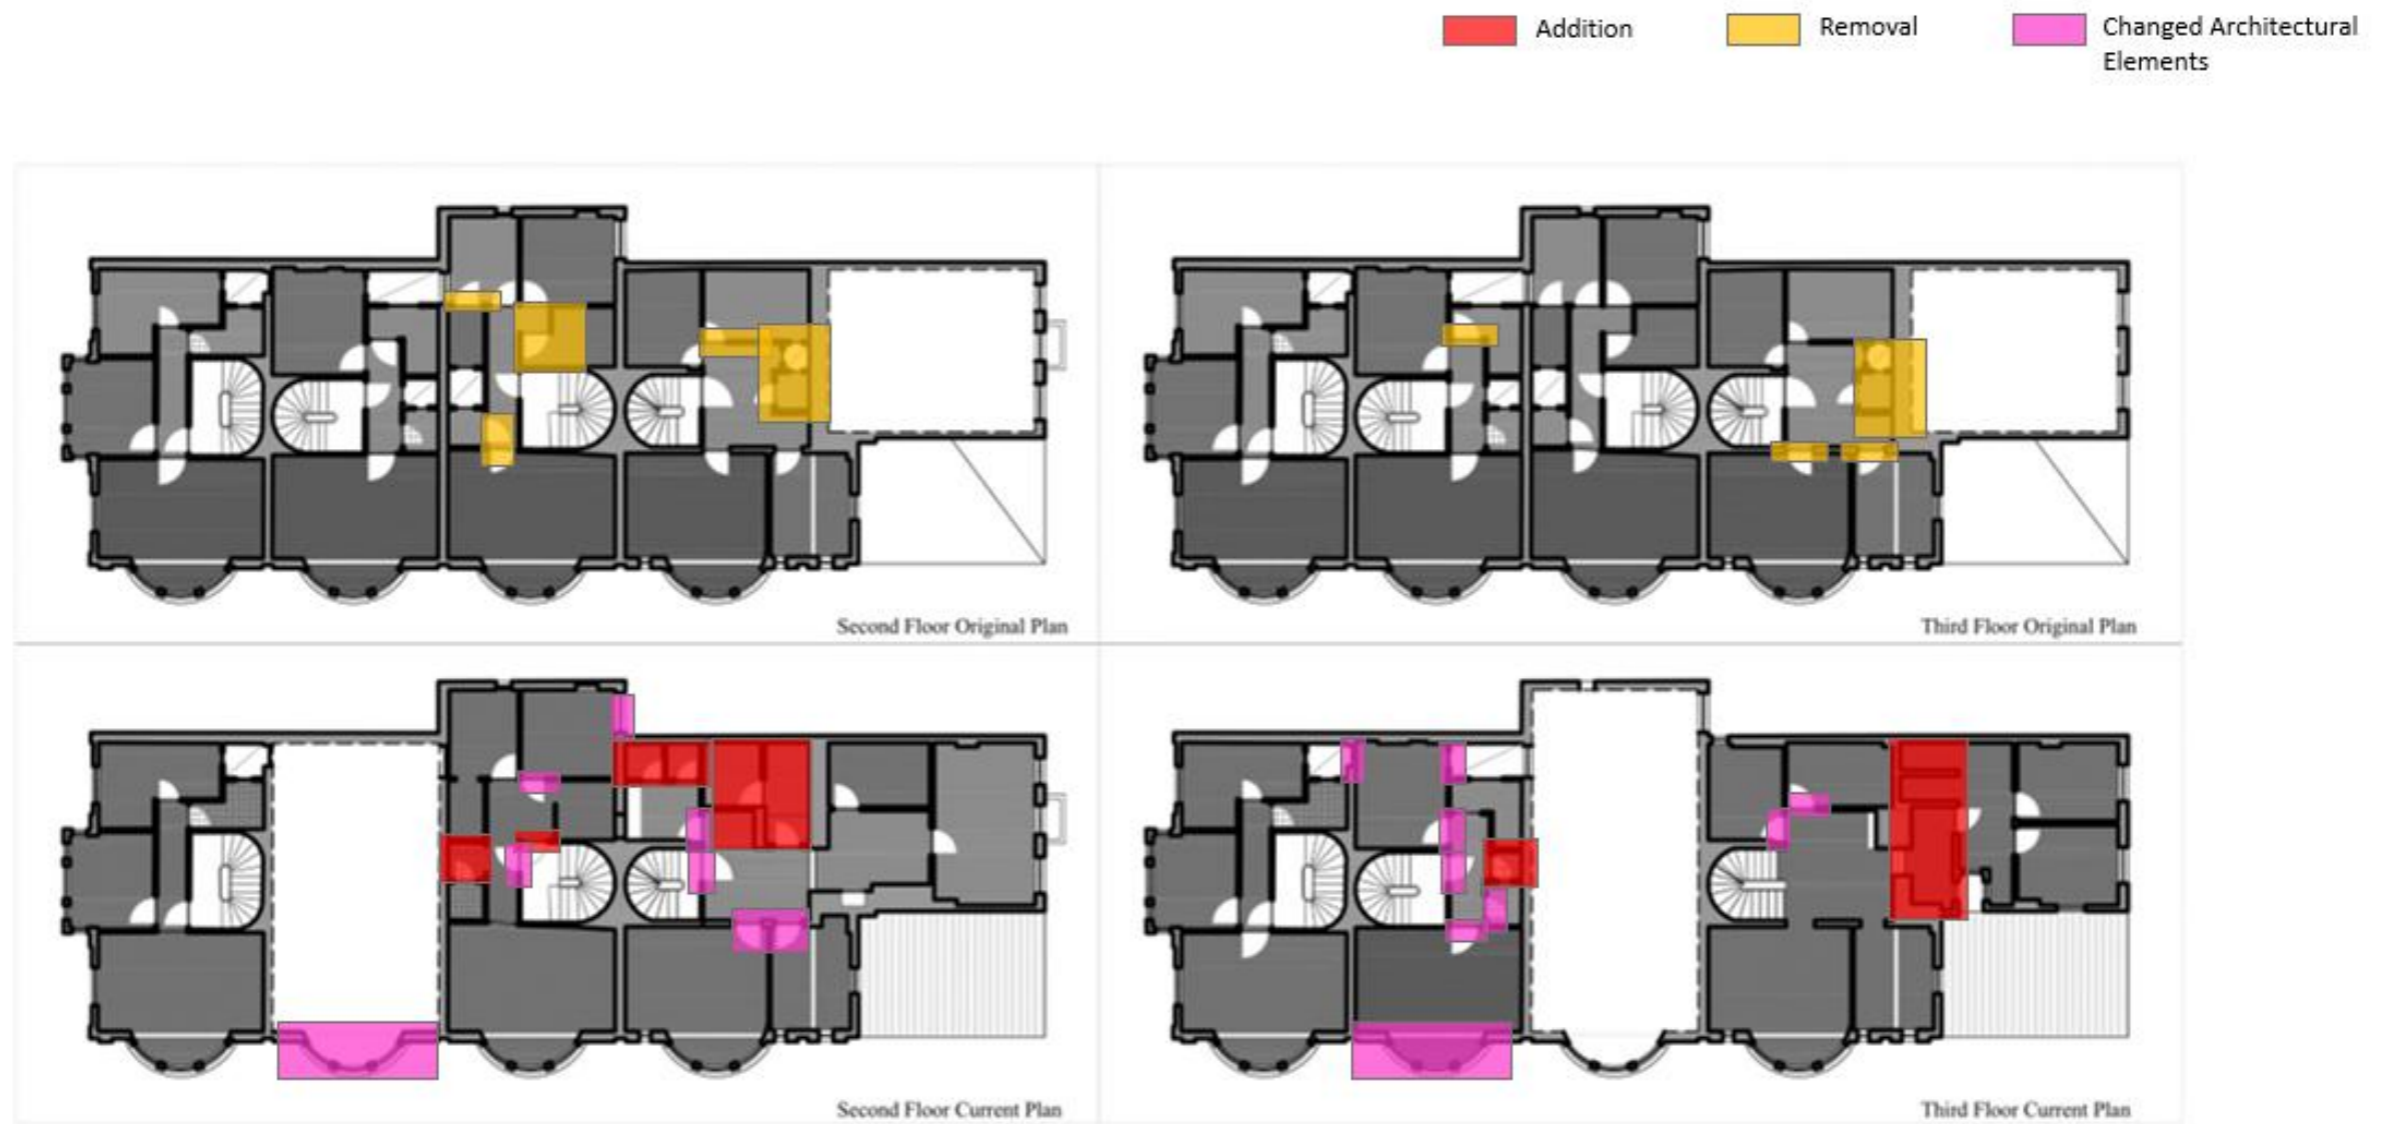
Figure 4.2. Changes in Second Floor and Third Floor

■ Addition ■ Removal ■ Changed Architectural Elements
