AN ASSESSMENT AND RE-IDENTIFICATION OF THE RURAL HERITAGE  
SITE OF SANTA (DUMANLI KÖY, GÜMÜŞHANE)

A THESIS SUBMITTED TO  
THE GRADUATE SCHOOL OF NATURAL AND APPLIED SCIENCES  
OF  
MIDDLE EAST TECHNICAL UNIVERSITY

JANUARY 2023

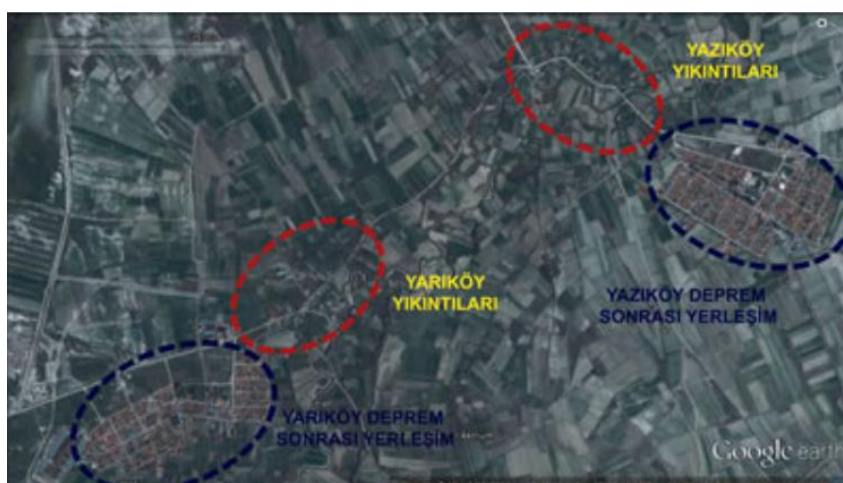
Figure 2.2: Yazıköy-Yarıköy villages and post-earthquake settlements (Özyıldırım 2016)

Yazıköy and Yarıköy villages in Burdur are examples of rural areas abandoned because of natural disasters (Figure 2.1). After the Burdur earthquake of 1971, inhabitants of these villages abandoned their homes. As far as can be understood from the old photographs and existing ruins, the traditional texture of the village before 1971 consisted of two-storey, mud-brick structures with hipped roof. While the old villages of Yazıköy and Yarıköy remained untouched, a new settlement was established very close to these two villages, consisting of single-storey, single-type houses with gardens (Figure 2.2).<sup>44</sup>

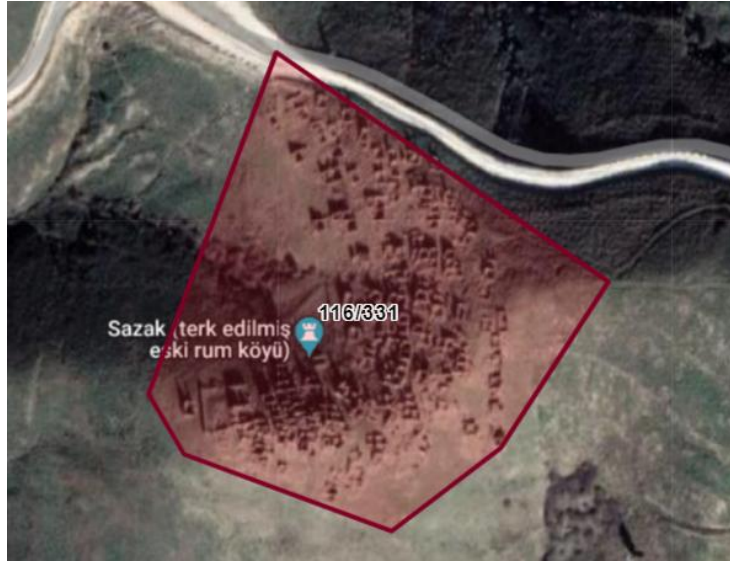
Figure 2.9: The deserted village of Sazak located on a single building lot (as taken from the website of TKGM)

It is highly possible the area's fate will be similar to Kayaköy. All of the buildings in Sazak are located on a single lot (116 block / 331 lot) owned by the Treasury (Figure 2.9).<sup>131</sup> The fact that the area is in public ownership makes it easy for the area to become a tourism center as in the case of Kayaköy. The news-item titled "The old *Rum* village of Sazak will be İzmir's Kayaköy", dated 2019, also confirms this situation. According to the news, the Mayor of Karaburun, İlkay Girgin Erdoğan, argues that in order to increase the tourism potential of the region, necessary promotions should be made on national and international platforms.<sup>132</sup> In this context, the site was introduced to the public with a video clip of the song *Gafil Gezme Şaşkın* by the Rhythm Ensemble Ahura (Figure 2.10).<sup>133</sup> This example shows that artistic events are important in terms of promoting a site and establishing a connection between the public and the site. As noted by the NSW Heritage Office, "the connections between people and natural and cultural heritage are often expressed through art, music, literature, dance, food and other creative works and traditions. These are traditional forms of 'interpretation.'" <sup>134</sup>

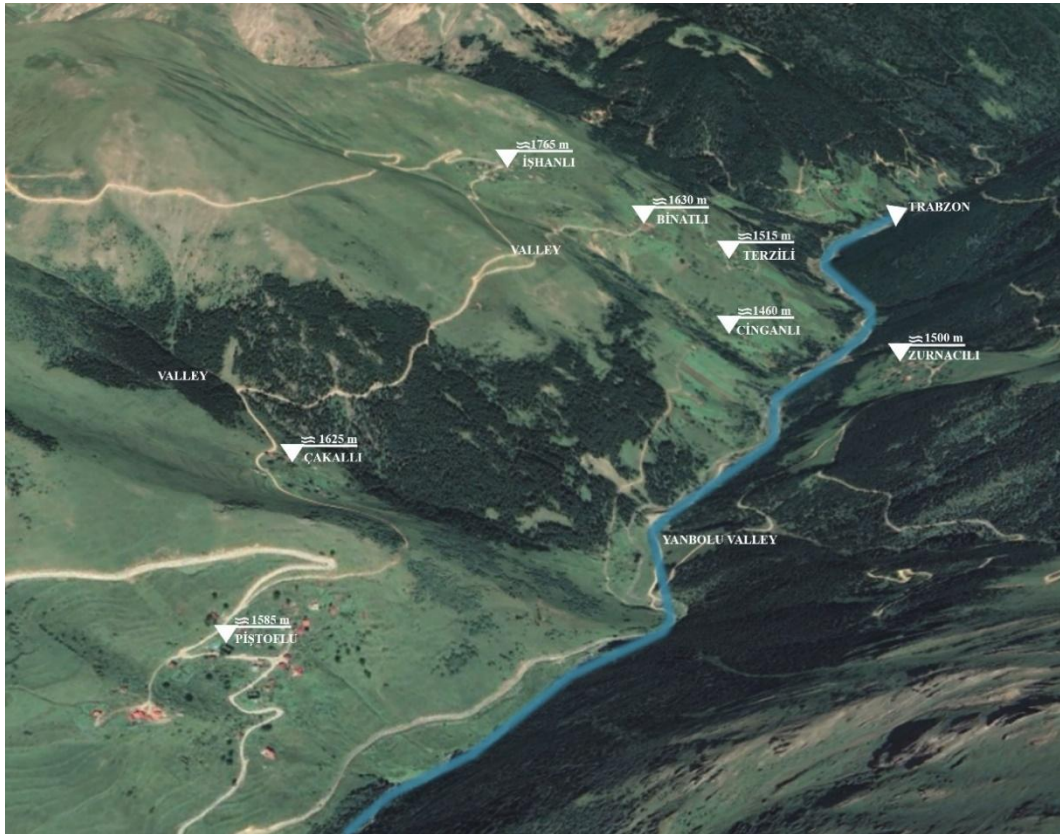
Figure 3.4: Location of the seven neighborhoods on the mountainous terrain (from Google Earth, as developed by the author)

The seven neighborhoods of Santa are located at an altitude of between approximately 1400 m and 1800 m. The Zurnacılı neighborhood is located on the eastern slope of the Yanbolu valley while the other six neighborhoods are located to the west of the valley. The Piştöflu and Çakallı neighborhoods are separated from the İşhanlı, Binatlı, Terzili and Cinganlı neighborhoods by small valleys. In Santa,

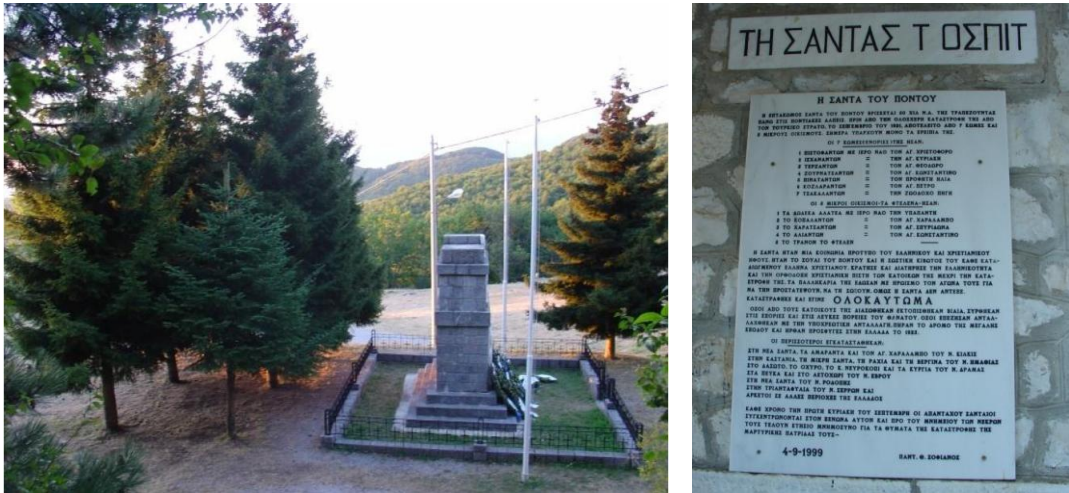
Figure 3.8: Kastania, the Monument of Santa with the pine trees (left) (Liddle 2013, p. 97); the marble plaque on the wall of the House of Santa (right) (Liddle 2013, p. 94)<sup>174</sup>

There are six pine trees at one side of the stone monument representing the six neighborhoods which are Piştoflu, Çakallı, İşhanlı, Binatlı, Terzili and Cinganlı at the west side of the Yanbolu valley, and one pine tree at the other side representing the Zurnacılı neighborhood on the east side of the Yanbolu valley. The pine trees represent the location of the neighborhoods in the Yanbolu valley. There are marble

plaques on the wall of the building giving information about Santa and how the *Rums* experienced the conflicts in 1921 and the migration process (Figure 3.8).<sup>170</sup>

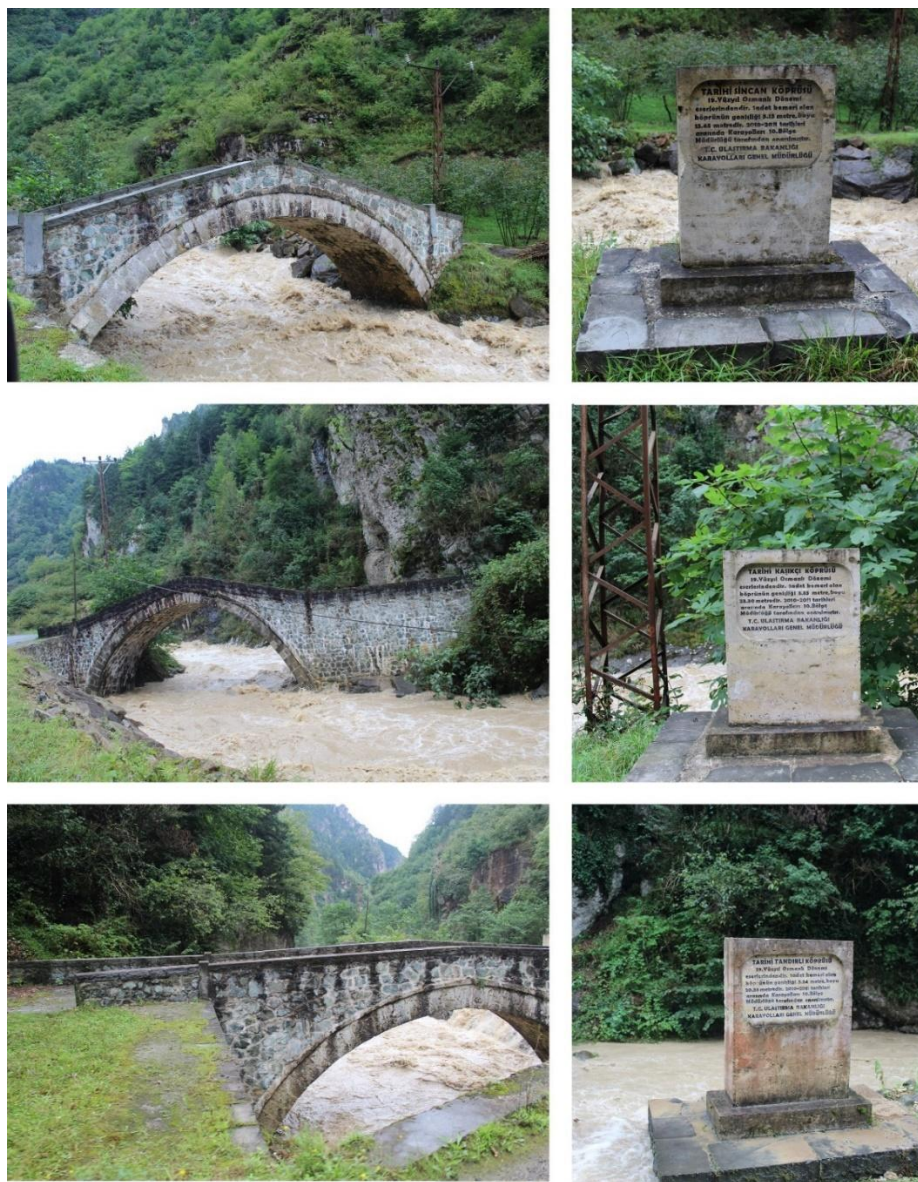
Figure 3.10: Yanbolu valley, stone bridges

The Yanbolu Basin, including the Dumanlı (Santa) village, maintained its importance as a caravan route throughout history until the 19th century. The Taşköprü Highland, which is 11 km away from Santa, was located on the first summer route of the Silk Road. The 28 stone-vaulted bridges in the Yanbolu Valley also show the commercial importance of the basin in the Ottoman Empire (Figure 3.10).<sup>181</sup>

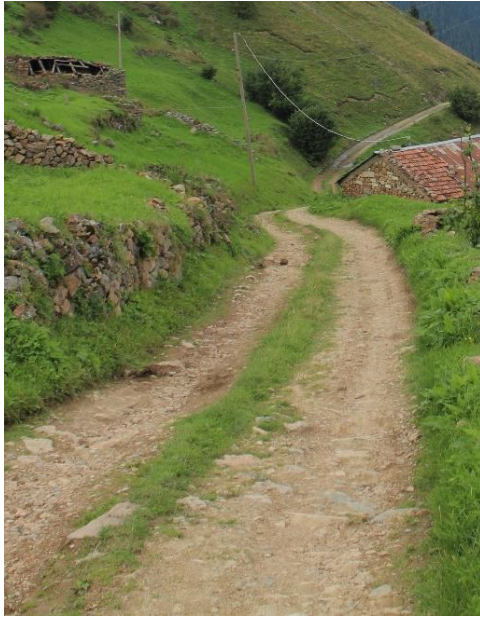
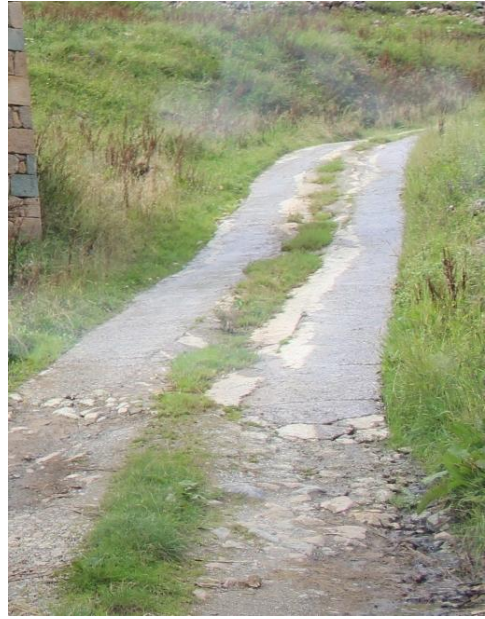
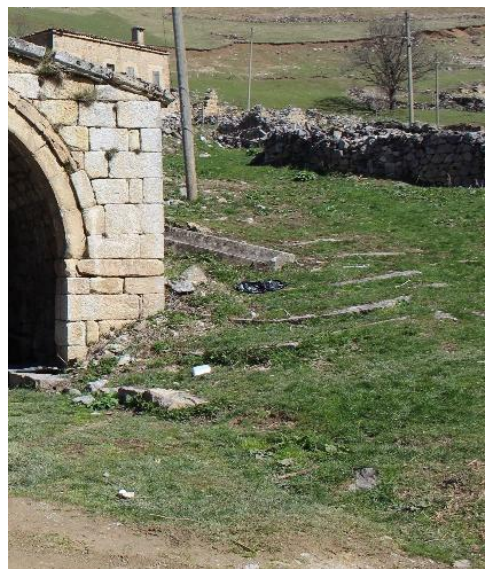
Figure 3.23: Santa, street pavements: dirt road (above left); cement-based repair (above right); narrow pathway (below left); stone steps (below right)

<sup>206</sup> In some parts of the earth roads, cement-based repairs are seen.

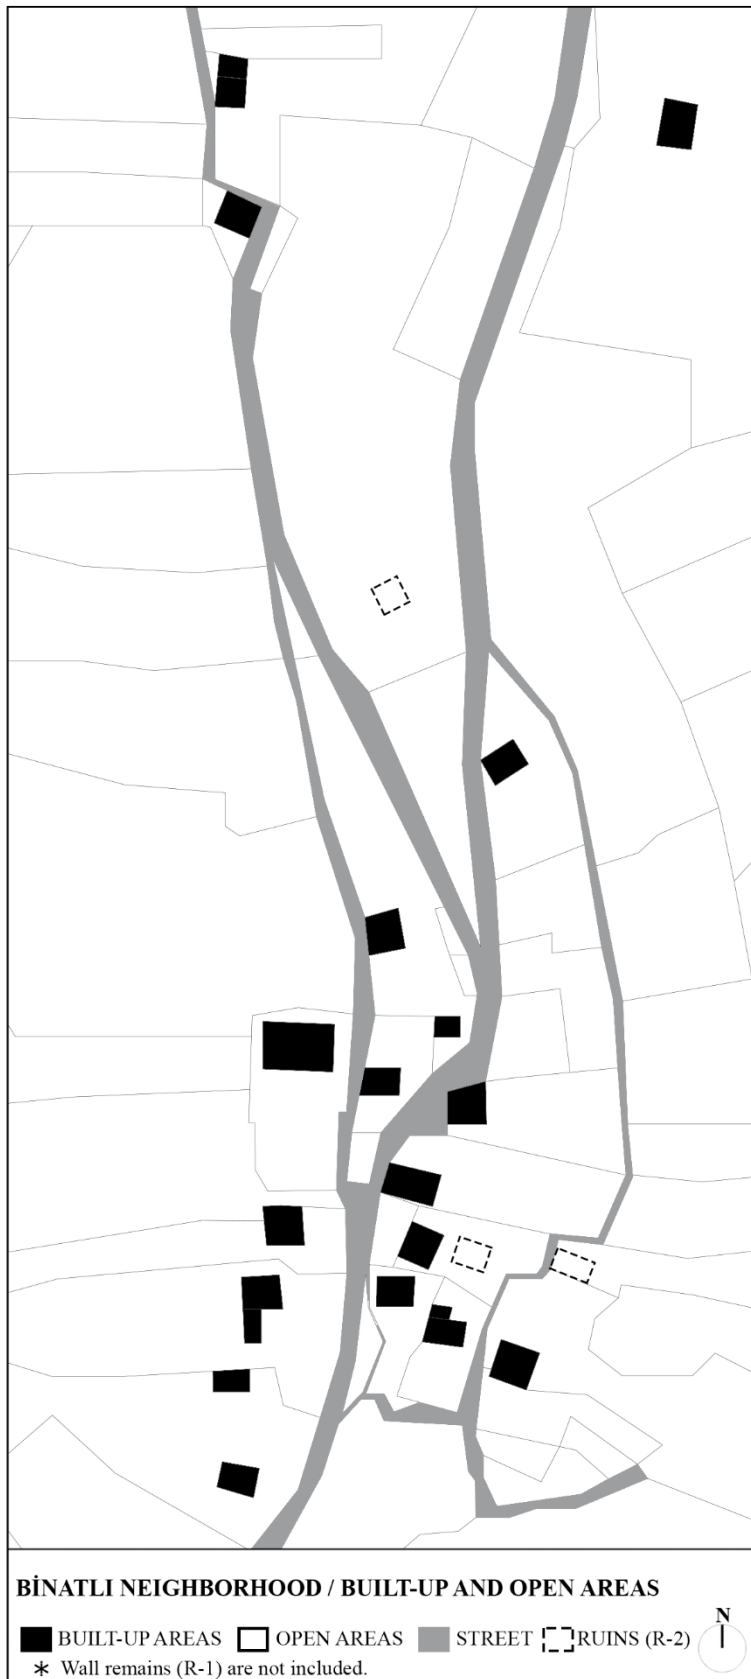
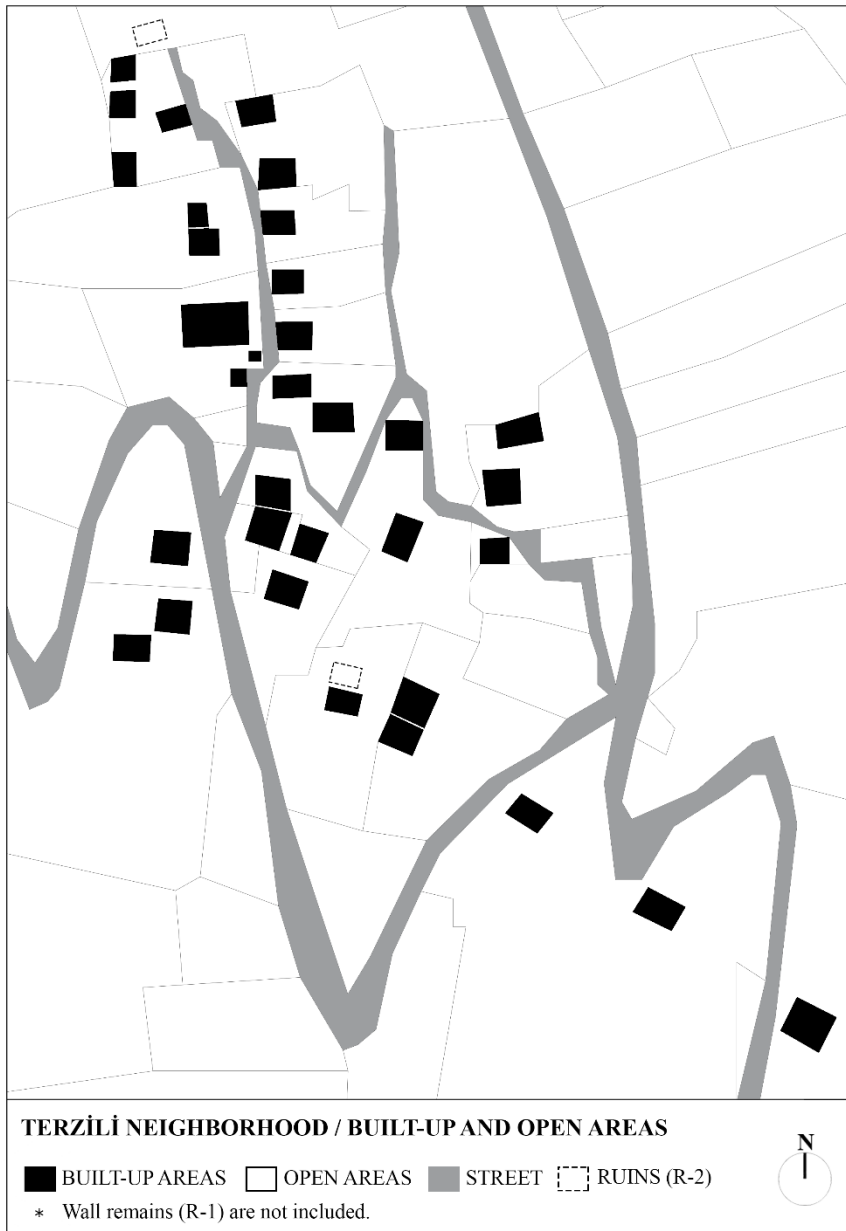
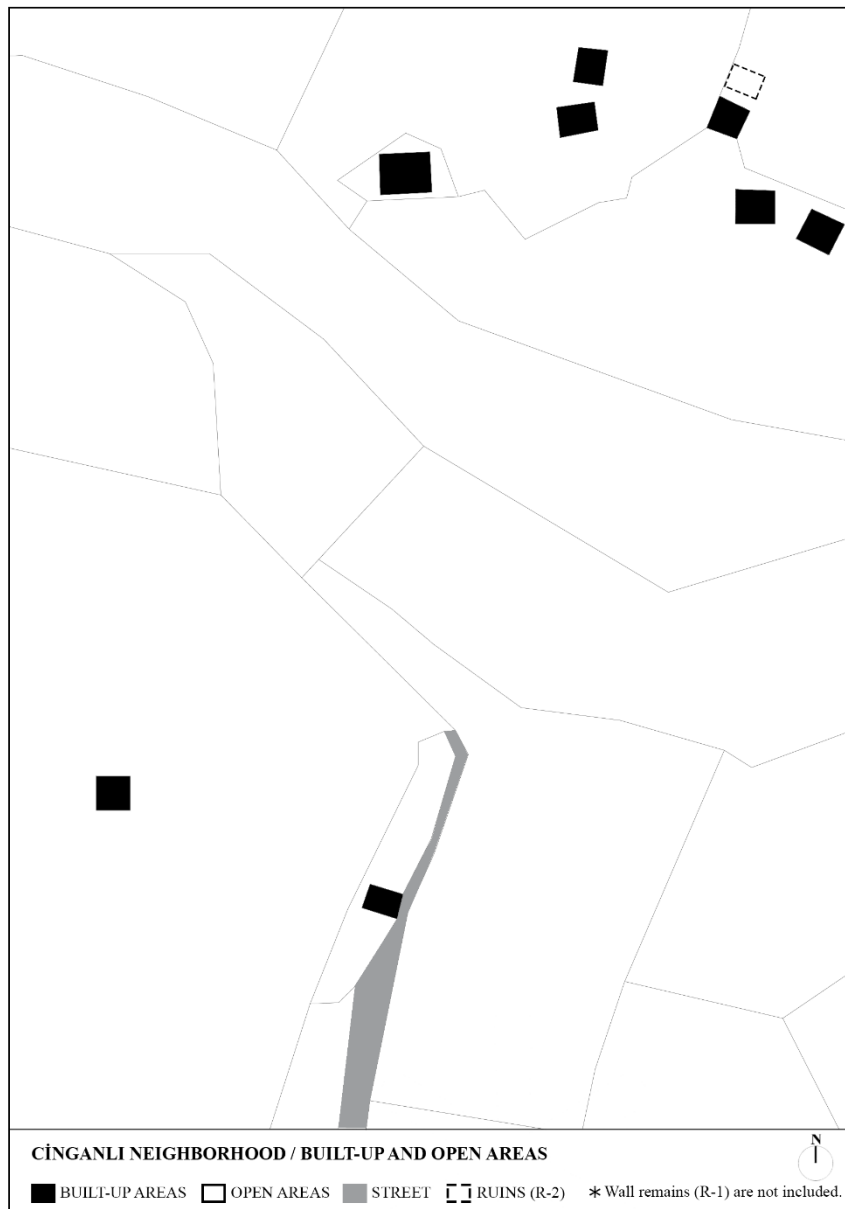
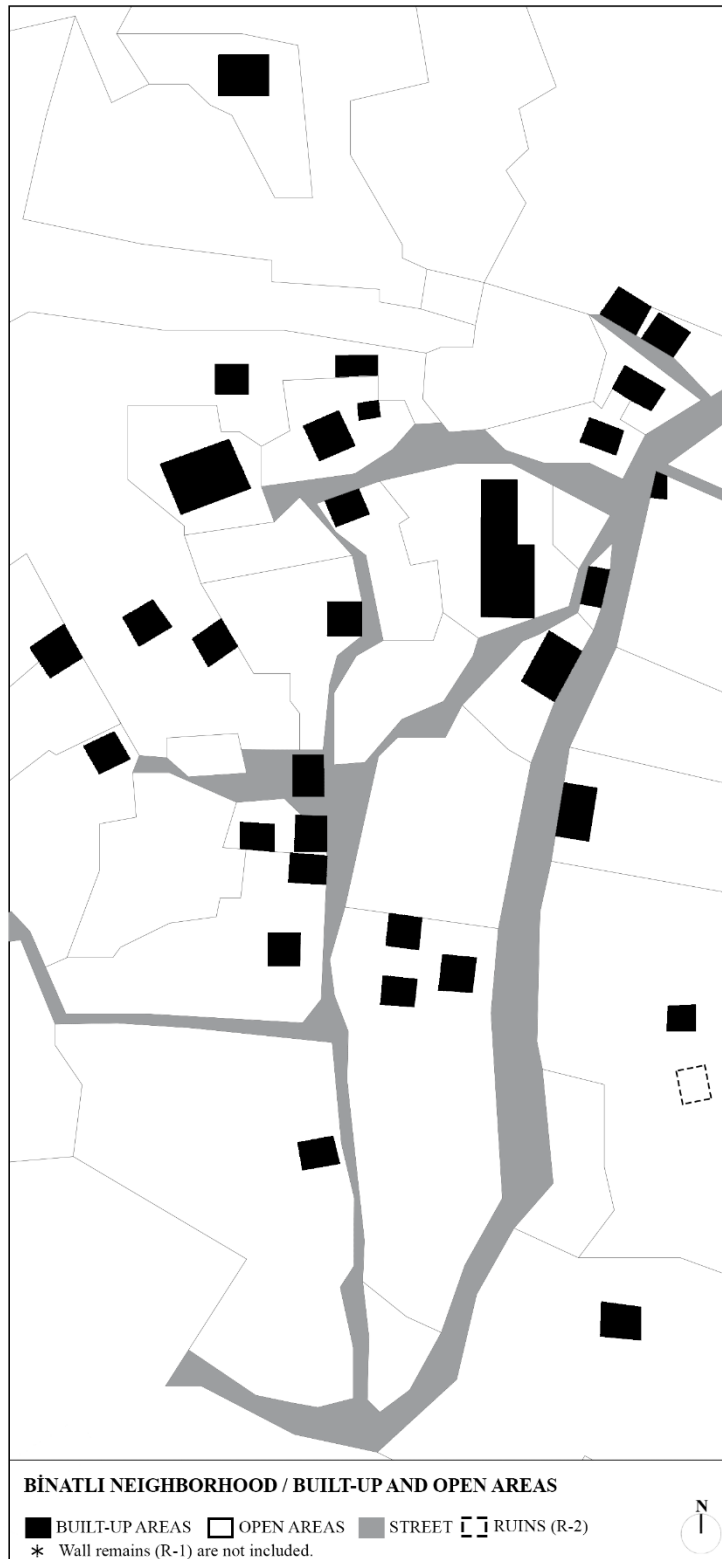
Figure 3.25: The seven neighborhoods of Santa, built-up and open areas

The block and lot organizations of the neighborhoods have an organic character. There are several lots of different sizes, uses and shapes. Only 20% of the lots within the boundaries of the archaeological site have buildings (Figure 3.25).<sup>207</sup> The rest of the lots is empty because most of the buildings were destroyed. Some lots have more than one structure.

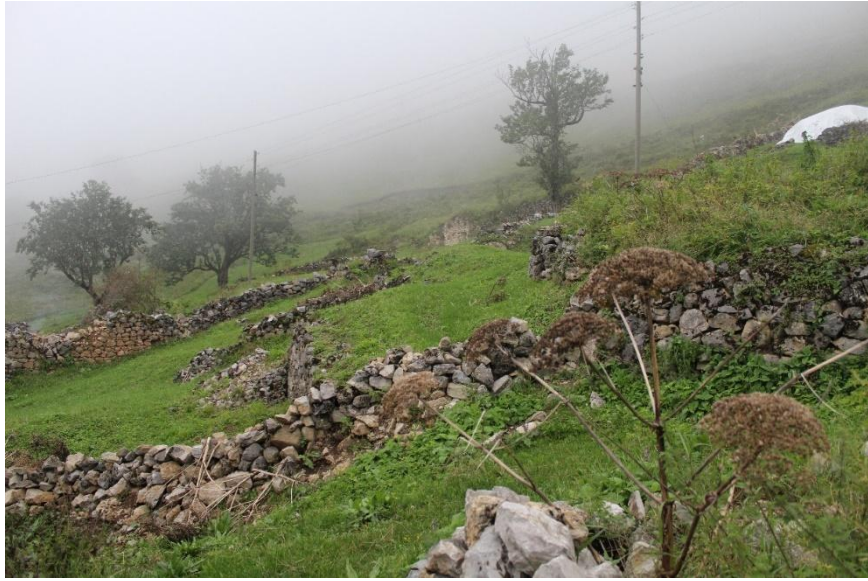
Figure 3.26: Piştoflu neighborhood, the surviving courtyard walls

Except for most of the fountains, which cover complete lots in the neighborhoods, the structures cover only a small part of a lot. Most of the structures have courtyards. The courtyards are separated from each other by stone walls forming the boundary of the building lots (Figure 3.26). While the courtyards of public buildings, i.e. churches and schools, provided a suitable area for gathering, the courtyards of the houses were used as a cultivation area or garden in the past. Now, the inhabitants still grow food only in the courtyards of their houses when in use in the summer season.

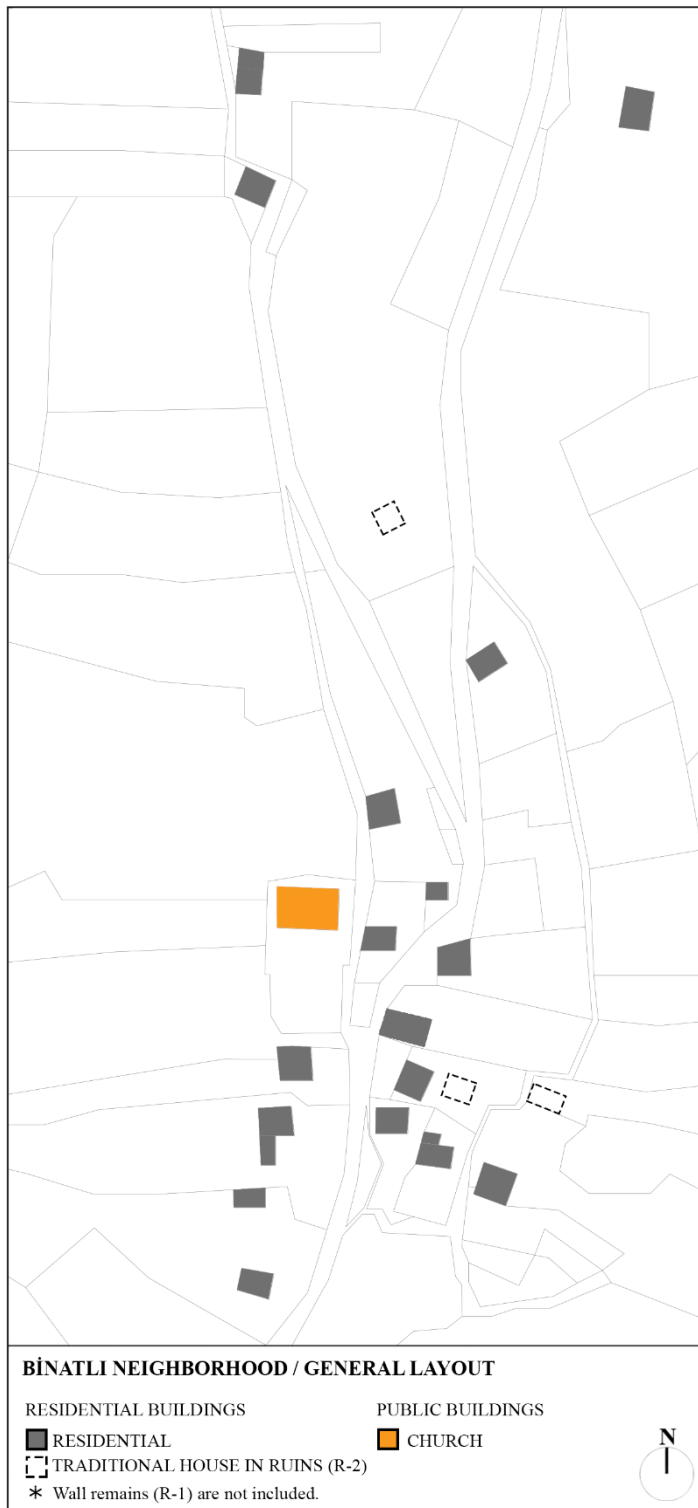
Figure 3.30: Binatlı neighborhood, general layout

In the İşhanlı neighborhood, there are one church in ruins, one bell tower in ruins, forty-four residential (including newly built houses), six traditional houses in ruins, one fountain, one mosque (built by the Turkish inhabitants) and wall remains (approximately sixty) (Figure 3.29). There are one church in ruins, seventeen residential buildings (including a newly built house), three traditional houses in ruins, and approximately twenty wall remains in the Binatlı neighborhood (Figure 3.30).

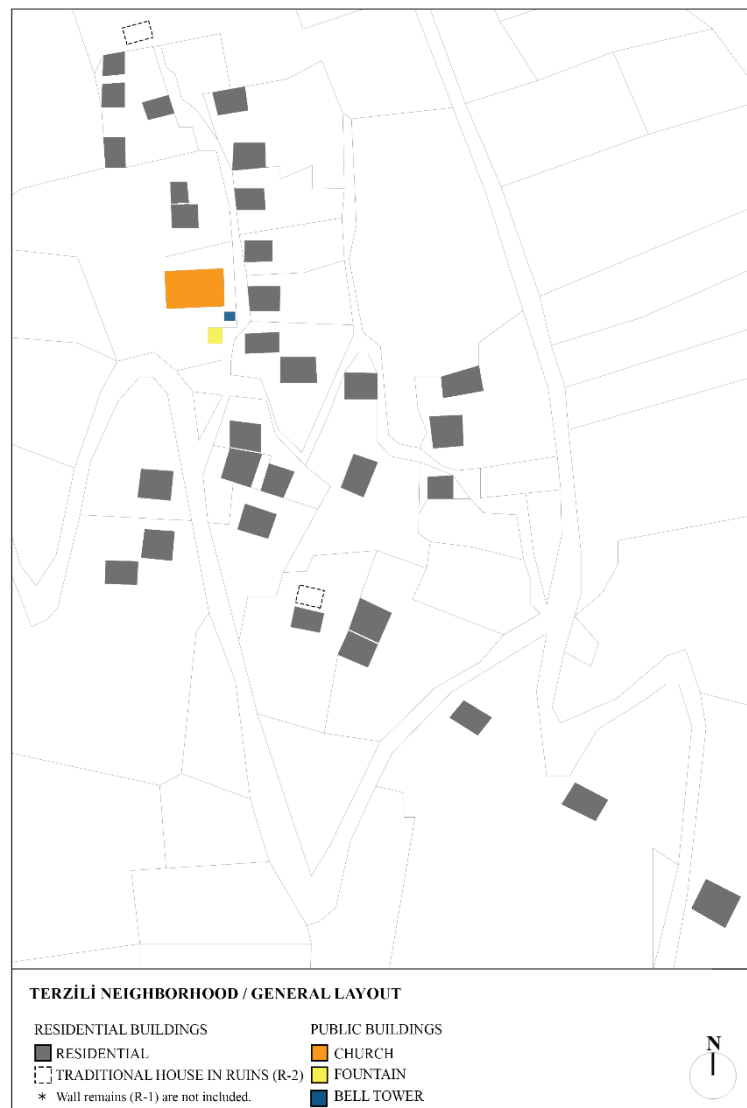
Figure 3.31: Terzili neighborhood, general layout

One church in ruins, one bell tower in ruins, twenty-one residential buildings, two traditional houses in ruins, one fountain and approximately thirty wall remains survive in the Terzili neighborhood (Figure 3.31). There are one church in ruins, seven residential buildings, one traditional house in ruins and approximately ten wall remains in the Cinganlı neighborhood (Figure 3.32). There are two churches, thirty residential buildings (including newly built ones), one house in ruins, one fountain and approximately twenty wall remains in the Zurnacılı neighborhood (Figure 3.33).

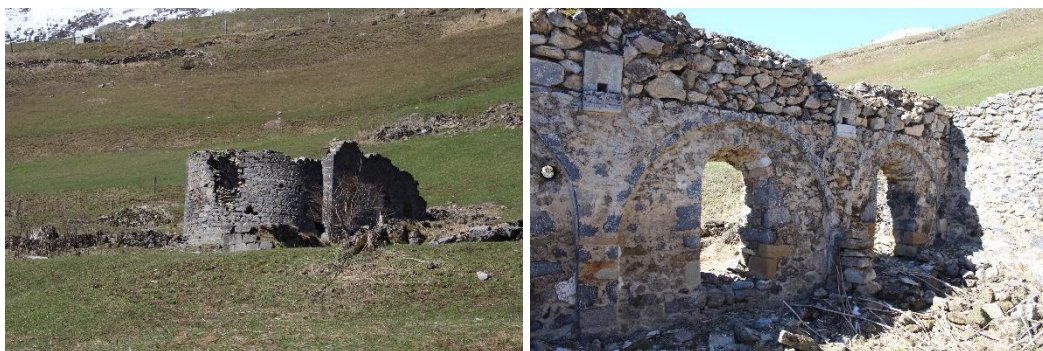
level because of landslide. The exterior walls of the church, built of soft grey rubble stone, have structural problems and have lost material. Moreover, with its roof collapsed, the interior is deteriorating.

Figure 3.34: Piştoflu neighborhood, the church with a single apse, exterior (left); interior (right)

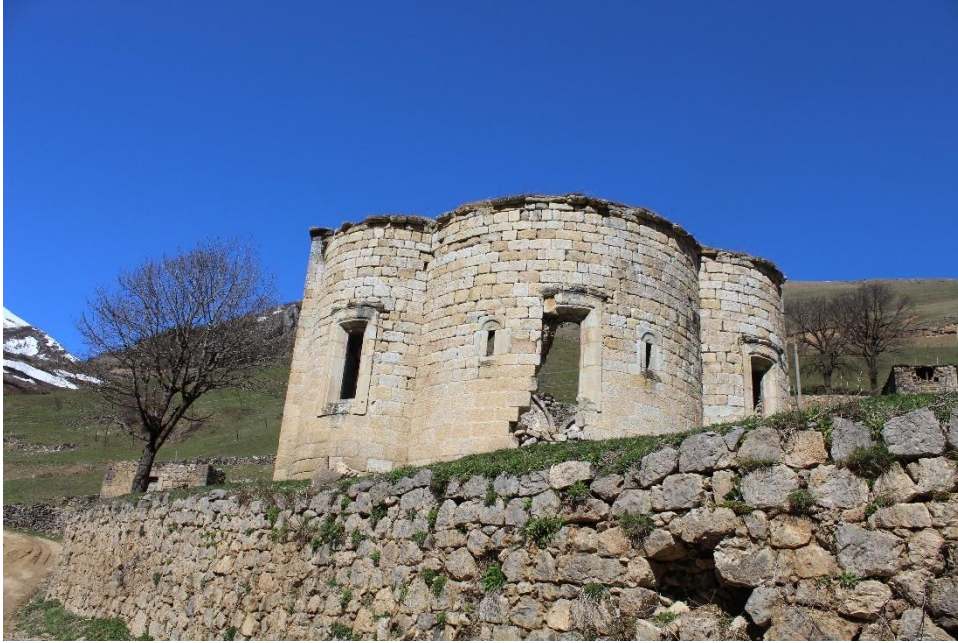
Figure 3.35: Piştoflu neighborhood, the St. Christopher Church

The courtyard of the church is accessed via stone steps starting from the main street. It was built on flat ground most convenient for the people to gather on (Figure 3.35). The church was built with rubble stone, while the exterior surface of the east wall (apse wall) was dressed with cut stone. According to Bryer, the three-aisled church was topped with barrel vaulting before that collapsed as in the other churches,

although the bay at the center seems to have been once covered with a dome (Figure 3.36).<sup>219</sup>

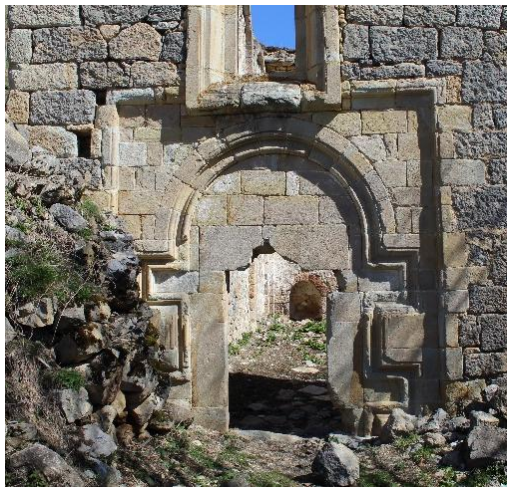
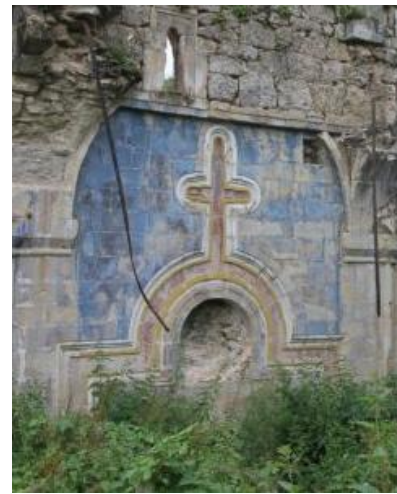
Figure 3.37: St. Christopher Church, south entrance (left); north entrance (right)

The entrances are from the north and the south. The north entrance, which is now filled with stone, is more elaborate. The frame of the entrance, where a cross shape surmounts the circular arch, is plastered red, yellow, and blue (Figure 3.37). The west wall leans against the slope up to a certain level. The frame of the window openings is a depressed arched, viewed from the exterior. The decorative blind arcades surmounting the apse wall and traces of frescos depicting religious scenes on the interior walls are still visible (Figure 3.38). The exterior walls, except for the middle apse wall, are in good condition; however, the interior is left open to deterioration since its roof has completely collapsed.

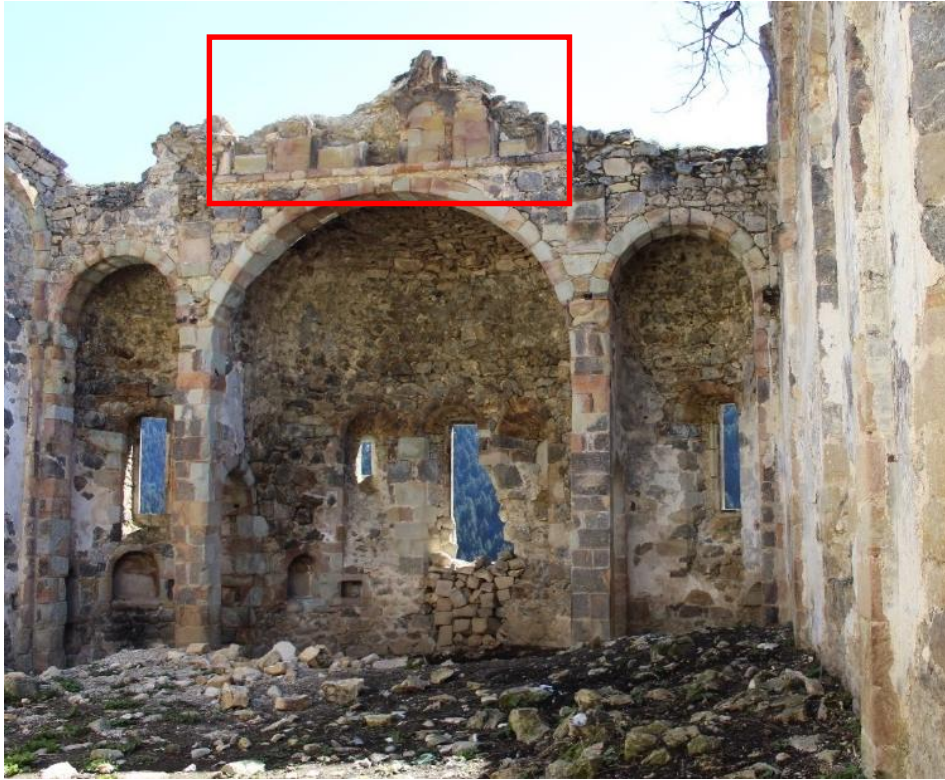
Figure 3.38: St. Christopher Church, the remaining parts of the decorative blind arcades

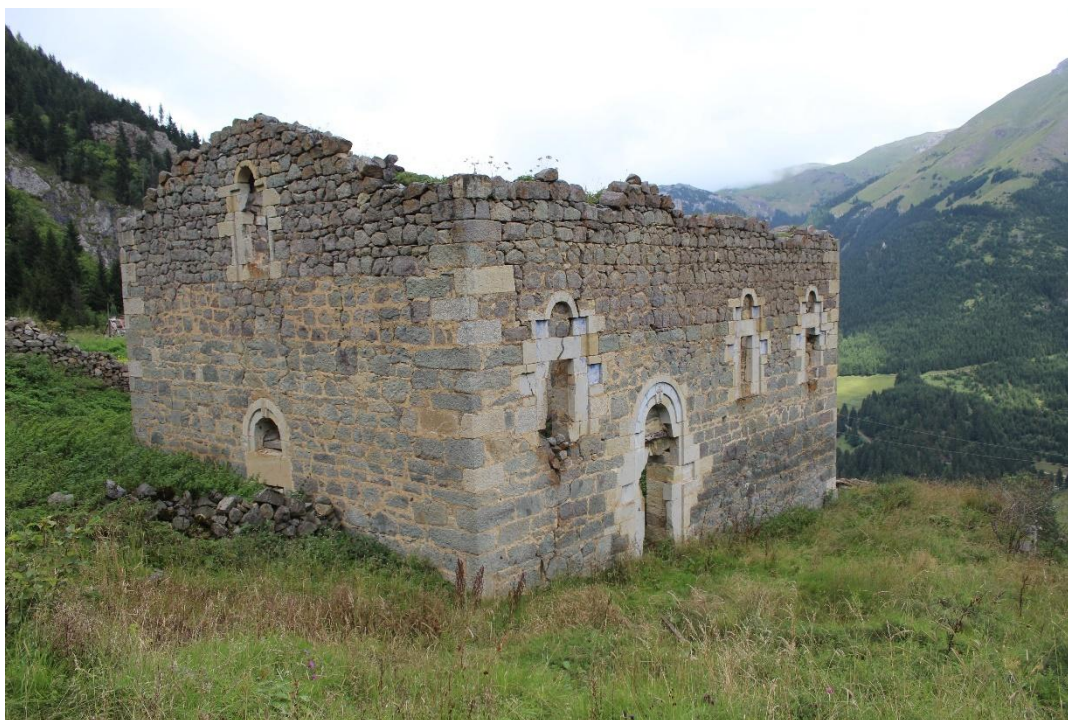
The Life Giving Spring Church is located on flat ground to the northeast of the Çakallı neighborhood (Figure 3.39). The access to the church is provided by a pathway. The church, built with soft grey rubble stone, has entrances at the south and the west: a cross is incised on the circular arches above the lintels at each door. The west entrance is filled with stone and soil because of a landslide. The traces of blue plaster on the frames of the windows and doors can be still seen. Only the outer walls of the church, which has structural and material problems, now survive to some extent thanks to minor interventions made to prevent the walls from completely collapsing. The roof, columns, arches, and floor coverings have fallen.

Figure 3.39: Çakallı neighborhood, the Life Giving Spring Church

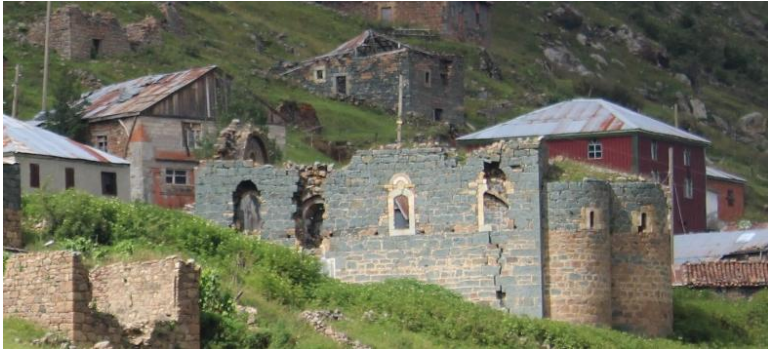
Figure 3.40: İřhanlı neighborhood, the St. Kyriake Church

The St. Kyriake Church is located on flat ground in the Işhanlı neighborhood (Figure 3.40). The church, built with mixture of soft grey stone and sandstone, is now reached via a pathway. The three-aisled church looks as if it should have a dome over the square-shaped bay at the center, but it was in fact covered with barrel vault (Figure 3.41).<sup>220</sup> The entrances are provided at the south and the west: the lintels of both entrances are elaborately decorated (Figure 3.42). The west entrance is now filled with stone and soil because of a landslide. There are severe structural cracks and material-based problems affecting the walls of the church, whose architectural elements, i.e. roof, columns, floor coverings, etc. are completely destroyed. Some minor repairs were made on the walls to prevent further damage.

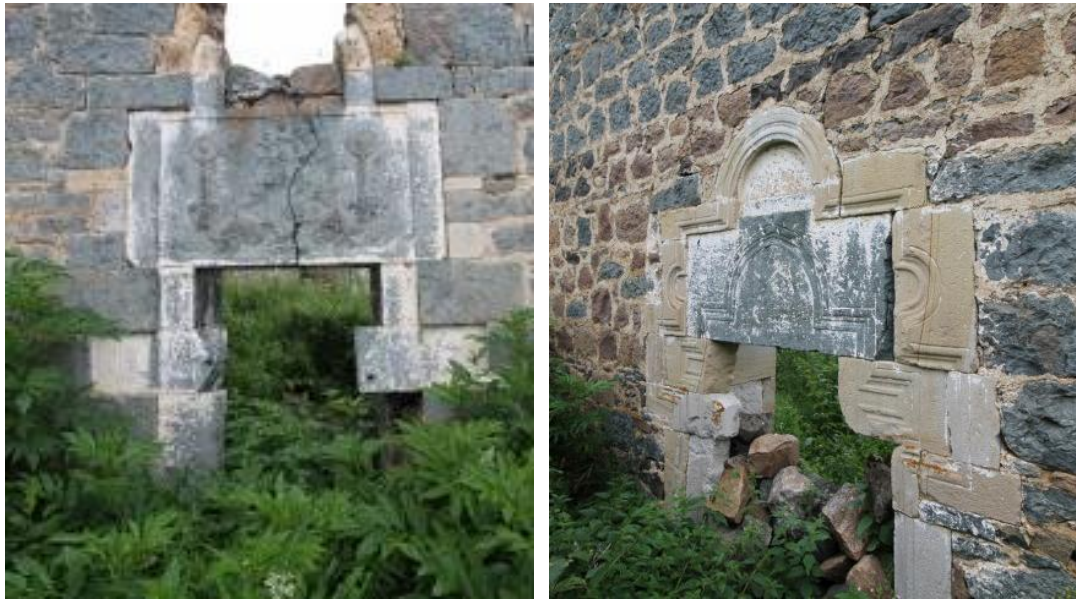
Figure 3.42: St. Kyriake Church, south entrance (left); west entrance (right)

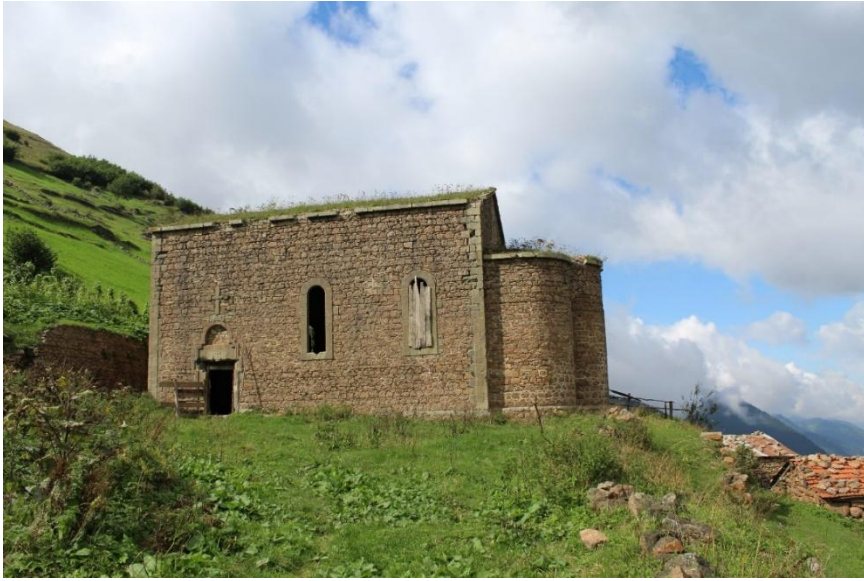
Figure 3.43: Binatlı neighborhood, the Prophet Elijah Church

The Prophet Elijah Church which was used as a stable (*ahır*) after the Population Exchange is located on flat ground to the northwest of the Binatlı neighborhood (Figure 3.43). The access to the church is by a pathway. The church, built with sandstone, has entrances on the south and the west: the west entrance is now blocked with stone. It is the best conserved church among all those at Santa. Since the barrel-vaulted ceiling of the church is in good condition, the degree of deterioration is less. The interior elements are preserved to a great extent: the four columns with the Doric capitals supporting the arcade, and the circular arched high windows rising above the apse wall remain in place (Figure 3.44). The floor coverings were probably removed during treasure hunting.

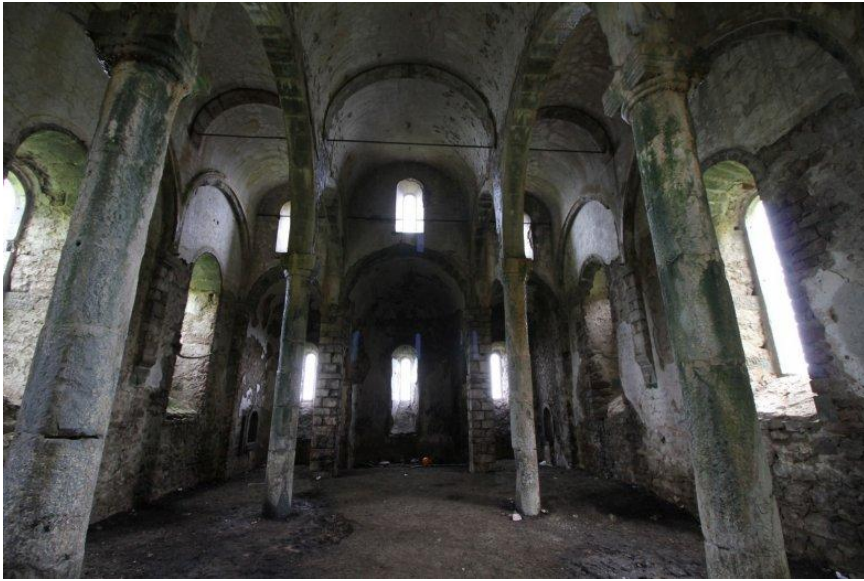
Figure 3.44: Prophet Elijah Church, interior

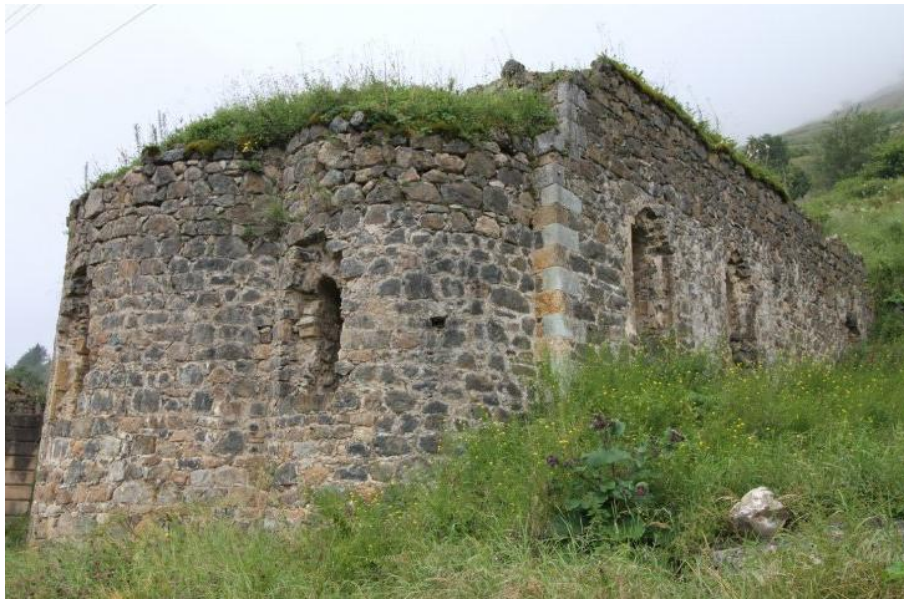
Figure 3.45: Terzili neighborhood, the St. Theodore Church

The St. Theodore Church, accessed via a pathway, is located on sloping terrain in the Terzili neighborhood (Figure 3.45). The three-aisled church had a barrel vault before its collapse instead of a dome which one would expect over the bay at the

center (Figure 3.46).<sup>221</sup> The church was built with a mixture of sandstone and soft gray stone. The entrances are provided from the south and the north. The west wall leans against the slope. The church has been open to deterioration since its roof has collapsed: its architectural elements, i.e. columns, window frames, and floor coverings were destroyed. The exterior walls of the church survive thanks to minor interventions made on the walls.

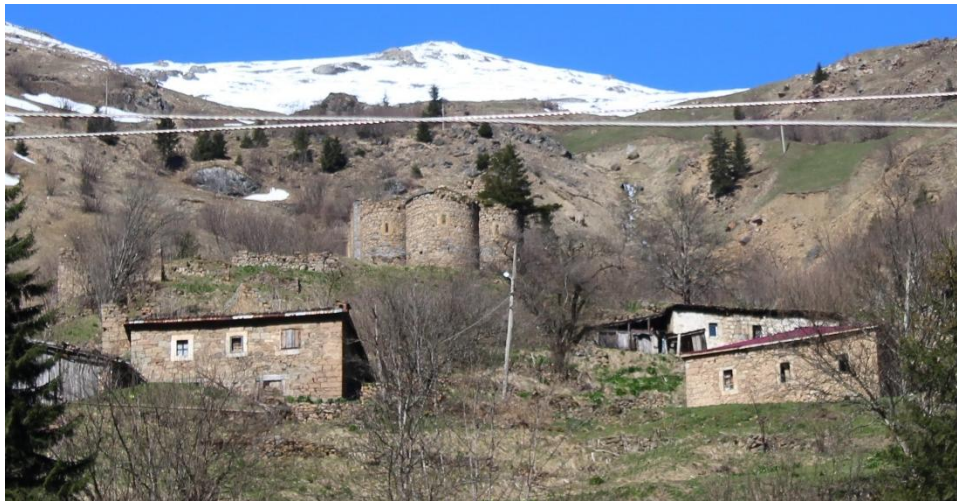
Figure 3.47: Cinganlı neighborhood, the St. Peter Church

The St. Peter Church is located on flat ground in the Cinganlı neighborhood (Figure 3.47). The church is reached by a pathway. The church, built of sandstone, has entrances from the south and the west. The exterior walls of the church whose roof has completely collapsed are in relatively good condition, while the interior has deteriorated.

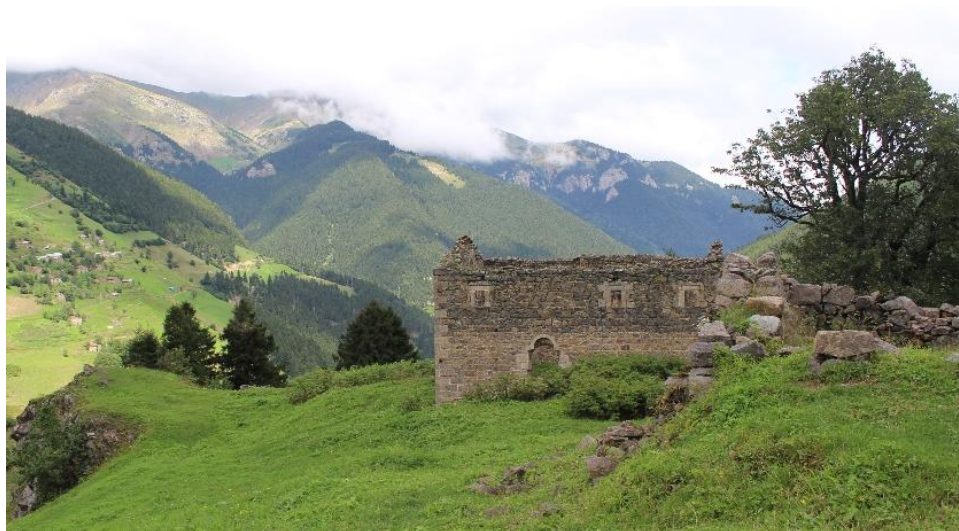
vault.<sup>222</sup> The church, built with soft grey stone, has entrances at the south and the west. The outer walls of the church, whose roof, columns, and floor coverings are completely destroyed, are in good condition thanks to the minor repairs.

Figure 3.48: Zurnacılı neighborhood, the St. George Church

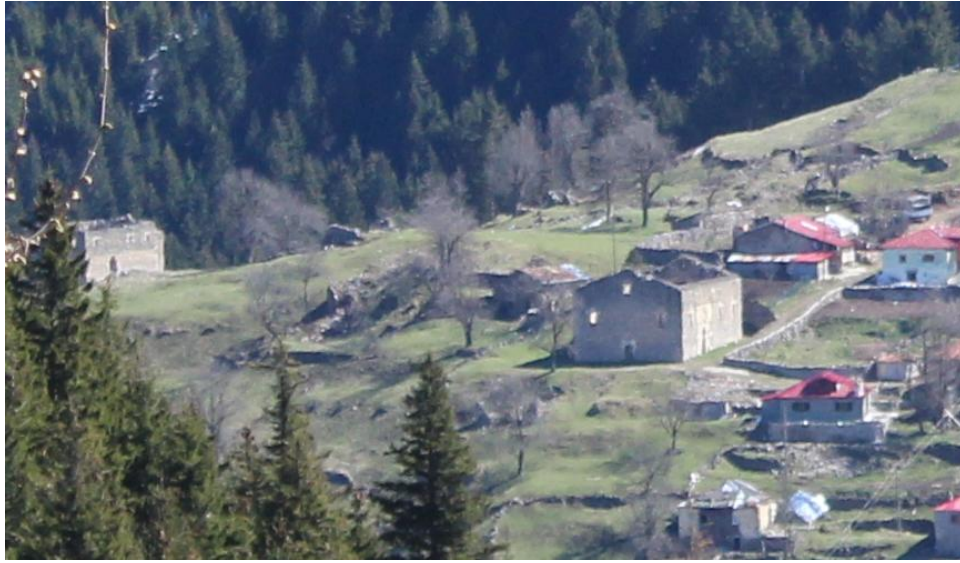
Figure 3.49: Zurnacılı neighborhood, the St. George at the left and the St. Constantine Church at the right

The main church here – to St. Constantine – is located on flat ground at the center of the Zurnacılı neighborhood (Figure 3.49). The access to both the churches is provided via pathways. The church was built with soft grey stone, and it has entrances from the south and the west: the west entrance is filled with stone. The south doorway is the most elaborate among all the entrances of the churches at Santa (Figure 3.50). The round upper windows surmounting the apse wall still survive (Figure 3.51). The roof of the church has completely collapsed, and the interior is open to deterioration: the architectural elements, i.e. columns and floor coverings, etc. were demolished. The outer walls are in good condition thanks to the minor interventions.

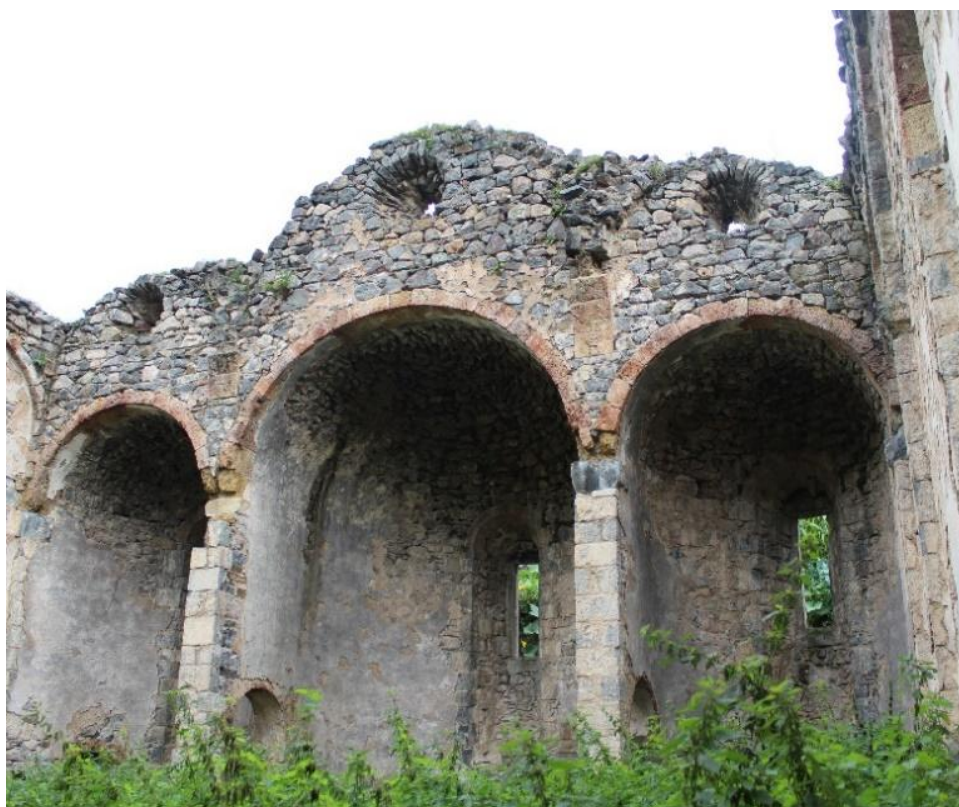
Figure 3.51: St. Constantine Church, the round upper windows

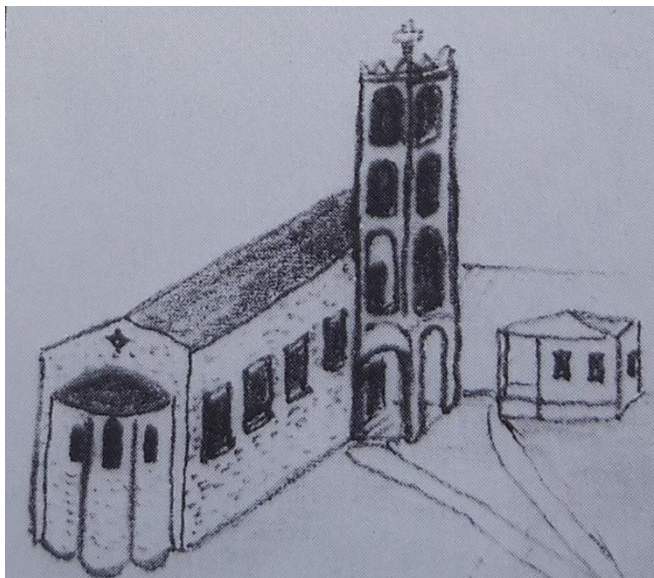
Figure 3.52: Piştoflu neighborhood, the bell tower ruin adjacent to the St. Christopher Church as seen in the drawing by Angelides (Bryer, *et al.* 2002, p. 123)

the tower had four floors (Figure 3.52).<sup>224</sup> The northwest column and the arch remnants connecting the tower to the church can be still seen (Figure 3.53).
