AN ASSESSMENT AND RE-IDENTIFICATION OF THE RURAL HERITAGE  
SITE OF SANTA (DUMANLI KÖY, GÜMÜŞHANE)

A THESIS SUBMITTED TO  
THE GRADUATE SCHOOL OF NATURAL AND APPLIED SCIENCES  
OF  
MIDDLE EAST TECHNICAL UNIVERSITY

JANUARY 2023

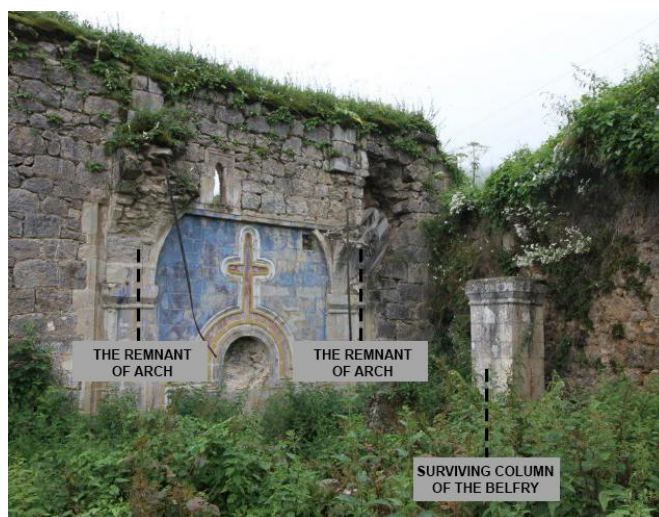
Figure 3.53: Piştoflu neighborhood, the bell tower ruin adjacent to the St. Christopher Church

the tower had four floors (Figure 3.52).<sup>224</sup> The northwest column and the arch remnants connecting the tower to the church can be still seen (Figure 3.53).

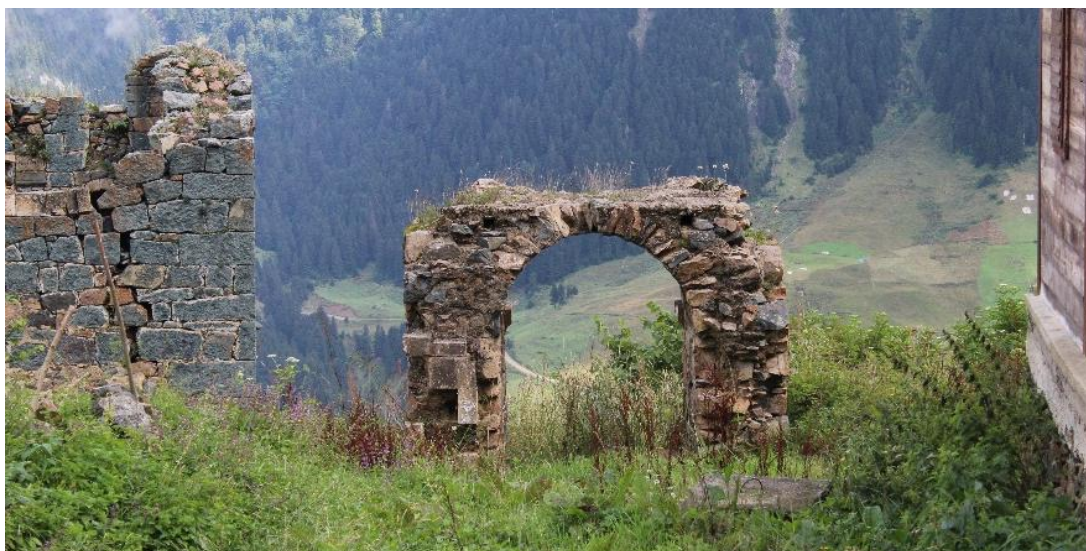
The freestanding bell tower in the İřhanlı neighborhood was built to the southwest of the St. Kyriake Church. It is of rubble stone on the interior and cut stone on the exterior, as can be seen from the traces. According to the drawing by Angelides, it had three floors.<sup>225</sup> The basement of the tower, whose upper floors were completely destroyed, is in ruins. (Figure 3.54).

Figure 3.54: İřhanlı neighborhood, the bell tower ruin next to the St. Kyriake Church

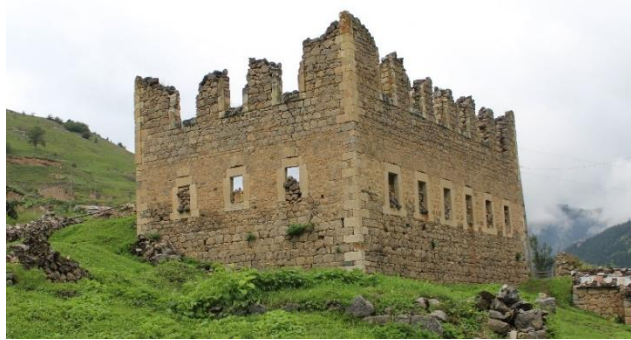
Figure 3.56: Piřtoflu neighborhood, the school

The rectangular school building in the Piřtoflu neighborhood is the only surviving school at Santa (Figure 3.56). The school was built in stone masonry of rubble while cut stone was used at the wall intersections, and the frames of the windows, and doors. The school had originally three floors.<sup>228</sup> The exterior walls of only two floors of the building now survive (Figure 3.57). The interior is open to deterioration since the roof has been demolished. The other school, whose traces cannot be made out today, but can be located from the sources, was on the north side of the St. Kyriake

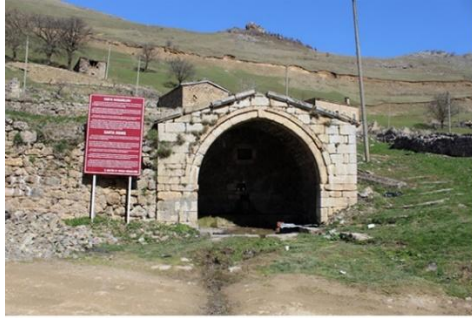
F - 1 The Fountain next to St. Christopher Church

Figure 3.59: Piştöflu neighborhood, the public fountains

The Piştöflu neighborhood has five fountains (Figure 3.59). The main fountain (F-1) is located in front of the St. Christopher Church on the main street of the neighborhood. The other four fountains set in different parts of the neighborhood are reached via pathways. The fountains, except F-3, are in relatively good condition. The F-3 fountain underwent major changes: its roof, arched entrance and water basin were rebuilt with concrete. The niche above the faucet seen in other examples seems

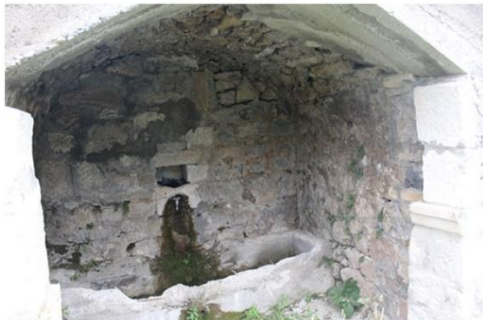
Repairs on F - 3 Fountain

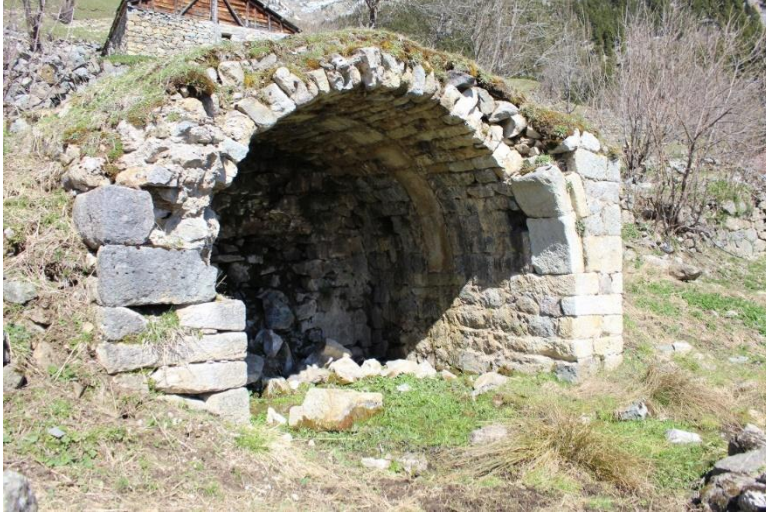
Figure 3.60: Çakallı neighborhood, the public fountain

to have been closed up with mortar then. The only fountain in the Çakallı neighborhood is located to the west of the Life Giving Spring Church (Figure 3.60). There is material loss at the entrance wall and roof of the fountain, whose back wall and the basic elements, i.e. water basin, faucet, niche were demolished.

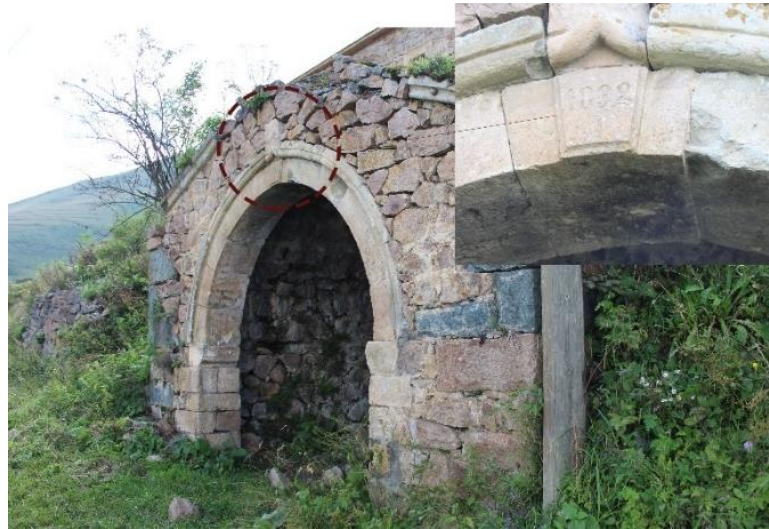
Figure 3.61: Işhanlı neighborhood, the public fountain

The fountain in the İřhanlı neighborhood is located at the north end. According to the inscription on it, it was built in 1892 (Figure 3.61). The fountain is well preserved. That in the Terzili neighborhood is located next to the St. Theodore Church and the bell tower (Figure 3.62). It was used as holy spring (*ayazma*) for sacred purposes.<sup>230</sup> The niche on the back wall is a pointed arch, unlike the niches in other fountains at Santa. The roof of the fountain has largely collapsed (Figure 3.63). The fountain in the Zurnacılı neighborhood is located at the northeast (Figure 3.64). This one is different than the others at Santa: it is not a rectangular building enclosed with walls. It is rather a structure open on three sides with a single wall and a water basin. This situation calls into question its genuineness as a planned fountain. Since the fountains in the Binatlı and Cinganlı neighborhoods were destroyed, their locations could not be determined.

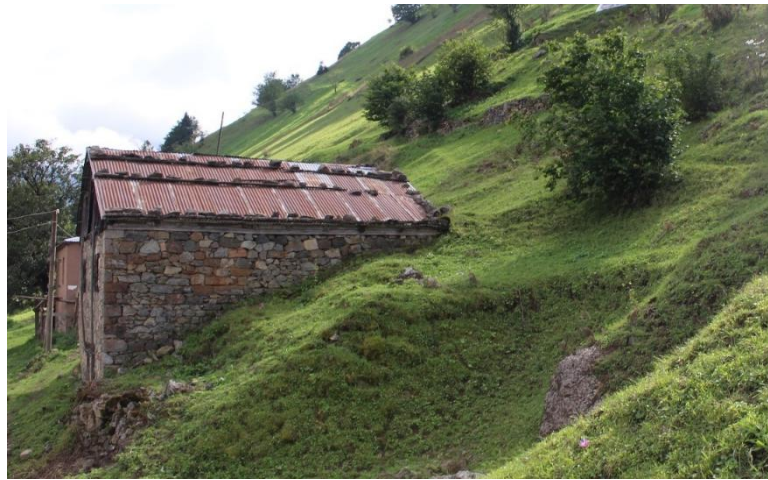
Figure 3.65: Terzili neighborhood, a traditional house set into the slope

used as dwellings or are left empty.<sup>231</sup> The houses have a very simple spatial and facade arrangement: they are generally two and rarely one or three storey structures of stone.<sup>232</sup> The slope of the natural terrain is the main determining factor in the orientation of these houses. The short side of the house is parallel to the slope. The back walls set into the slope are usually blind (Figure 3.65). The side walls are either blind walls or have a door with a small window next to it. The windows are located on the front facade overlooking the valley.

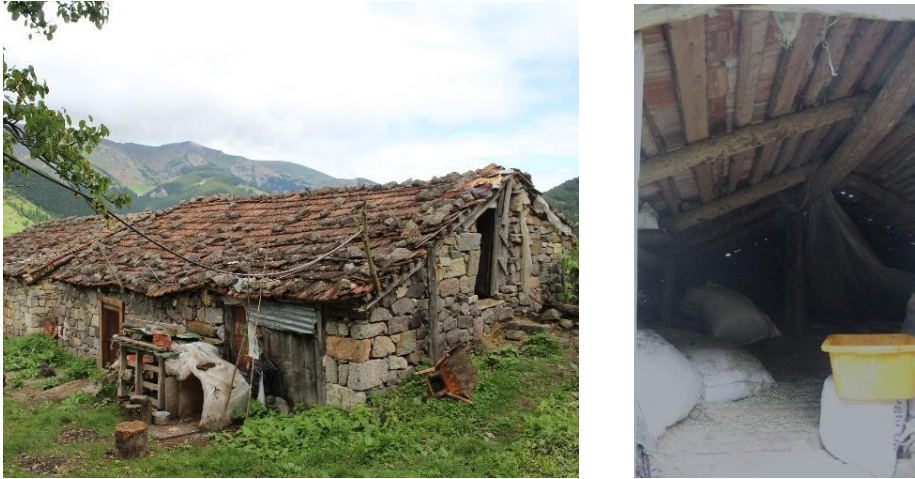
Figure 3.66: Zurnacılı neighborhood, one storey houses transformed into a barn, exterior (left); interior (right)

The earlier housing examples in Santa are one-story and one-room dwellings which were built before 1837. Some of these stone structures, most of which were destroyed, are used as barns (*samanlık*) today (Figure 3.66). Their heights do not exceed 2 m internally and they recall defensive structures because of the lack of windows (Figure 3.67). In the houses with one storey, the entrance is usually provided from the side facade. Approximately at the middle of the back wall, there is a fireplace. In front of the fireplace, the earth floor is covered with stone slabs. Some part of the floor is covered with wooden logs placed at distances of 15-20 cm:

the rest is earth. The change in the flooring shows the functional change of the structure: one part of the building was used as a dwelling for people and the other part was used as a barn for animals. There is a groove passing under the wooden threshold of the entrance door channeling the waste of the animals outside the house.<sup>233</sup>

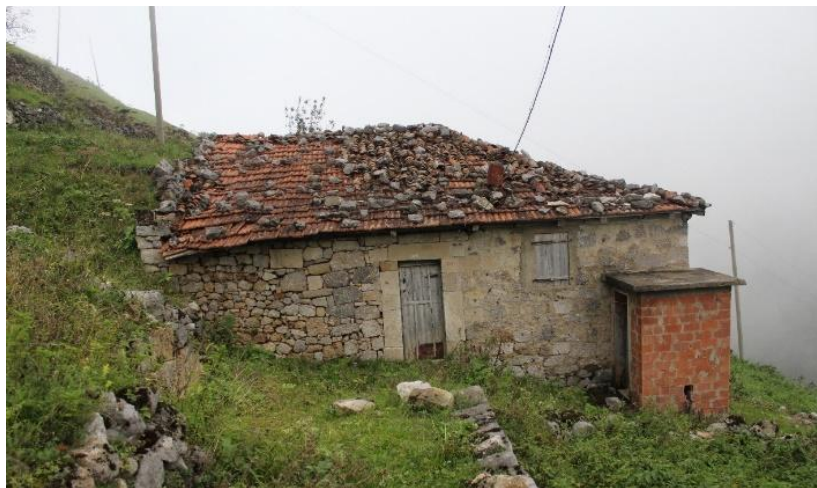
Figure 3.69: Piştoflu neighborhood, out-building made of brick

There is no internal staircase providing access from the ground floor to the first floor. In the houses with two storeys, the entrance to the ground floor is from the front facade at the bottom elevation, and the entrance to the first floor is from the side facade at the top elevation. In the houses with three storeys, the top floor is used as a barn/storage area. According to the site observations, it is seen that sometimes built units are added to the houses to be used as a toilet (Figure 3.69).

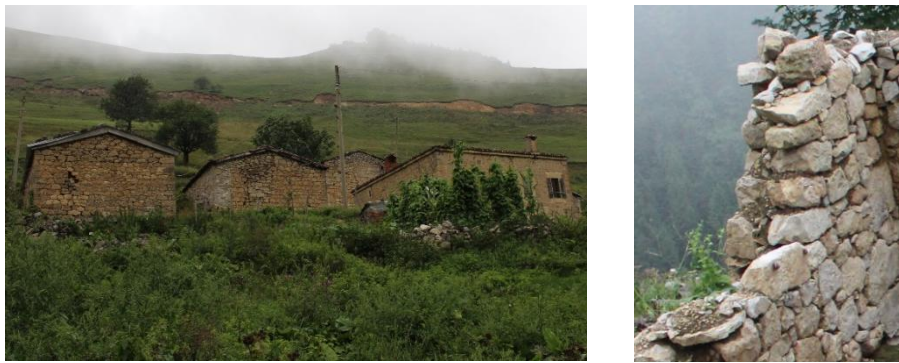
Stone is the main construction material for the traditional houses as all the other building categories, i.e. churches, bell towers, schools, and fountains at Santa. Sandstone and soft grey stone are those used in building the walls which are approximately 50 cm thick. The houses are built in stone masonry with rubble and the core of the wall is filled with earth (Figure 3.70). Rough-cut stone was used at the intersection of the exterior walls for stability. The walls are unplastered.

Figure 3.70: Piştöflu neighborhood, stone masonry houses (left); Piştöflu neighborhood, section of a wall of a house

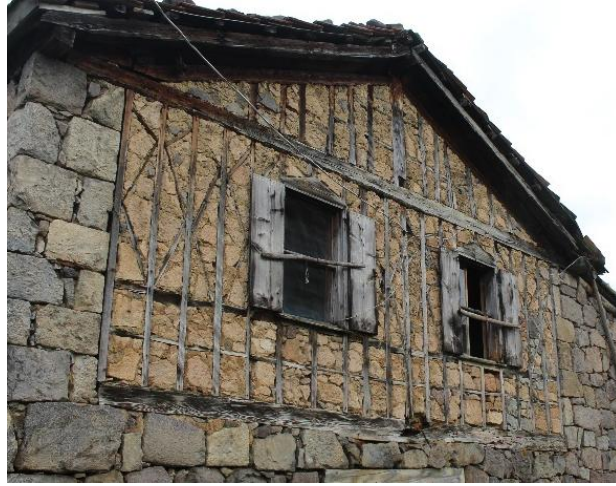
Figure 3.71: Zurnacılı neighborhood, mixture of göz dolma and *muskalı* technique

timber panels.<sup>235</sup> Therefore, in the examples of houses with horizontal timber panels, it is highly probable that the upper floor was used as a barn.

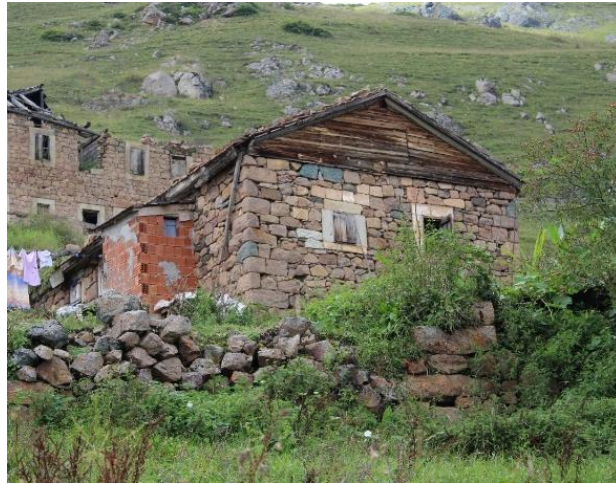
Figure 3.72: İşhanlı neighborhood, horizontal timber panels

Although timber is one of the most locally available materials around Santa, it is not used as an exterior wall construction material except in a few examples. The construction system used in these examples is the timber frame one peculiar to the Black Sea Region: only the front facade of the first floor facing the east is built with this system while the rest is built with stone masonry. In the field trip, two houses with the *muskalı* technique in the Piştöflu neighborhood and one house with the mixture of *muskalı* and *göz dolma* technique in the Zurnacı neighborhood were observed (Figure 3.71). As infill material, rubble stone with clay mortar is used. In almost every neighborhood, it is seen that horizontal timber panels, which are nailed to the load-bearing timbers, are used on the upper floor of at least one house (Figure 3.72). It is known that buildings which need ventilation, such as barns, are built with

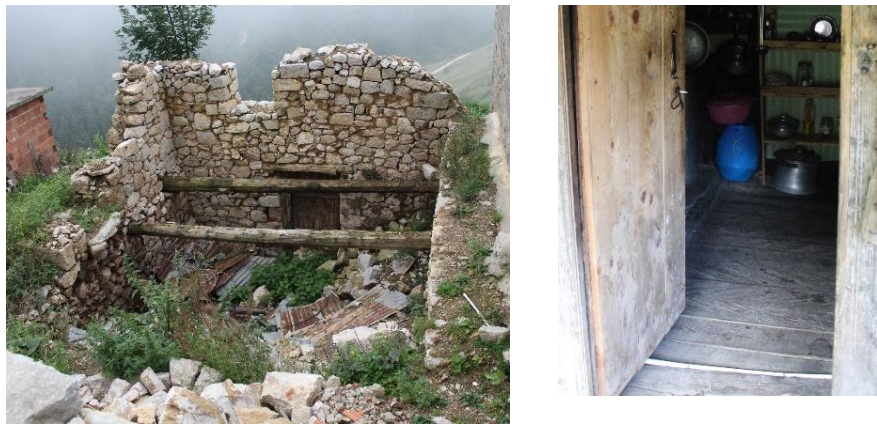
the beams perpendicularly. Timber planks are then simply nailed to these joists in the first floor (Figure 3.73). On the ground floor, timber, stone or compacted soil are used as floor covering. Ceiling planks are not observed on the ground floors which are used as stable and storage. In the houses where the barn is located in the upper floor of the traditional houses, ceiling planks are not observed there either: the construction of the roof is thus clearly visible. The ceiling planks are only seen in the living spaces (Figure 3.74).

Figure 3.73: Piştoflu neighborhood, timber beams (left); Zurnacılı neighborhood, timber planks (right)

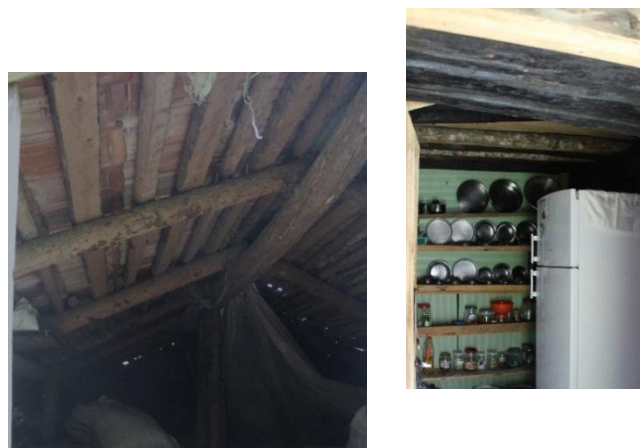
Figure 3.74: Zurnacılı neighborhood, barn, open roof construction (left); Zurnacılı neighborhood, surviving ceiling planks (right)

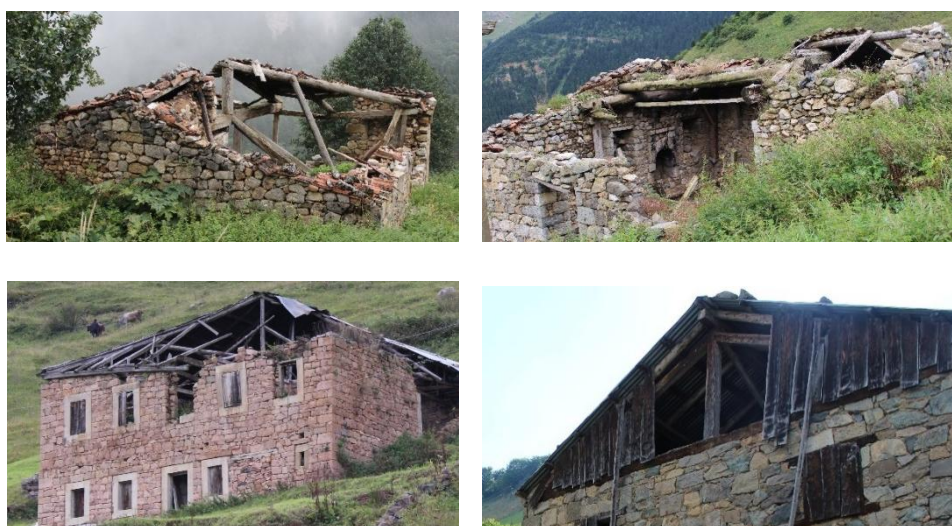
Figure 3.75: Roof construction, Piştöflu neighborhood (above left); Çakallı neighborhood (above right); İřhanlı neighborhood (below left); Terzili neighborhood (below right)

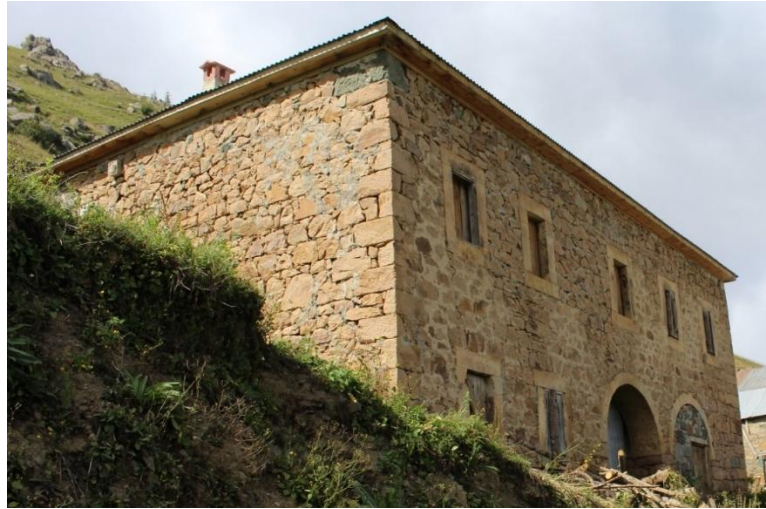
Figure 3.76: İşhanlı neighborhood, arched door openings

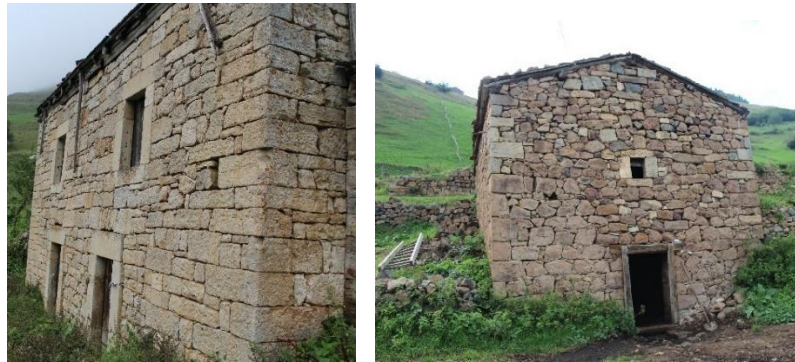
Figure 3.77: Piştöflu neighborhood, doors framed with cut stone (left); Binatlı neighborhood, doors framed with timber (right)

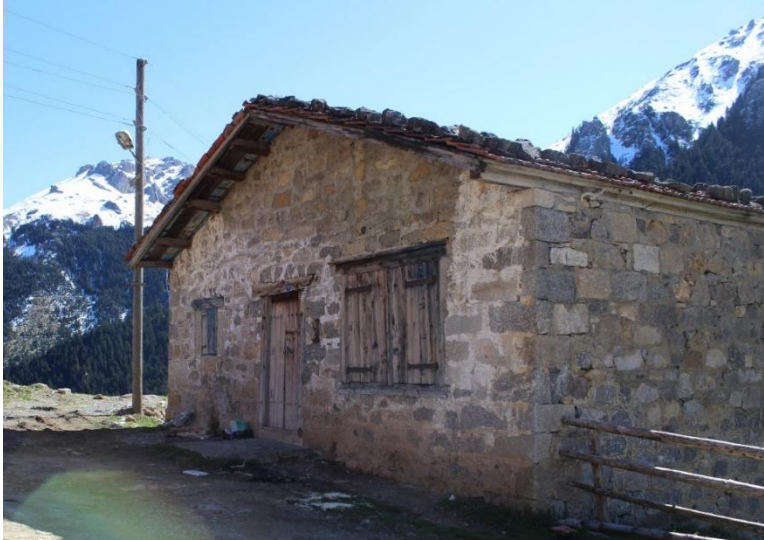
Figure 3.78: Piştöflu neighborhood, an original double-winged shutter

The rectangular or square-shaped window openings are either framed with cut stone or timber, as are the doors. Window openings used for ventilation are reduced to 15 cm in size in the ground floor. The number of windows is kept low, and some are closed with stone now for protection from the weather conditions.<sup>236</sup> The timber shutters are either single- or double-winged (Figure 3.78). Fireplaces and chimneys are usually located on the east side of the houses. There is a desk made of iron in

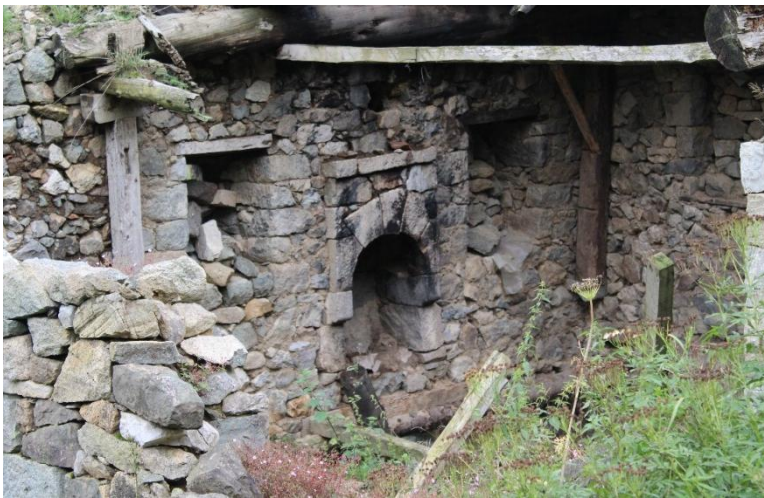
Figure 3.79: Çakallı neighborhood, a fireplace and niches

front of the fireplace used to place the food bowl.<sup>237</sup> There are usually niches with stone lintels next to the stone fireplaces (Figure 3.79).

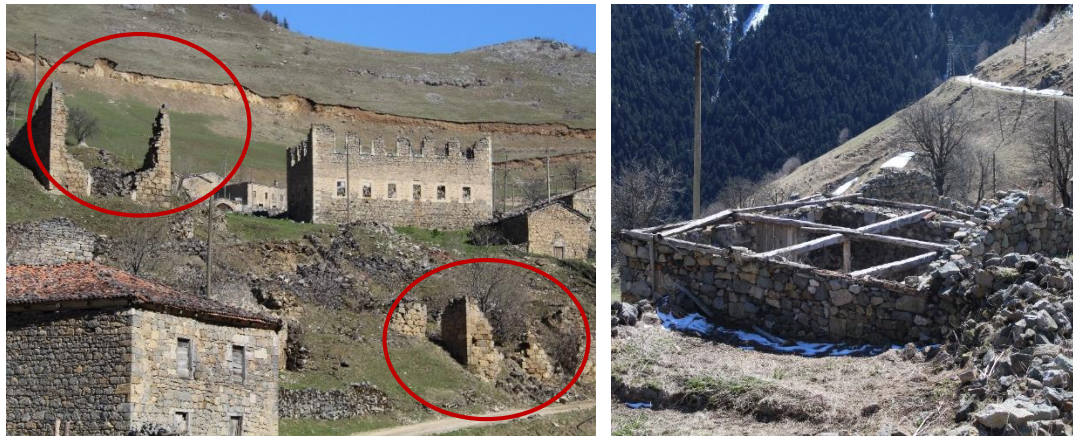
Figure 3.80: Piştoflu neighborhood, cluster of R-1 (left); Çakallı neighborhood, an example of R-2 (right)

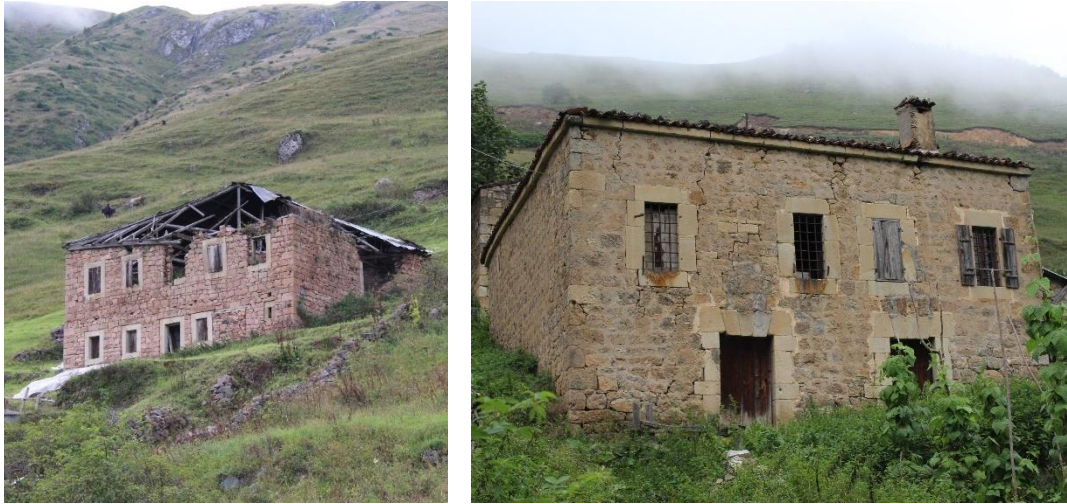
Figure 3.81: Işhanlı neighborhood, an example of TH-1 (left); Piştöflu neighborhood, an example of TH-2 (right)

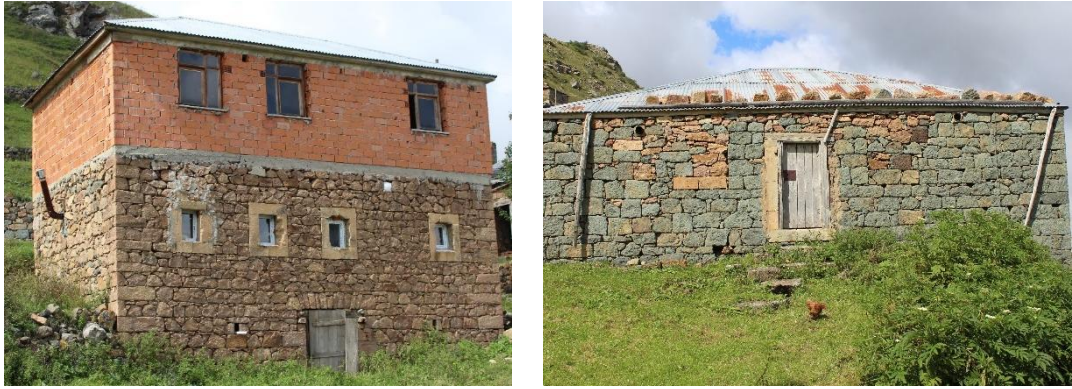
Figure 3.82: Işhanlı neighborhood, an example of TH-3 (left); Piştöflu neighborhood, an example of TH-4 with a roof repair (right)

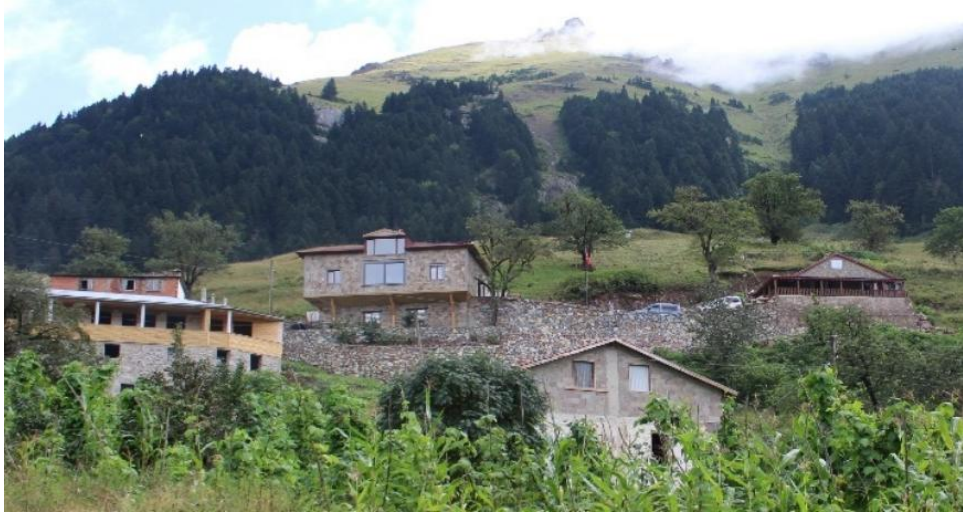
Figure 3.83: Zurnacılı neighborhood, newly built houses

There are also newly built houses which are not included in the traditional house category (Figure 3.83). Most of these houses are in the Piştöflu, Işhanlı and especially in the Zurnacılı neighborhoods. They are built with incompatible materials such as aerated concrete, brick, reinforced concrete etc. and with different construction techniques. Some architectural elements such as a balcony and porch, which are attached to these houses, do not fit the traditional texture either. Newly built stone masonry structures, on the other hand, are incompatible in terms of plan and facade organization.

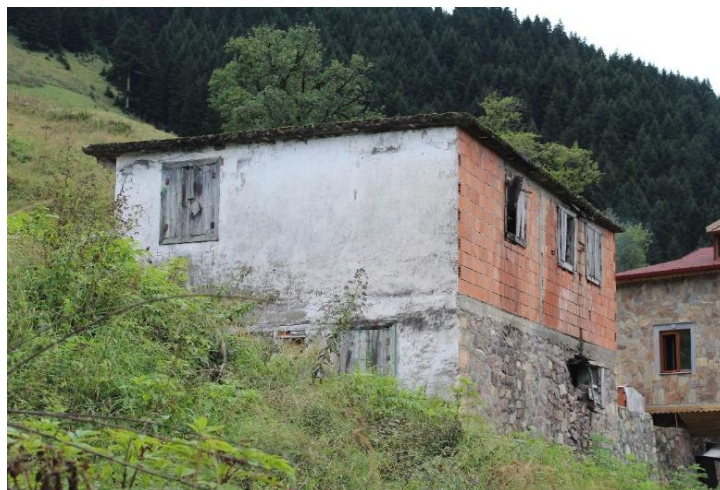
Figure 4.4: Zurnacılı neighborhood, a house with a reconstructed upper storey
