LEARNING FROM CHANGE: ADAPTING TRADITIONAL HOUSES
THROUGH USER INTERVENTIONS, CASE STUDY: ANTAKYA, HATAY

IN PARTIAL FULFILLMENT OF THE REQUIREMENTS
FOR
THE DEGREE OF MASTER OF SCIENCE
IN
CONSERVATION OF CULTURAL HERITAGE IN ARCHITECTURE

MAY 2023

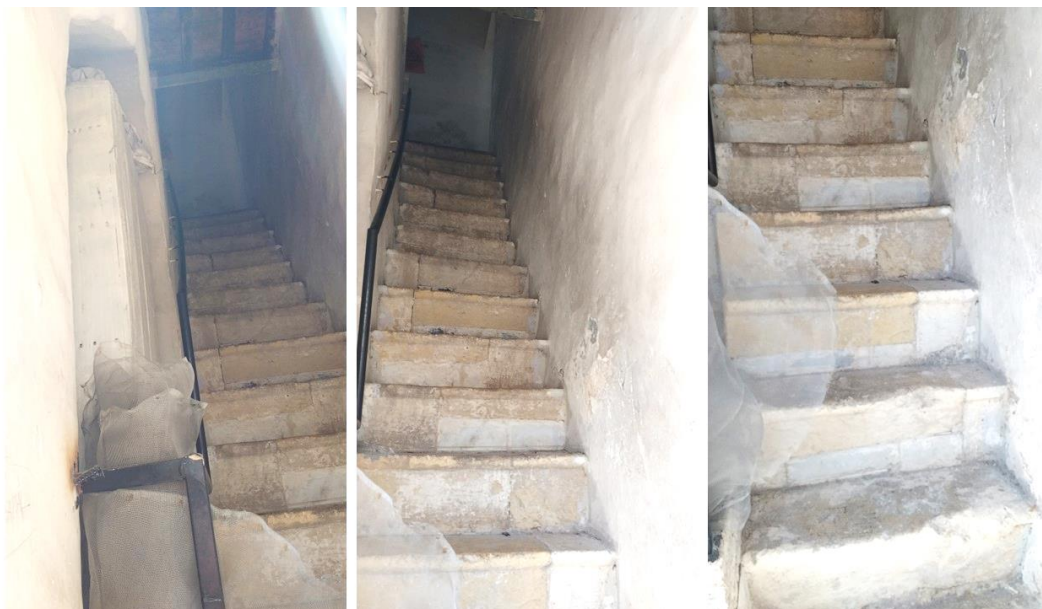
Figure 3.23. *Mabeyn* with stone steps on the Mass A (Author, 2022)

The staircase to the upper floor is located between two rooms and currently, the access to the staircase is through the courtyard with a door. However, it is thought to be the traditional *mabeyn* in original, which is a secret staircase between the rooms (Figure 3. 23).

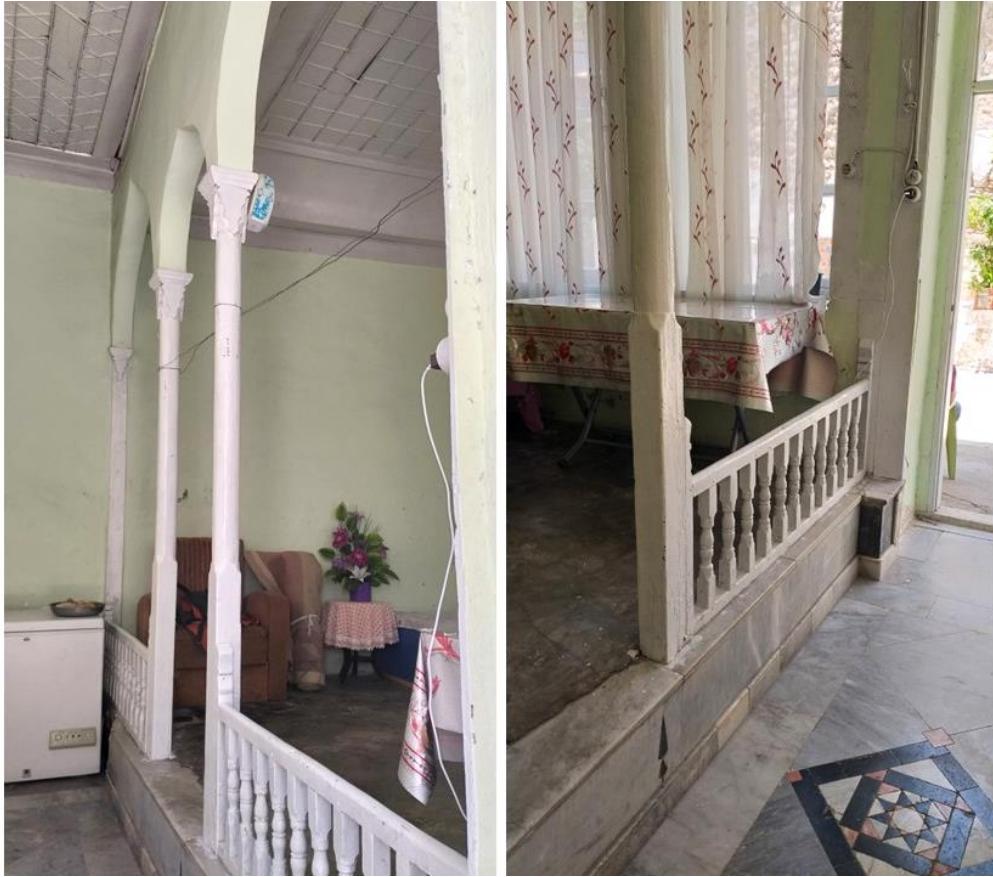
Figure 3.24. The *seki* on the ground floor of the Mass B (Author, 2022)

There is only one room on the ground floor of the second main mass of the house which is the Mass B. It is being used as a guest bedroom and there are two single beds and a double bed in the room, standing attached to one another. The entrance to the house is on the same level with the courtyard but the rest of the room is elevated which creates the traditional *seki* area. The *seki* is separated from the entrance area not only with the height difference but also with timber arches and fences (Figure 3.24). The flooring of the entrance area is marble which is laid to create a pattern at the middle of the area, and the floor of the *seki* area is covered with a concrete slab. There is also an ornamented wooden cladding on the ceiling of the room where a florescent light is fixed at the middle of it (Figure 3.25).

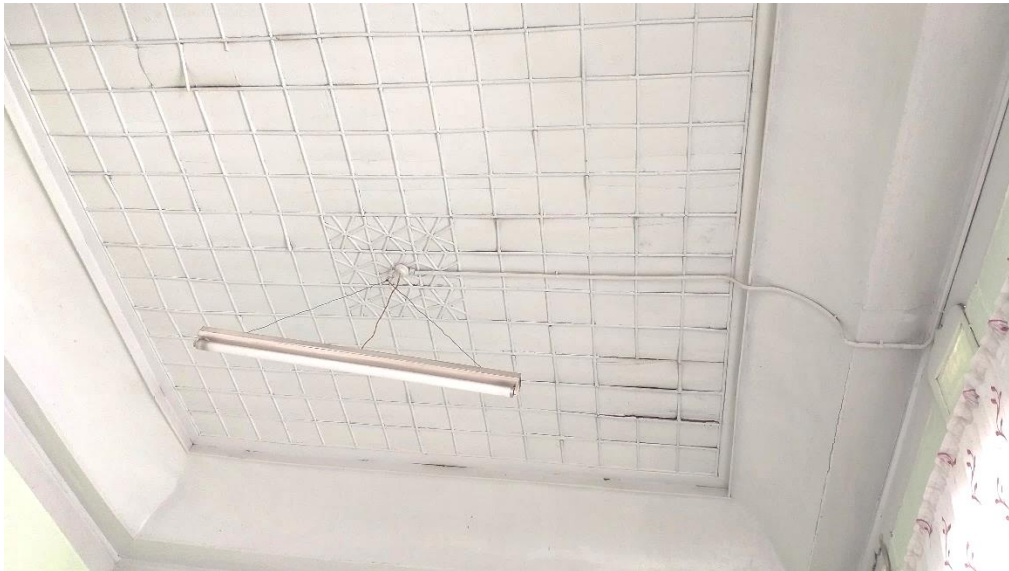
Figure 3.25. The ornamented ceiling of the room, and the fluorescent light fixture (Author, 2022)

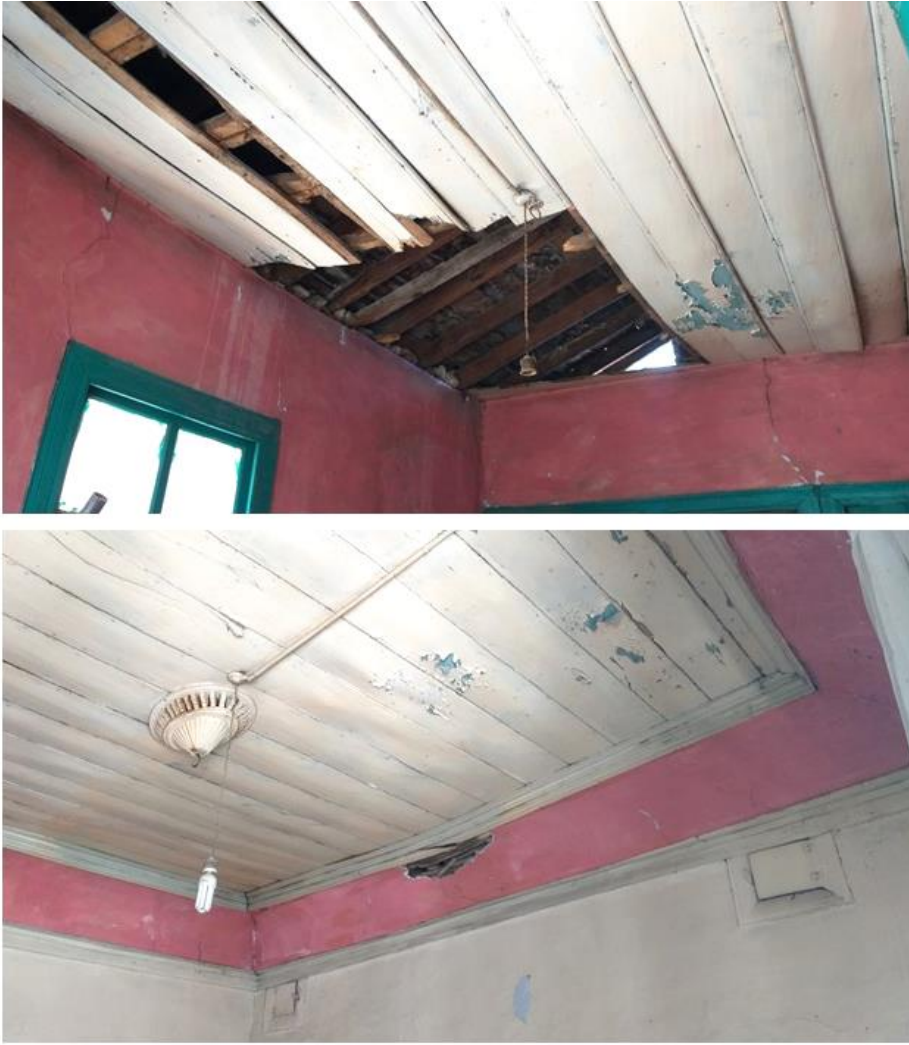
Figure 3.30. The ceilings of the first-floor rooms of the Mass B (Author, 2022)

First floors of the main masses are underused spaces which are used as storage areas or rather left empty (Figure 3.27). The construction techniques of the floors also differ. The first floor of the Mass A is stone masonry with cut stone covering, except from the partially reconstructed section which is done with concrete blocks. The first floor of the Mass B is timber framed with unidentified filling. There are two rooms at the timber-framed first floor of the Mass B. Also, there is balcony-like corridor in front of the rooms which is also one of the characteristic features of the traditional Antakya houses (Figure 3.28). Both rooms have traditional cabinets, and *kitabiye* next to the entrance of the rooms (Figure 3.29). The roof of the Mass B is partially damaged, and it can be seen from the rooms, since the traditional wooden cladded ceilings are partially collapsed in one room, and damaged in the other room (Figure 3.30). The first floor of Mass A could not be entered.

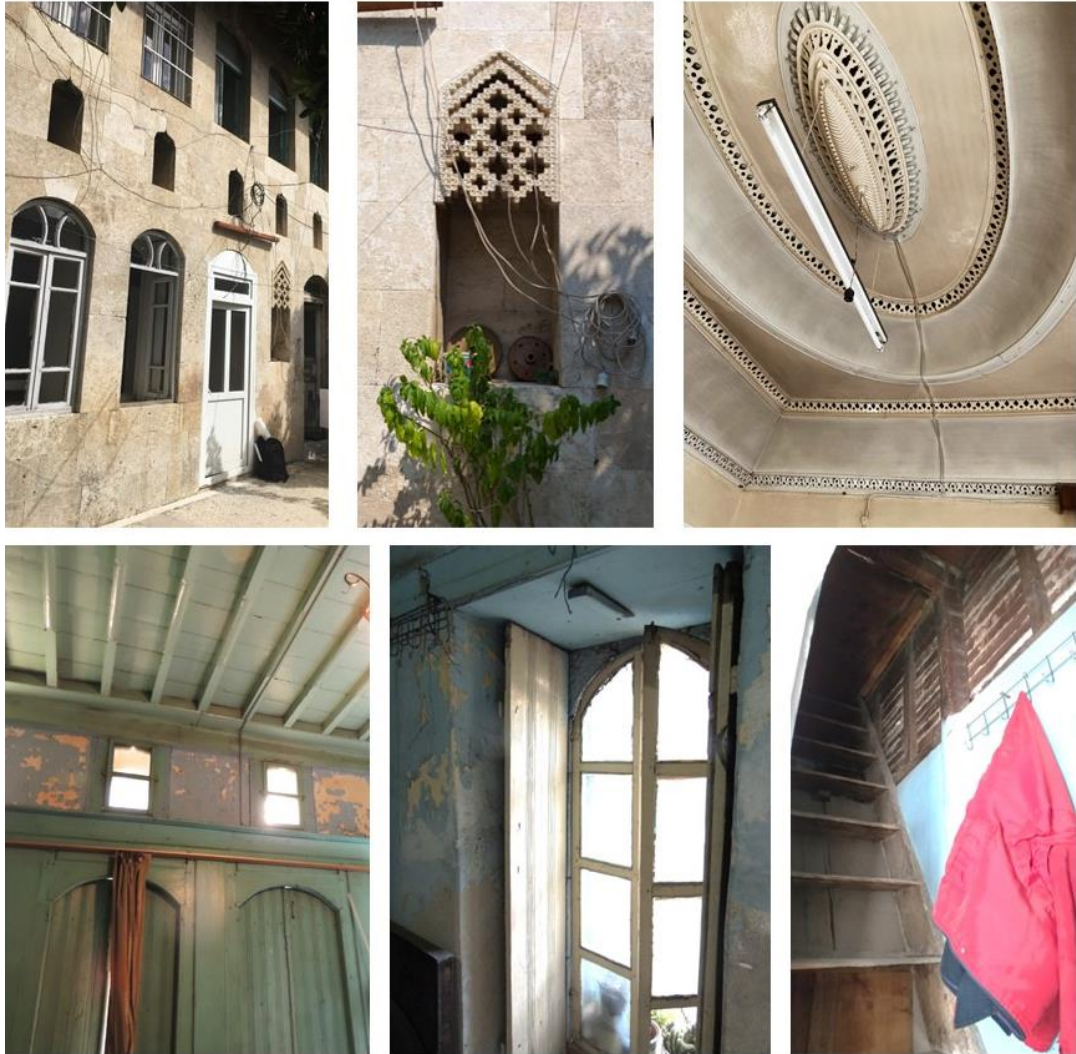
Figure 3.33. The traditional architectural elements of Ülkü-19 House

The rooms reflect the characteristics traditional Antakya houses with the wooden cabinets, *mahmel* and *kitabiyeye*, traditional wooden cladding on the ceilings, transitional *eşiklik* areas, the wooden shutters for the windows, and the traditional top windows called *kuş takası* (Figure 3.33). Moreover, there is a *mabeyn* with wooden steps which is the traditional secret staircase, between the living room and the empty room. The door to the mabeyn is located at the living room and the door is crafted similarly to the cupboard doors, and the secrecy of the staircase is achieved through the traditional design.

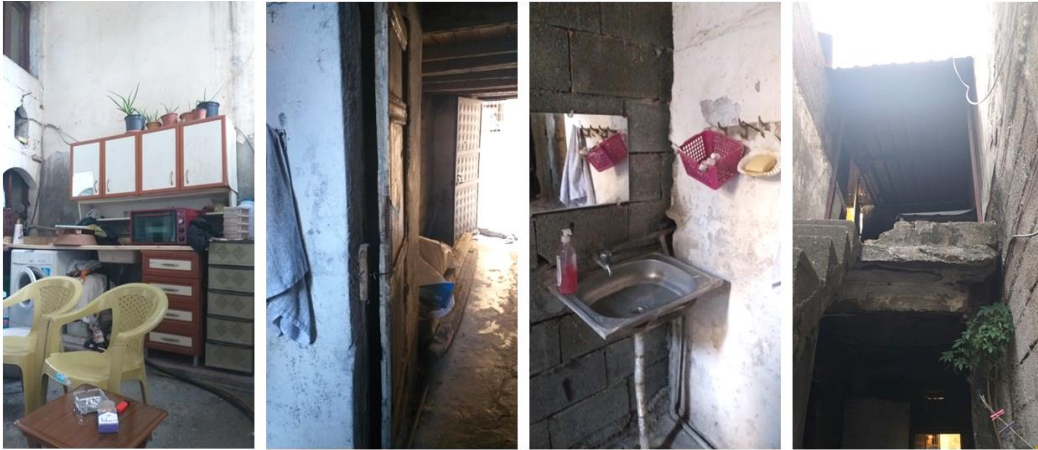
Figure 3.43. The kitchenette, WC, washbasin, and the storage area of the Ülkü-5 House (Author, 2022)

Although the service spaces are relatively new, constructed with new techniques, and contemporary appliances had been used, they are in poor condition with deteriorated materials (Figure 3.43).

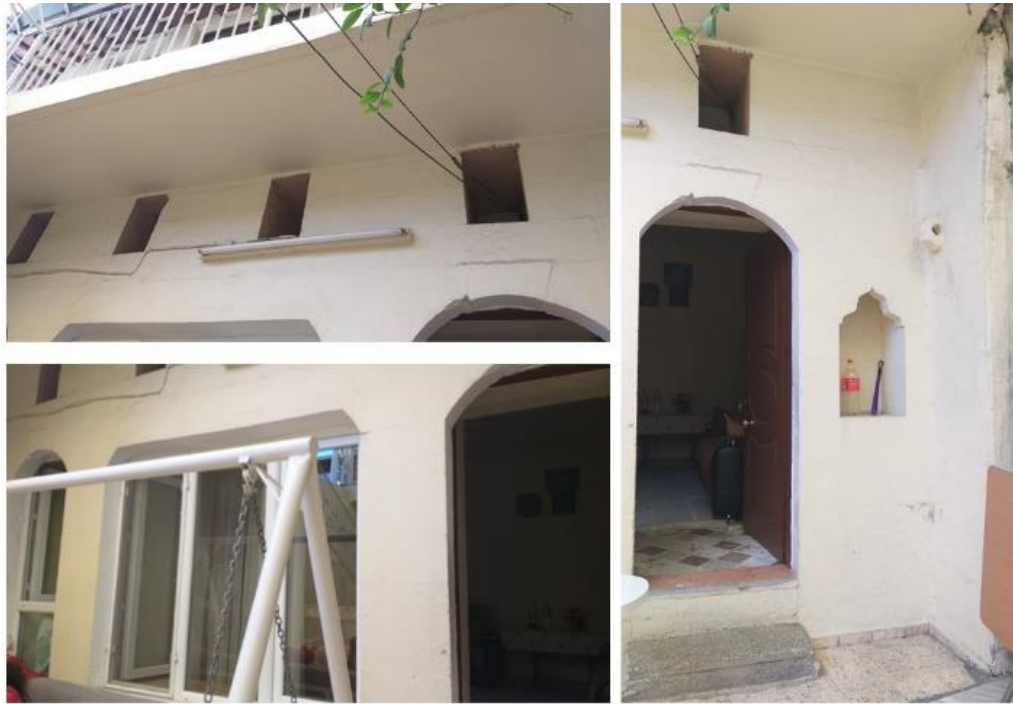
Figure 3.47. Front façade of the Mass B (Author, 2022)

The living room on the Mass B is entered from the courtyard through a step and it is furnished with a contemporary seating unit. Although the sizes and materials of the windows and the door have been altered, and original cut-stone cladding on the walls have been limewashed, the front façade of the Mass B reflects the characteristics of traditional Antakya houses with the traditional top windows called *kuş takası* and the niche called *fanus takası* (Figure 3.47).

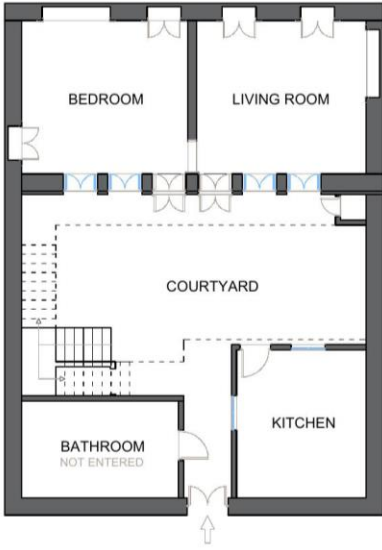
Figure 3.52. Current ground floor plan of the Ülkü-63 house (Author, 2023)

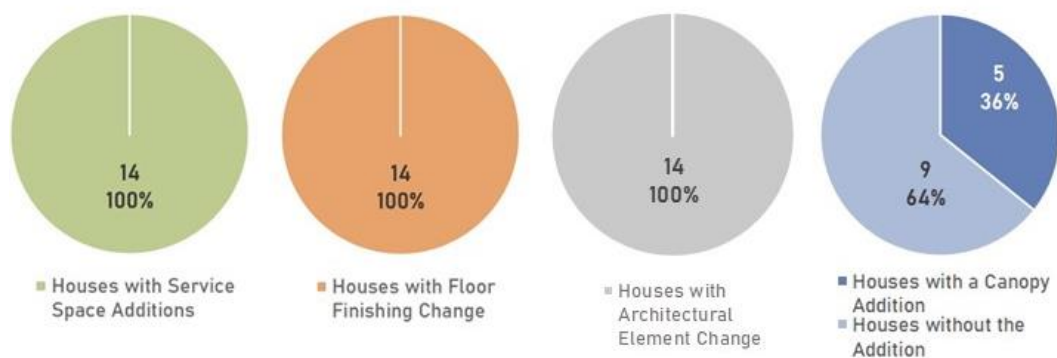
Figure 3.108. The most common user interventions seen on the case study site

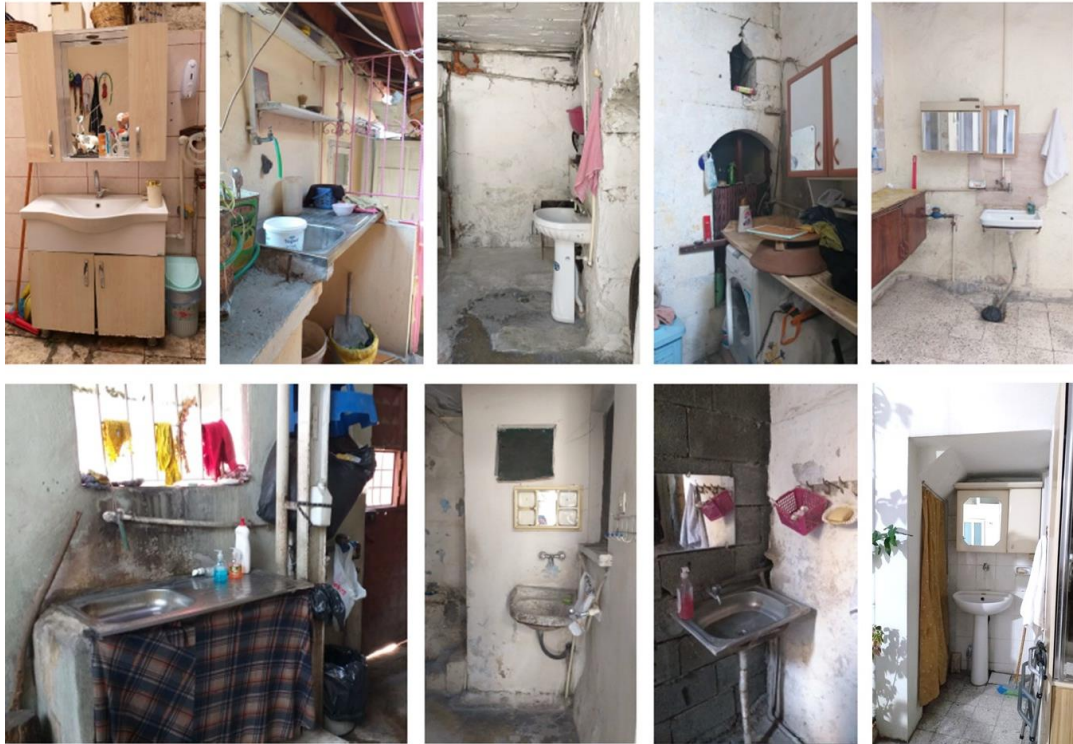
Figure 3.114. Washbasin additions in the courtyards of the studied houses (Author, 2022)

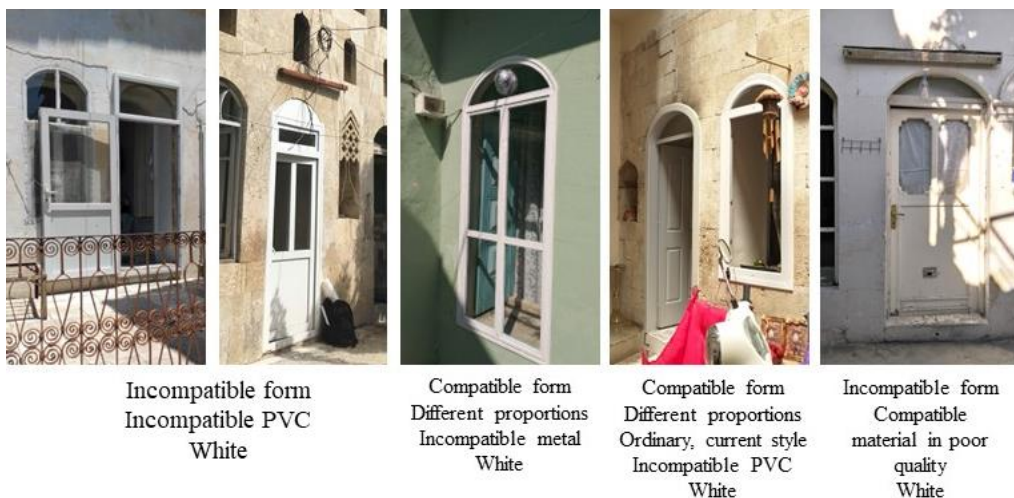
Figure 3.115. Replaced architectural element examples from the site (Author, 2022)

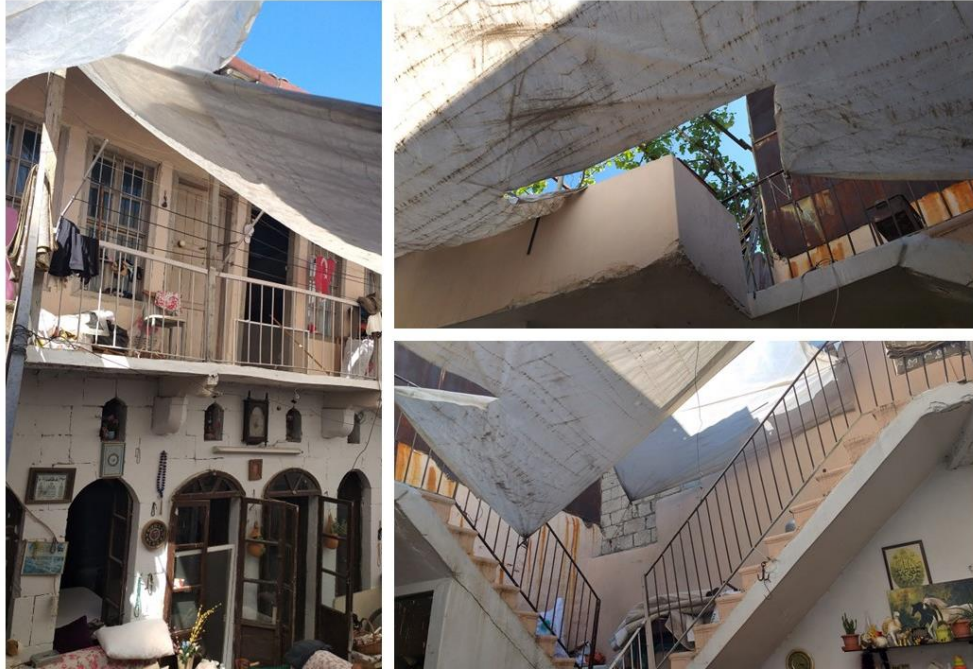
Figure 4.2. The awning addition in Ülkü-63 House (Author, 2022)
