BY

SERA NAZ ERSOY

JANUARY 2023

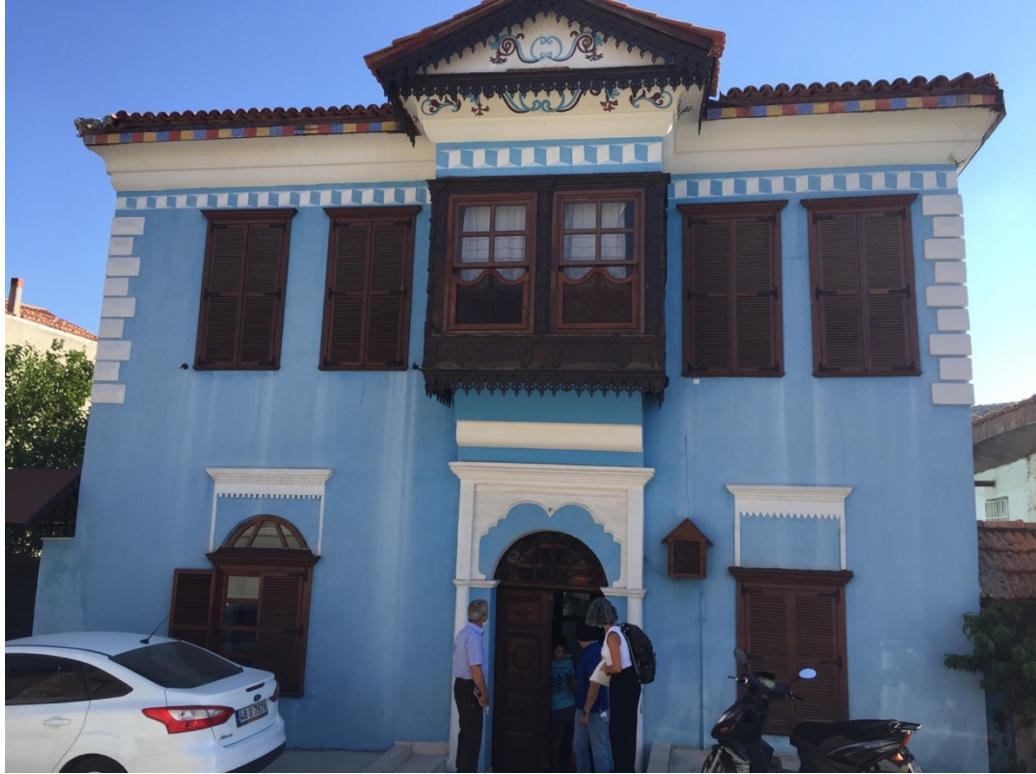
Figure 13 Case #1 House - Street Facade

Overall, it is a two-storey plastered and painted (blue) building with stone masonry ground floor and timber framed upper floor walls. The added space on the ground floor, consisting of a sink and bathroom was constructed with reinforced concrete. Also, there is a projection in the middle of the street façade.

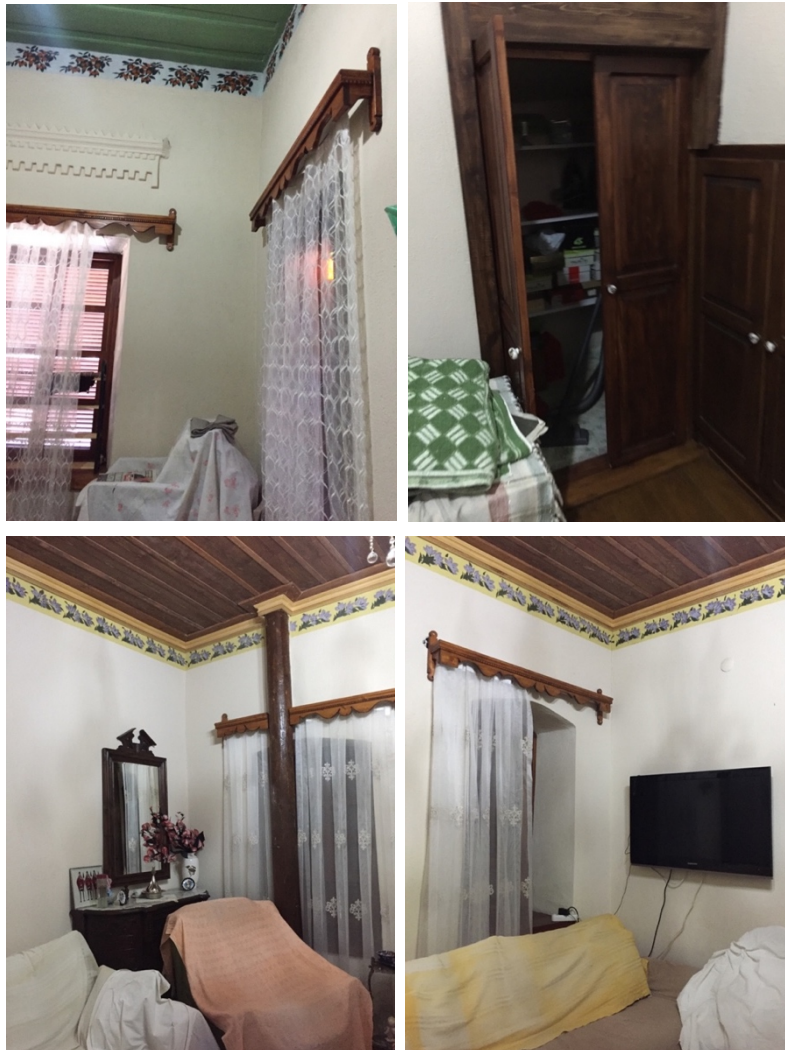
Figure 17 Case #1 House - Ground Floor - Rooms

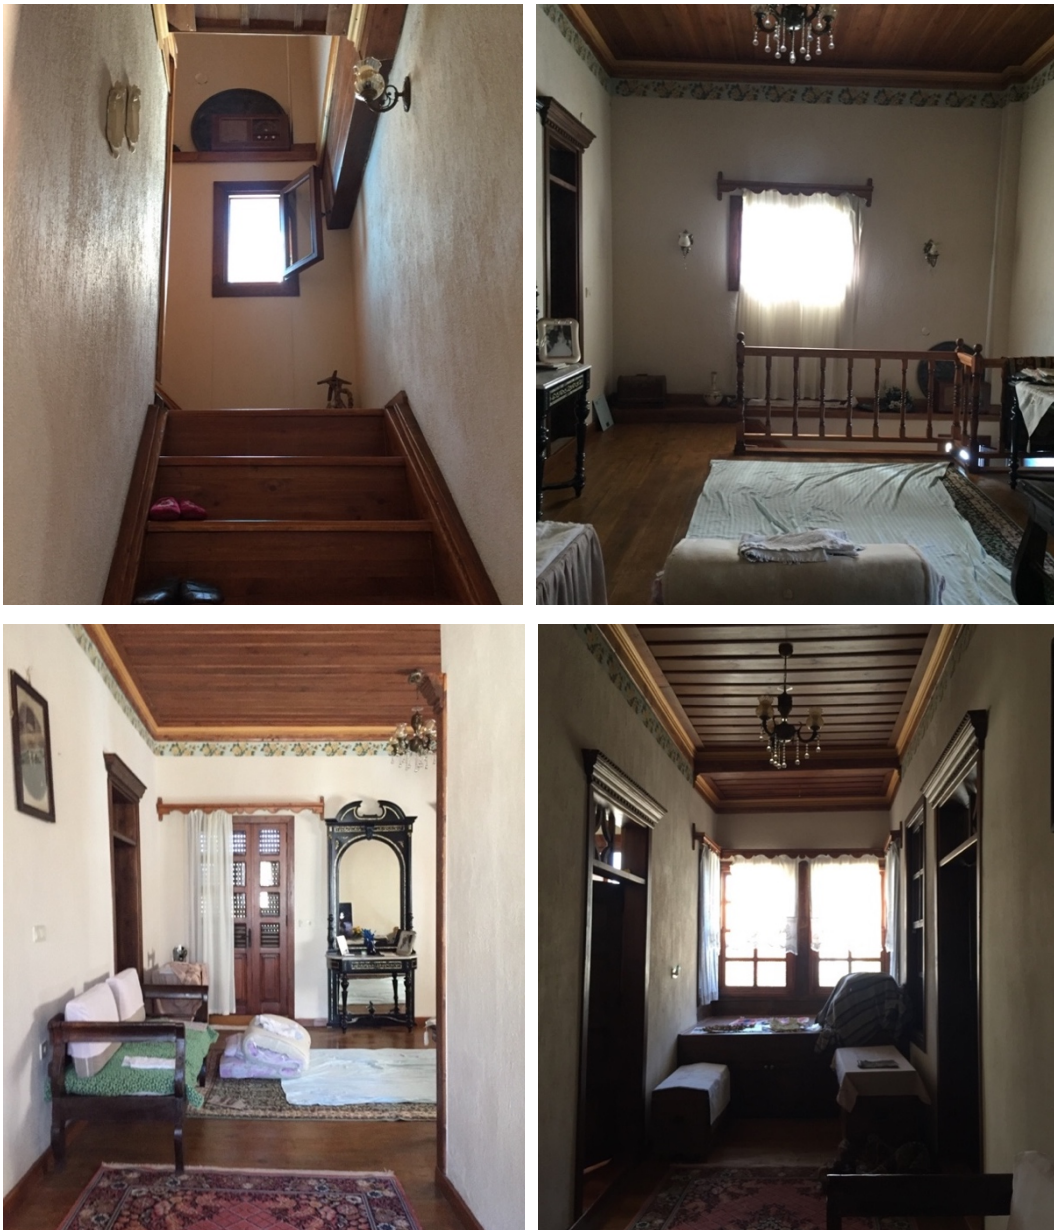
The upper floor can be accessed through the stairs on the right side of the sofa, between the two rooms. There is an 'L' type sofa on the upper floor, and a *divanhane* at the other end of the sofa. On this floor, there are three rooms and a bathroom. While two of the rooms are used as bedrooms, one is used as storage. There is an *ocak* in the bedroom across the stairs.

Figure 18 Case #1 House - First Floor - Staircase and Sofa

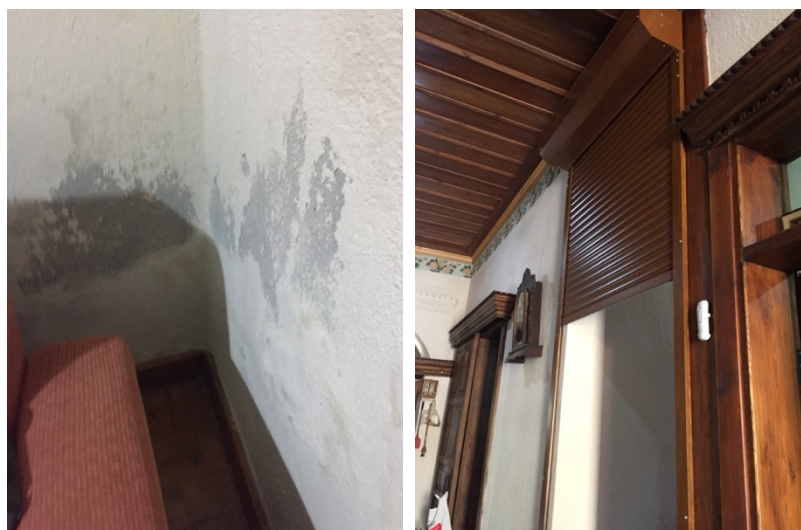
Figure 20 Case #1 House - Ground Floor Walls and Shutter

In winter, air conditioning and catalytic stoves are used for heating. The house is partially heated. To provide thermal insulation between the two floors, they use an electric shutter they have installed at the beginning of the staircase. In the coldest period of the year, she moves to Istanbul to live with her children for 1.5-2 months. A few years ago, during the renovation of the house, heating pipes were installed in the building. Due to costs and heating performance, she is considering using a heat pump or solid fuel.

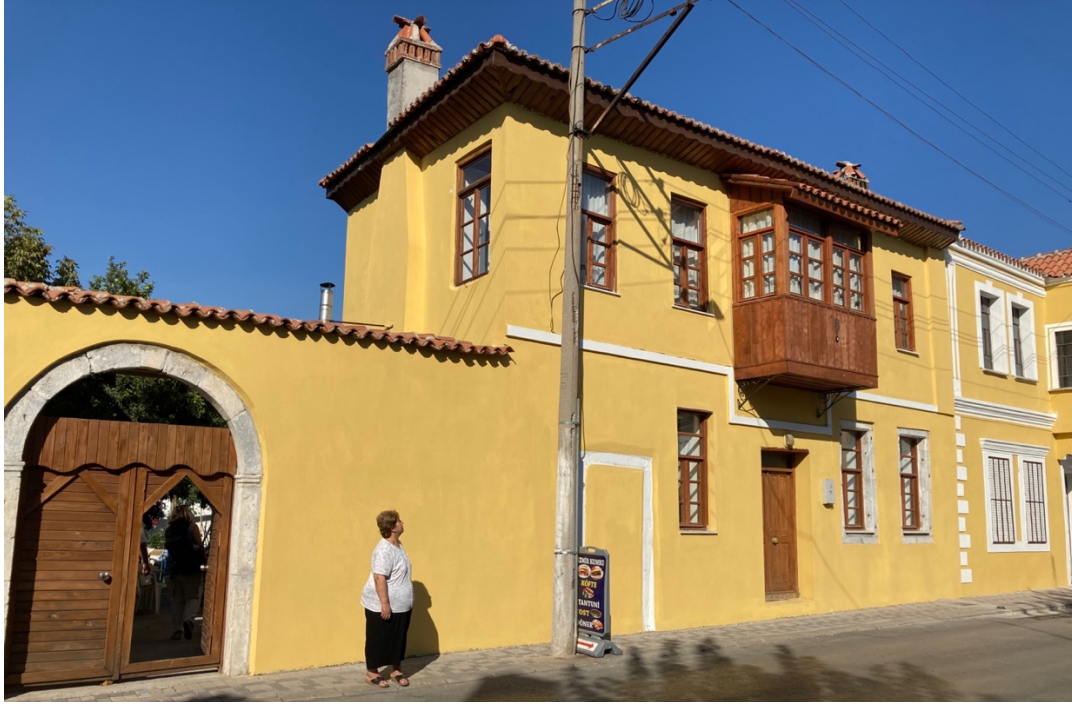
Figure 21 Case #2 House - Street Facade

Overall, it is a two-storey plastered and painted (yellow) house with stone masonry ground floor and timber framed upper floor walls. Also, it has two projections, one on the street and one on the courtyard façade. The added bedroom on the ground floor was constructed with reinforced concrete.

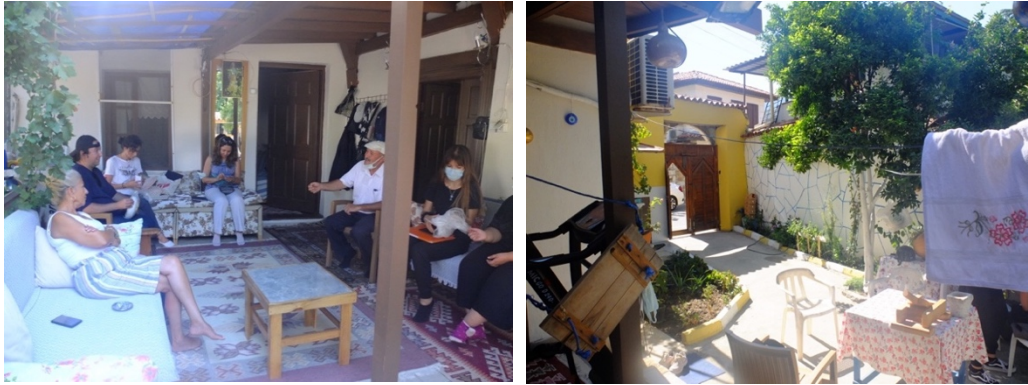
Figure 23 Case #2 House - Courtyard

When entered the courtyard, the main building is located on the right side. There is a platform-like space in front of the main building, which is covered with an extension to the roof and organized as a sitting place. At the left side of this space, there is an additional space adjacent to the main building, which is used as the bedroom.

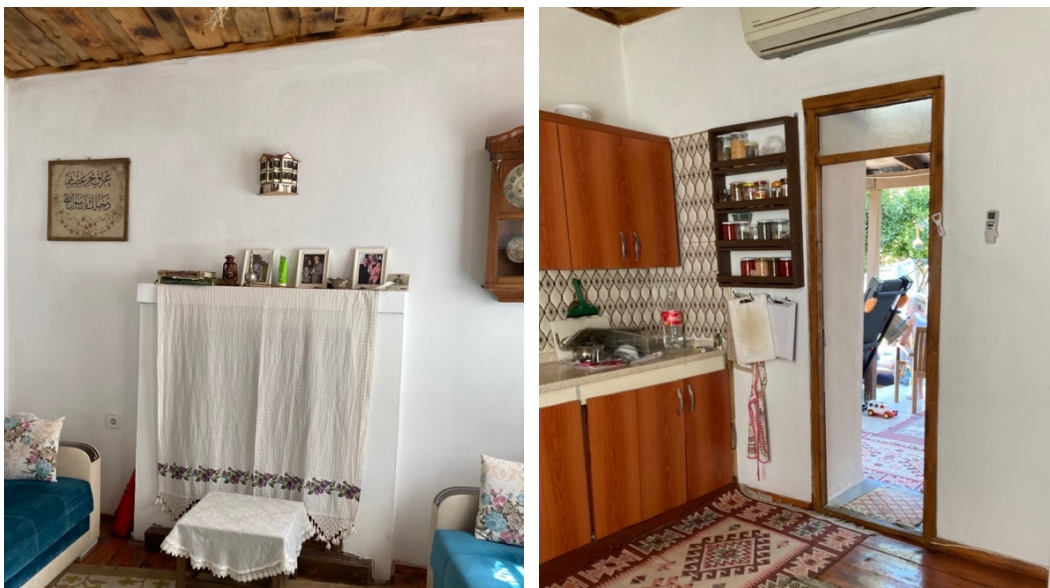
Figure 24 Case #2 House - Ground Floor - Living Room and Kitchen

The main building has two entrances from the courtyard. One of these entrances open to the sofa on the ground floor. The room on the left is used as the living room, whereas the one on the right was refunctioned as kitchen. There is an *ocak* in the living room. The other entrance from the courtyard opens directly to the kitchen. Upstairs can be accessed through the staircase located in the sofa.

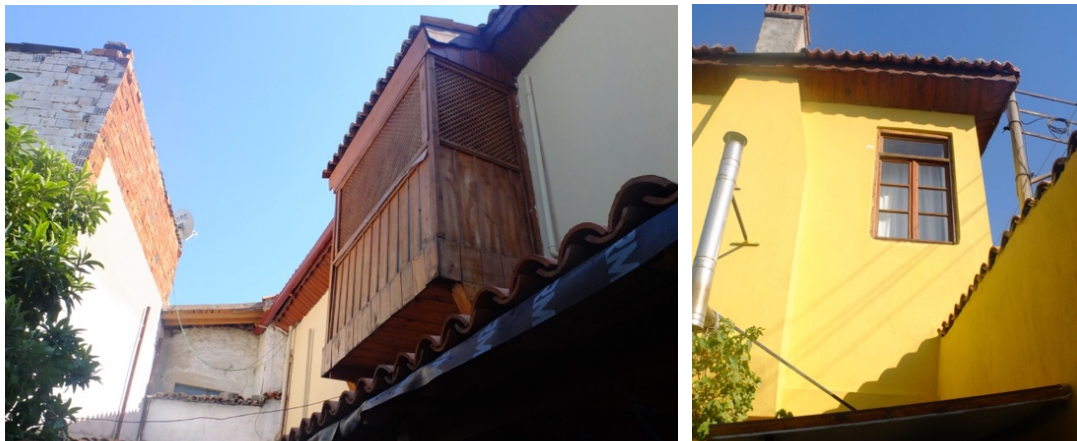
Figure 26 Case #2 House - Courtyard Facade - Projections

On the upper floor, there are two projections in the sofa, and it is possible to see the authentic shutters. There are two rooms on both sides of the sofa. It is learned that they used to be bedrooms, but today the one on the left is used as a living room and the one on the right is used as a bedroom. There is also a *gusulhane* in this bedroom, which is still used as a bathroom with a recently installed European-style toilet.

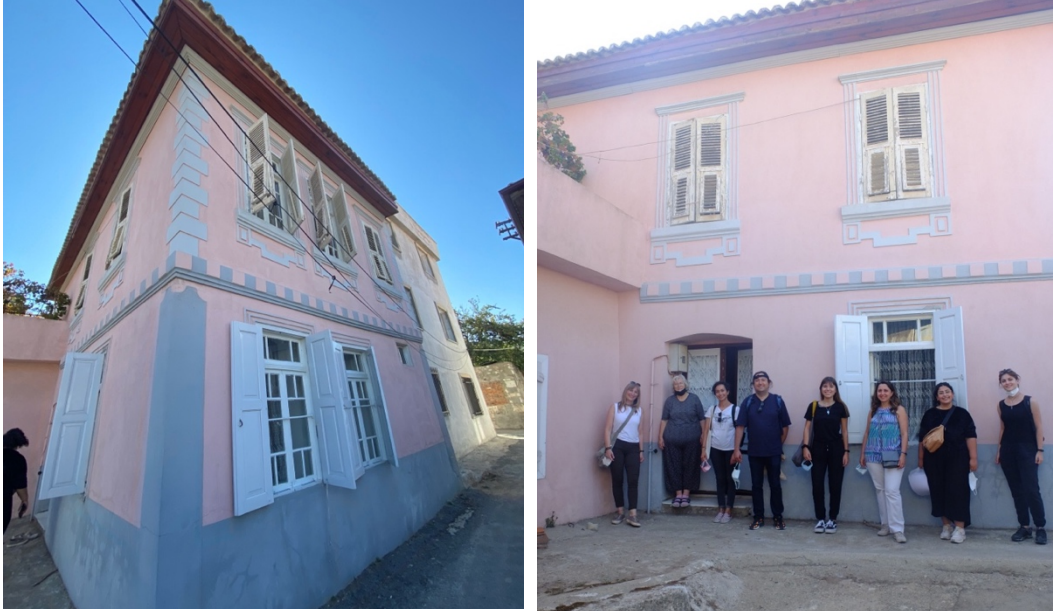
Figure 29 Case #3 House - Street Facade

Overall, it is a two-storey plastered and painted (pink and grey) house with stone masonry ground floor and timber framed upper floor walls. The kitchen and bathroom were constructed with reinforced concrete. The service building on the courtyard, which is used as storage, was constructed with clay brick.

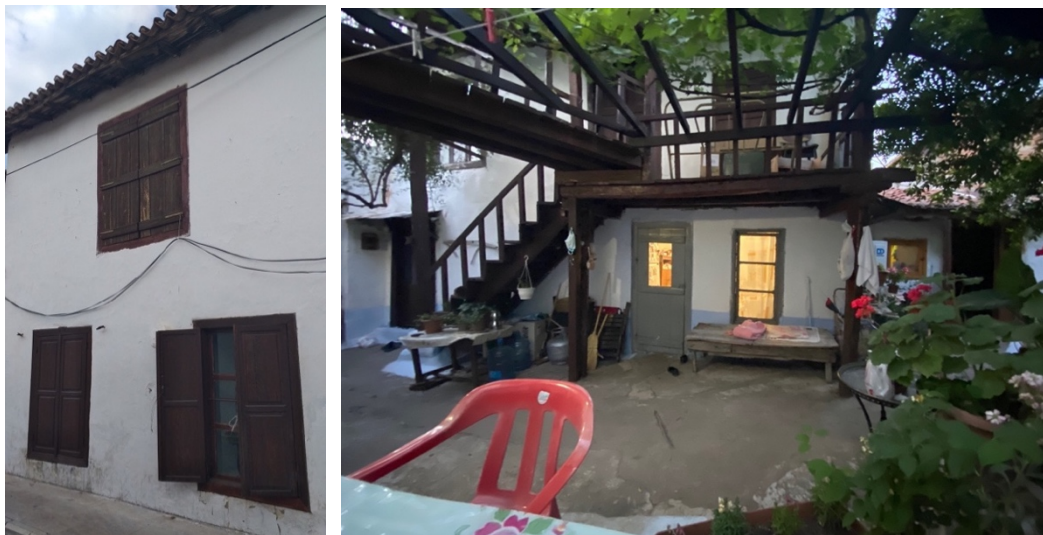
Figure 35 Case #4 House - Main Building - Street Facade and Courtyard Facade

Overall, the main building is a plastered and painted (white) two-storey building with stone masonry ground floor and timber framed upper floor walls. The original bathroom, which is currently used as the henhouse, has stone masonry walls as well. The service building is a plastered and painted (white) single storey reinforced concrete building with a terrace.

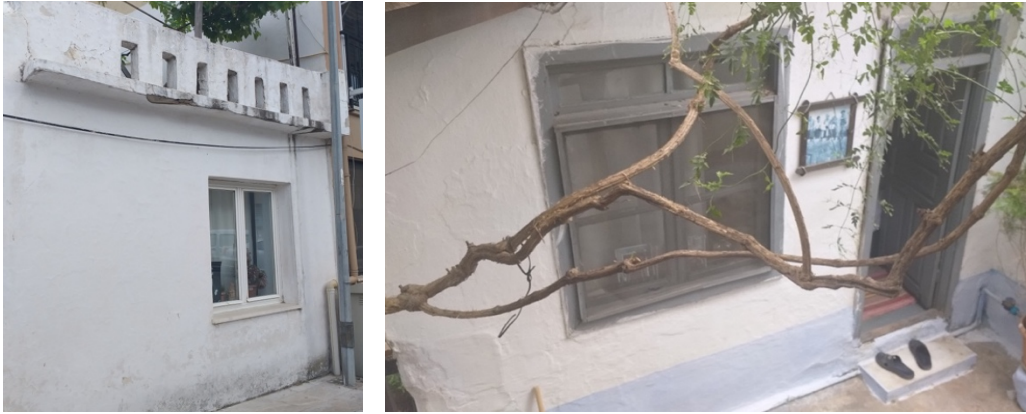
Figure 36 Case #4 House - Service Building - Street Facade and Courtyard Facade

The service building consists of a single room. This room, which was used as a guest room, is currently used as a bedroom. Upper floor of this building is used as a terrace. It is learned that they used to sleep in the terrace in summertime, under the bednet set up by U4's mother.

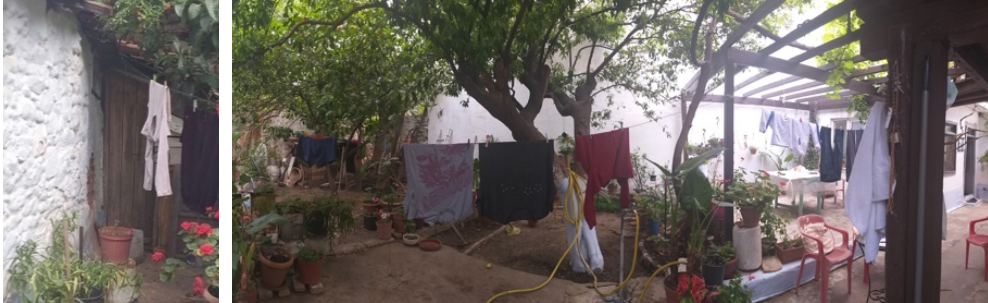
Figure 37 Case #4 House - Courtyard

There is another structure in the courtyard adjacent to the bathroom in the main building, which was originally the bathroom but currently used as a henhouse. Also, there is an elevated space covered with a pergola, where they spend most of their time when the weather gets warm.

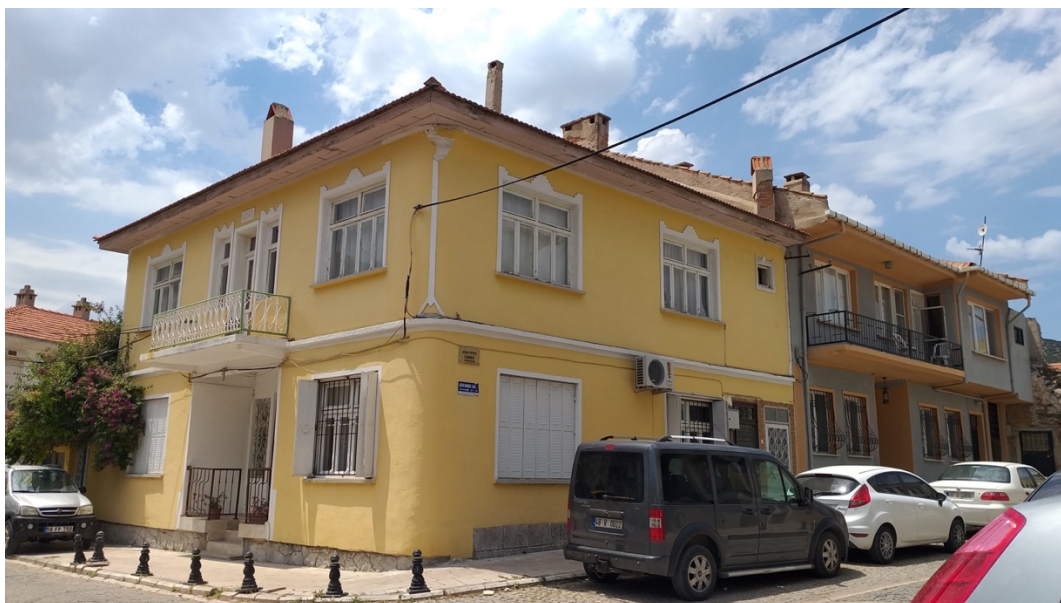
Figure 38 Case #5 House - Street Facade

Overall, it is a plastered and painted (yellow) two-storey building with stone masonry ground floor and timber frame upper floor. There is a balcony on the street façade. The corridor accessed through the door located at the end of the sofa on the ground

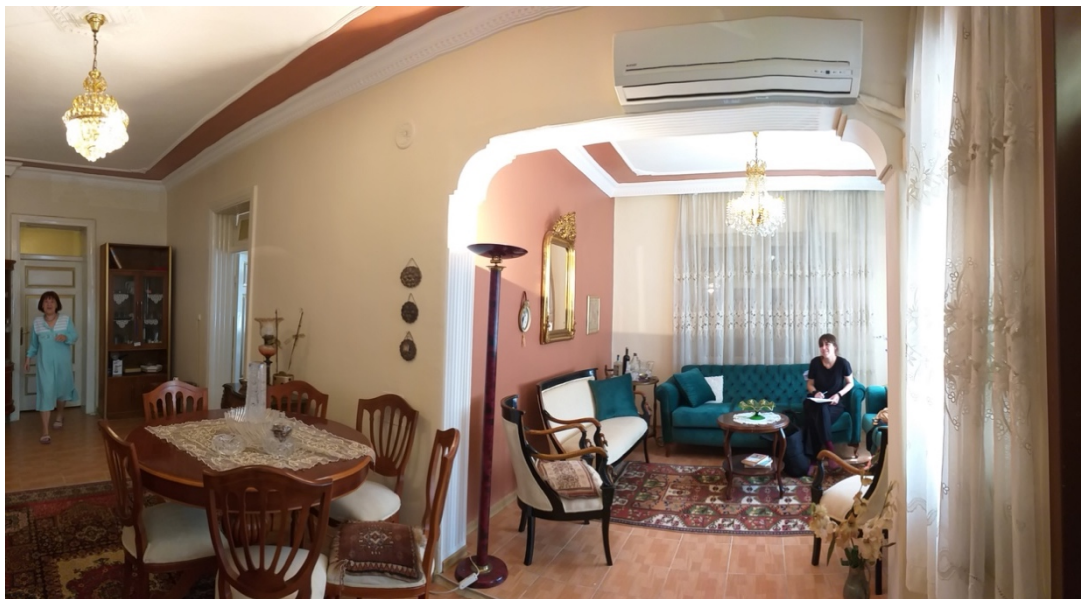
Figure 40 Case #5 House - Ground Floor (sofa and living room)

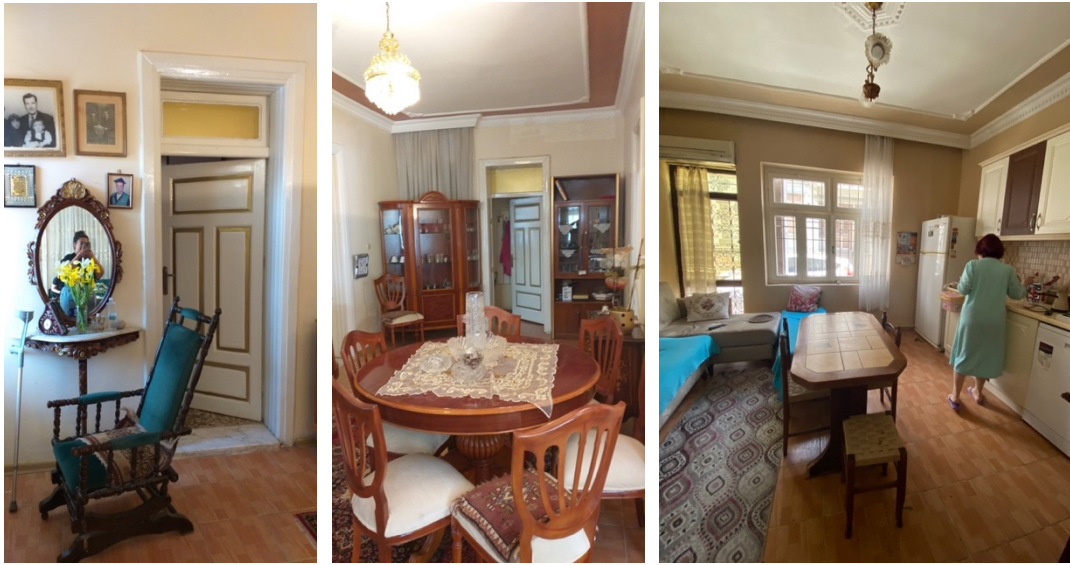
Figure 41 Case #5 House - Ground Floor (sofa and kitchen)

There is a door right across the entrance, at the back of the sofa, which opens to a corridor that continues from one end of the building to the other. On the left end of the corridor, there is another door which opens to a semi-open space in the courtyard. Apart from this space, there is also another semi-open space in the courtyard which is constructed with reinforced concrete and organized as a sitting area. Although the courtyard is visible and accessible from the street, they use the door inside the house to reach the courtyard.

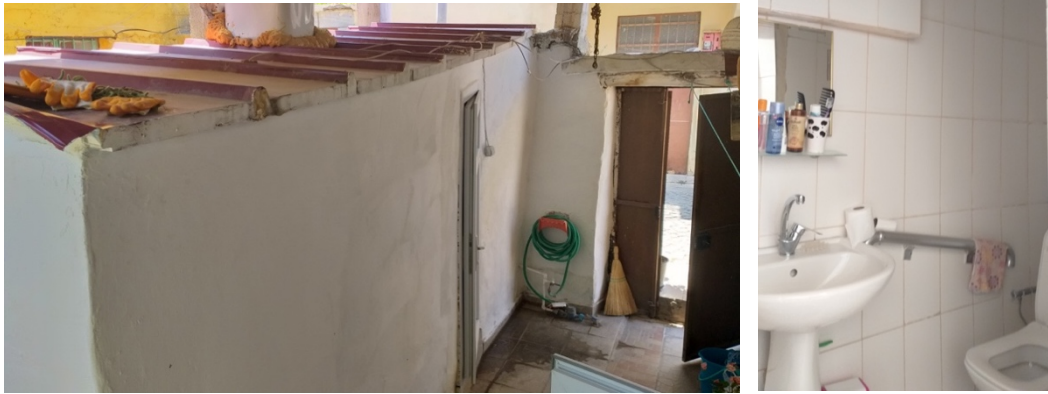
Figure 47 Case #6 House - Courtyard and Kitchen

The building on the left is the main building with separate entrances for each floor. The ground floor of the house is entered through a recessed window-like entrance. Currently, there is a kitchen and a room (storage) on the ground floor, however it is learned that this floor was originally functioned as a barn.

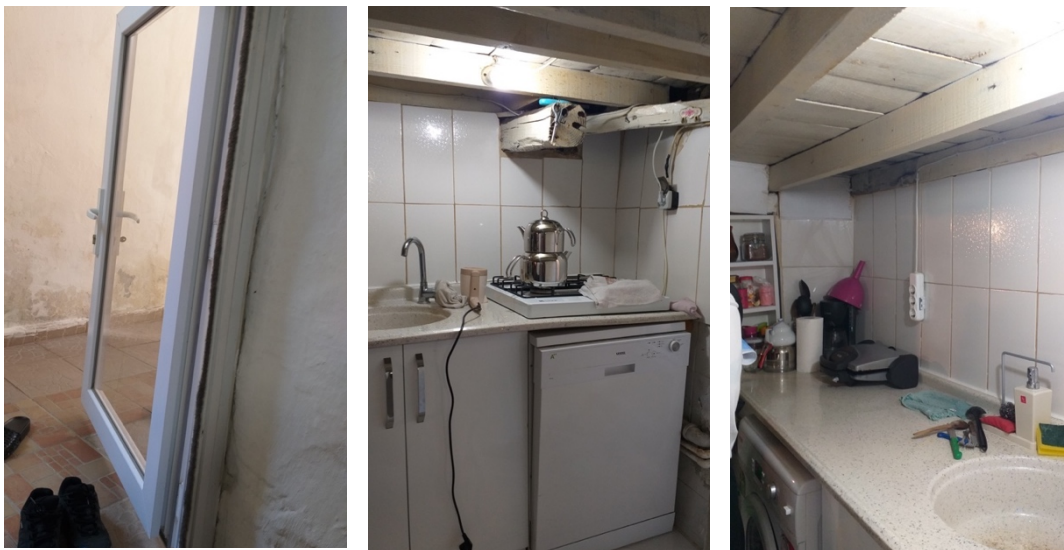
Figure 48 Case #6 House - Ground Floor

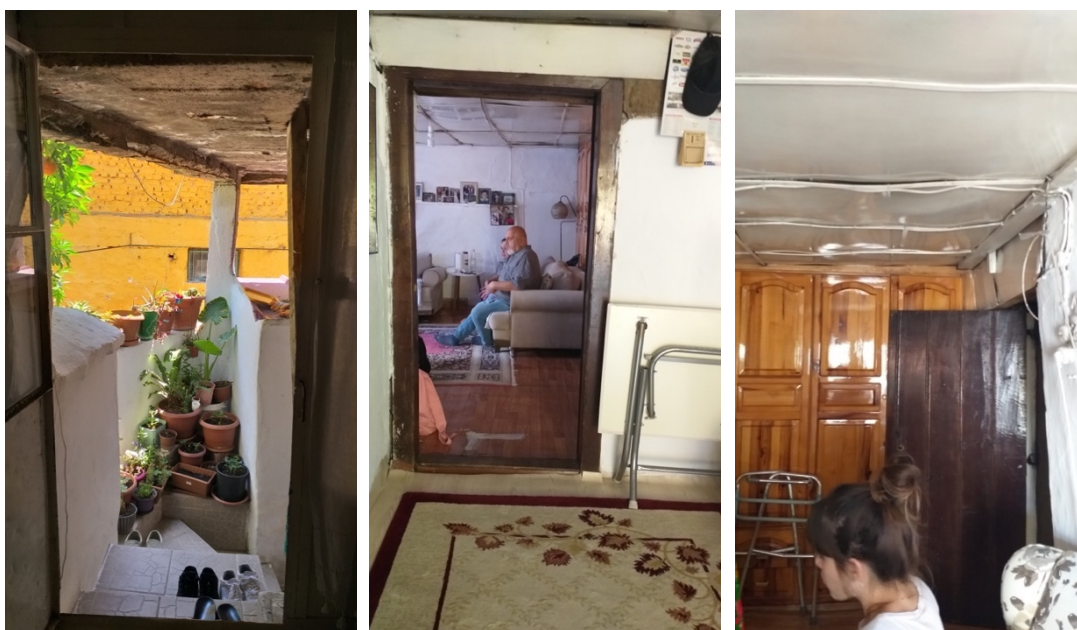
Upper floor of the main building, which is the living space, is entered through a staircase (facing the courtyard door) from the courtyard. There is a closed corner sofa, a bedroom, and a living room on this floor.

Figure 49 Case #6 House - First Floor

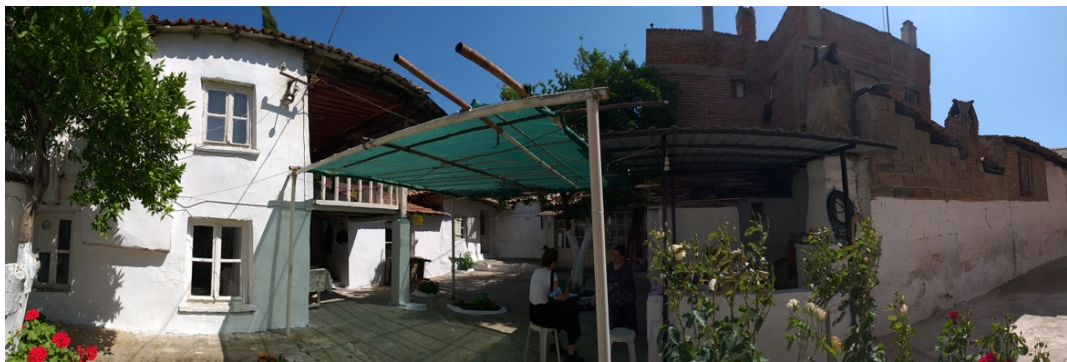
Figure 53 Case #7 House - Courtyard

Next to the main building, there is a kitchen, a cellar, and a room, respectively. Also, there is a semi-open space with an *ocak*, across the kitchen. These service buildings each have their own entrances from the courtyard. The courtyard is partially covered.

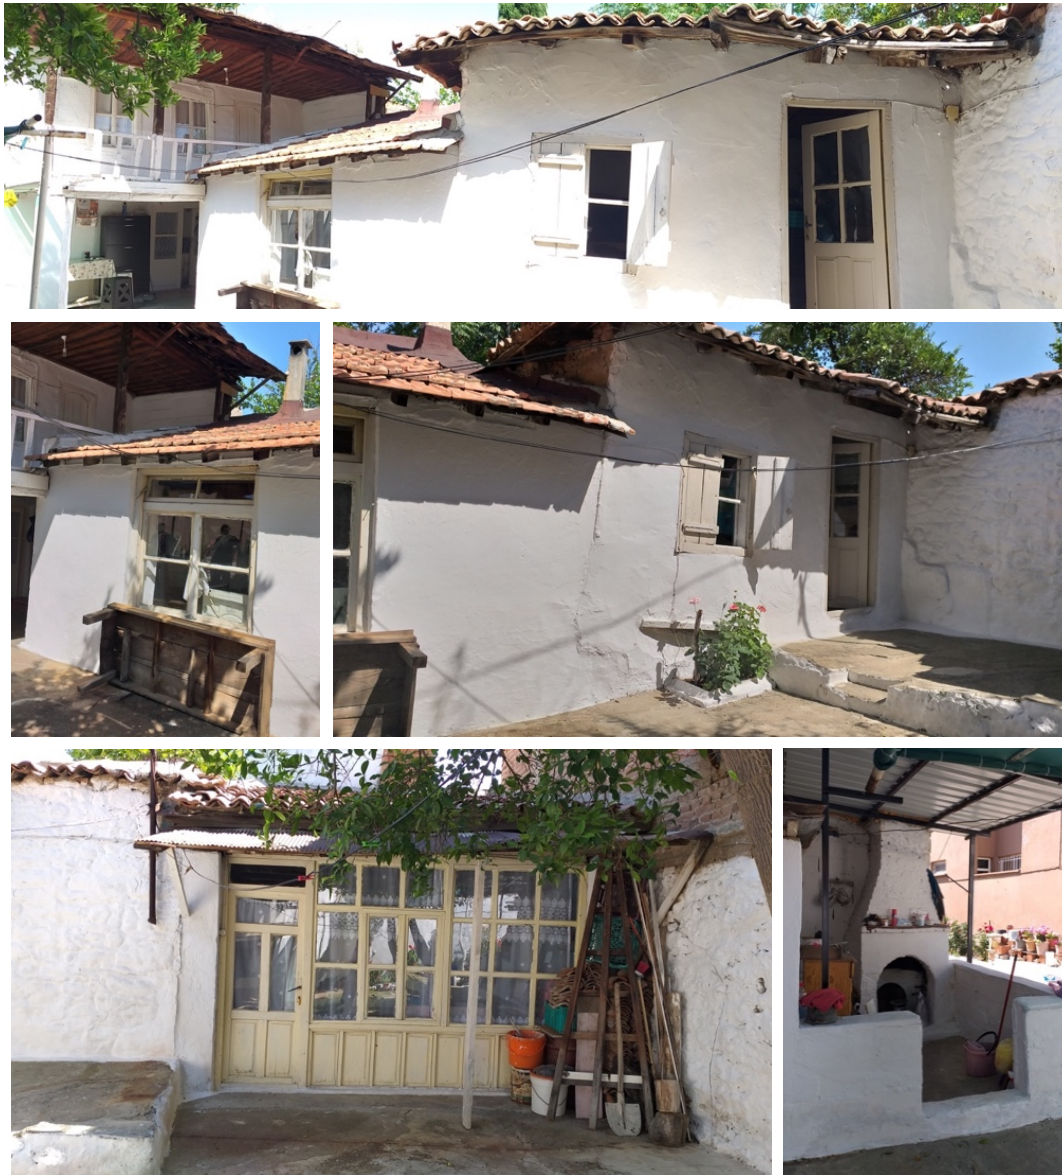
Figure 54 Case #7 House - Service Buildings

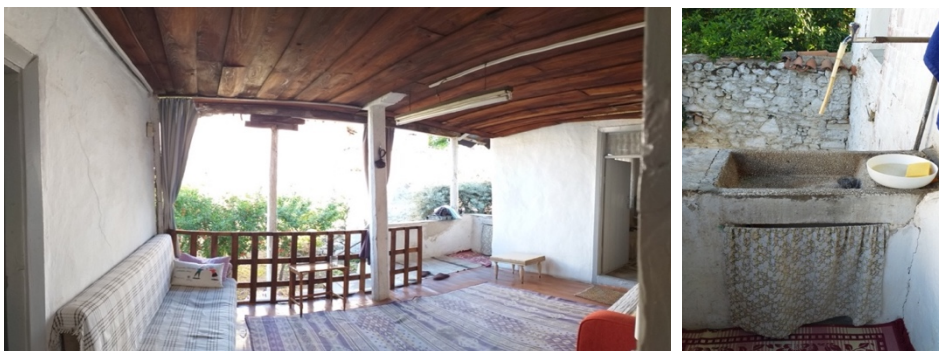
Figure 57 Case #8 House - *Önlük*

Overall, it is a single storey partially plastered and painted (white, only the courtyard façade) house with a basement. The basement has stone masonry walls, whereas the ground floor has stone masonry walls except the timber framed walls separating the kitchen from both the living room and the *önlük*.

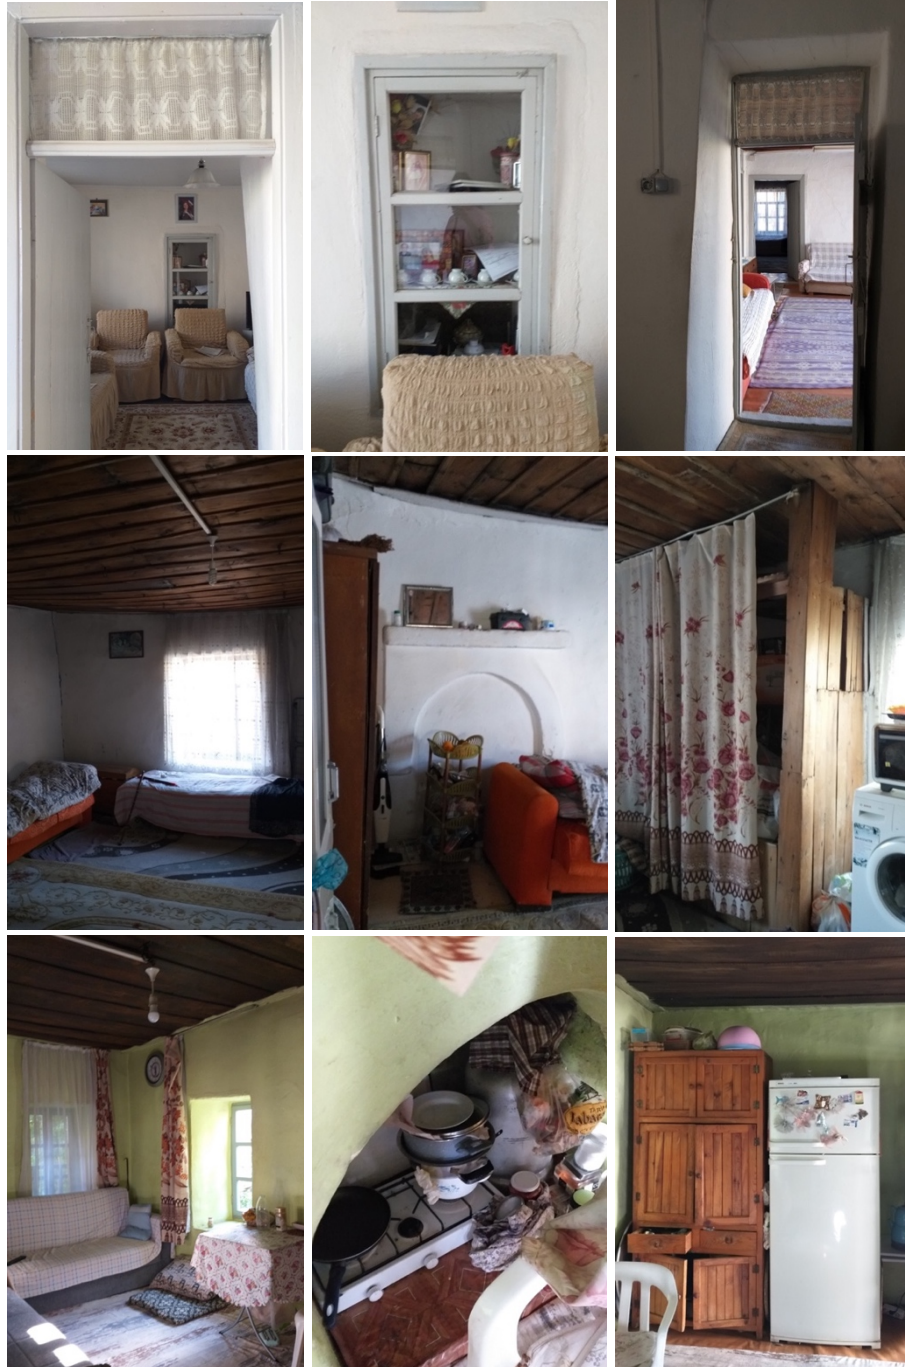
Figure 58 Case #8 House - Rooms

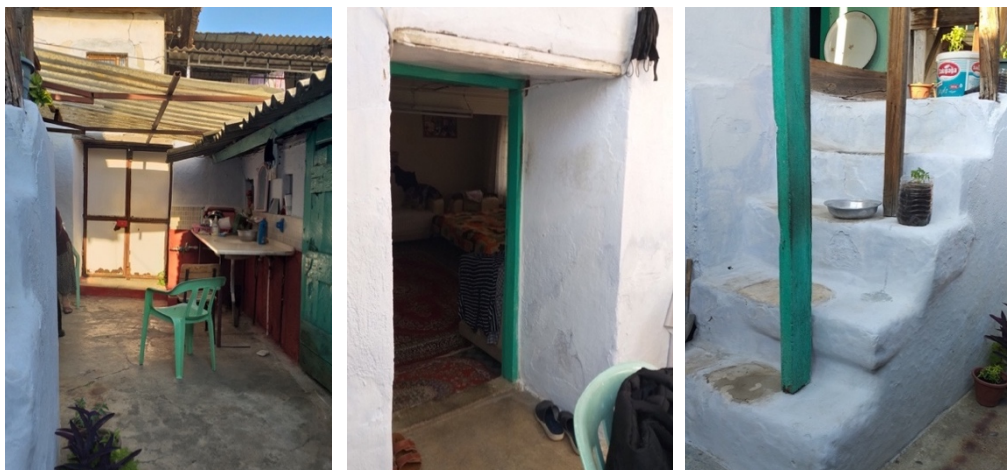
Figure 61 Case #9 House - Courtyard

The upper floor can be accessed through the stone stairs located in the courtyard. The upper floor has a narrow outer circulation space and a room that is currently used as storage. There is an *ocak* in this room.

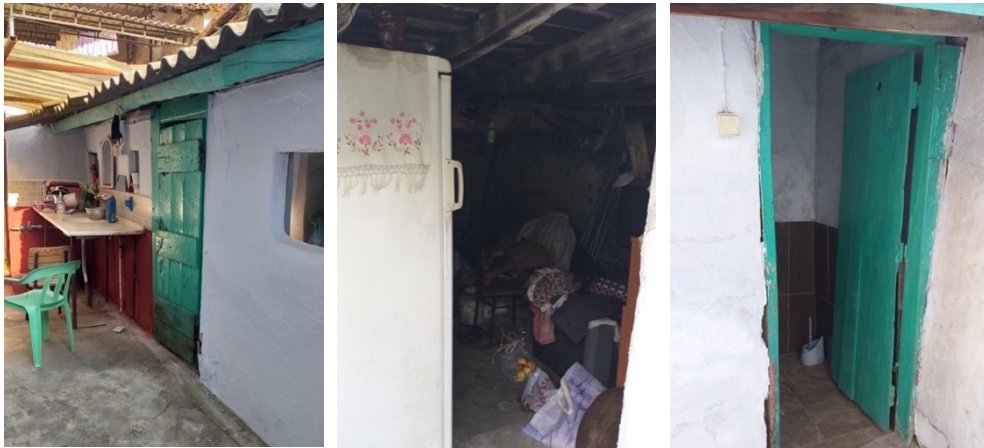
Figure 63 Case #9 House - Service Building

Overall, the main building is a two-storey partially plastered and painted building (white, street and courtyard facades) with stone masonry ground floor, and timber framed upper floor walls. The side wall of the outer circulation space was constructed later with reinforced concrete. The service building is a plastered and painted (white) single-storey building with brick infilled timber framed walls.

The service building consists of a storage and a bathroom, respectively. There is a sink in front of the service building. The storage is used for keeping the kitchen appliances and foods.

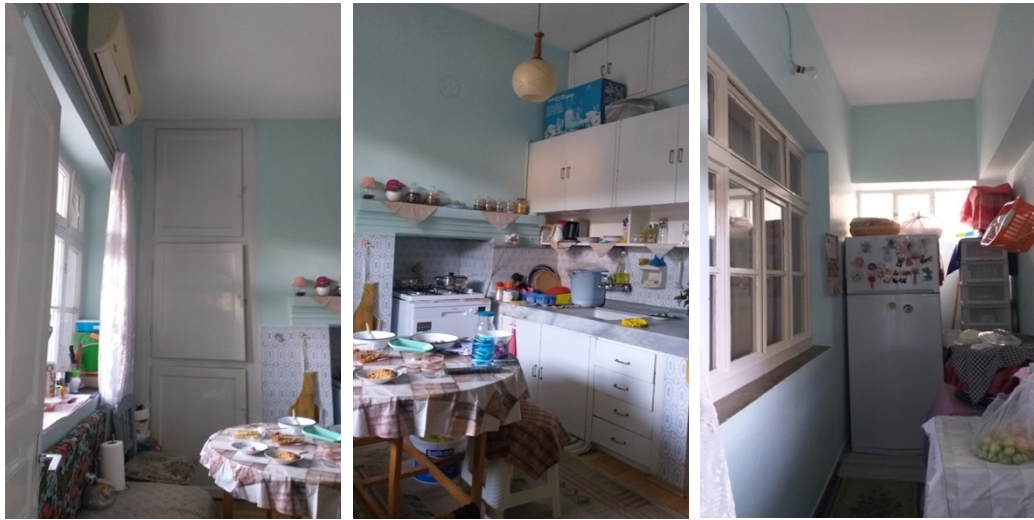
Figure 69 Case #10 House - Kitchen

The kitchen opens to the terrace. There are stairs on the terrace that lead you to the courtyard. The courtyard, located at the back of the building, is only accessible through the house. There is a pool in the courtyard, which is currently not in use.

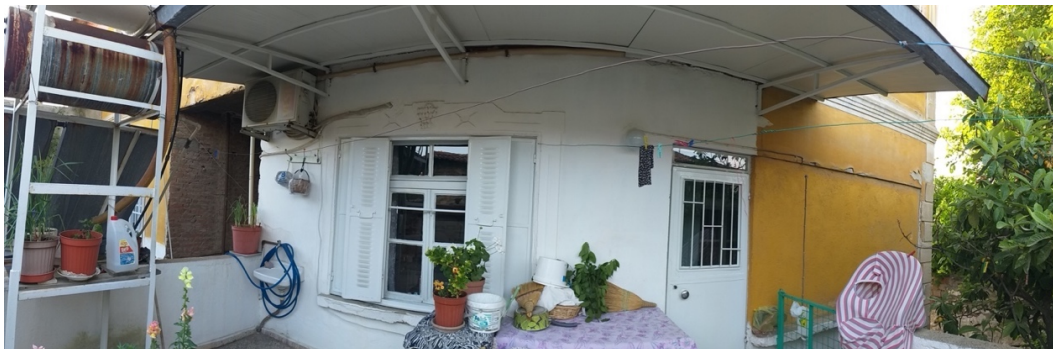
Figure 70 Case #10 House - Terrace

Overall, it is a two-storey plastered and painted (yellow) building with stone masonry basement and clay brick walls (all floors). The terrace was constructed with reinforced concrete.

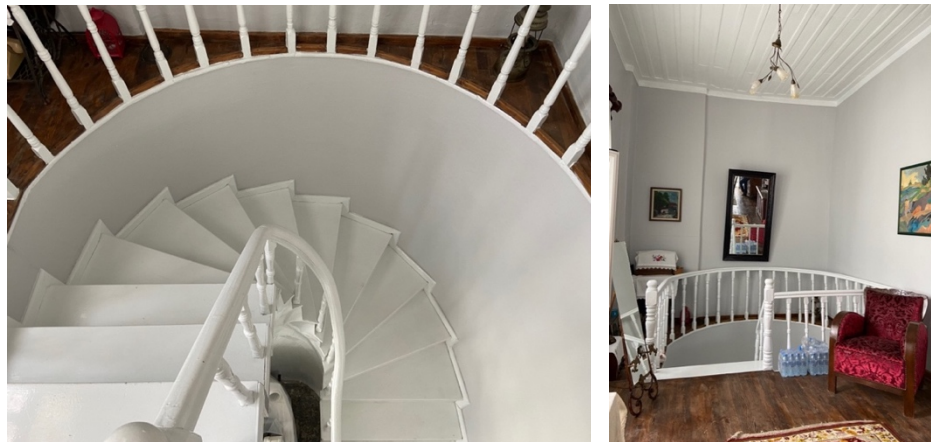
Figure 75 Case #11 House - Staircase

Upper floor is accessed through the stairs right across the entrance door. On the upper floor, there is a sofa, 2 bedrooms, a living room, a kitchen, and a bathroom. The bedrooms are located on the left side of the sofa, while the other spaces are on the right. Although not indicated by U11, the living room on the upper floor was merged with the sofa in order to create a larger living room.

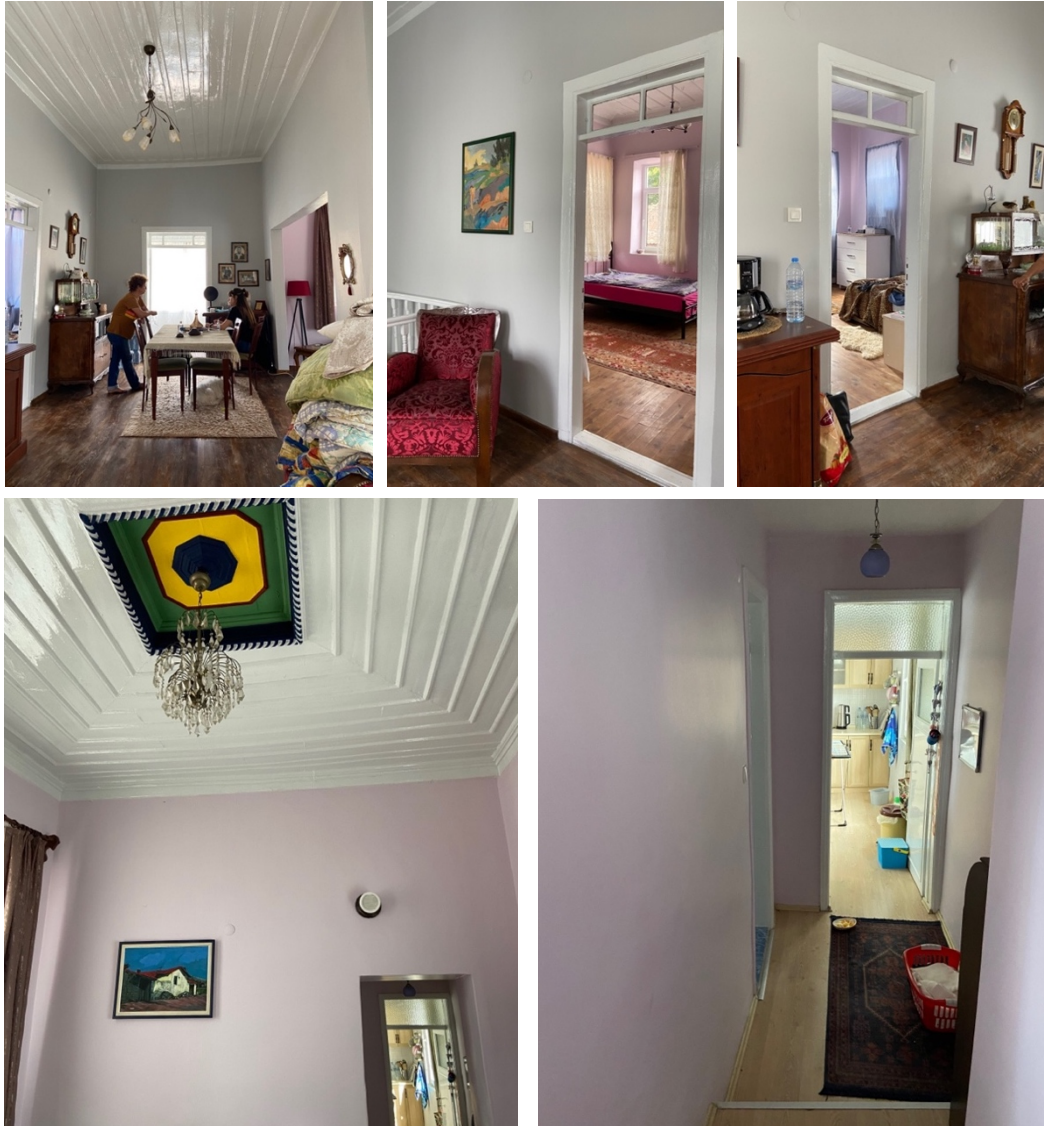
Figure 76 Case #11 House - First Floor - Sofa and Rooms

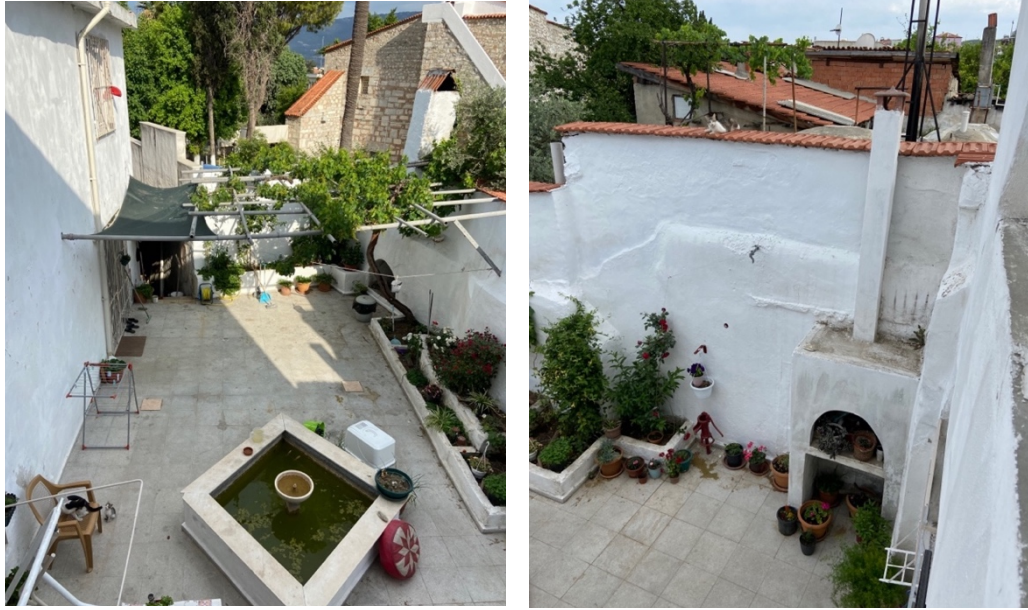
The courtyard is accessed through the sofa on the ground floor. It is partially covered with a pergola. There is a pool and an *ocak* in the courtyard.

Figure 77 Case #11 House - Courtyard

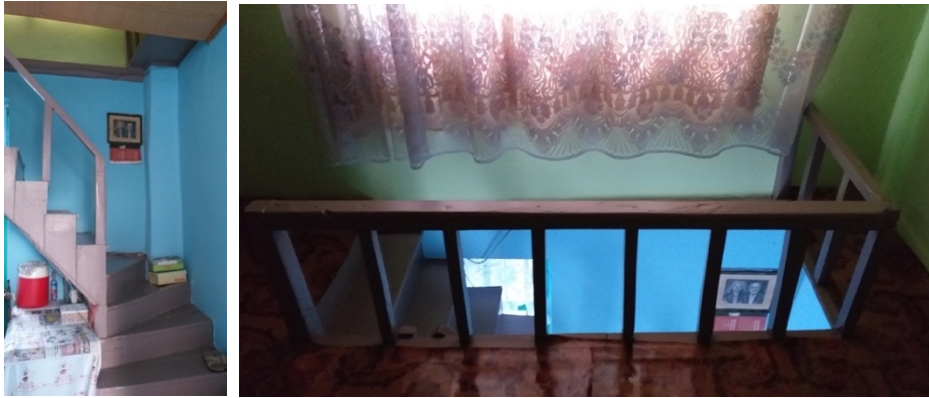
Figure 82 Case #12 House - Staircase

The upper floor is accessed through the stairs right across the entrance door. However, the upper floor is currently not in use due to inconvenience. There is a sofa, a room, and a terrace upstairs.

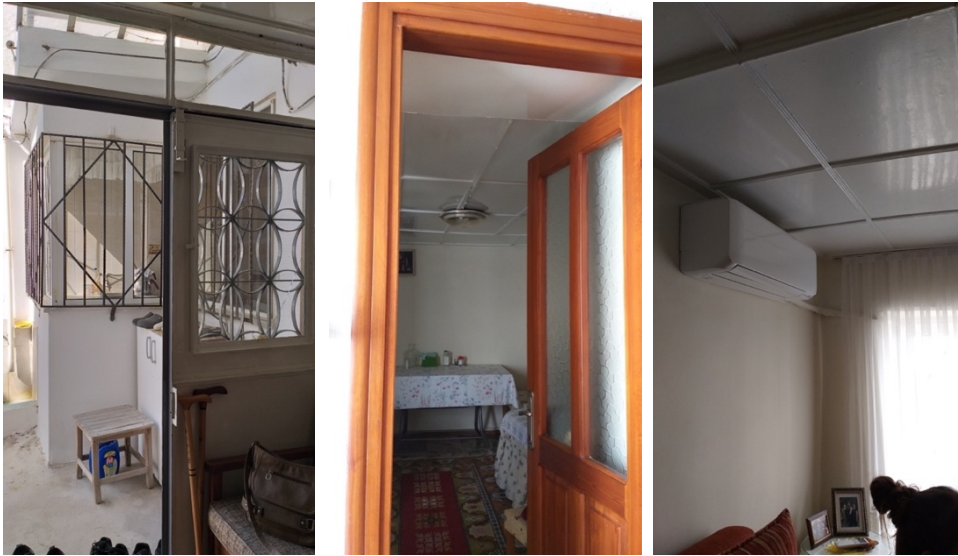
Figure 86 Case #13 House - Ground Floor - Rooms

On the ground floor of the main building, there is a sofa, a kitchen (to the left), and a living room (to the right). The kitchen was expanded with an additional structure, which can be seen from the courtyard façade. The upper floor is accessed through the stairs inside the house, at the sofa. There is a door at the beginning of the staircase in order to prevent heat loss. Also, there is a space under the staircase, which was used as a storage and a cellar.

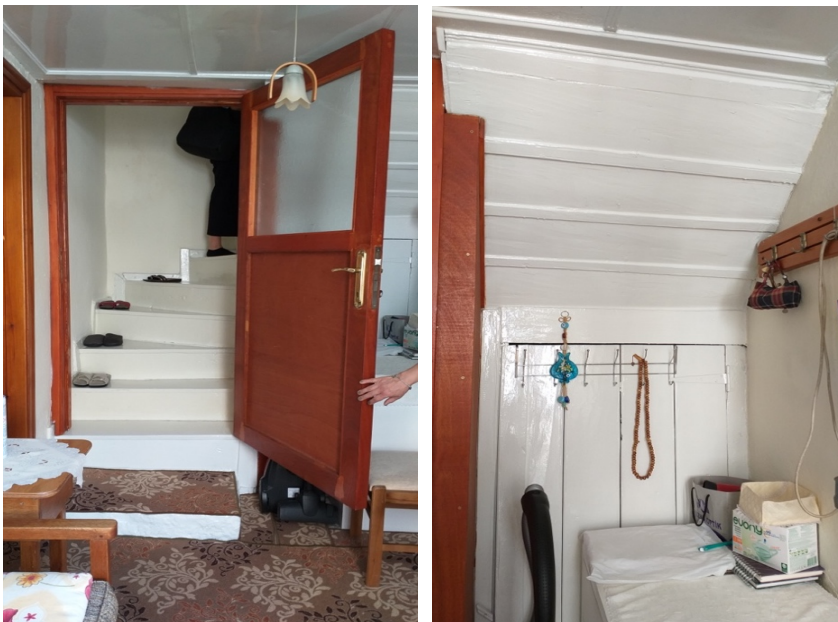
Figure 87 Case #13 House - Staircase

On the upper floor, there is a sofa and there are two rooms, one on each side. Currently, U13's parents do not use the upper floor since it is difficult for them to use the stairs and there is no bathroom on the upper floor.
