BY

SERA NAZ ERSOY

JANUARY 2023

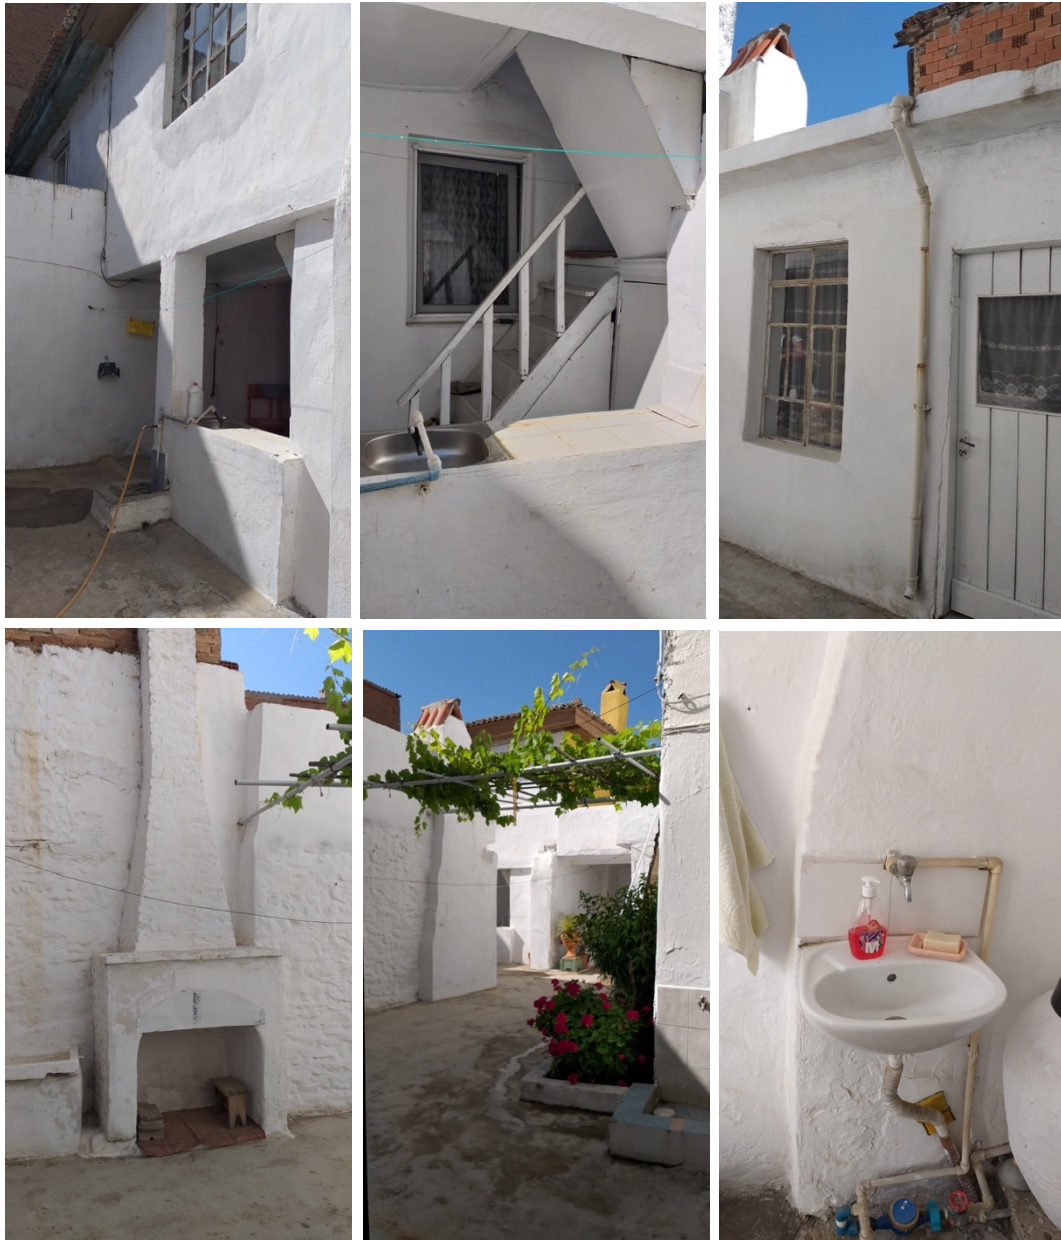
The other buildings in the courtyard, which are used as service buildings for storage purposes, are a part of a different lot. At the time, it was bought by U13's parents and all the buildings on these two lots formed a living space within a single courtyard wall. Also, there is a sink and an *ocak* in the courtyard.

Figure 88 Case #13 House - Service Buildings and Courtyard

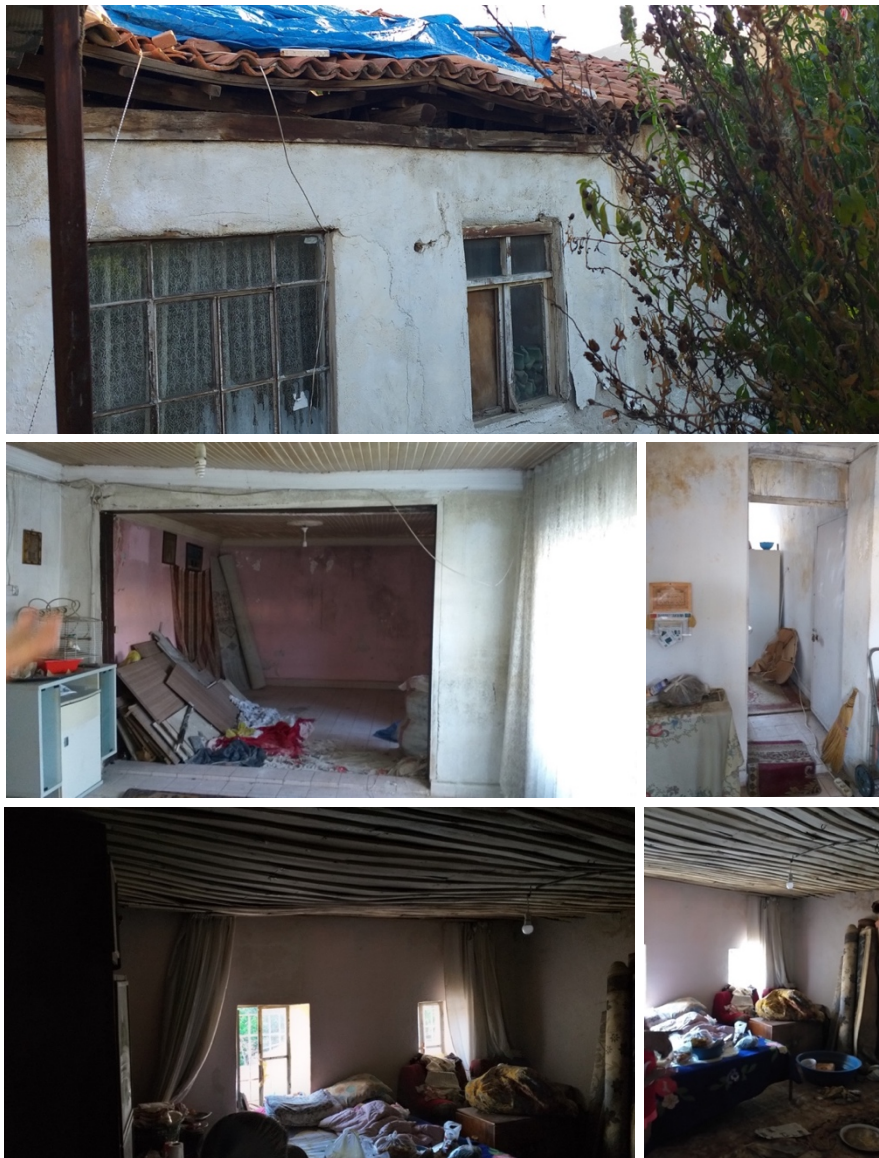
Figure 92 Case #14 House - First Floor

The service building connected to the main building is used as storage. There is also a structure adjacent to the main building, which used to be the toilet of this house. Currently, it is not in use.

- Kitchen and bathroom on the upper floor were added with reinforced concrete,
- The ceiling of the upper floor sofa
- The ceiling of the ground floor and the flooring of the upper floor was originally timber, but they have changed it with reinforced concrete since it was damaged,
- Posts were added in order to strengthen the building
- The *ocak* and the niches on the upper floor were covered since they were not used

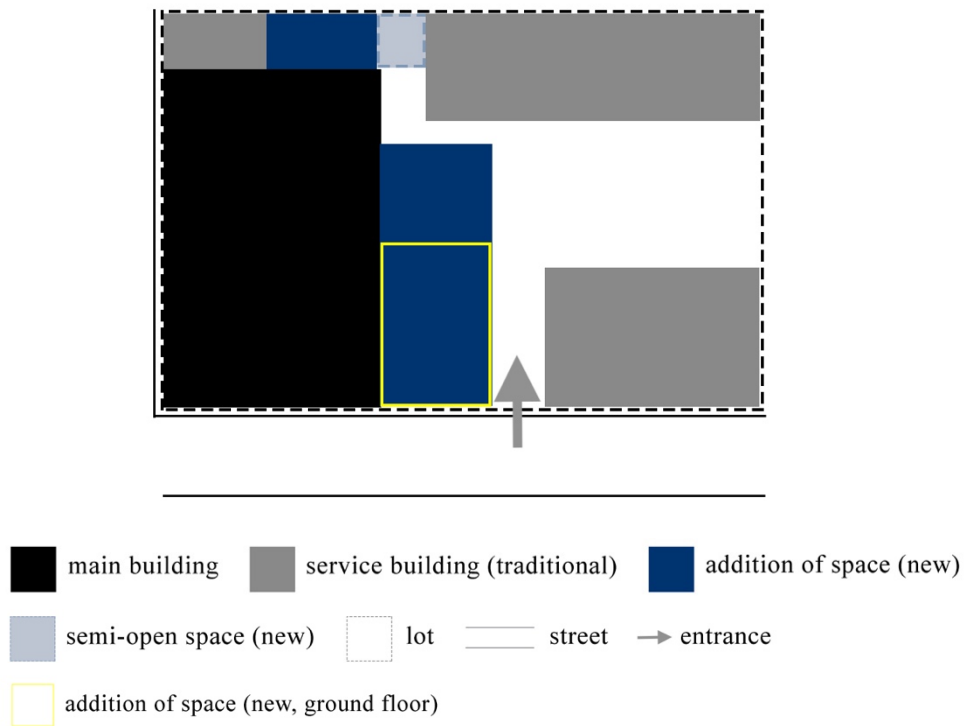
The main building is located on one side of the lot. The house is accessed through the courtyard. When entered the courtyard, the main building is located on the left, and there are two service buildings facing each other on the right.

Figure 94 Case #15 House - Organization of the Buildings on the Lot

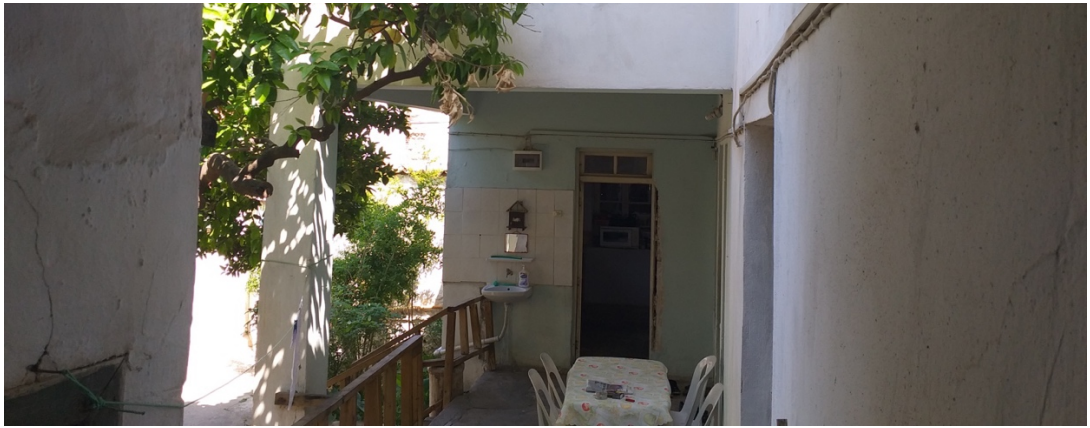
Figure 95 Case #15 House - Space Addition (Kitchen)

There is a platform-like space in front of the entrance of the house that is organized as an outdoor sitting area. To the left, there is an additional space, which is used as the kitchen and entered from outside. When you enter the house, you enter the sofa. There are two rooms on this floor, one on each side of the sofa. The one on the left

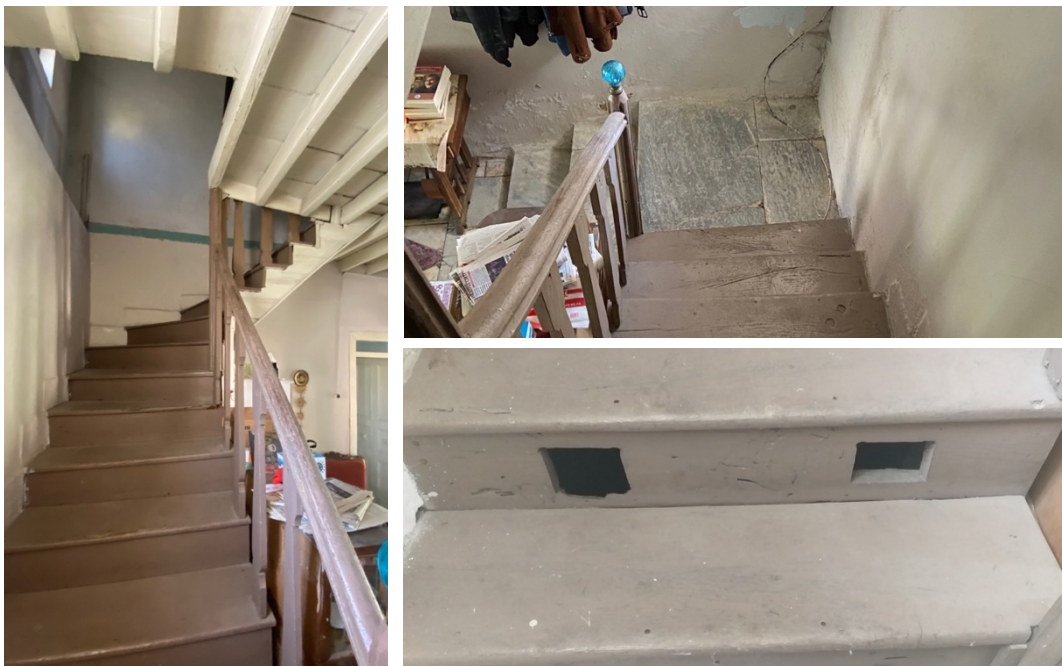
Figure 97 Case #15 House - Staircase

The upper floor can be accessed through the staircase located in the sofa, which has a cellar underneath. On the upper floor, there is a sofa surrounded by three rooms. The room across the stairs has access to a terrace, which was added later with the construction of the kitchen on the ground floor. The room on the left has an authentic cupboard with a *gusülhane* on one side and an *ocak* on the other. Currently, this room is used as storage. The other room on the right side of the stairs is a bedroom. It is learned that when U15 got married and moved to this house, her parents-in-law, sisters-in law, and she and her husband each had their own rooms. Currently, this floor is not frequently used, they use it as storage and a space to hang and dry clothes in winter.

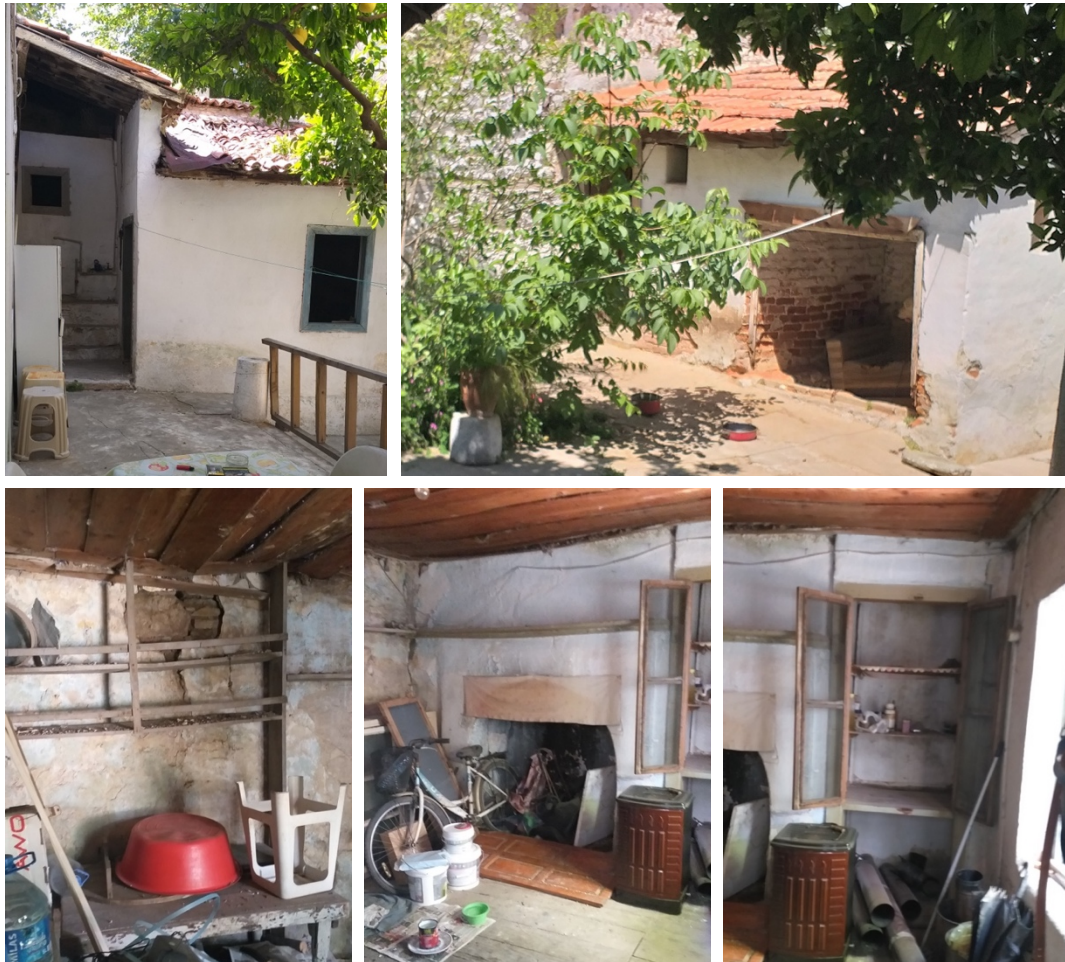
There are two service buildings in the courtyard, facing each other. One of them is located to the right of the courtyard entrance. This building was constructed later, and it is currently used as storage and a shelter for their dog. The other service building is connected to the main building with a roof, but it does not have an entrance from inside the house. This building has two rooms with separate entrances from the courtyard. The room that is closer to the main building used to be the kitchen with an *ocak* and the other was the laundry room where they used to set up a boiler stove and wash their clothes. Currently, these two rooms are used as storage.

Figure 100 Case #15 House - Service Buildings

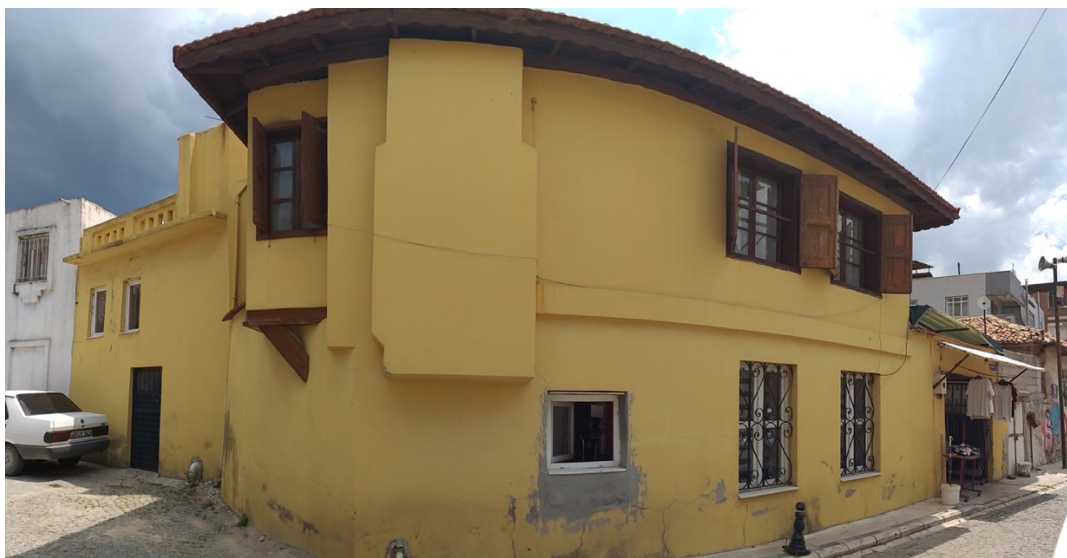
Figure 101 Case #16 House - Street Facade

Overall, it is a two-storey plastered and painted (yellow) building with stone masonry ground floor and timber framed upper floor with reinforced concrete interventions. Also, there is a triangular projection on the street façade, in order to use right angles on the upper floor. The service building is a single storey plastered and painted structure with brick walls.

It is learned that minor repairs were made every year. Also, they paint the house every 5 years. 10 years ago, they have made extensive changes in the house. Although the house could not be accessed, made changes were listed according to U16's statements and observations made from the exterior. Overall, the interventions are as follows:

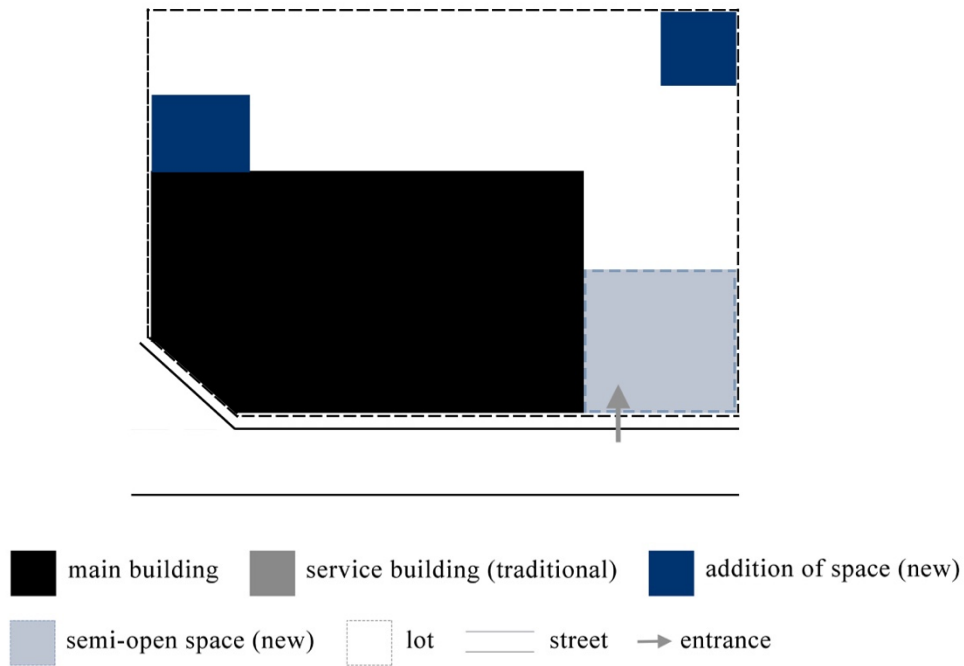
The building is located on the front of the lot, partially. The entrance to the house is through the shop (which was originally a part of the courtyard).

Figure 102 Case #16 House - Organization of the Buildings on the Lot

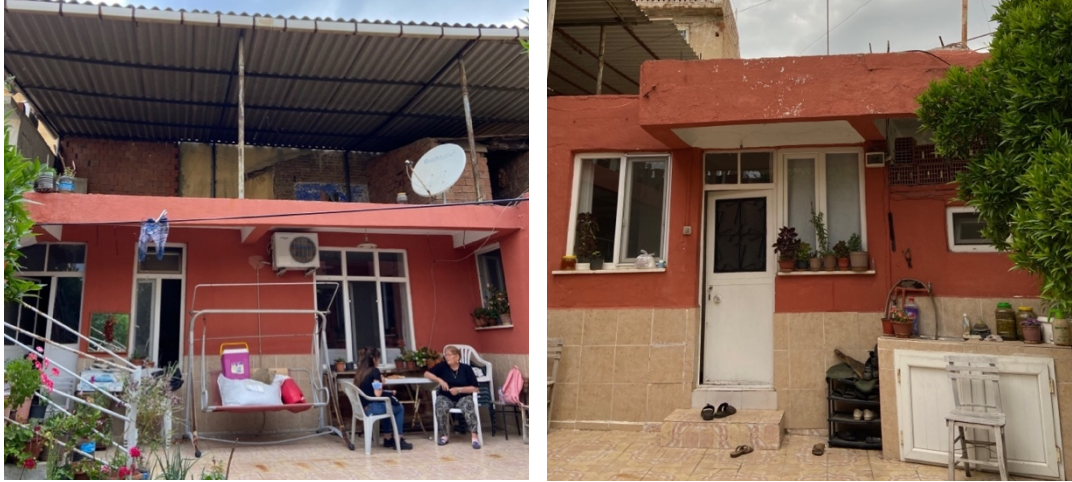
Figure 106 Case #17 House - Courtyard Facade

Overall, it is a two-storey plastered and painted (red) house with stone masonry sub-basement and reinforced concrete upper floors. The service buildings on the courtyard have stone masonry walls.

It is learned that minor repairs were made every year. Also, they paint the house every 4-5 years. They have renewed the bathroom (this year) and closed the well in the courtyard (16 years ago).
