Preliminary documentation of coseismic ground failure triggered by the February 6, 2023 Türkiye earthquake sequence

ABSTRACT

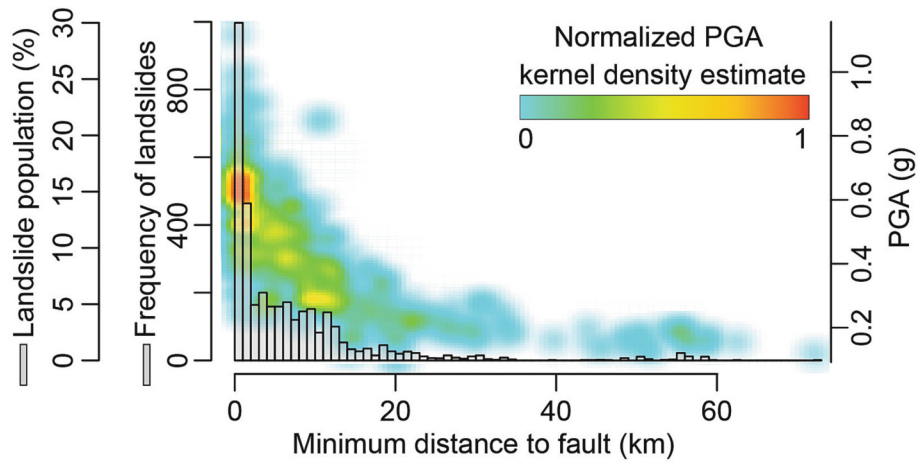
Fig. 6. Population and frequency distributions of landslides as a function of distance to the fault. The background colors show the kernel-density estimates of the PGA at landslide locations with respect to fault-rupture distance.

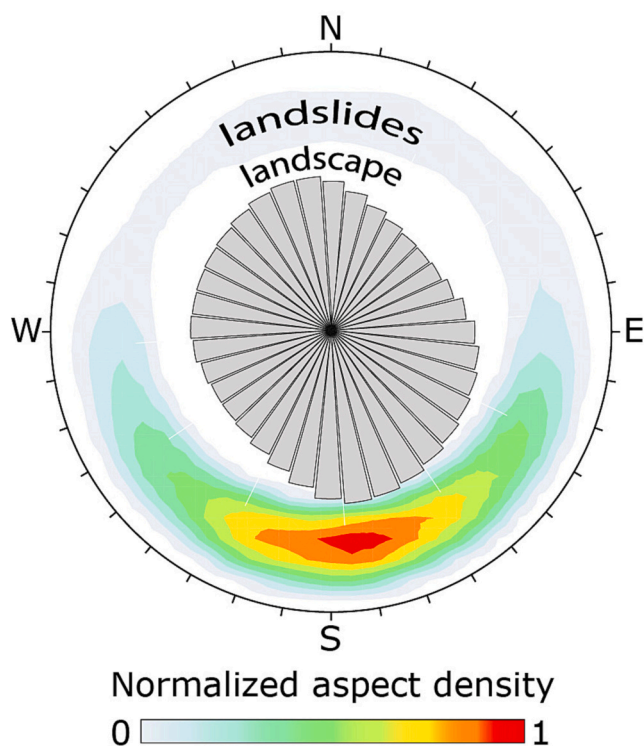
Fig. 8. Rose diagram showing the aspect distribution of coseismic landslides (contouring) and the landscape (binned rosette plot) in the examined area. (For interpretation of the references to colour in this figure legend, the reader is referred to the web version of this article.)

We also analyzed the slope-aspect distribution of failed hillslopes and the entire landscape. Results showed slopes of all azimuths with the greatest concentration in the NNW and SSE direction. Failed slopes faced primarily south (Fig. 8). This could be associated with differences in vegetation type and density that can result in higher causing a relatively high landslide susceptibility on south facing hillslopes in some semi-arid environments in the Northern Hemisphere (e.g., Li et al., 2021; Deng et al., 2022).

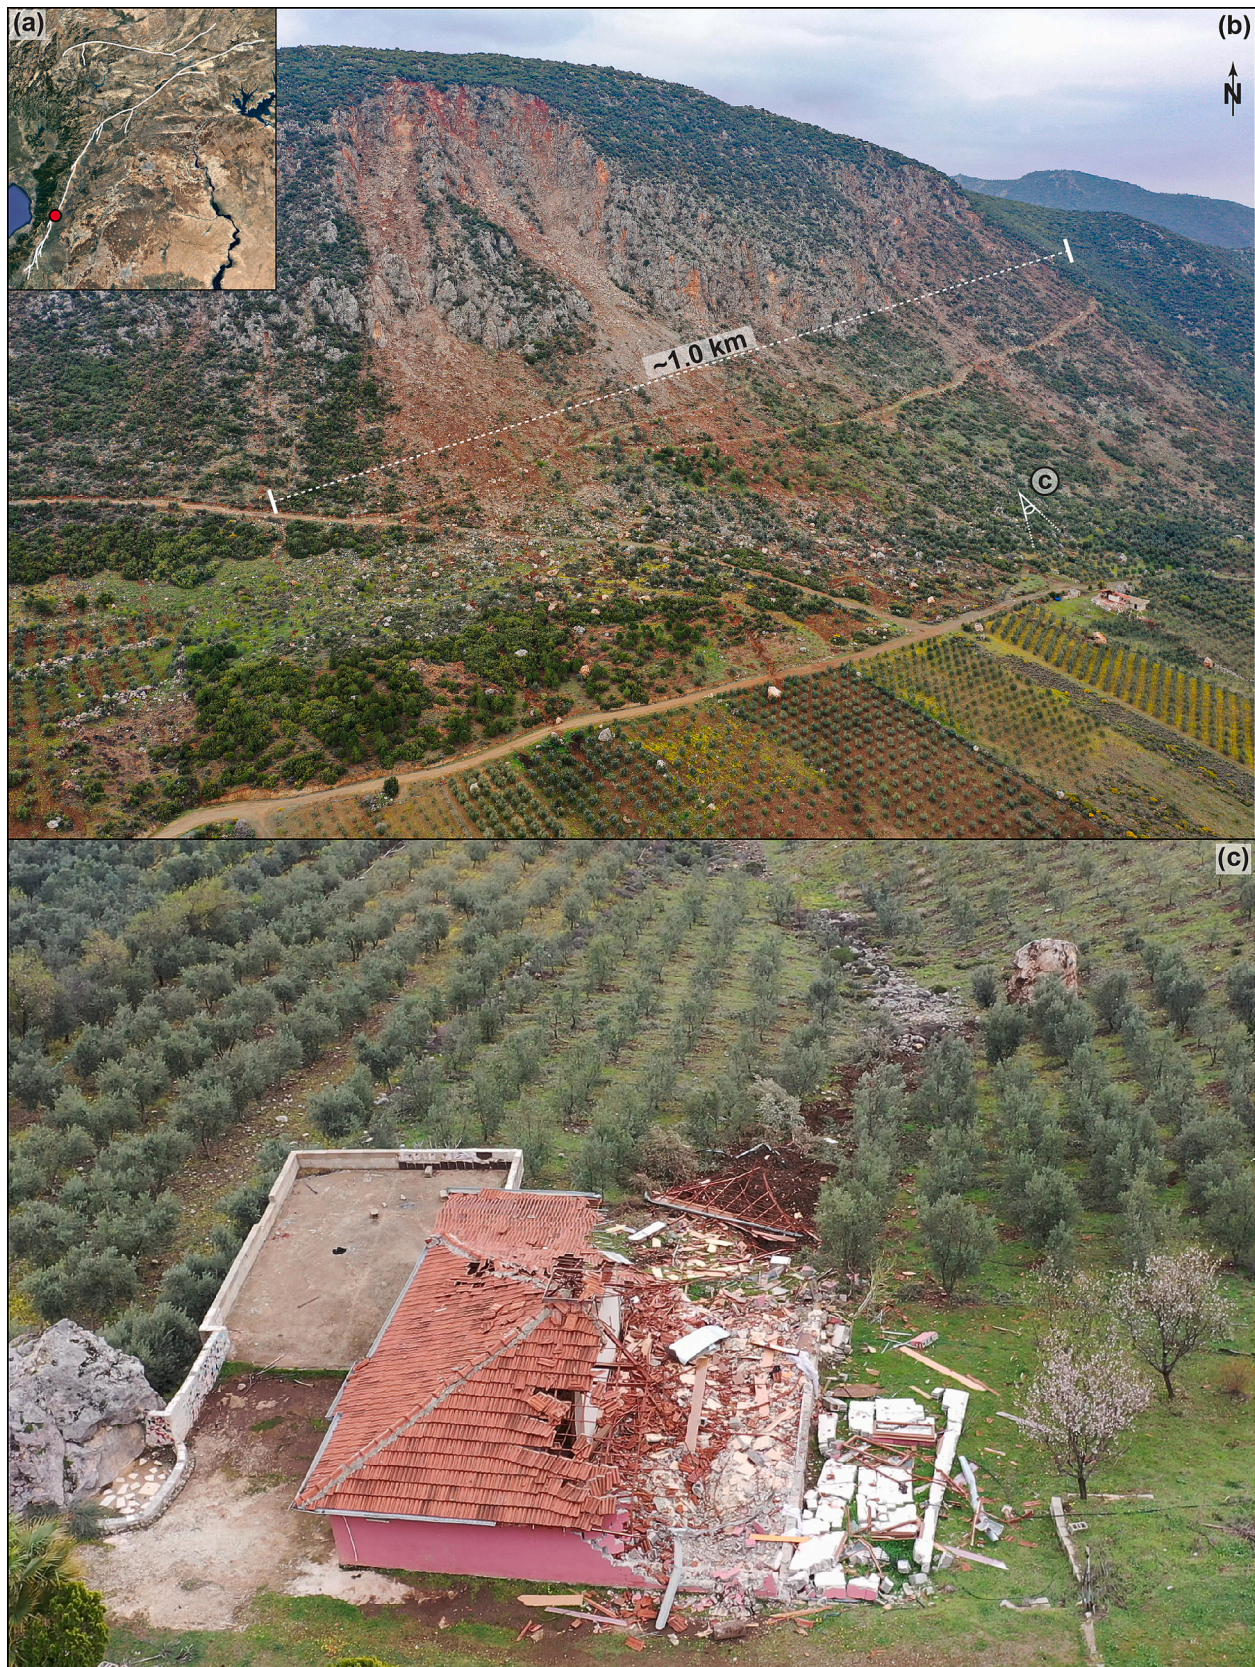
Fig. 10. Drone images showing an area affected by rock falls (lat: 36.67°, lon: 36.43°) near Kırıkhan, Hatay. The red point in panel (a) shows the landslide location. Panels (b) and (c) show the entire hillslopes exposed to rock falls and a house destroyed by a rock fall, respectively. The width of the hillslope was indicated in panel (b) as a bar scale. The viewing angle of panel (c) was indicated in panel (b). (For interpretation of the references to colour in this figure legend, the reader is referred to the web version of this article.)

Rock falls are the most abundant coseismic landslides in the study area. Most originated in limestone, and individual blocks were as large as six to seven meters in some areas. Some of these rock falls hit populated areas and caused financial losses and fatalities. Fig. 10 shows farmland and a house that were damaged extensively by rock falls. Some rock falls traveled as far as 600 m from their source areas.

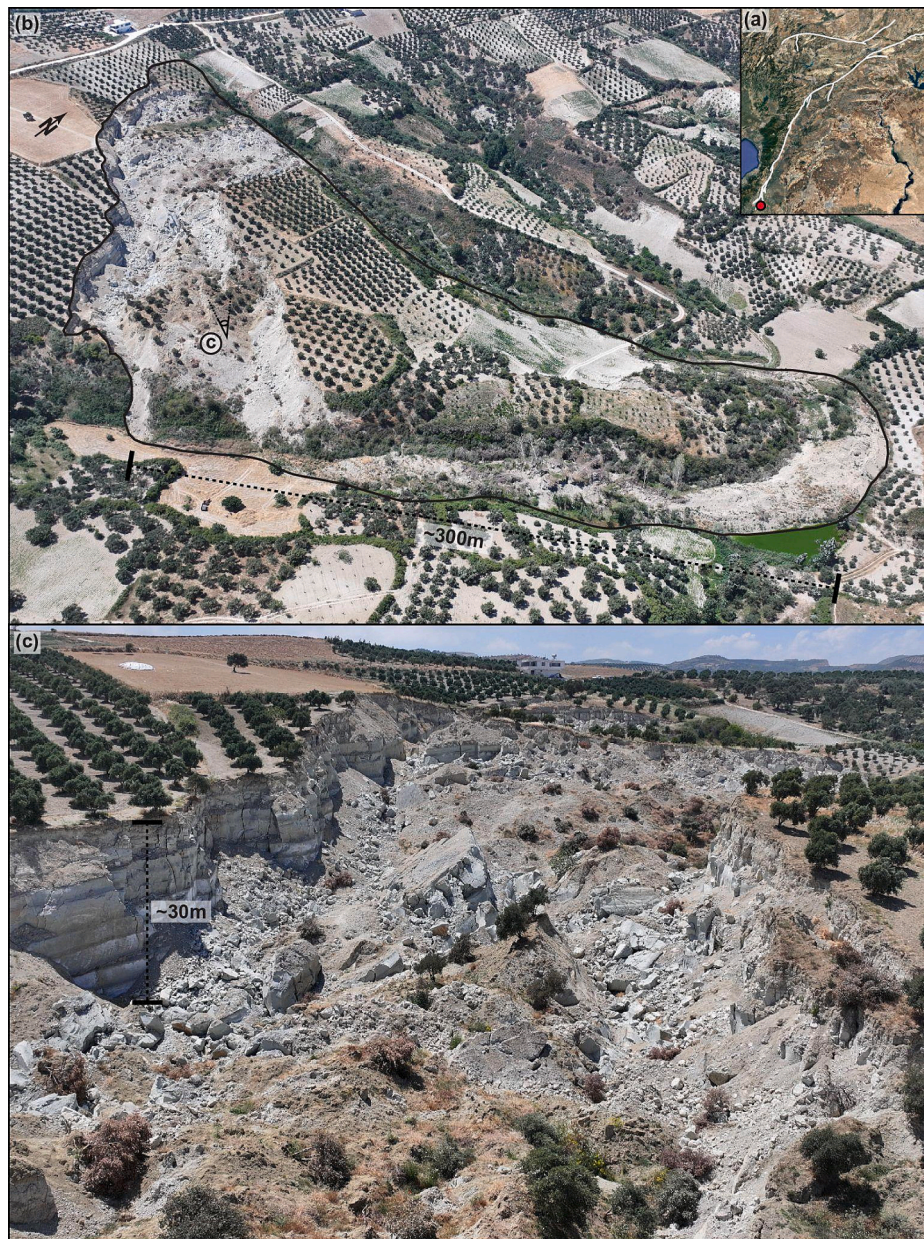
Fig. 12. Aerial photos showing the translational slide (lat: 36.16°, lon: 36.22°) triggered near Altınözü, Hatay. The red point in panel (a) shows the landslide location. Panels (c) and (d) show the entire landslide body and the crown of the landslide, respectively. The viewing angle of panel (c) was indicated in panel (b). (For interpretation of the references to colour in this figure legend, the reader is referred to the web version of this article.)

An example of translational landslide is in Tepehan village near Altınözü, Hatay. A landslide with an area of $\sim 1.3 \text{ km}^2$ occurred in marl and clay-rich limestone. The slide formed deep cracks along undulating hillslopes (Fig. 12). The thickness of the failure is 20 m, and the sliding basal surface is the upper bedding surface of a clay-rich limestone unit interbedded with marl, which is intensely weathered in the upper parts (Sümer et al., 2023).

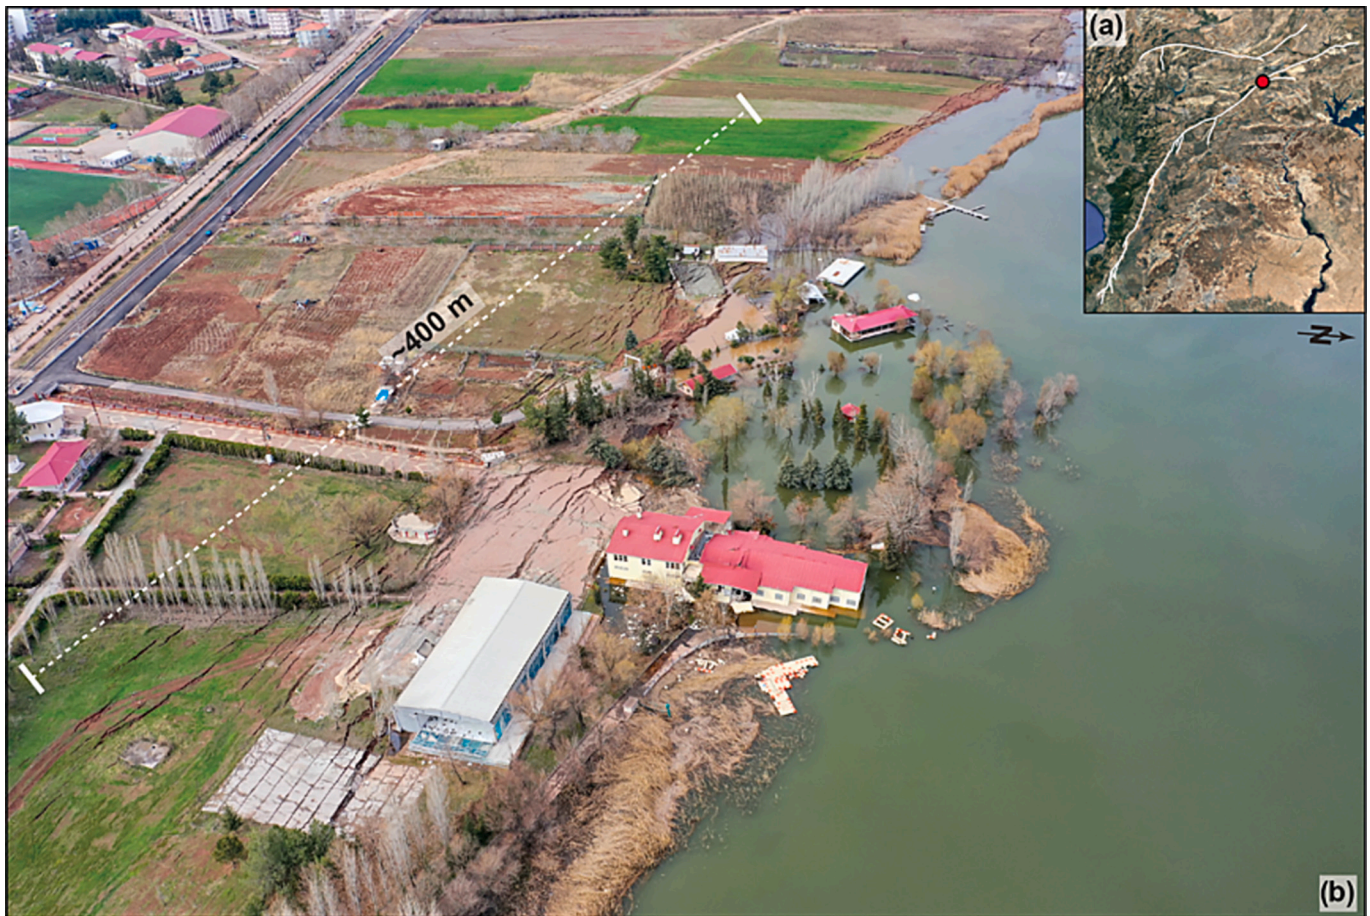
Fig. 13. Drone image showing an area affected by lateral spreading (lat: 37.79°, lon: 37.65°) near Golbasi, Adiyaman. The red point in panel (a) shows the landslide location. Panel (b) shows the area from the top with a bar scale. (For interpretation of the references to colour in this figure legend, the reader is referred to the web version of this article.)

province. This is because slopes in this area are gentler, and the soils are more loose and sandy (Taftsoğlu et al., 2023). Lateral spreading also occurred in some flat areas in the central sector but was not observed in the north where the slopes are steeper (Taftsoğlu et al., 2023). One of the most notable examples of lateral spreading in the central area occurred at Golbasi Lake, located in Adiyaman. In this case, the lateral spreading caused several buildings to collapse and sink into the lake (Fig. 13).

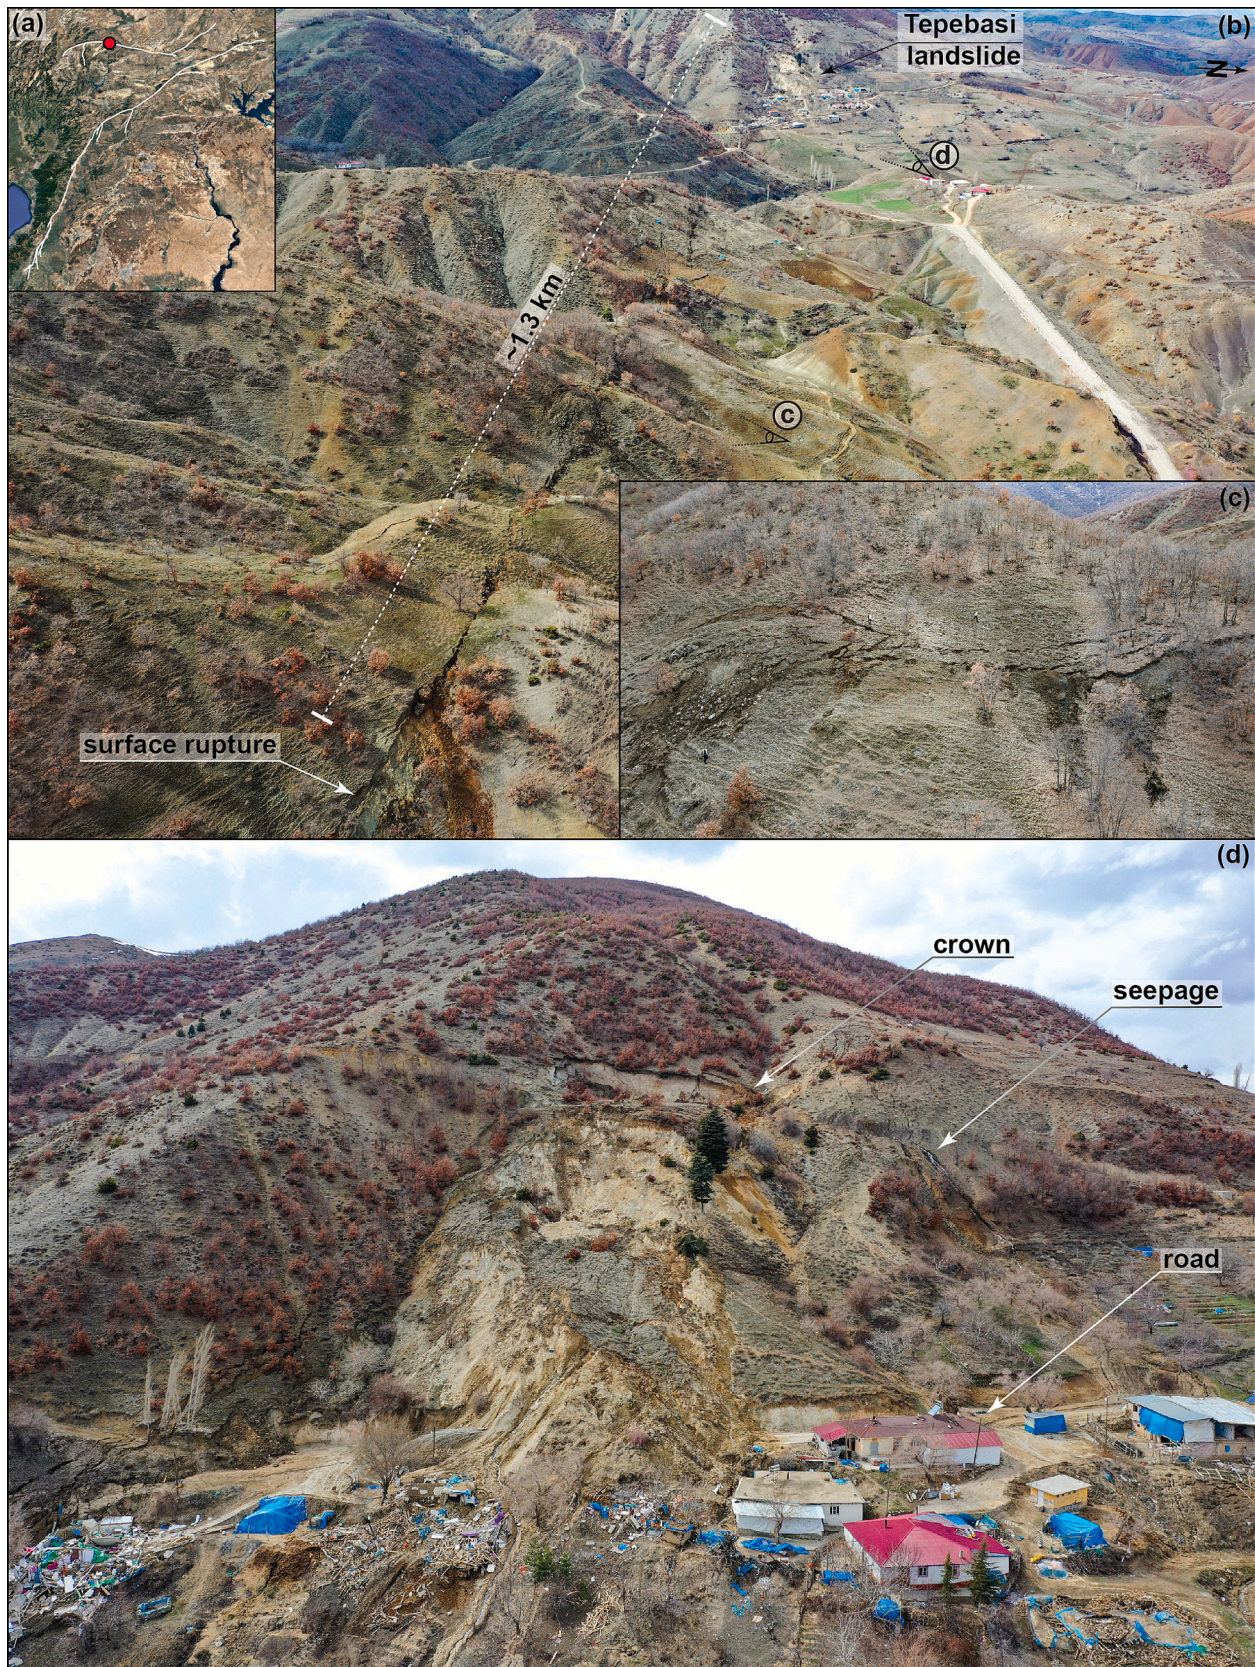
Fig. 14. Drone images showing a coseismic landslide occurred along the surface rupture (lat: 38.06°, lon: 36.99°) near Ekinözü, Kahramanmaraş. The red point in panel (a) shows the landslide location. Panels (b-c) and (d) show surface rupture and zoom-in view of landslide location, respectively. The viewing angles of panels (c) and (d) were indicated in panel (b). (For interpretation of the references to colour in this figure legend, the reader is referred to the web version of this article.)

The 0.5 km^2 Tepebasi landslide is an example of the destructive power of landslides triggered by this mechanism. The earth slide killed eight people and buried or damaged several houses (Fig. 14). It occurred in highly weathered volcanic rock. Drone images in Fig. 14 show how surface rupture extends just above the Tepebasi village and forms the upper part of the sliding surface.

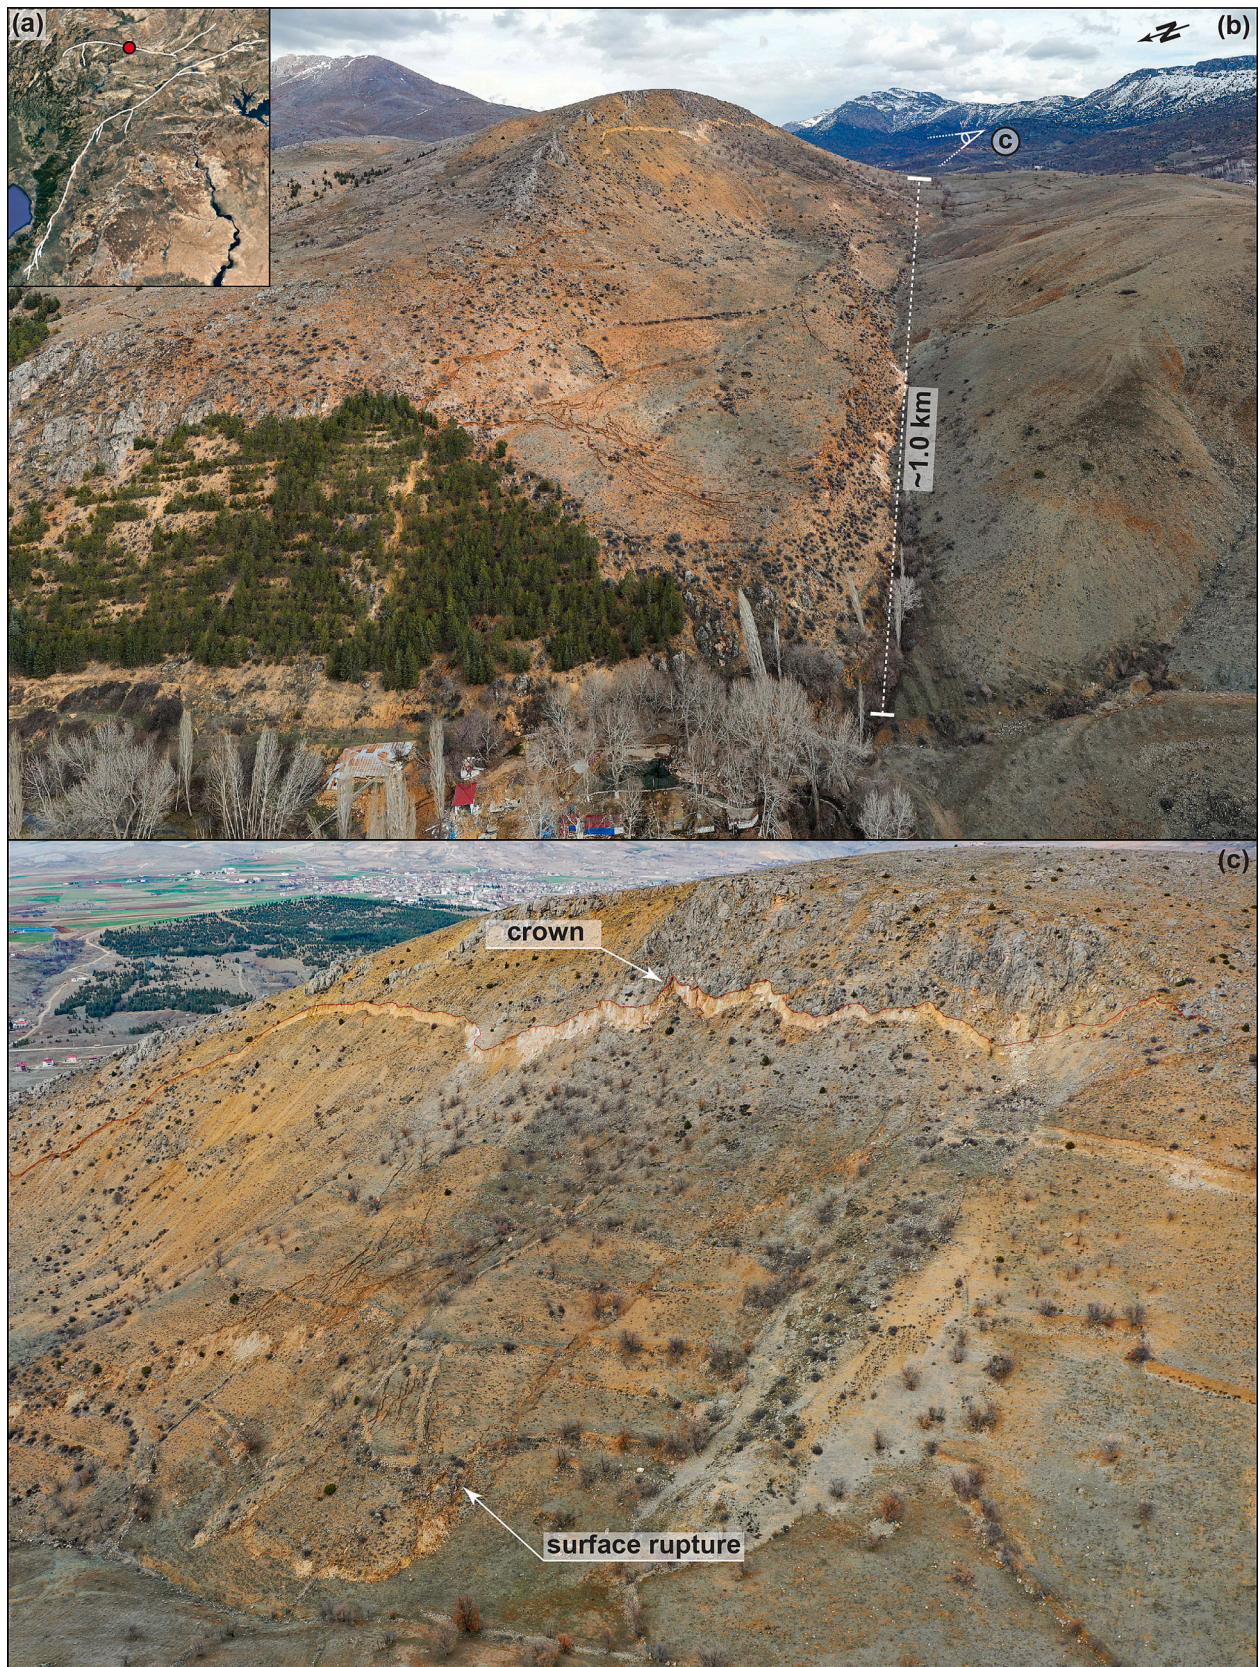
Fig. 15. An incipient landslide (lat: 38.03°, lon: 37.18°) near Ekinözü, Kahramanmaraş. The red point in panel (a) shows the location of the selected hillslope. Panels (b) and (c) show the landslide location from different angles. The viewing angle of panel (c) was indicated in panel (b) (For interpretation of the references to colour in this figure legend, the reader is referred to the web version of this article.)

formed in massive limestone units along ridges crests adjacent to the fault rupture. Fig. 15 shows the crown of an incipient landslide crossing the entire hillslope along ridges crests around the Ekinözü, Kahramanmaraş region close to the epicenter of the second earthquake. The vertical displacements along the crown reach up to a few meters, and some surface deformations were also visible toward the lower part of the same hillslope.

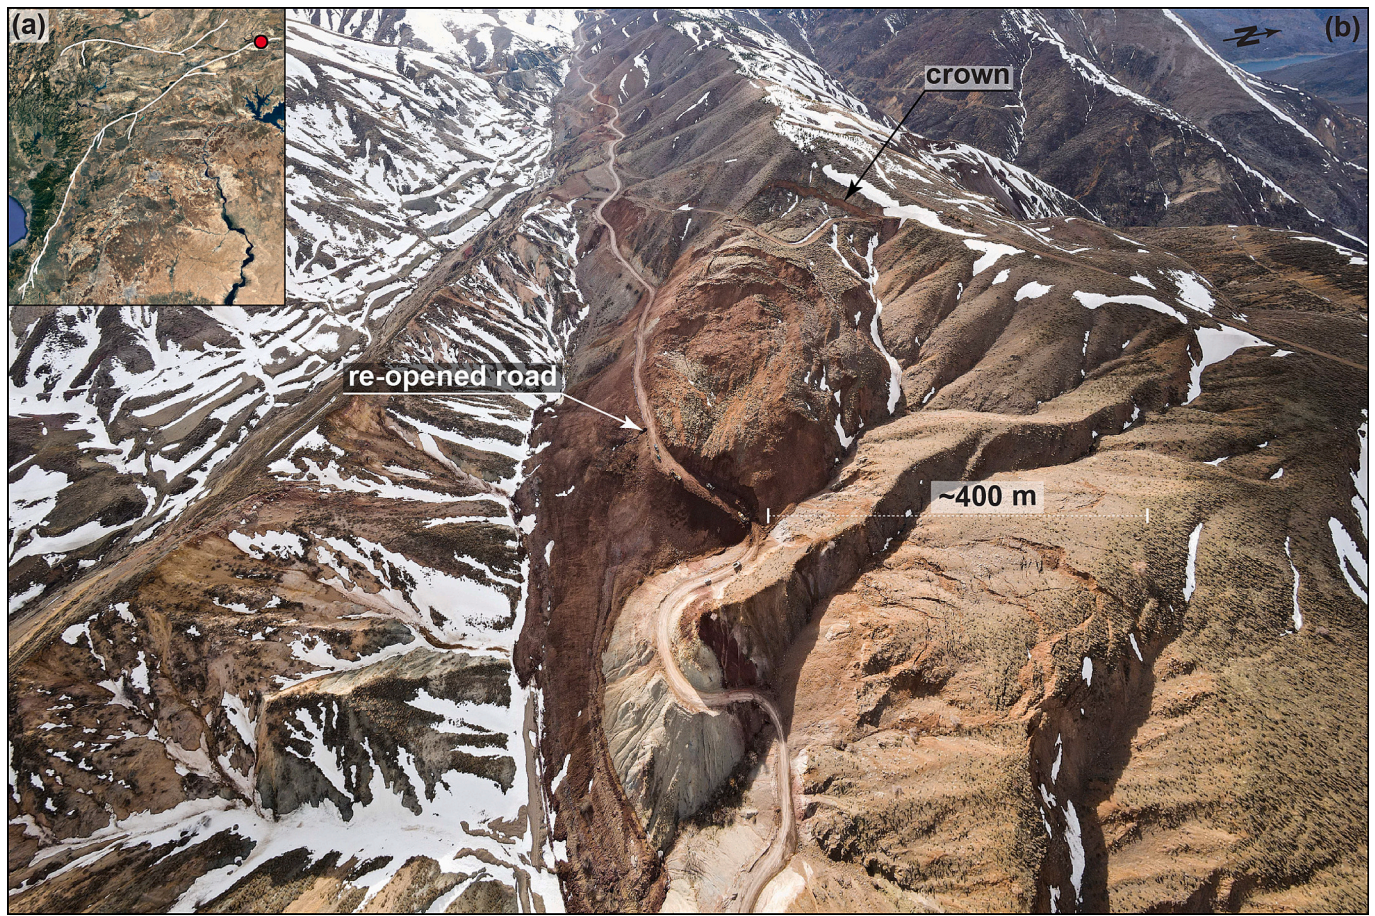
Fig. 17. View of the main road connecting the mountainous hamlets and district blocked by coseismic landslides (lat: 38.05°, lon: 38.36°) near Adiyaman. The red point in panel (a) shows the landslide location. Panel (b) shows the road, failed landslide and crown cracks. (For interpretation of the references to colour in this figure legend, the reader is referred to the web version of this article.)

g., Harp and Jibson, 1996; Kargel et al., 2016; Kieffer et al., 2006) hampering not only emergency response actions following the earthquake but also recovery in the post-seismic phase. A striking example that occurred in Çelikhan, Adiyaman, toward the northeastern edge of the first earthquake fault rupture, shows how problematic blocked roads can be. Many landslides were triggered in this area by the mainshock, some of them fatal. For instance, in Mutlu village (Çelikhan, Adiyaman) 49 people were killed by the compound effect of collapsed buildings and coseismic landslides. In this mountainous terrain, only two roads access Mutlu village, and both of those roads were blocked by landslides at several locations. Fig. 17 shows one of those road sectors blocked by a large coseismic landslide in highly weathered metamorphic rock. A ~500 m long section of the road was blocked on February 6 and remained closed until early March. Reopening the road took more than a month because the landslide body was still prone to reactivation, and thus removal of the toe material was difficult and risky. This hampered post-seismic disaster response operations.

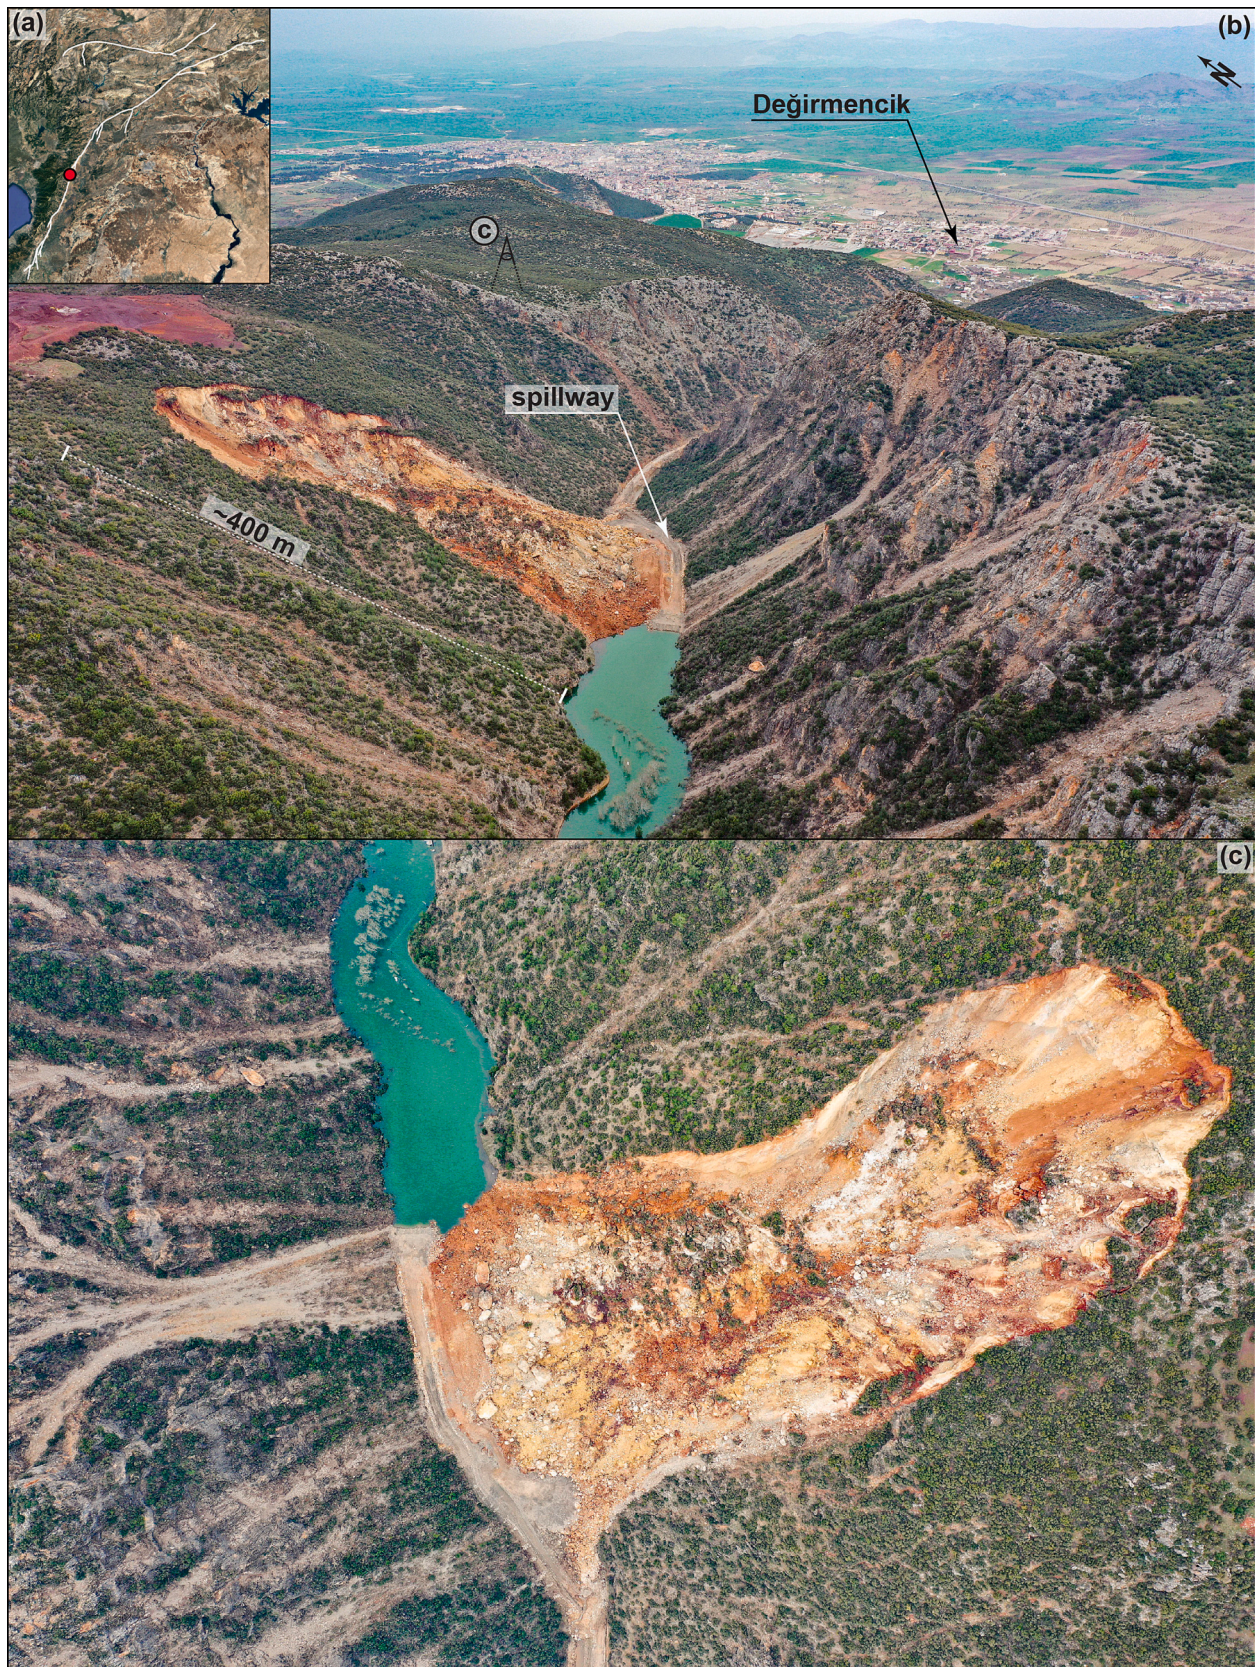
Fig. 18. Aerial photos showing an example of a landslide dam (lat: 37.00°, lon: 36.59°) near Islahiye, Gaziantep. The red point in panel (a) shows the landslide location. Panel (b) and (c) show landslide body from different angles. The viewing angle of panel (c) was indicated in panel (b). (For interpretation of the references to colour in this figure legend, the reader is referred to the web version of this article.)

mainshock, and water impounded rapidly behind the dam in the following month (Fig. 18). The General Directorate of State Hydraulic Works (DSI) opened a spillway on top of the landslide dam to reduce the lake level and prevent failure of the dam. However, a settlement downstream appears to be at risk from flooding if failure were to occur.

The rock slide that formed the dam is one of the largest (~1.2 km²) landslides in the south. Most landslides near the landslide dam are much smaller rock falls and shallow landslides. An open pit mine has been operating directly upslope of the failed hillslope for approximately the last 10 years, which might have influenced the stability of the slope that failed due to blasting operations.
