COMPARATIVE ANALYSIS OF  
MULTIPLE MACHINE LEARNING ALGORITHMS  
FOR POST-EARTHQUAKE BUILDING DAMAGE ASSESSMENT  
IN HATAY CITY FOLLOWING THE 2023 EARTHQUAKE

A THESIS SUBMITTED TO  
THE GRADUATE SCHOOL OF NATURAL AND APPLIED SCIENCES  
OF  
MIDDLE EAST TECHNICAL UNIVERSITY

IN PARTIAL FULFILLMENT OF THE REQUIREMENTS  
FOR  
THE DEGREE OF MASTER OF SCIENCE  
IN  
GEODETIC AND GEOGRAPHIC INFORMATION TECHNOLOGIES

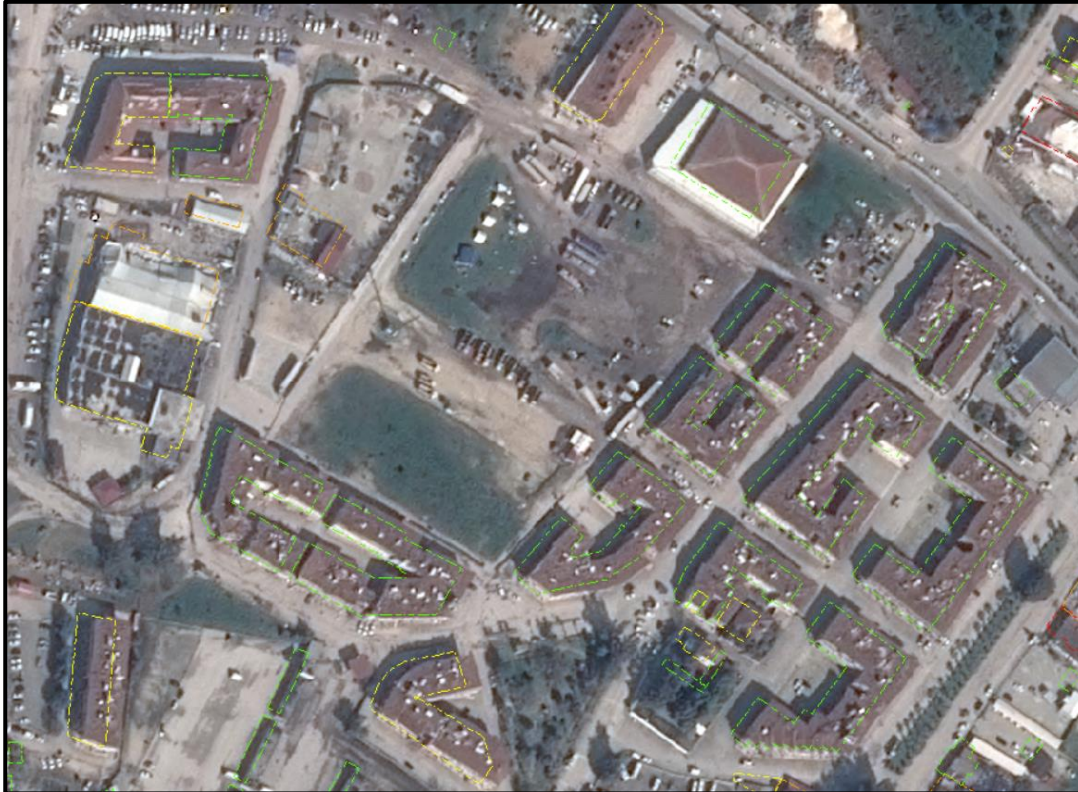
Figure 3.6. Pre-edit vector data where the vector data is not aligned with the buildings from the satellite images.

Since the Pleiades image is off-nadir, the building footprints do not match the buildings in the image; the vector data manually to be aligned with the buildings in the satellite image. Figure 3.6 and Figure 3.7 show the pre and post-edited vector data, respectively.

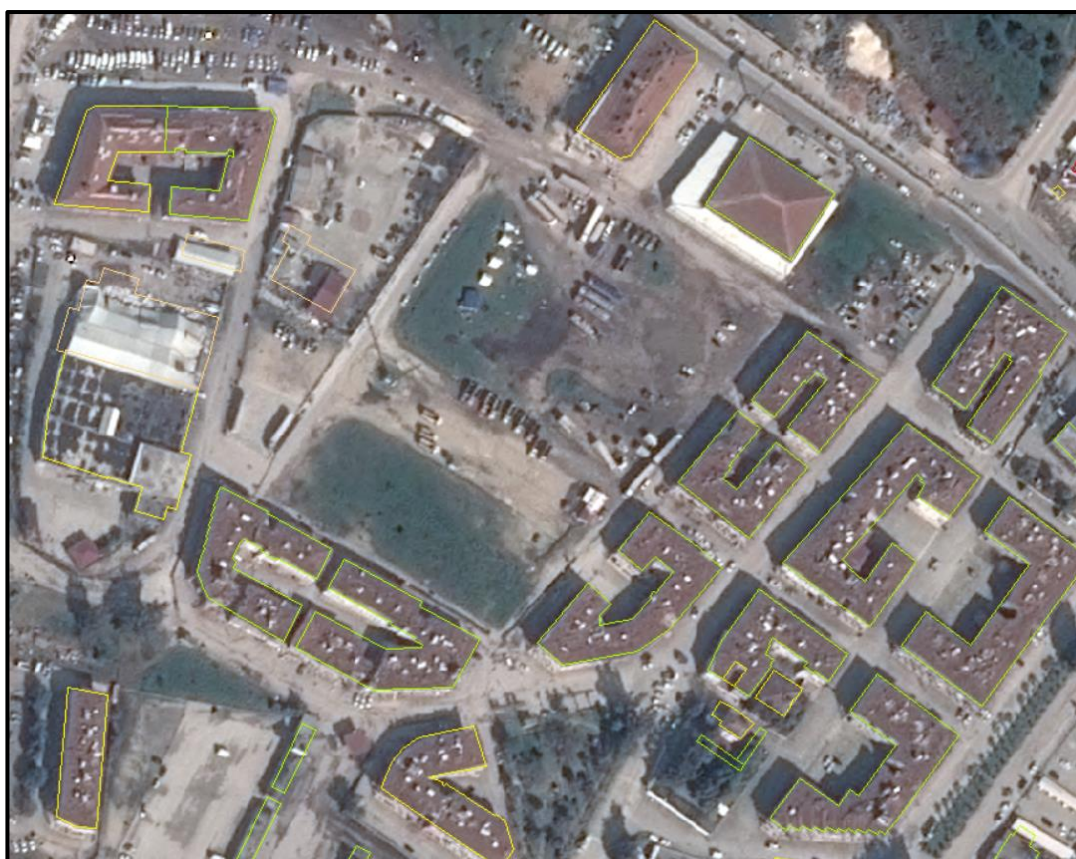
Figure 3.7. Post-edited vector data where the satellite image and vector data building footprints match.

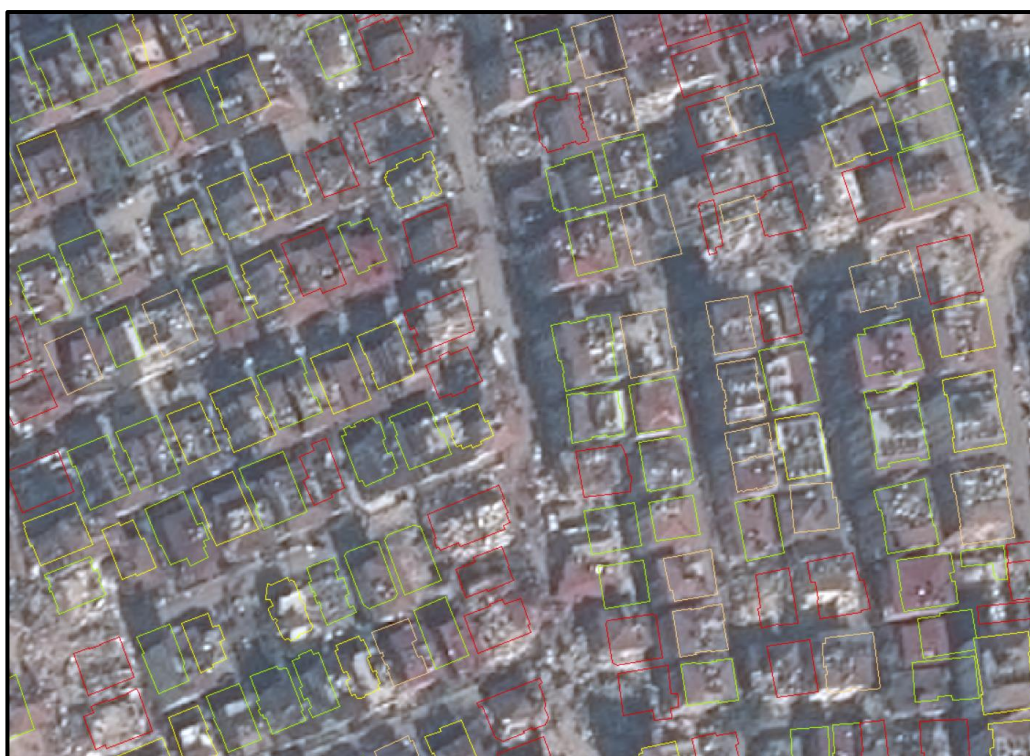
Figure 3.8. Part of the study area shows the density of buildings where shadows cannot be detected individually.

The primary objective of the research is to leverage the intricate relationship between the shadows cast by damaged buildings and their surroundings, particularly in the context of multi-story structures. Specifically, the study aims to discern distinctive patterns and cues within building shadows, exploiting them as vital indicators for identifying and delineating damaged polygons. Notably, collapsed buildings are anticipated to exhibit an absence of shadow due to their structural failure, contrasting with intact structures that maintain discernible shadow features. This approach underscores the significance of shadow analysis as a pivotal tool in detecting and characterizing damaged building footprints. As highlighted by previous research by (Turker and San, 2004), the resulting polygonal representations of buildings, derived from shadow cues and stored within Geographic Information Systems (GIS) as vector polygons, serve as invaluable assets for comprehensive disaster management and urban planning endeavors. Unfortunately, in this case, it can be seen that while some areas have a low density in means of buildings where the shadows can be extracted, most of the study areas for this research do not meet the feature criteria for the building features. Therefore, extracting the building's footprint vectors from the shadows is not feasible, as mentioned in the cited articles. This situation is presented in Figure 3.8.

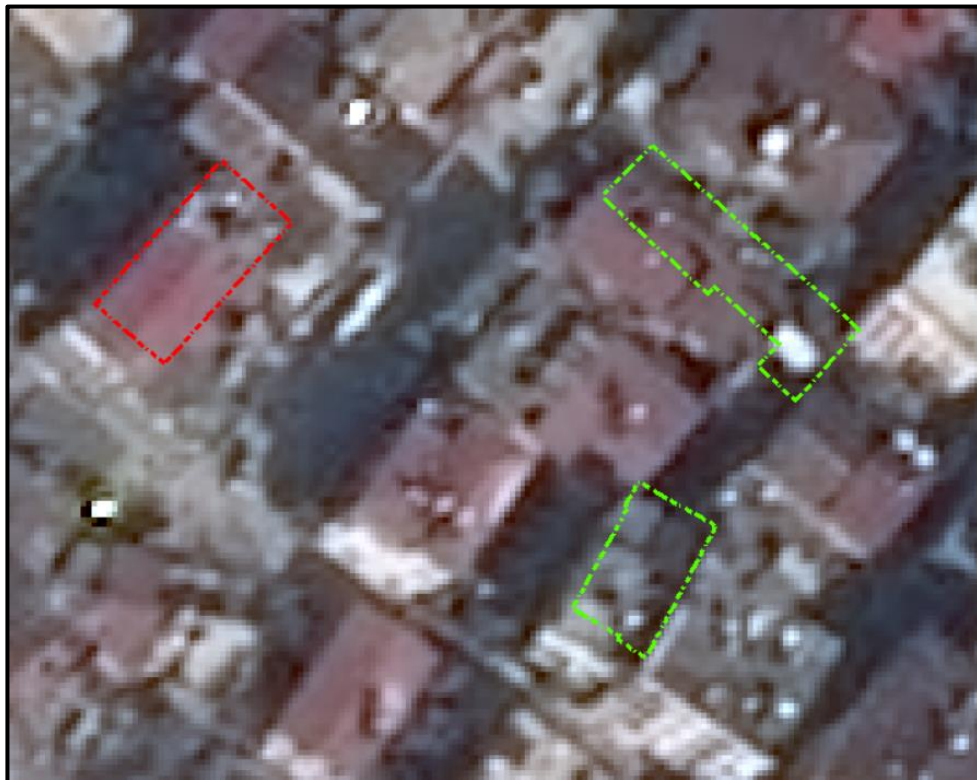
Figure 4.45. True positive (green) and true negative (red) examples of uniform building reflectance.

The study area's southeastern region comprises buildings close to each other, and shadows from nearby hills add complexity to the analysis. It becomes apparent that the footprint of each building aligns directly with the roof, which is visible in satellite imagery. This trend is consistent throughout the study area. The uniformity in the reflectance of building footprints significantly influences the classification results of the ML algorithm. Figure 4.45 provides visual examples of both true positive and true negative classifications.

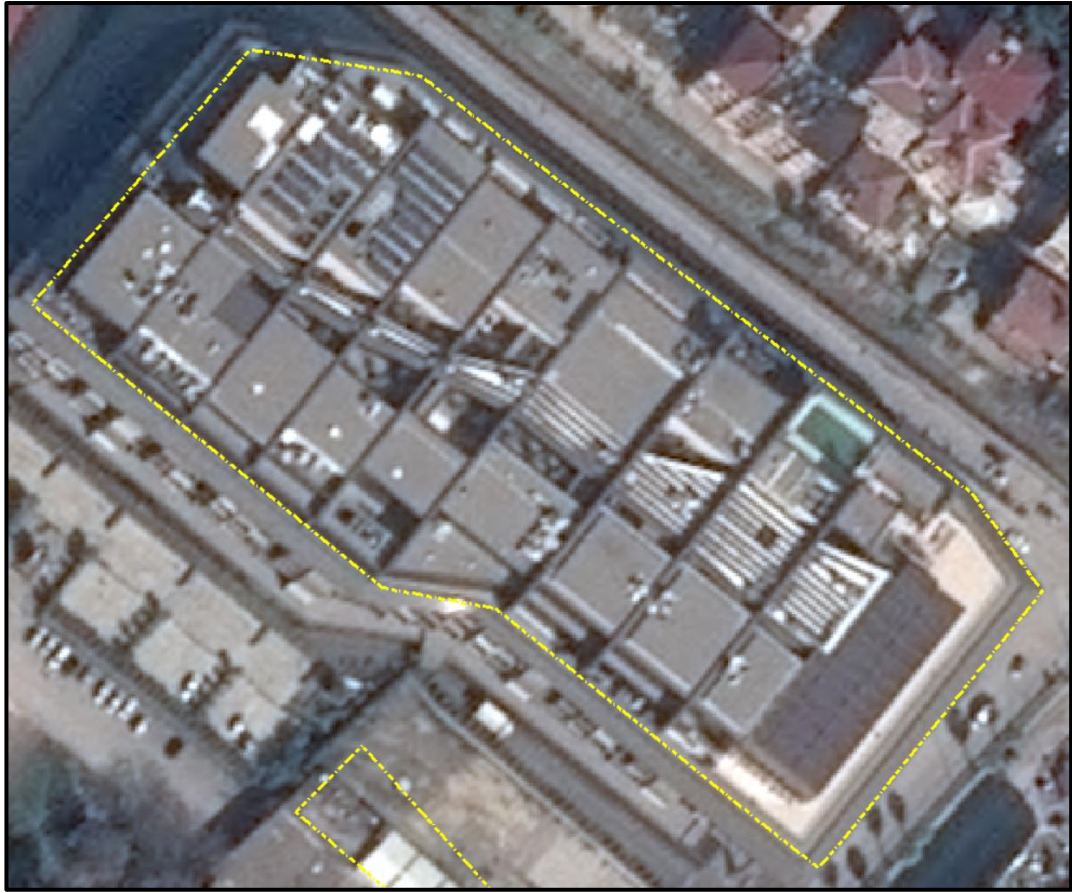
Figure 4.47. Large area building with non-uniform building footprint reflectance.

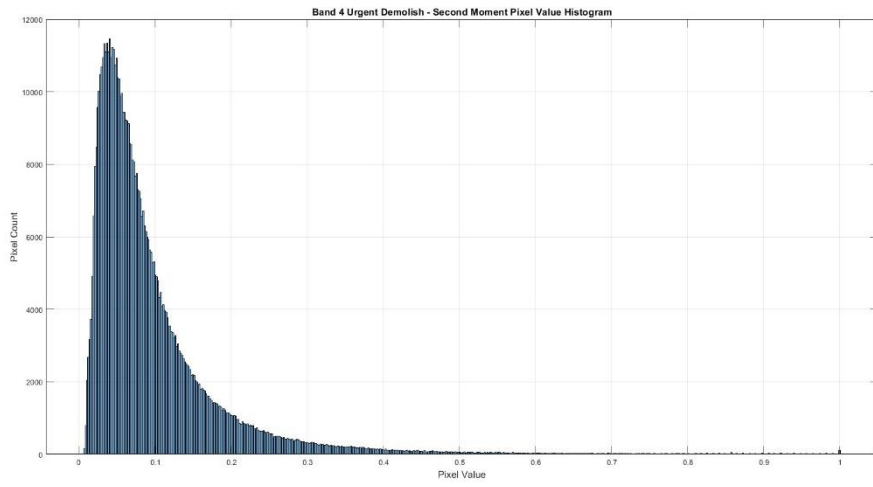
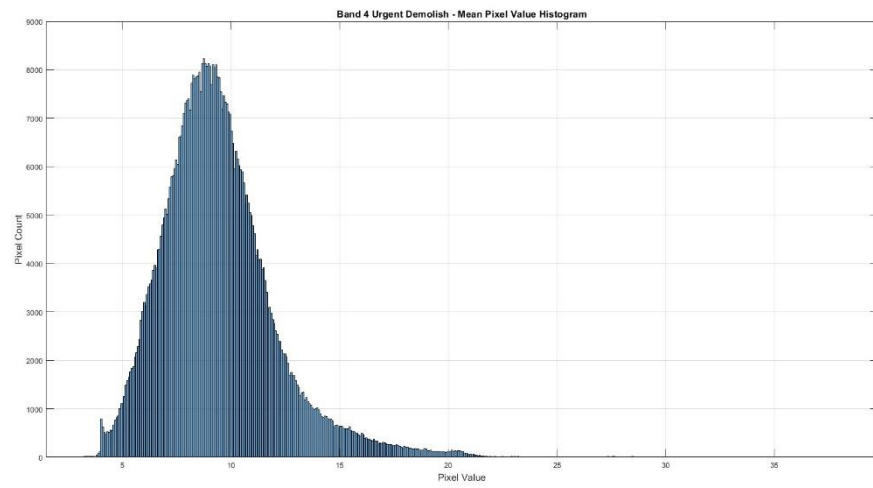
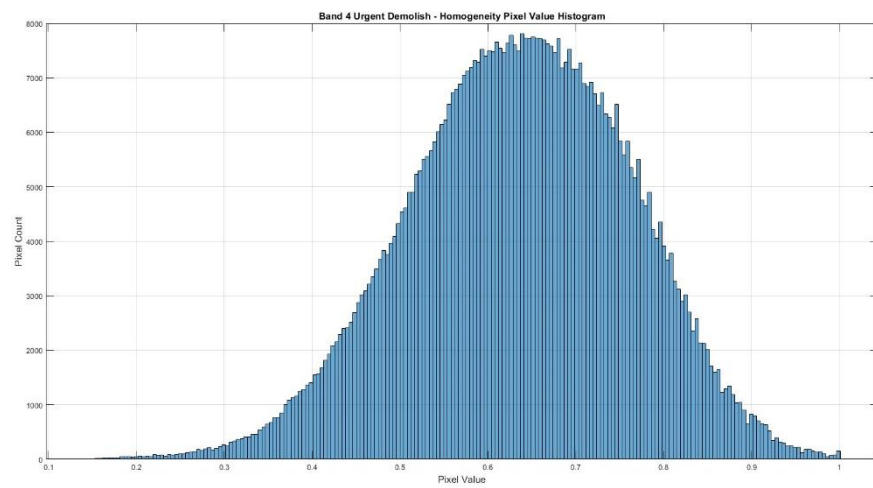
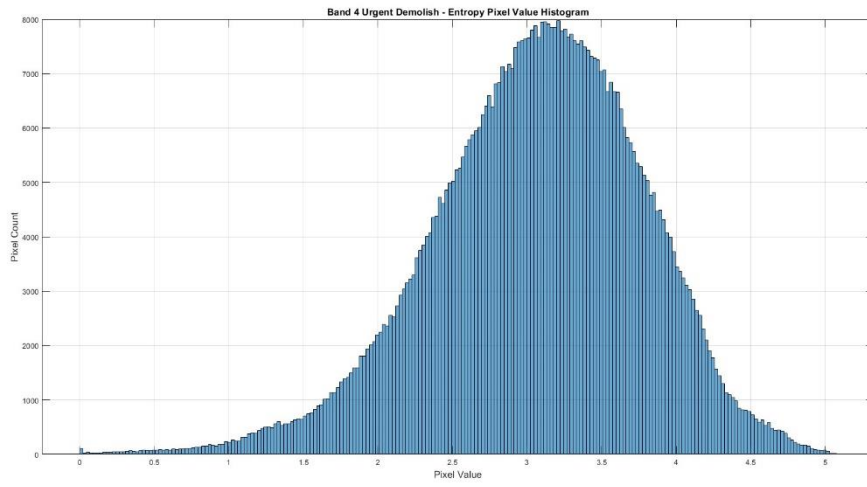
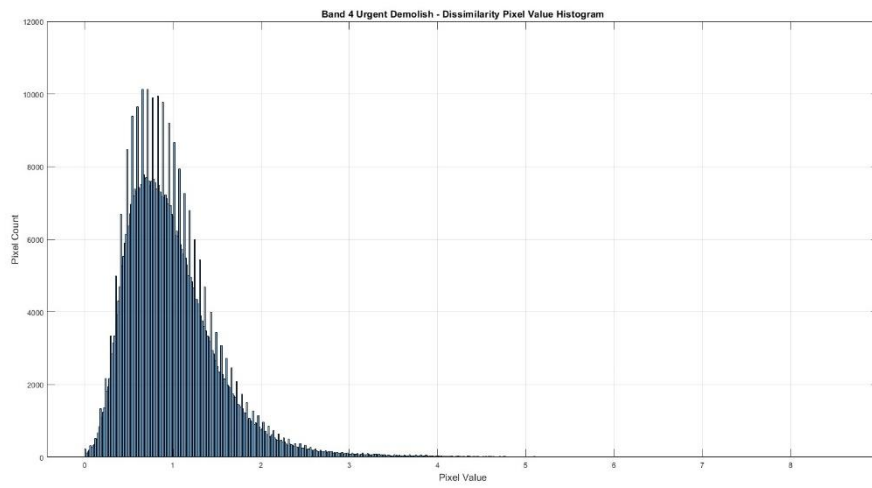
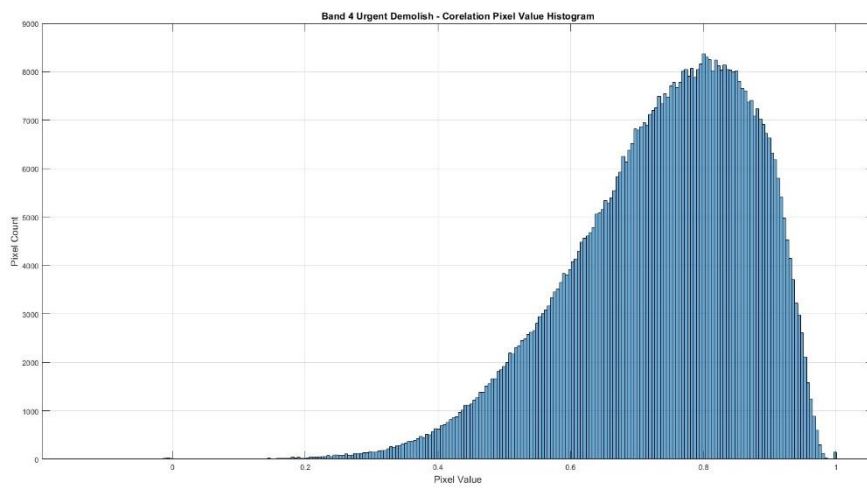
### **A. Histogram Charts of Texture Images Produced from Reflectance Image Bands**

The histograms demonstrate no direct separation between building damage classes using texture images produced from reflectance images. The reader is encouraged to inspect the histograms within each building damage class of the same texture image across all image bands. It is seen that after the inspection, the four building damage classes show the same trend, with the peak points and the curvatures being the same. This comparison allows the inspector to discern variations between different image bands featuring the same texture image. Notably, no distinct differentiation is observed among damage classes within these histograms.
