ASSESSING THE INTEGRITY OF THE HISTORIC LAYERS OF A MULTI-
LAYERED SETTLEMENT TO THE CURRENT URBAN CONTEXT: THE
CASE OF ANKARA

A THESIS SUBMITTED TO
THE GRADUATE SCHOOL OF NATURAL AND APPLIED SCIENCES
OF
MIDDLE EAST TECHNICAL UNIVERSITY

ZEYNEP BUKET ÜSTÜN

SEPTEMBER 2024

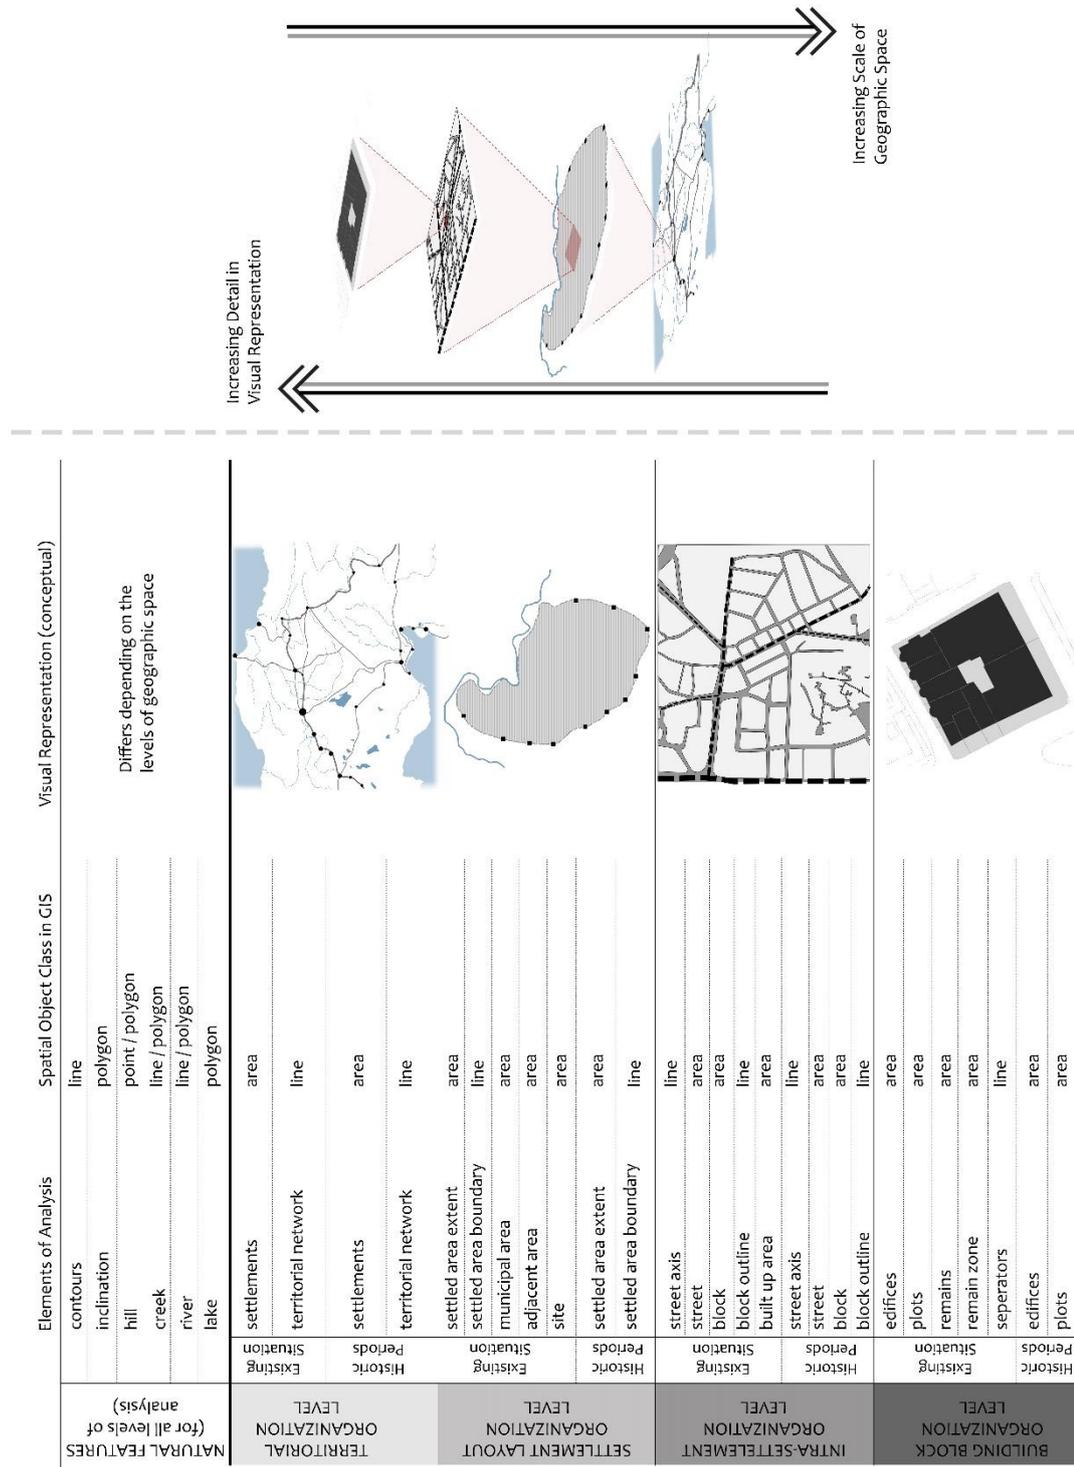
Figure 2.3. Different Components of Urban and Natural Space for GIS environment based on different levels of resolution (adapted from Bilgin Altınöz, 2002).

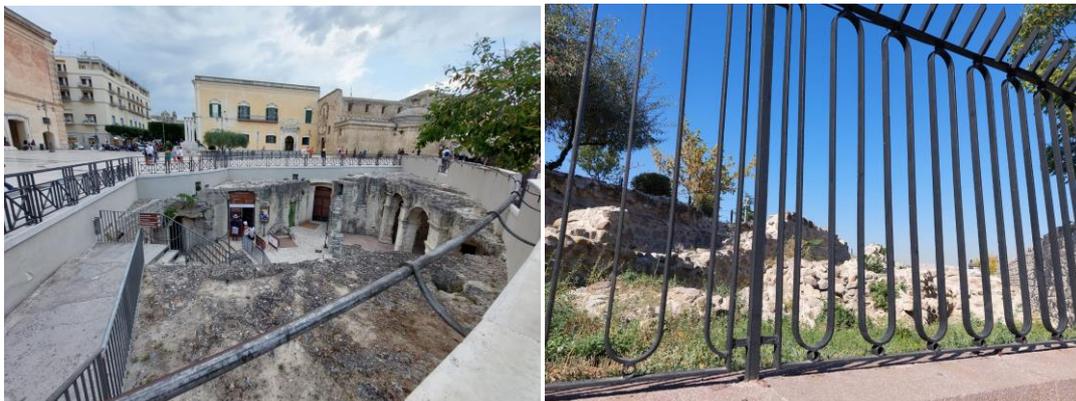
Figure 2.5. Bird-eye Perception of Palombaro Lungo Remains in Matera-Italy (left) and Low Perception of Roman Bath Remains in Ankara (right) (taken by author)

Although not mentioned much in the literature, the **visual relationship of the heritage assets and areas with the street** is also important for their perception. For instance, if the heritage site is located on top of a mound, the visibility from the street level decreases due to the mound's shape. Contrary to this situation, if a heritage place remains below the street level, it creates a bird-eye effect and increases the perceptibility of the area more. Therefore, depending on the leveling, there should be specific arrangements at the surrounding area to enhance better perception.

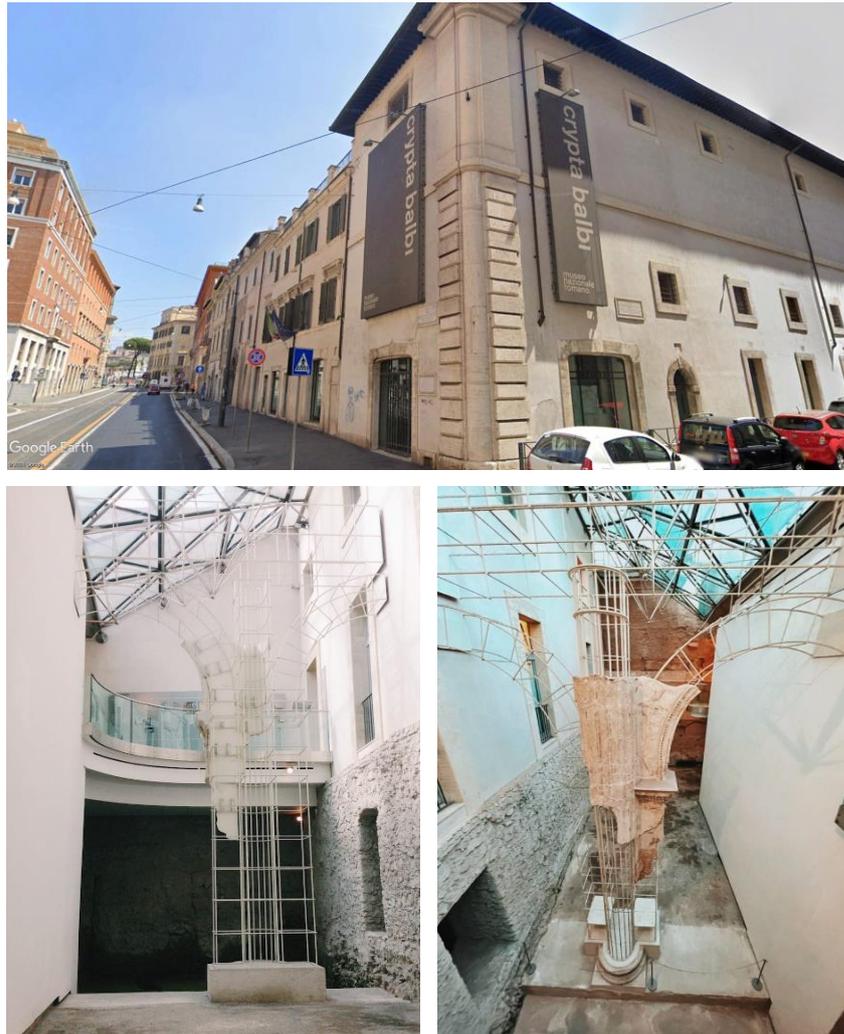
Figure 2.6. Crypta Balbi - Museo Nazionale Romano, layering at the facades (top), completion of archs by wire meshes to clarify how was the whole (below) (Source: Google Earth Street View -top-, milestonerome.com -below-)

The area serves for various types of togetherness of the layers successfully by the restorations and completions of lost parts of archaeological remains. This is because, if some layers are fragmented a lot or completely lost, inhabitants and visitors need to understand how was the whole. As a result, some lost parts were hypothetically completed with mesh to visualize and represent the general architectural attributes. Within the museum, the presentation and interpretation activities do not only prioritize the archaeological layer but also put emphasis on socio-economic, architectural and urban changes throughout the history to reflect the spatial evolution.

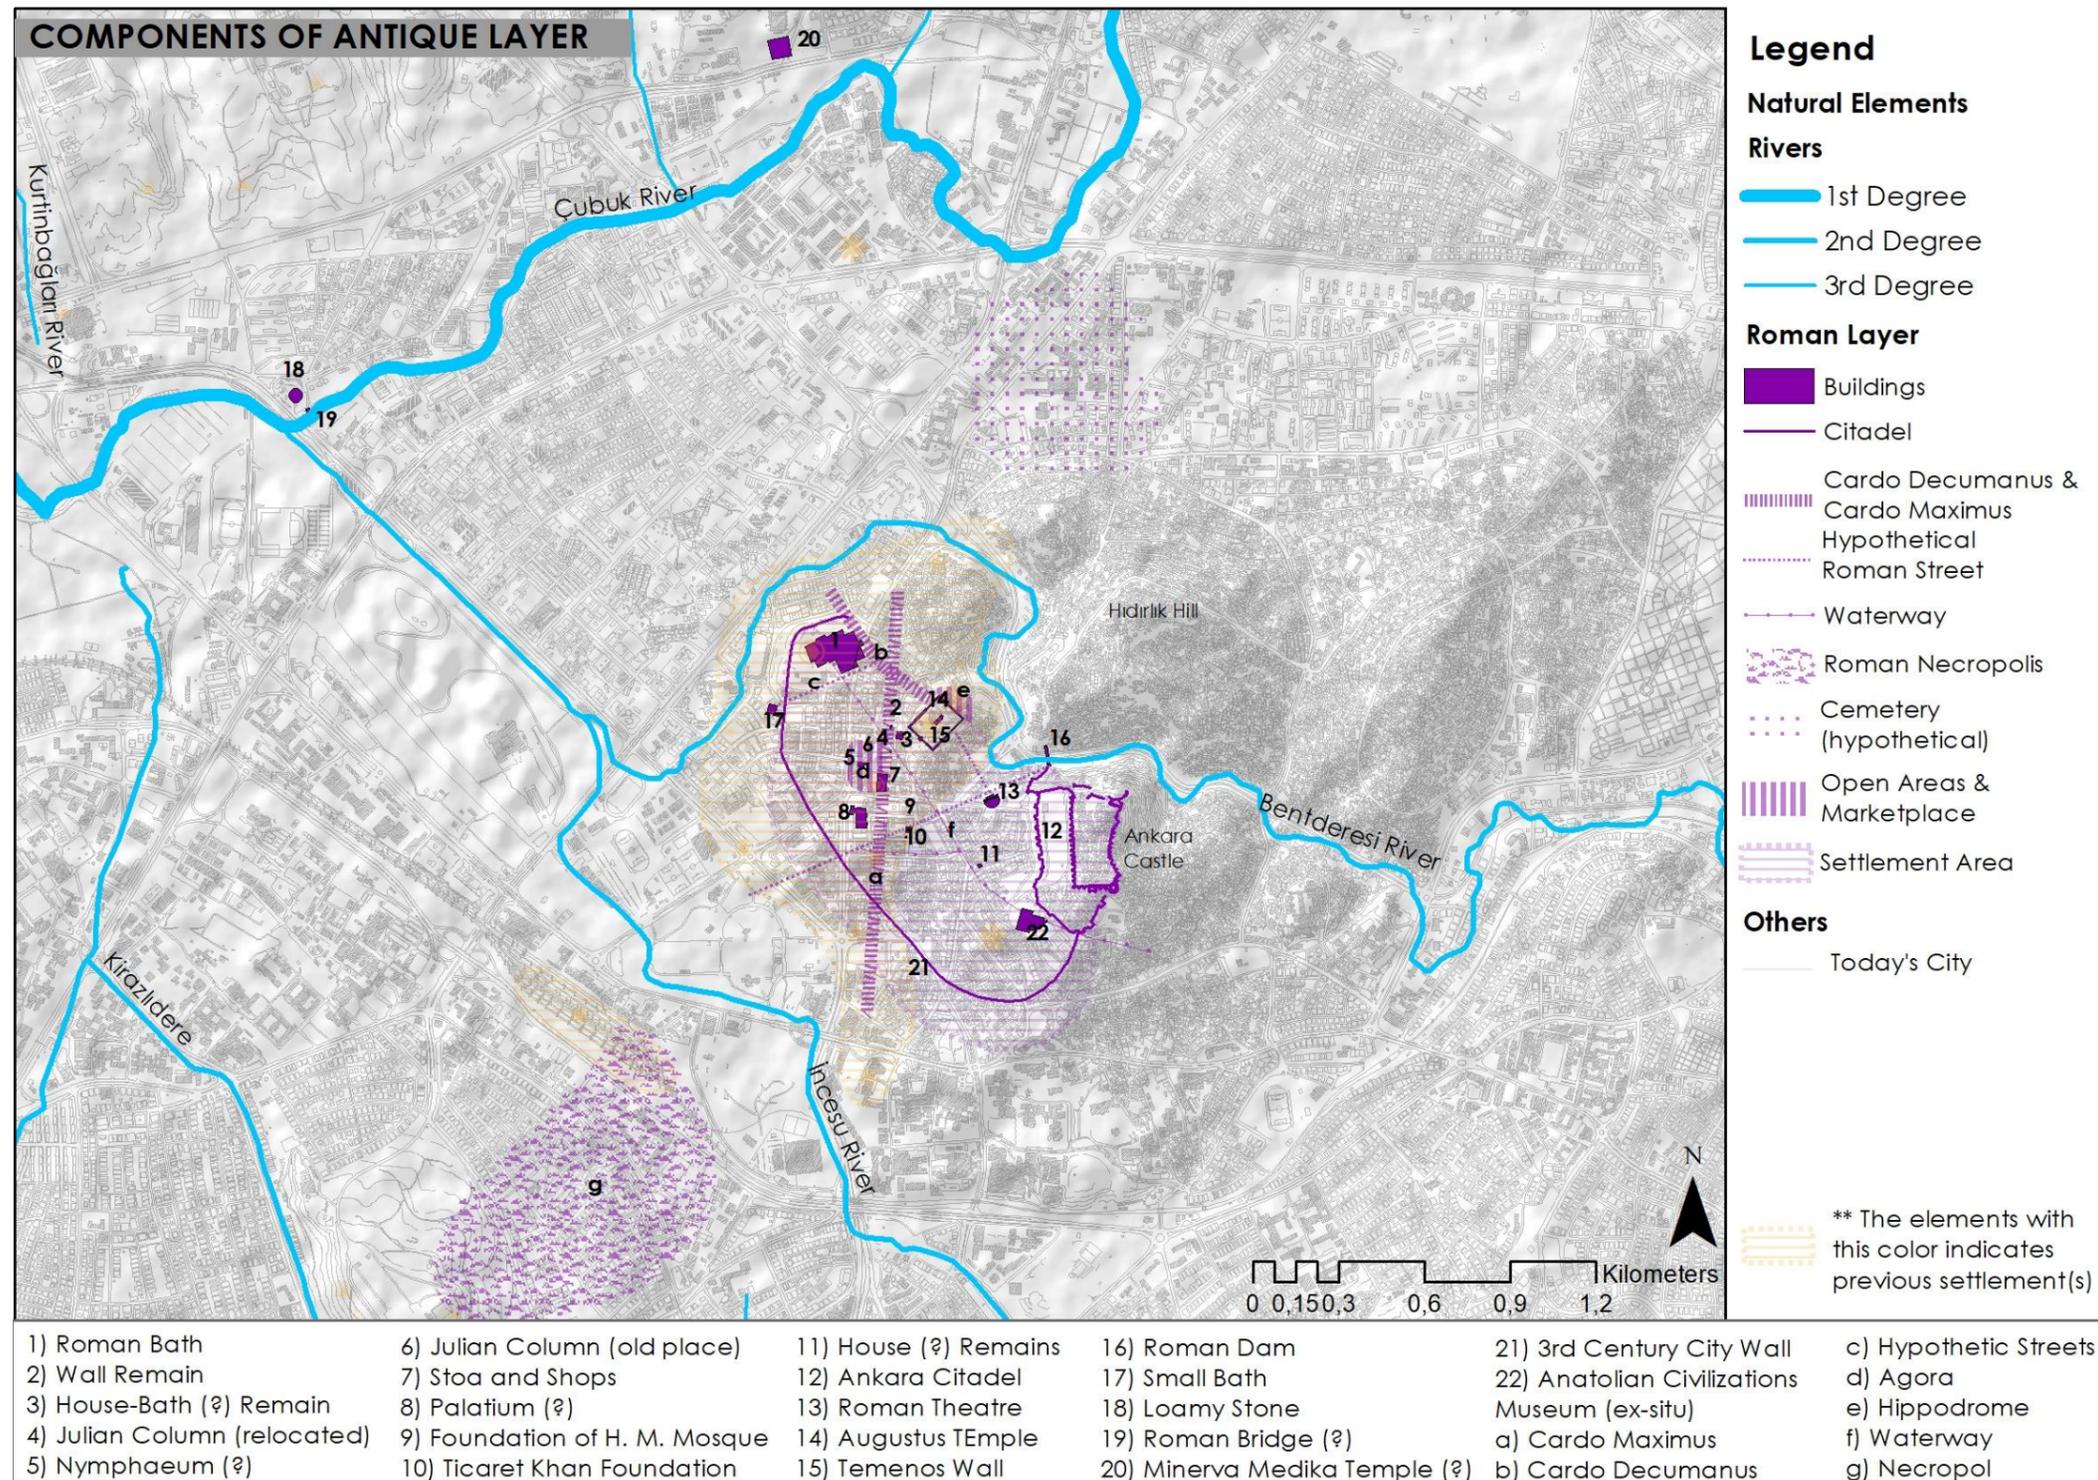
Figure 3.6. Roman Ankara overlapped on today's Ankara (Produced by author in GIS with the information obtained from Ayhan Koçyiğit, 2018; Aydın et al., 2005, Kadioğlu et al., 2011).

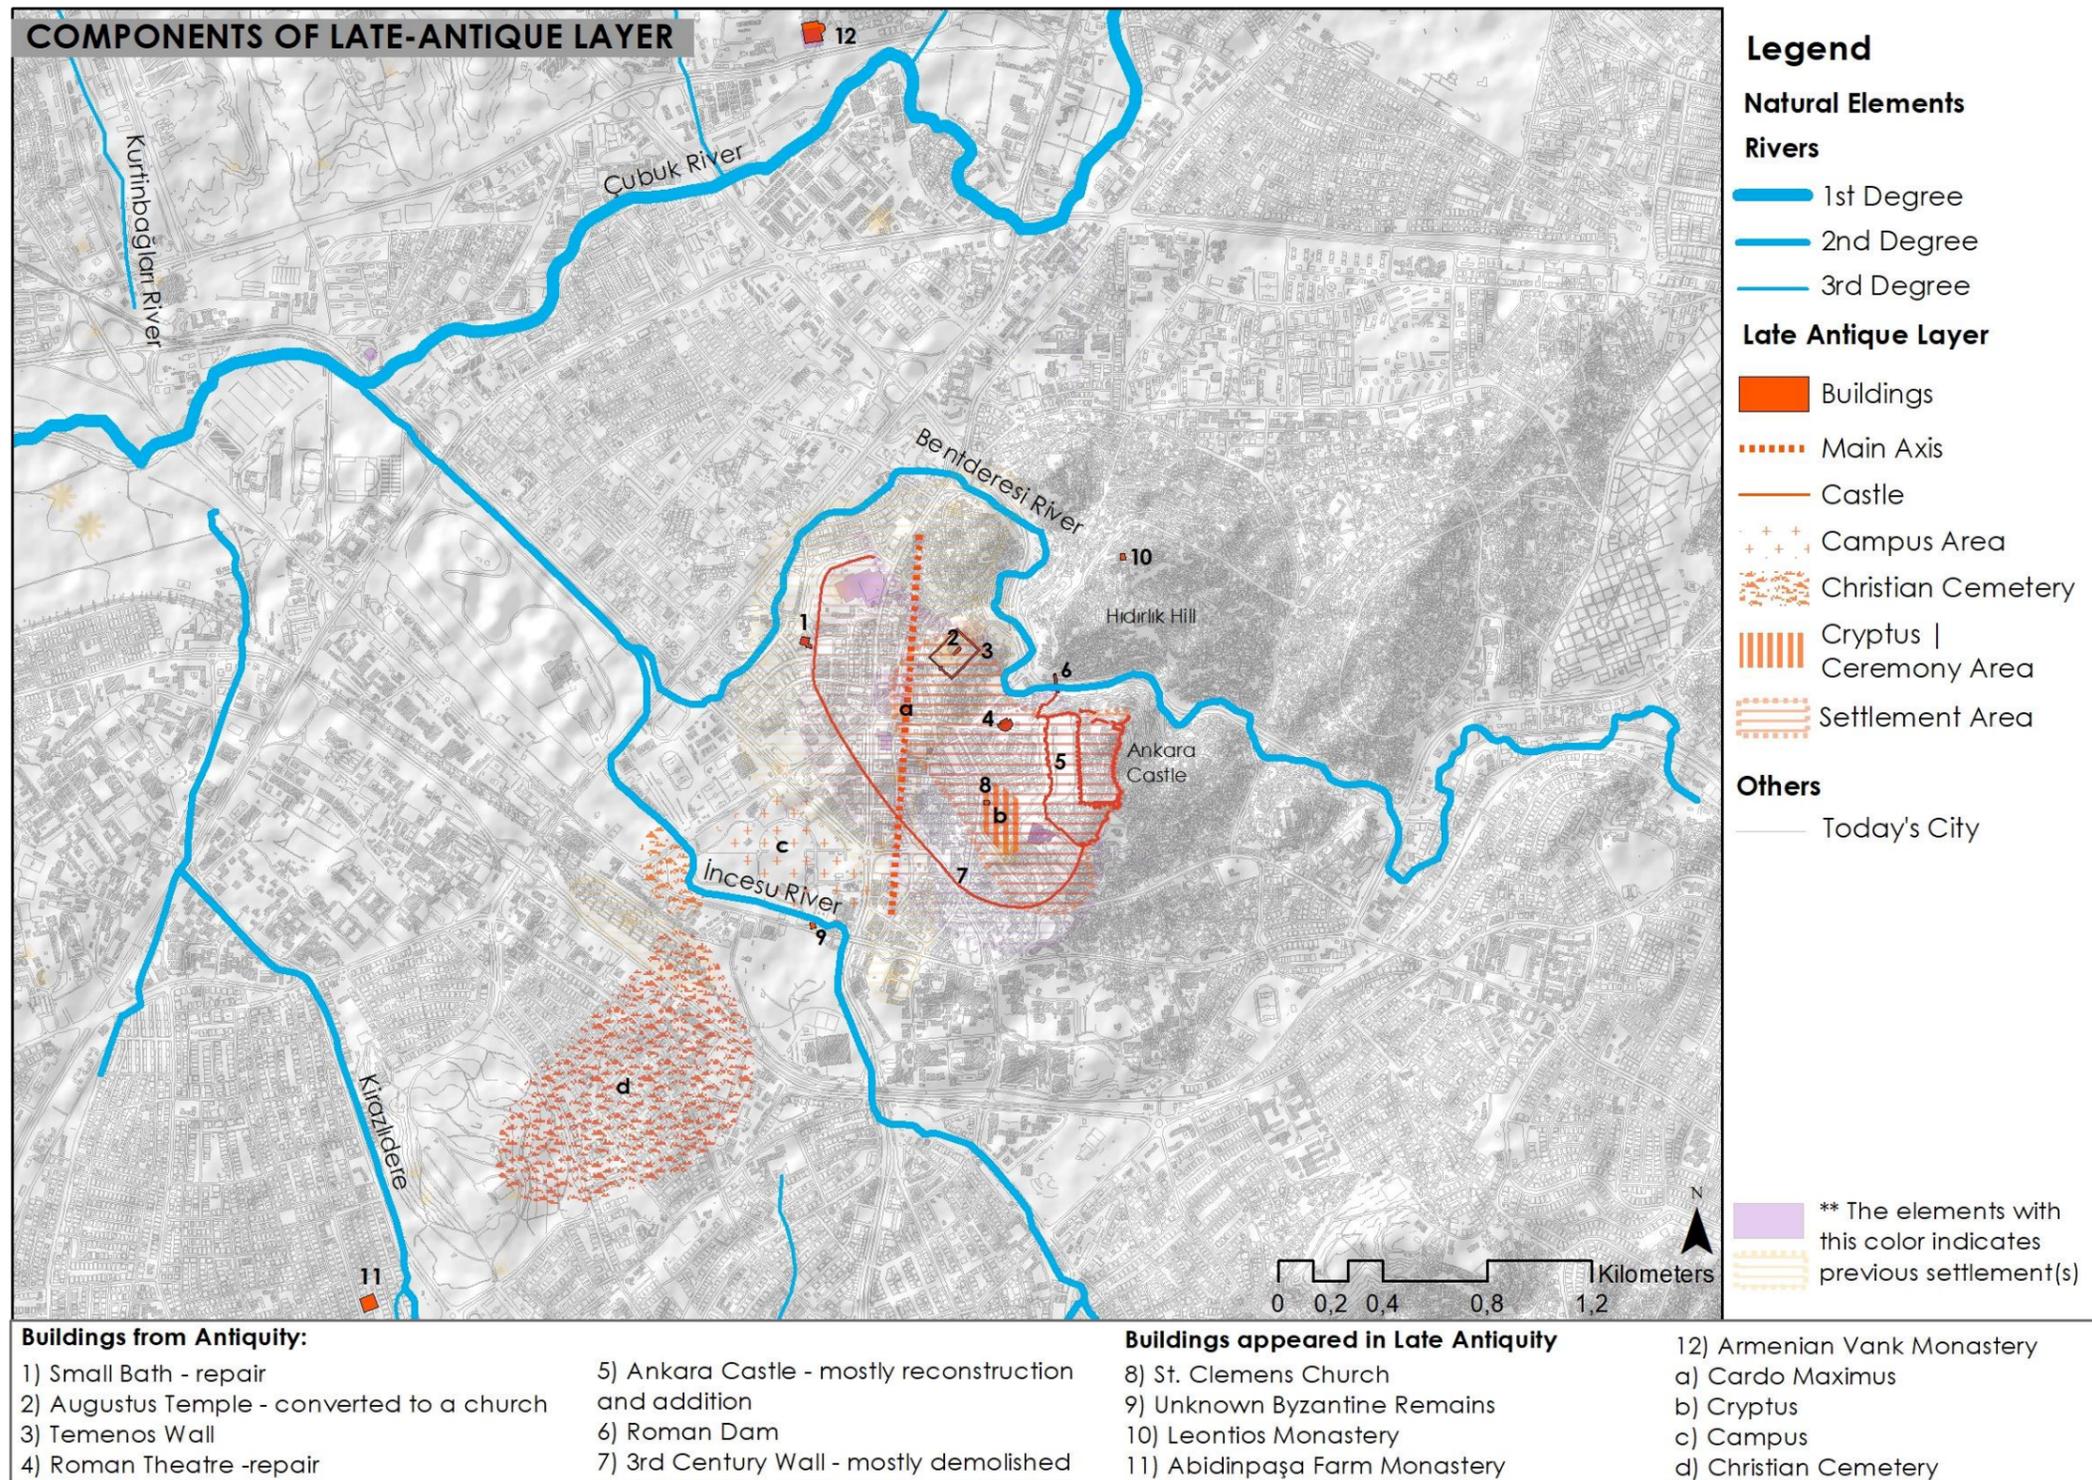
Figure 3.8. Late Antique Ankara overlapped on today's Ankara (produced by author in GIS with the information obtained from Aydın et al., 2005; Foss, 1977; Renda et al., 2004; Ayhan Koçyiğit, 2018)

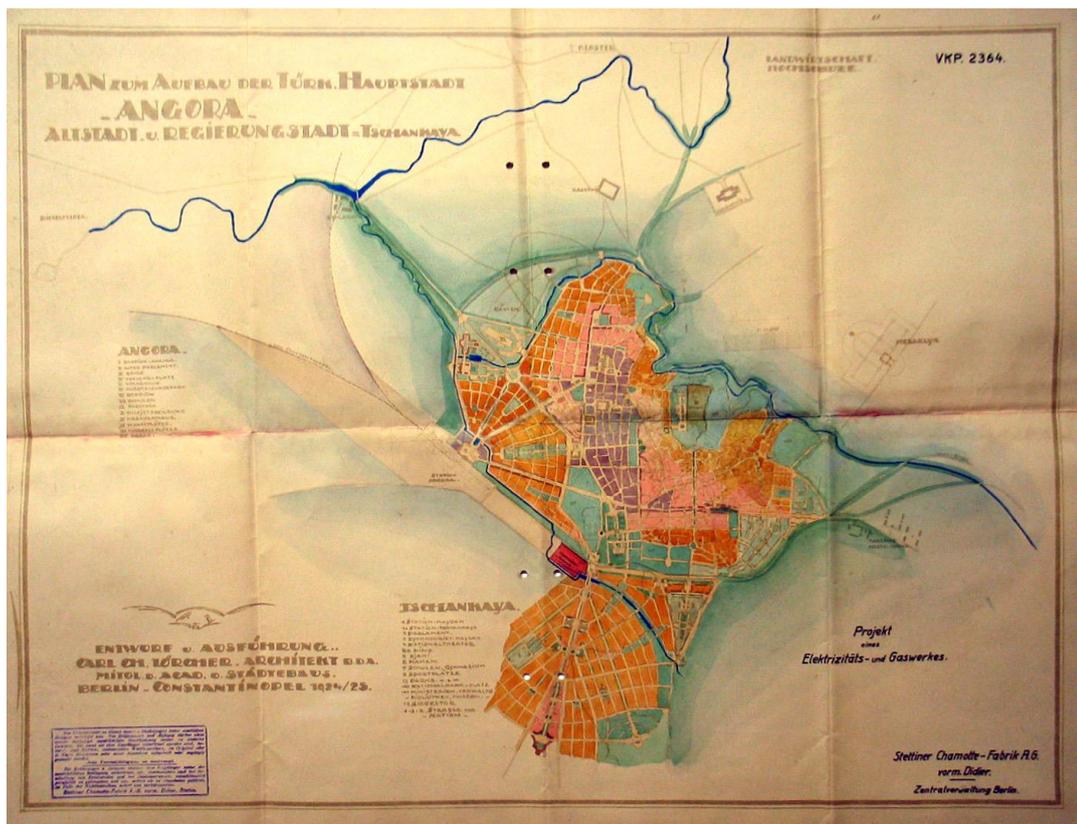
Figure 3.11. Lörcher’s Ankara Plan for “Old” and “New” City (taken from Maps, Plans and Documentation Archive of METU, City and Regional Planning Department)

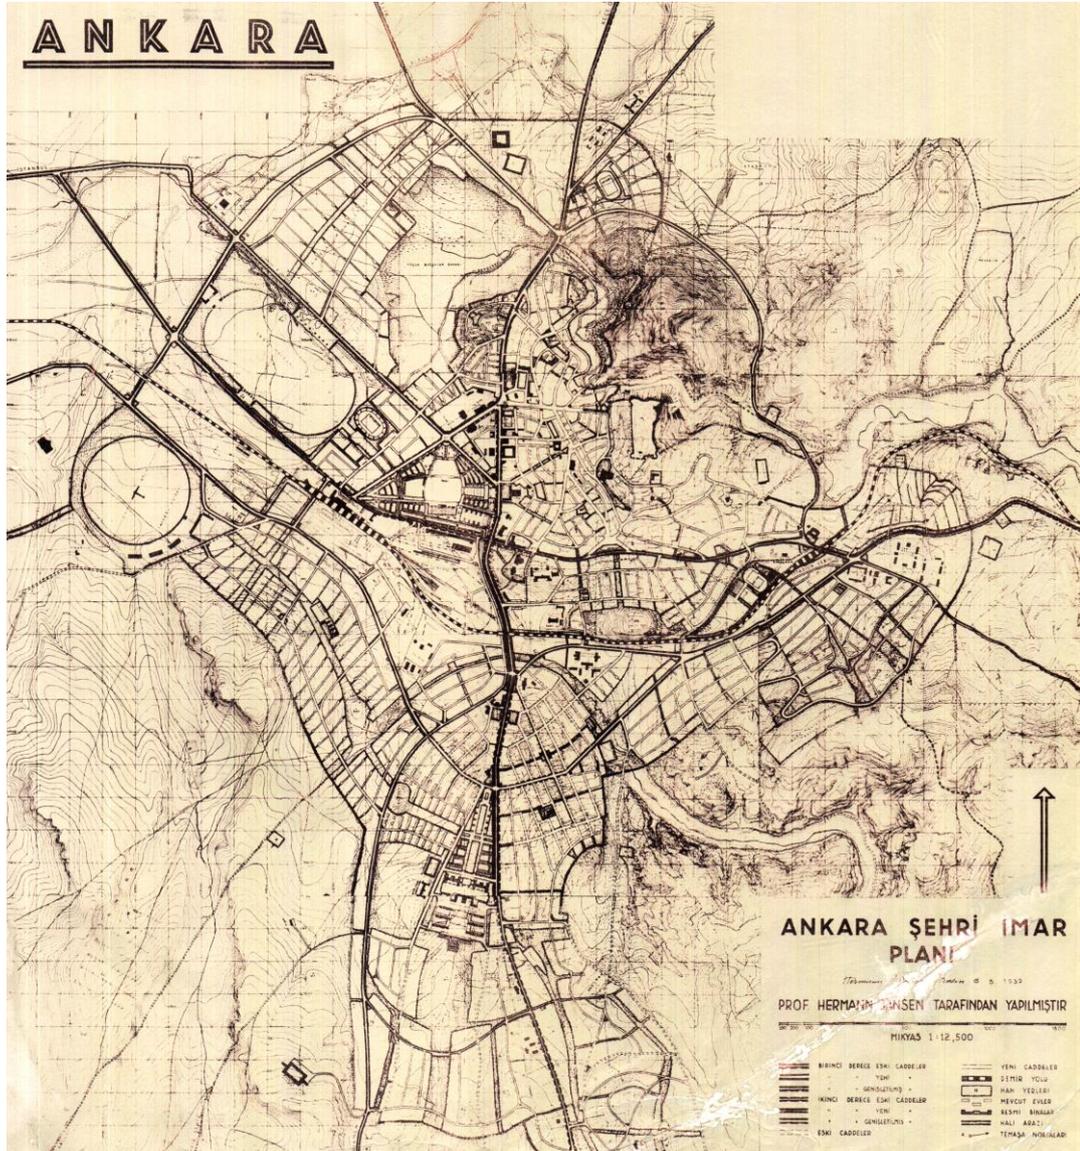
Figure 3.12. Jansen's Plan for Ankara (taken from Maps, Plans and Documentation Archive of METU, City and Regional Planning Department)

Moreover, the Jansen Plan established new development directions for the city, extending westwards, southwards and south-westwards, as a result of the decision to conserve the historical fabric of the city, which had been built up over previous layers to the north (Özgönül and Gökçe, 2001). Despite the Jansen Plan's attempts to establish connections between vineyard houses through green wedges and continuities, it ultimately proved unsuccessful. It was inevitable that the new development, which was concentrated in the south, would be oriented towards the vineyard houses constructed in the nineteenth century. Over the course of the following century, these areas were abandoned as a result of the transformation of their rural character into a central urban district. As a result of their abandonment, these structures lost their original functions and were converted into apartment buildings with further plans (Özgönül and Gökçe, 2001). Consequently, with the exception of a few vineyard houses located in Keçiören, Etlik, Çankaya, and

All in all, Jansen's Plan was highly determinant in the creation of Early Republican Ankara with its boulevards, streets, squares, green areas and characteristic buildings. Atatürk Boulevard begins with Hakimiyet-i Milliye Square (today's Ulus Square).

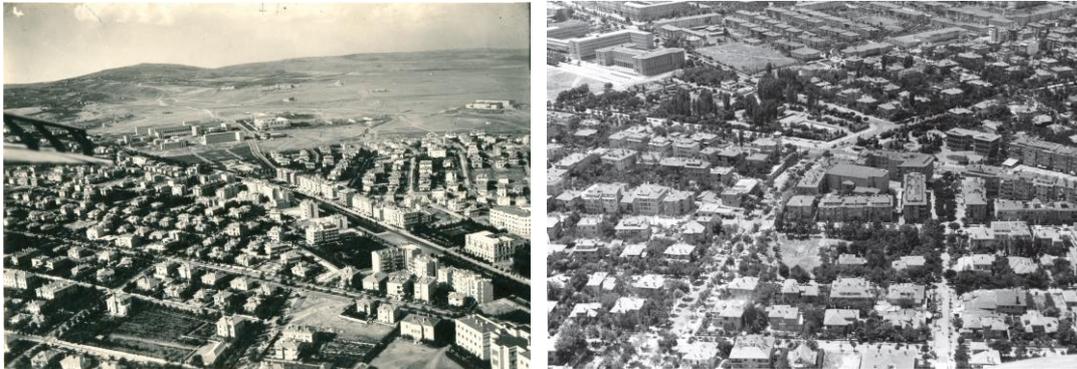
Figure 3.14. A section of new city around Vekaletler Area (left), A section of new city around Sakarya Street (right) (source: Cengizkan, 2022).

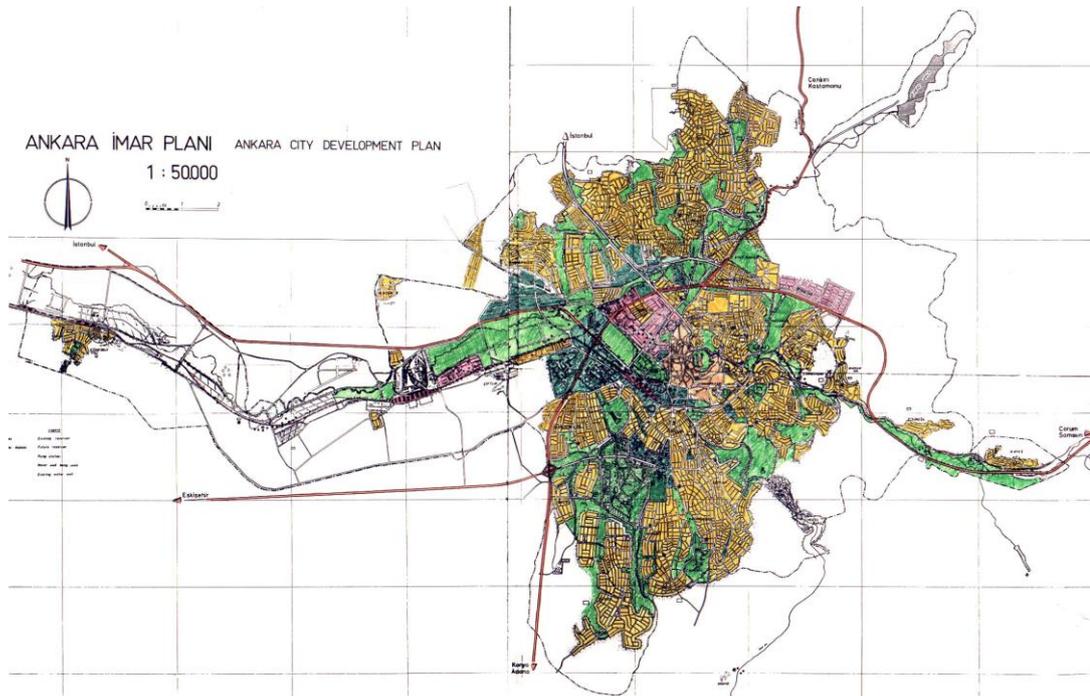
Figure 3.17. Uybadin-Yücel Plan of Ankara in 1957. (taken from Maps, Plans and Documentation Archive of METU, City and Regional Planning Department)

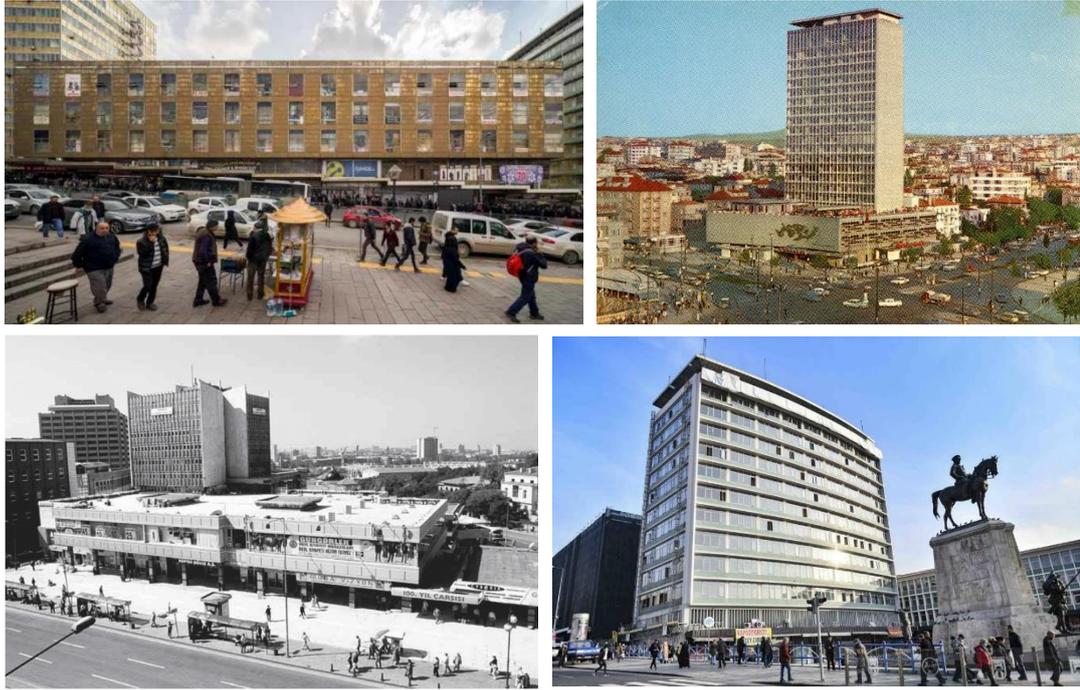
Figure 3.18. Late Republican Modern Heritage Buildings: Anafartalar Bazaar –top left- (source: Gazete Duvar Website), Emek Workplace –top right- (source: Salt Archive), 100. Yıl Bazaar –below left- (source: Yetkin Report Website), and Ulus Commercial Building –below right- (source: Medya Başkent Website)

However, besides the adverse developments affecting the integrity of historic layers of the city mentioned above, those decisions regarding the building heights and massive building footprints brought new architectural style to the urban space. Reflecting the 2nd National Architectural trend that was followed within the country, modernist buildings such as Anafartalar Marketplace, 100. Yıl Marketplace, Ulus Commercial building and Marketplace and *Emek* Marketplace were constructed. Main open areas of the Republic started to be surrounded by these architecturally significant buildings, affecting and diversifying the character of the urban area. Furthermore, the construction of these buildings facilitated an increase in commercial density by incorporating multiple commercial facilities and offices within a single structure. Consequently, the decisions made as part of this plan contributed to the emergence of a new architectural language and a distinct identity for the urban space.

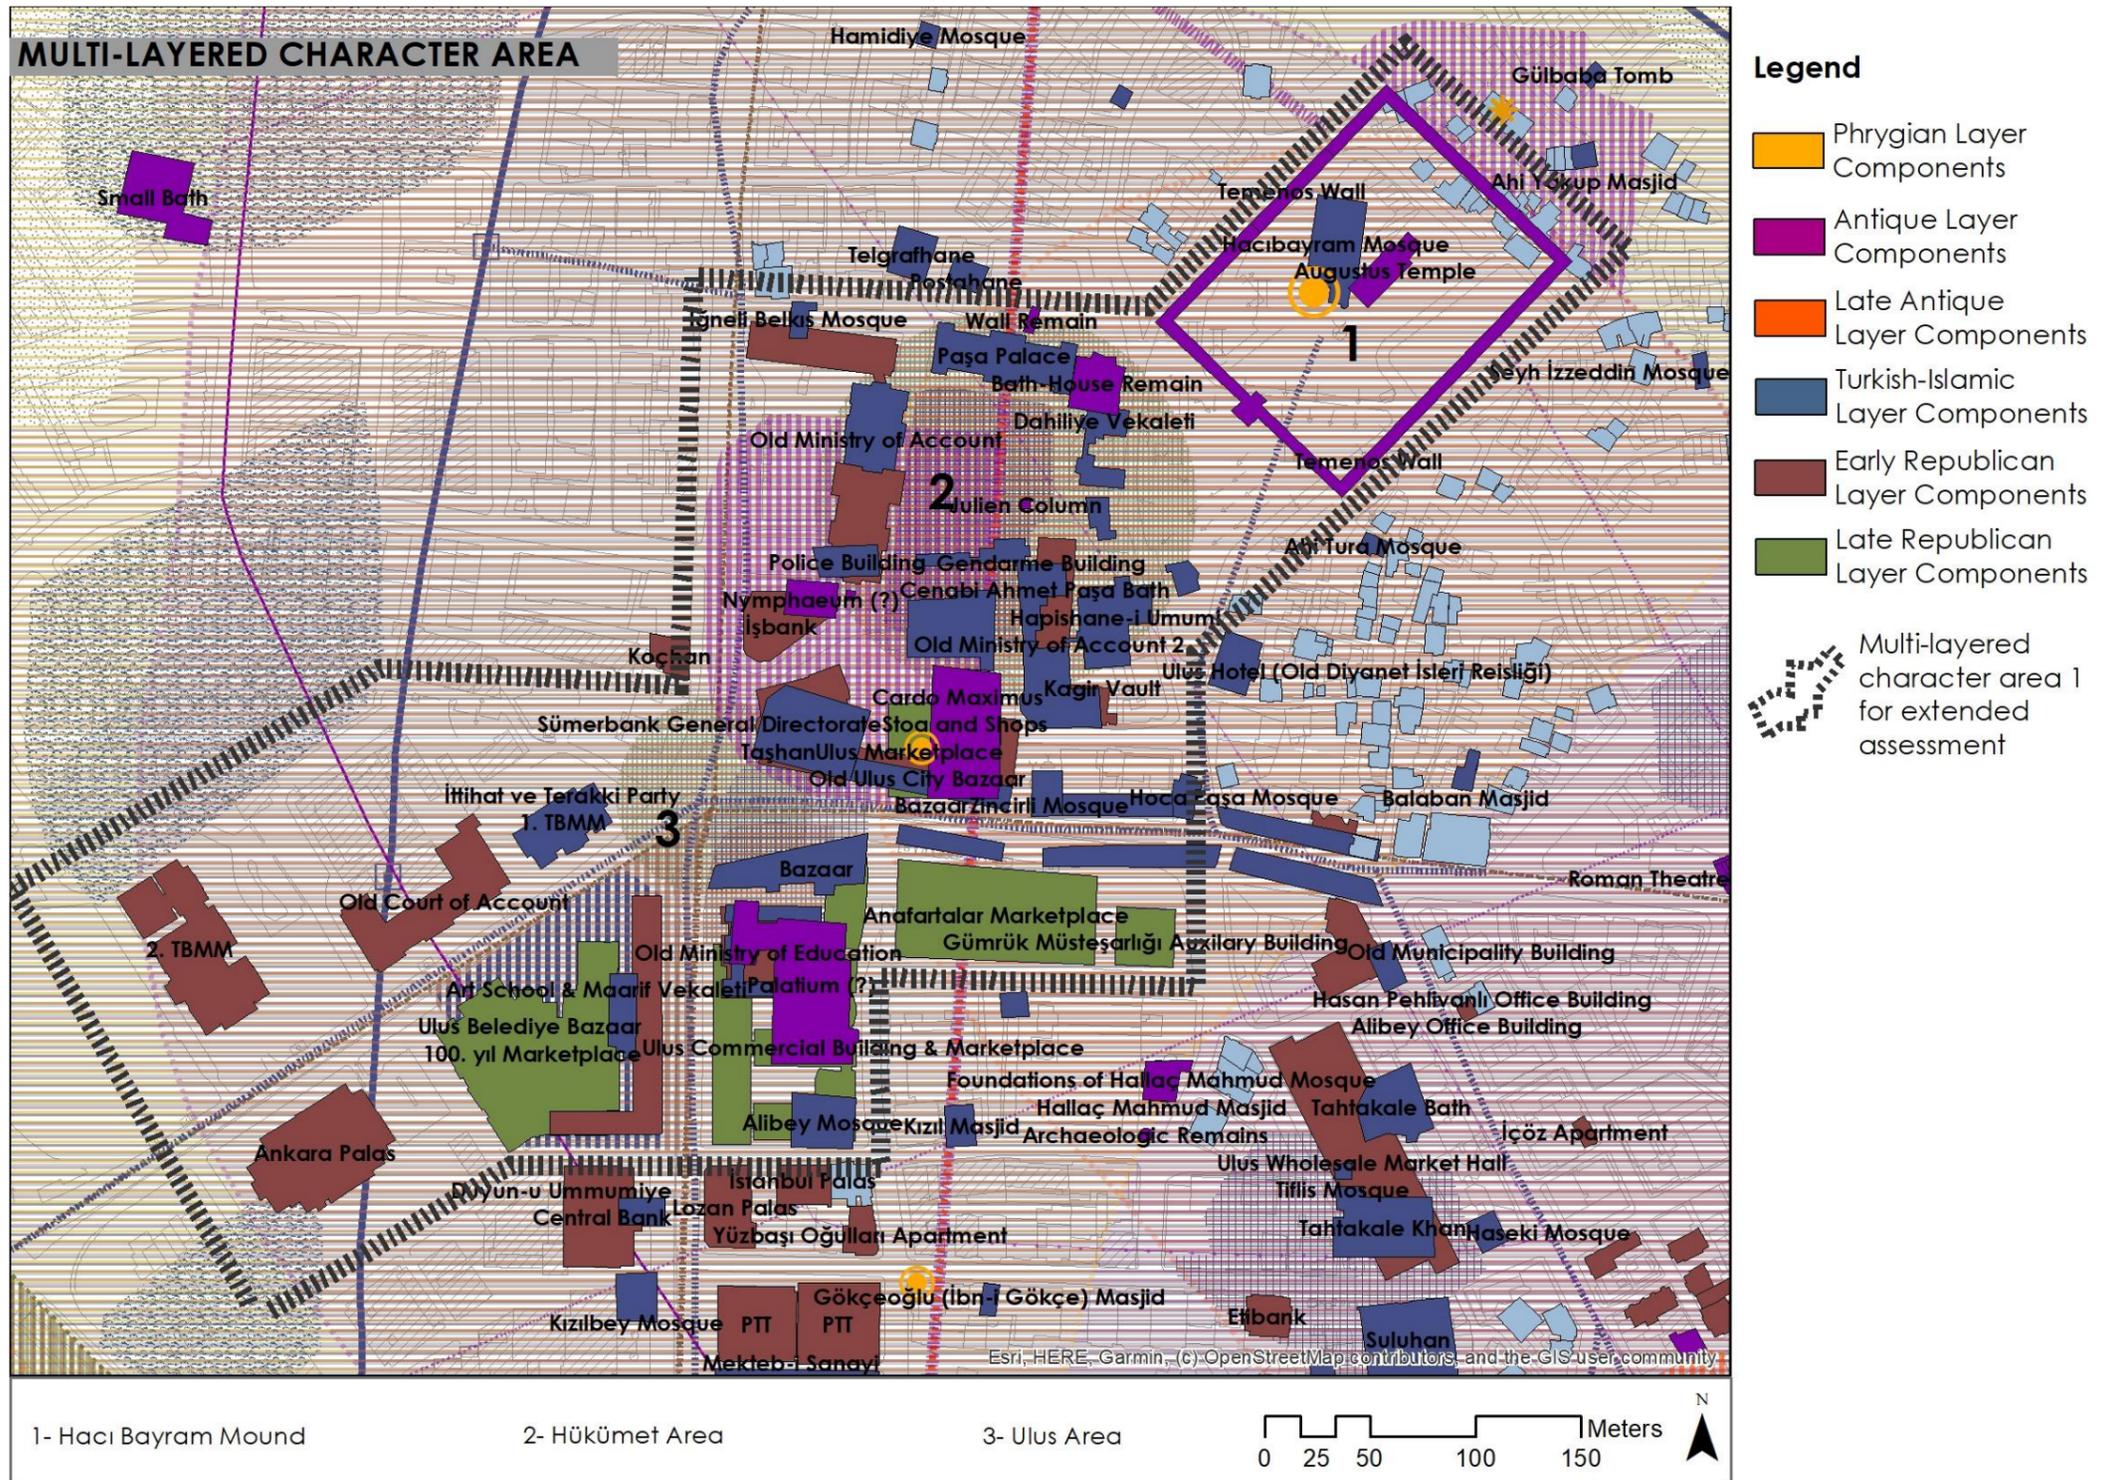
Figure 4.2. Components of Multi-layered Character Area 1 (produced by the author in GIS)

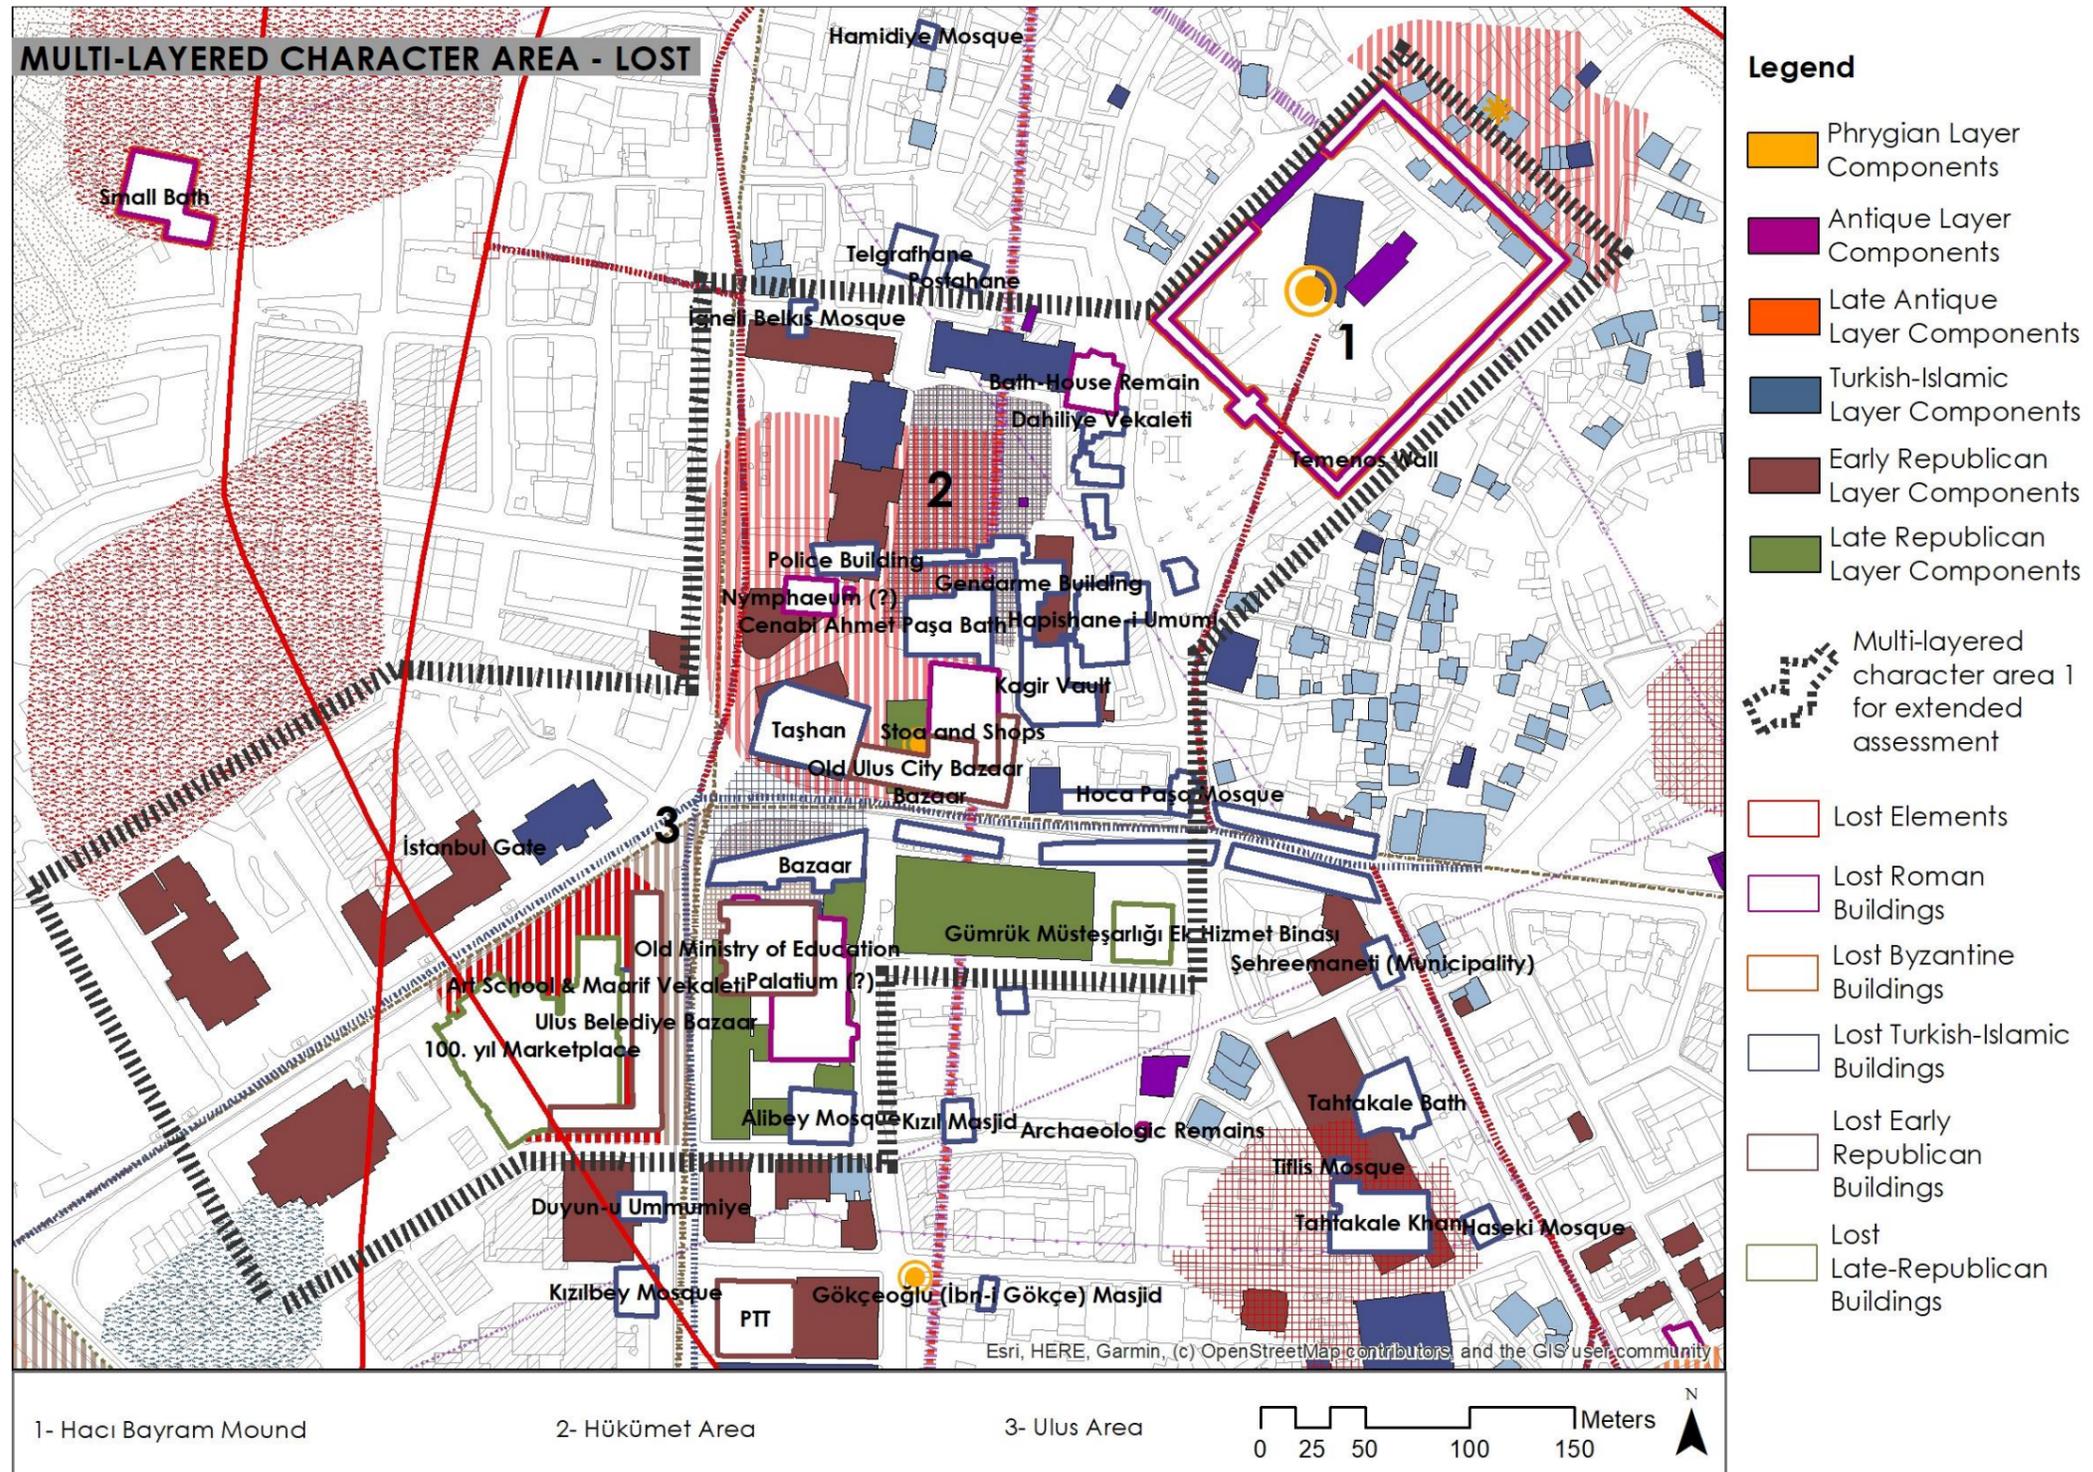
Figure 4.3. Lost Elements of Multi-Layered Character Area 1 (produced by the author in GIS)
