ASSESSING THE INTEGRITY OF THE HISTORIC LAYERS OF A MULTI-
LAYERED SETTLEMENT TO THE CURRENT URBAN CONTEXT: THE
CASE OF ANKARA

A THESIS SUBMITTED TO
THE GRADUATE SCHOOL OF NATURAL AND APPLIED SCIENCES
OF
MIDDLE EAST TECHNICAL UNIVERSITY

ZEYNEP BUKET ÜSTÜN

SEPTEMBER 2024

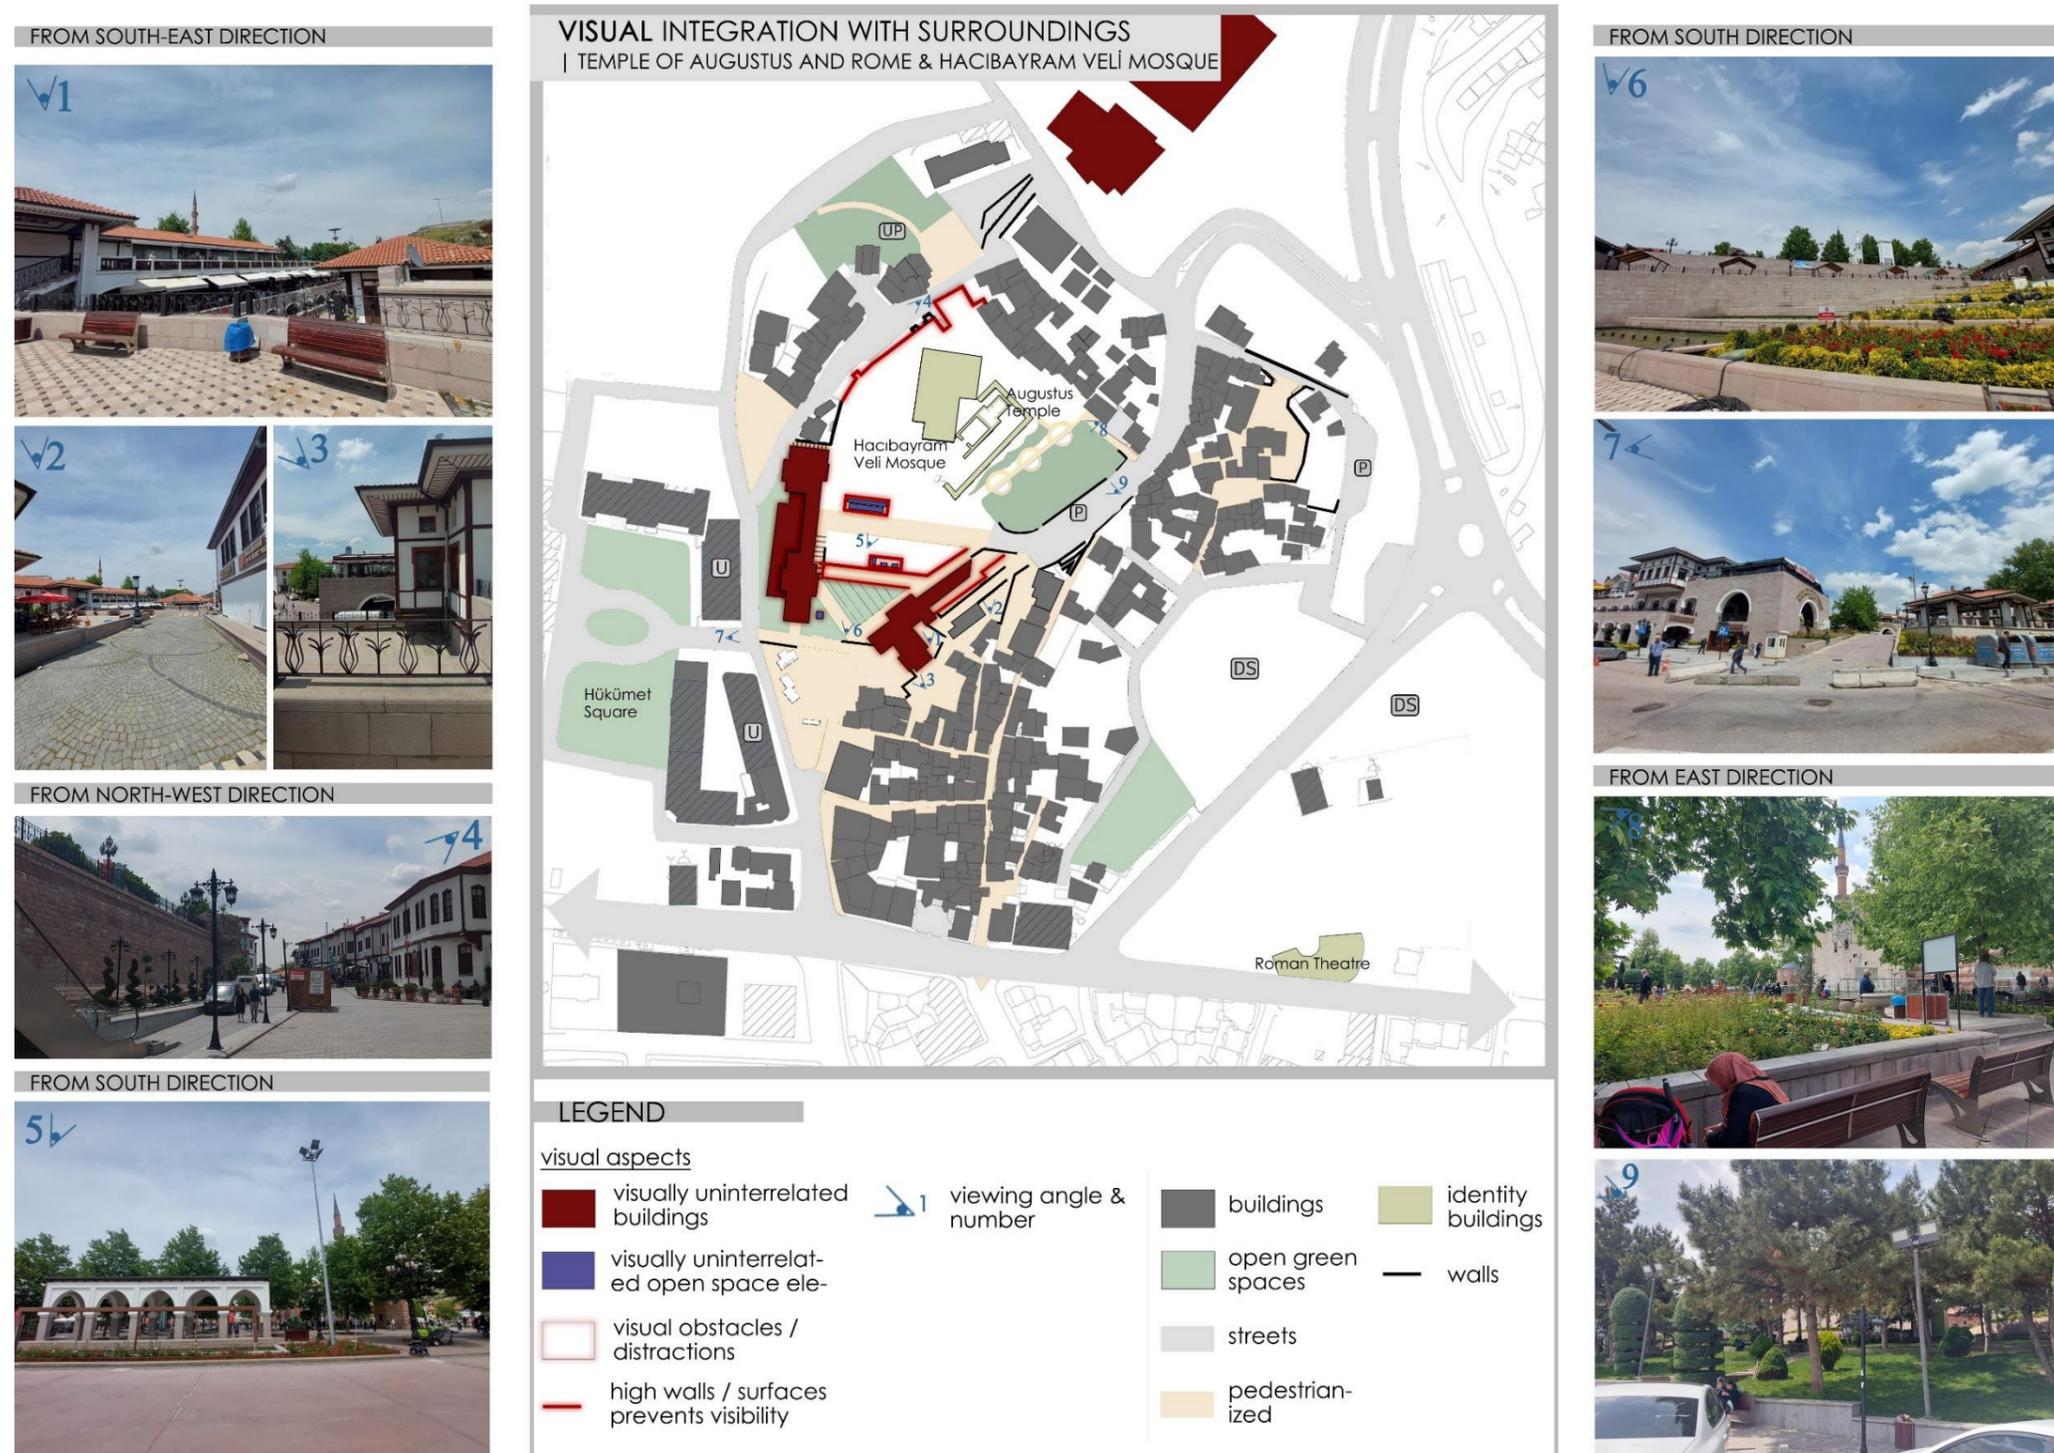
Figure 4.7. Visual relations of the surroundings with Hacı Bayram mosque and the Augustus Temple (produced by the author)

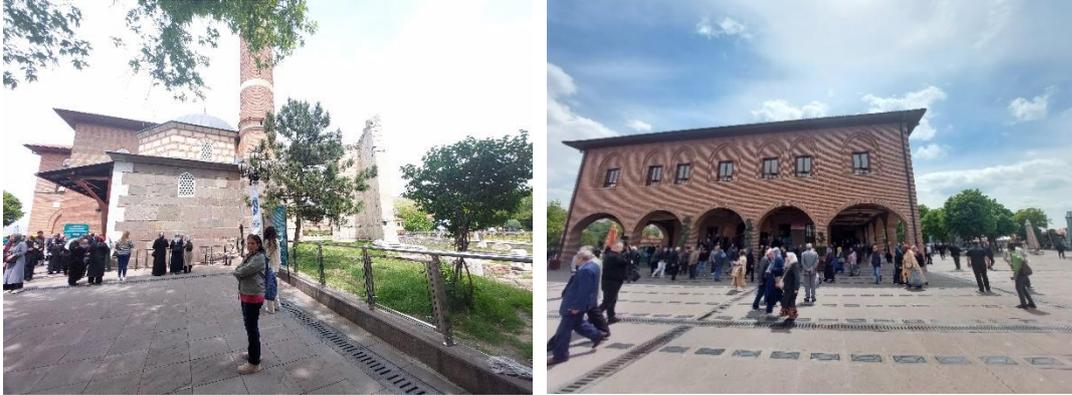
Figure 4.9. People using the mosque actively while turning their backs to the temple (left). The daily usage of Hacı Bayram Veli Mosque (right) (taken by the author)

Contrary to the mosque, the temple of Augustus and Rome does not have an active contemporary usage, which leaves the temple in a disintegrated state. As a result, it is not a part of the daily usage of the local people, and it is not able to create socio-cultural and socio-economic benefits. Since it does not have a usage, neither the quality of the usage nor the type of users can be questioned. As it is possible to walk around the site without entering, there are numerous visitors from different parts of the world due to the significance of the site. Unfortunately, it is not possible to

approach the remains and have an experience opportunity with archaeology. The lack of functionality has resulted in the complete disintegration of the temple.

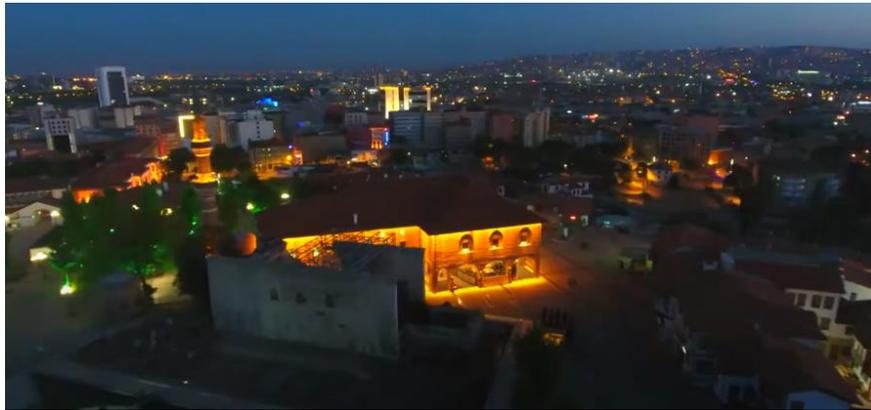
Figure 4.10. The lightings of Hacı Bayram mosque and non-visible Augustus Temple next to it (source: Google Images).

The temple is also visible, although it is encircled by a barrier. Since the barrier is approximately one meter in height and entirely transparent, it does not present any challenges with regard to visibility and the perception of elevation and plan features.

Additionally, the foundations at the lower levels of the public space allow for a bird's-eye view effect, thereby facilitating the perception of the plan features of these areas. Nevertheless, within the site, there are some sections where the grass closes the plan layout of the foundation walls due to lack of maintenance, although it does not create a very big problem for now. Therefore, the daily visibility condition is considered as high. Nevertheless, the night visibility is poor due to lack of proper lighting. Another issue is that, the “Res Gestae Divi Augusti” inscription has also its own value. However, it is very hard to perceive the inscription as no measures were taken for its intelligibility. It is not easy to understand on which wall it was inscribed. Therefore, this problem should also be addressed regarding the visibility.

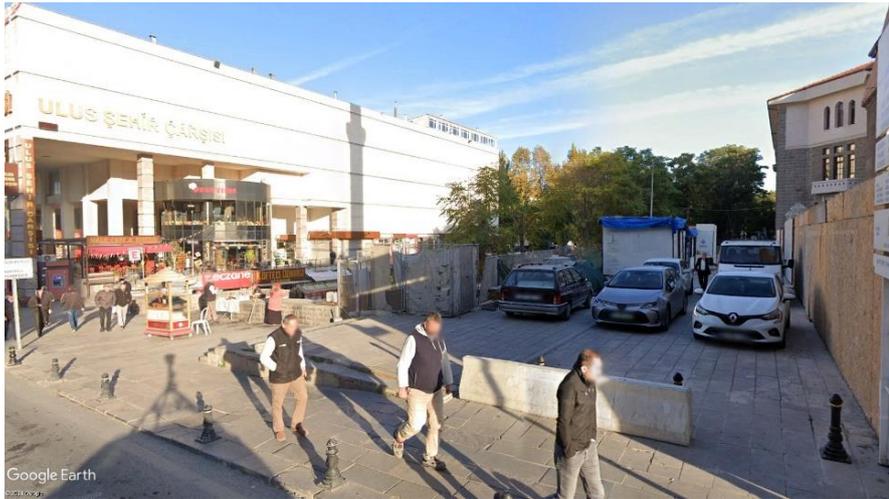
Figure 4.12. Elements preventing visibility of Cardo Maximus from Anafartalar Street (taken by the author)

Because the buildings are not very close to the Roman road due to having side setbacks, the beginning point of the road can be detectable even from the junction of Atatürk Boulevard and Anafartalar Street, which is a positive aspect regarding its visibility. However, the raised sidewalk next to Zincirli mosque, visual separator barriers and parked cars over it prevents visibility when approaching to the site from east towards west.

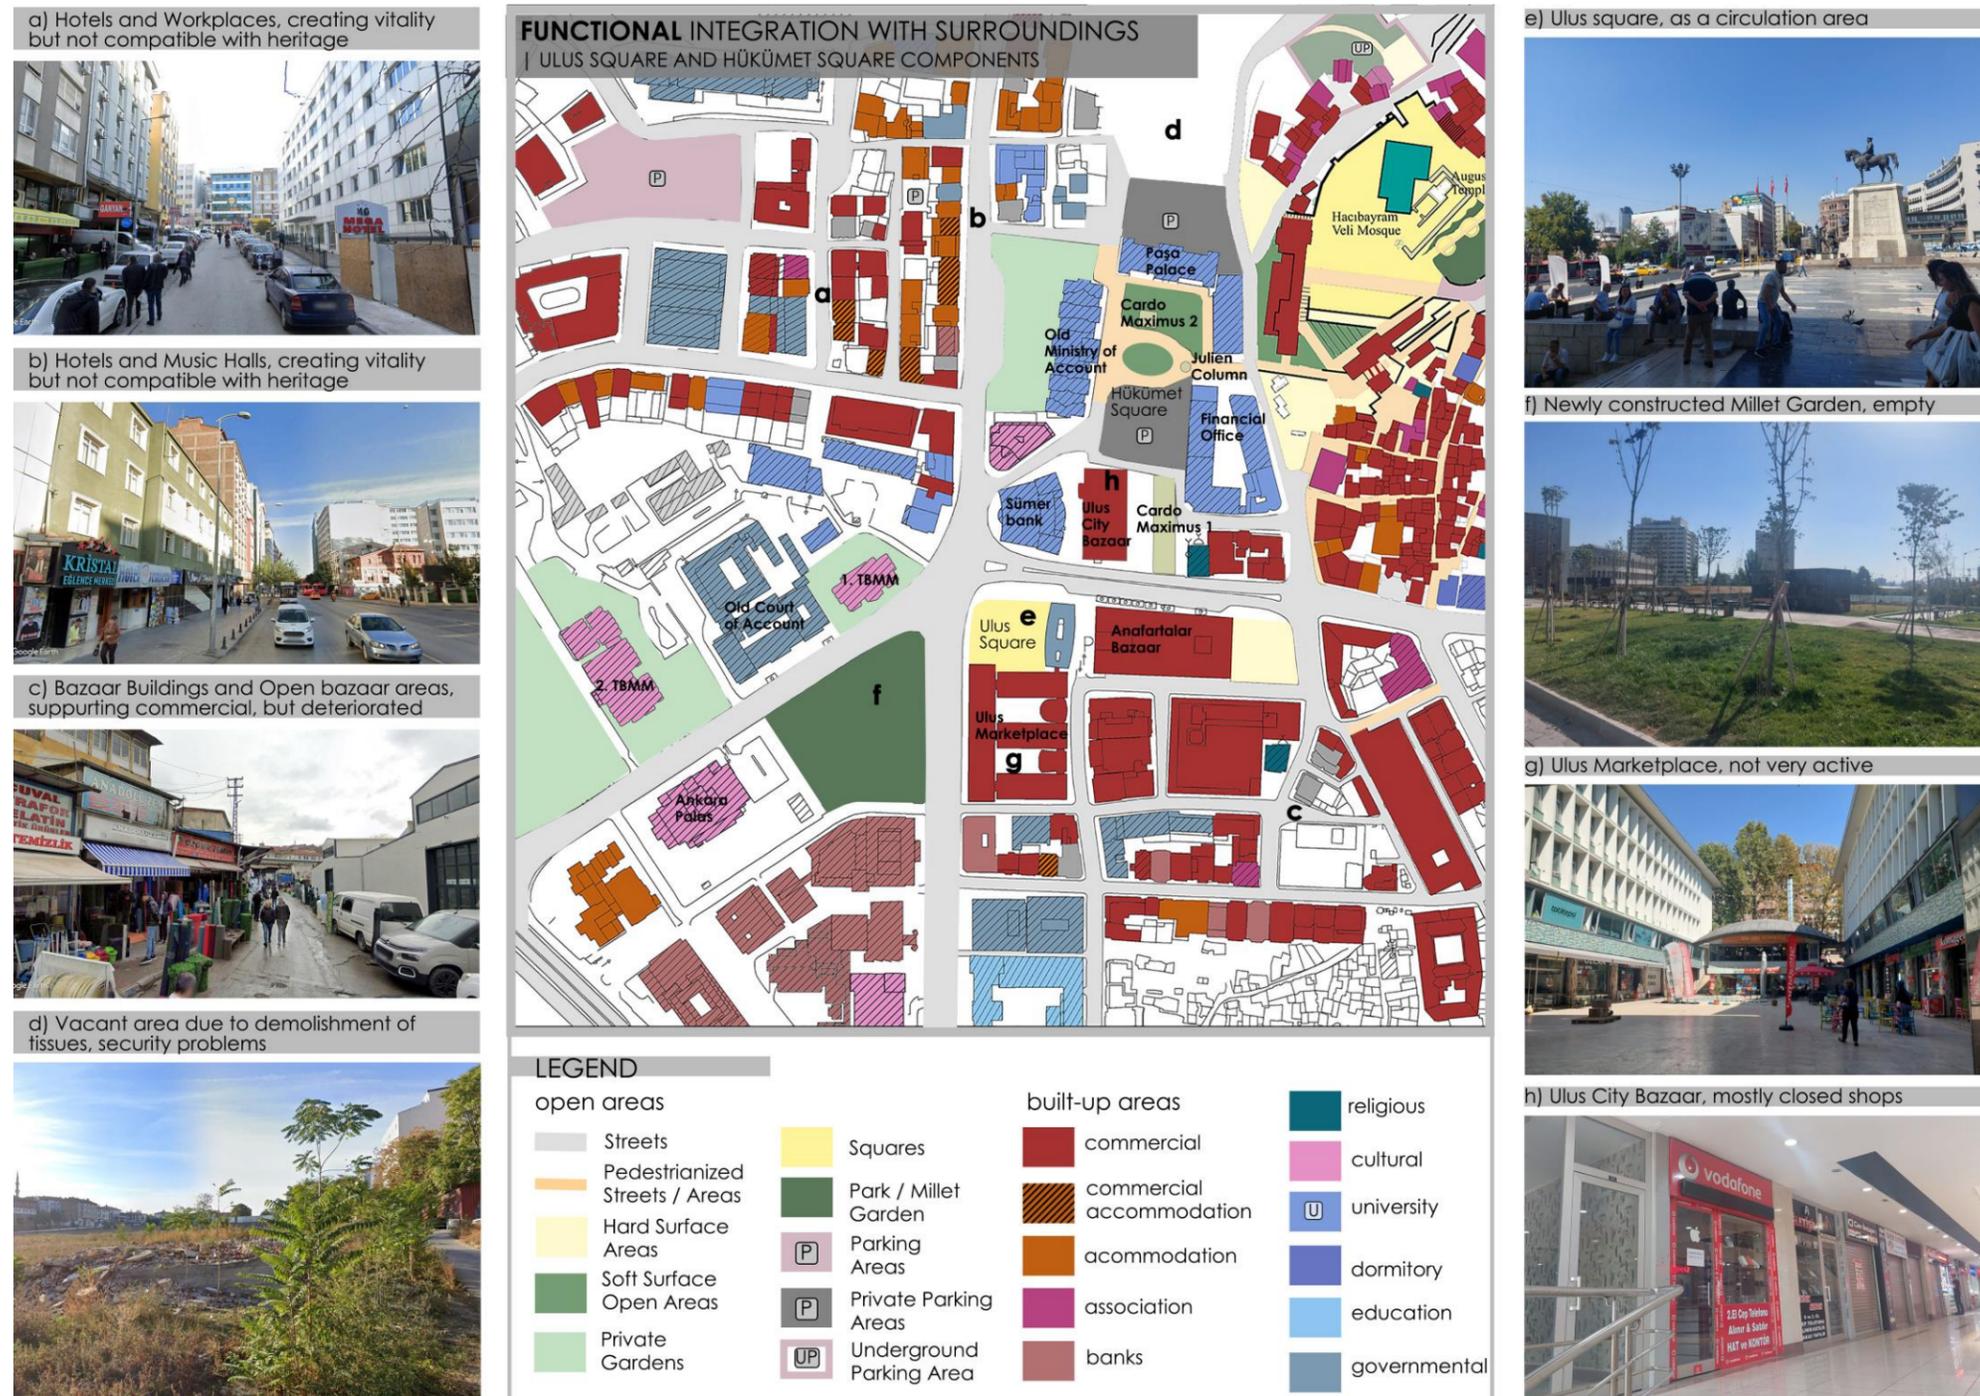
Figure 4.13. Functional interrelationships of the surroundings with Ulus Square and Hükümet Square heritage buildings (produced by the author)

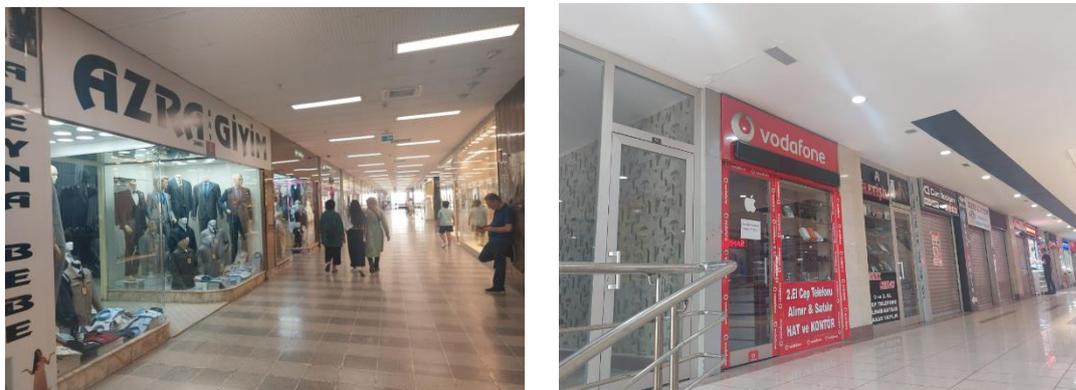
Figure 4.15. The Anafartalar Marketplace actively used by citizens -left-, some vacant shops in Ulus City Marketplace -right- (taken by the author)

The marketplaces within this multi-layered character area are accessible to the general public due to the nature of the public use they offer. As a result of the numerous commercial facilities, the conditions of ownership vary considerably. Nevertheless, as the ownership status does not impact the ability to access the buildings, it is of less consequence than in other contexts. All individuals are permitted to enter the marketplaces without restriction. However, following the business hours' end, the shop owners close their shops. Despite the continued accessibility of the marketplace buildings, the opportunity to purchase goods is no longer available. Moreover, due to the increasing tendency in shopping-mall culture especially after 2000s, the usage and users of the marketplaces has gradually decreased. However, despite this decrease, they still provide an important socio-cultural and economic benefits to the city.

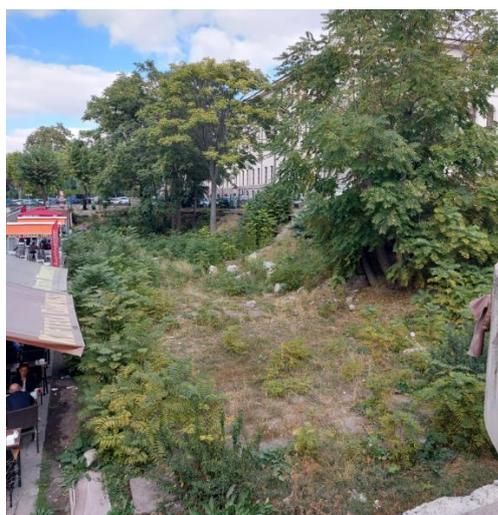
Figure 4.16. Low intelligibility of Cardo Maximus due to poor maintenance (taken by the author)

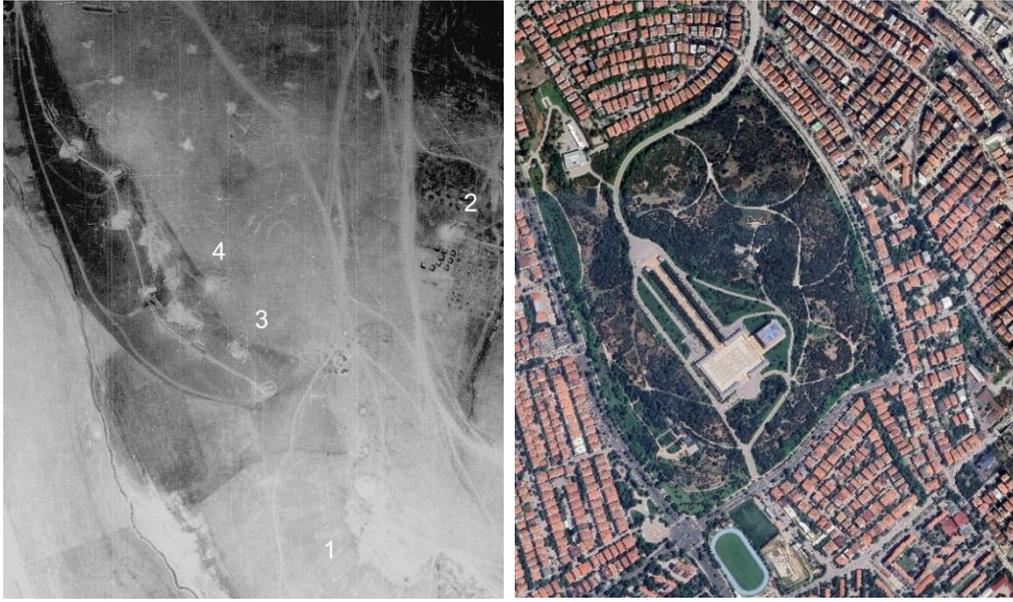
Figure 4.20. The tumuli numbered 1, 2, 3 and 4 in Anıttepe in 1942 Aerial Photo – left- (taken from Alanyalı Aral, 2017), disappeared tumuli today in Anıttepe –right- (taken from Google Earth)

In the aerial photographs of Ankara taken in 1942, it is evident that the urban settlement had only extended to the Bahçelievler housing cooperative area. This allowed for the observation of all of the western tumuli from the aerial photographs. The urban development of the early republican period was carried out with consideration of the natural landmarks created by the tumuli. During the construction of Anıtkabir, which was opened to the public in 1945, four tumuli within the boundaries of Anıtkabir's campus were destroyed. It is probable that the surrounding area was levelled in order to make Anıtkabir a landmark visible from every point in the city. This process resulted in the destruction of the tumuli.

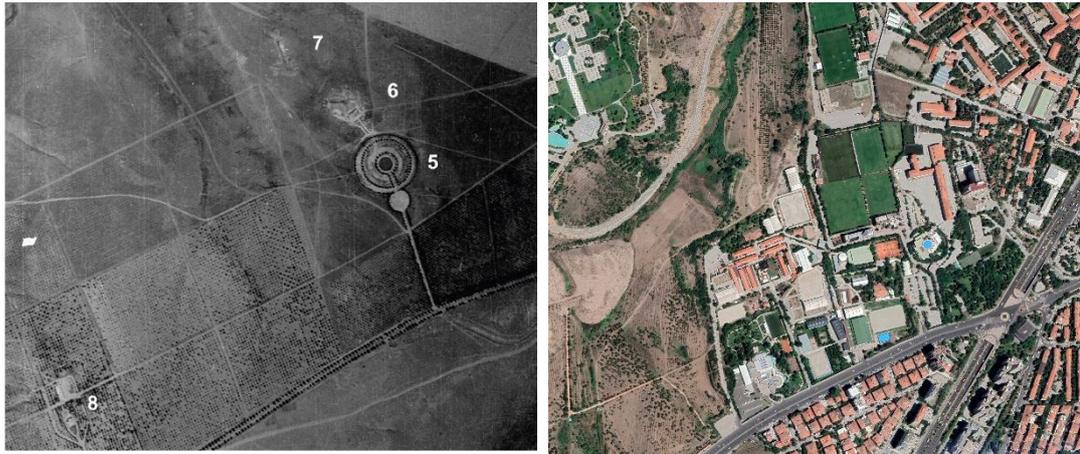
Figure 4.21. The tumuli numbered 5, 6,7 and 8 in 1942 Aerial Photo –left- (taken from Alanyalı Aral, 2017), Disappeared Tumuli today –right- (taken from Google Earth)

In the 1960s, the Ankara Equestrian Sports Facilities area and the Gençlerbirliği Sports Facilities area were established within the boundaries of Atatürk Forest Farm. Subsequently, edifices such as the Atatürk Anatolian High School and the Başkent Teacher house were erected just to the east of this area and have undergone further development until the present day. Three tumuli situated to the west of the present-day junction of Mevlana Boulevard and Beştepe Street have not survived to the present day as a result of urban development in the surrounding area. The only surviving feature of the tumulus is its circular shape, which has been preserved to some extent. However, this space has been transformed into an event and wedding venue, Wonders Event Wedding. Despite the retention of the circular form, the tumulus itself has been entirely destroyed. Furthermore, aerial photographs from 1942 show a road and a building on the site of tumulus number 8. This indicates that the tumulus was also demolished and has not contributed to the cityscape in its current form.

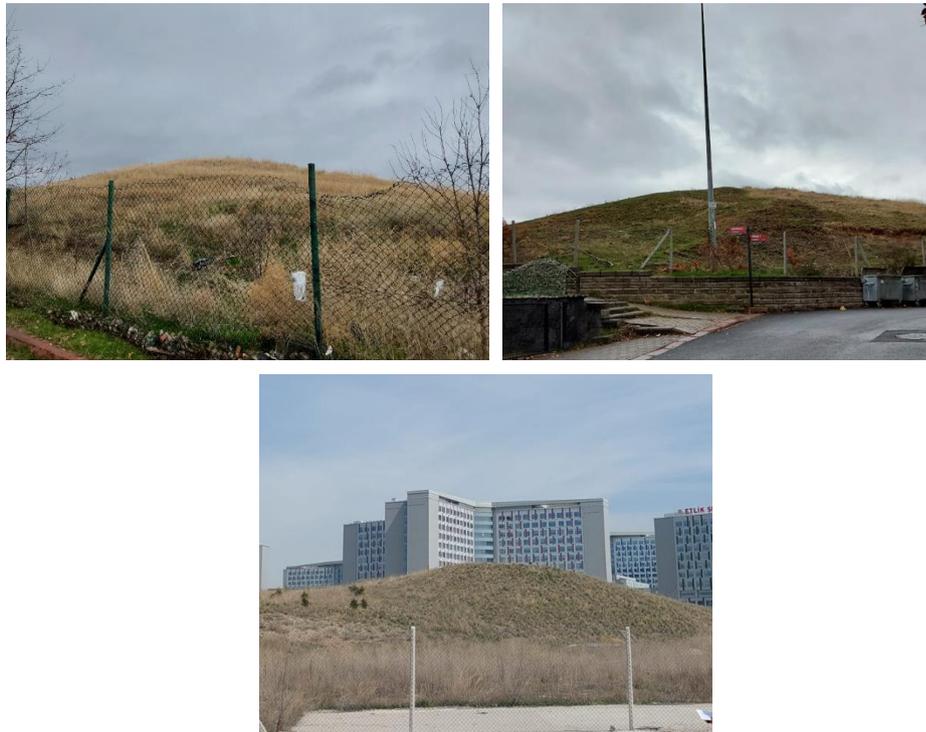
Figure 4.25. The intactness of the tumuli 10 -left-, 9 -right-, C -below- (taken by the author)

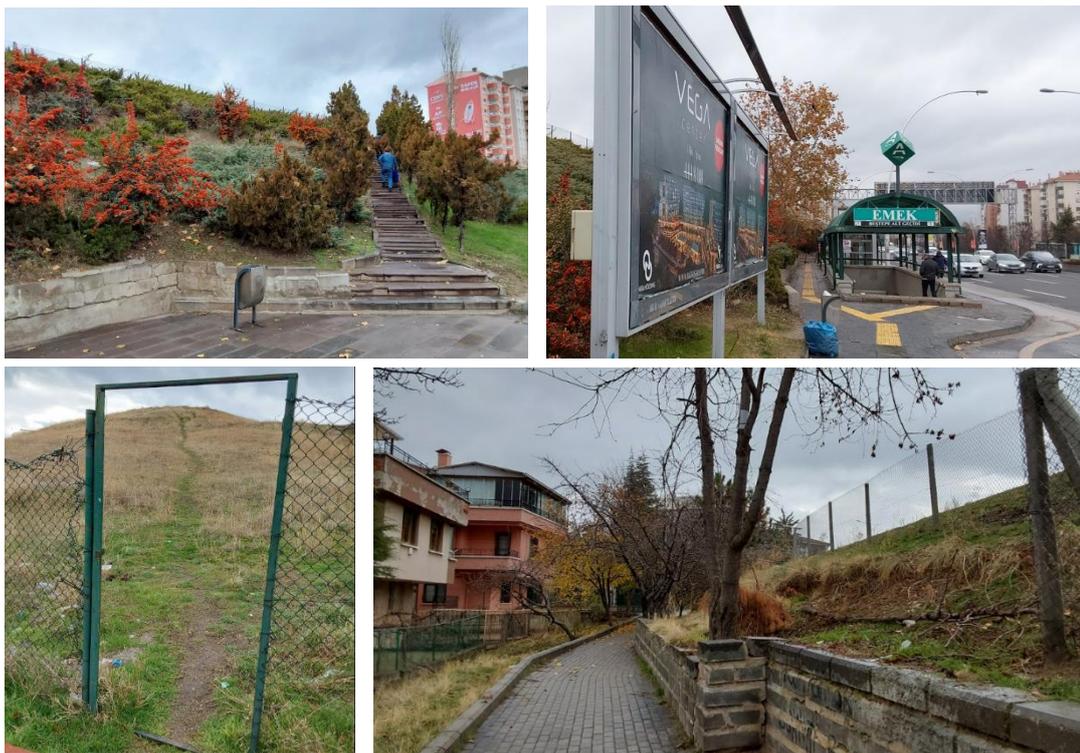
Figure 4.26. The payhways designed passing next to the tumulus 10 -left top-, metro station in front of tumulus 10 -right top-, the informal entrance to the tumulus 10 -left bottom-, the barriers around tumulus 9 -right bottom- (taken by the author)

However, when the access condition from the surrounding area is taken into account, it becomes evident that there are a number of potential access points for the existing tumuli. Tumulus number 10 is situated in close proximity to the Metro Station, while tumulus 9 is located on the main Boulevard, where public transportation options are plentiful. Tumulus C is situated within the boundaries of the Etlik City Hospital, and there are public transportation options that provide access to the hospital. Furthermore, as the Beştepelers neighbourhood, in which tumuli 9 and 10 are situated, is predominantly residential, individuals can reach the tumuli by private vehicle without encountering significant difficulties in finding parking. As a result, although the inner accessibility of the tumuli is impossible, the means of access towards the tumuli forms potentials for their integrations and enhances their physical integrations with their setting.

In the context of restricted access, the inhabitants, who had previously utilized the tumuli informally for activities including gathering, observing the surrounding landscape and even skateboarding during the winter months, are also subject to such restrictions. Previously, some of the inhabitants were attached to the tumuli in a way, ascribing certain uses to them despite the absence of designated functions. The disappearance of all activities associated with the tumuli has resulted in their functional disintegration from the current life context, particularly in terms of their designated uses and purposes. In the case of Tumulus 10, pathways have been constructed that traverse the lower levels of the tumulus, which are used by people as a means of accessing their homes after leaving the metro station. This usage, though perhaps unintentional, has led to the lower parts of the site being integrated into the daily lives of the local population.

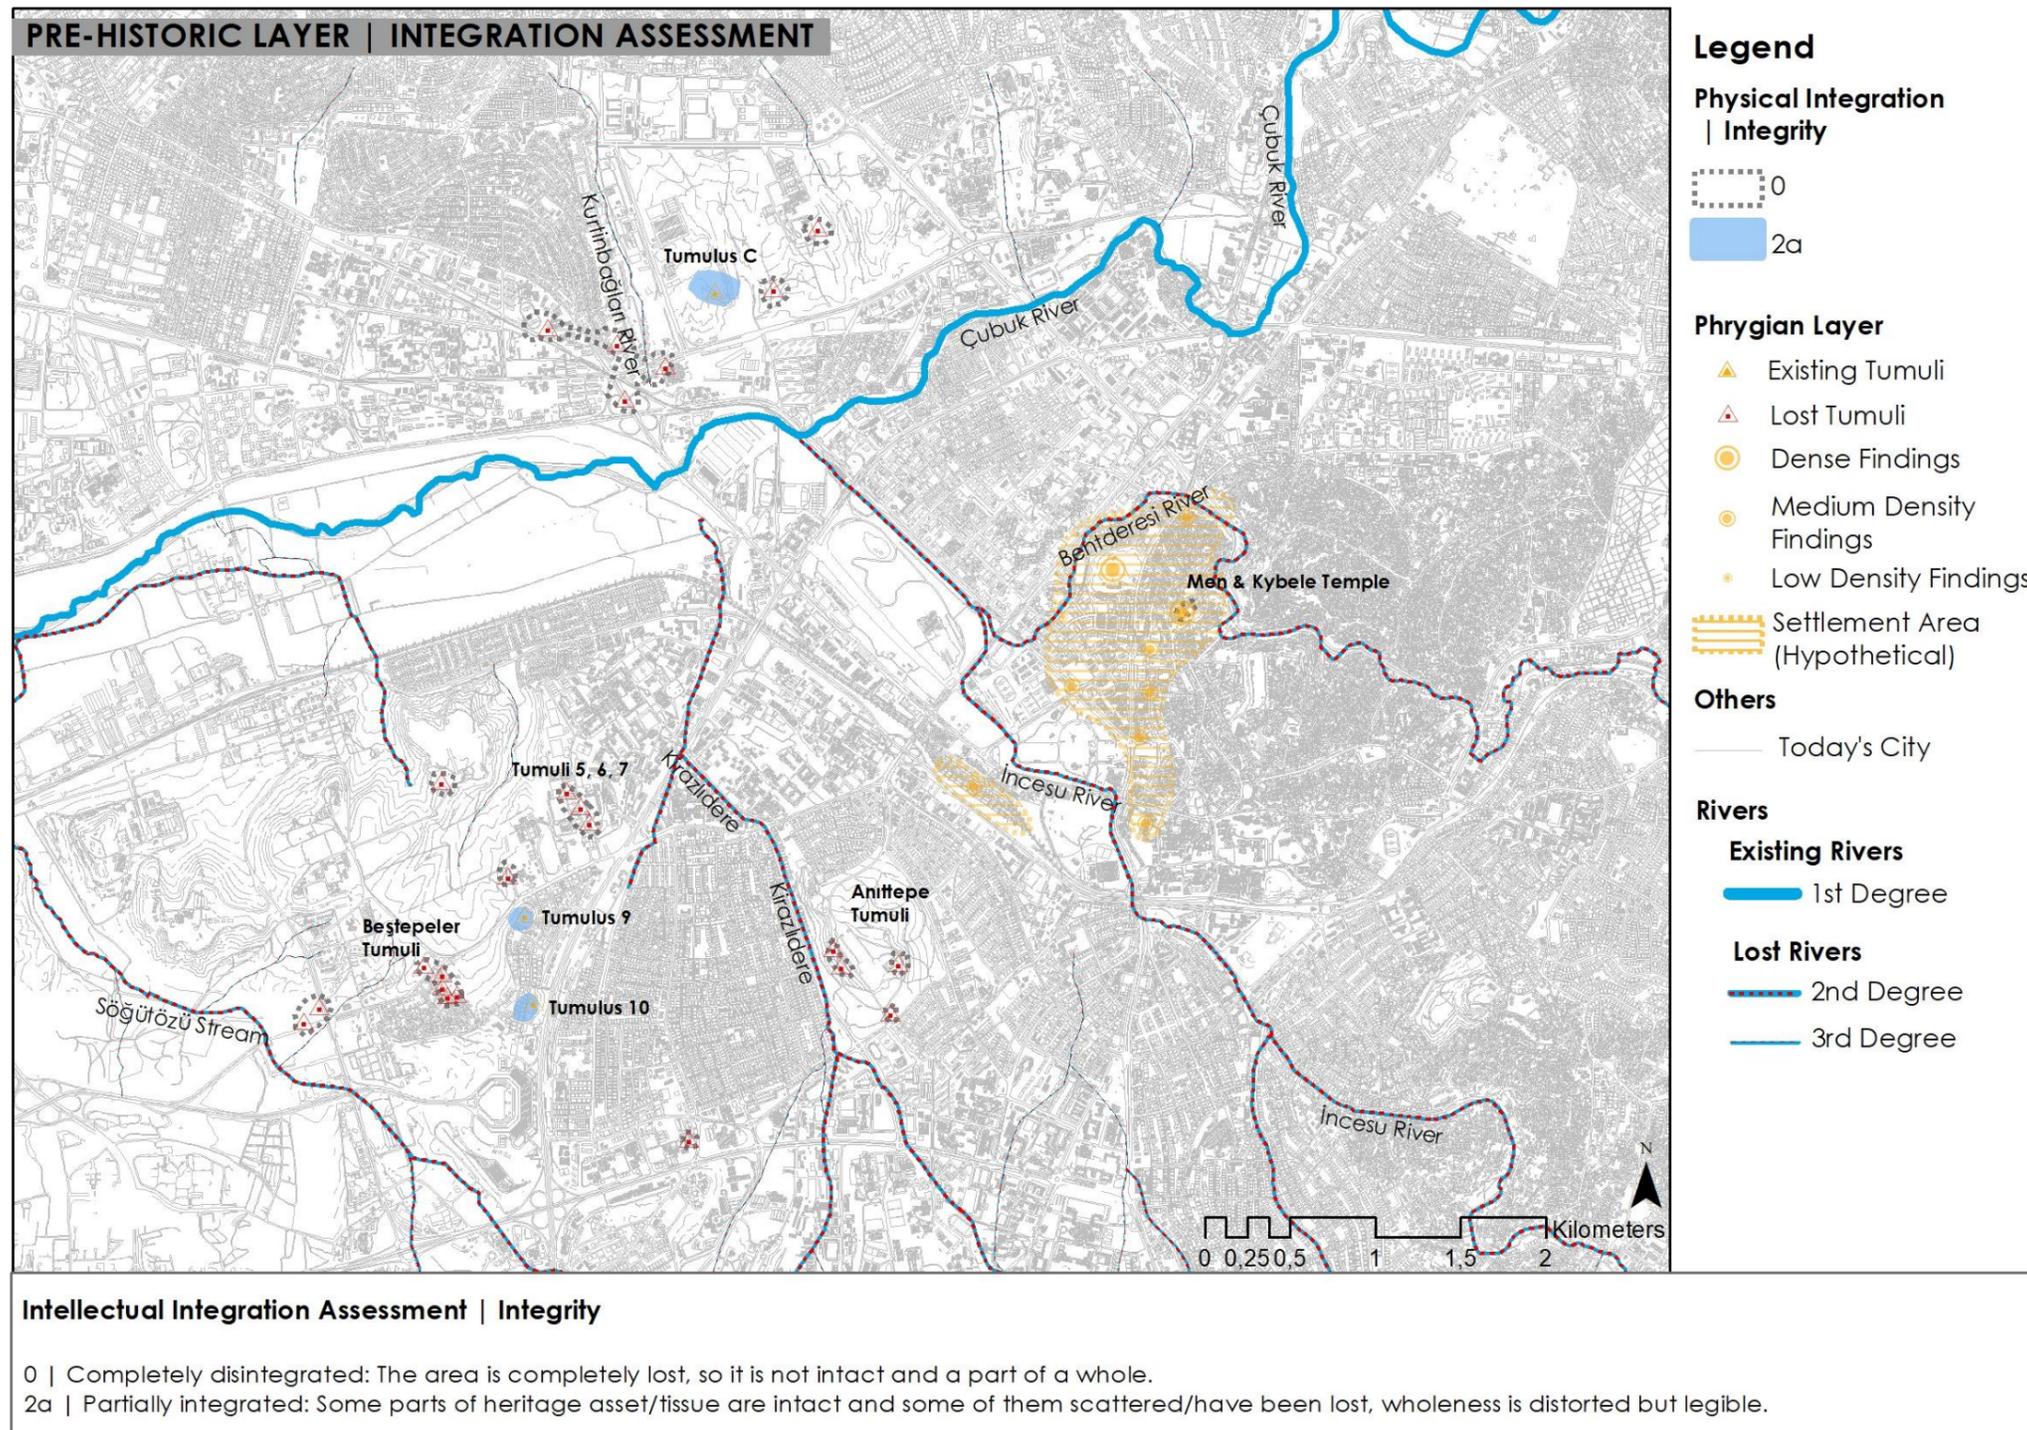
Figure 4.27. Integrity of Pre-Historic Identity Areas with current context for Physical Integration (produced by the author in GIS)

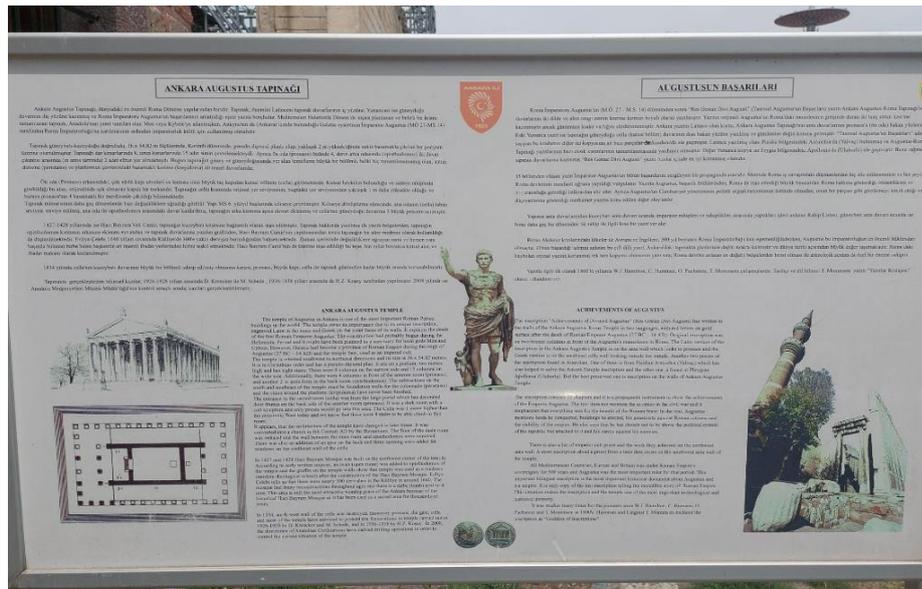
Figure 4.38. The informative signboard of the Temple of Augustus and Rome (taken by the author)

In terms of the temple's historical and architectural significance, the available information includes details of the temple's history, the various functions it has served throughout its history, and the importance of the *Res Gestae Divi Augusti* inscription carved on it. The aforementioned information is made available to the public in a comprehensive manner. The only aspect that is lacking is an account of the relationships between the temple and its surrounding context throughout history. Nevertheless, despite the presence of a substantial information, the methods of its presentation and interpretation are inadequate. The information is presented via signboards, which are characterized by an excess of text. The presentation activities do not consider the use of different means or different audience groups. Furthermore,

the signboards do not refer to the site's context when providing information, which makes it impossible to attach an understanding and meaning between what is written and what is present within the site. Even the inscription carved on the wall is hardly recognized due to the ineffectiveness of the presentation, which ultimately prevents the values and significance of the site from being communicated to the local people.

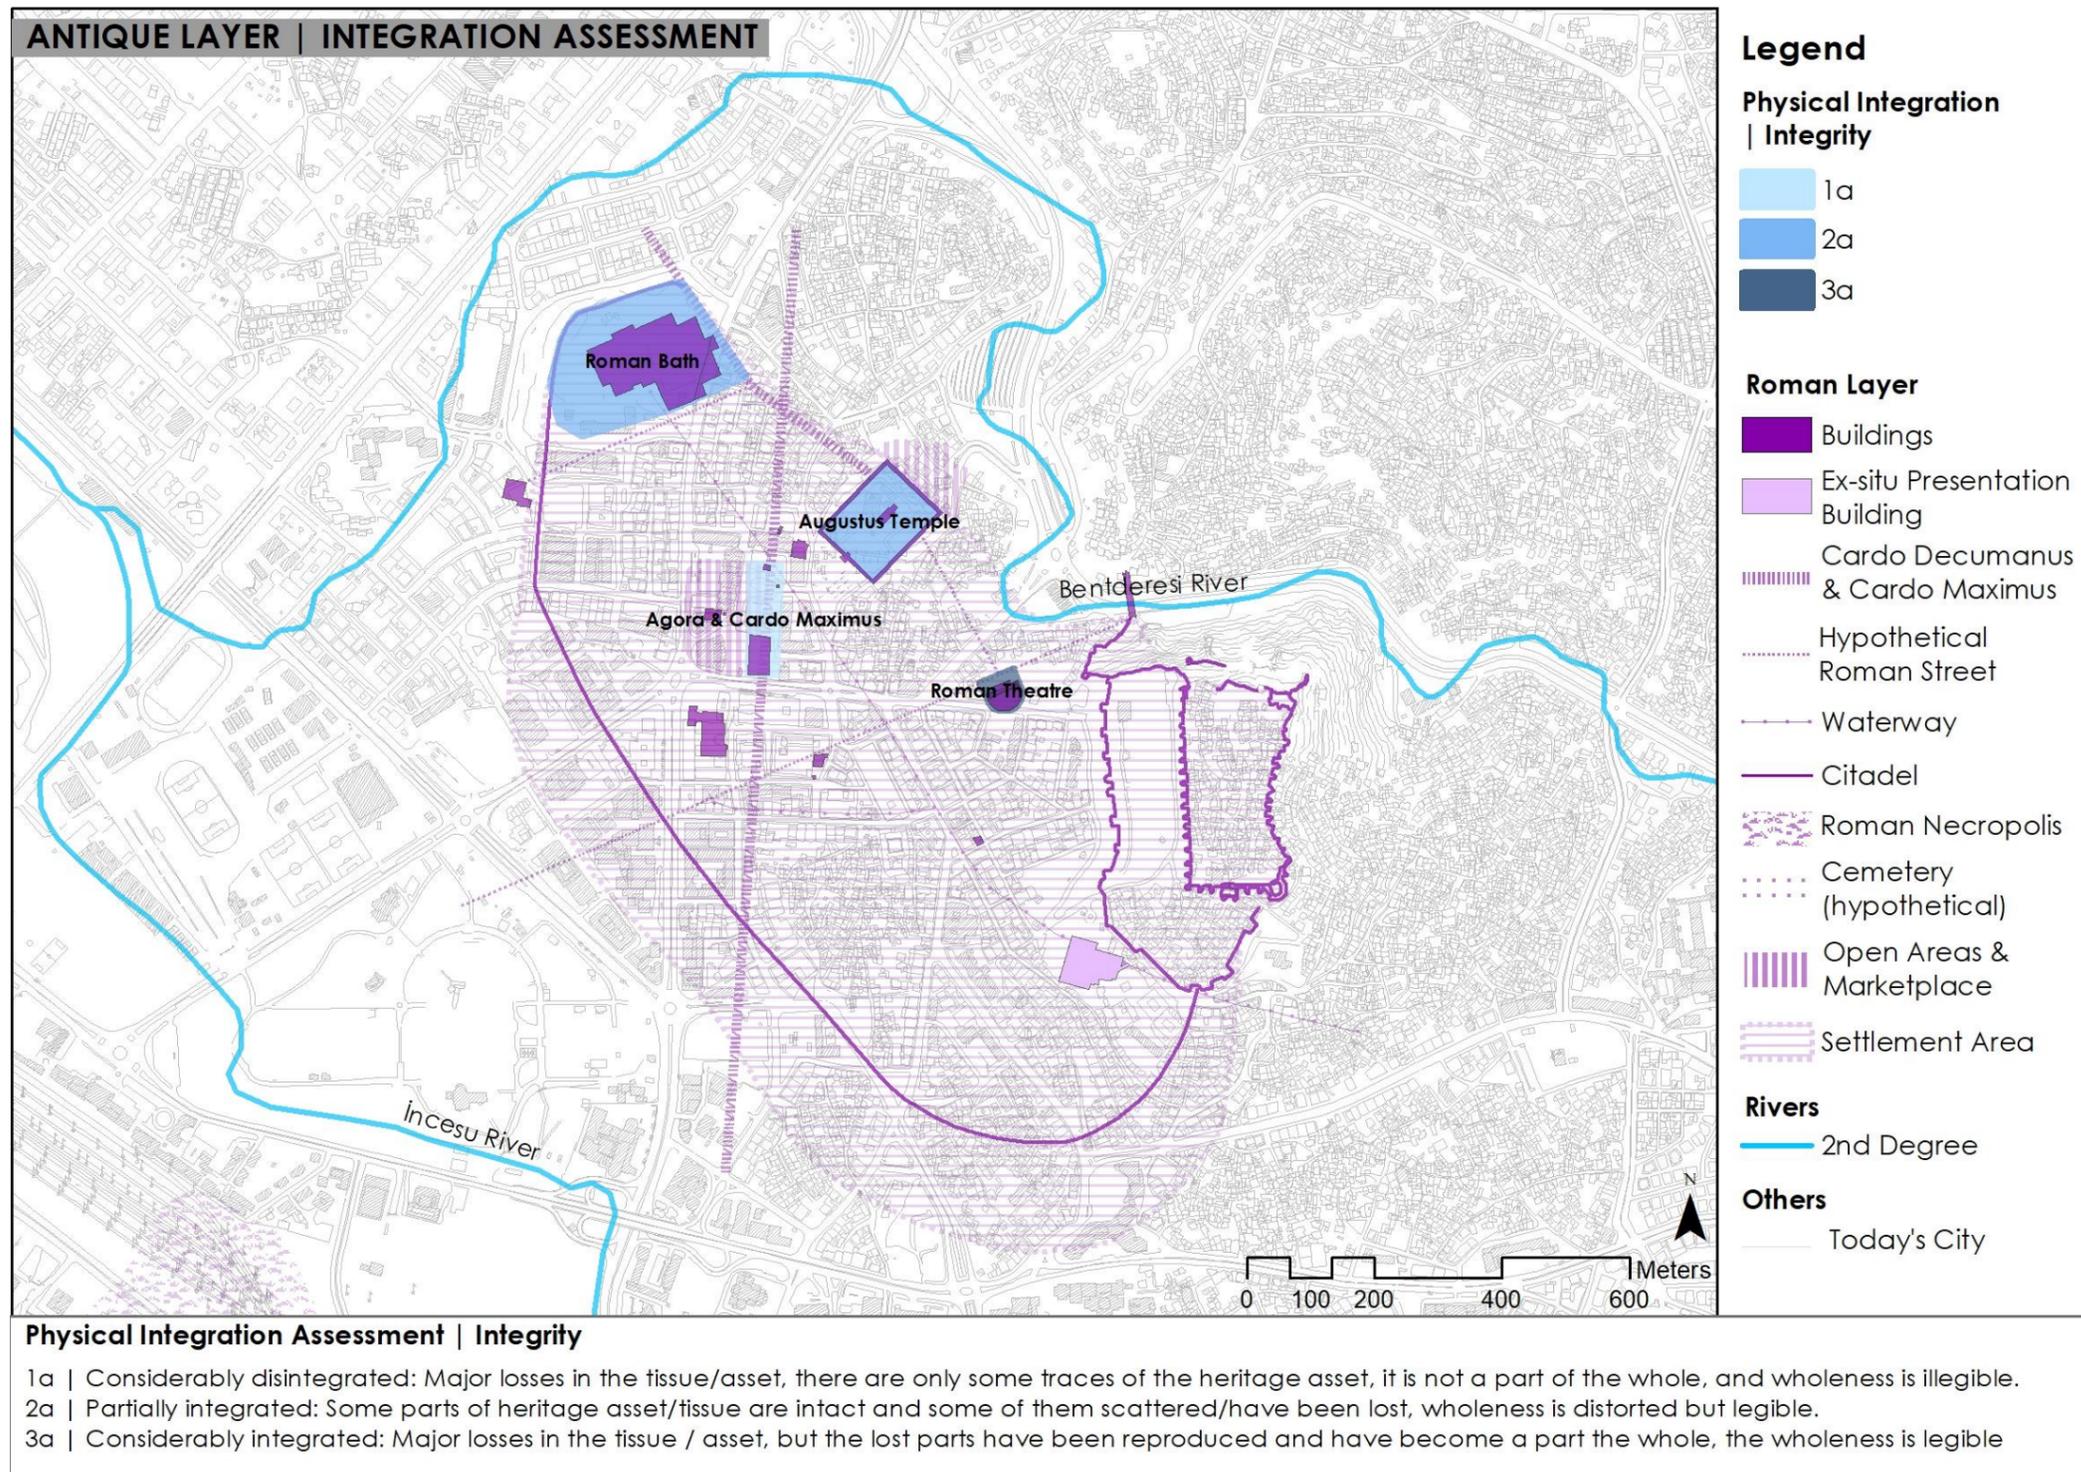
Figure 4.40. Integrity of Antique Identity Areas with current context for Physical Integration (produced by the author in GIS)

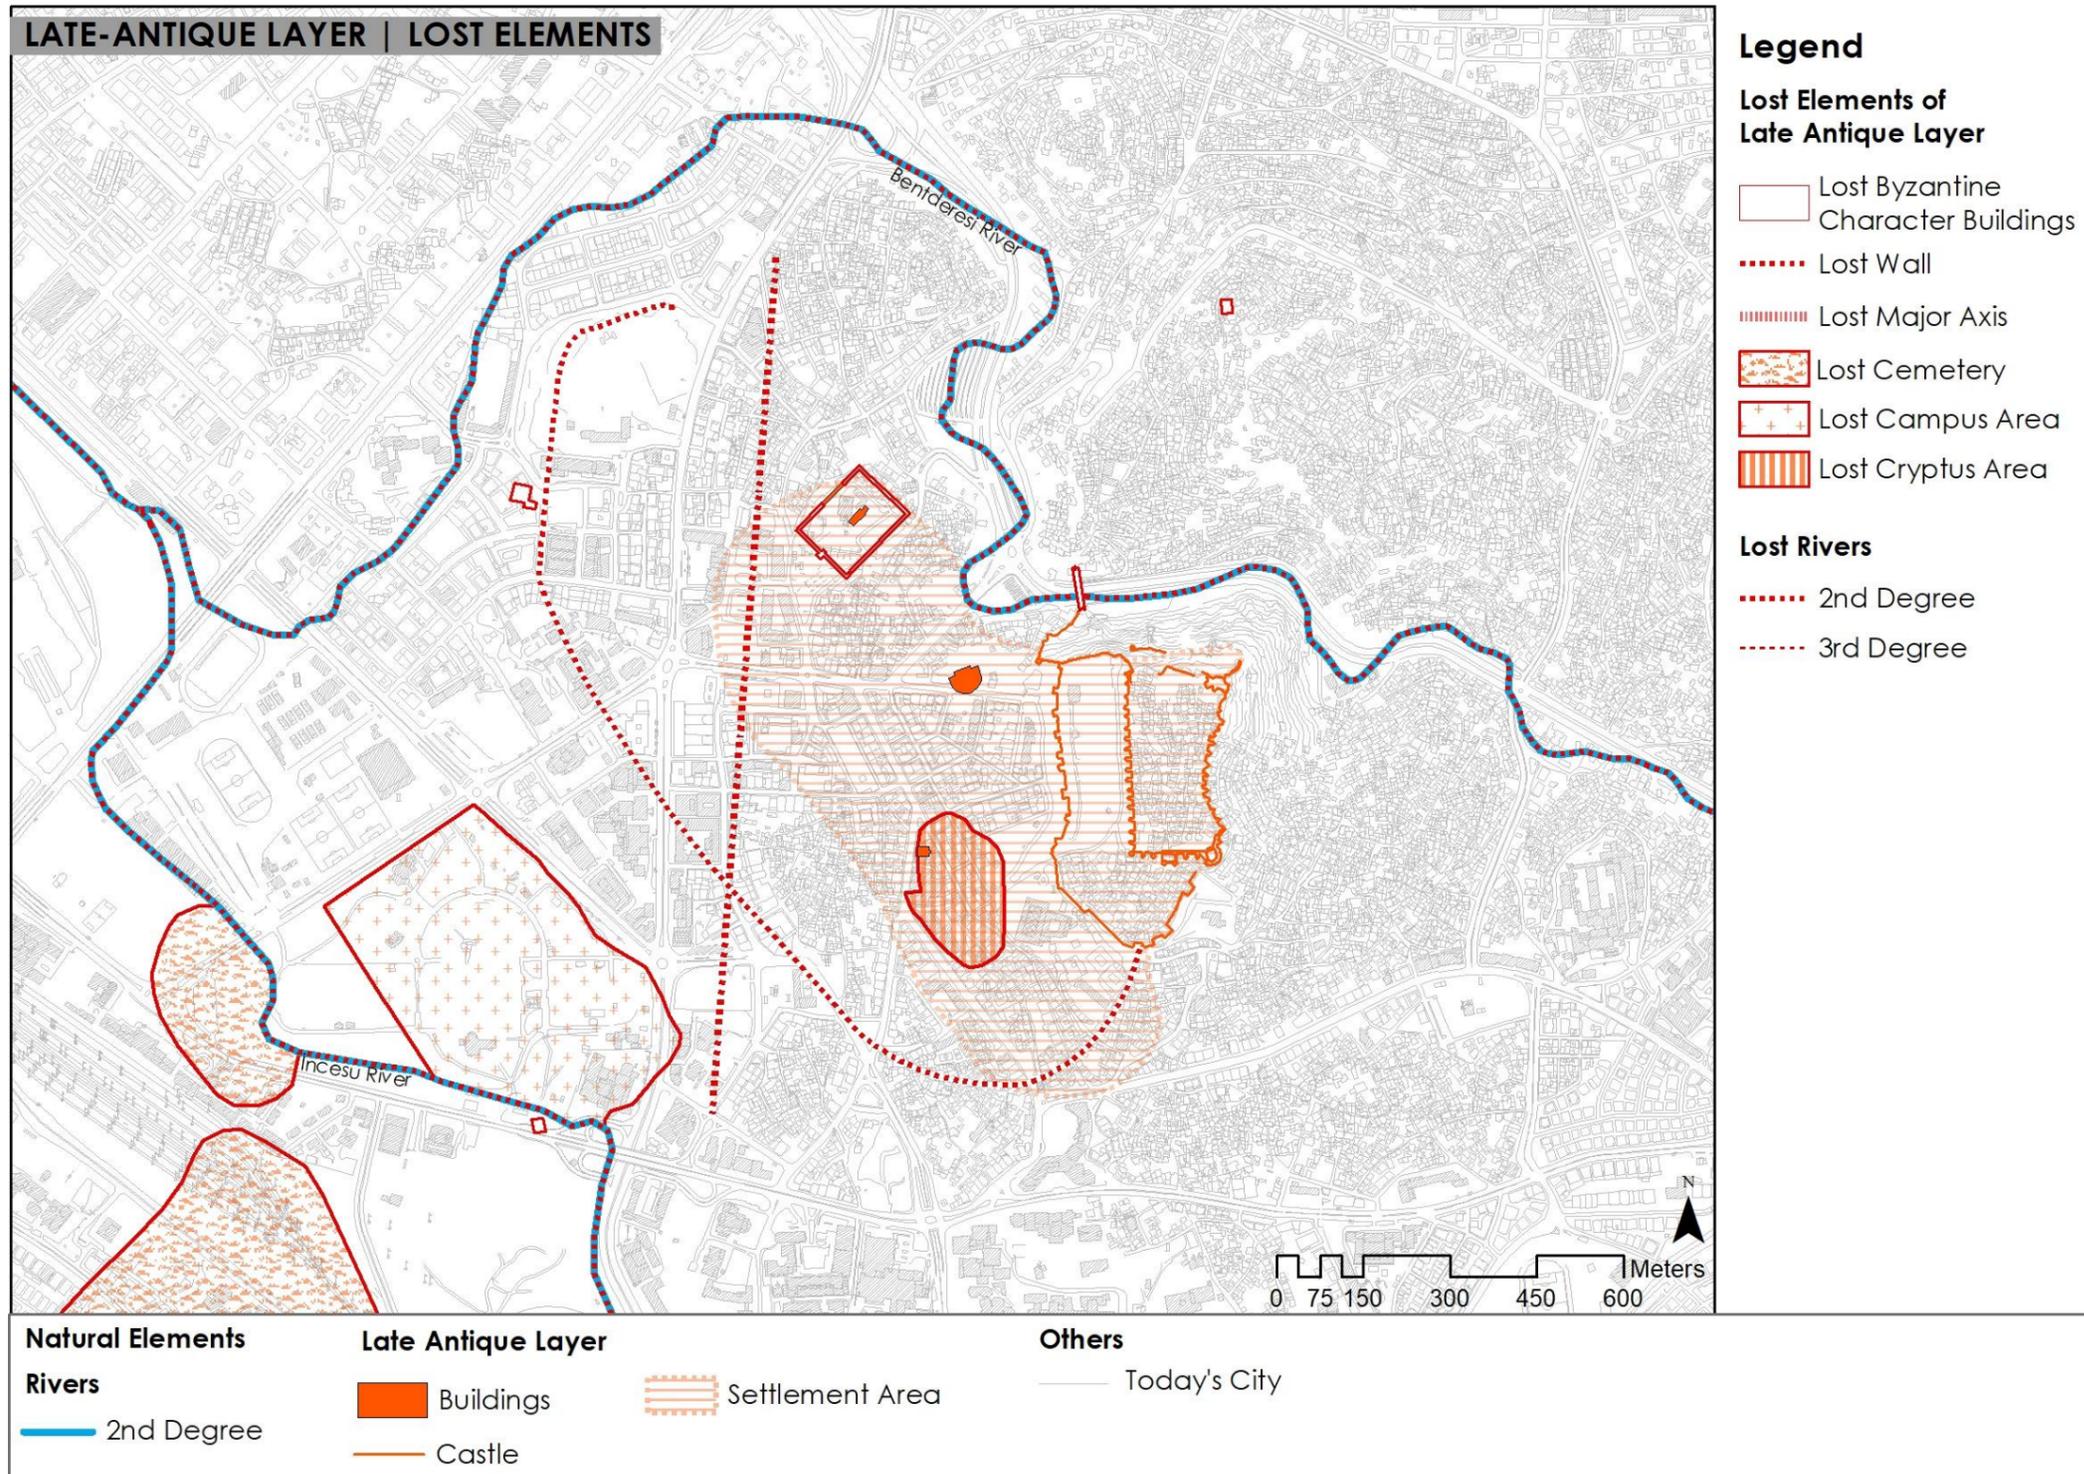
Figure 4.49. Lost Elements of Late-Antique Ankara: Buildings, city walls, streets, cemeteries, open areas which could not reach today (Produced by the author in GIS)
