ASSESSING THE INTEGRITY OF THE HISTORIC LAYERS OF A MULTI-
LAYERED SETTLEMENT TO THE CURRENT URBAN CONTEXT: THE
CASE OF ANKARA

A THESIS SUBMITTED TO
THE GRADUATE SCHOOL OF NATURAL AND APPLIED SCIENCES
OF
MIDDLE EAST TECHNICAL UNIVERSITY

ZEYNEP BUKET ÜSTÜN

SEPTEMBER 2024

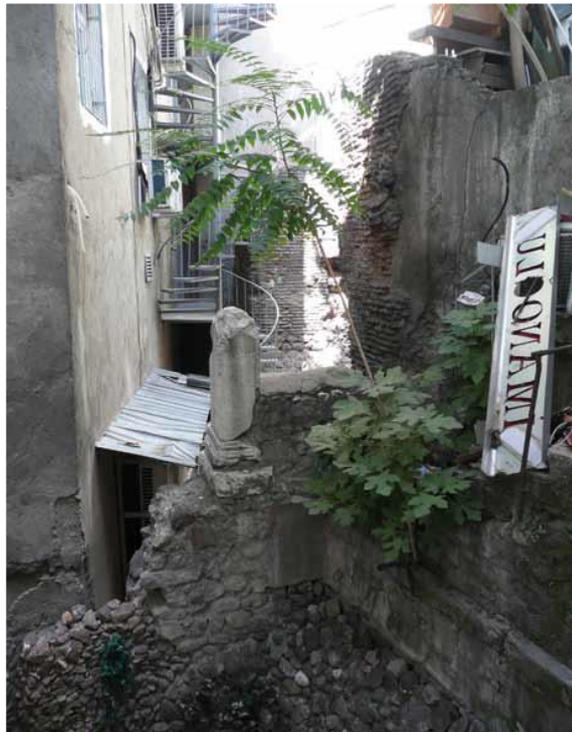
Figure 4.51. Current integrity level of St. Klemens Church of Byzantine Ankara (source: Serin, 2014)

St. Klemens Church and the Kryptus Area, which represent one of the most significant religious and ceremonial sites in Byzantine Ankara, have suffered a considerable loss of integrity. Currently, the majority of the structure's components have been dispersed, with only a minor section remaining within the urban space, rendering the original integrity and coherence of the edifice unattainable. Only an interior section of a wall and a marble block containing a Latin cross have been preserved in the current context (Serin, 2014). As Serin (2014) notes, the church was already in a severely deteriorated state by the 19th century, and its accessibility was severely restricted by the surrounding construction. The only means of accessing the remains is by passing through other buildings, which presents significant challenges and limitations for the local population.

Due to the loss of integrity, the church is no longer capable of utilizing a function. Consequently, the church lost its functionality and the meanings that were previously associated with it. Moreover, the site is physically and visually accessible only through the passage of some buildings, which renders it imperceptible to citizens as the surrounding tissue has completely obscured the view of the remains. This significantly decreases its visual integration with the surrounding environment. Despite its numerous significant architectural features, including some parts of columns, column capitals and the alternating brick and stone technique within the walls, the damage to its integrity prevents these features from creating an aesthetically pleasing impression. Consequently, the lack of maintenance has a negative impact on the architectural features, making the remains unattractive to the inhabitants.

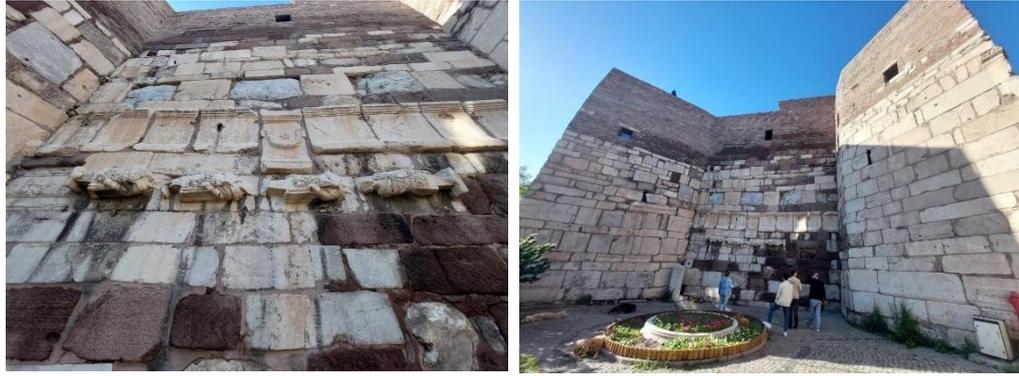
Figure 4.52. Ankara Citadel as a memory structure, due to the presence of numerous scattered findings (taken by the author)

It is evident that St. Clement Church represents a significant loss to the architectural heritage of Byzantine Ankara, as do numerous other ecclesiastical structures and edifices that once flourished in that period. This situation renders the Ankara Citadel Wall of considerable value, as it is not only a Byzantine structure but also provides numerous visual clues regarding cultural assets that have not survived to the present day. The stones of the walls provide clues to the city's history, from the ancient period to the Ottoman period, through the spolia they contain. As a result, the citadel wall is not only the sole intact Byzantine structure but also a source of memory in itself.

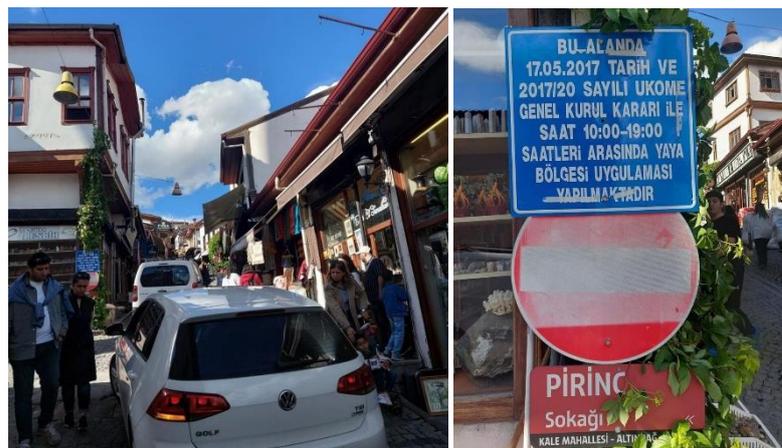
Figure 4.53. Vehicle entrances to the streets which the entrance is not allowed (taken by the author)

Access to the Citadel is challenging due to the site's topographical features. The streets leading to the Citadel are characterized by elevated altitudes, which present a challenge for pedestrians due to the lack of street furniture for resting areas. The streets are characterized by a high level of congestion due to the high density of commercial activities. Additionally, despite vehicle entrance being prohibited during specific hours, vehicle drivers frequently disregard the regulations and enter the street by car. This has the effect of disrupting the pedestrian flow, as the roads are narrow. Furthermore, there is a lack of parking facilities in the immediate vicinity, which results in vehicles being parked on the sides of Atpazarı Square. Consequently, both pedestrian and vehicular access are limited due to the aforementioned challenges.

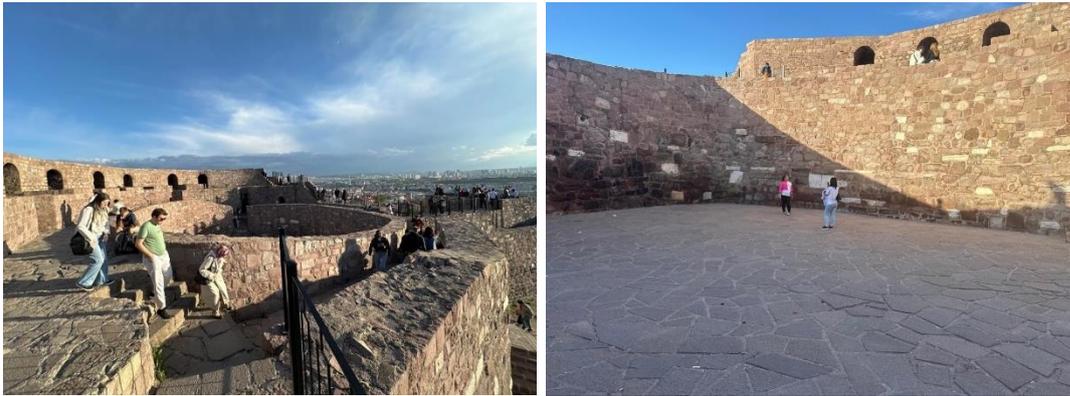
Figure 4.54. The visits to the Ankara Citadel -left- and the empty spaces at the inner parts of the citadel -right- (taken by the author)

The Citadel is visited for purposes of tourism, as it does not host other events. The Ankara citadel is a popular tourist destination for both locals and visitors, offering a unique perspective on the city's landscape. However, the majority of visits remain limited to these activities. Despite its frequent visits, the duration of stay remains relatively brief. While some inner areas have potential to be utilized for specific activities, they are currently underutilized. Consequently, instead of having diverse "users", the citadel primarily attracts "visitors".

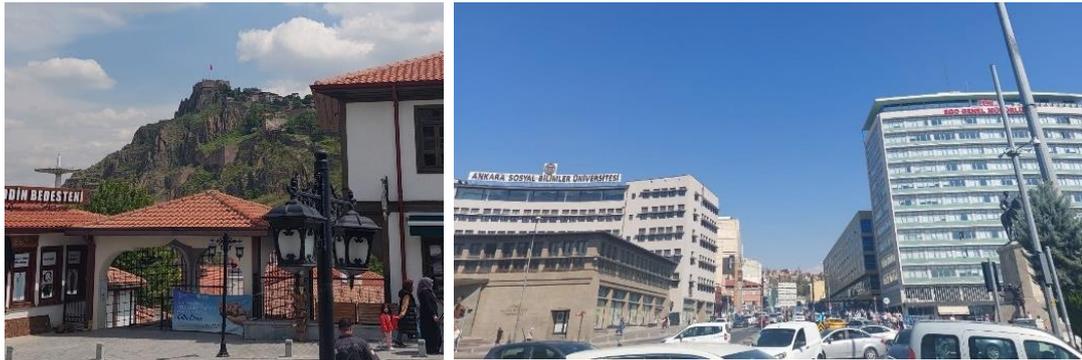
Figure 4.55. The viewpoints towards the Citadel from Hac1 Bayram Mound and from U1us Square (taken by the author)

The location offers considerable advantages in terms of visibility from the majority of the city. The citadel is visible from numerous viewpoints, both in its immediate vicinity and from more distant locations. The Atpazarı square, situated at the entrance to the Outer Castle Wall, is characterized by a sense of monumental scale, which leaves a profound impression on visitors. Given its elevated position, the citadel also affords numerous vistas of the city, thereby establishing a strong visual connection between the monument and the citizens. Furthermore, despite some maintenance problems, the monumentality and other architectural elements contribute to its visual attractiveness. Its visual attractiveness is enhanced by its location, pentagonal towers considered optimal for defensive strategies, other architectural features, construction techniques and materials, and its harmony with the historical topography of Ankara during the Byzantines when it was constructed.

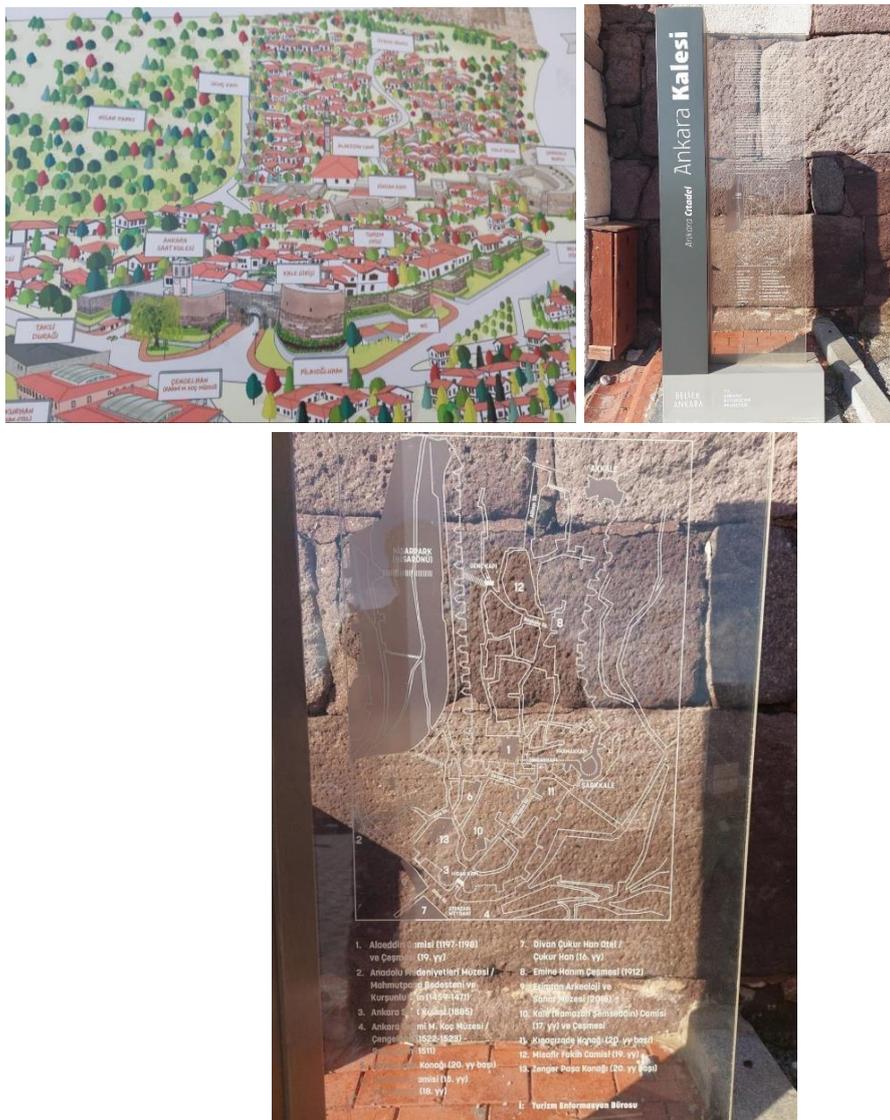
Figure 4.57. The informative tools located at the entrances of Outer and Inner Castles (taken by the author)

A number of initiatives have been implemented with the objective of providing information regarding the Ankara Citadel Wall and the subsequent period of settlement within the citadel. A conceptual drawing is displayed at the entrance of the citadel, which illustrates the buildings that are currently existing within the space. The objective is to facilitate orientation within the citadel and provide information about the names associated with the castle wall, such as Zindan Kap1 and Őarkkale Burcu. Additionally, around the inner castle entrance, there is another informative tool designed by Bellek Ankara, which contains a brief history of the citadel and significant elements from different periods, including the Alaeddin Mosque, Anatolian Civilization Museum, Clock Tower, Khan Buildings, and others.

This tool offers a more comprehensive understanding of the citadel than the other one, as it not only includes the existing nodes but also the previous names and periods of the buildings, thereby establishing connections with the past and between the periods. However, it remains solely a written tool, which is not particularly effective for the presentation of the site. Given that the architectural components of the wall provide significant insights into other periods' edifices, even the stones used as spolia deserve an effective presentation of the site that encompasses all components.

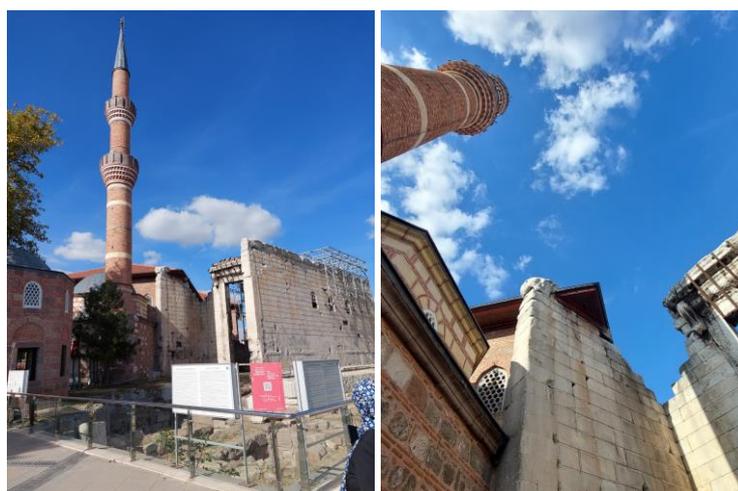
Figure 4.66. The togetherness of Hacı Bayram Veli Mosque and Augustus Temple as a continuous religious identity area (taken by the author)

The area representing the greatest historic continuity is characterized by the gradual evolution of the surroundings of Augustus Temple and Rome during this period. This was influenced by shifts in religious affiliation and population growth. The Hacı Bayram Veli Mosque, named after the prominent figure Hacı Bayram Veli, was constructed in close proximity to the Augustus Temple and Rome, forming a one-point intersection. In this manner, the identity area of the preceding layers also constitutes an identity character during the Turkish-Islamic Period, functioning as a religious focus. Within this area, residential buildings were constructed around the "Hacı Bayram Mound," which also represents the architectural characteristics and facets of daily life. Consequently, the area serves not only as a religious but also as a residential focus during the Turkish-Islamic period.

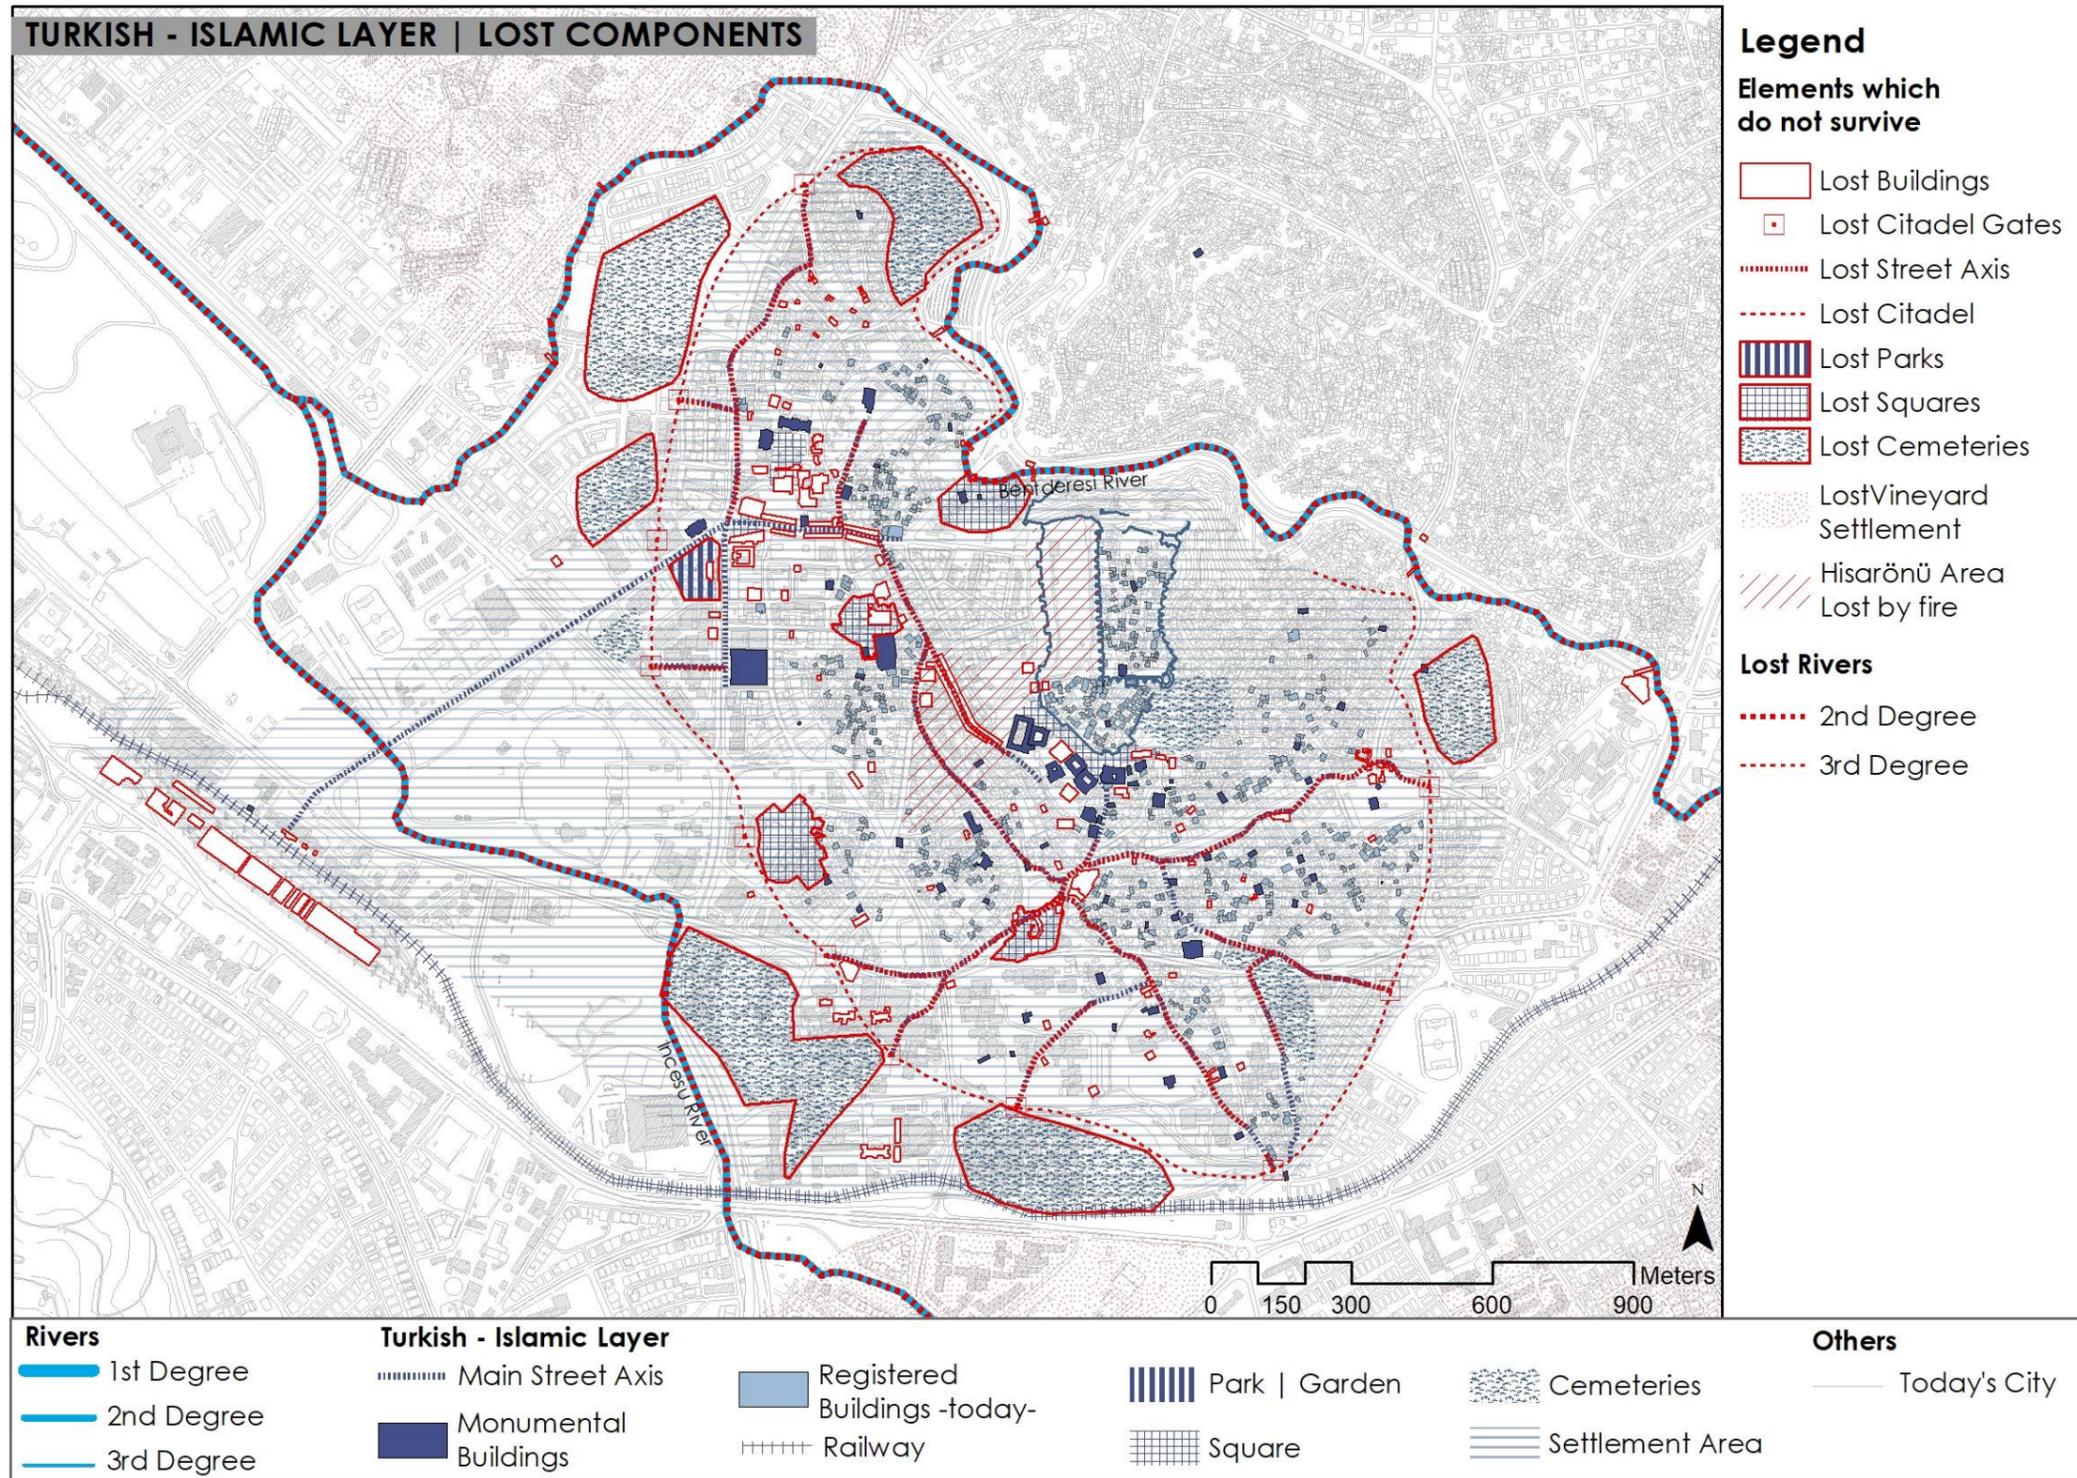
Figure 4.68. Lost Elements of Turkish-Islamic Ankara: Buildings, city walls and gates, streets, cemeteries, squares which could not reach today (Produced by the author in GIS)

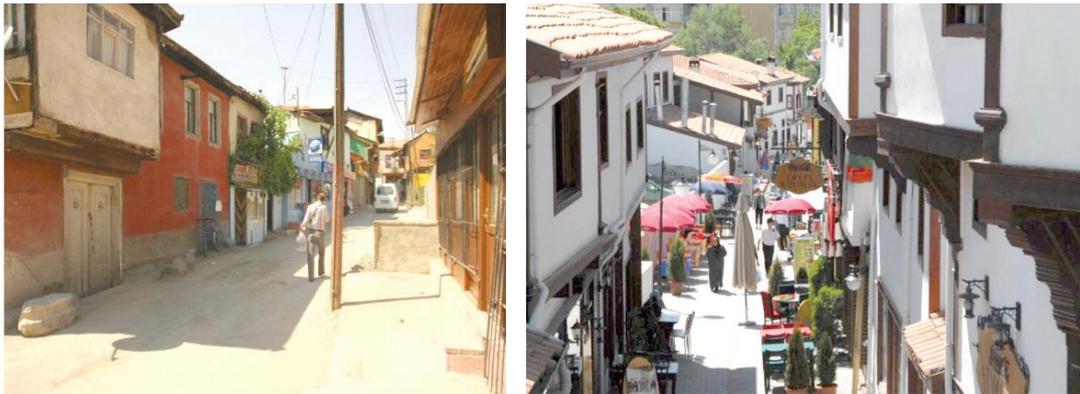
Figure 4.70. Old Situation of Sarıkadı Street in Erzurum Quarter, Hamamönü –left- and the New Situation of Sarıkadı Street after rehabilitation –right- (source: Kurtar & Somuncu, 2013).

reconstructed. Despite the reconstruction being said to be in line with the original components of the fabric, the colours, elements and façade characteristics have largely been altered and are now similar to one another. Currently, the traditional fabric of these areas can be considered a "replica" of the original tissue. However, as the majority of them were reconstructed by considering the general mass and façade compositions, the fabric has retained its integrity despite being reproduced.

Moreover, some squares that have no historical precedent were constructed at the defined entrances of Hamamönü and Hamamarkası, through the demolition of residential buildings and shops. While the registered buildings in the vicinity of the squares are undergoing reconstruction, new structures have been erected in accordance with the requirements of the designed square. In general, especially in Hamamönü, the physical aspects of the residential tissue have been subject to significant intervention, largely due to the fact that the majority of the existing buildings were demolished and have not been preserved to the present day. Furthermore, the construction of Hacettepe University and the subsequent development of the central dormitory area next to it has resulted in the destruction of the majority of the neighbourhood. Additionally, the Great Fire that occurred at the end of the Turkish-Islamic Period led to the destruction of the left section of the Inner Castle neighbourhood.

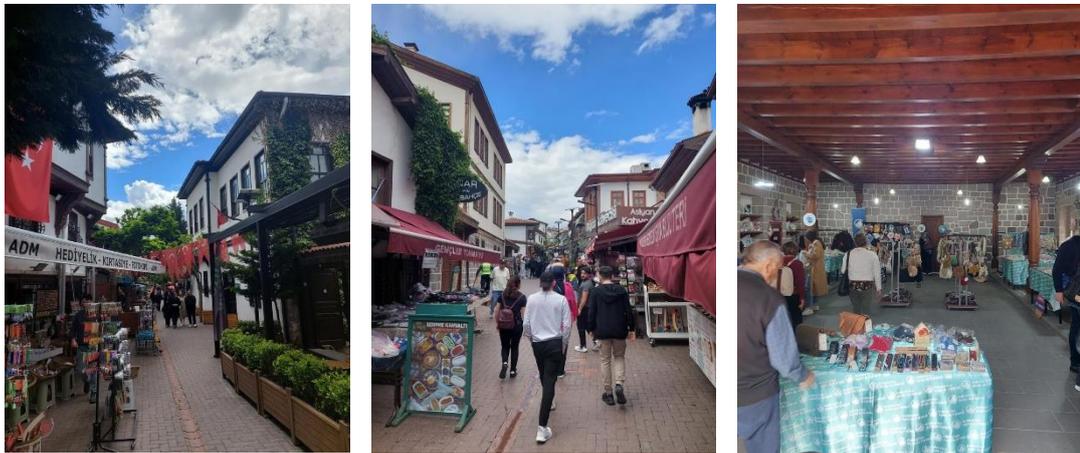
Figure 4.71. Recent usages and physical appearance of “rehabilitated” Hamamönü Streets –left and middle-, some uses enhancing women entrepreneurs as a positive contribution of Hamamönü Project. –right- (taken by the author)

There are several book-café houses, boutique restaurants, libraries, art house-atelier and exhibition house complexes, handicraft product bazaar of women entrepreneurs, and gift shops which serve touristic purposes. While these functions may have beneficial effects due to the diverse user capabilities of younger generations, children, and the elderly, the total number of functions is excessive. The balance of these touristic attractions and the residential life could not be achieved. As a result of this functional change, the residents of the area had to leave the area since they could not catch up with the high amount of rent generated by tourism-led transformation.

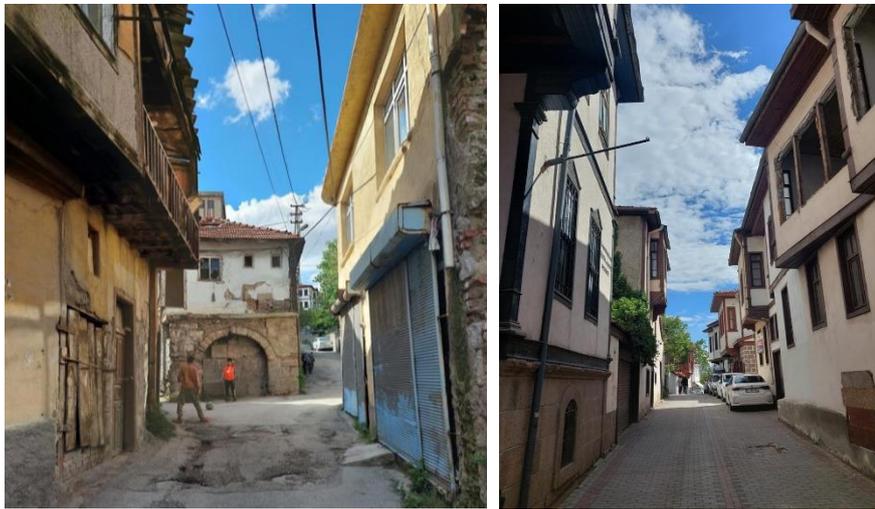
Figure 4.72. Signs for continuing life of original inhabitants where children play football by using the historic fountain –left-, the non-used streets and empty buildings in Hamamarkası area due to wrong intervention –right- (taken by the author)

An important difference between the functionalities of Hamamönü and Hamamarkası is that, most of the restored and reconstructed buildings have not been functionalized yet. They are either empty or offer a very specific use such as a museum or culture house, so could not be included into the daily usage of people. Therefore, the expected tourist attraction cannot be achieved yet. This situation presents an opportunity to reconsider the potential for redeveloping these sections of the area for residential use.

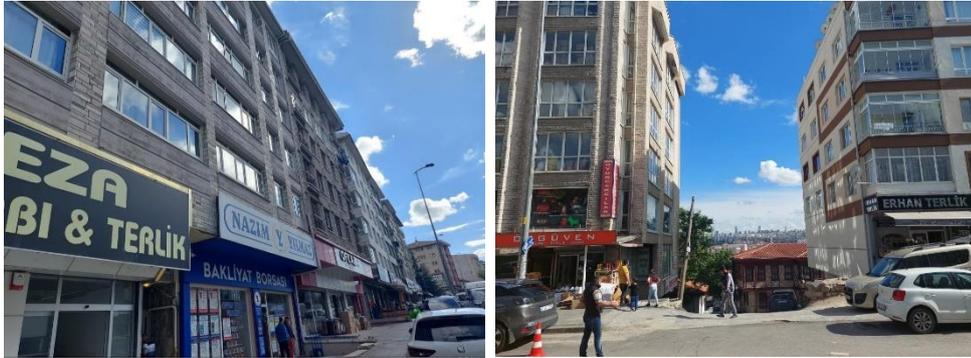
Figure 4.73. Closed Perception of Hamamarkası area from Ulucanlar Street (taken by author)

The Hamamönü and Hamamarkası areas present certain challenges in terms of the perception of the traditional fabric. Despite being divided by the Talatpaşa Boulevard, the tissues at both sides can be easily perceived since there are no high-story apartments along the boulevard closing their perception. Nevertheless, the Hacettepe area, comprising a vast campus of high-rise buildings, effectively obscures the view of the Hamamönü area from the south. Similarly, the Hamamarkası tissue is also obstructed by the high-rise apartments along Ulucanlar Street in the north. Consequently, both areas are partially perceptible from some public spaces. In contrast, the Inner Castle is situated at a considerable elevation, rendering it visible from most sections of the city.

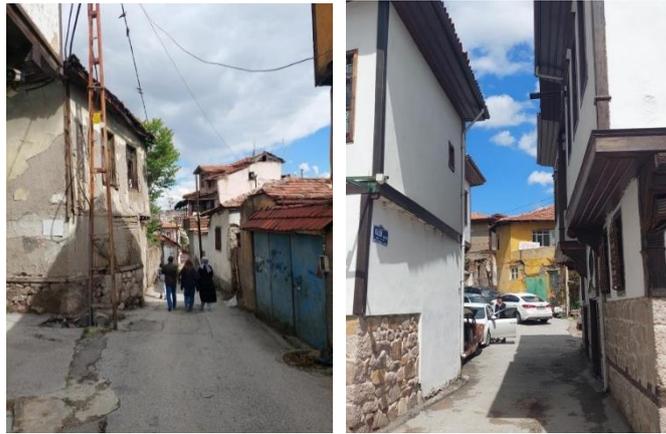
Figure 4.74. Deteriorated Residential Areas in Hamamarkası, especially at the north sections –left-, The deteriorated sections of Hamamönü behind the rehabilitated streets –right- (taken by the author)

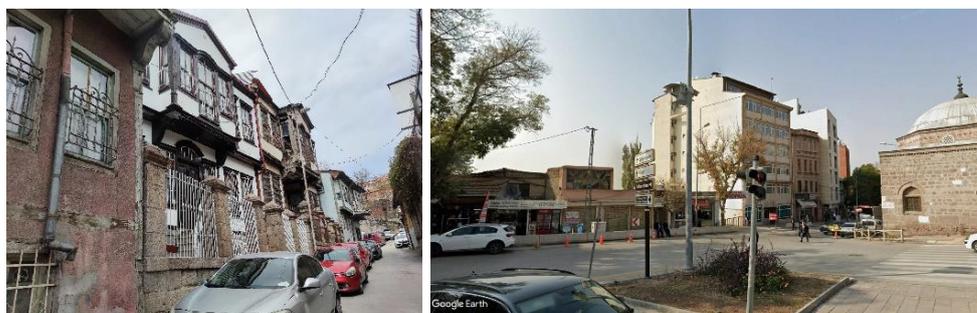
Figure 4.77. Integral İstiklal Neighborhood tissue (left), High-story buildings in front of İstiklal neighbourhood, distorting the wholeness of historic tissues (right) (taken by author)

were distorted. Furthermore, according to the literature, the northern part of the neighbourhood was destroyed due to the 1916 fire. Currently, with the exception of the areas along the major boulevards and the northern part destroyed by the fire, the historic residential tissue maintains its integrity and authenticity.

have no relationship with the historic tissue. Therefore, they also prevent the visibility of the intact historic tissue at the central part of the neighbourhood. Since their visual quality are also very low, they create a negative image about the neighbourhood since the people perceive the area as unqualified and unsafe.

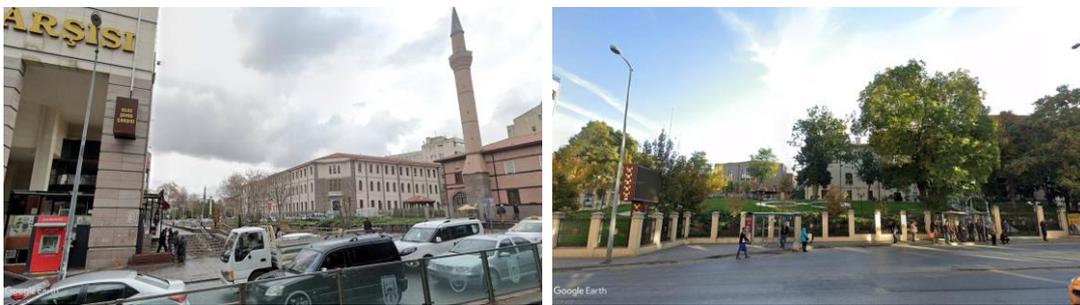
Figure 4.78. Sightlines towards Hükümet Area from Anafartalar Street –left-. Sightlines towards Hükümet Area from Çankırı Street –right- (Source: Google Earth Street View)

The visibility of the Hükümet area is subject to certain limitations as a result of the characteristics of the surrounding context. The location of the Cardo Maximus area adjacent to Anafartalar Street presents a valuable opportunity for enhancing the visibility of the Hükümet area, as it allows for unobstructed views of the area from major roads. Furthermore, the existence of a square between the buildings has a beneficial impact on the area, as individuals spending time within the square are able to observe the Hükümet buildings. From Atatürk Boulevard, the expansive garden of the ASSU rectorate building faces the boulevard, thereby providing visibility of the area from the boulevard. However, due to the presence of high-rise buildings surrounding Atatürk Boulevard, the area is not fully perceptible unless one is in close proximity.

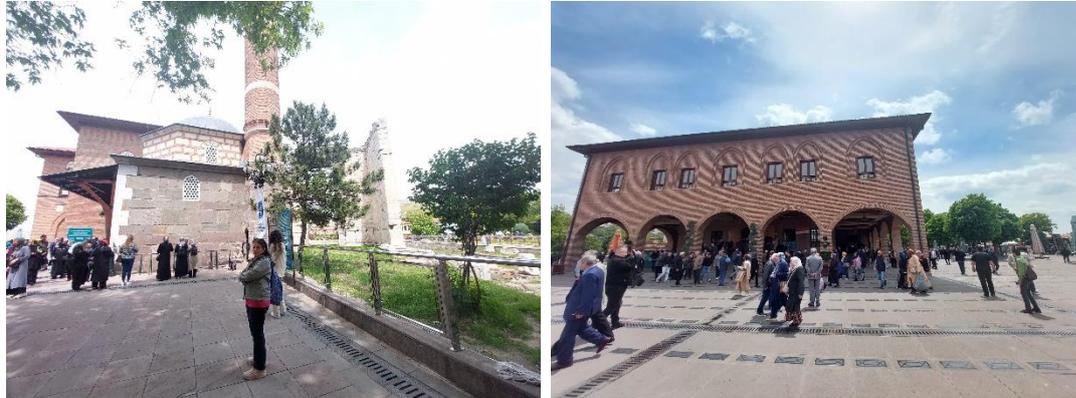
Figure 4.79. People using the mosque actively while turning their backs to the temple -left-, The daily usage of Hacı Bayram Veli Mosque –right- (taken by the author)

Furthermore, it is possible to utilize the mosque continuously, both during and after prayer times. Furthermore, numerous individuals utilize the mosque for continuous prayer, seeking the fulfilment of their aspirations. It is evident that the mosque is fully integrated into the daily lives of those who live in the surrounding area. Furthermore, as the original function of the mosque persists, the users remain consistent. During the site visit, it was observed that both women and men actively utilize the mosque for prayer. Since the mosque is integrated into the daily lives of the people, it is frequently used. Additionally, the mosque has generated socio-

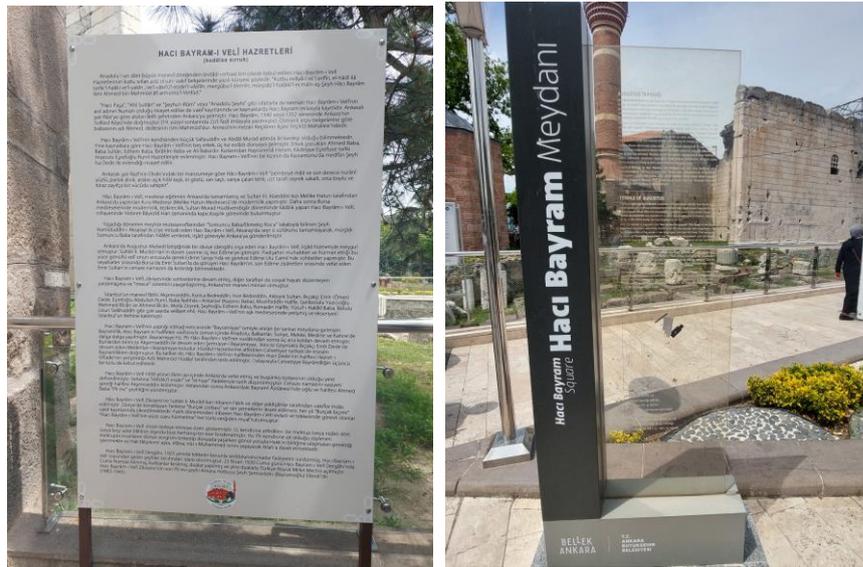
Figure 4.80. The information board about Hacı Bayram Veli and the mosque –left-, The information about Augustus Temple and the Hacı Bayram Veli Mosque in Hac1 Bayram Square –right- (taken by author)

The Hacı Bayram mosque continues to play an important role for the inhabitants. The surrounding area, including Hacı Bayram Square, provides information about the mosque's history, construction date, and dedication to Hacı Bayram Veli. The only shortcoming of the information provided about the mosque is that it is not

contextualized in relation to its surrounding environment and the historical relationships it has had with other structures. Although the information is presented in a comprehensive manner, it is only in written form, without any accompanying visual documentation, which reduces the effectiveness of the presentation.

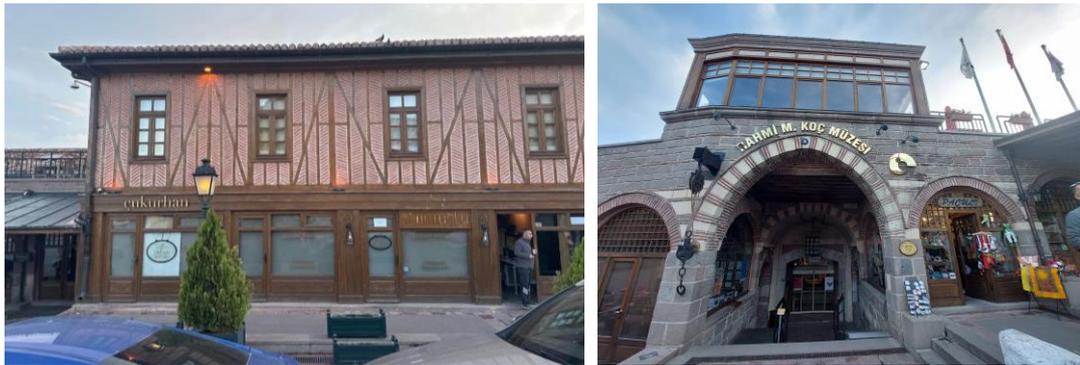
Figure 4.82. Çukurhan converted into Divan Hotel –left-, Çengelhan converted into Rahmi Koç Museum –right- (taken by the author)

A minority of the extant khans continue to serve a commercial and/or accommodation function, thereby ensuring the preservation of their cultural continuity and values. As a result of the area's visual transformation for tourism purposes, those facing Atpazarı Square have undergone significant restoration, with alterations to their functions. Those facing Atpazarı and Hisar Gate have been transformed into structures with different functions, including the Museum of Anatolian Civilizations, the Vehbi Koç Museum, and the Divan Hotel. The khans that have retained their functions are less well known due to their locations remaining further inside the traditional tissue.

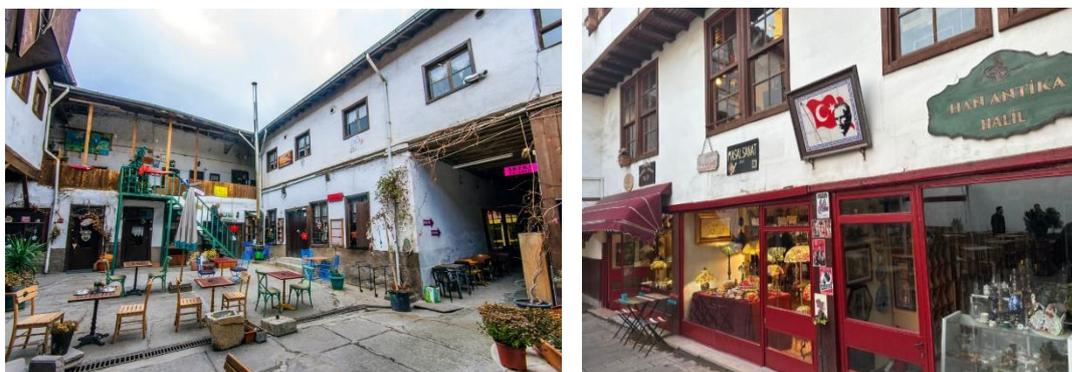
Figure 4.83. Art Houses, Cafes and specialized product shops in Pilavoğlu Khan – left- (source: Mustafa Taşkın's personal archive), Antique product shops and cafes in Pirinç Khan –right- (taken by the author)

As a result, the khans have been reused for alternative functions, including accommodation and museum space. These museums provide socio-cultural and economic benefits for both residents and tourists. Nevertheless, the hotel is not effectively integrated with the local population, as its primary users are tourists. Consequently, these functions are not integrated into the inhabitants' daily lives, as museums and accommodation offer a specific cultural experience. Therefore, only the Pilavoğlu, Pirinç and Bala Khans are functionally integrated with daily life, despite not being frequently used.

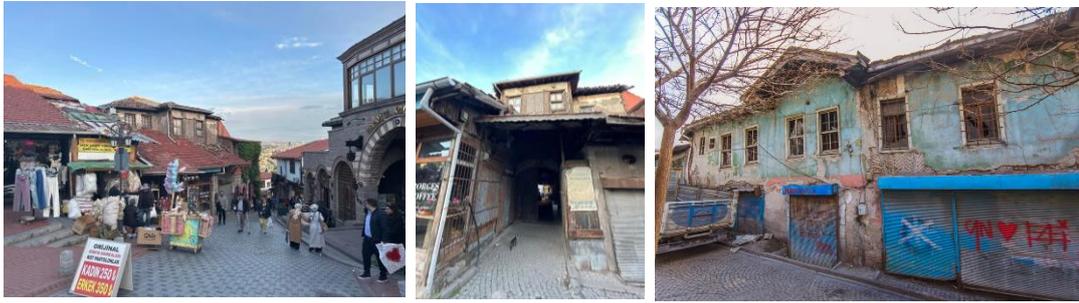
Figure 4.84. Pilavoğlu Khan in poor condition –left and middle- (taken by author), Kıbrıs Khan in a poor state –right- (source: Mustafa Taşkın’s personal archive)

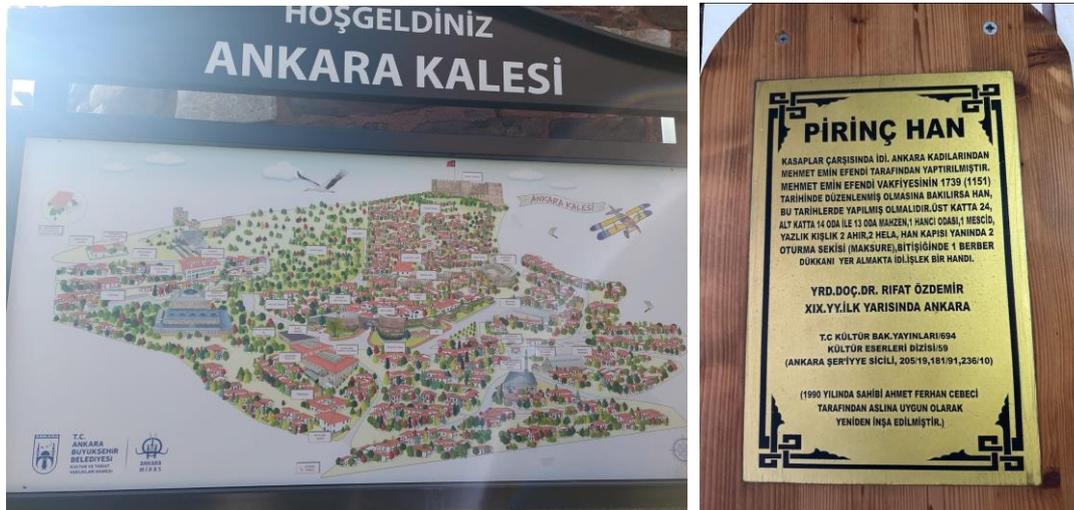
Figure 4.85. Schematic map showing the locations of important buildings, including Çukurhan, Çengelhan, Pirinç, and Pilavoğlu Khans –left-, the informative board inside Pirinç Khan –right- (taken by the author)

With respect to the provision of information, the region is lacking in terms of both comprehensiveness and accuracy. A schematic map is displayed at the entrance of Hisar Gate, providing an overview of some of the region's most notable architectural landmarks. With regard to the Khans Region, only the names and locations of Çukurhan, Çengelhan, Pirinçhan and Pilavoğlu Khans were included. The remaining Khans are not represented on the map, which negatively affects the perception of the region as a whole. Additionally, some Khans have minor informative tools that provide information about the name, history, functions, and interventions at the building scale. However, this is insufficient for presenting the Khans area as a "region" and integrating it intellectually with the inhabitants and visitors.

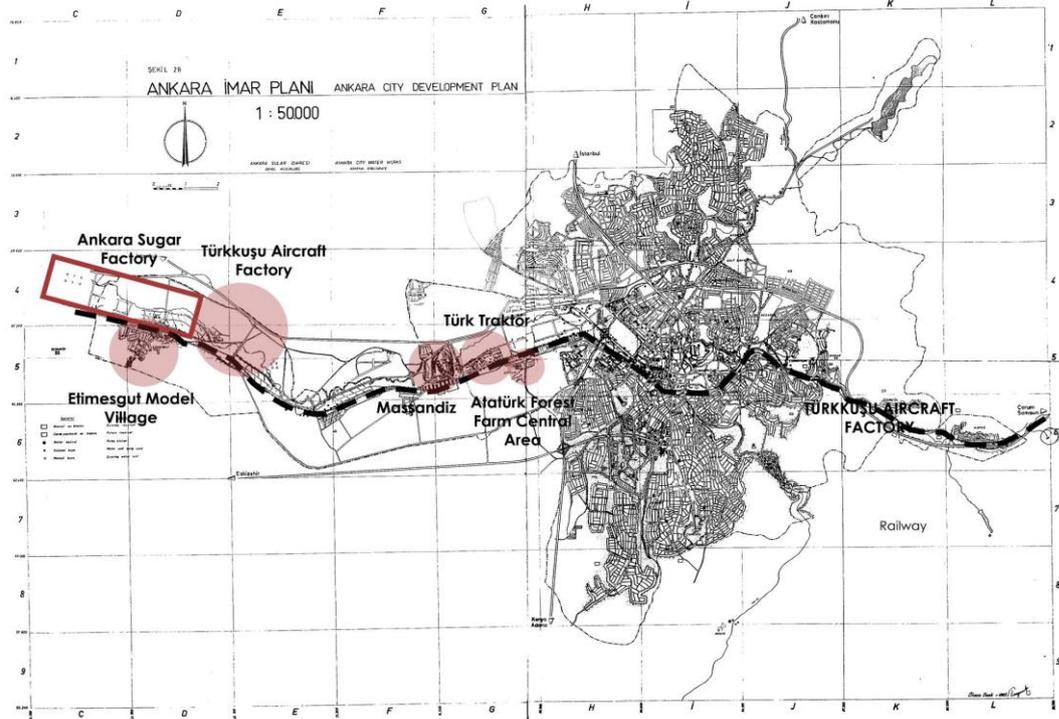
Figure 4.98. The location of Ankara Sugar Factory in 1957 Yücel - Uybadin Plan (produced by the author by using the Yücel-Uybadin plan as a base)

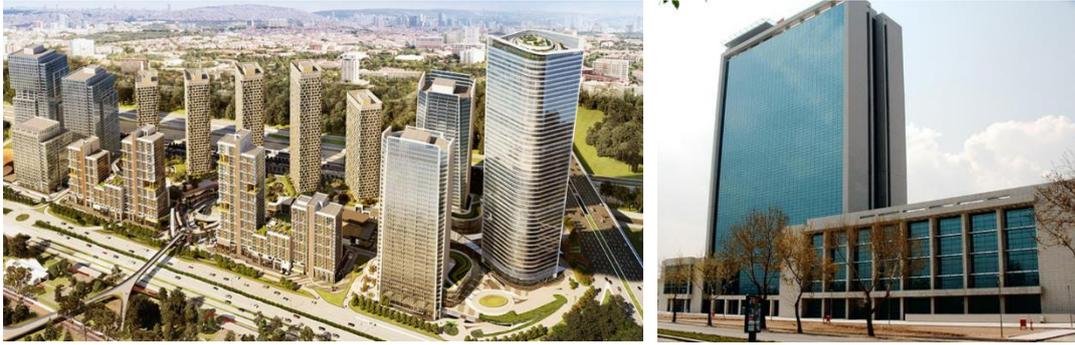
Figure 4.101. Merkez Ankara Project -left-, and Ankara Metropolitan Municipality Building on the Ego Hangars -right- (source: Merkez Ankara Website, Türkerler Website.)

This approach to urban space has resulted in the initiation of profitable projects on lands that were previously utilized for industrial purposes. The aforementioned structures were reused by various institutions and offices, university campus areas, the Metropolitan Municipality building, the Merkez Ankara Project, and so forth. Despite the integration of these functions into the area adjacent to the railway axis, the resulting congestion and inaccessibility are evident. The Ego Hangars, Coal Gas Factory, and Cer Ateliers are examples of early production spaces in Ankara that have not been preserved.

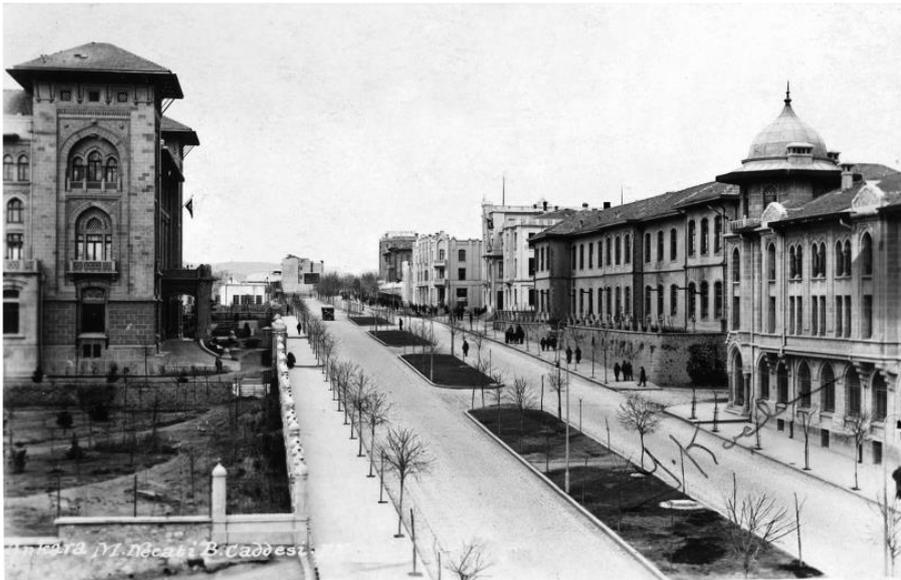
Figure 4.102. Banks Street from Opera Square towards Ulus Square (source: Keskinok, 2009).

and meaning of the area have been adversely affected by certain additions or demolitions. The physical losses in the area include Duyun-ı Umumiye, Kızılbey Tomb and Mosque from the Ottoman period, İller Bankası, Posta Sarayı, and the original facade features of Lozan Palas from the Republican period. Furthermore, the recently constructed PTT building and the edifices situated on either side of the Ziraat Bank have been incorporated into the area. While the recently constructed PTT building does not align with the architectural style and characteristics of the surrounding area, the buildings situated near the Ziraat Bank do not harm to the overall coherence of the urban fabric, largely due to their relatively modest scale and facade features. It can, therefore, be concluded that the Bankalar region retains its integrity despite the aforementioned losses.

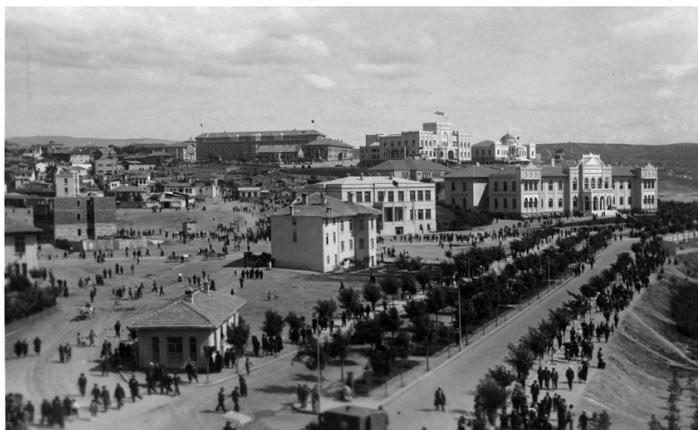
Figure 4.104. The socio-cultural zone of Early Republic from Atatürk Boulevard.
(source: Keskinok, 2009)

The socio-cultural zone of the Republic of Ankara was formed in the area where the old city and the new city meet, in the area currently known as Opera and Sıhhiye. This area is characterized by a harmonious integration of structures and open spaces on both sides of the boulevard, creating a unified urban landscape. The built environment of this area comprises the Exhibition House, Ministry of Culture and Tourism, situated between Fire Department Square and Opera Square, and a number of other institutions, including the Turkish Aeronautical Association, İsmet Paşa Women's Institute and Maturation Institute, Women's High School, Radio House, Faculty of Language, History and Geography, Turkish Historical Society, Türkocağı and Ethnography Museums, located between Opera and Sıhhiye Squares. The Youth Park, 19 Mayıs Stadium and Hippodrome open spaces in the west of the boulevard are also of significant importance in this socio-cultural area. Despite the loss of a part of the open spaces and structures, including the Hippodrome and 19 Mayıs Stadium, the built environment has only lost the Exhibition House. The remaining structures continue to exist and contribute to the region's overall cohesion. Consequently, the region has retained its integrity despite the aforementioned losses.

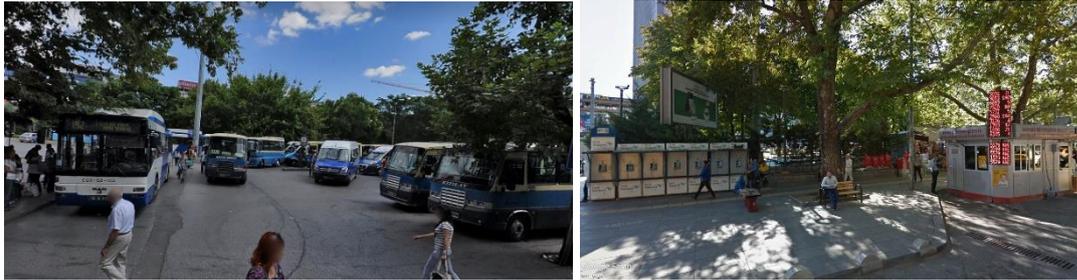
Figure 4.106. Minibus Station Area -left- and taxi stands and kiosks -right- closing the perception of Güvenpark (source: Google earth street view)

Additionally, a number of environmental factors make it challenging to perceive Güvenpark and Kızılay Square visually. The visual accessibility of the square is restricted by the occupation of the western part by minibuses, bus and taxi stands, which are situated in close proximity to one another and contribute to a sense of

enclosure. Furthermore, the presence of small-scale structures, such as kiosks and taxi stand, surrounding the square hinders the legibility of the park's entrances, circulation routes, and overall design. The square and park, which are perceived relatively more strongly from Atatürk Boulevard, are less perceptible from Milli Müdafı Avenue due to the aforementioned obstacles.

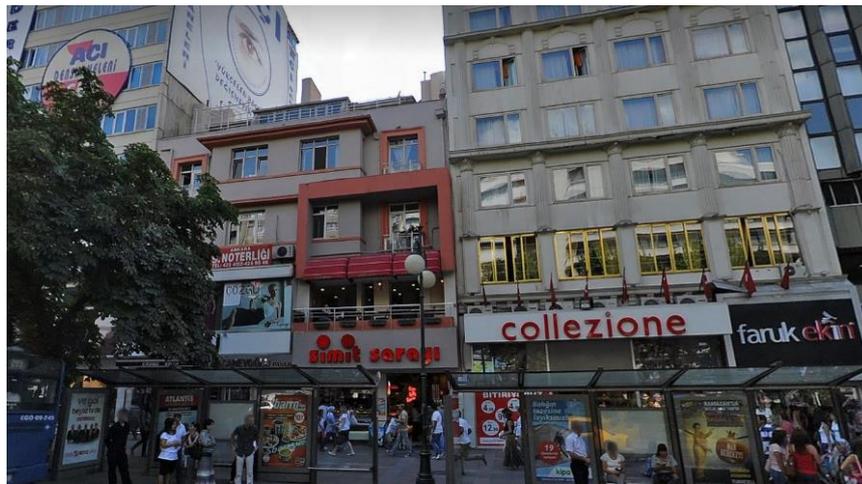
Figure 4.107. Crowded and poorly designed signboards of commercial areas closing the perception of passages. (source: Google earth street view)

The transformation of consumer culture in the late 2000s has resulted in a decline in the use of the passages, which have subsequently been subjected to a lack of maintenance and repair, increasing their state of deterioration. The decline in commercial activity and the ongoing concerns of remaining traders regarding the

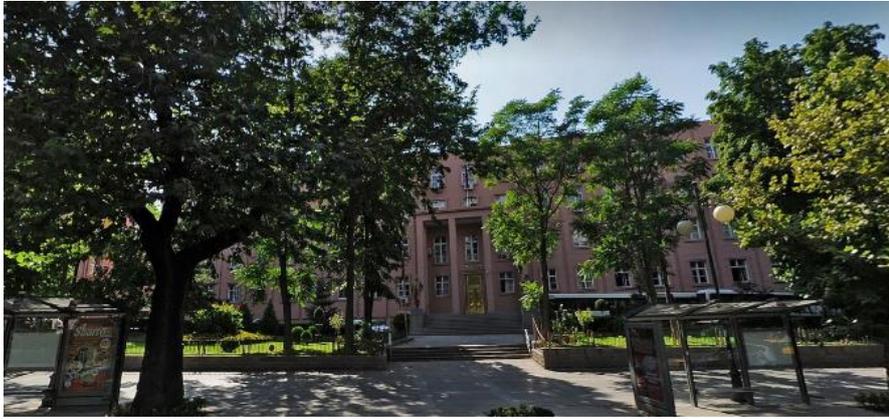
Figure 4.108. High perceptibility of Ministries from Atatürk Boulevard (source: Google earth street view)

In terms of visual integration with the surrounding environment, the administrative section of the Vekaletler zone is highly visible due to its location on the main boulevard, with no obstacles. The transparent barriers facilitate visual connections. However, the residential section was initially surrounded by barriers due to the area's perceived risk and subsequently due to the revitalization project. This restricted the visual connections of the neighborhood with the surrounding area for years. Although the project's outcome is yet to be observed, it is anticipated that it will establish a visual relationship with the surroundings in the near future.

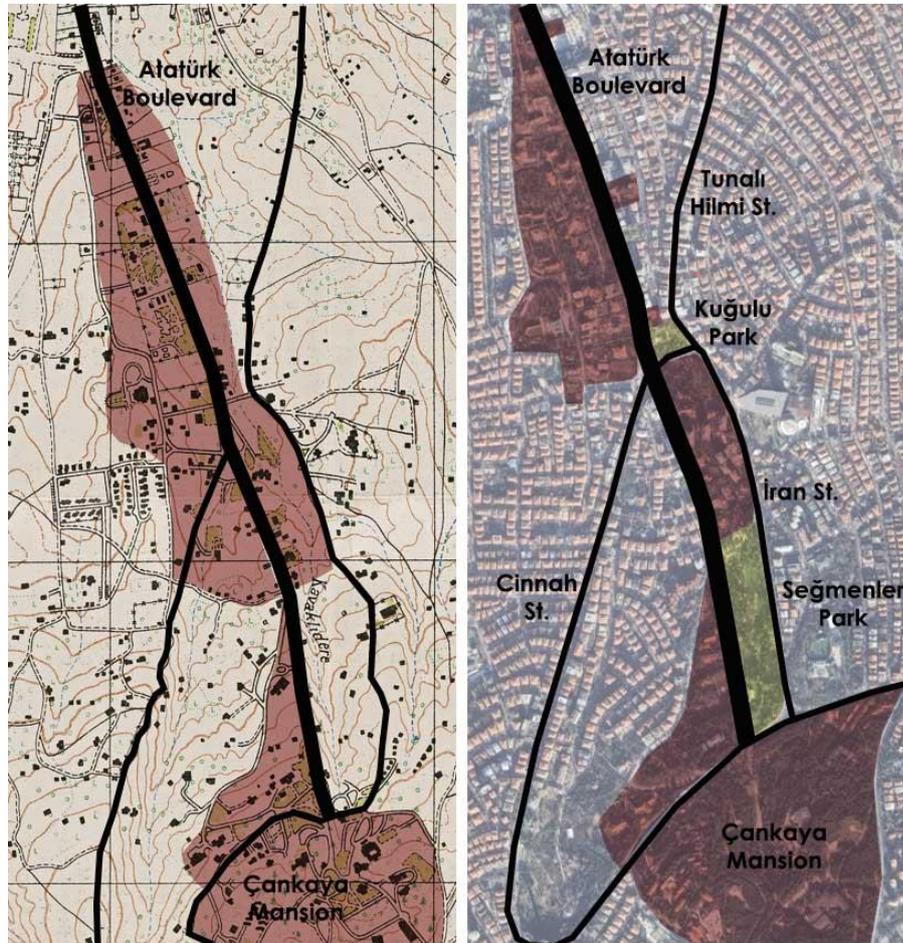
Figure 4.109. Integrity of Great Embassies and Çankaya mansion in 1940s -left- and in current context -right- (produced by the author by using 1940s Ankara map and Google Earth image as basemaps)
