ASSESSING THE INTEGRITY OF THE HISTORIC LAYERS OF A MULTI-
LAYERED SETTLEMENT TO THE CURRENT URBAN CONTEXT: THE
CASE OF ANKARA

A THESIS SUBMITTED TO
THE GRADUATE SCHOOL OF NATURAL AND APPLIED SCIENCES
OF
MIDDLE EAST TECHNICAL UNIVERSITY

ZEYNEP BUKET ÜSTÜN

SEPTEMBER 2024

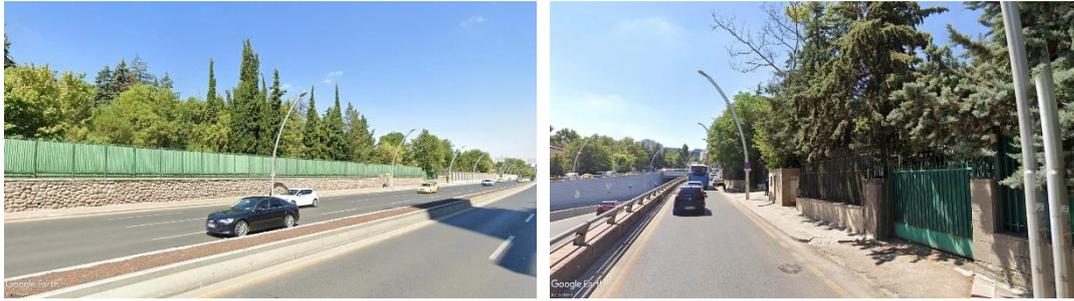
Figure 4.110. High walls surrounding the Germany Great Embassy –left- and Hungary and Egypt Great Embassies –right- (source: Google Earth Street View)

The majority of embassies are situated behind high walls, which prevent them from being perceived from Atatürk Boulevard. The lack of visual connection with pedestrians on the road, coupled with the increasing use of vehicles, has resulted in the boulevard becoming primarily a transportation axis, rather than a public space that fosters interaction and engagement. A similar situation can be observed in the case of Çankaya Mansion, which is surrounded by high, non-transparent walls. In general, the area lacks visibility, which decreases the perception and understanding of the area. However, it should be noted that the embassy and Çankaya mansion buildings are maintained regularly and do not have any major physical problems. Nevertheless, since the bureaucrats' mansions are mostly out of use, they lack maintenance, which decreases the visual attractiveness of such significant buildings.

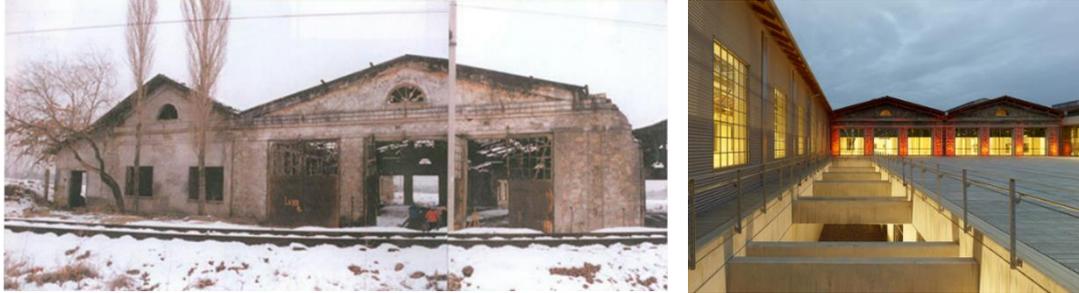
Figure 4.112. Cer Ateliers -left-, Cermodern Exhibition Hall -right- (source: <https://www.cermodern.org/hakkimizda.html>)

In contrast with the other station buildings, the situation with Cer Ateliers differs in significant ways. As a consequence of the decision to remove industrial activities from that part of the city, some of the Cer Ateliers were partially destroyed. The remaining Cer Ateliers, which were originally utilized as a maintenance facility for railway cars, have been reused as a contemporary art center by conserving the industrial heritage. The organization of numerous events and fairs has facilitated the meeting of individuals from diverse backgrounds, enabling the realization of socio-cultural activities. Consequently, Cermodern has become a valuable resource for the city and its citizens, offering socio-cultural benefits and contributing to the daily

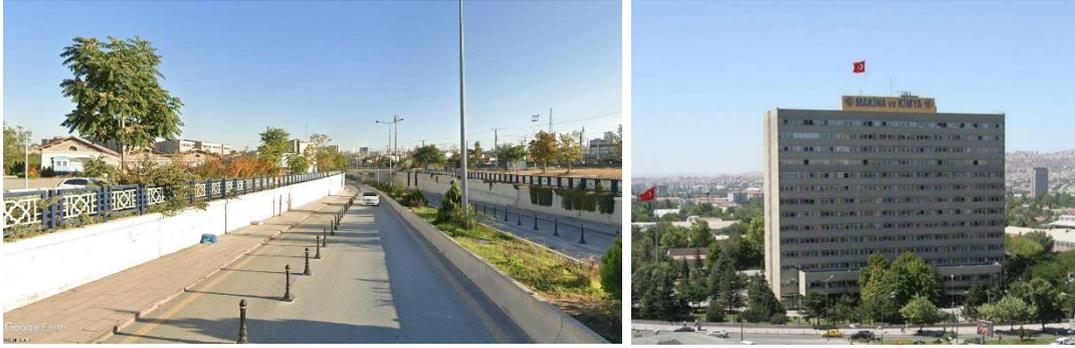
Figure 4.114. The level difference and high walls of Cermodern -left- (source: Google earth street view), and MKE General Directorate building closing the view of MKE Museum -right- (source: <https://bts.com.tr/referanslar/mkek-genel-mudurluk-binasi/>)

In 2005, a new directorate building for MKE was constructed in front of the MKE Industry area, facing Kazım Karabekir Street. Consequently, the visual connection of MKE building with the main street was severed. Moreover, the MKE gun sales outlet situated along Celal Bayar Boulevard obscures the museum's perceptibility from that road. Consequently, the museum is currently not perceptible from the outside. The Cermodern complex is situated within the site of the Presidency Symphony Orchestra building. The Orchestra structure was designed as a vast complex, which makes it challenging to perceive the Cermodern from the garden.

Additionally, the sole route passing through the Cermodern is Altinsoy Street. Due to the elevation difference between the Cermodern area and the street, the site is surrounded by high walls, which further diminishes its visibility.

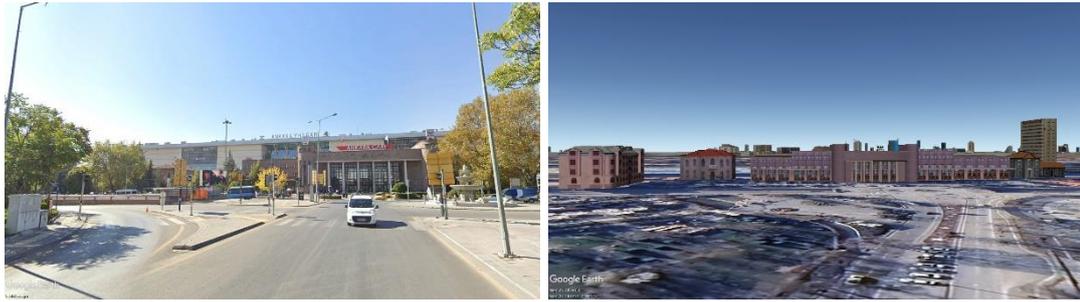
Figure 4.115. HSR Station Building at the back, dominating the perception of train station area -left-, 3D train station buildings that was perceptible as a whole before the HSR station (source: Google Earth street view and 3D view)

Considering the station area, the scale of the High Speed Train Station Building is not compatible with the train station buildings, which distorts the perception of the station area to a great extent. When approaching the site from Cumhuriyet Street, the HST station building distorts the view despite being located at the background. When the background is more dominant than the front in terms of mass proportions, the legibility and perception of the front buildings decrease. Also, some components of the station buildings were visible from today's Celal Bayar Boulevard before the construction of HST station building, such as the upper floors of Operational General Directorate -today's Medipol University central building-, and the clock tower. Yet, the HST station building completely closed the view of the station buildings from Celal Bayar Boulevard, decreasing the visual integration of the area from its surroundings

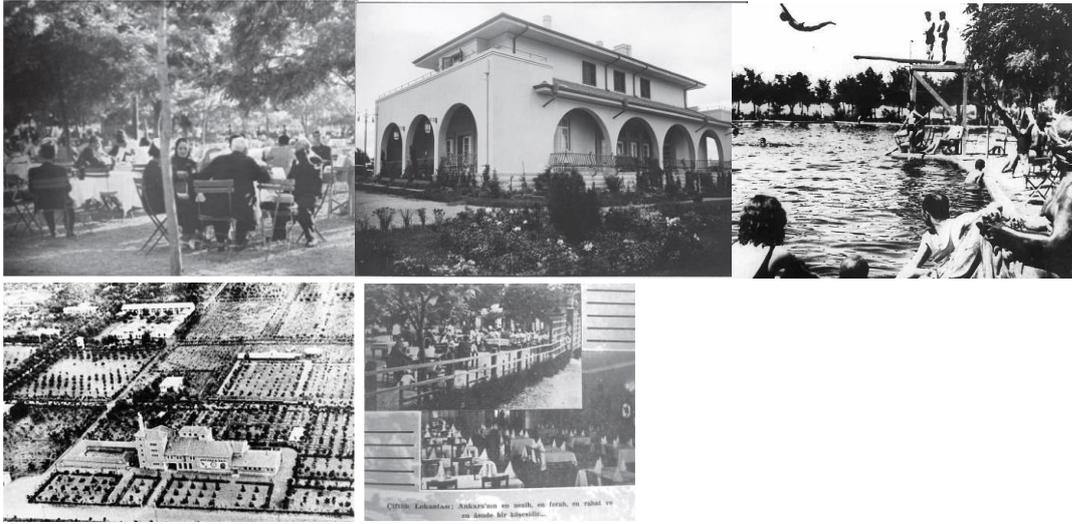
Figure 4.121. Atatürk Forest Farm Components, Marmara Mansion, Marmara Pool, Beer Factory and Beer Park (source: Çavdar Sert, 2017a)

The central area of AFF was shaped mostly by social infrastructure, recreation and accommodation facilities constructed in relation to the Beer Factory as one of the first representative buildings of AFF. The socialization and recreational areas included swimming, sunbathing and other entertainment activities. The places of these activities were Marmara and Black Sea Pools, Marmara Mansion and Gazino, Beer Park, recreation, and walking parks (Kimyon & Serter, 2015). These new entertainment areas offered places for the whole society to spend time together, and the local people were actively using these social amenities, especially on weekends (Aycı, 2020). There was also a Zoo for recreational purposes on the north side of the central part of the campus. Not only the functions but also the architectural attributes represent the ideology of the new regime as they were built when the modern architectural style became dominant. Therefore, the central area of AFF is very significant for the collective memory of the users.

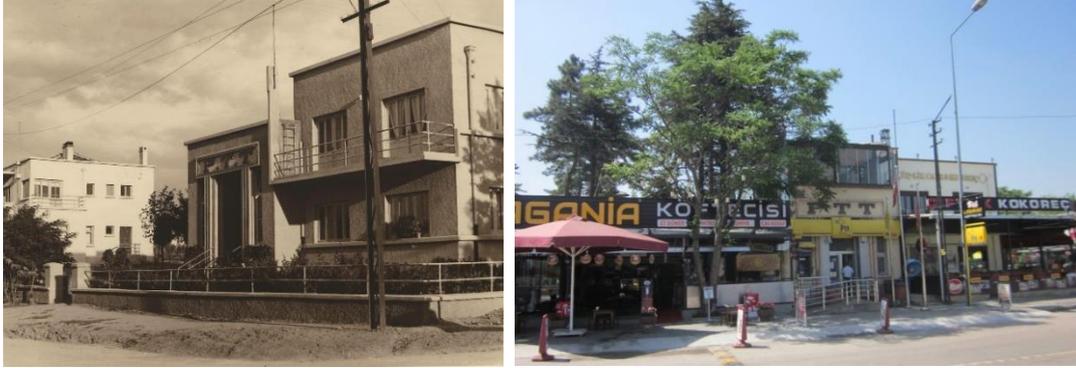
Figure 4.124. AFF Post Office Building -left- (source: Çavdar Sert, 2017a), today's visual situation of the building preventing the perception -right- (source: Google Earth street view)

As the AFF campus is one of the most significant representatives of the ideology of the Republic, the visual characteristics of the built assets also represent the architecture of that time. While most of the buildings were converted to different functions, the visual and architectural characteristics of the buildings highly changed. Especially the buildings at the central core are either changed by the later additions and restorations or some elements are closing the perception of the buildings' characteristics such as the extensive use of signboards of commercial usages. Moreover, people pass through Ankara Boulevard –the highway separating

the AFF into two- without noticing the presence of the AFF buildings due to the billboards and railings closing the view of the assets.

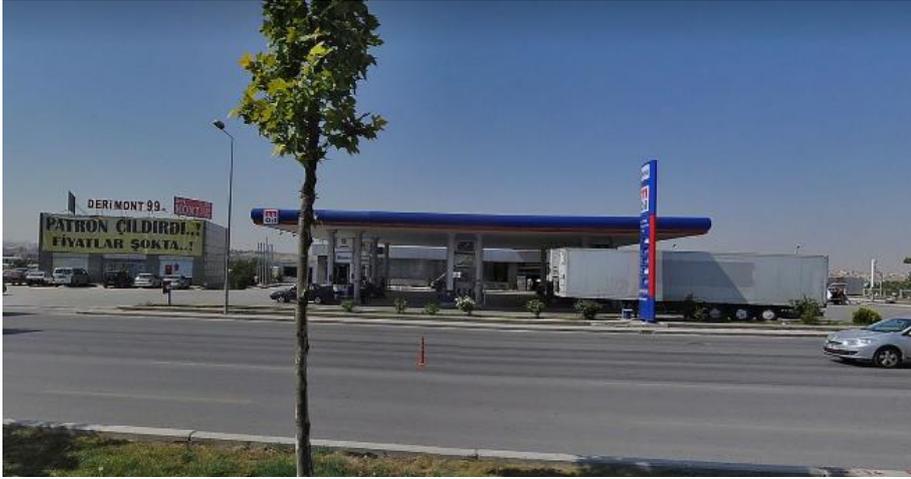
Figure 4.125. Gas Stations surrounding the Türkkuşu Campus, preventing its perception (source: Google Earth Street View)

Regarding the visibility, the area has some problems due to the surrounding context. Since the Çubuk River and railway route limit the campus area to the north, there is no road in the close vicinity passing by the south section. The only boulevard that is used and passes at the north periphery is Fatih Sultan Mehmet Boulevard. Nevertheless, there are gas stations built next to each other along the north border of the campus. This situation decreases the perception from that boulevard since the passer-byes perceive the gas stations and cannot be aware of the presence of the Türkkuşu area. In addition, the runway area is lack of maintenance and there are some overgrown trees. As a result, the visual attractiveness of the site decreases from the perceiver's eyes.

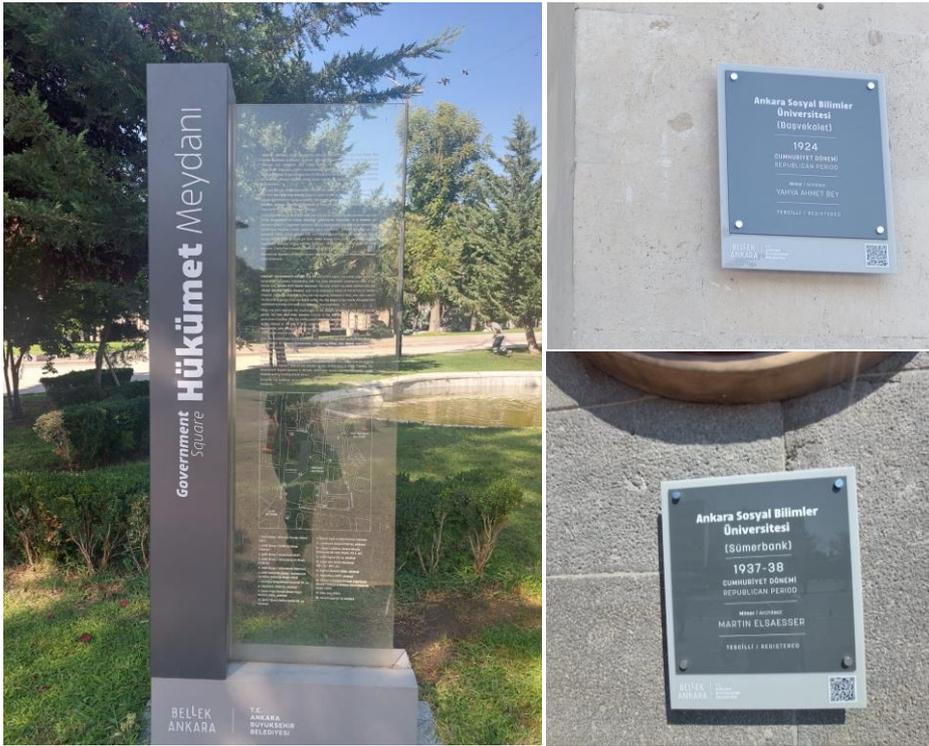
Figure 4.142. The initiative of Bellek Ankara to raise awareness of general public (taken by the author)

It is evident that this initiative is of considerable importance and should be more widely implemented in other areas that encompass a multiplicity of values, at both the area and building levels. Further development of the design of the informative boards is recommended. At present, the boards are transparent, which makes them difficult to read. However, transparency is beneficial in terms of how the area is perceived, as the informative tools should not overshadow the surrounding area. Nevertheless, incorporating some colors according to the historical periods would be advantageous. Furthermore, the presence of informative tools should be emphasized in the urban spaces at the street level. This would ensure that people are informed of their existence before they proceed to the site.
