A RESTITUTIVE APPROACH TO THE ARCHITECT A. H. KOYUNOĞLU'S
PUBLIC BUILDINGS IN ANKARA

A DOCTOR OF PHILOSOPHY THESIS

Middle East Technical University

March 1989

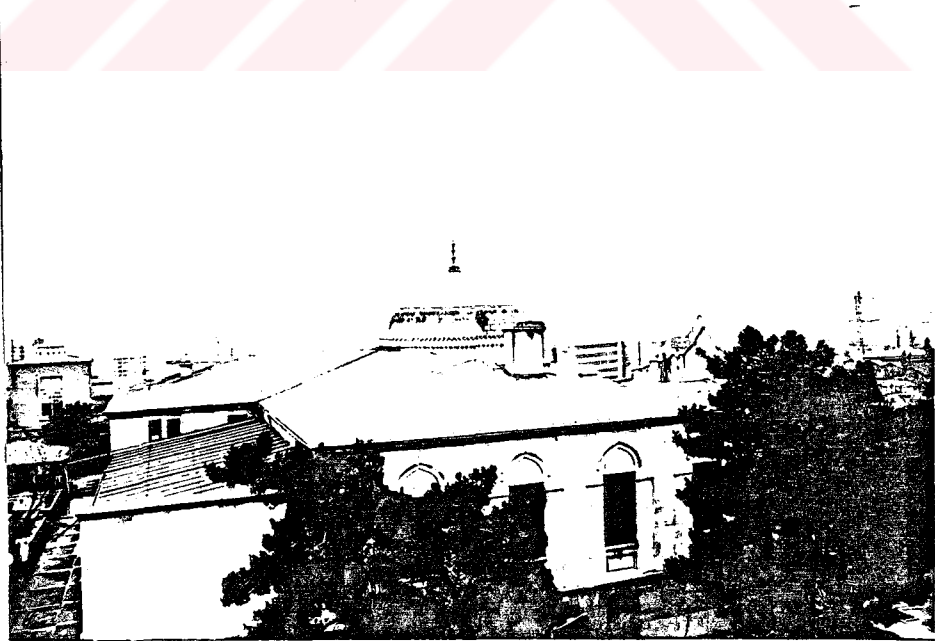
Photo.147 A view from roof (1987)

In 1959-1961, it was requested that the glass panes covering the inner courtyard be removed and be replaced by a concrete covering,³⁸ but this requirement was realized during the alteration and repair of the roof, which has gained its present form in 1981 (Photo. 147-157).

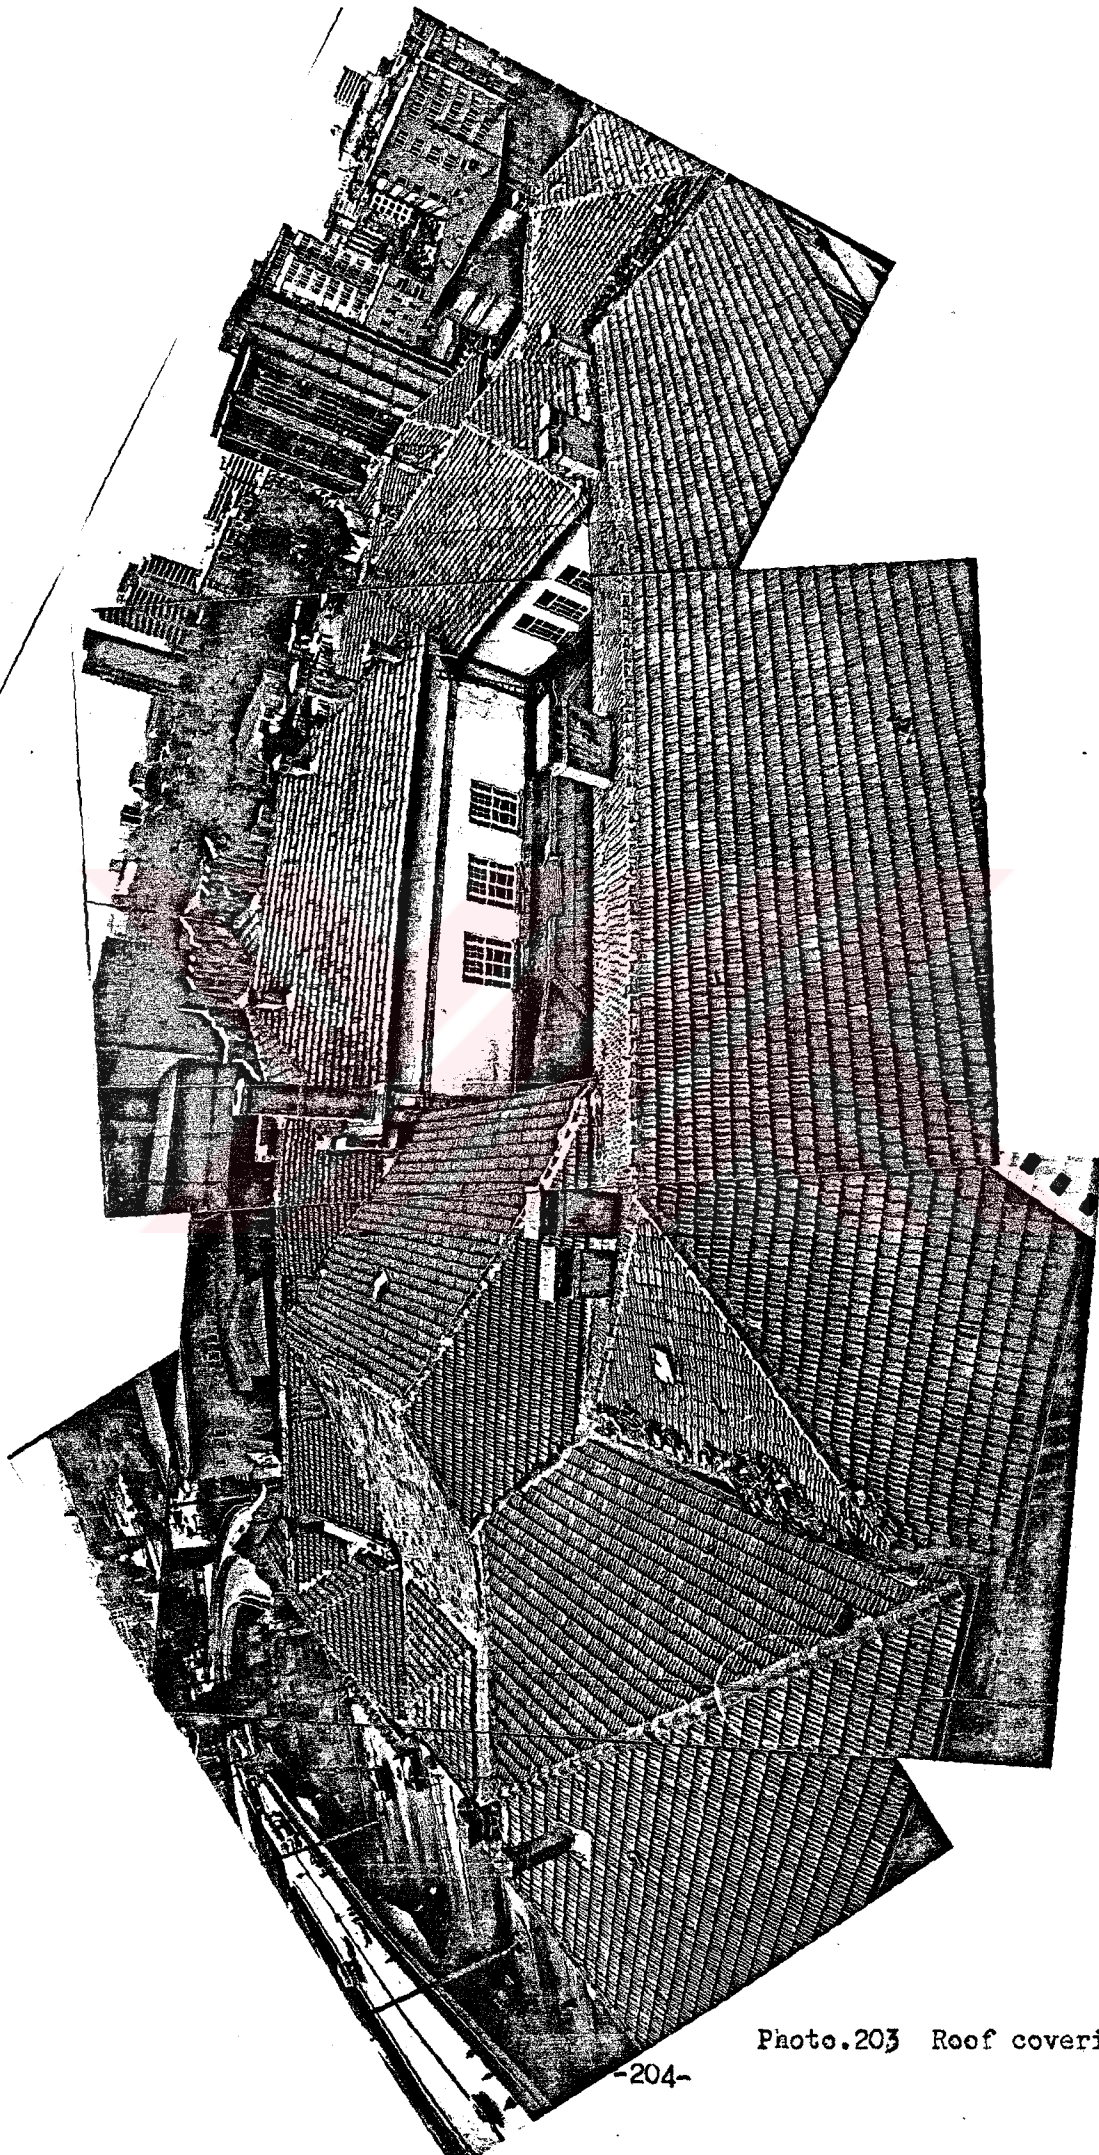
Photo.203 Roof covering

The roof of the SW projected and raised portion is seen in Photo. 202, of the year 1933, and Photo. 200 belonging to the year 1938. Photo. 203 shows the same roof in 1987. The inclination of this roof in the NW direction seen in Photo. 200, 202 was levelled and the ridge was attached to the pediment in Photo. 203. If it is considered that the building is symmetrical, the same level of inclination had to be realized for the NE portion which is symmetrical to the SW portion. The alteration date of the above arrangement could not be determined.

In the 1960s, according to Hüseyin Balıkkaya and Zeki Onaycı, the hall used as a library was covered by an iron framework with glass panes. Probably, during the roof repair in 1975, this section was closed by a timber gable roof covered with eternite.

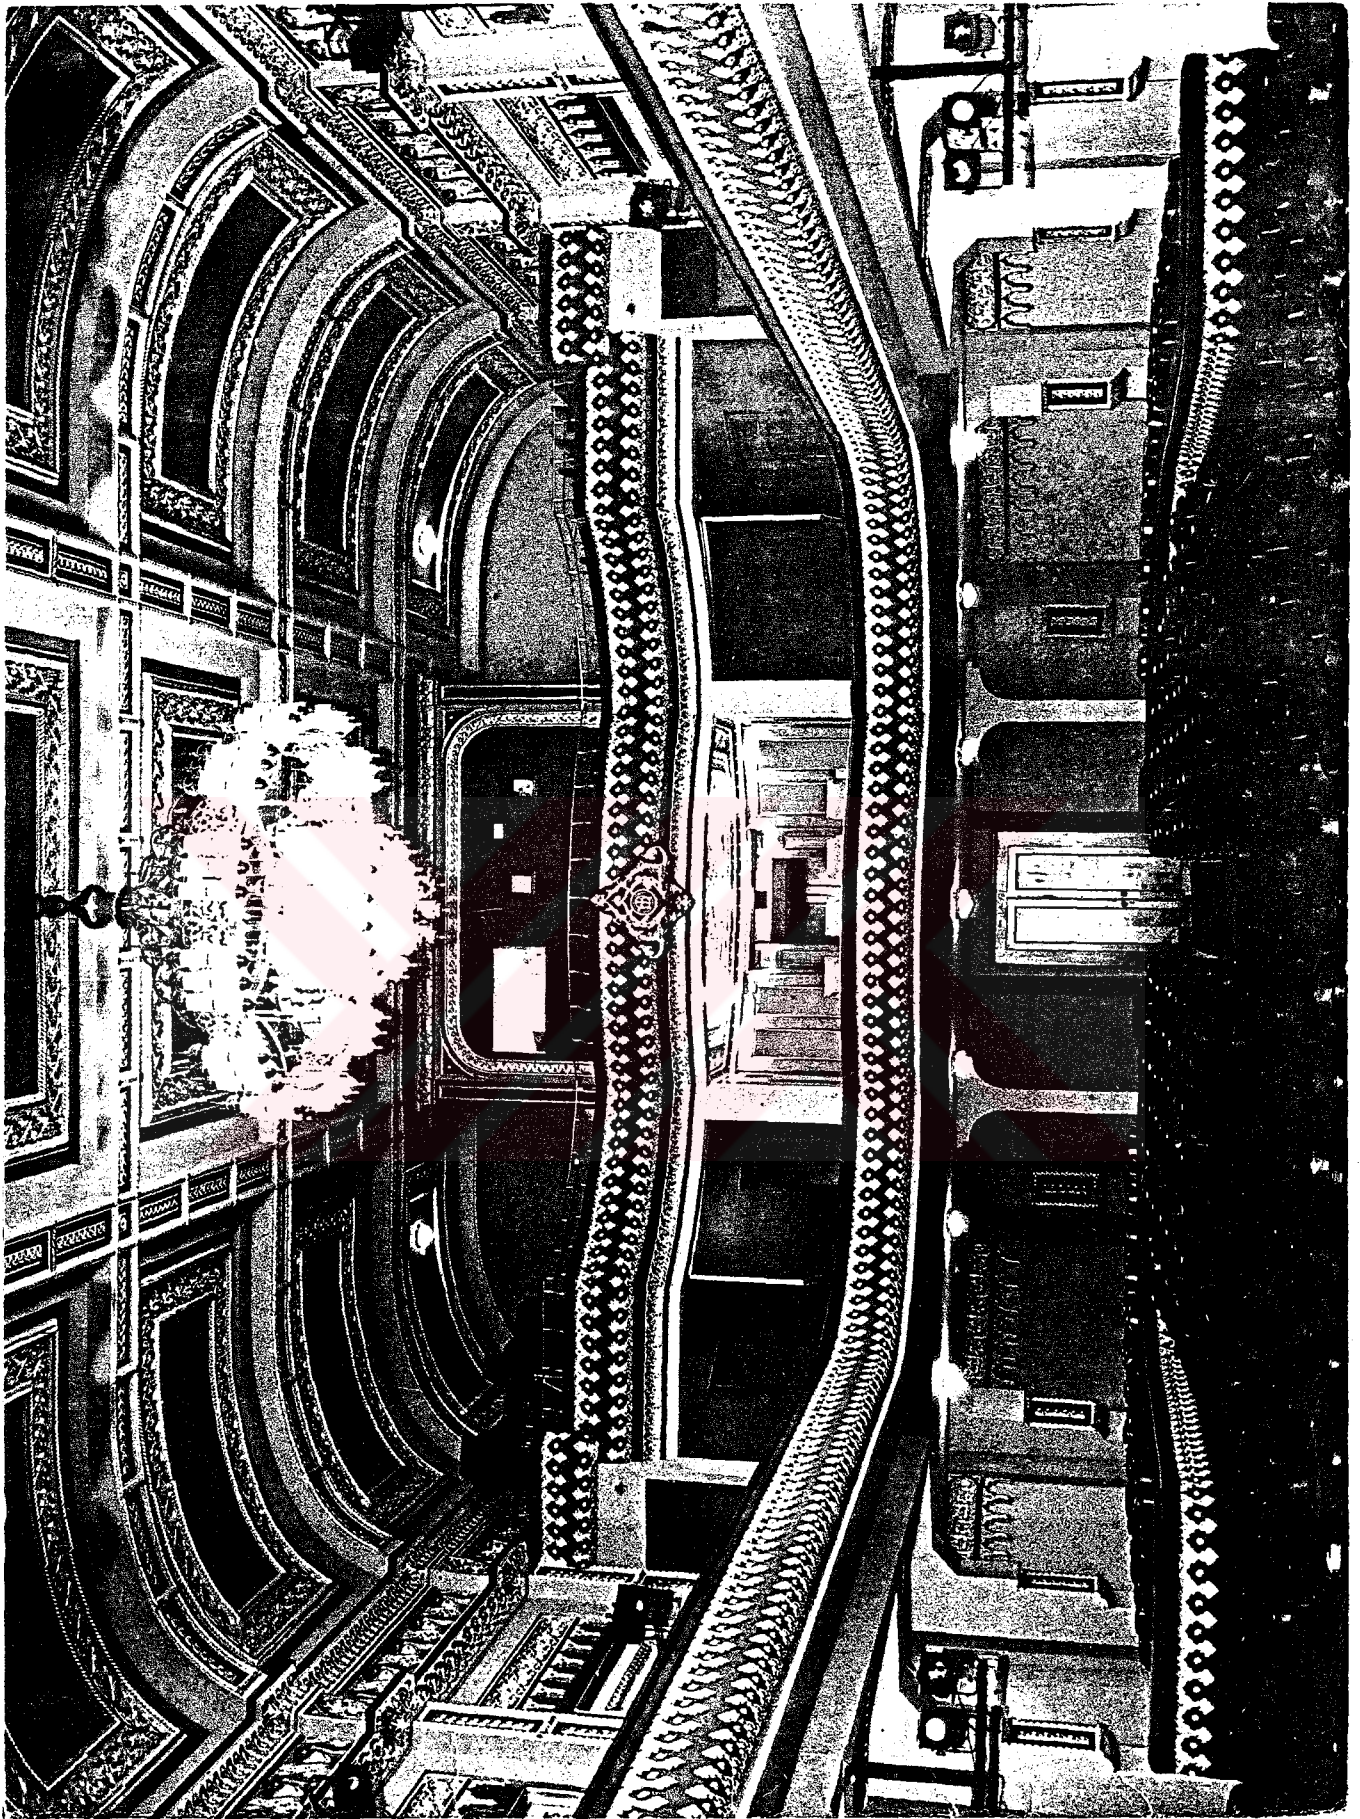
Photo.257 Theatre after the 1977-1985 restoration

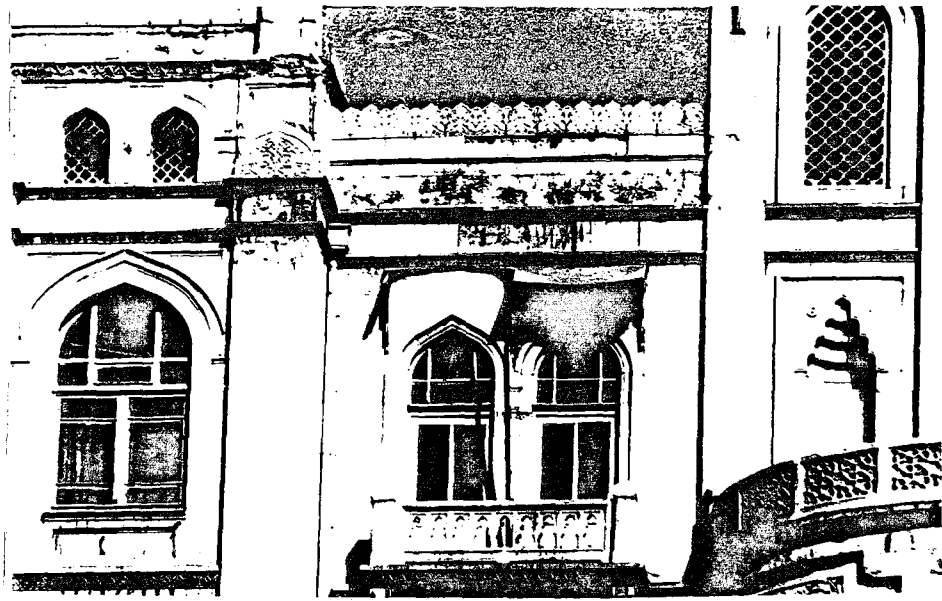
Photo.270 NW facade - broken shelters on the upper balcony (1976)

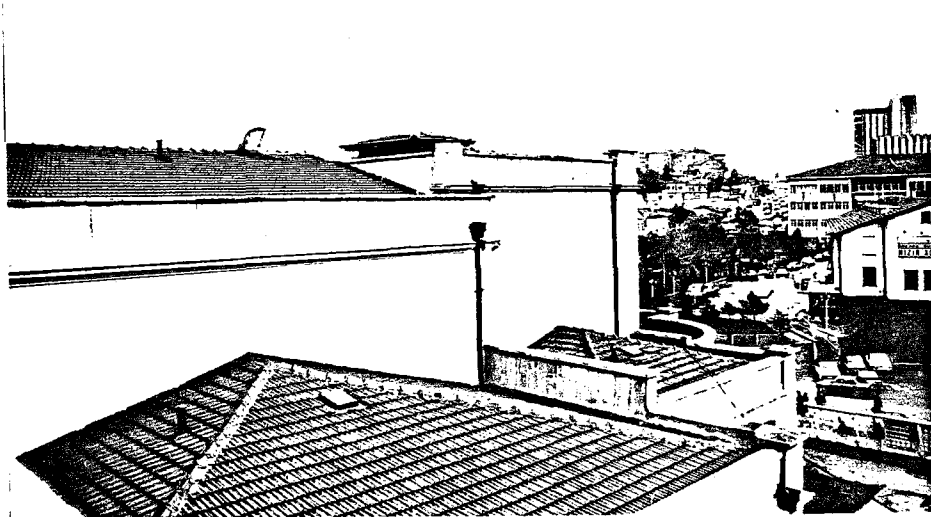
Photo.279 Tiles replaced with eternite (1988)

In the 1977-1985 restoration, the timber construction of the roofs were renovated. The copper covering of the theatre (date of change unknown) and the eternite placed in 1938 and also the tiles on the other parts (Photo. 276, 277, 278) were replaced by Marseilles type tiles (Photo. 279, 280). The skylight (Photo. 281) on the theatre was left under the ridge when it was raised (Photo. 280). For concealing the roof, parapets were constructed on the walls of the theatre rising behind the roofs of the foyers on the NE and SW facades (Photo. 279). The zinc gutters and rain pipes were replaced as well.

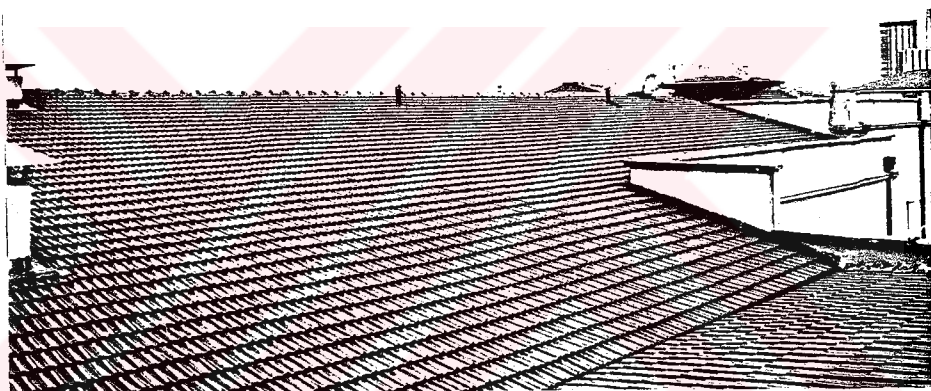
Photo.280 Raised roof (skylight was left under the roof) (1988)

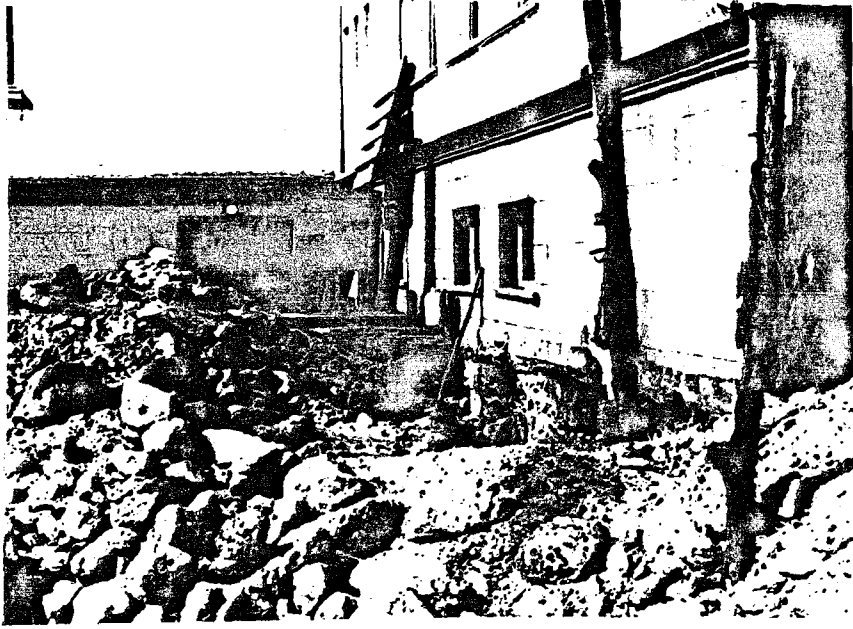
Photo.282 Türk Ocağı Building - isolation of the foundations (1977-1985 restoration)

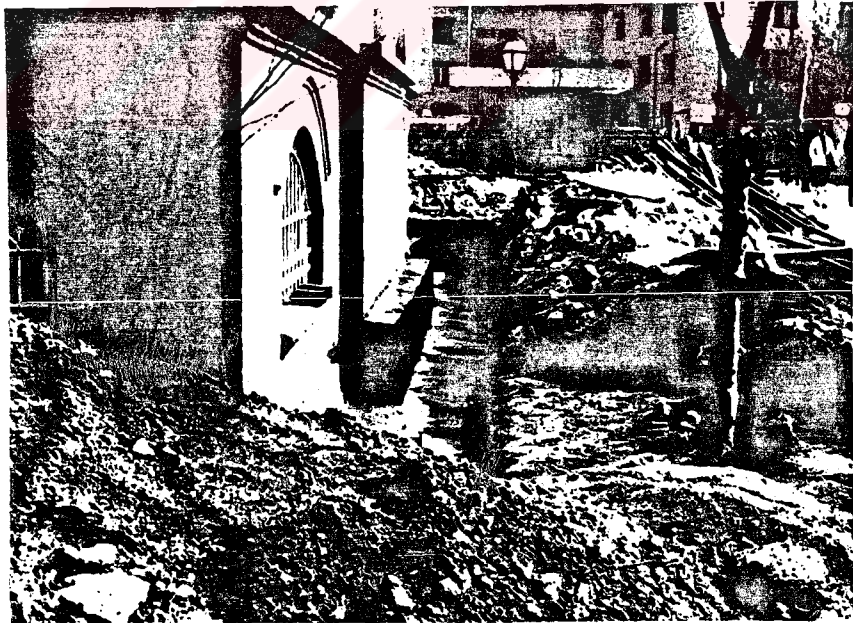
Photo.283 Türk Ocağı Building - isolation of the foundations (1977-1985 restoration)

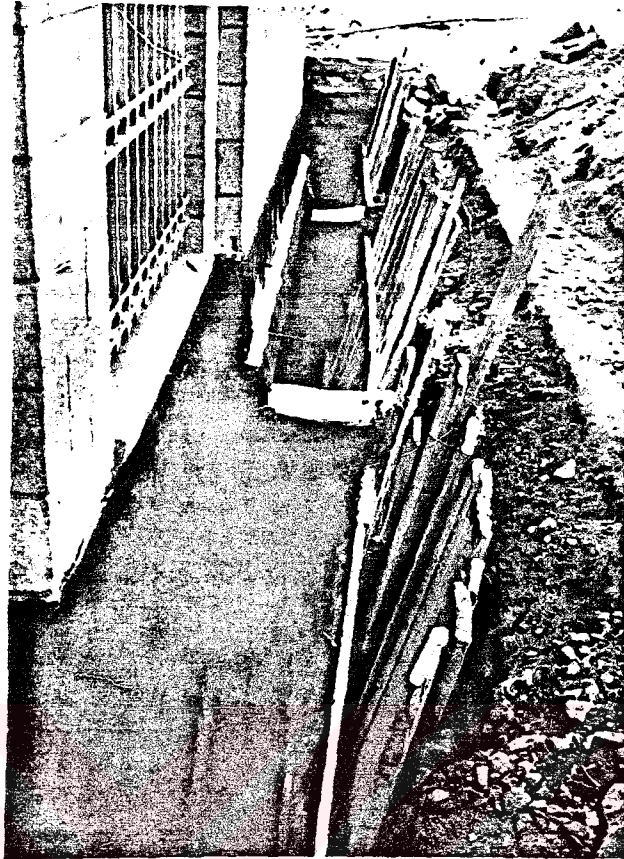
Photo.284 Türk Ocağı Building - isolation
of the foundations (1977-1985
restoration)
