**AN EXPERIMENTAL INVESTIGATION ON UNIAXIAL TENSILE, SLIP-  
BOND AND CREEP BEHAVIOR OF CARBON TEXTILE REINFORCED  
CEMENTITIOUS COMPOSITES (C-TRCC)**

**A THESIS SUBMITTED TO  
THE GRADUATE SCHOOL OF NATURAL AND APPLIED SCIENCES  
OF  
MIDDLE EAST TECHNICAL UNIVERSITY**

**IN PARTIAL FULFILLMENT OF THE REQUIREMENTS  
FOR  
THE DEGREE OF DOCTOR OF PHILOSOPHY  
IN  
CIVIL ENGINEERING**

**JANUARY 2025**

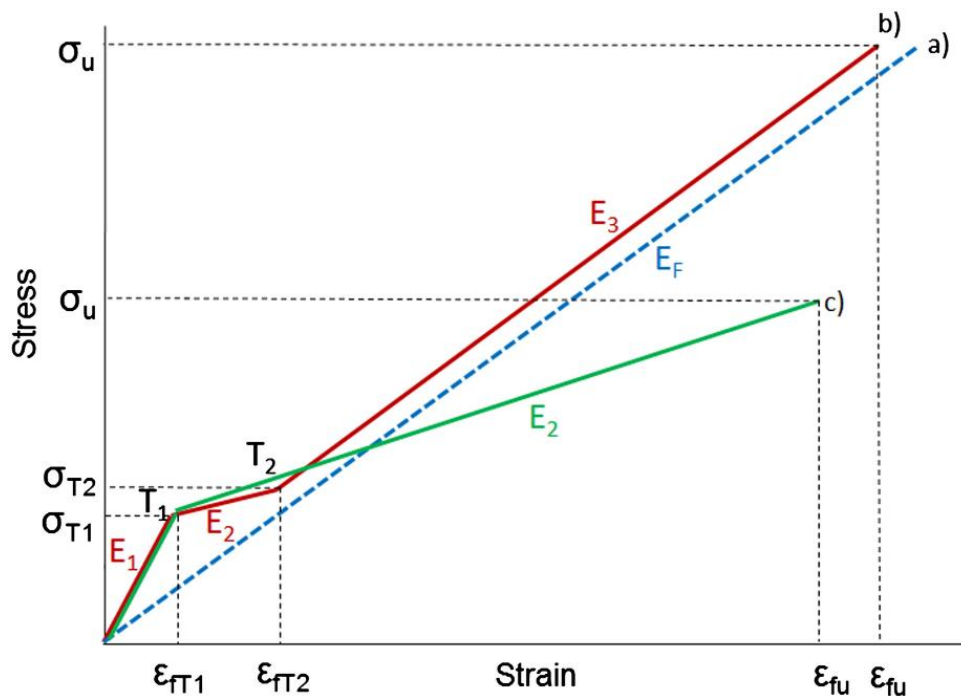
Figure 2-8 Idealized stress-strain graphs: (a) bare textile (b) clevis gripping (c) clamp gripping (Santis et al., 2018)

geometry, and yarns impregnation conditions. In this phase, the fabric merely acts against the applied load. Hence, the curve's slope typically illustrates the bare textile's elastic modulus. Under specific circumstances, a tension-stiffening phenomenon is observable where the modulus in this phase aligns parallel, although at a slightly increased stress level compared to the fabric Figure 2-8(a). This phenomenon is attributed to the involvement of the uncracked matrix existing between the cracks. When the specimens in the gripping area were not under side pressure, the matrix exhibits deficient strength, or the yarn experiences slippage, the modulus of the third phase may be indistinguishable from the second phase, resulting in a bilinear behavior instead (Figure 2-8(c)).

The cracking strength is the tensile stress at the point where linear behavior ends in the stress-strain curve,  $T_1$  ( $\sigma_{T_1}$ ,  $\epsilon_{T_1}$ ) in Figure 2-8

TRCC's ultimate tensile strength is the peak point in the stress-strain curve at which the TRCC specimen fails, shown as  $(\sigma_u, \varepsilon_{fu})$  in Figure 2-8 for both bilinear and trilinear responses.

In the trilinear stress-strain response scenario, it is necessary to determine the elastic moduli corresponding to the initial elastic phase ( $E_1$ ), the crack propagation phase ( $E_2$ ), and the crack widening phase ( $E_3$ ).  $E_1$  is the slope of the line segment between points O and  $T_1$ ,  $E_2$  is the slope of the line segment between points  $T_1$  and  $T_2$ , and  $E_3$  is the slope of the line section between points  $T_2$  and the peak  $(\sigma_u, \varepsilon_{fu})$ , as shown in Figure 2-8(b).

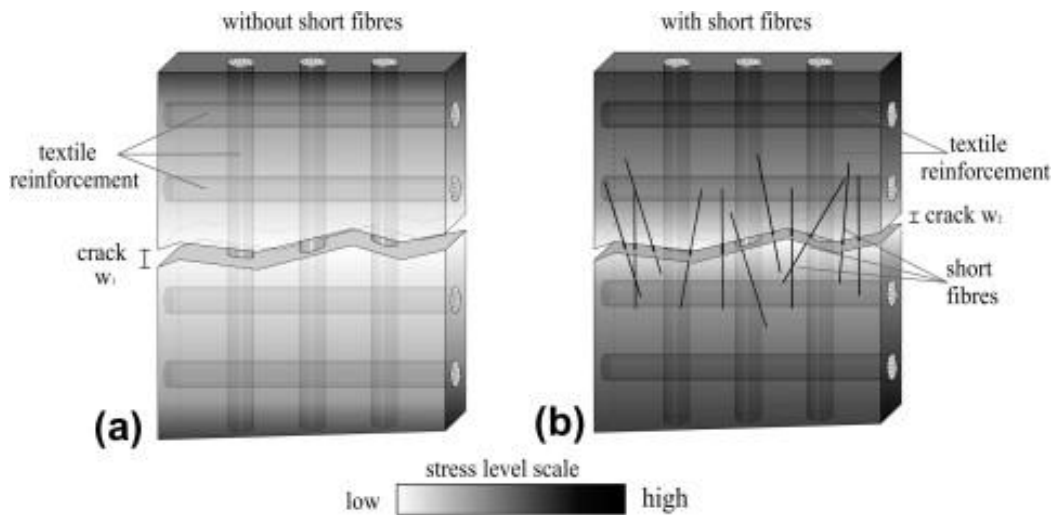
Figure 2-13 Stress gradient distribution in the vicinity of a macro-crack in TRCC (a) without short fibers and (b) with fiber (Barhum & Mechtcherine, 2013)

Furthermore, the addition of short fibers to cementitious mortar can also enhance the mechanical properties of TRCC by contributing to micro-cracks bridging (Figure 2-13) which improves the stress value needed to propagate to macro-cracks (Barhum & Mechtcherine, 2012; Deng et al., 2020; Zhang & Deng, 2022). A set of uniaxial, deformation-controlled tension tests was conducted by Barhum & Mechtcherine, 2013 to analyze the strength, deformation, and fracture characteristics of slender, thin plates constructed from TRCC with and without short fibers (glass and carbon). A notable enhancement of the initial cracking stress was attained, with the value rising by 1.5 and 2 times due to the short glass and carbon fibers, respectively. Although the increased quantity and fineness of cracks were evident in the samples with added short fibers, a moderate enhancement in tensile strength was recorded.

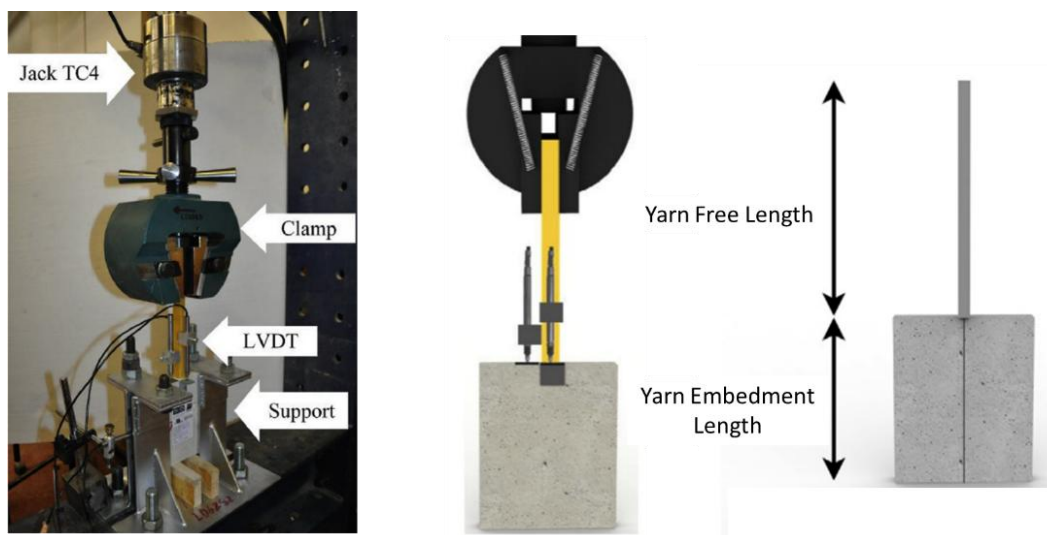
Figure 2-20 TRCC yarn pull-out test setup test setup (Dalalbashi et al., 2018)

strain distribution along the embedded length, it is a common practice to assume a stress/strain distribution. In order to reduce the impact of contact compression force experienced at the support, introducing a tube in the concrete positioned at the loaded section of the yarn is recommended. This approach aligns with the established bond test for determining the bond strength of conventional RC, resulting in a less disrupted bonded area and a more realistic representation of bond behavior. However, owing to the considerable thickness of the samples, which often do not mirror the thickness of actual TRCC specimens, the probability of splitting failure is typically minimized, and the force-slip correlation derived from these tests typically represents an upper bound of the bond strength.

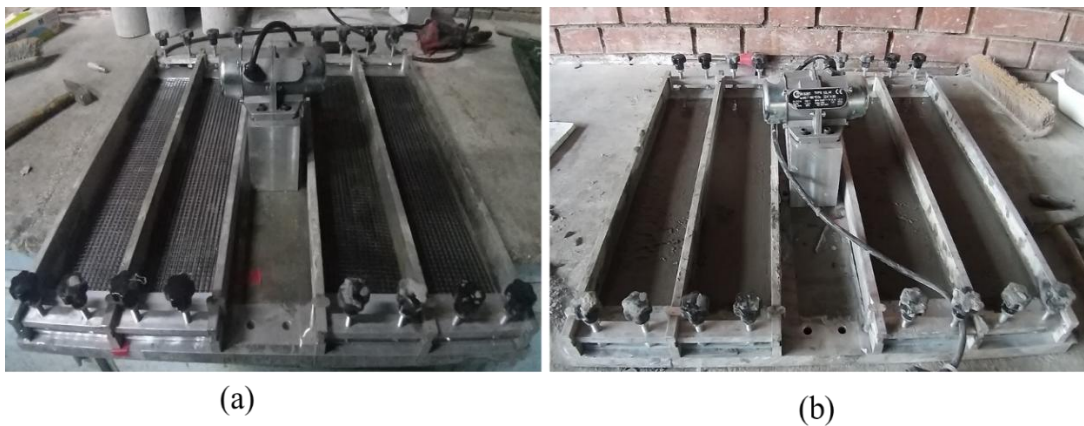
Figure 3-13 C-TRCC formwork: (a) textile placement in the forms (b) placement of cementitious mortar

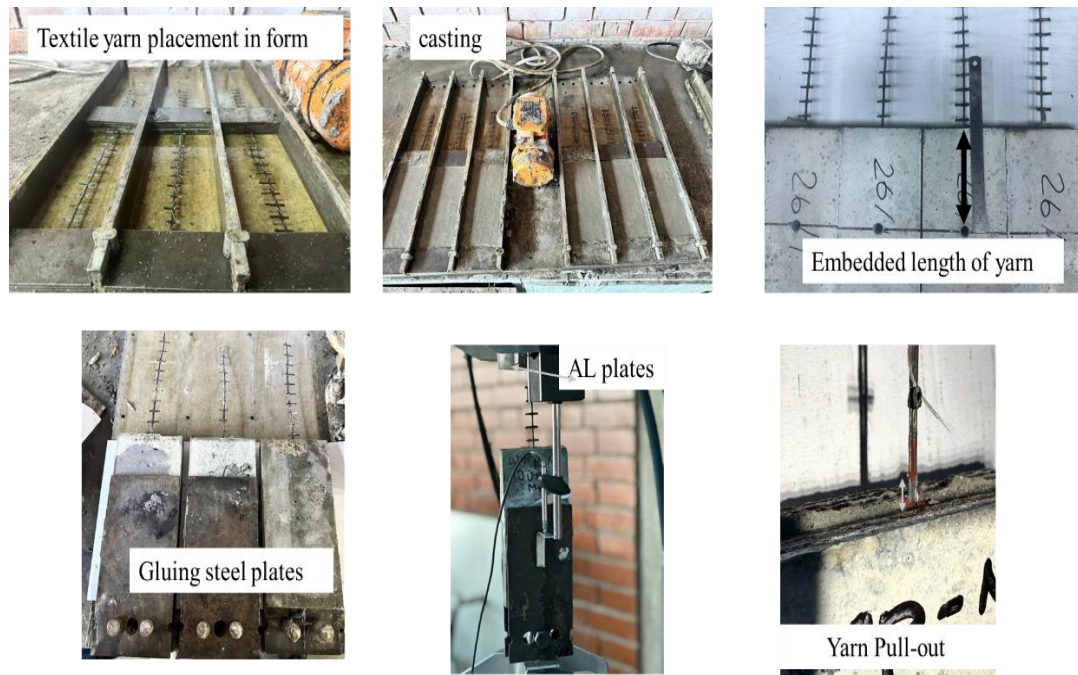
Figure 3-18 C-TRCC yarn pull-out tests specimen preparation and testing procedure.

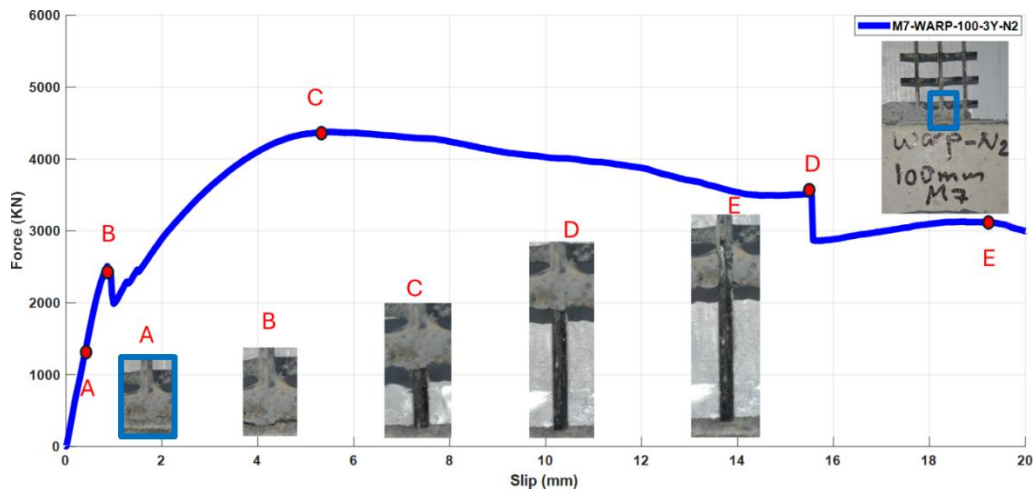
Figure 4-13 Textile pull-out failure mode

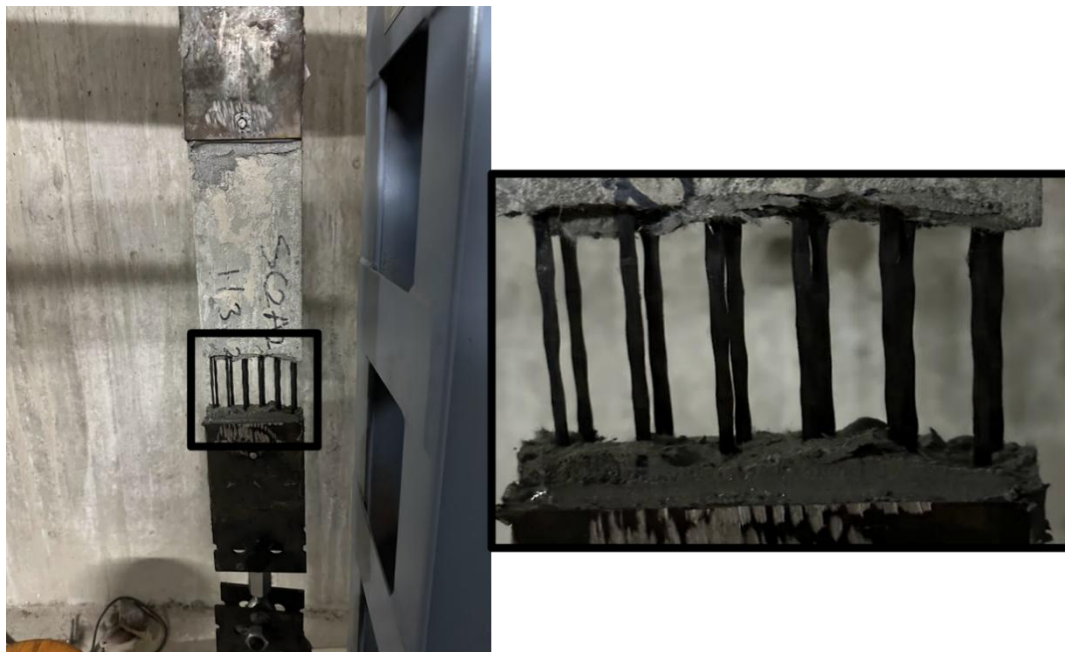
Figure 4-39 Pull out of carbon textile yarns in dummy specimens at 75% loading

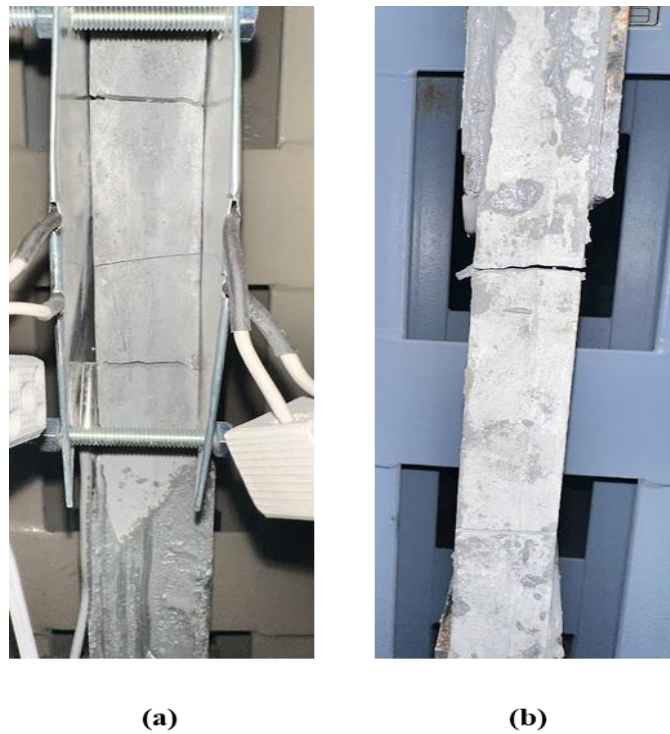
Figure 4-46 Cracking pattern in (a) 50°C,(b) 20°C
