EVALUATION OF THE TRANSFORMATION PROCESS IN BURSA
MURADIYE BETWEEN 1984 - 1995

A THESIS SUBMITTED TO
THE GRADUATE SCHOOL OF NATURAL AND APPLIED SCIENCES
OF
THE MIDDLE EAST TECHNICAL UNIVERSITY

RESTORATION

DEPARTMENT OF ARCHITECTURE

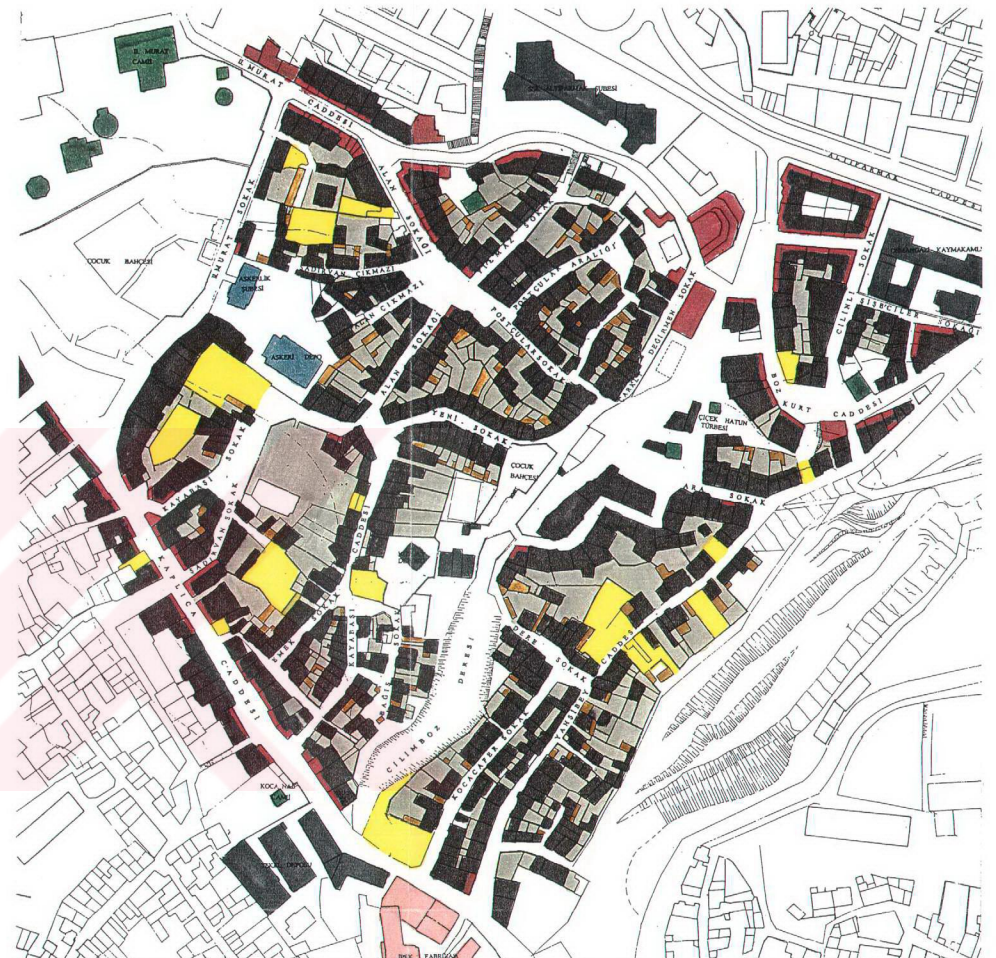
STATE IN 1995

LAND USE	Symbol/Color	Description
	Dark Grey	RESIDENCES
	Orange	OUTHOUSES
	Red	COMMERCE
	Dark Red	RESIDENCE+COMMERCE
	Pink	FACTORY BUILDINGS
	Green	RELIGIOUS BUILDINGS
	Dark Grey	PUBLIC BUILDINGS
	Blue	MILITARY BUILDINGS
	Light Grey	GARDENS
	Yellow	EMPTY LOTS

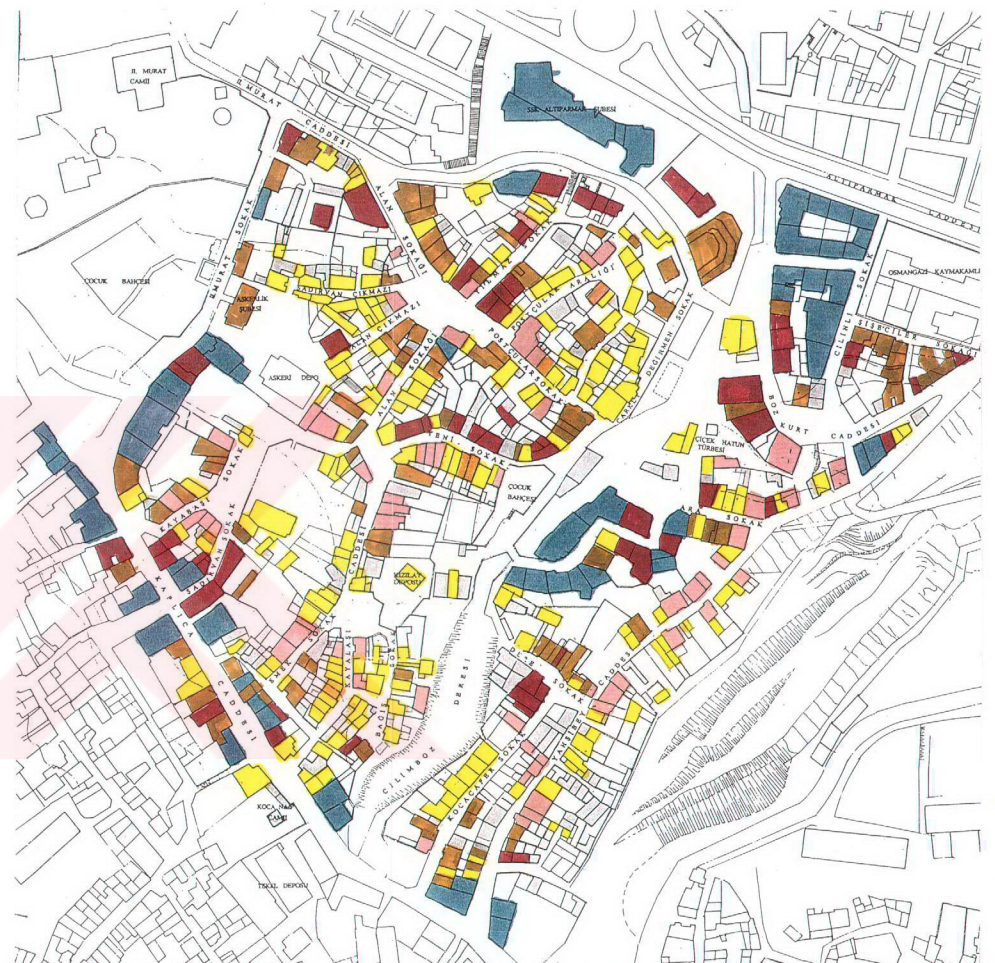
According to the survey in 1984, it has been found out that two and a half and three storied buildings formed a considerable part of the area, as these were traditional buildings in general. The single storied buildings, it was pointed out that all these were in the group of buildings classified without definite architectural characteristics.

According to the survey carried out in 1995, it was found out that the changes in building heights occurred in the form of increase. (Figure 7) The increase mainly depends on the construction of new buildings in general. There is only one example with an addition of a floor that is located on 'Bozkurt Caddesi'. The other change is the decrease in the number of buildings due to the demolished buildings. The distribution of the building heights in 1995 is indicated in Table 2.

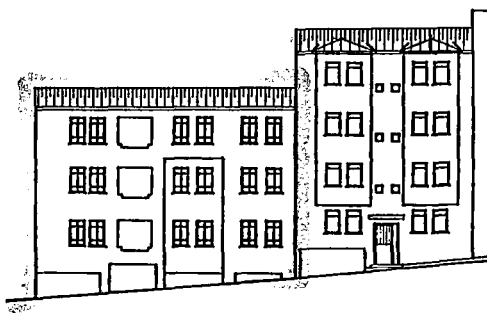
CONSERVATION PLAN PERIOD EXAMPLE 9 : CPE 9

Table 19 Architectural Characteristics of New Buildings Constructed During the Conservation Plan Period, Example 9; CPE 9

Address: Şadırvan sokak

Function: Residential

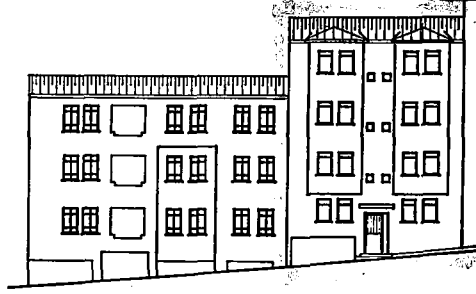
CONSERVATION PLAN PERIOD EXAMPLE 10 : CPE 10

Table 20 Architectural Characteristics of New Buildings Constructed During the Conservation Plan Period, Example 10; CPE 10

Address: Şadırvan sokak

Function: Residential

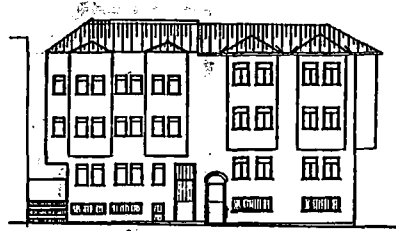
CONSERVATION PLAN PERIOD EXAMPLE 16 : CPE 16

Table 26 Architectural Characteristics of New Buildings Constructed During the Conservation Plan Period, Example 16; CPE 16

Address: Kocacafer sokak

Function: Residential

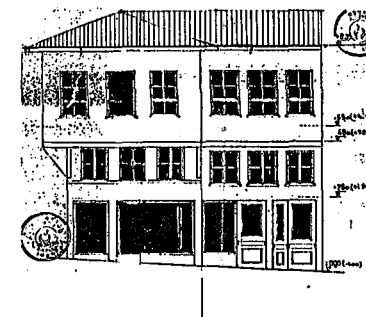
Table 51 State of Building Before the Implementation, Example 4 : RE 4

SECOND GROUP IMPLEMENTATION
‘RESTORATION’ EXAMPLE NO 4: RE 4
<p>Address: Kayabaşı sokak 36</p> <p>Location: Corner lot</p> <p>Function: Residential + Commercial on ground floor</p> <p>Plan Scheme</p> <p>Ground Floor : The building consists of two separate buildings one as single storey and one as three storey high. On the ground floor there are three entrances to the building. The single storeyed building consists of two rooms, a kitchen and a WC which is entered through a narrow corridor. On the ground floor of the three storeyed building there are two rooms at the front side and a kitchen together WC at the rear side. The shop is entered separately from 'Kaplıca caddesi'.</p> <p>First Floor : On the first floor, at the front side there are two rooms which are different in size entered from a small hall. At the rear side, there is a kitchen together with the WC.</p> <p>Second Floor: From the hall reached by the stairs, the storage space, the front room and the kitchen together with the WC at the rear side are entered. From the front room, it is entered to a projected 'başoda'.</p> <p>Facade organization: The projected 'başoda' is an important aspect of the facade organization. On the facade facing 'Kayabaşı sokak', there are six rectangular window openings on the first and second floors that are different in size and shape. The ground floor facade consists of the large window openings belonging to the shop and the front room together with the entrance door. On the facade facing 'Kaplıca caddesi', the projected 'başoda' continues through the whole facade on the three storeyed building. On the ground floor, there are the shop entrance door with its large glazed openings and the glazing of the single storeyed building.</p> <p>Space Quality: The arrangement of the spaces on a polygonal geometry and the relation of the 'sofa' with the inner spaces are the significant character of the building. The architectural elements as the 'sedir', 'yükçük' and the fire place articulate the space quality.</p> <p>Structural System : The structural system of the building is timber frame no information was given about the infill material.</p> <p>Condition Of Service Spaces :The kitchen and WC are located at the rear side on each floor of the three storeyed building but no information was given for the bath. On the single storeyed building there are the kitchen and WC located adjacent to the three storeyed building.</p> <p>Architectural Elements : The architectural elements in the building are indicated as follows but no information was given about the originality.</p> <p>The 'seki' on first and second floor</p> <p>The closet on first floor</p> <p>The niche on the second floor</p> <p>The staircases</p> <p>Ornamentations :The profiled buttresses and the 'silme' indicating the floor level can be accepted as ornamentation.</p>

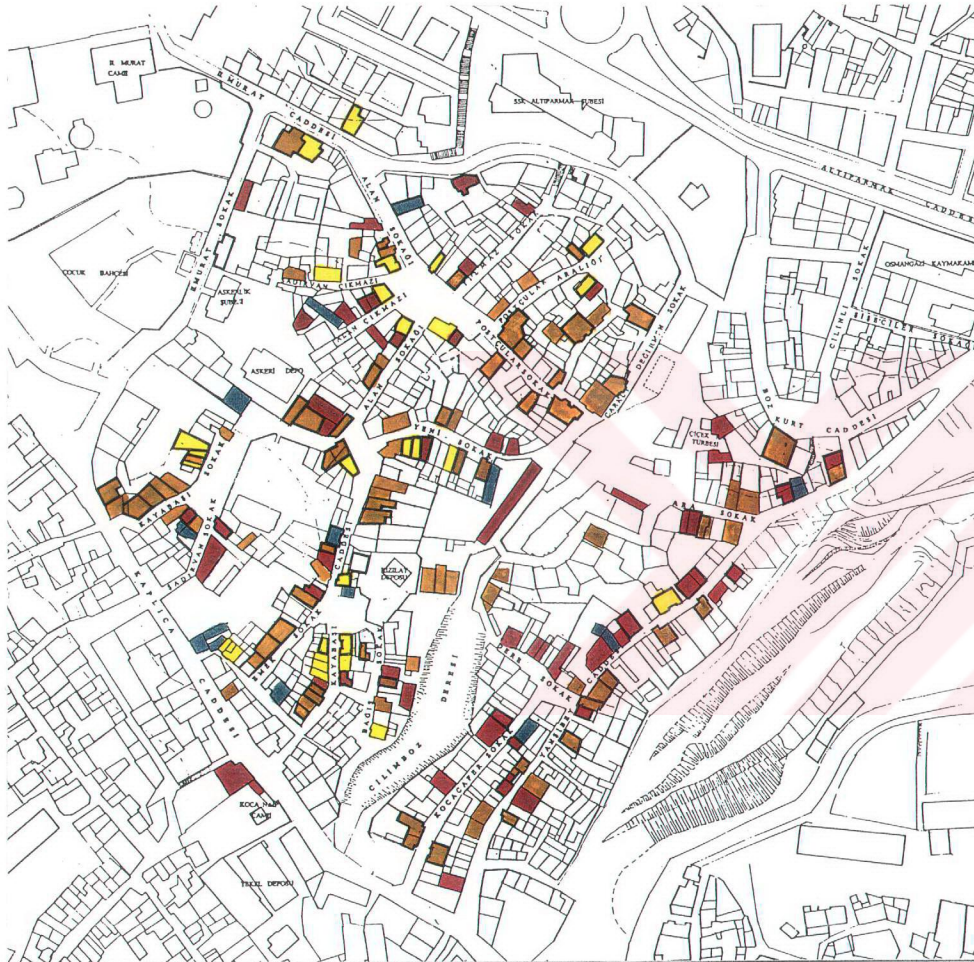
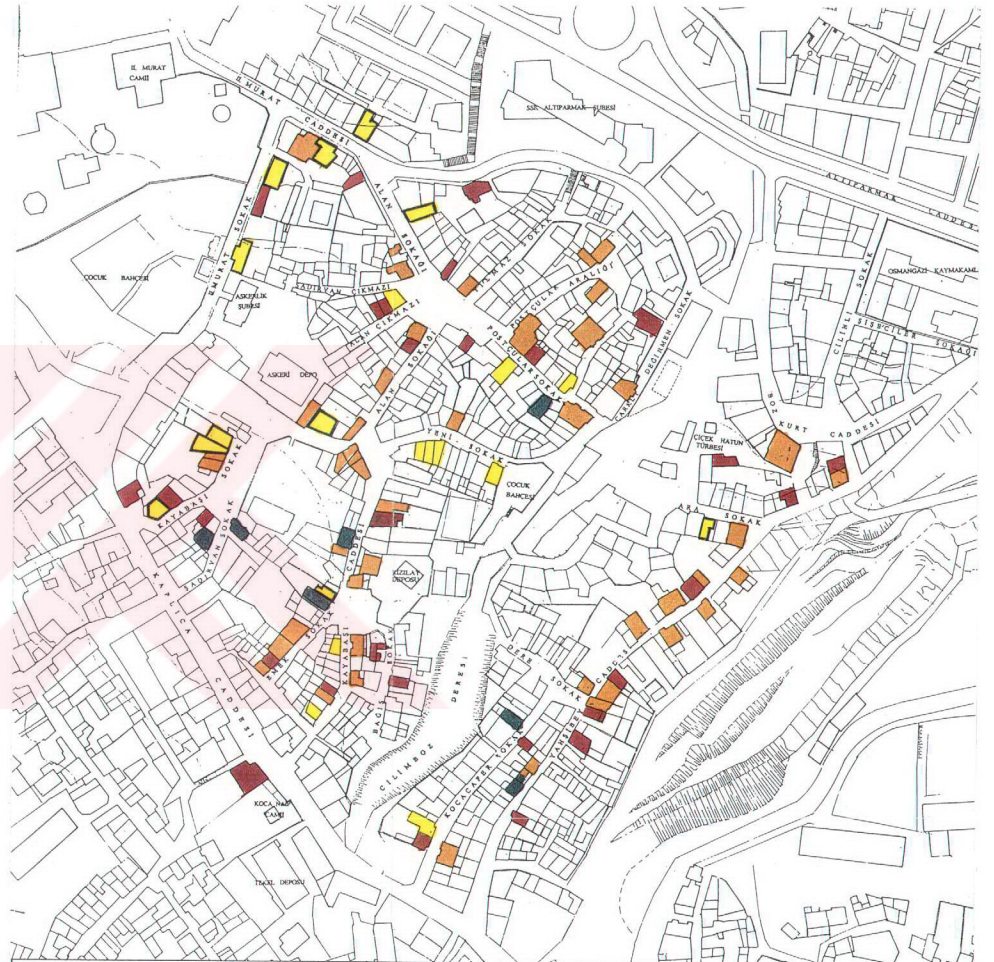
After the definition, The main problem in the structural condition of the buildings in the study area has been defined as material problems rather than problems in the structural system. The decay of timber elements, especially utilized in the

structural systems, is a common problem. Humidity has also been defined as a general problem resulting from rising damp and surface water.

The problems within the structural system were defined as the saffing floor and inclinations on the walls. The material problems of timber were detected from the falling parts, holes and deformation. The problems in the plaster were defined cracks and falling parts.
