LOW CYCLE FATIGUE EFFECTS IN THE DAMAGE CAUSED BY
THE MARMARA EARTHQUAKE OF AUGUST 17, 1999

A THESIS SUBMITTED TO
THE GRADUATE SCHOOL OF NATURAL AND APPLIED SCIENCES
OF
MIDDLE EAST TECHNICAL UNIVERSITY

SEPTEMBER 2004

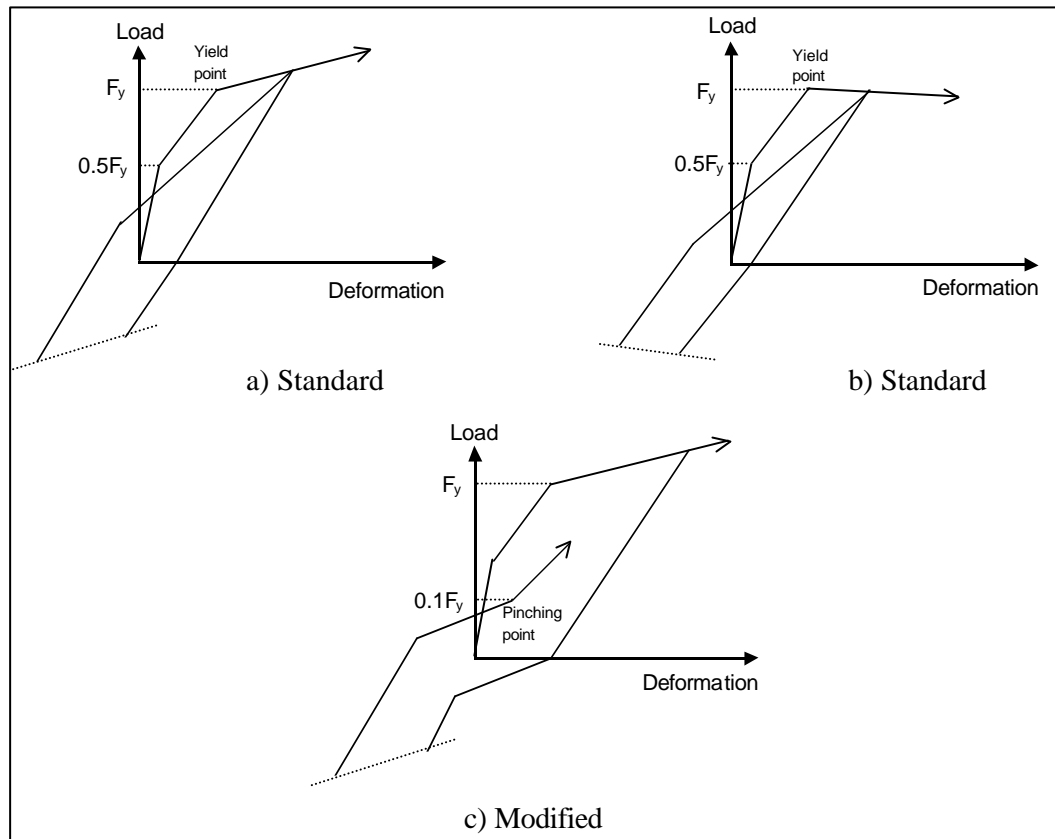
Figure 1.1 Evolving Takeda models

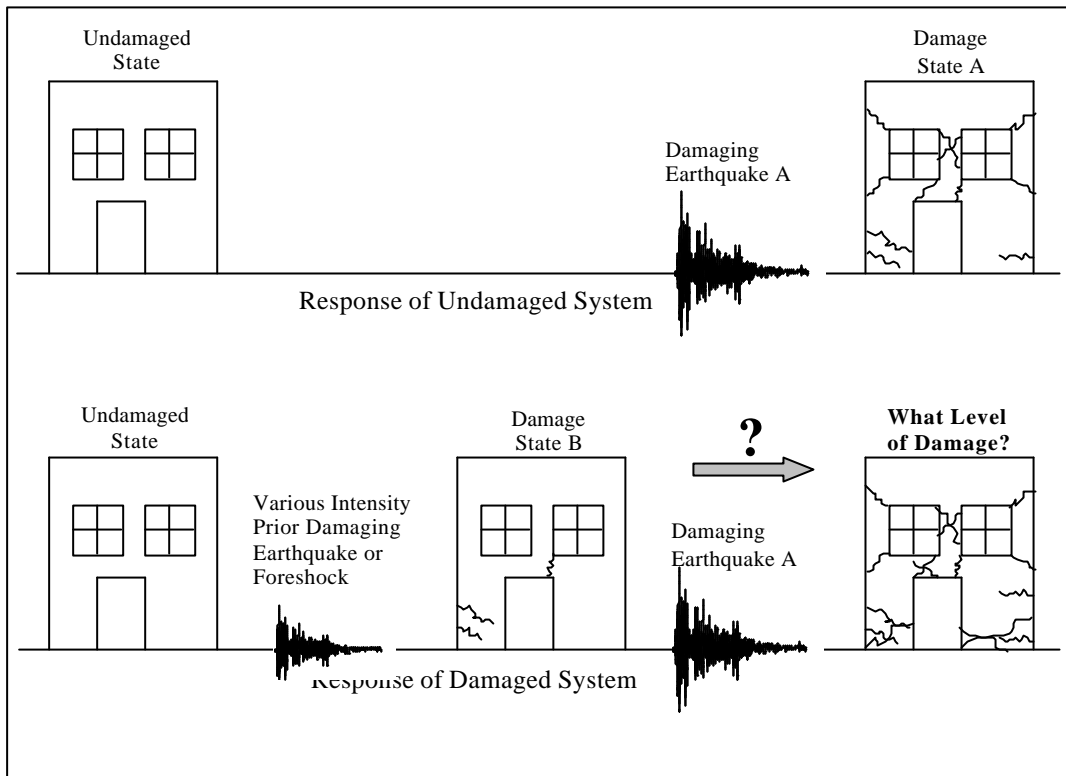
Figure 1.4 Prior earthquake damage

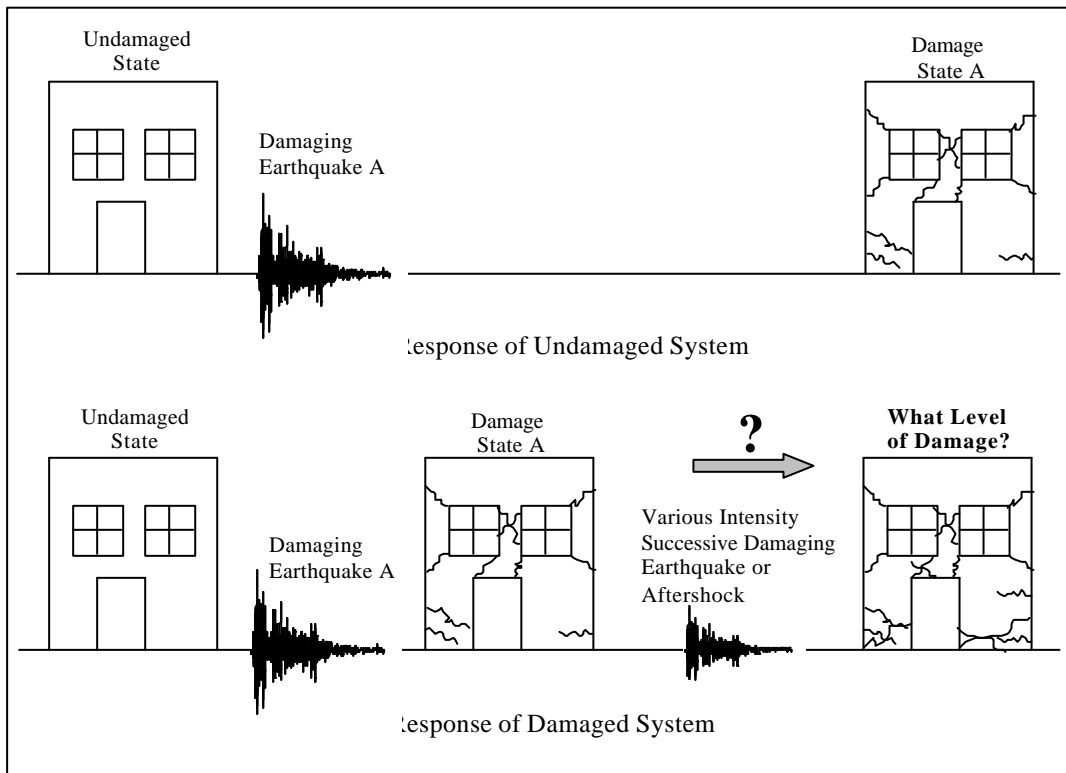
Figure 1.5 Successive earthquake damage

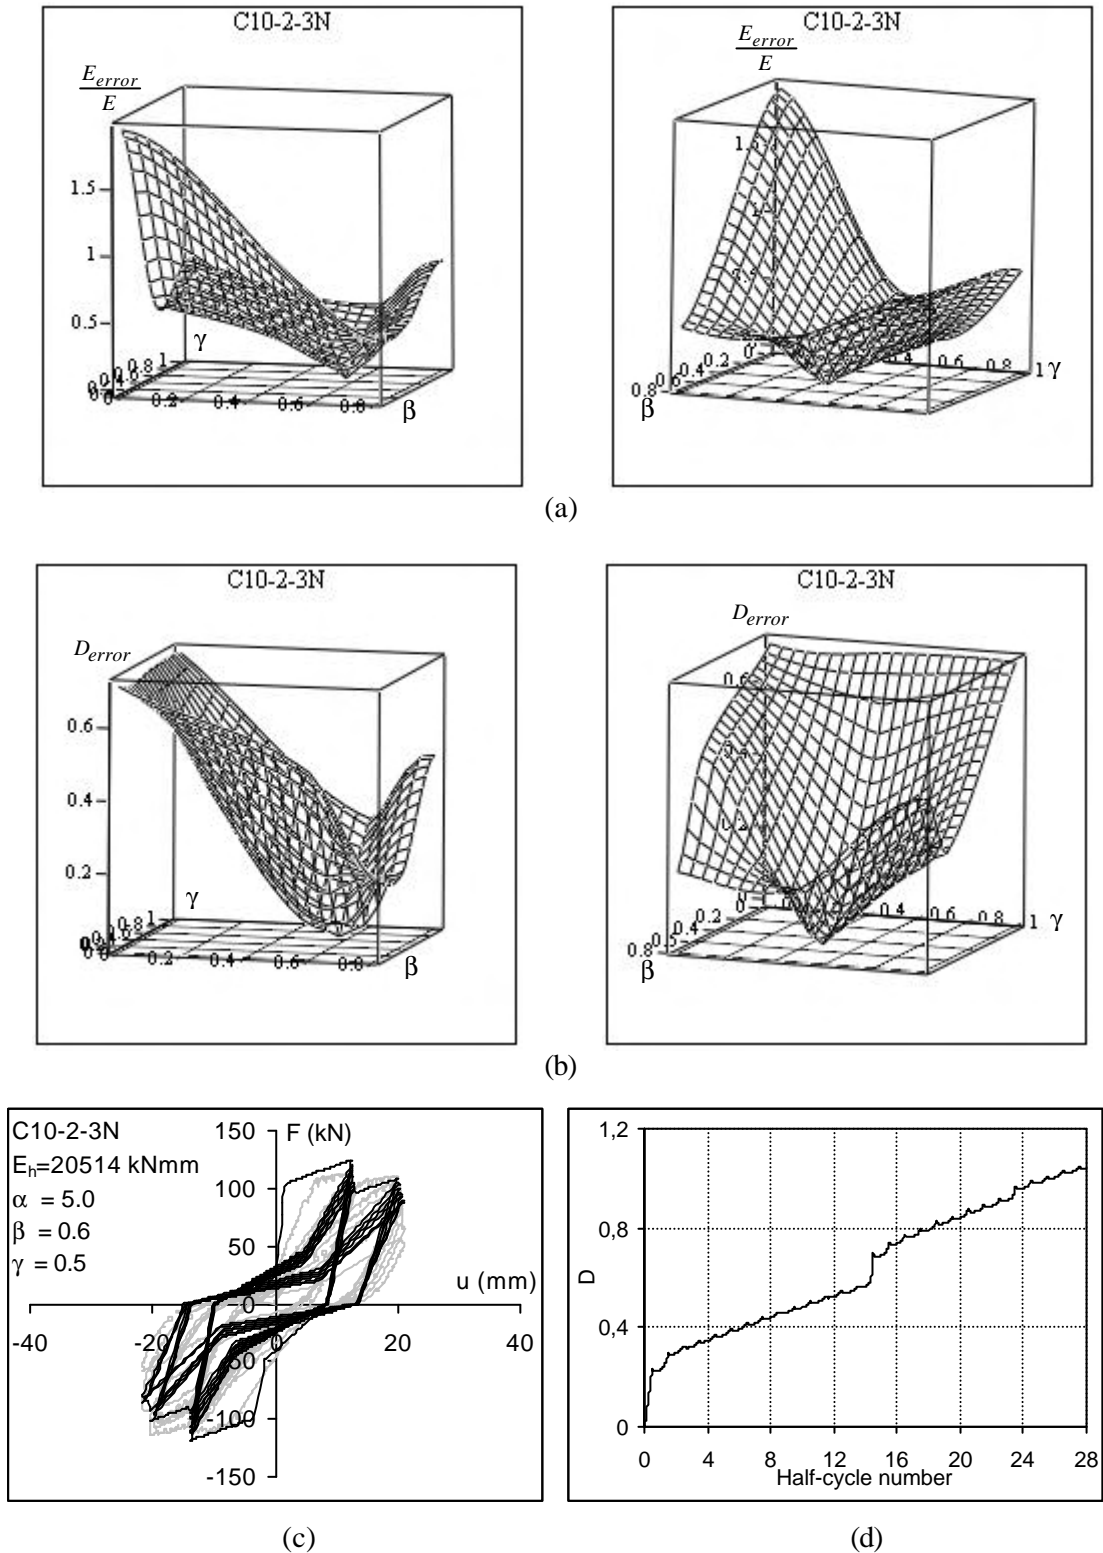
Figure 3.14 Pujol column test specimen C10-2-3 North: **a)** Surfaces of variation in the dissipated hysteretic energy error ratio for $\alpha=5.0$ and β and γ parameters, **b)** Surfaces of variation in the damage index error for $\alpha=5.0$ and β and γ parameters, **c)** Comparison of the experimental (gray curve) and analytical (black curve) force-deformation relationships, **d)** Analytical progressive damage curve

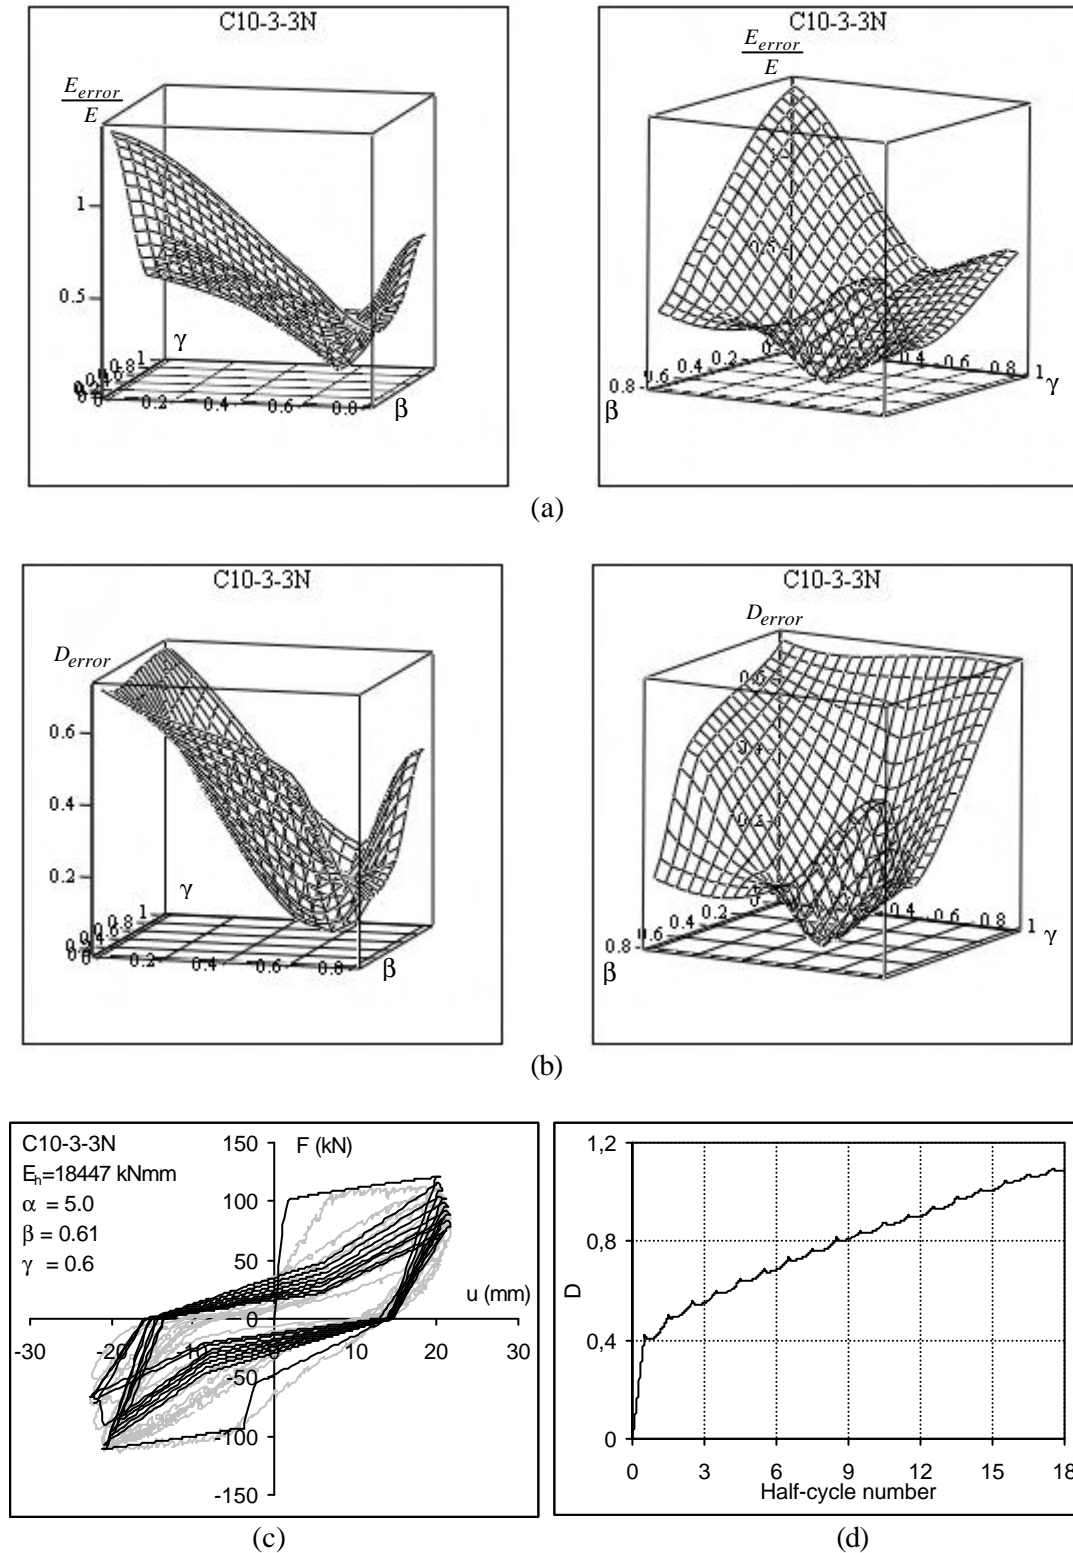
Figure 3.16 Pujol column test specimen C10-3-3 North: **a)** Surfaces of variation in the dissipated hysteretic energy error ratio for $\alpha=5.0$ and β and γ parameters, **b)** Surfaces of variation in the damage index error for $\alpha=5.0$ and β and γ parameters, **c)** Comparison of the experimental (gray curve) and analytical (black curve) force-deformation relationships, **d)** Analytical progressive damage curve

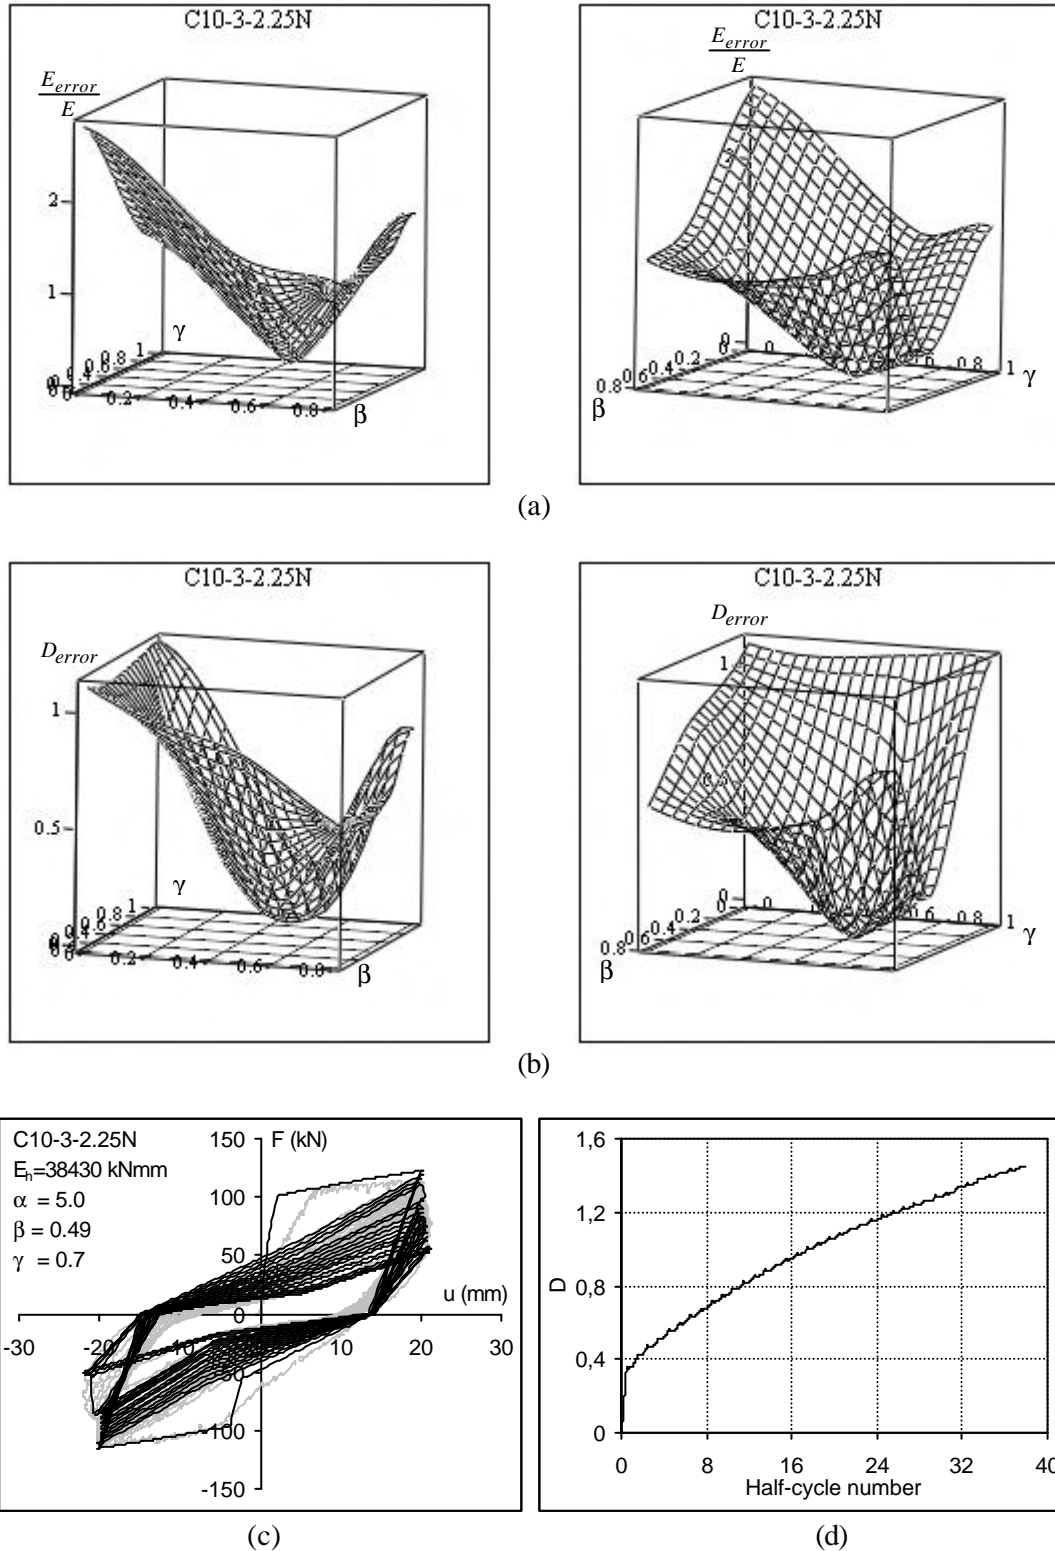
Figure 3.17 Pujol column test specimen C10-3-2.25 North: **a)** Surfaces of variation in the dissipated hysteretic energy error ratio for $\alpha=5.0$ and β and γ parameters, **b)** Surfaces of variation in the damage index error for $\alpha=5.0$ and β and γ parameters, **c)** Comparison of the experimental (gray curve) and analytical (black curve) force-deformation relationships, **d)** Analytical progressive damage curve

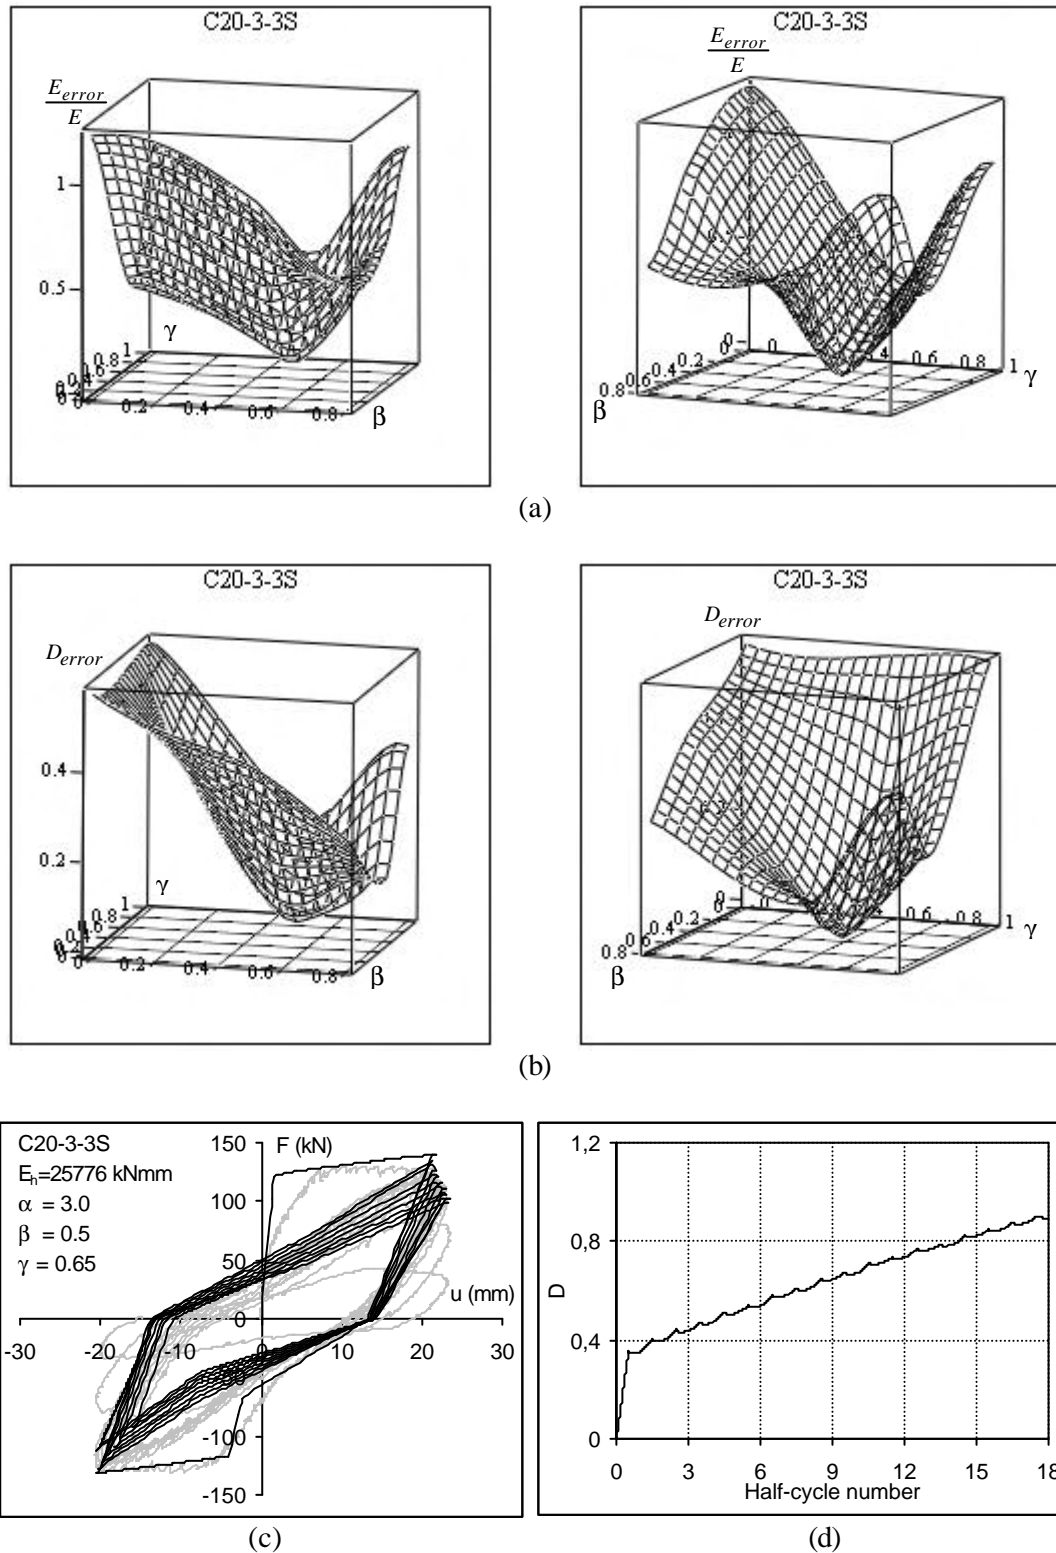
Figure 3.18 Pujol column test specimen C20-3-3 South: **a)** Surfaces of variation in the dissipated hysteretic energy error for $\alpha=3.0$ and β and γ parameters, **b)** Surfaces of variation in the damage index error for $\alpha=3.0$ and β and γ parameters, **c)** Comparison of the experimental (gray curve) and analytical (black curve) force-deformation relationships, **d)** Analytical progressive damage curve

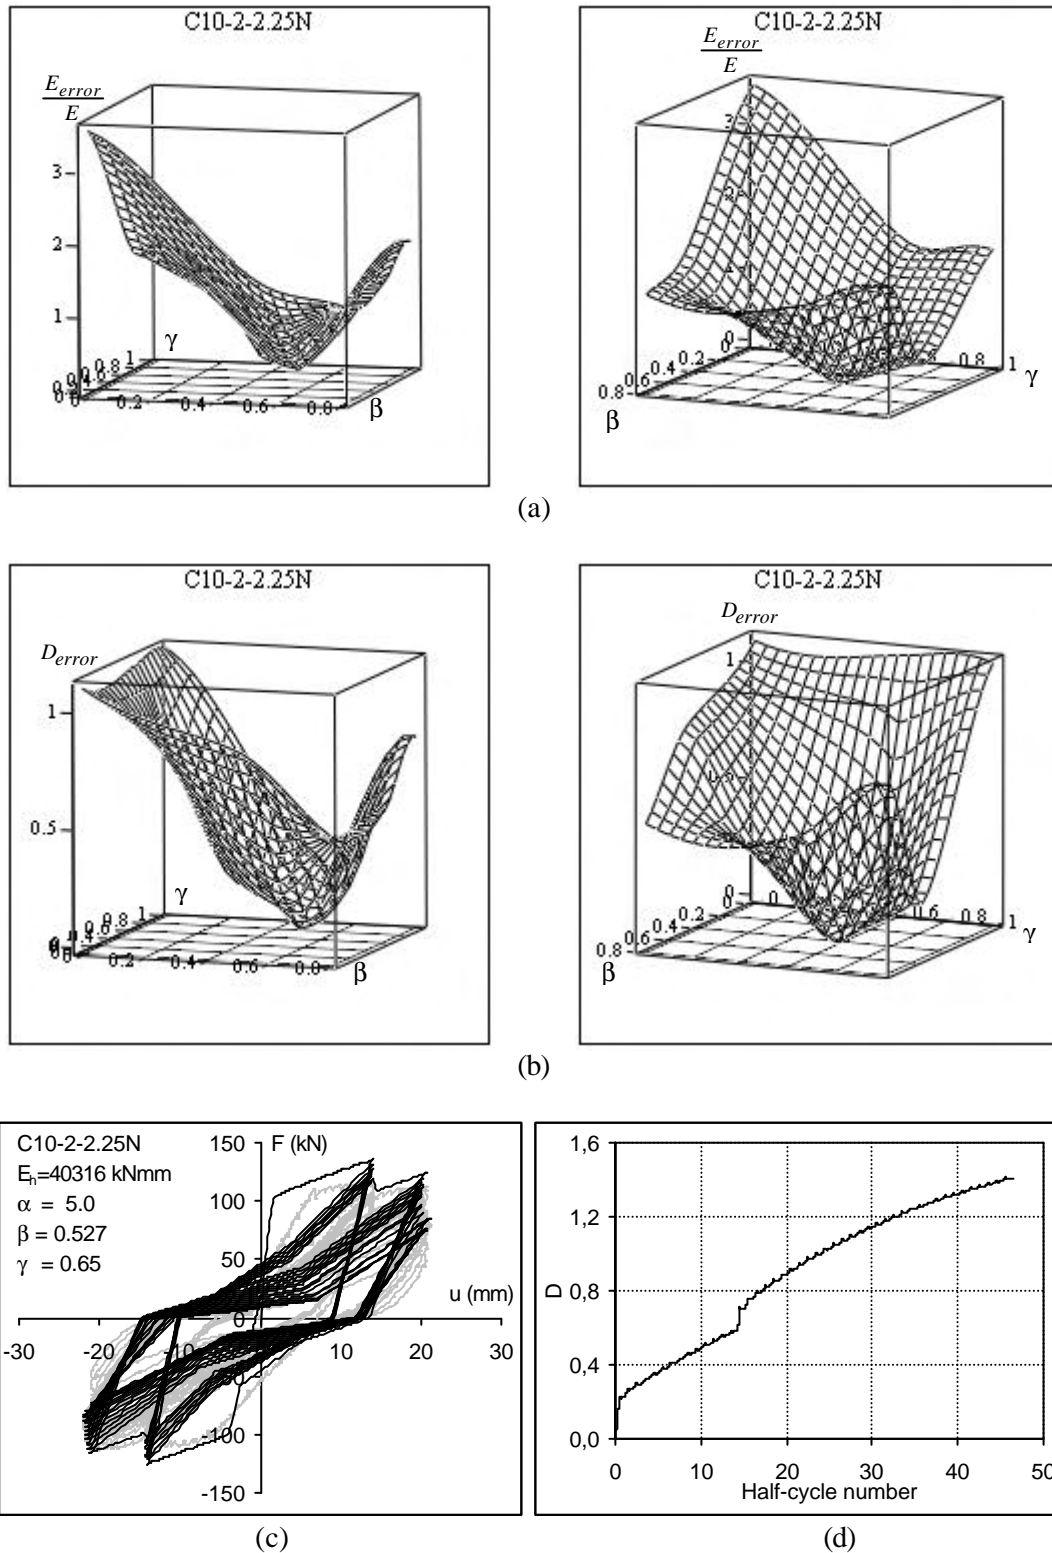
Figure 3.19 Pujol column test specimen C10-2-2.25 North: **a)** Surfaces of variation in the dissipated hysteretic energy error ratio for $\alpha=5.0$ and β and γ parameters, **b)** Surfaces of variation in the damage index error for $\alpha=5.0$ and β and γ parameters, **c)** Comparison of the experimental (gray curve) and analytical (black curve) force-deformation relationships, **d)** Analytical progressive damage curve

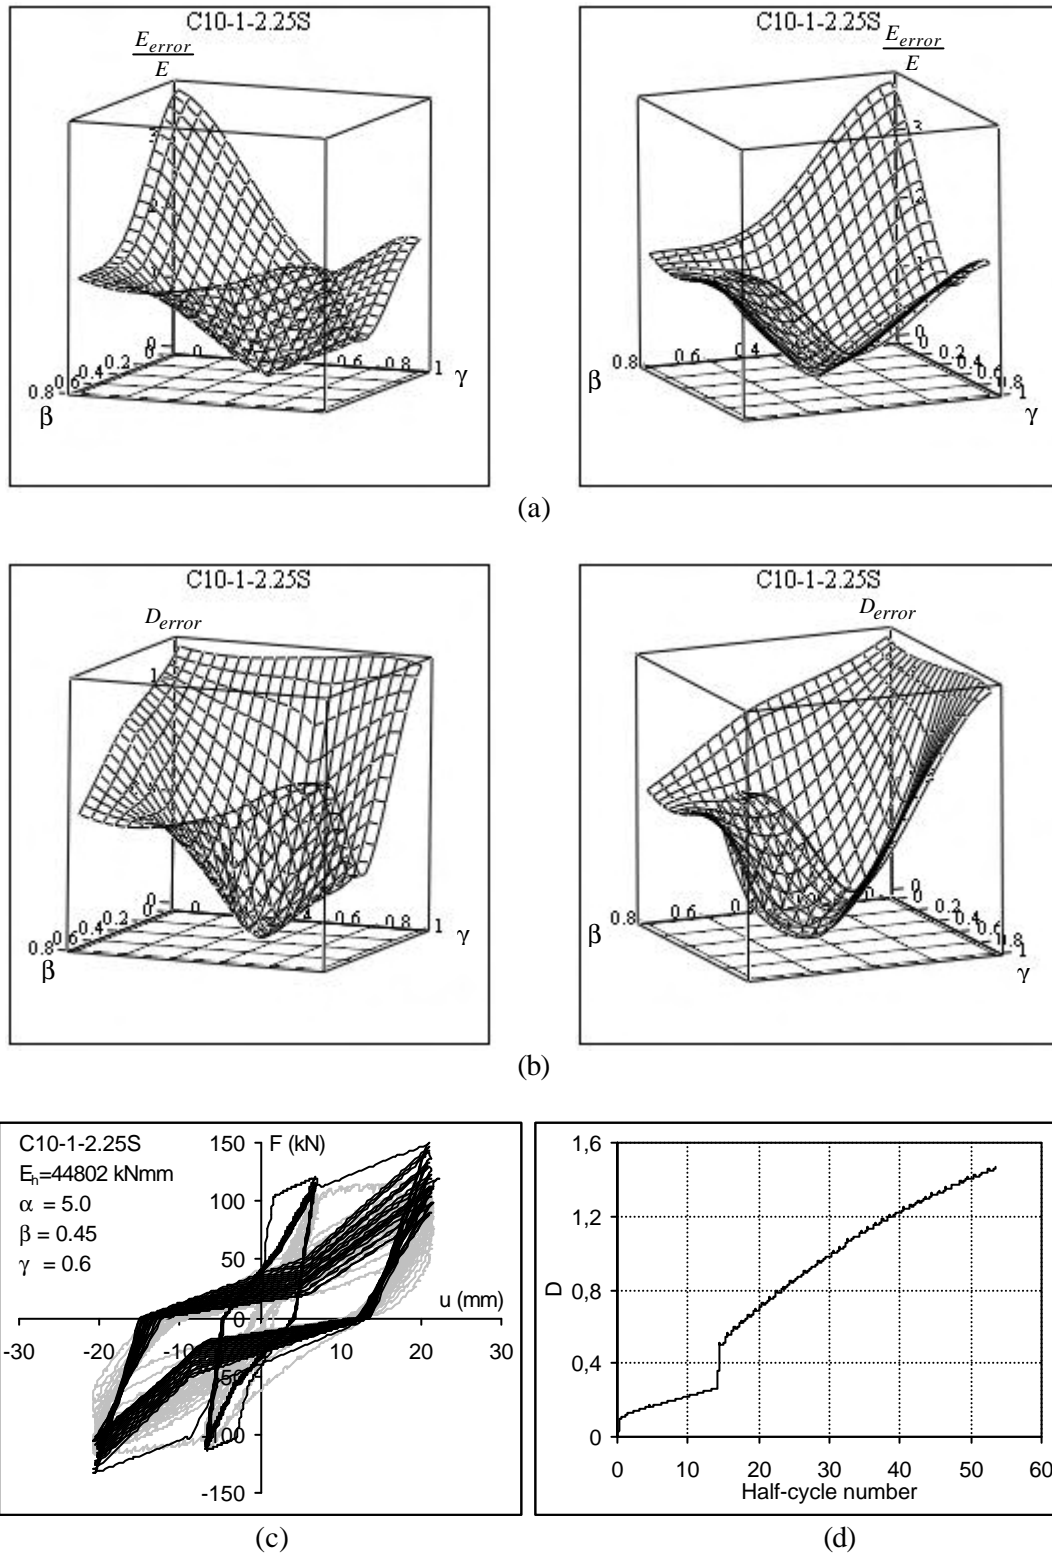
Figure 3.20 Pujol column test specimen C10-1-2.25 South: **a)** Surfaces of variation in the dissipated hysteretic energy error ratio for $\alpha=5.0$ and β and γ parameters, **b)** Surfaces of variation in the damage index error for $\alpha=5.0$ and β and γ parameters, **c)** Comparison of the experimental (gray curve) and analytical (black curve) force-deformation relationships, **d)** Analytical progressive damage curve

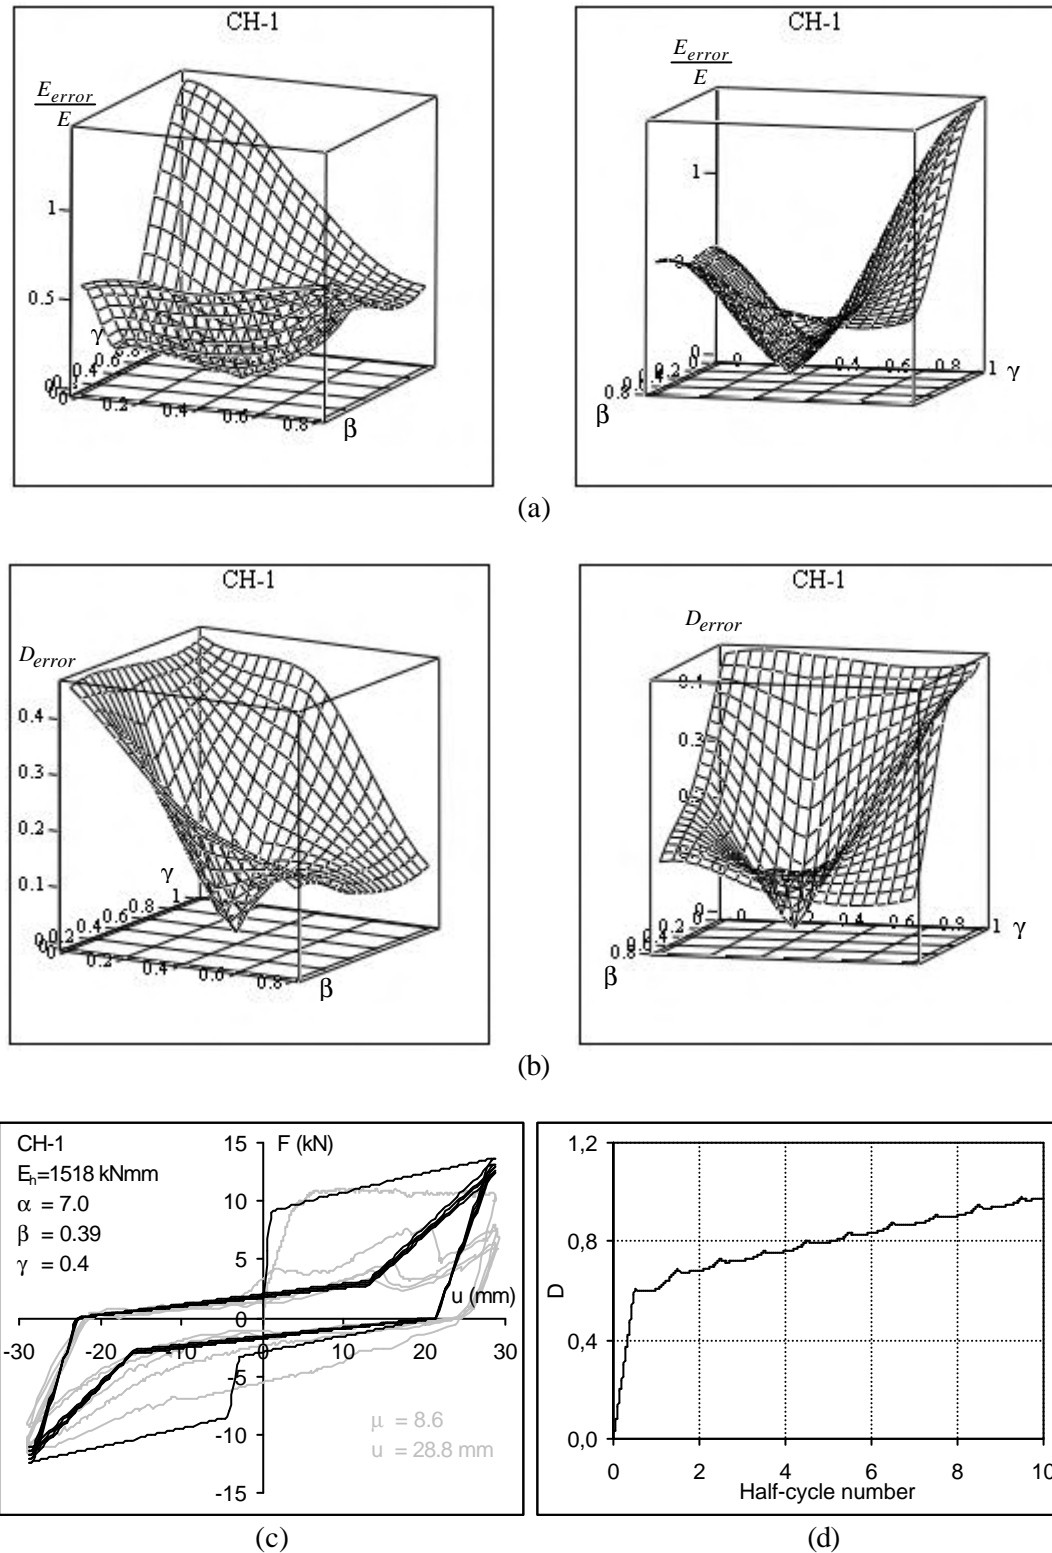
Figure 3.21 Erberik and Sucuođlu beam test specimen CH-1: **a)** Surfaces of variation in the dissipated hysteretic energy error ratio for $\alpha=7.0$ and β and γ parameters, **b)** Surfaces of variation in the damage index error for $\alpha=7.0$ and β and γ parameters, **c)** Comparison of the experimental (gray curve) and analytical (black curve) force-deformation relationships, **d)** Analytical progressive damage curve

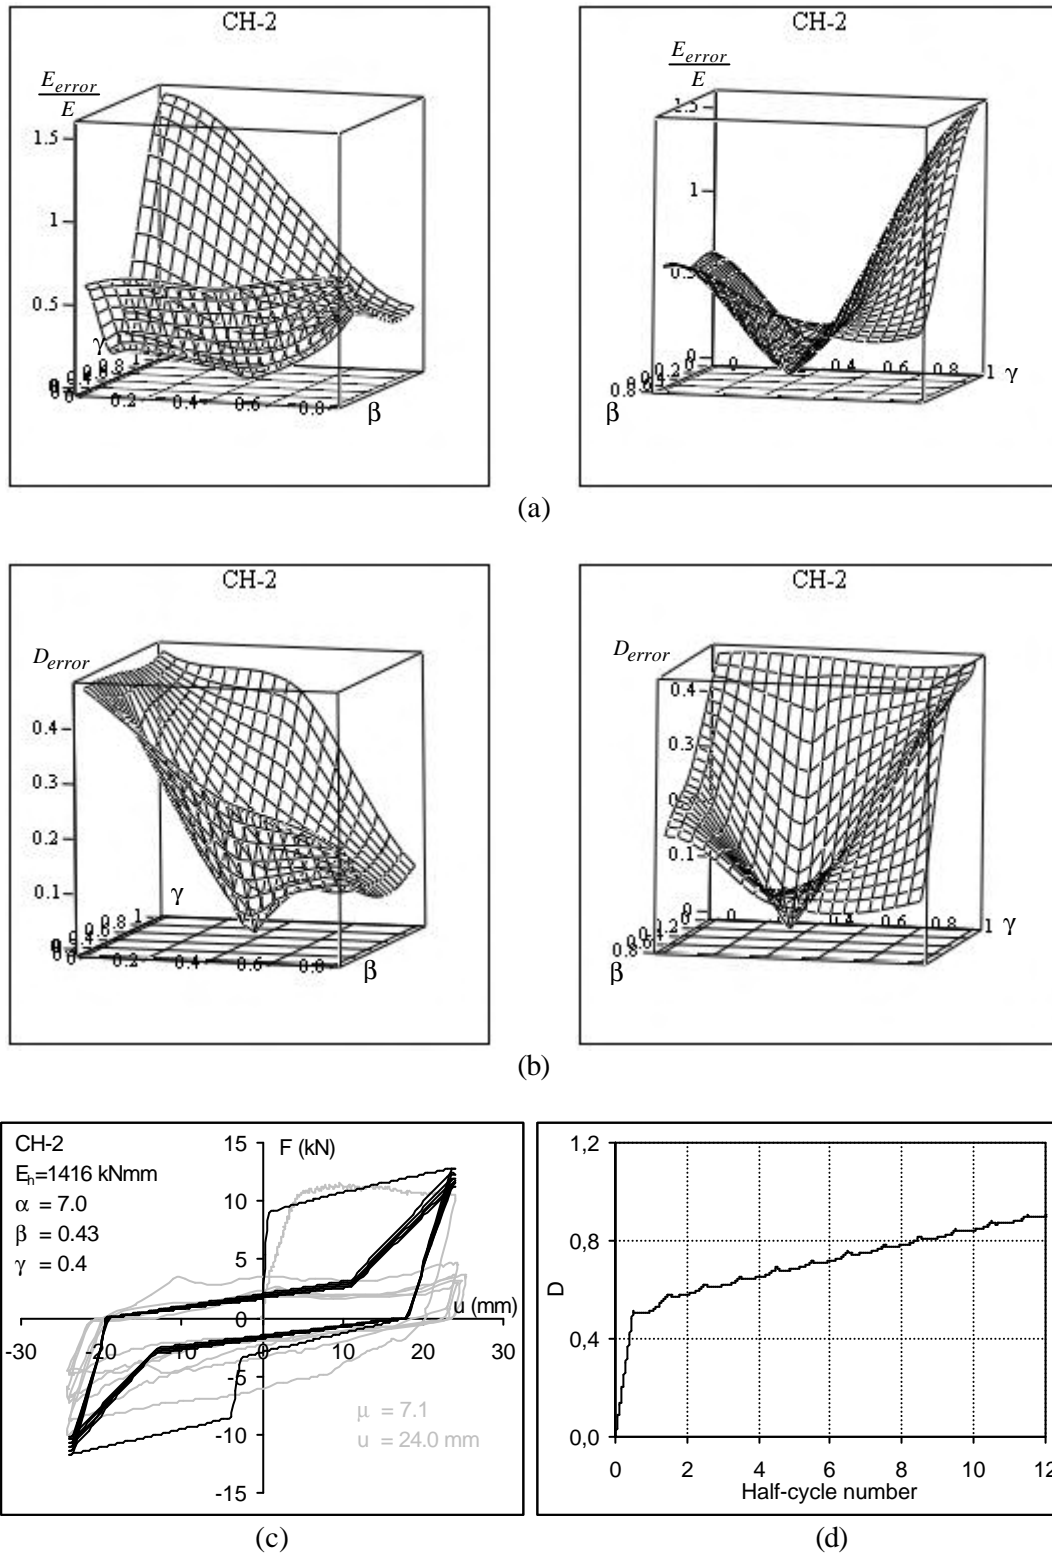
Figure 3.22 Erberik and Sucuođlu beam test specimen CH-2: **a)** Surfaces of variation in the dissipated hysteretic energy error ratio for $\alpha=7.0$ and β and γ parameters, **b)** Surfaces of variation in the damage index error for $\alpha=7.0$ and β and γ parameters, **c)** Comparison of the experimental (gray curve) and analytical (black curve) force-deformation relationships, **d)** Analytical progressive damage curve

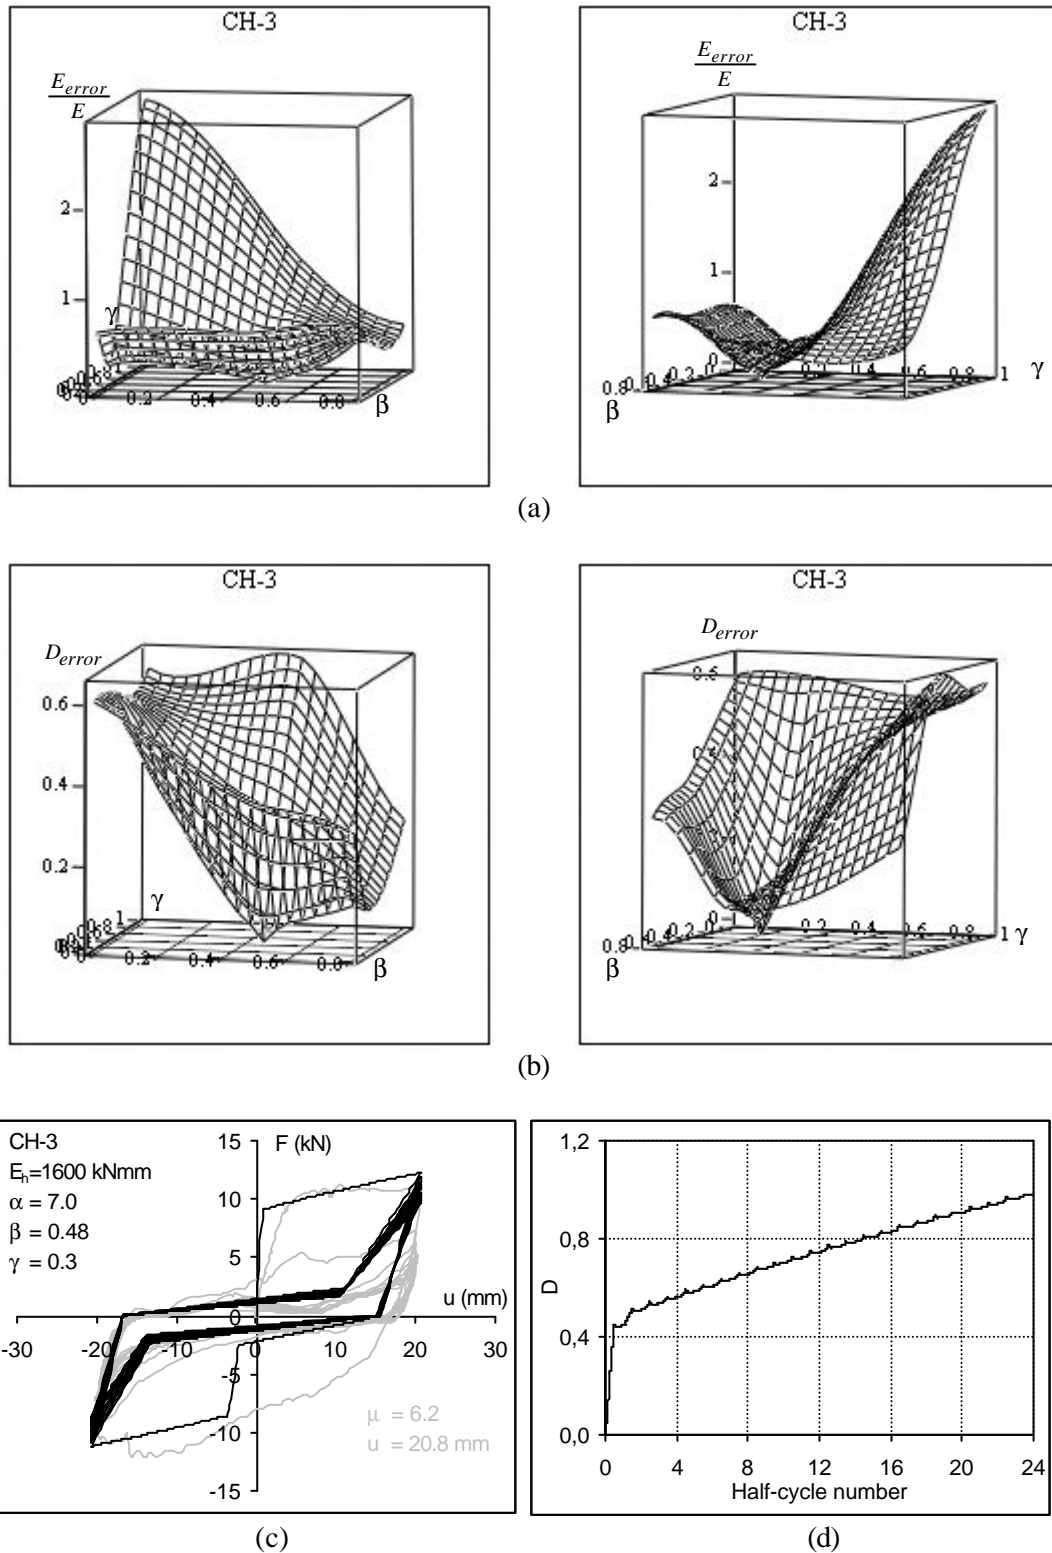
Figure 3.23 Erberik and Sucuođlu beam test specimen CH-3: **a)** Surfaces of variation in the dissipated hysteretic energy error ratio for $\alpha=7.0$ and β and γ parameters, **b)** Surfaces of variation in the damage index error for $\alpha=7.0$ and β and γ parameters, **c)** Comparison of the experimental (gray curve) and analytical (black curve) force-deformation relationships, **d)** Analytical progressive damage curve

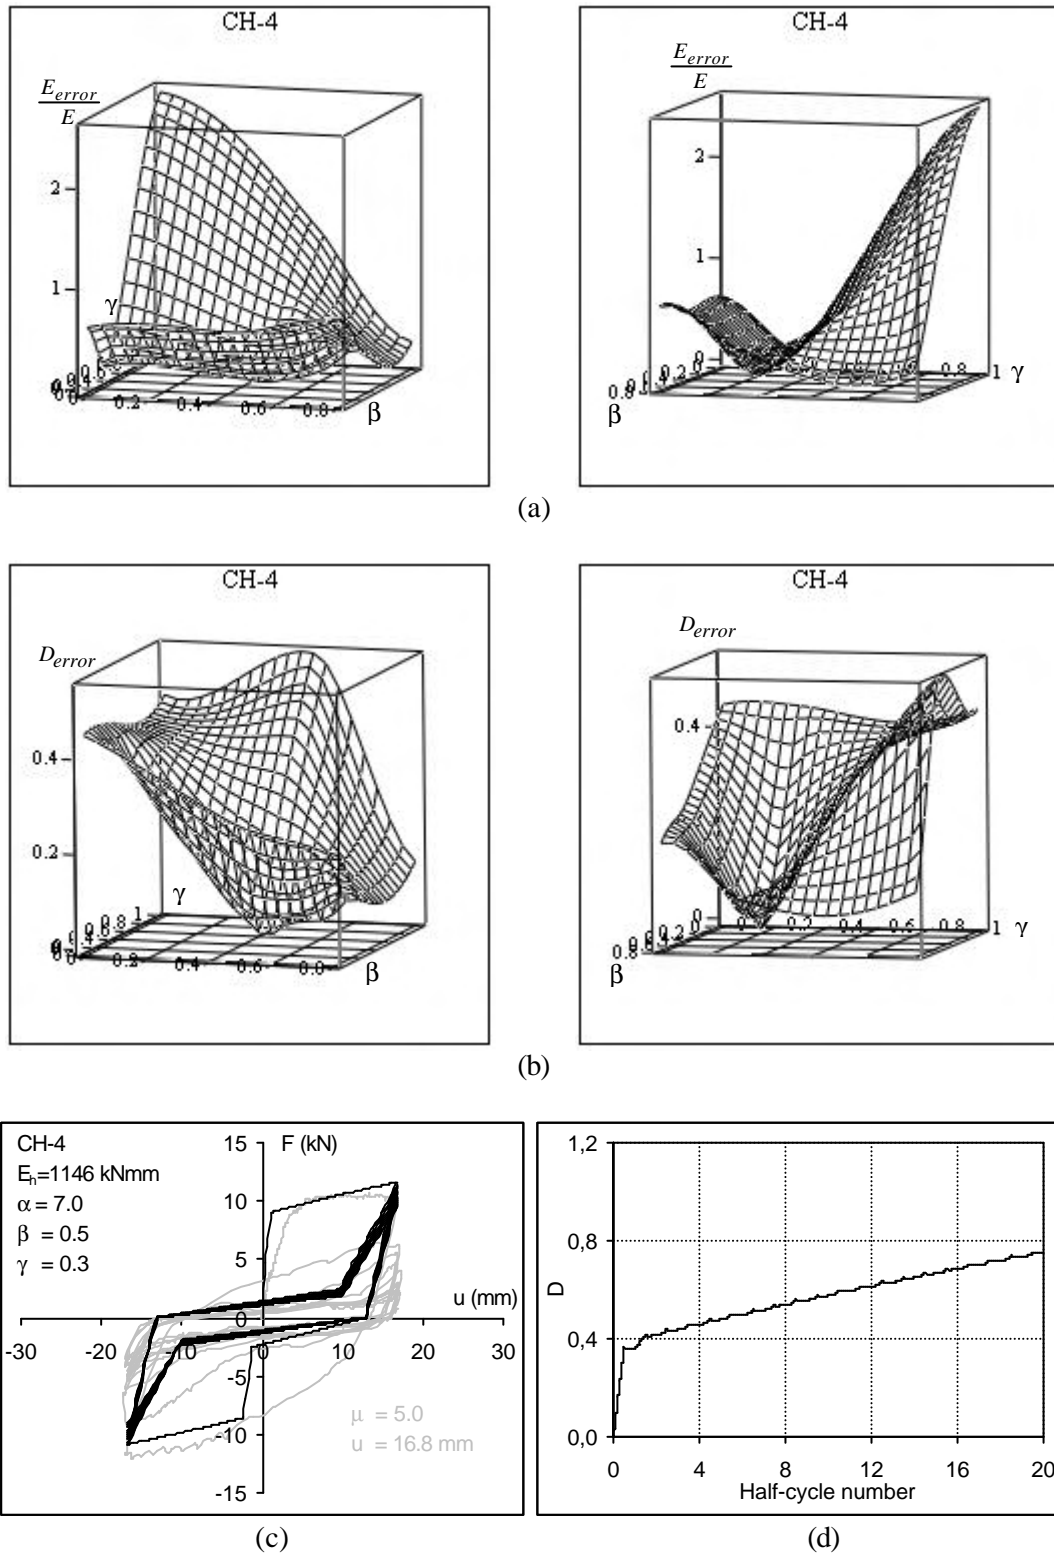
Figure 3.24 Erberik and Sucuođlu beam test specimen CH-4: **a)** Surfaces of variation in the dissipated hysteretic energy error ratio for $\alpha=7.0$ and β and γ parameters, **b)** Surfaces of variation in the damage index error for $\alpha=7.0$ and β and γ parameters, **c)** Comparison of the experimental (gray curve) and analytical (black curve) force-deformation relationships, **d)** Analytical progressive damage curve

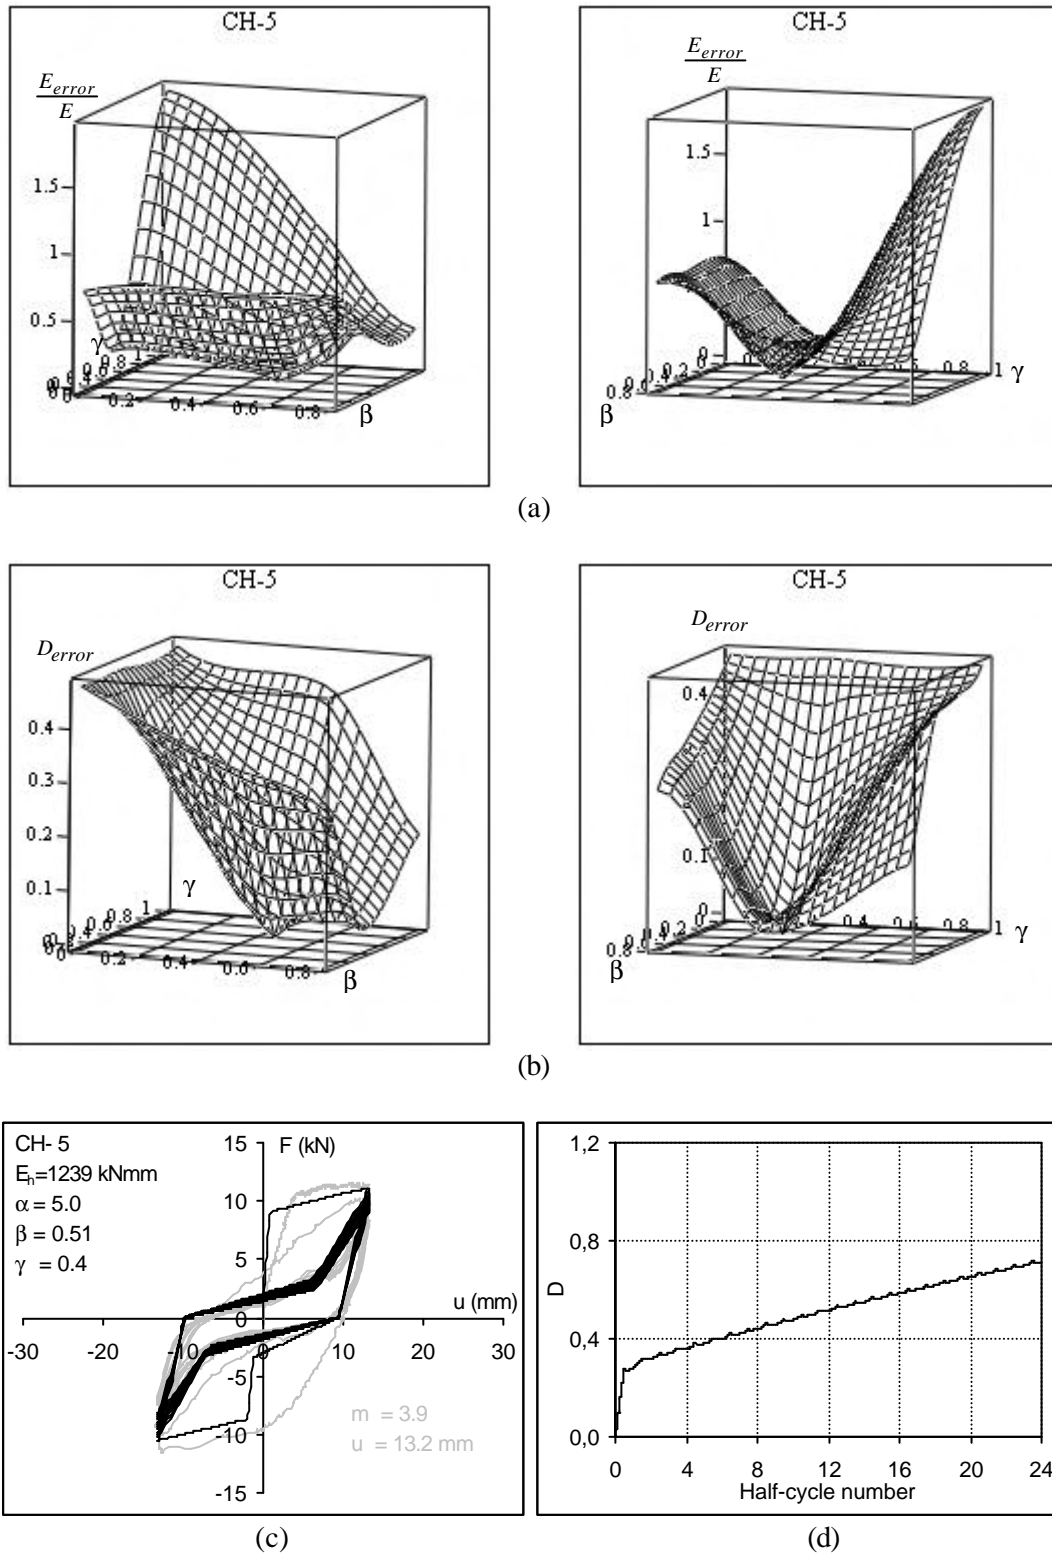
Figure 3.25 Erberik and Sucuođlu beam test specimen CH-5: **a)** Surfaces of variation in the dissipated hysteretic energy error ratio for $\alpha=5.0$ and β and γ parameters, **b)** Surfaces of variation in the damage index error for $\alpha=5.0$ and β and γ parameters, **c)** Comparison of the experimental (gray curve) and analytical (black curve) force-deformation relationships, **d)** Analytical progressive damage curve
