LOW CYCLE FATIGUE EFFECTS IN THE DAMAGE CAUSED BY
THE MARMARA EARTHQUAKE OF AUGUST 17, 1999

A THESIS SUBMITTED TO
THE GRADUATE SCHOOL OF NATURAL AND APPLIED SCIENCES
OF
MIDDLE EAST TECHNICAL UNIVERSITY

SEPTEMBER 2004

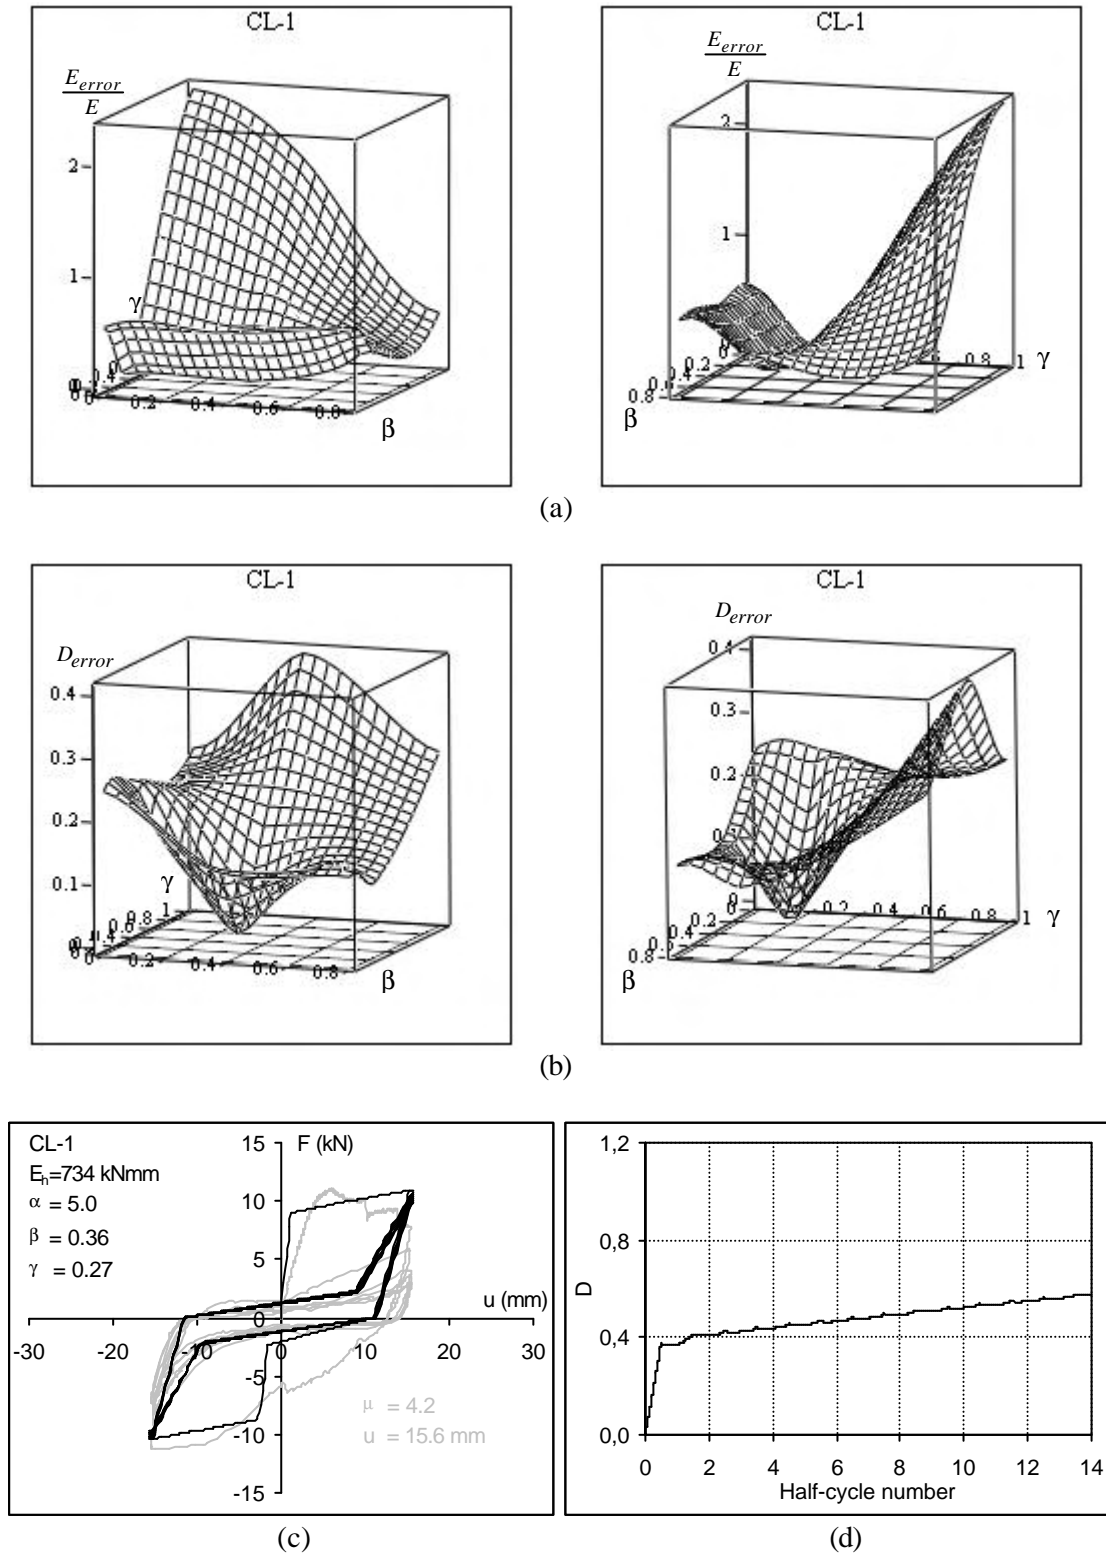
Figure 3.27 Erberik and Sucuođlu beam test specimen CL-1: **a)** Surfaces of variation in the dissipated hysteretic energy error ratio for $\alpha=5.0$ and β and γ parameters, **b)** Surfaces of variation in the damage index error for $\alpha=5.0$ and β and γ parameters, **c)** Comparison of the experimental (gray curve) and analytical (black curve) force-deformation relationships, **d)** Analytical progressive damage curve

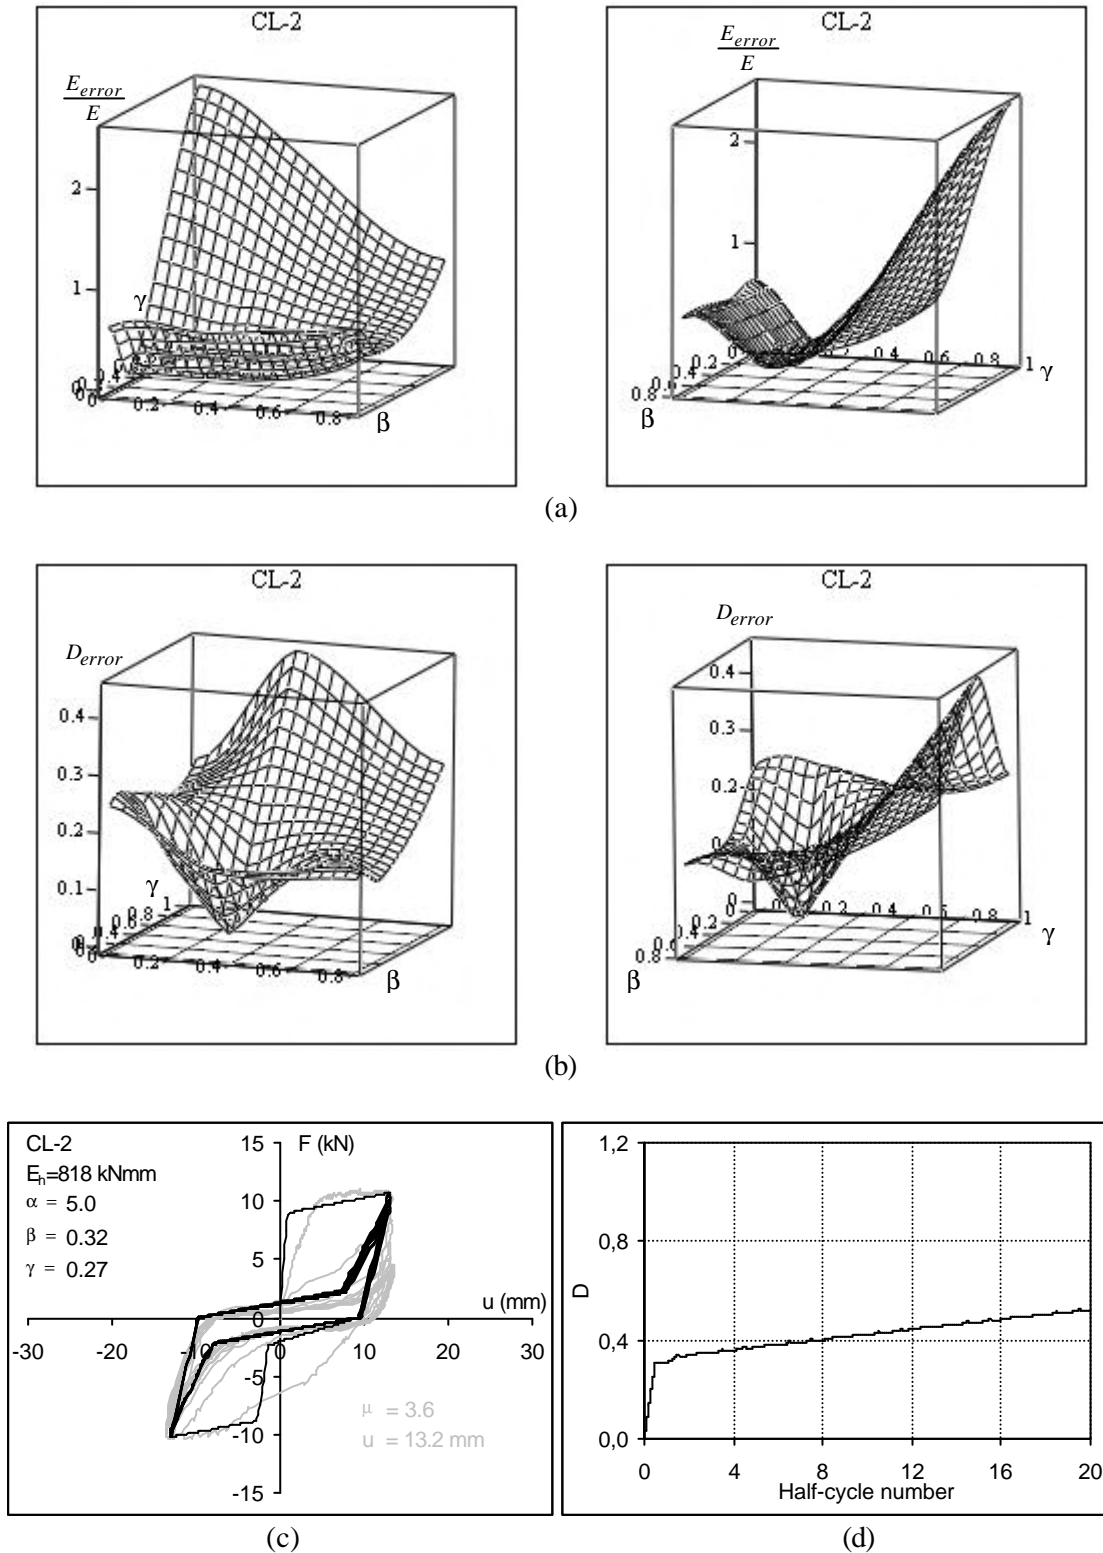
Figure 3.28 Erberik and Sucuođlu beam test specimen CL-2: **a)** Surfaces of variation in the dissipated hysteretic energy error ratio for $\alpha=5.0$ and β and γ parameters, **b)** Surfaces of variation in the damage index error for $\alpha=5.0$ and β and γ parameters, **c)** Comparison of the experimental (gray curve) and analytical (black curve) force-deformation relationships, **d)** Analytical progressive damage curve

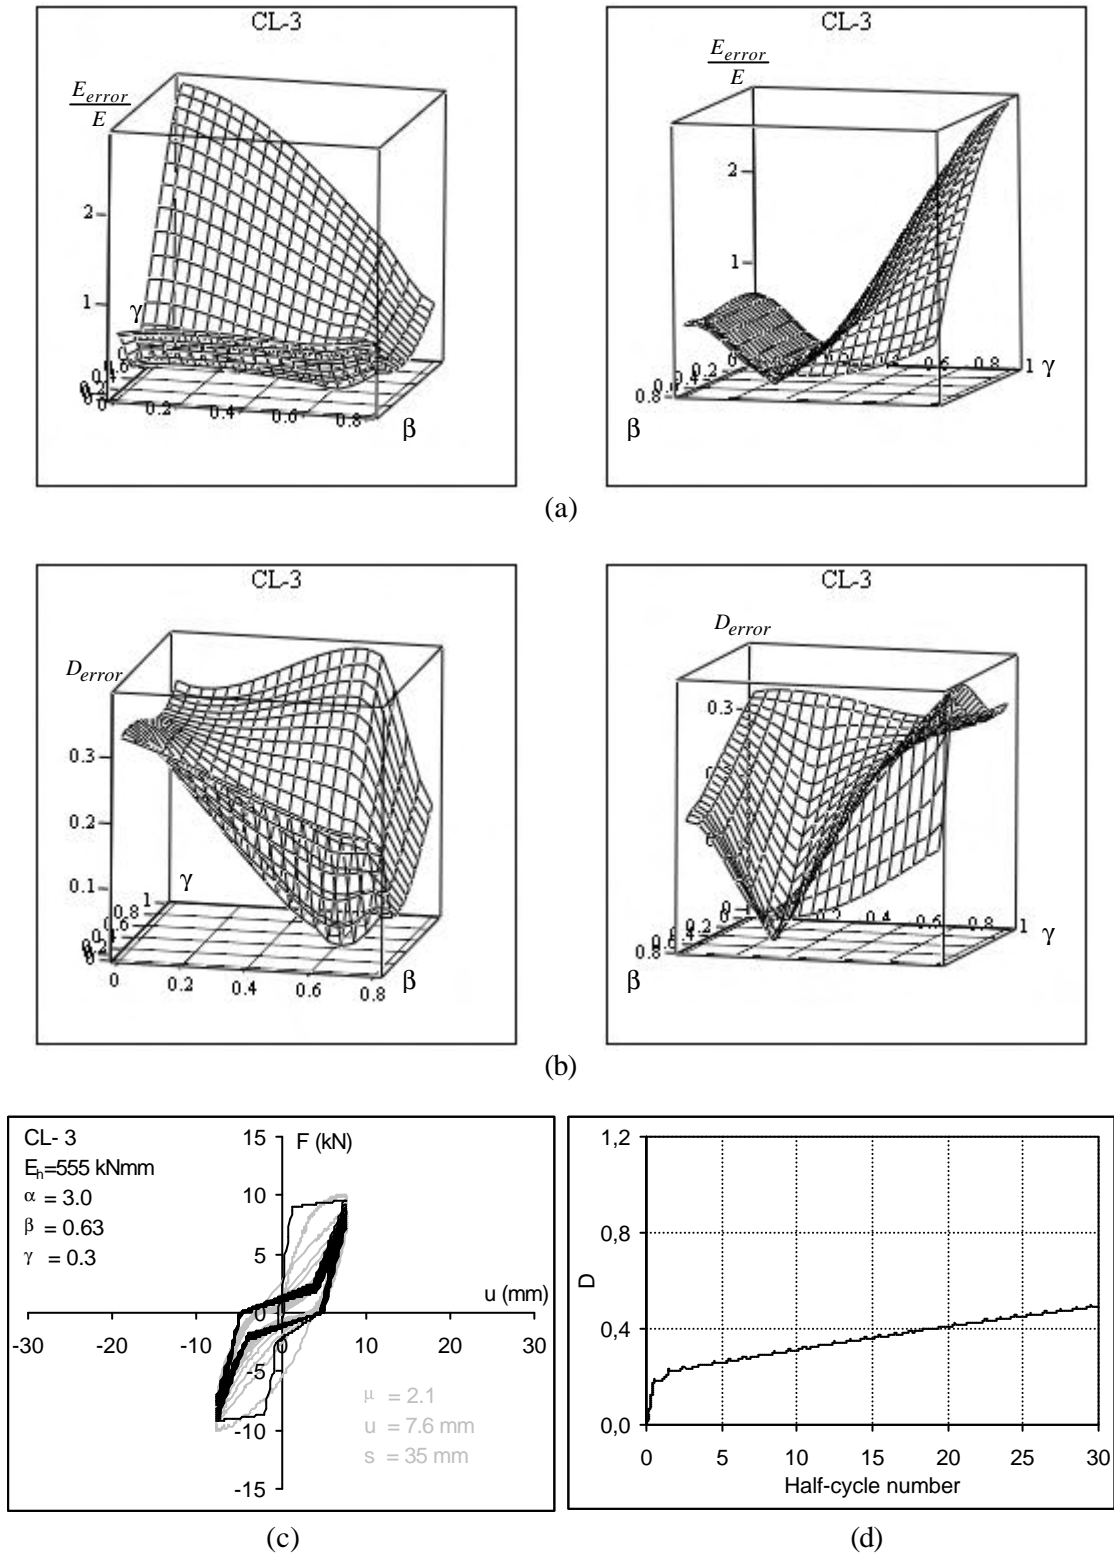
Figure 3.29 Erberik and Sucuođlu beam test specimen CL-3: **a)** Surfaces of variation in the dissipated hysteretic energy error ratio for $\alpha=3.0$ and β and γ parameters, **b)** Surfaces of variation in the damage index error for $\alpha=3.0$ and β and γ parameters, **c)** Comparison of the experimental (gray curve) and analytical (black curve) force-deformation relationships, **d)** Analytical progressive damage curve

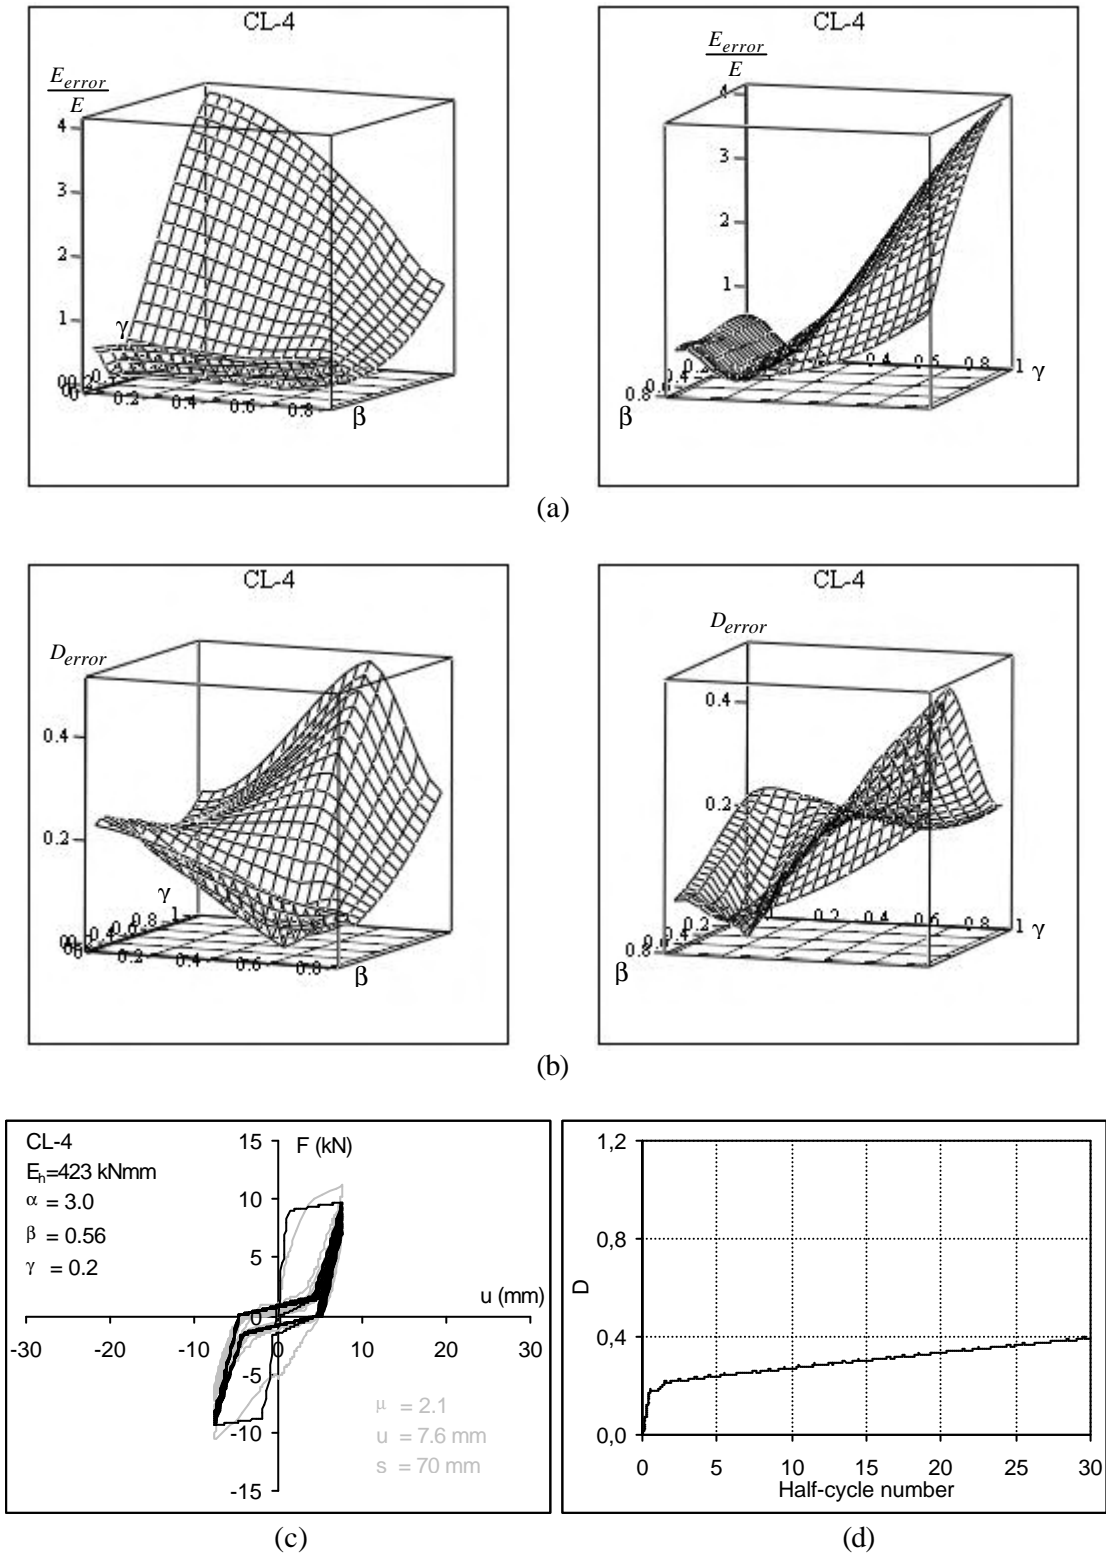
Figure 3.30 Erberik and Sucuođlu beam test specimen CL-4: **a)** Surfaces of variation in the dissipated hysteretic energy error ratio for $\alpha=3.0$ and β and γ parameters, **b)** Surfaces of variation in the damage index error for $\alpha=3.0$ and β and γ parameters, **c)** Comparison of the experimental (gray curve) and analytical (black curve) force-deformation relationships, **d)** Analytical progressive damage curve

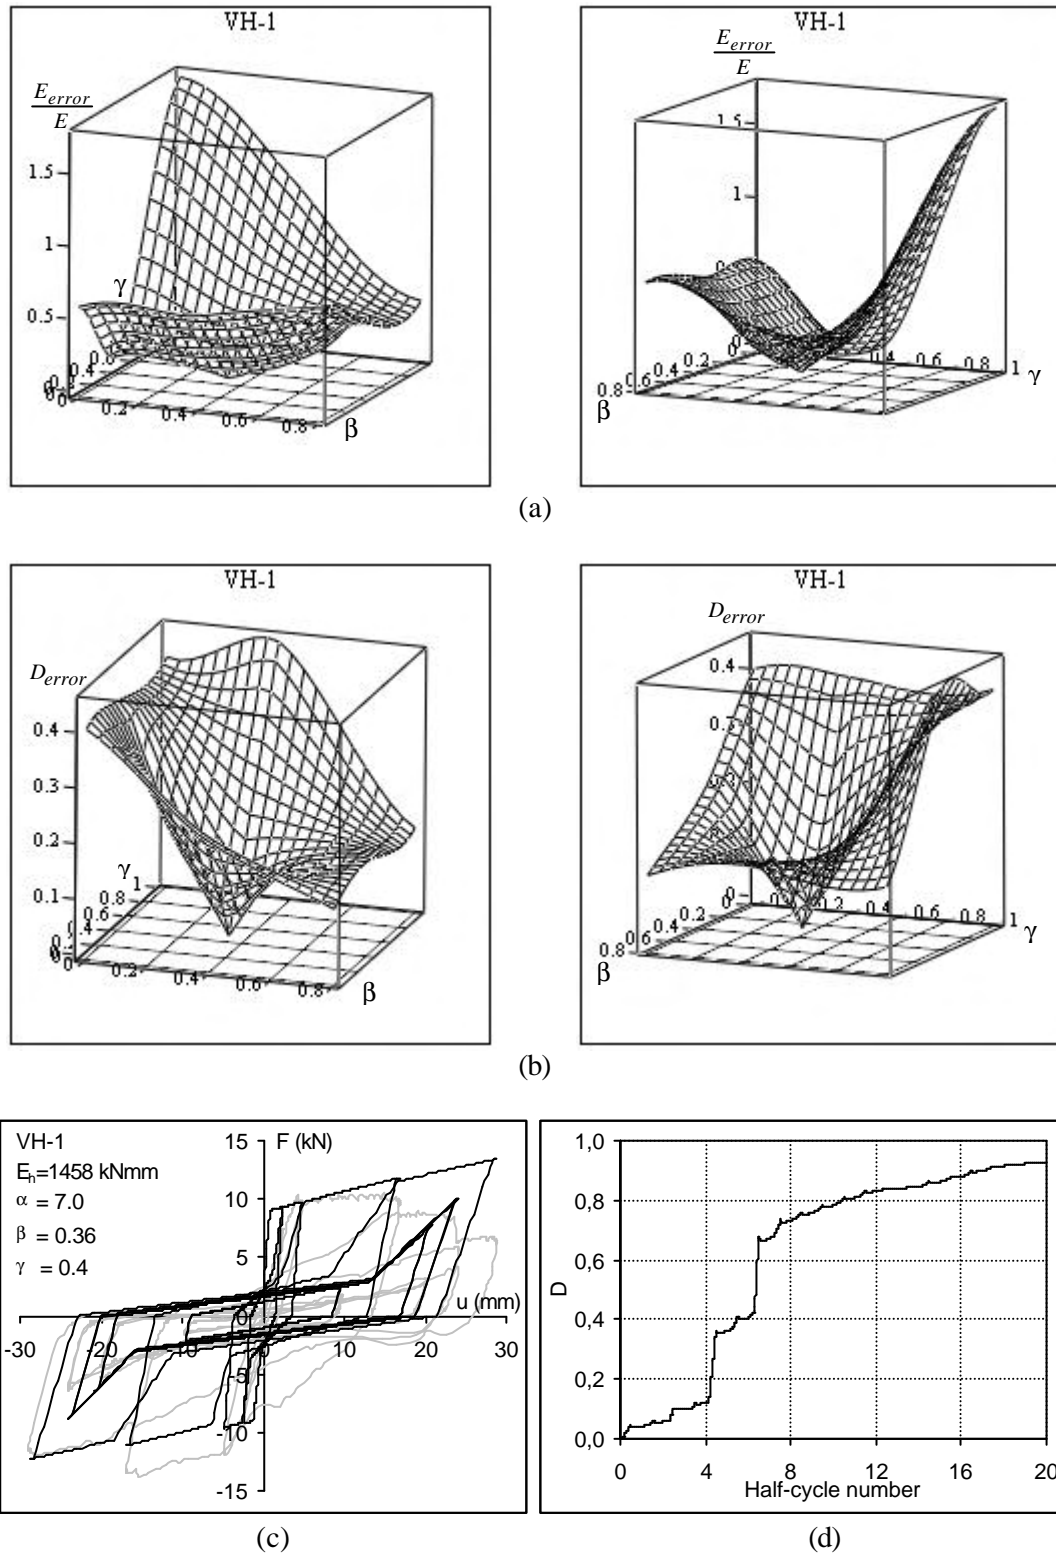
Figure 3.32 Erberik and Sucuođlu beam test specimen VH-1: **a)** Surfaces of variation in the dissipated hysteretic energy error ratio for $\alpha=7.0$ and β and γ parameters, **b)** Surfaces of variation in the damage index error for $\alpha=7.0$ and β and γ parameters, **c)** Comparison of the experimental (gray curve) and analytical (black curve) force-deformation relationships, **d)** Analytical progressive damage curve

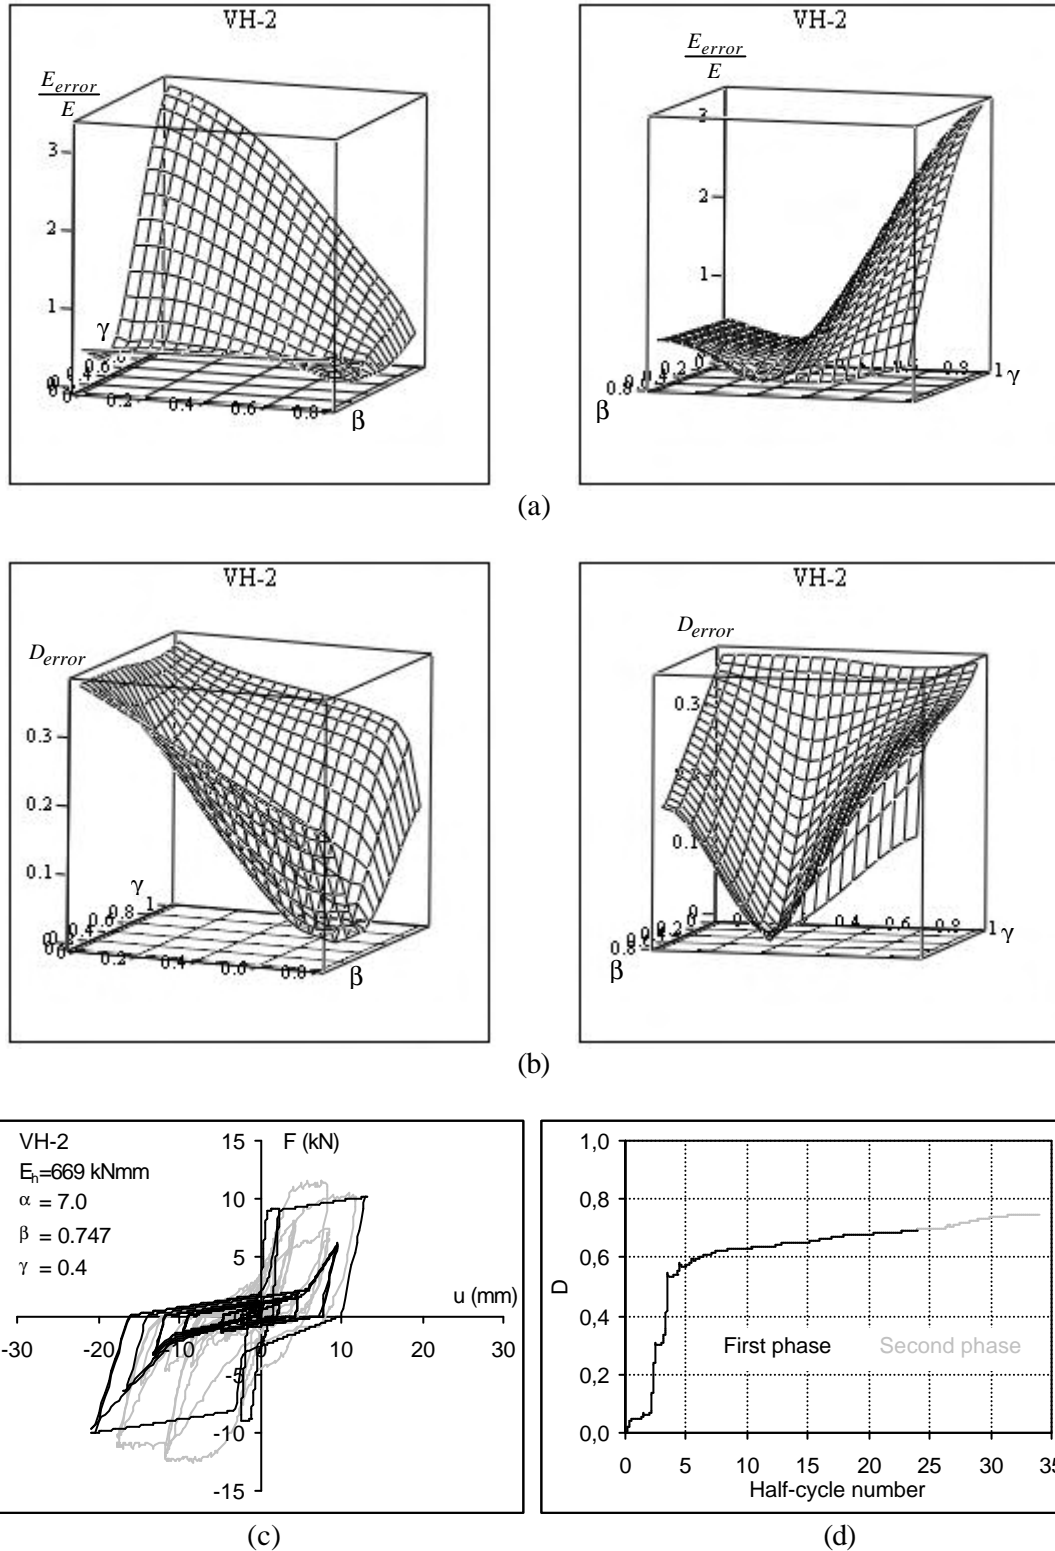
Figure 3.33 Erberik and Sucuođlu beam test specimen VH-2: **a)** Surfaces of variation in the dissipated hysteretic energy error ratio for $\alpha=7.0$ and β and γ parameters, **b)** Surfaces of variation in the damage index error for $\alpha=7.0$ and β and γ parameters, **c)** Comparison of the experimental (gray curve) and analytical (black curve) force-deformation relationships, **d)** Analytical progressive damage curve

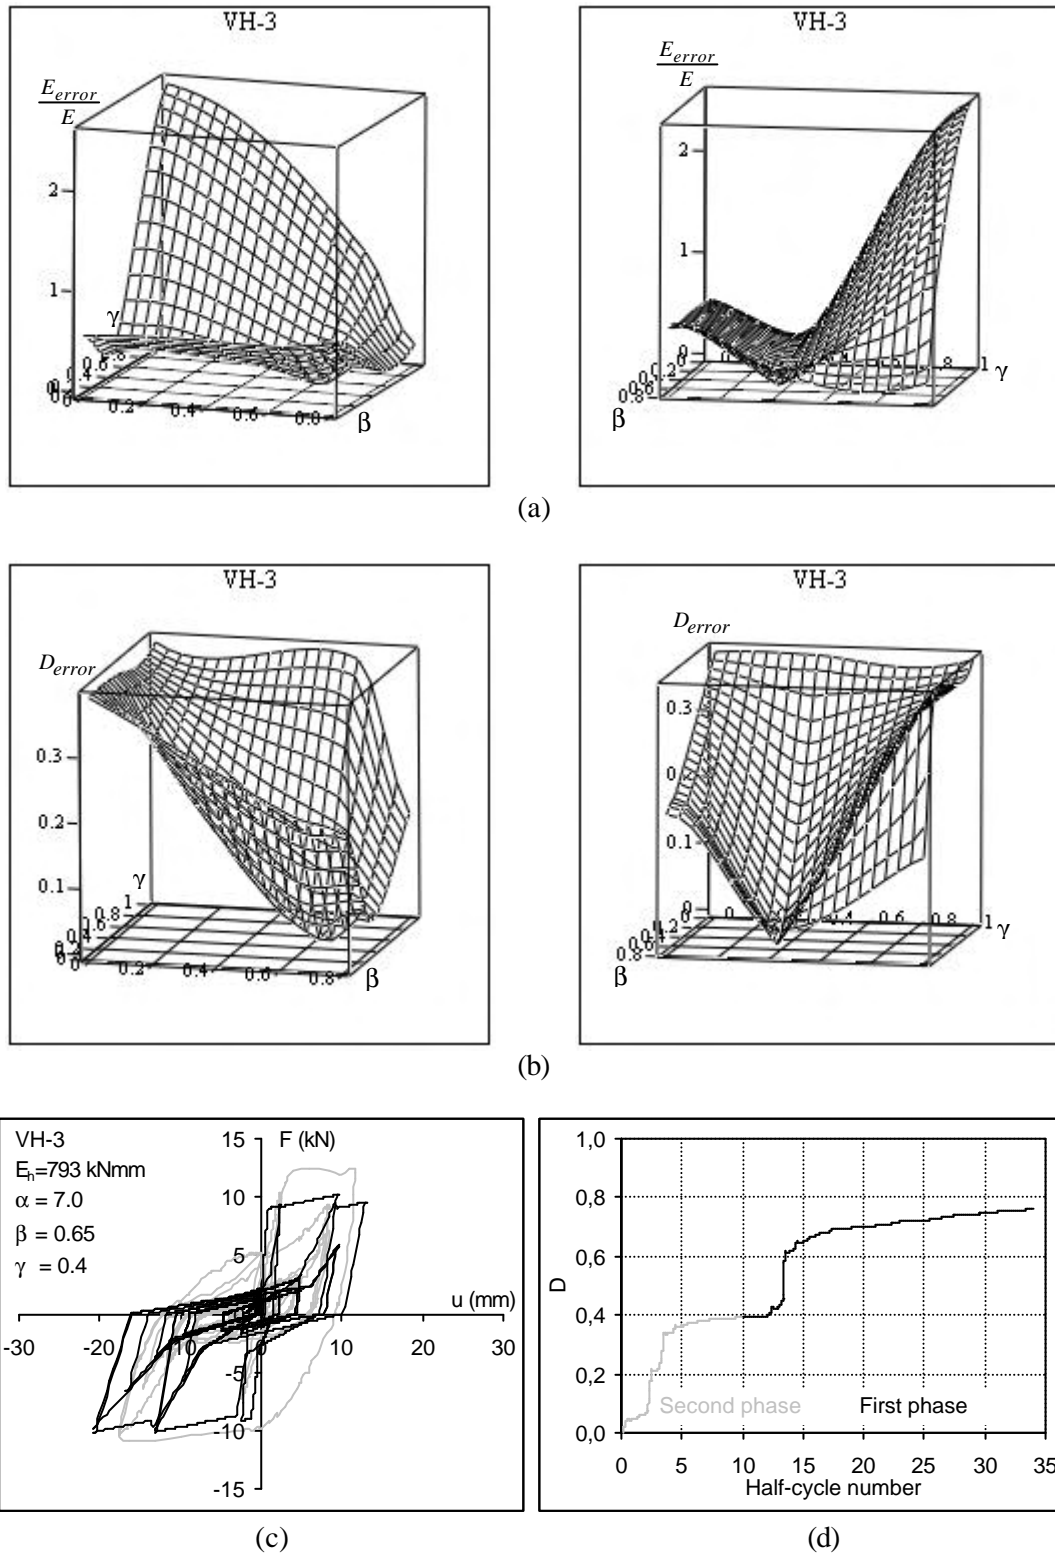
Figure 3.34 Erberik and Sucuođlu beam test specimen VH-3: **a)** Surfaces of variation in the dissipated hysteretic energy error ratio for $\alpha=7.0$ and β and γ parameters, **b)** Surfaces of variation in the damage index error for $\alpha=7.0$ and β and γ parameters, **c)** Comparison of the experimental (gray curve) and analytical (black curve) force-deformation relationships, **d)** Analytical progressive damage curve

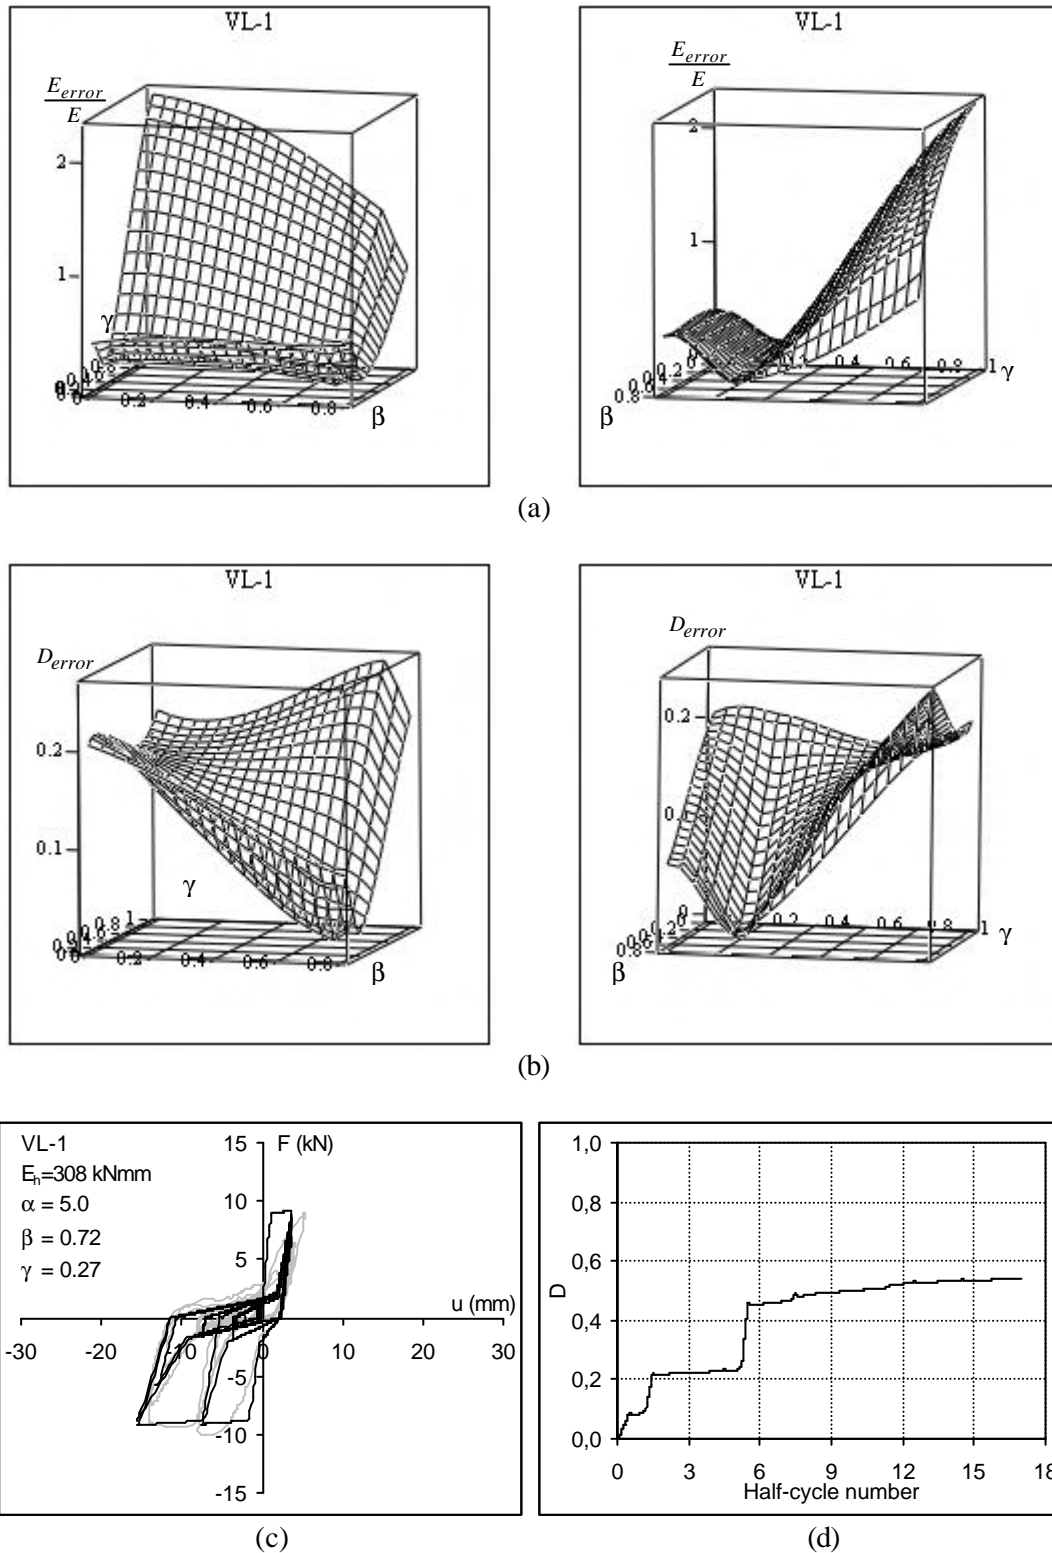
Figure 3.35 Erberik and Sucuođlu beam test specimen VL-1: **a)** Surfaces of variation in the dissipated hysteretic energy error ratio for $\alpha=5.0$ and β and γ parameters, **b)** Surfaces of variation in the damage index error for $\alpha=5.0$ and β and γ parameters, **c)** Comparison of the experimental (gray curve) and analytical (black curve) force-deformation relationships, **d)** Analytical progressive damage curve

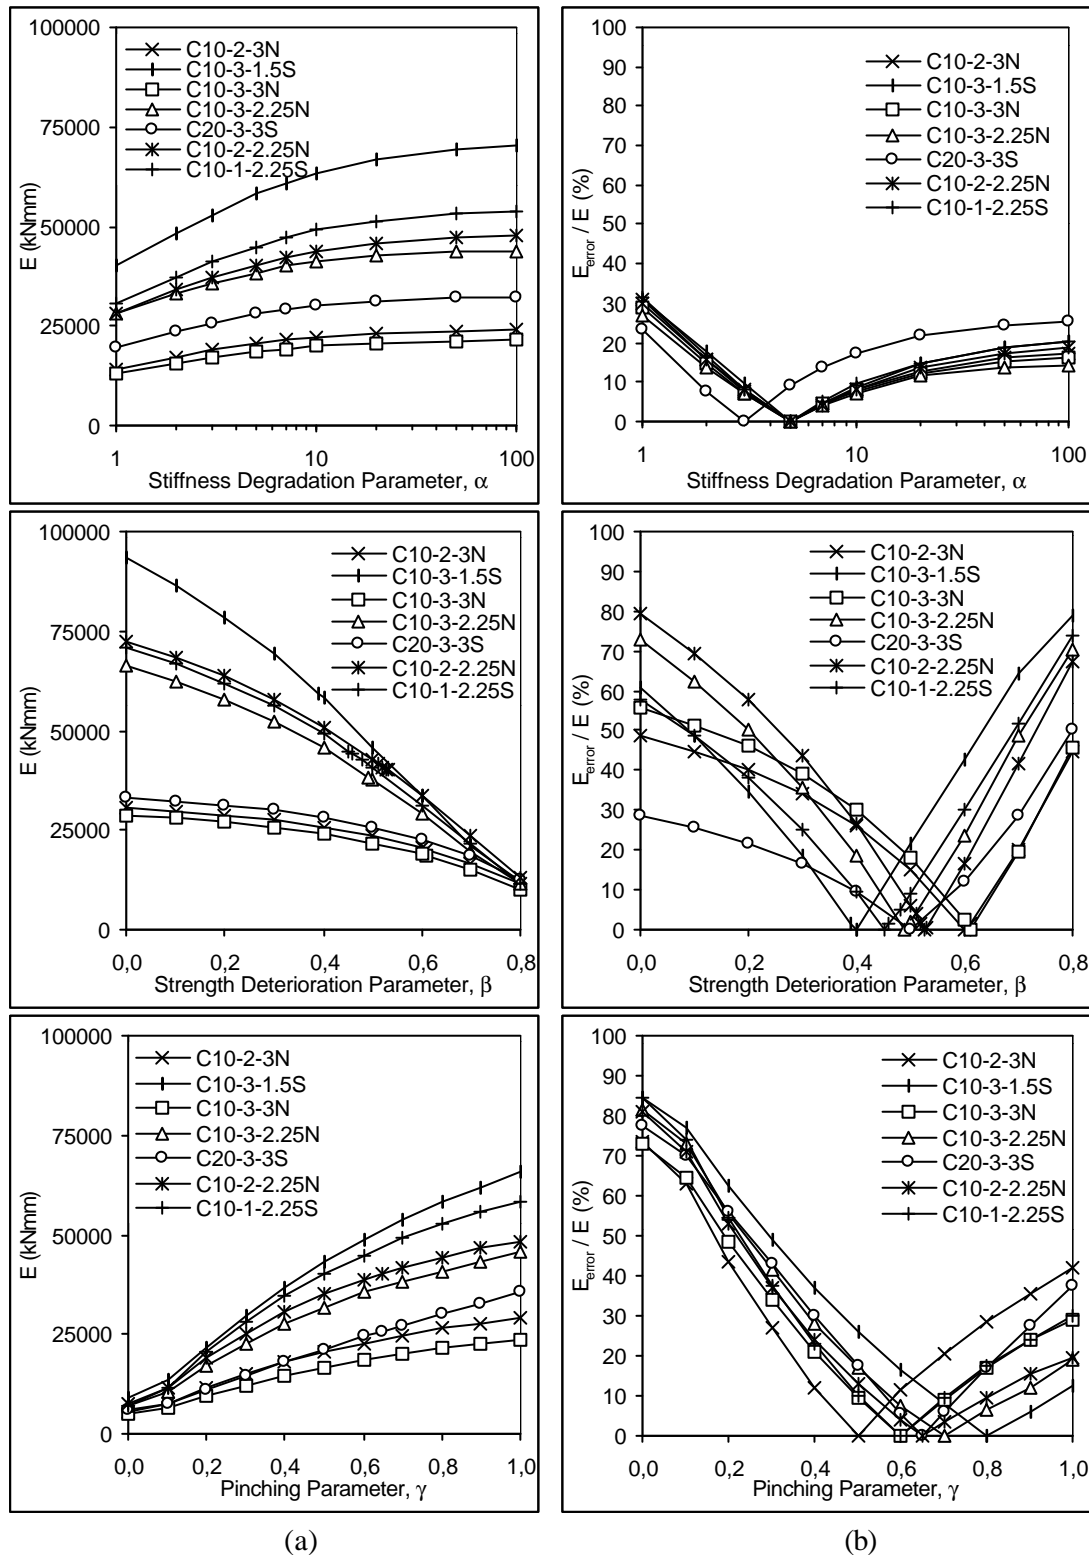
Figure 3.36 Effect of various characteristics (transverse reinforcement, axial load level and loading history) a) Dissipated hysteretic energy vs. deterioration parameters α , β and γ , b) Dissipated hysteretic energy error ratio vs. deterioration parameters α , β and γ

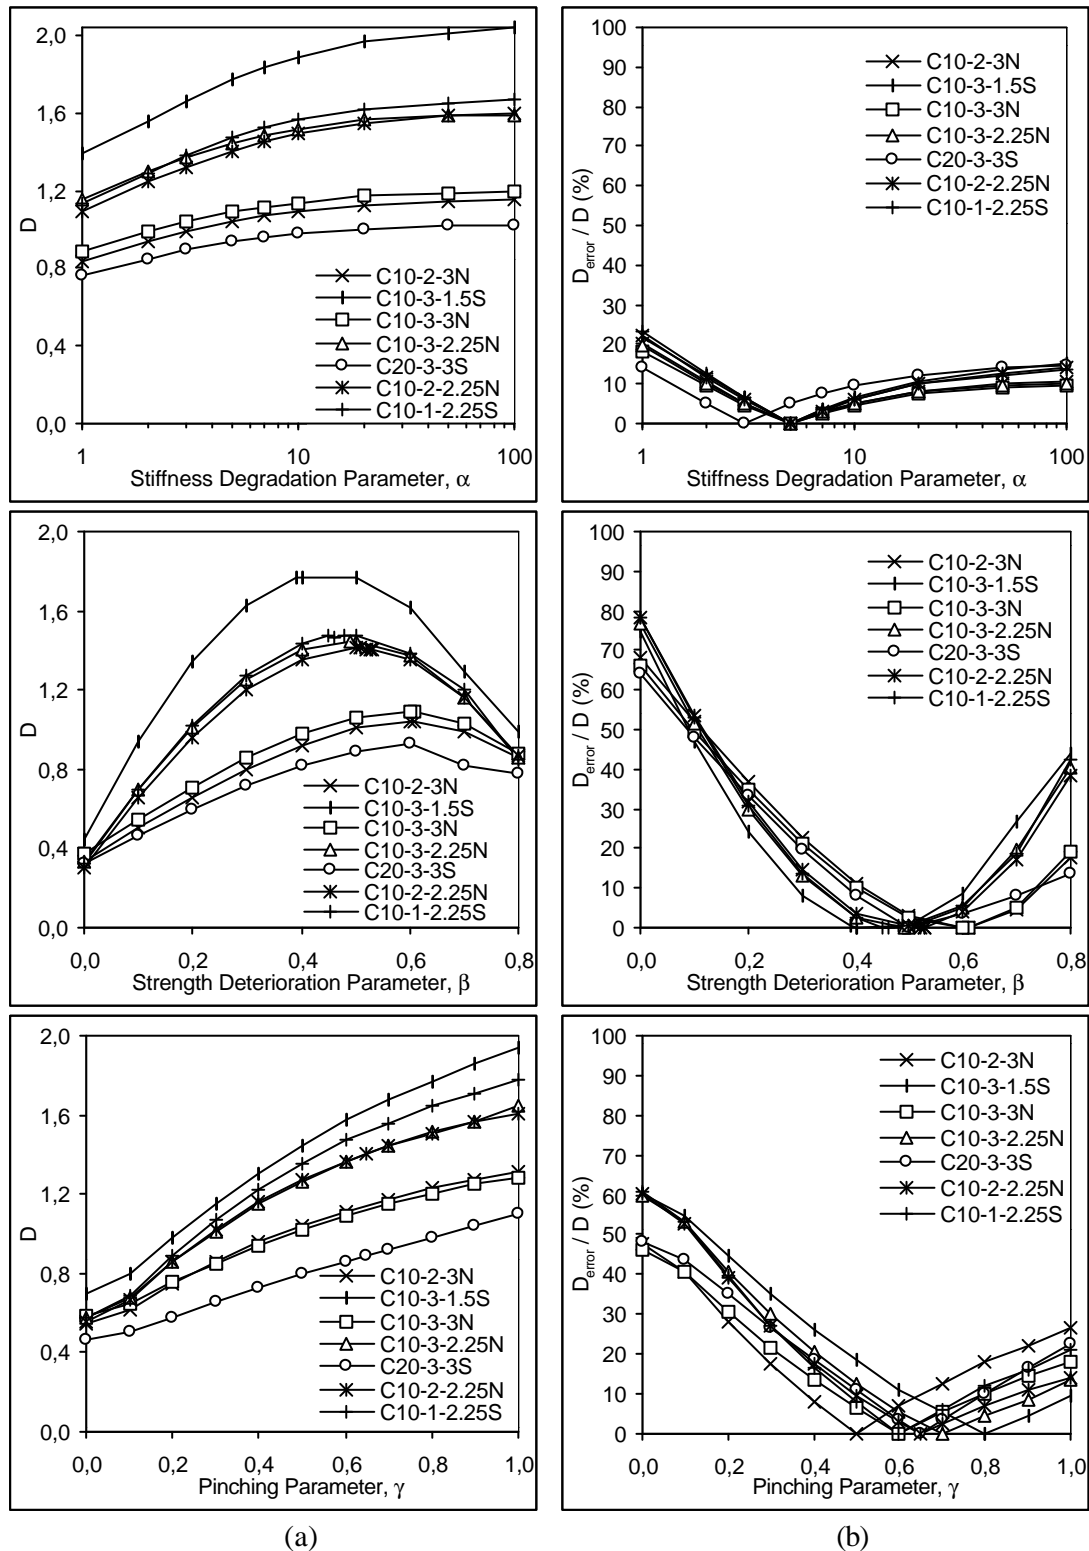
Figure 3.37 Effect of various characteristics (transverse reinforcement, axial load level and loading history) **a)** Damage index vs. deterioration parameters α , β and γ , **b)** Damage index error ratio vs. deterioration parameters α , β and γ

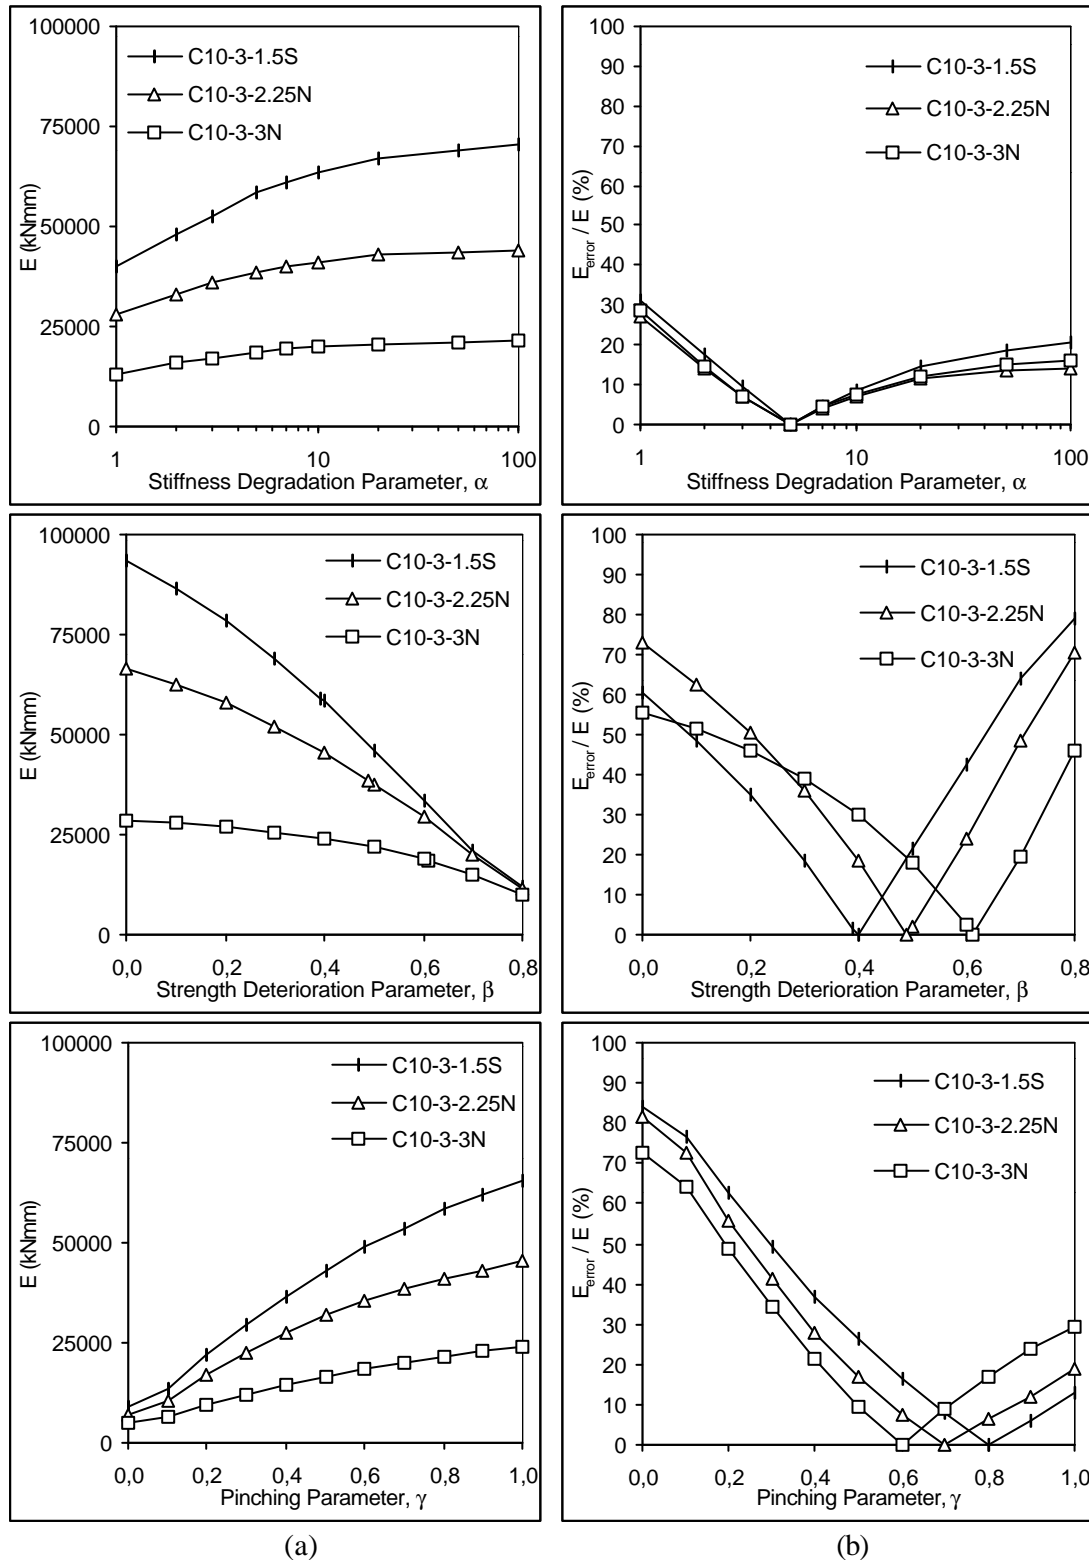
Figure 3.38 Effect of amount of transverse reinforcement-Set I **a)** Dissipated hysteretic energy vs. deterioration parameters α , β and γ , **b)** Dissipated hysteretic energy error ratio vs. deterioration parameters α , β and γ

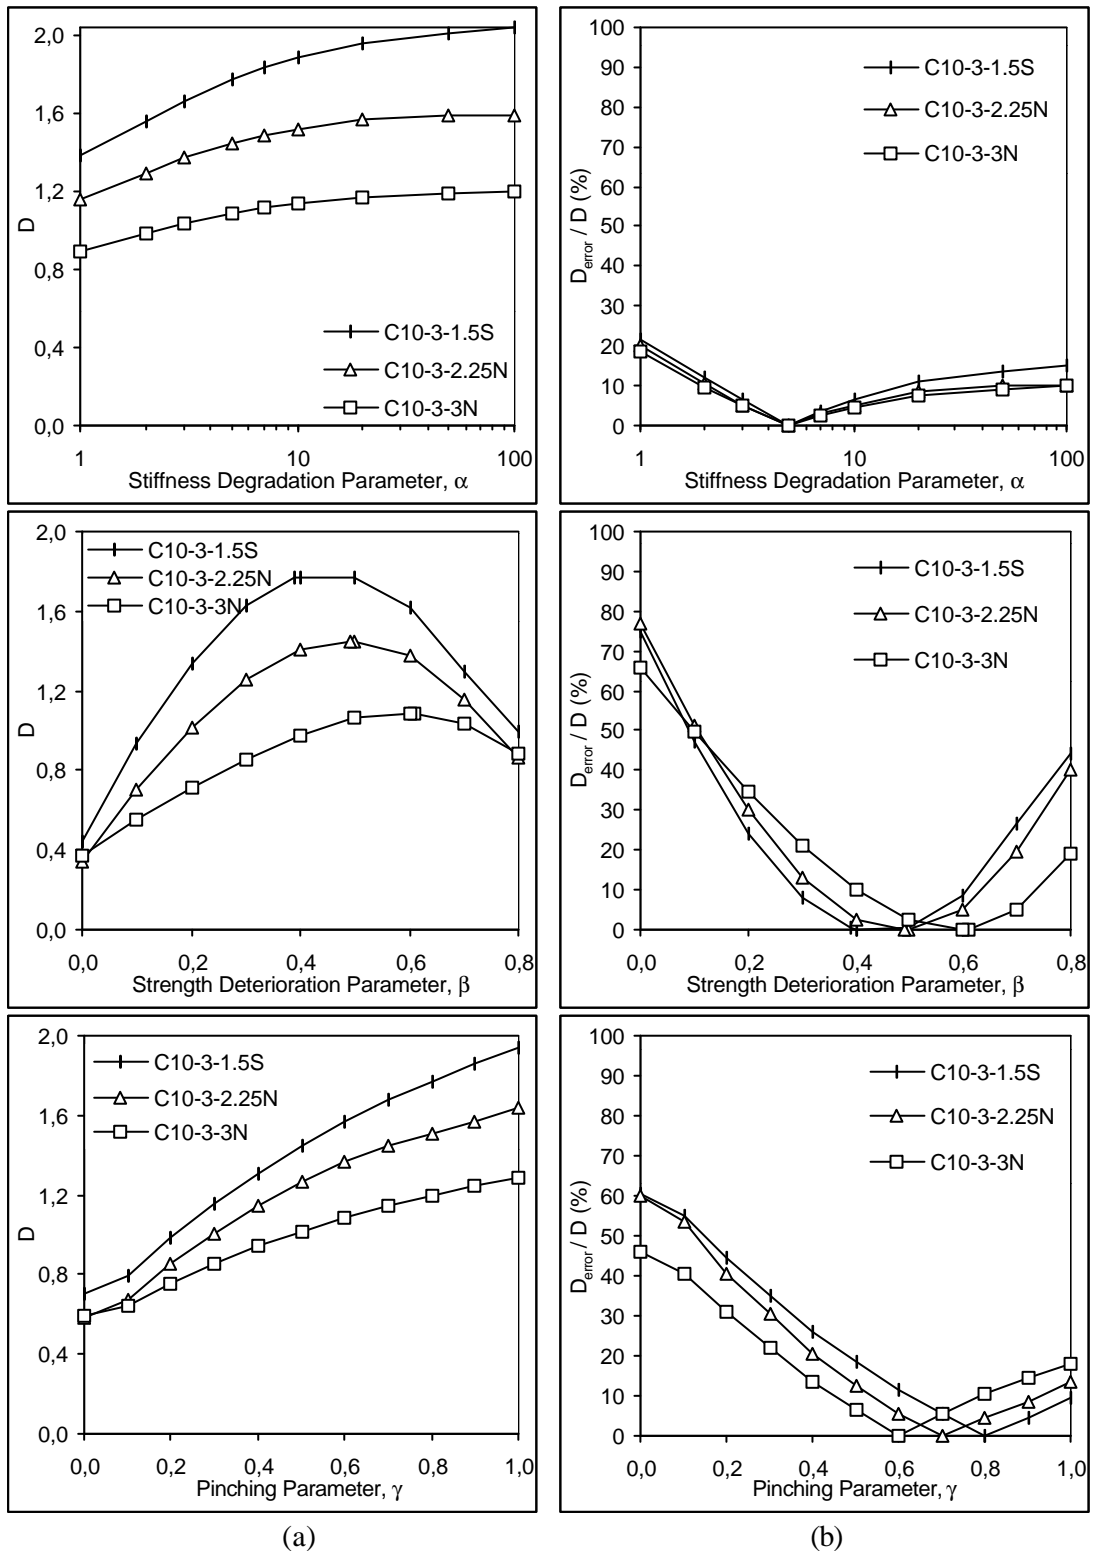
Figure 3.39 Effect of amount of transverse reinforcement-Set I **a)** Damage index vs. deterioration parameters α , β and γ , **b)** Damage index error ratio vs. deterioration parameters α , β and γ

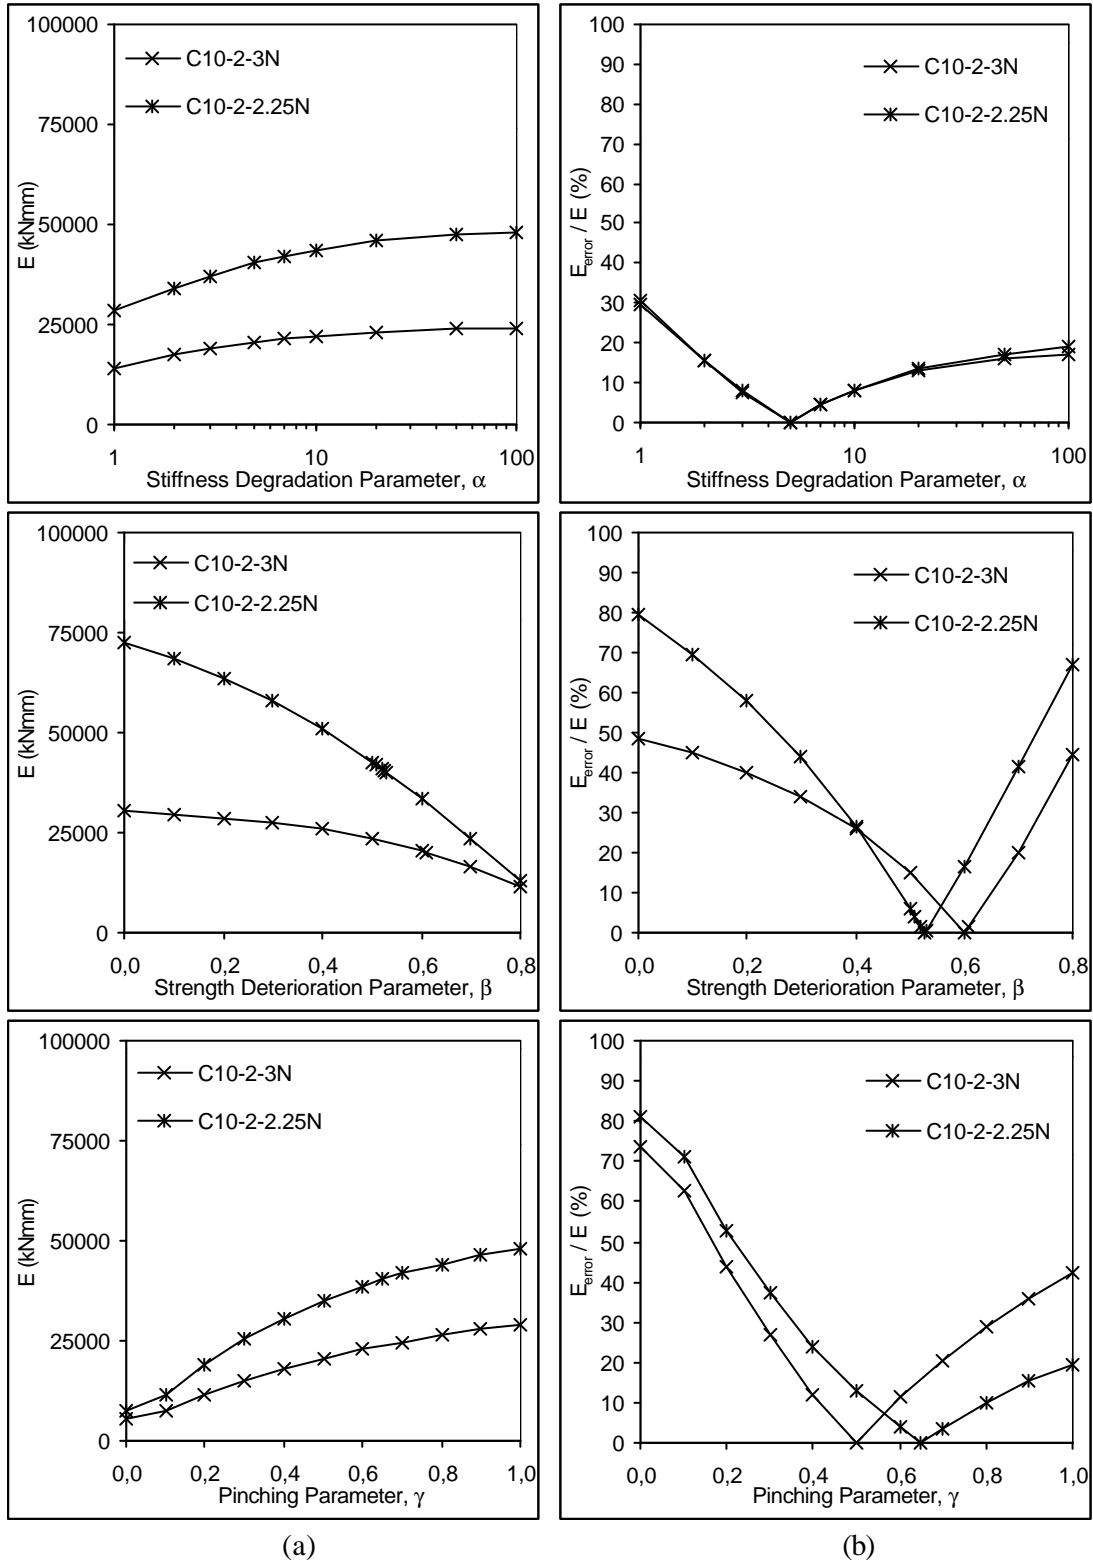
Figure 3.40 Effect of amount of transverse reinforcement-Set II **a)** Dissipated hysteretic energy vs. deterioration parameters α , β and γ , **b)** Dissipated hysteretic energy error ratio vs. deterioration parameters α , β and γ
