LOW CYCLE FATIGUE EFFECTS IN THE DAMAGE CAUSED BY
THE MARMARA EARTHQUAKE OF AUGUST 17, 1999

A THESIS SUBMITTED TO
THE GRADUATE SCHOOL OF NATURAL AND APPLIED SCIENCES
OF
MIDDLE EAST TECHNICAL UNIVERSITY

SEPTEMBER 2004

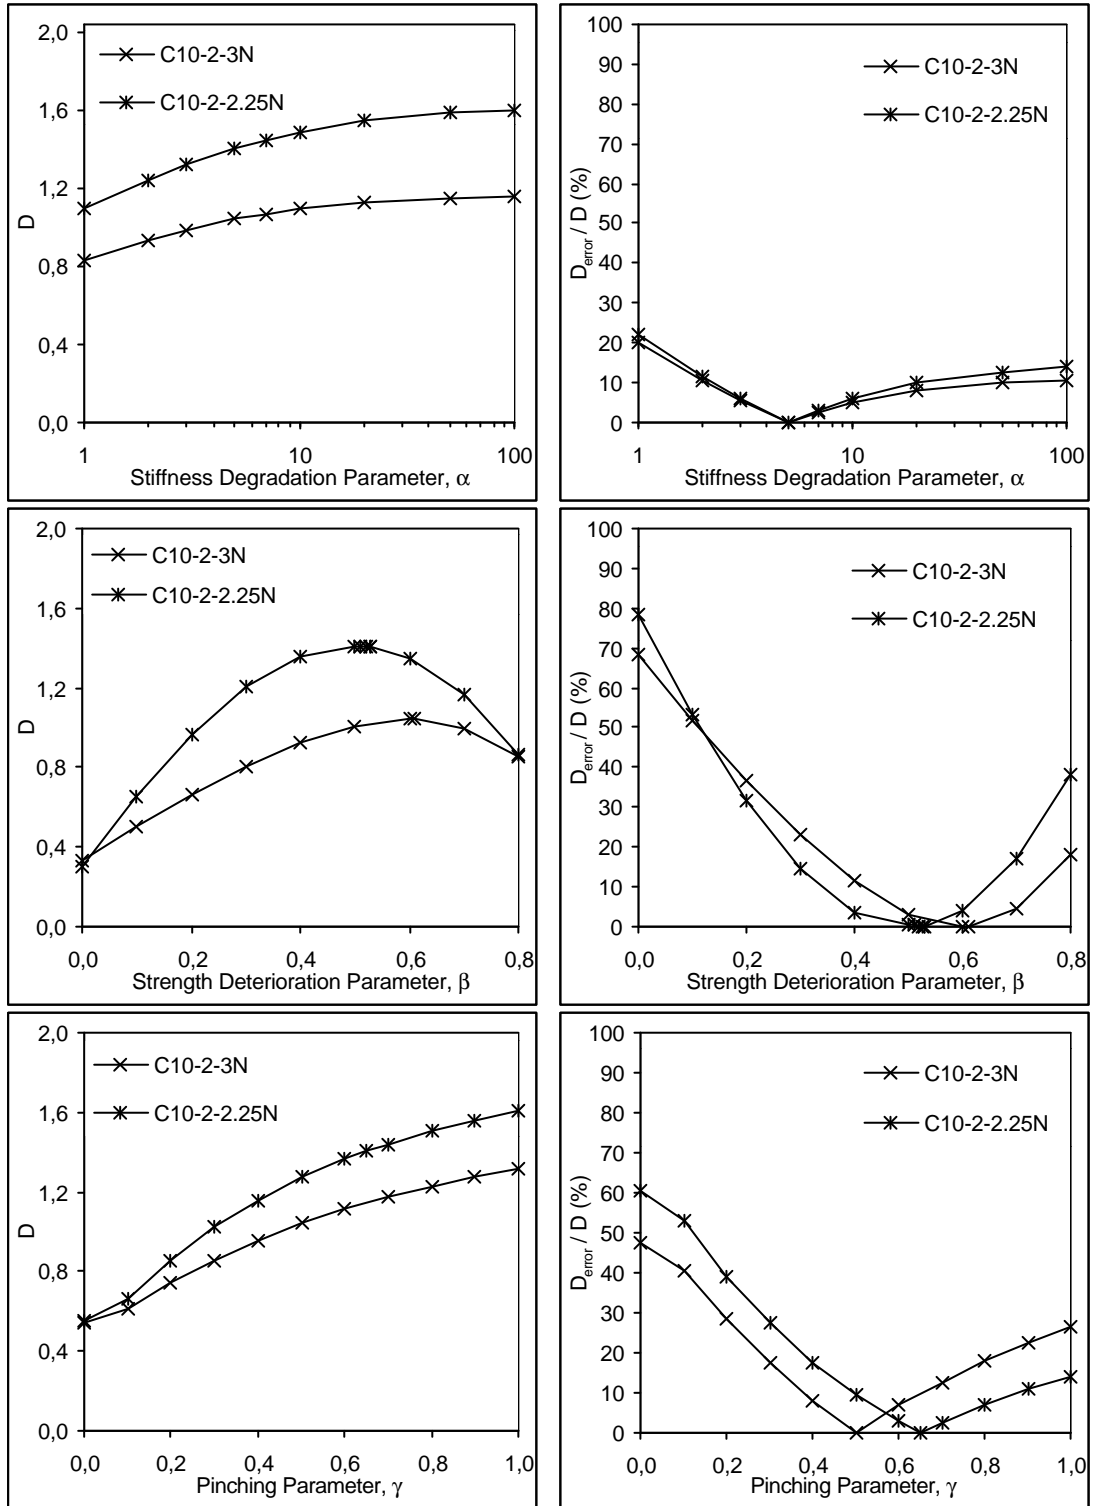
(a) (b)
Figure 3.41 Effect of amount of transverse reinforcement-Set II **a)** Damage index vs. deterioration parameters α , β and γ , **b)** Damage index error ratio vs. deterioration parameters α , β and γ

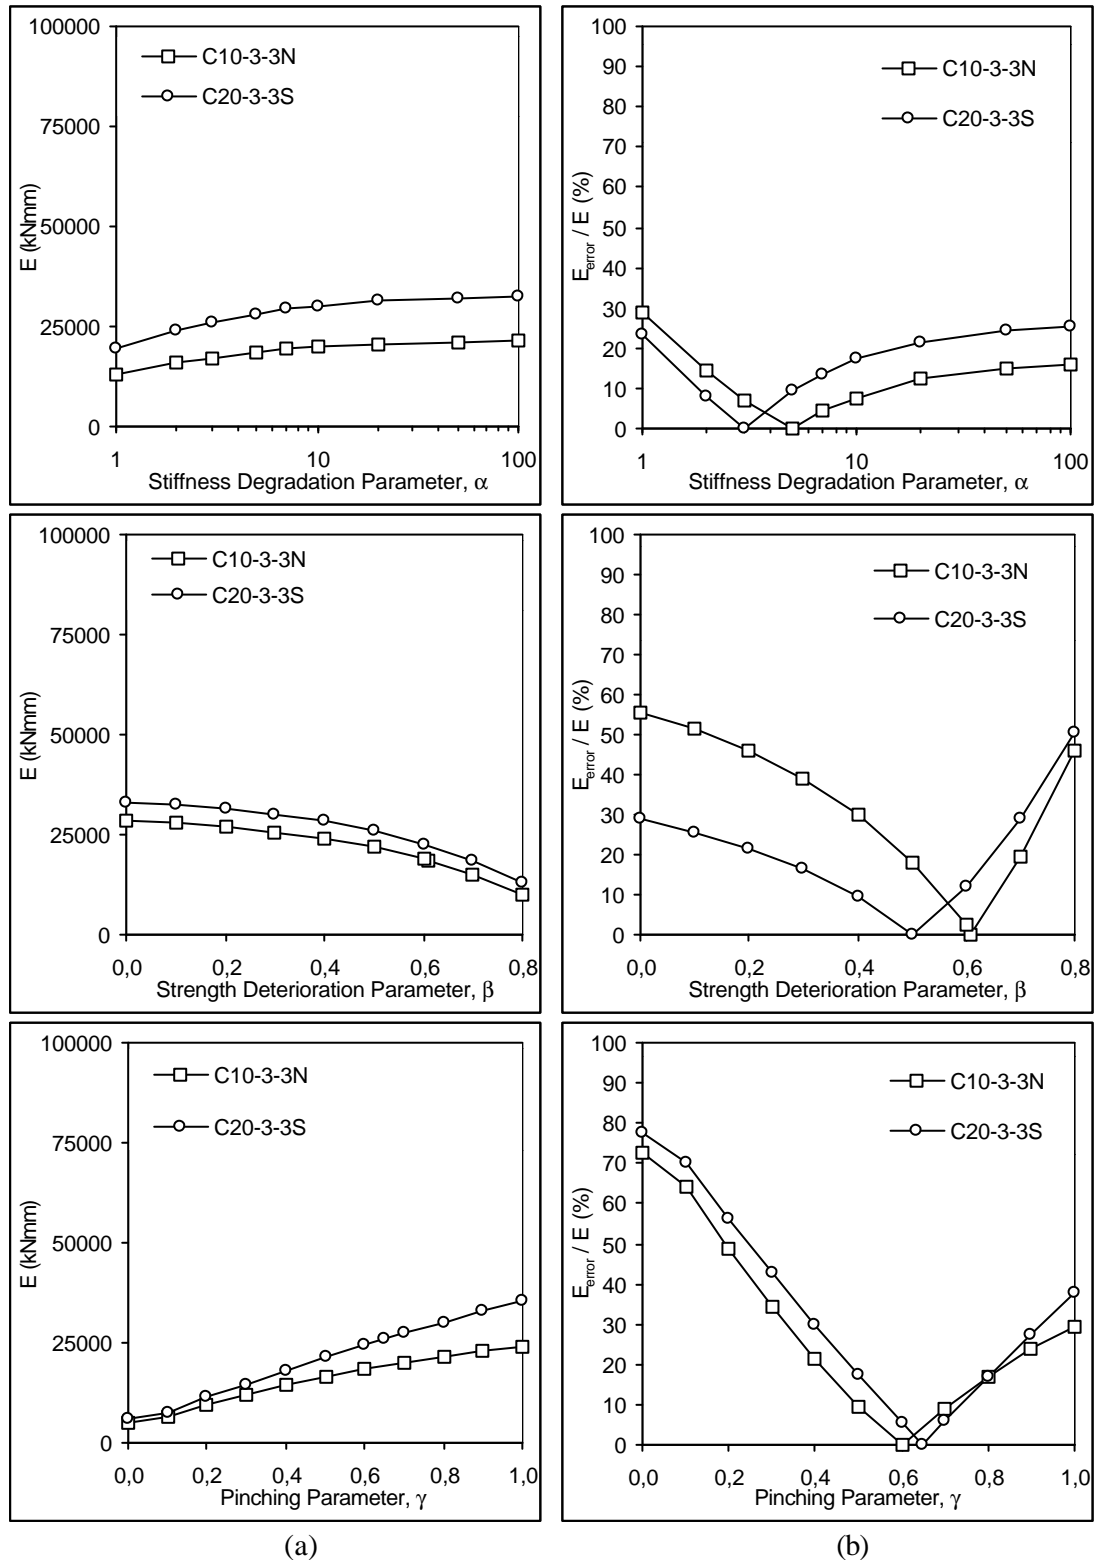
Figure 3.42 Effect of axial load level **a)** Dissipated hysteretic energy vs. deterioration parameters α , β and γ , **b)** Dissipated hysteretic energy error ratio vs. deterioration parameters α , β and γ

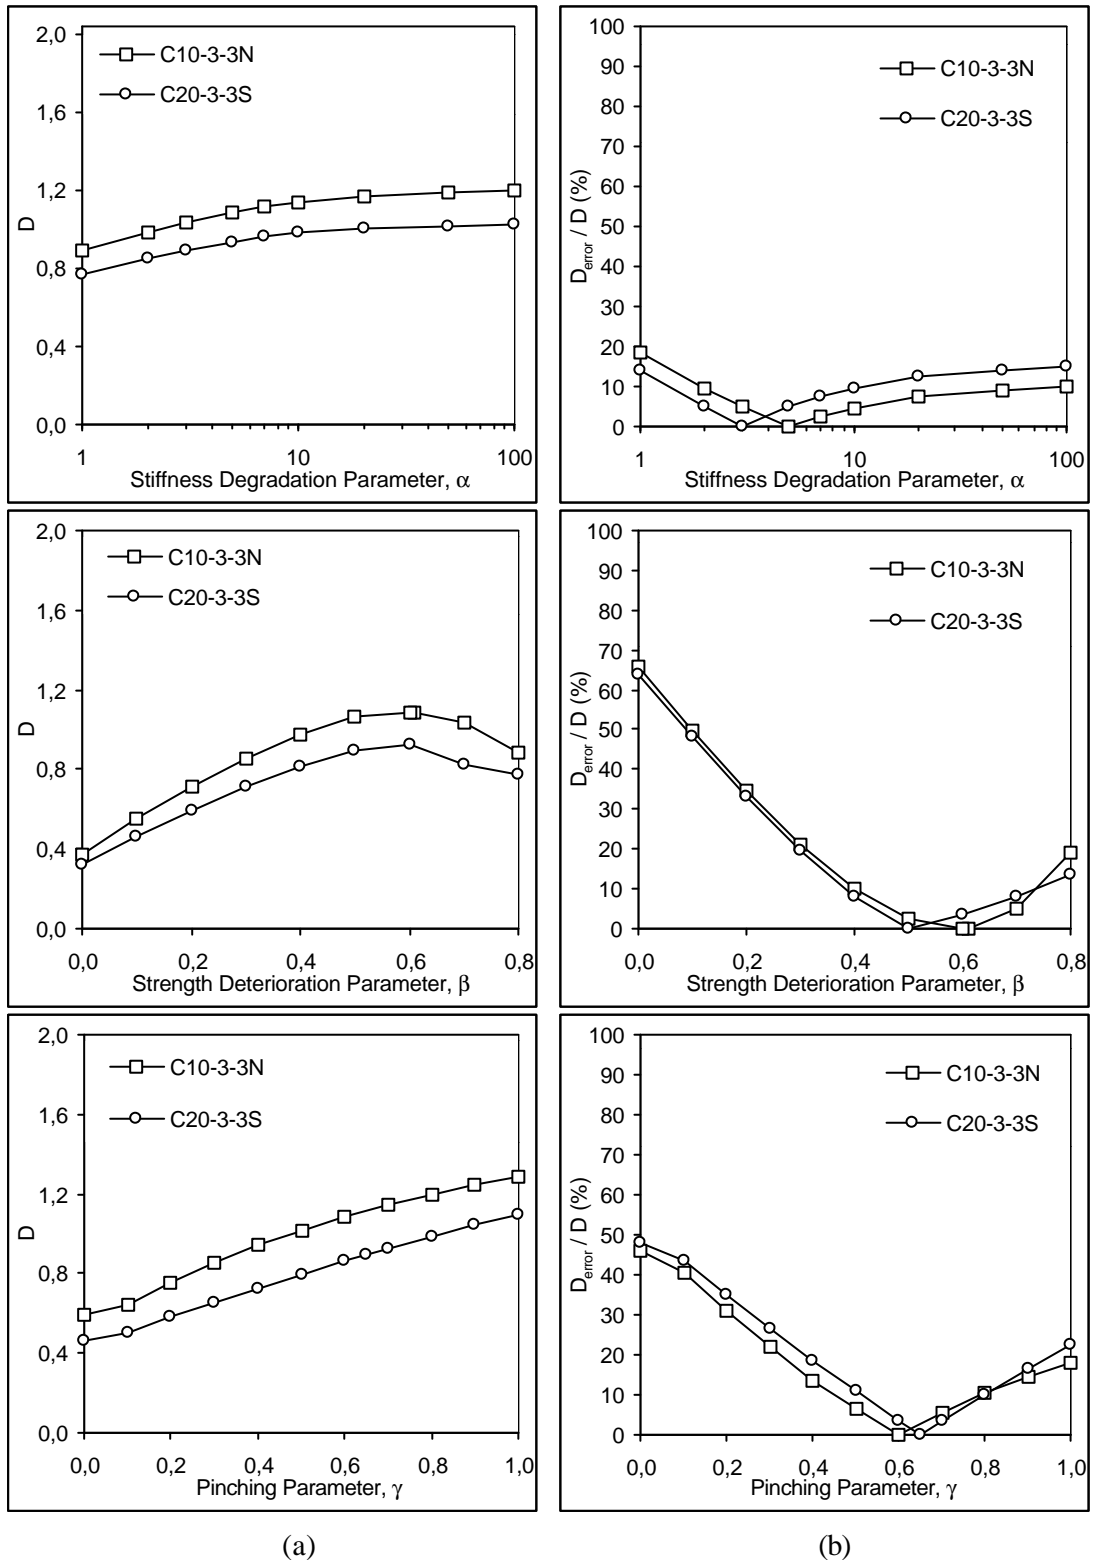
Figure 3.43 Effect of axial load level **a)** Damage index vs. deterioration parameters α , β and γ , **b)** Damage index error ratio vs. deterioration parameters α , β and γ

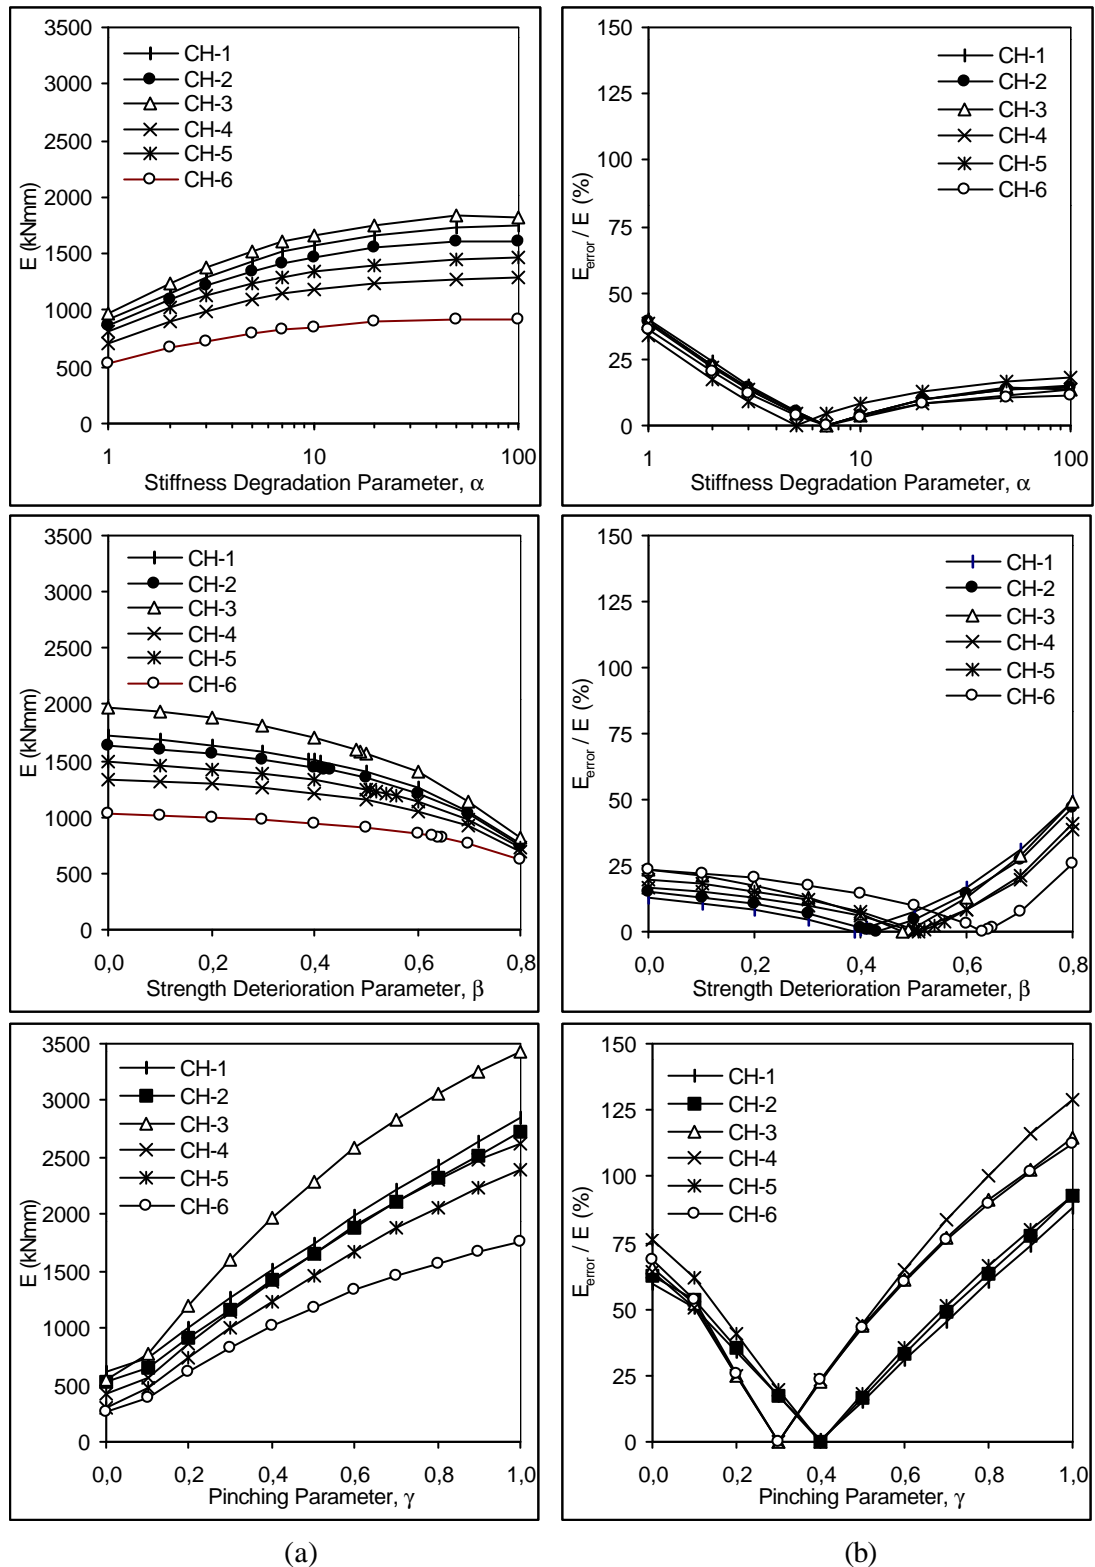
Figure 3.45 Effect of concrete strength and loading history-Set I **a)** Dissipated hysteretic energy vs. deterioration parameters α , β and γ , **b)** Dissipated hysteretic energy error ratio vs. deterioration parameters α , β and γ

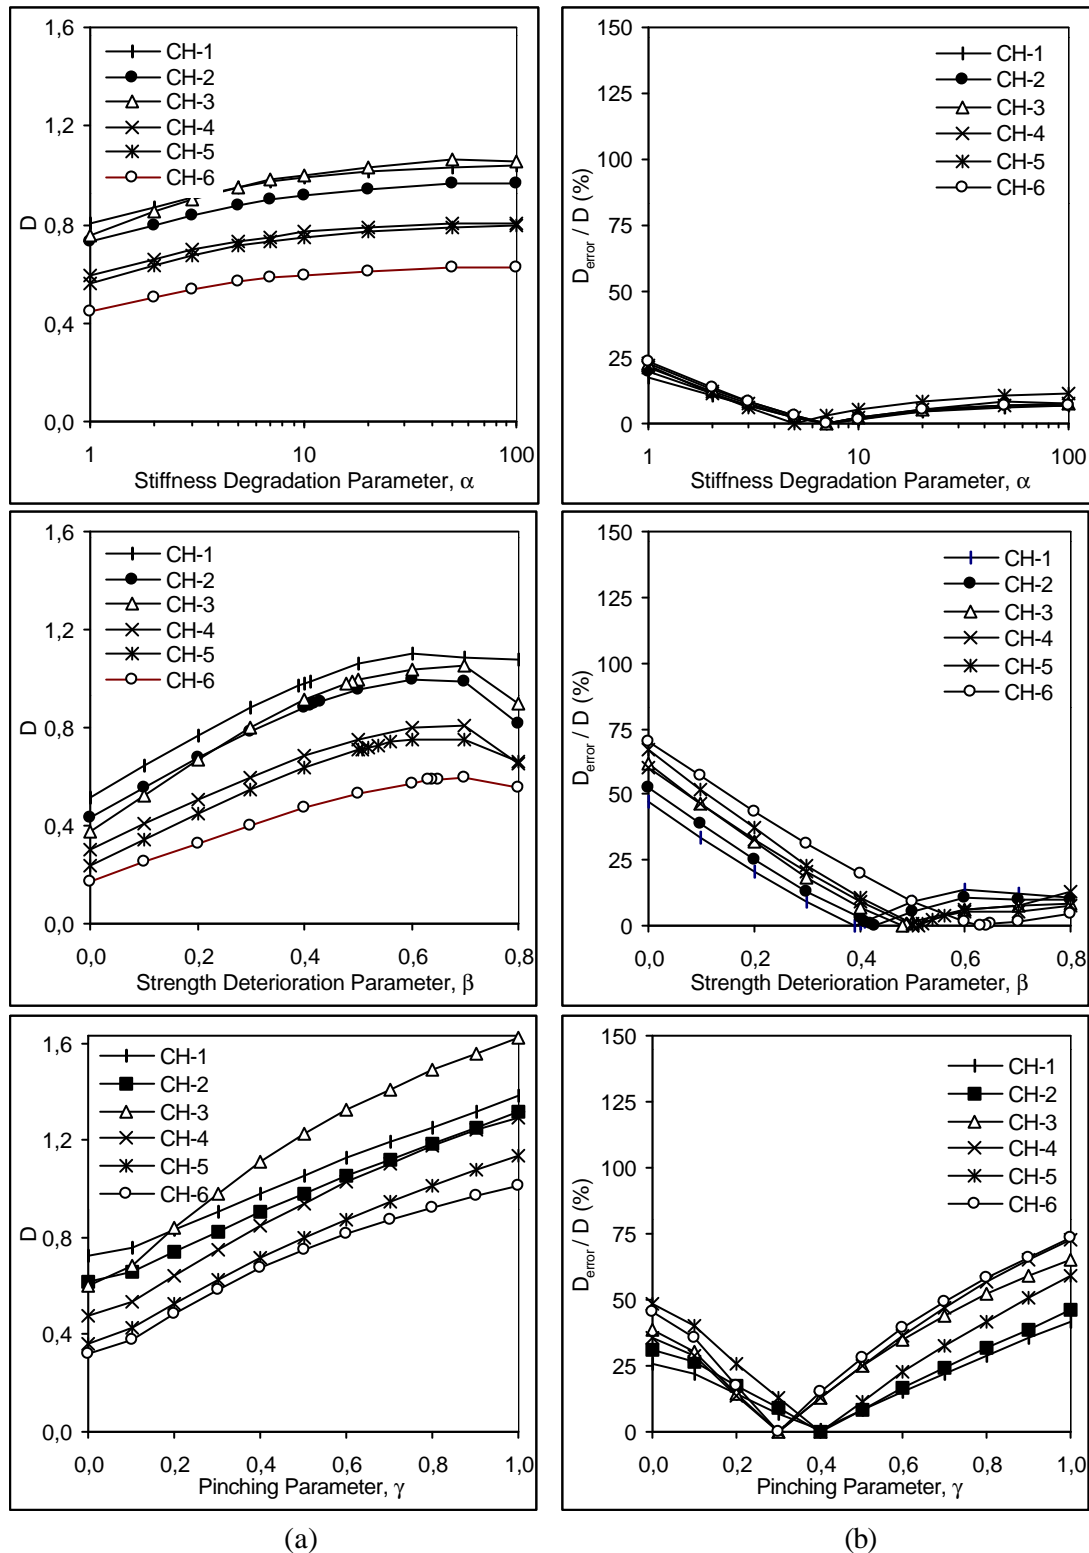
Figure 3.46 Effect of concrete strength and loading history-Set I **a)** Damage index vs. deterioration parameters α , β and γ , **b)** Damage index error ratio vs. deterioration parameters α , β and γ

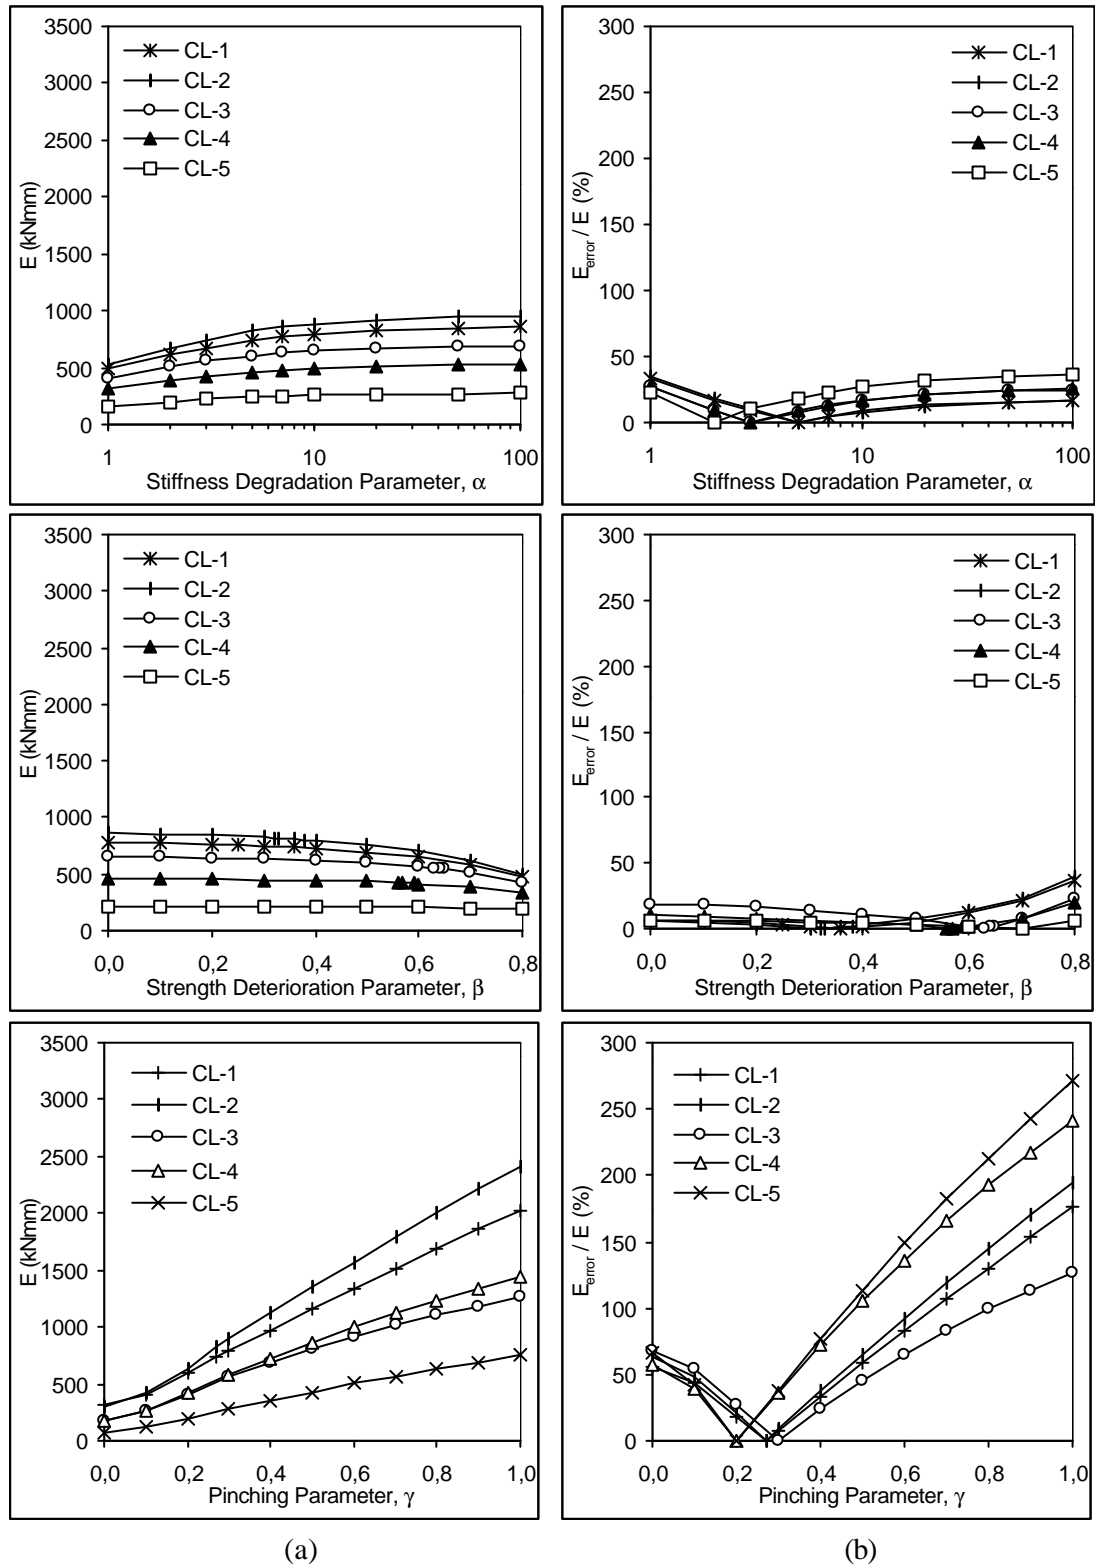
Figure 3.47 Effect of concrete strength and loading history-Set II **a)** Dissipated hysteretic energy vs. deterioration parameters α , β and γ , **b)** Dissipated hysteretic energy error ratio vs. deterioration parameters α , β and γ

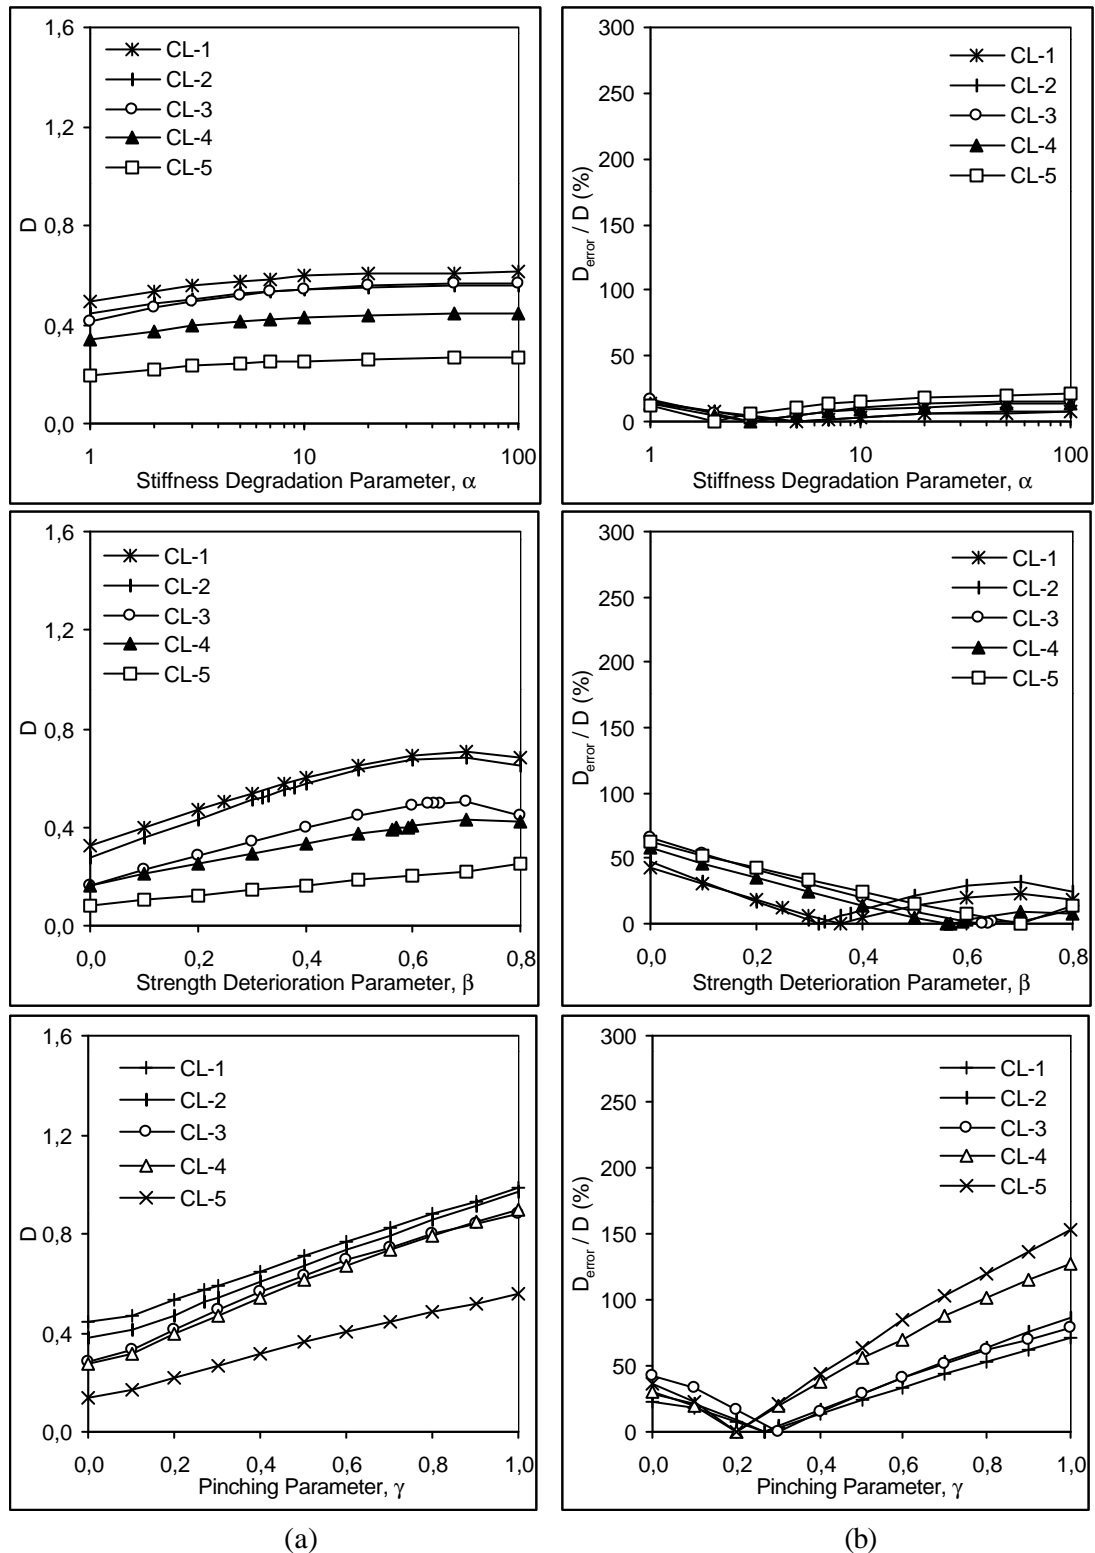
Figure 3.48 Effect of concrete strength and loading history-Set II **a)** Damage index vs. deterioration parameters α , β and γ , **b)** Damage index error ratio vs. deterioration parameters α , β and γ

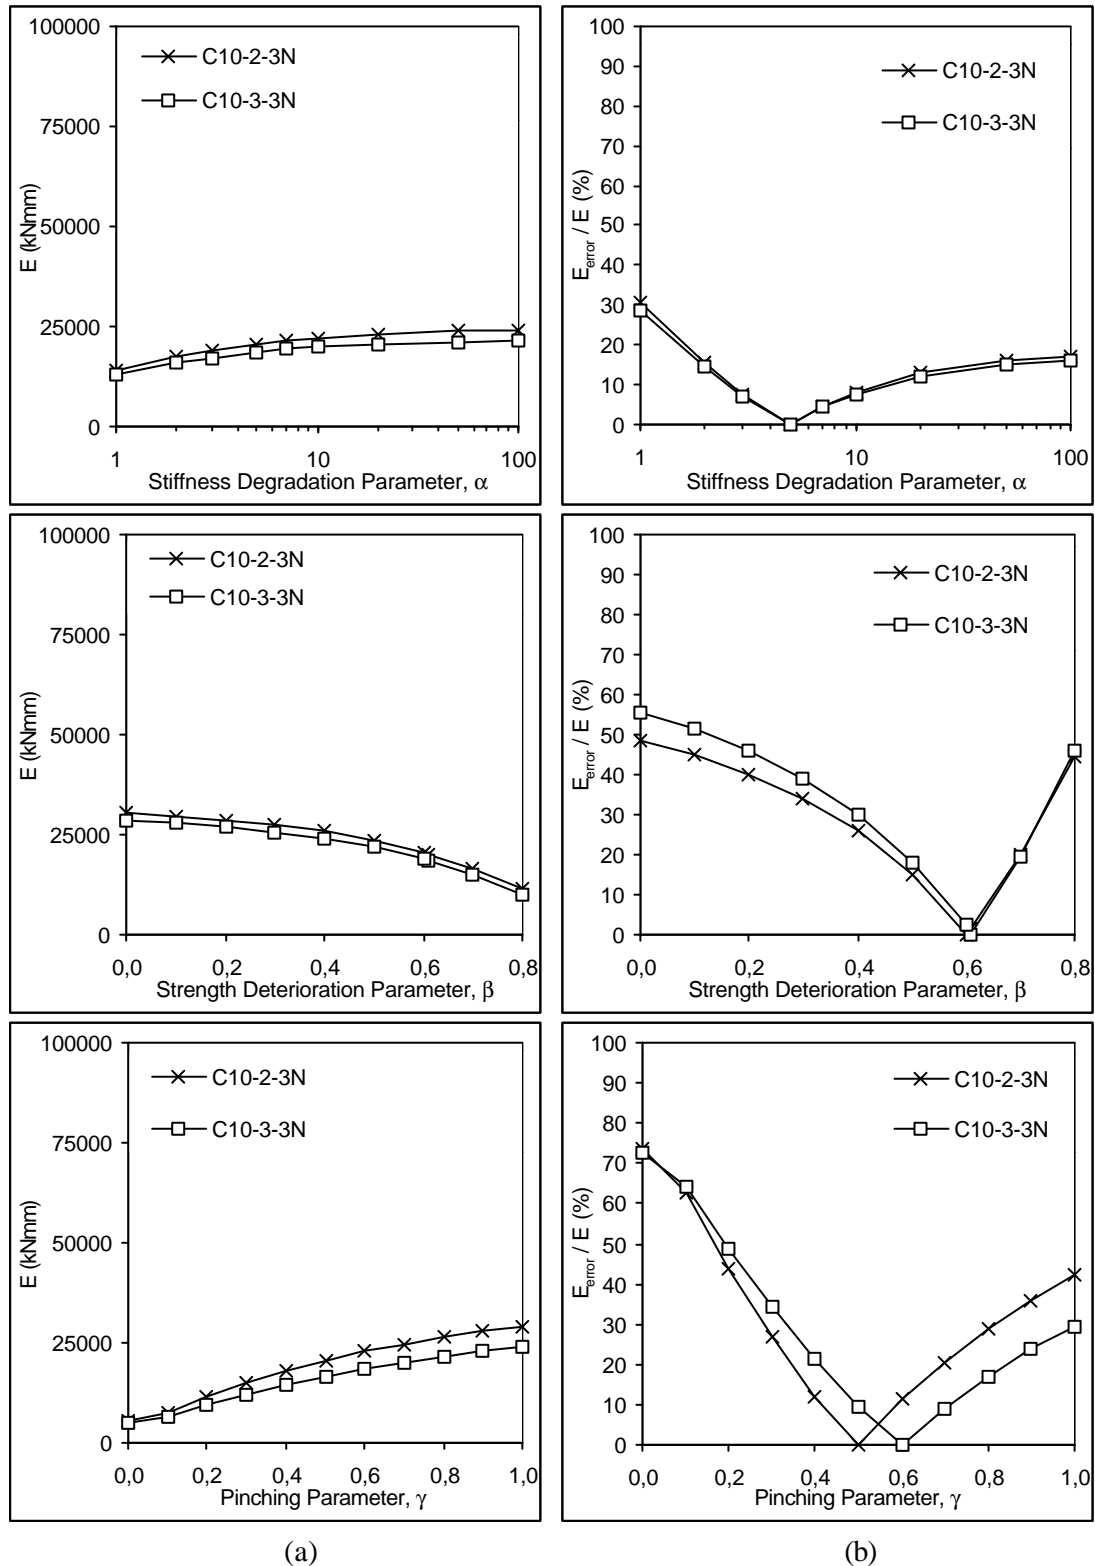
Figure 3.51 Effect of loading history-Set I **a)** Dissipated hysteretic energy vs. deterioration parameters α , β and γ , **b)** Dissipated hysteretic energy error ratio vs. deterioration parameters α , β and γ

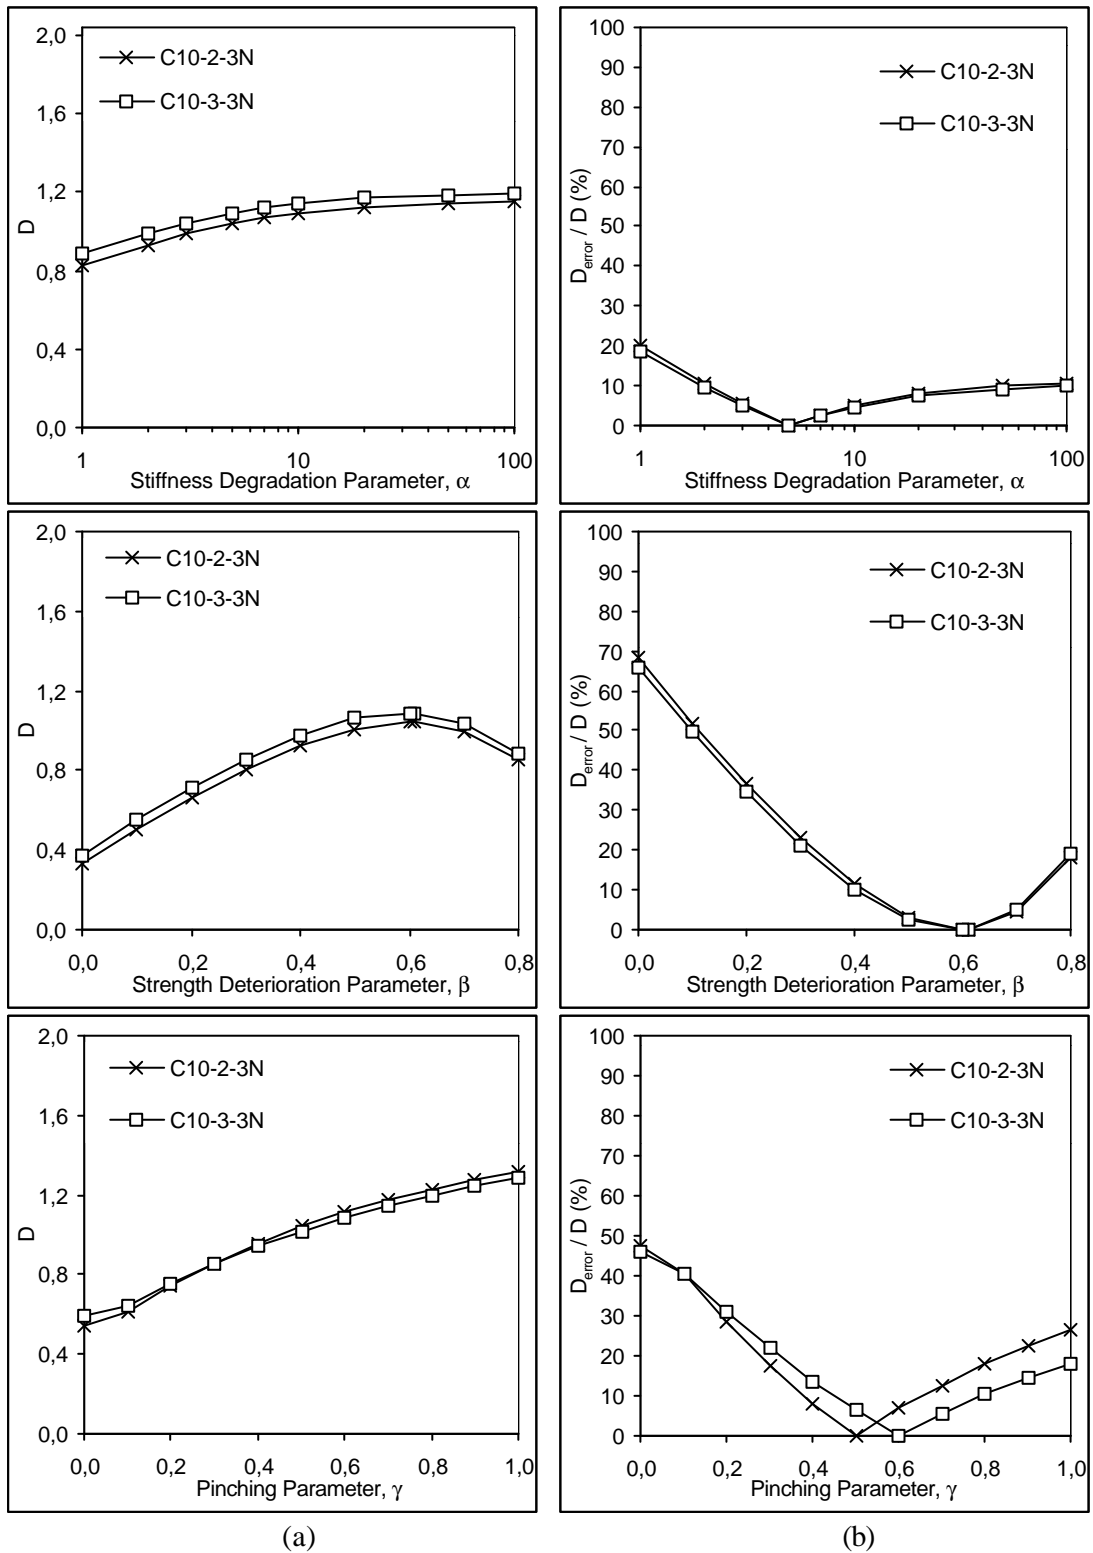
Figure 3.52 Effect of loading history-Set I **a)** Damage index vs. deterioration parameters α , β and γ , **b)** Damage index error ratio vs. deterioration parameters α , β and γ

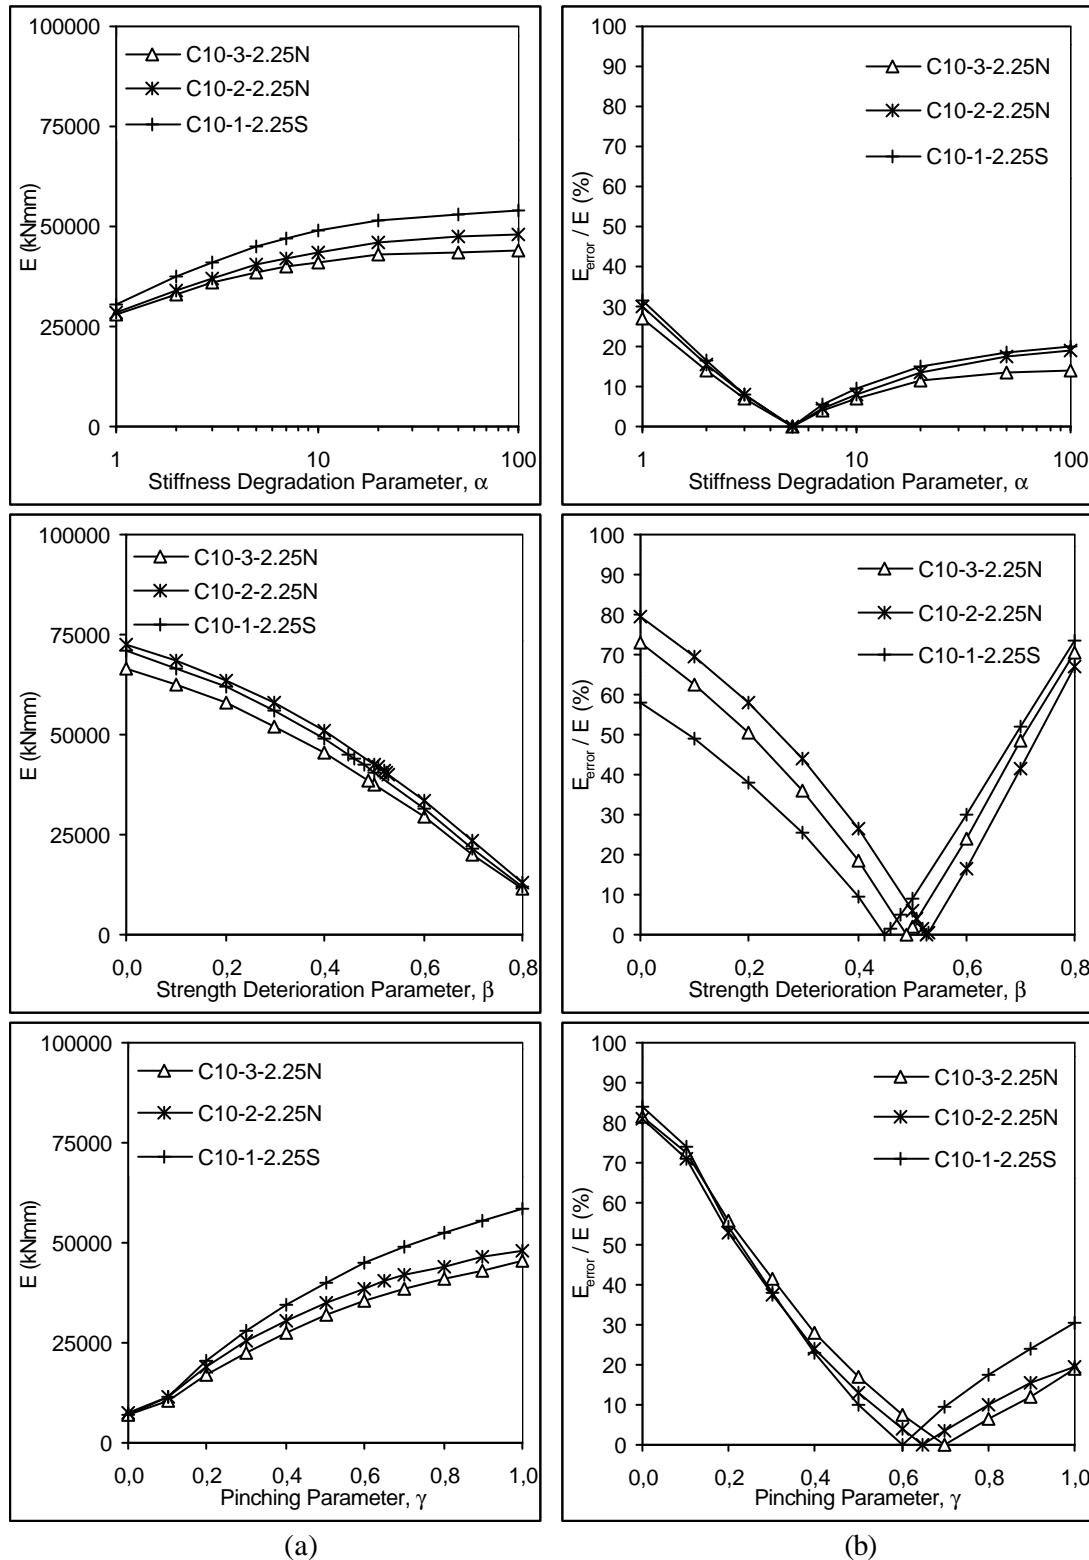
Figure 3.53 Effect of loading history-Set II **a)** Dissipated hysteretic energy vs. deterioration parameters α , β and γ , **b)** Dissipated hysteretic energy error ratio vs. deterioration parameters α , β and γ

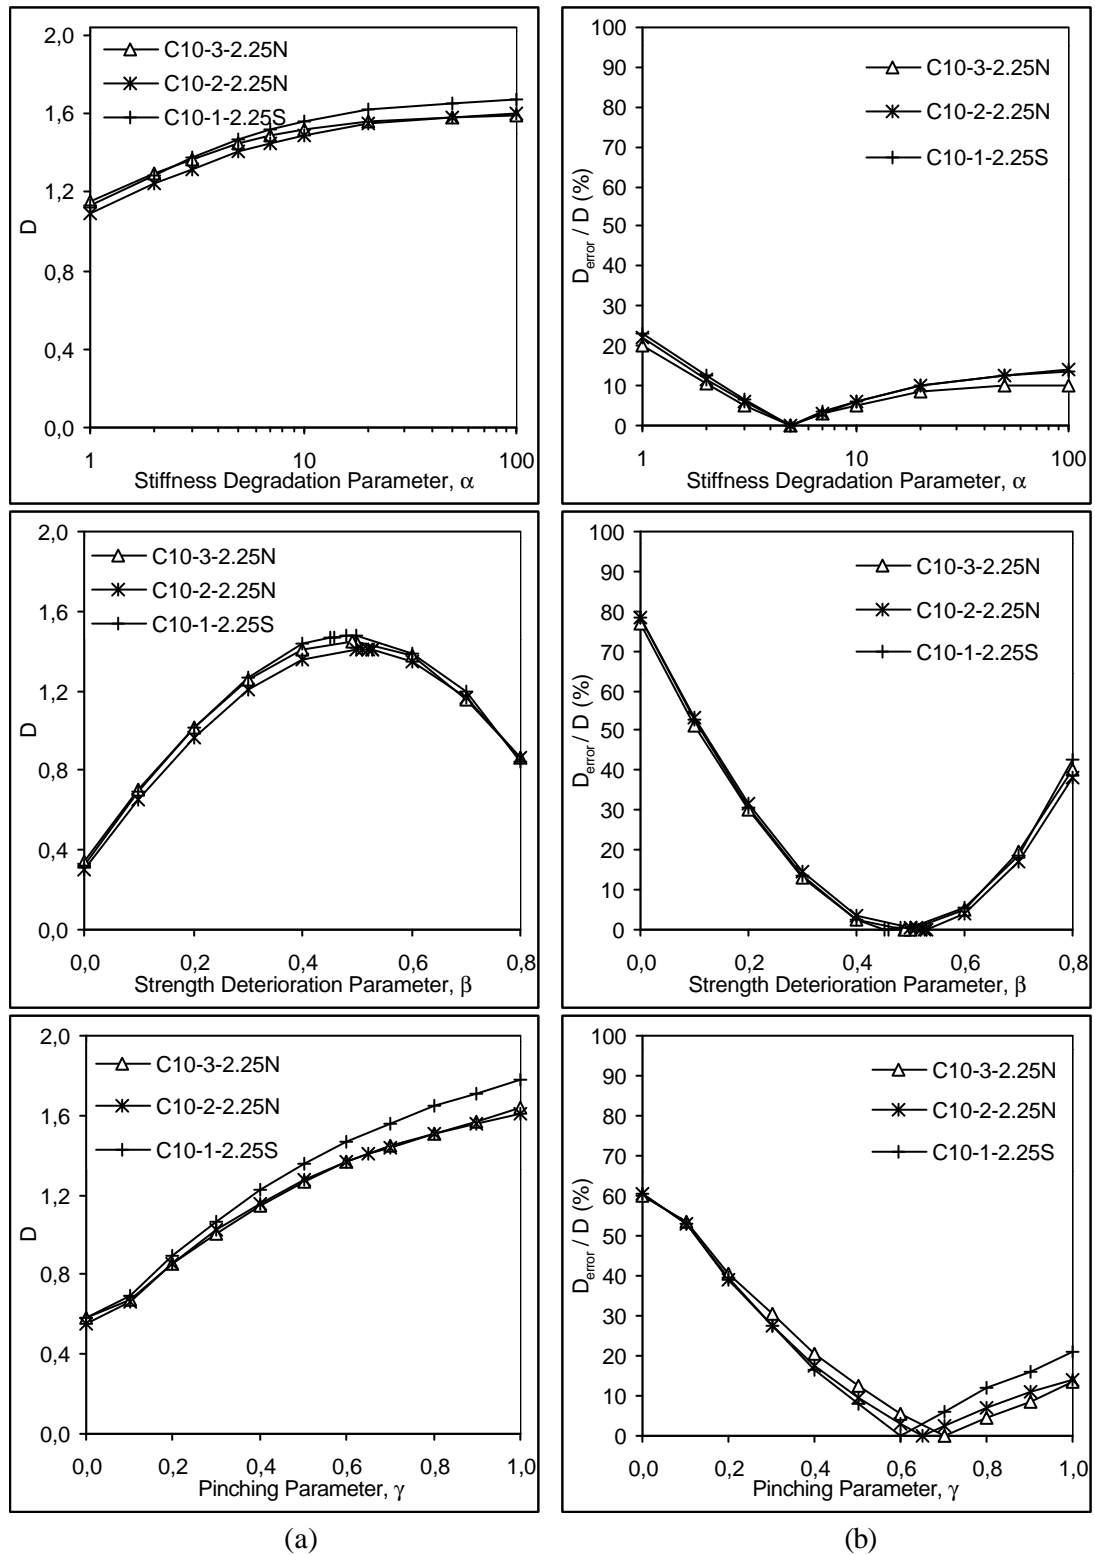
Figure 3.54 Effect of loading history-Set II **a)** Damage index vs. deterioration parameters α , β and γ , **b)** Damage index error ratio vs. deterioration parameters α , β and γ

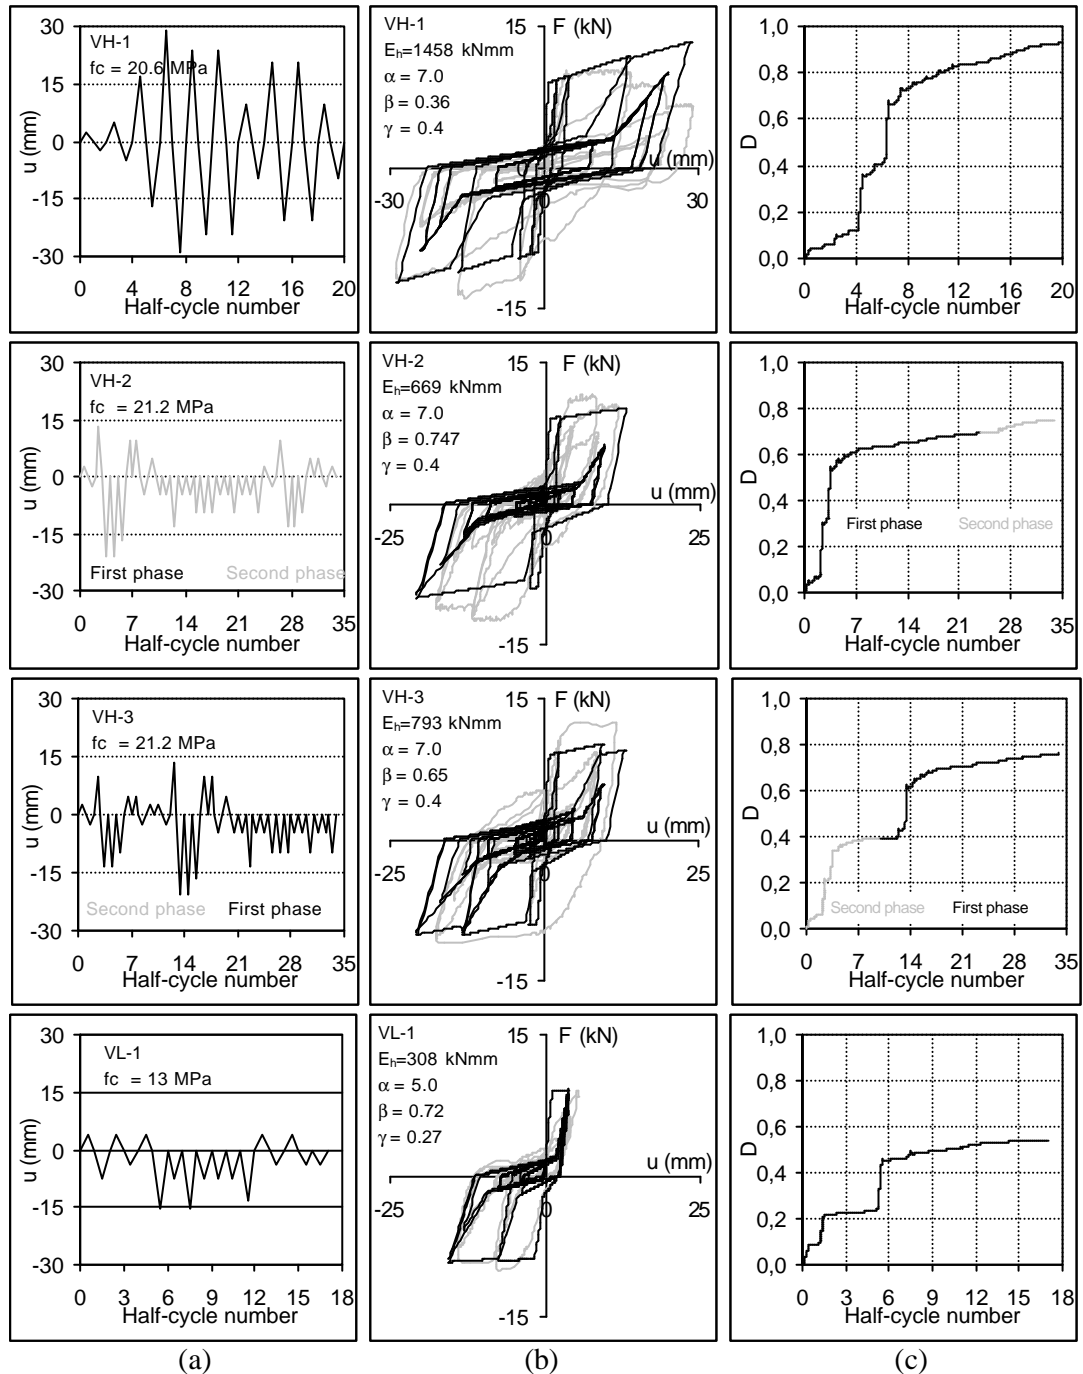
Figure 3.56 Effect of loading history (Erberik and Sucuođlu specimens) **a)** variable-amplitude displacement histories **b)** Experimental (gray) and analytical (black) force-displacement curves **c)** Damage curves

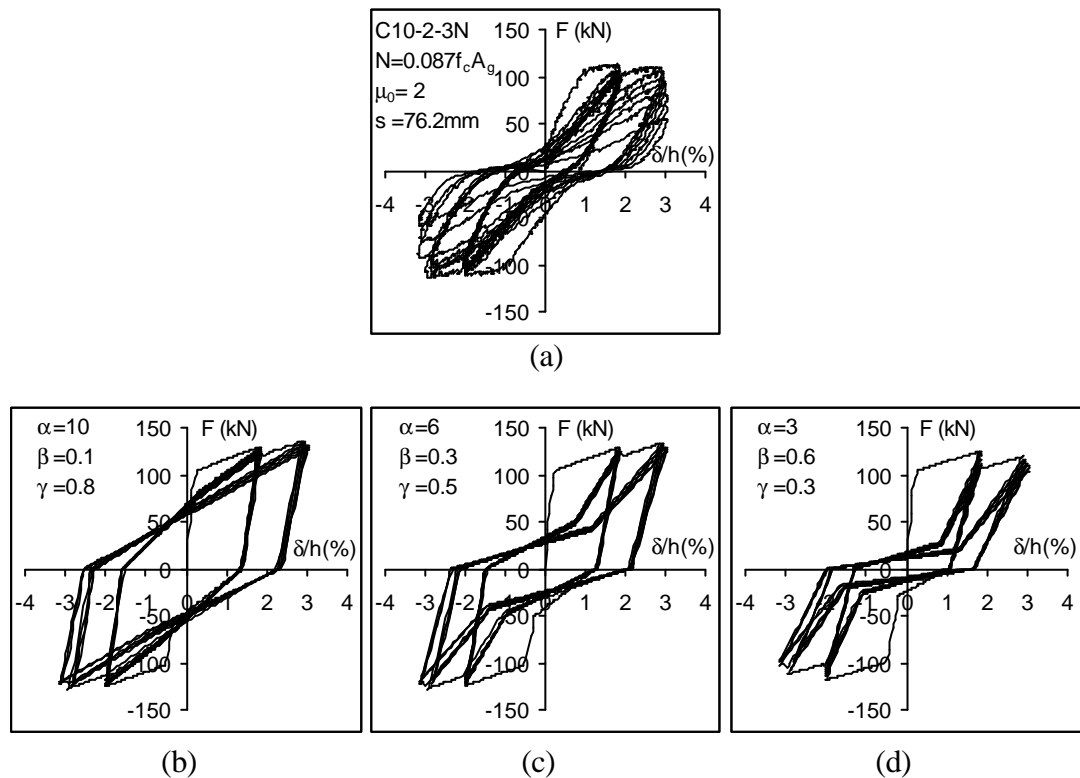
Figure 3.57 Sensitivity analysis of three-parameter model: **a)** Experiment, **b)** Simulation using $\alpha=10$, $\beta=0.1$ and $\gamma=0.8$, Mild deteriorating system (MLD), **c)** Simulation using $\alpha=6$, $\beta=0.3$ and $\gamma=0.5$, Moderate deteriorating system (MOD), **d)** Simulation using $\alpha=3$, $\beta=0.6$ and $\gamma=0.3$, Severe deteriorating system (SVD)

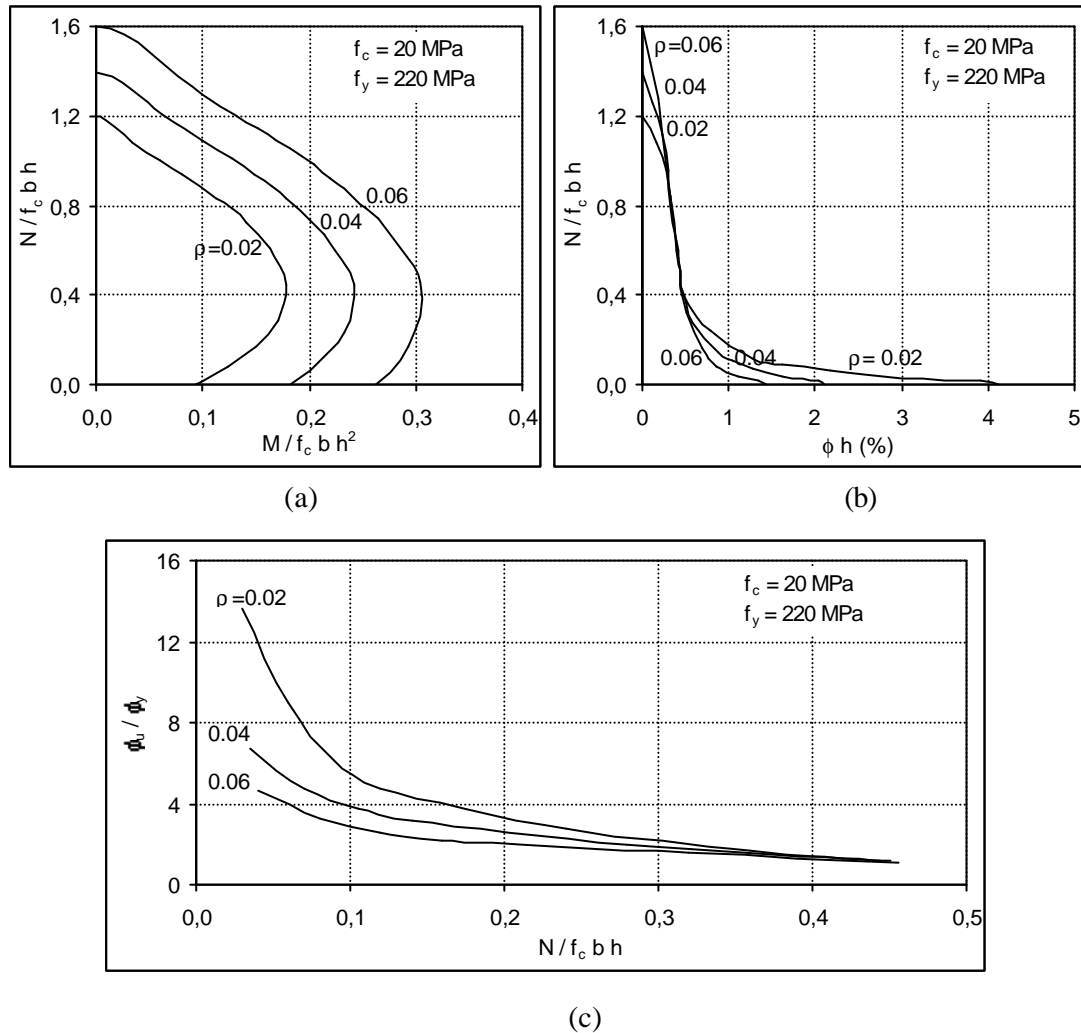
Figure 4.2 Strength and ductility of column sections with different values of reinforcement ratio **a)** Interaction diagrams **b)** Axial load level versus curvature **c)** Curvature ductility versus axial load level
