LOW CYCLE FATIGUE EFFECTS IN THE DAMAGE CAUSED BY
THE MARMARA EARTHQUAKE OF AUGUST 17, 1999

A THESIS SUBMITTED TO
THE GRADUATE SCHOOL OF NATURAL AND APPLIED SCIENCES
OF
MIDDLE EAST TECHNICAL UNIVERSITY

SEPTEMBER 2004

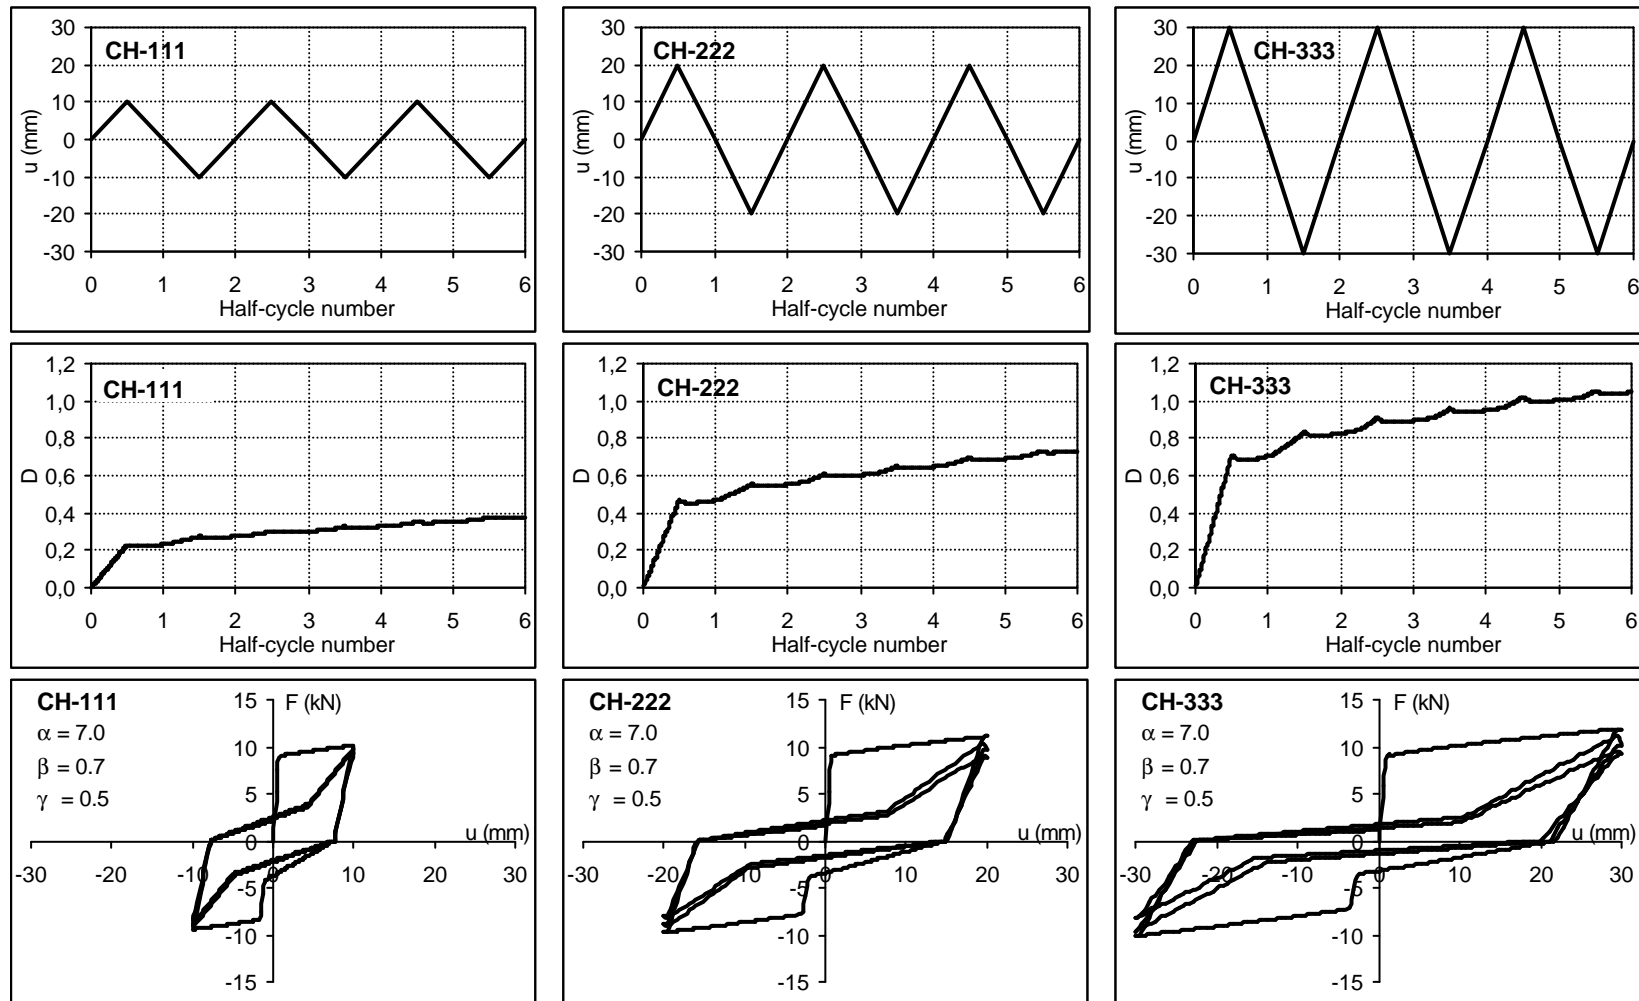
Figure 5.1 Constant amplitude loading histories, damage progression curves and force-displacement relationships

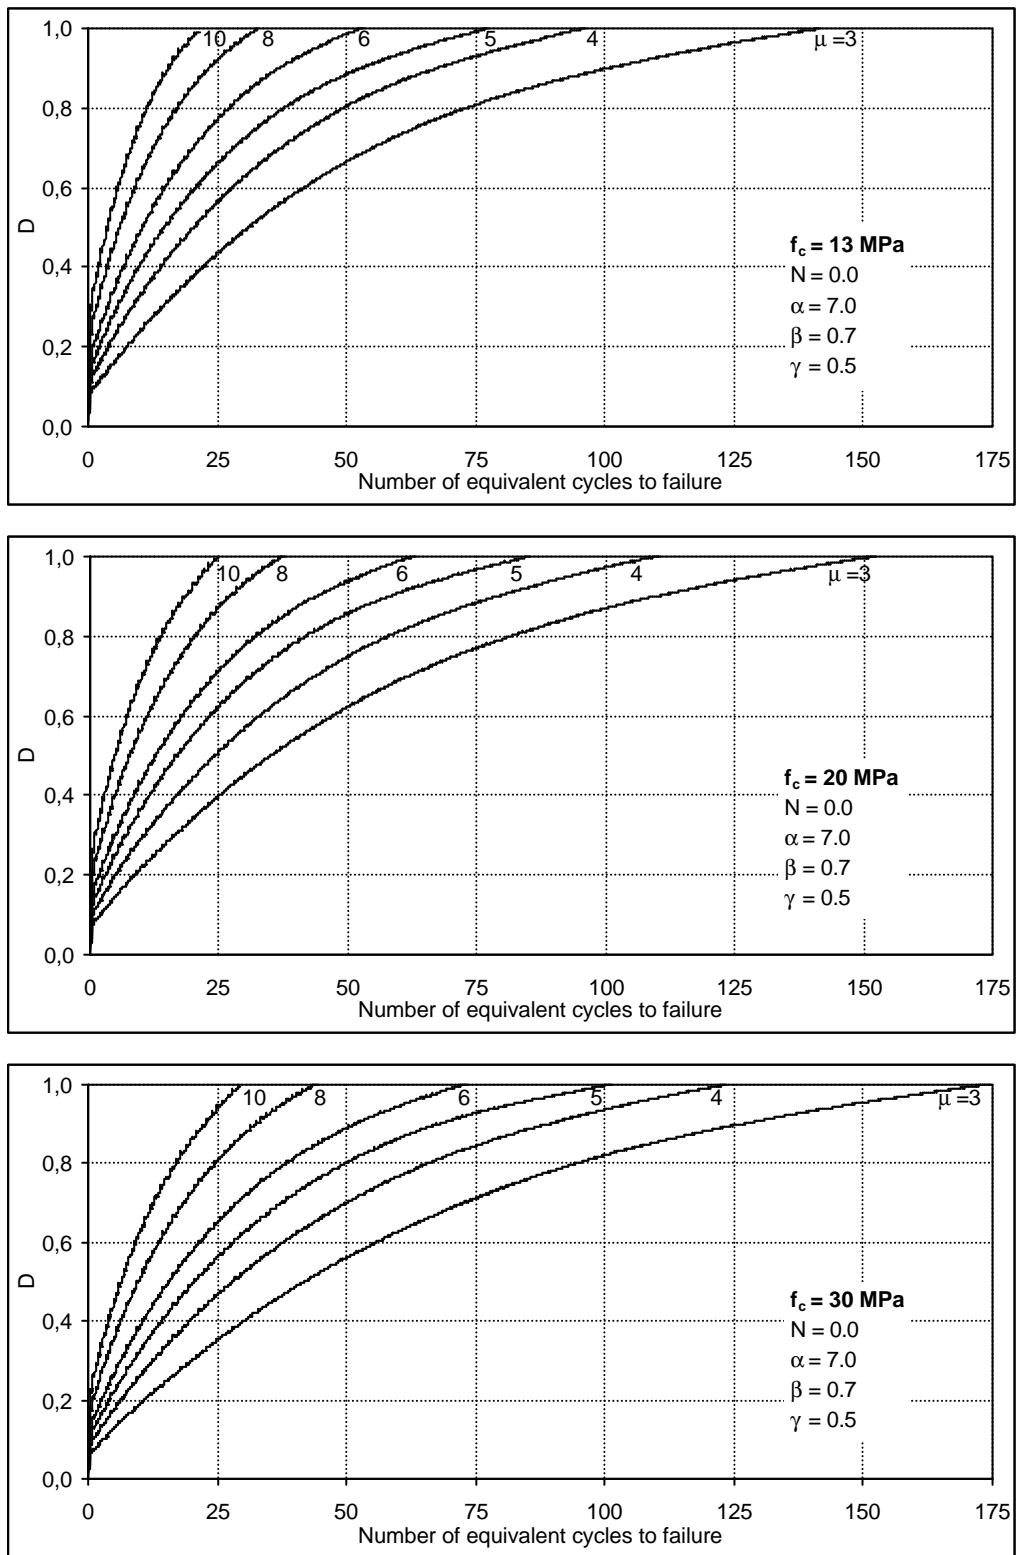
Figure 5.2 Damage progression curves for constant amplitude displacement cycles of various ductilities and concrete grades

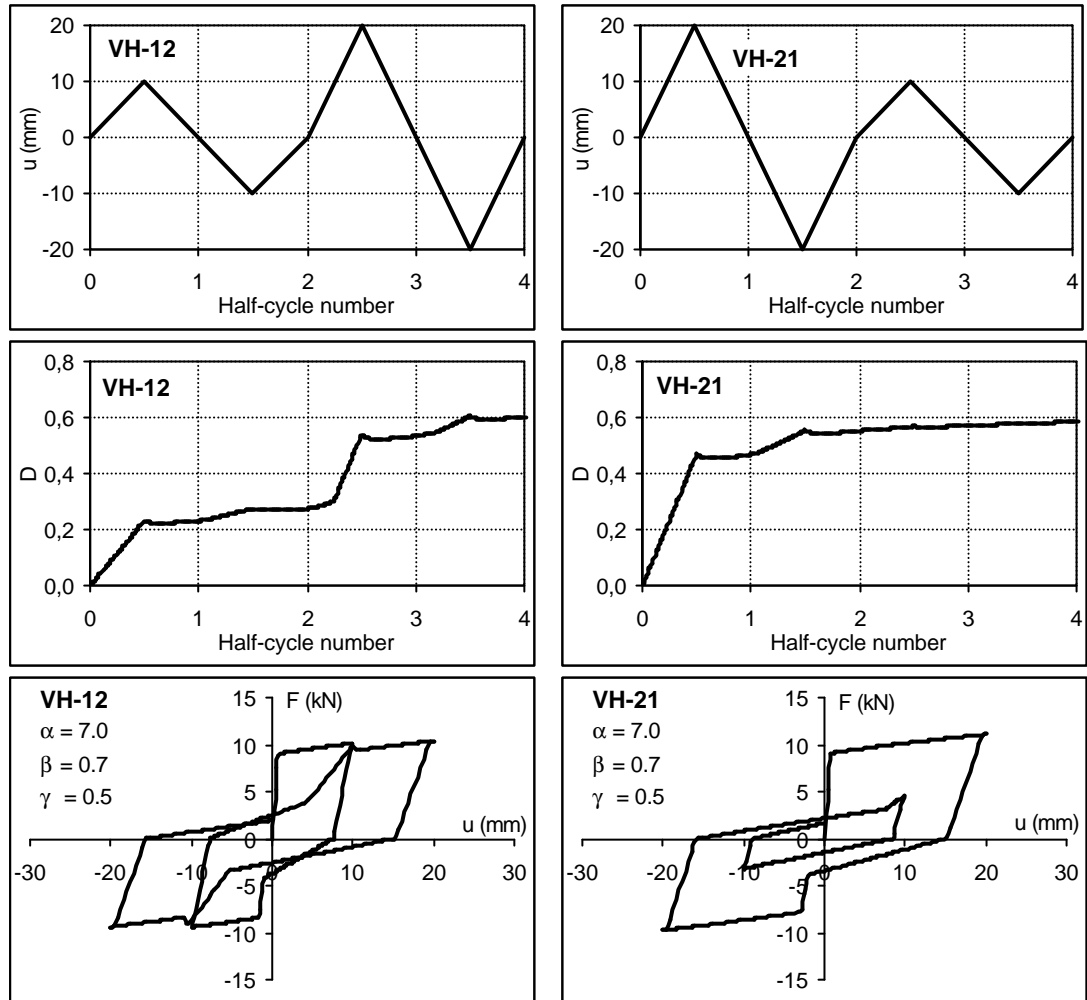
Figure 5.4 Variable amplitude loading histories, damage progression curves and force-displacement relationships

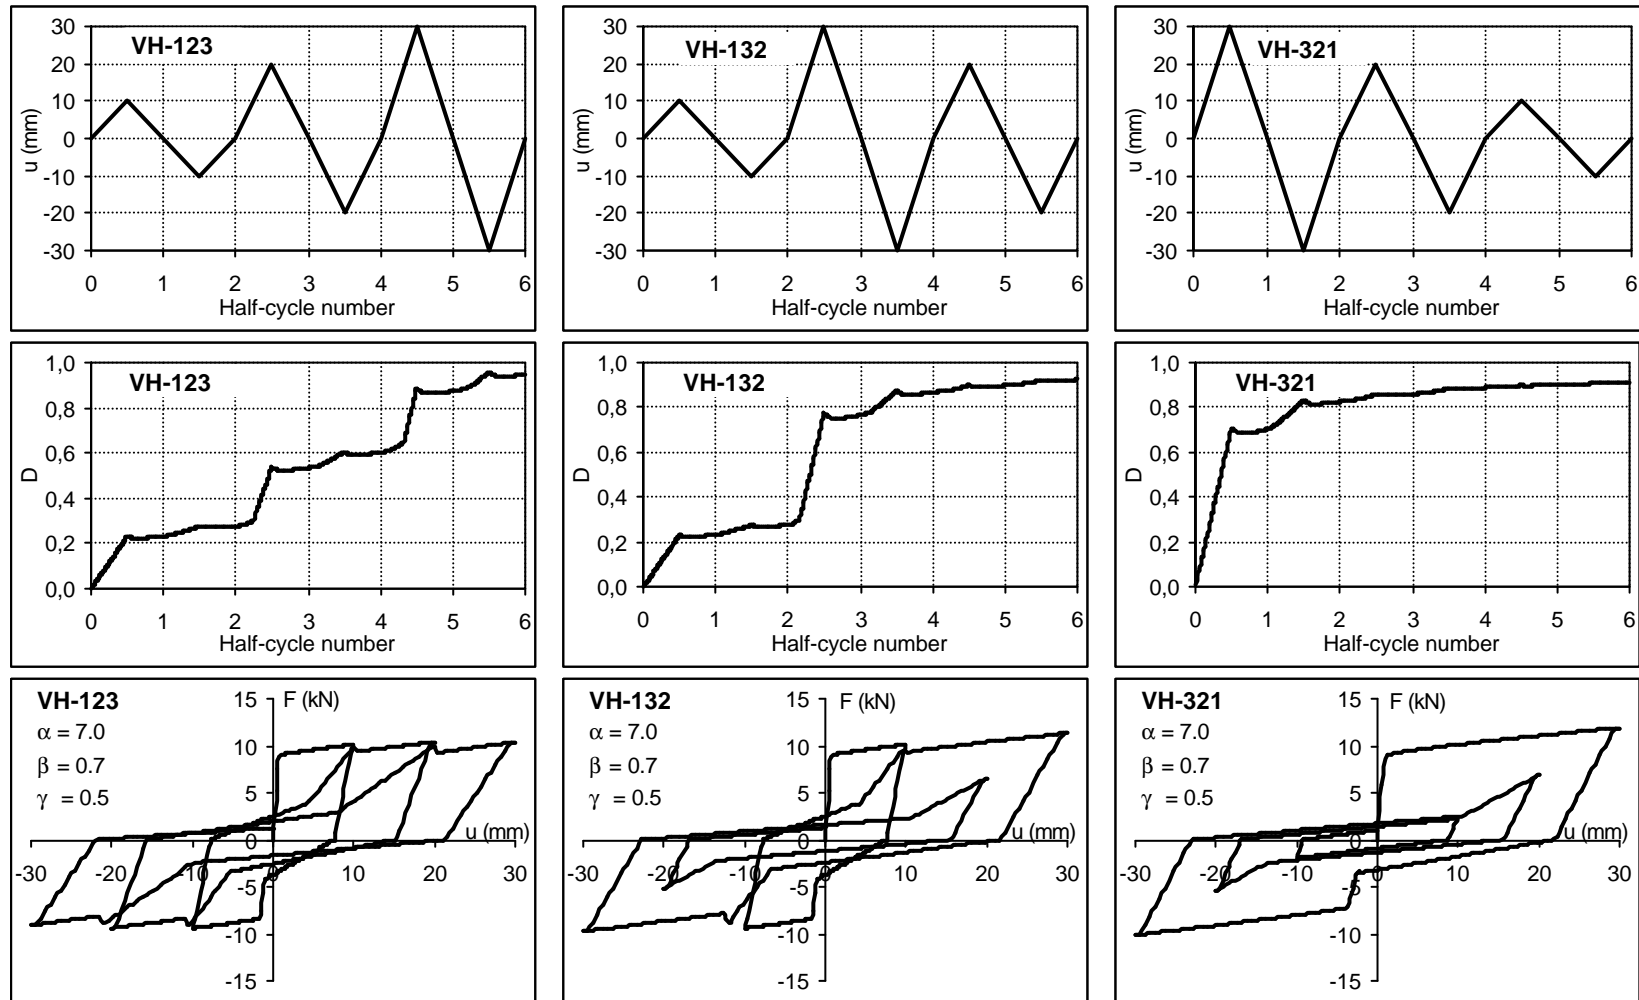
Figure 5.5 Variable amplitude loading histories, damage progression curves and force-displacement relationships

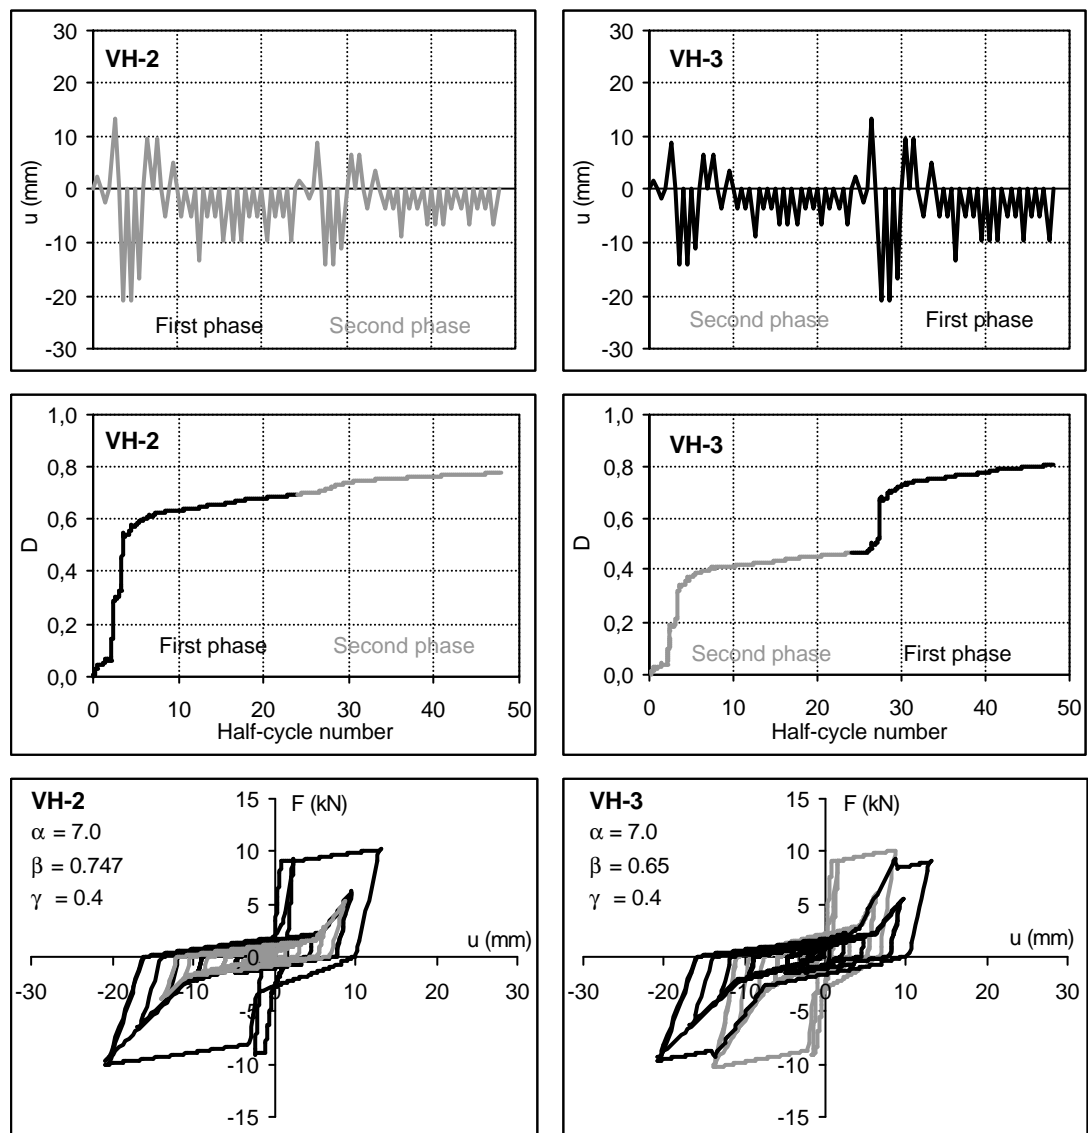
Figure 5.6 Force-displacement relationships, imposed loading histories and damage curves of the specimens VH-2 and VH-3

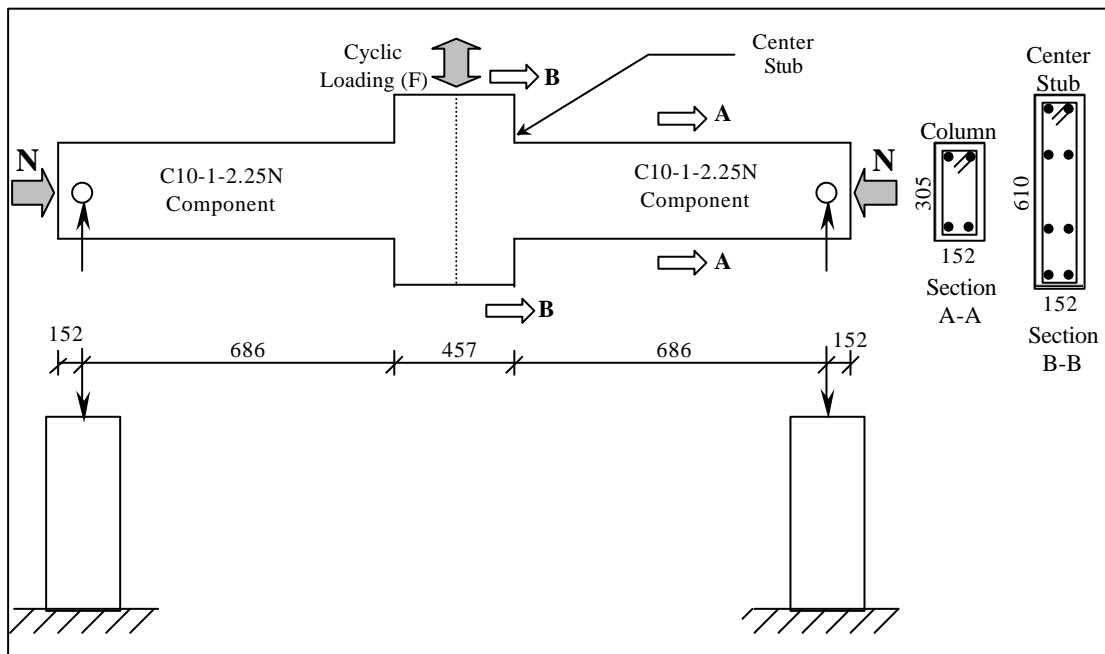
Figure 5.7 Description of test assembly (dimensions in mm)

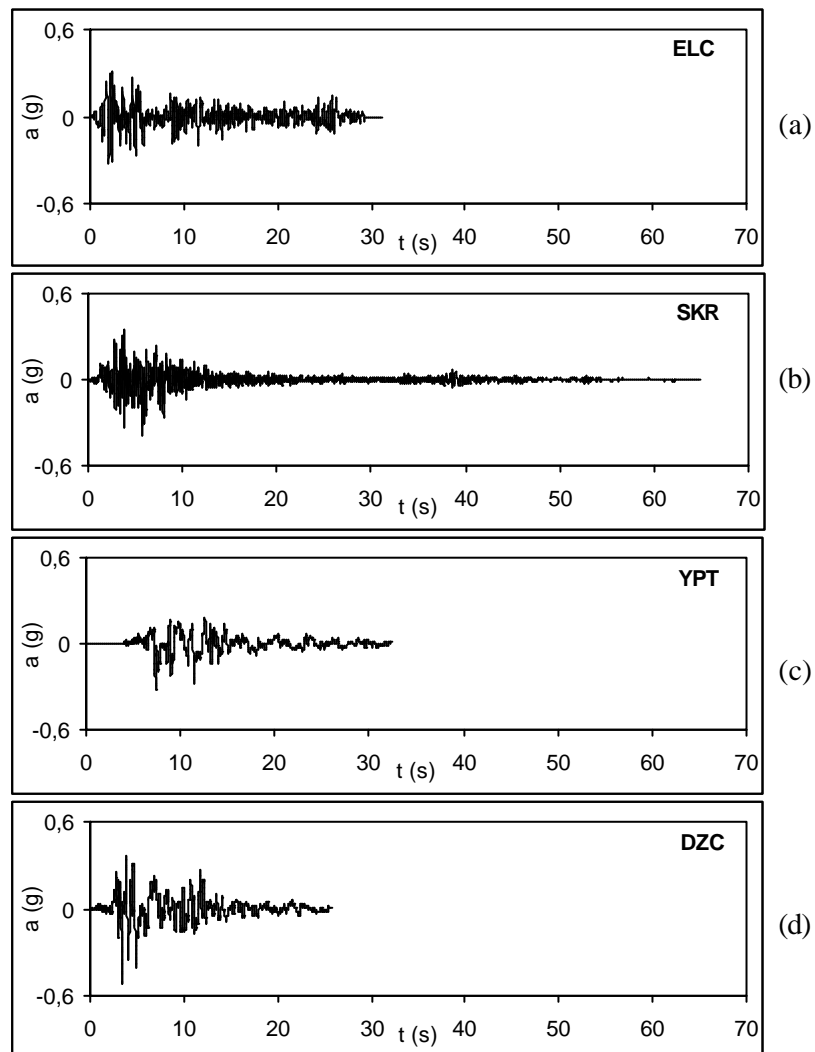
Figure 5.8 The ground motions used in this study. **a)** El Centro 1940, NS component, **b)** 17 August 1999 Marmara Earthquake, Sakarya Station, EW component, **c)** 17 August 1999 Marmara Earthquake, Yarýmca Petrochemical Complex (YPT) Station, NS component, **d)** 12 November 1999 Düzce Earthquake, Düzce Station, NS component

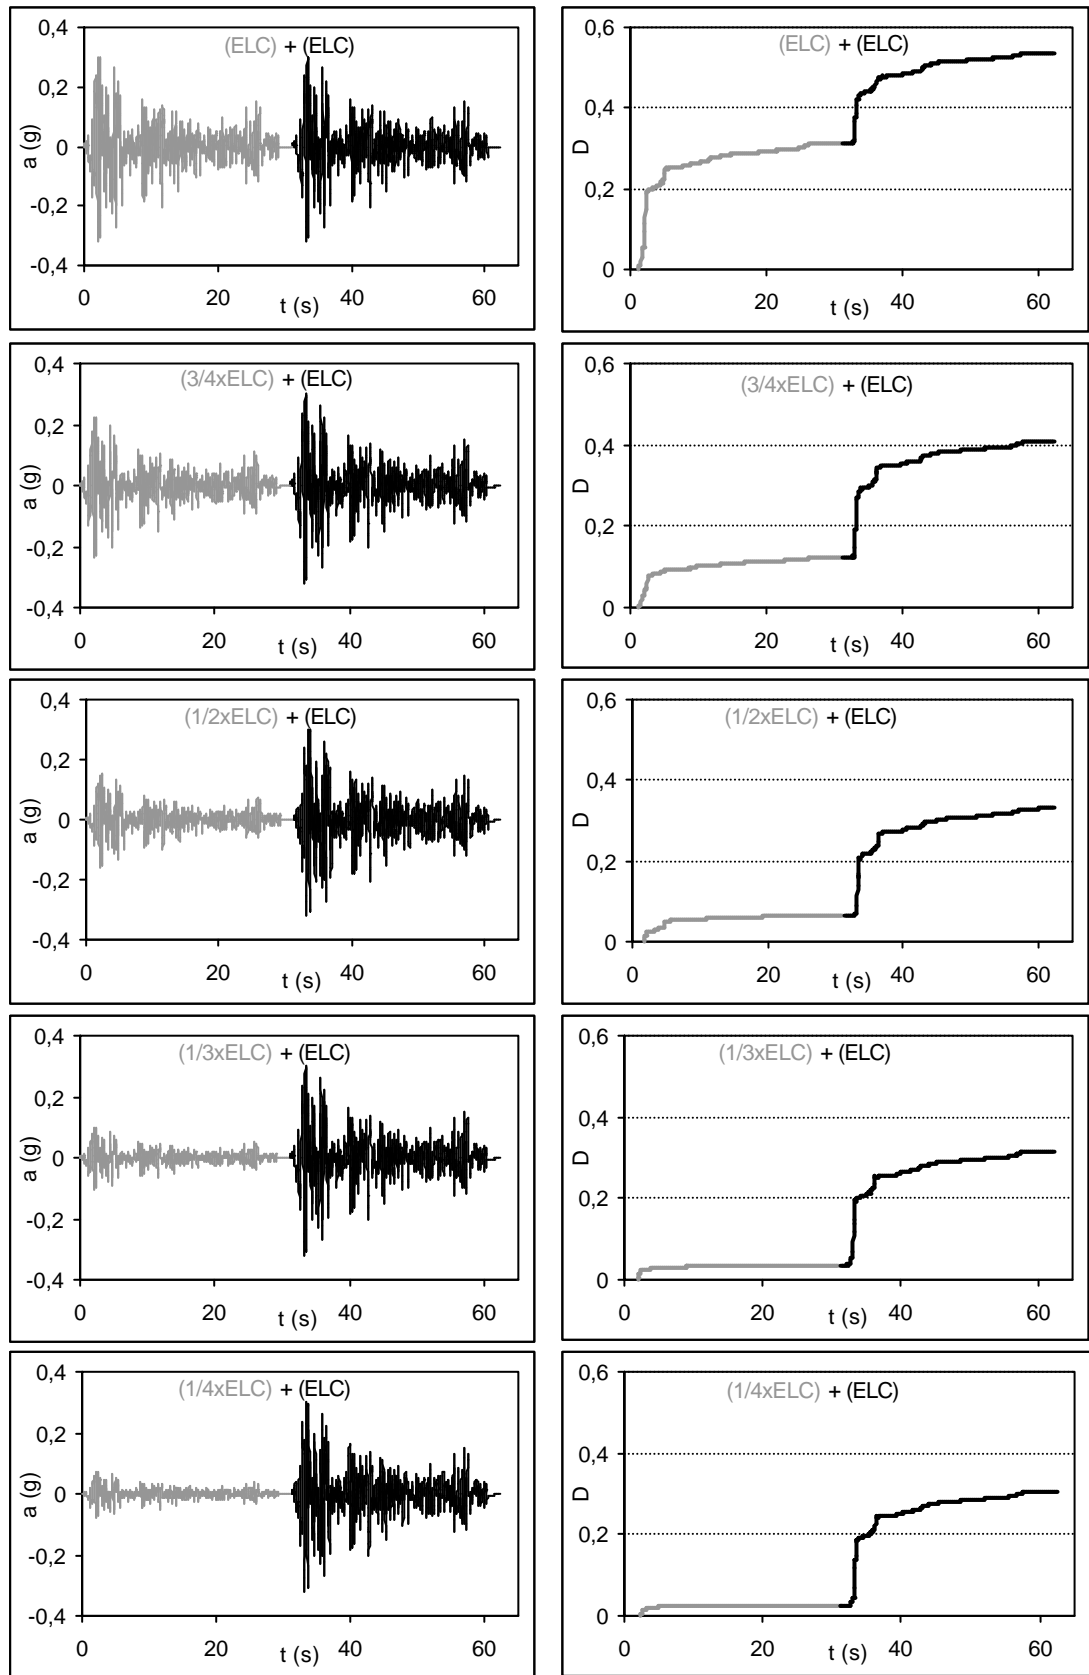
Figure 5.9 Synthetic ground acceleration histories (El Centro 1940, NS component preceded by various amplitude foreshocks) and damage variation curves for Pujol column

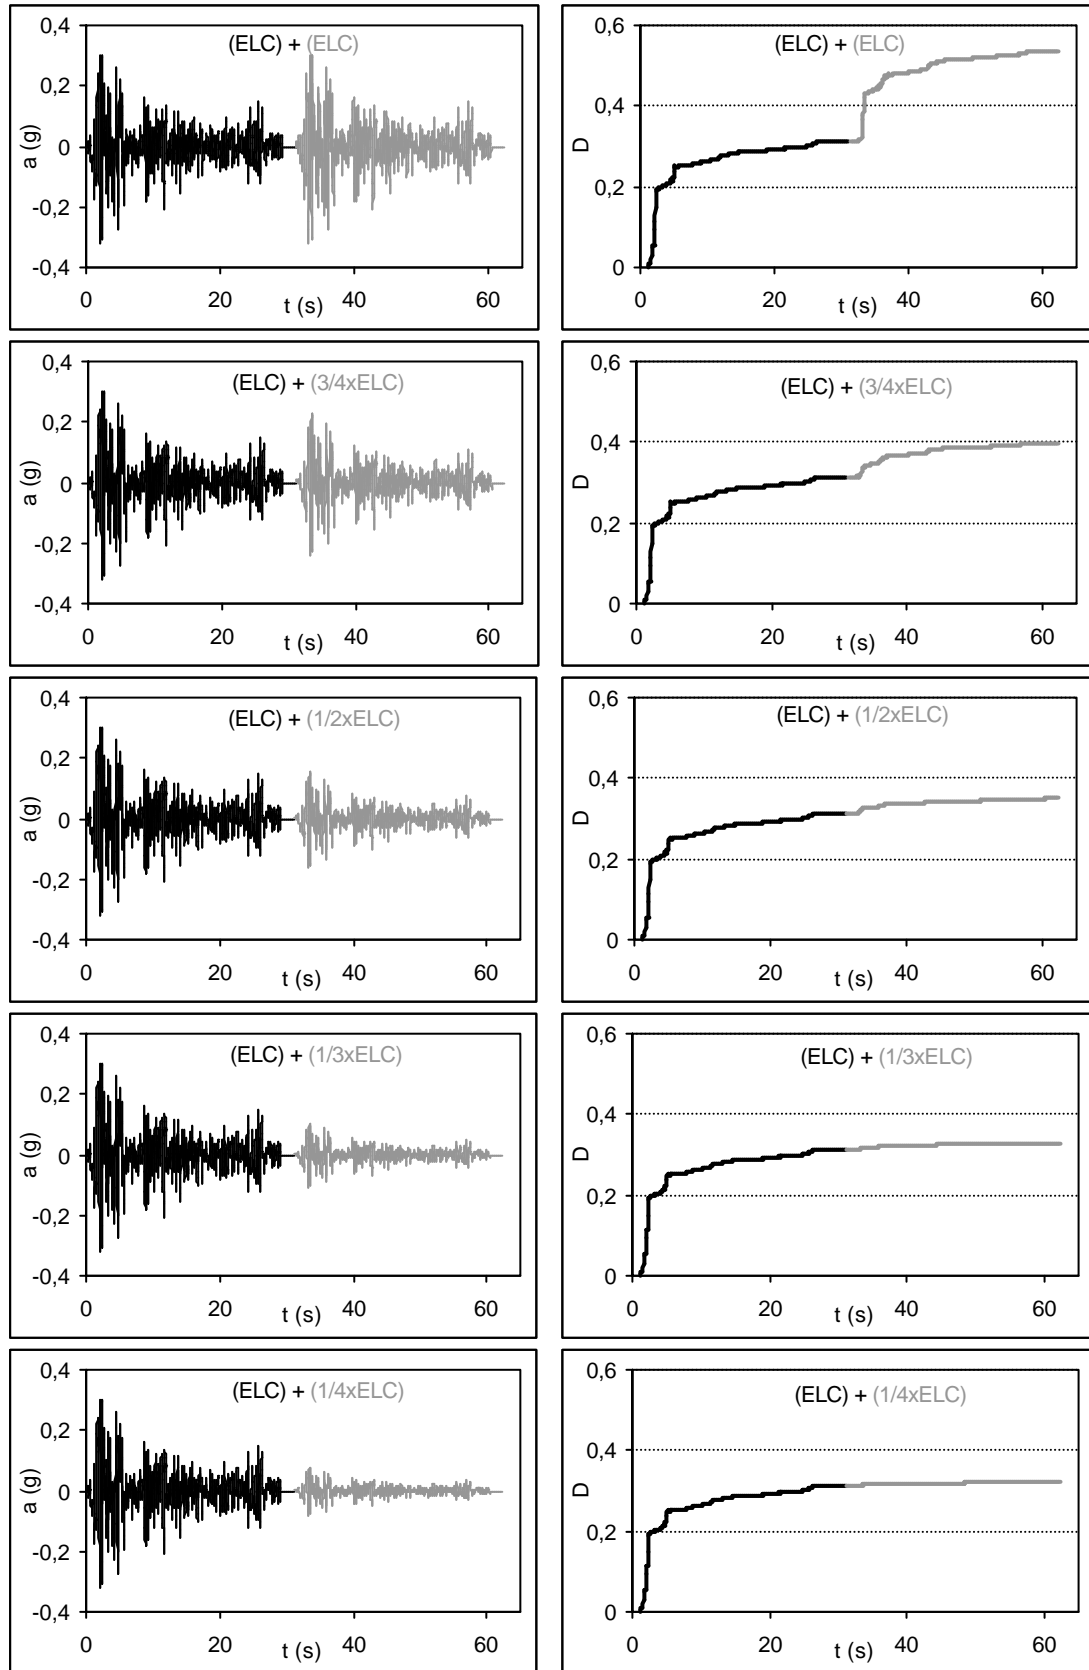
Figure 5.10 Synthetic ground acceleration histories (El Centro 1940, NS component followed by various amplitude aftershocks) and damage variation curves for Pujol column

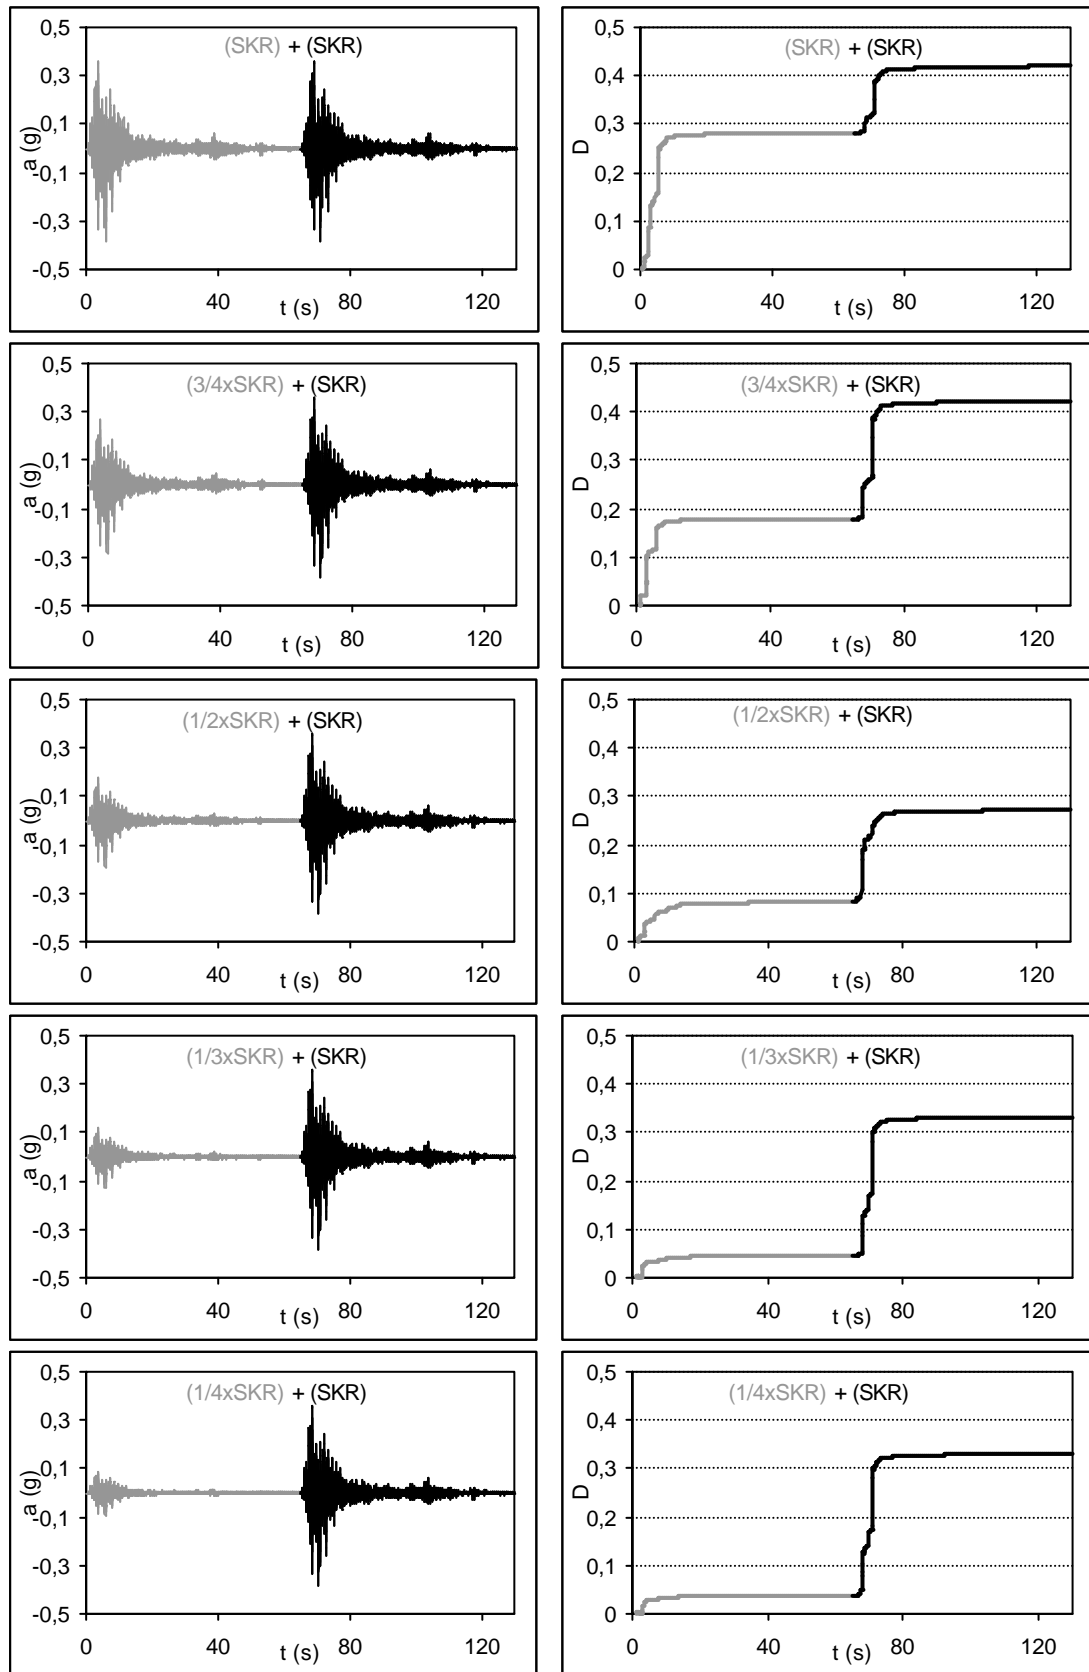
Figure 5.14 Synthetic ground acceleration histories (17 August 1999 Marmara Earthquake Sakarya-EW component preceded by various amplitude foreshocks) and damage variation curves for Pujol column

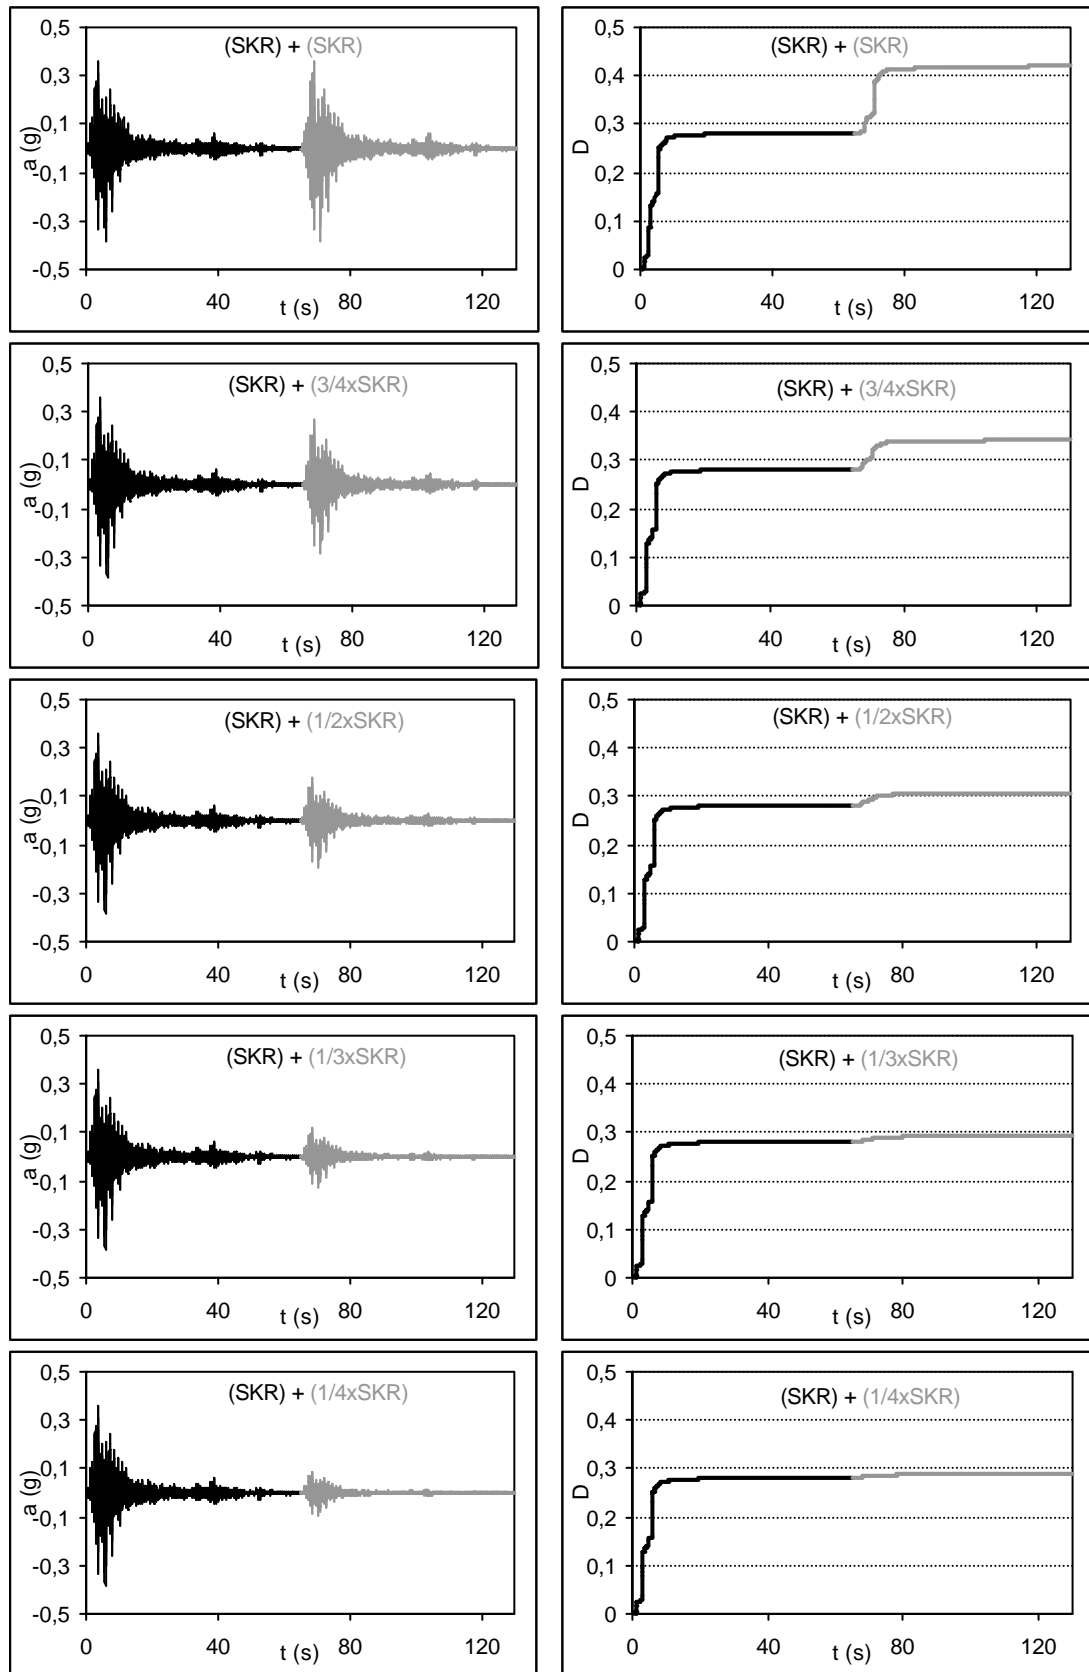
Figure 5.15 Synthetic ground acceleration histories (17 August 1999 Marmara Earthquake Sakarya-EW component followed by various amplitude aftershocks) and damage variation curves for Pujol column

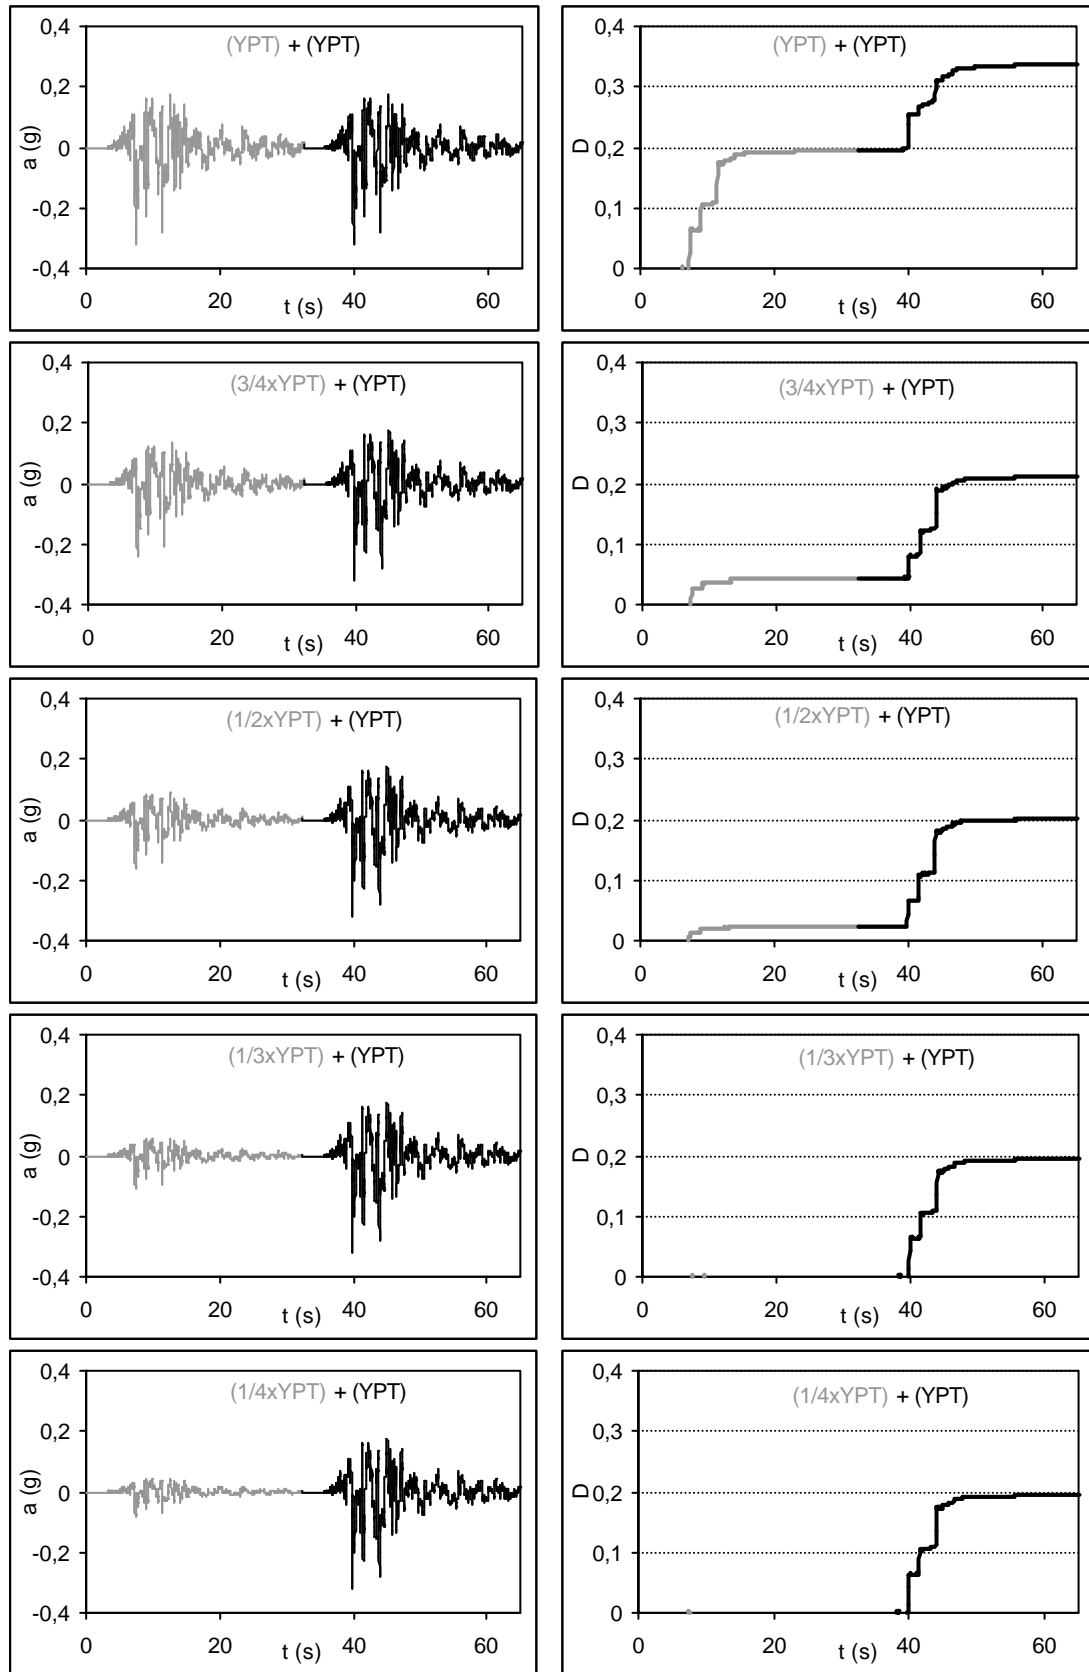
Figure 5.19 Synthetic ground acceleration histories (17 August 1999 Marmara Earthquake YPT (Yarýmca Petrochemical Complex) Station, NS component preceded by various amplitude foreshocks) and damage variation curves for Pujol column

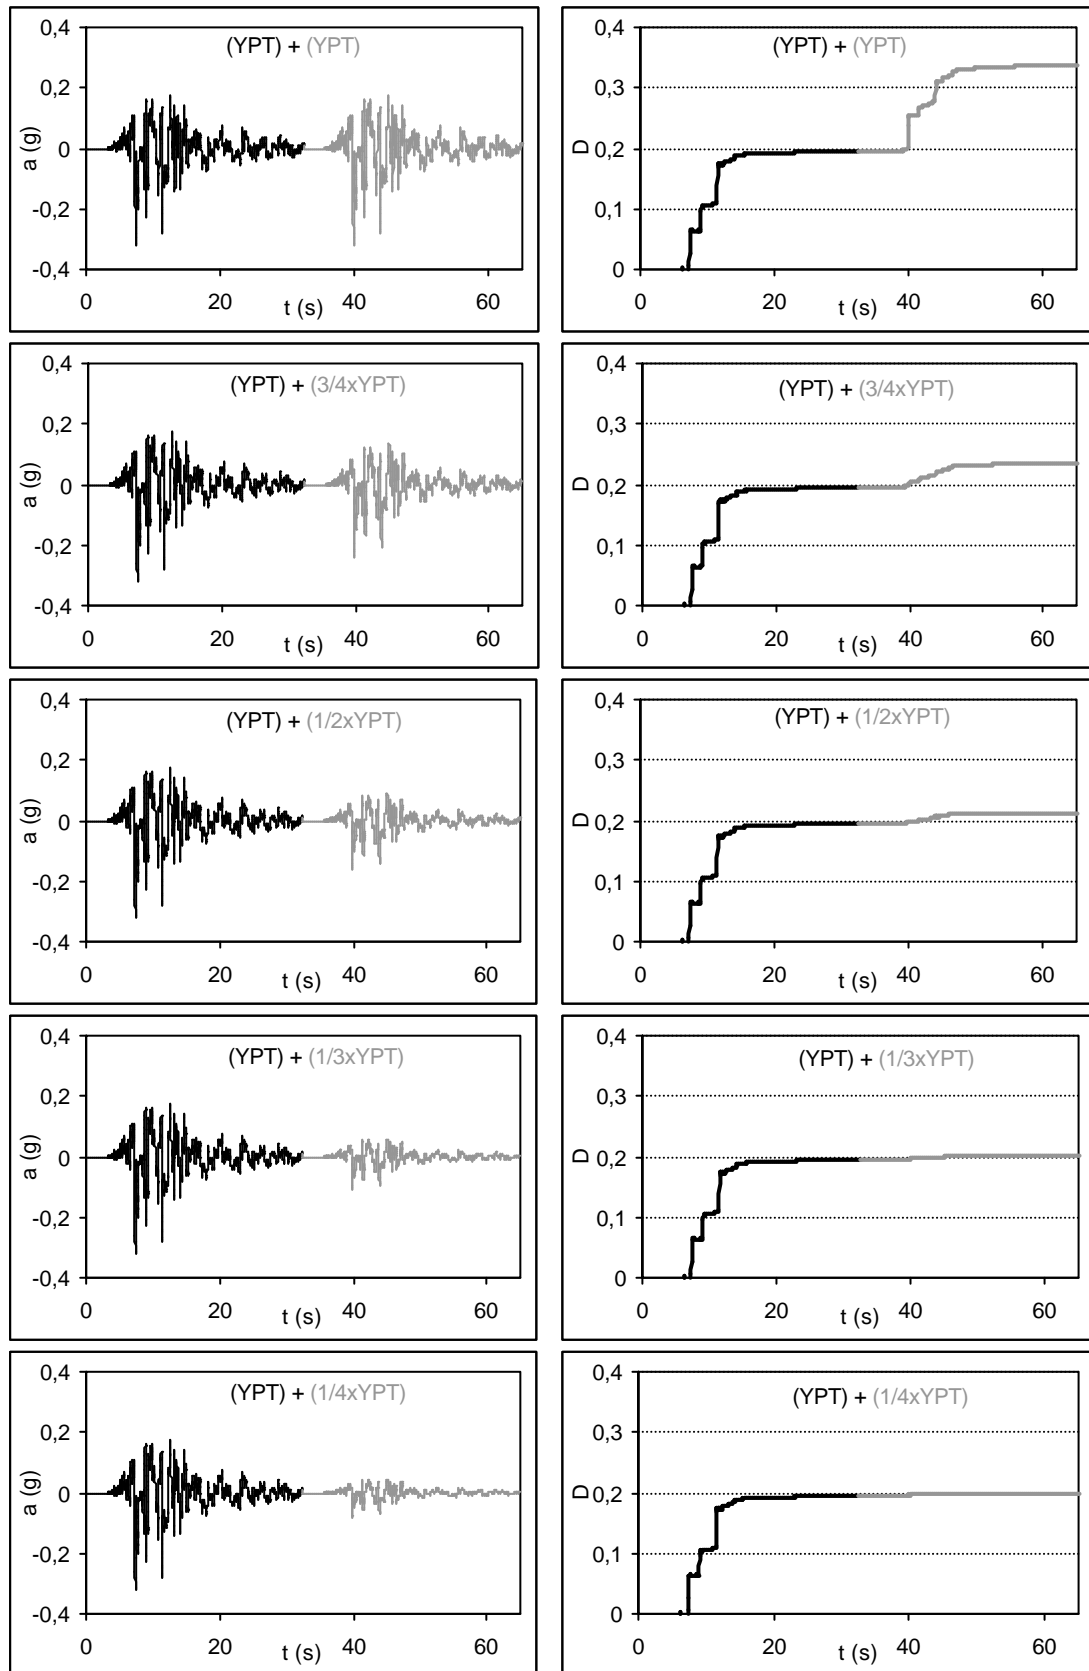
Figure 5.20 Synthetic ground acceleration histories (17 August 1999 Marmara Earthquake, YPT (Yarýmca Petrochemical Complex) Station, NS component followed by various amplitude aftershocks) and damage variation curves for Pujol column

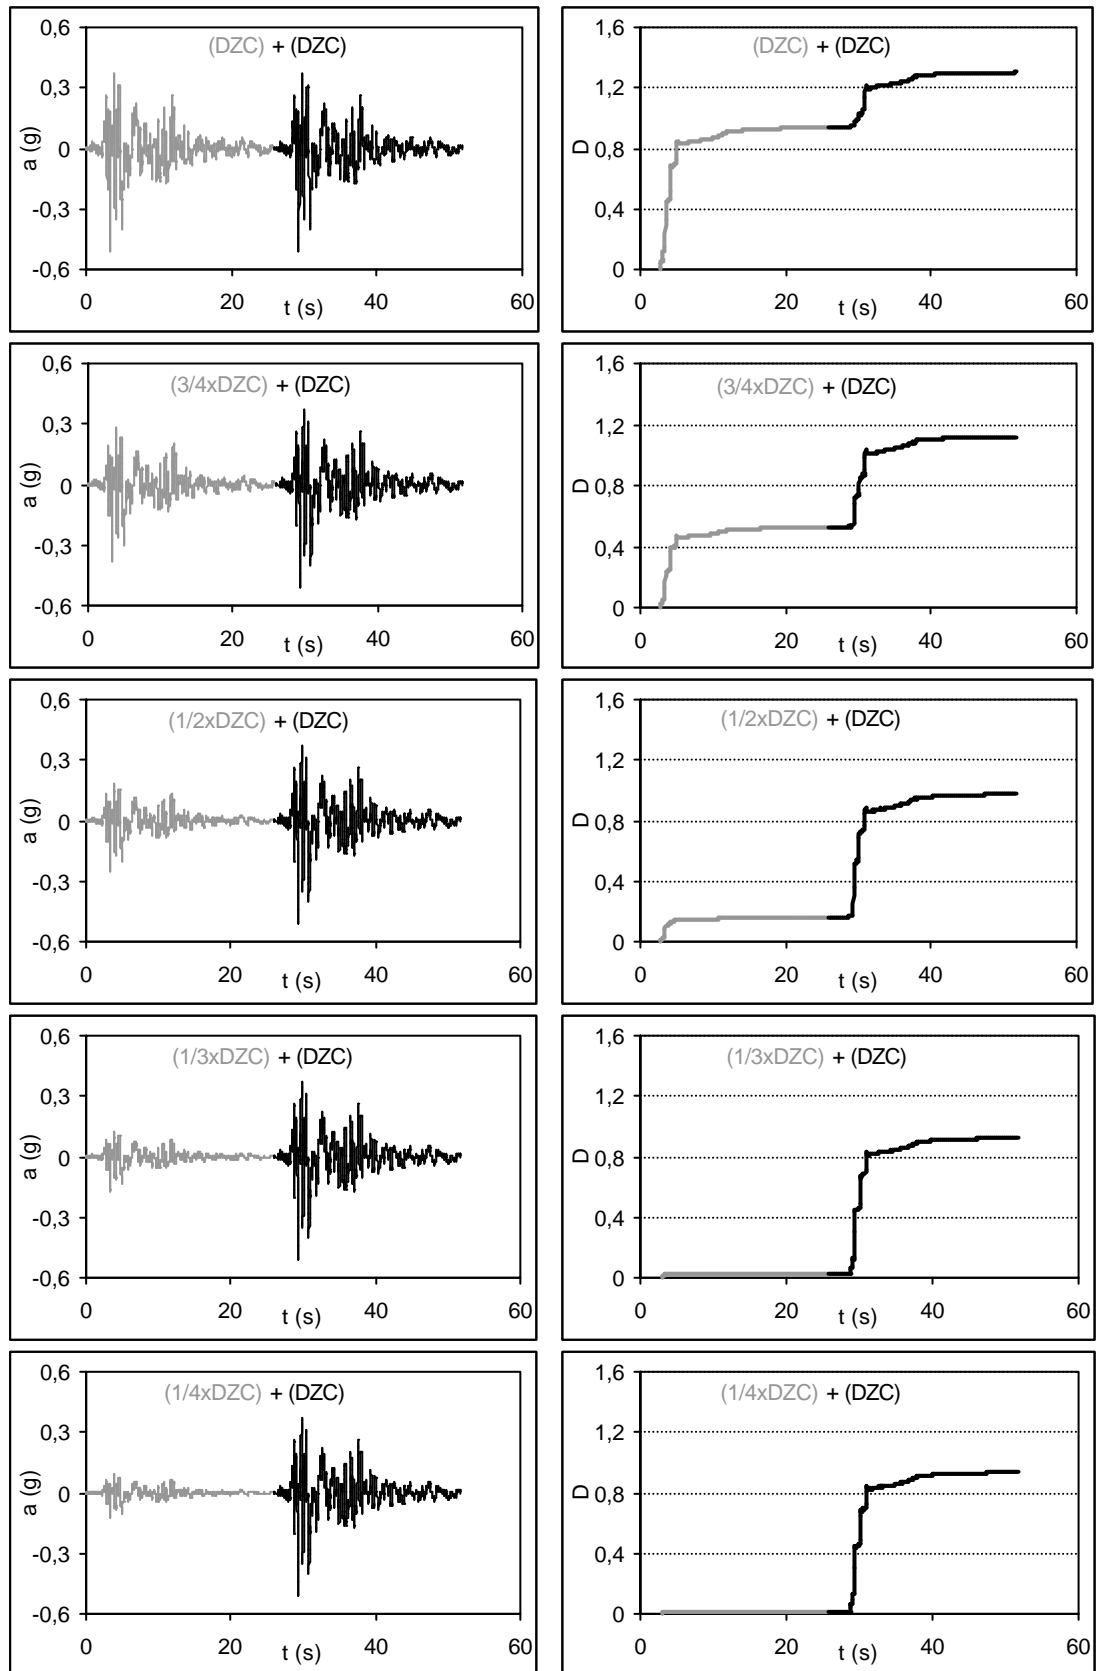
Figure 5.24 Synthetic ground acceleration histories (12 November 1999 Düzce Earthquake, Düzce Station, NS component preceded by various amplitude foreshocks) and damage variation curves for Pujol column
