LOW CYCLE FATIGUE EFFECTS IN THE DAMAGE CAUSED BY
THE MARMARA EARTHQUAKE OF AUGUST 17, 1999

A THESIS SUBMITTED TO
THE GRADUATE SCHOOL OF NATURAL AND APPLIED SCIENCES
OF
MIDDLE EAST TECHNICAL UNIVERSITY

SEPTEMBER 2004

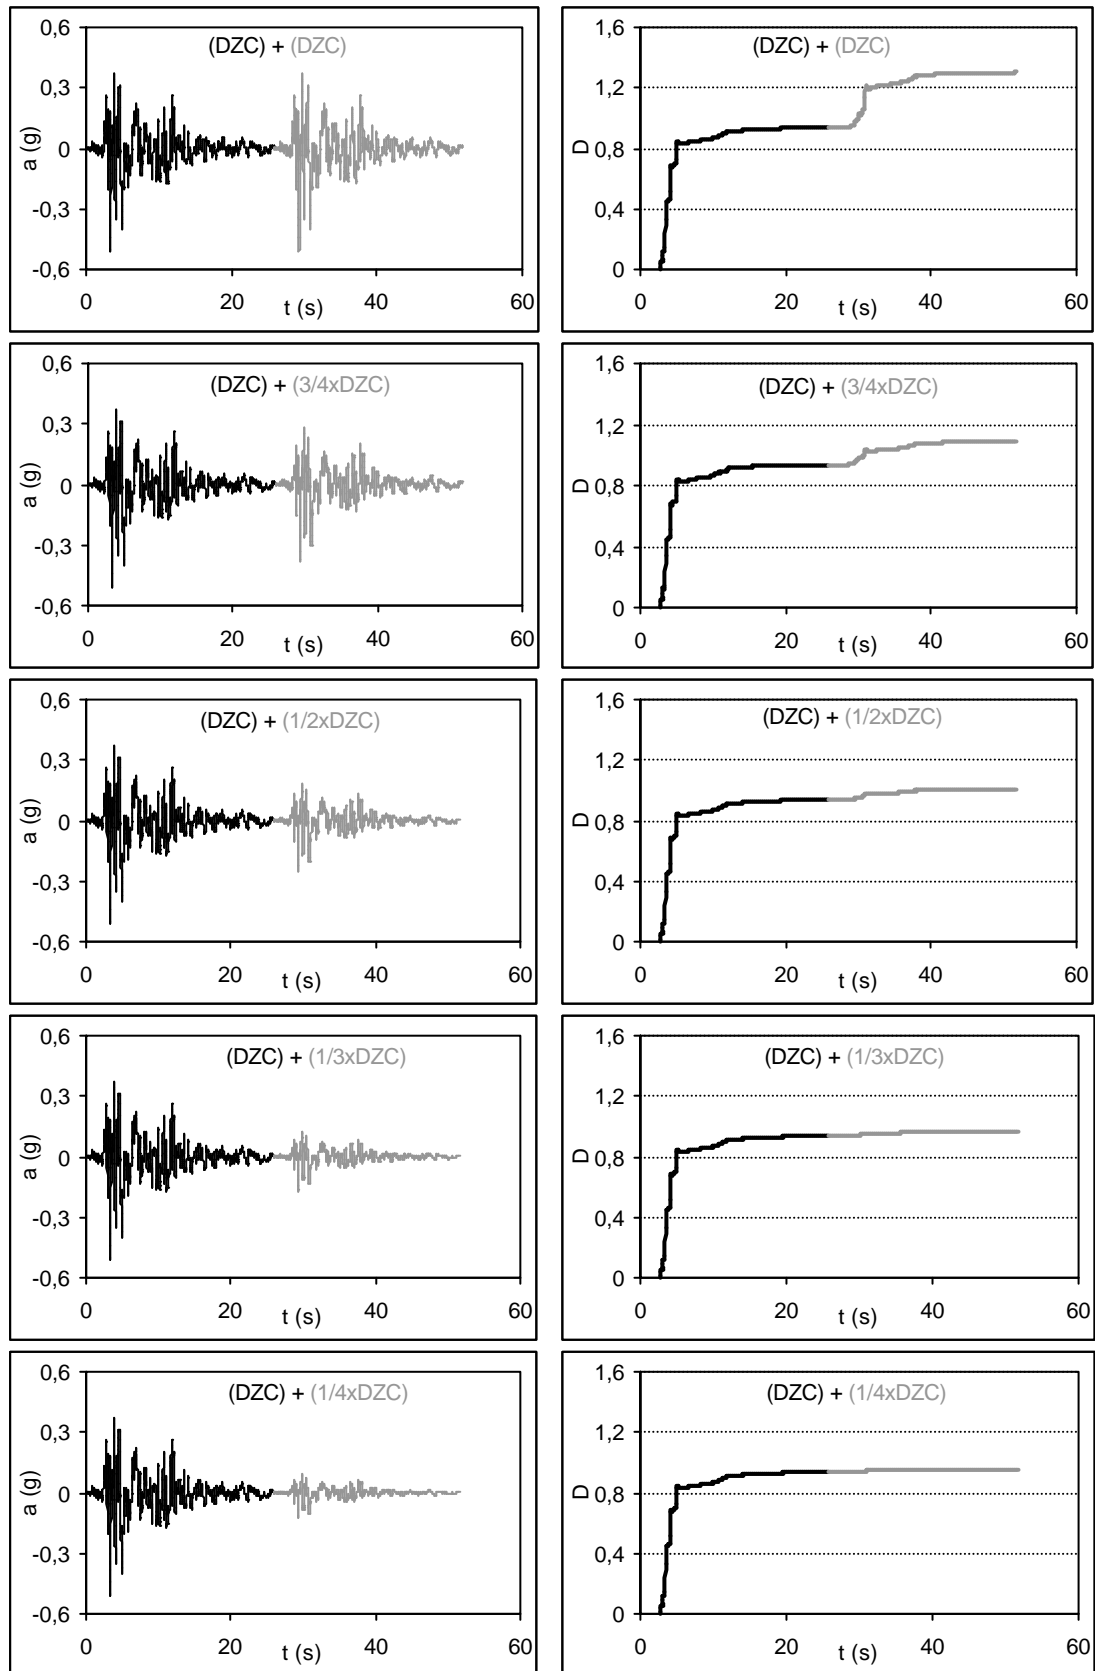
Figure 5.25 Synthetic ground acceleration histories (12 November 1999 Düzce Earthquake, Düzce Station, NS component followed by various amplitude aftershocks) and damage variation curves for Pujol column

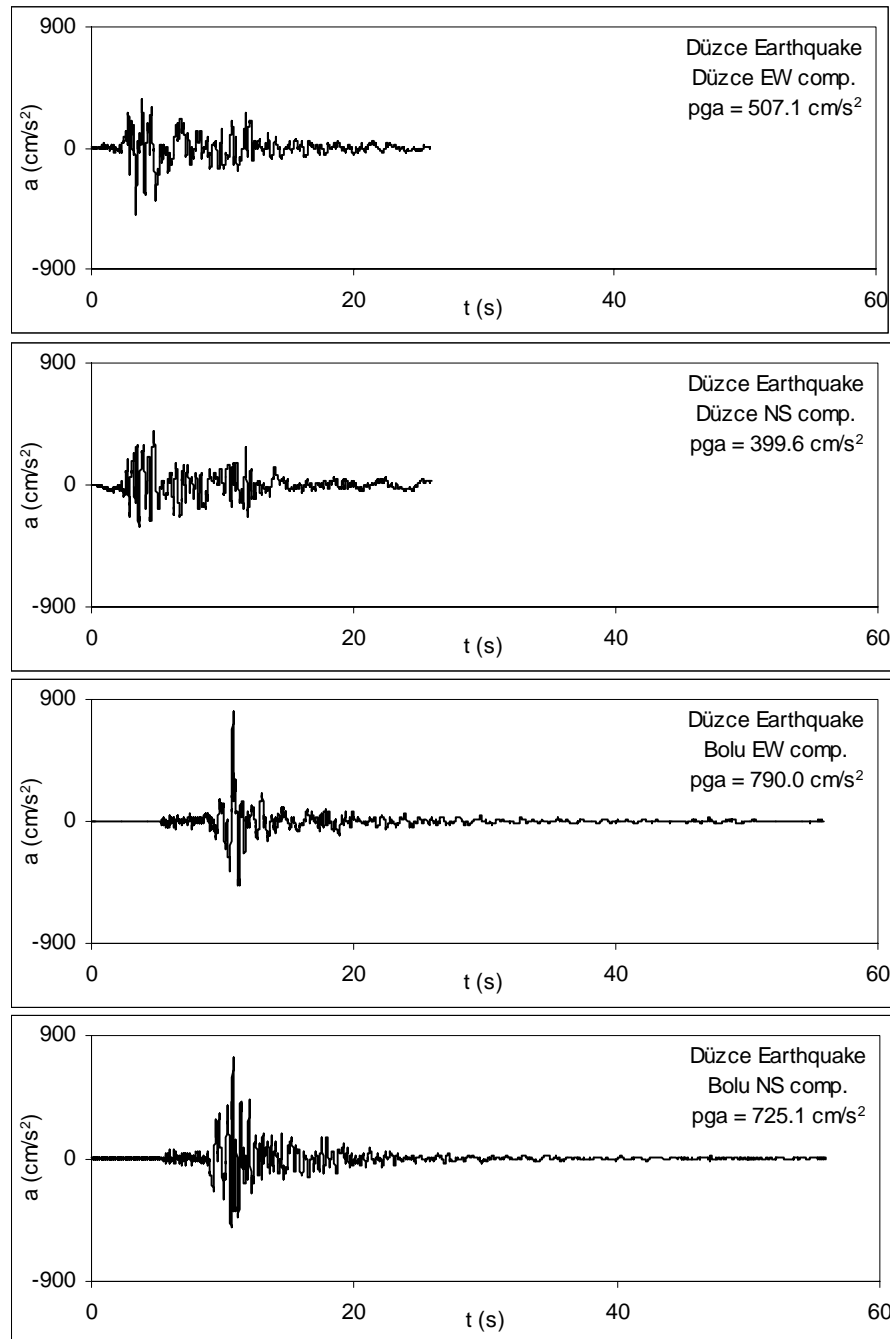
Figure 6.2 The ground motion acceleration histories of the 12 November 1999 Düzce earthquake, Düzce and Bolu records
