DEVELOPMENT OF MASONRY HOUSE WALL STRENGTHENING  
TECHNIQUES AGAINST EARTHQUAKES USING SCRAP TIRES

A THESIS SUBMITTED TO  
THE GRADUATE SCHOOL OF NATURAL AND APPLIED SCIENCES  
OF  
MIDDLE EAST TECHNICAL UNIVERSITY

MUSTAFA GÖLALMIŞ

JULY 2005

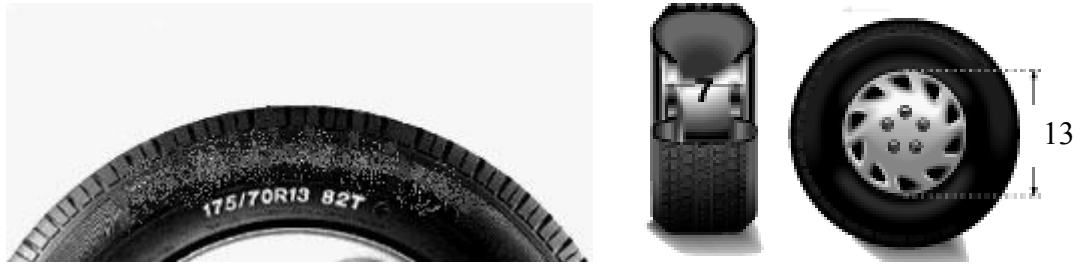
The dimensions and properties of tires are marked on the sidewalls of tires (see Figure 2.3). The numbers, 175 / 70R-13, marked on the sidewalls, denote that tread section is “175 mm” wide, the percentage of the section height to section width is “70 %” and the diameter of the rim is “13 inches (33 cm)” respectively. In addition, the number 82T gives information about pressure resistance and velocity characteristics of the tire.

**Figure 2.3** Tire marking [24]

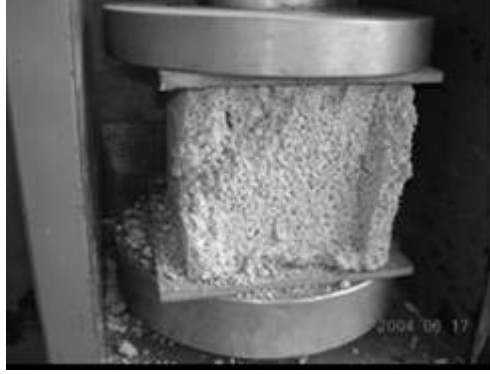
Unlike bricks, briquettes are not commonly used in the construction of masonry houses in Turkey, but they are mostly preferred in secondary construction types such as stables, huts etc. The briquettes used in this study were the type that is commercially available on the market (see Figure 2.7) with width, length, and height dimensions of 40 cm x 20 cm x 40 cm respectively. The void ratio was measured as 60% of the total cross-section area. The compression strength tests, conducted on three briquettes, showed that their average axial compression capacity was 50 kN (or 1.46 MPa) for the full area including voids.

**Figure 2.7** Briquette compression test

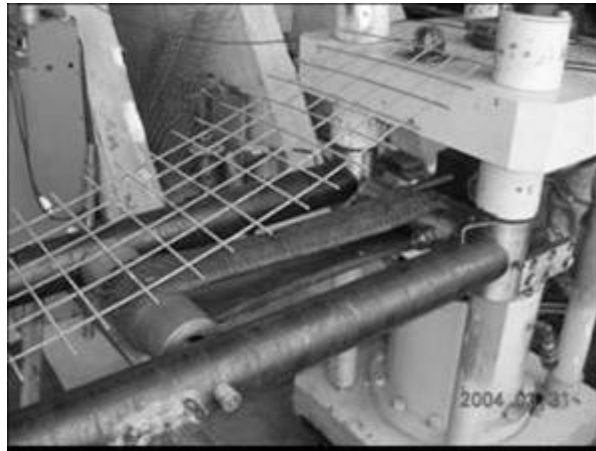
**Figure 3.3** Single-STR test

Forty-three single-STRs which belong to nine different commonly available and mostly used trademarks in Turkey were tested for direct tension (see Figure 3.3). The mean and standard deviation of ultimate tensile load capacities of STRs were found to be 132.6 kN and 27.72 kN, respectively. As well as, the minimum and the maximum tensile strengths for the tested specimens were measured to be about 90 kN and 190 kN, respectively (see Figure 3.4).

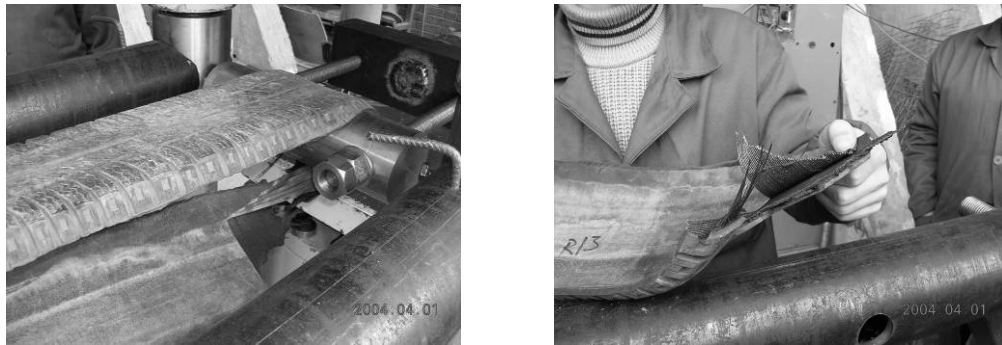
**Figure 3.5** Failure of STRs

STR specimens are tested in direct tension up to failure (Figure 3.5). Seventeen STR specimens were tested in April and May 2004 (see Figure 3.6(a)) and twenty-six specimens after being outside about one year were conducted in May and June 2005 (see Figure 3.6(b)). Visual investigation on scrap tires that are exposed to direct sunlight for extended periods of time show that sunlight has unfavourable damaging effects on the rubber of scrap tires

Although the STRs have steel mesh reinforcement inside them, the overall shape of the curves resembled the behaviour of rubber material. Bi-directional layout of the steel mesh probably affected the load resistance of STRs, and larger resistance is obtained as the reinforcing steel mesh lines up with the direction of load application. This behaviour is somewhat verified since the cross-section of each STR starts to shrink (see Figure 3.3) and fails suddenly as the load is further increased. The sudden failure of STR resembles snapping of rubber band or tensile failure of high strength brittle steel. High strength steel wire mesh is used in tires which also support the failure mechanism observations (Figure 3.5).

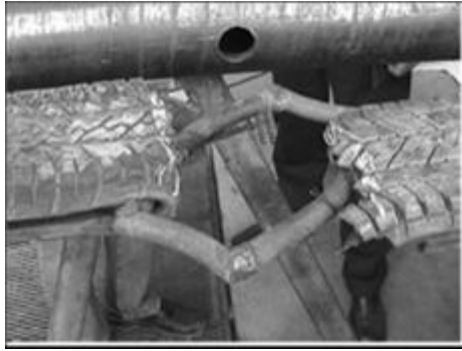
(a) ct-1

First,  $\Phi 18$  St420 re-bars welded together in a rectangular shape were used to connect two consecutive STRs (see Figure 3.7 (a)). During the test, however, the bars have bent and tore the STRs cutting like a knife. When the tensile load reach about 31 kN

**Figure 3.7** Types of connectors tested for STR

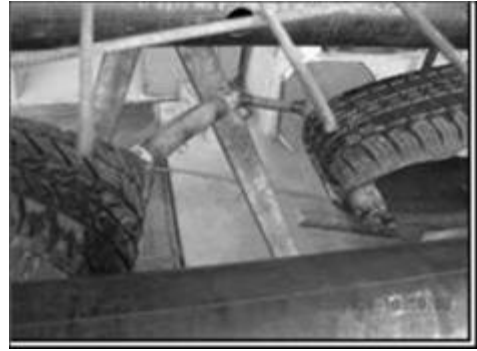
(b) ct-2

In the second attempt,  $\phi 34$  St37 water pipes were used in the connector to increase the section moment of inertia as well as to provide a larger bearing surface to reduce stress concentration on STR. The pipes were welded to each other using steel re-bars. The connection failed close to the welding on the re-bar (see Figure 3.7(b)) under about 38.5 kN of tensile load (see Figure 3.8, ct-2). The performance of the welded connection was considered poor and it was decided to use a bolted connection in the following test.

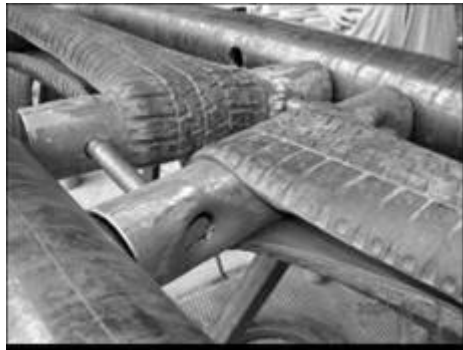
(c) ct-3

The remaining three connectors were composed of larger diameter pipes with holes on either side for passing and tightening bolts. The connector utilised in the third attempt was constructed using a pair of St37 steel pipes with dimensions of 78mm x 4mm x 380mm for diameter, thickness, and length, respectively. This connector also failed the test but its capacity was measured as 82 kN, which was twice as much as the capacity of the connectors tested in the previous experiments (see Figure 3.8 ct-3). The connector failed where the bolts punched the pipes (see Figure 3.7 (c)). As the diameter of the pipe increases, the section becomes more vulnerable to punching.

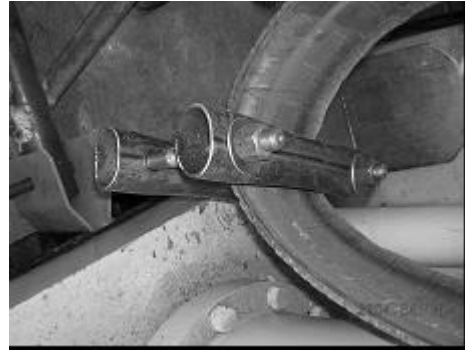
(d) ct-4

The penultimate connector design test was carried out using 72mm diameter pipes with 4mm pipe thicknesses, which has a smaller pipe diameter. Washers were used in addition to better distribute the bolt forces to prevent punching failure. The maximum tensile load was measured to be 82 kN when the STRs broke off suddenly (see Figure 3.8, ct-4). The connector design was somewhat successful since the failure was governed by the STR. On the other hand, although washers were used to reduce the stress concentration around the pipe holes and enlarge the load-bearing area, the pipe have shown indications of bearing failure around the holes of the 72mm diameter pipe (Figure 3.7(d)).

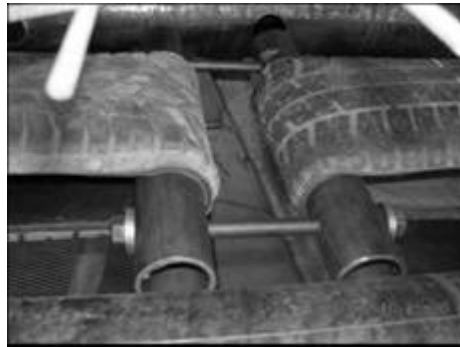
(e) ct-5

In the last connector test, the pipe diameter was further reduced to 49 mm in order to prevent bearing and punching failure (Figure 3.7(e)). The connector remained elastic and successfully transferred STR tensile forces. The hole diameters were also reduced by using smaller bolts (in an attempt to optimize the cost) and double washers were used at each bolt location. The 49 mm diameter pipe connector did not govern the STC capacity. One of the STRs have failed at about 88 kN axial force, as desired and expected (see Figure 3.8, ct-5).

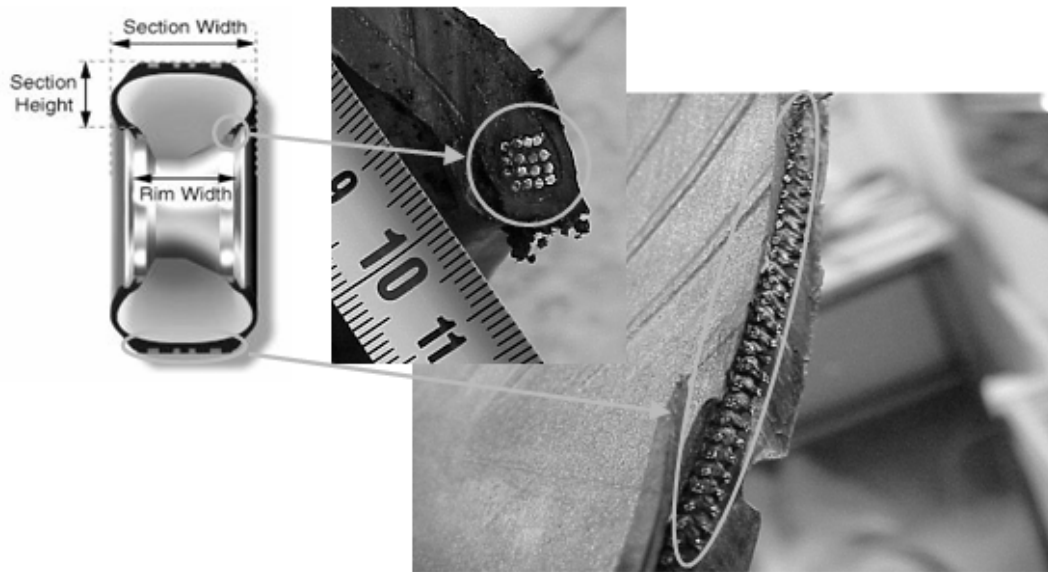
**Figure 3.10** Steel wires distribution in rim-rings compared to STR [25]

Rim-rings (also called as beads) have many layers of continuous wire hoops (Figure 3.10) and are located on either side of the tires at the rim section. In order to investigate the tensile load capacities of rim-rings, nine single rim-ring direct tension tests were conducted. The mean and standard deviation of ultimate tensile load capacities of nine rim-rings were found to be 53.5 kN and 10.9 kN, respectively. The load-deflection graphs are shown in Figure 3.11. Steel wires found in rim-rings are more densely placed compared to the STRs (Figure 3.10). The load-deflection curves for rim-rings (Figure 3.11) show similarities to tensile load behavior of high-strength steel material.

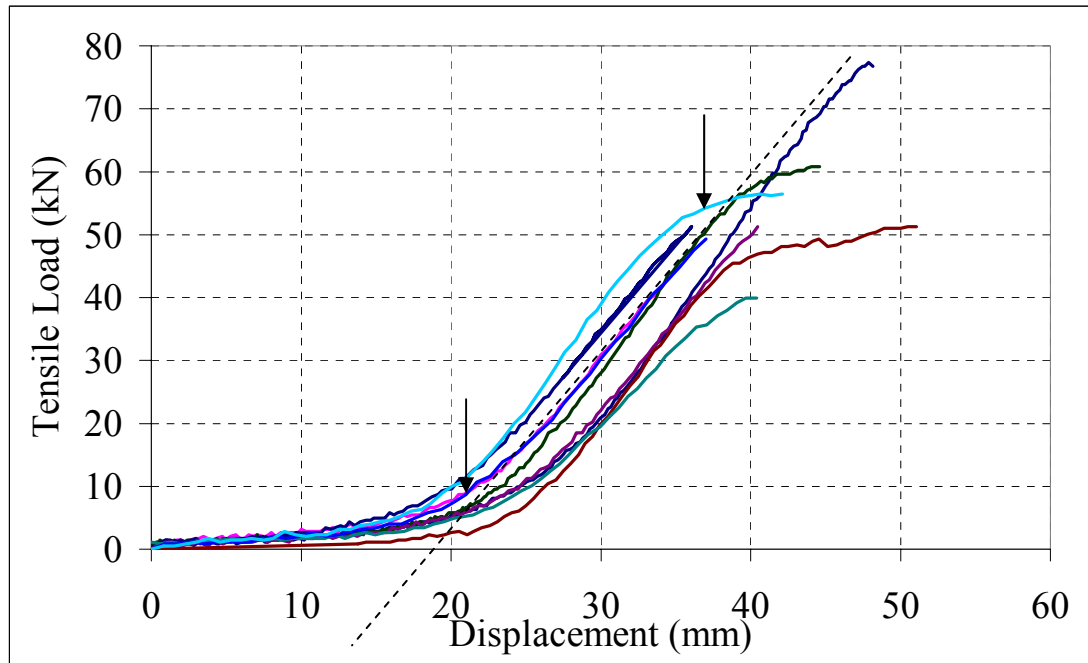
**Figure 3.11** Tensile Load vs. Displacement of Rim-rings

The initial low stiffness loading plateau is the part where circular shape of the rim-ring is straightened out and rubber material between the steel cords and tension application apparatus is squeezed tight. The high-stiffness curve observed between 20mm and 40mm deformation in Figure 3.11 is the part where steel rings take the axial tensile load. The approximate total length of a 14 inch rim ring is 112 cm. A total linear deformation of about 1.5 cm (over ring length of 56 cm) refers to about 2.6% strain ( $26\,800\mu\epsilon$ ). The tensile load capacity of 53.5 kN (2130 MPa) relates to a ultra-high strength steel level (considering the example shown in Figure 3.10 with a total number of  $2 \times 16$  rim-ring wires of  $\phi 1$  mm diameter located on either side of the ring for a total area of  $32\text{ mm}^2$ ). The High-Alloy Hardenable Steels and Martensitic Stainless Steels have yielding capacities of 1240 MPa and 1750 MPa, respectively [27]. Ultra-high strength steel types may have ultimate strength as high as 3500 MPa [28, [29]. Although exact steel type used in rim-rings is not known, based on the low-ductility (about 2.6%) and ultra-high strength (about 2130 MPa), the rim-ring wires are expected to be one of the two types mentioned above or their similar equivalents. The tensile capacity of the rim-rings is affected by the brand name; however, the level of deterioration is not expected to have a great influence on the

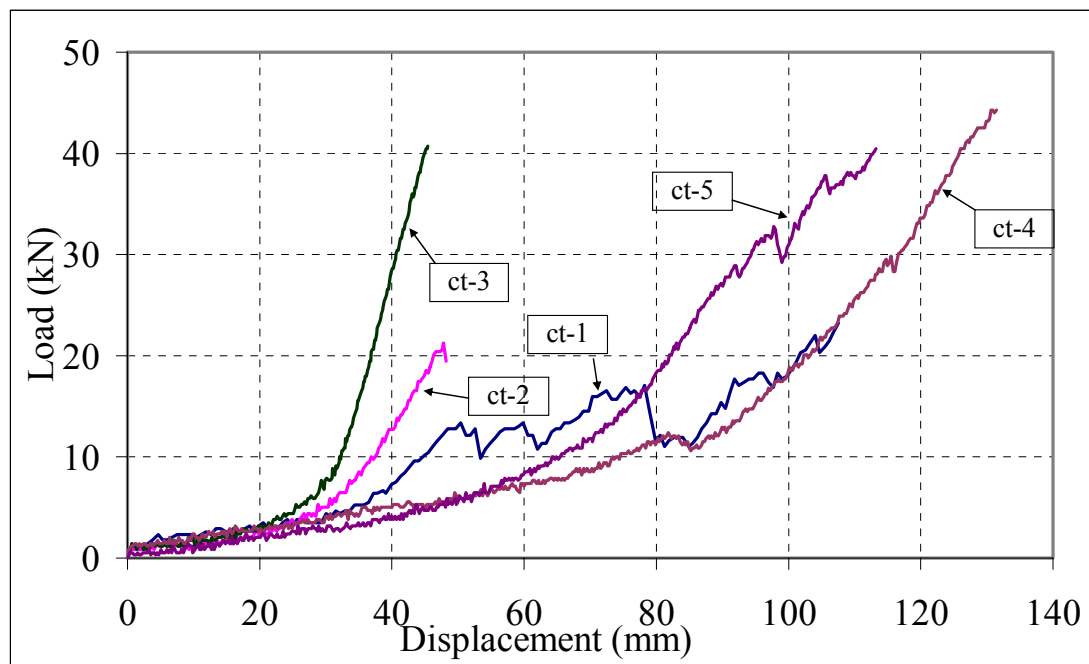
**Figure 3.12** Tensile Load vs. Displacement of Connected Rim-ring

Similarly to STRs, A chain of rim-rings can be used to apply post-tensioning. The connection between the rim-rings should be capable of transferring the axial load to the next rim-ring. Furthermore, the connector should be thick enough not to damage the rim-ring and therefore prevent a premature failure. Five connection design tests were conducted in order to achieve adequate strength in rim-ring connections. The first two attempts to bond two rim-rings were made by passing rim-rings inside of each other to form a knot (Figure 3.13 (a), (b)). Excessive bending and stress concentrations at the knot joints caused premature failure of the connections at about 20kN (see Figure 3.12, ct-1) as cracking and snapping sounds were heard. The single rim-ring tension tests revealed much higher capacities, 53 kN on average.

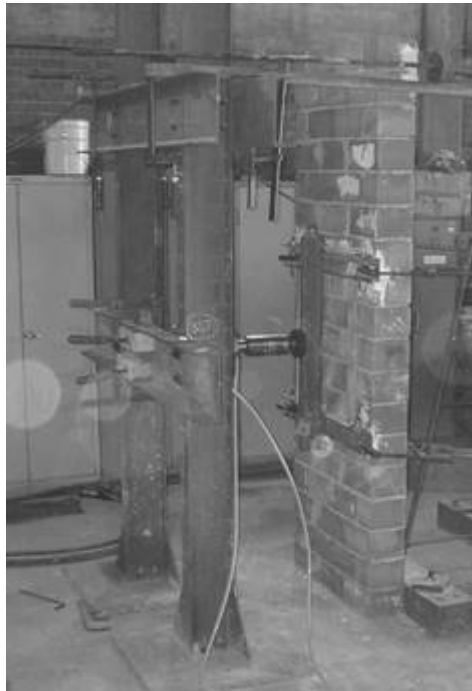
Six masonry wall strips (four brick and two briquette wall strips) were constructed by an experienced mason in the Structural Laboratory of Civil Engineering Department at METU. The width of each brick wall strip was equal to the length of three bricks (885 mm in total including approximately 7.5 mm of mortar thickness between the bricks). The thickness of the walls was 185 mm, and the distance between the supports was 2500 mm. The height of the wall was 2600 mm comprising of 18 brick layers including 10 mm-thick mortar layers (see Figure 3.15). The distance between the middle load application points (Y) was 800 mm leaving about 850 mm of distance (X) to the outer supports (see Figure 3.14 (a)). On the other hand, each briquette wall had length of 2.5 briquettes length (about 1000 mm including mortar), 200 mm thickness, and a distance of 2400 mm between the supports. A total of 12 briquettes layer were used in the vertical direction with about 10 mm mortar thickness in between equaling in total height of 2500 mm. The distance between middle load application points (Y) was 800 mm leaving 800 mm of distance (X) to the outermost supports.

**Figure 3.15** Brick wall

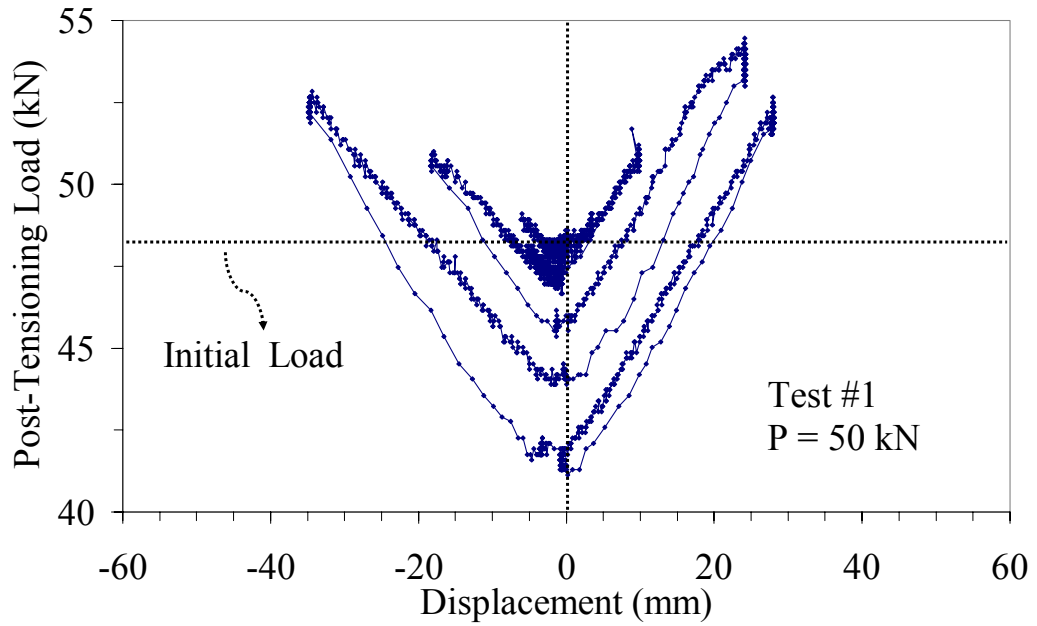
**Figure 3.23** Axial post-tensioning force versus horizontal displacement of stage#2

related to lateral displacement ( $\Delta$ ) using triangles ( $\hat{abc}$ ) and ( $\hat{dea}$ ) as shown in Figure 3.24 (b). Crack opening displacement ( $2\delta$ ) causes stretching of the post-tensioning STC, which increases the post-tensioning load (see Figure 3.23).

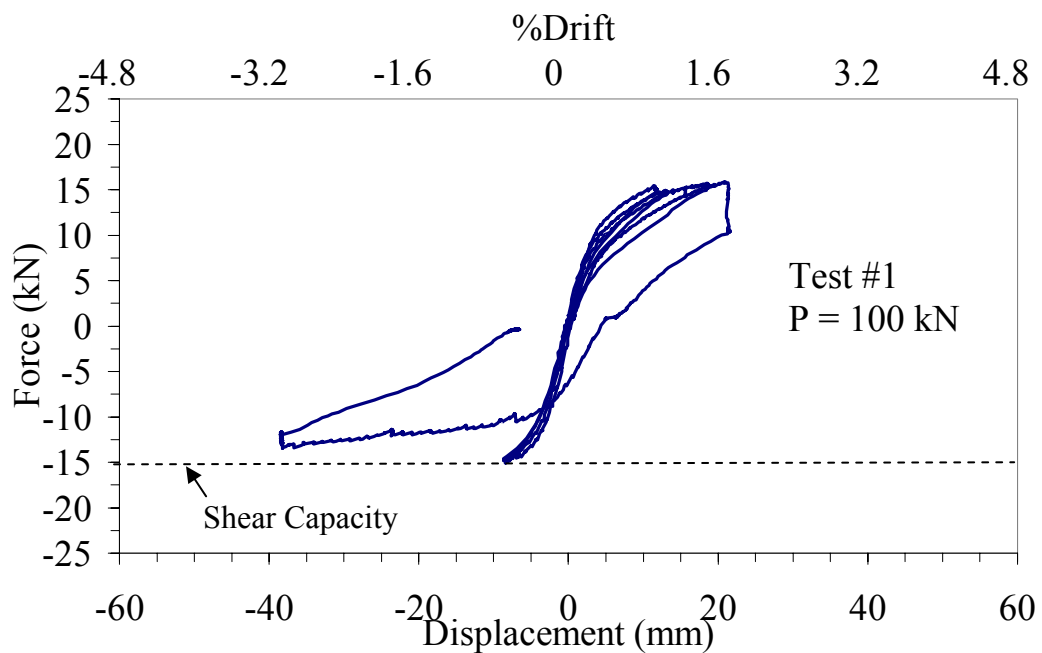
**Figure 3.25** Third stage test results of the first brick wall

crack was opened. The ultimate capacity was measured as 15.8 kN when the lateral displacement reached 21.3mm (see Figure 3.25). Premature failure was initiated by diagonal shear cracks at the base of the wall when -38.3 mm displacement was applied in the reverse loading direction (see Figure 3.19 (c)). The post-tensioning load level dropped down to 47 kN from the 97 kN initial load (see Figure 3.26 and Figure 3.27) as the scrap tire crushed the bricks at the bottom of the wall (at the location of stone). A half-cylindrical wooden log was used in the second test to evenly distribute stresses from the STR to the wall thus preventing premature failure.

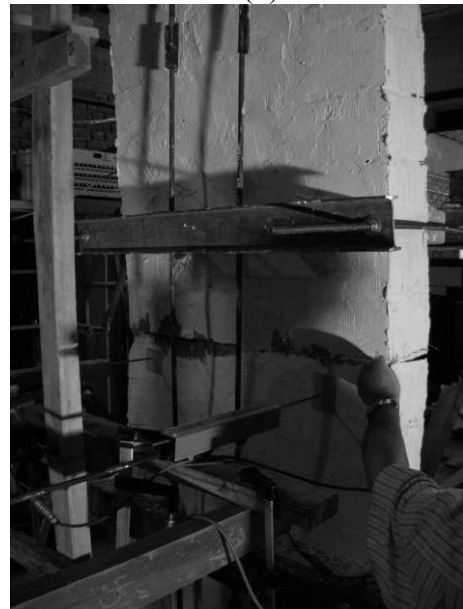
The first crack was formed in the stage #1 (0 kN axial load) on the mortar layer located closest to the upper leg of load application frame (Figure 3.47 (a)). In the second stage (50 kN axial load), this crack was re-opened and followed by additional small cracks at the middle range of the walls (Figure 3.47 (b)). Since the maximum lateral displacement of the wall in stage #2 (50 kN axial load) was kept smaller than 5 mm, excessive damage to the wall was prevented. In the third stage, the lateral displacement of wall was increased up to 50 mm (4% drift ratio). The crack formed in the second stage at the middle layer was opened again as seen in Figure 3.47(c)&(d).

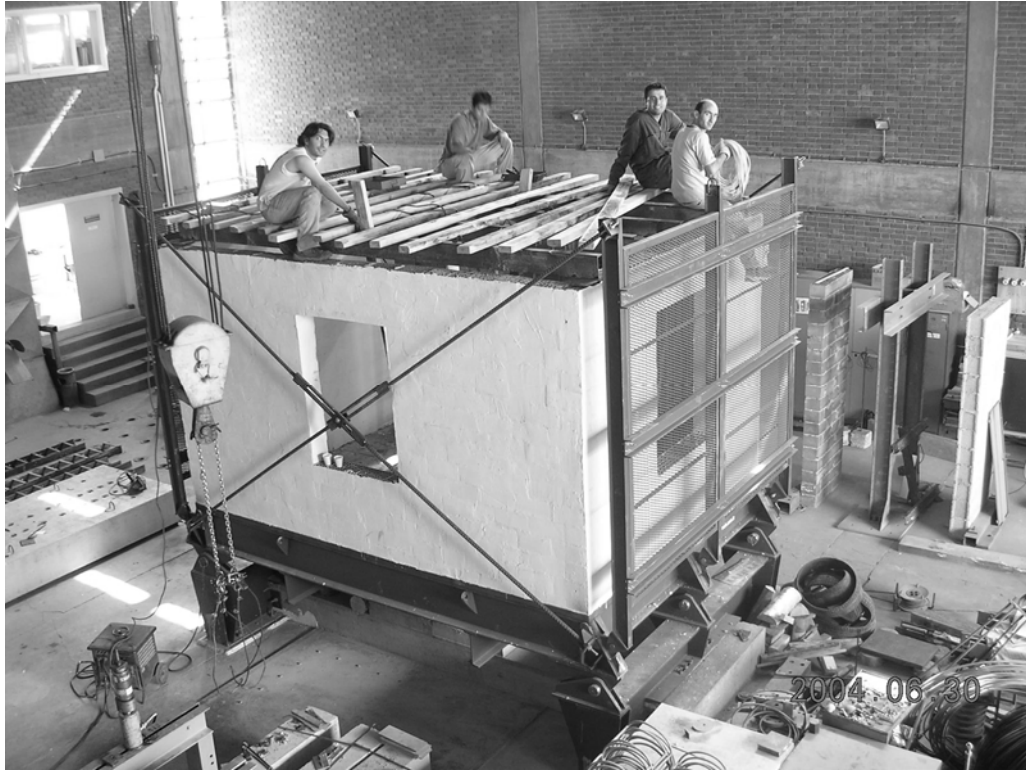
**Figure 3.68** Masonry house roof construction

In order to simulate the weight of the roofs found in practice, both models were subjected to 55 kN roof weight carried by five INP-260 sections on reciprocal walls in the tilting direction (Figure 3.68). In the unstrengthened model, sand bags were used as a substitute of the soil-type roof mass in practice; whereas, in the strengthened model, two concrete blocks were used to substitute the same mass for simplicity of placement-removal process and also to provide additional security during the test. The second specimen was post-tensioned by applying Sacs in vertical and horizontal directions (9 Sacs in vertical and 1 STC in horizontal direction). The application of bi-directional post-tensioning was determined after examination of the damage pattern of the first original model test (see Figure 3.75 and Figure 3.76). The strengthening operation in both directions was applied as follows.

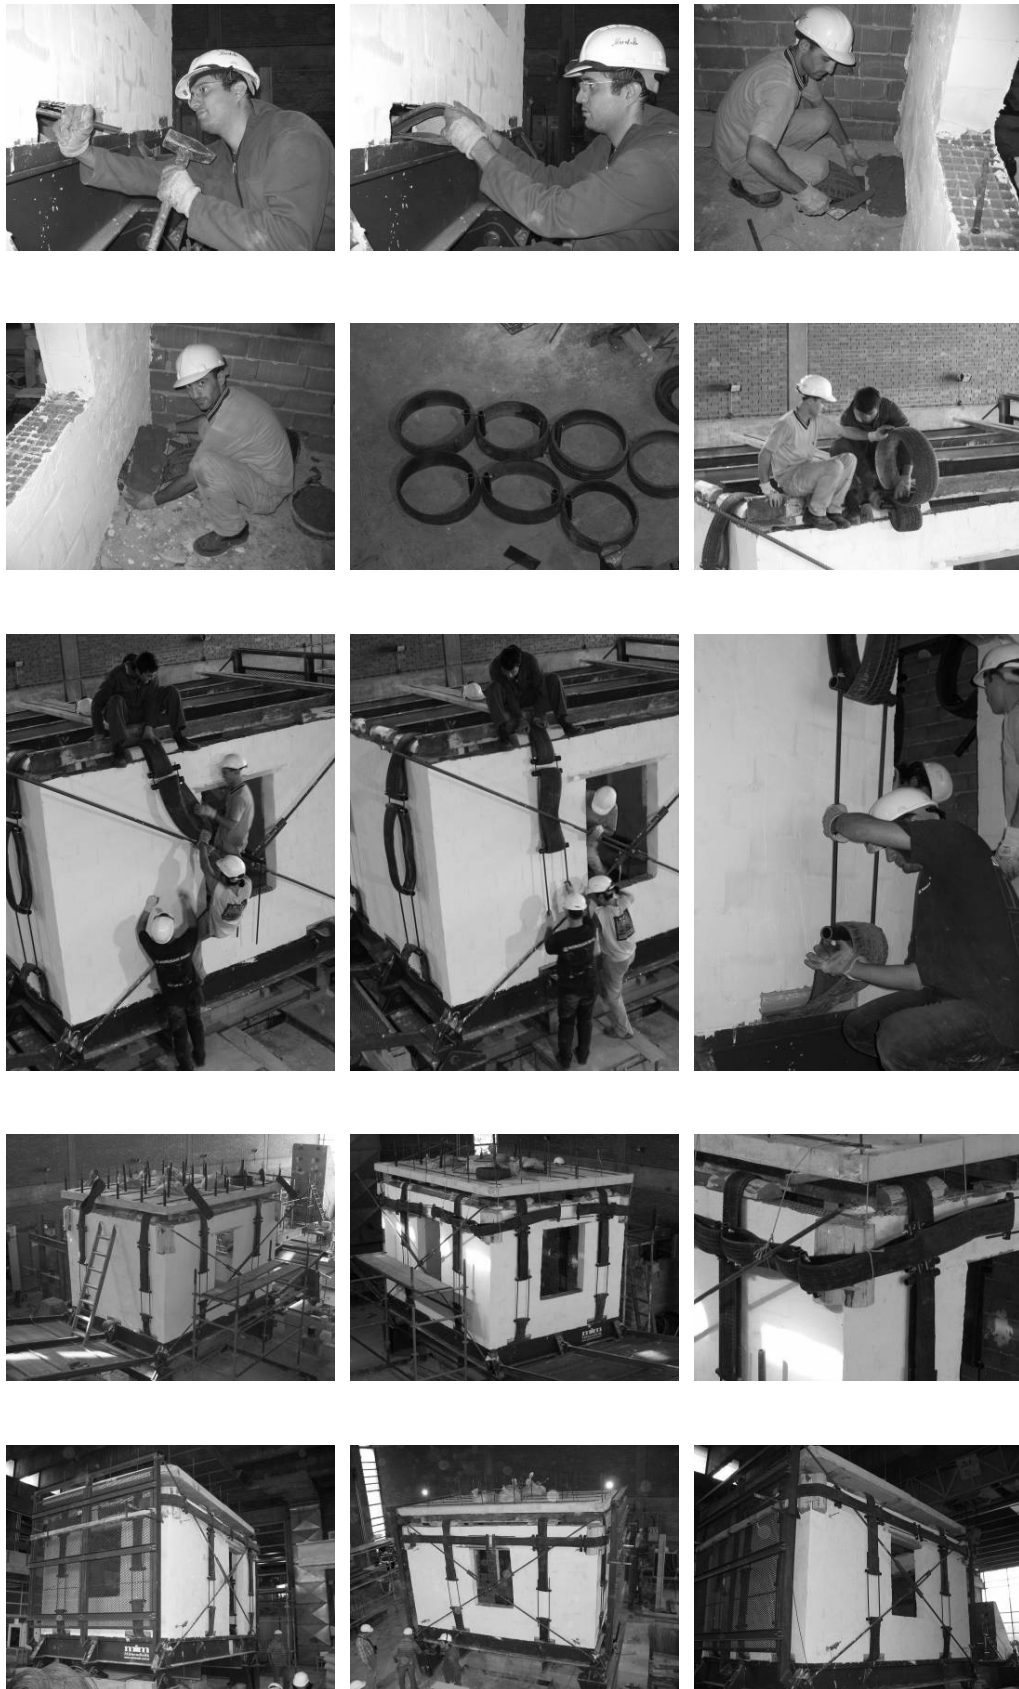
**Figure 3.69** Strengthening operation of the test specimen

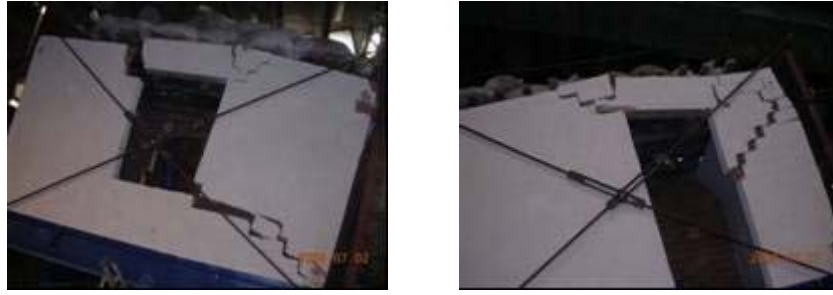
**Figure 3.75** Diagonal Cracks on in-plane walls (Model #1)

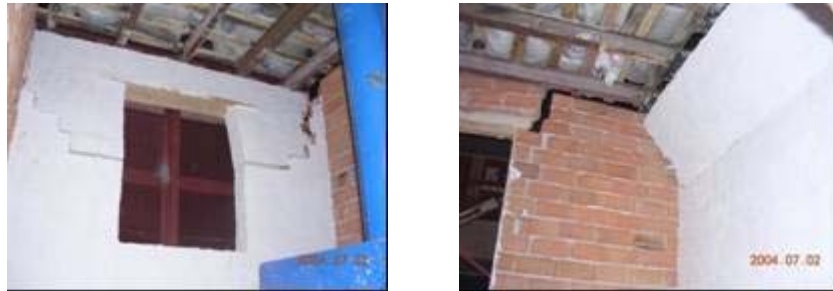
The crack formations commenced around the corners of the window and the door when the level of the shear stress reached to the limits of the walls in the in-plane direction (see Figure 3.75) and progressed diagonally. The failure of in-plane walls exposed the out-of-plane walls to an increased load and deformation demand beyond their limits thus leading to a sudden and progressive total collapse of the house. The crack formations following the collapse of the masonry house are shown in Figure 3.75 and Figure 3.76.

**Figure 3.76** Diagonal Cracks on out-of-plane walls (Model #1)

The position of the post-tensioned forces applied on the walls of the second model by Sacs in Figure 3.78 were determined by the results of previous experiments where shear stress concentration for in-plane walls and bending moment concentration for out-of-plane walls were maximum (see Figure 3.74, Figure 3.75 and Figure 3.76). 50 kN and 25 kN post-tensioning force were applied on the walls in the vertical and horizontal directions respectively. The magnitude of post-tensioning force was determined according to the strength properties of materials (i.e., STR, brick and mortar) and out-of-plane test results.
