IDENTIFYING THE VALUES OF
KÜÇÜKBAHÇE VILLAGE THROUGH ITS ARCHITECTURE AND
COLLECTIVE MEMORY

METU
2007

A THESIS SUBMITTED TO
THE GRADUATE SCHOOL OF NATURAL AND APPLIED SCIENCES
OF
MIDDLE EAST TECHNICAL UNIVERSITY

IN PARTIAL FULFILLMENT OF THE REQUIREMENTS
FOR
THE DEGREE OF MASTER OF ARCHITECTURE
IN
ARCHITECTURE

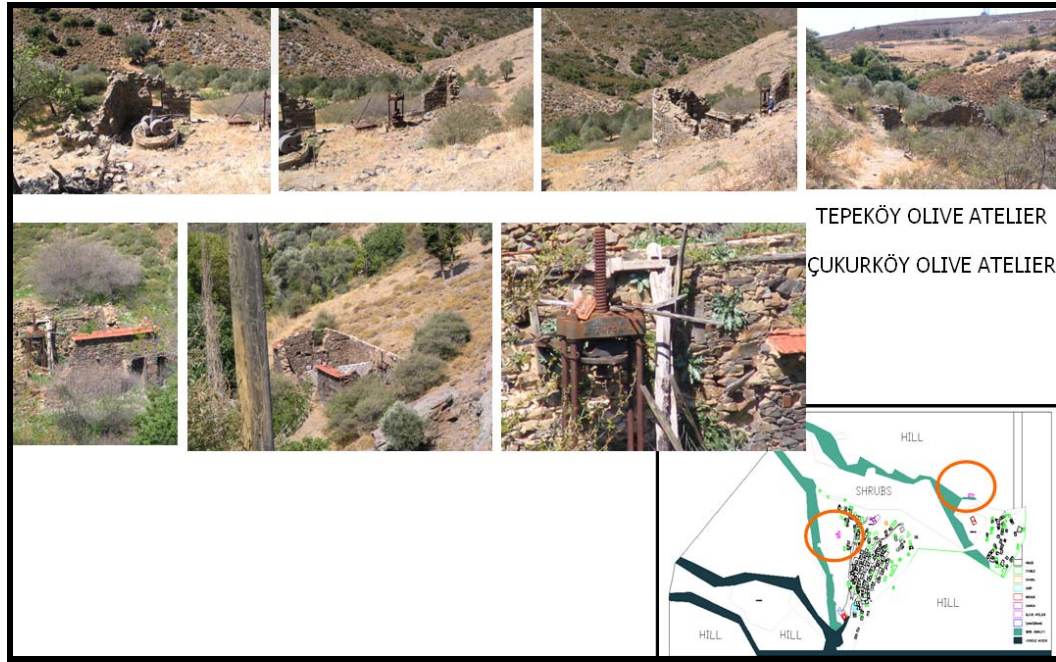
Figure 19 Olive oil mills

As the recent locals of Küçükbahçe stated, the mill in Çukurköy was in use until 1970s when it caught fire, it got abandoned after. As the ruins show, they both have a similar form of a rectangular space constructed by stone masonry with a pitched roof covered with tiles. In both mills, it can be perceived that the rectangular space is divided into different parts by short walls. They are equipped with different materials at different levels, giving clues for different uses. A metal screw type press and grindstone are the equipments that take place in different sections. Basing on the givens of the mills in Küçükbahçe, the system resembles to the mill in the study of Brumfield (2002: 79). As Brumfield states, basing on a study on the evolution of olive oil production methods and depending on the equipment being metal and advanced, the olive oil mills were in use in mid 19th century which juxtaposes with the date existing on one of the presses in Küçükbahçe as 1884. (Brumfield, 2002: 79) As she explains, the mill's location was to be near a water source due to the need of a lot of hot water for olive oil producing, which justifies the function of buildings in Küçükbahçe being olive oil mills and gives clues on the existence of a fireplace space in ateliers. Current traces of these buildings resemble the descriptions defined by Turan-Hamamcıoğlu (2005: 4) for Saip Village mills near Küçükbahçe.

Following, olive and olive oil producing was as important as viticulture. Though no information comes from the OTR, two olive oil producing ateliers with collapsed structures but occupying equipment with Greek writings still exist in Küçükbahçe. One sits at the lower part of Tepeköy, edging the *Hamamlı Dere* and the other sits, at the lower level of Çukurköy, siding the *Kovanlı Dere*.

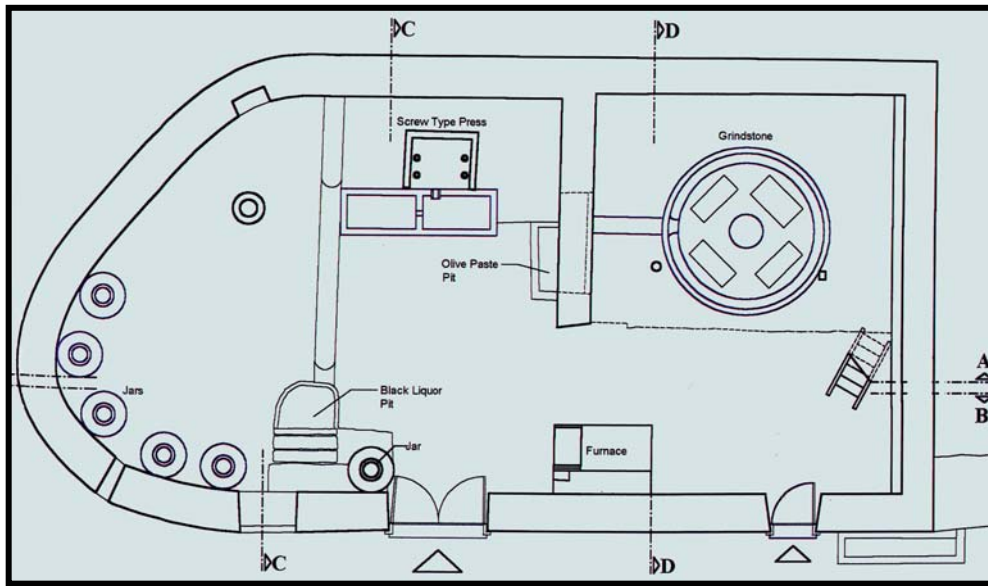
Figure 21 Spatial organization of the ground storey, Mill 1, Saip, restitution (Turan, 2005: 2)

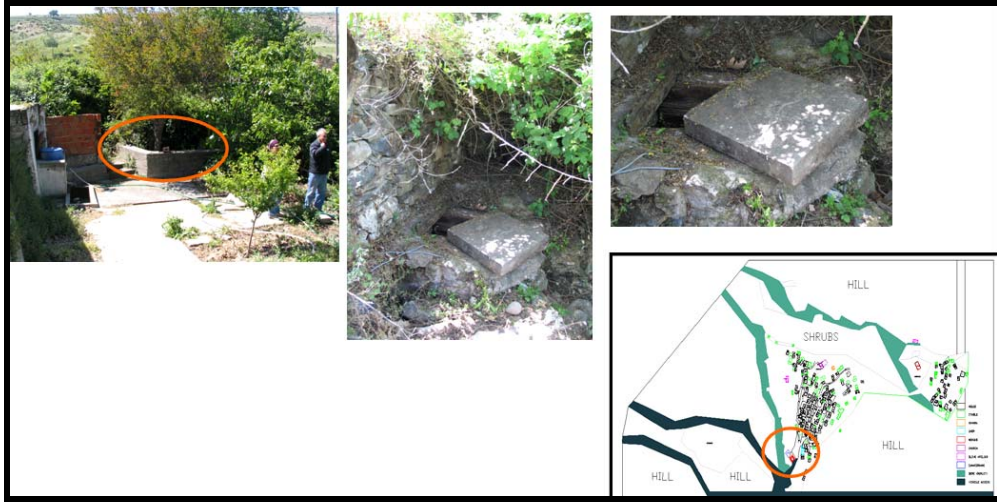
Figure 37 Ruins of foundation walls of Çamaşırhane, near Hamamlı Çeşme

The existence of çamaşırhane is known but is almost forgotten by the recent locals of Küçükbahçe, probably, due to its lost structure besides the ruins of its foundation. However, a more detailed information has given by OLK2 and with a remind, the missing information on its place and use is being told by RLK1. Additionally, existence of a *hamam* or *çamaşırhane* is no unexpected regarding the runlet, flowing by siding the ruins, to be named as Hamamlı Dere and the fountain, just being near the ruins, being referred as Hamamönü Pınarı both in testimonials of old *Rum* and recent Turkish locals. For the OTR, OLK2 had told about existence of a *çamaşırhane*, which, she had noted, to be a hamam before. OLK2 had described it as: “There was a rectangular room. It had no roofing structure. It had sinks both from inside and outside. There was one *gourna*⁶⁷ in this room and it was surrounded by marble seats. Both Turkish and us were going to this *gourna* to wash.. In this room there was also a place to put the cauldrons and heat the water...it was said that before this was a *hamam* but we couldn’t reach it. It was very close to us”(Appendix B: 150).

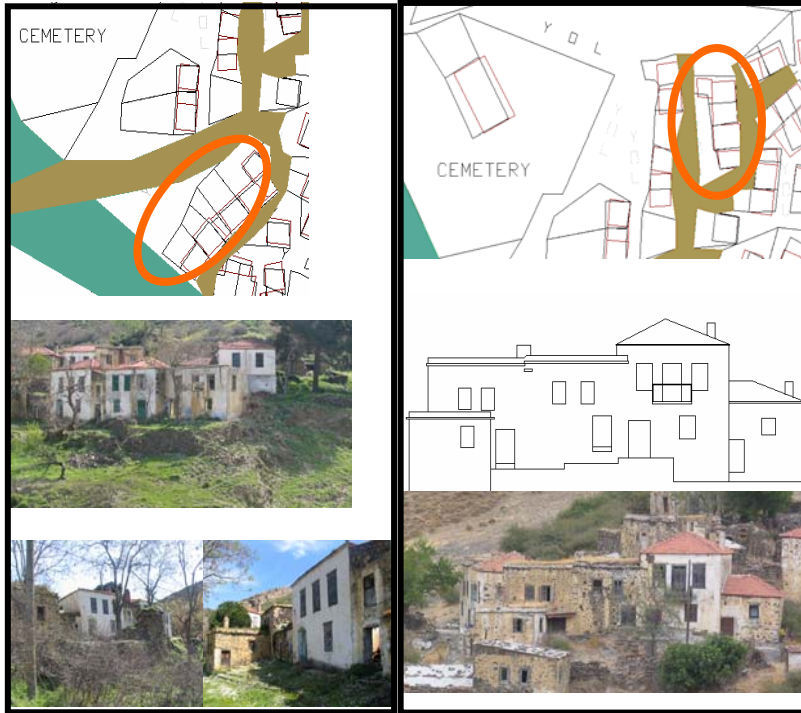
Figure 39 Attached houses, no: 163-164-165-166-67, in Çukurköy that sit 1/1 to the lot

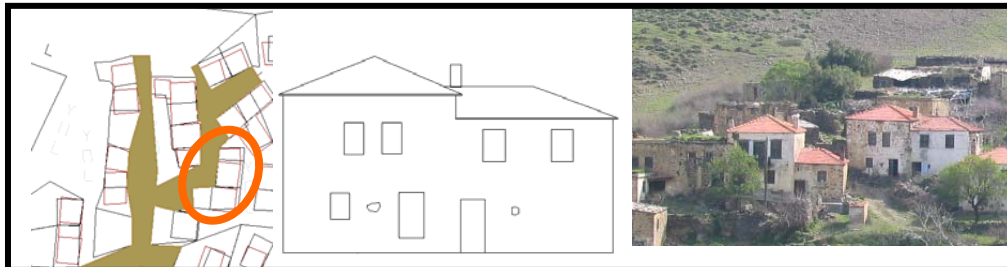
Figure 41 Two adjacent houses, no: 168- 169, in Çukurköy; 168 sits 1/1 and 169 sits about 1/2 of the lot

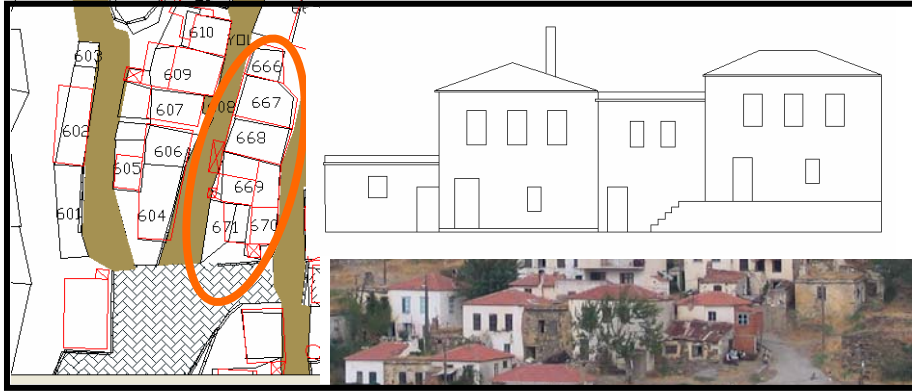
Figure 42 Attached houses, no: 93-94-95-96, in Tepeköy that sit 1/1 to the lot

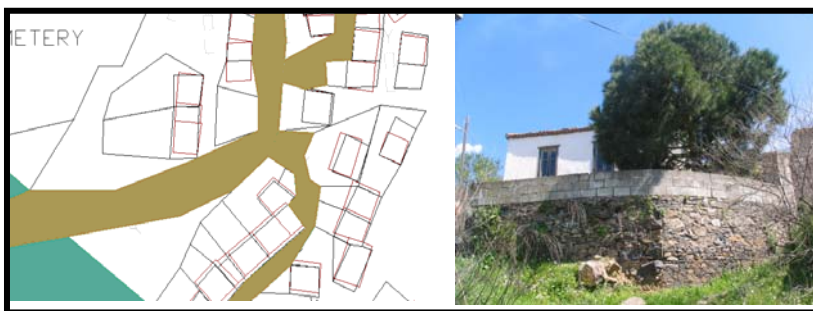
Figure 44 Two single houses, no:191- 192, in Çukurköy that edge the paths

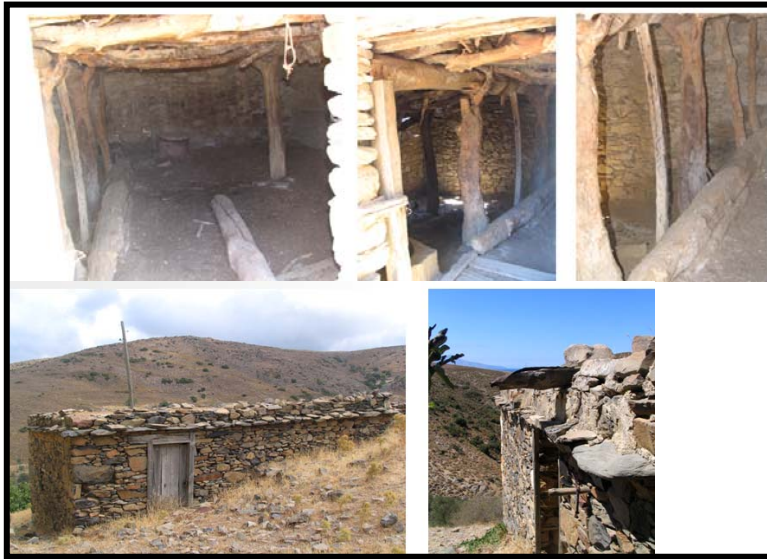
Figure 45 Outside and inside of a common type of stable

As being numerous as houses, even in the existing pattern, the stables have a role in formation of the settlement pattern of the village. The stables are mostly one storied and, similar to houses, are stone masonry with flat timber roof with earth covering. They are either small and in the village or large and out on the borders of the village. However, RLK5 stated that they had stables with two storeys in which they would keep the crib in the upper floor and animals in the ground floor. RLK5 also noted that while Turkish families had their mules and cows in the stables near their houses to take care of, *Rums* had their stables for their porks under their neighborhood.

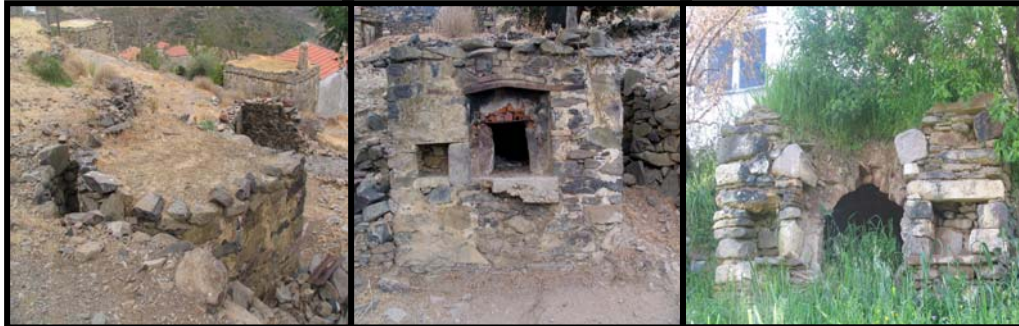
Figure 46 Bakery ovens are constructed of stone masonry

going through small rooms on terraced roof of these one storey spaces. However, no example of these rooms exists today. In addition to all, they bakery ovens accompany houses as common spaces or private to themselves.

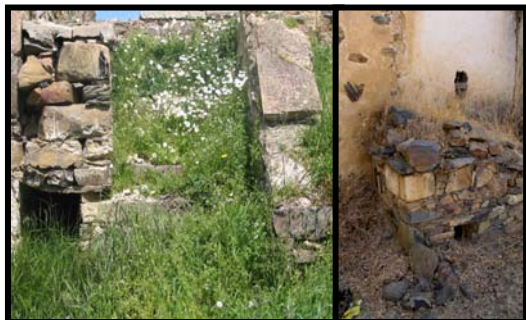
Figure 47 Coops are attached to the front façade and accompanied with *folluk* holes or fitted to the space under outdoor stair of houses

Among the group of built up spaces described above, coops are the inevitable elements of houses. In most of the houses, they seem as if randomly placed adhoc spaces but in deed, they are characteristic elements of front façades with *folluk* holes.

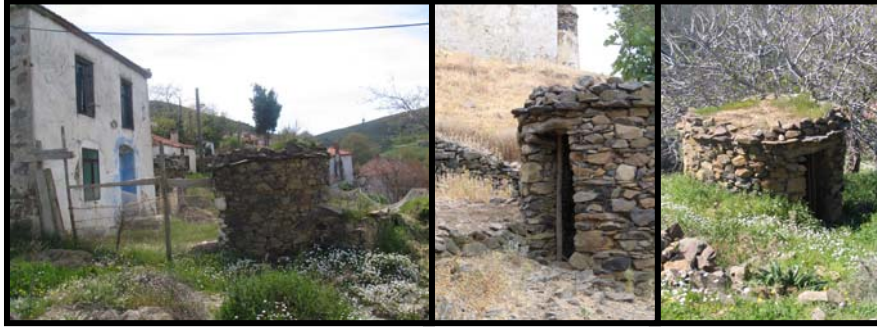
Figure 48 Circular buildings constructed of vernacular technique and material

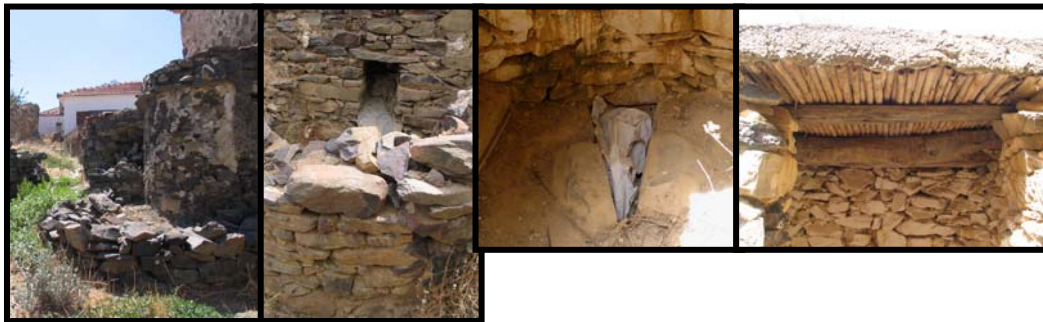
Figure 49 The circular toilet spaces are surrounded by a shorter stone wall which edges the in between space that is full with earth

Following, the circular toilet spaces are attached or single units. They are akin to the construction technique and material use of houses as being stone masonry and having an earth covered flat roof.

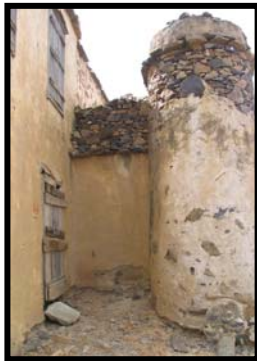
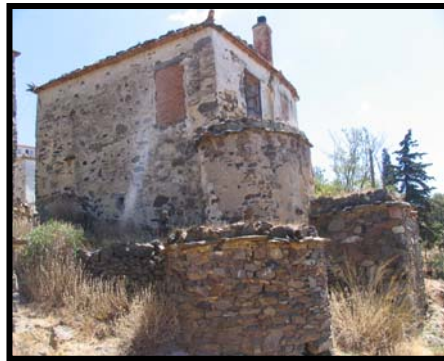
Figure 50 The attached combination of house-stable – circular toilet space. The distinction in the placement of the circular space affects its mass, too. The ones attached to the stable are mostly two storied and the separate ones are single storied.

Having explained the stables before, the group of built up spaces accompanying the house have unity and coherence in construction technique and material use among themselves and with houses. However, the combination and layout of these built up spaces together with the houses have variety.

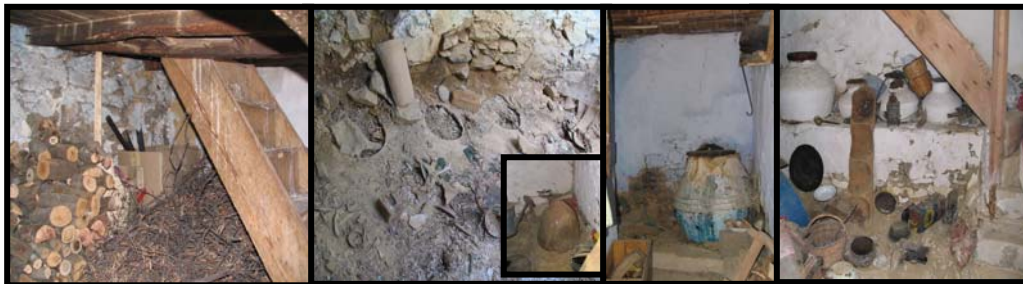
Figure 52 Depot spaces in ground floors

Complying with above, the ground floors are single spaces as depots, they store wood logs, agriculture equipments and built in baked earth cups. The space is divided in perception by a timber column standing in the center, in the houses that owe, and by a change in the floor decking, which is earth after the line of the first step of the stair and timber planks in the front, entrance area. If a hearth exists in the ground floor, it locates on the section with timber floor decking. Additionally, a stone platform either lies adjacent to the wall and under the staircase or make an L shape covering also the perpendicular wall to the wall where the stair sides. It is altered about 60 centimeters and pierced with holes to inhabit the cups. Besides, the wood logs and equipments are kept randomly.

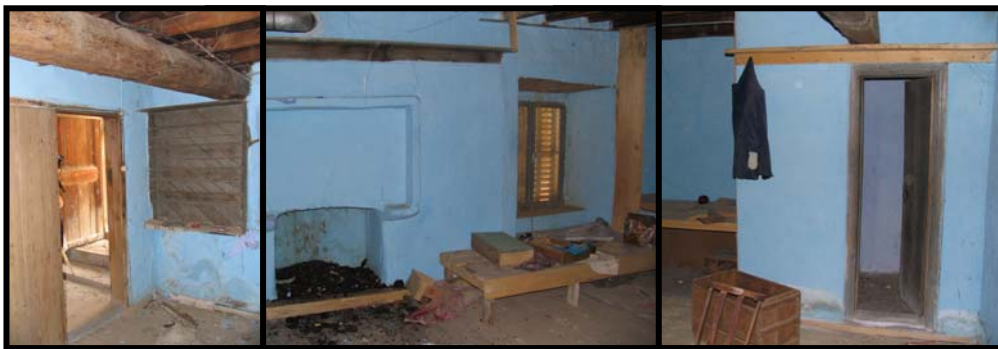
Figure 53 Elevations of the interior walls of ground floor rooms

wall of the room which is also a part of the back side of the house is being shared by a built in cupboard and a bath space which is enclosed by a timber plank partition or a stone wall. Additionally, the wall facing the entrance of the room, which is also the perpendicular wall of the front façade, locates a hearth with niches and shelves. The rooms are mostly illuminated through the window openings on the wall of the front façade. This window opening niche is also utilized as a washing space. It occupies a carved base with a hole at its exterior wall end that lets the poured water out. This washing space also locates as a niche at the front wall or one of the side walls. The washing niche takes place both at ground and/or first floor.

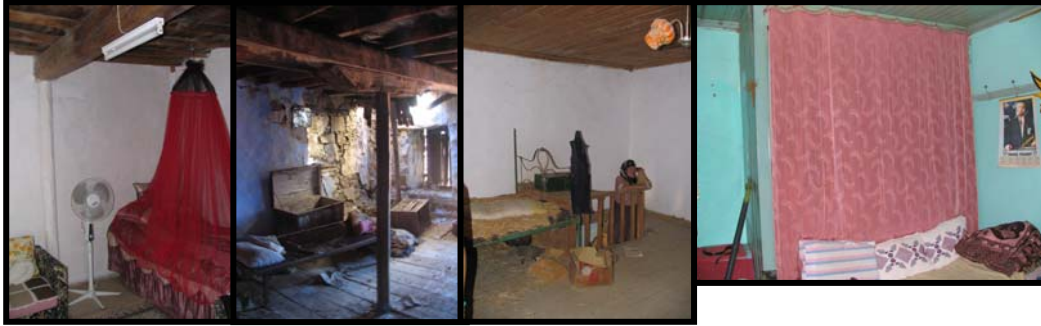
Figure 54 Use of first floors are as bedroom and living space

Following, the first floors are used as or carry the traces of being used as living spaces. They are either a single space or intervened to have two or three rooms. The single spaced first floors are used as bedroom and living room in change but in the divided first floors all the rooms are used as bedrooms while the living room gets transferred to the ground floor room. Usually one hearth exists in most of the first floors, except the old houses, which have gone through less intervention, that have a hearth in the ground level. The lavatory space for washing adapted to a window opening exists in most of the single spaced first floors while this use is enhanced by an addition of a bath space as a separate niche on a corner of the first floor. This is usually more common in less intervened houses which have single space in both floors.

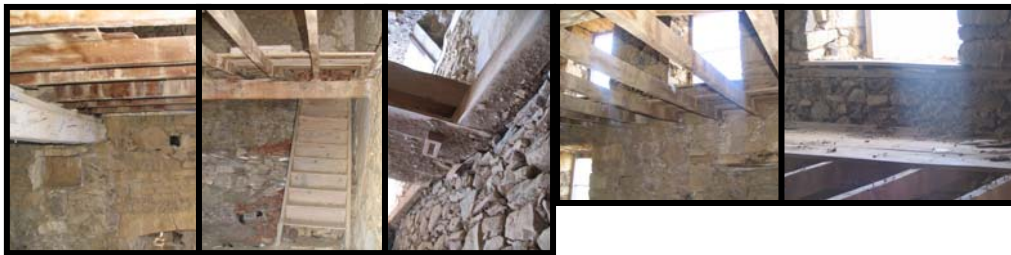
Figure 57 10 to 12 centimeters difference in the width of the ground and first floor walls is utilized as a base for the perpendicular timber beams of the floor of the first storey

The envelope of houses is of stone walls. As OLK2 had stated and a local of Küçükbahçe had told similarly “they were first putting mortar in between inner and outer walls and then were filling the in between space with gravels to abound the walls.”⁷⁸ The size of the walls, forming the envelope, range from 60 to 70 centimeters at ground floors and from 50 to 60 centimeters in first floors.

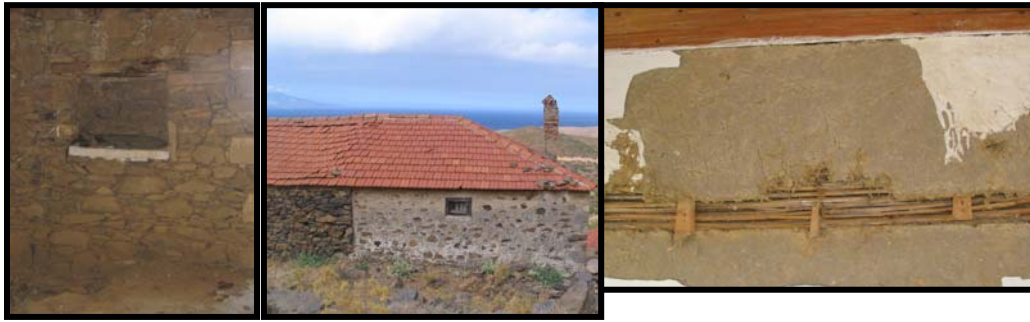
Figure 58 Inside and outside of an exterior wall is constructed with same stone and technique. The partition walls are applied in the traditional technique

Additionally, RLK6 explained how to construct an inner wall and what materials to use for interior and outer wall mortars. Accordingly, an inner wall that has a width of 13 to 22 centimeters, was constructed by pinning of straw horizontally on two sides of timber columns, leaving the in between space empty and then covering the straw surface with mud mortar and applying a smooth surface over. They were to make the wall surface coverings by applying two layers of mortar and lime based plaster over. As RLK6 told they were to prepare the first layer of mortar, that they call mud mortar, by mixing sand and thin straw pieces and the second layer by using sand with small and thin particles and lime. RLK6 noted that they would apply the second layer for about two centimeters thickness to have a smooth surface to apply the lime based plaster over. The existing houses carry the traces of the habit of plaster application on, in and outside walls however there are also some examples with no traces of plaster covering on the inside walls of ground floors nor on the outside of the envelope walls.

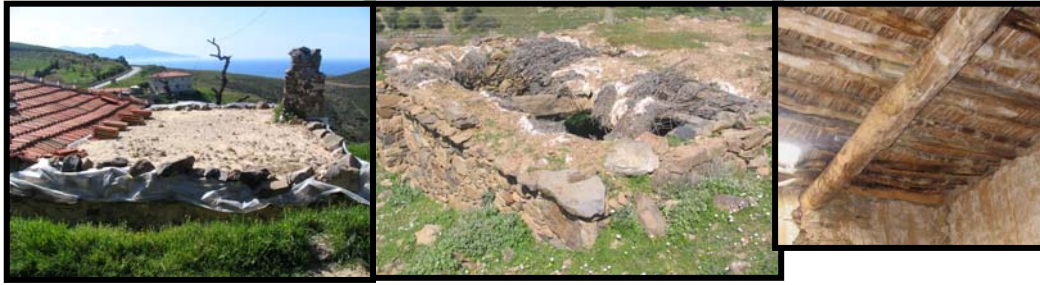
Figure 59 Layers of a timber flat roof with earth covering

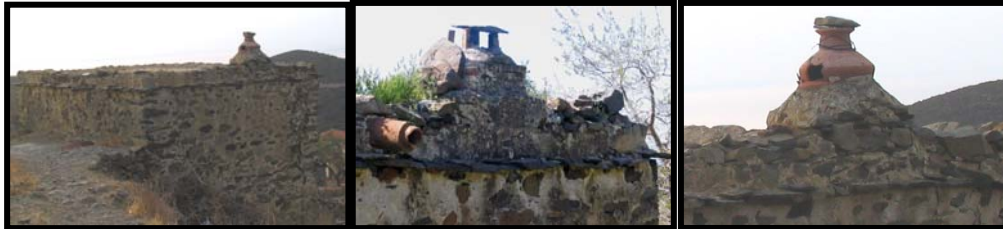
Figure 60 Traditional chimneys are built of stone and topped with baked earth cups

Recently these flat roofs rarely exist but referring to the examples; they have about 50 centimeters height on the façade. The 30 centimeters earth topping separates from the walls by a layer of flat stones that have a width about 10 centimeters, projecting about 10 to 15 centimeters on all sides. Together with flat roofs it is difficult to find original chimneys. Referring to the existing ones, the stone chimneys of the houses with flat roof raise through the wall of the house without making any projection on sides. They have a width of 40 to 50 centimeters and rise over the earth of the roof about 80 to 90 centimeters. They are topped with a large baked earth cup whose base or sides are partially broken to let the smoke out.

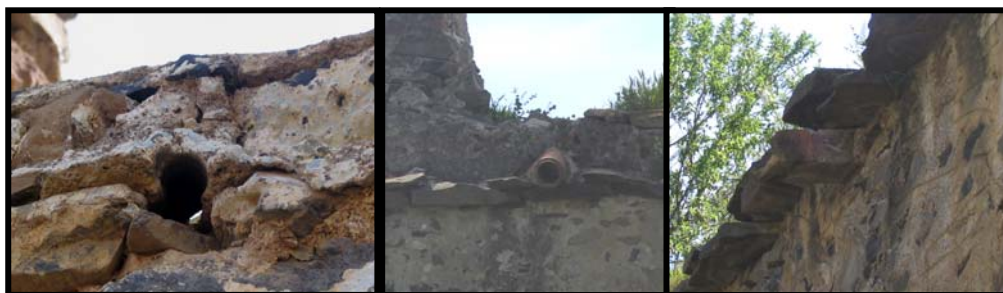
Figure 61 Drainage of the roof water is either through a hole carved in a roof stone, a clay water pipe or a carved stone gargoyle

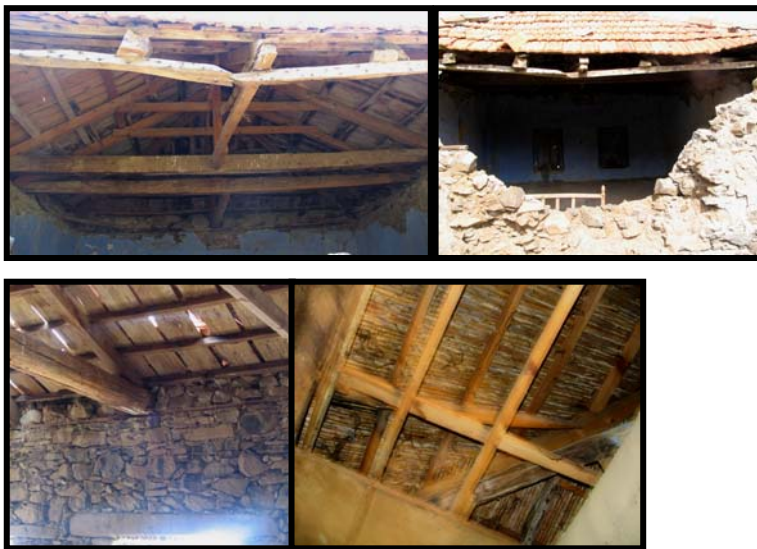
Figure 62 Pitched roof is either decked by timber planks over beams and the structure is exposed or it is decked by straw, the traditional material of flat roofs, and covered by timber planks as the ceiling material

On the other side, regarding the recent condition, the pitched timber roofs are substitutes of flat roofs. They extend the height of flat roofs to a higher level but they are not steep and they don't project to make large eaves, akin to the flat roofs. They are covered with tiles and the roof structure, similar to the flat roofs, separate from the walls with a layer of tiles, stones, concrete or marsilly tiles. The chimneys of the pitched roofed houses are intervened too. They are either of stone or brick with a height exceeding 40 to 50 centimeters over the peak of the roof. They are plastered and capped with tile, baked earth cups or a concrete slab. Some of them are also intervened in width by projecting on the side wall.

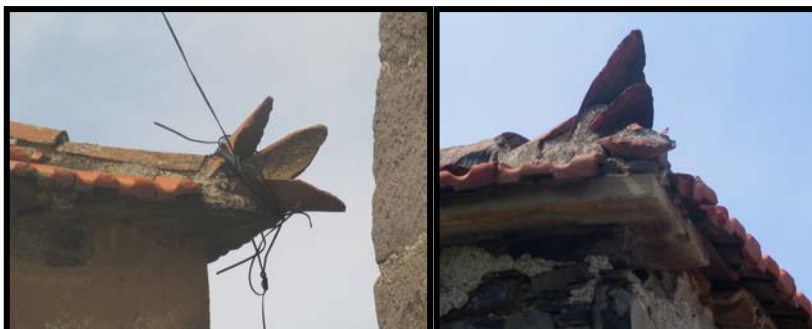
Figure 63 Eave ends of pitched roofs are decorated

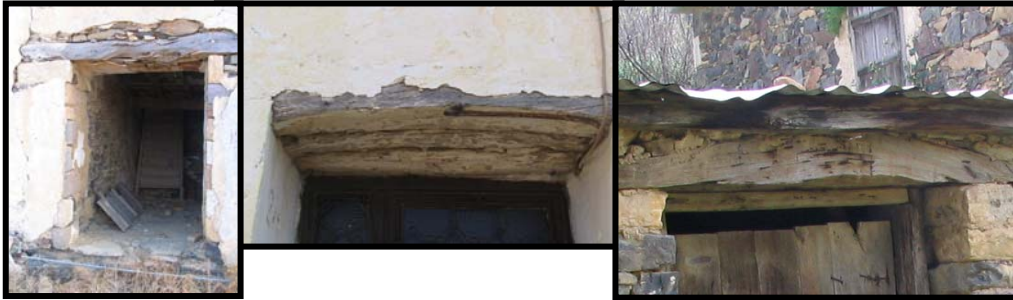
Figure 64 Flat and arched door openings

Houses of Küçükbahçe have same kind of doors and door openings no matter they are old or new buildings. The door openings vary in size, free from the size of the façade or the building. Their width differs from 70 to 120 centimeters while the heights change between 160 and 225, where the widths extend over 105 and heights exceed over 180 centimeters in the arched openings. The door openings are mostly spanned by flat timber beams in both one storey and two storey houses, albeit there are few two storey houses where openings are spanned by timber beams bent in arch form. The arched openings are also the rare examples of decorated door openings, which are decorated with plaster relieves.

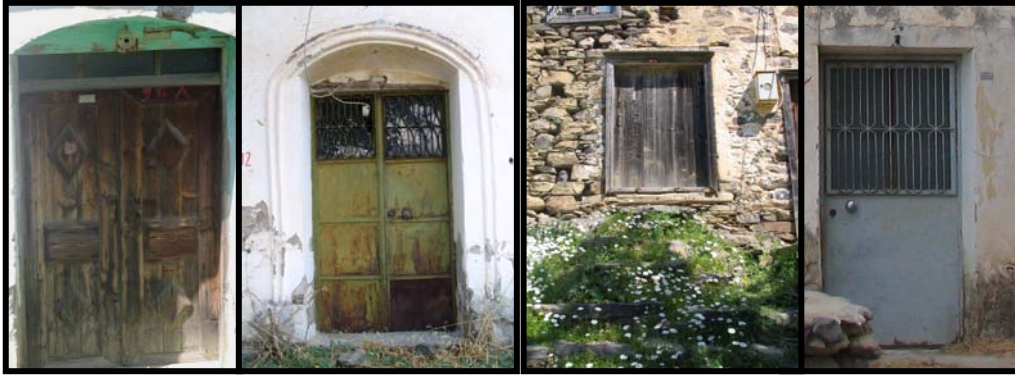
Figure 65 No. 29 and no. 112 are double winged doors with an arched door opening and no. 85 and no. 141 are single winged doors with flat door opening. No. 112 and no. 141 are metal doors with glass and metal balustrade, which is the most common intervention type on old timber doors

Doors have no distinction in their choice of material or size when a comparison made regarding the size of the house or the façade or the door being inside or outside. They are, apart from one storied house, altered at least a step and at most to a level determined by the topography of the lot. They are, discounting the altered ones; timber elements formed of 8 to 12 centimeters wide wood plates being vertically pinned together. All one storied buildings and most of the two storied ones have single winged doors while some two storied houses, especially the ones with arched door opening, have double winged timber doors that are formed with the same technique of single winged doors. The single winged doors sit on the outer edge of the door opening so their size depend on the size of the opening while the double winged doors sit on the inside edge of arched openings and they have smaller dimensions than the size of the opening. For example in the house numbered 33, the arched door opening has 267 centimeters of height and 126 centimeters of width while the double winged timber door has a width of 110 and a height of 185 centimeters.

On the other side, the altered doors are either of timber or metal with same dimensions that fit in the prevailing door opening. The new timber doors are simple with no paint coating while the metal ones have upper half of their wing of glass protected with metal balustrades and are also rarely painted.

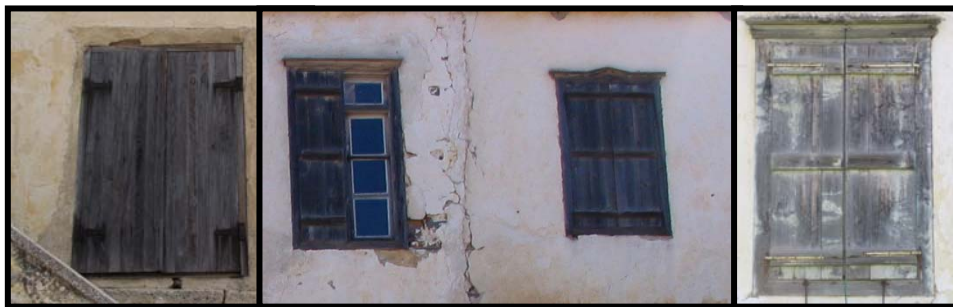
Figure 67 Two kinds of shutters; fitting to the opening and framing the opening

The shutters are inseparable parts of windows. Akin to windows, they are plain, dark brown timber with no paint and ornamentation. They are attached by simple iron nails. They sit on the outer edge of a window opening. They either fit in the opening or make a timber frame around the opening. The shutters have an 8 centimeters wide border of timber framing the window opening and a wood lath, with a simple profile, projecting over. Besides shutters, timber balustrades of a window's half height only appear in two houses and wood plates or metal sheets projecting over the window openings are common in use for shadow making.

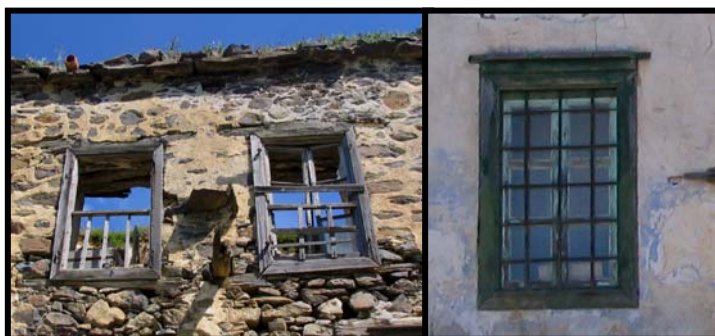
Figure 68 Two kinds of timber balustrades

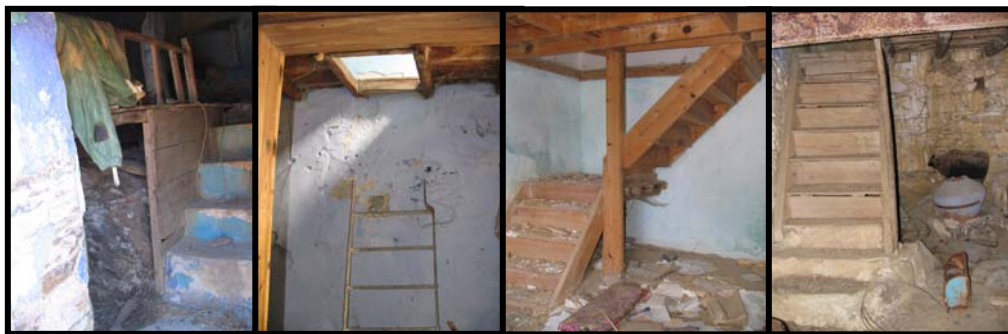
Figure 69 Only stone stairs in one storey houses/ Portable timber or iron stairs in double storey houses/ fixed timber stairs/ Timber stairs fixed on stone steps

Stairs, grouped according to their material, exist in three types. There are only timber or stone and combination of both. The most common one is the fixed timber stair. They are used in two storey houses in which first floor are accessed through an entrance door in the ground floor. Use of only stone is inside of altered one storey houses or outside of two storey houses where an alternative entrance to the house is given through the second storey, too. Rarely, the use of stone stairs with timber is valid for two storey houses. Especially in the houses built on rocks, first three or up to five steps are stone, utilizing the topography and then a timber stair bases on stone steps.

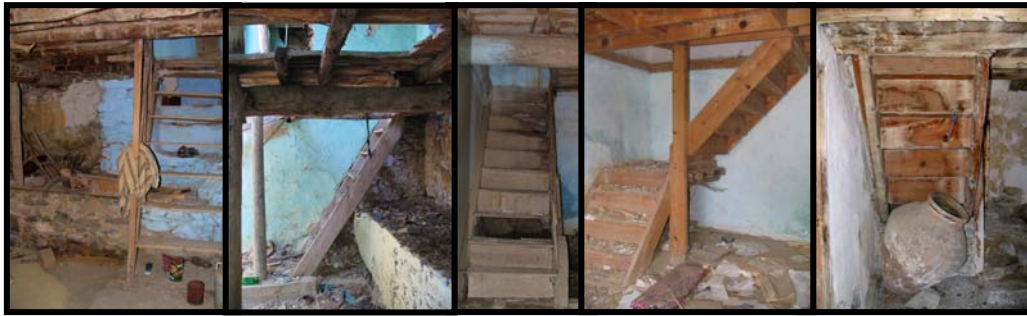
Figure 70 Varieties of timber stairs: straight with or without rise, L shaped and straight with opposite orientation

Timber stairs can be grouped according to their form. They are straight or L shaped, siding to a wall. They have 6 to 10 steps with or without rise. Their widths differ between 70 and 90 centimeters, including the width of balustrades that rise parallel. They are not elaborate in detailing or ornamentation but are simple and stable timber stairs. Their location in plan scheme is always facing the entrance door. They rise mostly along the entrance way, albeit some examples with an opposite orientation.

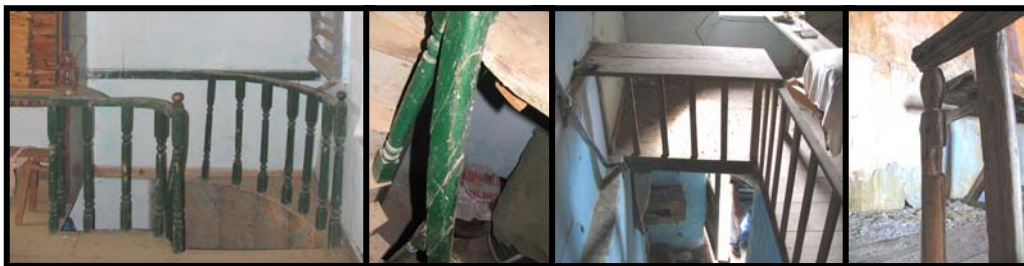
Figure 71 Most stairs are accompanied with simple not profiled balustrade but there are few exceptions which are profiled and painted

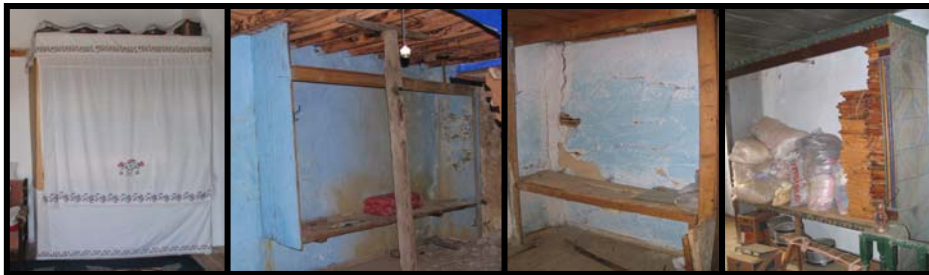
Figure 72 Built in cupboards are either fixed or side to a wall at least from one side

Built in cupboards are fixed cupboards that are randomly placed in houses. Though they have similar construction techniques, their width, height and placement show great variety. They are simple timber skeletons in rectangular prism shape where two vertical sides of it are edged either by wall or wooden plates. A horizontal wooden plate altered about 60 to 90 centimeters, is pinned in between the timber columns of the skeleton frame and a topping lies parallel to the horizontal plate, ending the skeleton frame. The width of the horizontal plate determines the width of the built in cupboard and it is mostly around 40 to 50 centimeters with exceptions reaching a width of 110. The height depends on the height of the ceiling but there are also examples with a height 20 to 60 centimeters lower than the height of the space. They are all covered with a curtain or left without a covering

yet they don't have caps. They are usually uncolored but in the houses numbered 166 and 39 how they were painted can be seen.

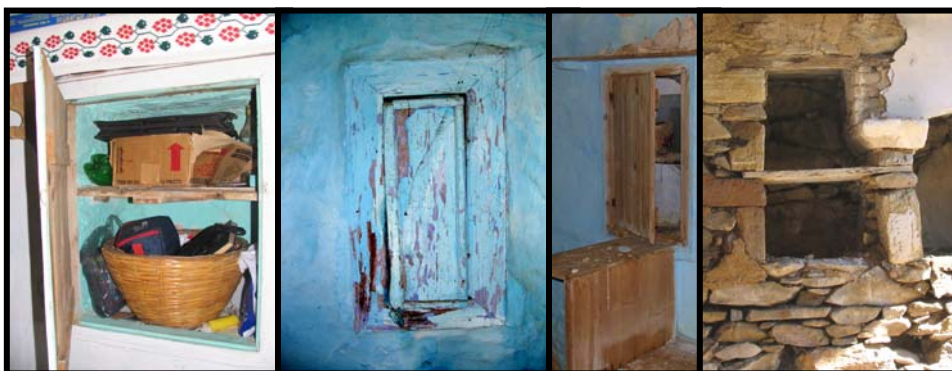
Figure 73 Niches for shelf, either have a lid or not. Sizes cannot be ranged

Niches exist as built in shelves with or without a lid or as openings in walls. Similar to other architectural elements, they are random in size, form and location. Thus, among the studied examples, they do not exist on the main façade but, on the other hand, a niche always exists in the wall where a fireplace takes place. In the studied examples, niches are usually small openings for putting or reserving small equipments. They are openings altered 60 to 90 centimeters with a height of 30 to 90, a width of 30 to 60 and a depth in wall, 30 to 45 centimeters.

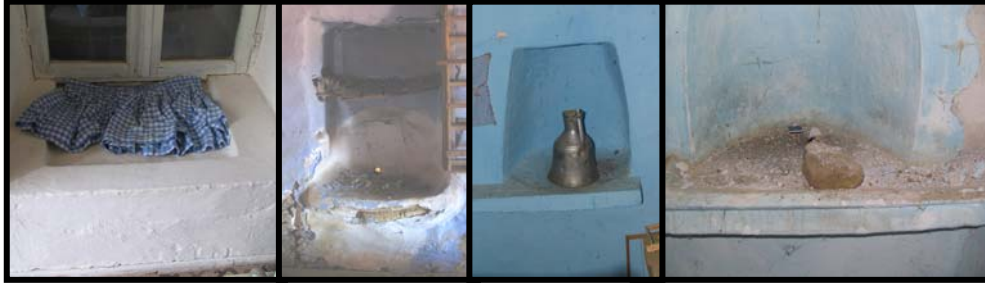
Figure 74 Niches for lavatory change in size and form

However, the houses also have niches for other functions. There, niches exist for lavatory and bathing. The niches for lavatory resemble to the common niche definition made above with an addition of a circular hole at the deep end of the base of the niche for the water

flow. They are altered for the same height but are larger in size and vary in form. They are 40 to 70 centimeters width and height and have 40 to 50 centimeters depth. They have circular or rectangular bases where the span is passed by an arch, a flat or a hemisphere.

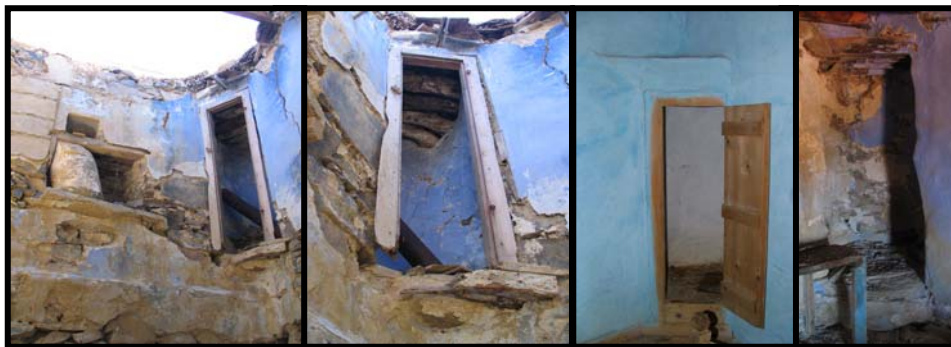
Figure 75 Niches for bathing exist on the opposite corner of main façade

On the other hand, the niches for bathing are totally different in size and they have a specific place. These niches take place at the first floor and on one of the opposite corners of the main façade wall. They are carved both as a cylindrical whole or as a volume with a polygonal base, where in both, the base has about 60 centimeters width and makes 8 to 12 centimeters extension through the walls. Additionally, the opening of the niche is covered with a diagonal timber lid that acts as a door.

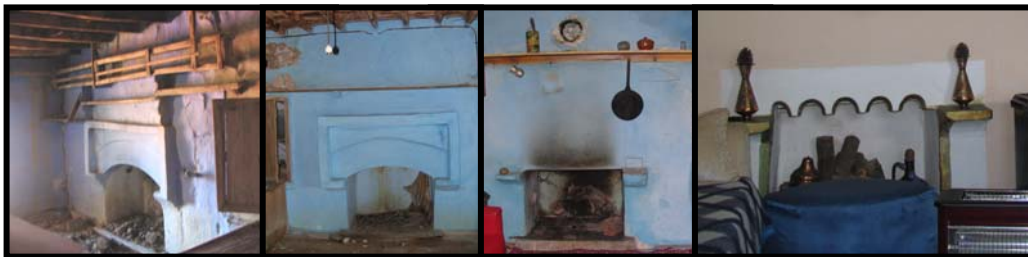
Figure 76 Arched hearth and a timber lath over as a shelf and Flat hearth with *tembellik* on sides

The hearths sit in the wall perpendicular to the main façade. They are all painted in the color of the wall with no ornamentation and they sit on a stone base on the floor, they are not altered. Their size change but this is independent of the size of the space. Especially in one storey houses, hearths are very dominant in size. Mostly hearths have an opening height around 70 and a depth in the wall around 45 centimeters. However, their width and size, with the shelf like border surrounding the hearth, vary a lot. The shelf like bordering is a, 8 to 15 centimeters plate that projects from the wall and makes a frame above the hearth. It consists of two larger projections to put matches and lighters, altered about 50 to 70 centimeters and has a width of 17 to 22 centimeters, on two sides of the hearth which are called as *tembellik*⁸⁰.

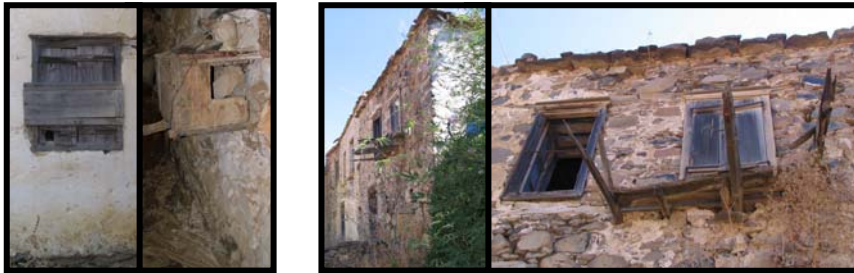
Figure 77 *Folluk* for keeping eggs and timber shelves for keeping flowers

are wood plates running over hearths and the wooden shelves for dishes near the lavatories. Additionally, *folluk*, a wooden cage that fits in the interior side of the front façade wall which has an opening on the outside for collecting eggs; and wooden plates attached to the timber columns, that stand on the middle of a room, to put candle or oil lamp are other fixed complementary elements that take place in houses.

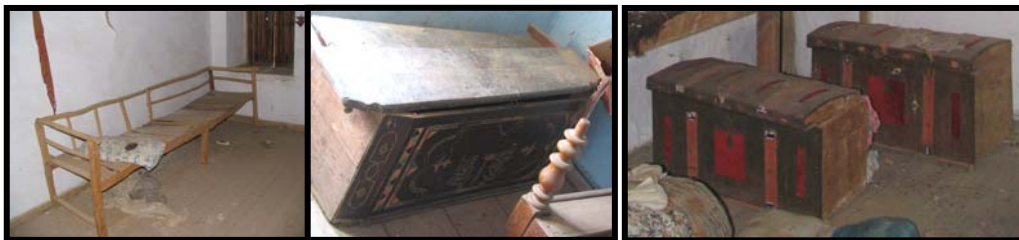
Figure 78 Timber *sandık* and coach are simple and authentic furniture

Apart from the fixed ones, *sandıks*, that are wooden boxes with a lock and mostly used for keeping precious textiles or jewelry, and special timber seats for putting olive oil and water vases, are widely existing portable equipments of houses. Similarly, these portable timber equipments are plain and uncolored with some exceptional *sandıks* that are painted.

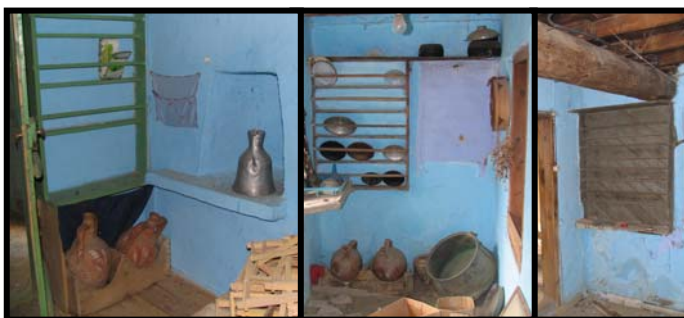
Figure 79 Timber shelves for dishes and boxes for oil and water

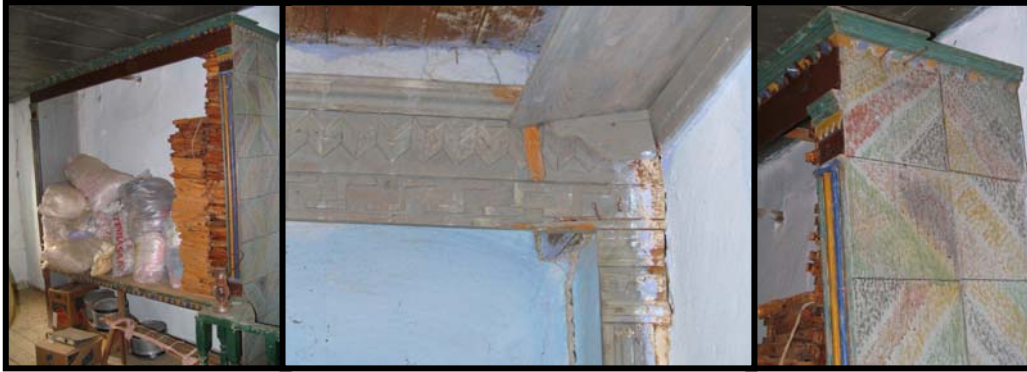
Figure 80 Use of color: blue, white and yellow, in the interior walls and white on the exterior walls are the common choices

Houses of Küçükbahçe are modest in furnishing, ornamentation and in use of color in coherence with their context and construction technique. Basing on the existing or survived examples, color use, besides the plasters of walls, exists on *yüklüks*, *sandıks* and brackets of stairs; ornamentation appears in profiles of wood plates and in bars of the brackets of the stairs. Yet, only in the house numbered 166, a plaster decoration as a relief on the wall to put candle and again plaster relief ornamentation on a hearth take place.

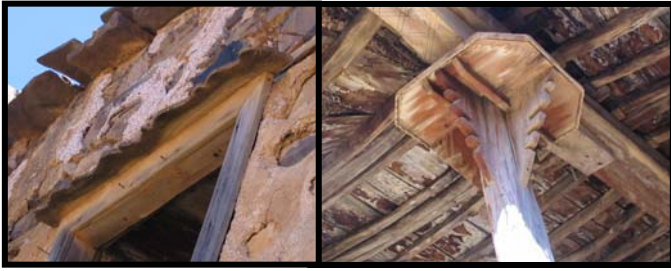
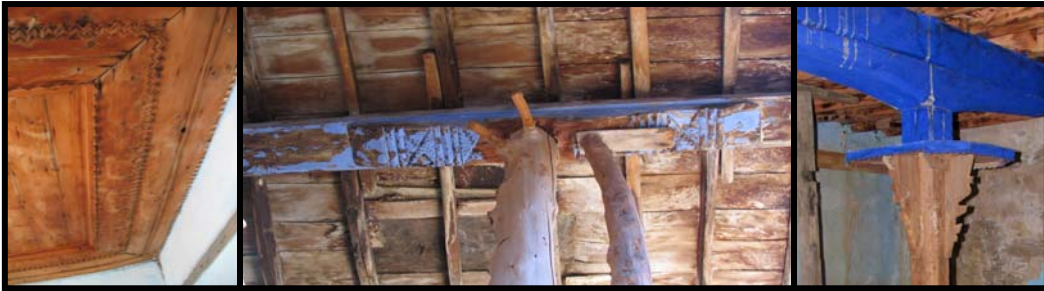
Figure 81 Profiled use of timber elements

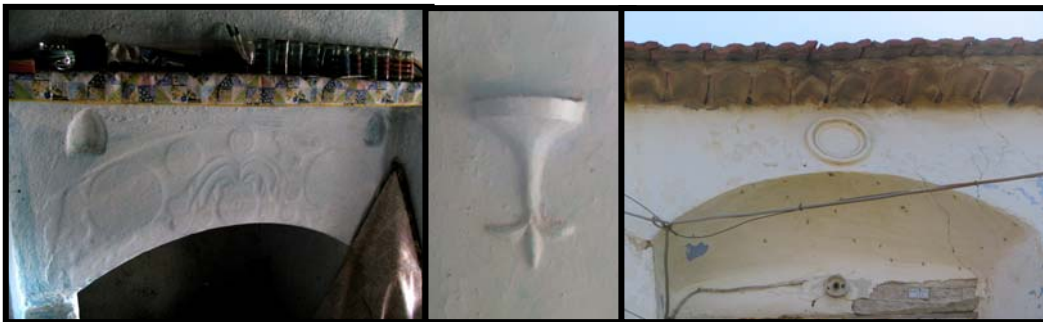
Figure 82 Indoor and outdoor plaster applications
