STRENGTHENING OF REINFORCED CONCRETE FRAMES BY CUSTOM
SHAPED HIGH STRENGTH CONCRETE MASONRY BLOCKS

A THESIS SUBMITTED TO
THE GRADUATE SCHOOL OF NATURAL AND APPLIED SCIENCES
OF
MIDDLE EAST TECHNICAL UNIVERSITY

GÜRAY ARSLAN

JANUARY 2009

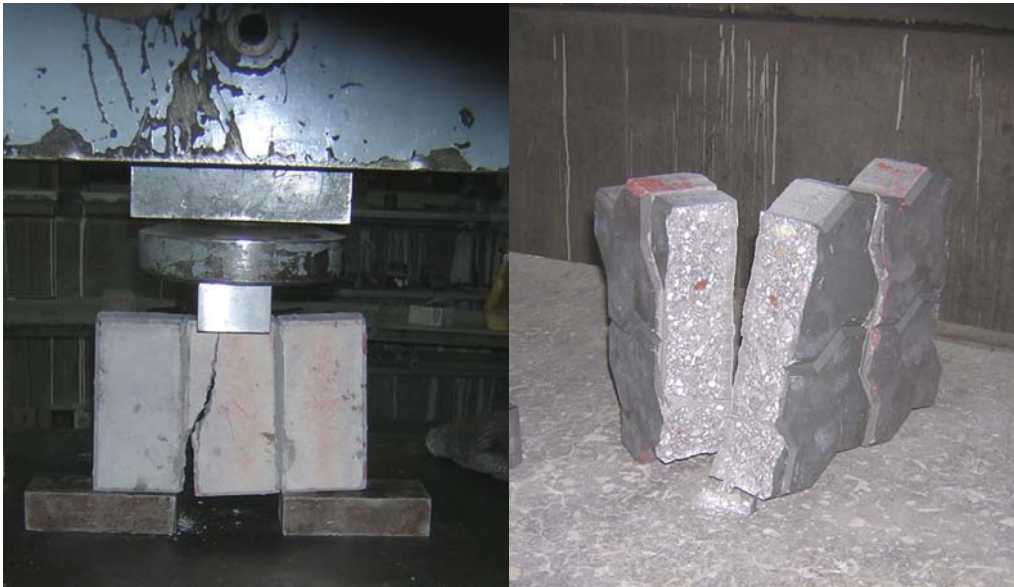
Figure 1.3 - Failure of Concrete Blocks Joined by Concrete 1406 Mortar

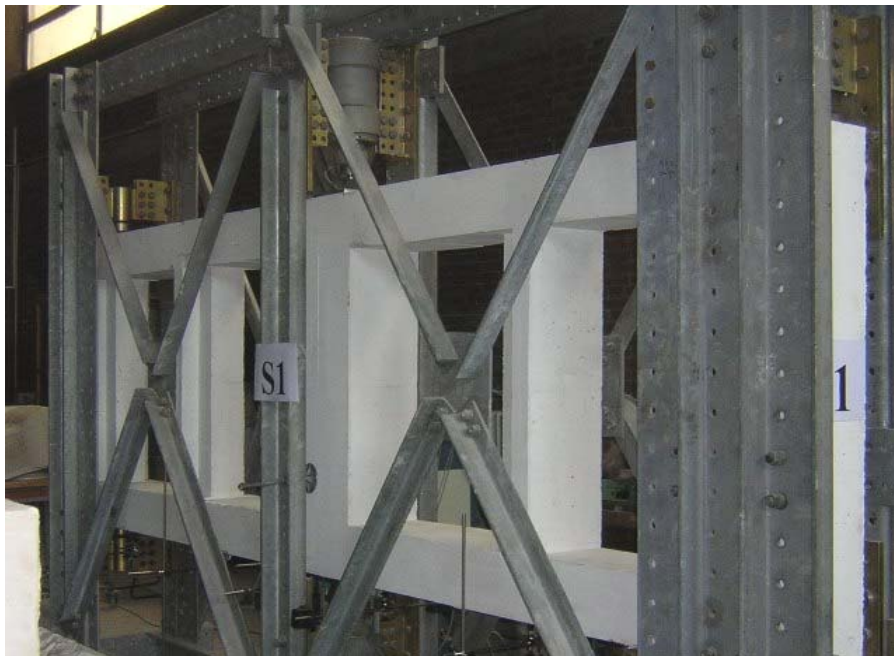
Figure 3.1 - General View of the Bare Frame

The test specimens used in this experimental study are one-bay, two-story reinforced concrete frames. The main test frame is composed of two frames connected back to back by a strong foundation beam. The aim of forming this kind of a frame is to test two identical frames in a single run by benefiting from the advantage of symmetry. Figure 3.1 shows a general view of the bare frames.

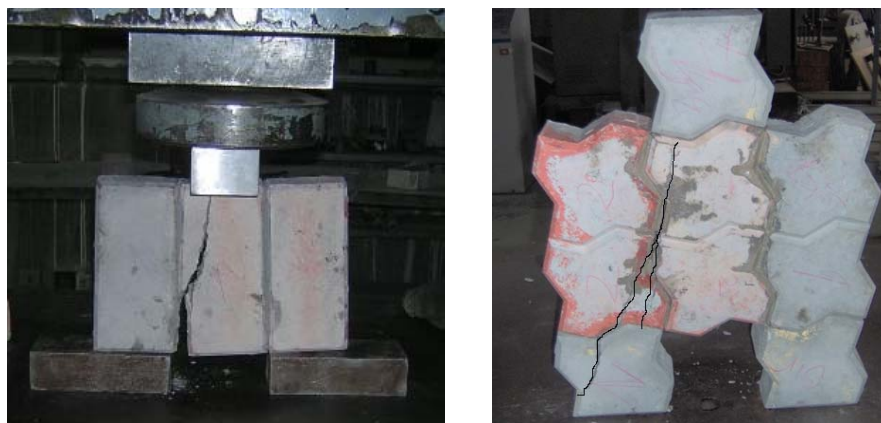
Figure 3.14 – Concrete Blocks After the Compression Test

Concrete 1406 epoxy mortar was used for bonding the concrete blocks to each other and to frame. Concrete blocks bonded to each other with epoxy mortar were tested for axial compression. Test results showed that the bond between the blocks was so strong that failure was due to crushing of blocks (Figure 3.14). Walls made of concrete blocks behaved monolithically by the means of this mortar. Concrete 1406 is a preferred adhesive for concrete repair works, anchorage works and fitting works. The material properties of Concrete 1406 are given in the commercial catalog by the producer as presented in Table 3.8.

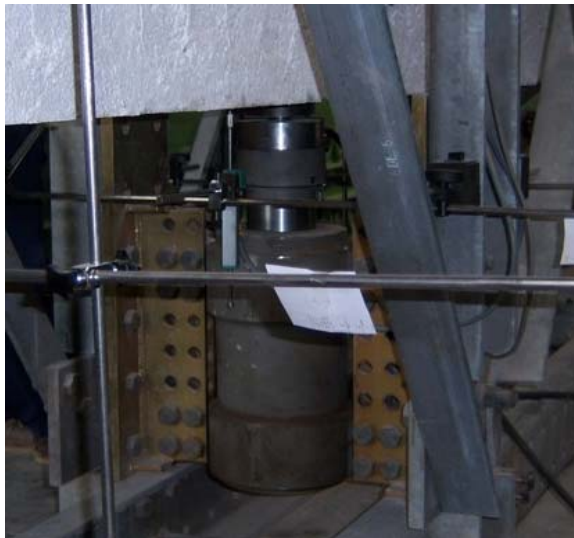
Figure 4.5 - Loading System

The loading system attached to the steel closed frame consisted of a load cell, a hydraulic jack and adaptors for connecting the load cell and the hydraulic jack. A photograph of the loading system is given in Figure 4.5. Reversed cyclic lateral loading was applied by two hydraulic jack, both of them were capable of only 500kN in compression. One of them was located at the top and middle of the steel closed frame and the other was located at the bottom and again middle of the steel frame.

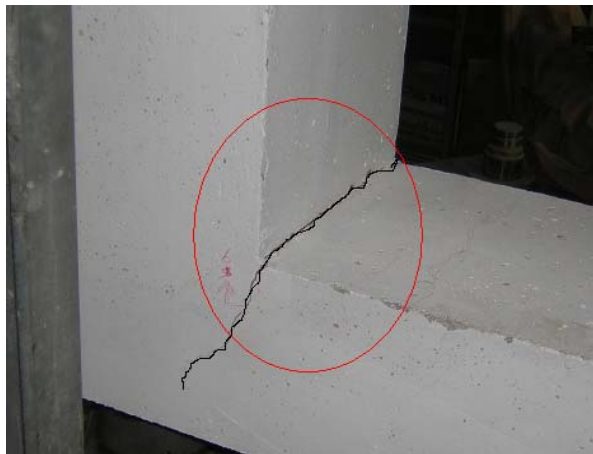
Figure 5.7 - Column-Foundation Joint Crack

- In the first upward half cycle, hairline cracks were formed at the column-foundation beam joints (Figure 5.7). In the next load stage, similar cracks were observed at the column-first story beam joint as shown in Figure 5.8.

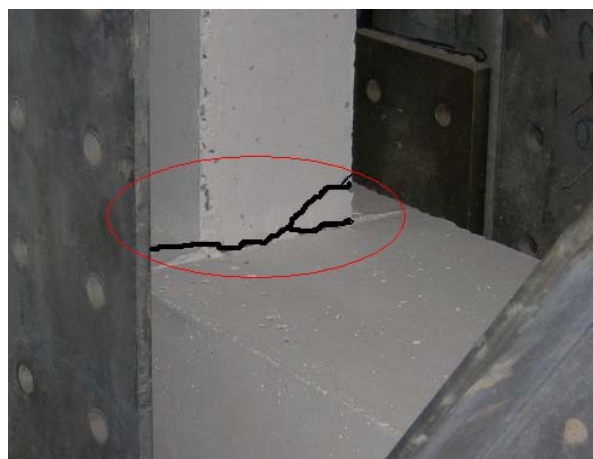
Figure 5.8 - Column-First Story Beam Joint Crack

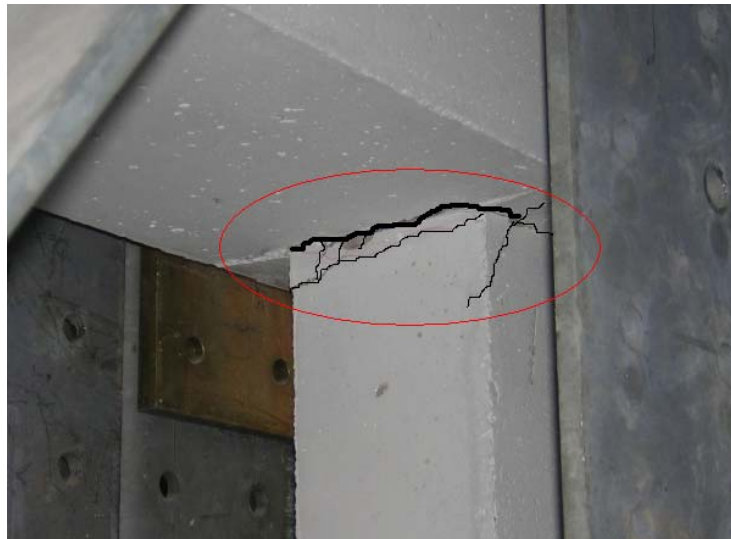
Figure 5.9 - Column-Beam Joint Crack at the Second Story Level

- In the second cycle, new cracks appeared at the base of the first story columns and cracks at the joints widened. At this cycle, the maximum load of 44.8 kN was recorded.
- In the third upward half cycle, first cracks were formed at the second story top column-beam joints of frames as shown in Figure 5.9. In the downward half cycle, similar cracks were formed at the opposite joints. In this cycle, second story level displacements reached 14 mm and 19 mm for both half cycles.

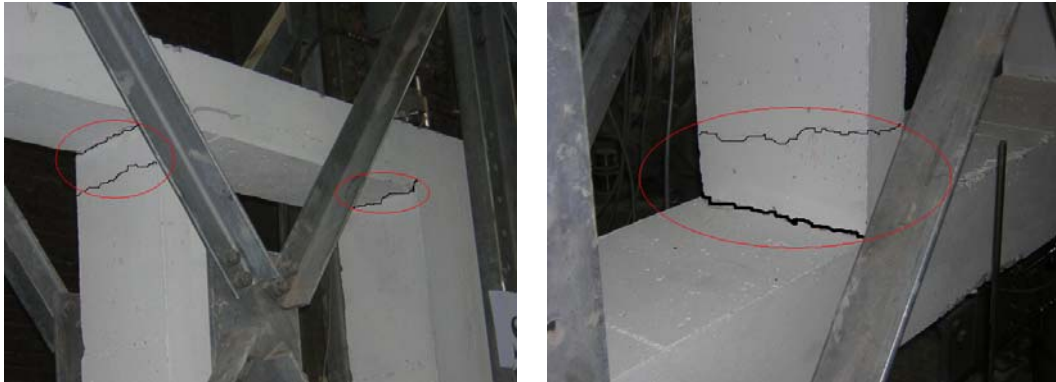
Figure 5.10 - Column-Beam Joint Cracks in the Fourth Cycle

- In the fourth cycle, new cracks occurred at the column-beam joints (Figure 5.10). For this full cycle, column bottom cracks reached a width of 4 mm. In this cycle, maximum forward load was recorded and second story level displacement reached 26 mm.

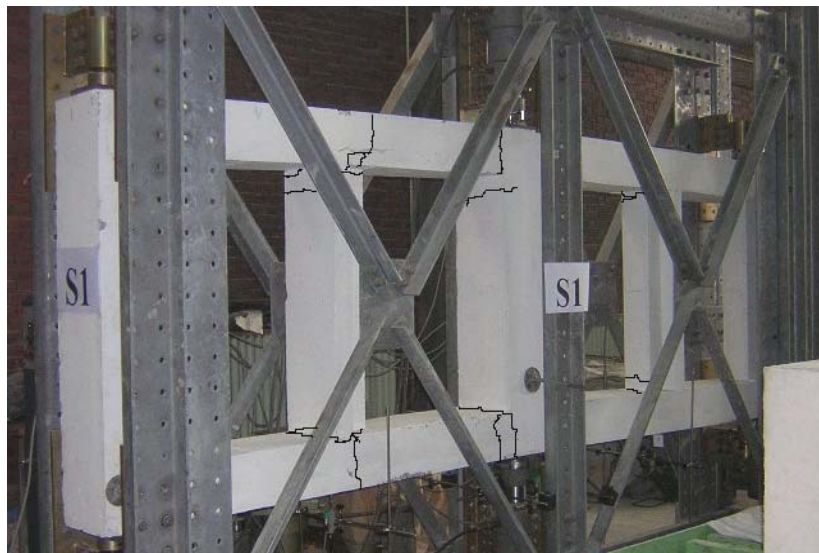
Figure 5.11 - Specimen S1 After the Test

- In the fifth upward cycle, the crushing of columns accelerated. At this cycle, the maximum load of 60.1 kN was recorded. In the fifth downward cycle, the frame could not take any further load due to crushing of the columns. Hence, the test was terminated. The front view photograph of Specimen S1 after the test is given in Figure 5.11.

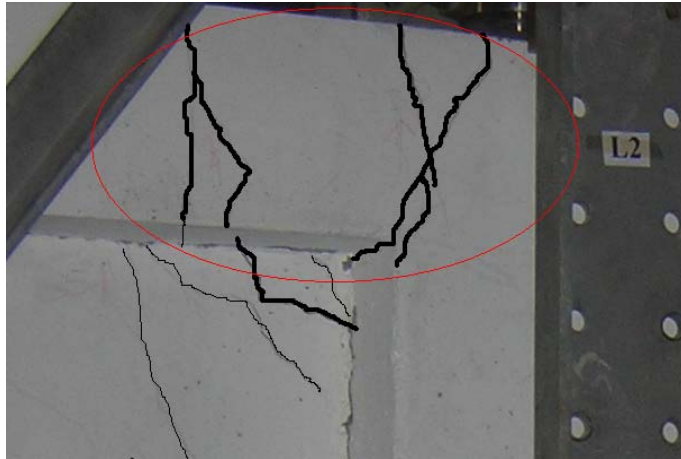
Figure 5.19 – Foundation Beam-Column Joint Cracks

- In the ninth upward half cycle, flexural crack width on the foundation beam-column joints approximated as 5 mm as shown in Figure 5.19. New cracks were observed on the first and second story infill walls. Second story level displacement reached 28 mm in this cycle.

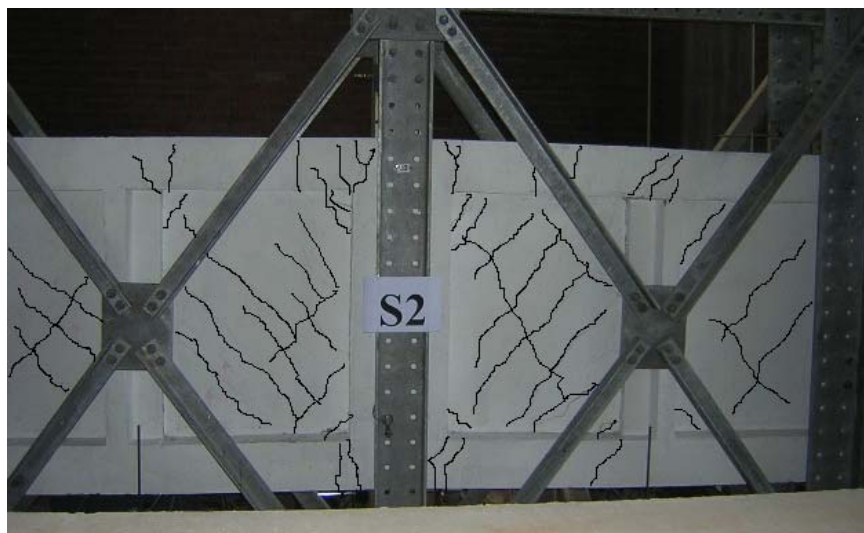
Figure 5.20 – Specimen at the End of the Test

- In the tenth upward half cycle, due to excessive deformations, the loading was stopped at 262.0 kN. The final view of the specimen at the end of the test is shown in Figure 5.20.

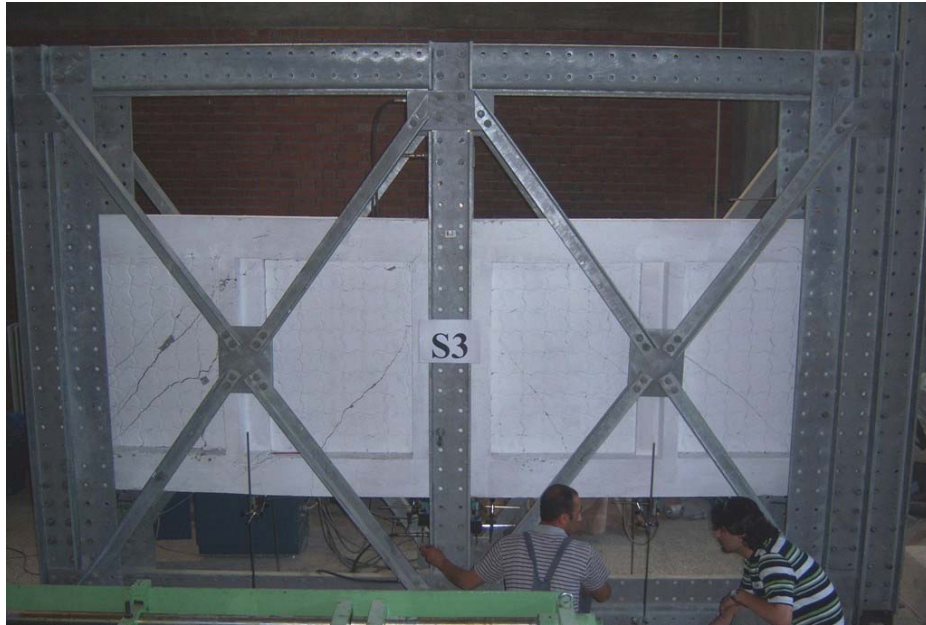
Figure 5.28 - Specimen S3 at the End of the Test

- In the seventh downward half cycle, diagonal crack width on the second story infills of both frames approximated as 4 mm. The number of cracks on the first story columns increased so much. The maximum lateral load of the test was recorded as 206.8 kN. In the upward cycle, both columns developed many cracks again and their deformation was noticeable. Due to excessive damage, the experiment was ended at the end of this cycle. The final view of the specimen from the front is given in Figure 5.28.

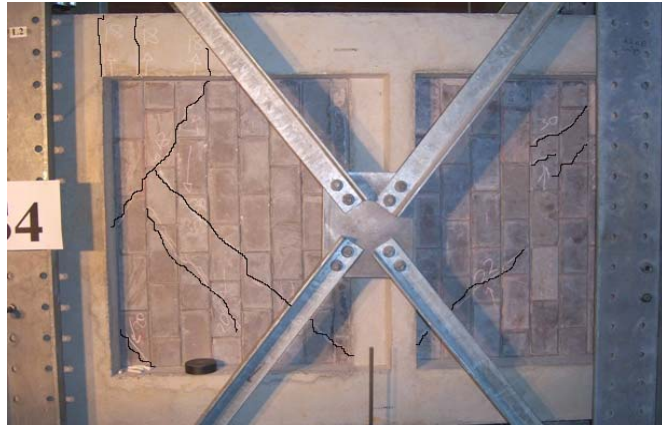
Figure 5.35 - Cracking on the Infill in the Six Cycle

- Column-foundation joint cracks increased in number in the sixth upward half cycle. Some diagonal cracks grew as wide as 2 mm (Figure 5.35). In the next load stage, cracks formed at the beam-column joints and on the second story columns of the left frame. Diagonal crack width on the second story infills approximated as 1 mm.

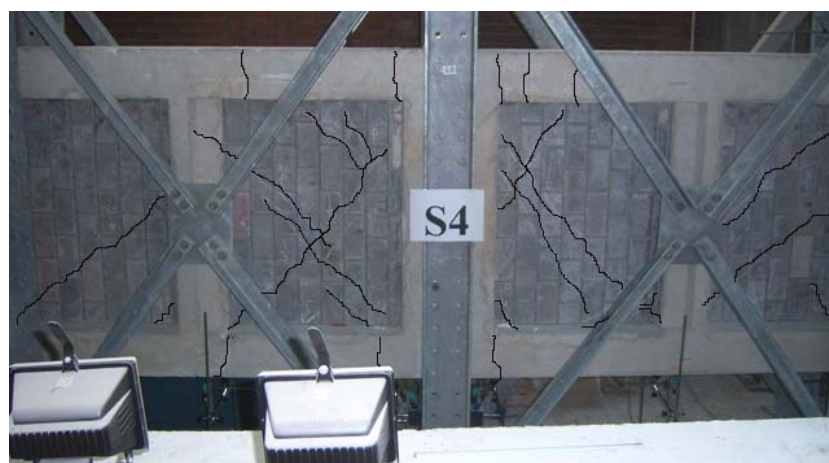
Figure 5.36 - Final View of the Specimen S4

- In the seventh upward half cycle, new cracks were observed on the first story beams and at the second story beam-column joints. Diagonal cracks increased and formed X marks on the infills. Crack width on the beam-column joints approximated as 1 mm. In the seventh backward half cycle, due to excessive deformations, the loading was stopped at 205.3 kN. The final view of the specimen at the end of the test is shown in Figure 5.36.

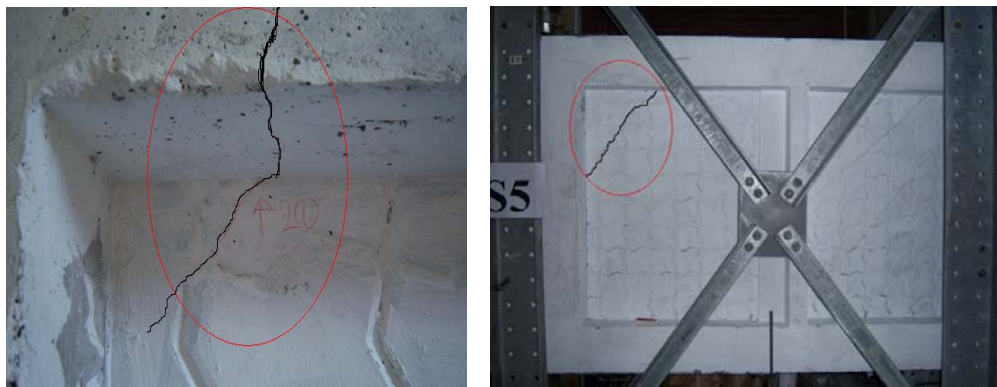
Figure 5.42 - Hairline Crack on the First Story Infill

- In the first two loading cycle, no cracks were observed on the frame or infills.
- In the third upward half cycle, first hairline crack was observed at the top column-foundation joint of the right frame. Same type of crack was observed at the bottom column-foundation joint of the left frame in the third downward cycle.
- Hairline cracks formed on the first story infills near the top column-foundation joints in the fourth upward half cycle (Figure 5.42). No new cracks were observed on the symmetric frames but the existing cracks widened in the next load stage.

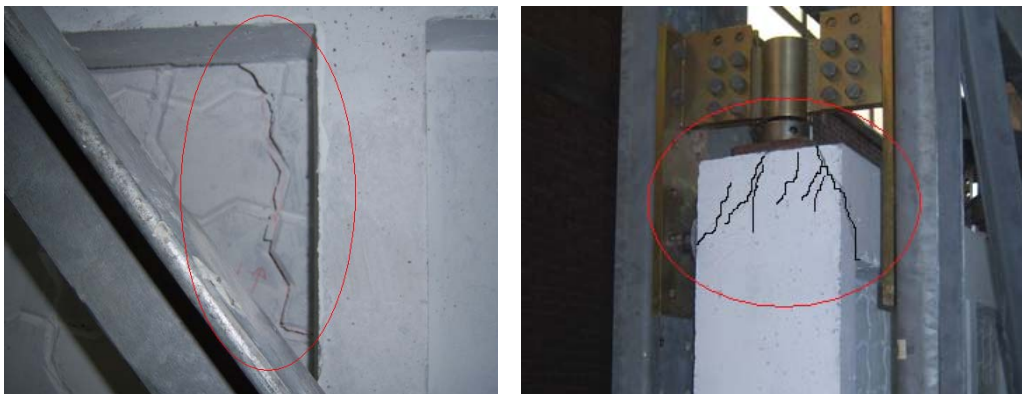
Figure 5.44 - Separation Between Blocks (left) and Cracks on the Support (right)

- In the sixth upward half cycle, cracks on the first story infill of the left frame widened and partial separation between the second story concrete blocks was observed (Figure 5.44). Crushing began at the supports of the left frame (Figure 5.44). In the sixth downward half cycle, first crack formed on the second story infill of the right frame. New diagonal cracks were observed on the second story infill of the left frame.

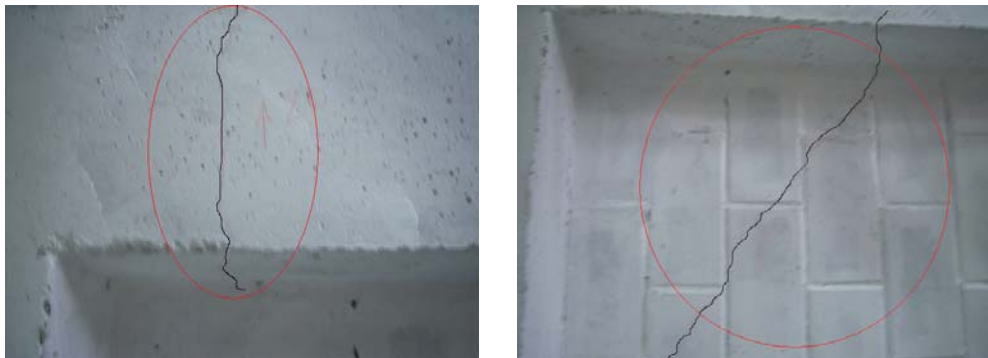
Figure 5.51 – Cracks on the Column (right) and on the First Story Infill Wall (left)

- In the first two loading cycle, no cracks were observed on the frame or infills.
- Hairline cracks was formed at the base of the top columns of the both frames in the third upward half cycle, also first diagonal hairline crack appeared on the first story infills near the top column-foundation joint (Figure 5.51). Symmetric cracks were observed in the downward half cycle.

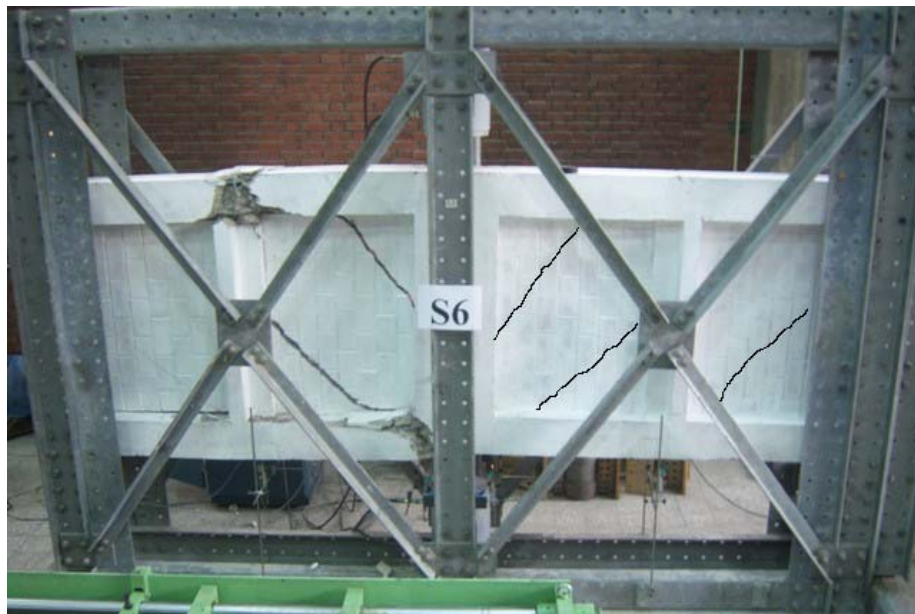
Figure 5.54 - Front View of Specimen S6 after the Test

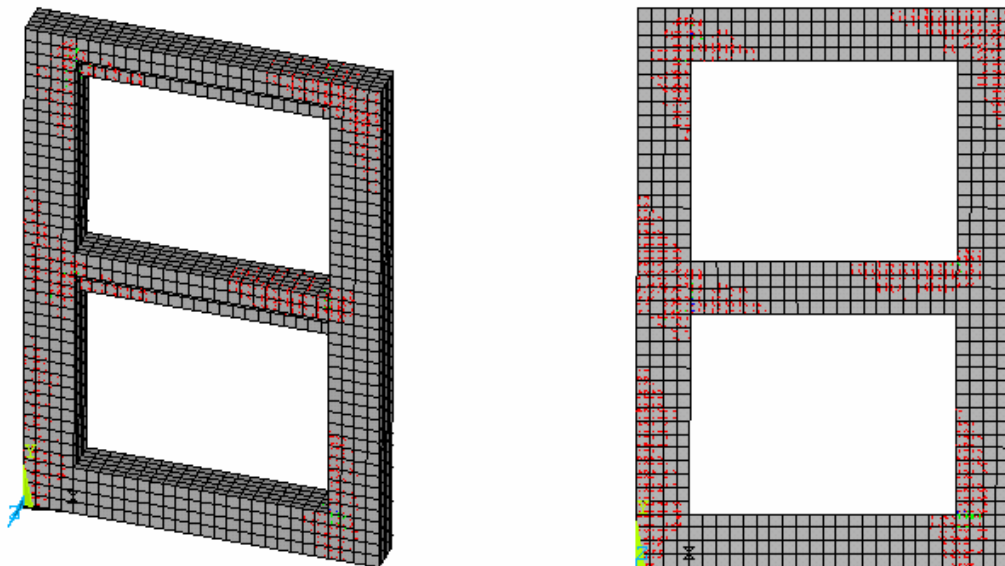
Figure 7.7 - Cracking at 40.0 kN

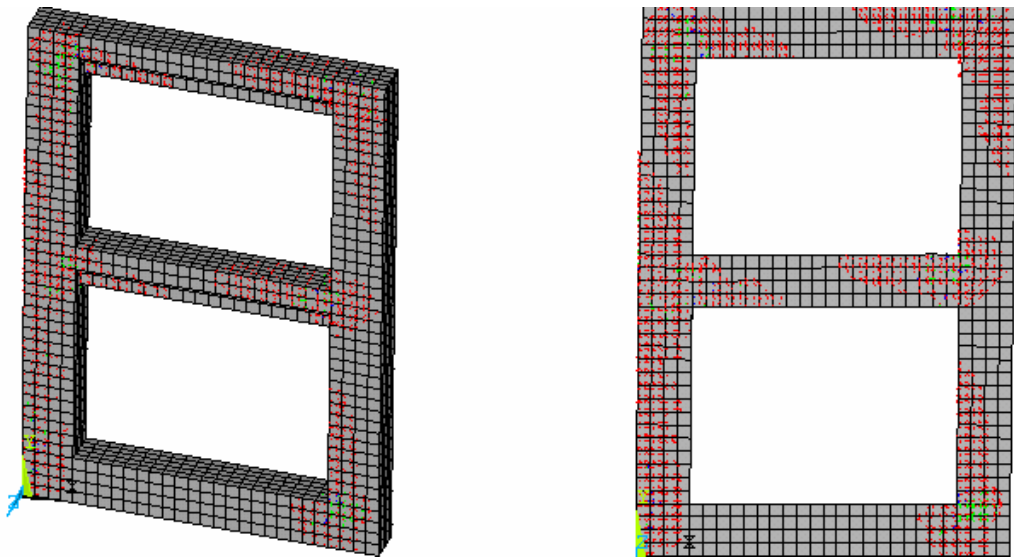
Figure 7.8 - Cracking at Maximum Load Carrying Capacity (69.5 kN)

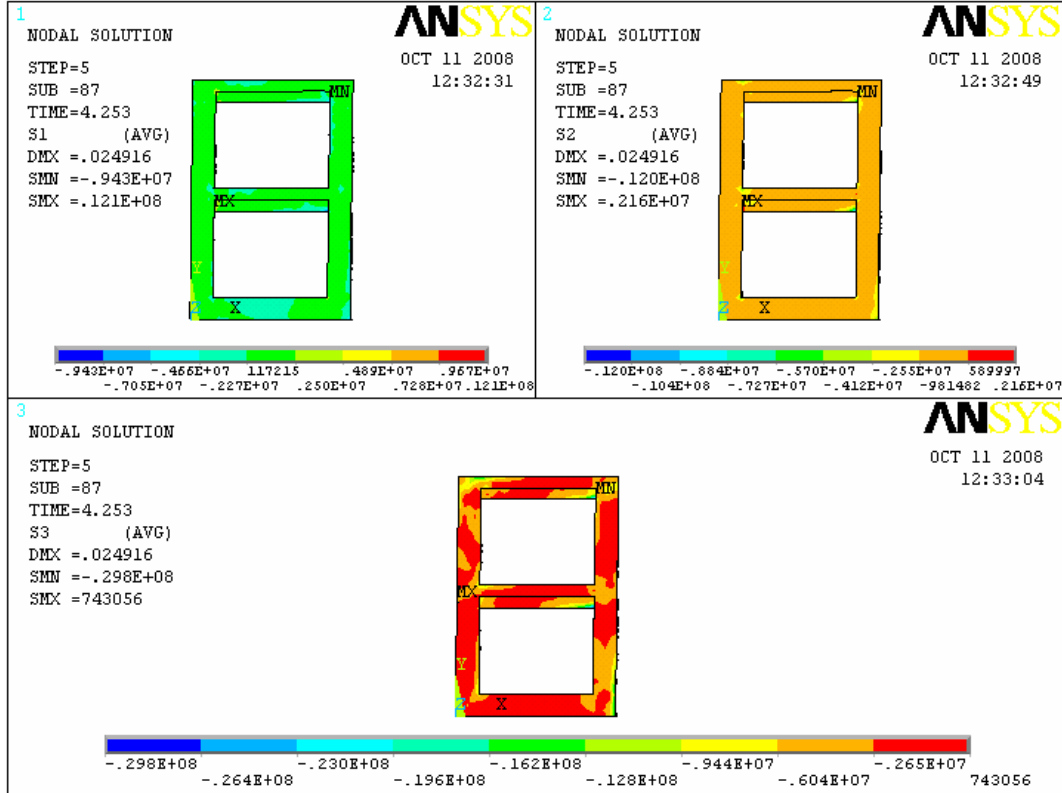
Figure 7.10 - Principal Stresses (N/m²)

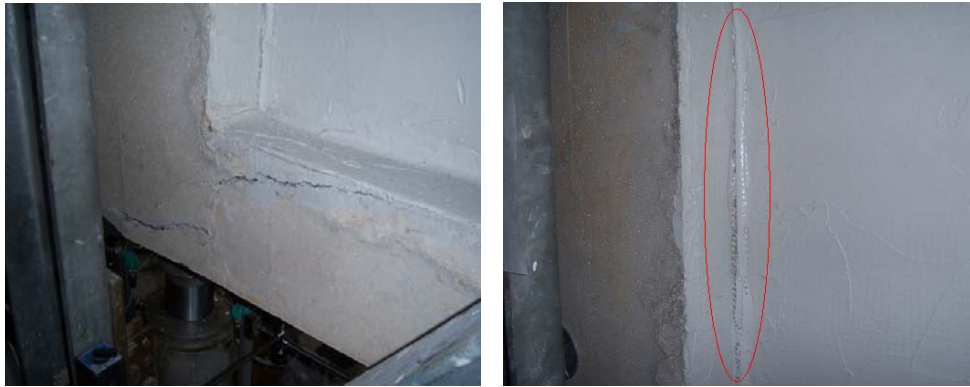
Figure A.6 - Column-Foundation Joint Crack (left) and Crack on the Infill (right)
