INVESTIGATION OF KOYULHİSAR (SİVAS) SETTLEMENT AREA IN TERMS
OF SLOPE INSTABILITY

A THESIS SUBMITTED TO
THE GRADUATE SCHOOL OF NATURAL AND APPLIED SCIENCES
OF
MIDDLE EAST TECHNICAL UNIVERSITY

IN PARTIAL FULFILLMENT OF THE REQUIREMENTS
FOR
THE DEGREE OF MASTER OF SCIENCE
IN
GEOLOGICAL ENGINEERING

SEPTEMBER 2009

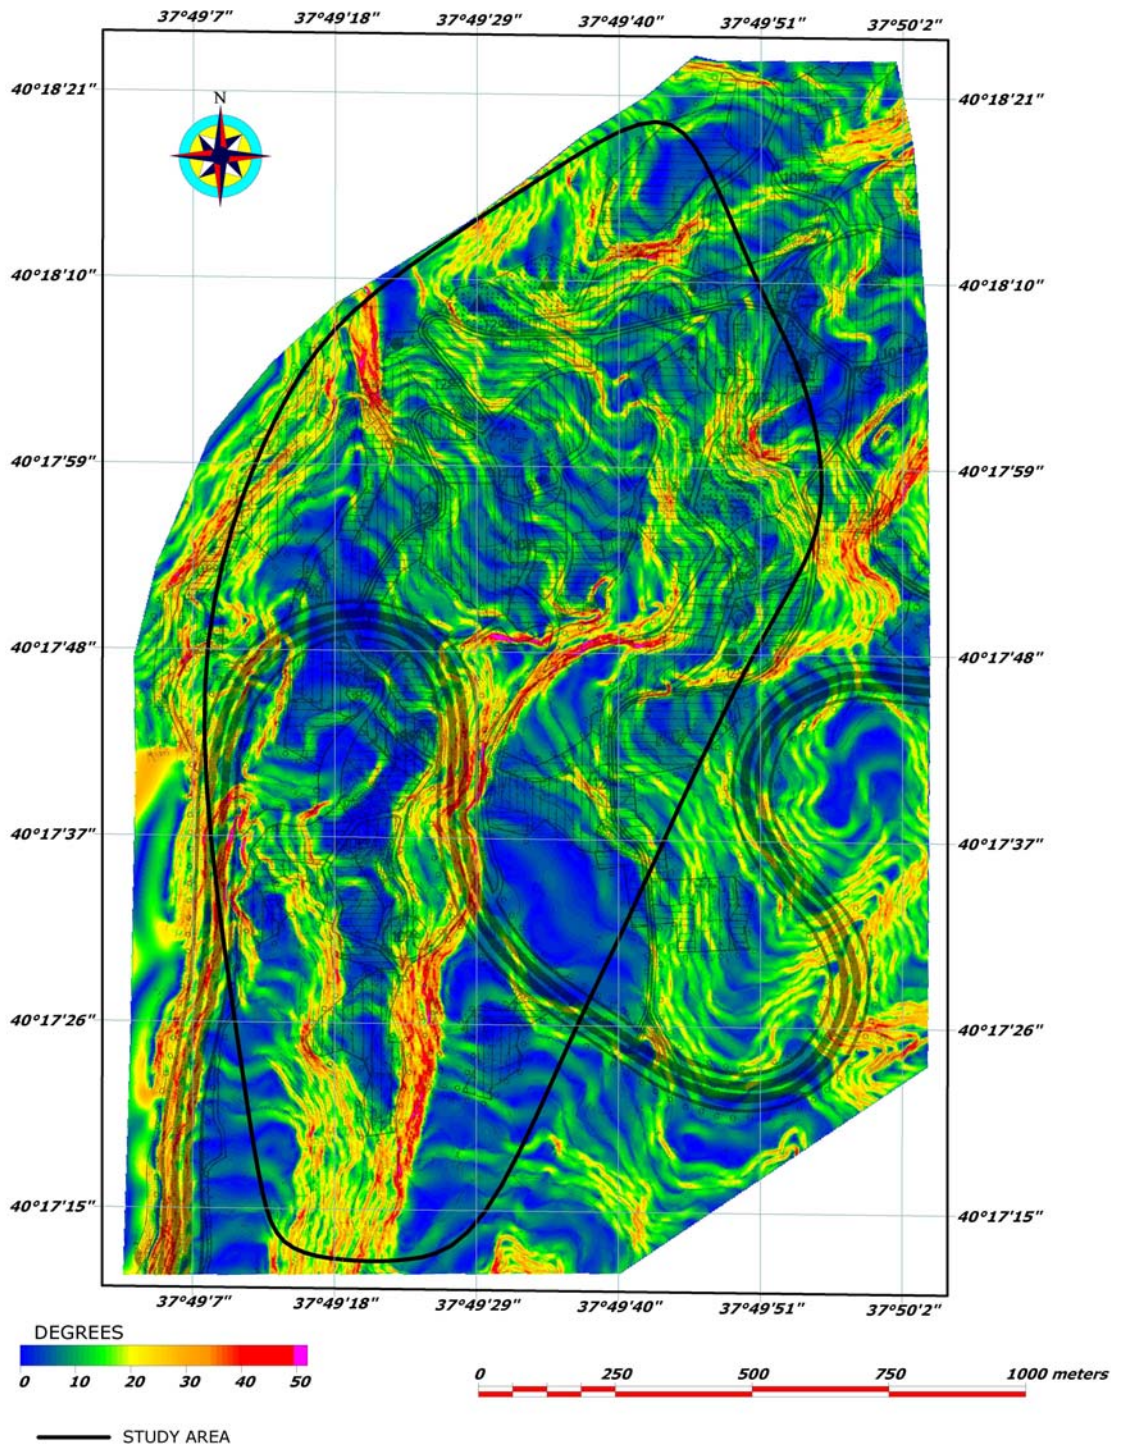
Figure 1.3 Slope map of the study area

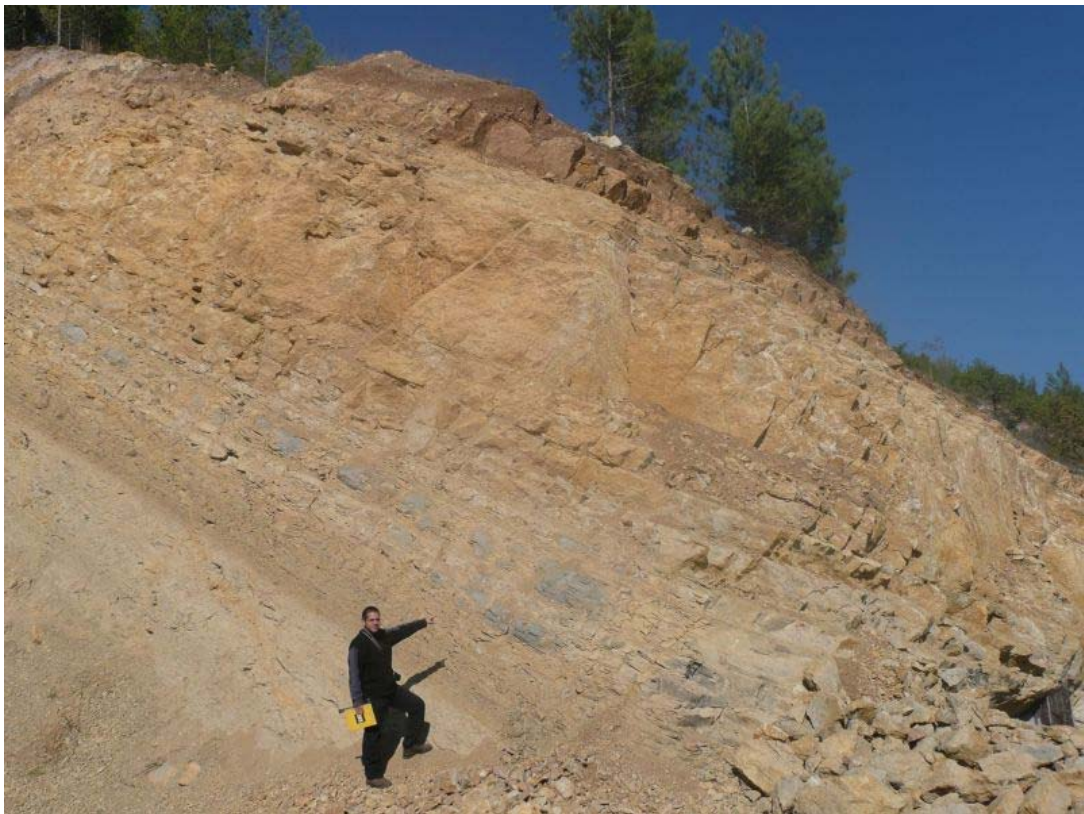
Figure 2.3. A view from flyschoidal sequence

2.3). At the field exposures, the general bedding direction is measured as N23°W/24°NE and bed confined joints are observed at the road cuts. This sequence is composed of Upper Maastrichtien volcano-clastics and the Early Paleocene shallow marine to continental clastics (Toprak, 1989) and involved in the Düdenyaylası formation.

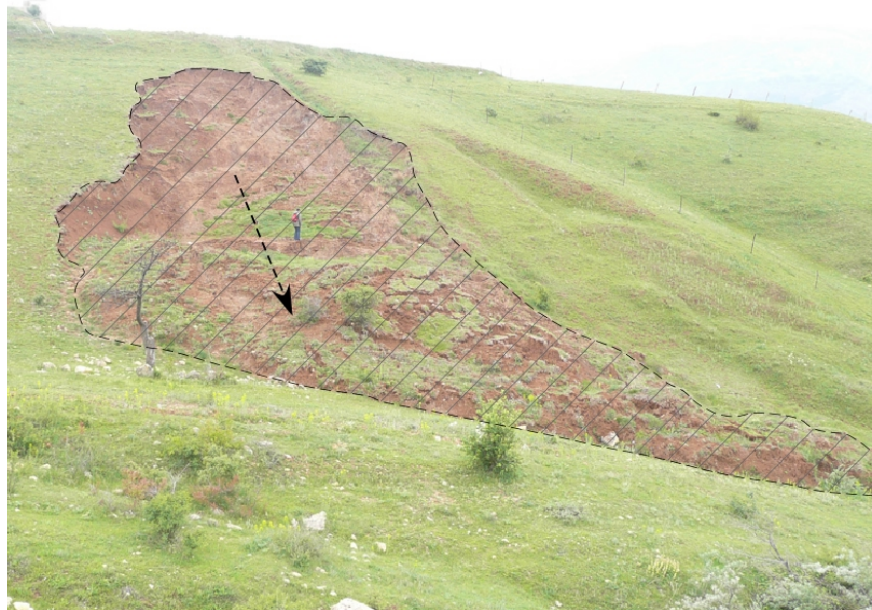
Figure 3.2. Landslide occurred in north-west of the settlement area which falls out of the study area (photo taken from point a in Figure 4.1)

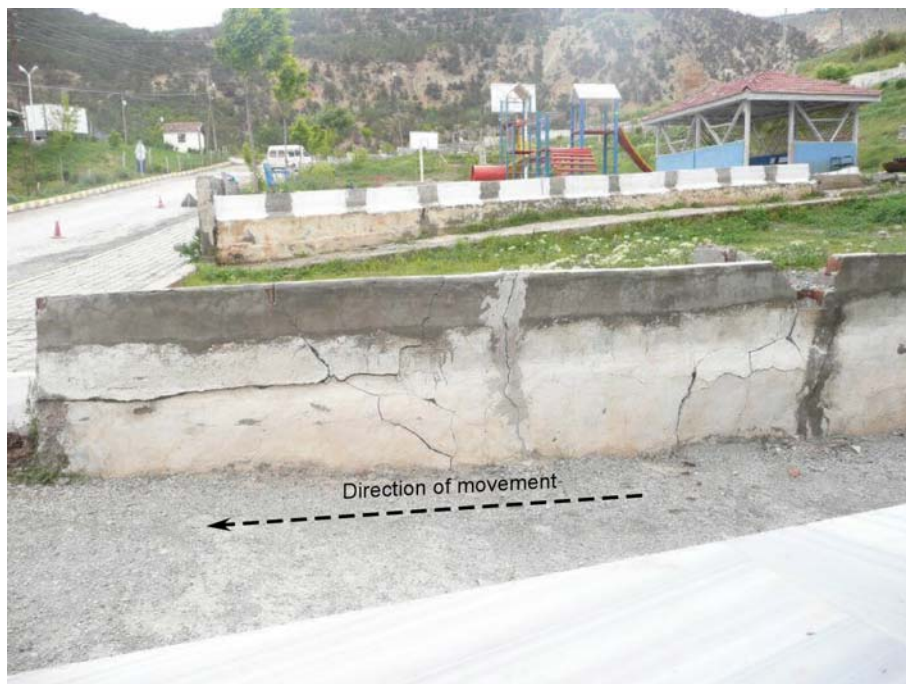
Figure 3.5. Cracks on wall near Police Station (photo taken from point d in Figure 4.1)

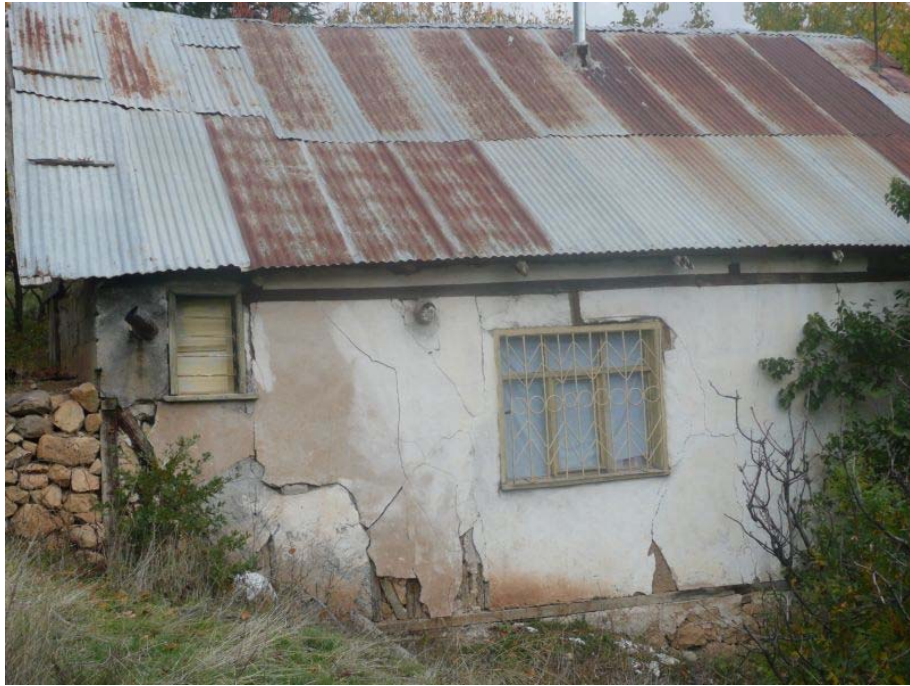
Figure 3.6. Cracks on the wall of house located at west of settlement area (photo taken from point e in Figure 4.1)

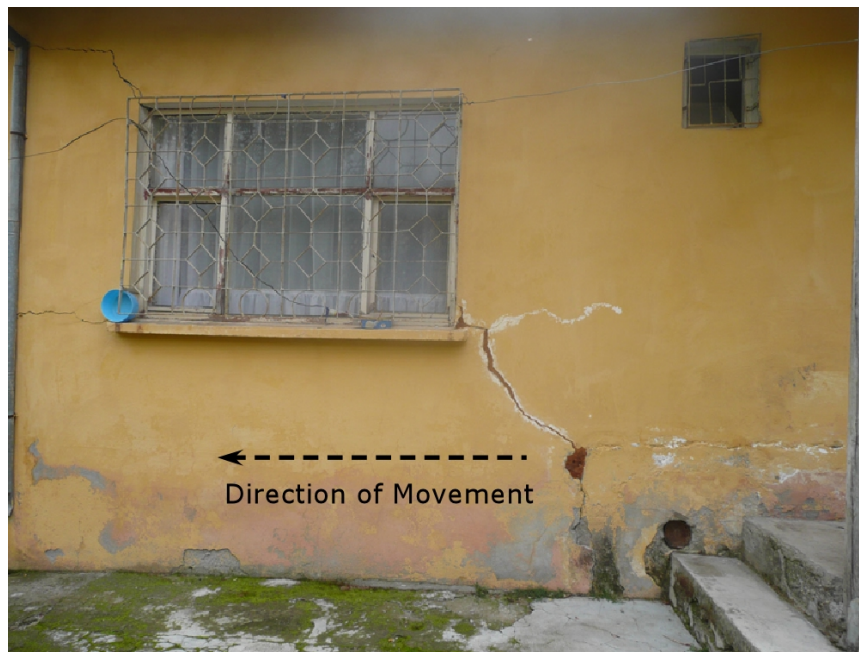
Figure 3.7 Cracks and fissures on the wall of house (photo taken from point f in Figure 4.1)

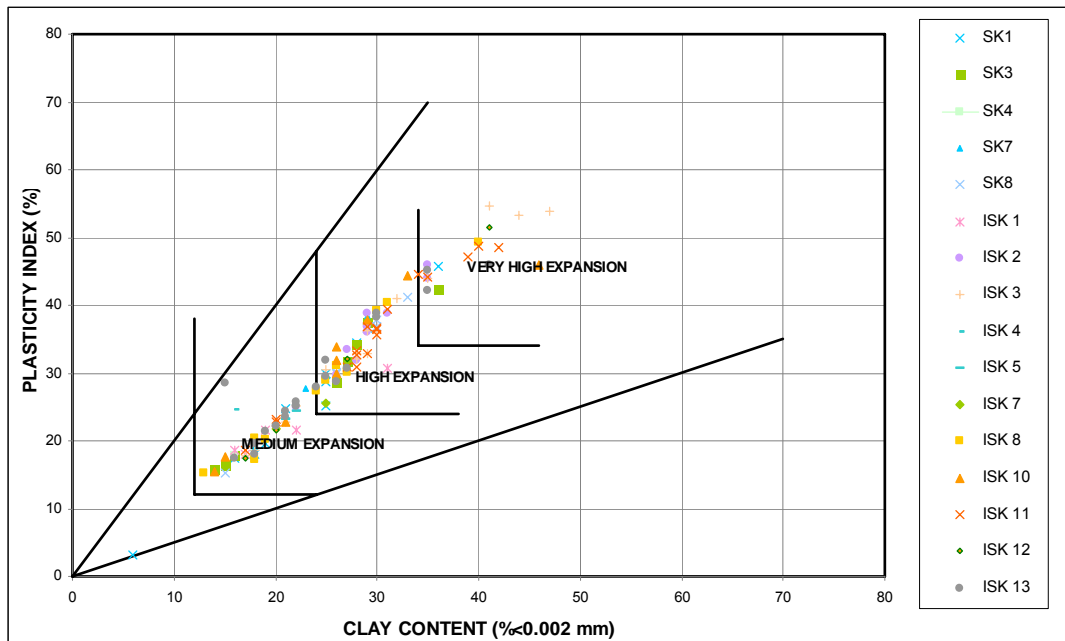
Figure 3.21. Activity chart indicating the swelling potential

In this study, atterberg limits of the samples were determined by Casagrande method according to the ASTM D 4318 (2004) standard. The test results of each sample including liquid limit, plastic limit, and plasticity index of soil specimens are given in Appendix C. Their plots on plasticity chart and activity chart are indicated in Figure 3.20 and Figure 3.21, respectively.

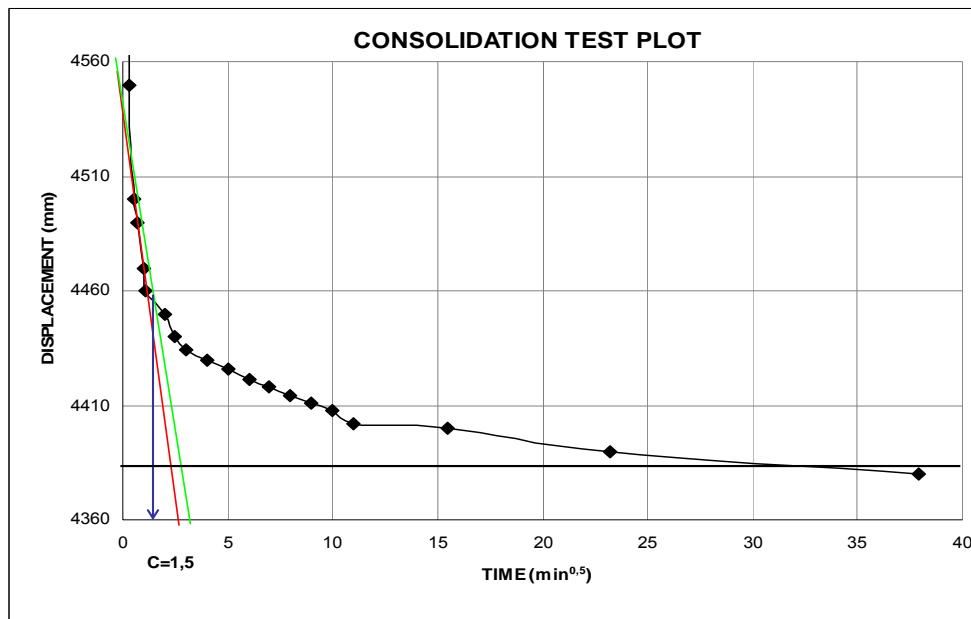
Figure 3.22. Consolidation plot of undisturbed specimen for CD direct shear test

$t_{50} = t_{90}/4,28$. The representative plot (4 kg load) for the first sample is shown in Figure 3.22, all consolidation test reports of first experiment for all different loads are presented in Appendix D;

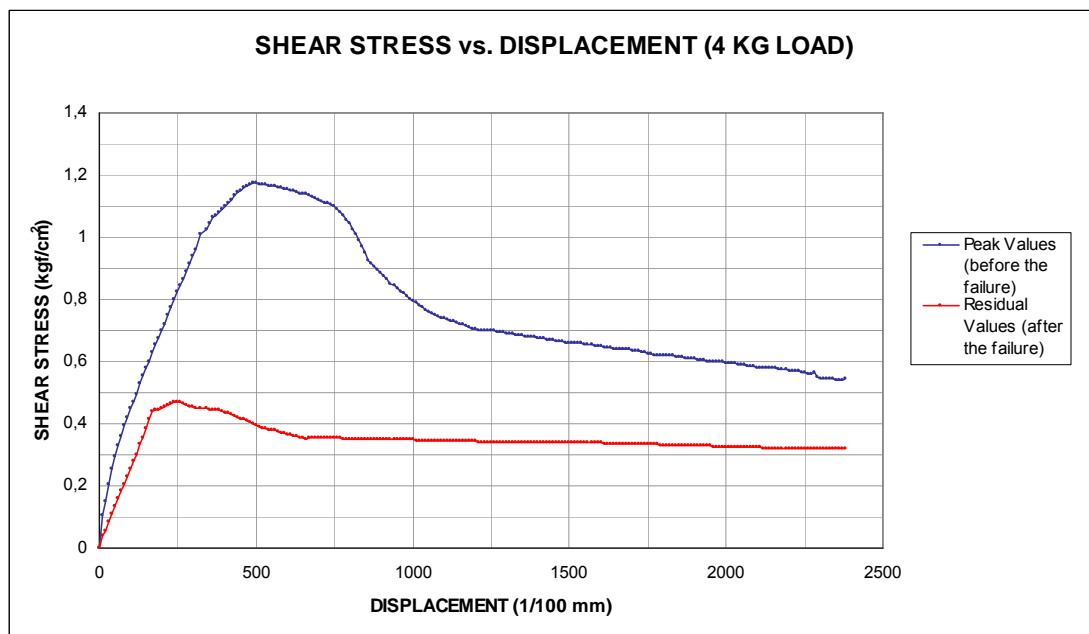
Figure 3.23 Shear stress vs. displacement plot with 4 kg normal load

the calculated speed until the failure of the sample is achieved. The results are expressed in a typical shear stress versus deformation graph. After this stage, the sample is moved forward and backward in the shear box to simulate the soil conditions in the failure plane as explained in the previous section and by this way we were able to reach the minimum residual values. The same procedure is repeated with the same speed and a new shear stress versus deformation graph is obtained. This experiment is applied for two specimens collected from 3rd and 6th meters of ISK-03 borehole for three different normal loads which are 4, 8 and 16 kg. Three different loads which are 4, 8 and 16 kg, in other words 111,1, 222,2 and 444,4 kN/m², respectively are calculated according to the corresponding load at 5th, 10th and 20th meters soil thickness above the failure surface in the field. These plots for different loads (4 kg, 8 kg and 16 kg) of the first experiment are shown in Figure 3.23 thru Figure 3.25, the post-failure plot has smaller shear stress values than the first experiment.

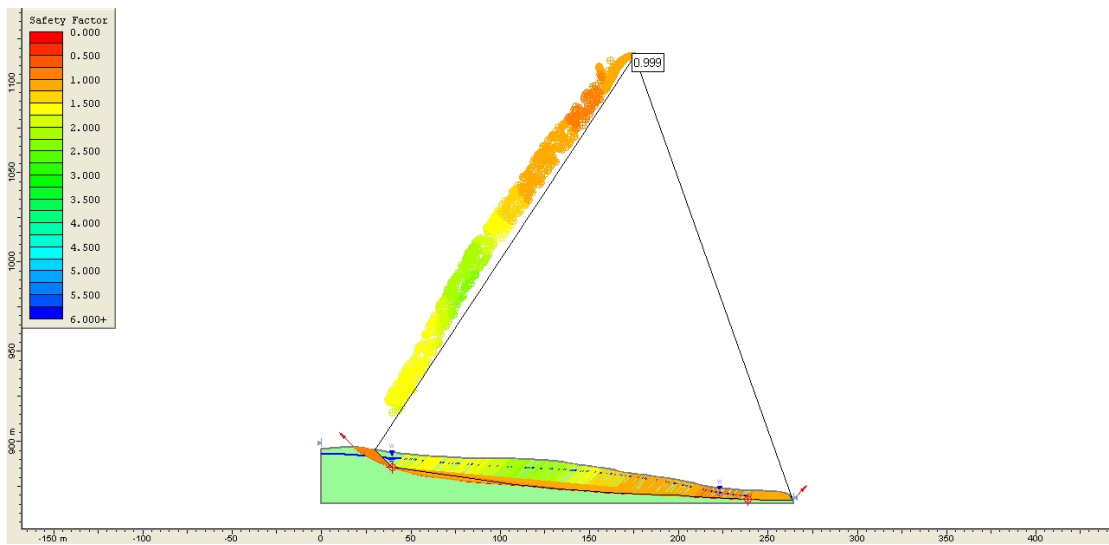
Figure 4.5. Back analysis output along cross section 3 (between ISK-8 and ISK-11)

computation. When the factor of safety from the simplified method is multiplied with this correction factor, the result will be close to that from the analysis which takes into account both forces and moment equilibrium (Cheng and Lau, 2008). For instance, while the Simplified Janbu procedure without the correction factor underestimates the factor of safety by about 7%, the corrected version agrees within 1% with the value of the factor of safety calculated using methods that satisfy moment equilibrium (Duncan and Wright, 1996). Therefore, considering the shape of slip surface observed in study area, Janbu's corrected method with 25 slices was chosen for the back analysis based on the suitability of this method to our case. These cross-sections together with the sliding surfaces and groundwater table for the analysis are indicated in Figure 4.3 thru Figure 4.5.
