SOUNDNESS ASSESSMENT OF HISTORIC STRUCTURAL TIMBER  
BY THE USE OF NON-DESTRUCTIVE METHODS

A THESIS SUBMITTED TO  
THE GRADUATE SCHOOL OF NATURAL AND APPLIED SCIENCES  
OF  
MIDDLE EAST TECHNICAL UNIVERSITY

AYŞENUR KANDEMİR

MARCH 2010

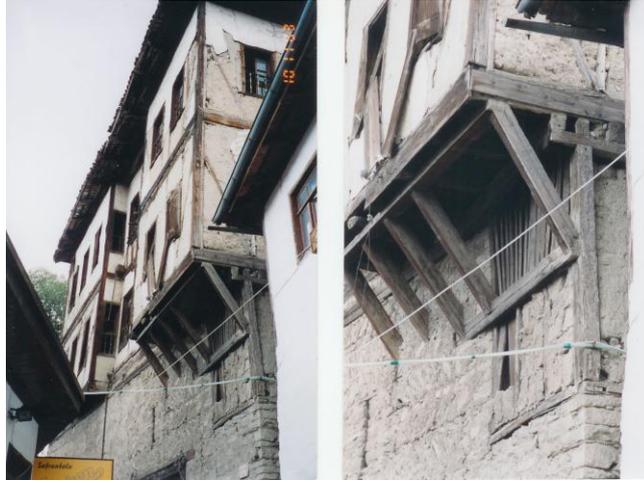
Figure 2.2 A Safranbolu House with the projection with bracing element

The projection with bracing elements was supported by two or more bracing elements. The extending length of the projection with bracing element is about 80-130 cm in Safranbolu houses (Figure 2.2) (Kaya, 1996).

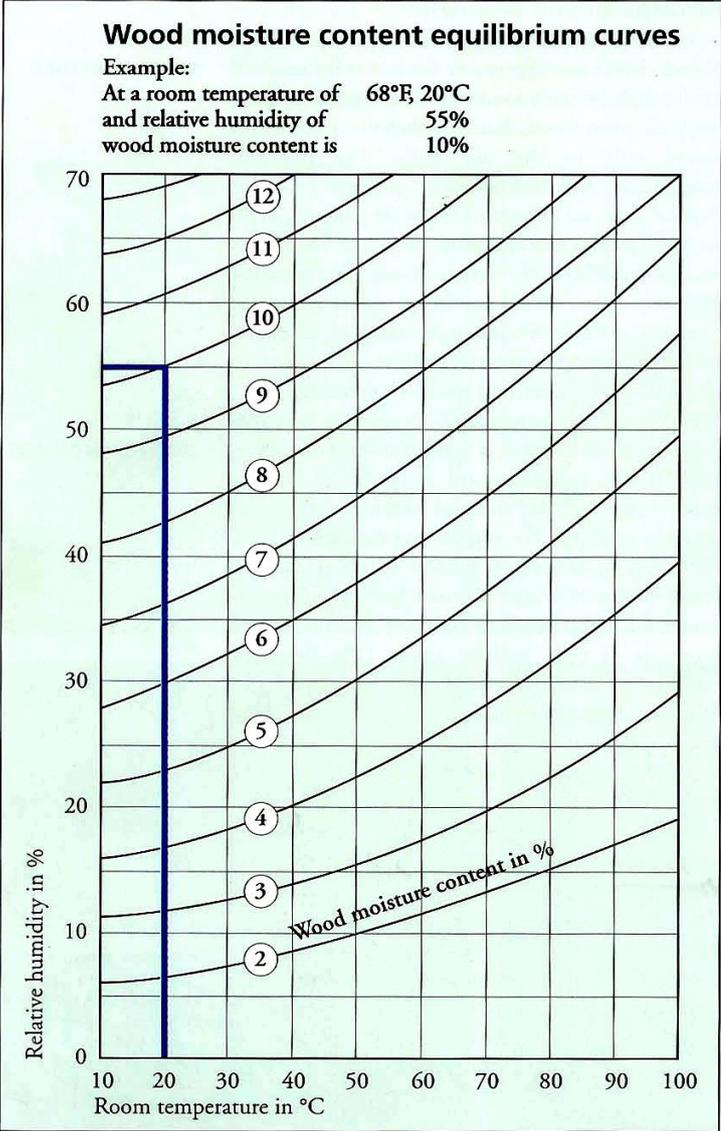
Figure 3.2 Wood Moisture Content Equilibrium Curves (Knut,1999: 20)

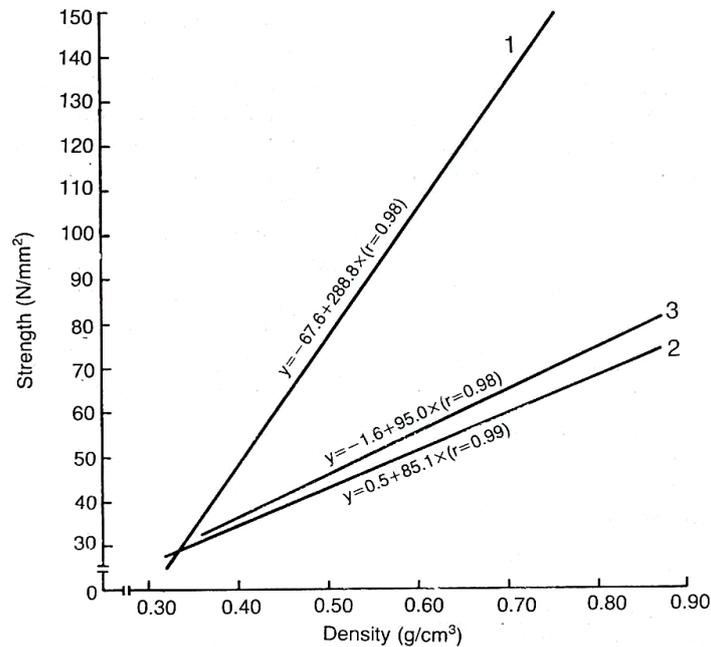
Figure 3.3 The relationship of strength(y) and density(x), 1. Static Bending(MOR), 2. Axial compression, 3. Hardness (Tsoumis,1991: 175)

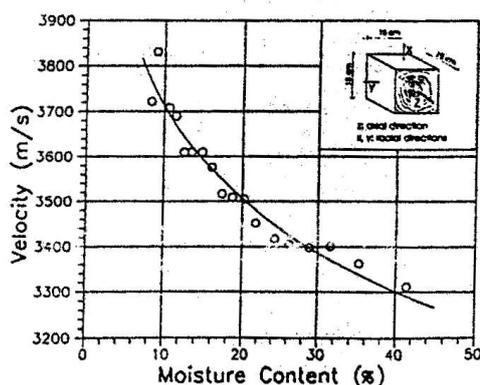
Figure 4.1 Pulse velocity versus moisture in the axial direction (Olivito, 1996: 515)

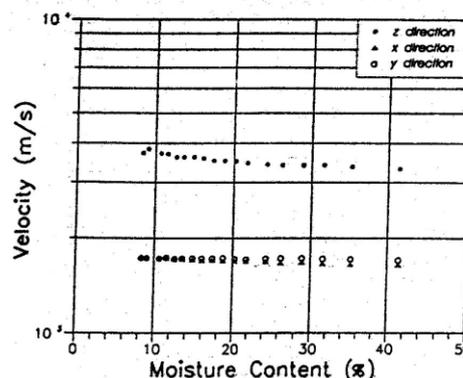
Figure 4.2 Pulse velocity vs. content content-z direction: axial direction x and y direction: Radial Direction (Olivito, 1996: 516)

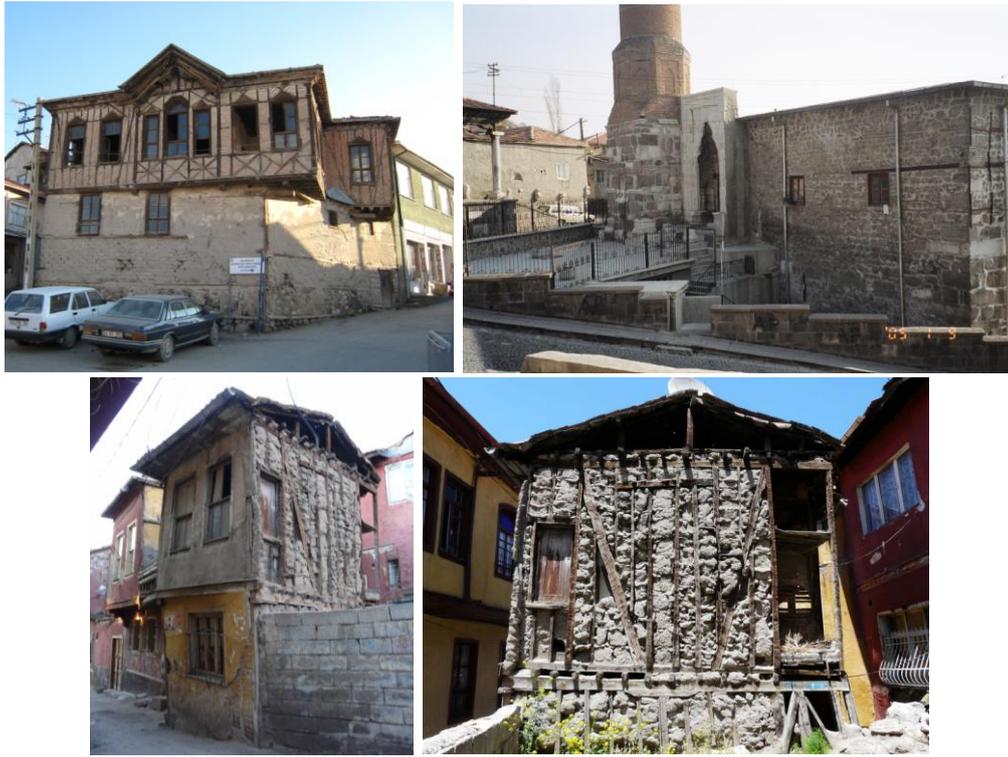
Figure 5.1. Front views of Ayaş House (at the top left) and Aslanhane Mosque (at the top right), front and side views of the Istiklal House (at the bottom)

The studies were conducted on a mosque constructed in 13<sup>th</sup> century, Aslanhane Camisi, 19<sup>th</sup> century traditional timber dwellings, Ayaş House and Istiklal House in Ankara (Figure 5.1). Aslanhane Camisi, belonging to Selçuk Period was constructed in 1289-1290 according to its inscription panel (Öney, 1990). It is one of the most important mosques belonging to Selçuk Period located on the south of the Citadel Ankara (Figure 5.2). Aslanhane Camisi, was a stone masonry structure

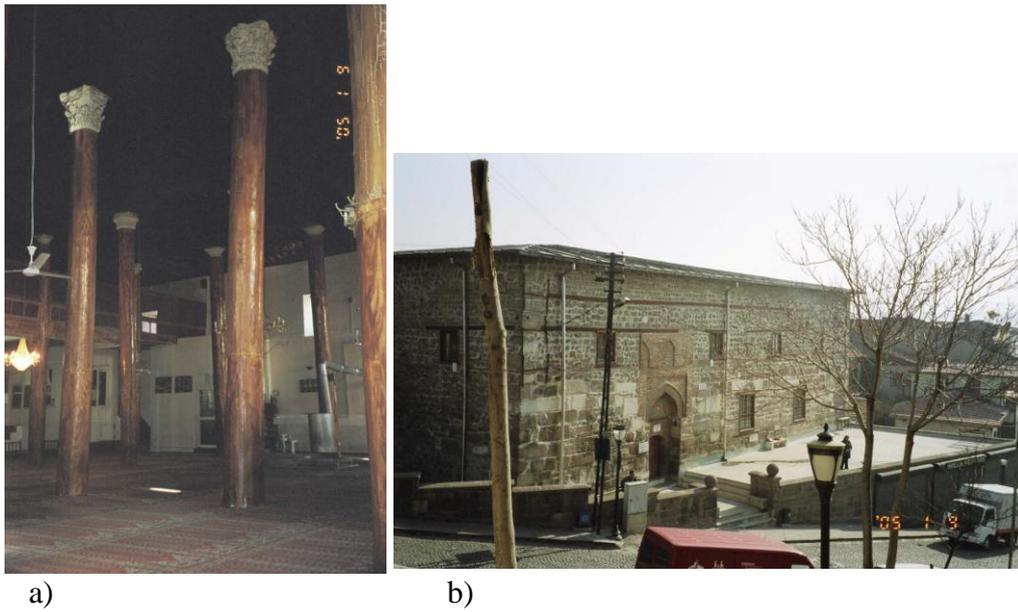
Figure 5.4 a) Interior view from the Aslanhane Mosque showing the some timber columns supporting the roof and timber ceiling structure b) The view of west façade showing the stone masonry walls with timber lintels and bond beams

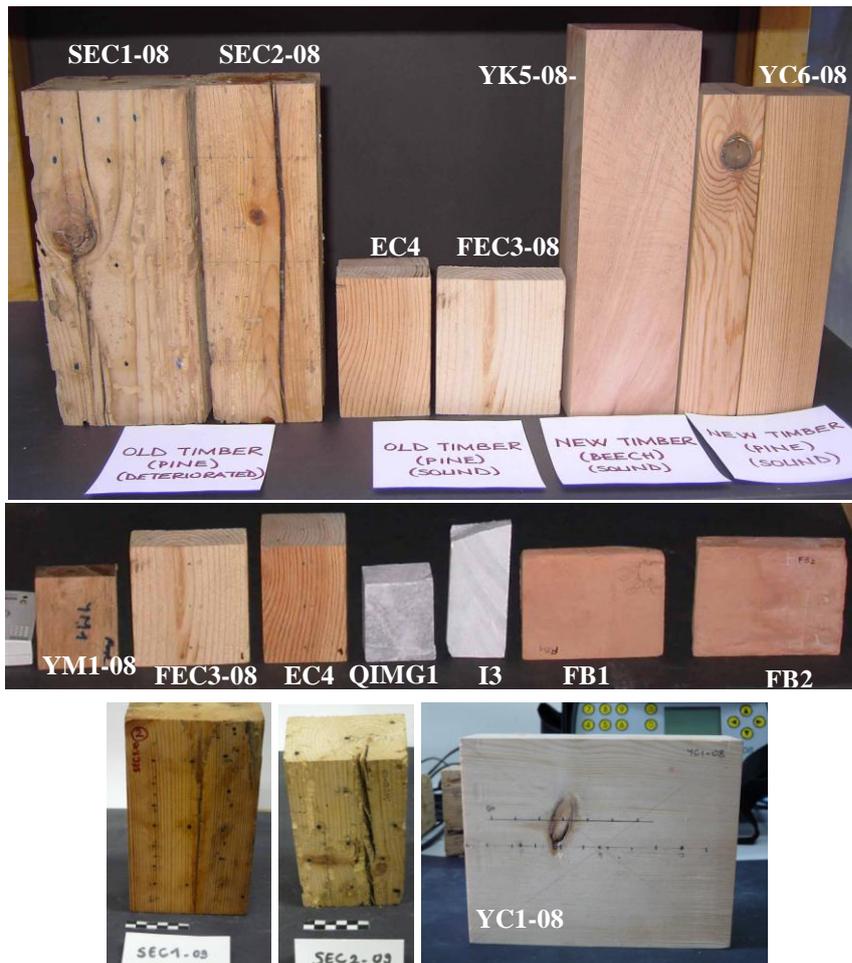
Figure 5.8 Old sound and deteriorated timber samples, new pine, beech, oak timber samples, stone and fired brick infill samples

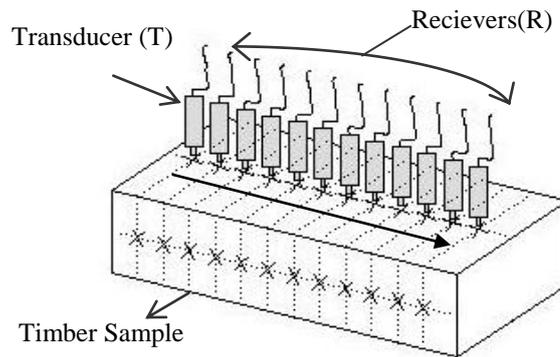
Figure 5.9 Schematic drawing showing the indirect UPV measurements

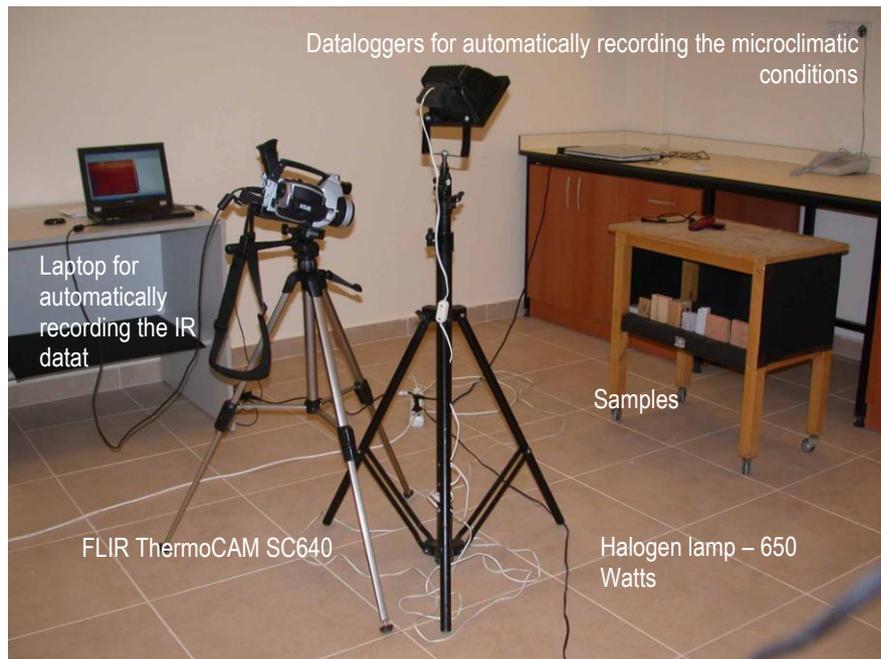
Figure 5.11 The experimental setup of sequential IR imaging at laboratory for the monitoring of sound oak timber, sound pine timber marble, fired brick samples during heating and then cooling periods.

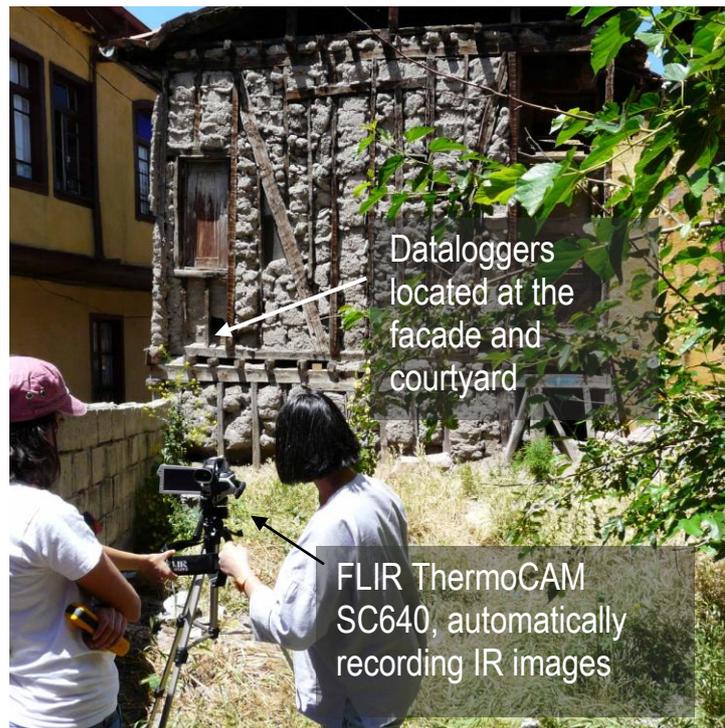
Figure 5.12 The QIRT experimental set-up at İstiklal House showing IR camera automatically-recording IR images of target area at 10s intervals during the heating and cooling periods of a day

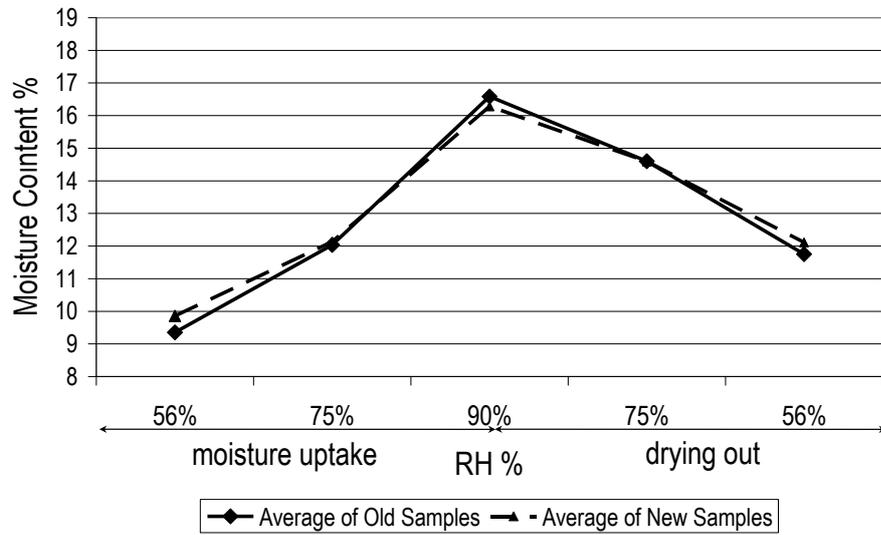
Figure 6.1 The average EMC of all old and new timber samples during moisture absorption and desorption indicating slower desorption (Kandemir *et al.*, 2007).

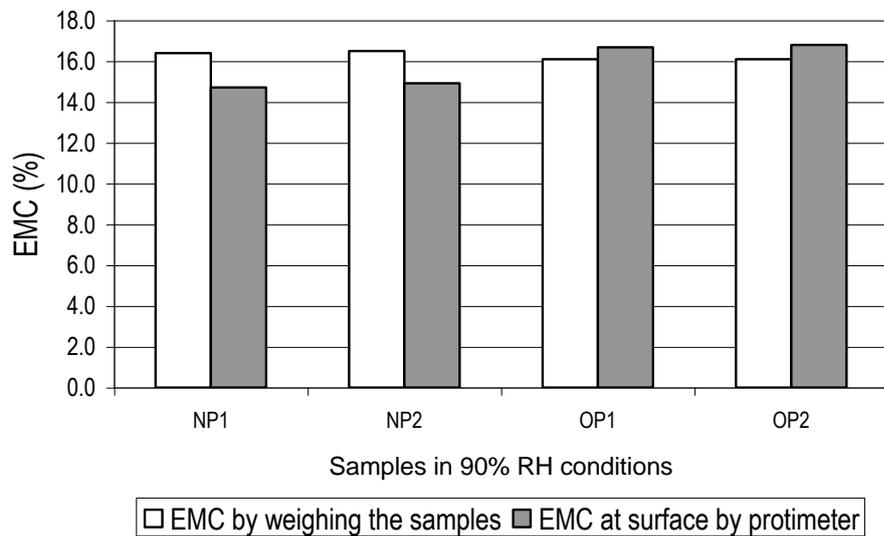
Figure 6.2 EMC of old and new pine by weight measurements and surface moisture readings by protimeter (Kandemir *et al.*, 2007).

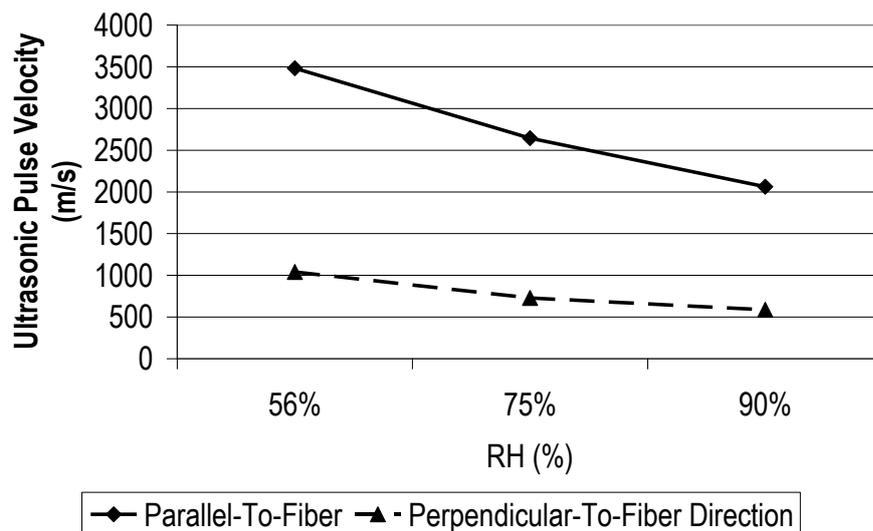
Figure 6.3 Changes in ultrasonic velocity values of old and new timber samples due to the changes in moisture content (Kandemir *et al.*, 2007)

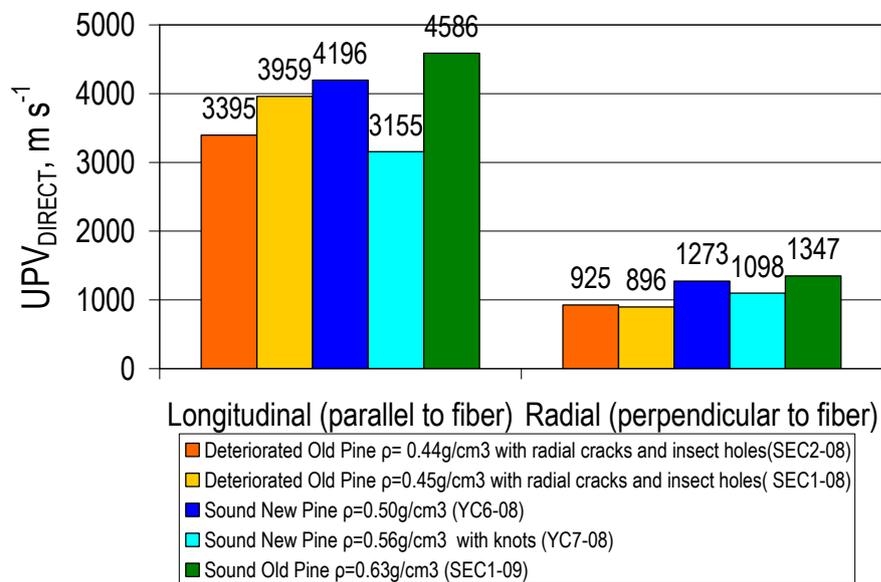
Figure 6.4 The  $UPV_{L-DIRECT}$  and  $UPV_{R-DIRECT}$  measurements for the deteriorated and sound old pine samples collected from traditional houses and sound new pine samples

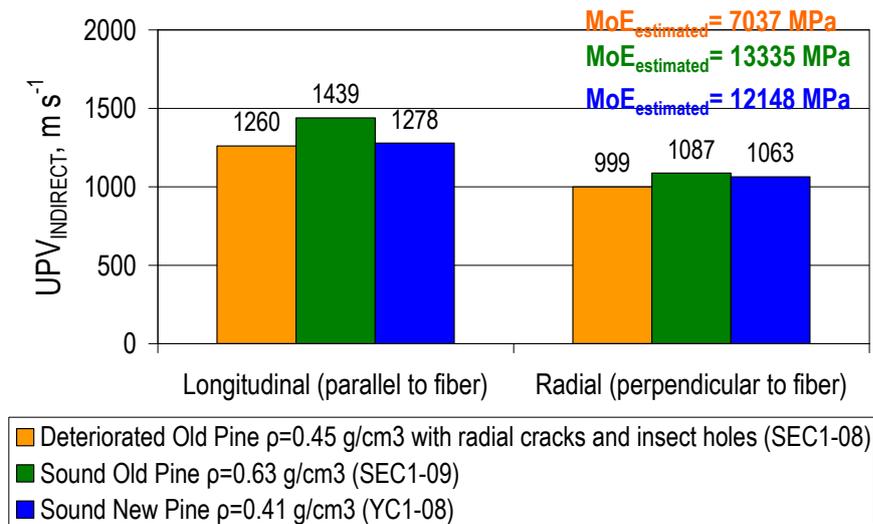
Figure 6.5 The laboratory UPV measurements taken in indirect mode both perpendicular and parallel to fiber direction.

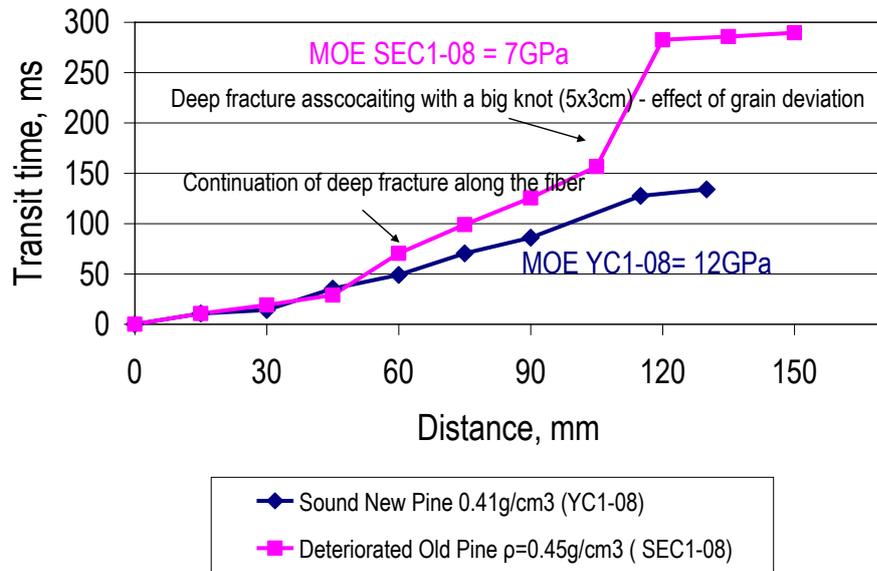
Figure 6.6 The transit time versus distance showing the presence of the knots on the timber surfaces.

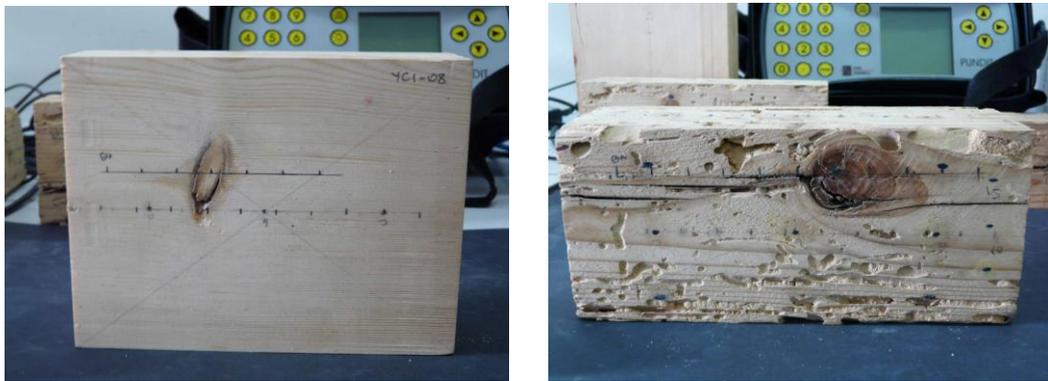
Figure 6.7 Indirect UPV measurements taken from the surface of timber sample with knot; YC1-08 (left) and SEC1-08 (right)

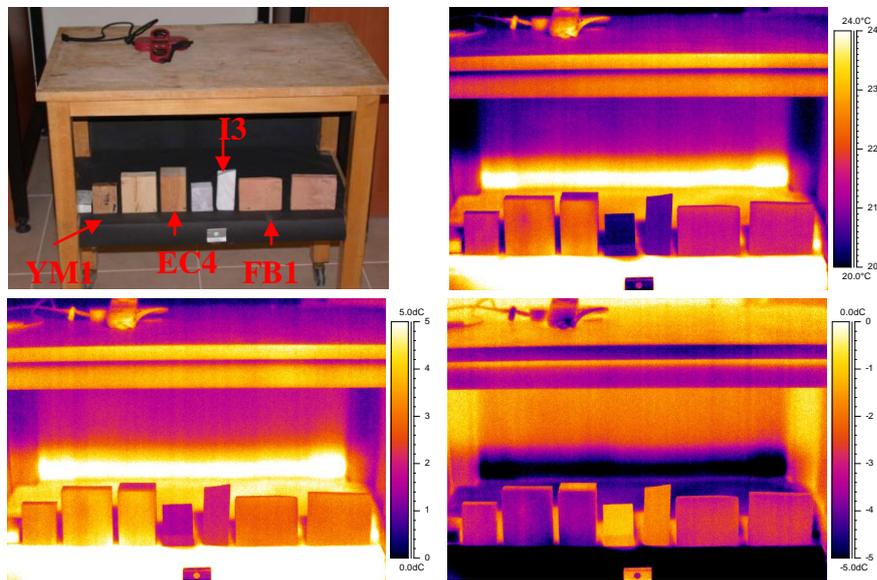
Figure 6.8 a) Laboratory samples oak (YM1), pine 1(EC3), pine 2(EC4), marble 1(QIMG1), marble 2(I3) and fired brick 1(FB1), fired brick 2 (FB2) b) IR image of samples at the beginning of heating period c) Differential IR image of samples at the heating period d) Differential IR image of samples at the cooling period.

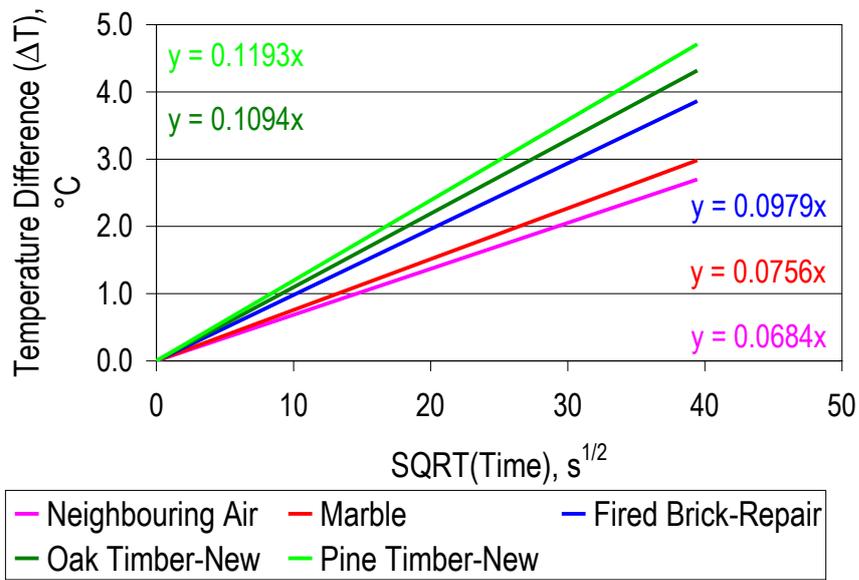
Figure 6.9.c The temperature difference lines versus square root of time for oak, pine, marble and repair fired brick samples heated by the halogen lamp (650 Watt) and then monitored by the sequential IR imaging during the heating period

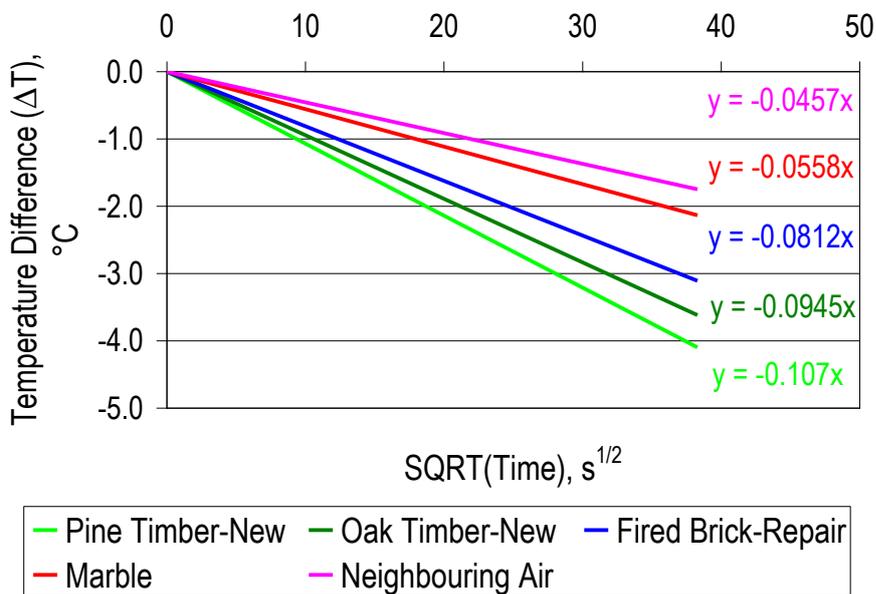
Figure 6.9.d) The temperature difference lines versus square root of time for oak, pine, marble and repair fired brick samples heated by the halogen lamp (650 Watt) and then monitored by the sequential IR imaging during the cooling period

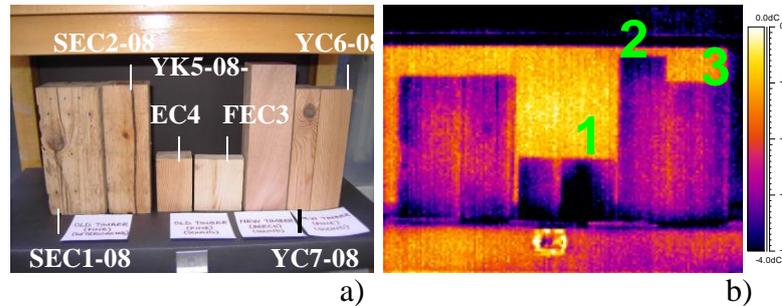
Figure 6.10 a) View of timber samples: Old pine (SEC1-08, SEC2-08), new pine (EC4, YC7-08, YC6-08) deteriorated pine (FEC3), new sound beech (YK5-08) b) Their differential IR image.

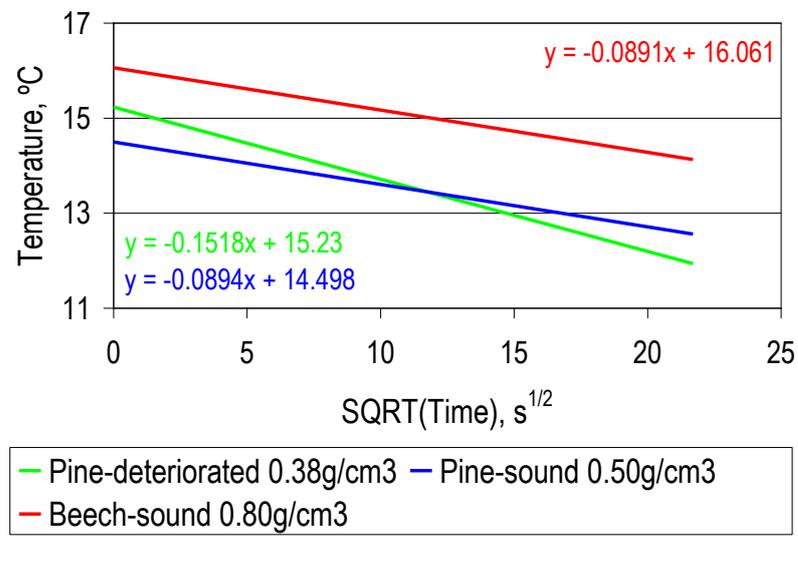
Figure 6.11 a) The surface temperature lines versus square root of time during cooling period

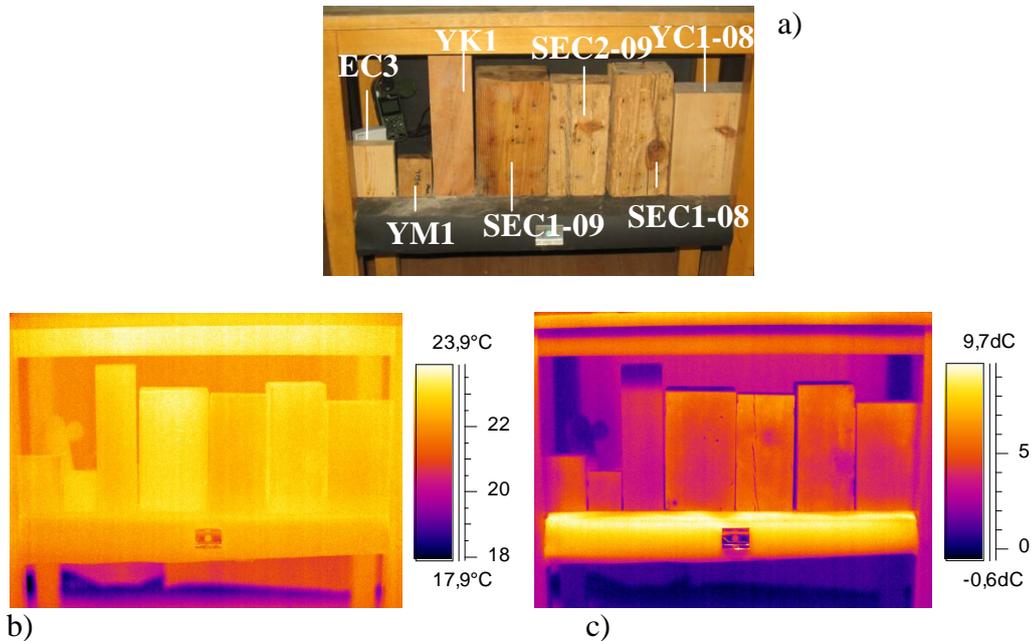
Figure 6.12 a) The view of samples before analyzed by QIRT: old pine with low density (FEC3- 0.38 g/cm<sup>3</sup>), new oak (YM1-0,870), new beech (YK5-0.784) sound old pine (SEC1-09-0.634), deteriorated old pine (SEC2-09-0.421 g/cm<sup>3</sup>) visually deteriorated but inner part sound pine (SEC1-08, 0.449 g/cm<sup>3</sup>), sound new pine (YC1-08- 0.408 g/cm<sup>3</sup>) b) IR image of sample at the beginning of heating period c) Differential IR image of samples during heating period of 814 seconds.

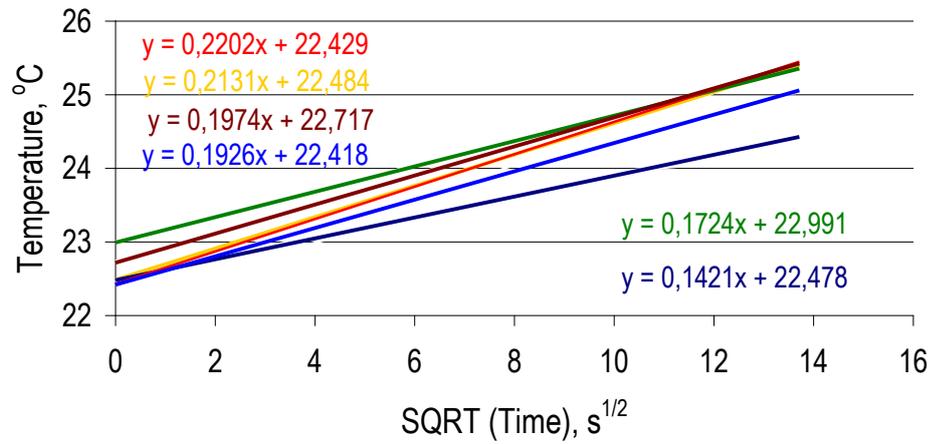
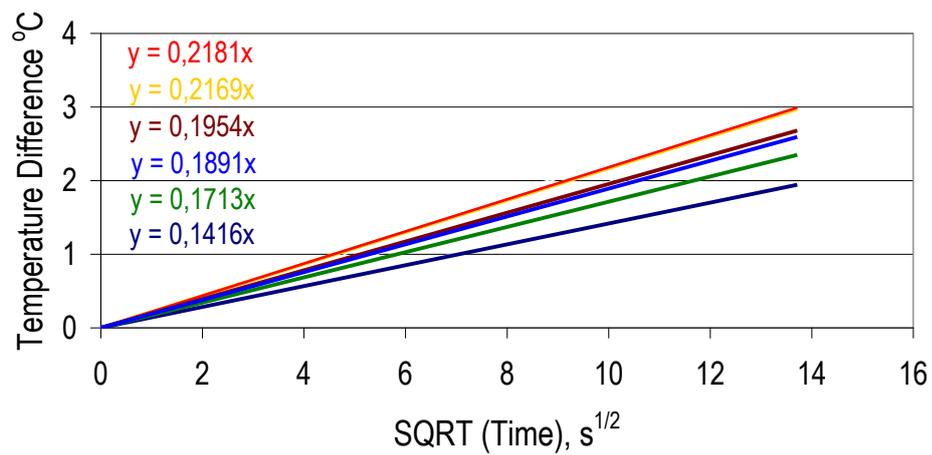
Figure 6.13 The surface temperature and temperature difference lines versus square root of time during heating period for the samples in Figure 6.12.a

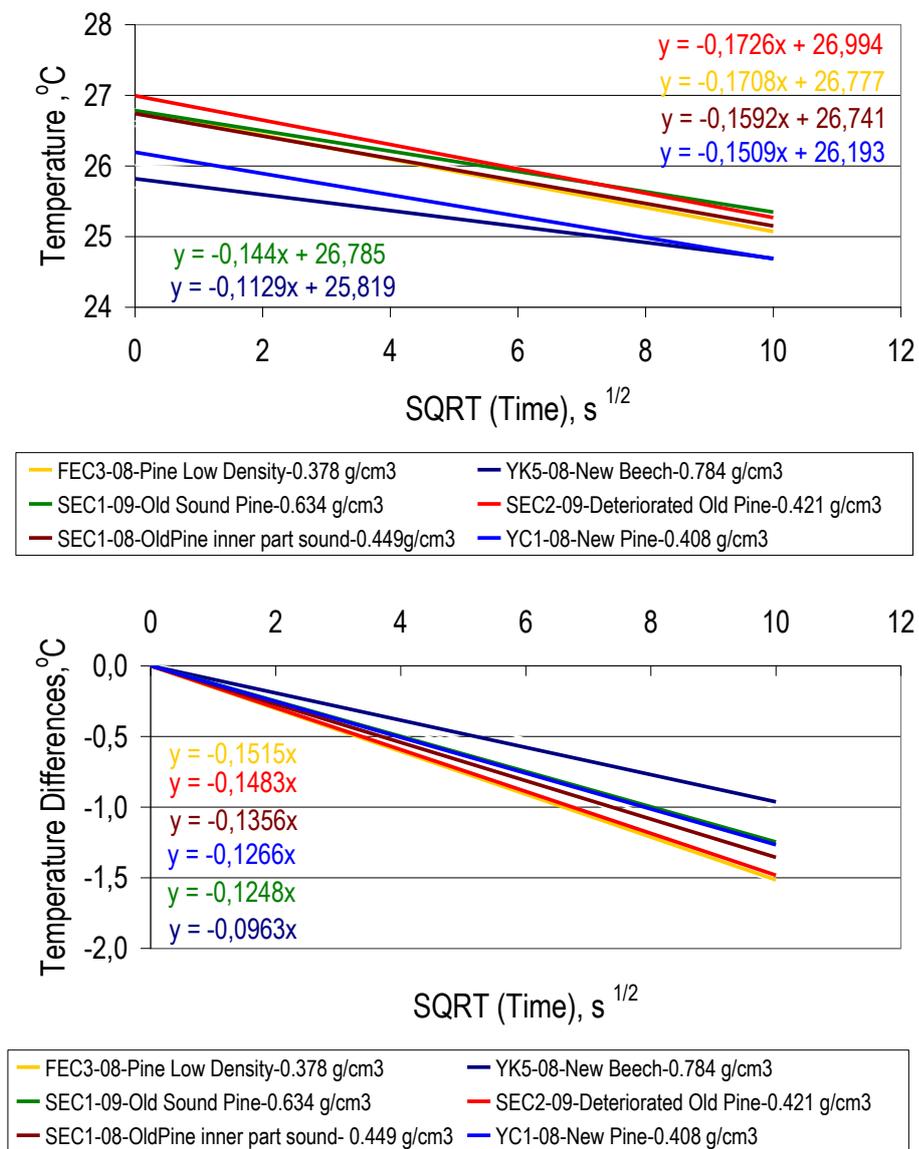
Figure 6.15 The surface temperature and temperature difference lines versus square root of time during cooling period for the samples in Figure 6.12.a

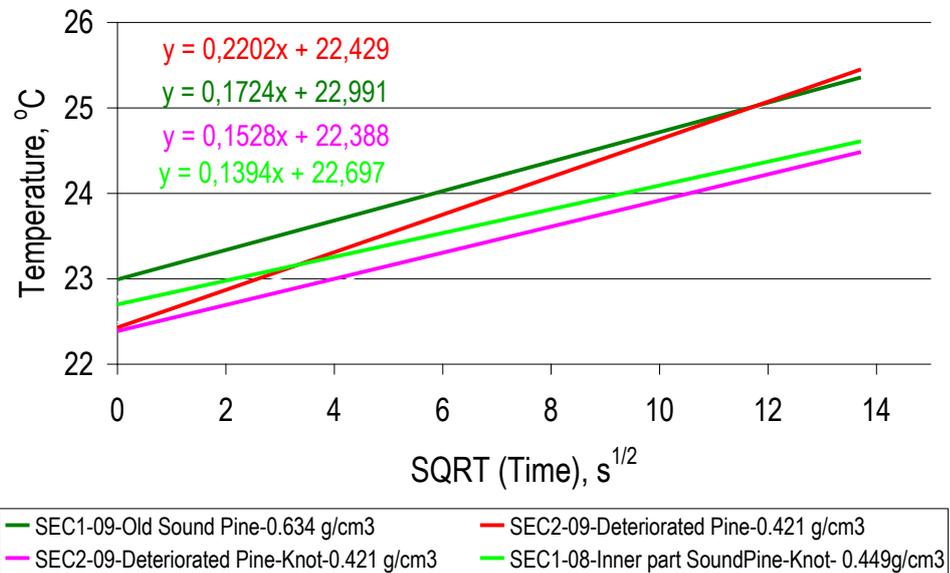
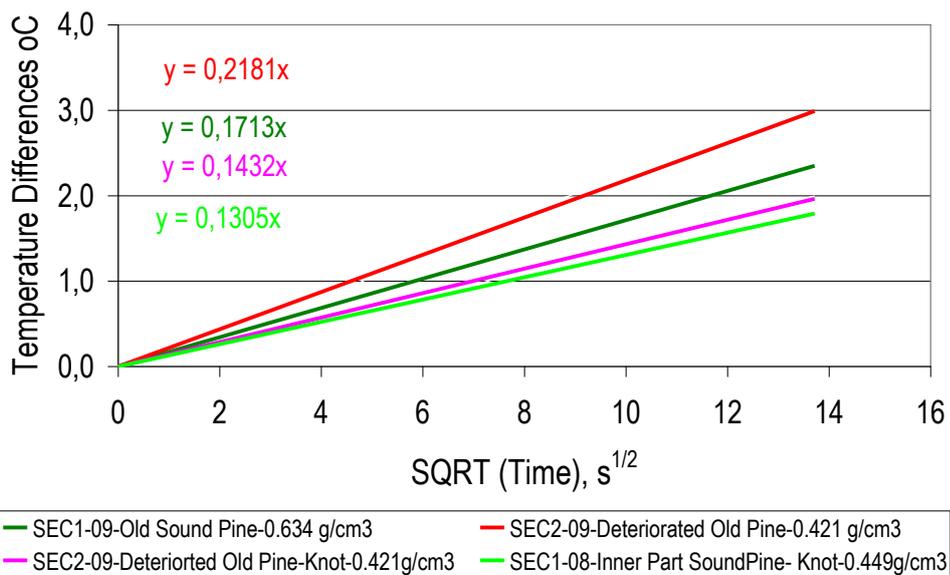
Figure 6.16.a The surface temperature and temperature difference lines versus square root of time during heating period compared with their knots for the samples in Figure 6.12.a.

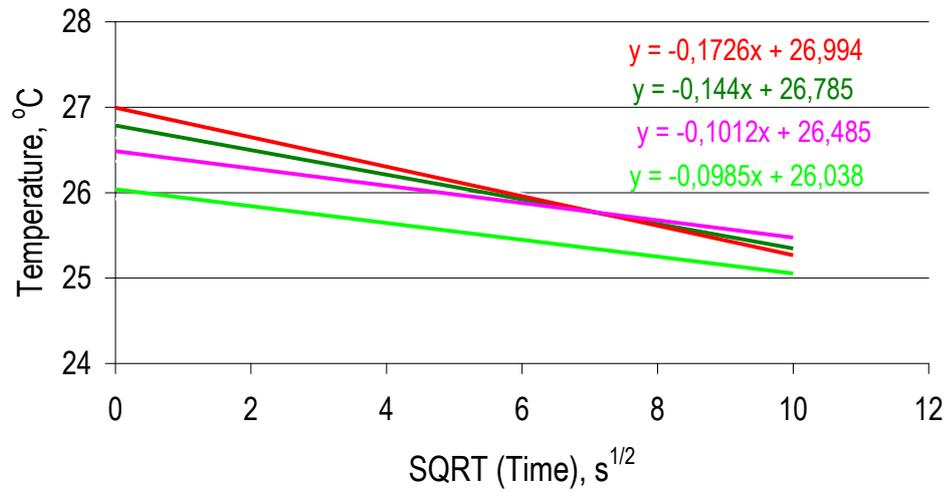
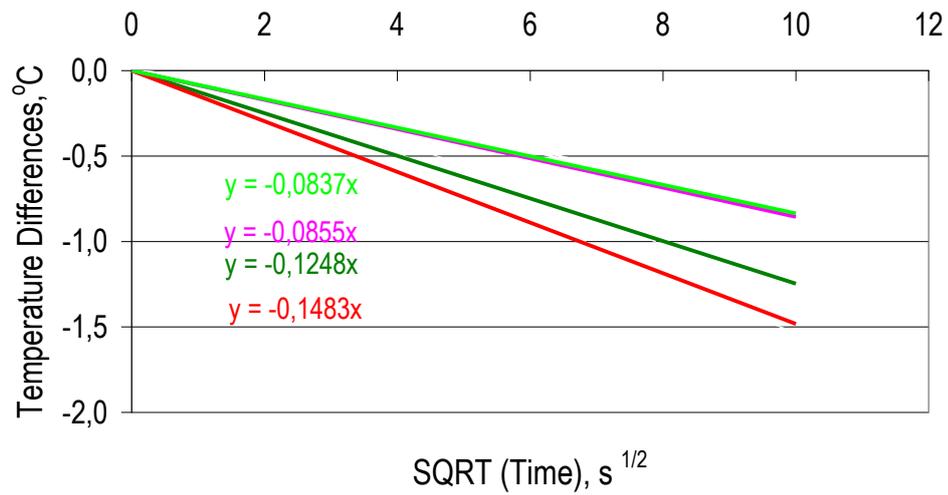
Figure 6.16.b The surface temperature and temperature difference lines versus square root of time during cooling period compared with their knots for the samples in Figure 6.12.a.

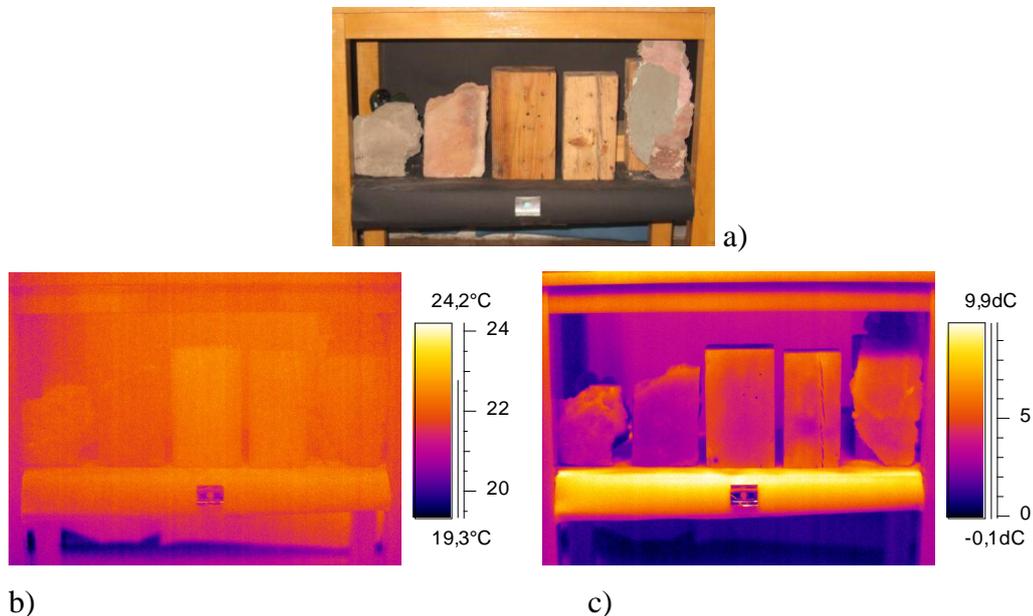
b) Figure 6.17 a) The view of samples before QIRT analyses: mud brick infill, fired brick infill, sound old timber (SEC1-09-0.634), deteriorated old pine (SEC2-09-0.421 g/cm<sup>3</sup>), exterior lime plaster together with its mud layer b) IR image of samples at the beginning of heating period c) Differential IR image of samples during heating period of 642 seconds.

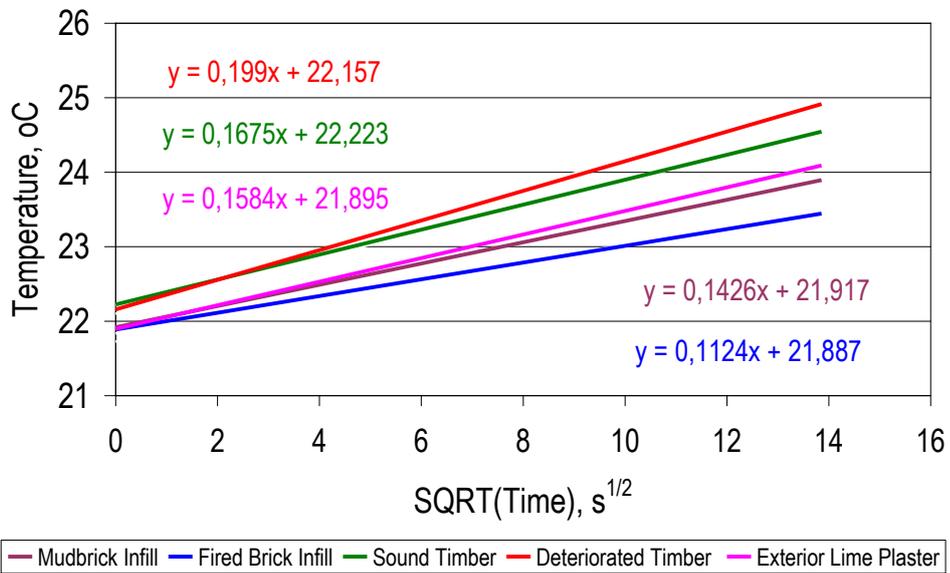
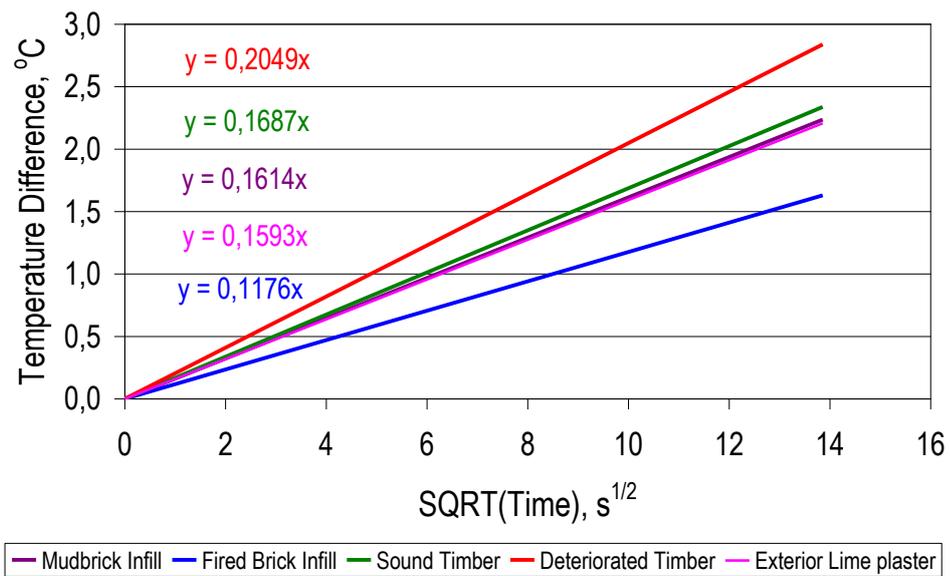
Figure 6.18 The surface temperature and temperature difference lines versus square root of time during heating period of the group consisting of mud brick, fired brick, sound and deteriorated timbers, exterior lime plaster together with its mud layer.

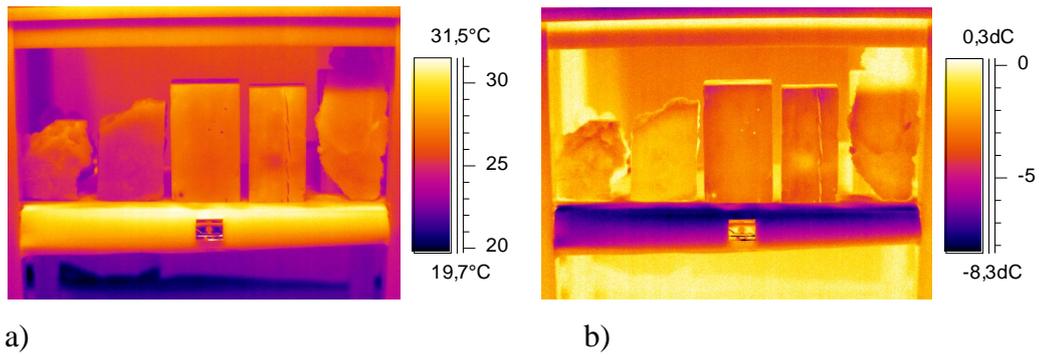
Figure 6.19 a) IR image of samples in Figure 6.17.a at the beginning of cooling period b) Differential IR image of samples during cooling period of 596 seconds.

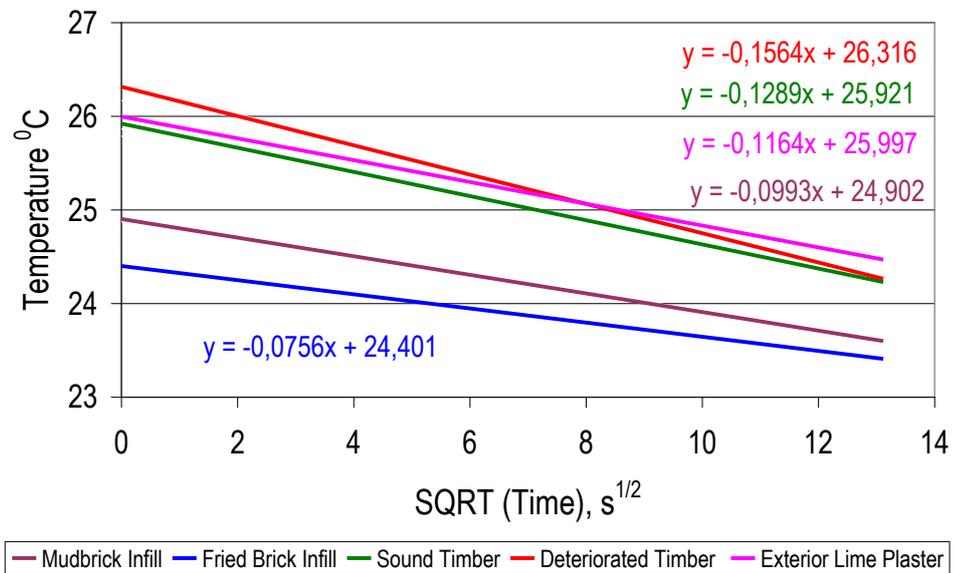
Figure 6.20 a) The lines of surface temperature versus square root of time during cooling period of the group consisting of mud brick, fired brick, sound and deteriorated timbers, exterior lime plaster together with its mud layer

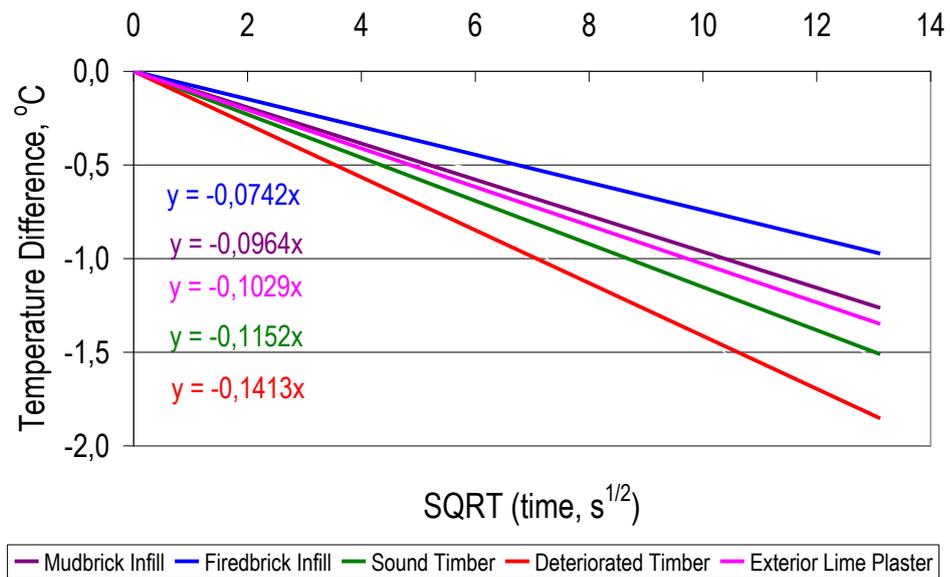
Figure 6.20 b) The lines of temperature difference versus square root of time during cooling period of the group consisting of mud brick, fired brick, sound and deteriorated timbers, exterior lime plaster together with its mud layer.

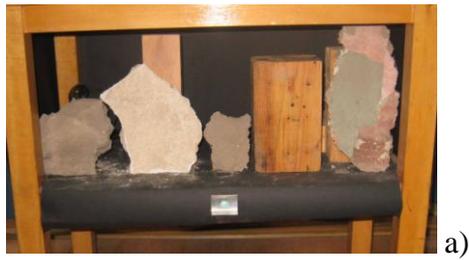
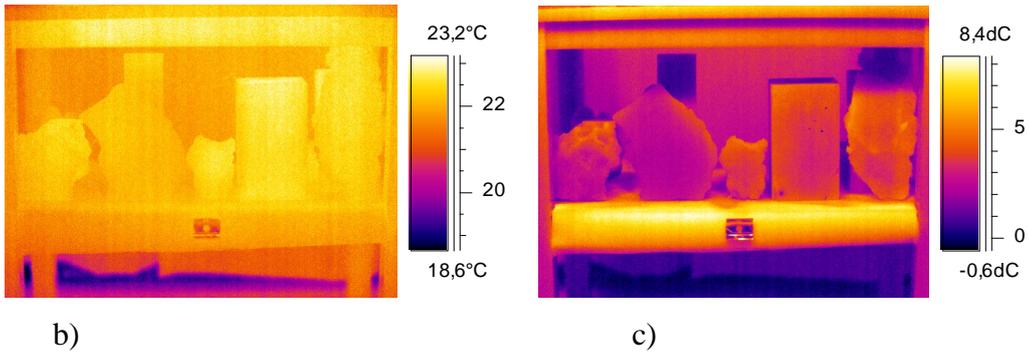
Figure 6.21 a) The view of samples before analyzed by QIRT: mud brick infill, thick interior repair plaster (high gypsum content) together with its mud layer, mud plaster, sound old timber (SEC1-09-0.634), exterior lime plaster together with its mud layer b) IR image of sample at the beginning of heating period c) Differential IR image of samples during heating period of 592 seconds.

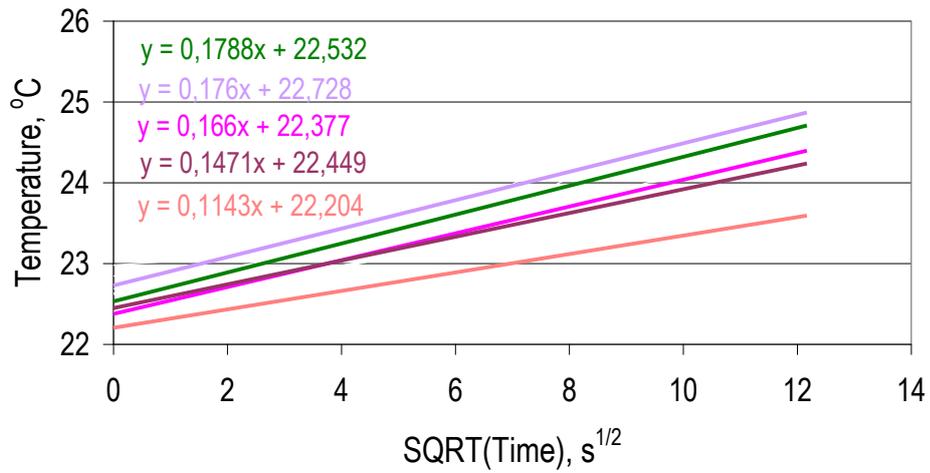
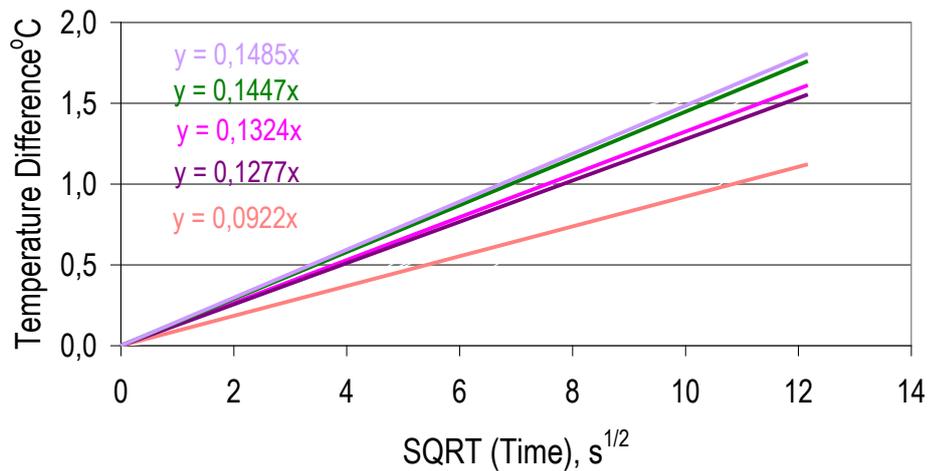
Figure 6.22 The lines of surface temperature and temperature difference versus square root of time during heating period of the group consisting of mud brick, interior lime plaster, mud plaster sound timber, and exterior lime plaster together with its mud layer.

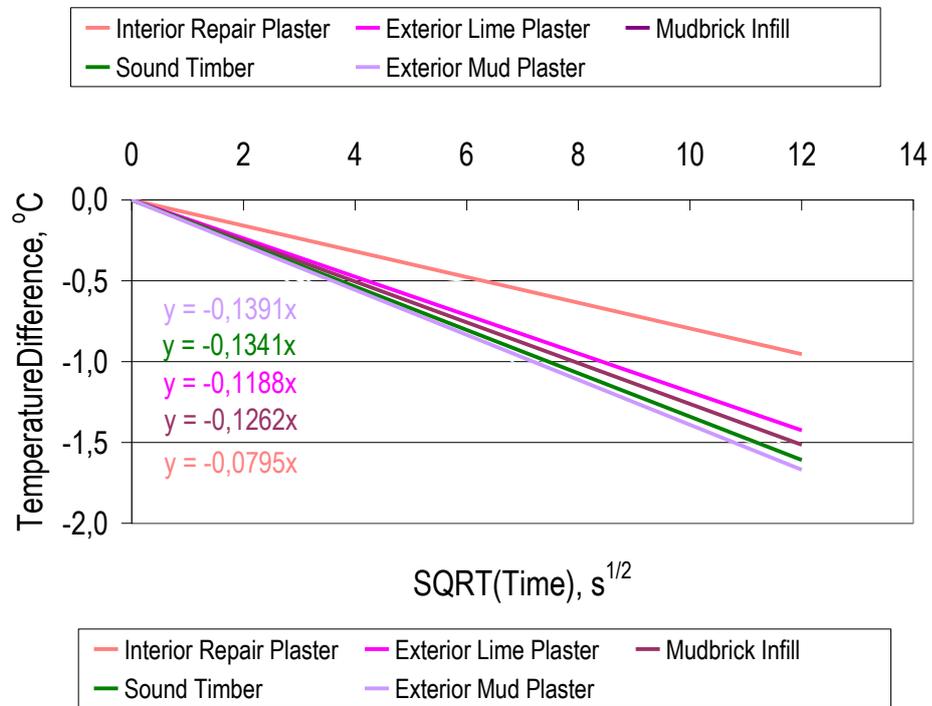
Figure 6.24 The lines of surface temperature and temperature difference versus square root of time during cooling period of the group consisting of mud brick, interior lime plaster, mud plaster sound timber, and exterior lime plaster together with its mud layer.

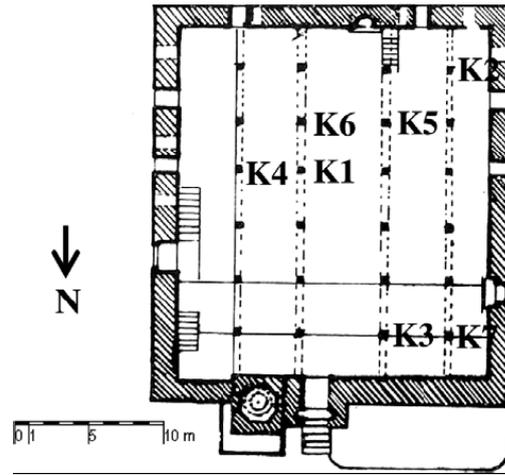
Figure 6.25 Plan of Aslanhane Mosque showing the columns investigated by UPV (Vakıflar Genel Müdürlüğü, 1983)
