SOUNDNESS ASSESSMENT OF HISTORIC STRUCTURAL TIMBER  
BY THE USE OF NON-DESTRUCTIVE METHODS

A THESIS SUBMITTED TO  
THE GRADUATE SCHOOL OF NATURAL AND APPLIED SCIENCES  
OF  
MIDDLE EAST TECHNICAL UNIVERSITY

AYŞENUR KANDEMİR

MARCH 2010

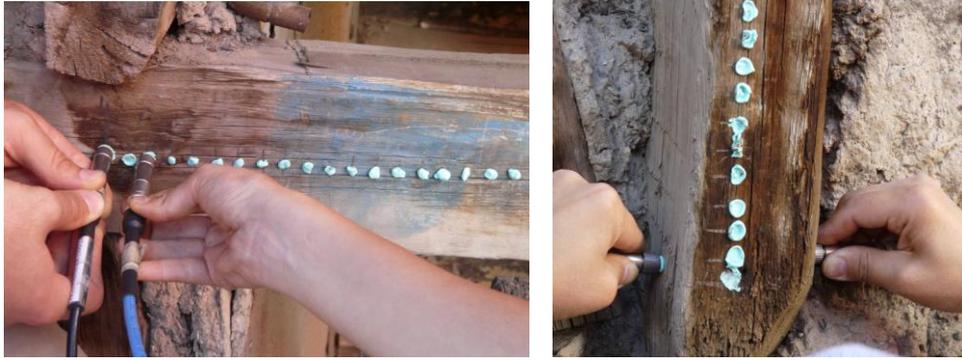
Figure 6.27 Indirect UPV measurements (left) from the beam and direct UPV measurements (right) from the post at İstiklal House.

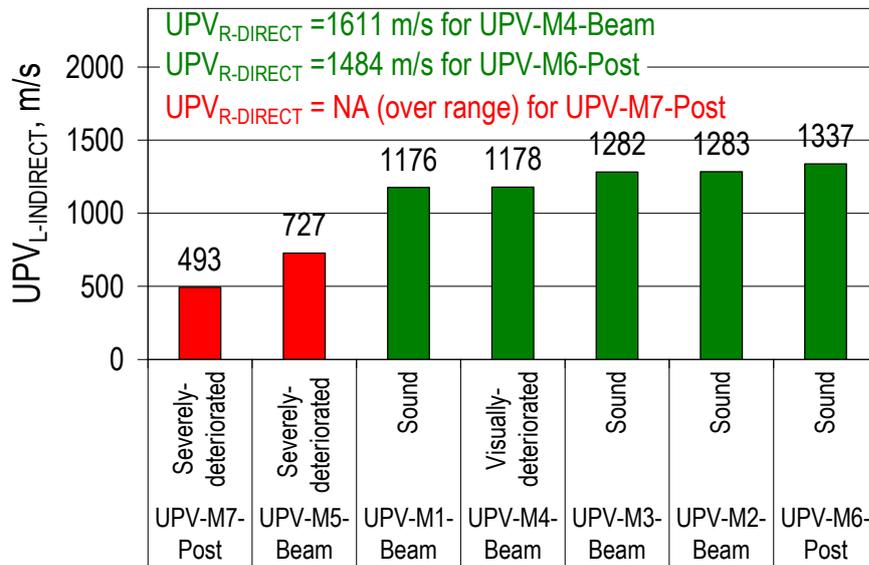
Figure 6.29 Indirect UPV measurements parallel to fiber direction. UPV<sub>L-INDIRECT</sub> (IN-SITU) = 1176 - 1337m/s for the sound timbers, UPV<sub>L-INDIRECT</sub> (IN-SITU) = 493 - 727m/s for the deteriorated timbers.

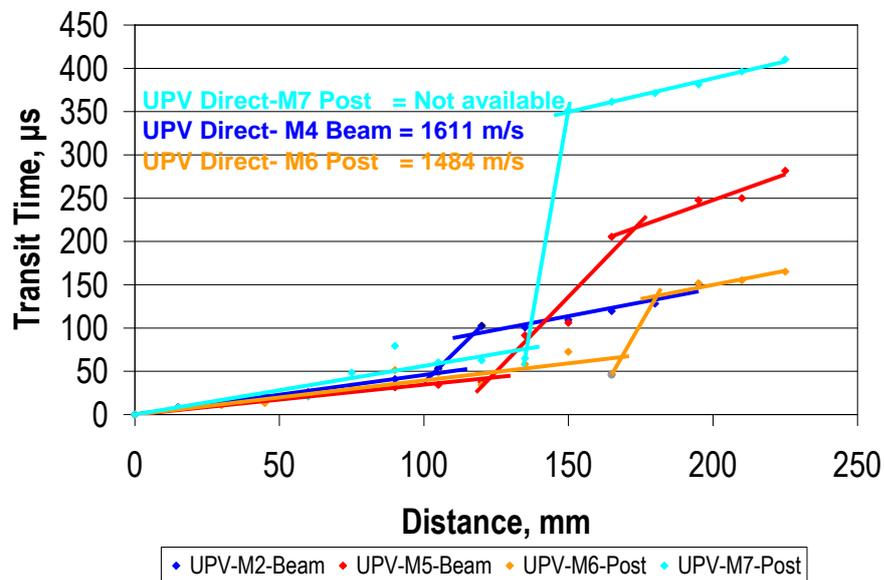
Figure 6.30 The lines of transit time versus distance showing in-situ indirect UPV measurements from the timber structural elements

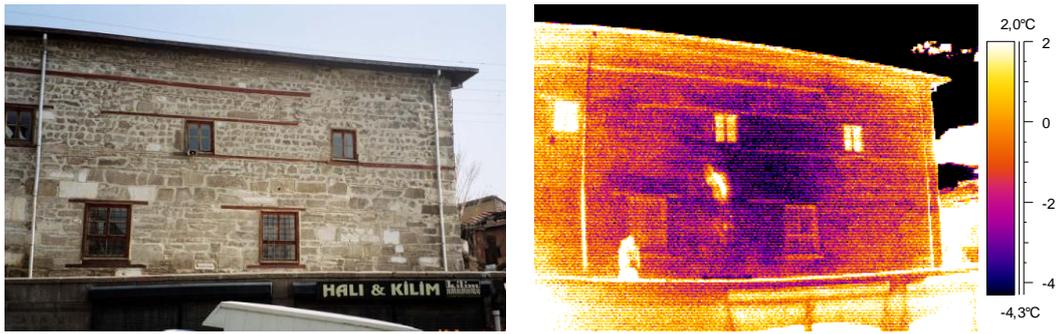
Figure 6.31 “View of the west façade of the building (left); IR image taken after sunset (right) showing that stone masonry façade with its timber lintels and bond beams had damp zones. Timber elements were warmer than stone masonry, but they had damp zones due to damp cement mortar repairs” (Kandemir *et al.*, 2007)

- Figure 6.31 View of the west façade of the building (left); IR image taken after sunset (right) showing that stone masonry façade with its timber lintels and bond beams had damp zones. Timber elements were warmer than stone masonry, but they had damp zones due to damp cement mortar repairs.....154

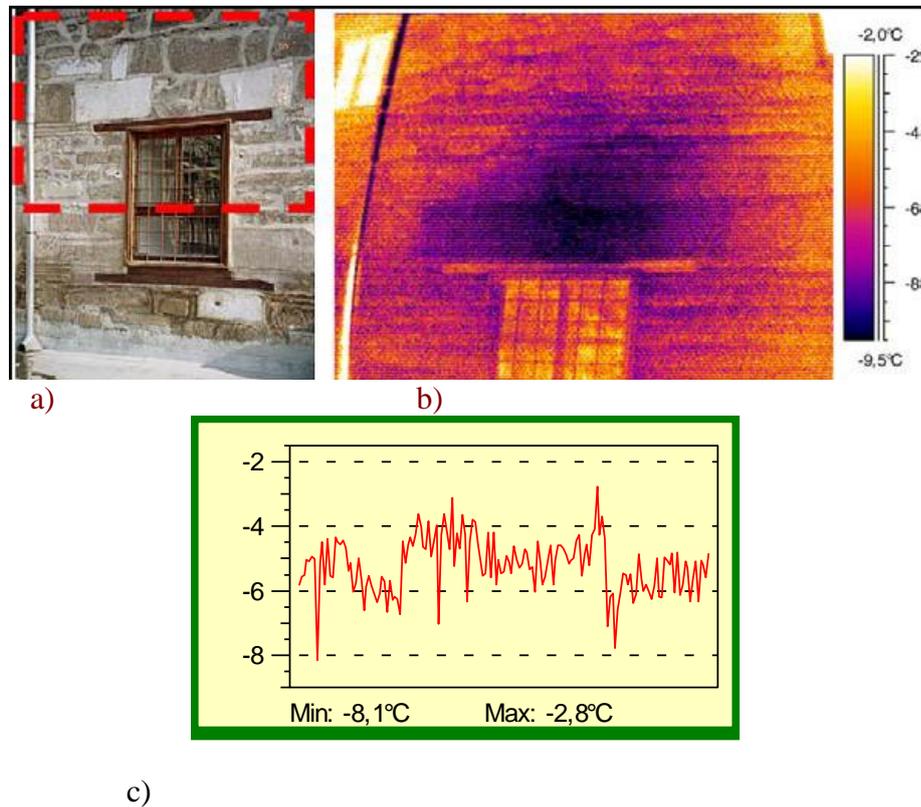
Figure 6.32 a)View of a window from the west facade of the building with timber lintel at its top b) IR image of the selected region, taken in day time c) Line temperature analysis of the timber lintel showing 5.5 °C surface temperature difference due to close relationship with wet cement neighbouring materials (Kandemir *et al.*, 2007)

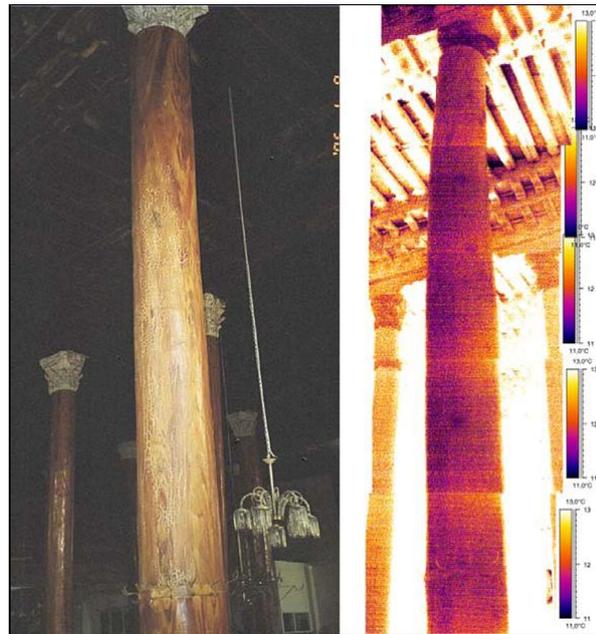
Figure 6.33 The view of the pillar K2 (left) and its IR image (right) showing an even temperature distribution on its surfaces with a difference of  $2^{\circ}\text{C}$  (Kandemir *et al.*, 2007).

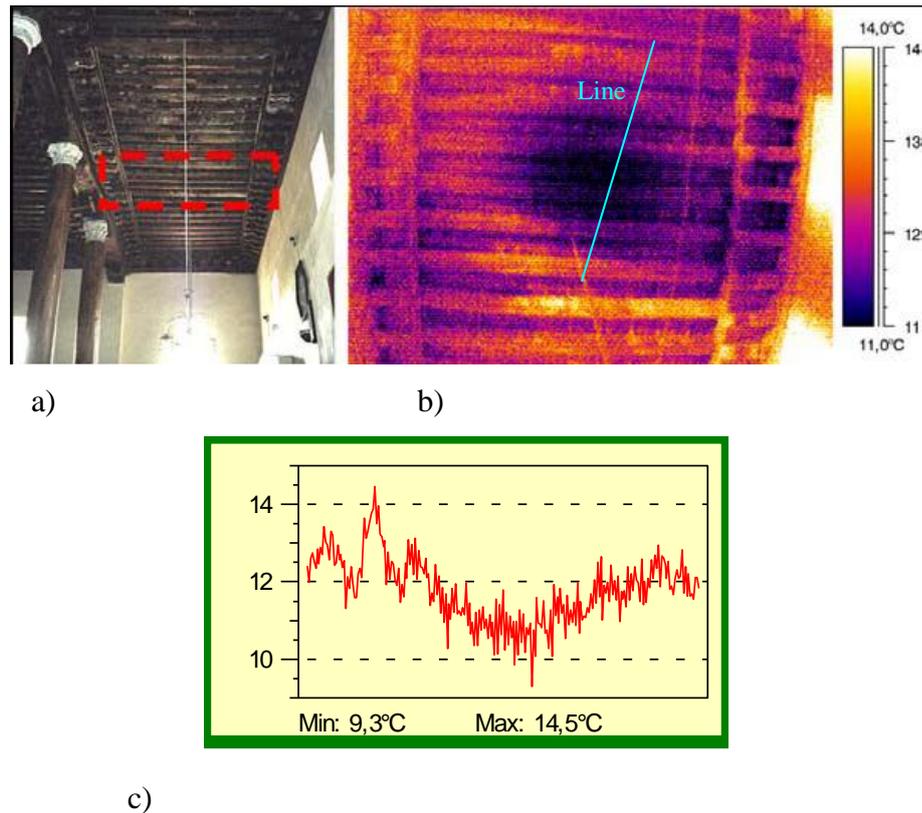
Figure 6.34 a) View of the timber ceiling b)IR image of the selected region showing the damp areas at ceiling c) The line analyses graph of timber ceiling

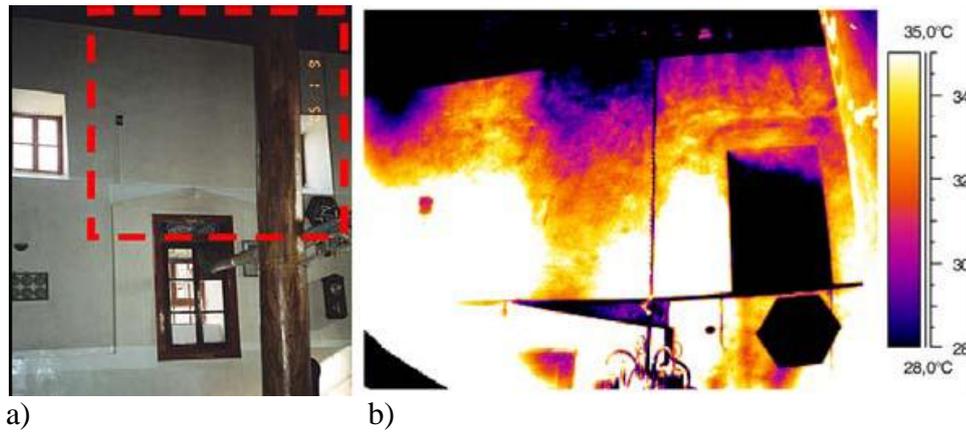
Figure 6.35 a) View of the interiors surfaces of the east wall b) IR image of the wall at the selected region showing the damp areas sourced from the faults in roof drainage.

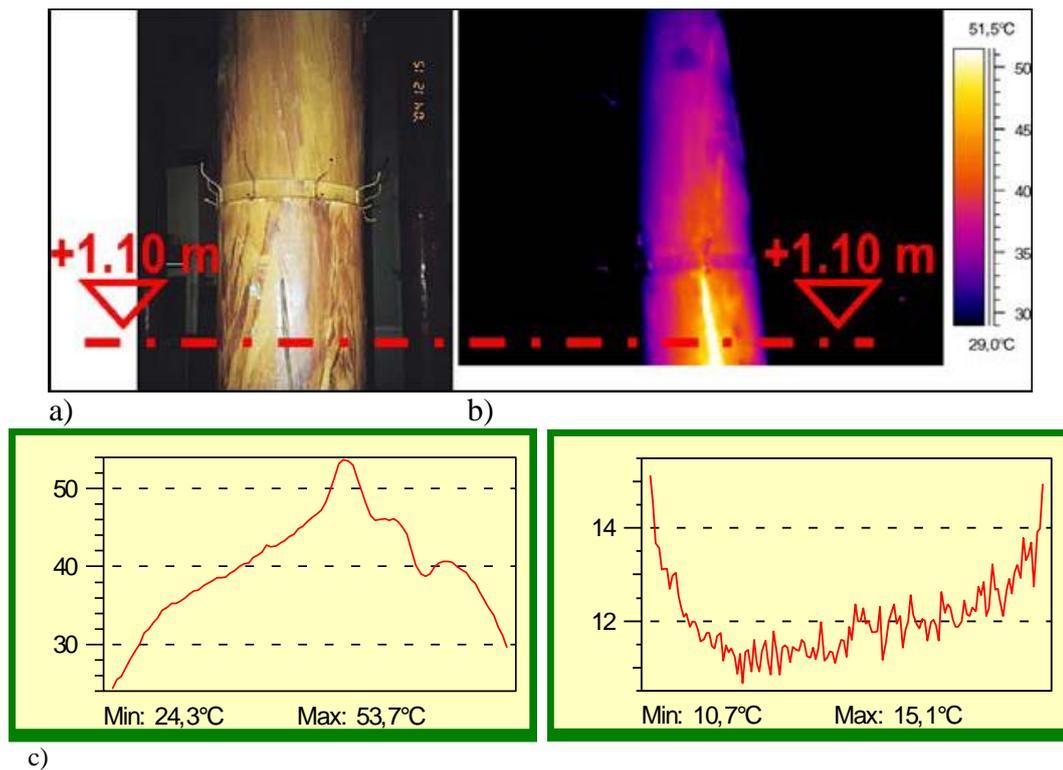
Figure 6.37 a) The view of Pillar K1 b) Its IR image showing that during an hour of heating with the stove there existed 39.3 °C temperature difference on the surfaces along the periphery of the pillar at +1.10 m height, and cracks were also detected as the hottest traces c) Line analysis of IR images of pillar K1 taken from the surfaces facing the stove (left) and at the back of the stove.

- Figure 6.37 a) The view of Pillar K1 b) Its IR image showing that during an hour of heating with the stove there existed 39.3 °C temperature difference on the surfaces along the periphery of the pillar at +1.10 m height, and cracks were also detected as the hottest traces c) Line analysis of IR images of pillar K1 taken from the surfaces facing the stove (left) and remaining at the back of the stove .....158

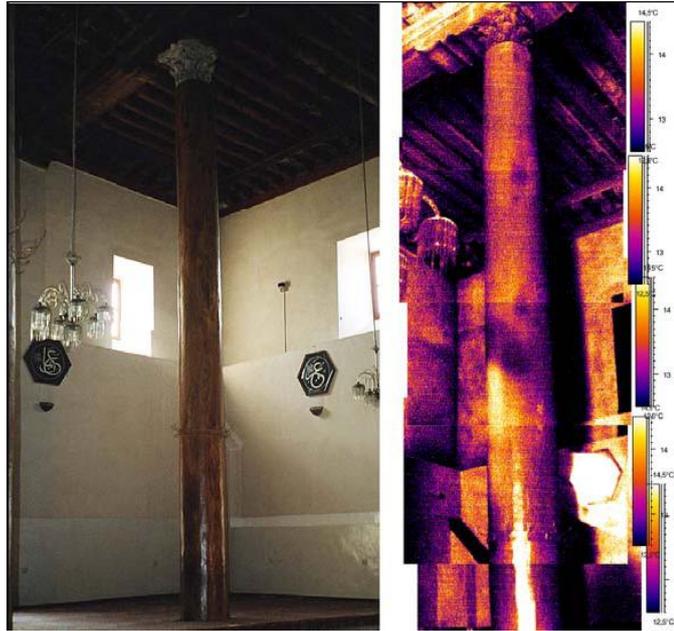
Figure 6.38 The view of Pillar K2 (left) and its IR image (right) showing that there was a temperature variation of  $27.8^{\circ}\text{C}$  which was similar to the temperature variations observed at the Pillar K1, and knots and cracks were easily detected as the coldest patches and the hottest patches/traces, respectively (Kandemir *et al.*, 2007).

- Figure 6.38 The view of Pillar K2 (left) and its IR image (right) showing that there was a temperature variation of 27.8 °C which was similar to the temperature variations observed at the Pillar K1, and knots and cracks were easily detected as the coldest patches and the hottest patches/traces, respectively.....159

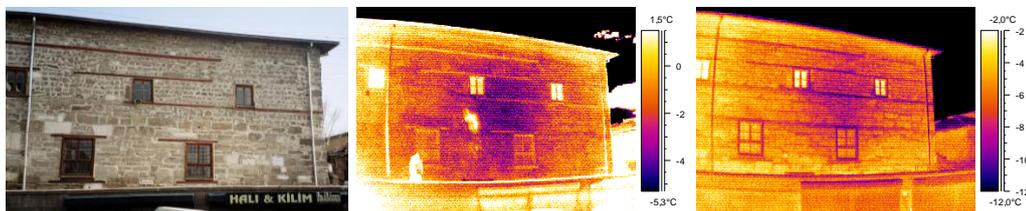
Figure 6.39 Partial view from the west façade of Aslanhane Camii and its IR images taken in December in daytime and at night, having the outside conditions of  $1.5^{\circ}\text{C}$  and 29%RH and  $-0.7^{\circ}\text{C}$  and 31%RH, respectively.

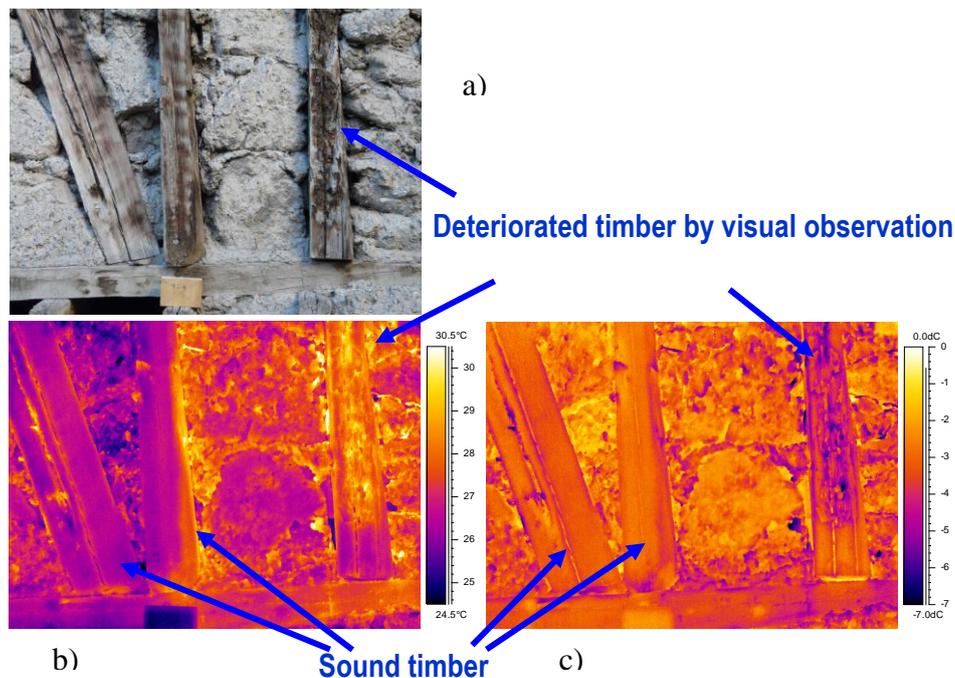
Figure 6.40 a) View of the wall section from Ayaş House b) The surface of the wall section was heated by hair dryer then monitored by the sequential IR imaging during the cooling period, first sequential image taken at the ambient conditions of 25.1°C and 33%RH c) The differential IR image showing the temperature difference between the initial and the last IR images of the cooling period of 603 seconds.

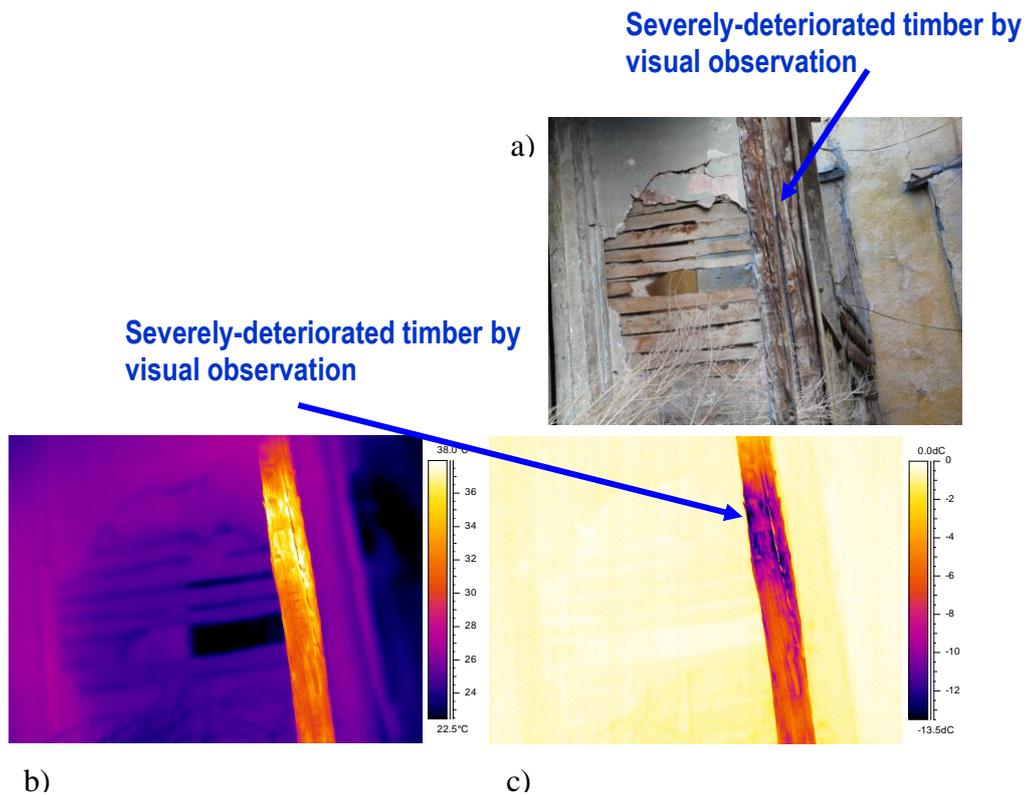
Figure 6.41 a) Partial view of the severely-deteriorated timber post (M7-Post) at Istiklal House b) The IR image of the timber taken at the ambient conditions of 25.5°C and 33%RH after heated uniformly with hair dryer for one minute c) The differential IR image showing the temperature difference between the initial and the last IR images of the cooling period of 476s.

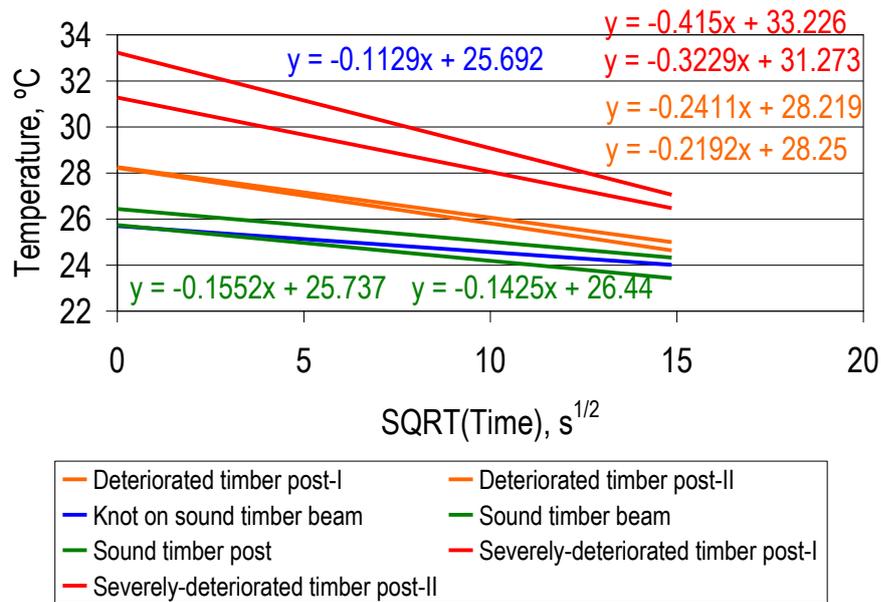
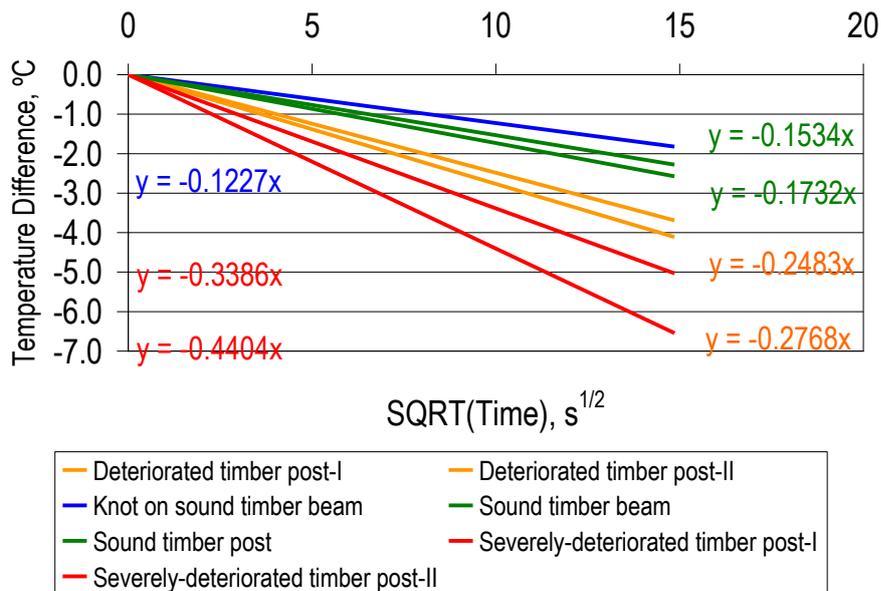
Figure 6.42 After the heating of the wall section of İstiklal House with hair dryer, and the temperature lines versus square root of time and the differential temperature lines versus square root of time for timber elements during cooling period of about 225s

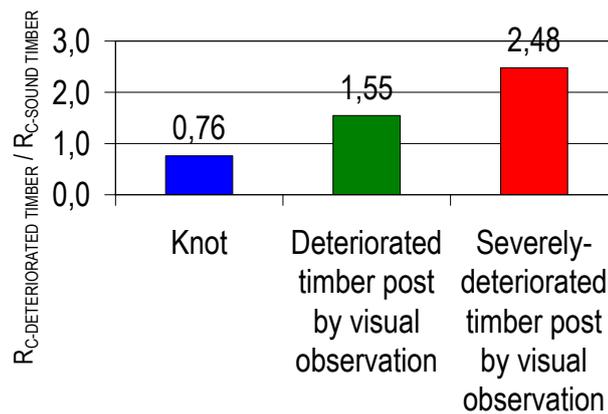
Figure 6.43 Rate of cooling down of deteriorated timber elements to rate of cooling down of sound elements.

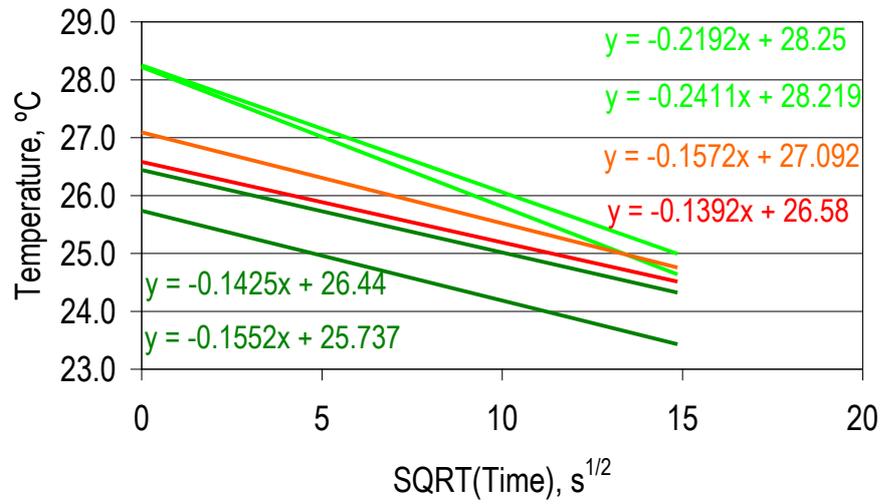
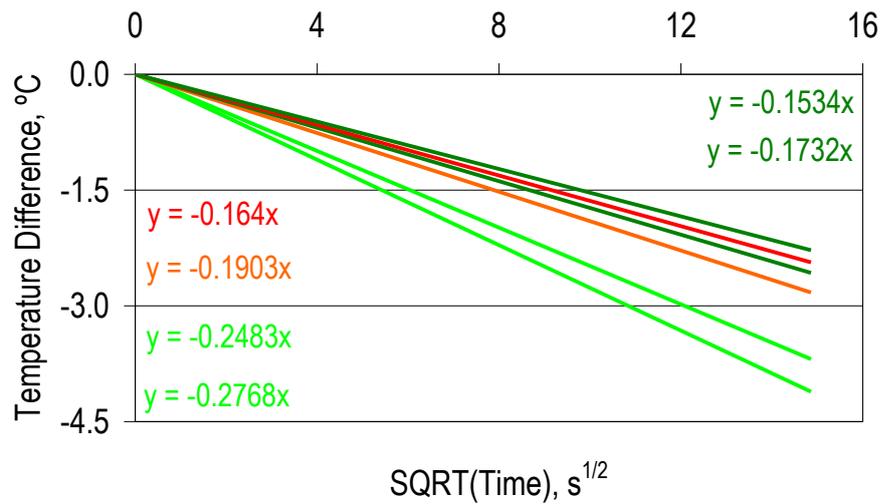
Figure 6.44 After the heating of the wall section of İstiklal House with hair dryer, and the temperature lines versus square root of time and the differential temperature lines versus square root of time for mudbrick infill and timber elements (at bottom) during cooling period of about 225s

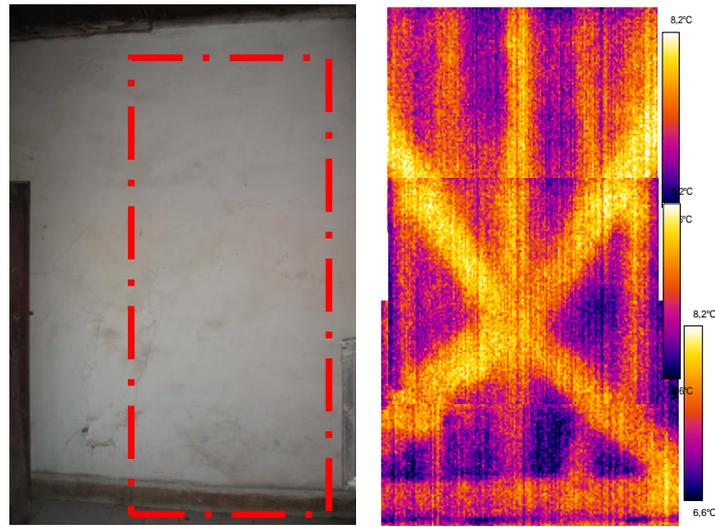
Figure 6.45 View of the interior wall at Ayaş House and the IR image of the selected region in November in daytime; showing that the timber frame structure underneath the historic plaster layers were clearly detected in IR images with a warmer and even surface temperature distribution ( $7.8^{\circ}\text{C}\pm 0.1^{\circ}\text{C}$ ).

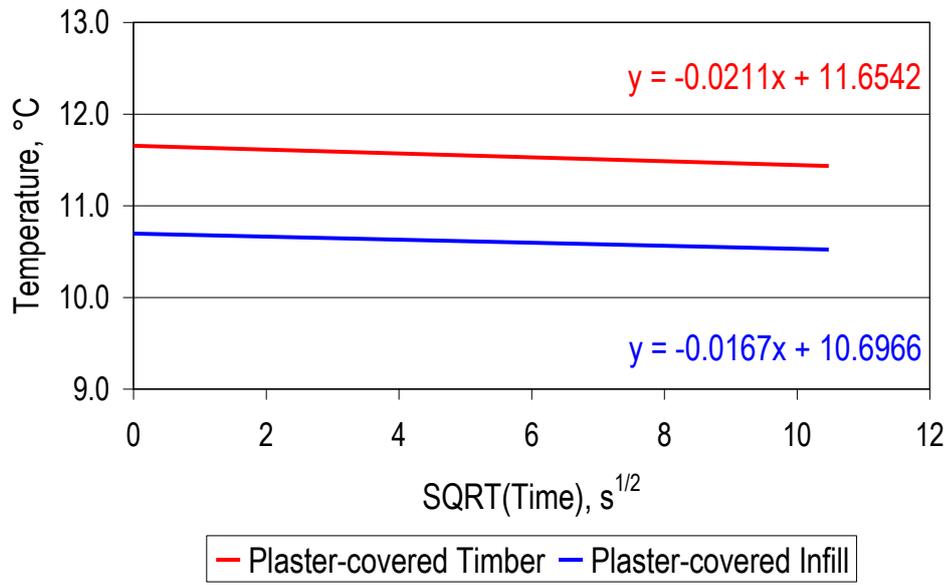
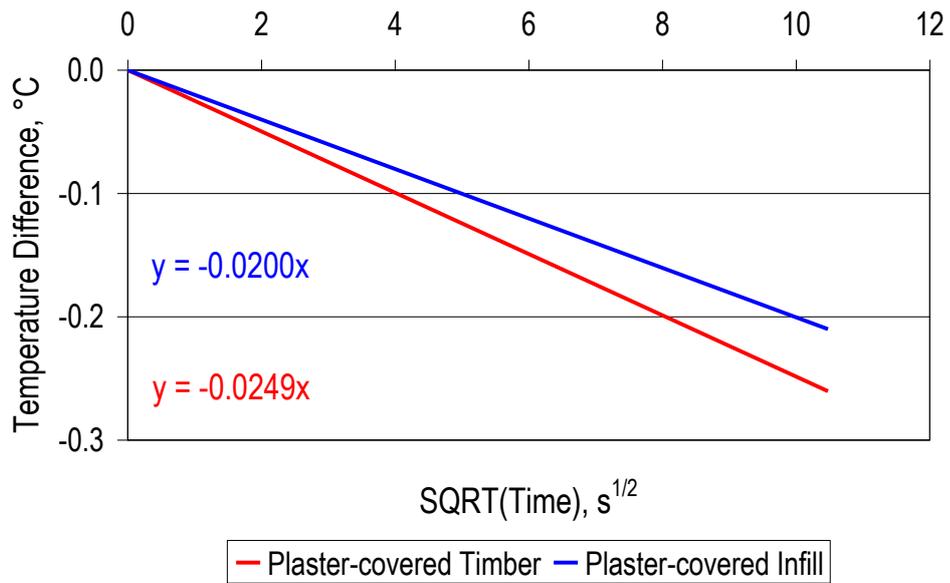
Figure 6.46 The surface temperature lines versus square root of time and temperature differences lines versus square root of time for the slightly cooling periods of daytime at the interior wall surface of Ayaş House.

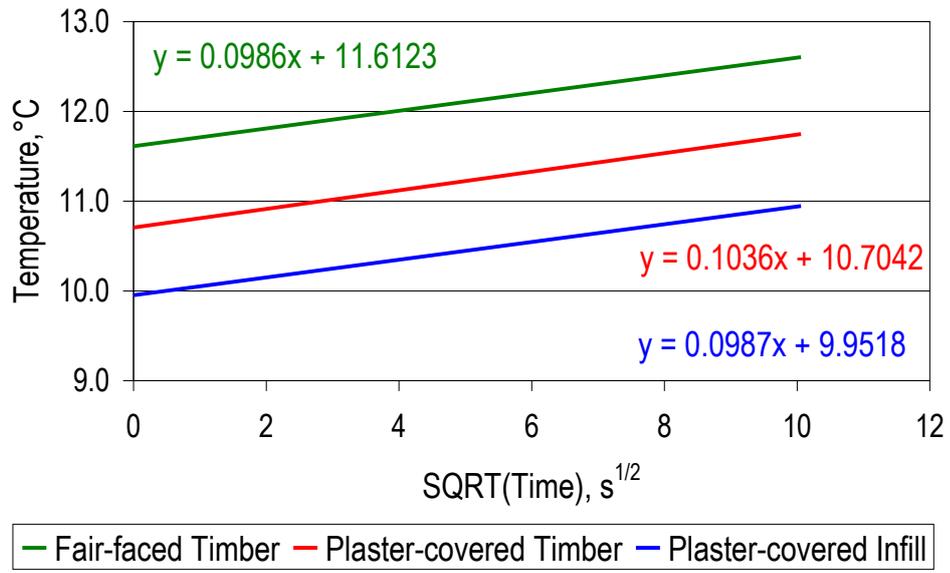
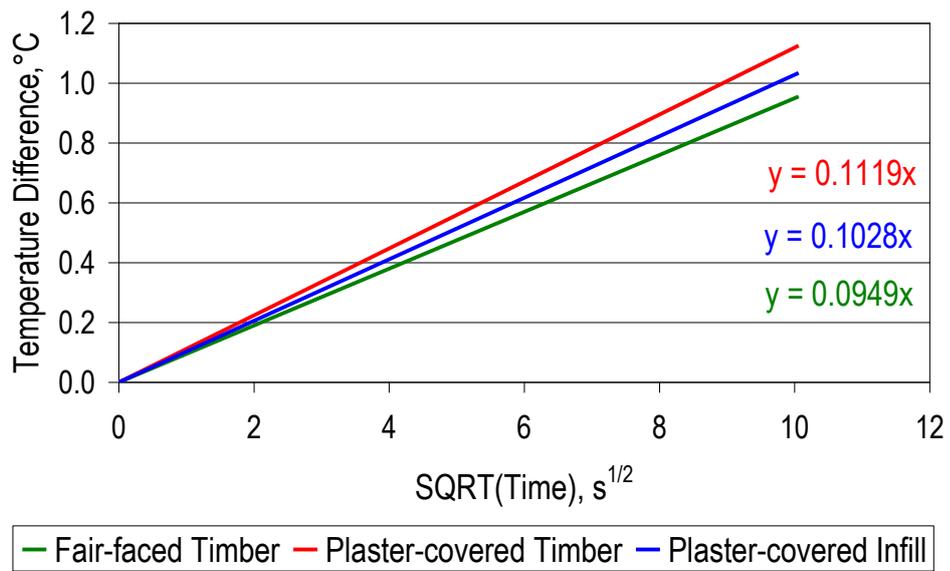
Figure 6.47 The surface temperature lines versus square root of time and temperature differences lines versus square root of time for the slightly heating periods of daytime at the interior wall surface of Ayaş House.

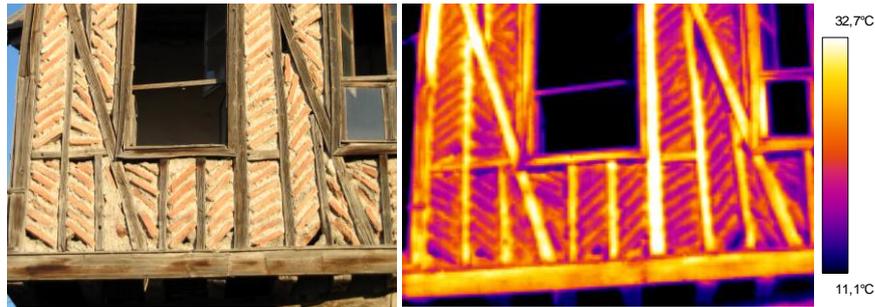
Figure 6.48 Partial view from the west side of the Ayaş House (at the left) and its IR image (at the right) taken in November under the exposure of solar radiation when the outside temperature was 12.2°C and 42%RH, showing that the brick infill had the coldest surface temperature of 21.9°C±0.1°C, the brick mortar had the warmer surface temperature of 25.2°C±0.5°C and the timber elements had the warmest surface temperature of 32.2°C ±1.7°C.

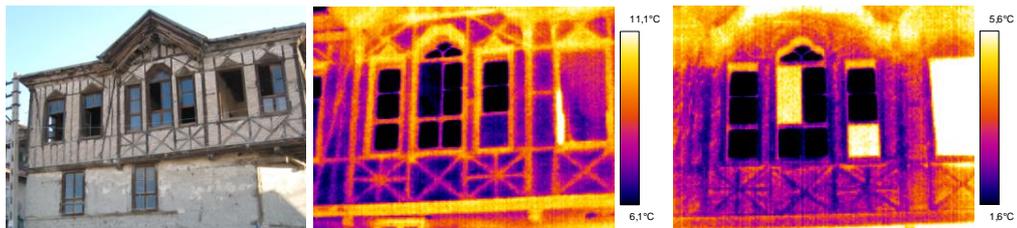
Figure 6.49 Partial view from the north façade of the Ayaş House and its IR images taken in November in daytime and at night, having the outside conditions of 13.0°C and 39%RH and 7.4°C and 62%RH, respectively. The analyses showed that the timber elements cooled down faster than the brick and mudmortar infill during the cooling period of 9977s. The differential temperature was calculated to be -6.03°C for timber elements while being -3.64°C for brick and mudmortar.

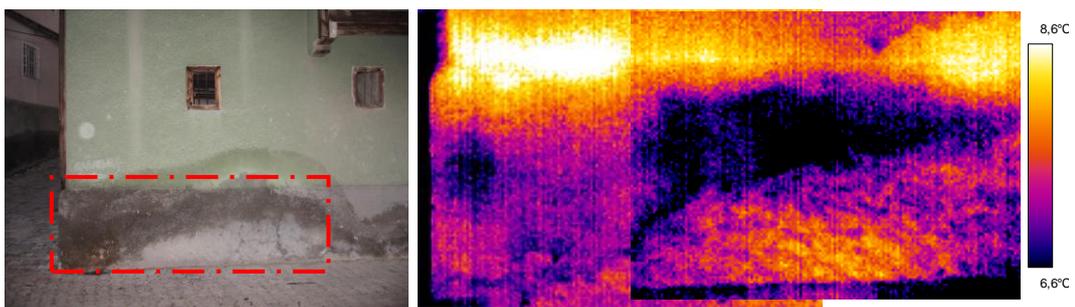
Figure 6.50 At Ayaş House, exterior plaster having damp zones, coldest areas with a difference of 3.2 °C below the ambient temperature.

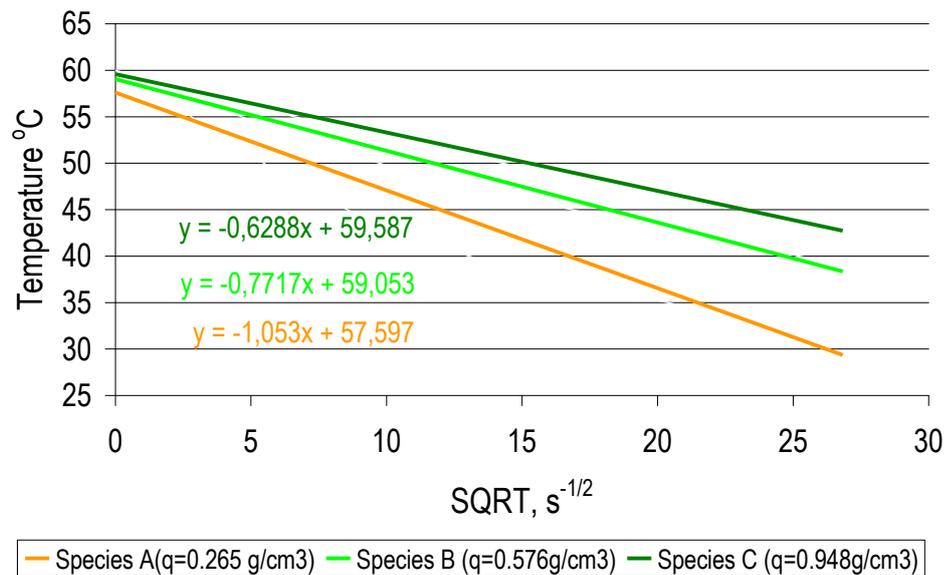
Figure 7.1 The surface temperature of different timber species with different density versus square root of time (The graph was drawn with the values of the graph given in Tanaka, (2001))
