INVESTIGATION OF STRENGTHENING TECHNIQUES USING PSEUDO-DYNAMIC
TESTING

A THESIS SUBMITTED TO
THE GRADUATE SCHOOL OF NATURAL AND APPLIED SCIENCES
OF
MIDDLE EAST TECHNICAL UNIVERSITY

JUNE 2010

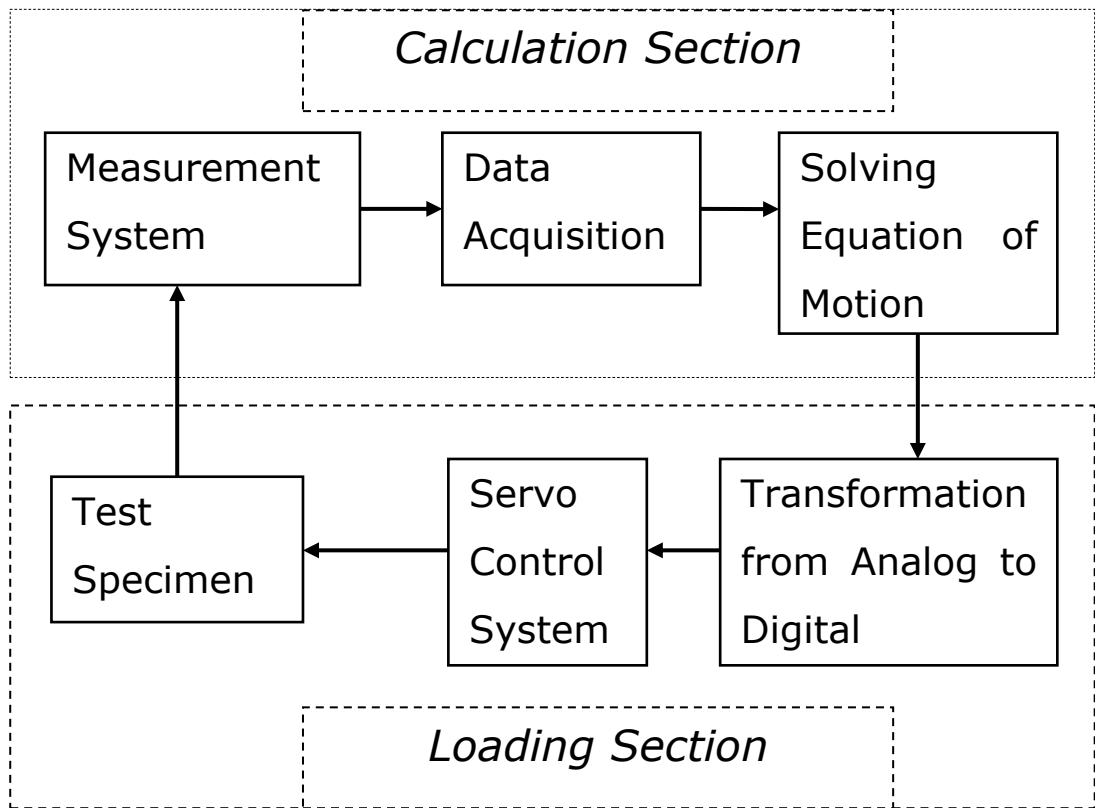
Figure 2.1 Loading and calculation sections of PsD testing

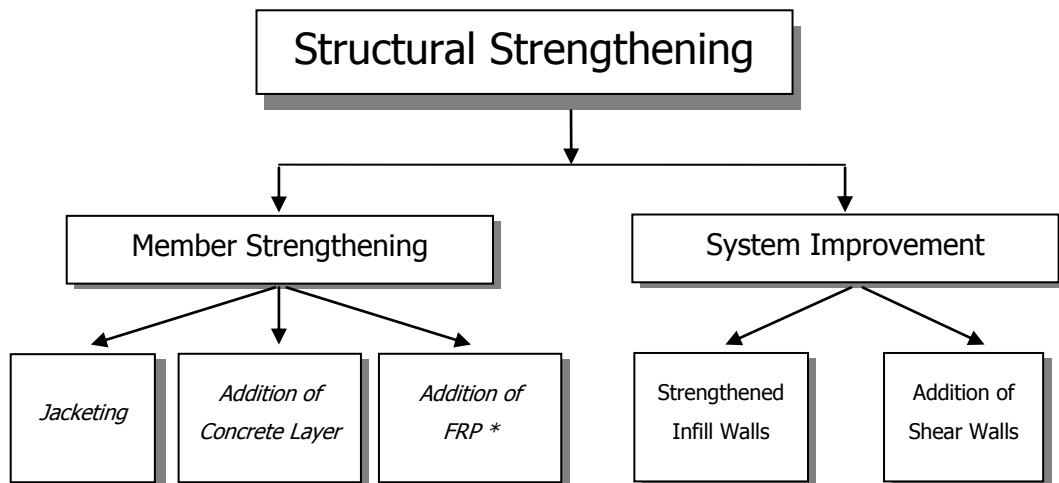
Figure 3.1 A brief scheme of structural strengthening

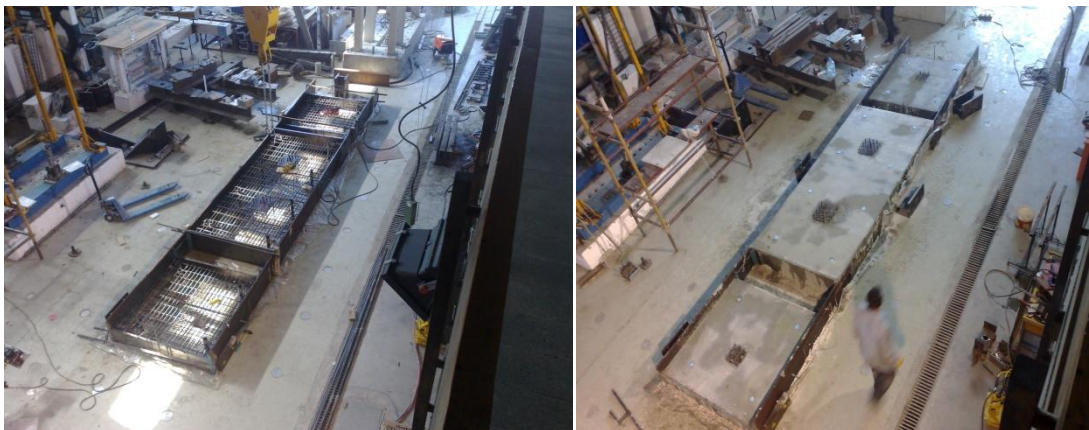
Figure 4.5 General views of the foundation before and after pouring of concrete

For foundation concrete, steel forms were assembled. Ready mixed concrete was ordered from a ready mixed concrete company. All the forms were cleaned and greased from inside in order to remove the steel forms easily. Approximately 3.5 m³ concrete was poured to the foundation. Mechanical vibration was used to set the concrete compactly. Cylinder specimens were taken to test the

quality of the concrete. General views of the foundation before and after pouring of concrete are shown in Figure 4.5.

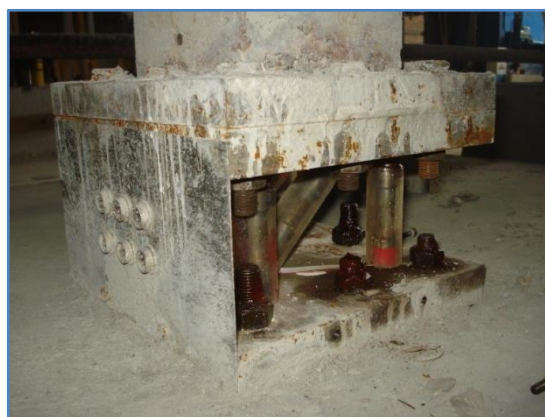
Internal forces at the exterior column ends were measured by means of force transducers. Each force transducer consists of six minor load cells. Four of these small load cells were placed vertically for axial force computation and two of them were placed diagonally for shear and moment force computations. Voltage outputs were taken from these small load cells by means of data acquisition system. Afterwards, a special S matrix, that transforms obtained mV/V values to force readings, is used. A general view of the force transducers are presented in Figure 4.7.

Figure 4.7 General view of the force transducers.

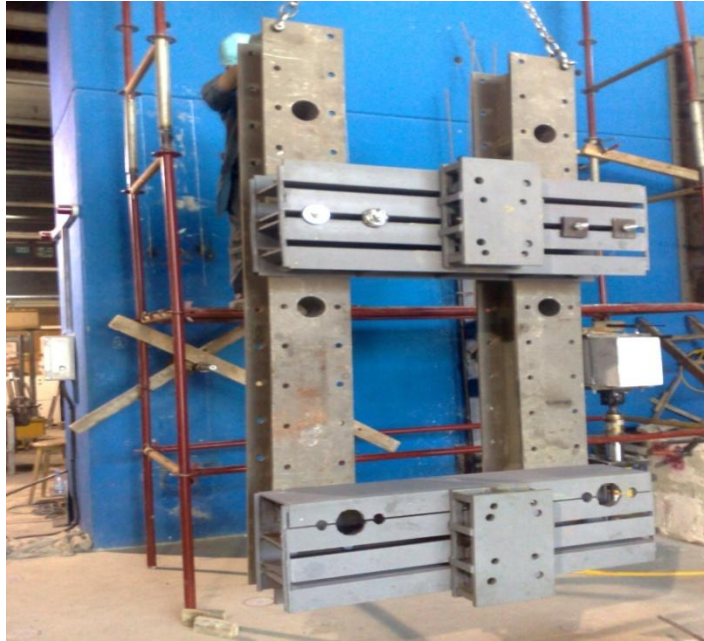
Figure 4.10 A general view of the movable loading system.

The lateral displacement was applied by using computer controlled actuators. The actuators was fixed to the adaptors and supported by specially designed table system. The table system consisted of 70 x 70 square steel sections, bolts having 42 mm diameter, 1 m x 1 m x 20 mm steel plates and steel tubes. Four 42 mm bolts were welded to the square steel sections. Steel plate was placed through the bolts and anchored with counter nuts. Steel tubes were placed over the bolts. Nuts were welded at the ends of the steel tubes to allow the movement of bolts throughout the steel tubes. Over the steel tubes 42 mm bolts were placed again and steel plate was placed

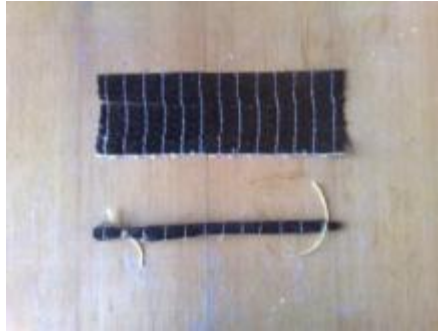
Figure 4.18 General views of FRP anchorage and the wrapped FRP sheet.

FRP retrofitting was employed by placing two FRP (fiber reinforced polymer) strips along the diagonal of the hollow clay tile (HCT) infills on both surfaces. The integrity of the FRP and the infill wall-plaster composite was provided by using FRP dowels passing through the walls. These dowels were fanned out on both faces of the infill wall. In this way it was aimed to delay FRP debonding from the plastered infill wall surface. The FRP diagonal braces were integrated to the boundary frame by FRP anchors embedded in holes drilled through the foundation, columns and slabs. Anchor dowels were obtained by wrapping FRP sheets (Figure 4.18). The depth of the anchor dowels was selected as 75 mm i.e. 1/2-scaled values of the code prescribed embedment depths.

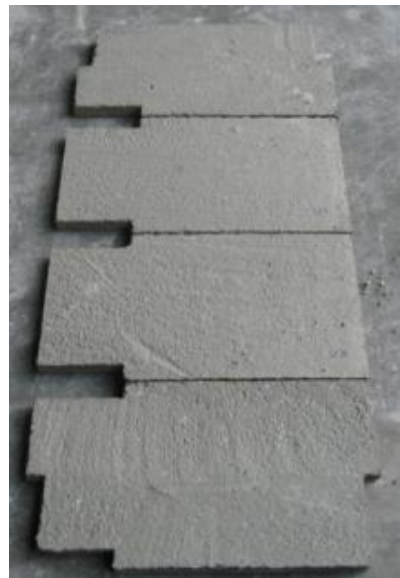
General view of the precast concrete panels is shown in Figure 4.22.

Figure 4.21 General view of the precast concrete panels.

Eight precast concrete panels (PCPs) with a thickness of 25 mm were bonded on the infill walls from one side at each floor. Dimensions of the precast concrete panels are shown in Figure 4.23.

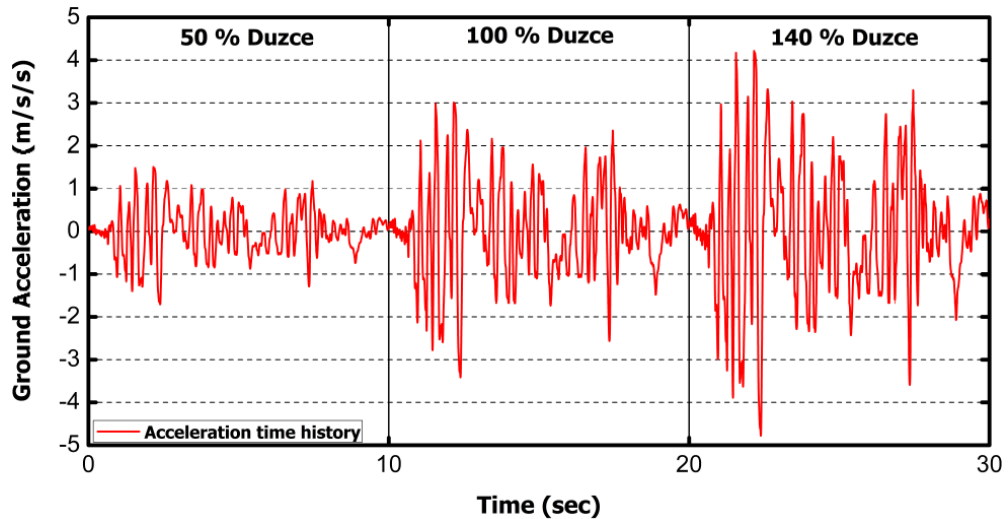
Figure 4.27 Ground acceleration time history.

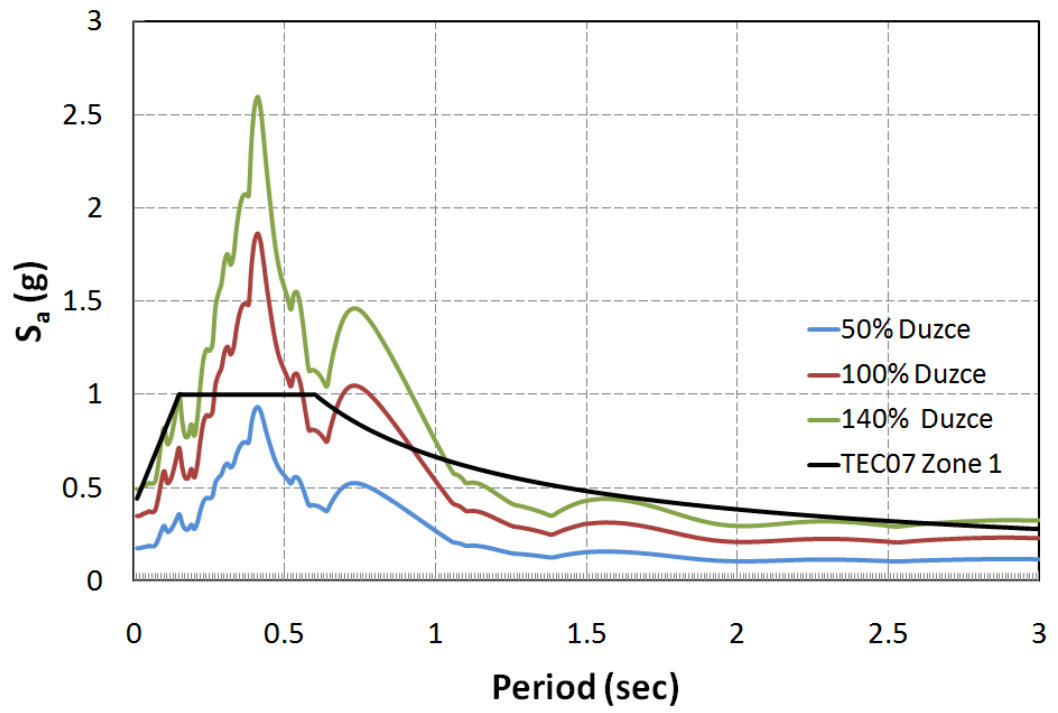
Figure 4.28 Spectrum of scaled ground motions

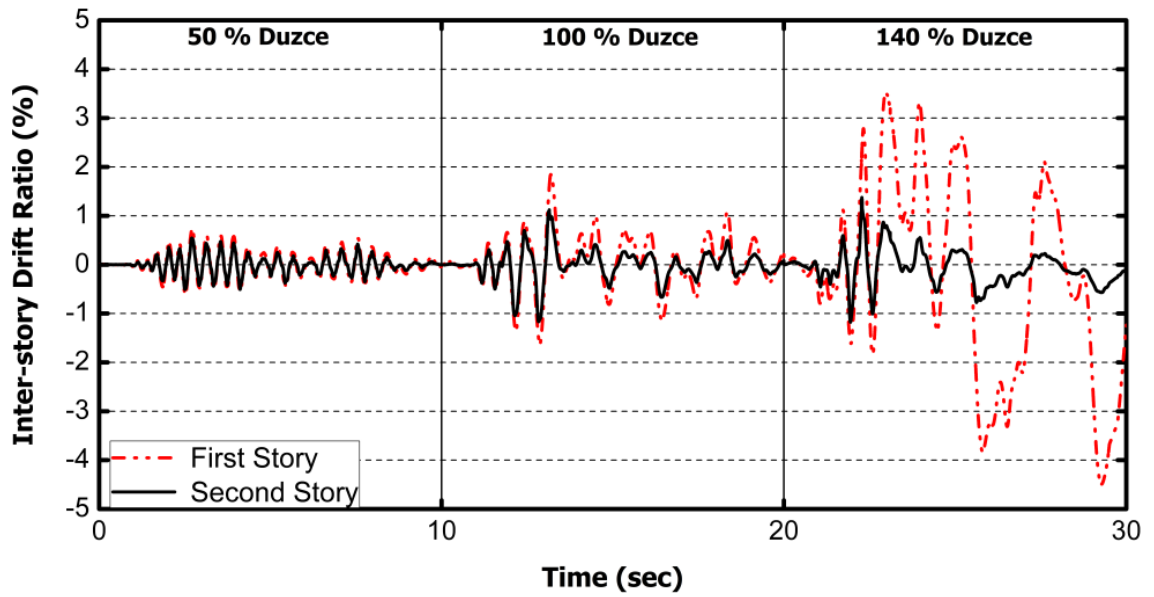
Figure 5.3 Time history of inter-story drift ratios.

Inter-story drift ratio is a considerable criterion for estimating damage states of a structure. Figure 5.3 shows time history of inter story drift ratios for first and second floors of the test frame. At 50% scaled experiment inter-story drift ratios are under 1% for both first and second floors. No significant damage was observed at interior and exterior columns. Interface cracks occurred on the infill wall. On the other hand, at 100% scaled experiment maximum inter-story drift ratios are around 2% for first floor and 1% for second floor. Plastic hinging at the bases of interior columns was observed and diagonal cracks were observed on the infill wall. At 140% scaled experiment inter-story drift ratio increased up to 4% for first floor.

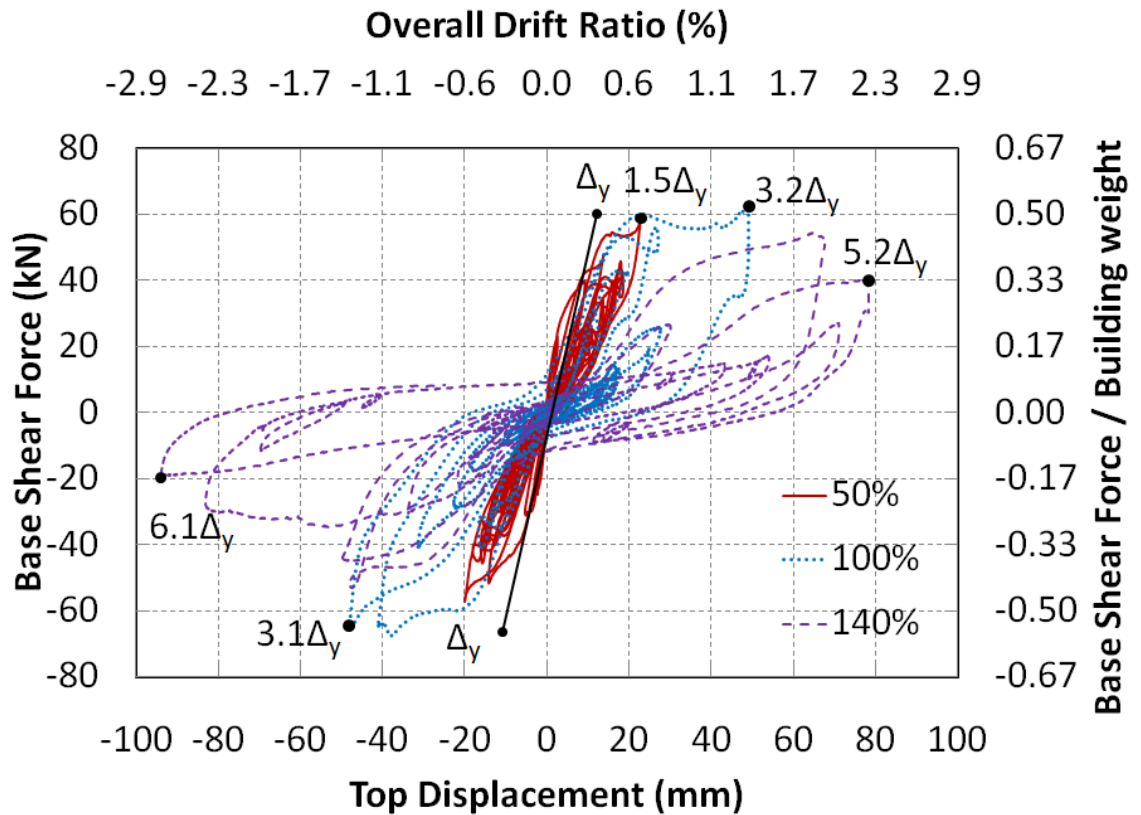
Figure 5.5 Force – Deformation Response.

In Figure 5.5 base shear versus roof displacement response of the displacement is presented. Yield displacement Δ_y (≈ 15 mm) is found by extending a line from origin and passing through a point on the initial loading curve that corresponds to 75% of the ultimate load carrying capacity. At 100% scaled experiment reached to its base shear capacity without any significant lateral strength drop at a displacement ductility of 3. At 140% scaled experiment lateral strength dropped about 30% of its maximum strength at a displacement of about 6 times its yield displacement.

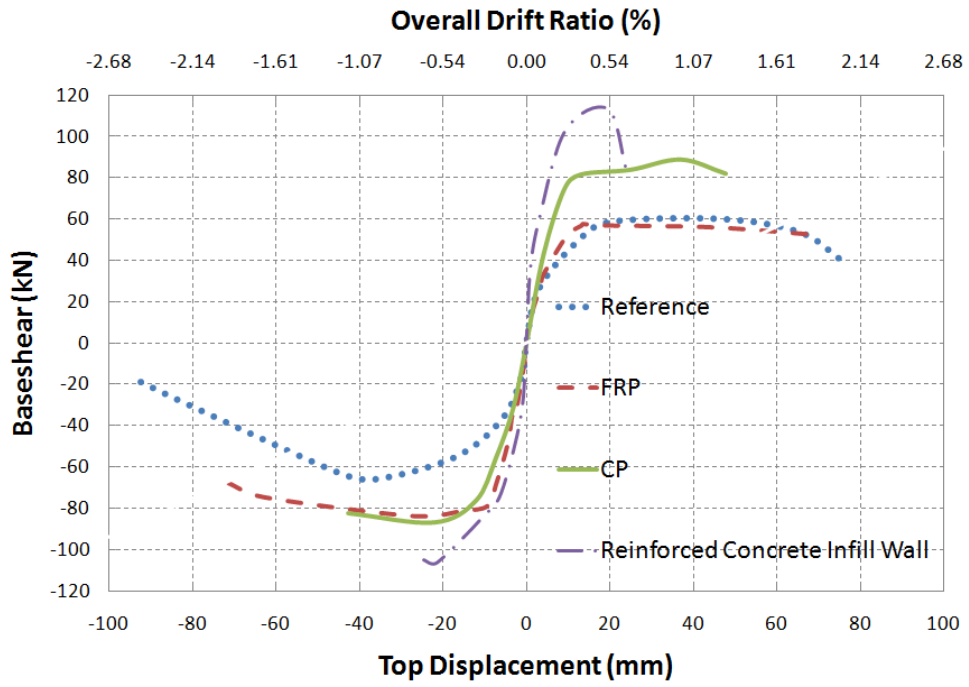
Figure 9.3 Demand Envelope Curves of Test Specimens
