CONSTRUCTION TECHNIQUES OF TRADITIONAL BİRGİ HOUSES

**A THESIS SUBMITTED TO
THE GRADUATE SCHOOL OF NATURAL AND APPLIED SCIENCES
OF
MIDDLE EAST TECHNICAL UNIVERSITY**

**IN PARTIAL FULFILLMENT OF THE REQUIREMENTS
FOR
THE DEGREE OF MASTER OF SCIENCE
IN
RESTORATION
IN
ARCHITECTURE**

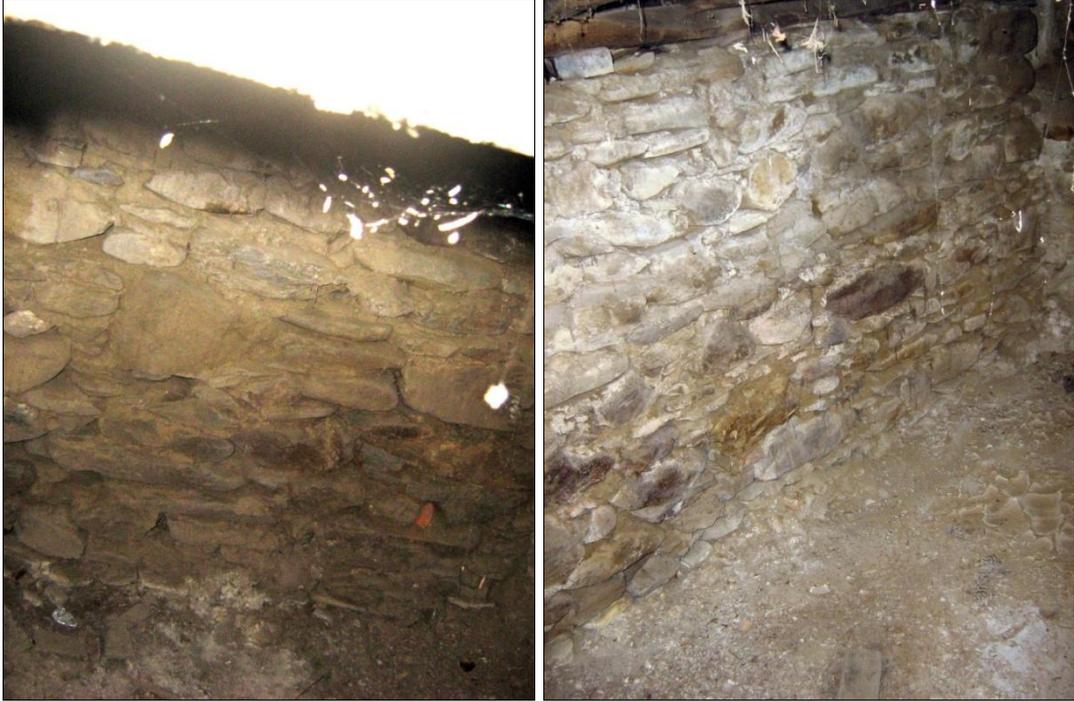
Figure 43, Continuous foundation (Camikebir Quarter Okul Street No:3)

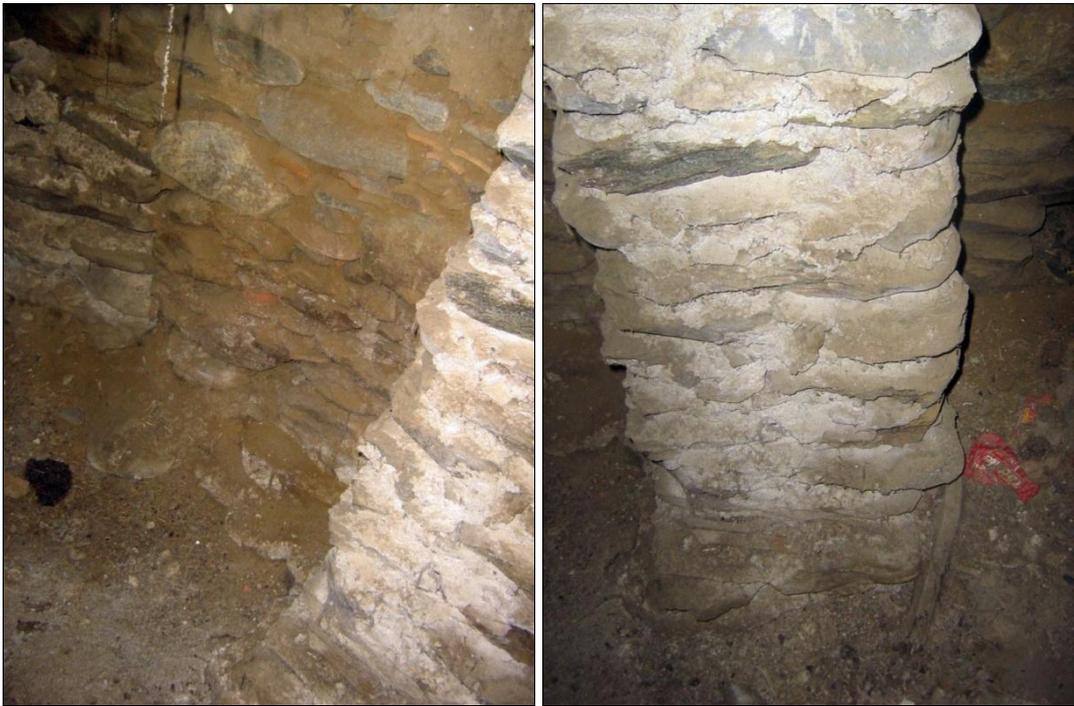
Figure 44, Composite foundation (Camikebir Quarter Camiönü Street No:20)

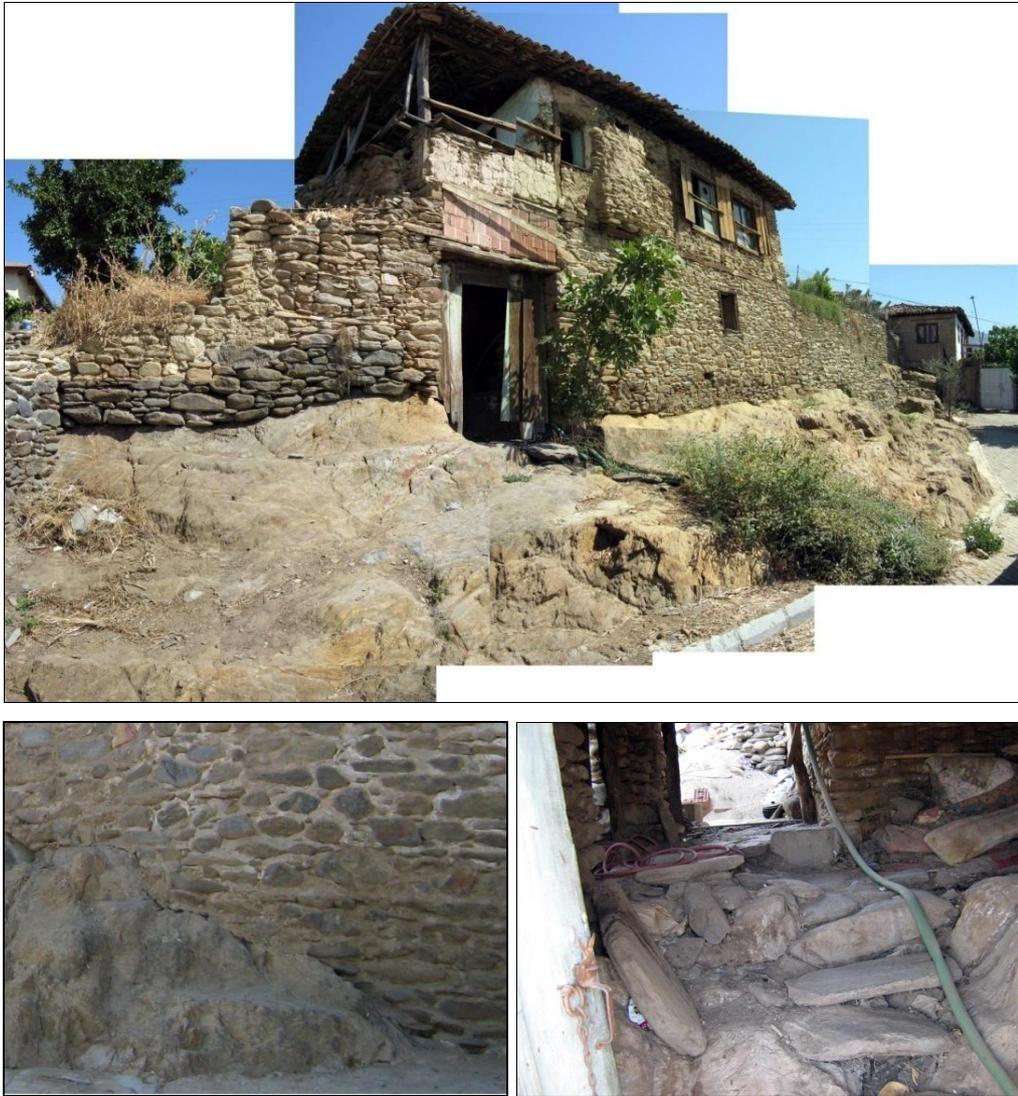
Figure 45, Living rock as a part of the foundation (Kurtgazi Quarter 3 Eylül Street Lot No:1301)

In certain houses where the first and second types of foundations were used, rocks, probably carried by previous floods, are seen within the construction area of the house (see Fig. 45, 46). These rocks are used as a part of the main structural system. Walls corresponding to these rocks were constructed directly on them. The foundation walls, on the other hand, were constructed without any special jointing technique, and adjacent to the rock surface, continuing their own axes. This type of foundation was used, for nearly all of the houses located in Kurtgazi Quarter.

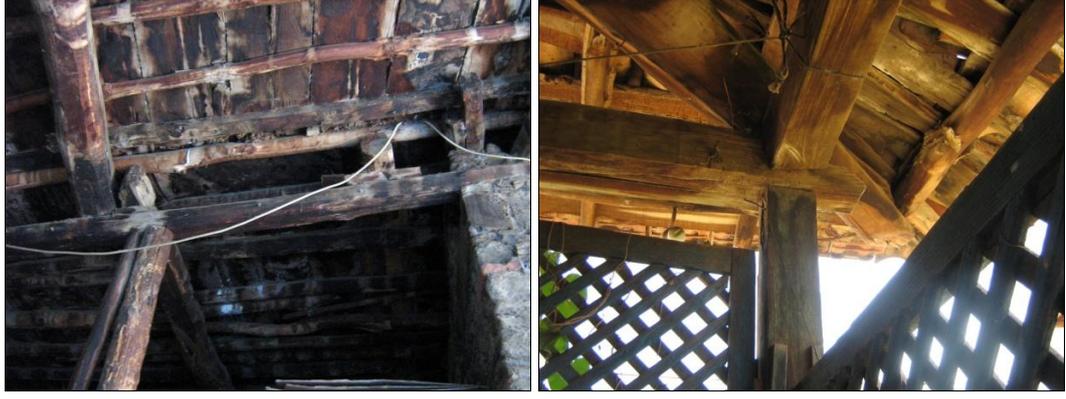
Figure 80, Examples of timber post Detail 1 – Plain connection- taşlık post (left) (Gaziumurbey (Demirbaba) Quarter Demirbaba Street No: 35), sofa post (right) (Kurtgazi Quarter Hıdırbey Street No: 14)

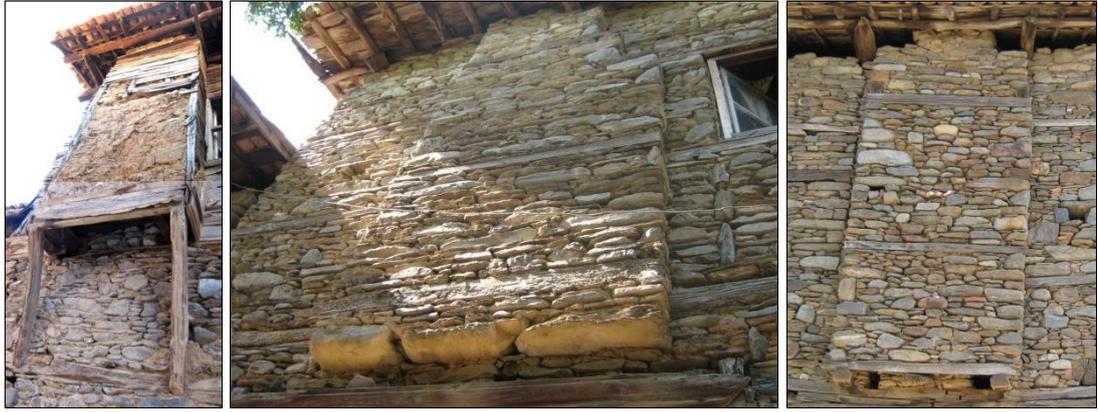
Figure 125, Fireplace projections – fireplace projection sitting on girders and supported by braces (left), fireplace projection sitting on slates (middle), fireplace projection sitting on girders (right)

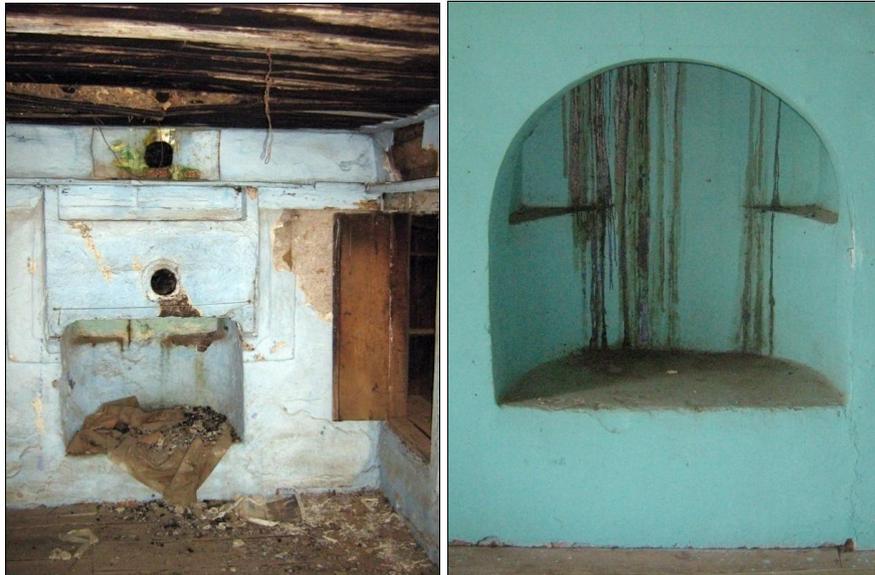
Figure 132, Fireplace Type 3 (Sandıkoğlu Konağı (left), Camikebir Quarter İmam Birgivi Street No:5 (right))
