INVESTIGATION OF A DAMAGED HISTORICAL MOSQUE WITH
FINITE ELEMENT ANALYSIS

A THESIS SUBMITTED TO
THE GRADUATE SCHOOL OF NATURAL AND APPLIED SCIENCES
OF
MIDDLE EAST TECHNICAL UNIVERSITY

JUNE 2011

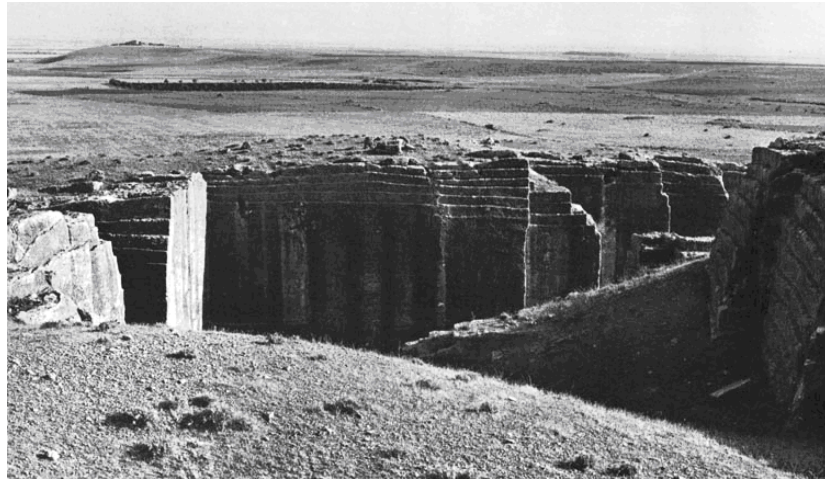
- Supplying the material.
- Quarrying of the material in guidance of the architect. (Figure 2.1)
- Transporting the material, lifting and laying the blocks in position.

Figure 2.1 Quarrying stages of limestone on Walls of Dara (Thais, 2010)

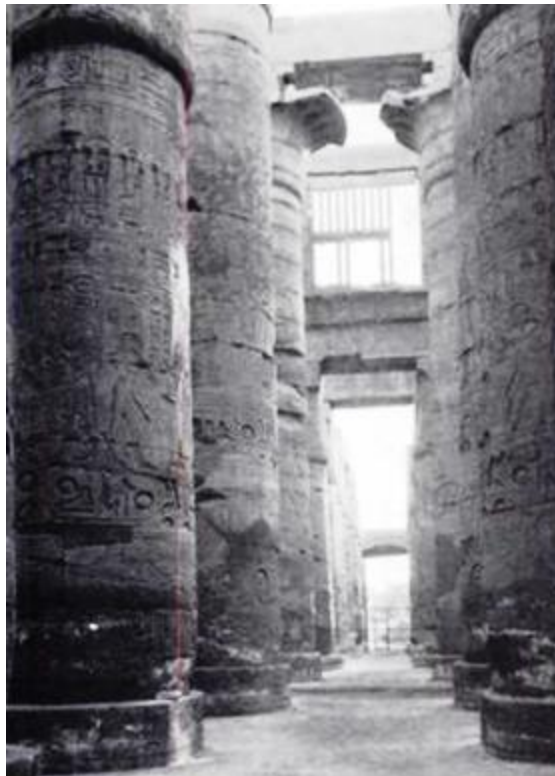
In terms of load carrying systems, one of the first examples of the masonry system is “Post and Lintel” where the horizontal lintels transfer the structural load to the vertical elements called posts. An early example in use of this system is the Stonehenge in United Kingdom and was also observed at the Temple of Amun, Karnak (Figure 2.5).

Figure 2.5 The Great Temple of Amun, Karnak (Fletcher, 1996)

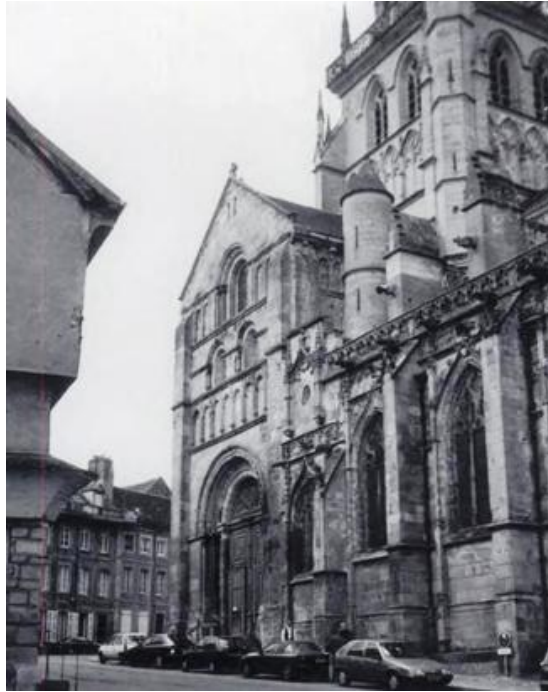
The stone masonry has been used in construction of many ancient structures such as Stonehenge and Cathedral of Saint-Lazare, Autun, France (Figure 2.12).

Figure 2.12 Cathedral of Saint Lazare, Autun, France (Seidel, 1999)

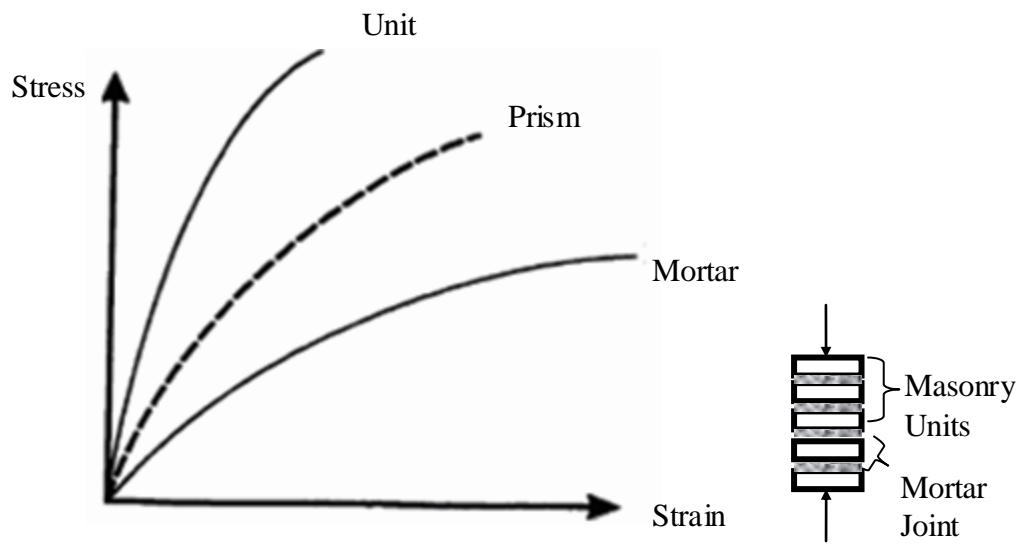
Figure 2.15 Stress-Strain Curves of Masonry Unit, Mortar and Prism (Ip, 1999)

in which (f_k) stands for the characteristic compressive strength of the unit. The variance of the stress-strain relation in units and masonry prism can be seen in Figure 2.15.

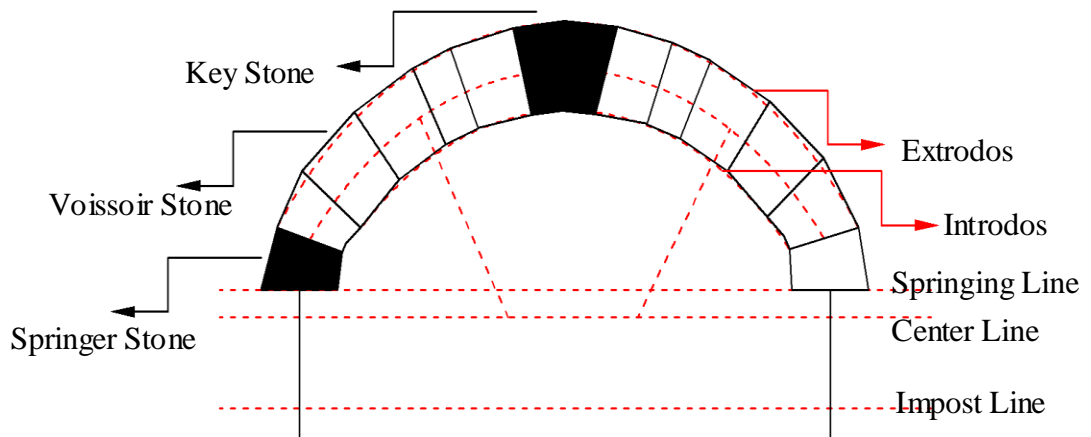
Figure 3.1 A Sample Arch Profile

The arch profile possesses certain unit elements like “Voussoir” and “Key Stone” and the representation of a sample arch profile may be seen in Figure 3.1, together with examples on different arch profiles below. (Figure 3.2) It should hereby be noted that, as also stated by Huerta, in a masonry arch under vertical load, the thrust action between the stones changes with the geometry and the curvature of the arch and it affects the stability of the profile. (Huerta, 2006)

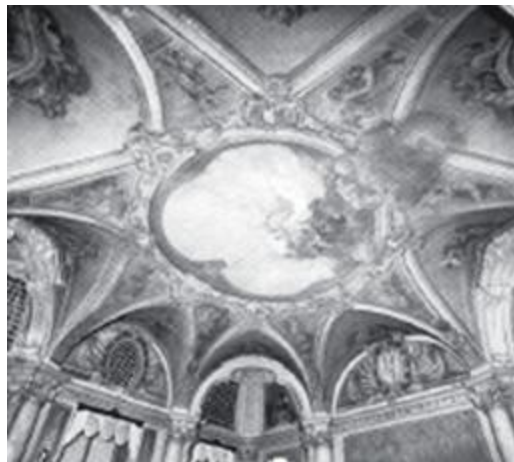
Vaults are one of the mostly used structural elements that were also used widely in Seljuk architecture. They are basically the structural elements formed by series of arches proceeding from surrounding walls to cover a space with several types used to form continuity. Some common types include Barrel Vault, (Figure 3.3 a) with continuous extension in one direction unlike Cross Vault, (Figure 3.3 b) in which the movement is in two directions. Moreover, Cloister Vault is obtained where the two directional movements continues with breaking (Figure 3.3 c) whereas in Star Vaults, the change in sections at various parts is observed in which coursing usually emphasizes an element that is usually a star or an octagon. (Figure 3.4)

Figure 3.4 Star Vault (Guerci, 2009)

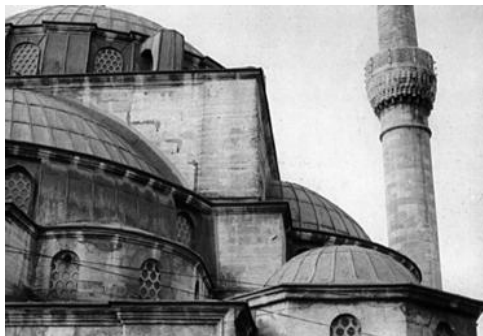
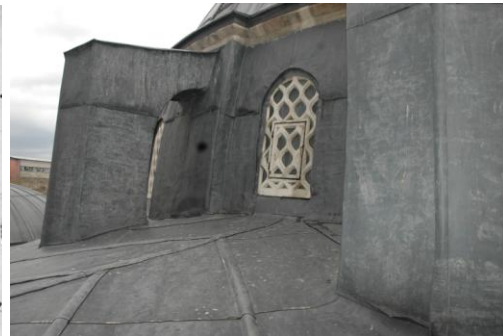
Beside these major elements, “Buttresses” are separate transition elements in the form of a partial arch supporting arches or a dome facing lateral loads as seen in Üsküdar Mihrimah Sultan Mosque and Cenabı Ahmet Paşa Mosque. (Figure 3.8)

Figure 3.8 Examples of Buttresses; (a) Üsküdar Mihrimah Sultan Mosque (Erzen, 1988), (b) Cenabı Ahmet Paşa Mosque

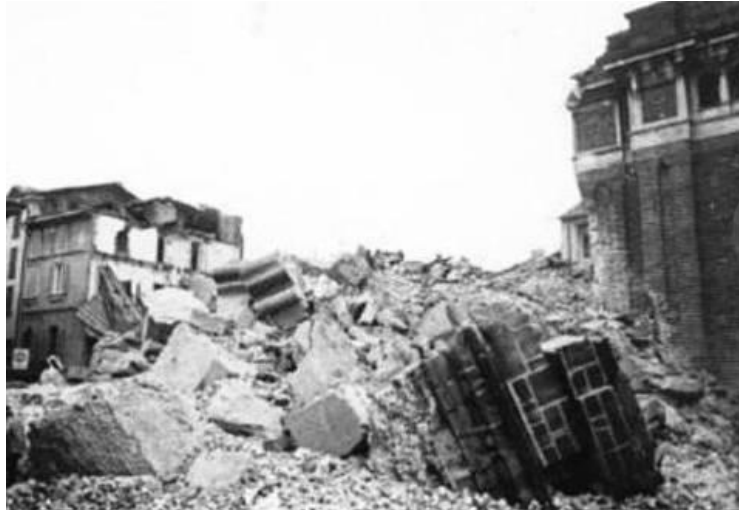
The structure is an 11th century brick masonry structure that suddenly collapsed at 1989, (Figure 3.13) which was composed of thick masonry walls with regular coursed brick layers and irregular courses of stone-brick layers in-between bonded together with mortar. (Binda et al., 2008) The causes of the failure have been examined through several investigations that have been carried out by researchers and it has been deduced that in case of multiple leaf masonry, differential creep displacements formed by the leaves' different deformation characteristics and persistent loads leading to retarded strains on the structure have been effective on the structure.

Figure 3.13 The ruins of The Civic Tower of Pavia after the collapse (Binda et al., 2008)

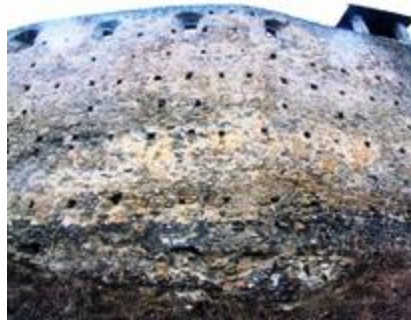
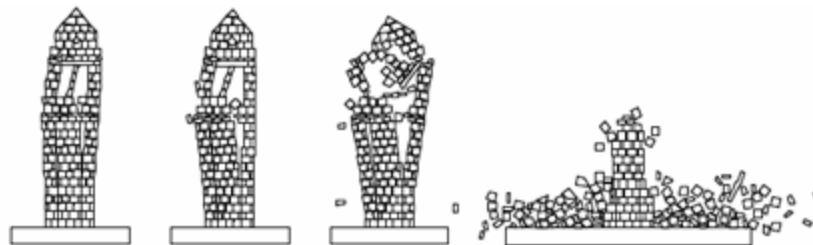
In addition to this type of loading, Figure 3.14 shows some examples of damages on masonry buildings including deterioration due to external weathering effects, differential settlements and earthquake actions.

Figure 3.14 Damages on Masonry Structures; (a) Deterioration on the defense walls of a medieval castle (Juhsova et al., 2008), (b) Damage on St. Torcato church due to differential settlements (Lourenço, 1999), (c) Collapse mechanism of St. Georgio in Trignano Bell Tower, Italy after the 1996 earthquake (Azevedo and Sinraian, 2001)

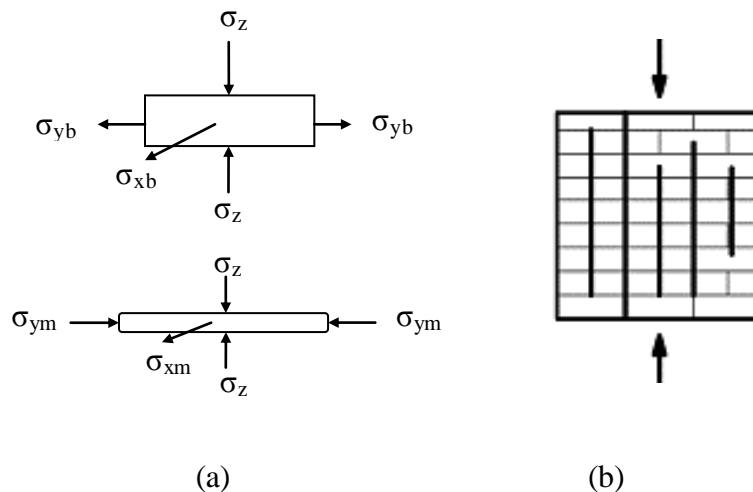
Figure 3.15 Masonry under axial compression; (a) Stresses acting on mortar and brick units, (b) Typical Fracture Pattern (Dhanasekar et al., 1985)

Under vertical loads, the behavior of masonry mainly depends on the elastic properties of the masonry units and the binding material. The failure is generally observed by vertical cracks through the units. (Figure 3.15) Under loading, due to different strain characteristics of these two materials, the mortar will tend to expand more than the relatively rigid masonry units. However, due to the bonding in-between, the expansion will be prevented. As a result, the masonry unit becomes under biaxial tension whereas the mortar will be under biaxial compression. When the ultimate tensile strength of the unit is reached, failure is observed.

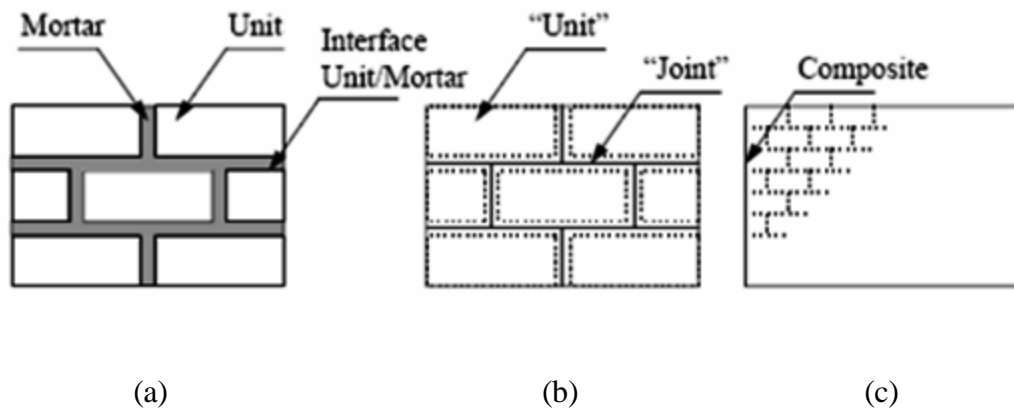
Figure 3.17 Modeling strategies; (Lourenço, 1999) (a) Detailed Micro Modeling (b) Simplified Micro Modeling (c) Macro Modeling

1. *Detailed Micro Modeling*: the units, mortar and interface are modeled including the material behavior of each constituent with the knowledge of masonry material properties. (Figure 3.17.a) Detailed modeling is advantageous especially for relatively small structural elements or sections of structural elements.
2. *Simplified Micro Modeling*: it considers the unified mortar-interface together with the masonry units, therefore with less accuracy compared to the detailed models. (Figure 3.17.b)
3. *Macro Modeling*: preferred for larger and more complex structures, where the overall behavior of masonry is more important or computational cost is rather critical. (Figure 3.17.c) In this case, the structural material should be well defined by experiments to avoid major mishandling.

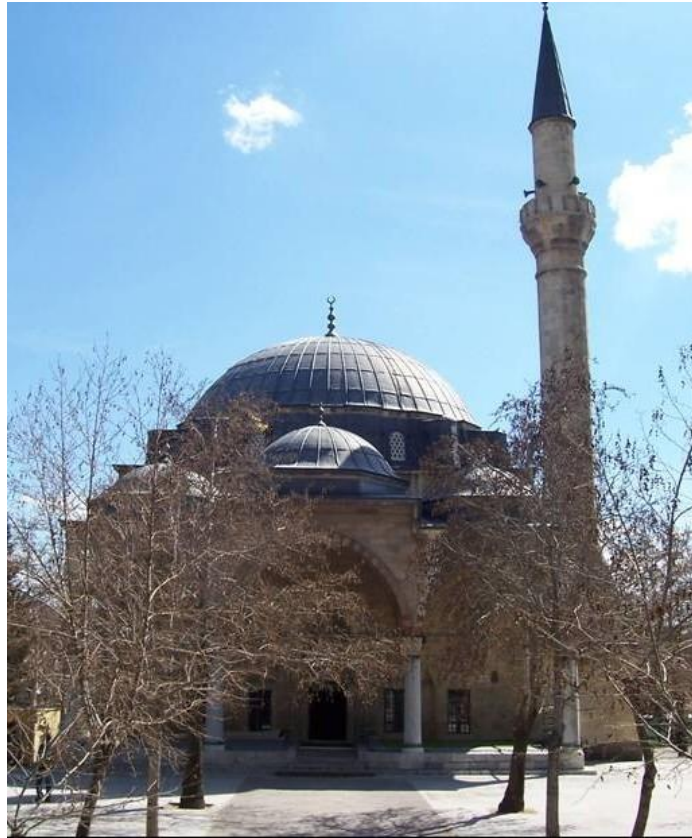
The structure that is selected in this study, Cenabı Ahmet Paşa Mosque or also known as Yeni Mosque, is located at Ulucanlar Avenue, Ankara. (Başkan, 1993) Figure 4.2 shows the general appearance of the structure. The attributed Cenabı Ahmet Paşa was appointed as the Anatolian Governor by the period's emperor Kanuni Sultan Süleyman. The structure's construction started by the governor and could only be finished at 1565-1566 after his death. In the detailed search, the history records about the structure stated the guide architect to be the Architect Sinan. It has been acknowledged that like many of the period's buildings' constructions he has been guiding, the construction of the structure was carried out by the group "Hassa Mimarlar Ocağı" and supervised by architect Sinan since 1539. (Başkan, 1993)

Figure 4.2 Photo of Cenabı Ahmet Paşa Mosque

The case study structure is a clear example of Ottoman period Architecture formed of a single central dome and three relatively smaller domes at the last congregational area attached to the main structure. There exists a cornered minaret which is made of cut stone like the main structure. The structure has, 17.2×17.8 meters dimensioned rectangular plan and the central dome's drum sits directly on the two- leaf structural masonry wall of 1.8 meters thickness.

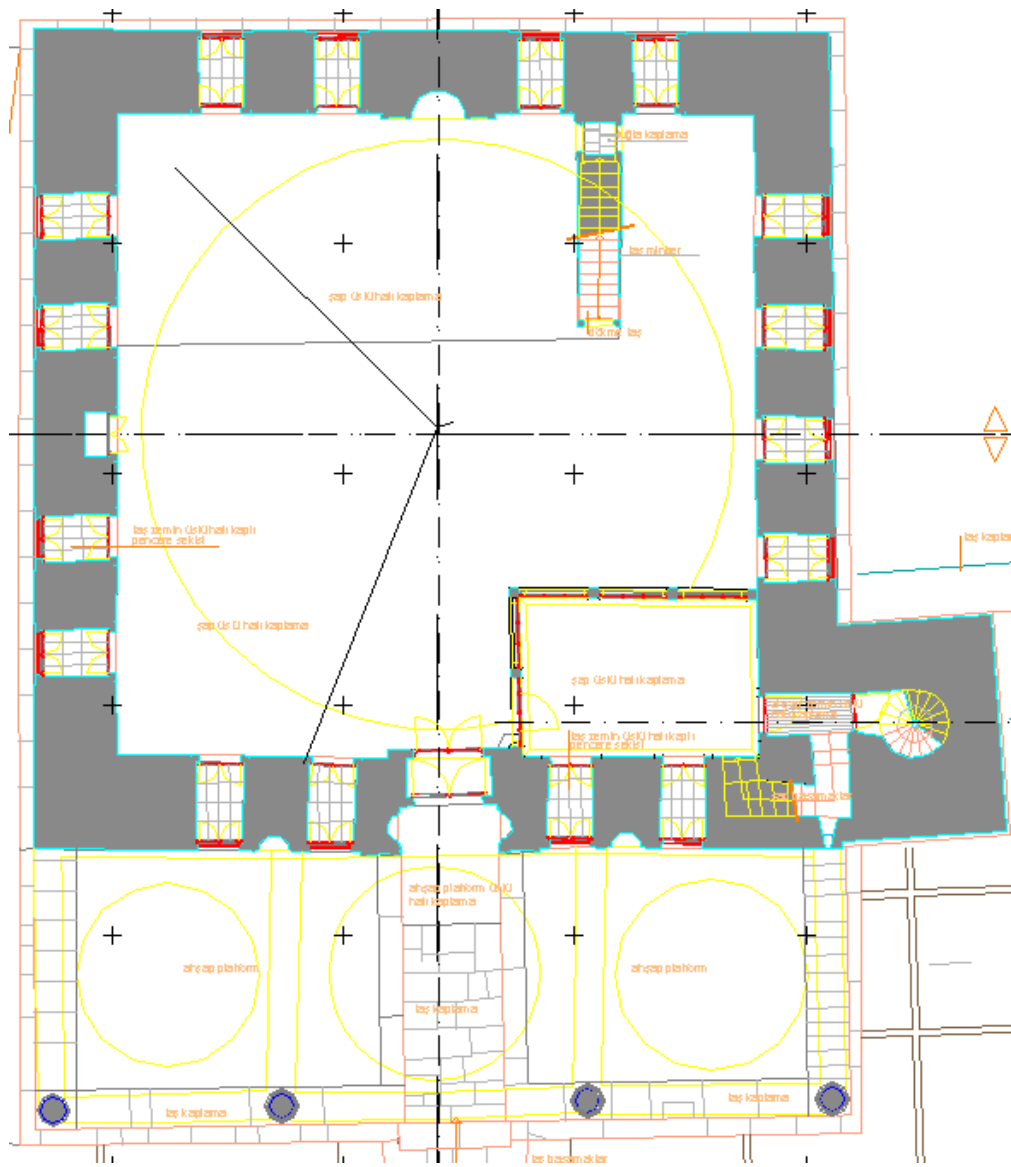
Figure 4.3 Structural Plan of the Mosque (drawings by SAYKA Construction Architecture Company, 2008)

The structural layout may be seen from the structural plan given in Figure 4.3 and a section of the front façade is given in Figure 4.4.

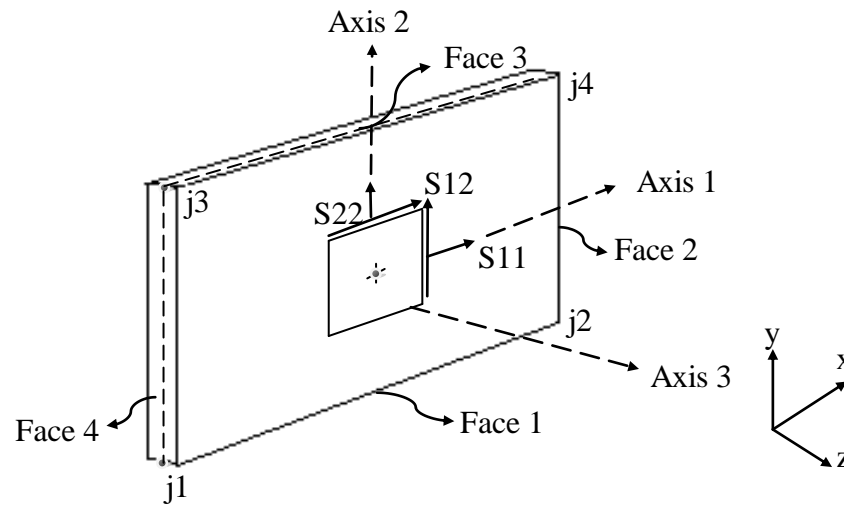
Figure 4.5 Local Axes and stress directions of the four-node quadrilateral shell element

The area element used at the structural walls and transitional elements is the four- node quadrilateral finite element. Each area element is defined with 4 joint connectivities making up 4 faces as shown in Figure 4.5. The element has 6 total degrees of freedom consisting of 3 translational; U_x , U_y , U_z , and three rotational; R_x , R_y , R_z degrees of freedom. The prepared model consists of 9852 nodes, 11 frame elements and 9564 area elements.

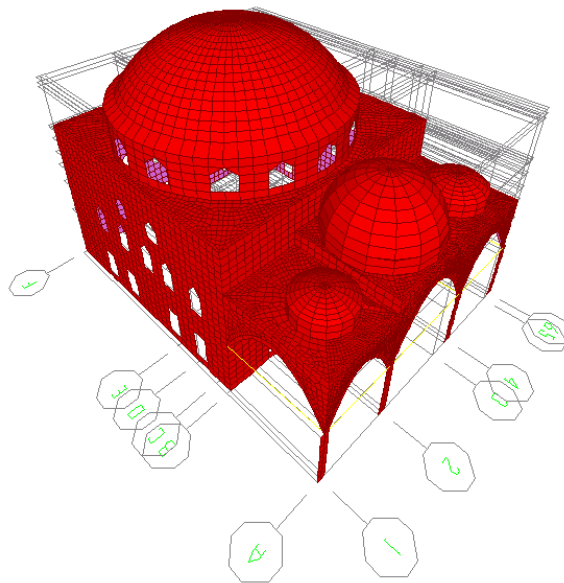
Figure 4.7 The Simplified basic Model

Initially a simpler model was conducted (Figure 4.7); however, as the connection details are not seen adequate, a more detailed model has been prepared.

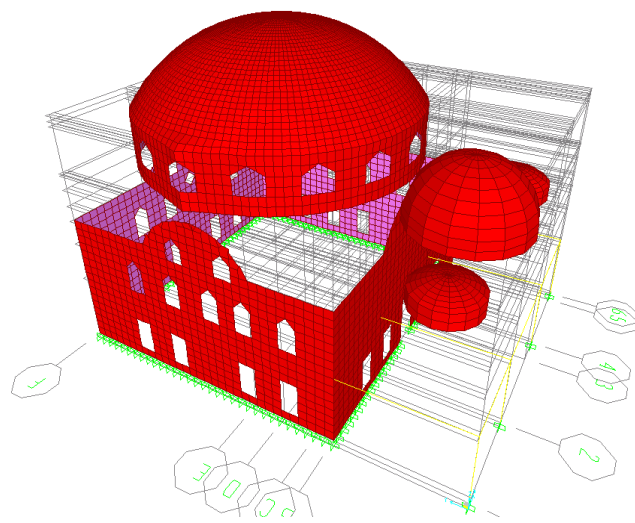
Figure 4.8 The structural model, main structure

In the main section, arch profiles have been used to define the layout of the area elements at the transition zones and the connections. In order to do this, a circular arch frame, which is later removed, has been drawn in segments at three nodes on the surrounding walls and then the adjacent area elements have been redrawn from the existing mesh elements to the circular arch frame. Later on, the joint connectivities at the area have been checked in detail. (Figure 4.8)

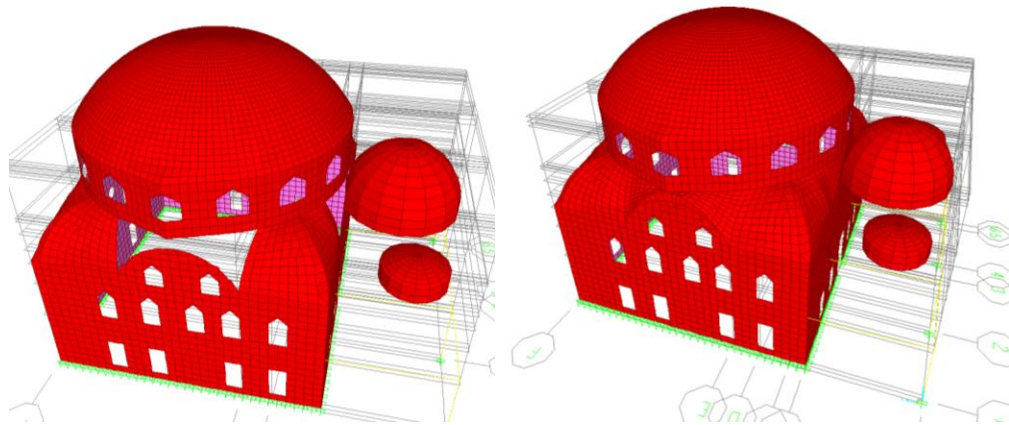
Figure 4.9 The structural model, transition zones

In the semi dome sections and the inner transition zones, additional arch frames have been added each having segments along their height and area sections have been drawn from node to node. (Figure 4.9) It should be noted that, the additional masses caused by the infill material above the semi domes has been added to the system via material definitions. Therefore, the unit weight of the area elements at this region is greater than the above mentioned unit weight of stone blocks.

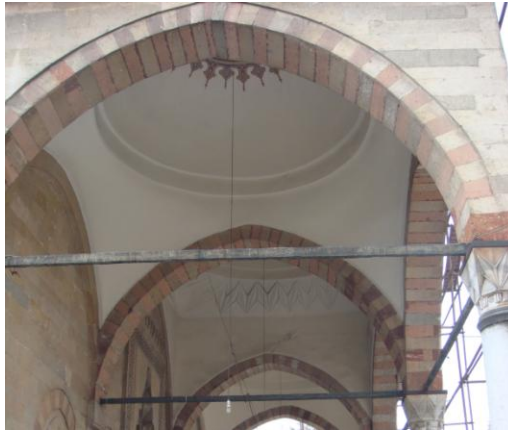
In the front section, arch sections have been similarly modeled between the horizontal frame elements, resembling the metal ties, and between the front domes and the front columns as seen in the structure (Figure 4.10) to aid the modeling of the pendentives.

Figure 4.10 Photo of the structure's front section

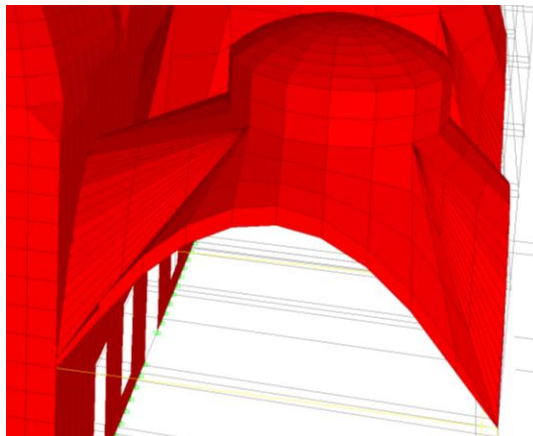
Figure 4.11 The structural model, front pendentives

It is hereby necessary to note that, the area meshes have been modeled with uniform sizes and the corner meshes have been specifically chosen to be of triangular 3-node mesh element for adequate representation of the structural connections between area and frame elements. (Figure 4.11) The complete model is given in Figure 4.12.

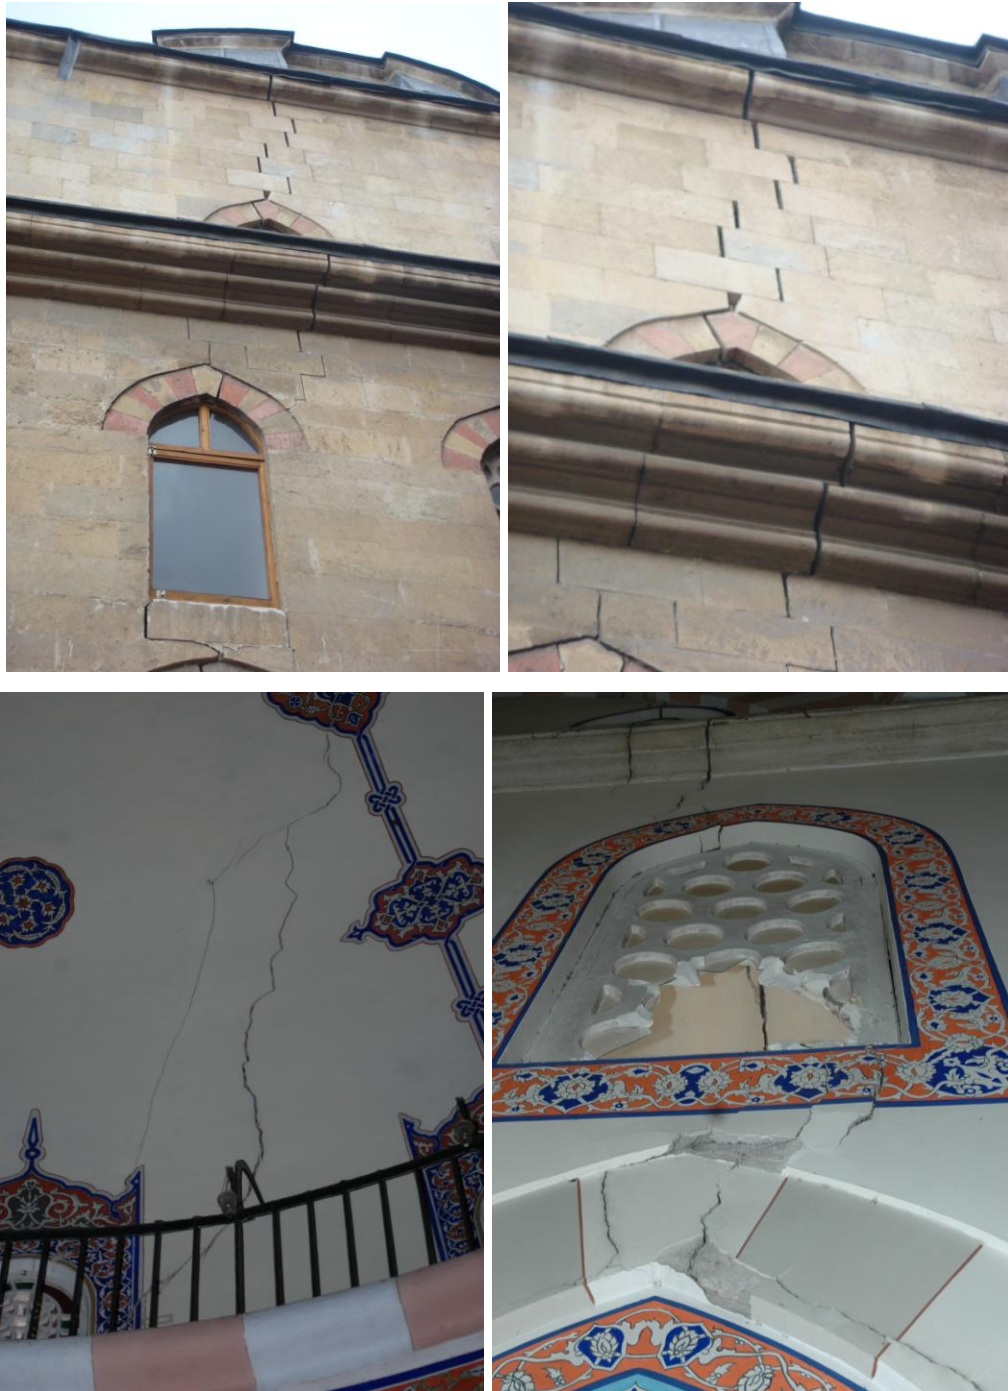
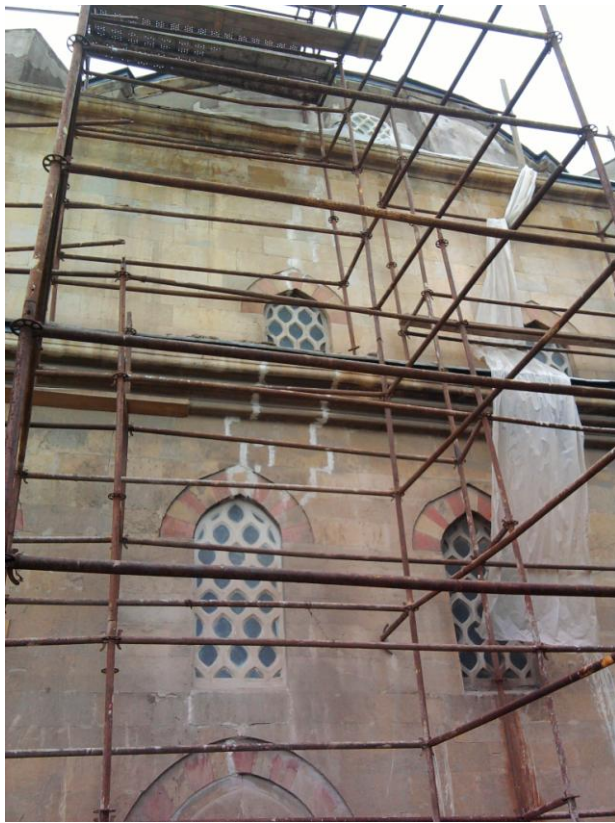
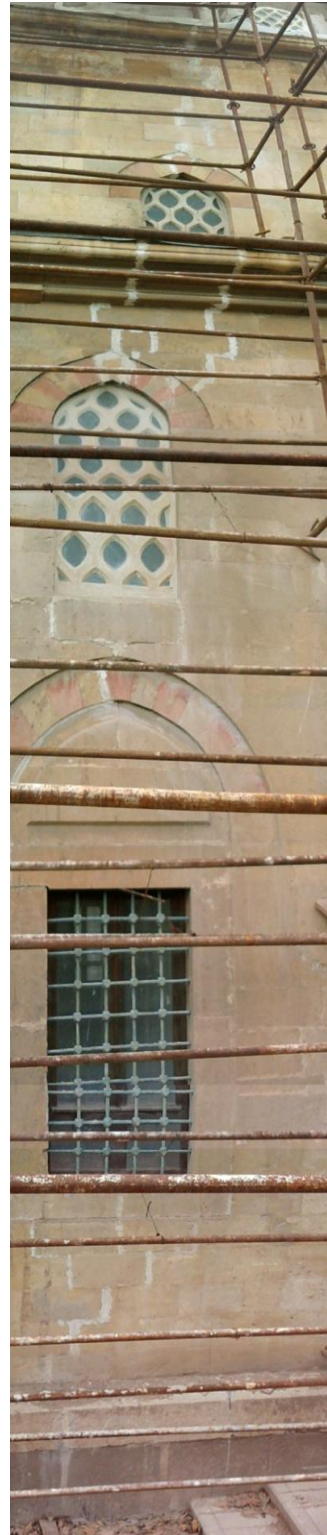
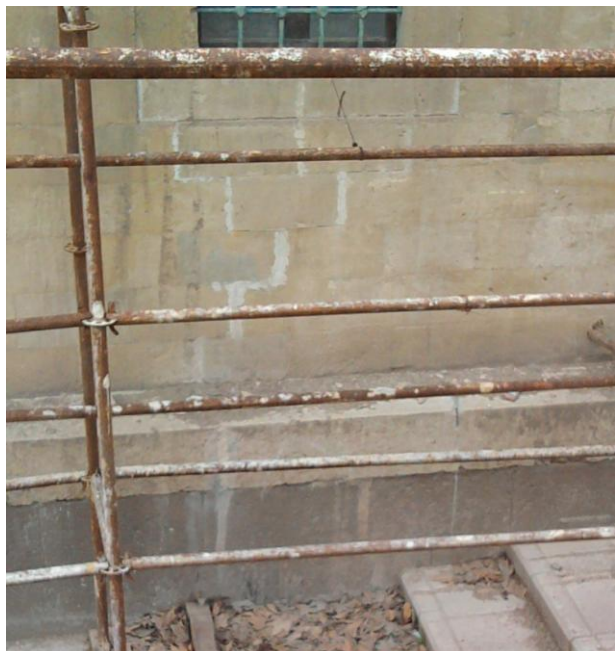
Figure 4.13 General views of cracks

In this study the present masonry structure shows serious crack patterns that can be followed from the ground up to the main dome. The stresses developed on the structure lead to cracks and disintegrations of stone blocks which lead to the structure's closure to service. The state of the damage (Figure 4.13) is evaluated as being caused by settlement problems. Therefore, the analysis stage of the structure shall involve the evaluations of the ground profile.

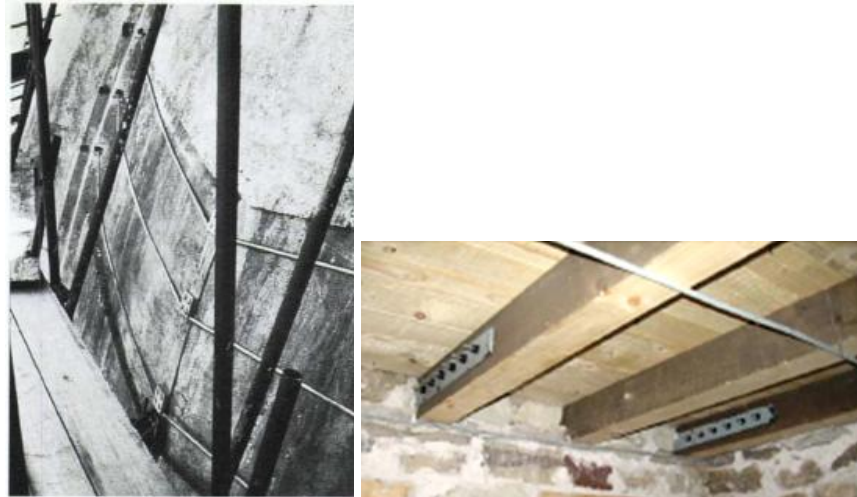
ties at springing line, rings around the dome drum, pre-stressed steel ties and stiffening wooden floors by addition of layer of timber planks. (Figure 5.1)

Figure 5.1 Sample improvement methods by; (a) Pre-stressed cables (St. Ignatio basilica, Spain), (Croci, 2005) (b) timber planks on wooden floors (Modena et. al., 2009)

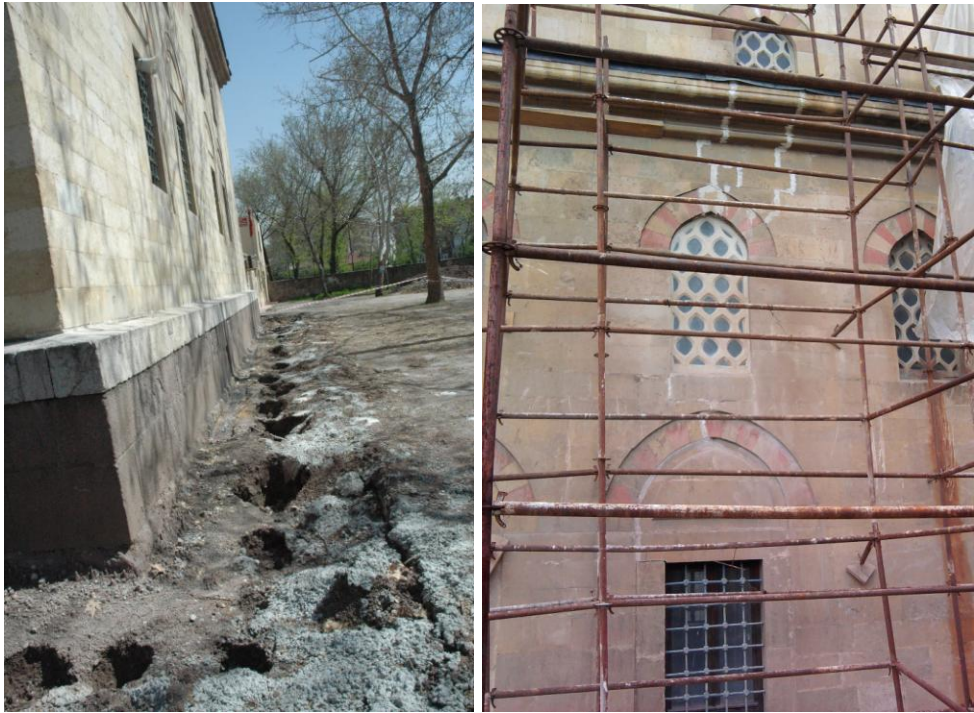
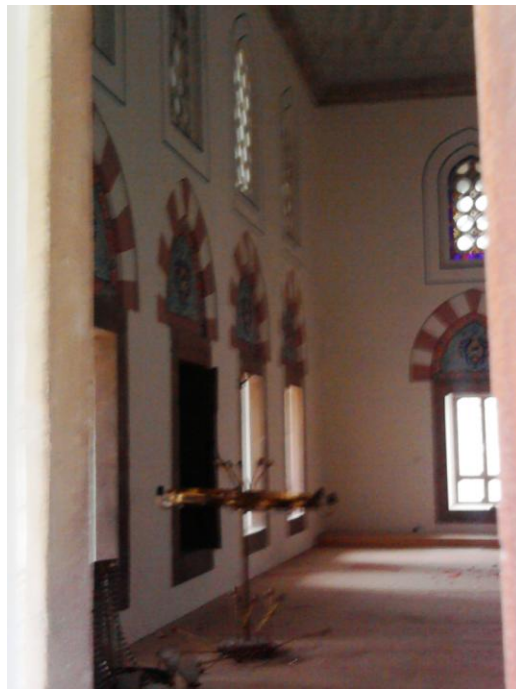
The strengthening method would be concluded by proper treatment of the cracks using suitable materials compatible with the structure's historic texture, advised to be of khorasan mortar. It should also be pointed out that, due to the state of the damage and the properties of the particular application, the method should be applied by experienced and qualified professionals. The restoration applications that have been carried out so far on the structure are given in Figure 5.6.

Figure 5.6 Photos of the applied restoration applications
