DETERIORATION OF NEMRUT SANDSTONE AND DEVELOPMENT OF ITS  
CONSERVATION TREATMENTS

A THESIS SUBMITTED TO THE GRADUATE SCHOOL OF NATURAL AND APPLIED  
SCIENCES  
OF  
MIDDLE EAST TECHNICAL UNIVERSITY

KIRAZ GÖZE AKOĞLU

September, 2011

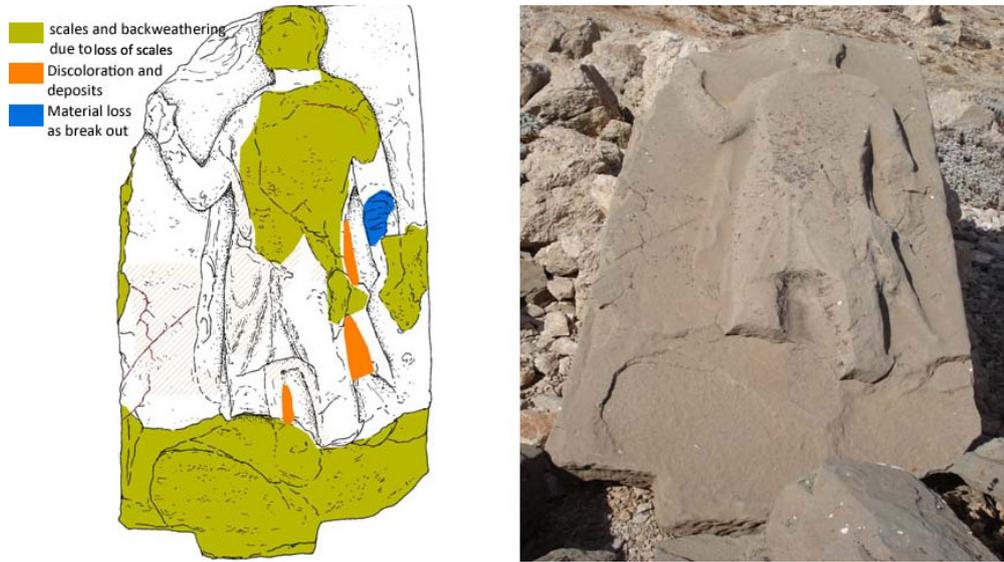
**Figure 4.1** Mapping of visual weathering forms of a relief (DTKM058) in the East Terrace (CNCDP, Final Report, 2011) (left) and its photo (right).

Two mapping examples representing weathering forms of the site, being a stele (DTKM058) and the Lion statue (DTKM066) at the East Terrace are given here.

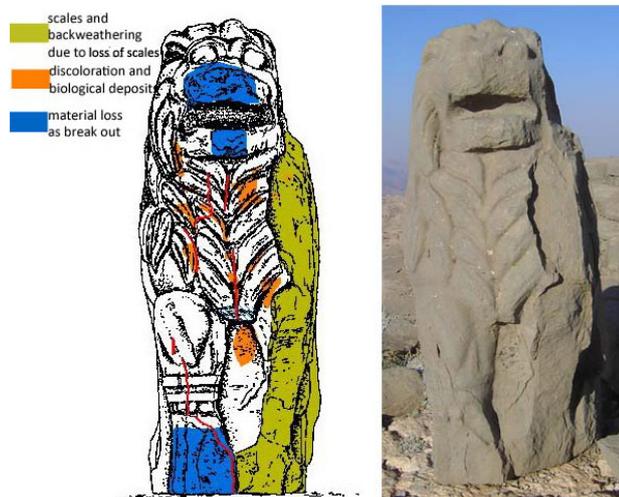
**Figure 4.2** Mapping of visual weathering forms of West face of Lion Statue (DTKM066) at East Terrace (CNCDP Final Report, 2011) (left) and its photo (right)

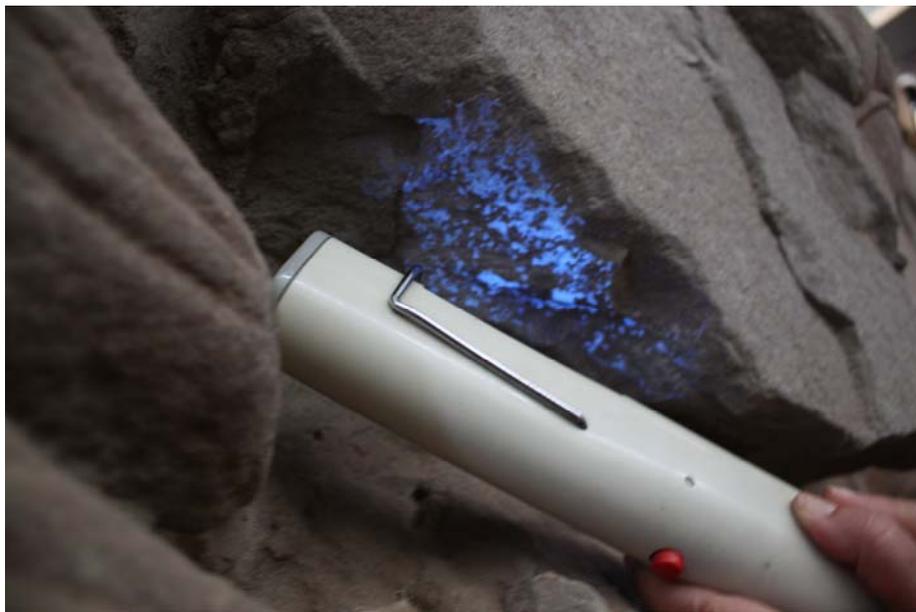
**Figure 4.3** The old PVA applications got florescent and became visible under UV light

*Previous Treatments:* At Nemrut Mount Monument some wrong interventions were done by the previous teams. Among those harmful interventions repairs with cement mortars and epoxy resins could be observed at the site, moreover, some consolidation interventions with polyvinyl acetate were also reported by Sanders (1996). Sanders (1996) reported that polyvinyl acetate (PVA) solutions in acetone were used on the animal statues around the altar and on some fragile sandstone pieces either by spraying or using brushes. Such a previous application was detected in this study in some breakout surfaces of lion horoscope in the temporary laboratory at the site. By using a UV lamp in the dark, the old PVA applications got florescent and became visible to the naked eye (Simon, 2011); and could be photographed (Figure 4.3)

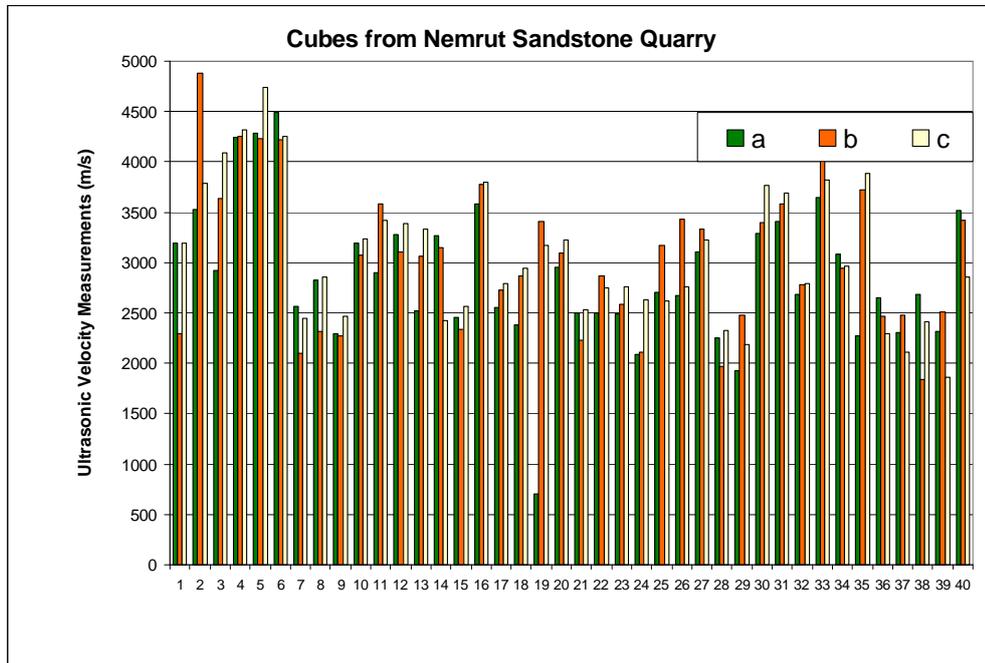
**Figure 4.4** UPV<sub>(a,b,c)</sub> values for each sandstone cube before salt crystallization tests.

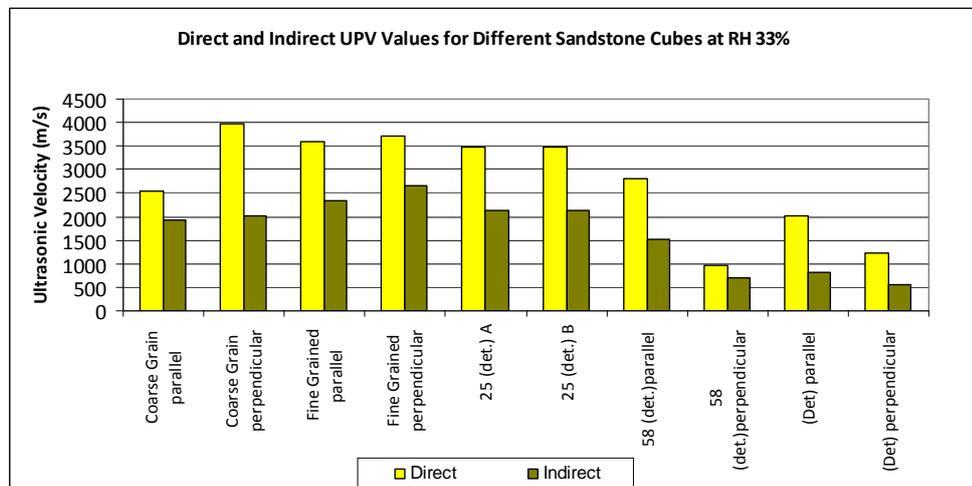
**Figure 4.8** Indirect and direct UPV values of undeteriorated and deteriorated sandstone cubes taken parallel and perpendicular to bedding planes at dry state (33% RH).

33 % RH		
UPV Measurement	Direct	Indirect
Coarse Grain parallel	2534	1929
Coarse Grain perpendicular	3971	2019
Fine Grained parallel	3581	2347
Fine Grained perpendicular	3716	2647
25 (det.) A	3484	2121
25 (det.) B	3474	2130
58 (det.)parallel	2802	1530
58 (det.)perpendicular	979	697
(Det) parallel	2005	825
(Det) perpendicular	1221	545

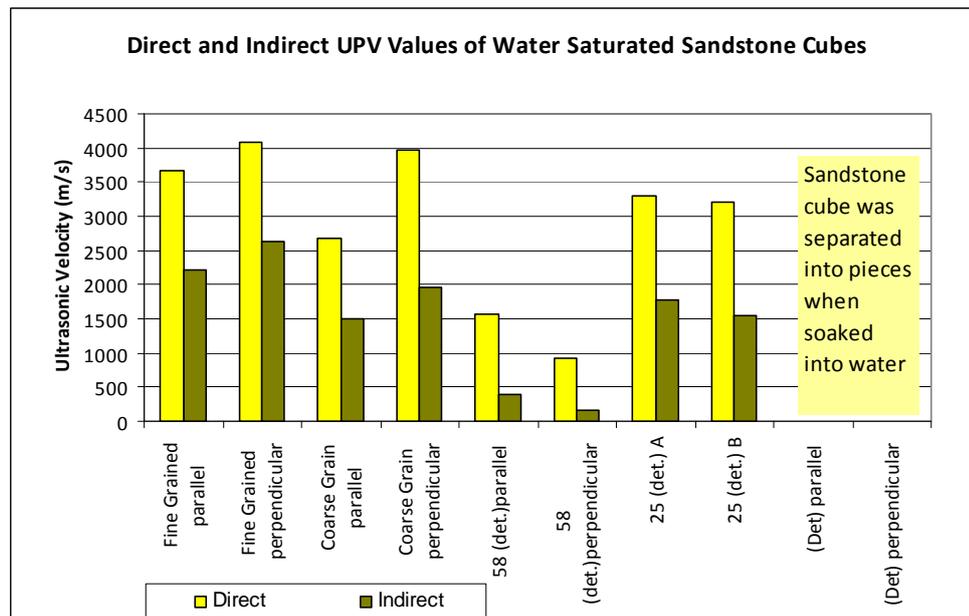
**Figure 4.9** Indirect and direct UPV values of water saturated undeteriorated and deteriorated sandstone cubes taken parallel and perpendicular to bedding planes.

Water Saturated		
UPV Measurement	Direct	Indirect
Fine Grained parallel	3675	2220
Fine Grained perpendicular	4085	2626
Coarse Grain parallel	2668	1509
Coarse Grain perpendicular	3968	1956
58 (det.)parallel	1572	403
58 (det.)perpendicular	922	171
25 (det.) A	3306	1780
25 (det.) B	3200	1552
Deteriorated sample	Sample separated into pieces when soaked into water

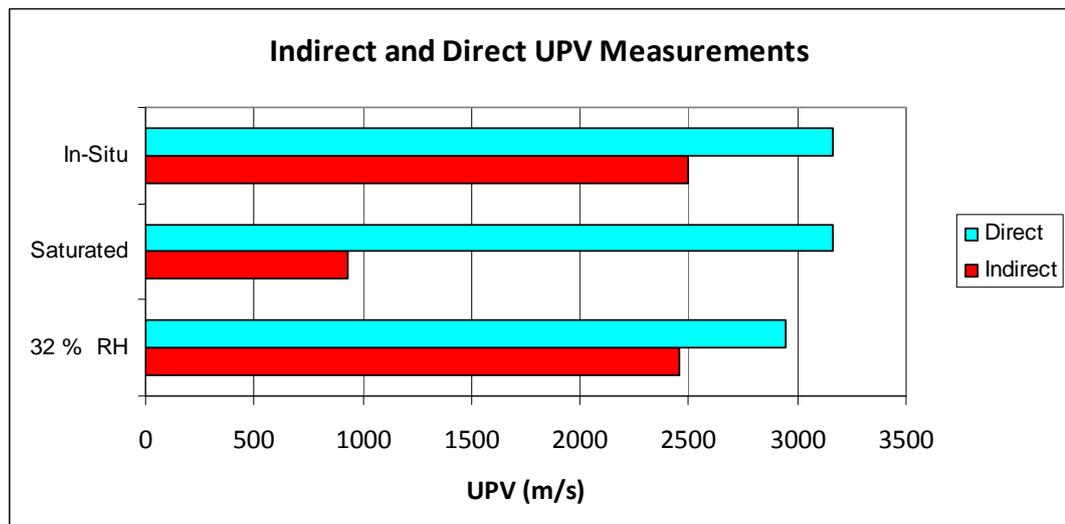
**Figure 4.10** Indirect and direct UPV values of a sandstone sample taken from the site (Figure 4.11) in situ, dry and water saturated states.

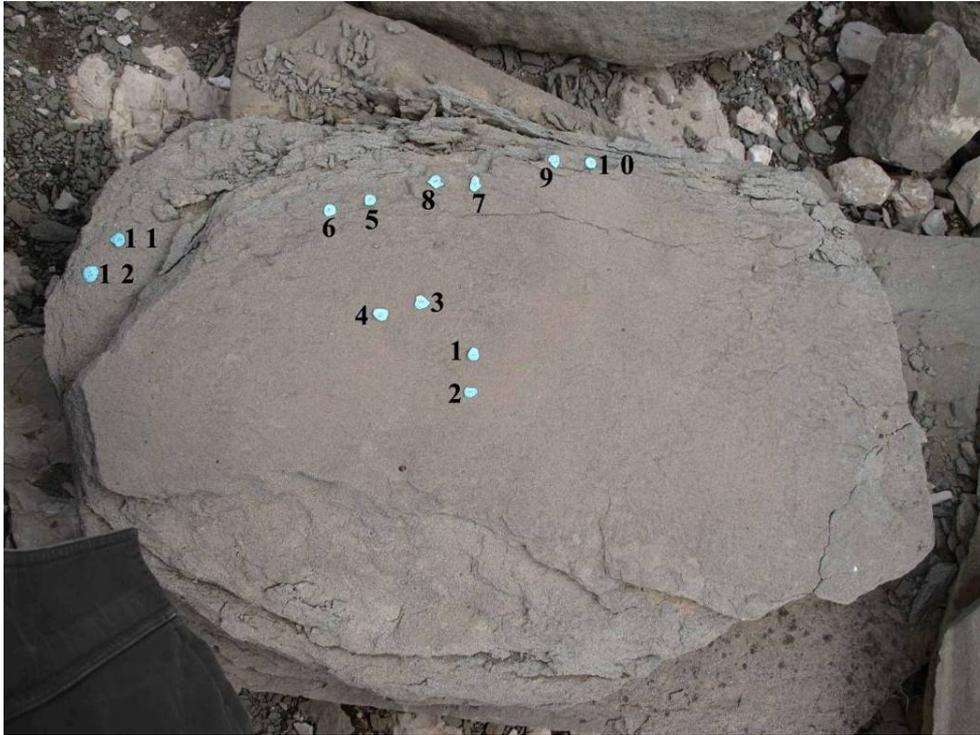
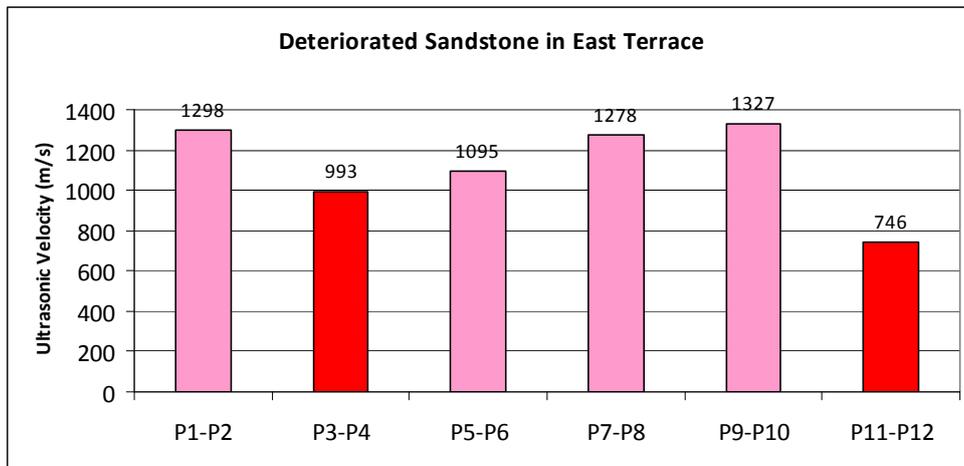
**Figure 4.12** Indirect UPV measurement taken from different points of a deteriorated sandstone block (above) in East Terrace, and graphic representation of the UPV values for each point pairs, red: very deteriorated parts, pink: deteriorated parts.

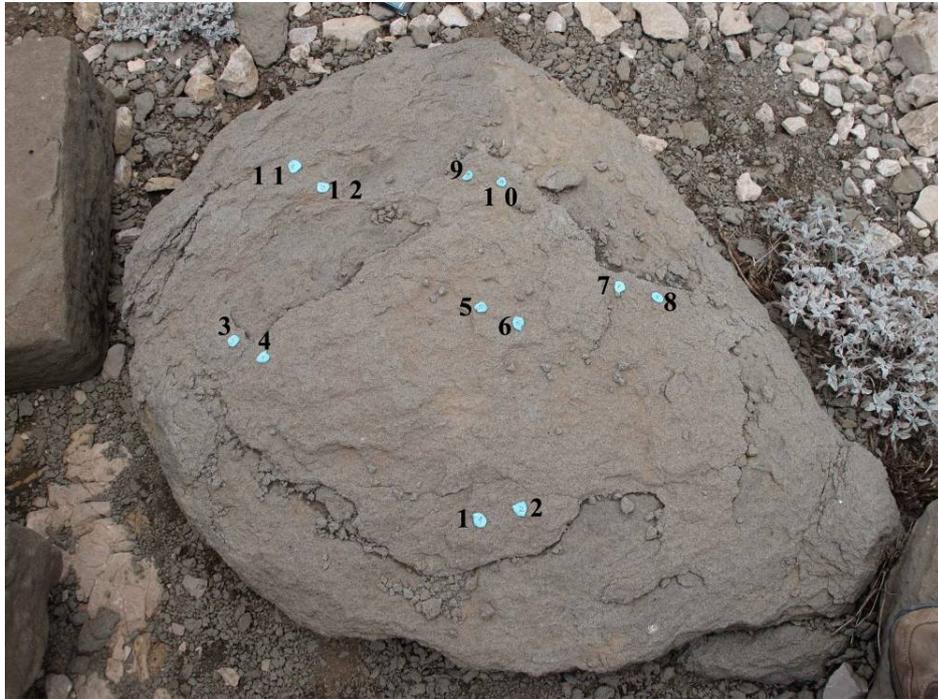
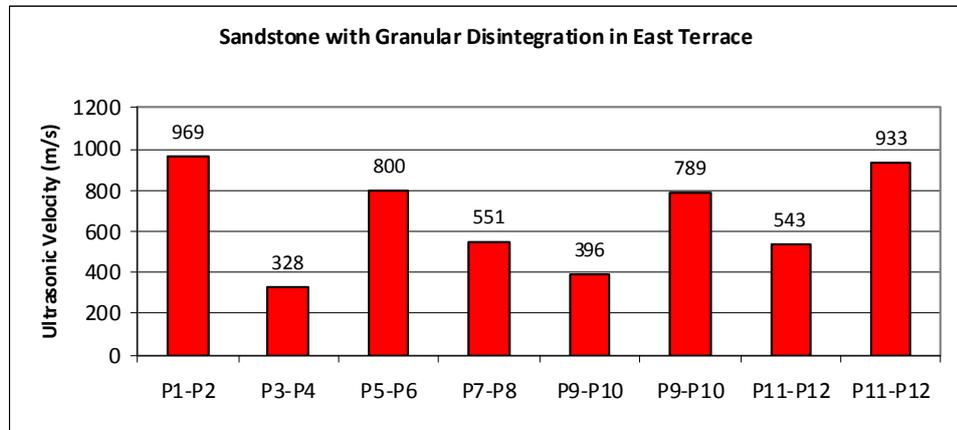
**Figure 4.13** Indirect UPV measurement taken from a sandstone showing granular disintegration (above) at East Terrace, and graphic representation of the UPV values for each point pairs, red: very deteriorated parts.

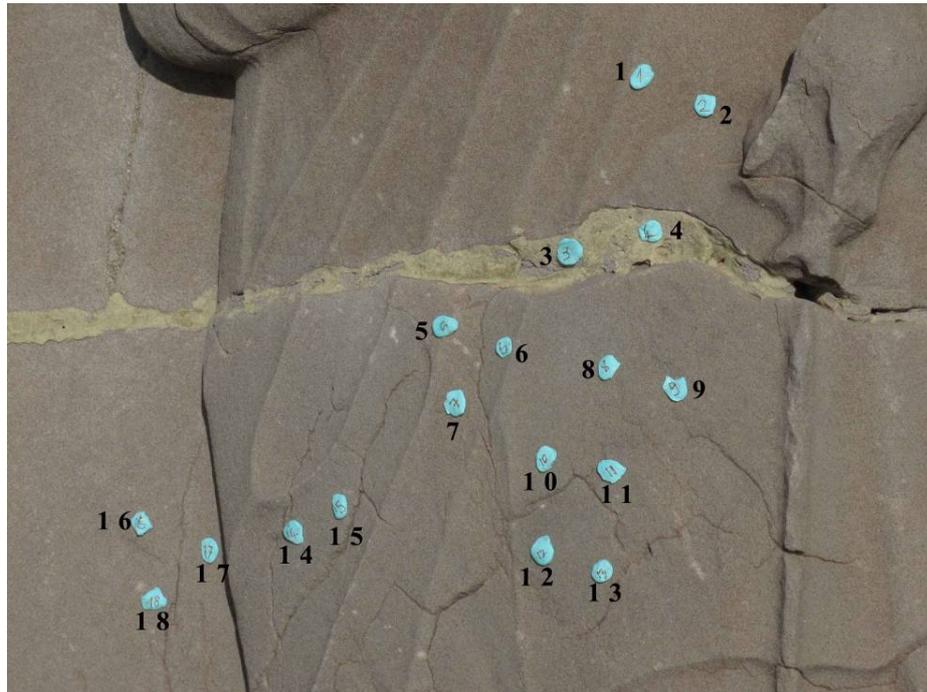
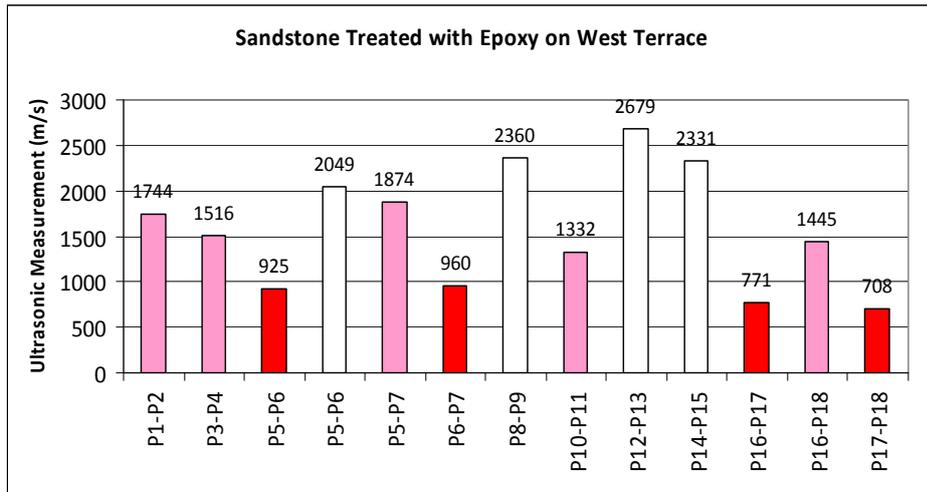
**Figure 4.14** Indirect UPV measurements from sandstone treated with epoxy by the old conservation team (East Terrace), and graphic representation of the UPV values for each point pairs, red: very deteriorated parts, pink: deteriorated parts, white: sound

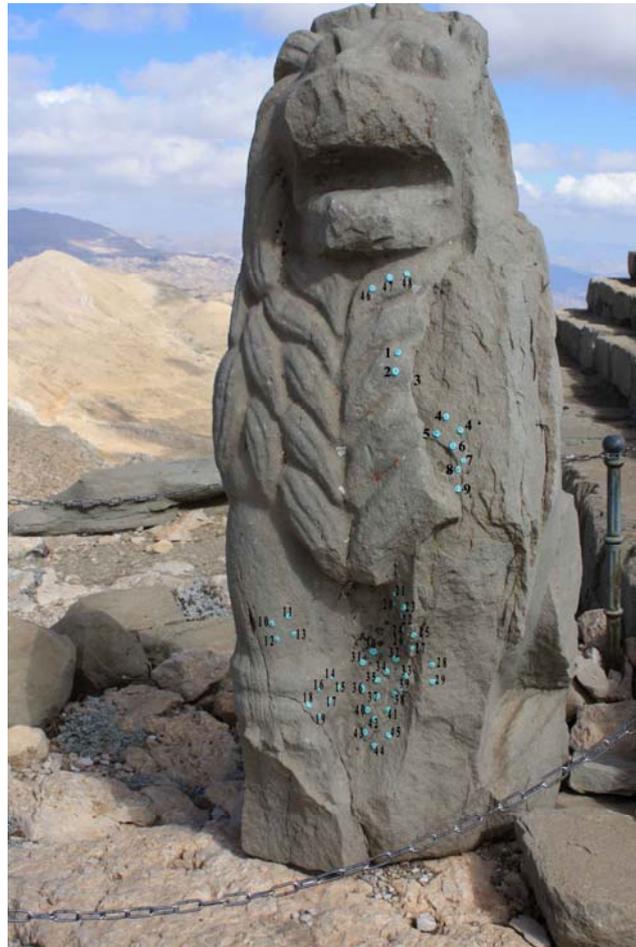
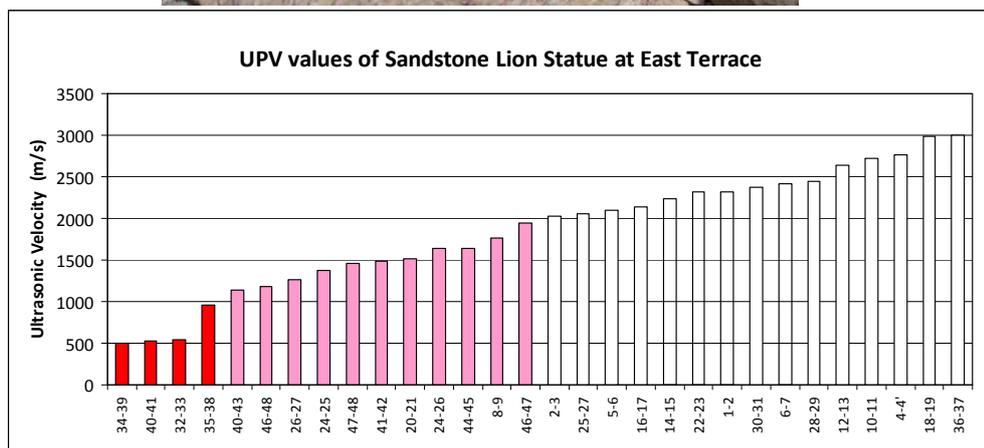
**Figure 4.15** UPV measurements from different points on Sandstone Lion Statue at East Terrace; the measurement points (above); and UPV values of those points pairs; red: very deteriorated parts, pink: deteriorated parts, white: sound.

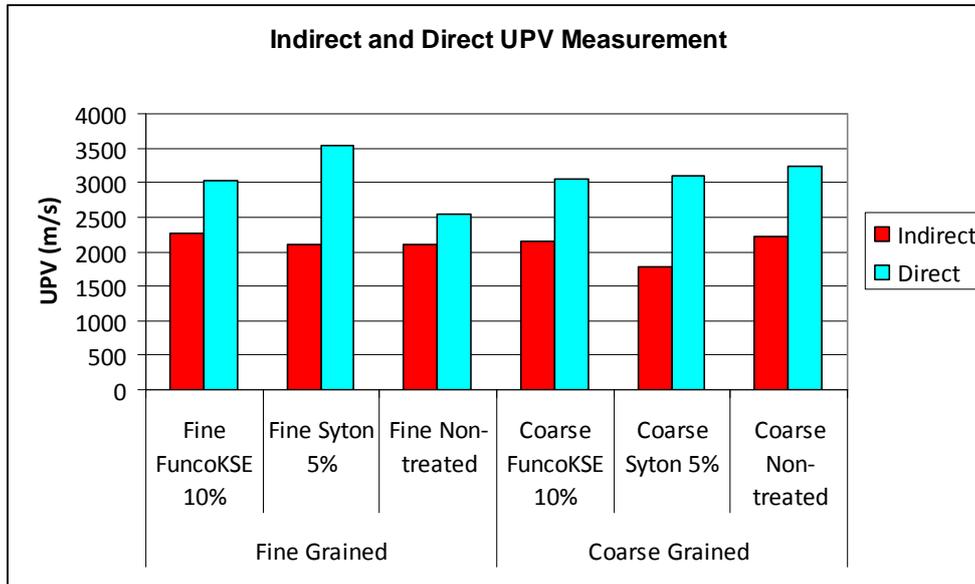
**Figure 4.16** Indirect and direct UPV values of sandstone cubes before and after consolidation treatments.

The UPV values of the sandstone cubes before and after treatments with Syton X30, Funcosil KSE500STE, KSE300 and KSE100 in laboratory and the sandstone blocks at the site before and after treatment were measured and evaluated together for the assessment of the treatments success (Figures 4.16, 4.17; Tables 4.5, 4.6). After the treatment with Syton X30 and Funcosil KSE500STE a slight increase in UPV values of sandstones was noticed (Figure 4.16, Table 4.5). After the treatment with KSE300 and KSE100 a slight increase in UPV was more noticeable parallel to the bedding plane (Figure 4.17; Table 4.6).

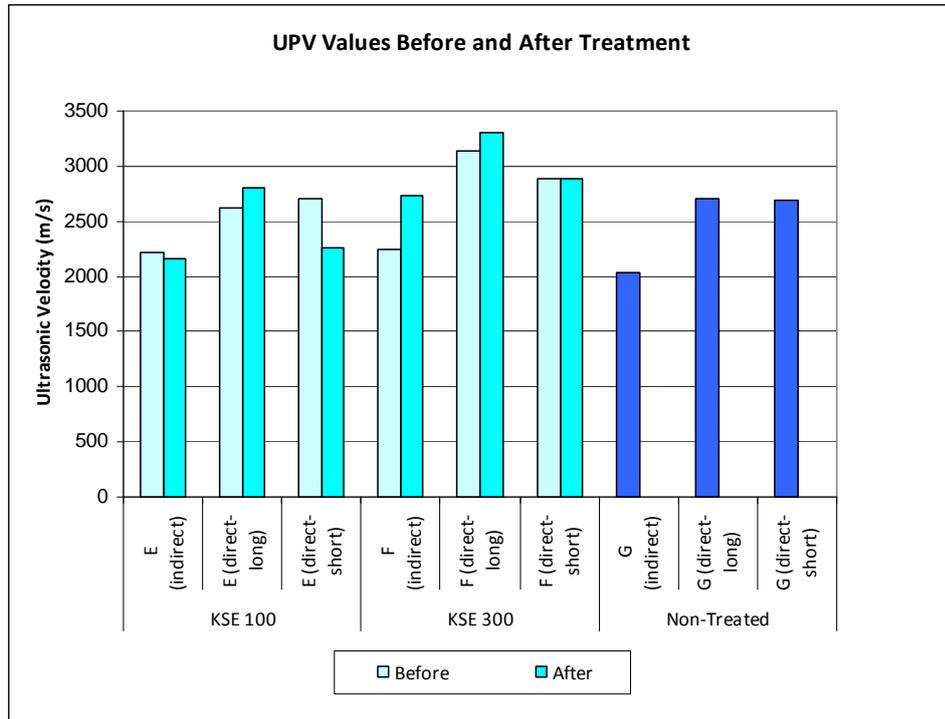
**Figure 4.17** Indirect and direct UPV values of sandstones blocks before and after consolidation treatments; direct (long) measurements are parallel to the bedding and the direct (short) being perpendicular to bedding.

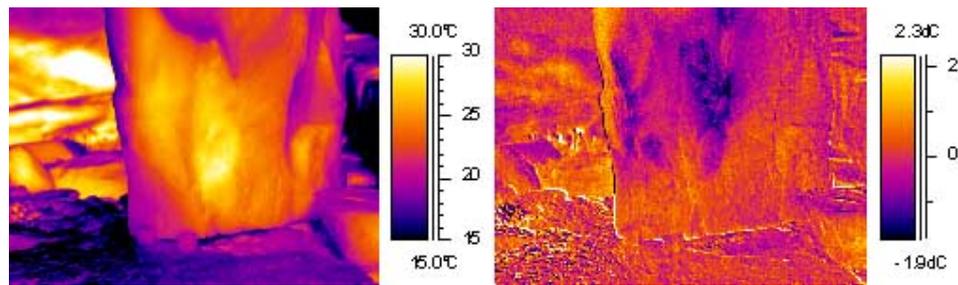
**Figure 4.19** Photograph of Lion Statue at East Terrace (left), single IR image of the statue showing the relatively hot surfaces and the cold surfaces of the statue (above left), differential IR image in cooling period (above right).

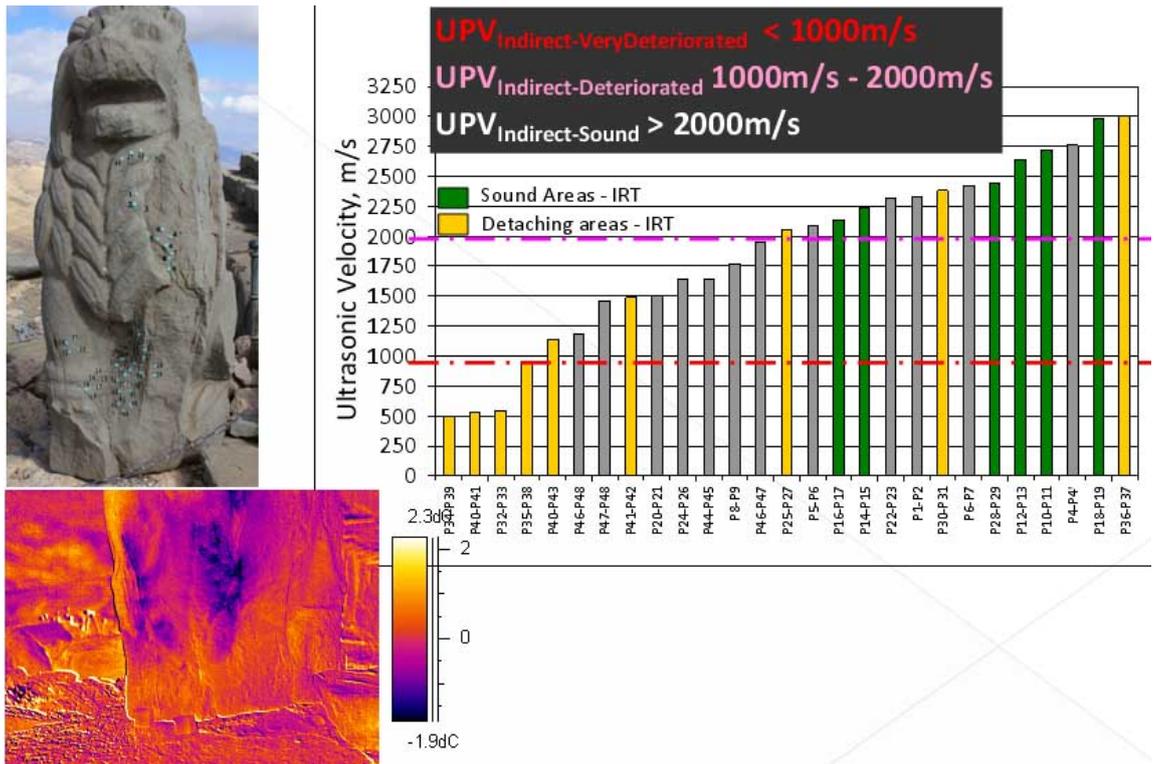
**Figure 4.20** Differential IR image and UPV measurements of the detaching scales. The degree of deterioration of detaching parts can be determined by the changes in UPV measurements that are taken parallel to the surface.

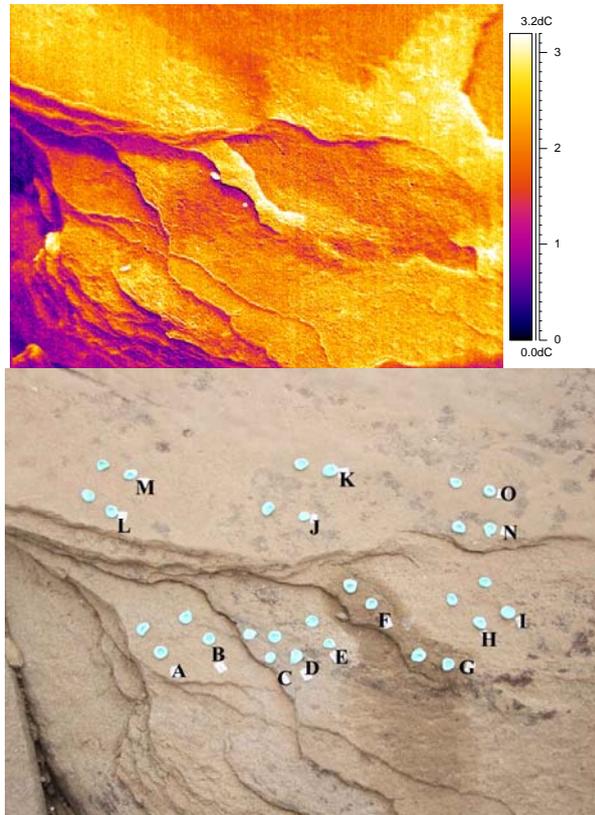
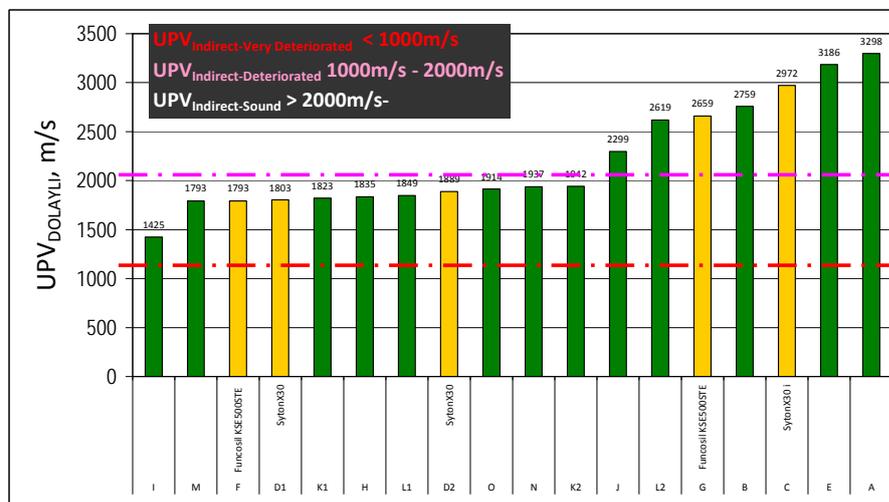
**Figure 4.21** Treated and non-treated layers of sandstone in North Terrace. The UPV and Differential IR images showing that the consolidation treatments done with Funcosil KSE500STE and SytonX30 improve the sandstones' UPV and thermal inertia characteristics.

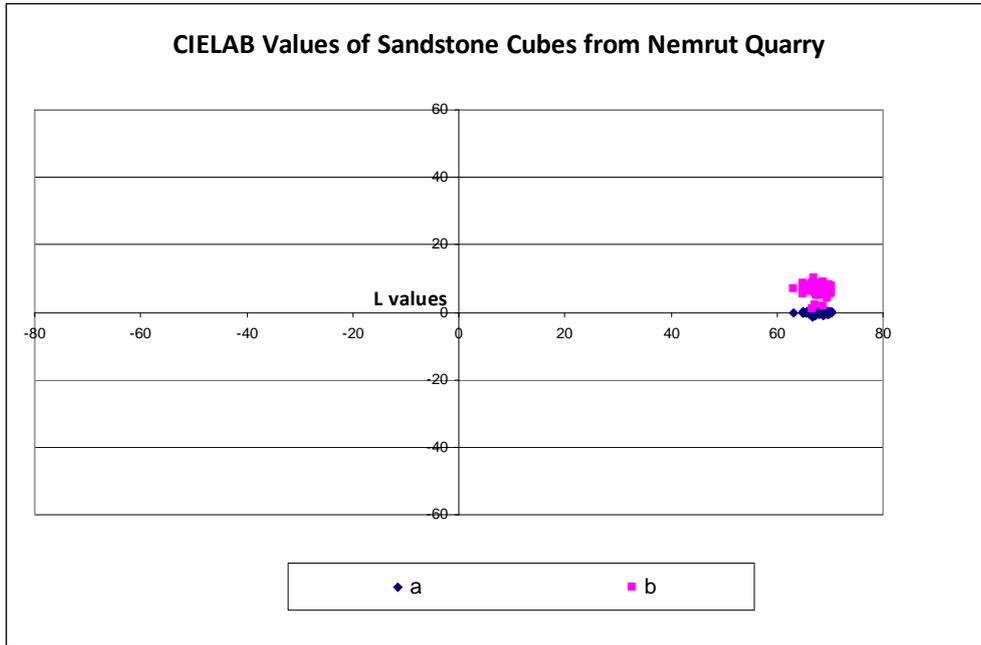
**Figure 4.22** CIELAB color values of sandstone cubes from Nemrut Quarry

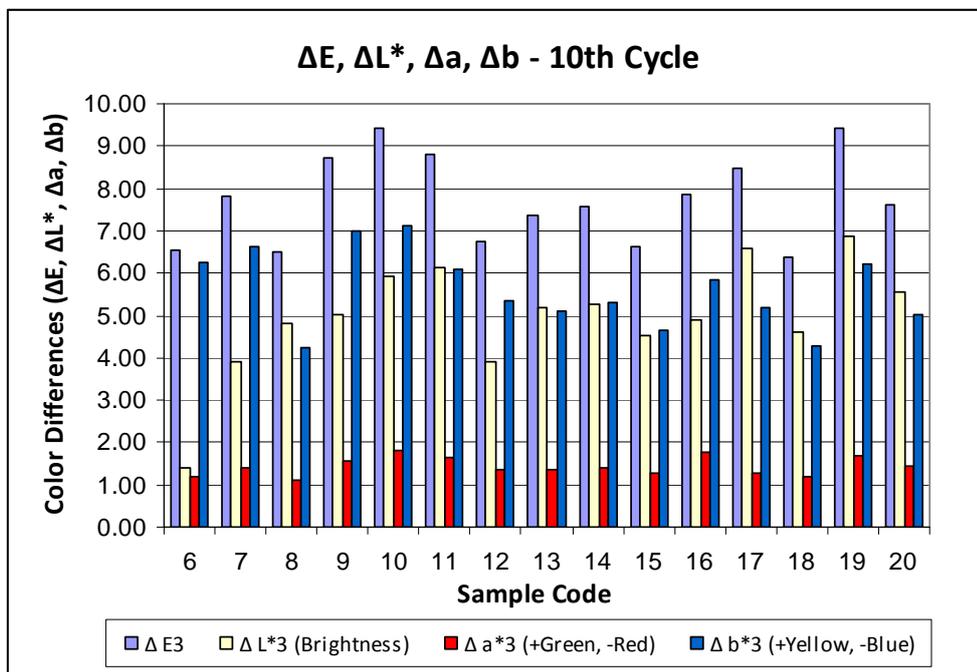
Figure 4.25  $\Delta E$ ,  $\Delta L^*$ ,  $\Delta a$ ,  $\Delta b$  values of artificially weathered sandstone samples after 10<sup>th</sup> cycle of salt crystallization.

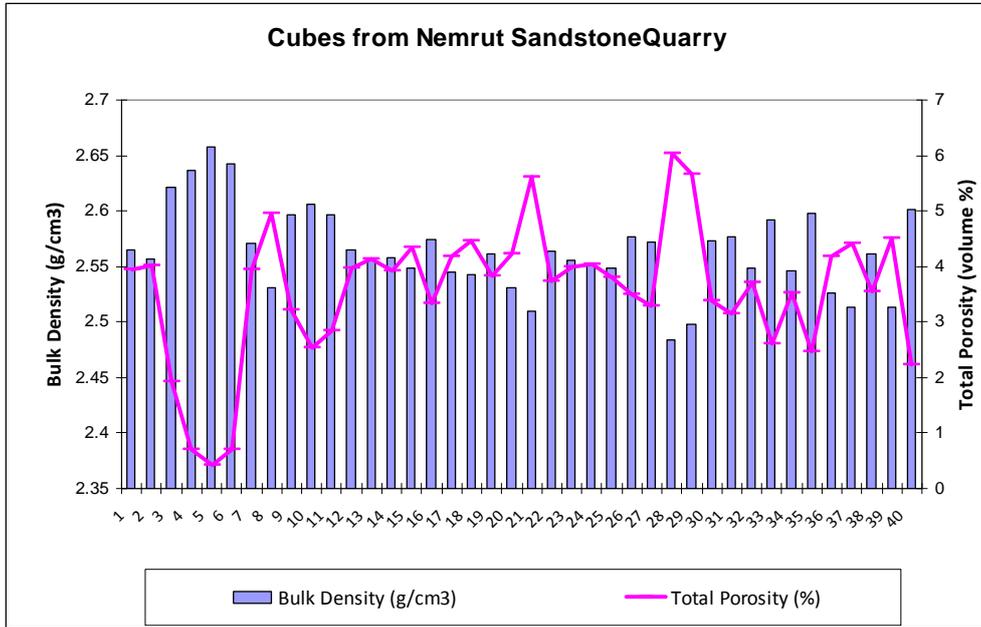
**Figure 4.31** Bulk density and total porosity of sandstone cubes from Nemrut Sandstone Quarry.

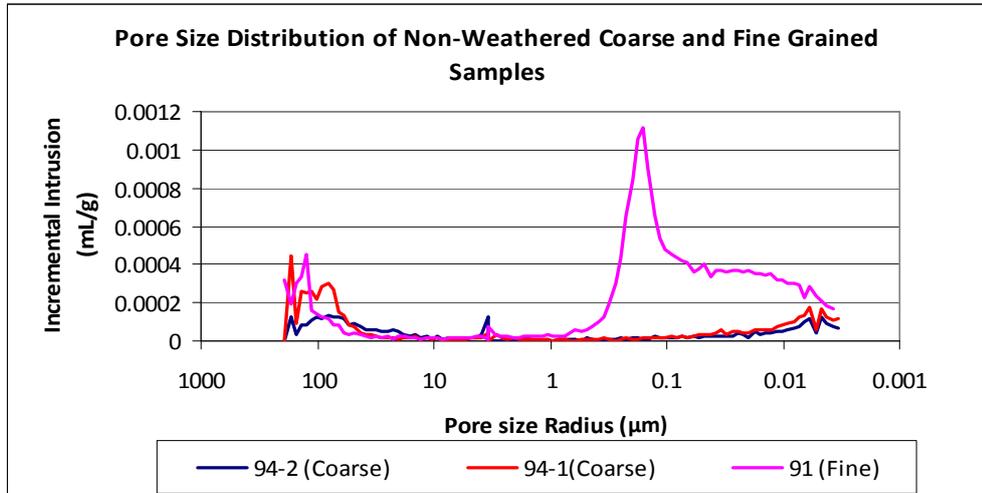
Figure 4.33 Pore size distribution of medium and fine grained sandstones from quarry.

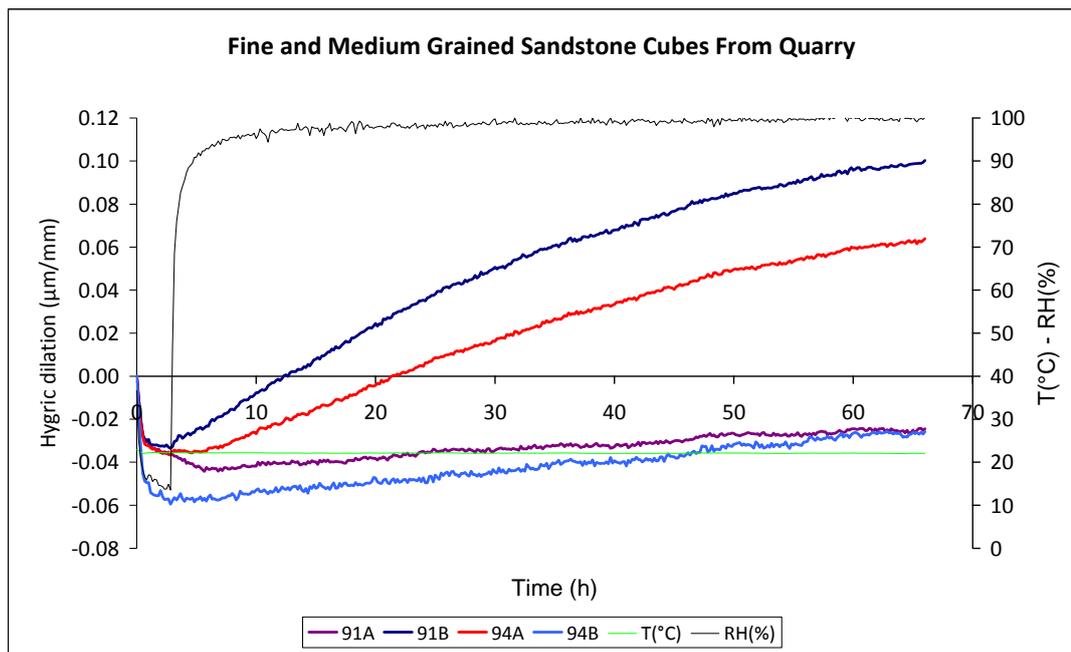
**Figure 4.39** Hygric Dilatation measurement of medium and fine grained sandstones; 94A: hygric dilatation of medium grained sandstone perpendicular to bedding; 94B: hygric dilatation of medium grained sandstone parallel to bedding; 91A: Hygric dilatation of fine grained sandstone perpendicular to bedding, 91B: Hygric dilatation of fine grained sandstone parallel to bedding.

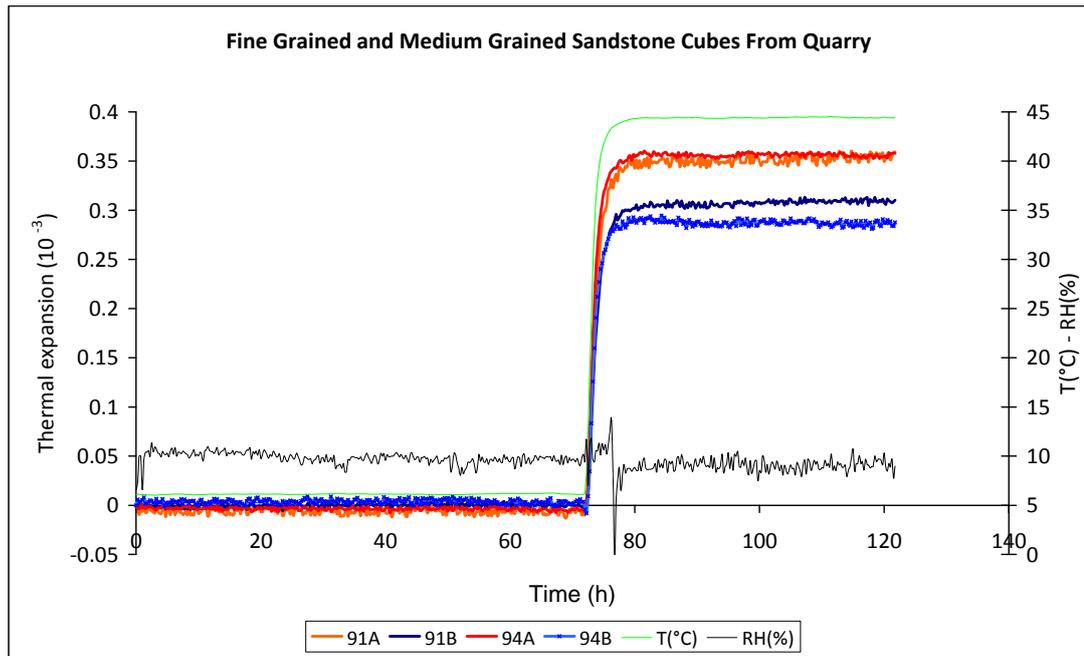
**Figure 4.40** Thermal Dilatation measurement of medium and fine grained sandstones; 94A: thermal dilatation of coarse grained sandstone perpendicular to bedding; 94B: thermal dilatation of medium grained sandstone parallel to bedding; 91A: thermal dilatation of fine grained sandstone perpendicular to bedding, 91B: thermal dilatation of fine grained sandstone parallel to bedding.

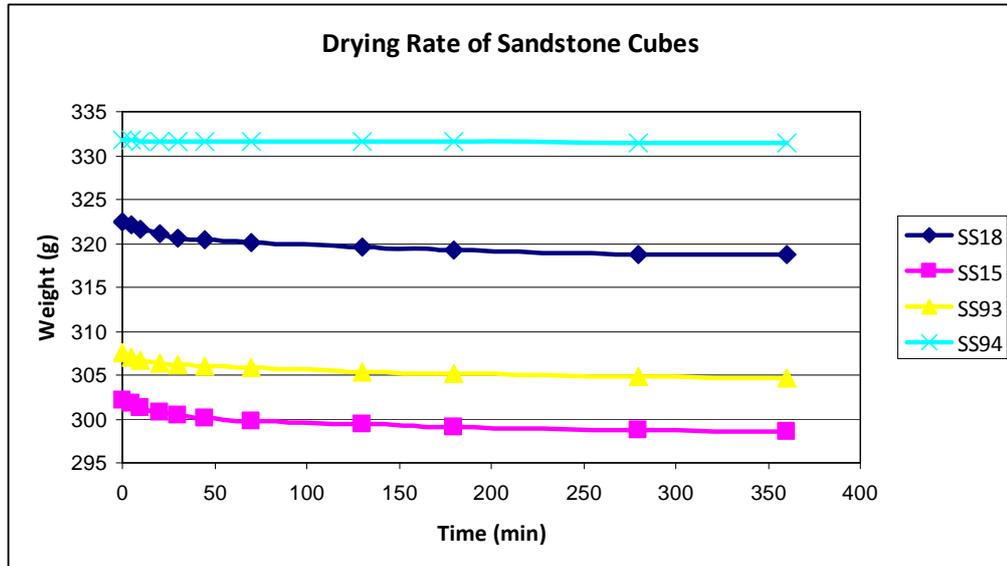
**Figure 4.46** Drying rate of saturated sandstone cubes at site.

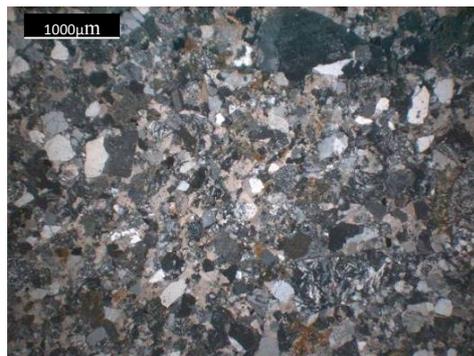
**Figure 4.47** Thin section photomicrograph of a fresh sandstone sample (crossed nicols). Showing the presence of quartz, plagioclase feldspar, granite, igneous rock fragments, alkali feldspar, biotite, orthoclase, calcedony, quartzite, calcite, Limestone particles

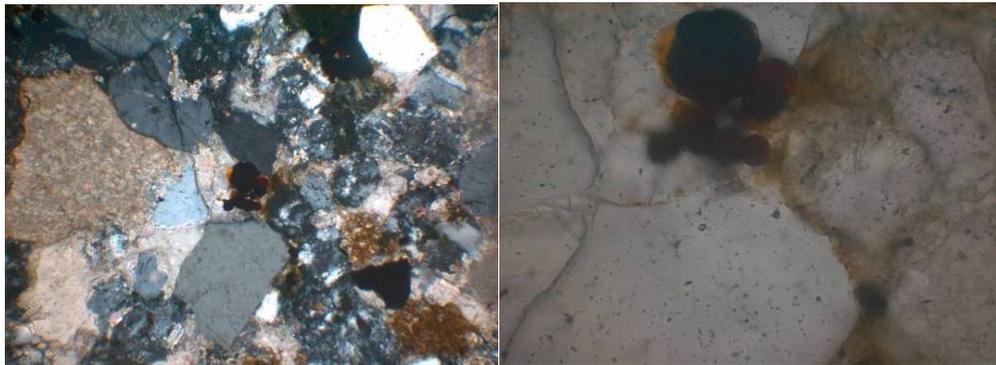
**Figure 4.49.** Thin section photomicrograph of a fresh sandstone sample, crossed nicols X10 (left) and single nicol X63 (right), showing opaque minerals as iron oxides and some amorphous phases around them observed as small spheres.

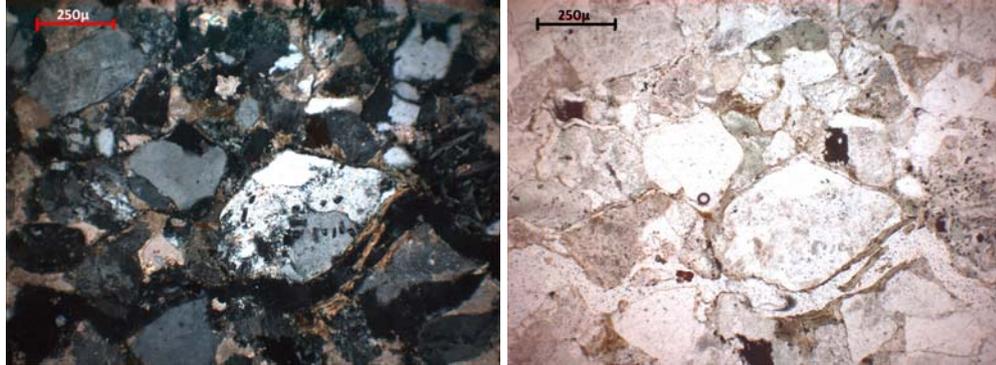
**Figure 4.50.** Thin section photomicrograph of naturally weathered sample crossed nicols (left) and single nicol (right). Cracks in the microstructure and clay accumulations on the surfaces of cracks are observed.

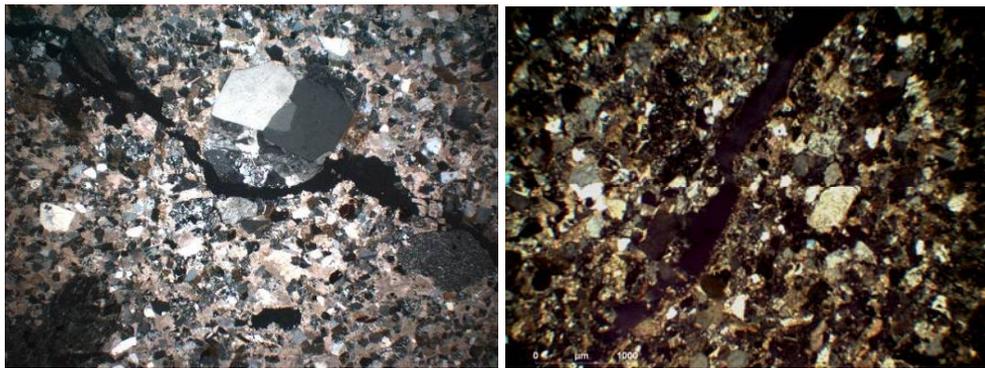
**Figure 4.51.** Thin section views from naturally weathered samples. Micro-cracks are observed in the microstructure.

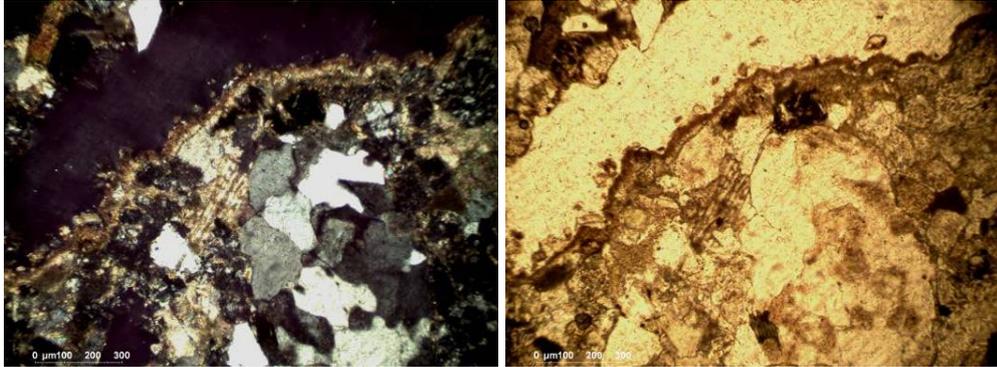
**Figure 4.52.** Thin section photomicrograph of naturally weathered sample crossed nicols (left) and single nicol (right). A crack of  $\sim 300\mu\text{m}$  size, accumulation of micritic calcite and clay minerals on one of its surfaces.

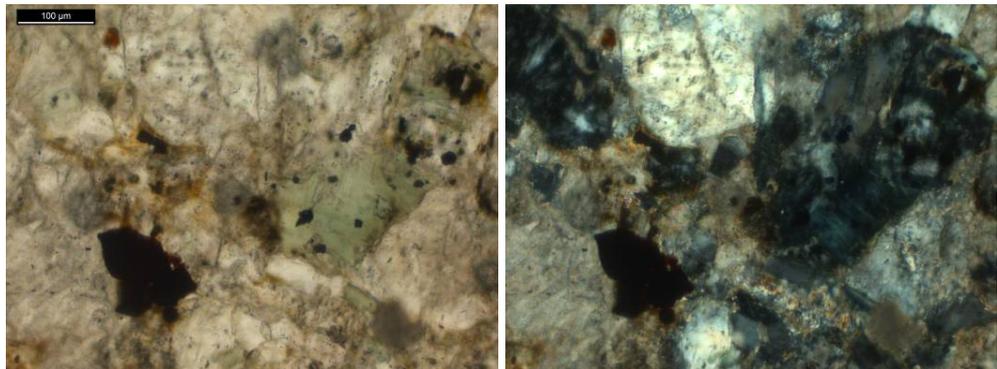
**Figure 4.53.** Chlorite and iron oxide minerals in deteriorated fine grained sandstone can be seen in the single nicol (left), cross nicols (right).

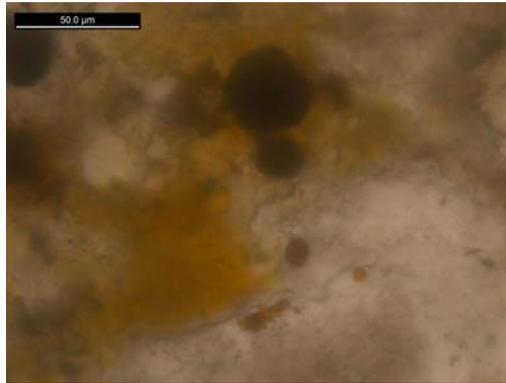
**Figure 4.54.** Aggregates of colloidal iron oxide in the matrix of deteriorated sandstone around the iron oxide minerals, single nicol.

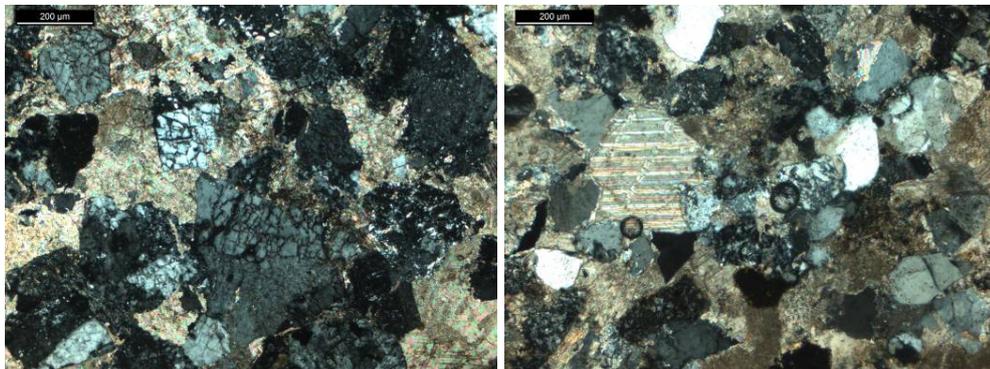
**Figure 4.55.** Thin section photomicrograph of fine grained deteriorated sandstone, crossed nicols, deterioration of feldspar minerals (left) and calcite in the matrix (right).

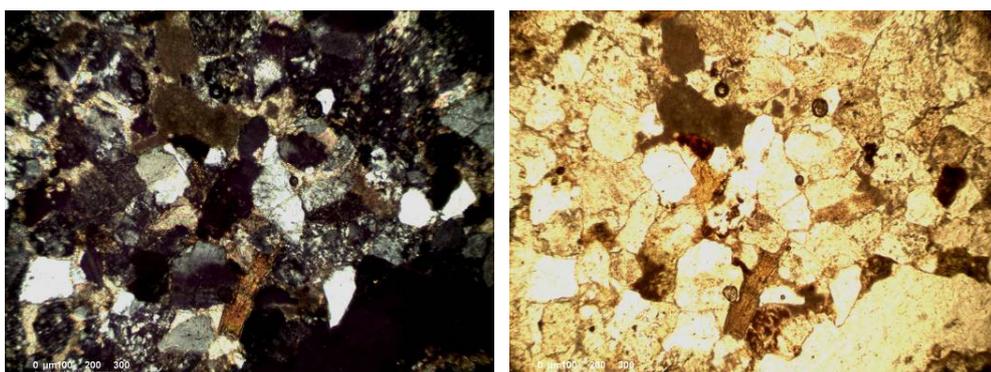
**Figure 4.56.** Thinsection photomicrograph of deteriorated sandstone from north terrace crossed nicols (right), single nicol (left)

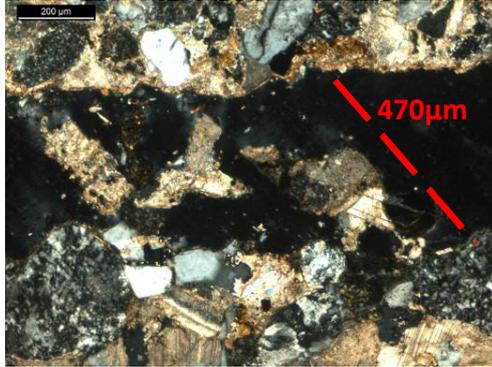
**Figure 4.57** Thin section photomicrograph of deteriorated sandstone from north terrace (crossed nicols), a closer look into the microcrack of about 470 $\mu$ m, detached minerals can be seen in the crack.

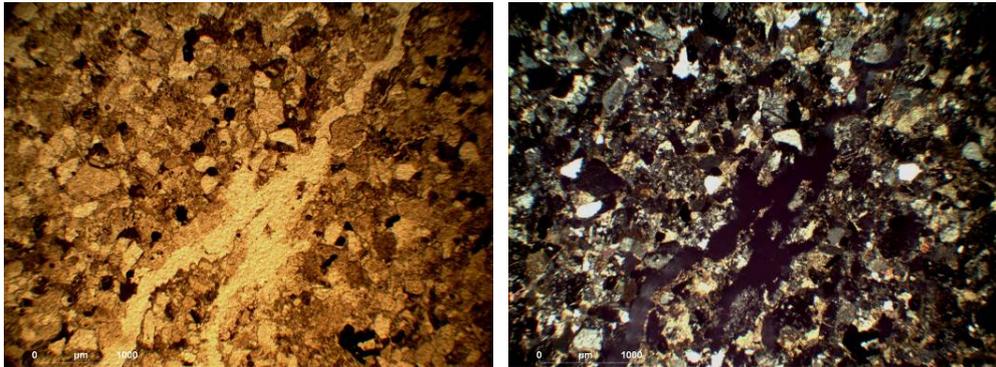
**Figure 4.58.** Thin section photomicrograph of naturally weathered sample (NS1) crossed nicols (left) and single nicol (right). A crack network can be seen.

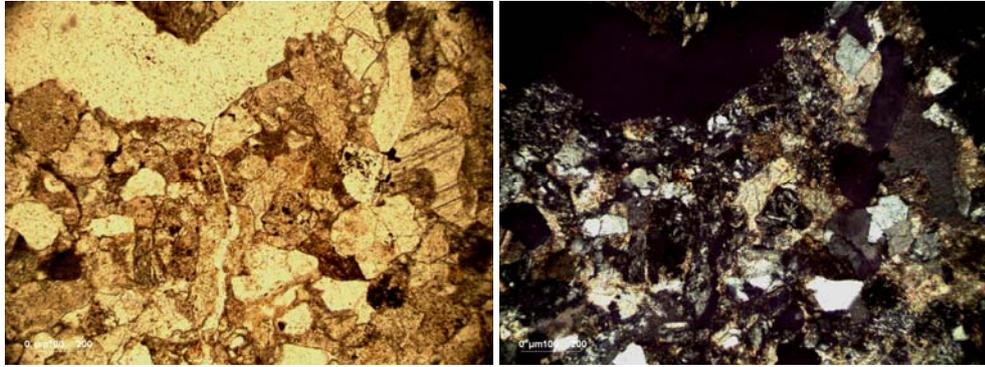
**Figure 4.59.** Thin section photomicrograph of deteriorated sandstone from east terrace, presence of opaque minerals, single nicol (left), crossed nicols (right).

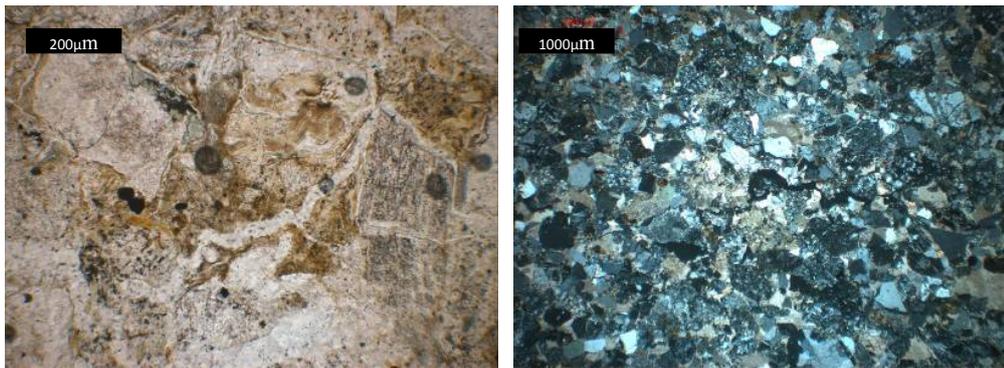
**Figure 4.60.** Thin section photomicrographs of artificially deteriorated sandstone presence opaque minerals single nicols (left) cross nicols (right).
