DETERIORATION OF NEMRUT SANDSTONE AND DEVELOPMENT OF ITS  
CONSERVATION TREATMENTS

A THESIS SUBMITTED TO THE GRADUATE SCHOOL OF NATURAL AND APPLIED  
SCIENCES  
OF  
MIDDLE EAST TECHNICAL UNIVERSITY

KIRAZ GÖZE AKOĞLU

September, 2011

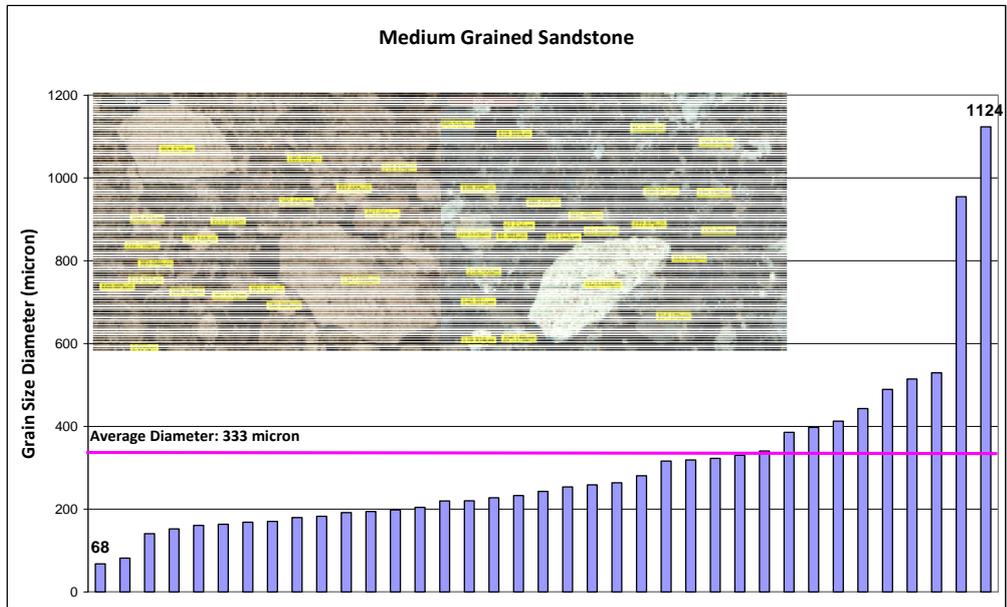
**Figure 4.61** Image analysis of medium grained sandstone. The average diameter was found to be 333 $\mu$ m.

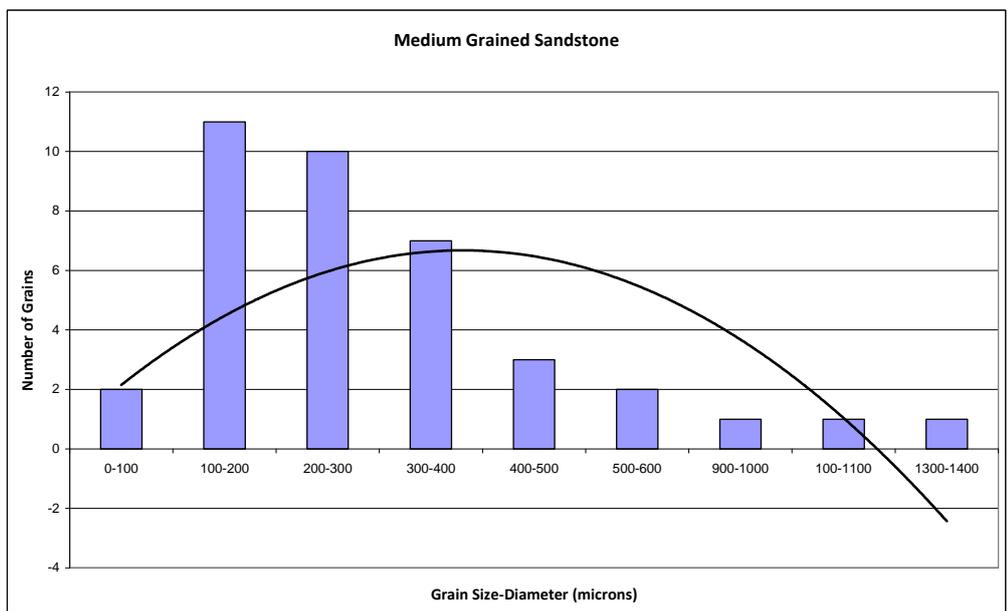
**Figure 4.62.** Frequency distribution of medium grained sandstone, it was found to be poorly sorted.

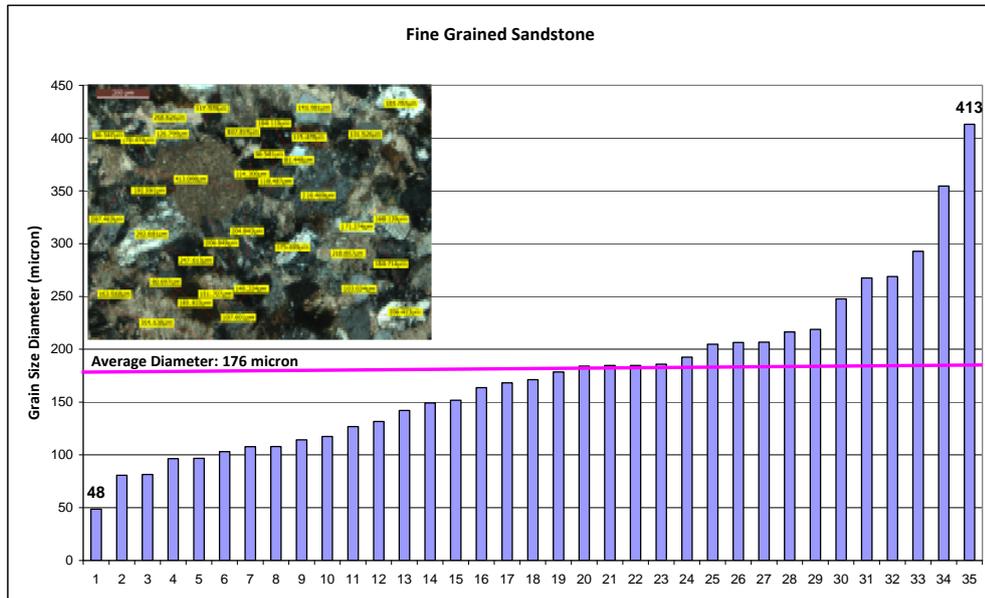
**Figure 4.63.** Image analysis of fine grained sandstone. The average diameter was found to be 176 $\mu$ m

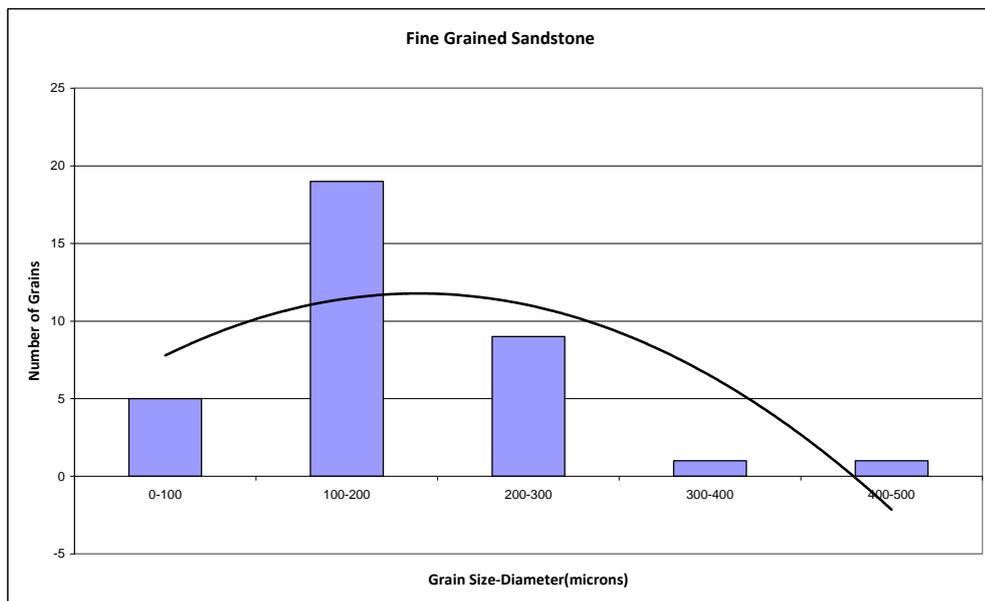
**Figure 4.64.** Frequency distribution of fine grained sandstone, it was found to be poorly sorted.

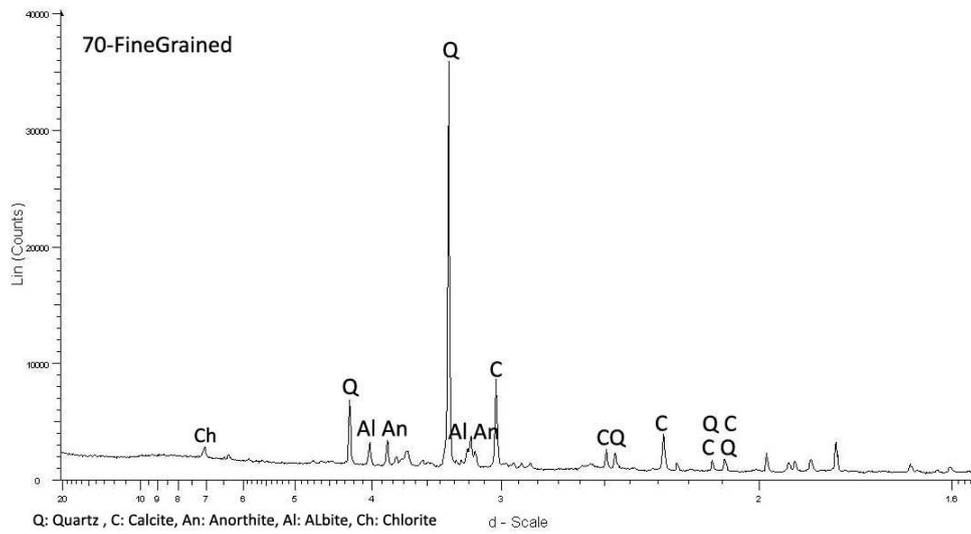
**Figure 4.65** XRD trace of fine grained powdered sandstone from Nemrut Quarry, C: Calcite, Q: Quartz, Al: Albite, An: Anorthite, Ch: Chlorite

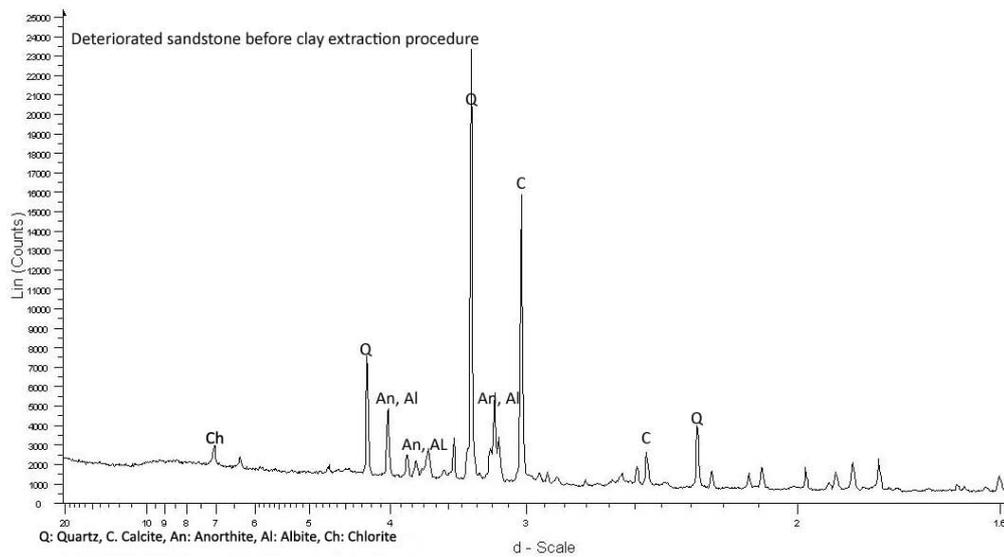
**Figure 4.68** XRD trace of powdered deteriorated sandstone before clay extraction , C: Calcite Q: Quartz, Al: Albite, An: Anorthite, Ch: Chlorite

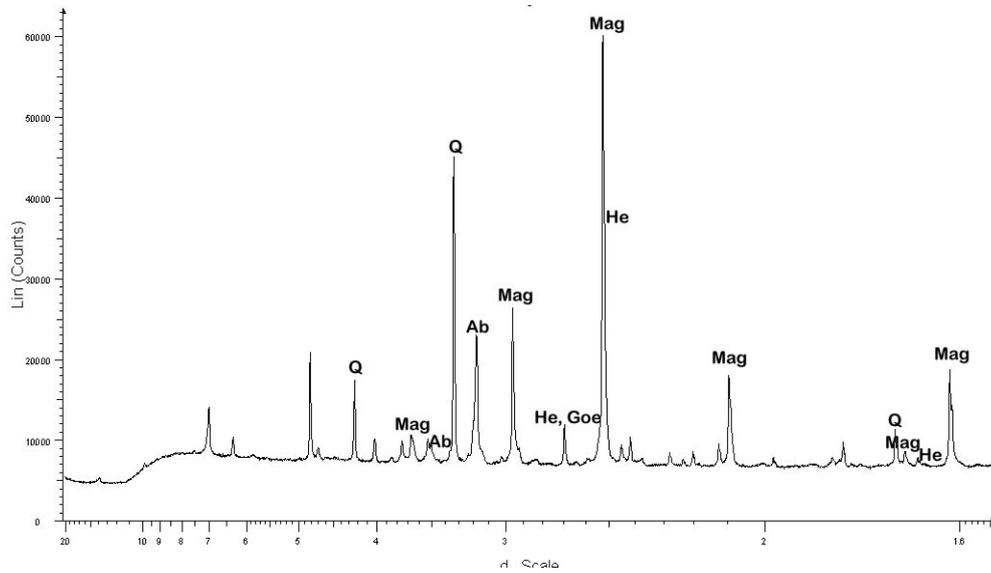
**Figure 4.69.** XRD trace of magnetically collected iron oxides during clay extraction procedure. He: Hematite, Goe: Goethite, Mag: Magnetite/Maghemite, Q: Quartz, Al: Albite

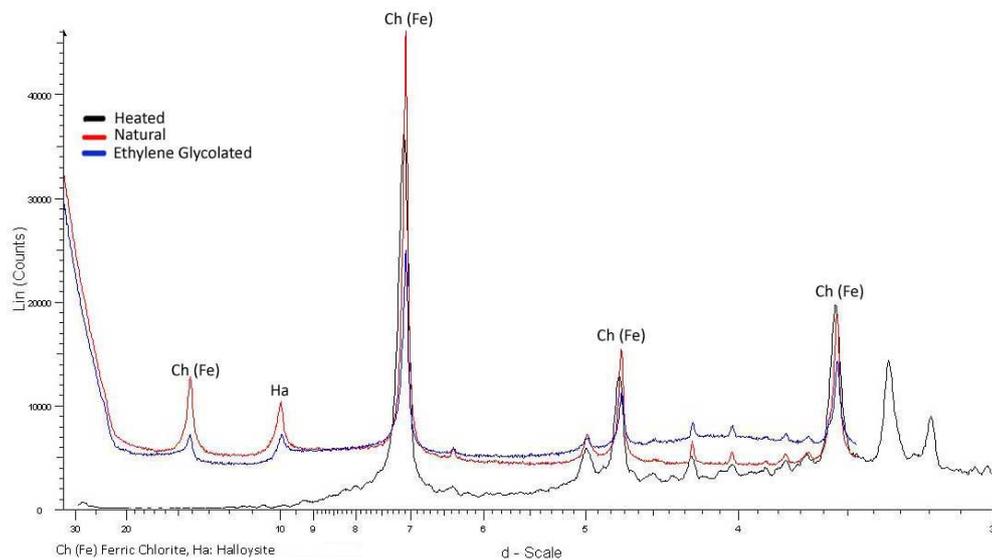
**Figure 4.70.** XRD trace of air dried, ethylene glycolated and heated clay extraction from nondeteriorated sandstone, Ch(Fe): Chlorite Ferric, Ha: Halloysite.

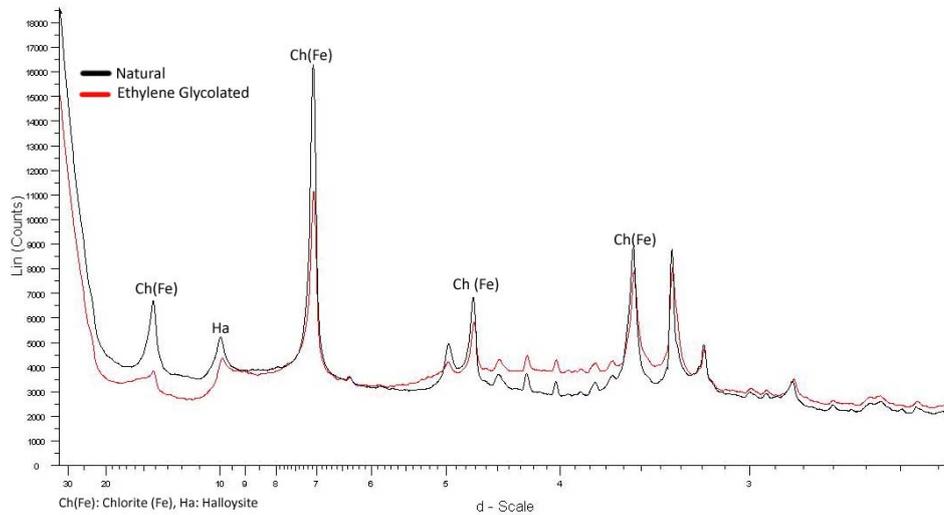
**Figure 4.71.** XRD trace of air dried and ethylene glycolated clay extraction from deteriorated sandstone Ch(Fe): Chlorite Ferric, Ha: Halloysite.

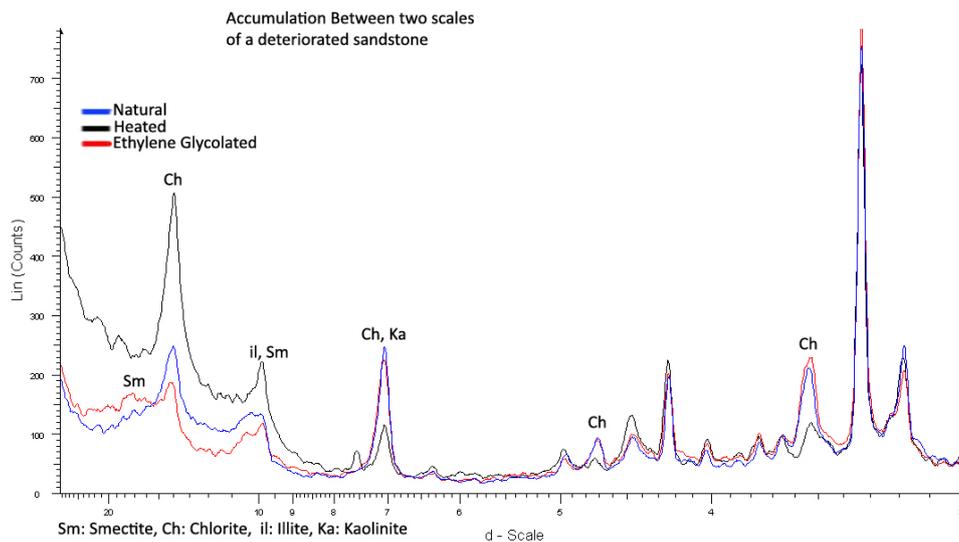
**Figure 4.72.** XRD trace of air dried, ethylene glycolated and heated accumulation between two scales of a naturally deteriorated sandstone sample, Sm: Smectite, Ch: Chlorite, Il: Illite; Ka: Kaolinite.

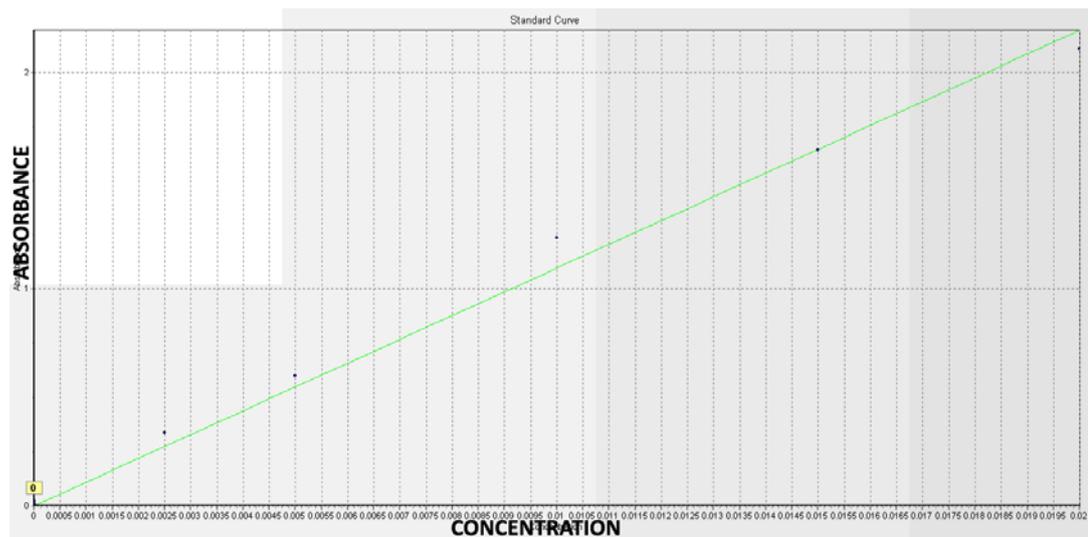
**Figure 4.73** Standard curve of methylene blue concentration versus absorption at 632 nm.

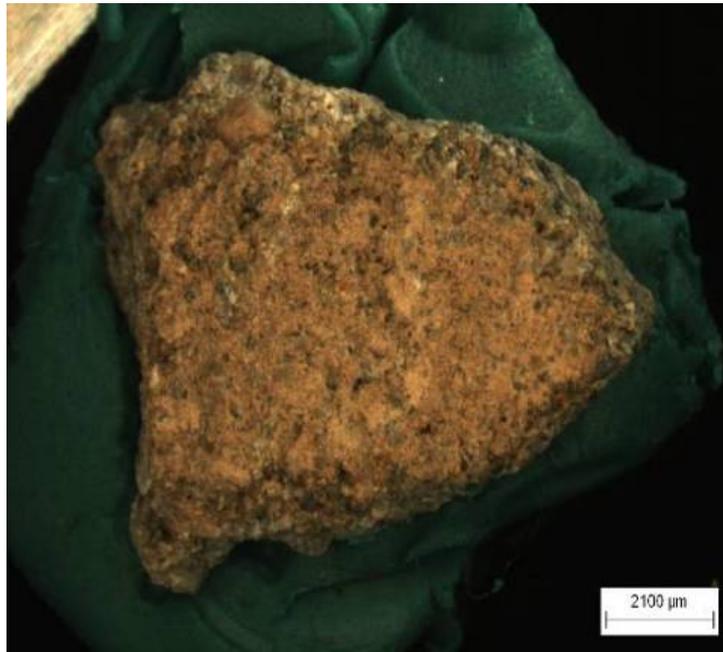
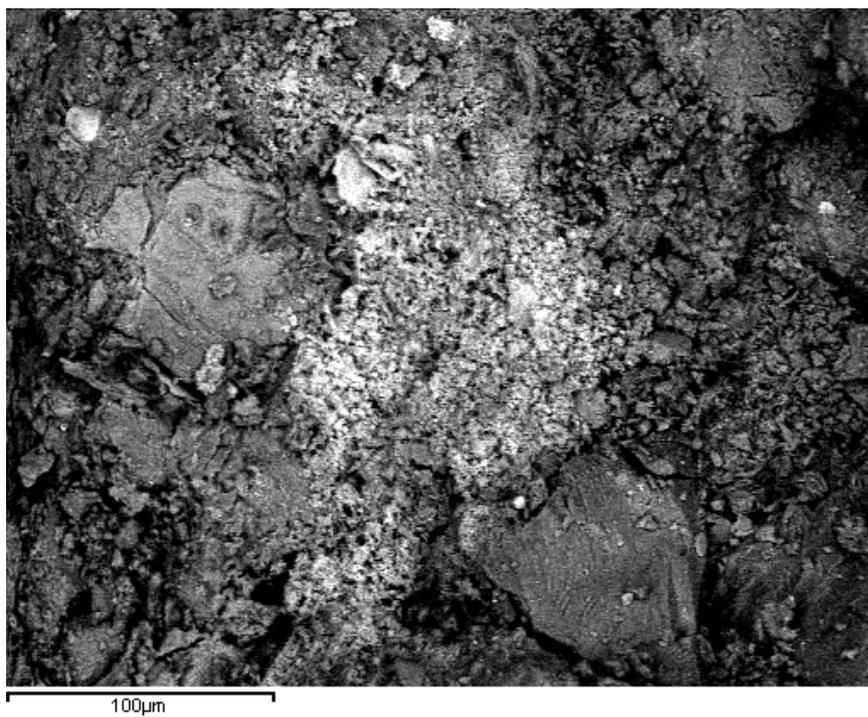
**Figure 4.74** Macro view of deteriorated sandstone sample (left), SEM image of interior face of deteriorated sandstone sample (right)

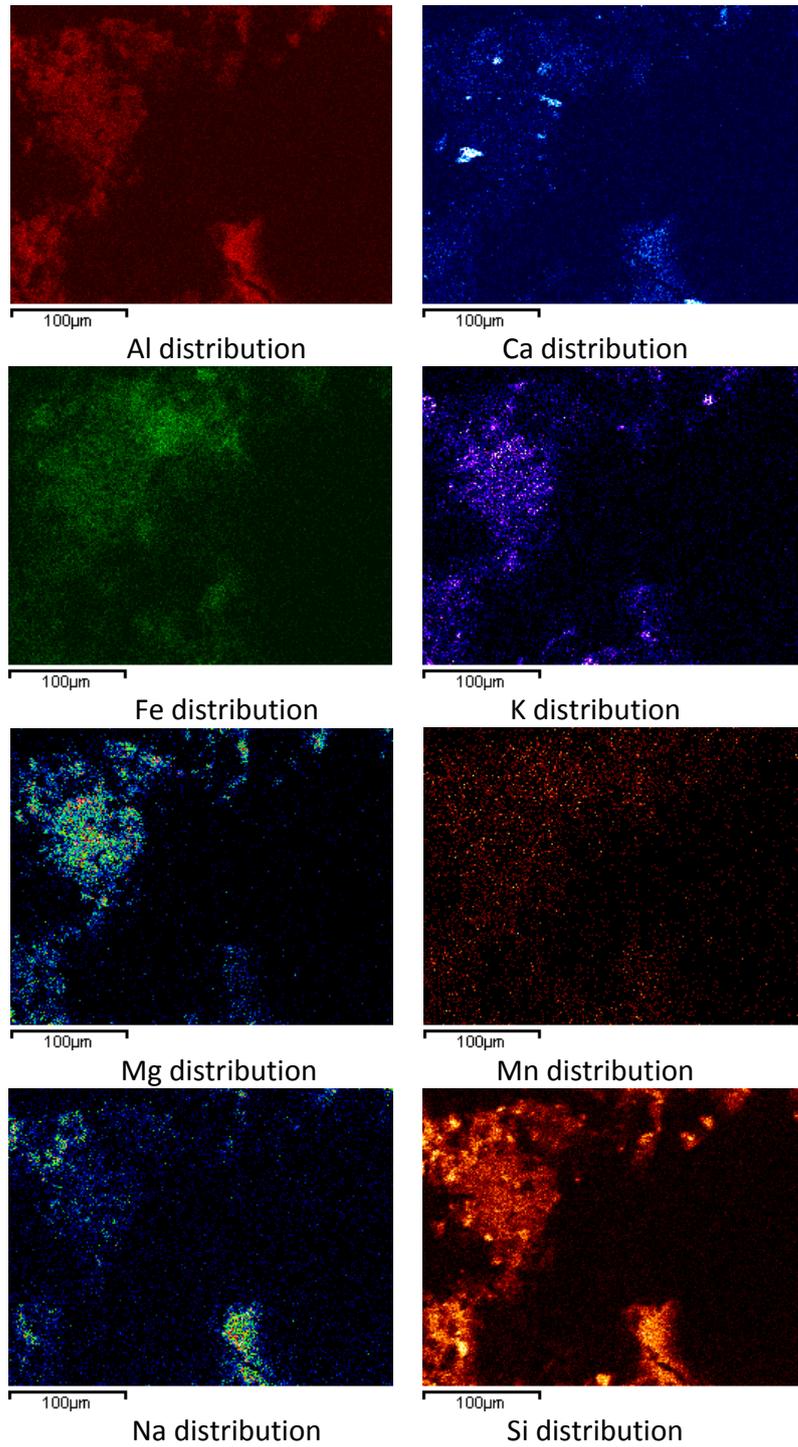
**Figure 4.75** Elemental (Ca, Al, K, Fe, Mn, Mg, Si, Na) mapping of surface of deteriorated sandstone sample.

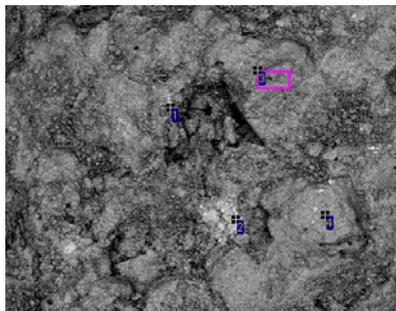
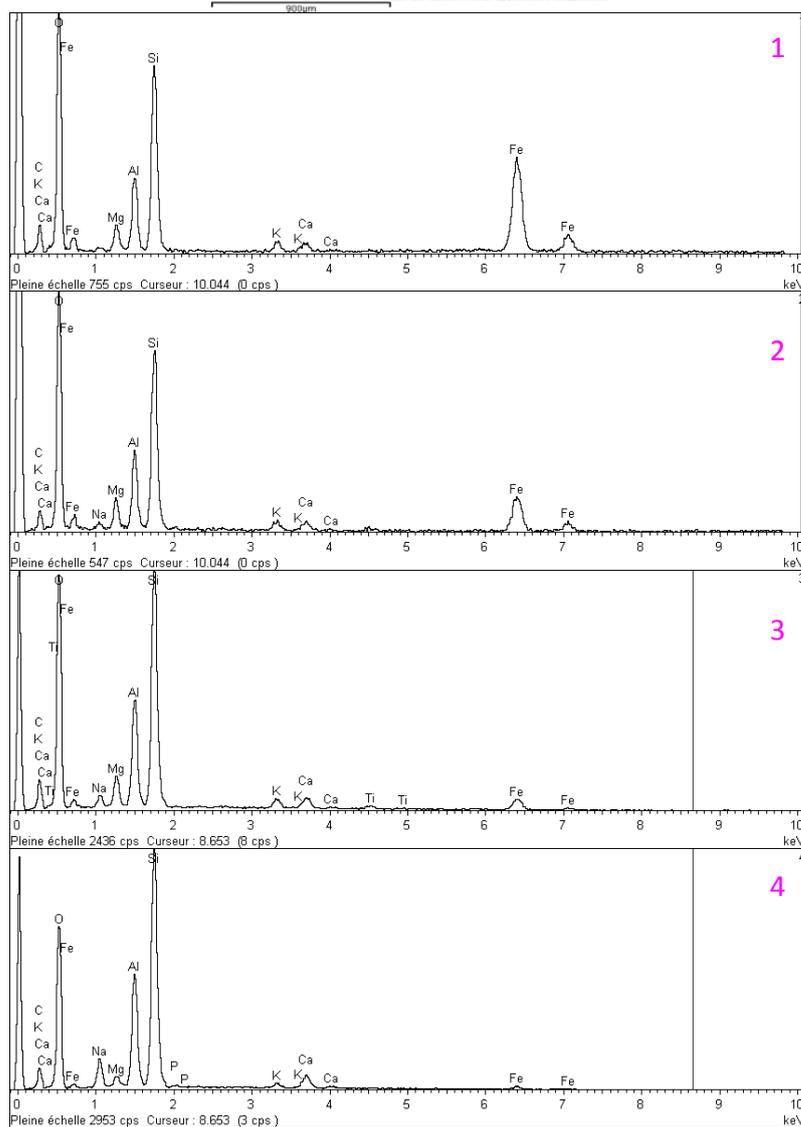
**Figure 4.76** SEM view from surface of deteriorated sandstone sample (on top) and EDX analyses from points (1, 2, 3,4) shown on the image.

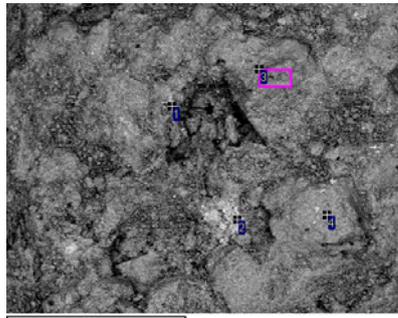
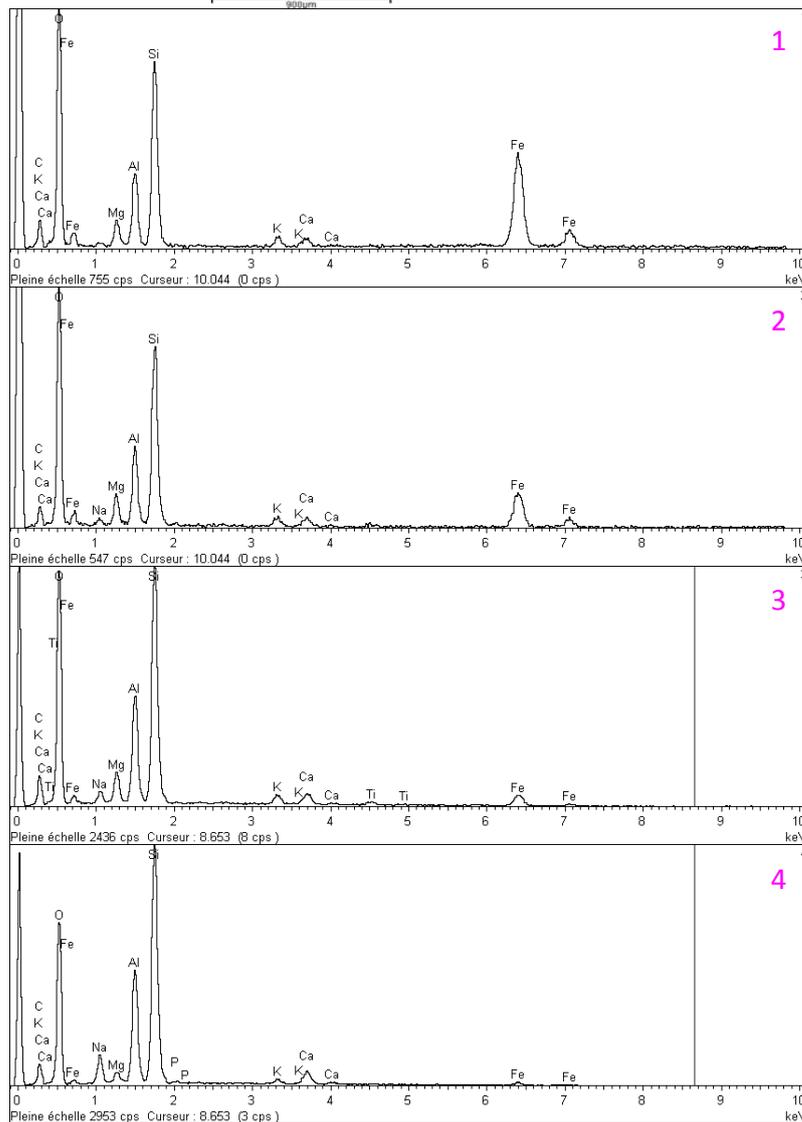
**Figure 4.77** SEM view from surface of deteriorated sandstone sample (on top) and EDX analyses from points (1, 2, 3,4) shown on the image.

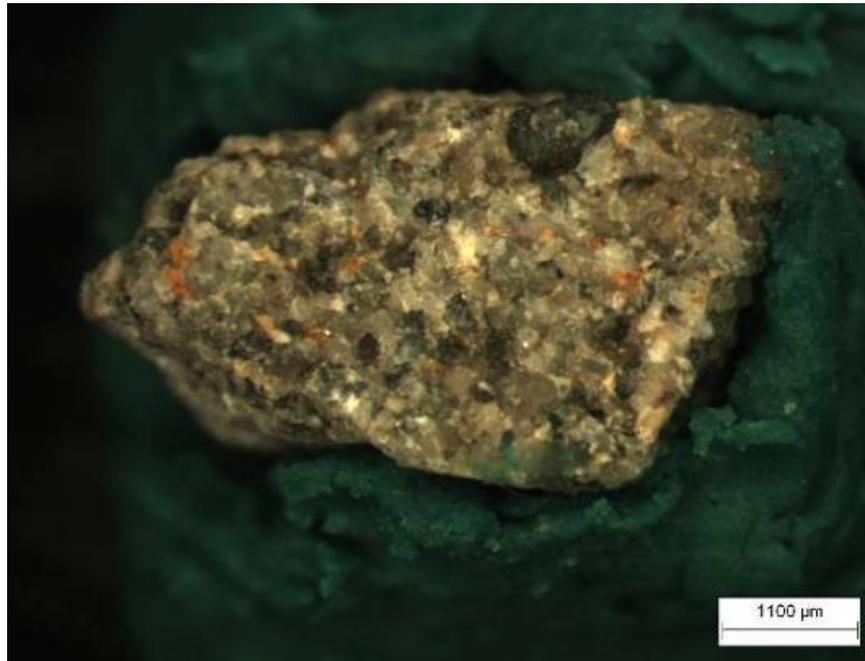
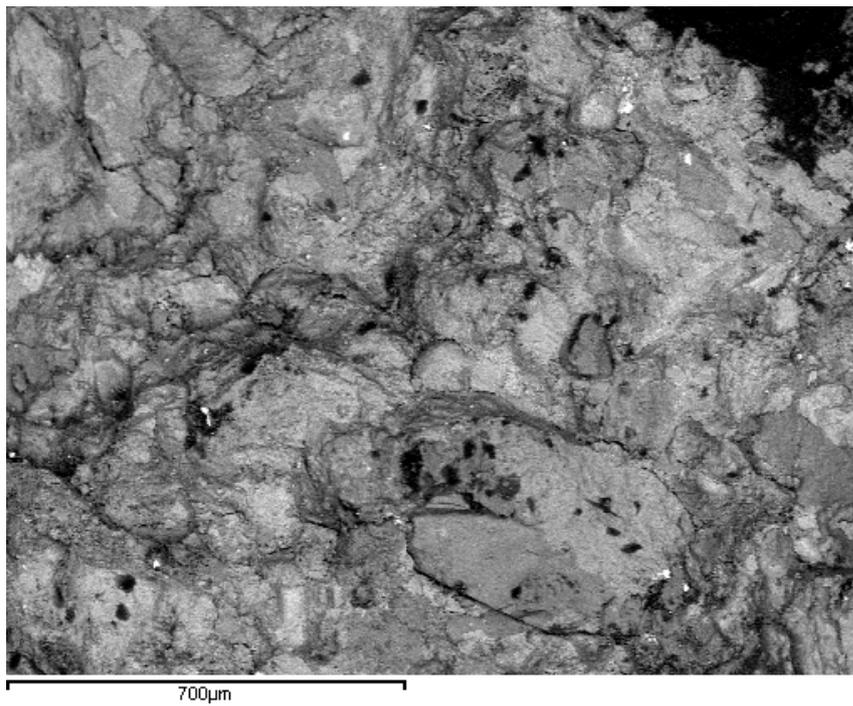
**Figure 4.78** Macro view of interior face of relatively nondeteriorated deteriorated sandstone sample (top), SEM image of interior face of deteriorated sandstone sample (bottom)

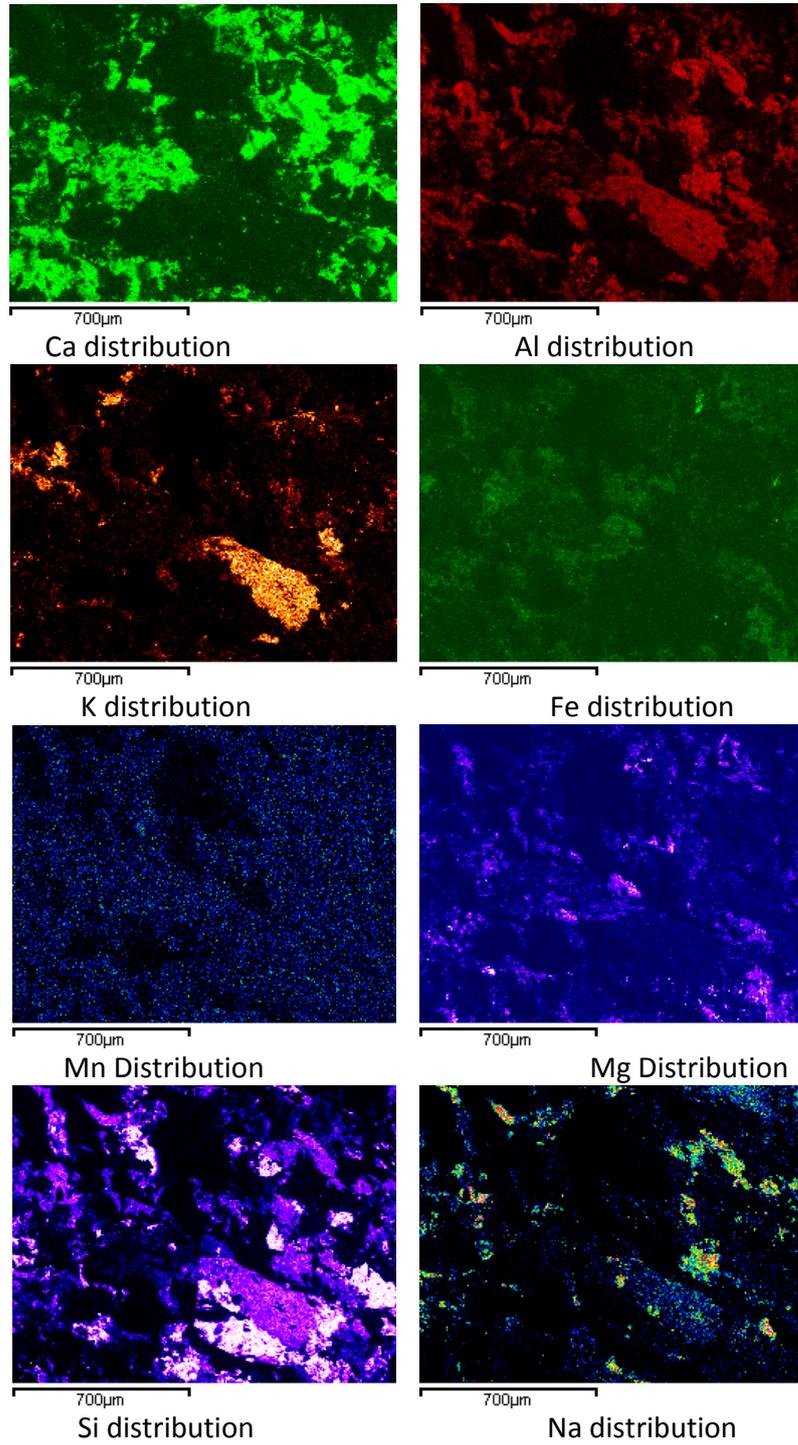
**Figure 4.79** Elemental (Ca, Al, K, Fe, Mn, Mg, Si, Na) mapping of interior face of deteriorated sandstone sample shown in Figure 4.77.

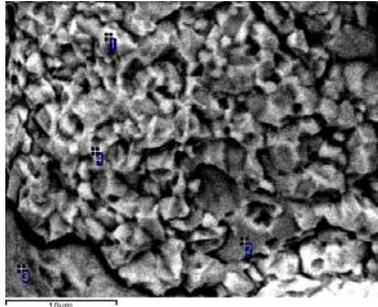
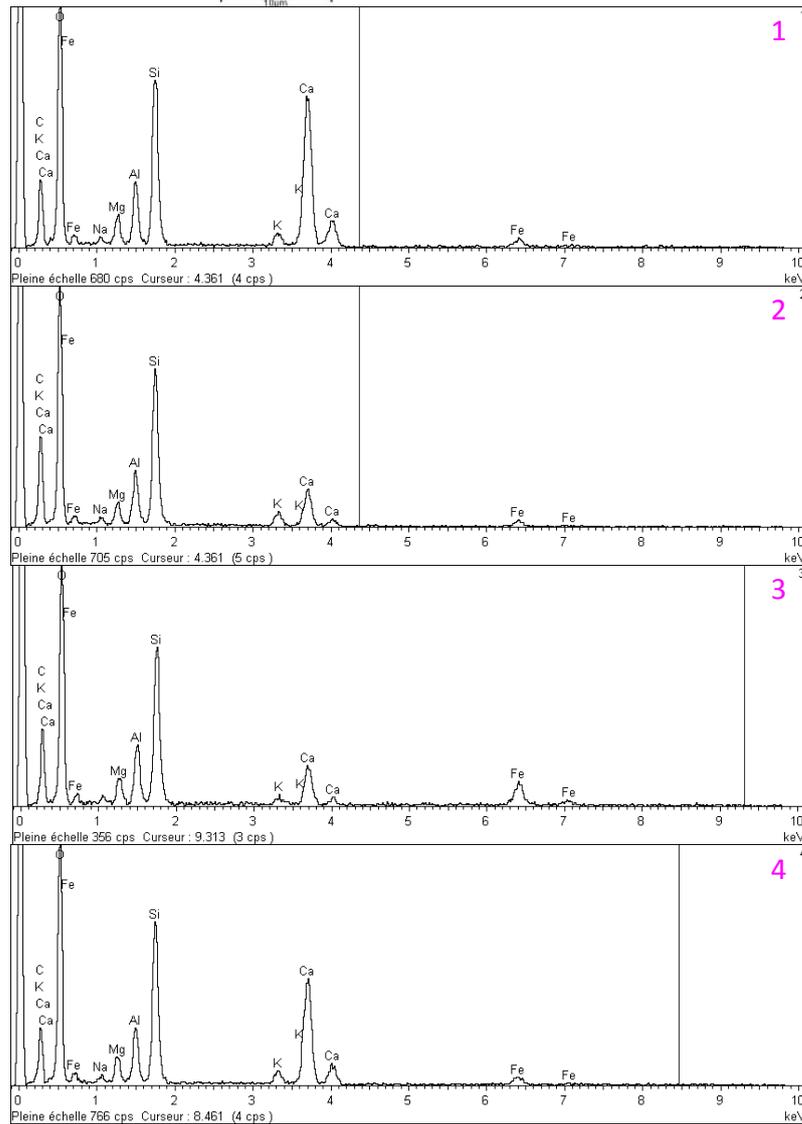
**Figure 4.80** SEM image of interior face of deteriorated sandstone piece (on top, and EDX analyses from points (1, 2, 3, 4) shown in image).

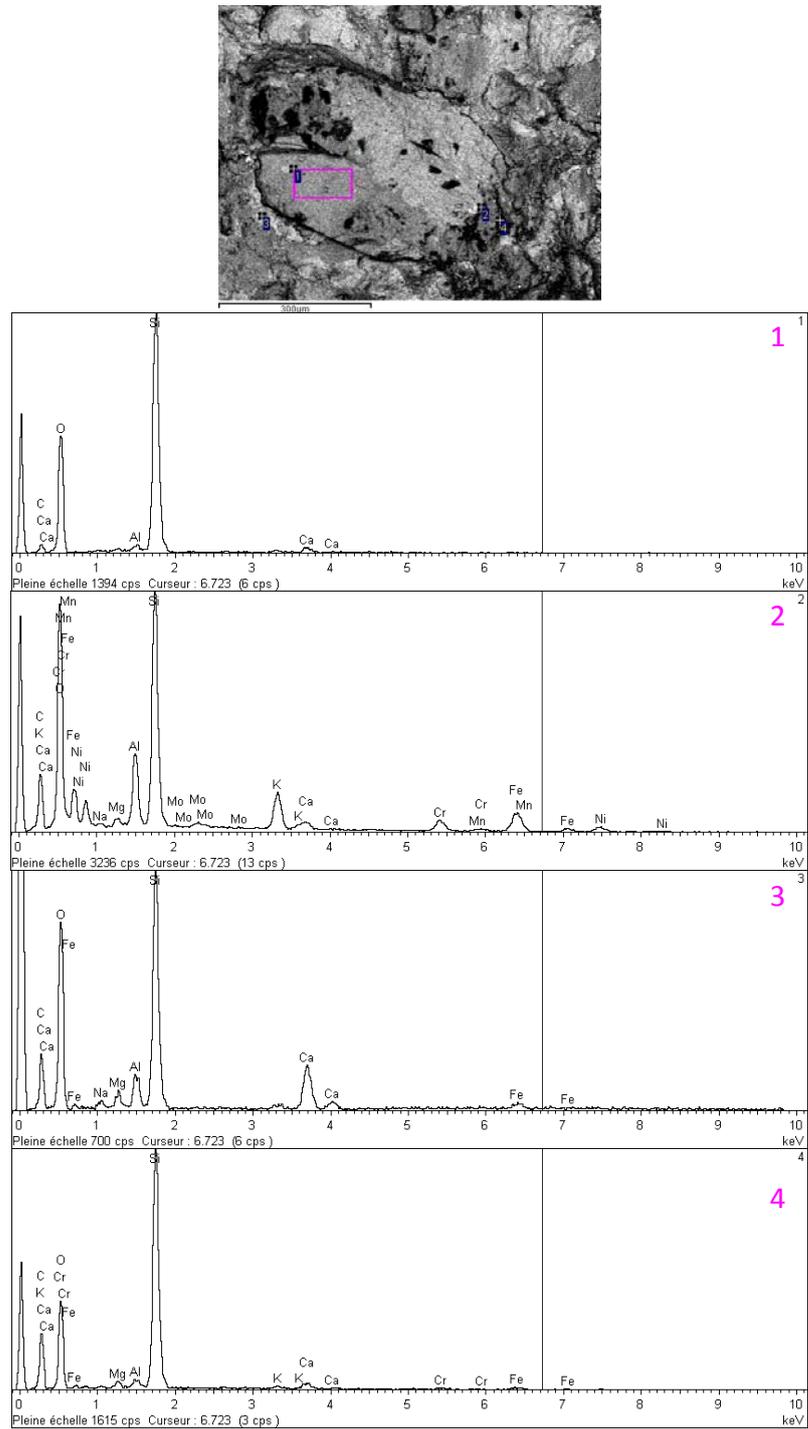
**Figure 4.81** SEM image of interior face of deteriorated sandstone piece on top, and EDX analyses from the points (1, 2, 3, 4) shown in image.

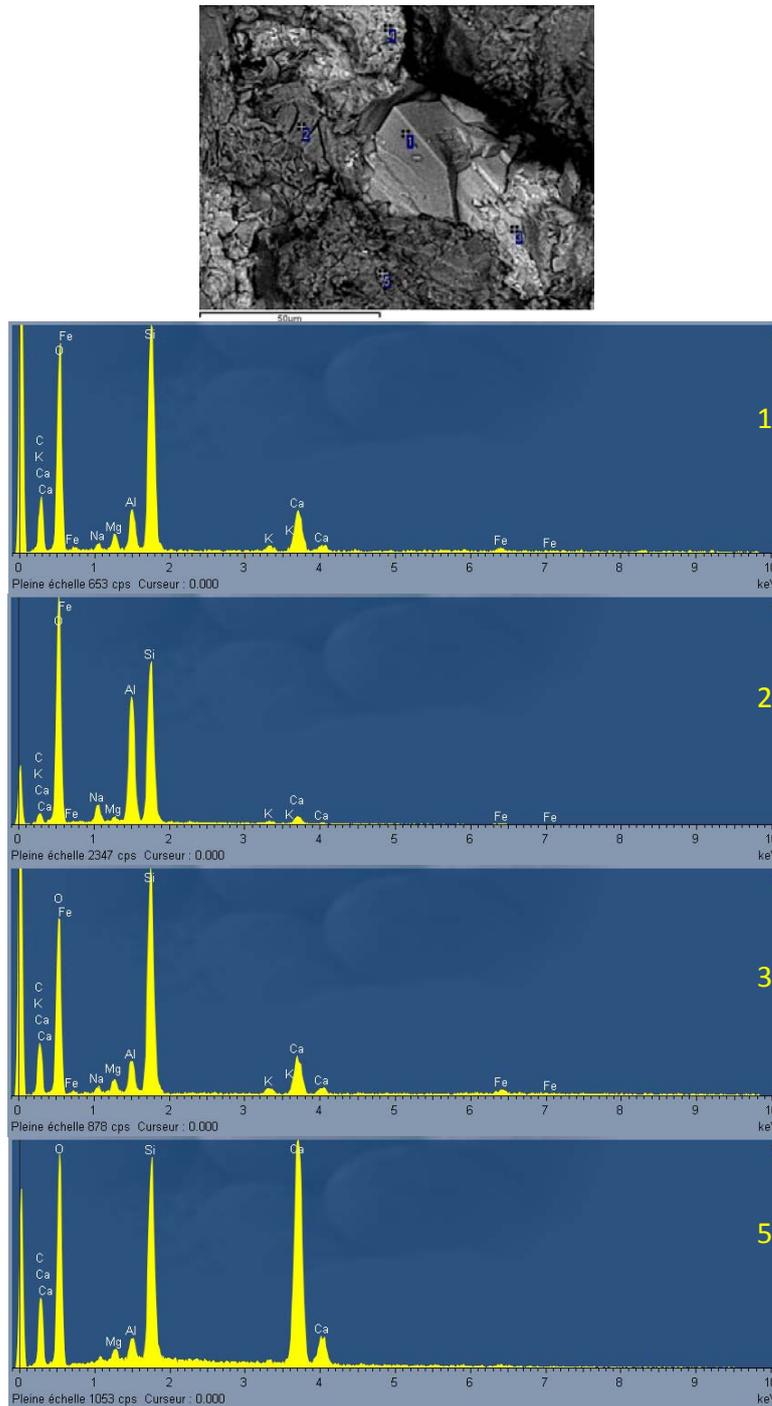
**Figure 4.82** SEM image of interior face of deteriorated sandstone piece on top, and EDX analyses from the points (1, 2, 3, 5) shown in image.
